Structural Assessment

Muscle Shoals Reservation
adaptive re-use study

Conditions/Market/Planning/Implementation

July 31, 2009
Revised August 25, 2009

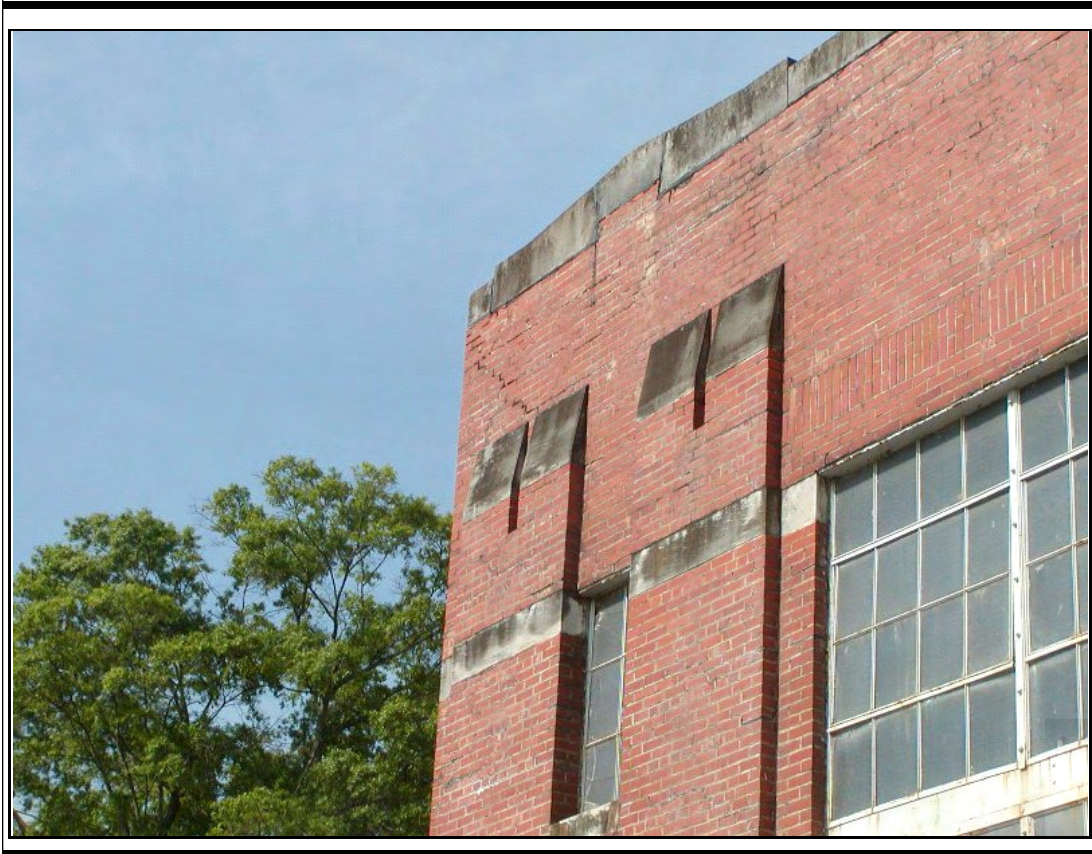
<p>Photograph #: 10</p> <p>Cracks in masonry at south end of east wall</p>

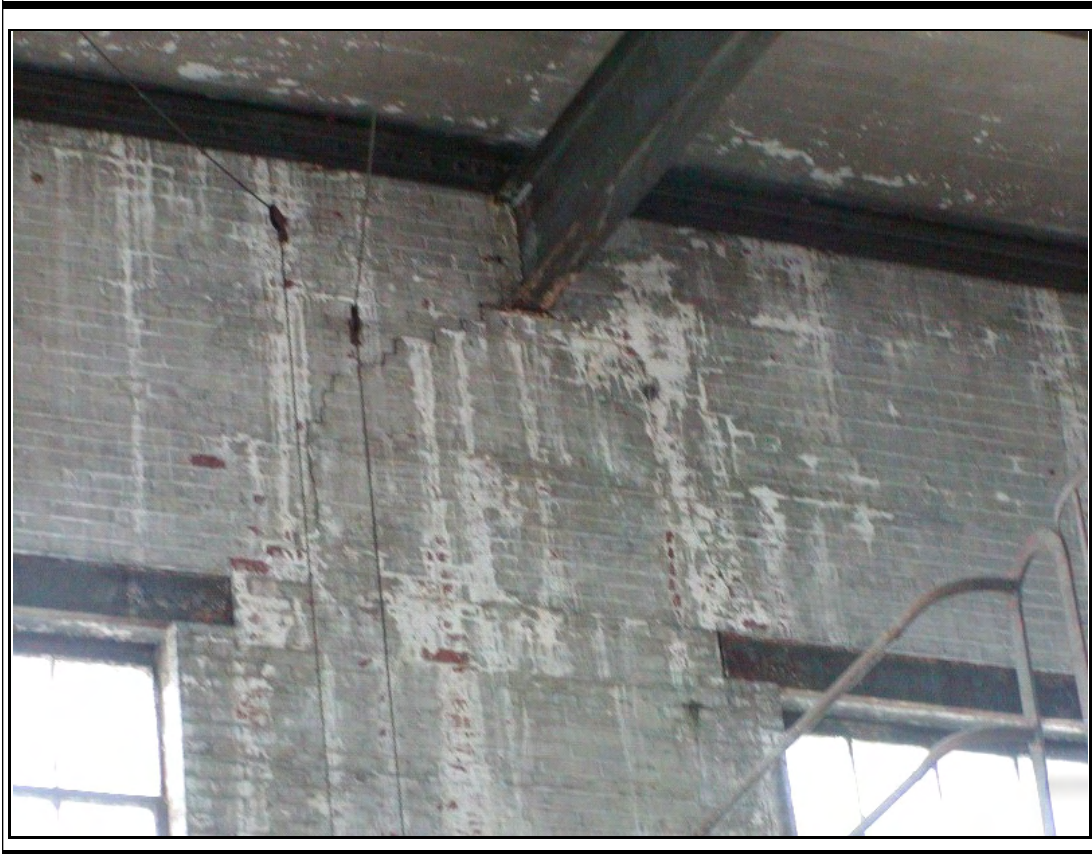
<p>Photograph #: 18</p> <p>Cracked and deteriorated masonry at south wall</p>

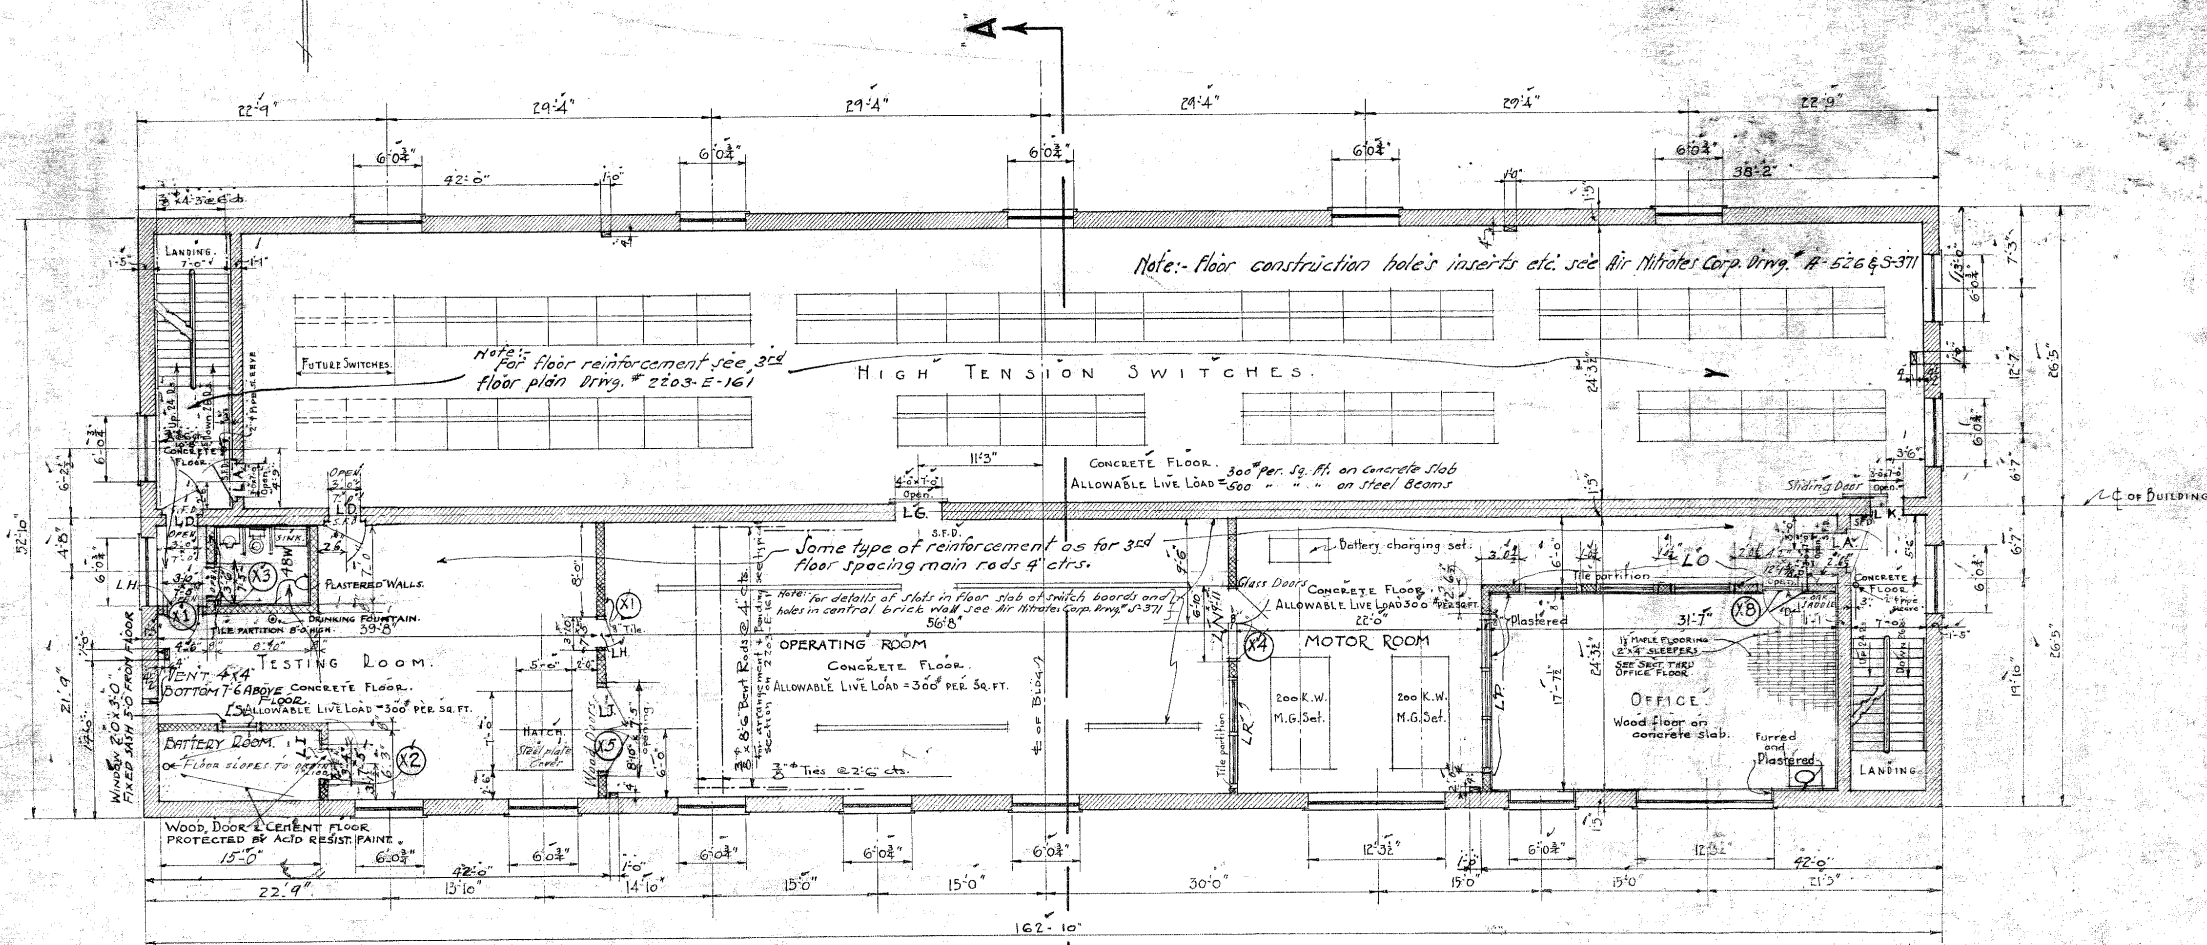
SECOND FLOOR PLAN.
Scale 1/8" = 1'-0"

MILD CORROSION AT STEEL BEAMS
BELOW THIRD FLOOR TYPICAL THIS
LEVEL (NO PHOTOS TAKEN)

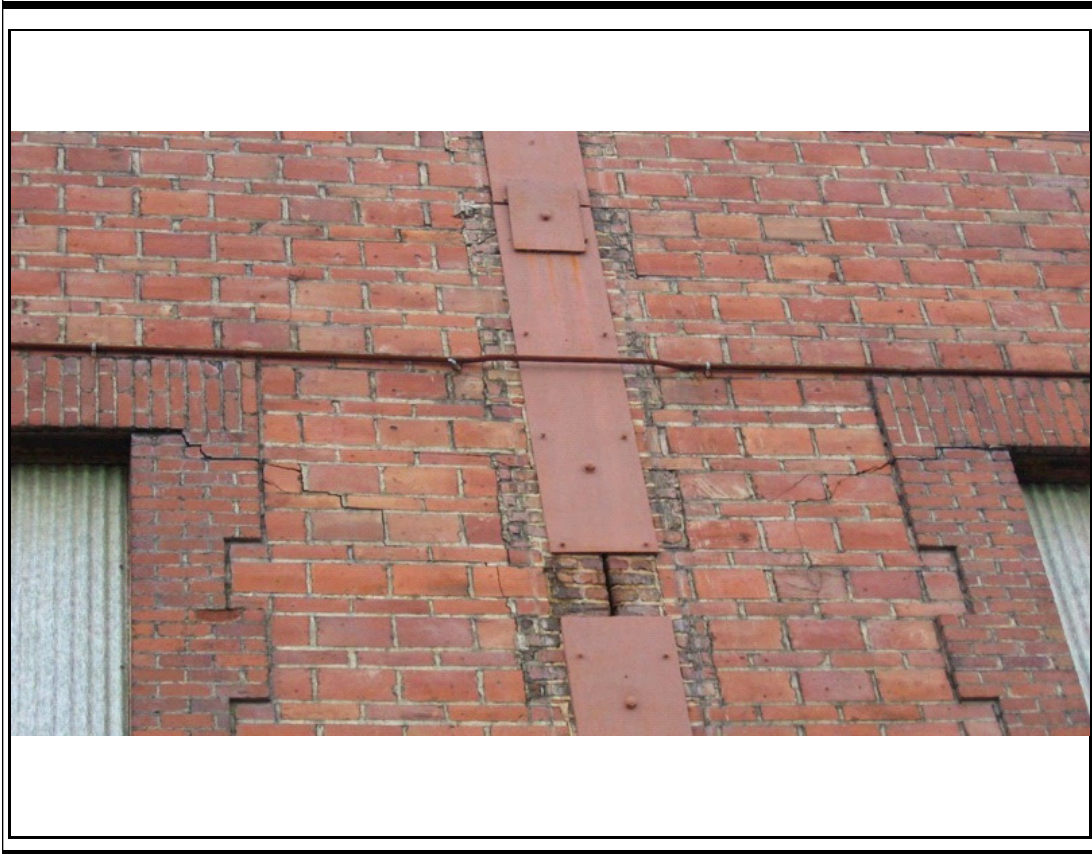
<p>Photograph #: 4</p> <p>Cracks in masonry at east wall</p>

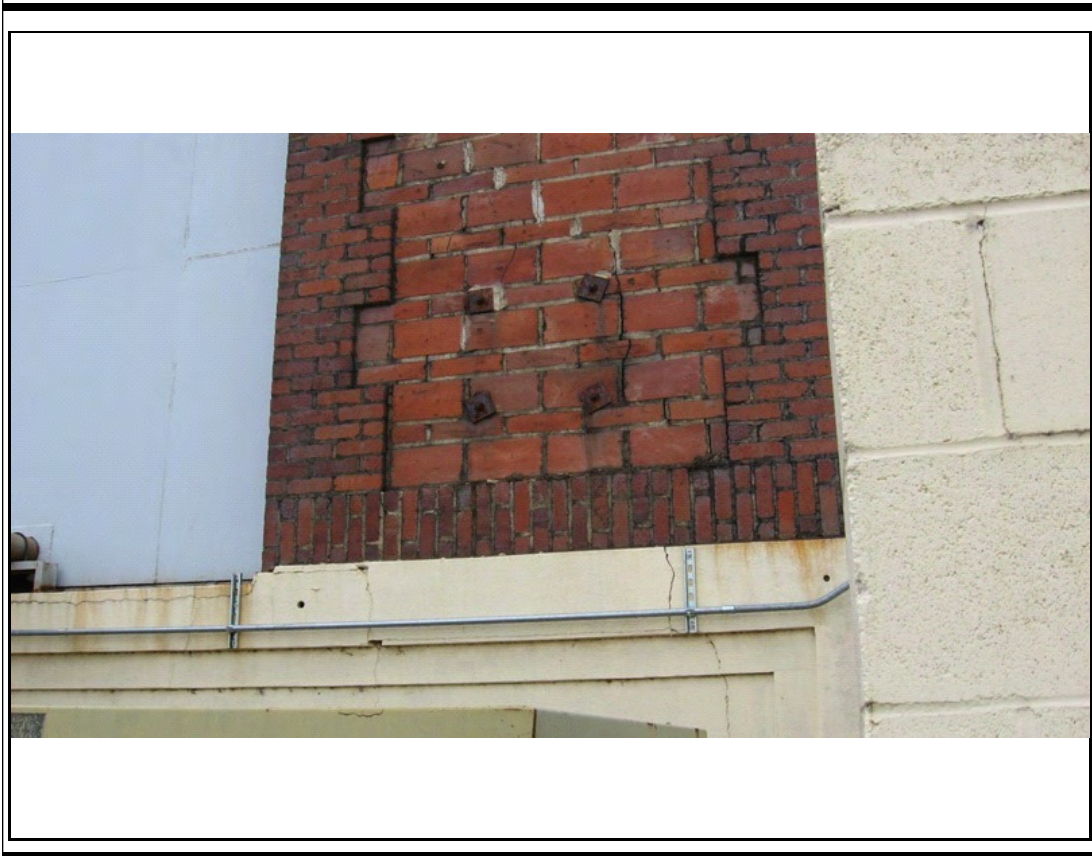
<p>Photograph #: 6</p> <p>Deteriorated masonry at roof line at north wall</p>

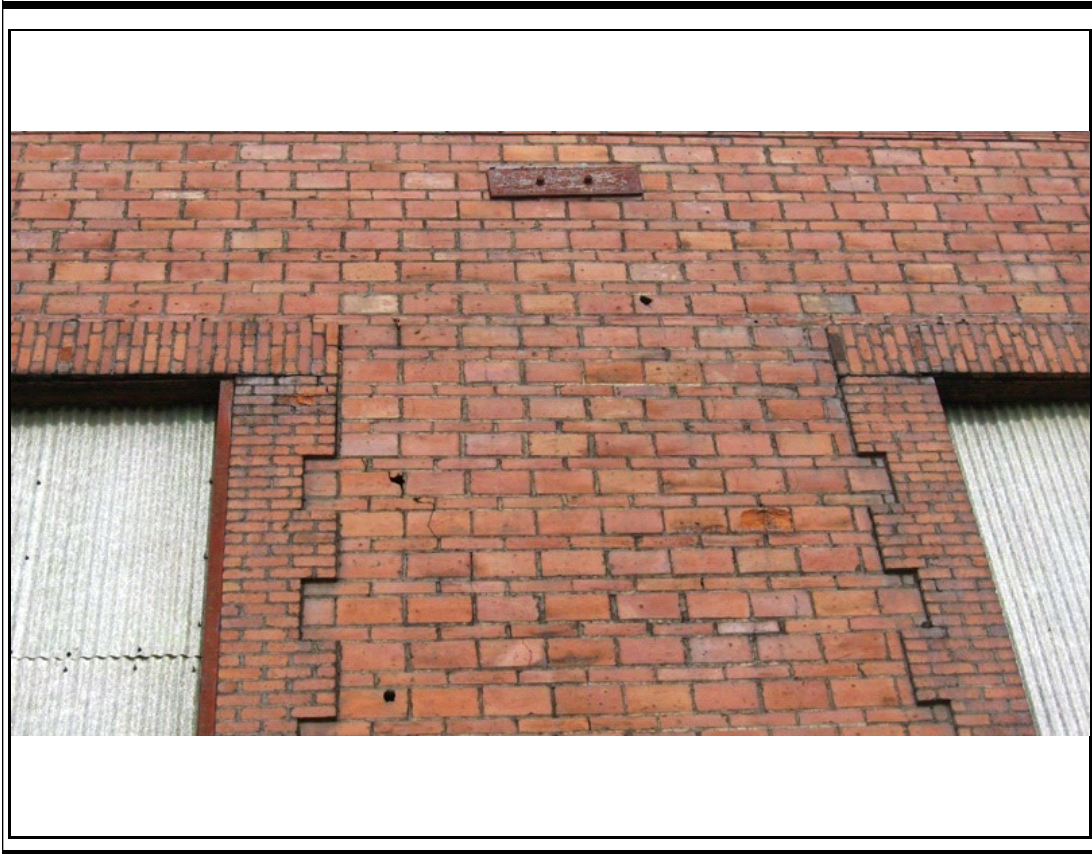
<p>Photograph #: 8</p> <p>Deteriorated plaster veneer at west wall</p>

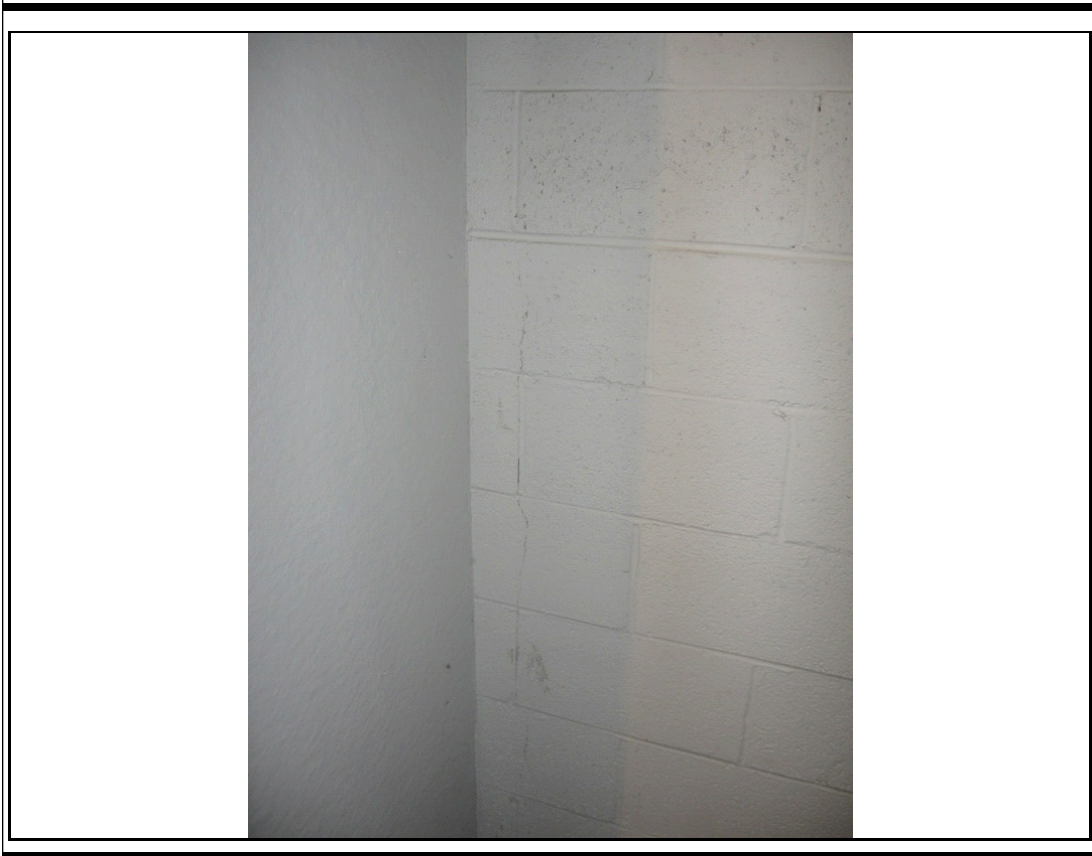
A close-up photograph of a vertical crack in a concrete masonry wall. The crack is located in the joint between two courses of blocks.	<p>Photograph #: 12</p> <p>ERC Building - minor crack in interior concrete masonry wall</p>

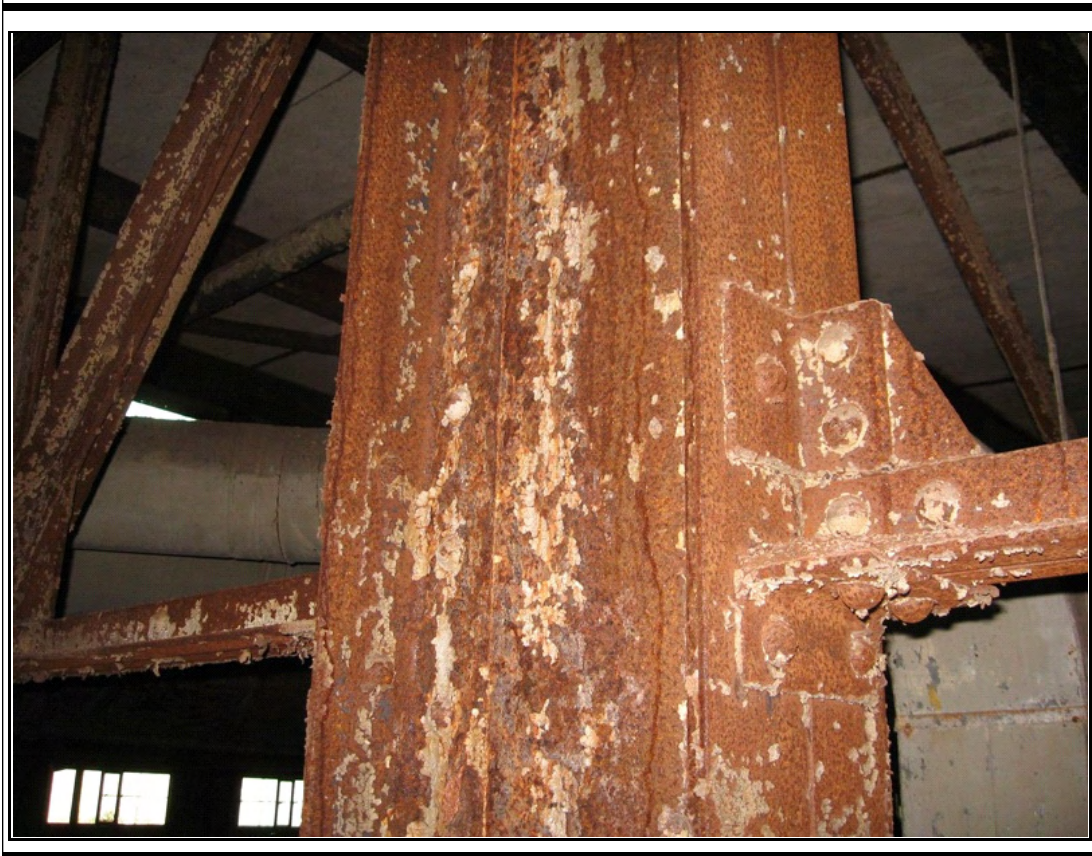
<p>Photograph #: 14</p> <p>Severely corroded structural steel</p>

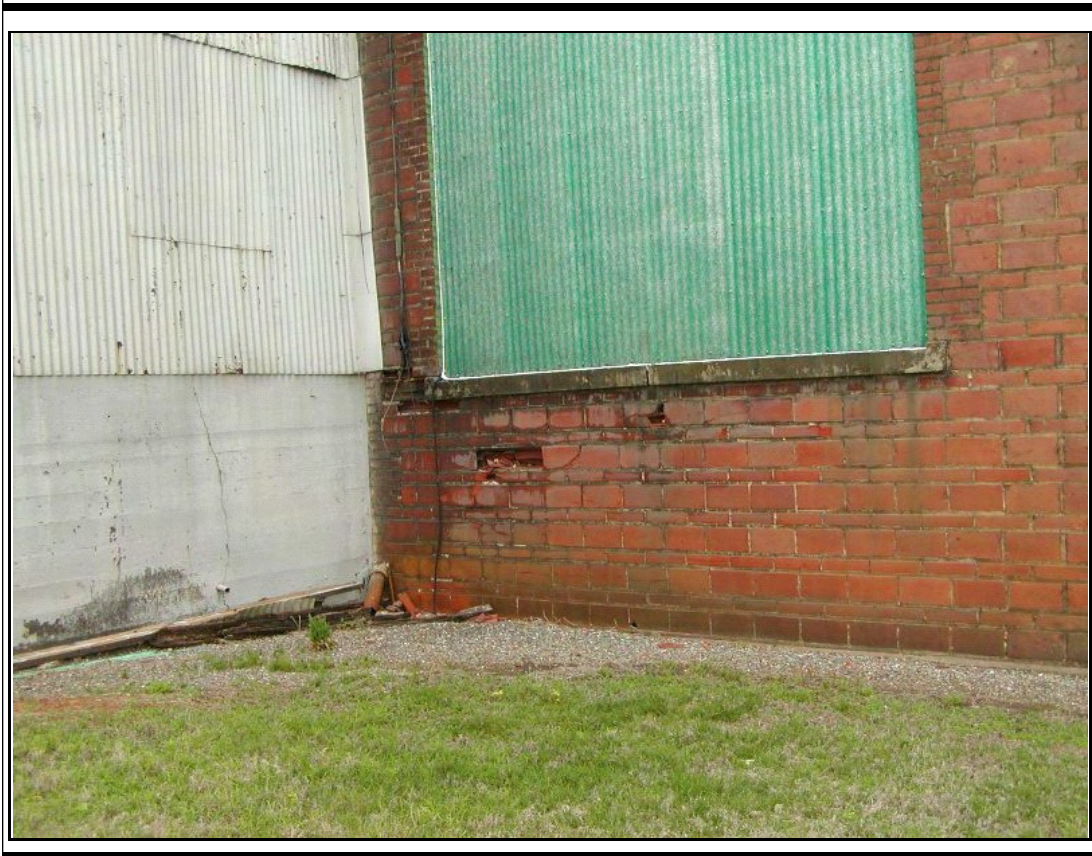
<p>Photograph #: 4</p> <p>Spalled masonry on west side at intersection with Building 24</p>

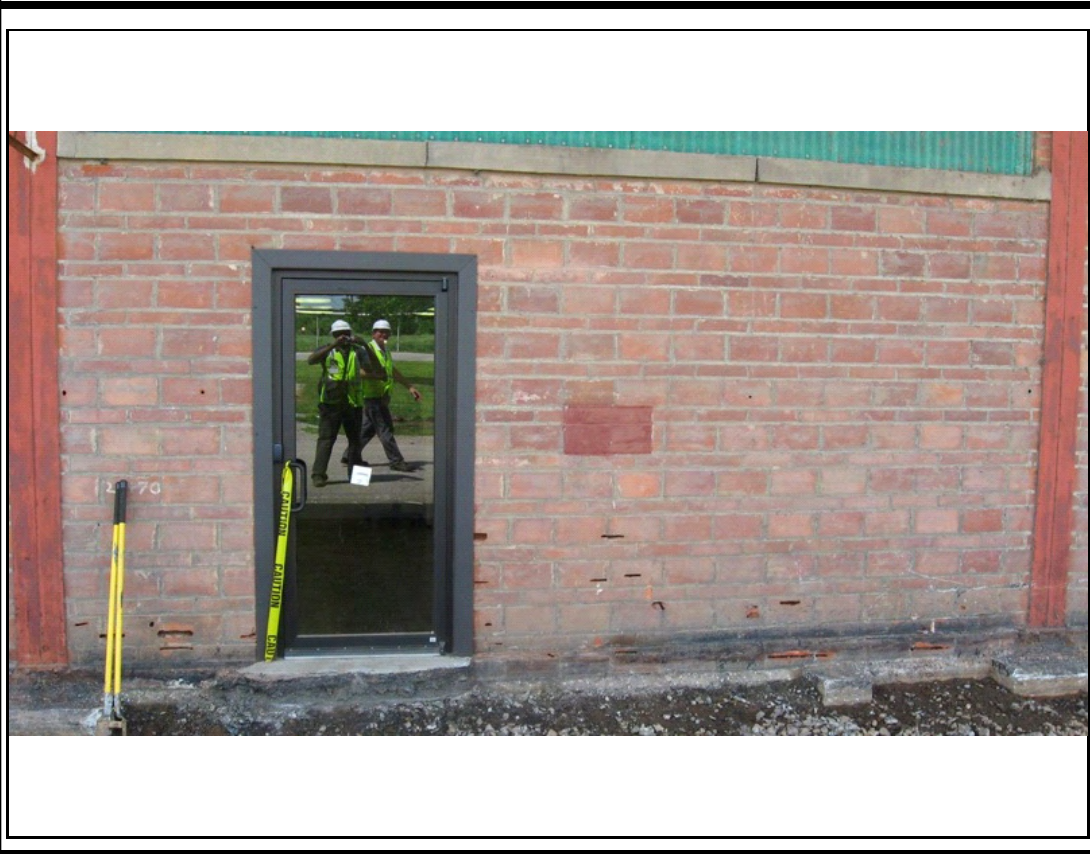
A photograph of a brick wall with a doorway. Two workers in safety vests and hard hats are visible through the doorway. The brickwork around the doorway shows signs of wear, including voids and spalls. A yellow caution tape is visible on the left side of the doorway.	<p>Photograph #: 10</p> <p>Voids and spalls in exterior masonry at north wall.</p>

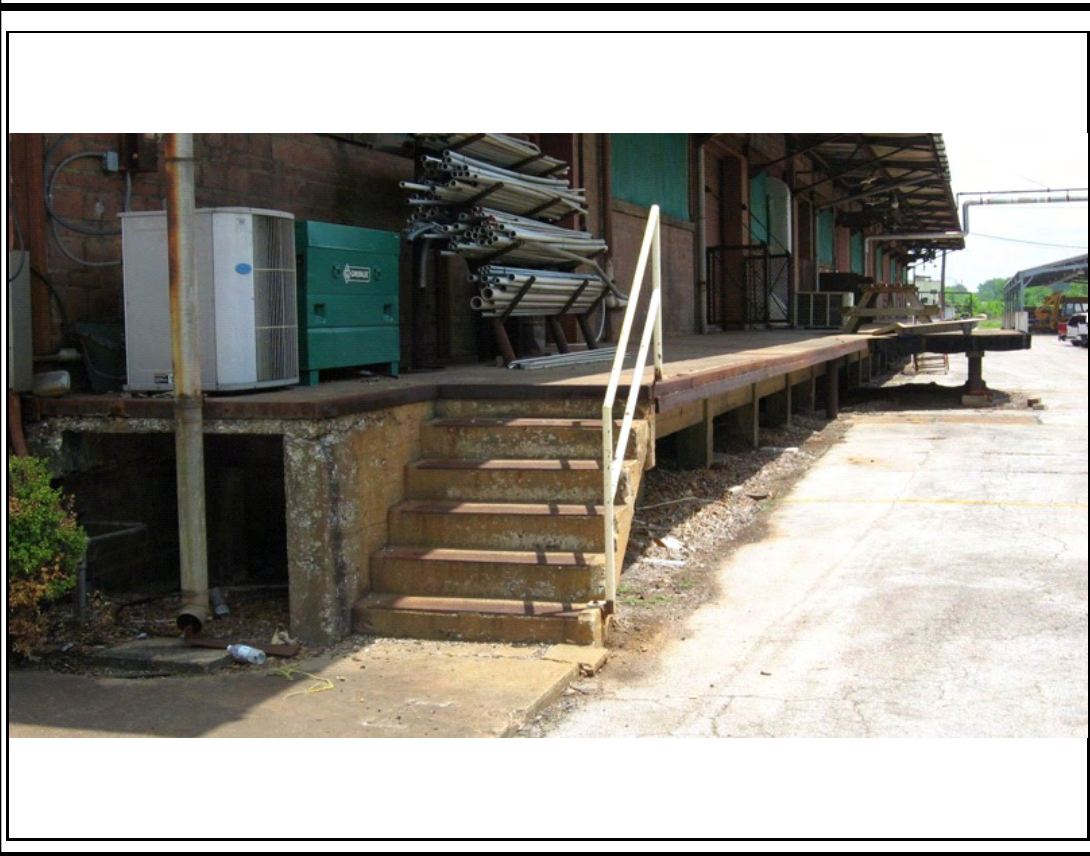
A photograph showing a set of concrete stairs leading up to a loading dock. The stairs are made of concrete and have a white metal handrail. The concrete appears aged and somewhat deteriorated. The loading dock is supported by a concrete wall. In the background, there is a brick building with a green door and some electrical equipment.	<p>Photograph #: 24</p> <p>Deteriorated concrete steps and support at west and south loading dock.</p>

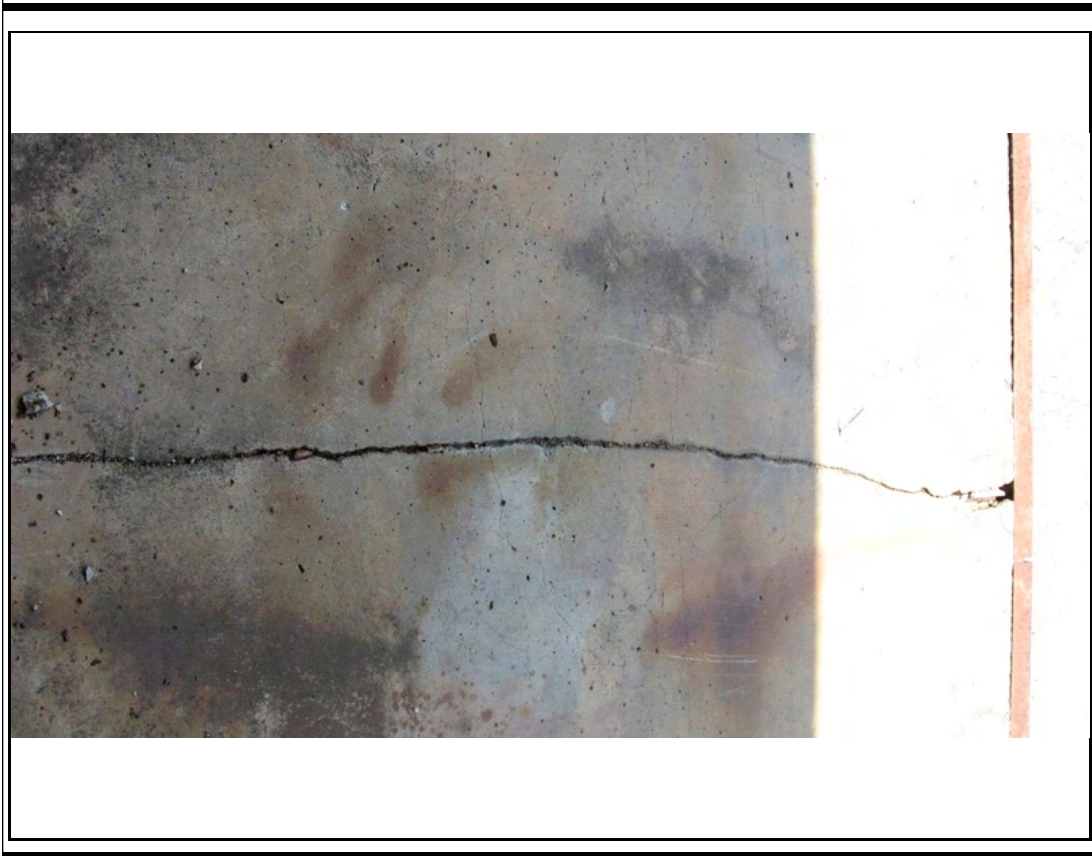
<p>Photograph #: 26</p> <p>Crack in south loading dock slab.</p>

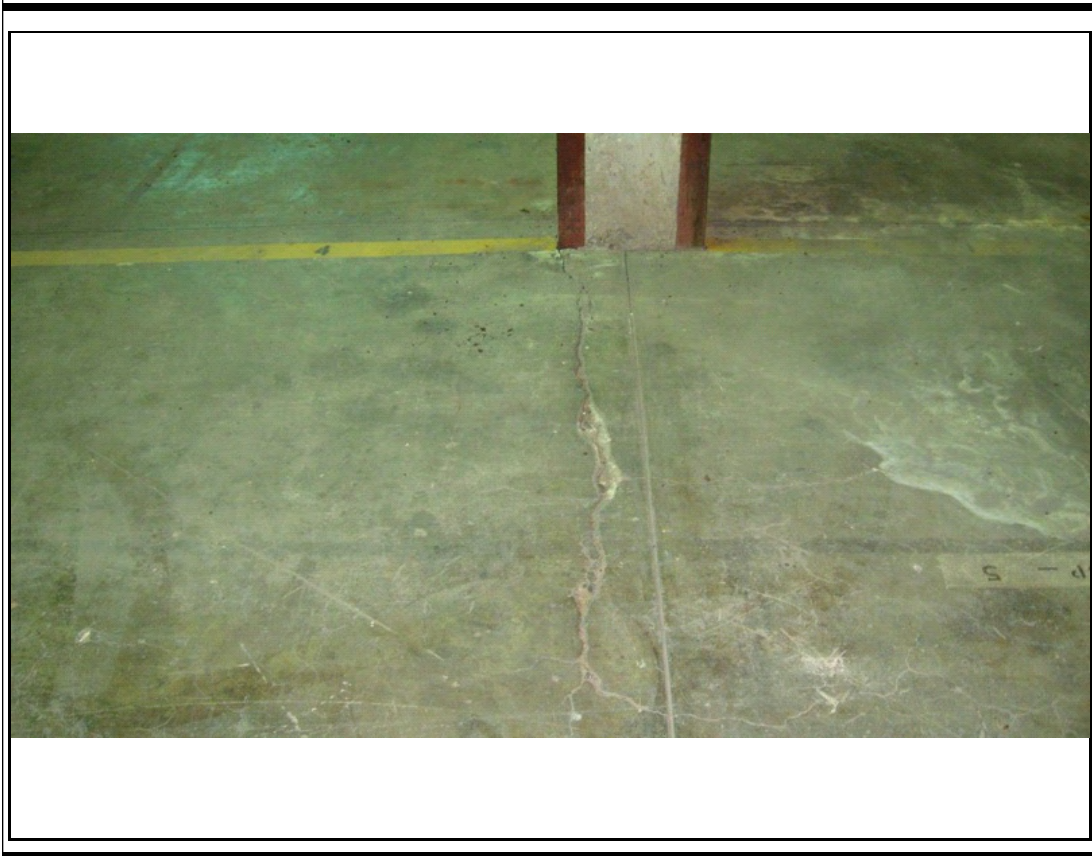
<p>Photograph #: 34</p> <p>Crack in west area of second floor slab.</p>

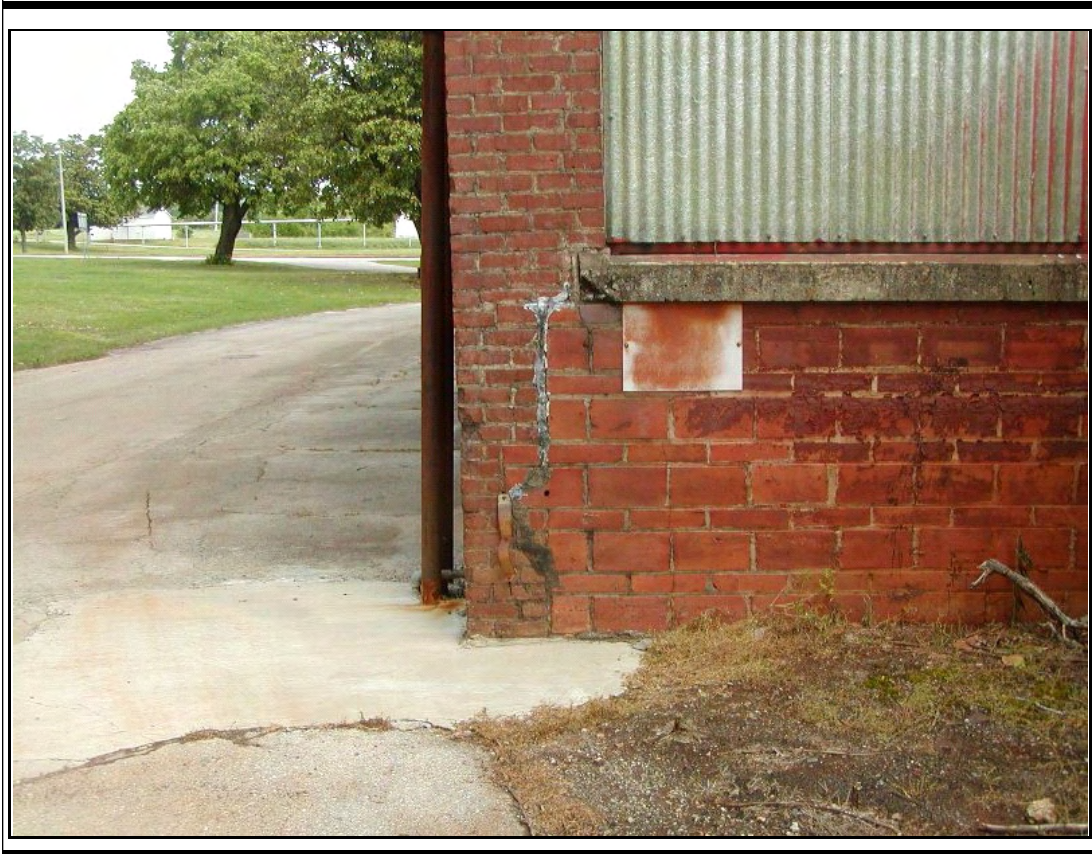
<p>Photograph #: 6</p> <p>Crack in masonry at southwest corner</p>

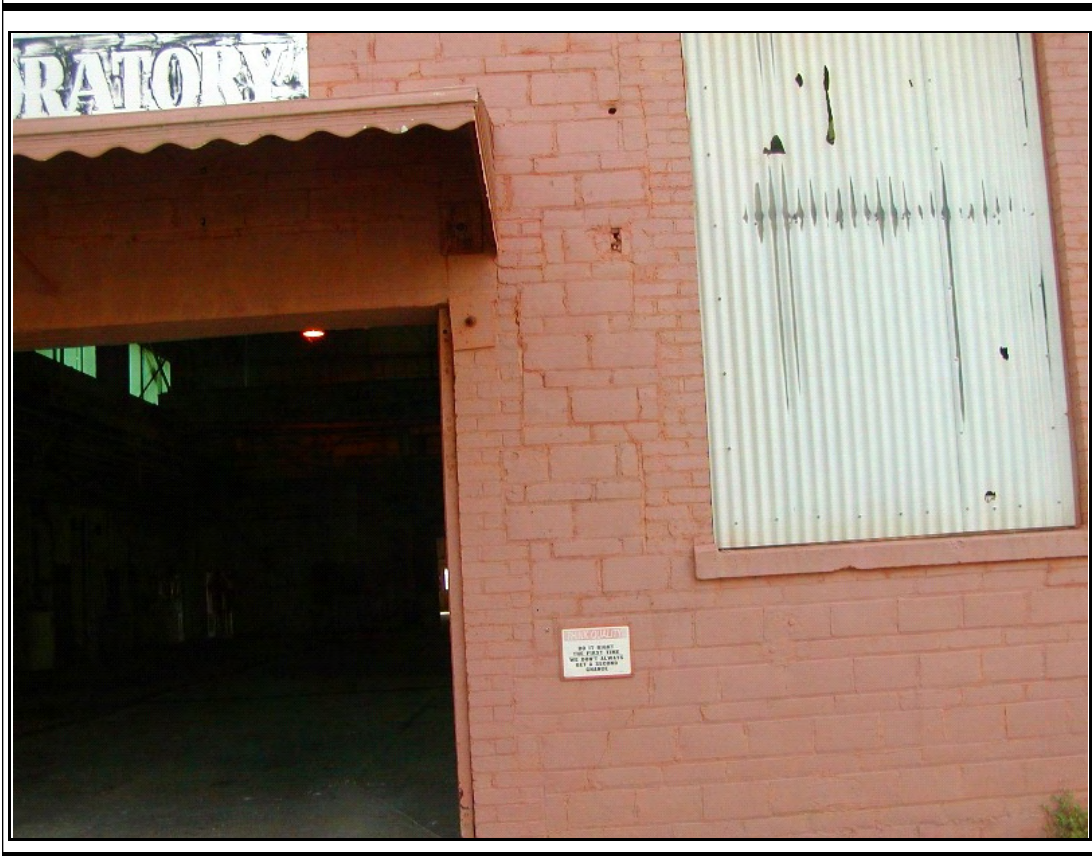
<p>Photograph #: 6</p> <p>Crack in wall by door opening west end</p>

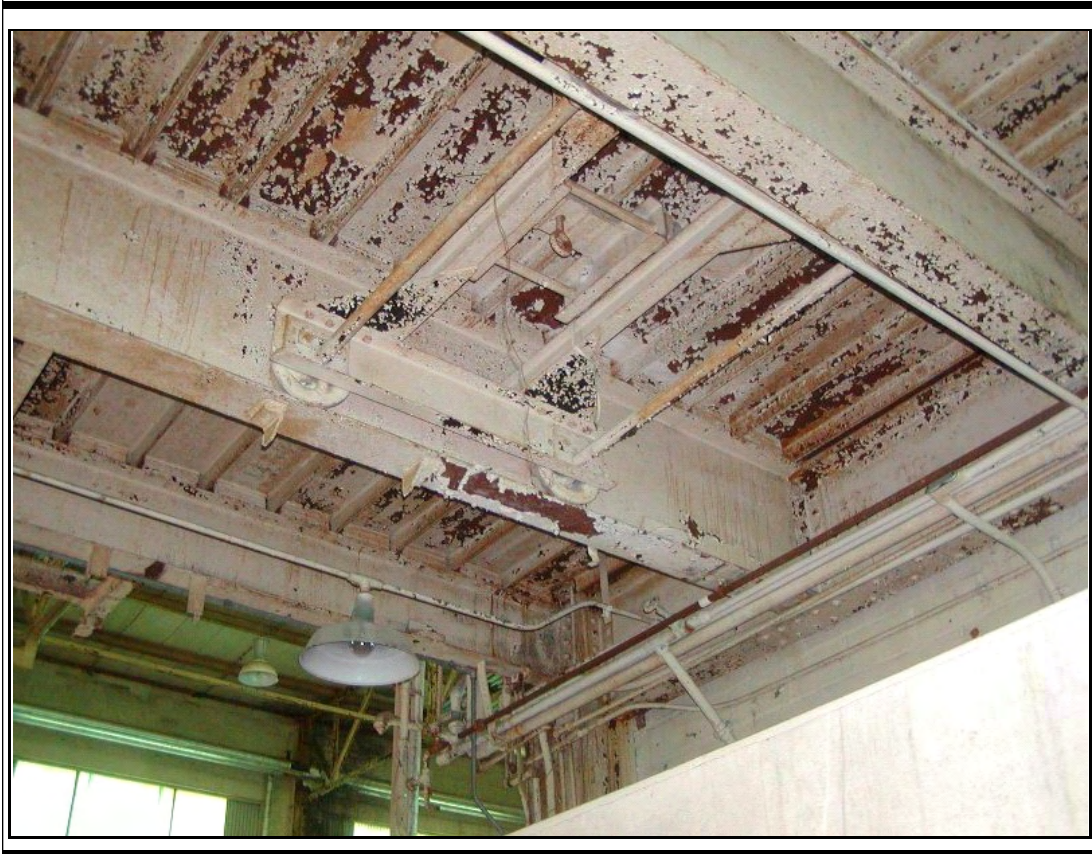
<p>Photograph #: 12</p> <p>Corroded steel below second floor at southwest corner</p>

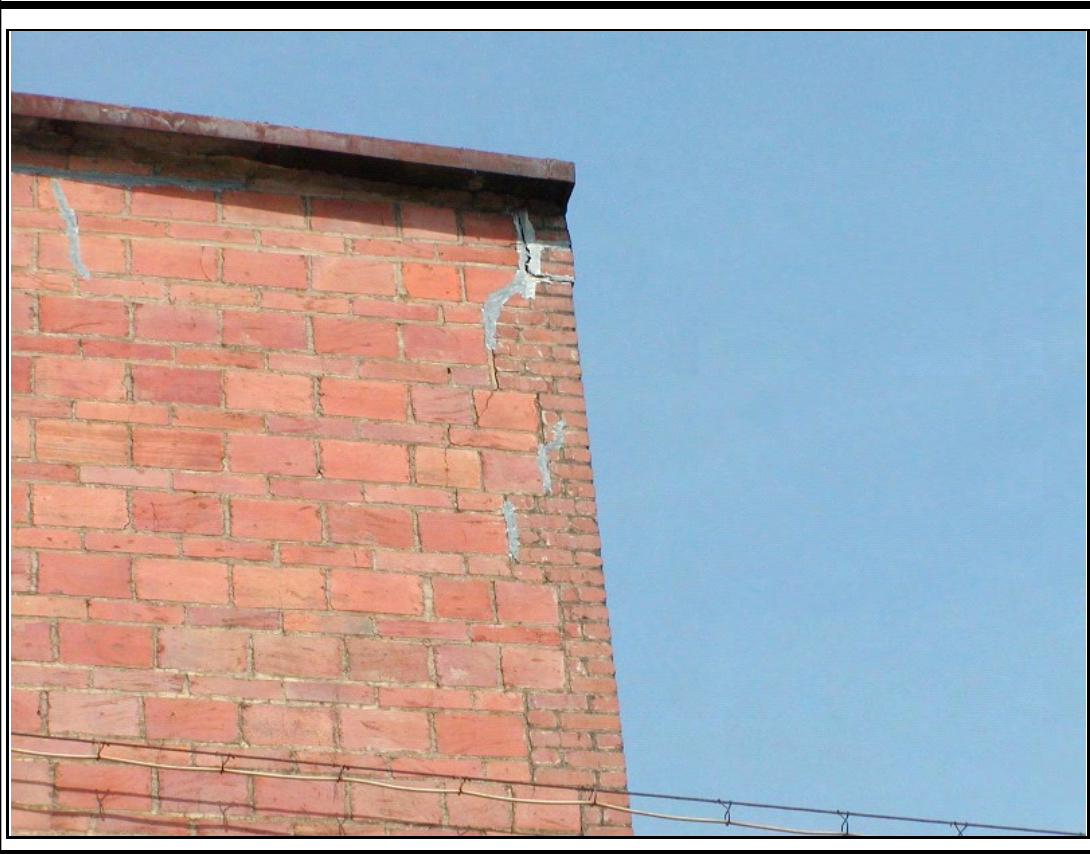
<p>Photograph #: 6</p> <p>Cracks in masonry at northeast corner</p>

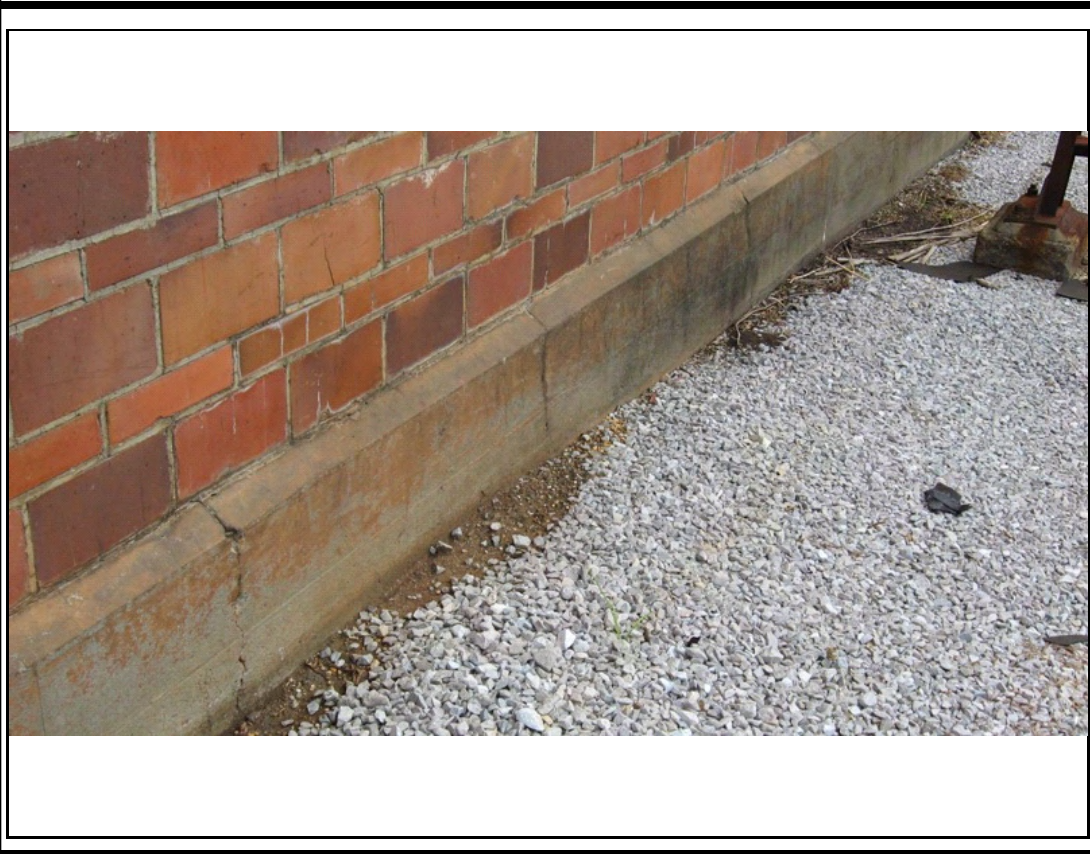
A photograph showing the base of a brick wall where it meets a concrete foundation. The foundation is made of concrete and is surrounded by a layer of white gravel. There are visible vertical cracks in the concrete foundation wall.	<p>Photograph #: 4</p> <p>Cracks in foundation stem wall south side.</p>

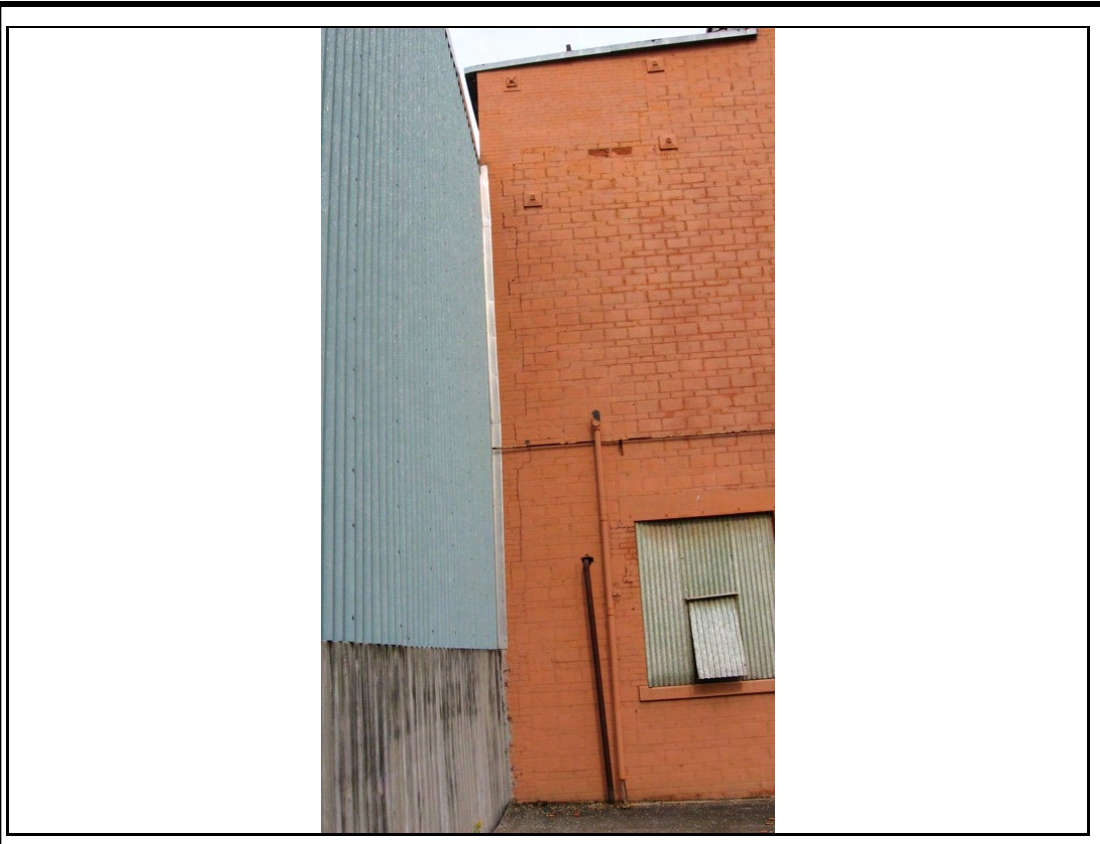
<p>Photograph #: 1</p> <p>Masonry crack in west wall at intersection with Building 46</p>

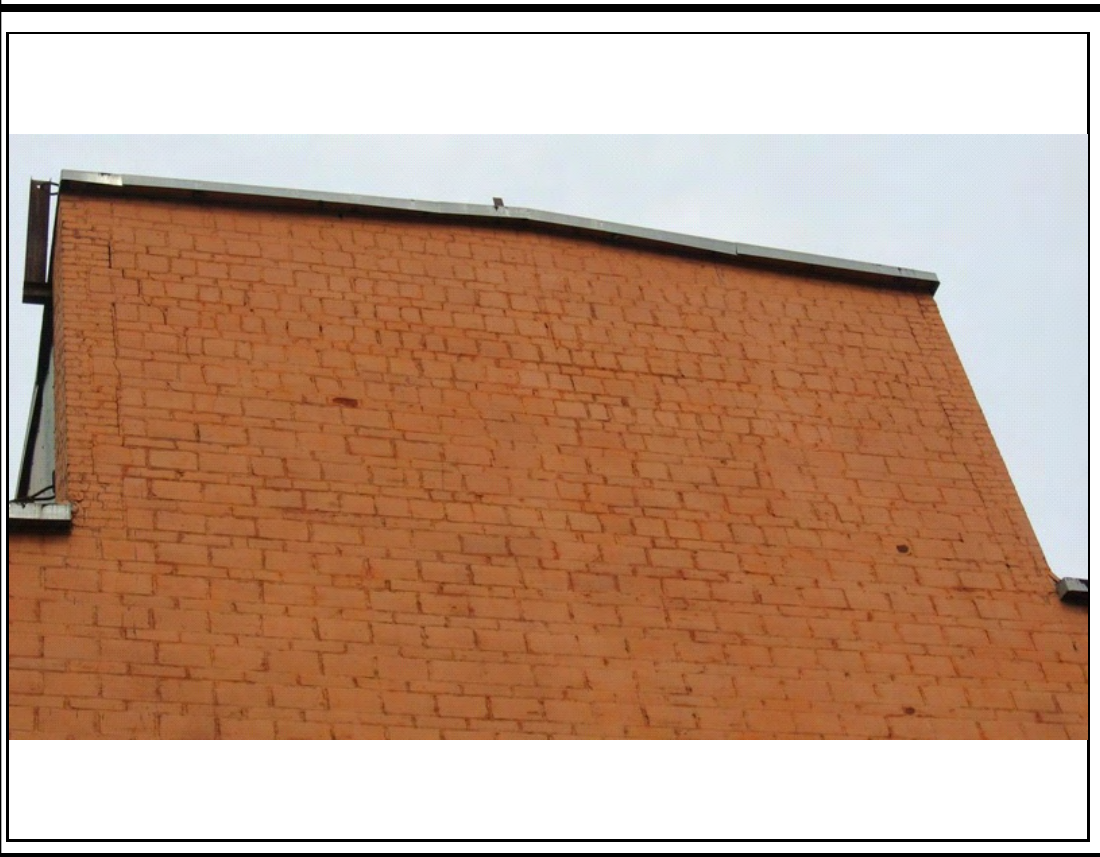
<p>Photograph #: 2</p> <p>Crack in masonry at west end of north monitor.</p>

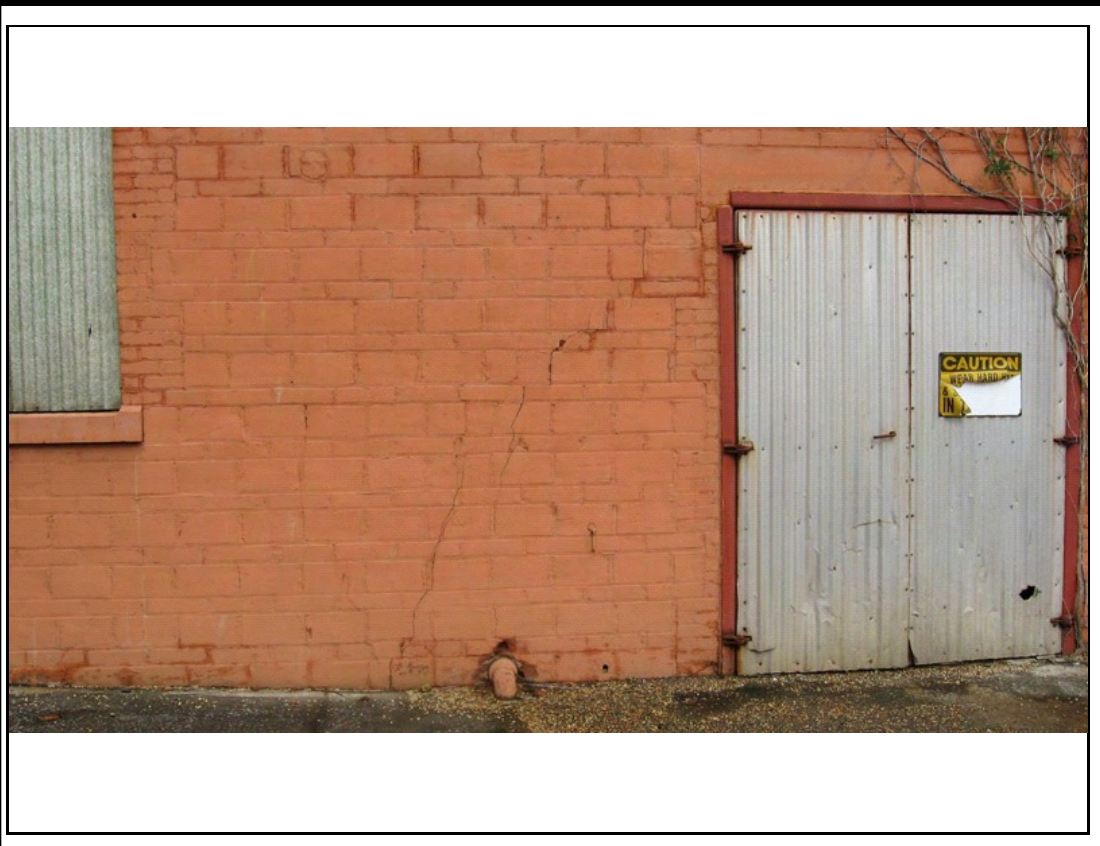
<p>Photograph #: 3</p> <p>Diagonal crack in west wall.</p>

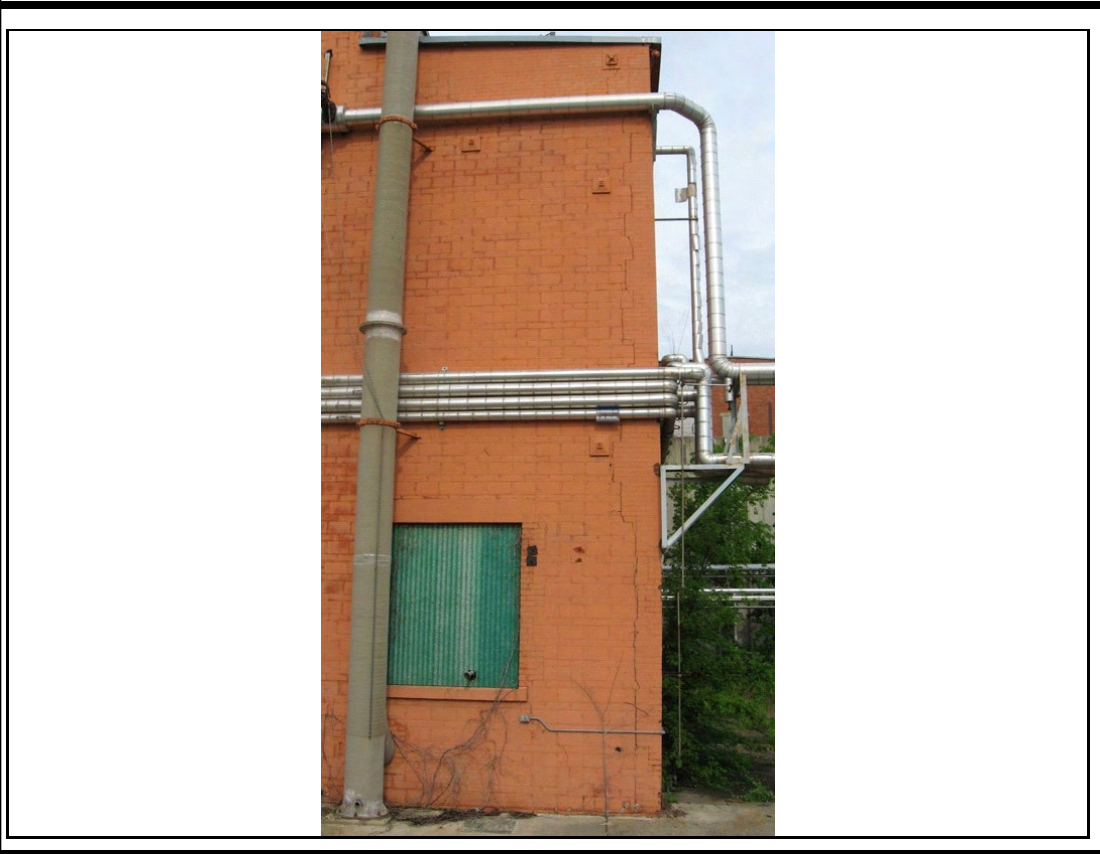
<p>Photograph #: 4</p> <p>Vertical crack in masonry on west side of southwest corner.</p>
