Structural Assessment

Muscle Shoals Reservation
adaptive re-use study

Conditions/Market/Planning/Implementation

July 31, 2009
Revised August 25, 2009

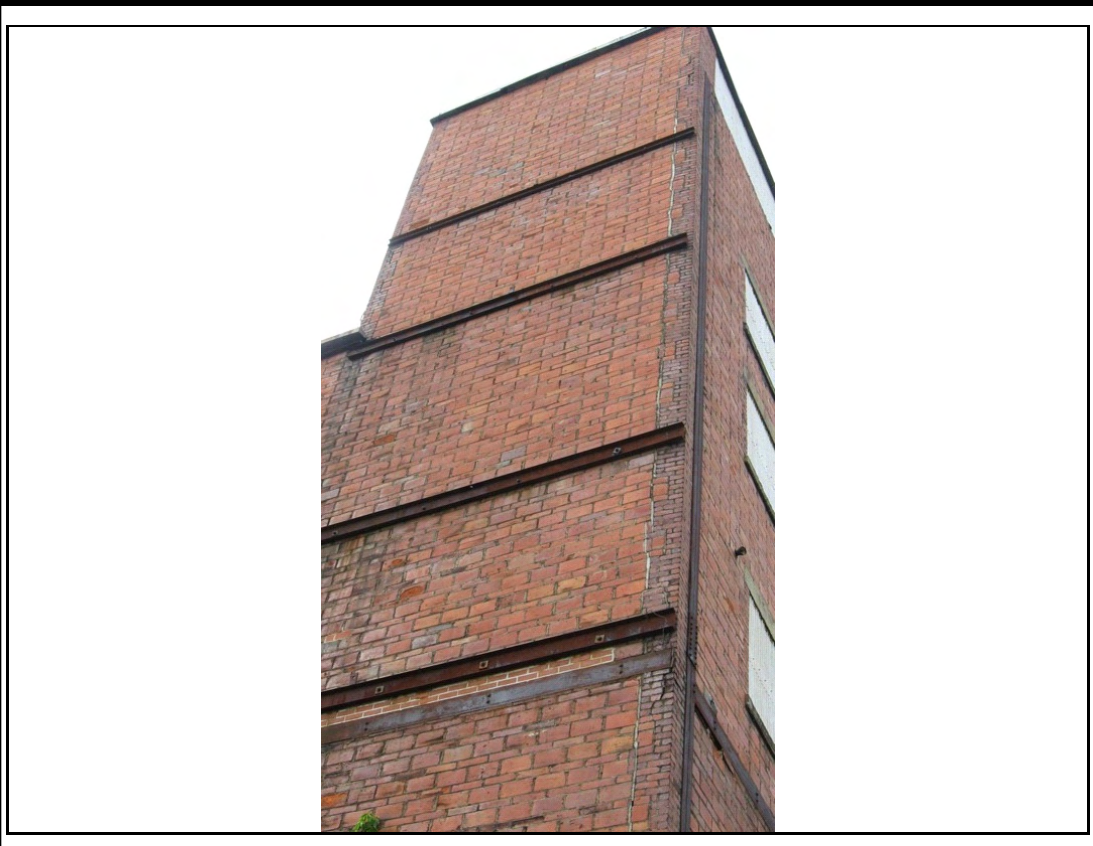
<p>Photograph #: 3</p> <p>Exposed steel framing and vertical crack in masonry, south side - east end.</p>

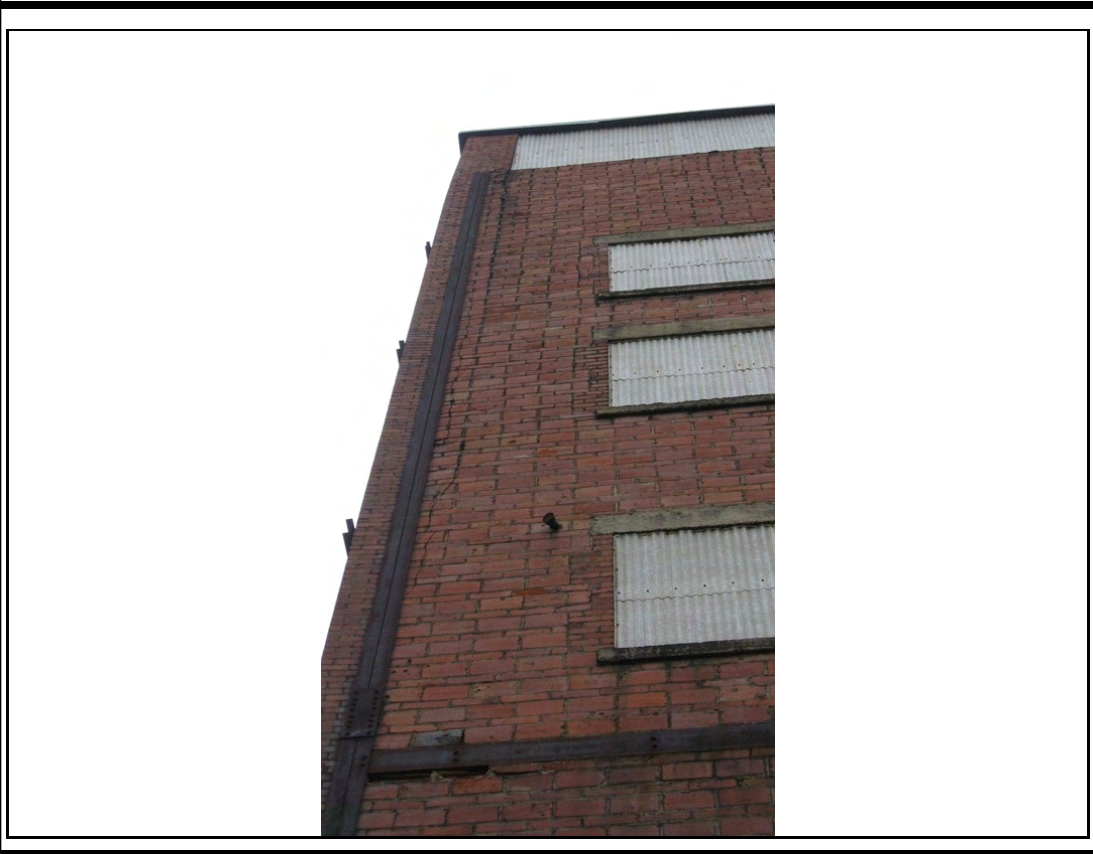
<p>Photograph #: 4</p> <p>Exposed steel framing and vertical crack in masonry, east side - south end.</p>

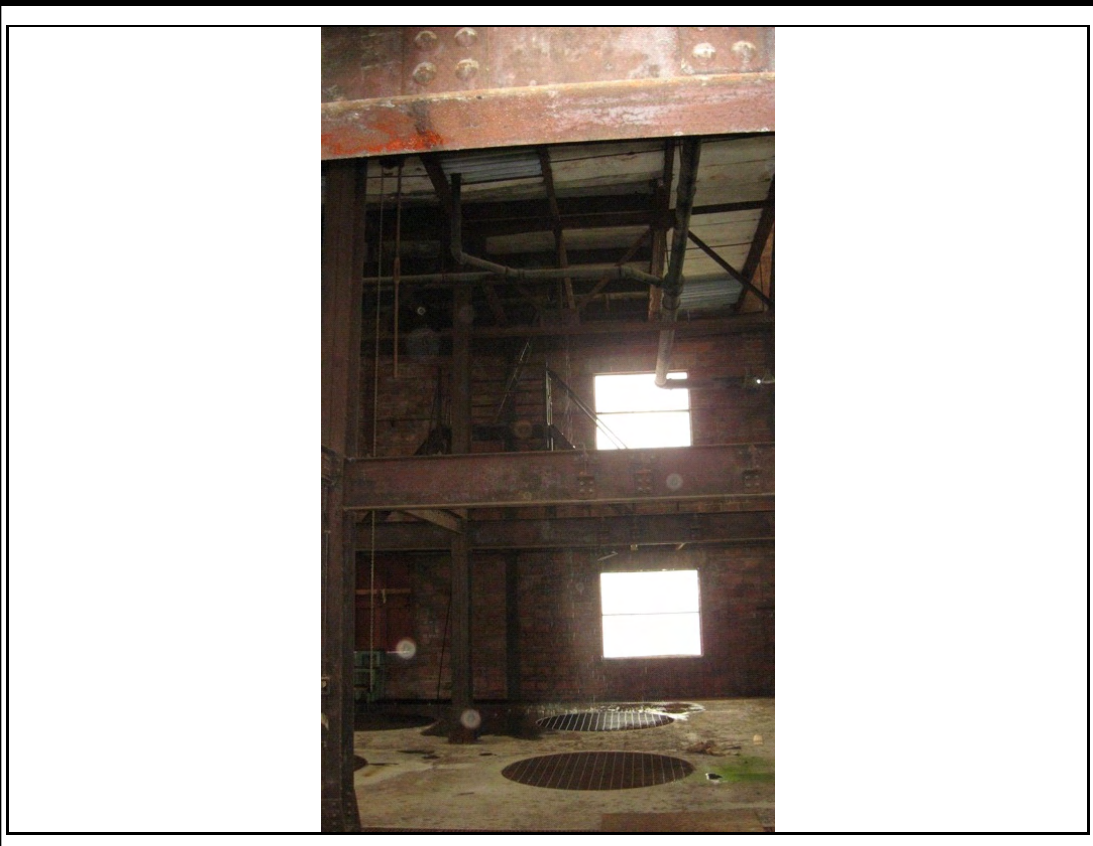
<p>Photograph #: 17</p> <p>Active water intrusion at roof deck</p>

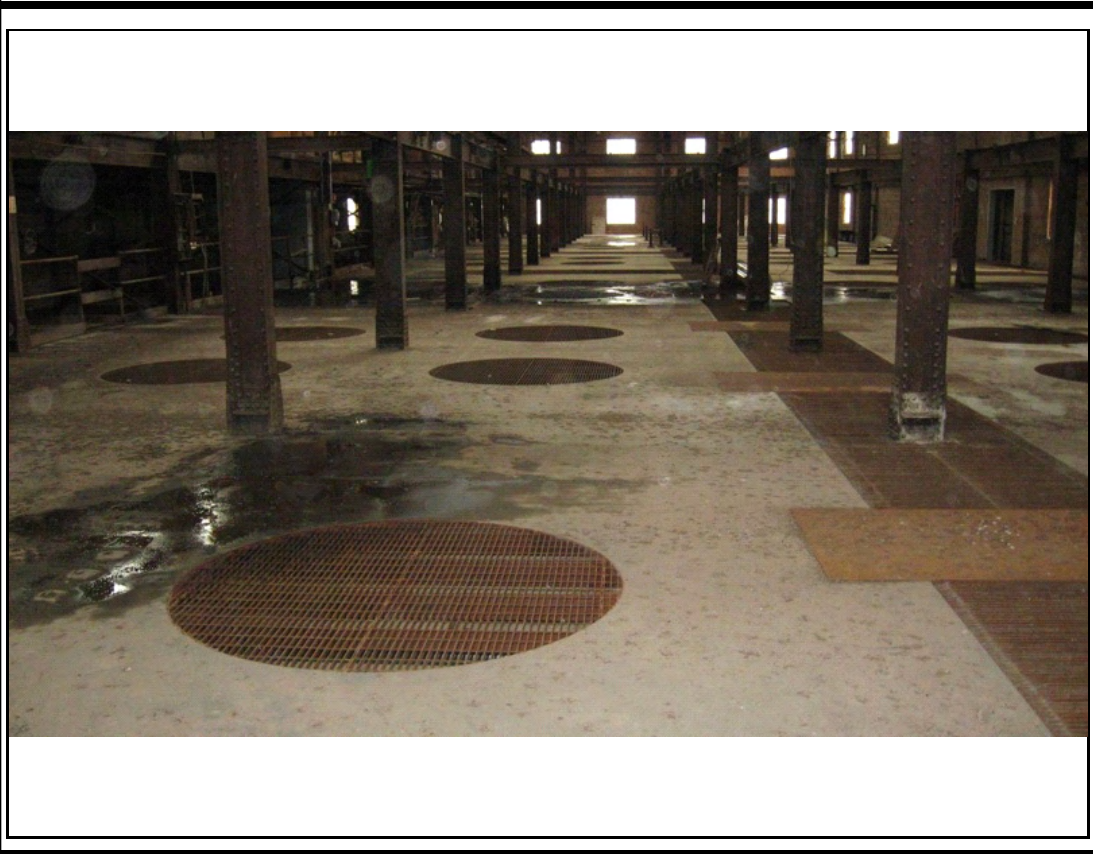
<p>Photograph #: 18</p> <p>View of 3rd floor looking south. Note: Water collecting on floor, typically below broken clerestory windows.</p>

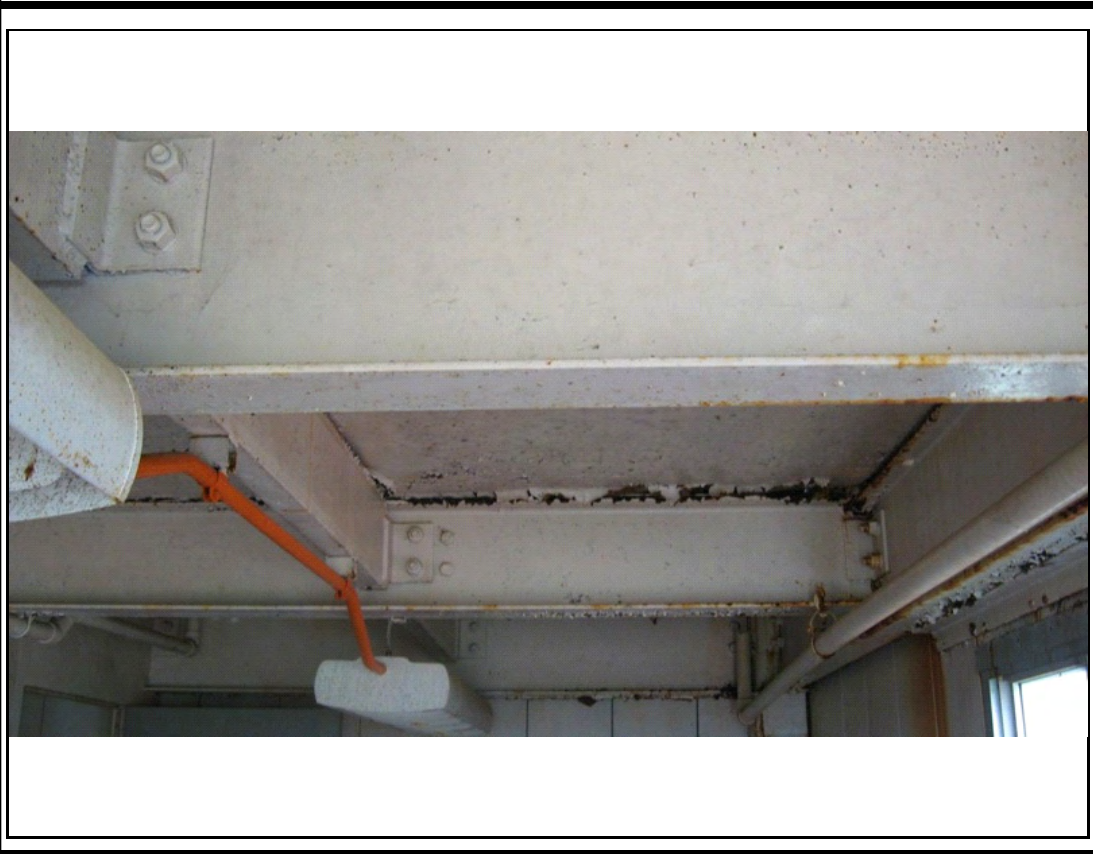
A photograph showing the underside of the upper penthouse floor. The structure is made of grey metal beams and plates. There is significant rust and corrosion visible along the edges of the metal. An orange pipe runs horizontally across the frame. A white cylindrical object, possibly a vent or a pipe, is visible on the left side.	<p>Photograph #: 28</p> <p>Interior view of upper penthouse floor (underside)</p>

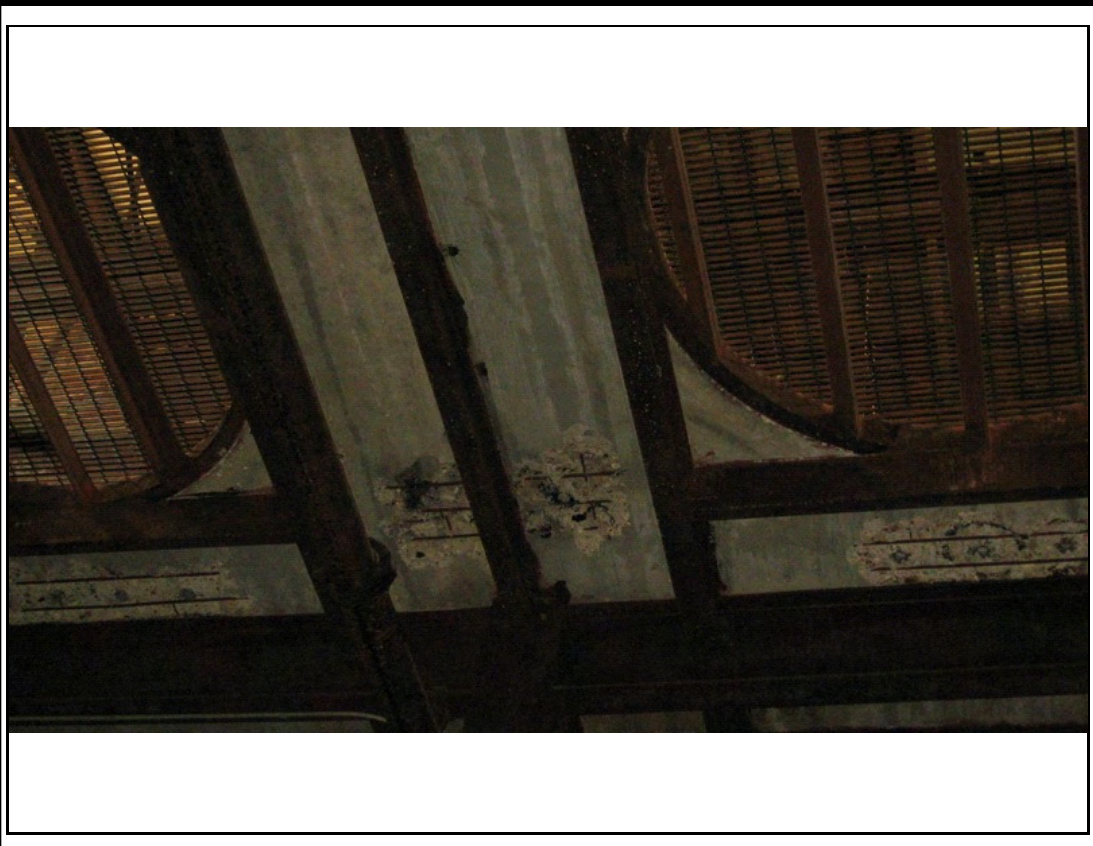
A photograph showing the underside of a third floor in a large industrial building. The view is looking up at a network of dark, heavy steel beams and girders. There are visible signs of structural damage, including rust, peeling paint, and some missing or damaged concrete or plaster on the horizontal surfaces. The lighting is somewhat dim, with some light coming from above.	<p>Photograph #: 35</p> <p>Structural damage at underside of 3rd floor.</p>

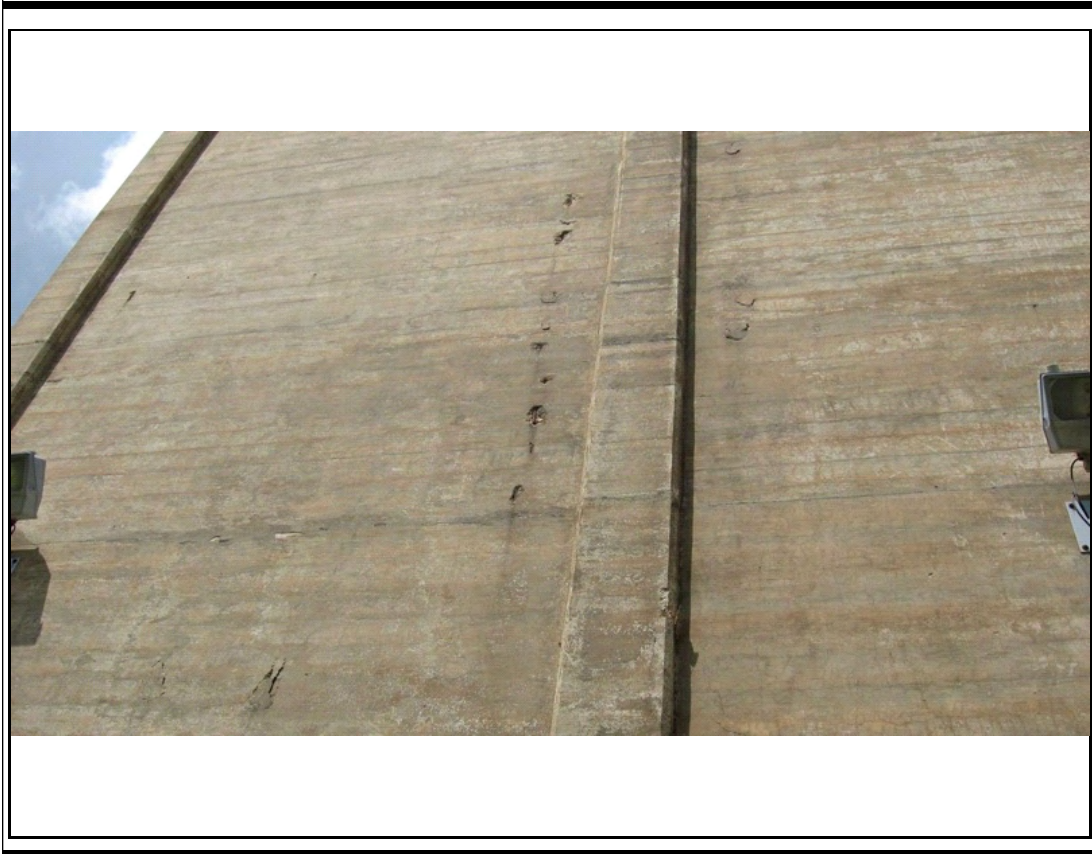
<p>Photograph #: 4</p> <p>Multiple spalls at concrete building - east side.</p>

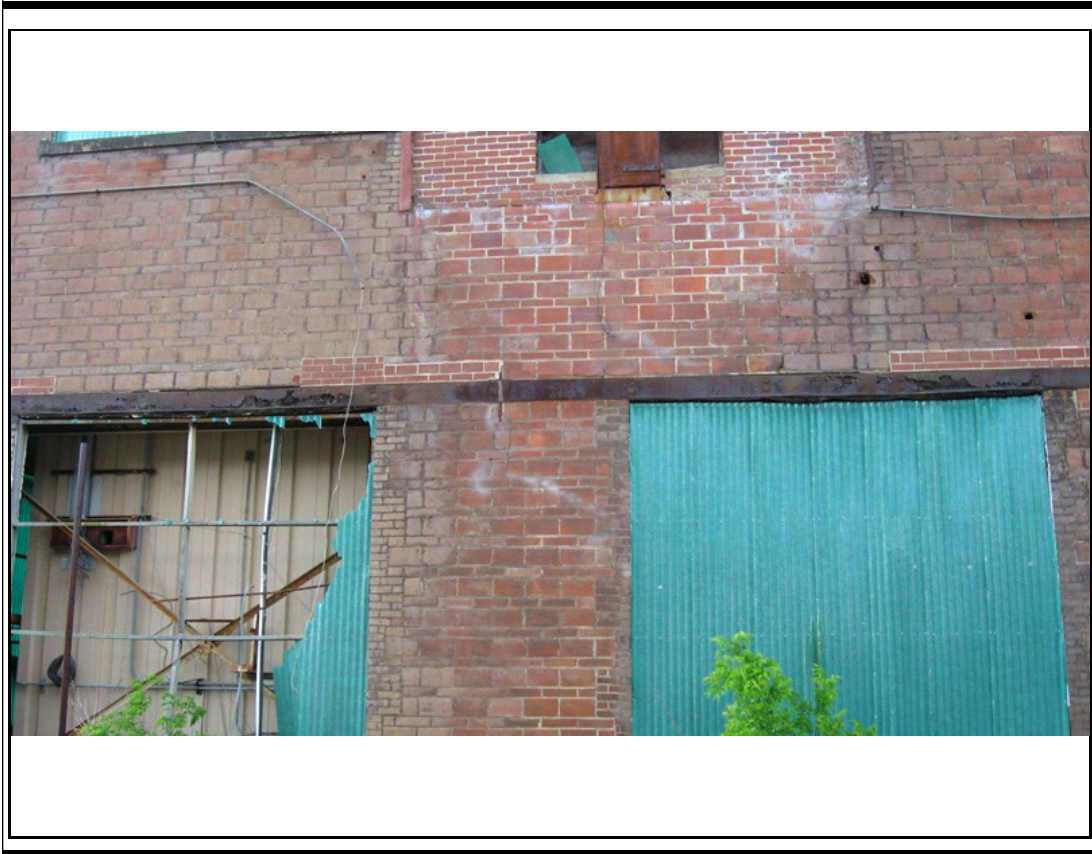
A photograph showing another section of the brick wall. A large opening is visible on the left, with a metal frame and some debris inside. To the right of this opening is a section of green corrugated metal siding. The brickwork is heavily weathered and shows signs of structural damage.	<p>Photograph #: 14</p> <p>Structurally unsound steel lintel beams - south side.</p>

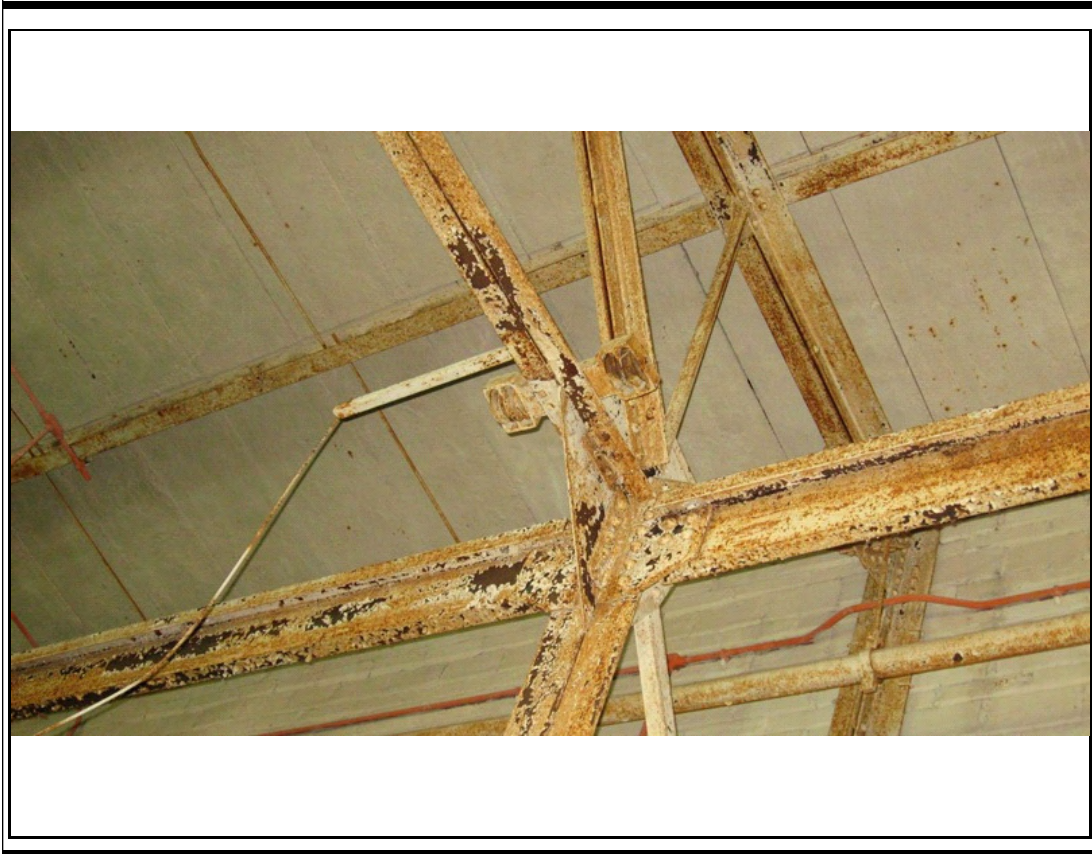
<p>Photograph #: 18</p> <p>Moderately corroded steel framing in masonry building.</p>

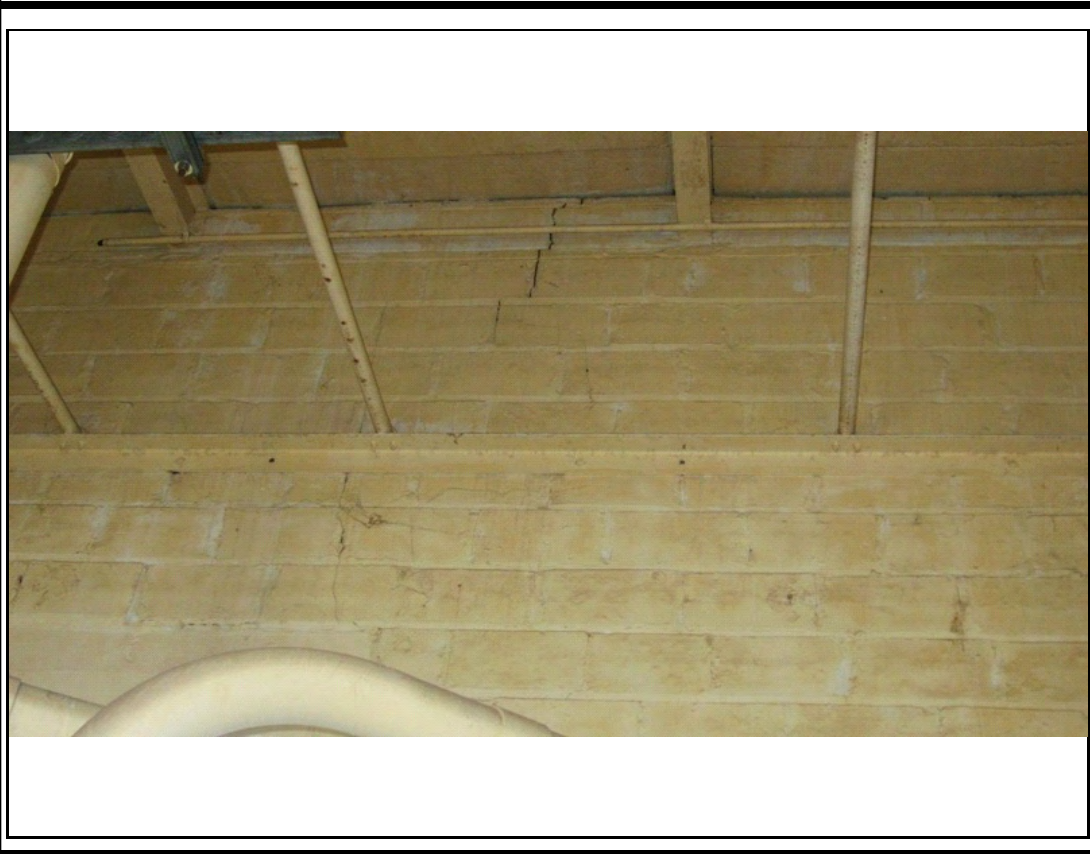
A photograph showing a close-up of a masonry wall. The wall is made of light-colored, rectangular blocks. There are several vertical and diagonal cracks visible in the mortar joints and the blocks themselves. A white cable or pipe runs diagonally across the upper part of the frame.	<p>Photograph #: 6</p> <p>Crack in masonry - west wall.</p>

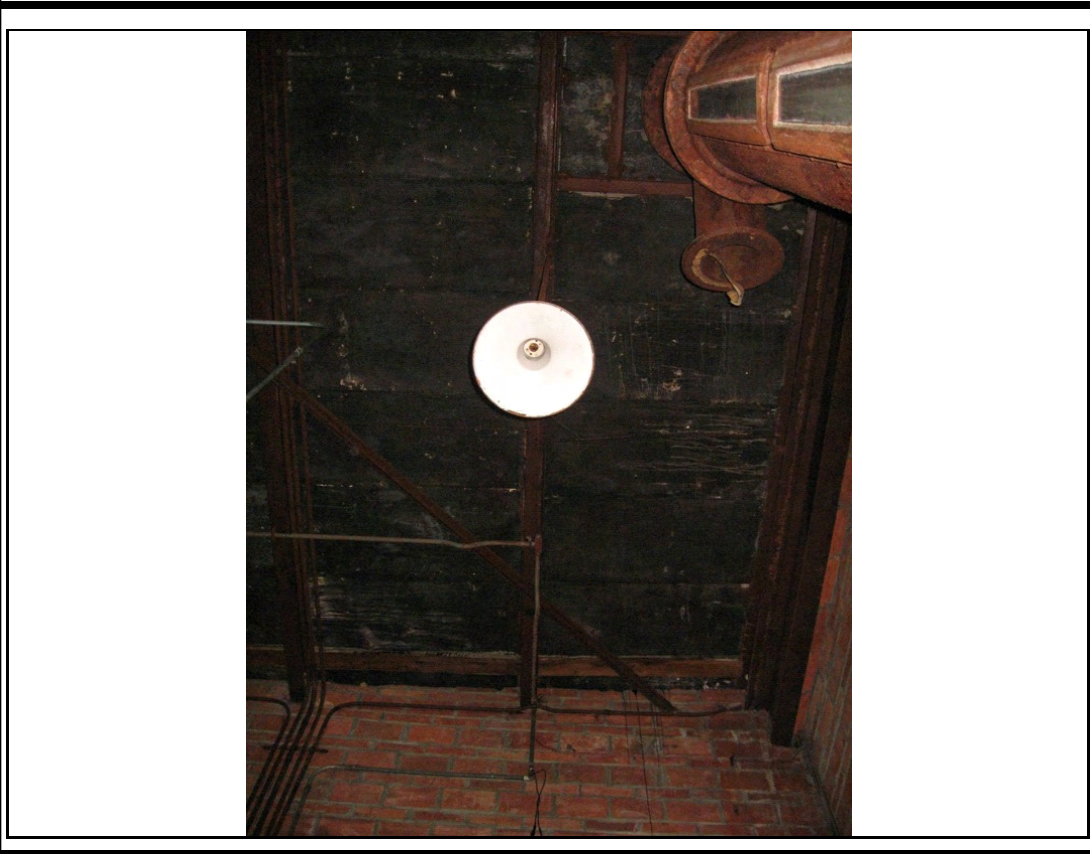
<p>Photograph #: 14</p> <p>Heavily deteriorated roof deck at west end</p>

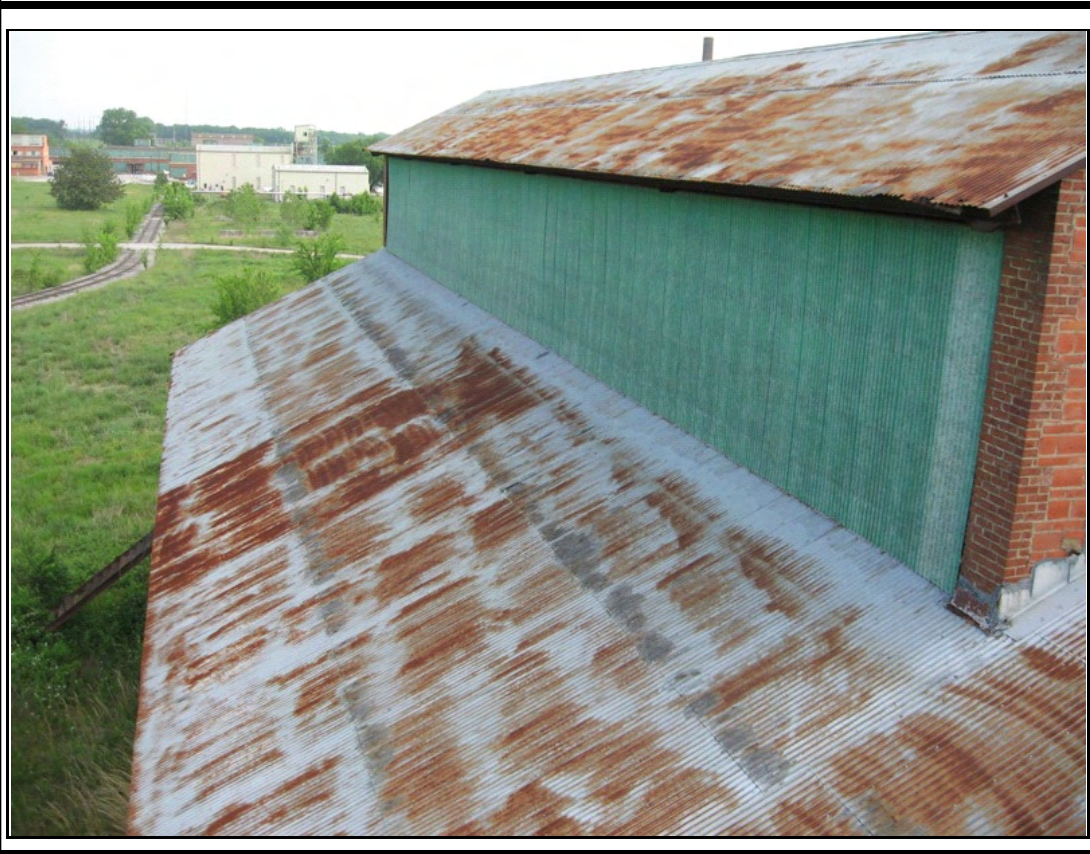
<p>Photograph #: 8</p> <p>Deteriorated metal roof on west side</p>

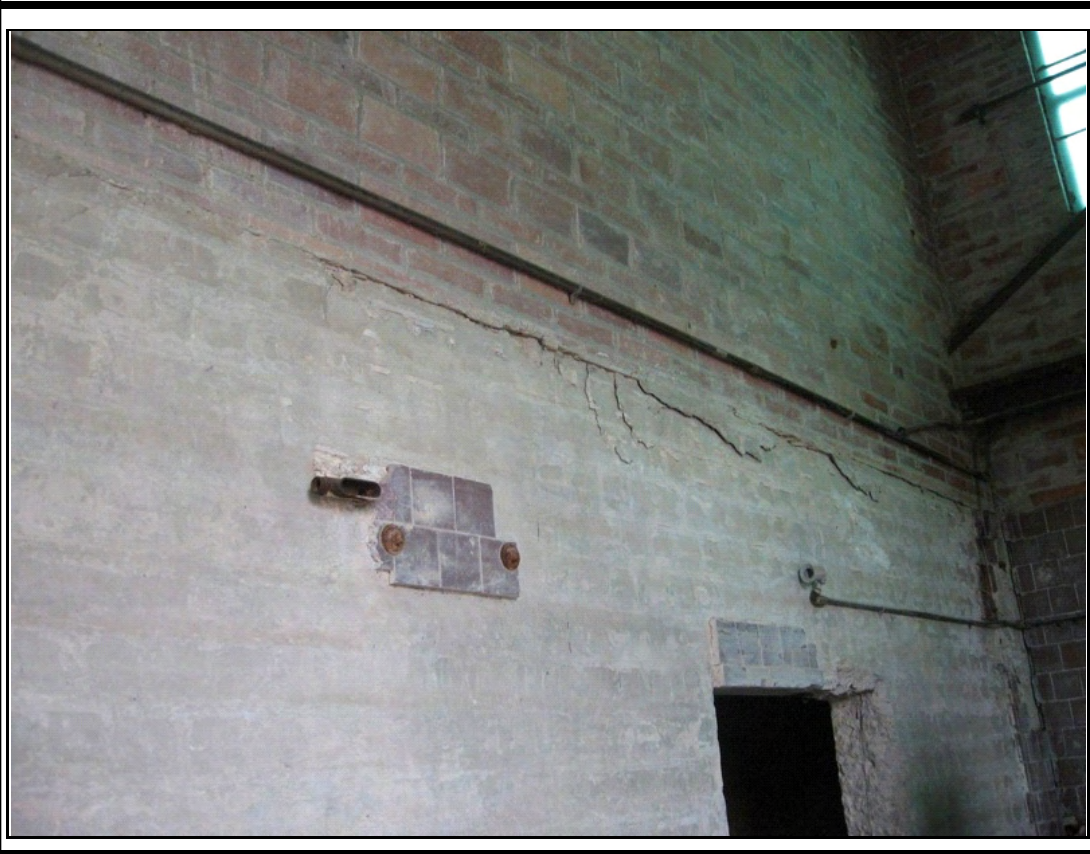
<p>Photograph #: 18</p> <p>Cracked and spalled concrete at interior wall</p>

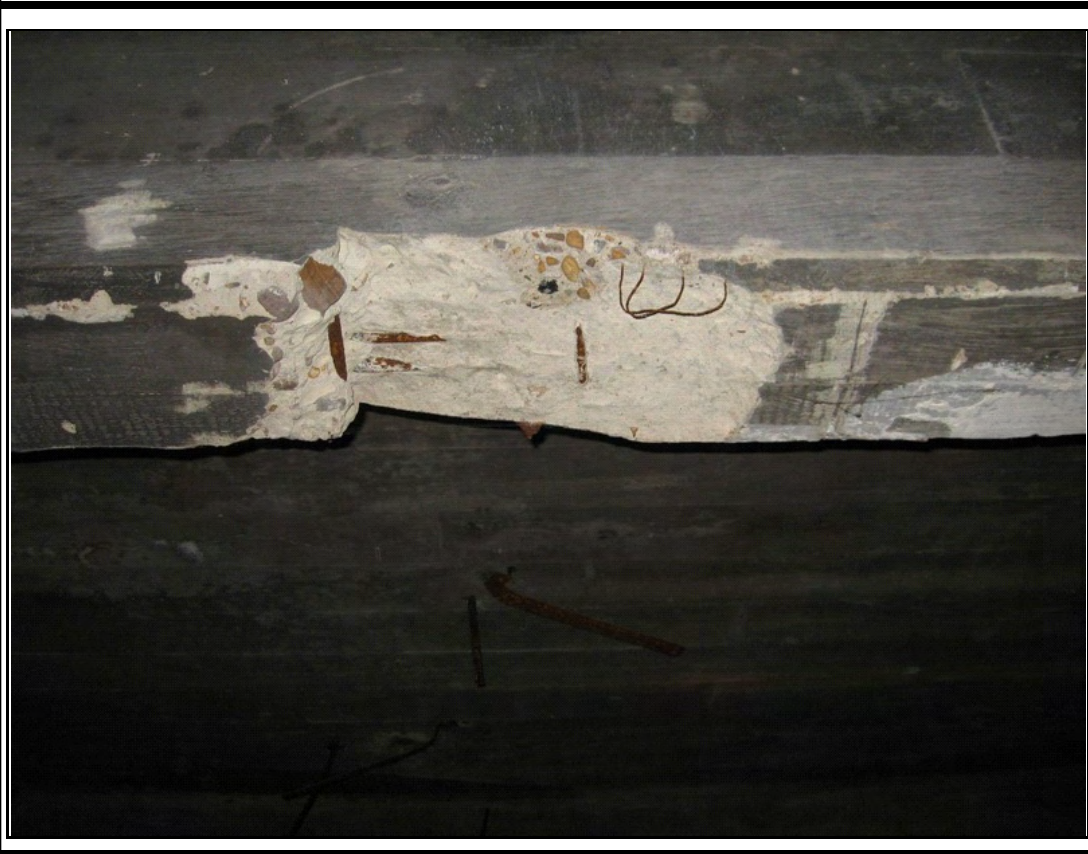
A photograph showing another view of a heavily damaged concrete beam. The beam is light-colored and shows significant cracking and crumbling. The top portion is missing, and the internal structure is exposed. The background is dark and indistinct.	<p>Photograph #: 24</p> <p>Heavily damage mezzanine concrete beam</p>

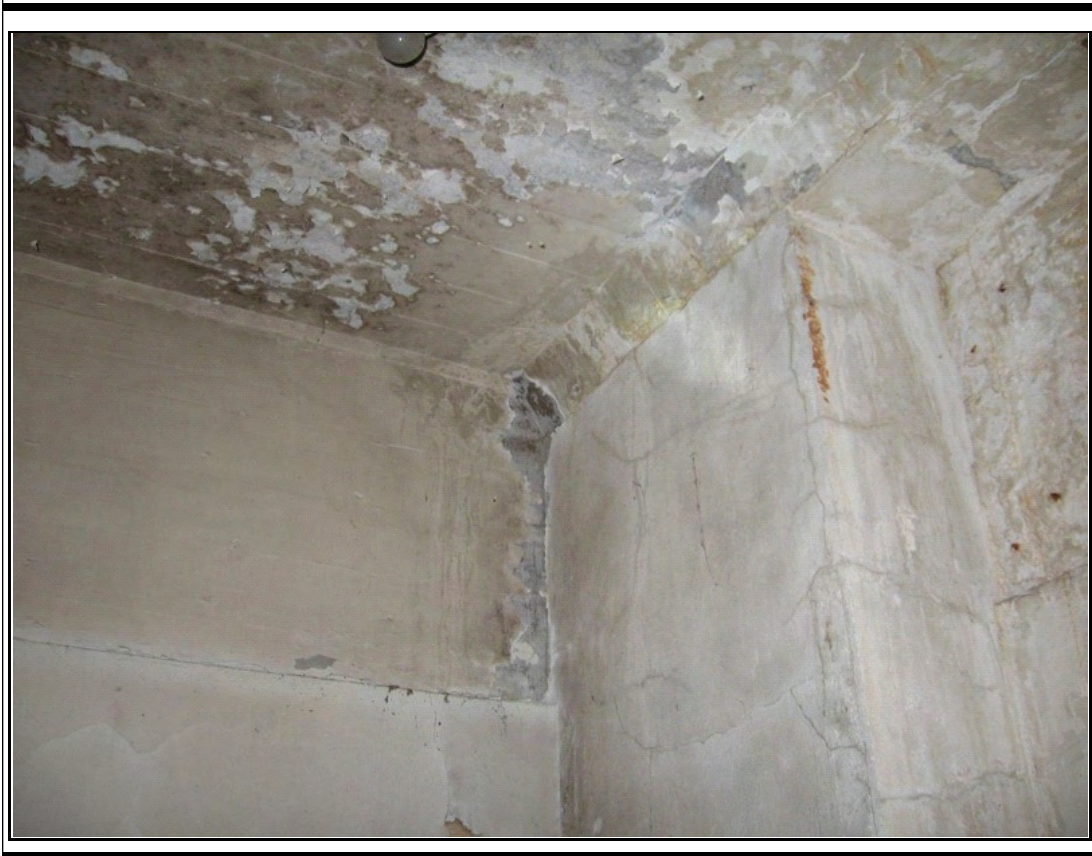
<p>Photograph #: 20</p> <p>Surface cracking and deterioration at mezzanine concrete frame</p>

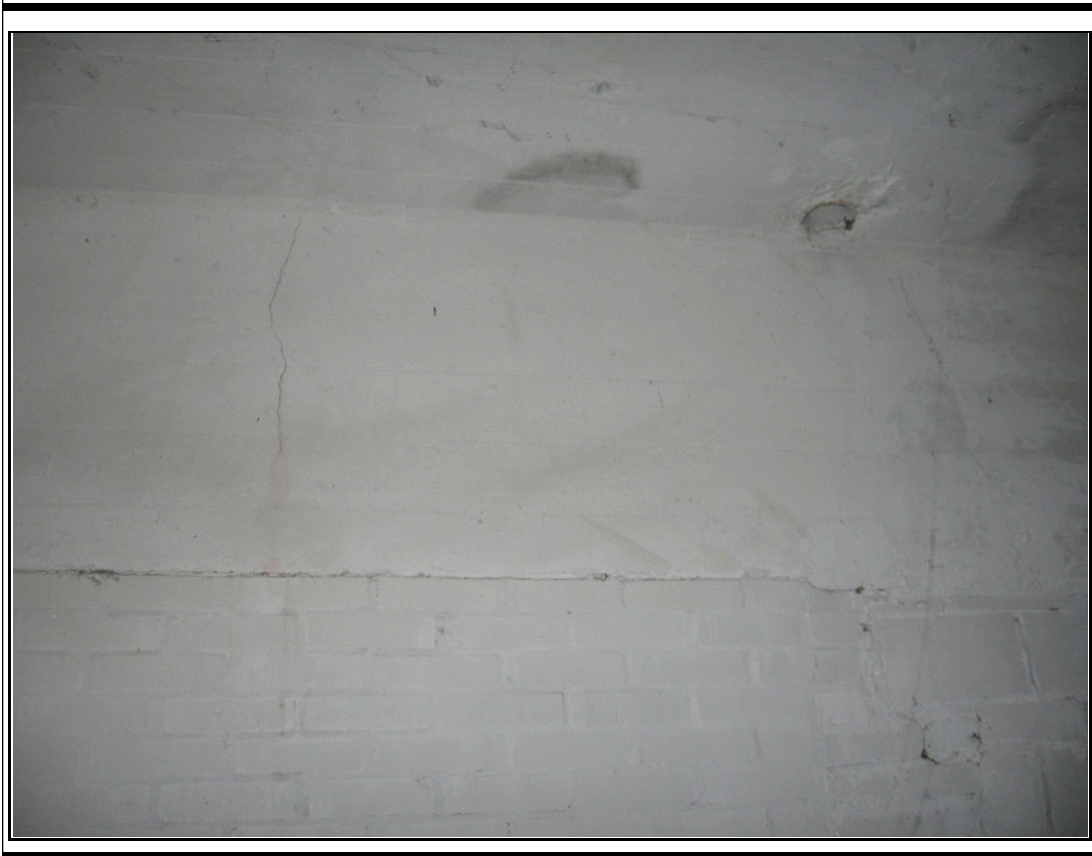
<p>Photograph #: 22</p> <p>Crack in exterior beam at mezzanine concrete frame</p>

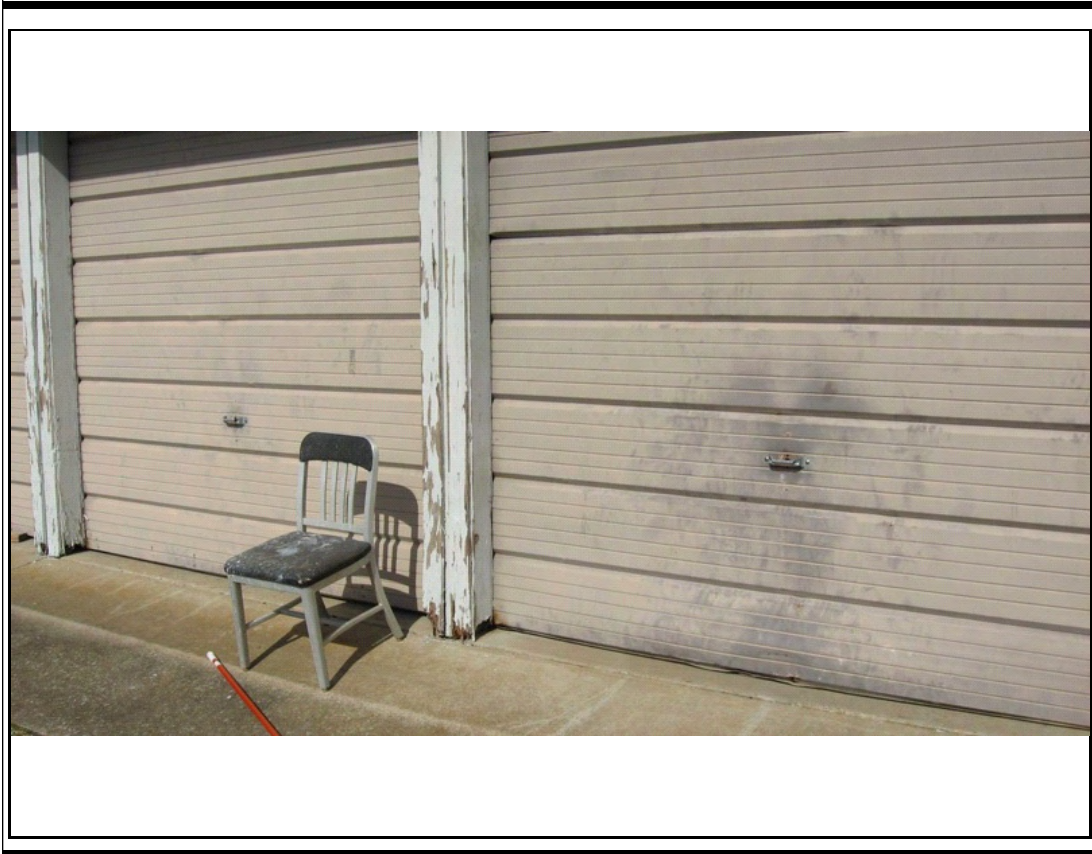
<p>Photograph #: 4</p> <p>Deteriorated wood frame and finish at supports between overhead doors on west side of west wing.</p>
