Tennessee Valley Authority

Cyclic Assessment Report
TVA Muscle Shoals, Alabama
September 16, 2013

Executive Summary

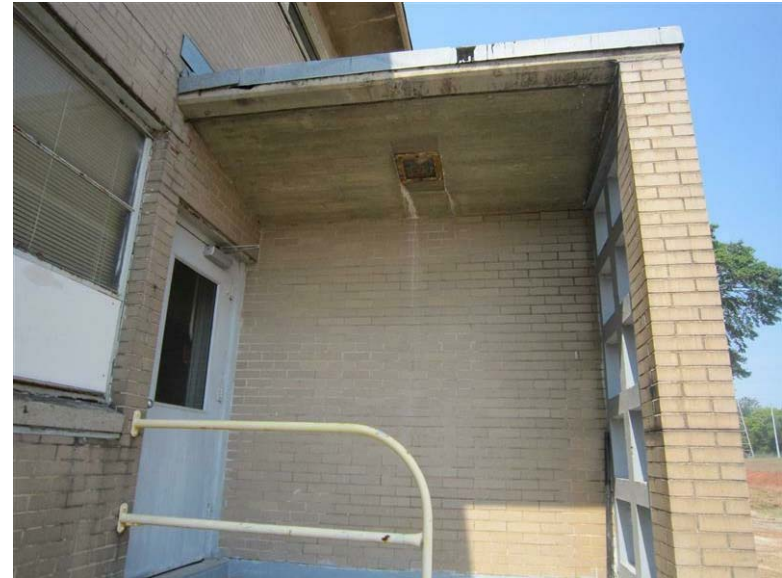
Building 01A - Chemical Feed House: Localized rusting of the steel lintels and metal windows are present.

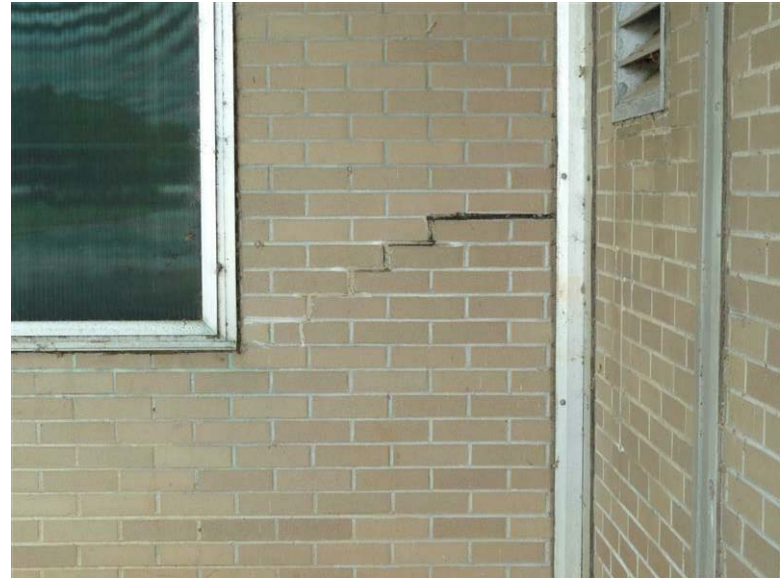
Building 17A - Environmental Research Center: The concrete beam is cracked at the southwest corner of the wing adjacent to the main circular entrance.

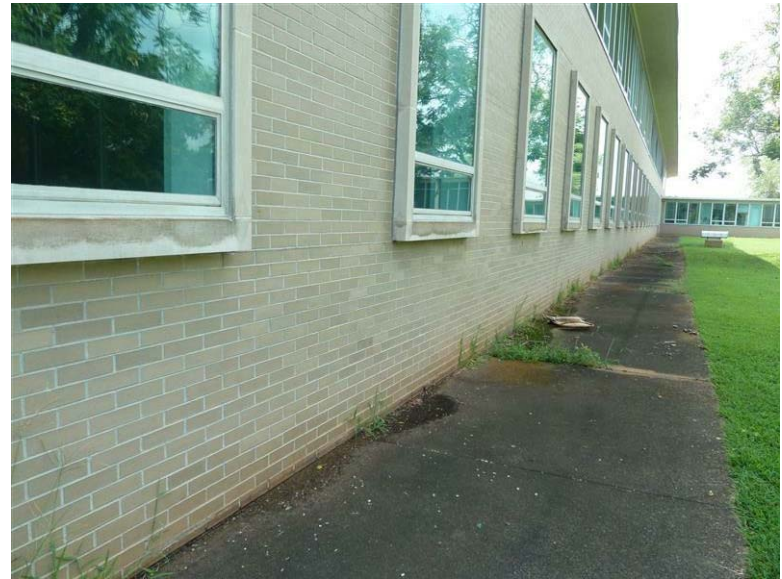
Building 17A - Environmental Research Center : The brick facade has shifted where the awning connects to the building at the southeast corner of this wing.

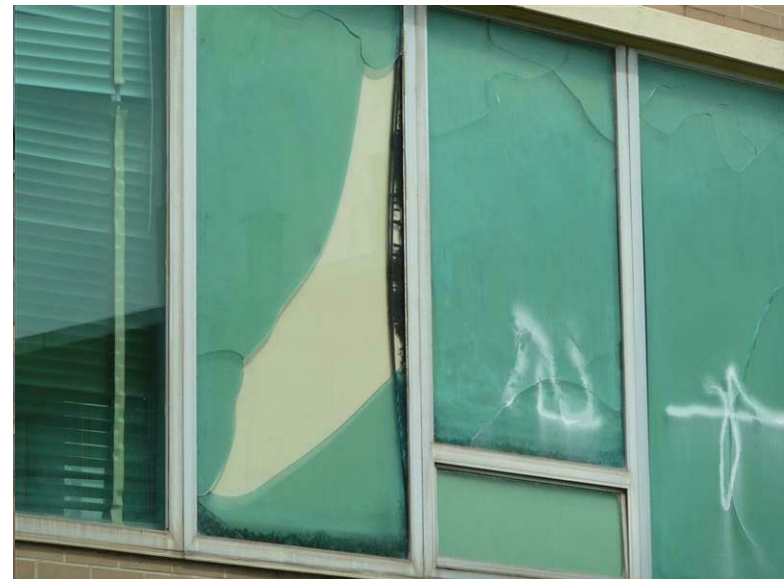
Building 17A - Environmental Research Center: Ladybugs have entered the window cavity indicating the joint/sealant is broken.

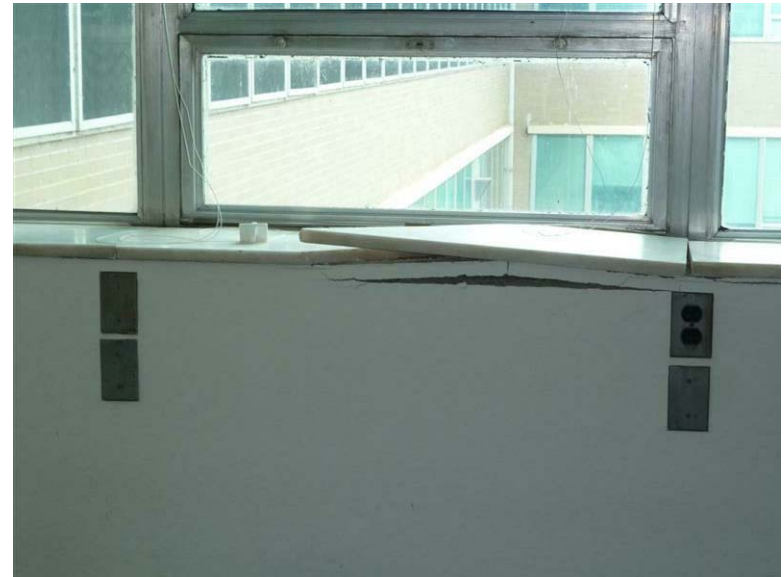
Building 17A - Environmental Research Center: This window has cracked on the east facade.

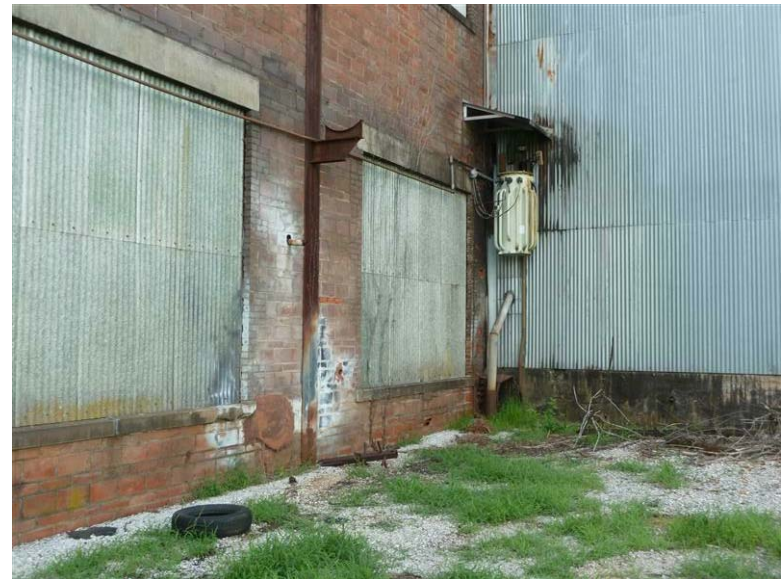
Building 26 – L / N Building Grounds Maintenance Shop: Spalling masonry and eroded mortar joints where water is flowing down the face of the building.

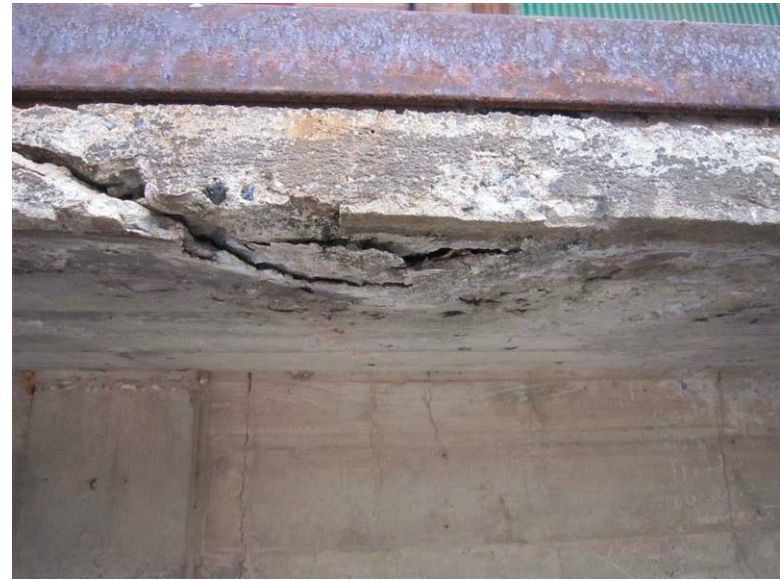
Building 33, 34, 35, 36 – Chemical Plant Warehouse: Concrete panels are spalling exposing the rebar at the north canopy.

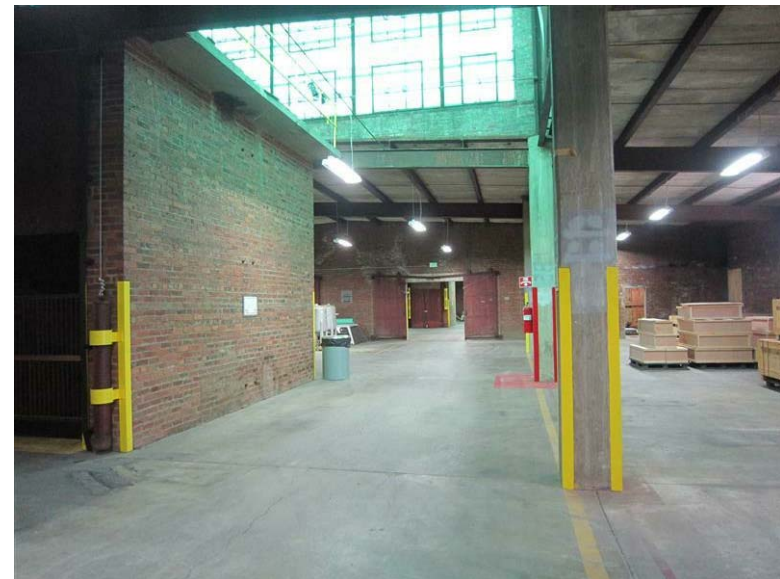
Building 35 – Chemical Plant Warehouse: Although interior cosmetic improvements have been made, the hollow clay tiles remain cracked beneath the paint.

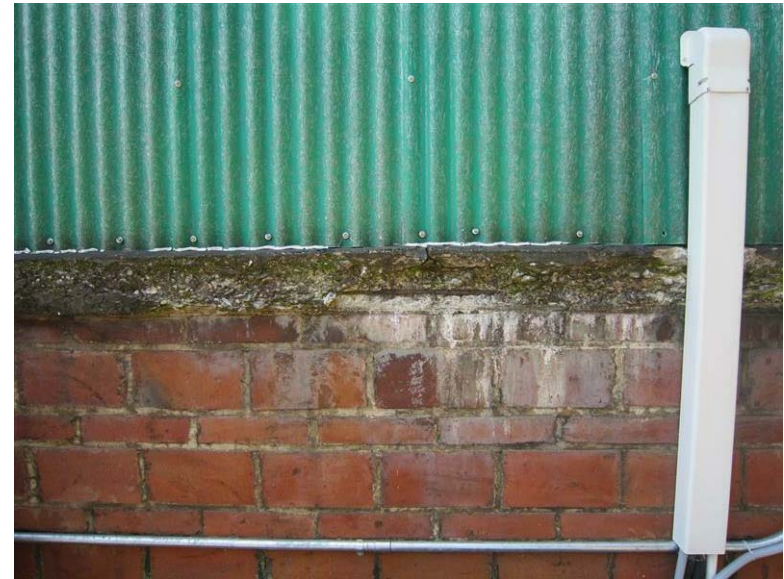
Building 37, 38 – Machine Shop: Several cracks occur in the brick surround, which has begun to shift above the window.

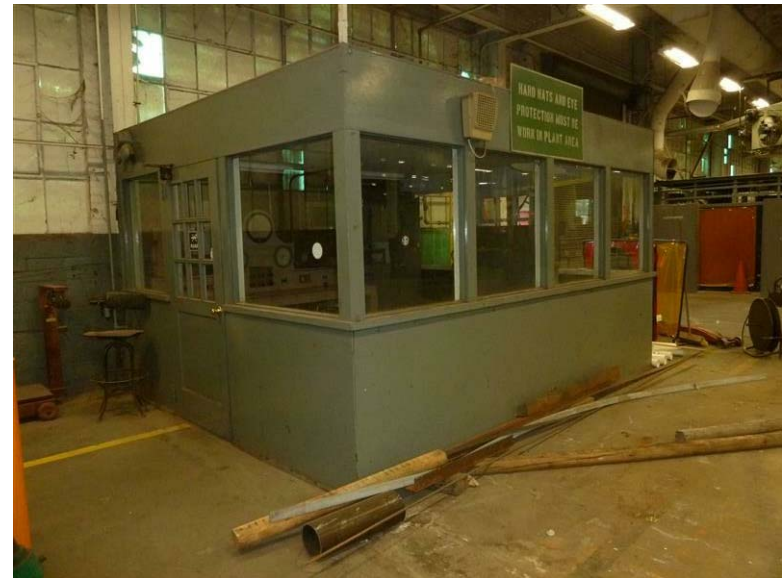
Building 37 – Machine Shop: The glass pane is broken on the wood door leading to the office space.

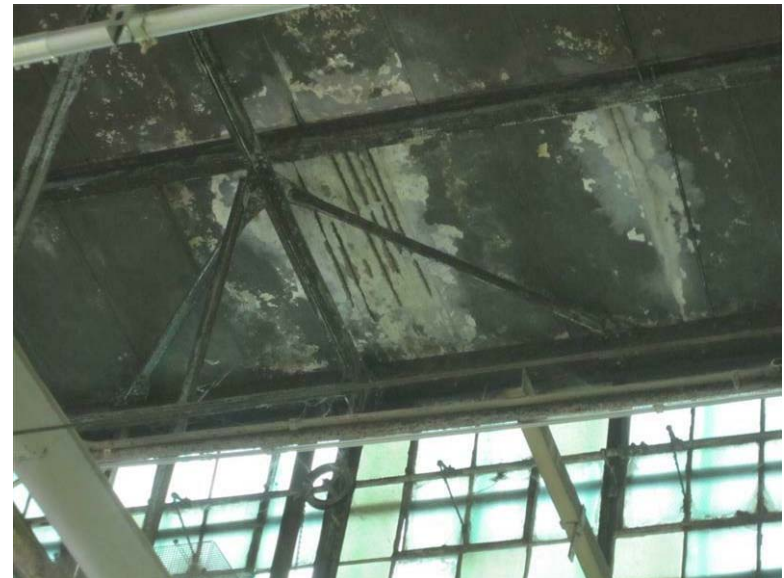
Building 38 – Machine Shop - Gas and Diesel Repair Shop: The hollow clay tile walls leading to the clerestory are stained.

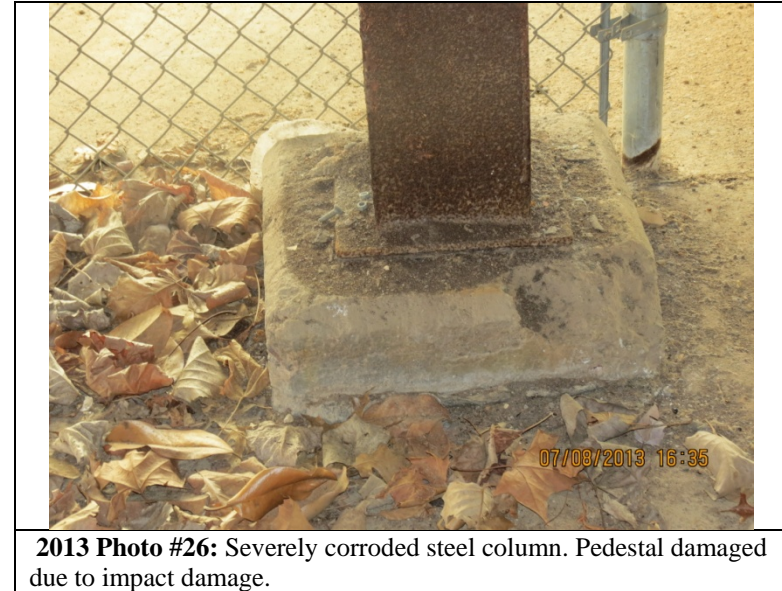
2013 Photo #26: Severely corroded steel column. Pedestal damaged due to impact damage.

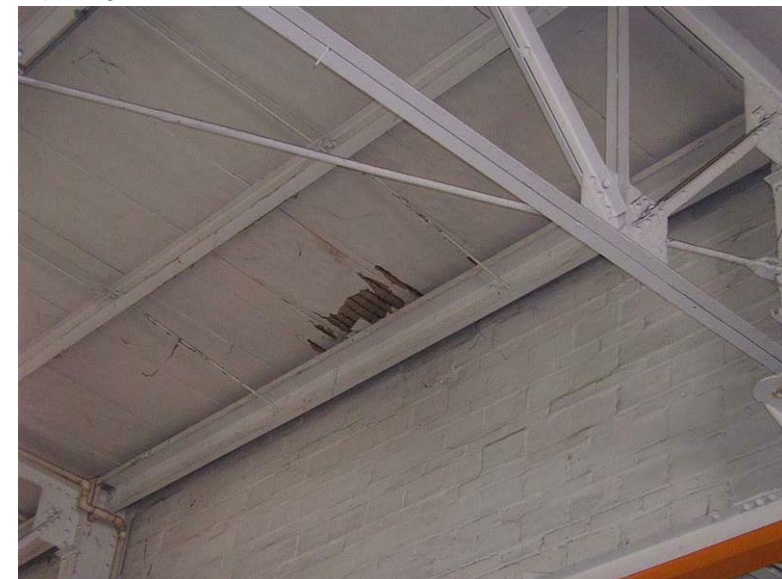
Building 41 – Sheet Metal Shop: The concrete ceiling panel has spalled, exposing the rebar.

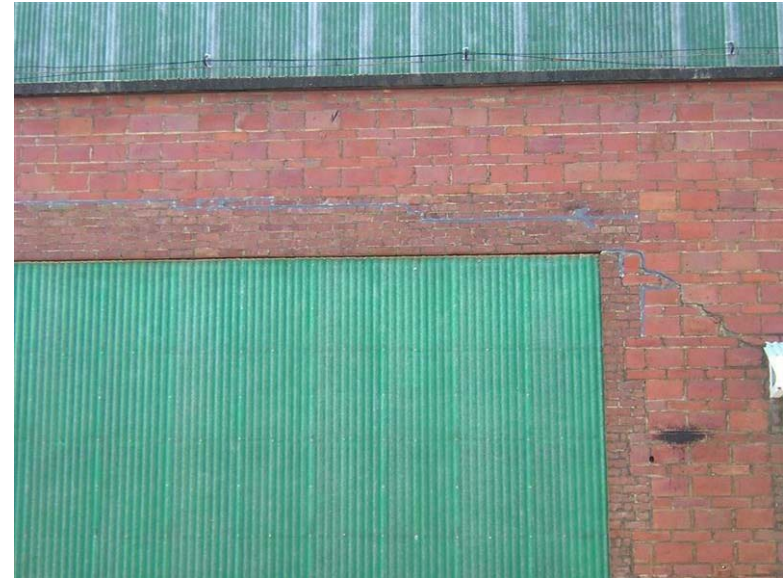
Building 42 – Pipe Shop: This horizontal crack continues across much of the south facade.

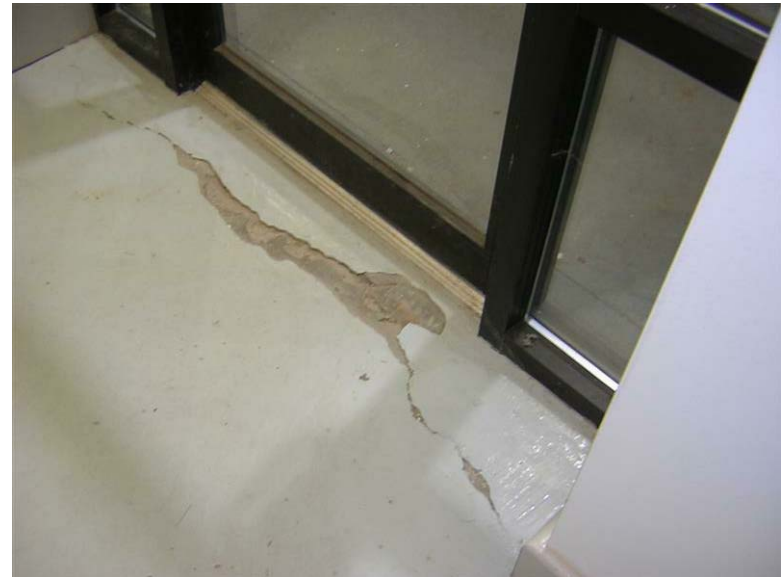
Building 44 – Project Operations Bath House: The concrete floor is cracked at the west entrance.

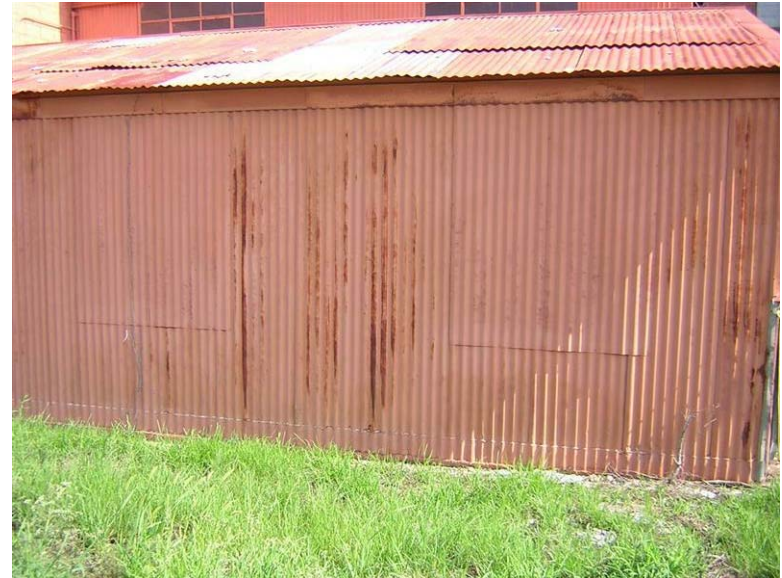
Building 53 – Tin Shop: The corrugated metal panels are rusting at the rear addition.

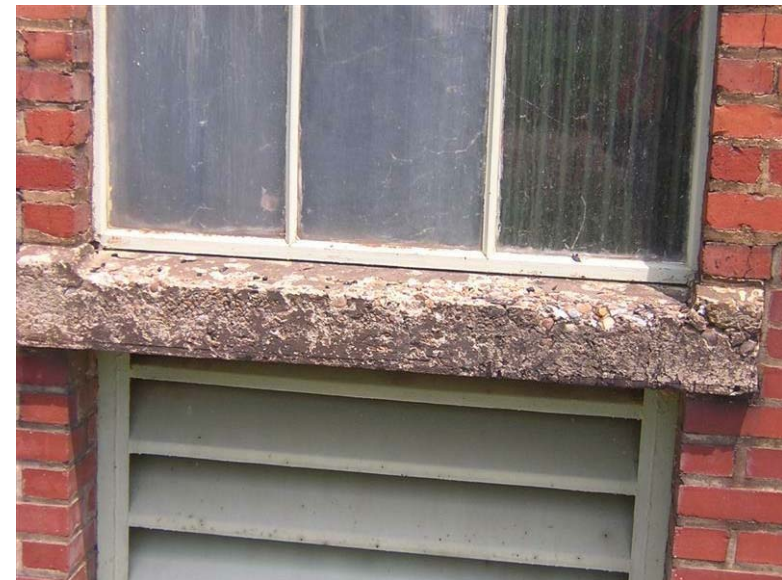
Building 57 – Substation No. 2: The concrete sill is damaged at several of the windows.

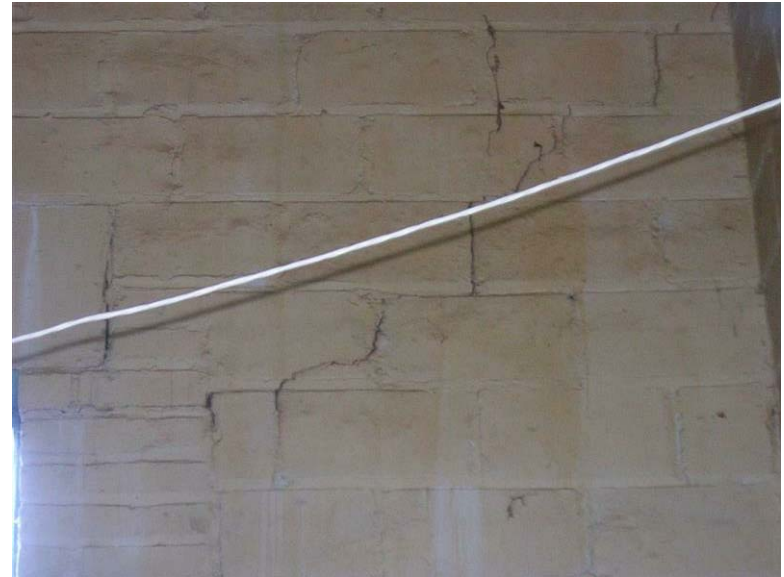
Building 57 – Substation No. 2: Diagonal cracks are visible at the upper walls.

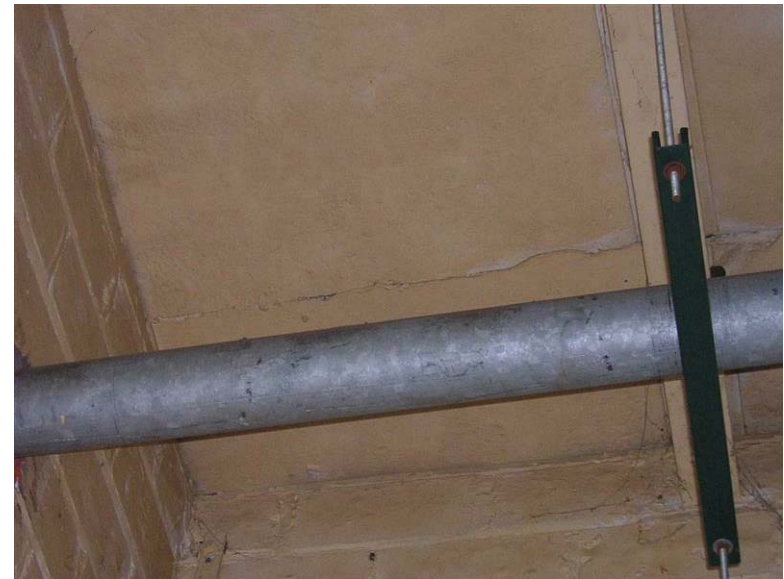
Building 57 – Substation No. 2: A line of concrete ceiling panels is broken.

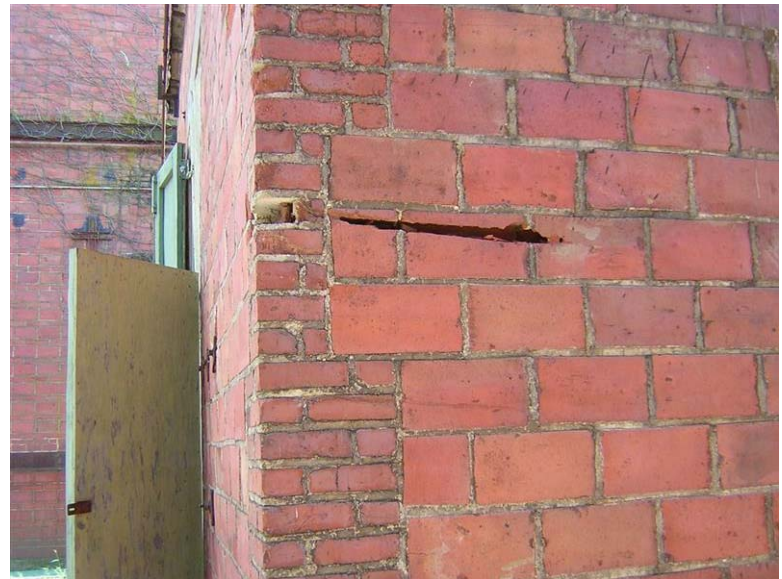
Building 68 – Substation No. 4: The hollow clay tile and brick is damaged at the northeast corner.

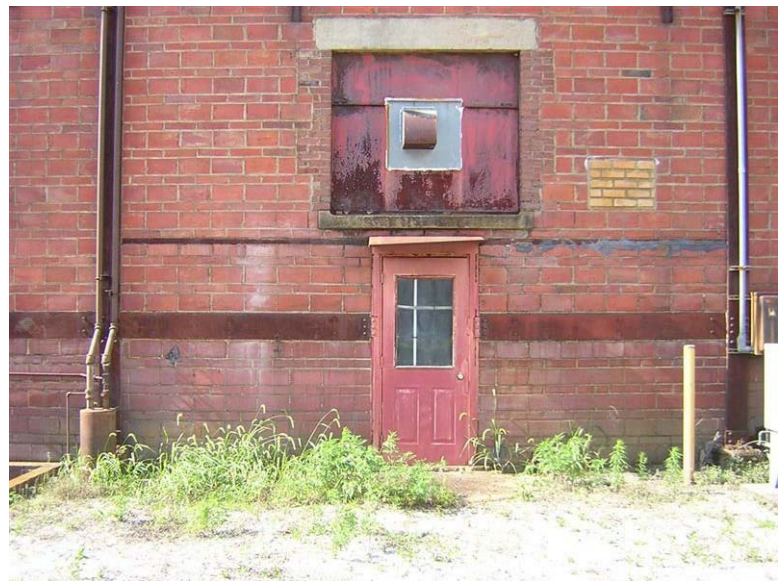
Building 69 – Catalyzer Building No. 1: The metal covering this window opening is rusted and the exposed steel structure is rusted.

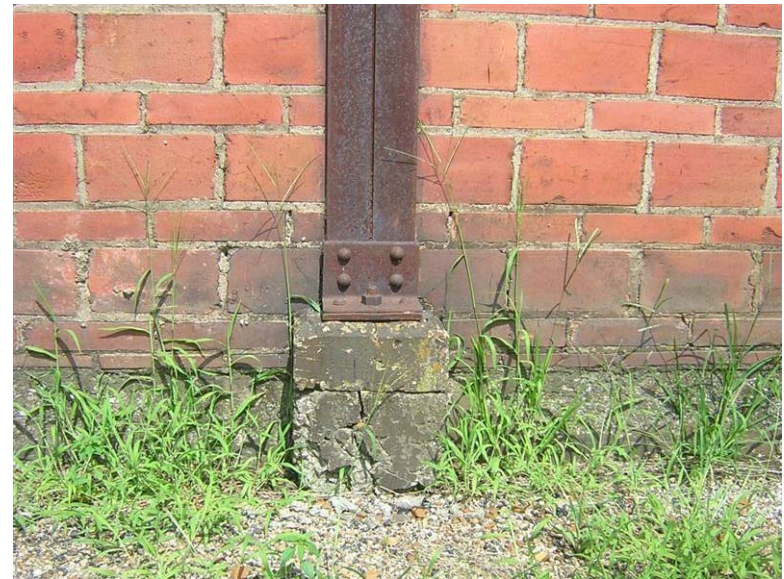
Building 71 – Catalyzer Building No. 3: The concrete footing is broken.

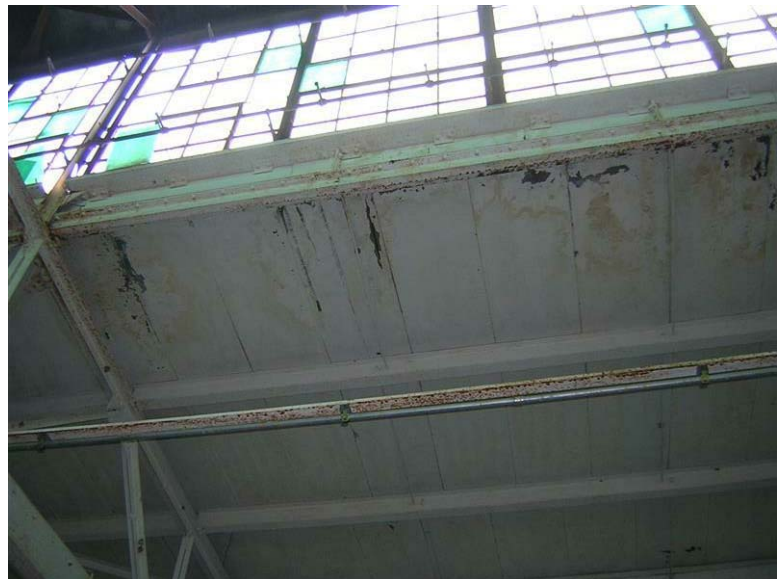
Building 71 – Catalyzer Building No. 3: Water infiltration has stained the concrete ceiling tiles.

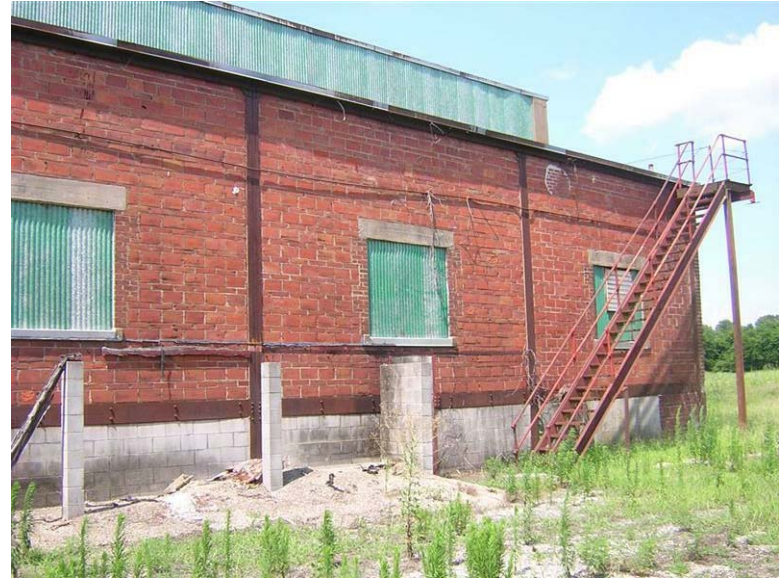
Building 72 – Catalyzer Building No. 4: The exterior metal stair is rusted and in poor condition.

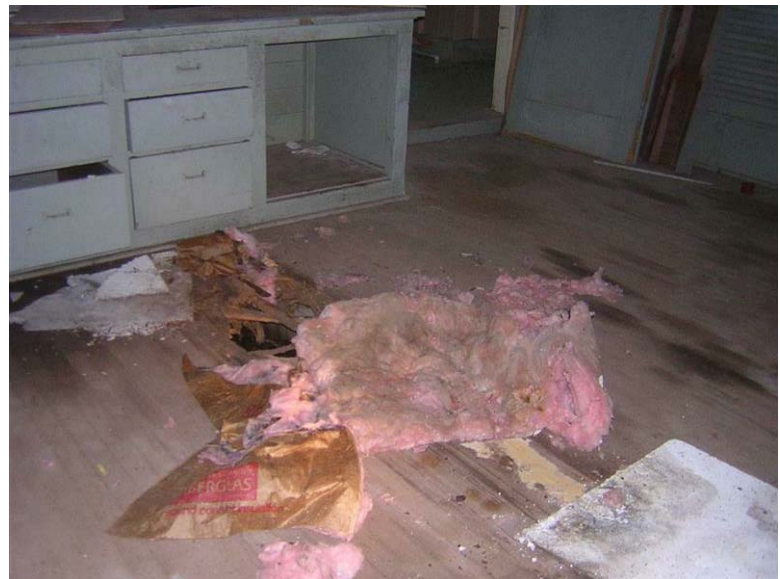
Building 72 – Catalyzer Building No. 4: Water infiltration has caused a hole in the wood flooring.

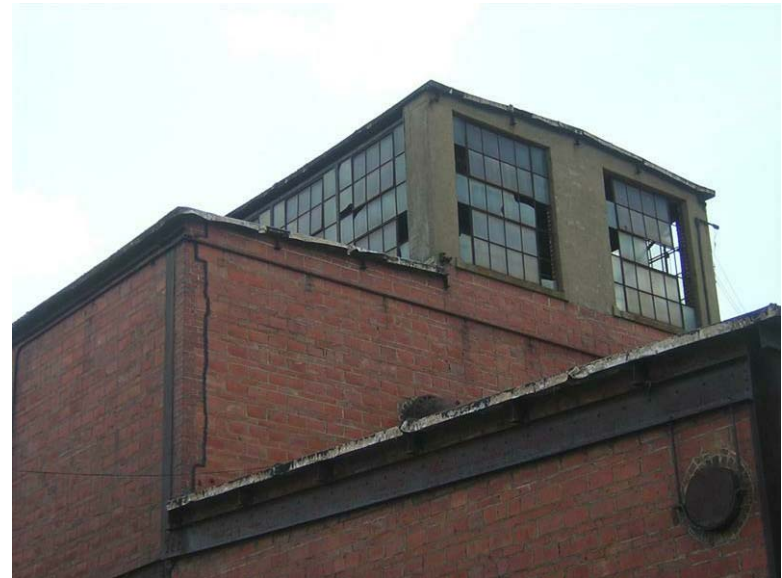
Building 73 – Catalyzer Building No. 5: There are several broken panes at the clerestory. The crack at the upper corner of the wall has been patched with a substance incompatible with the mortar.

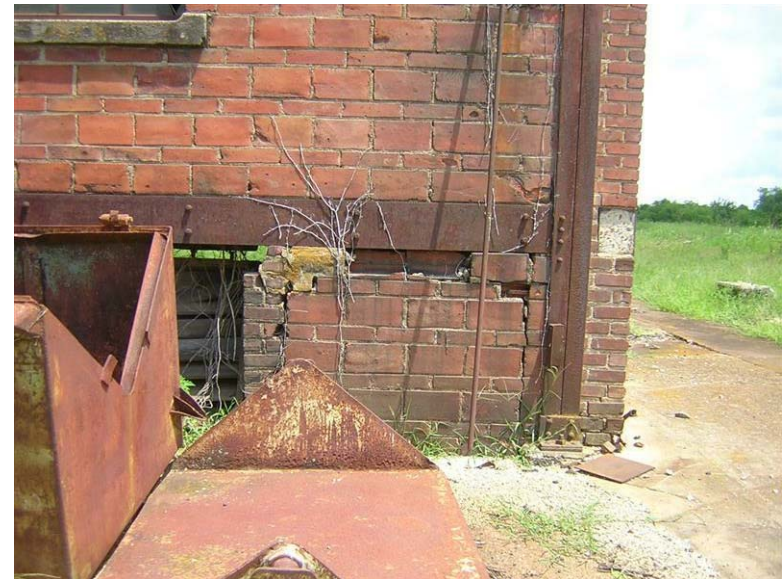
Building 73 – Catalyzer Building No. 5: There is a crack in the hollow clay tile adjacent to the exposed steel structure.

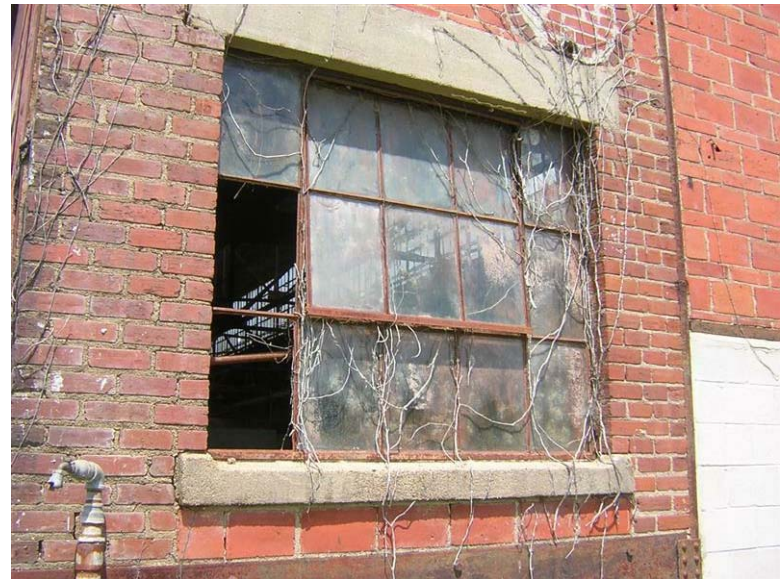
Building 74 – Catalyzer Building No. 6: Panes are missing in several of the steel windows.

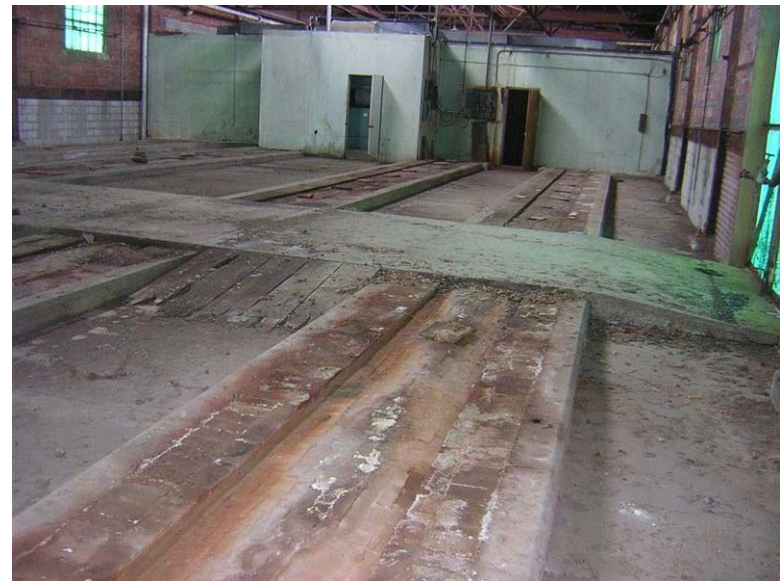
Building 74 – Catalyzer Building No. 6: The bricks in the raised floor have visible efflorescence.

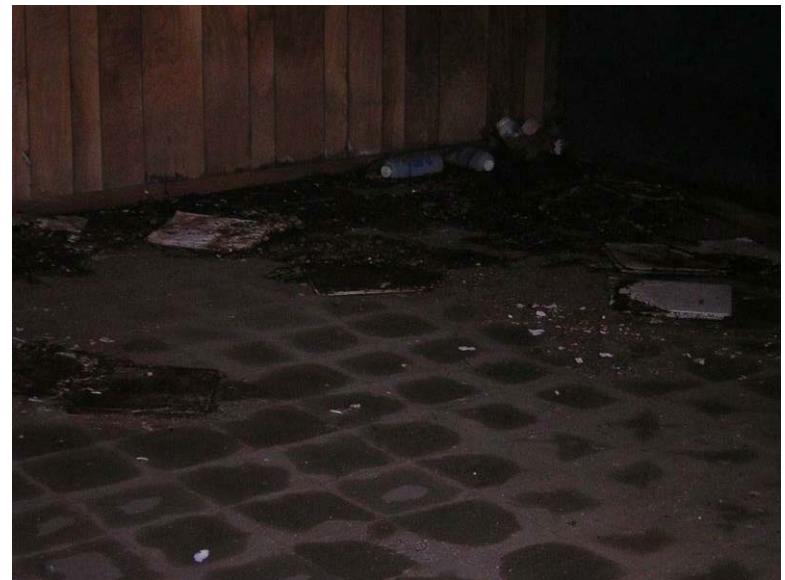
Building 74 – Catalyzer Building No. 6: The floor tiles are damaged from water infiltration.

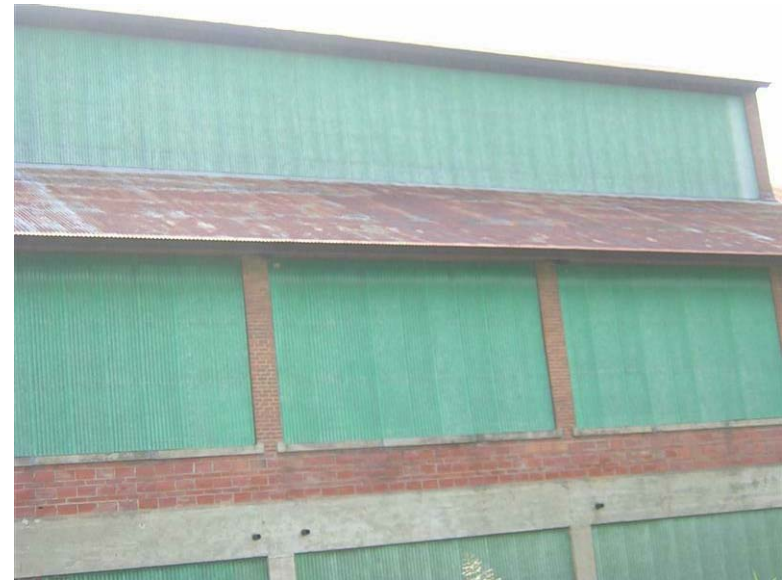
Building 79 – 3A – Nitrate House: Rusting of the metal roof is visible from the exterior.

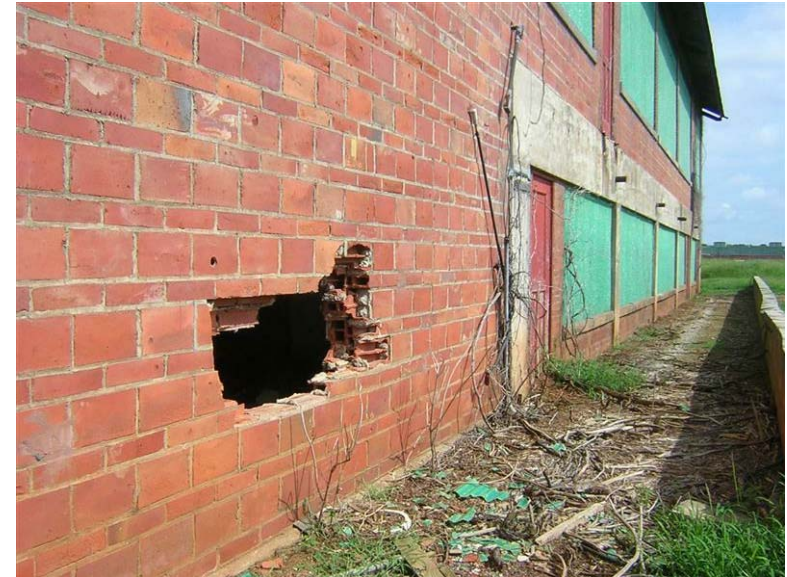
Building 79 – 3A – Nitrate House: There is a hole in the hollow clay tile on the east wall.

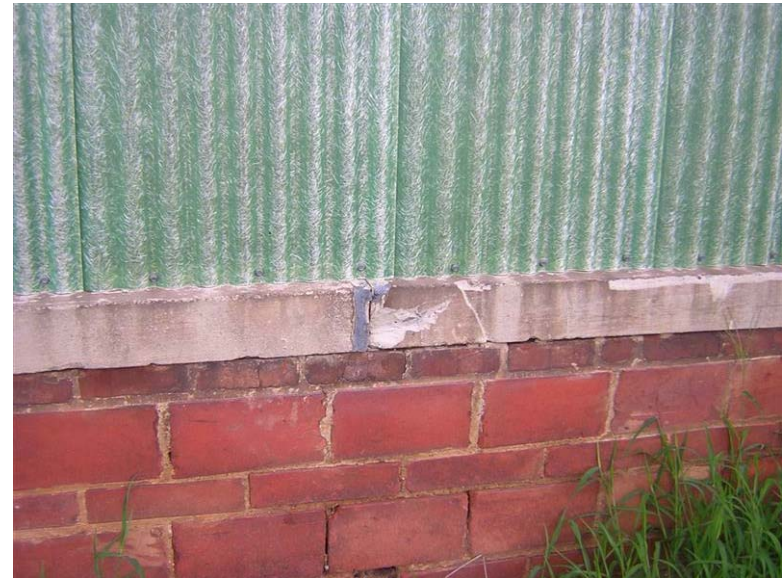
Building 79 – 3A – Nitrate House: Localized cracking and chipping is prevalent in the concrete sills.

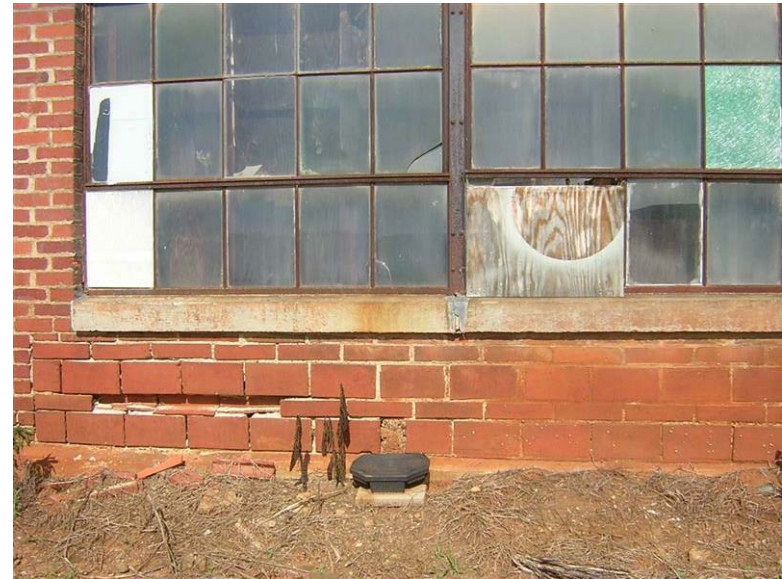
Building 81 – 5A – Nitrate House: Hollow clay tile and window panes are broken. The window has been partially covered with plywood.

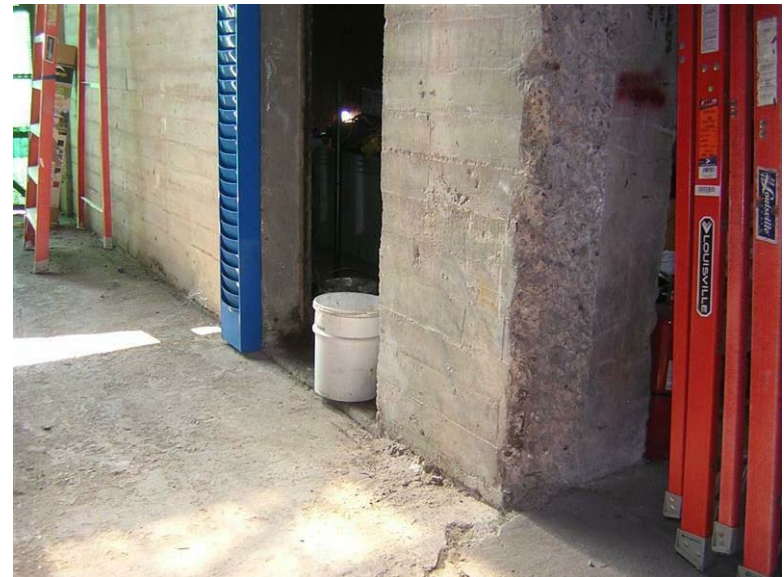
Building 81 - 5A - Nitrate House: The concrete wall is damaged.

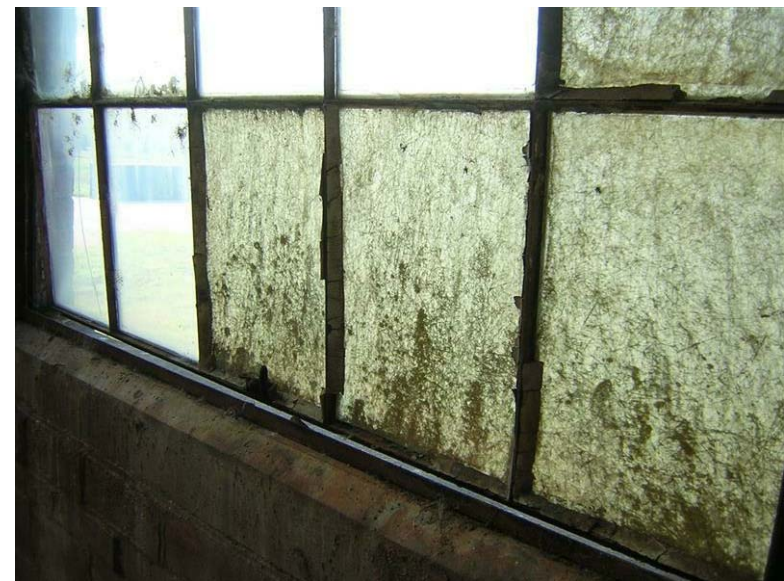
Building 81 - 5A - Nitrate House: The metal muntins are rusted and several window panes have been replaced.

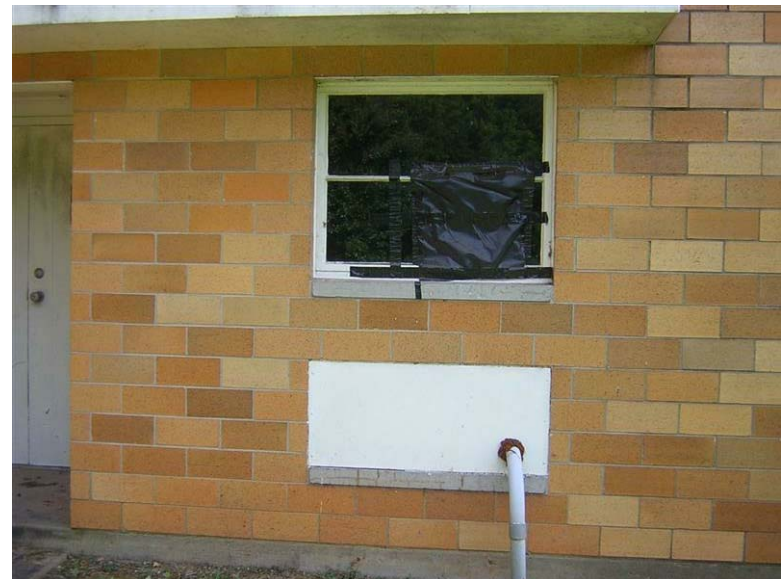
Building 118 – Greenhouse A: Plastic covers the broken window.

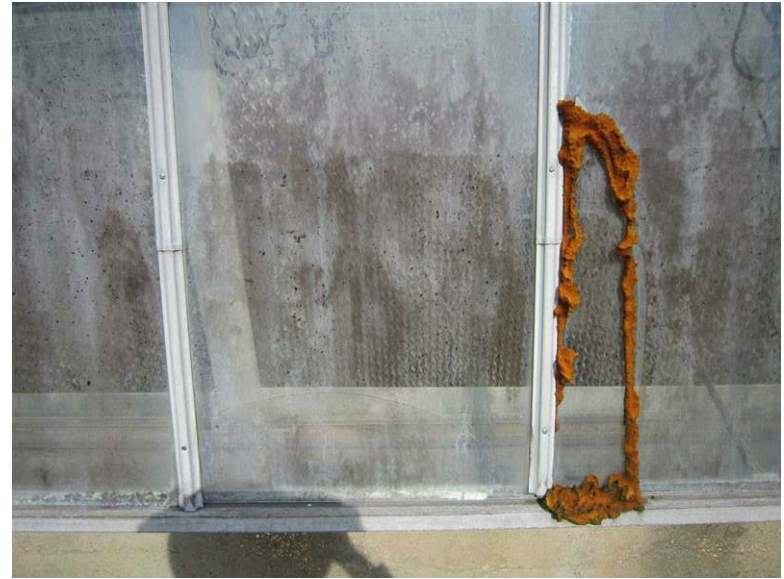
Building 118 – Greenhouse B-D: The broken pane has been sealed with an orange substance.
