# BOOK 2 . CONDITIONS

## Architectural and Historic Assessment

tennessee valley authority

Muscle Shoals Reservation  
adaptive re-use study  
Conditions/Market/Planning/Implementation

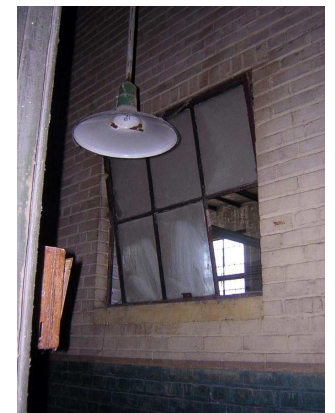
Significant cracking in masonry  
1st floor: cast concrete structure
