APPENDIX I.1 SEEP SUMMARY REPORT

John Sevier Fossil Plant Seep Summary Report

TDEC Commissioner's Order: John Sevier Fossil Plant Rogersville, Tennessee

July 30, 2021

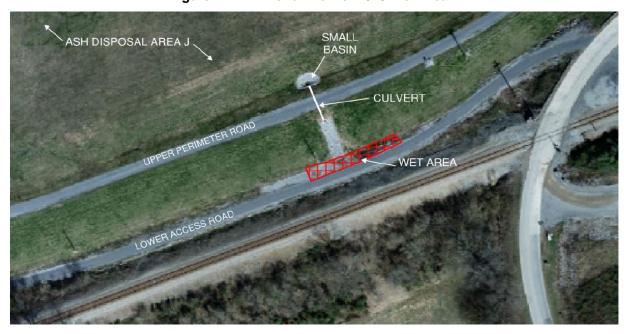
Figure 1. Aerial View of 2019 Wet Area

On September 2, 2019, a "wet area" was observed by TVA plant personnel at Ash Disposal Area J during a routine JSF Plant maintenance inspection. The wet area was specifically identified along the lower access road at the southern toe of Ash Disposal Area J, adjacent to the railroad (see Figure 1 below). Following weeks of monitoring the wet area, a strong correlation was found between the presence of standing water at this location and previous rainfall events. A precipitation event of 0.28 to 0.4 inches was recorded on August 28, 2019, five days before the initial observation on September 2, 2019.

On September 4, 2019, TVA and Stantec personnel observed standing water in the swale along the edge of the lower access road adjacent to the toe of Ash Disposal Area J. It was also observed that the standing water in the swale had accumulated in a rock-lined area of low relief along the toe of the slope that appeared to have obstructed positive drainage. The standing water was not observed to be turbid, flowing or discolored at the time of the site visit, and the wet area was isolated to the swale only.

The wet area was adjacent to a rock-lined flume located along the outslope that discharges flow from a culvert crossing under the upper perimeter road (see Figure 1 above). This culvert discharges water from a small stormwater basin located between the upper perimeter road and the top of Ash Disposal Area J. The small basin collects surface runoff from this portion of closed Ash Disposal Area J and appears to be contributing to the wet area.

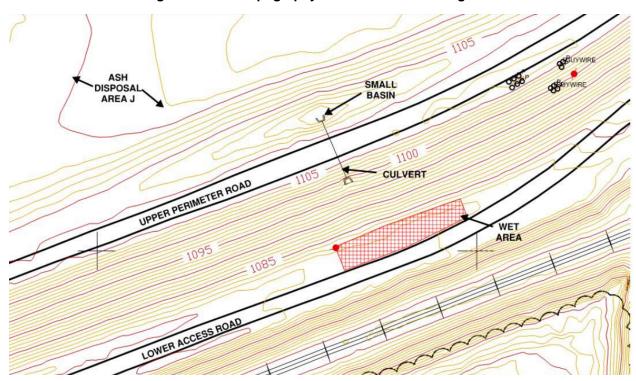
Figure 2. Topography of Aerial View from Figure 1

The topographic information presented in Figure 2 below shows the grade in this area to be less than one percent, confirming the field observations noted above.

Based on the observation reports and rainfall records, the accumulated water observed along the toe of Ash Disposal Area J appears to be from surface runoff during rainfall events originating from the rocklined flume and drainage from the road crossing located directly east of the flume.

Currently, information and observations suggest that poor drainage along the toe of Ash Disposal Area J is the cause of the wet area, and it was not considered an Area of Interest for further evaluation for the seep investigation. After a rain event, the standing water in the swale appears, and then slowly recedes and disappears during subsequent dry weather (see Appendix D).

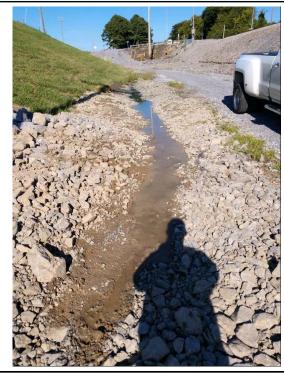
Standing water after rain event on 8/28/2019.

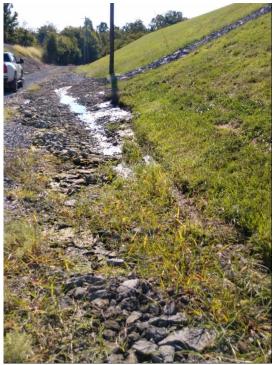
Photograph ID: 2

Standing water after rain event on 8/28/2019.

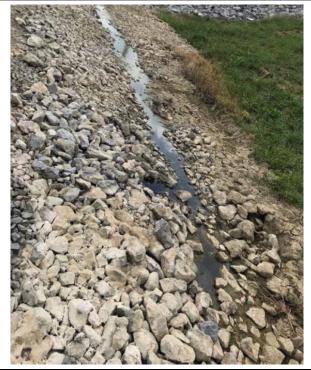
Wet area taken two days after the initial observation.

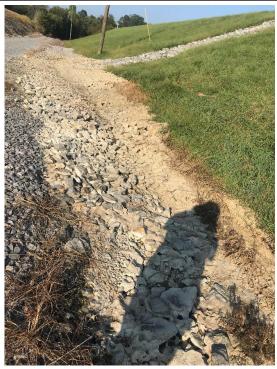
Photograph ID: 4

Former wet area is dry, 11 days after the initial observation.

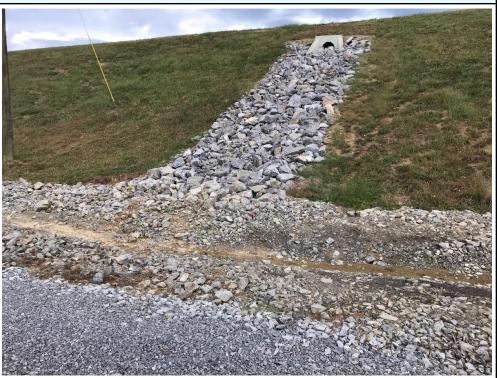
Former wet area is dry, 33 days after the initial observation.

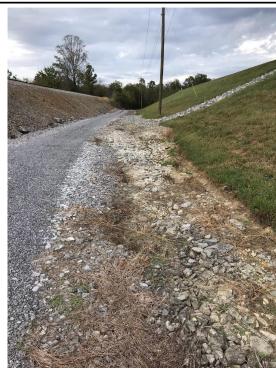
Photograph ID: 6

Former wet area is dry, 33 days after the initial observation.

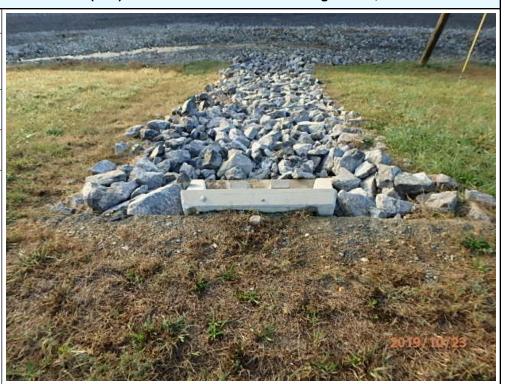
Standing water in the area after three rain events:
October 16th, the area reported 0.8 inches of rainfall; on October 20th, 1.6 inches of rainfall, and on October 23rd, 0.14 inches of rainfall.

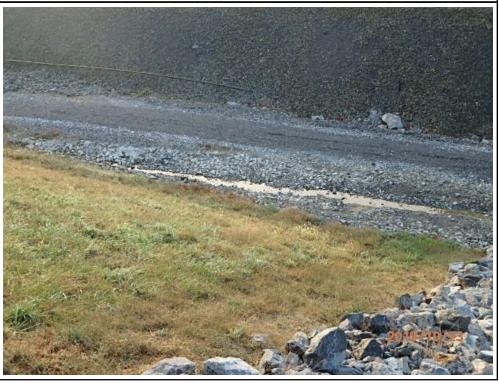
Photograph ID: 8

Standing water in the area after three rain events October 16th, October 20th, and October 23rd.

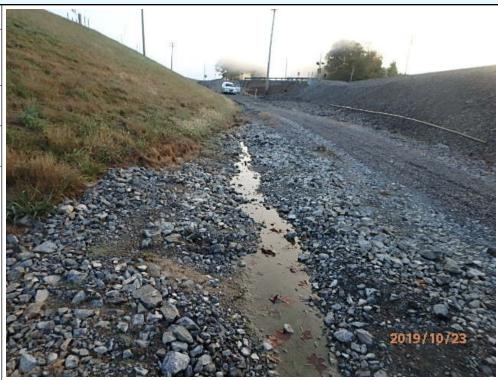
Standing water in the area after three rain events October 16th, October 20th, and October 23rd.

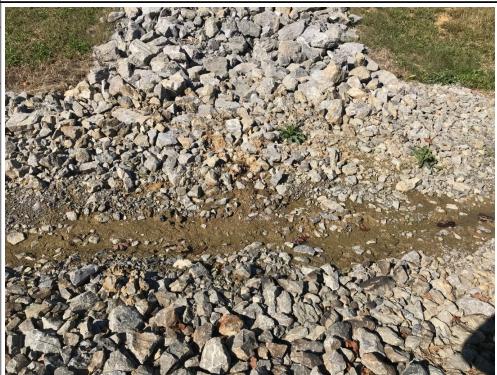
Photograph ID: 10

Wet area receding two days after October 2019 rain events.

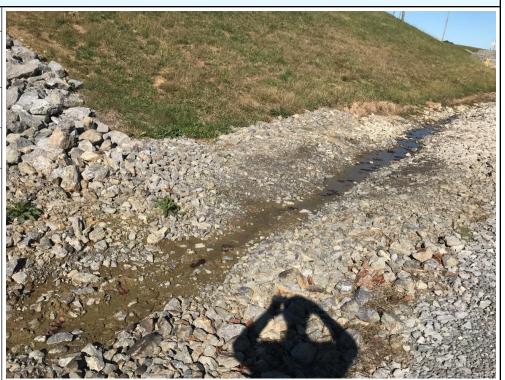
Wet area receding two days after October 2019 rain events.

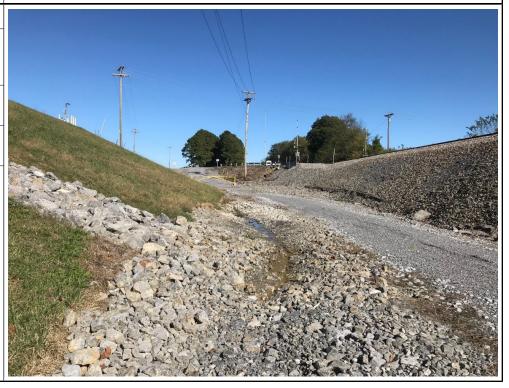
Photograph ID: 12

Wet area receding two days after October 2019 rain events.

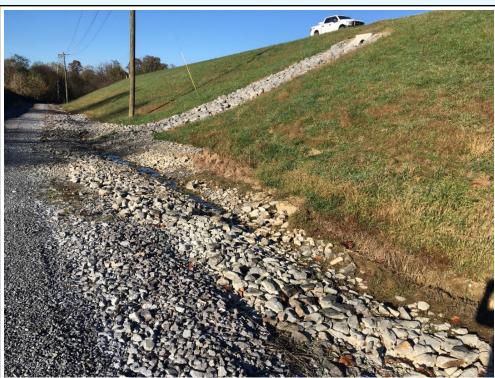
Standing water after October 26, 27, 31 and November 1, 2019 rain events.

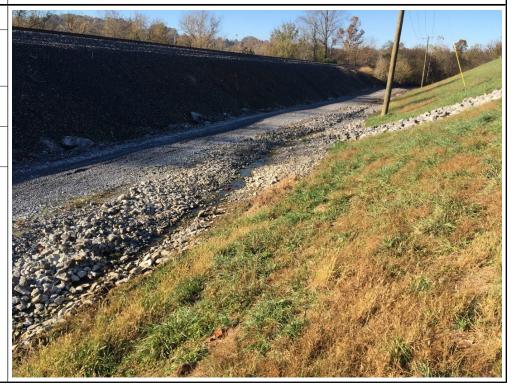
Photograph ID: 14

Standing water after October 26, 27, 31 and November 1, 2019 rain events.

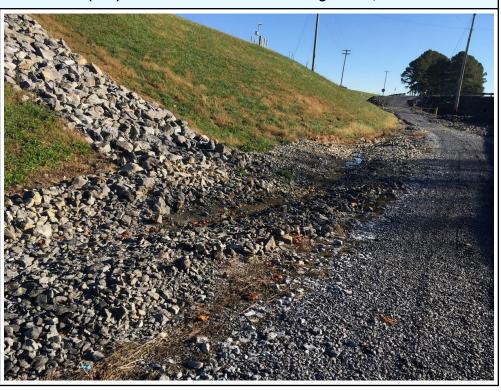
Standing water after October 26, 27, 31 and November 1, 2019 rain events.
