Document No. EPA-AO-063A

Kingston Ash Recovery Project

On-Scene Coordinator Report Addendum for the Non-Time-Critical Removal Action for the Embayment/Dredge Cell

**TVA Kingston Fossil Fuel Plant Release Site,
Roane County, Tennessee**

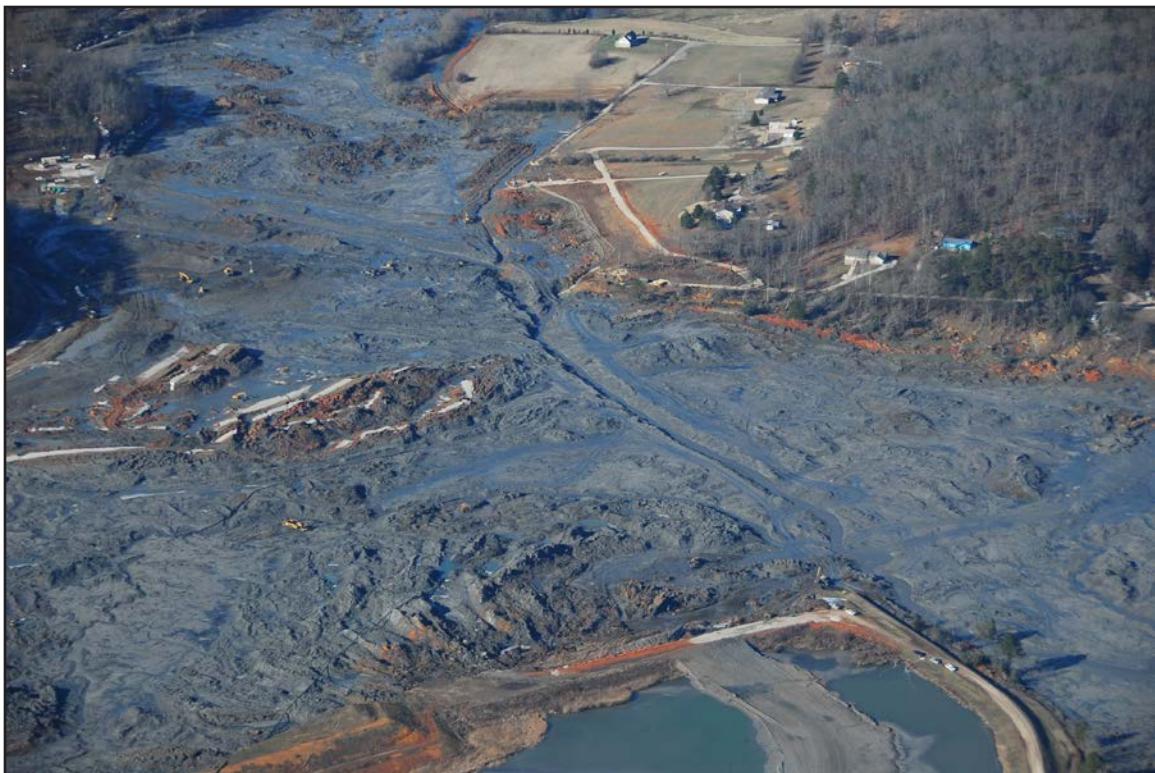
1A – Oblique of the Middle Embayment after release (viewing from the east). January 8, 2009.

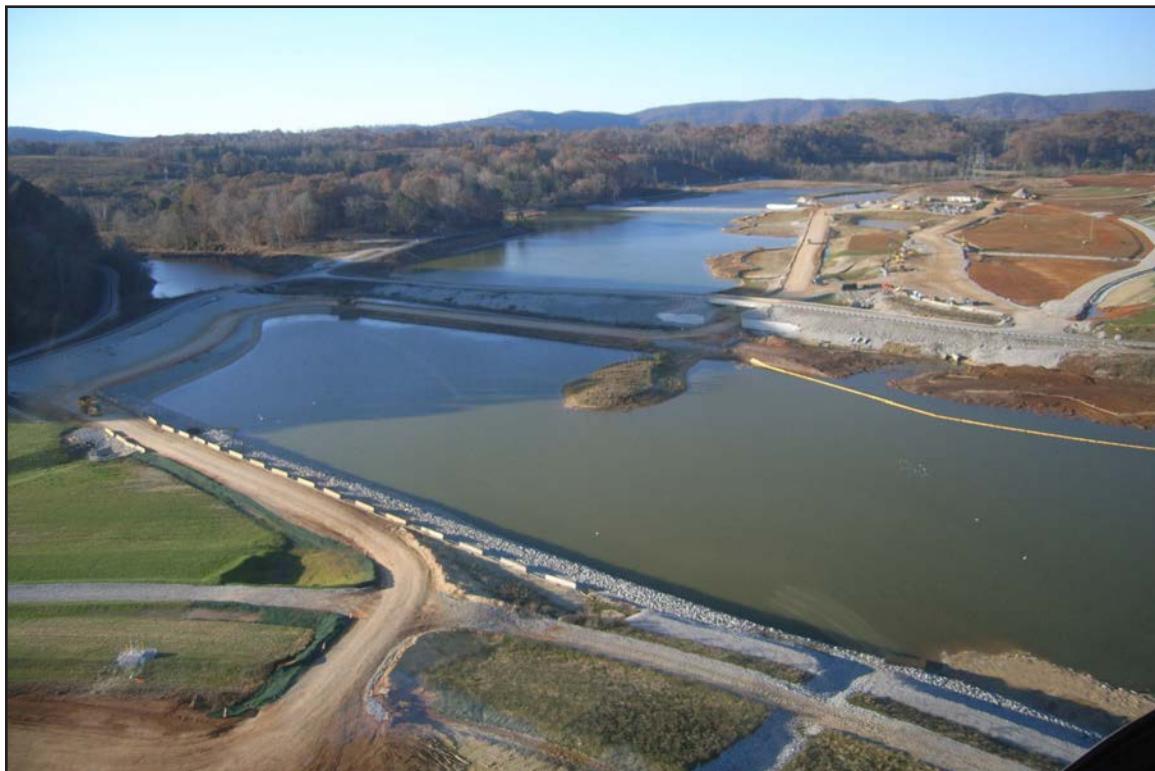
1B – Oblique of the Middle Embayment following SPEER Non-Time-Critical Removal Action. November 18, 2014.

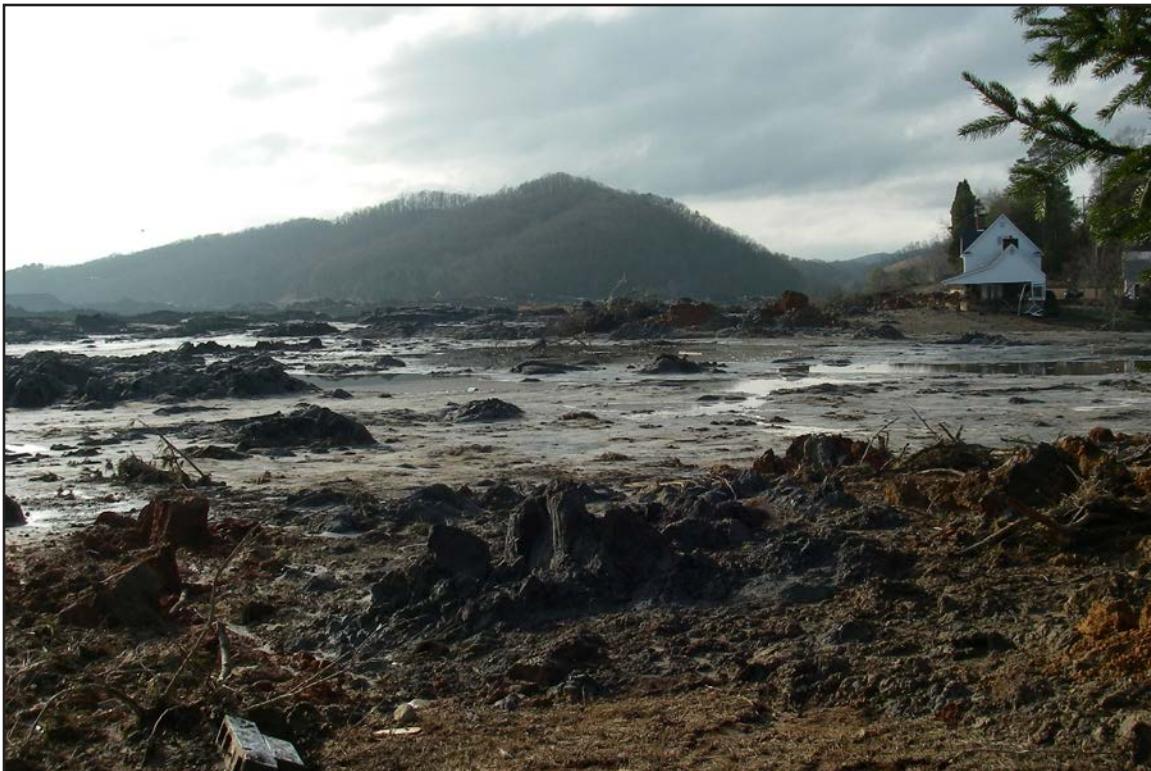
1C – Middle Embayment after release. December 27, 2008.

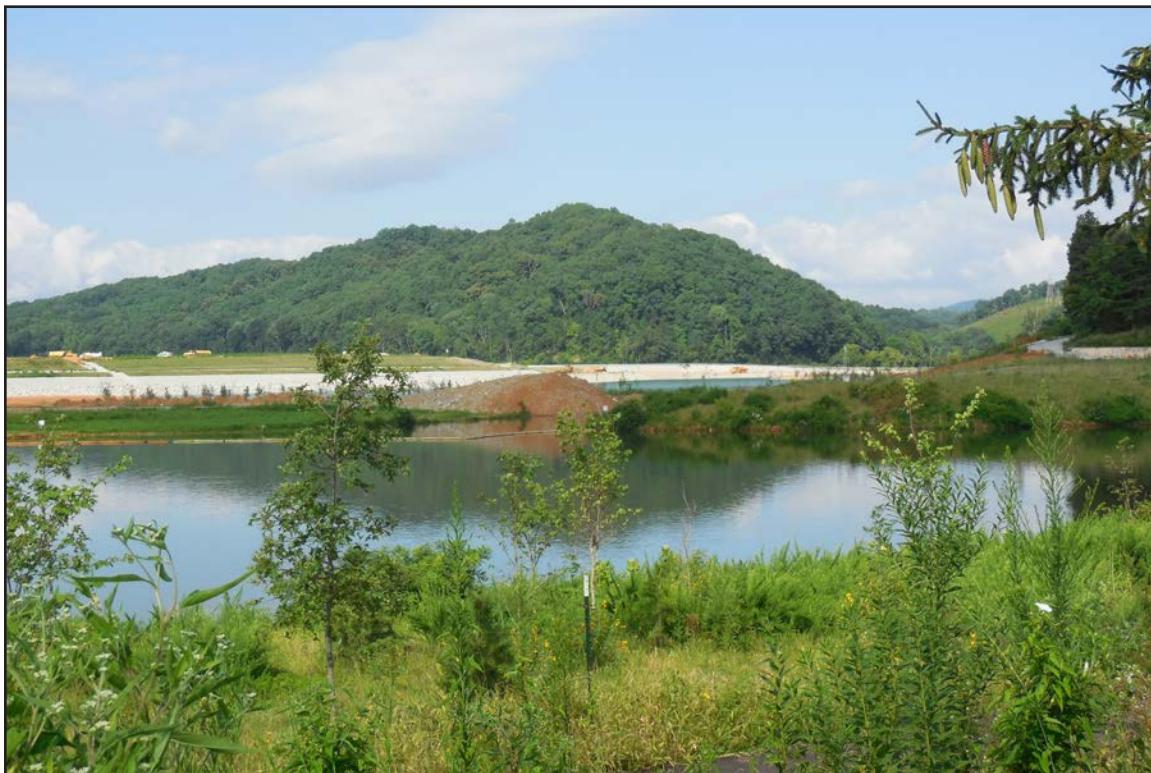
1D – Middle Embayment following SPEER Non-Time-Critical Removal Action. July 29, 2014.

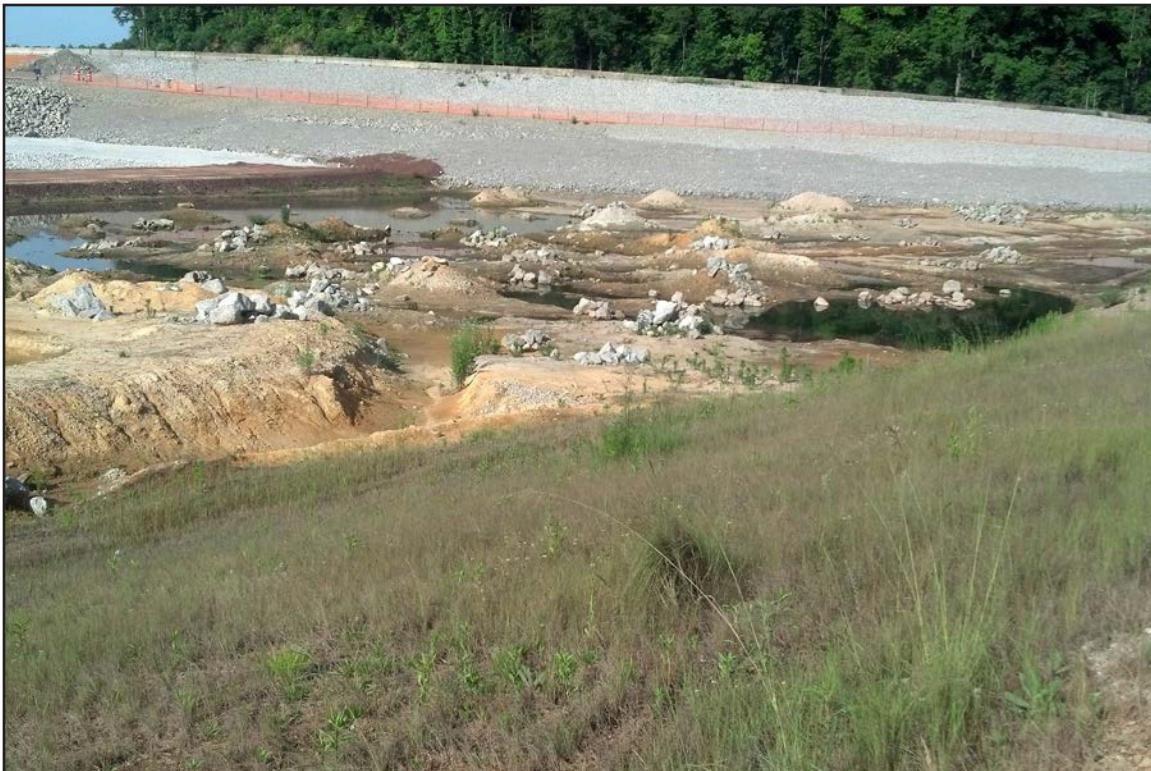
2A – Middle Embayment before inundation with rock piles as fish habitat. May 24, 2014.

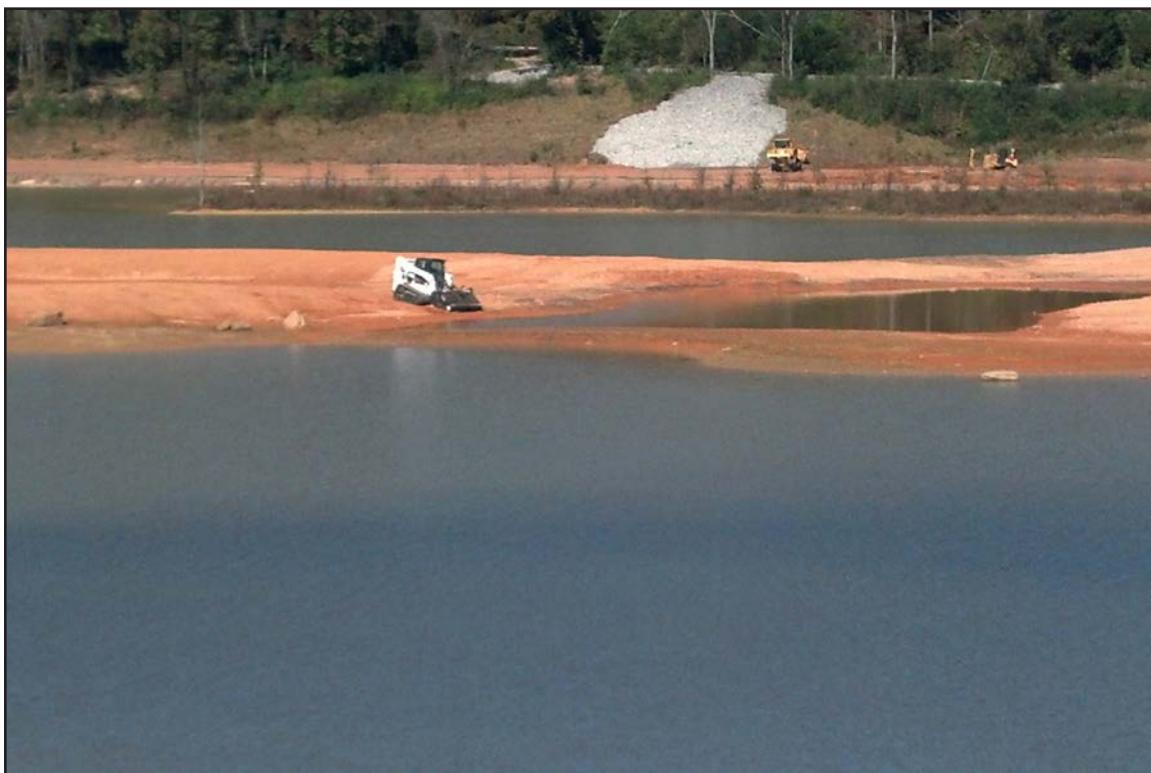
2B – Middle Embayment final grading by Merit to remove rocks. October 22, 2014.

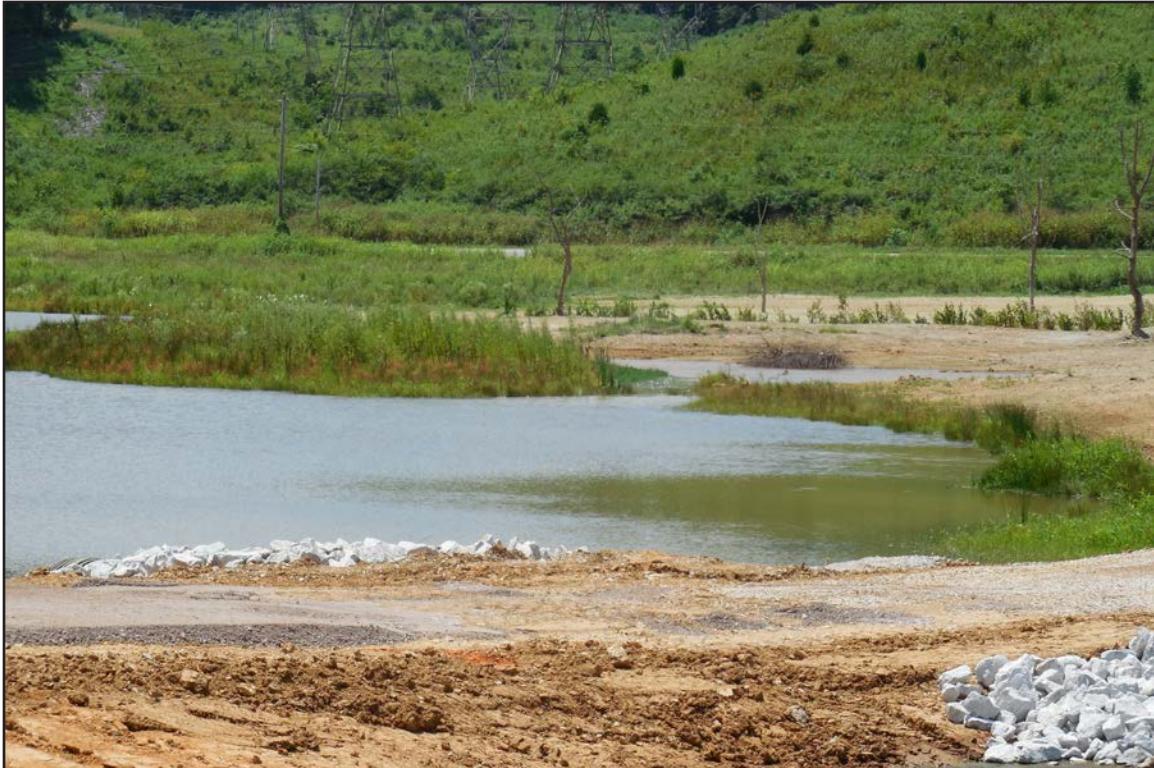
3A – North Embayment grading of transitional wetlands area. July 29, 2014.

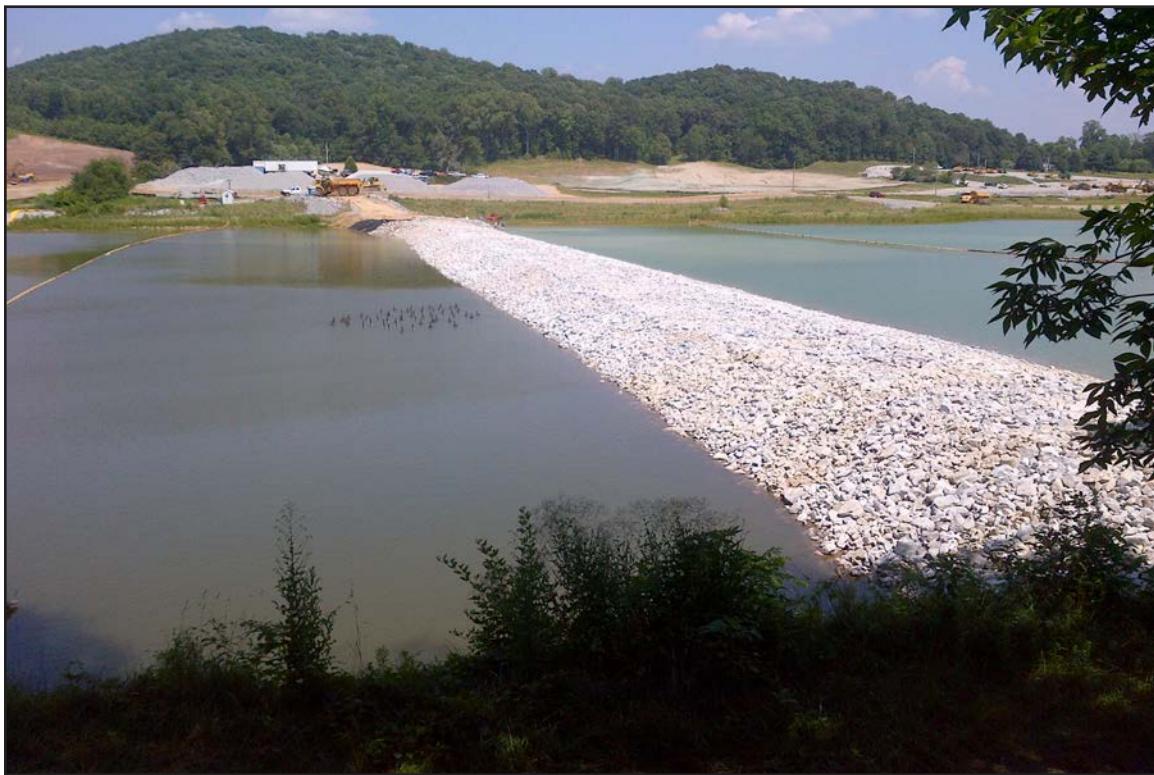
3B – North Embayment riprap armoring of the North Berm dike. July 7, 2014.

The berm traversing the North Embayment had been installed in 2010 as a temporary storm water control berm during ash removal from the North Embayment. In cooperation with the Natural Resource Damage Assessment (NRDA) trustees, it was agreed that the berm would remain permanently so as to establish optimum riparian habitat under a stable (fixed) shoreline in the upper half of the North Embayment. The TVA Dam Safety Governance organization classified the berm as a low risk dam that could be overtopped during significant storm events. As a result, riprap armoring was placed on the berm for erosion protection. The riprap extended partially down the upstream face of the berm, across the top of the berm, and full depth of the downstream face of the berm. The riprap armoring extended from abutment to abutment, approximately 670 ft. The riprap armoring was constructed by SCS in July and August 2014.

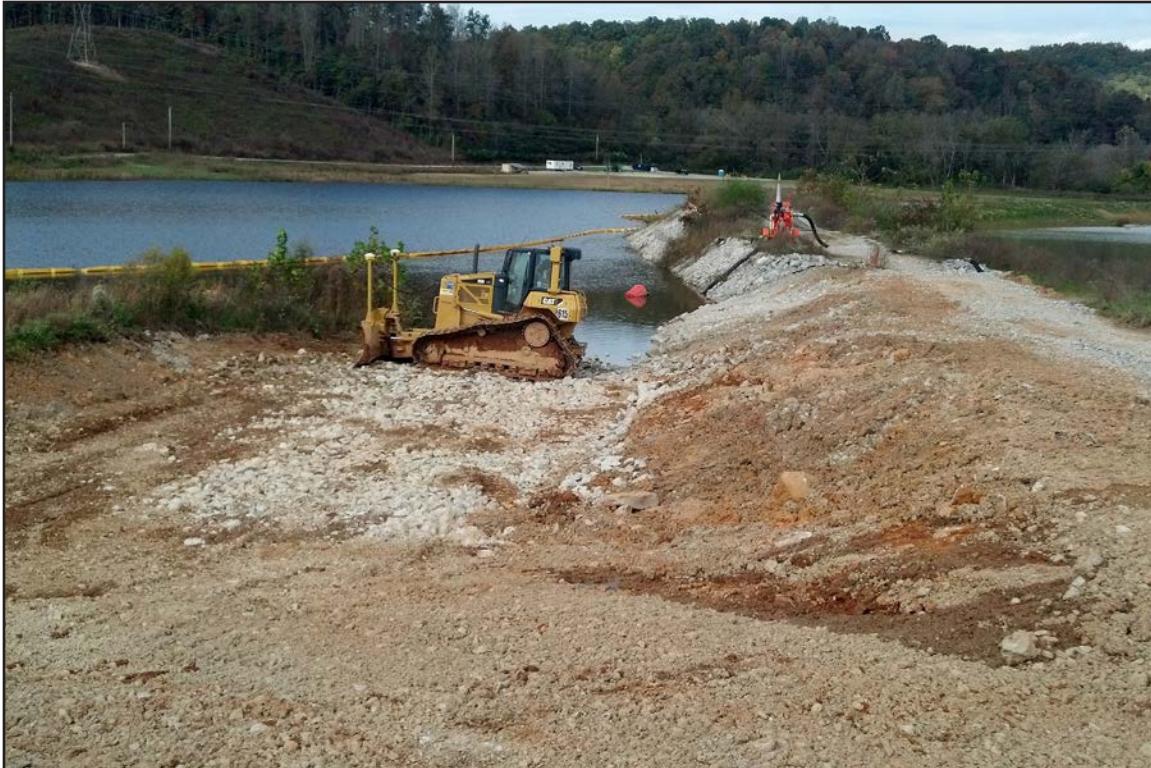
4A – Grading of clean water ditch - Filling in North Embayment. October 20, 2014.

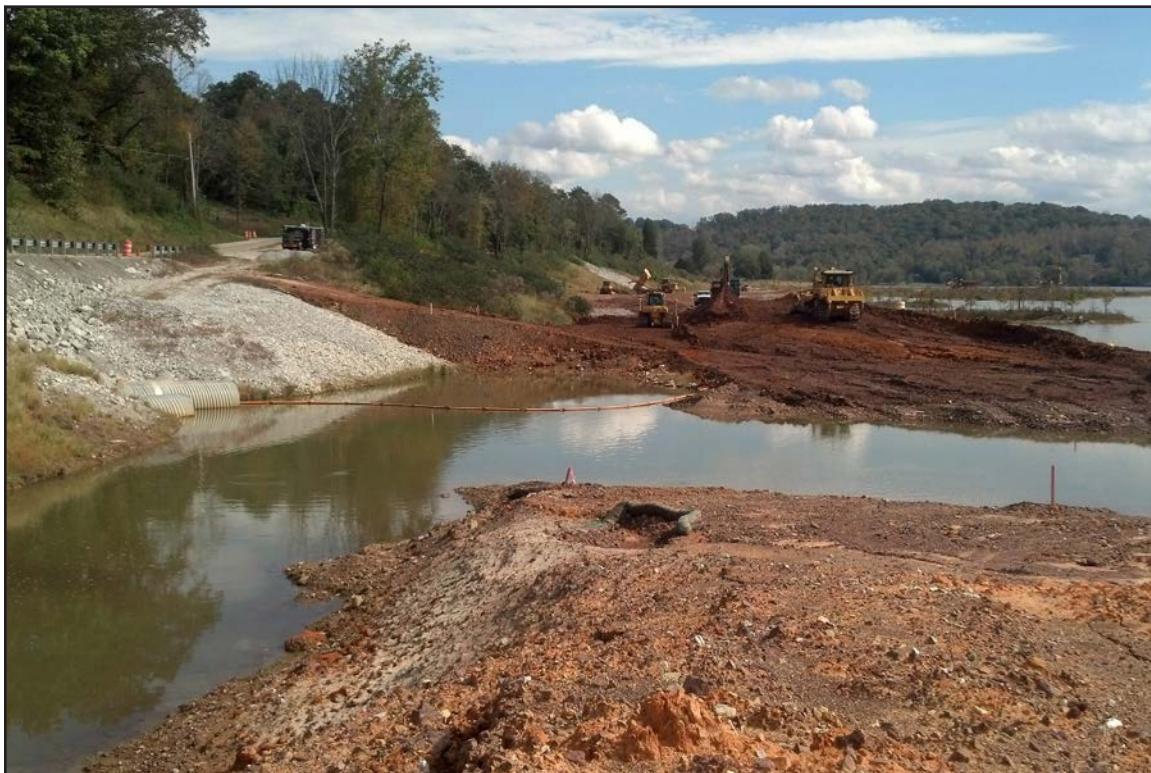
4B – Grading of clean water ditch - Filling in Middle Embayment. October 20, 2014.

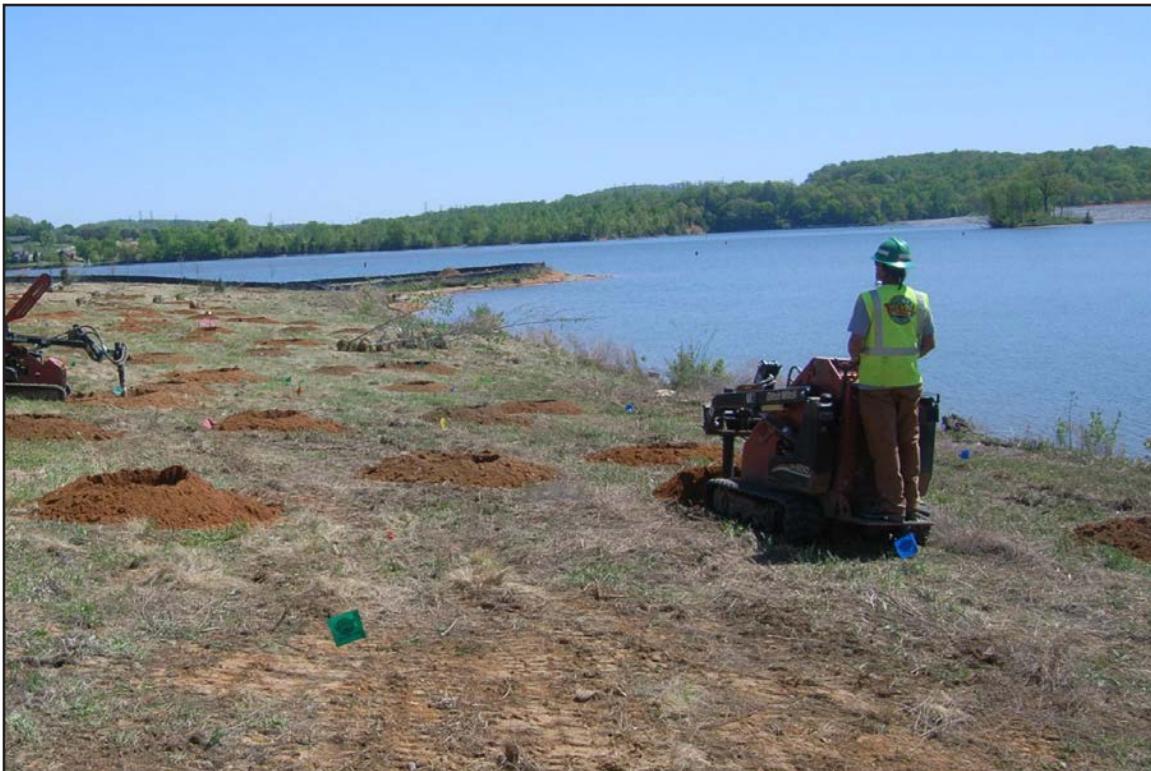
5A – Plantings - Augering holes for trees. April 23, 2014.

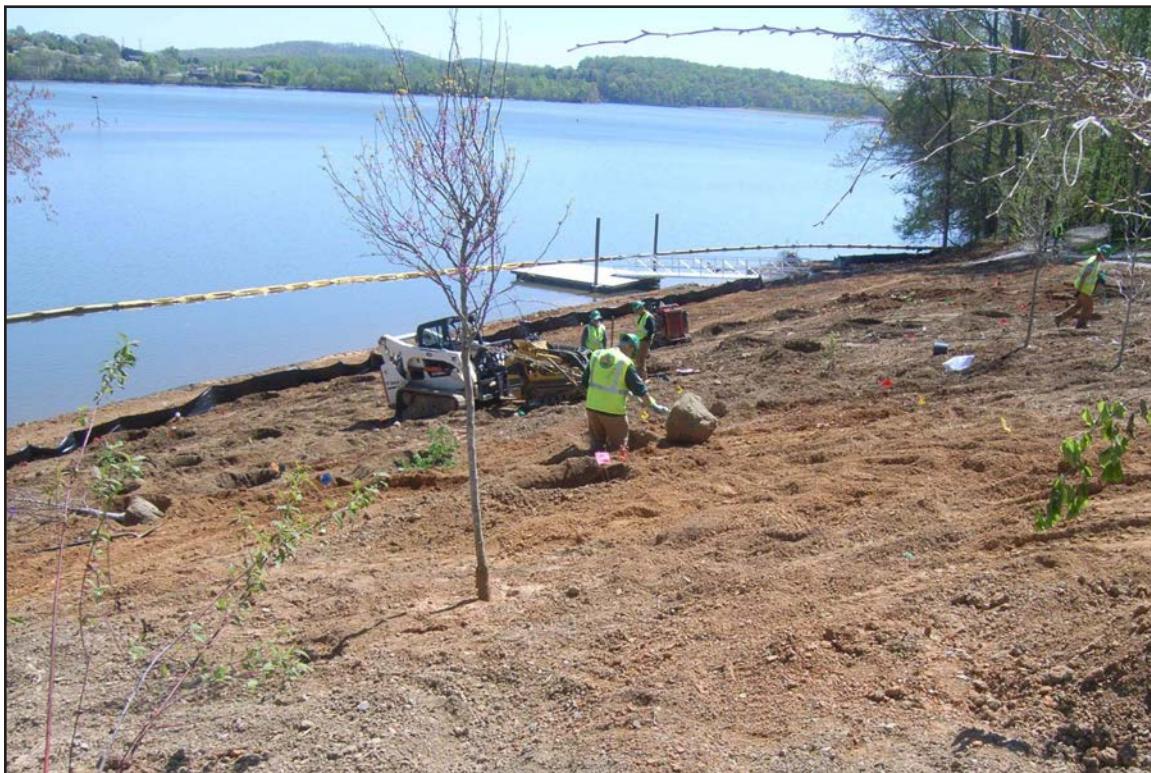
5B – Plantings - Placing balled and burlapped trees in reforestation areas. April 16, 2014.

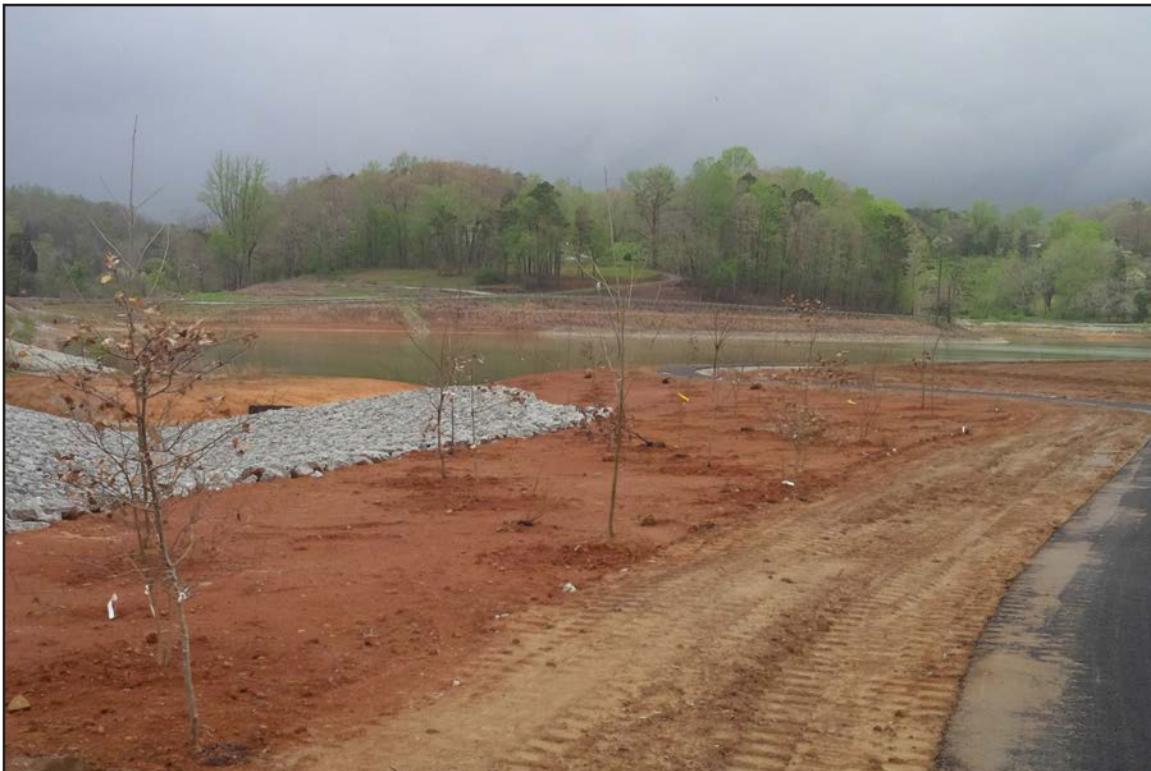
6A – Plantings - Reforestation area in the North Embayment. April 10, 2015.

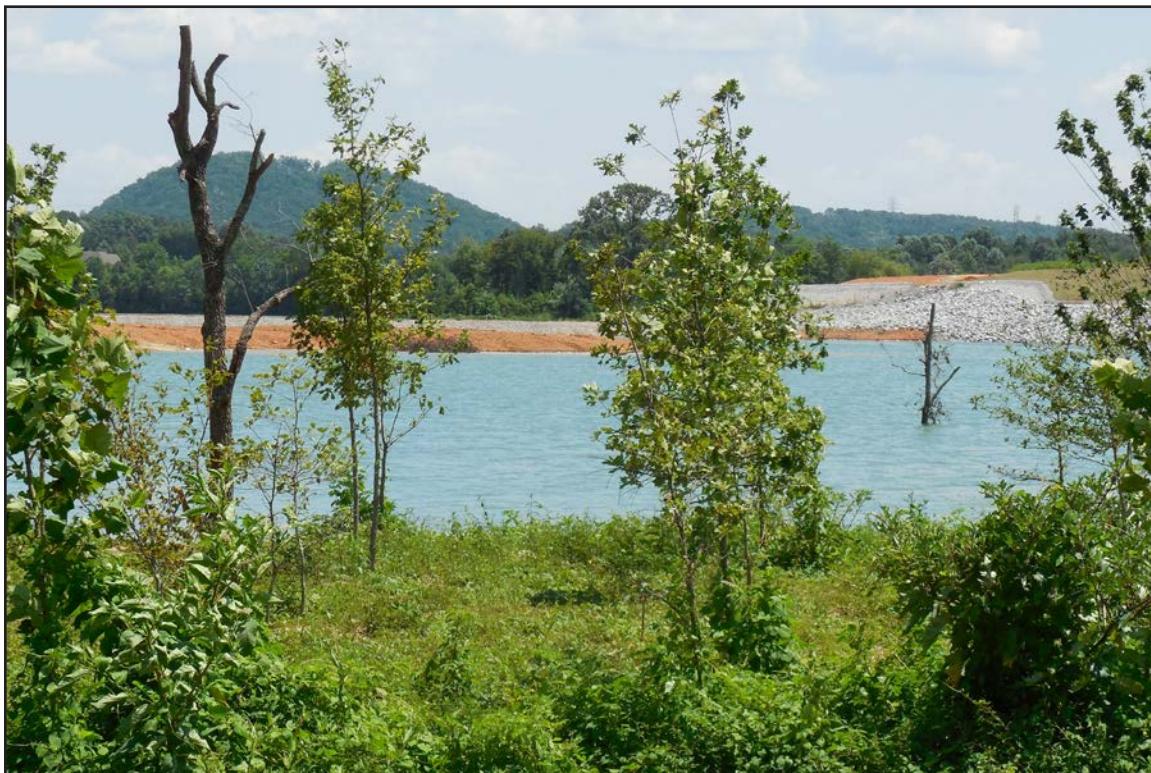
6B – Plantings - Reforestation area in the Middle Embayment. July 29, 2014.

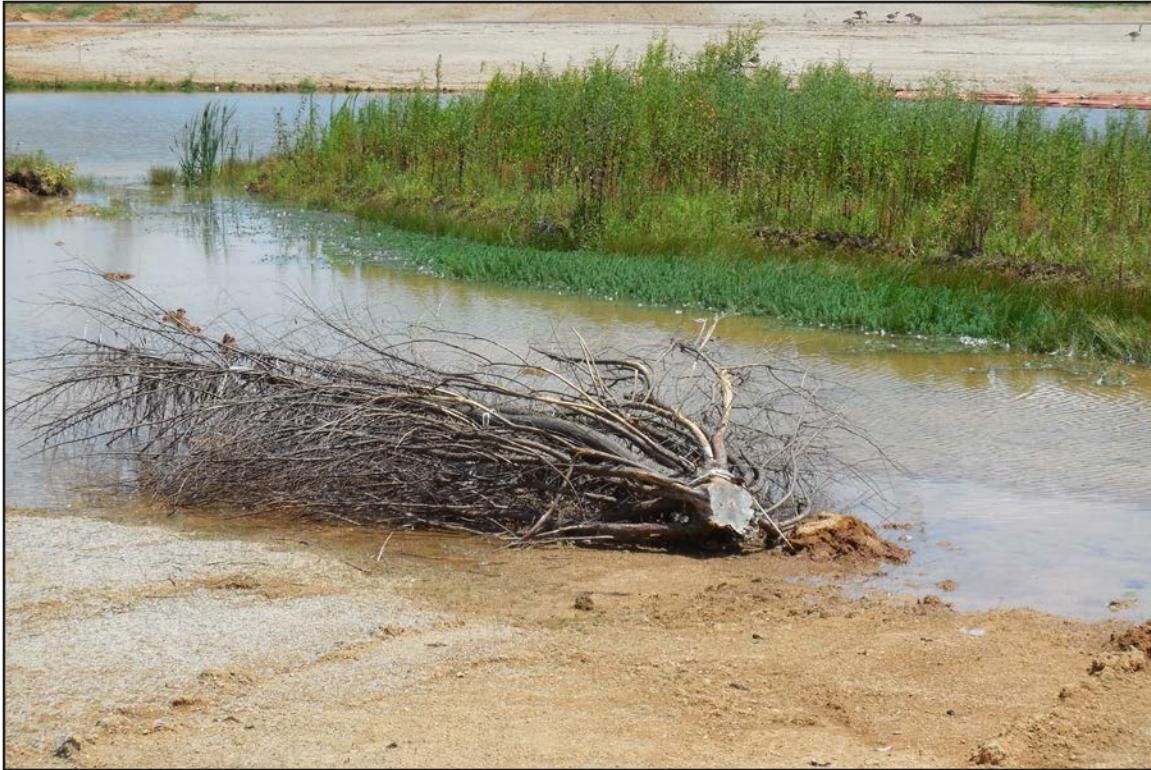
7A – Fish habitat structures - Fish attractor. July 29, 2014.

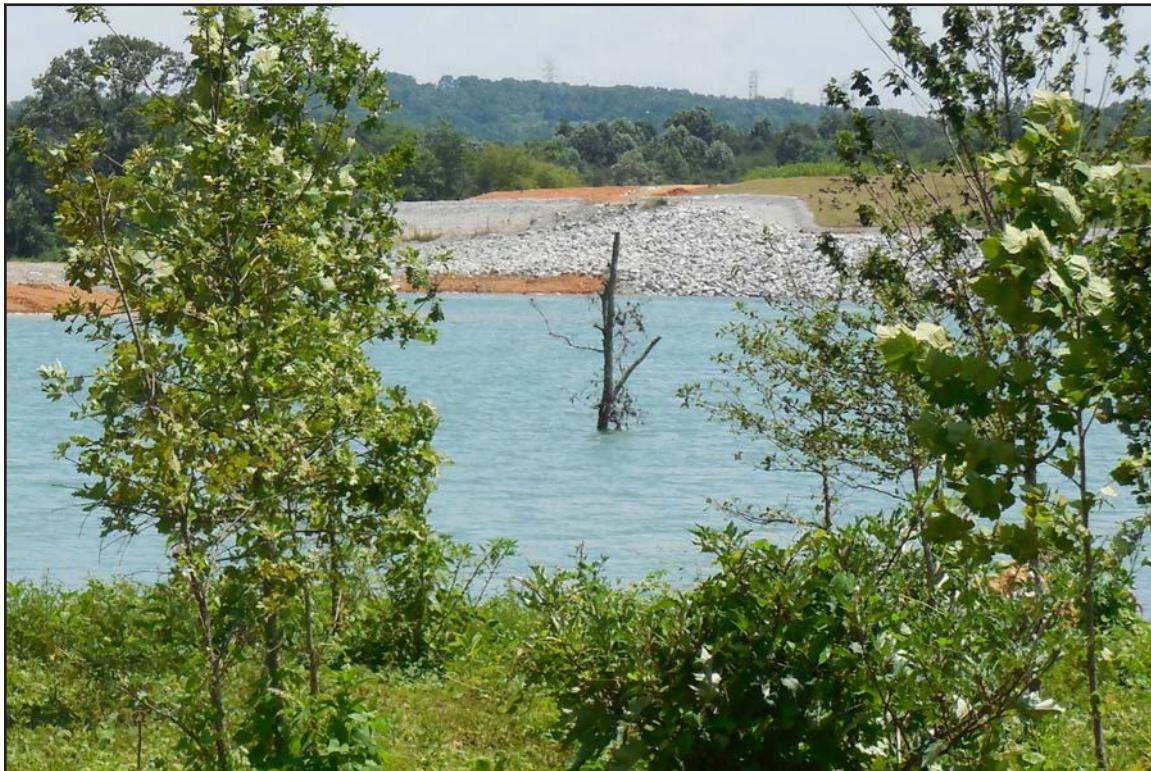
7B – Simulated tree snag in the Middle Embayment. July 29, 2014.

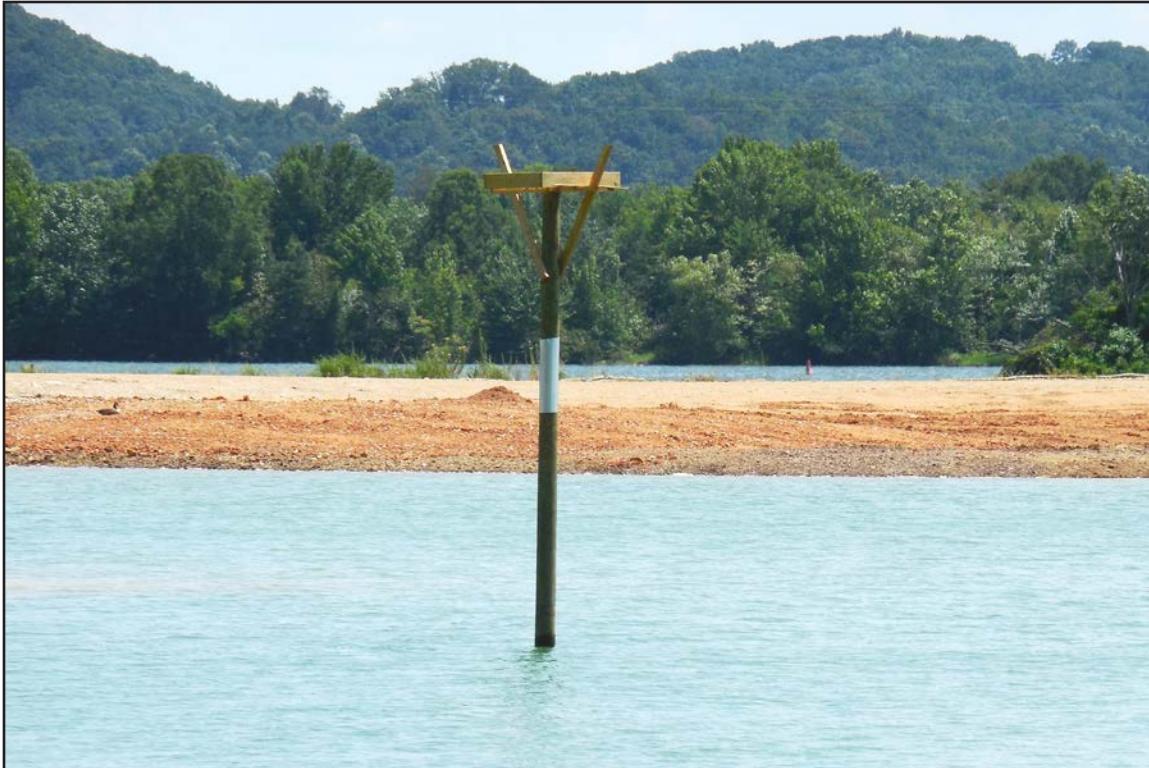
8A – Osprey platform erected in the Middle Embayment. July 29, 2014.

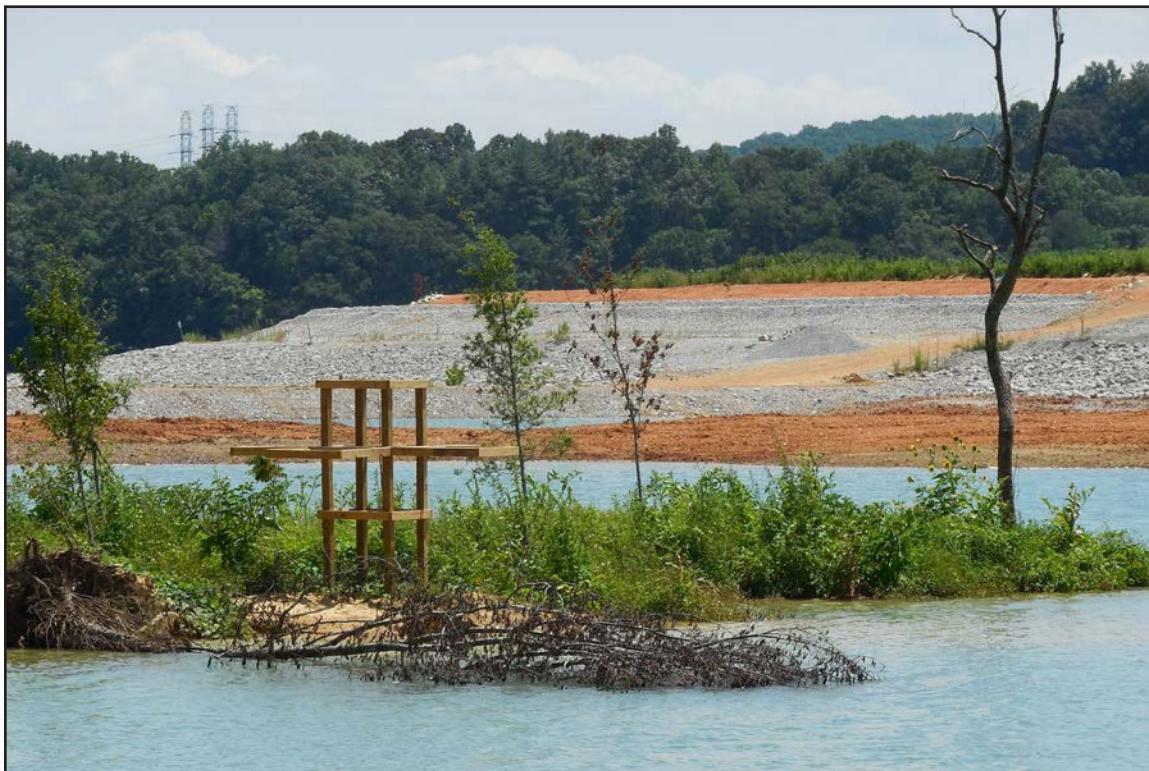
8B – Heron platform erected in the Middle Embayment. July 29, 2014.

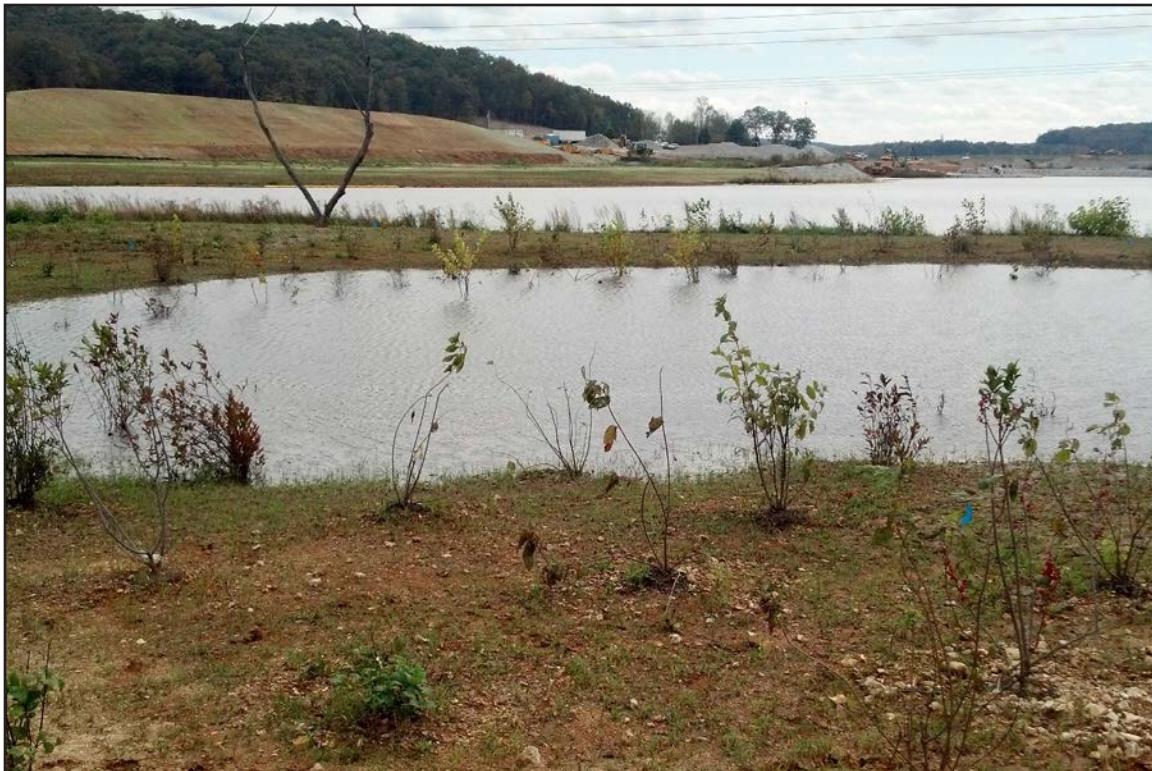
9A – Vernal pools in the North Embayment with plantings of wetland shrubs. October 20, 2014.

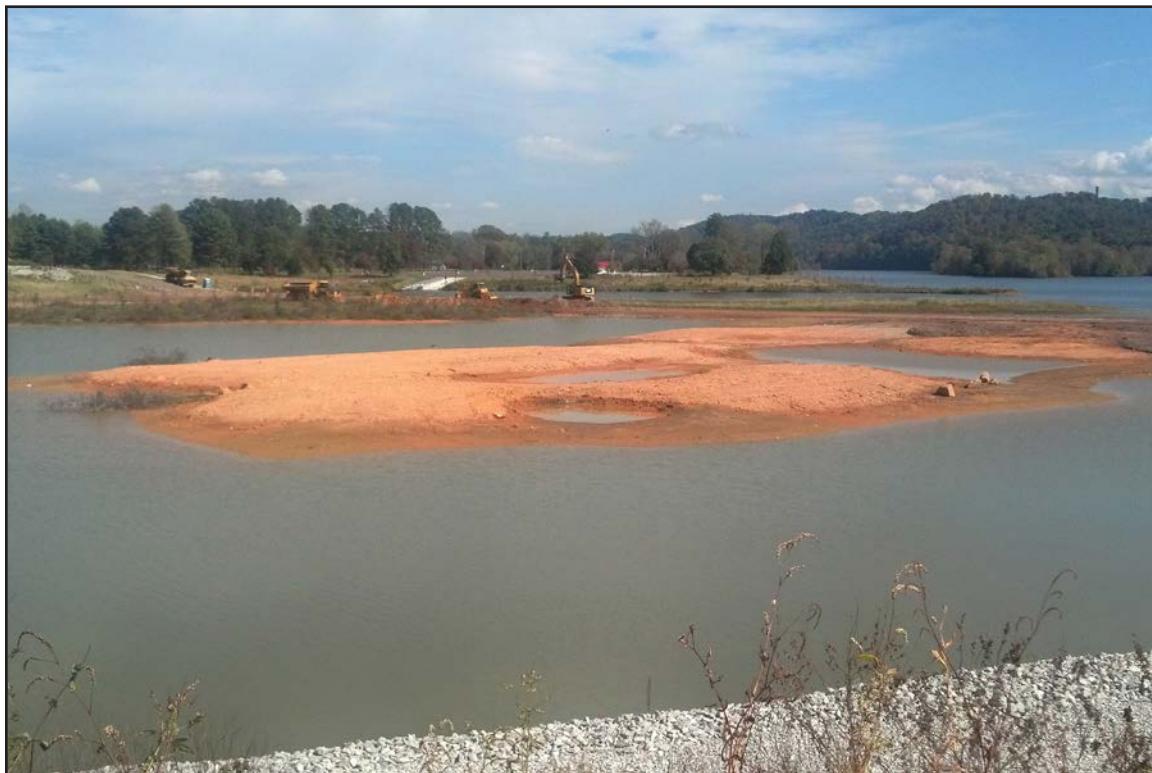
9B – Vernal pools in the Middle Embayment. October 20, 2014.

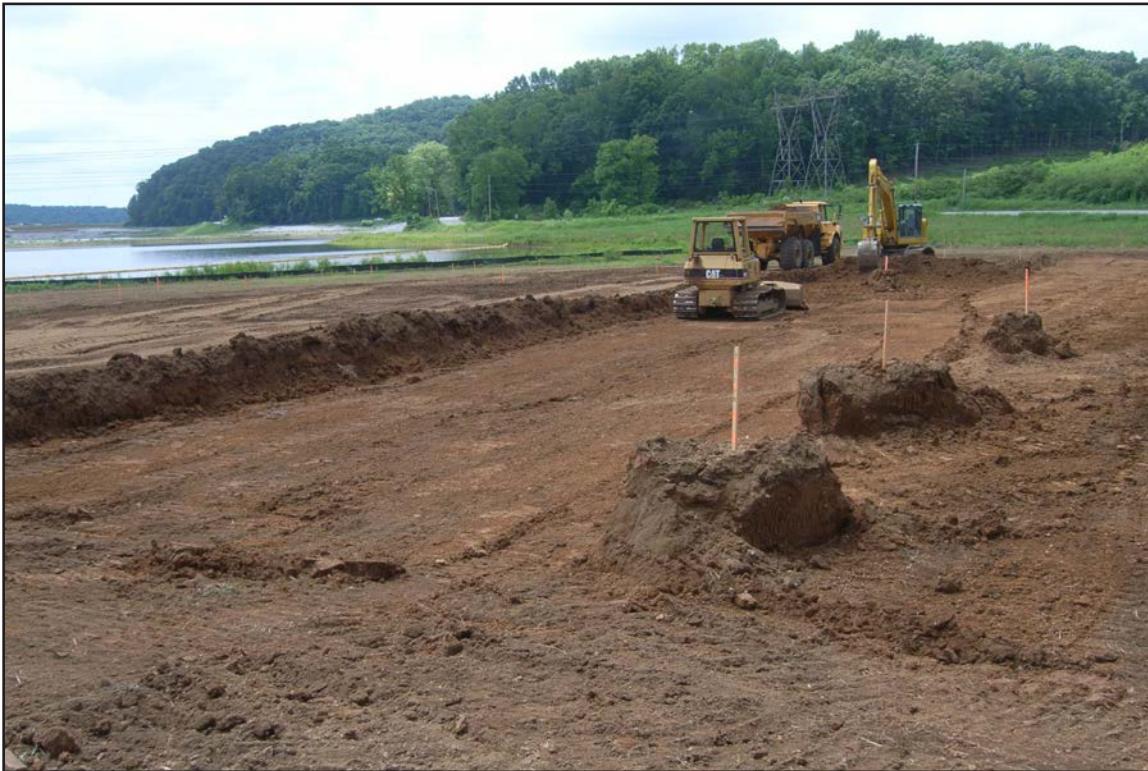
10A – Wetlands construction - Grading for wetland in the North Embayment. June 10, 2014.

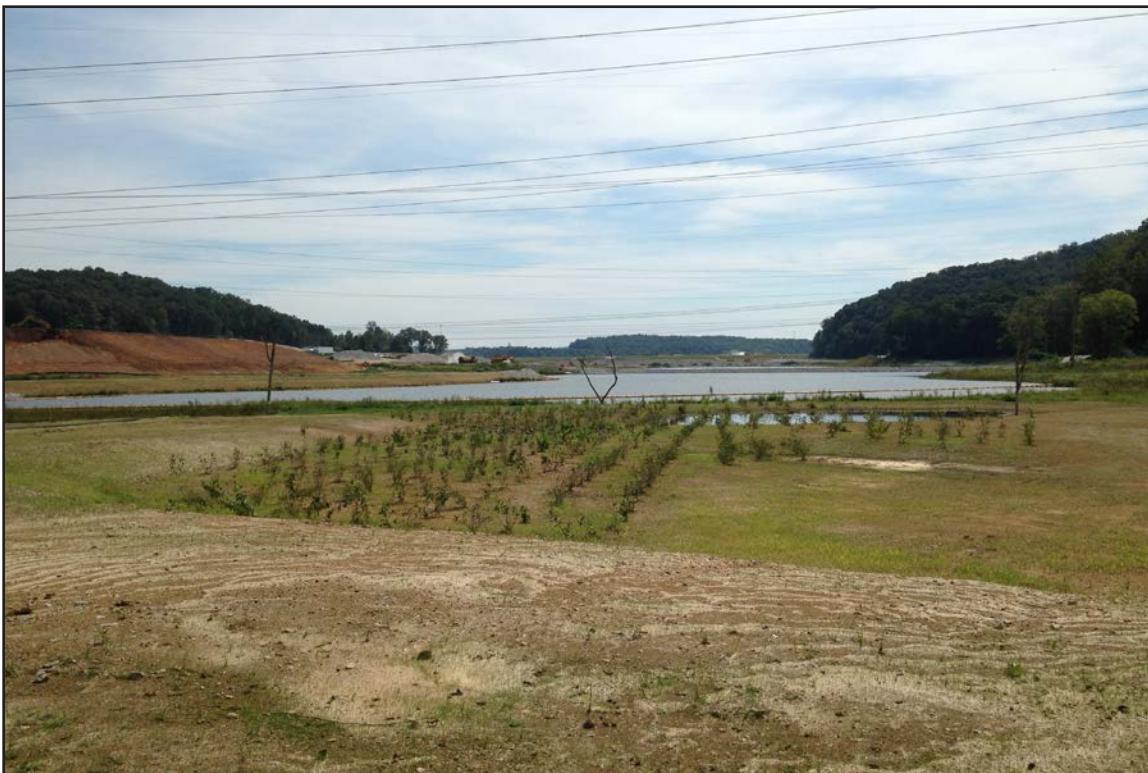
10B – Wetland construction - Completed wetland in the North Embayment. September 18, 2014.

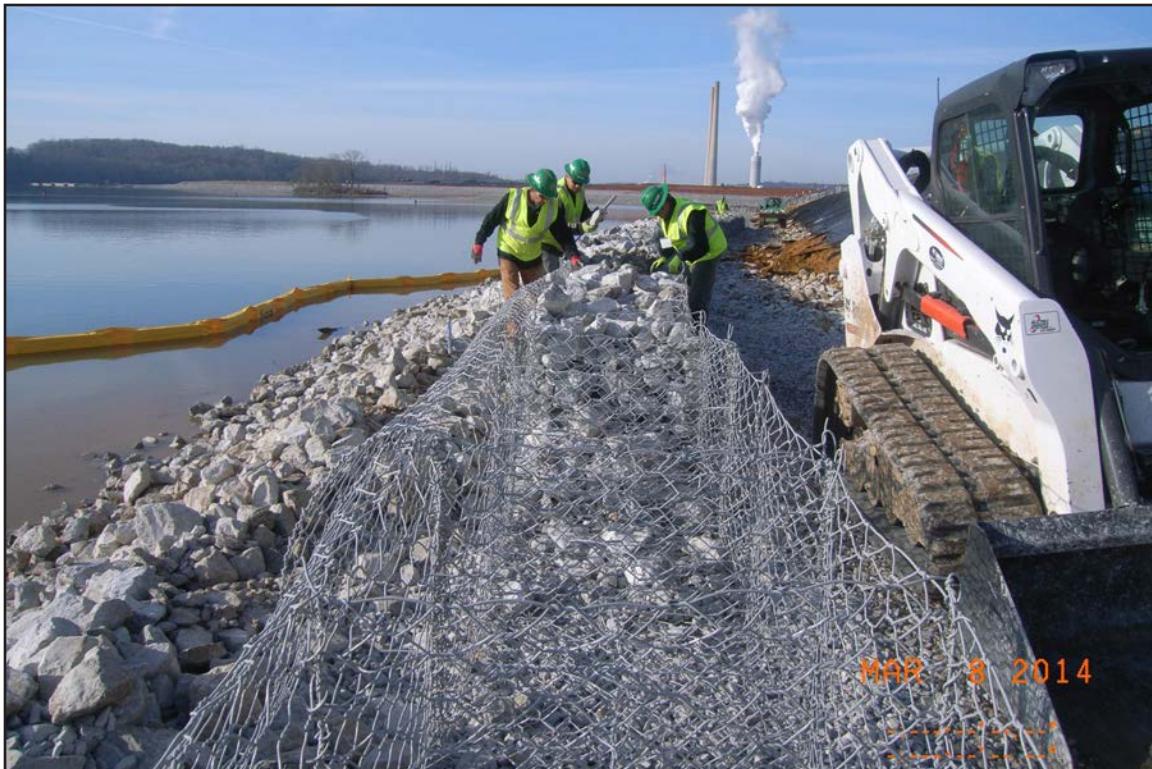
11A – Vegetative slope stabilization - Placing gabions. March 8, 2014.

Historical bank erosion in two areas along the Emory River shoreline had created unstable conditions. To stabilize the slope and provide for a natural-appearing bank, a vegetative retaining wall system was constructed. The retaining wall system consisted of modular units with mechanically-stabilized reinforced backfill. AMEC Environment and Infrastructure completed the wall design per Submittal 0173.

The wall was constructed in two parts: Wall A at the southern end of the Lakeshore peninsula was approximately 430 ft long and Wall B at the northern end was approximately 490 ft long. Initial construction, beginning on February 27, 2014, consisted of excavating to a firm, level foundation while water levels in Watts Bar Reservoir were relatively low. Although the original design called for two rows of gabions to be placed, one above the other, due to rising lake levels in early spring, an 18-inch layer of rock was placed first. The rock layer was placed between elevations 739.5 and 741.0 ft msl. A single row of gabions was then placed as foundation platform on top of the rock foundation. The gabions consisted of woven wire baskets 3 ft high and 3 ft thick that were filled with cobble-sized rock. Riprap was placed for scour protection outboard of the gabion and rock foundation, between elevations 735.0 and 744.0 ft msl.

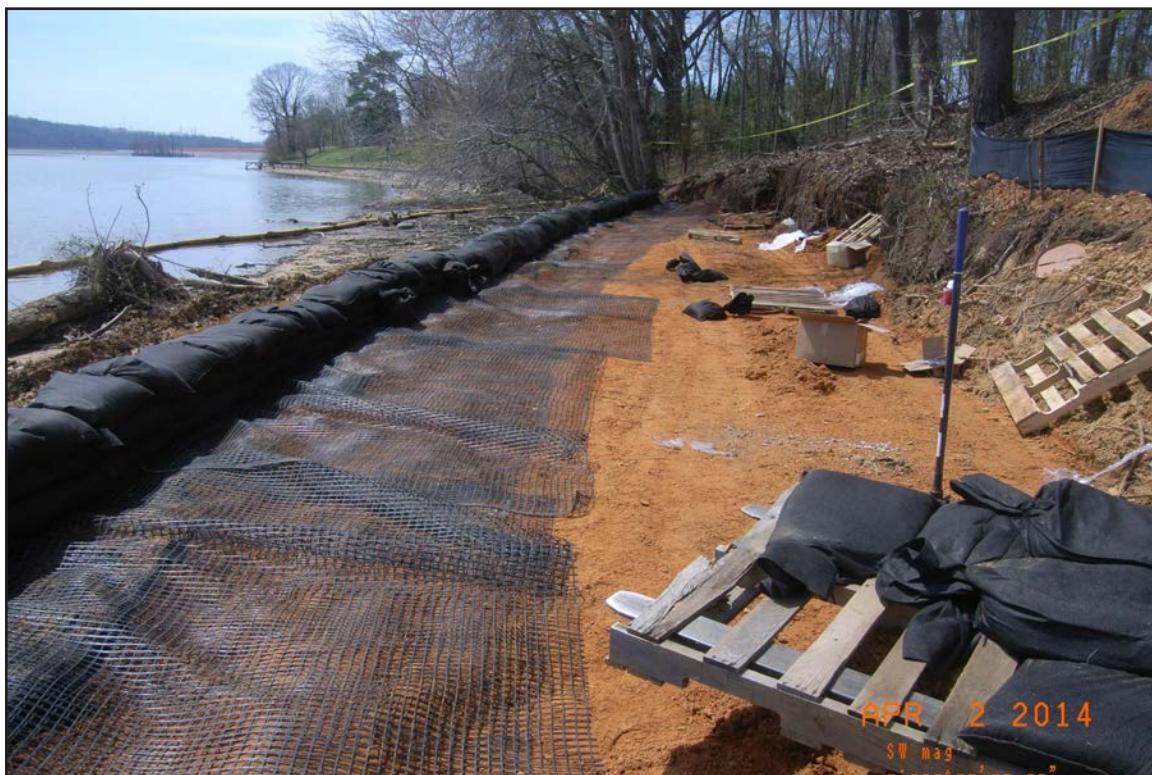
11B – Vegetative slope stabilization - Placing geogrid tiebacks. April 2, 2014.
