Document No. EPA-AO-063A

Kingston Ash Recovery Project

On-Scene Coordinator Report Addendum for the Non-Time-Critical Removal Action for the Embayment/Dredge Cell

**TVA Kingston Fossil Fuel Plant Release Site,
Roane County, Tennessee**

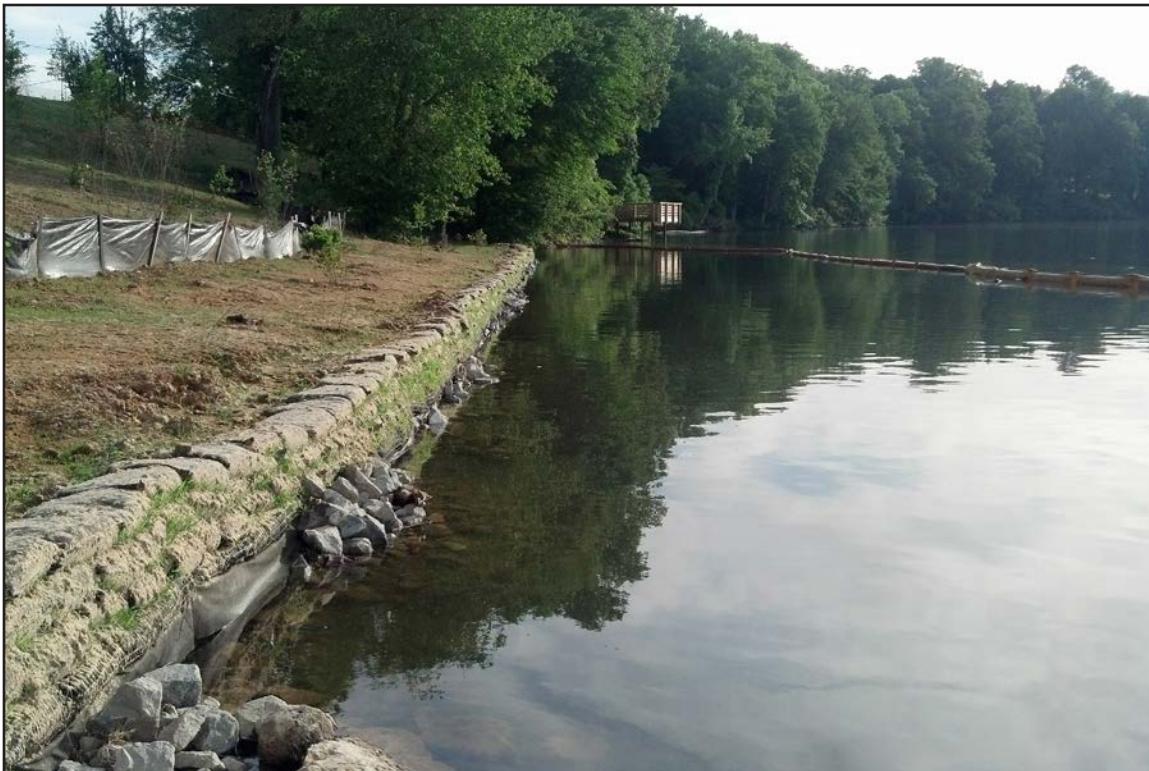
12A – Vegetative slope stabilization - Emory River shoreline. May 24, 2014.

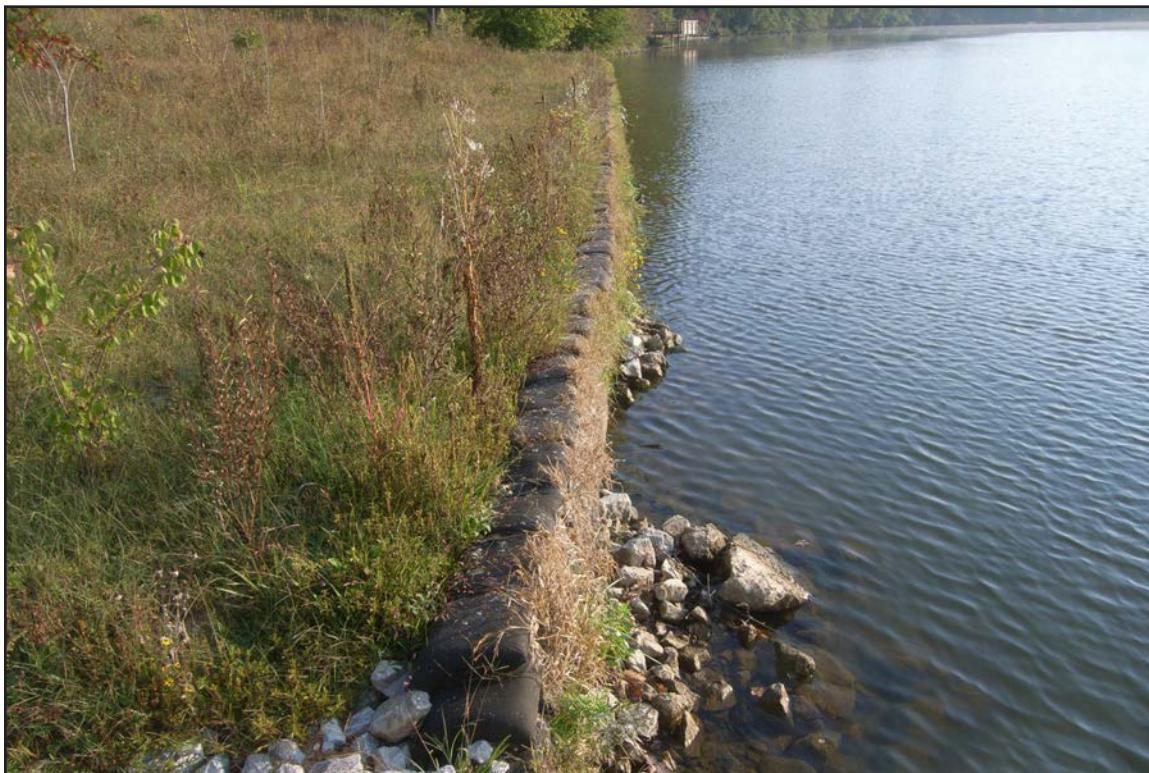
12B – Vegetative slope stabilization - Established wall vegetation. October 2, 2014.

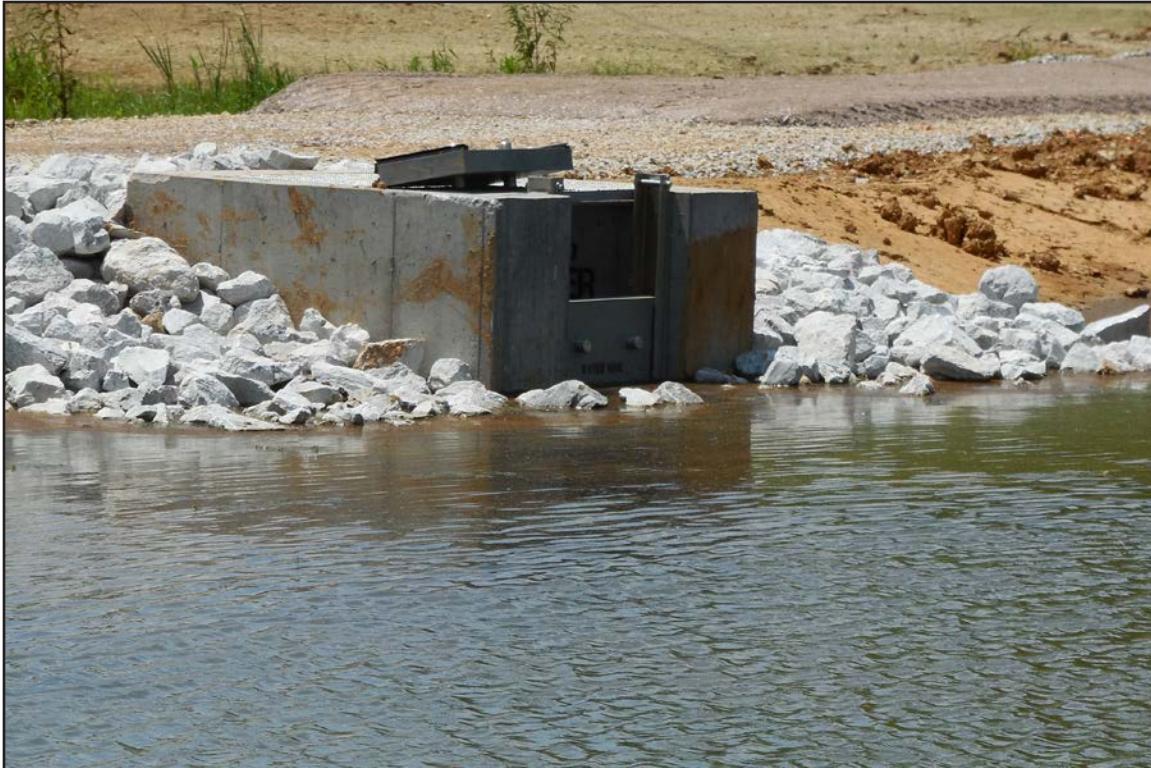
13A – Weir 1 at the transitional wetlands in the North Embayment. July 29, 2014.

Weirs will be inspected annually; their condition will be recorded and any debris interfering with their function will be removed.

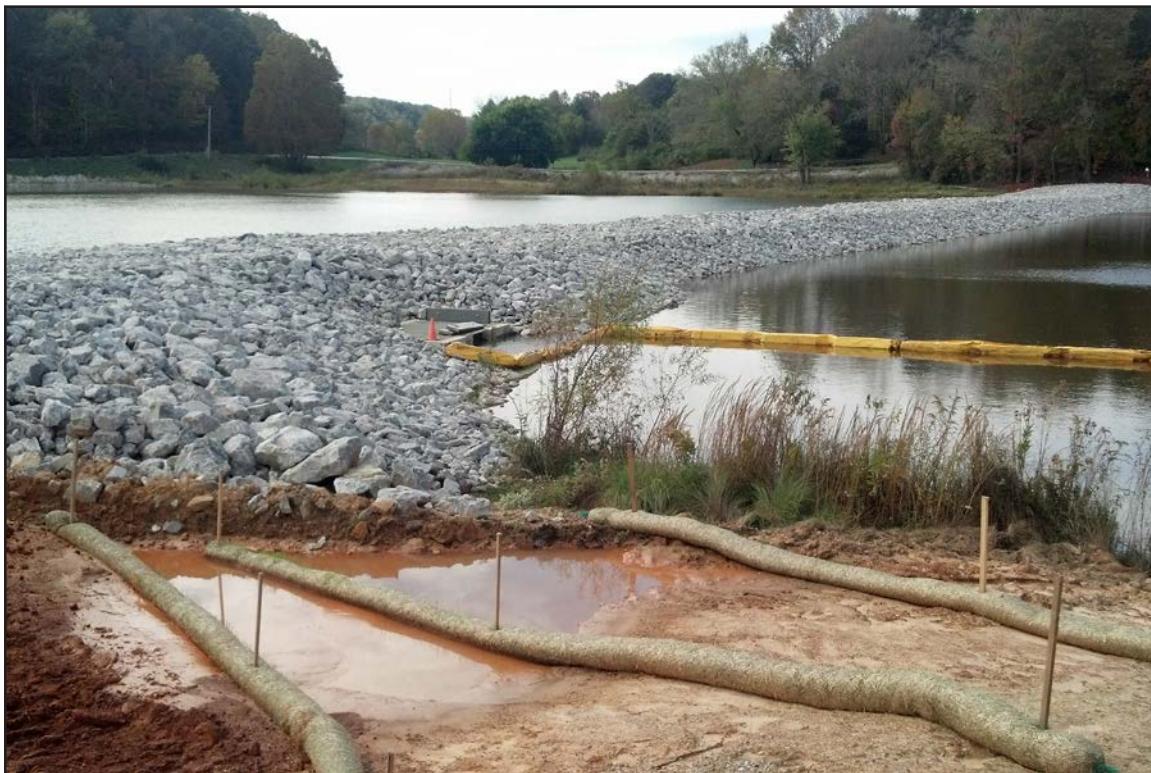
13B – Weir 2 at the North Berm dike in the North Embayment. October 20, 2014.
