**APPALACHIAN REGIONAL COMMISSION GRANT
PROPOSAL FOR EMORY VALLEY CENTER
SUPPLEMENTAL ENVIRONMENTAL ASSESSMENT**
Anderson County, Tennessee

Prepared by:
TENNESSEE VALLEY AUTHORITY
Knoxville, Tennessee

July 2015

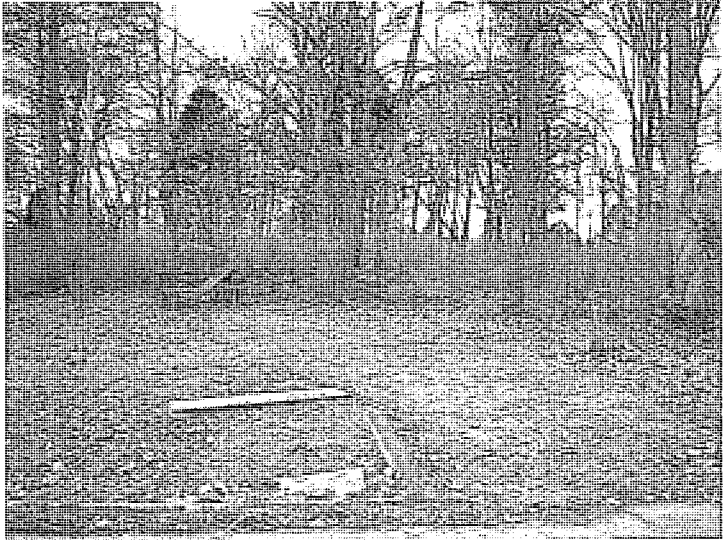
Photograph 1

<div style="display: flex; justify-content: space-between;"> <div> Location / Orientation Southeast corner of proposed development, facing north. </div> <div> Date: 12/19/07 </div> </div>	
<div style="display: flex; justify-content: space-between;"> <div> Remarks Proposed cut area on southeast side of proposed development. </div> <div> Photographer: Nathan J. Peterson </div> </div>

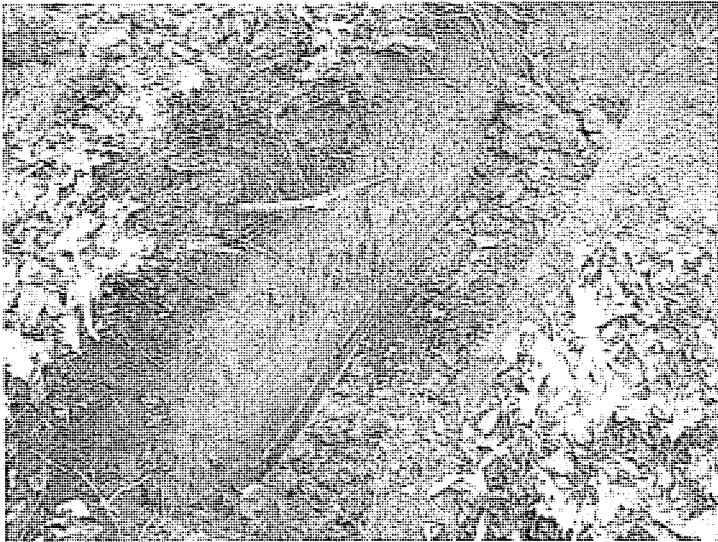
Photograph 3

<div style="display: flex; justify-content: space-between;"> <div> Photographer: Nathan J. Peterson </div> <div> Date: 12/19/07 </div> </div>	
Location / Orientation	View of TP-3 facing west.
Remarks	Materials encountered in TP-3 from ground surface to 5.0 feet.

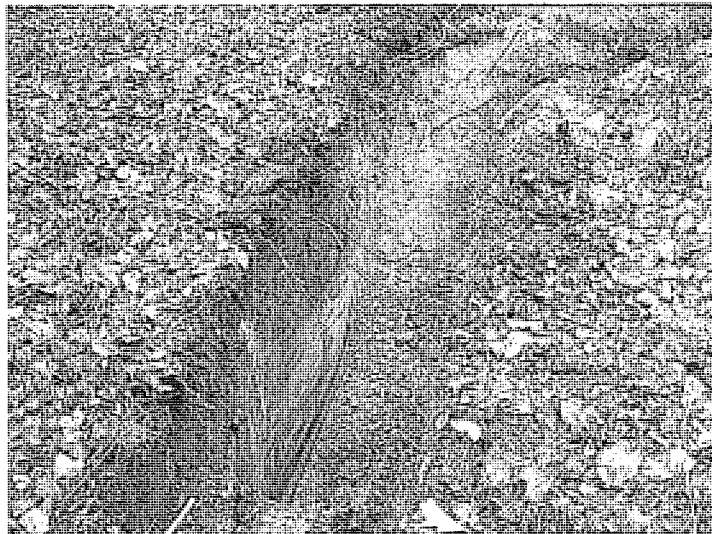
Photograph 4

<div style="display: flex; justify-content: space-between;"> <div> Photographer: Nathan J. Peterson </div> <div> Date: 12/19/07 </div> </div>	
Location / Orientation	View of TP-4 facing north.
Remarks	View of materials encountered in TP-4 from ground surface to 6 feet.

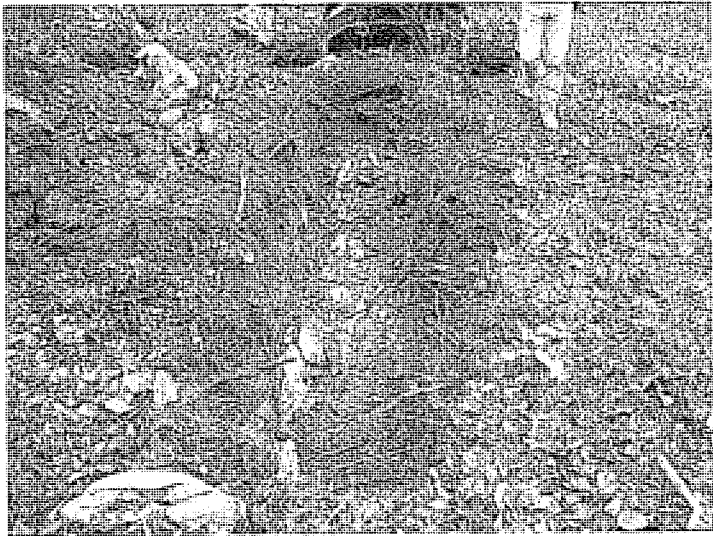
Photograph 6

<div style="display: flex; justify-content: space-between;"> <div> Photographer: Nathan J. Peterson </div> <div> Date: 12/19/07 </div> </div>	
Location / Orientation	View of TP-6 facing east.
Remarks	View of materials encountered in TP-6 from ground surface to 4 feet. Excavator encountered limestone at 0.5 feet and refused at 4.0 feet.

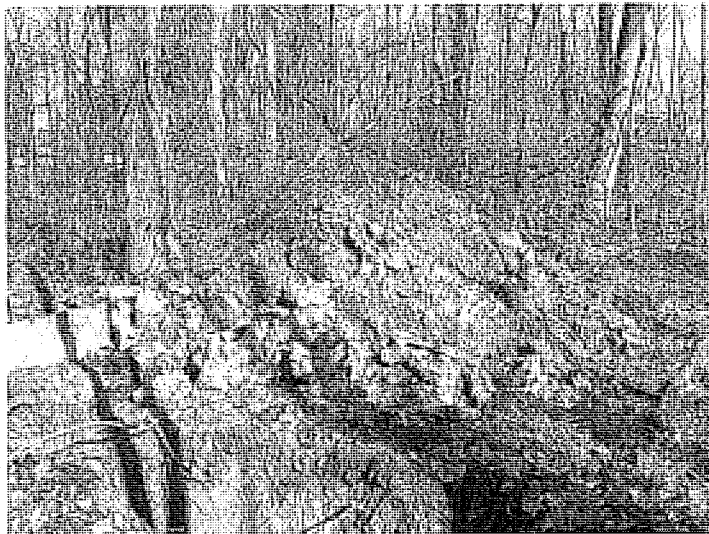
Photograph 10

<div style="display: flex; justify-content: space-between;"> <div> Location / Orientation View to the east of TP-8. </div> <div> Date: 12/19/07 </div> </div>	
<div style="display: flex; justify-content: space-between;"> <div> Remarks Wet materials excavated from TP-8. Water encountered flowing beneath the topsoil layer in TP-8. </div> <div> Photographer: Nathan J. Peterson </div> </div>
