Appendix E – 2007 Wetland Survey

RE: Wetlands Assessment and Delineation Proposed 30" Water Main Limestone and Morgan Counties, Alabama

SITE PHOTOGRAPHS 30" Water Main Limestone County, AL

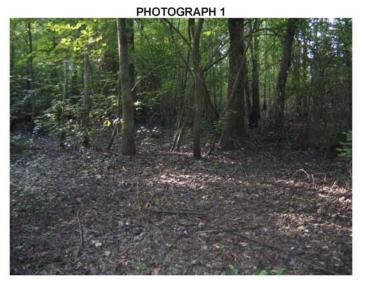
Description: View of Wetland W-1 – facing east. Taken by Jeff Selby, 8-13-07.

| Dor | ninant P | Plant Species | Indicator | Stratum | Dominant Plant Species | | Indicator | Stratum |
|---|---|--|---|---|---|---|---|---|
| Rer | narks: | A dominance of facultative / | hydrophitic v | egetation is p | presen | t | | |

| Recorded Dat | ta (describe in remarks) | 11 | WETLAND HYDROLOGY INDIC | CATO | RS | |
|---|---|---|---|---|---|---|
| Remarks: | Wetland hydrology is present. | 3.5 | | | Al- | |

| Series / P Drainage | | Melvin Poorly drained | | | Confirmed Map Typ Subgroup: | pe? yes | |

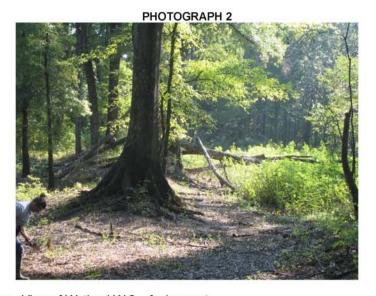
Description: View of Wetland W-2 – facing east. Taken by Jeff Selby, 8-13-07.

| Recorded Data (describe in remarks) | - 1 | WETLAND HYDROLOGY INDIC | ATC | RS | |
|---|---|--|---|---|---|
| Remarks: Wetland hydrology is present | 3.5 | 2)) | | | |

| Hydrophytic Vegetation Present? Wetland Hydrology Present? Hydric Soils Present? | | X | Yes | No | | x | | |
|--|---|---|---|---|---|---|---|---|
| Remarks: | Data Point W-2 is in a wetlan | d. | - | - | 101 | 7 | • | de- |

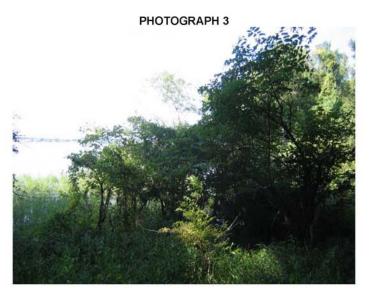
Description: View of Wetland W-4 – facing west. Taken by Jeff Selby, 8-21-07.

| Dor | ninant P | Plant Species | Indicator | Stratum | Do | minant Plant Species | Indicator | Stratum |
|---|---|--|---|---|---|---|---|---|
| Remarks: A dominance of facultative / | | | hydrophitic v | egetation is p | prese | nt. | | |

| Recorded D | ata (describe in remarks) | | WETLAND HYDROLOGY INDIC | ATC | ORS | |
|---|---|---|---|---|---|---|
| Remarks: | Wetland hydrology is present | | | | | |

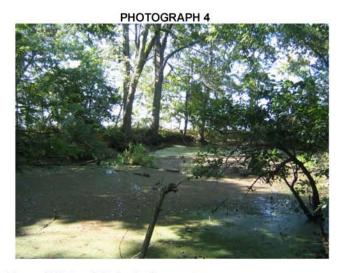
Description: View of Wetland W-4 – facing west. Taken by Jeff Selby, 8-21-07.

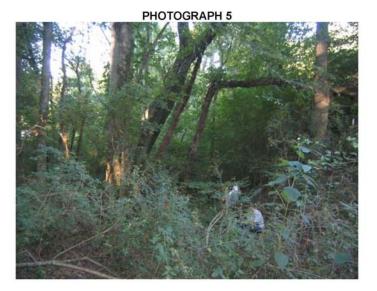
Description: View of Upland U-1– facing west. Taken by Jeff Selby, 8-13-07.

| Hydrophytic Vegetation Present? Wetland Hydrology Present? Hydric Soils Present? | | X | Yes | | No | | | | |
|--|---|---|---|---|---|---|---|---|---|
| Remarks: | Data Point U-1 is not in a wetlar | nd. | | | | • | | • | |
