Architectural and Historic
Assessment

Muscle Shoals Reservation
adaptive re-use study
Conditions/Market/Planning/Implementation

July 31, 2009
Revised August 25, 2009

LORD • AECK • SARGENT
ARCHITECTURE

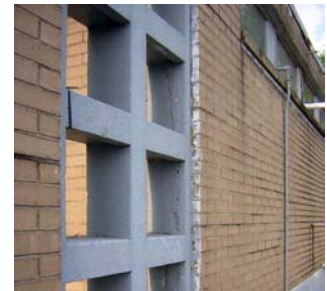
Comments

Chimney: Exterior End; Brick
 Efflorescence through deck at overhangs
 Serious cracking in masonry; significant repointing required
 Exterior doors not historic

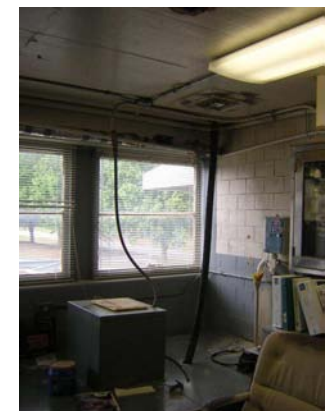
Tank containment bulkhead in Loading Dock area.

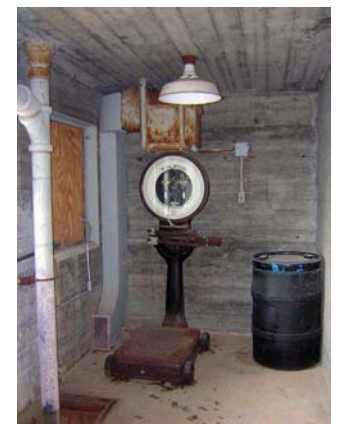
Building Component	Building Material	Condition
Corridors	N/A	
Primary Space	Open	1
Secondary Space	Filled with pipes, running water	2
Secondary Space	Open	1
Secondary Space	Cistern & Electrical: filled with pipes, running water	2
Flooring	Concrete, cast	1
Walls	Brick, painted	1
Ceiling	Concrete, painted	1

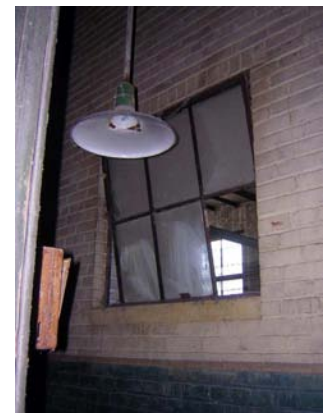
Mezzanine above corner office area

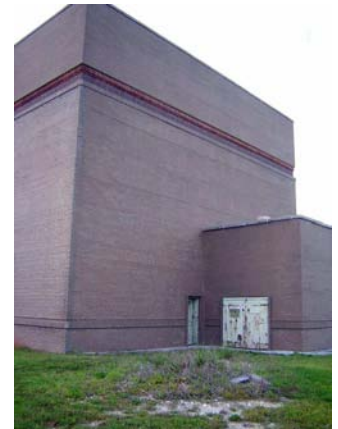
Entire facade covered with new brick
Original window openings infilled with brick or louvres

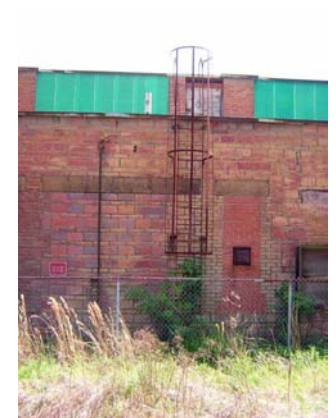
Windows removed at ground level and 1/2 of clerestory

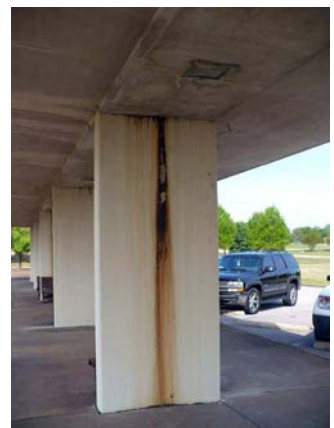
Roof drains appear to be internal and tie in to sewer below building; visible in garage area
 Cracking in brick sawtooth walls in police garage area
 Brick infill at Northeast corner not original to building; originally storefront in this area
 Metal coping and flashing are in disrepair at interior corners of building
 Bottom window panes are operable
 Concrete canopy in front of building was originally bus terminal; moderate water damage to concrete

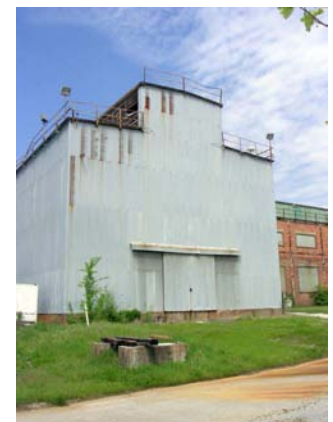
No surviving windows; openings covered with corrugated plastic panels.
 Louvres at East end of building.
 Evidence of rust on exposed steel structure.

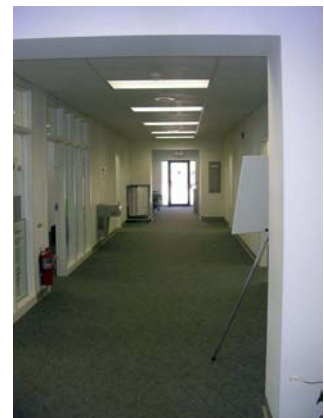
Interior recently renovated for office use, no historic features remain visible

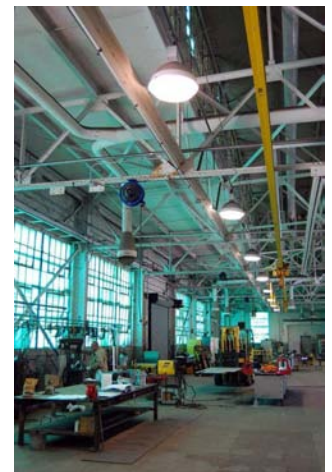
Concrete floors show signs of wear from shop equipment
Entire interior painted, including steel frame and steel windows

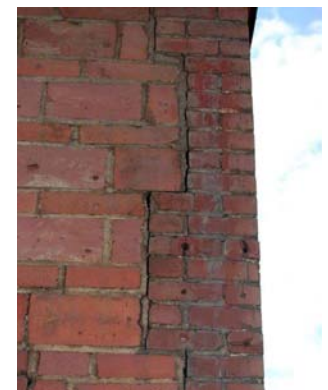
Wood fascia peeling and rotten in certain areas
 Significant cracking in concrete foundation around building perimeter
 Steel windows showing rust on exterior
 Lintels show signs of spalling and pocking

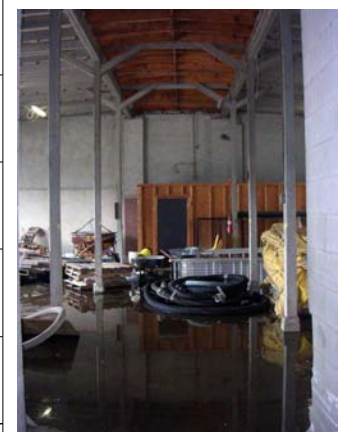
Major roof leak in Locker Room has resulted in standing water for large portion of floor
East end of building not accessible due to environmental hazard

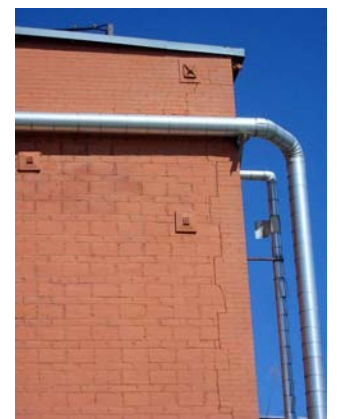
All original steel windows have been removed
 Concrete window sills vary in condition from good to poor
 Numerous structural ties at exterior corners of West facade; seperation evident in these areas
 Brick infill at large area on South facade

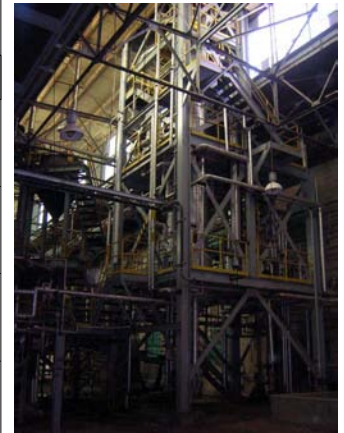
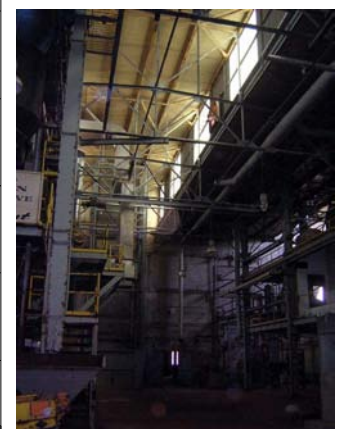
Large Pilot Plant equipment occupying majority of floor space
 Majority of concrete floor shows severe deterioration
 Floor has many trenches/grates running length of building
 Steel stairs and mezzanines provide access to upper levels of process equipment
 Water piping is damaged and water is flooding portions of this building and addition

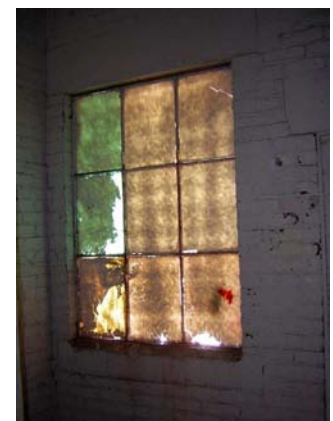
Interior of window sills severely deteriorated
Interior divided in several smaller storage areas

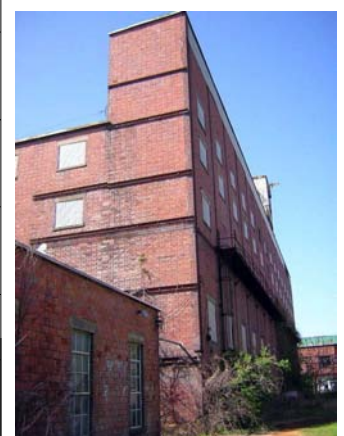
Corrugated metal addition on roof of 3rd story has visible rust and deterioration
 Areas of catwalk and fire escape on East side of building deteriorated or missing
 Steel frame exposed on exterior of building on East and West facades
 Corners of building show signs of cracking and separation in hollow clay tile/brick quoins

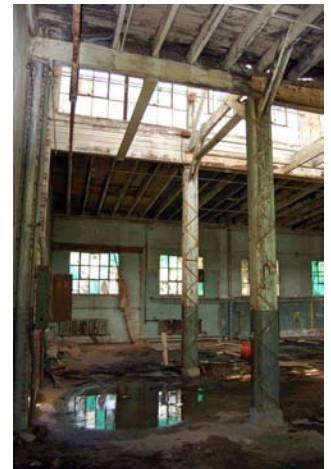
Concrete floor in main interior space in poor condition
 Wood decking missing or rotten in several areas, recently repaired in other areas
 Wood joists rotten in several areas
 Original wood doors between original building and main addition
 Standing water covering 30% of floor in original building

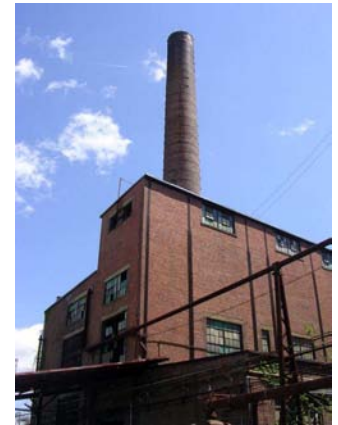
Chimney/Stack made of brick; several areas of disrepair including compression bands
 Drainage problems at East end of low shed roof
 Cracking at top corners of building
 Concrete lintels show some signs of deterioration
 Several single metal doors around perimeter of building heavily rusted

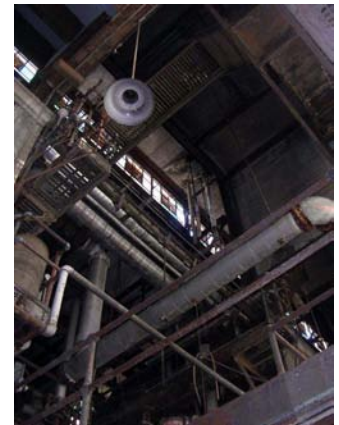
Primary space filled with Boiler Equipment and catwalks
 Mezzanines and catwalks inaccessible due to severe rust
 Majority of building inaccessible due to environmental hazard

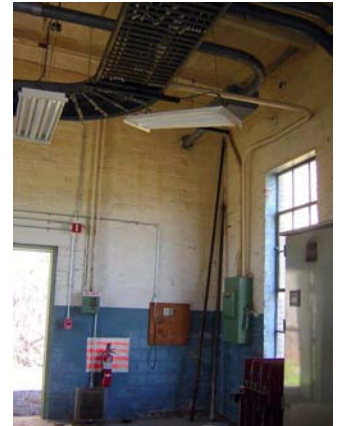
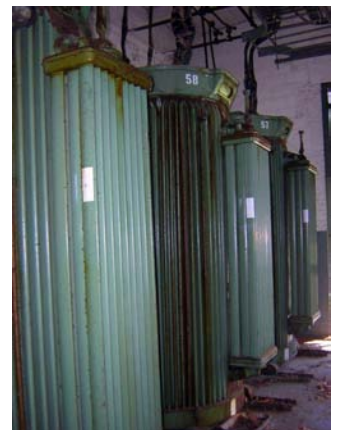
Entire interior of building is painted; paint peeling in some areas
 Interior fire door scrapes concrete floor

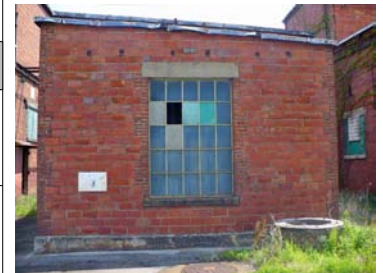
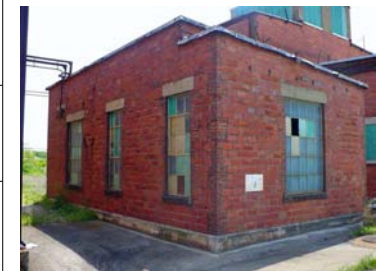
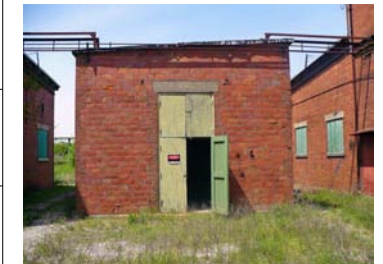
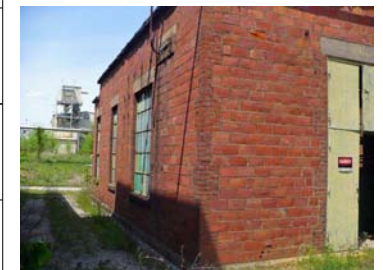
80% of window panes replaced with translucent fiberglass
 Misc. steel conduit/raceways connected to Buildings 69 & 70
 Roof has single large ventilation chimney

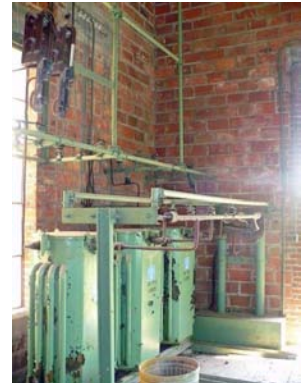
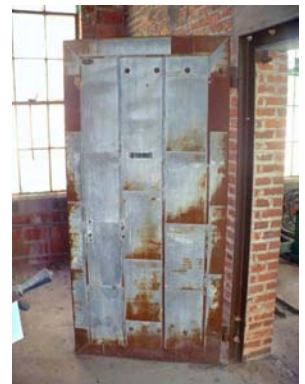
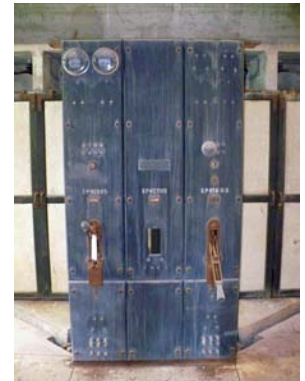
Primary space has floor mounted electrical transformers and equipment
 Secondary space has switchgear plus transformers in cast in place concrete housings
 Original tin-covered door in brick wall between interior spaces

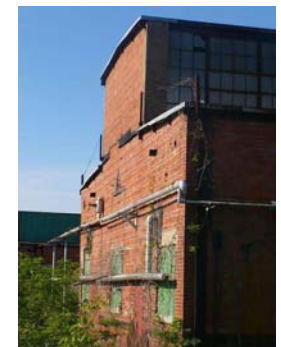
Ventilation/mechanical equipment added on shed roof
 95% of windows covered by translucent fiberglass
 Cracking in hollow clay tile at all exterior corners
 New metal awnings over entry doors

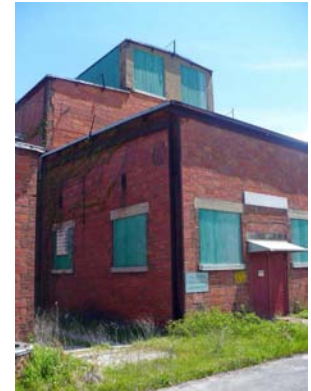
Rear 1/3 of building demolished - slab remains
 100% of windows covered by translucent fiberglass
 Cracking in hollow clay tile at all exterior corners
 New metal awnings over entry doors
 Ventilation/mechanical equipment added on shed roof

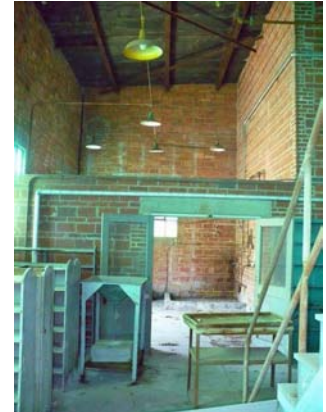
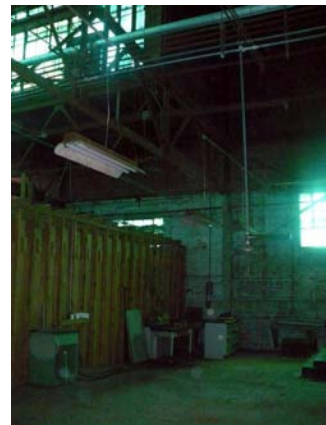
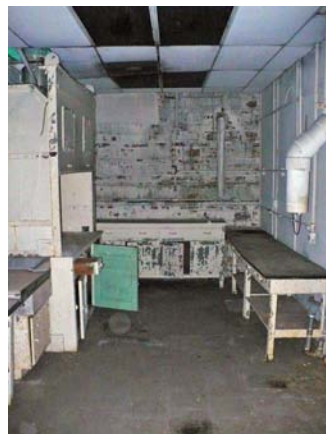
Office and Labs in poor condition - ACT failing due to water infiltration

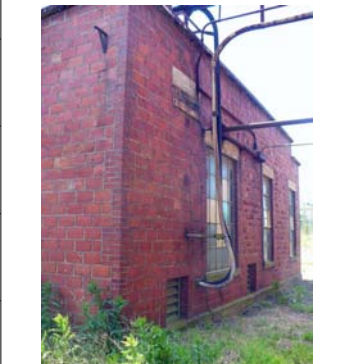
50% of window panes replaced with translucent fibergalss
 Misc. steel conduit/raceways connected to Buildings 71 & 72
 Roof has single large ventilation chimney

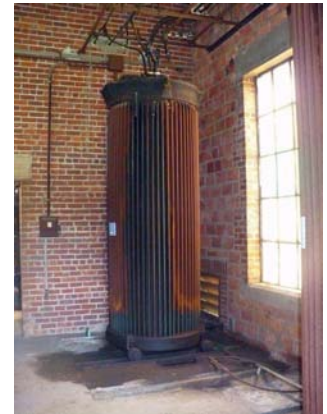
Primary space has floor mounted electrical transformers and equipment
 Secondary space has switchgear plus transformers in CIP concrete housings
 Original metal-covered door in brick wall between interior spaces

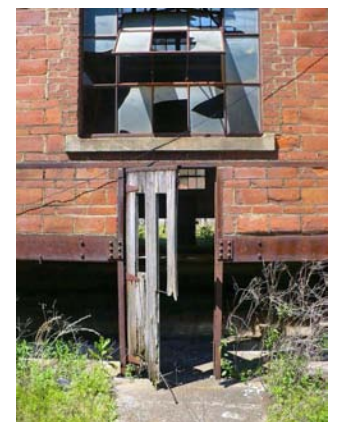
Wood louvres below sill beam - only four or five remain around entire perimeter
 Visible rust on steel window frames
 Serious cracking and displacement at upper East facade
 Metal frame openings at West facade appear to be added - no brick quoining adjacent to openings

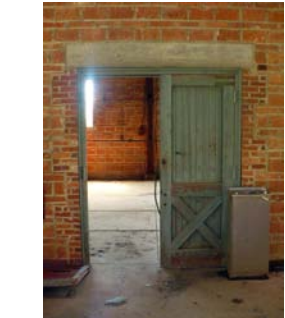
Flues and concrete pad raised about 7" above slab in Catalyzer Room
Building still retains much of its interior historic fabric

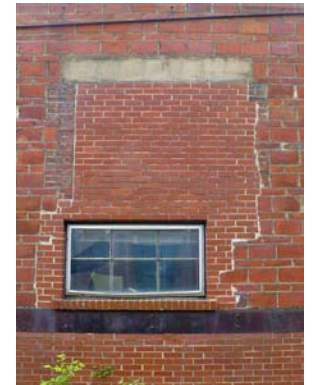
All original ground-level openings infilled with brick, new fixed aluminum windows added
 New metal awnings over entry doors
 Cracking in hollow clay tile at all exterior corners
 40% of clerestory windows covered by translucent fiberglass panels
 Some CMU infill at exterior walls and doors

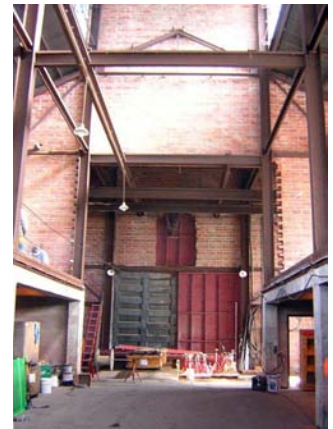
Center bay is open from ground level to Clerestory
 Mezzanine on each side consists of exposed concrete structural floor and beams
 Most windows at Clerestory intact and in good condition
 Concrete structure exposed at ground level, steel structure exposed above

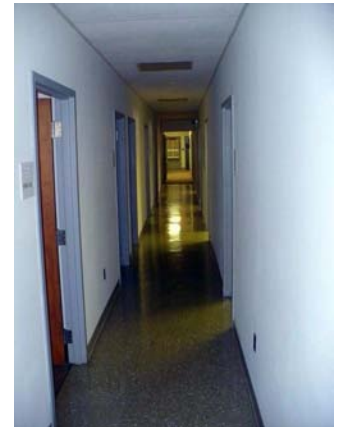
Office area has drywall partitions, carpet, and ACT
 Storage/Shop area has plywood partitions, concrete floors, and ceiling open to framing
