## **Appendix A – Public and Agency Comments and TVA's Response**

## **Appendix A – Public and Agency Comments Received on the Draft EA and TVA's Response to Comments**

# Phase I Cultural Resources Survey for the Gunstocker Creek Transmission Line Phase B

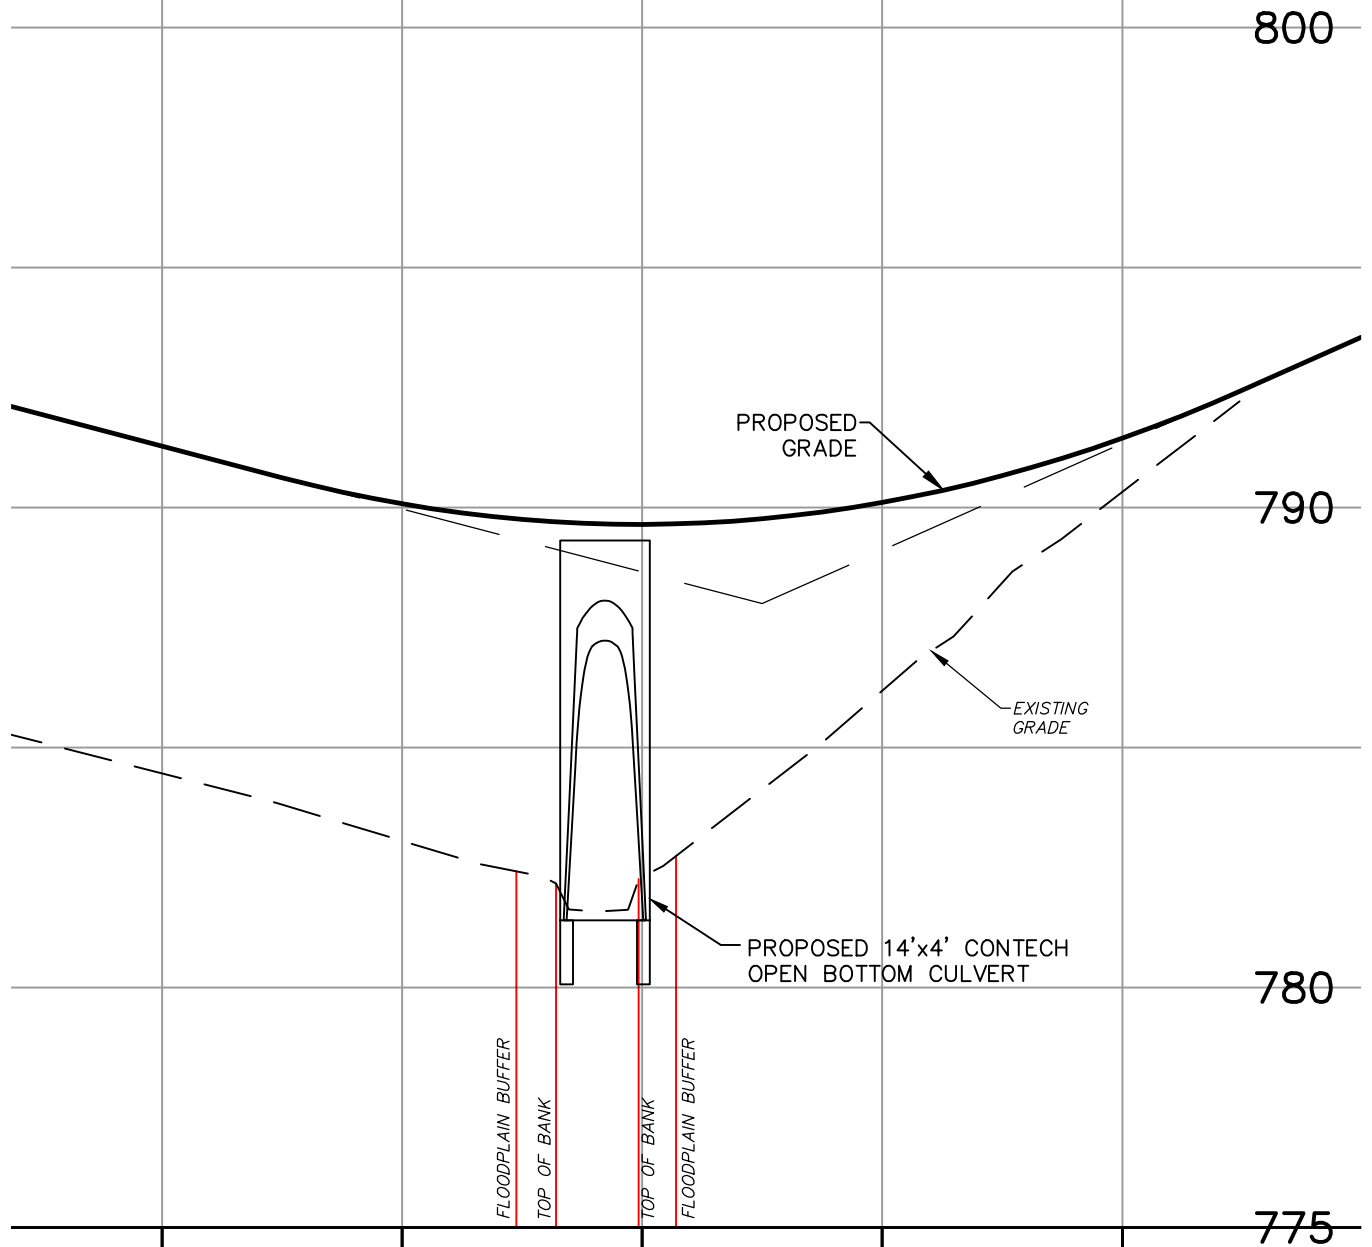
**WATERCOURSE ENCROACHMENT  
ACCESS DRIVE  
CULVERT CROSSING  
(CROSS-SECTION VIEW)**

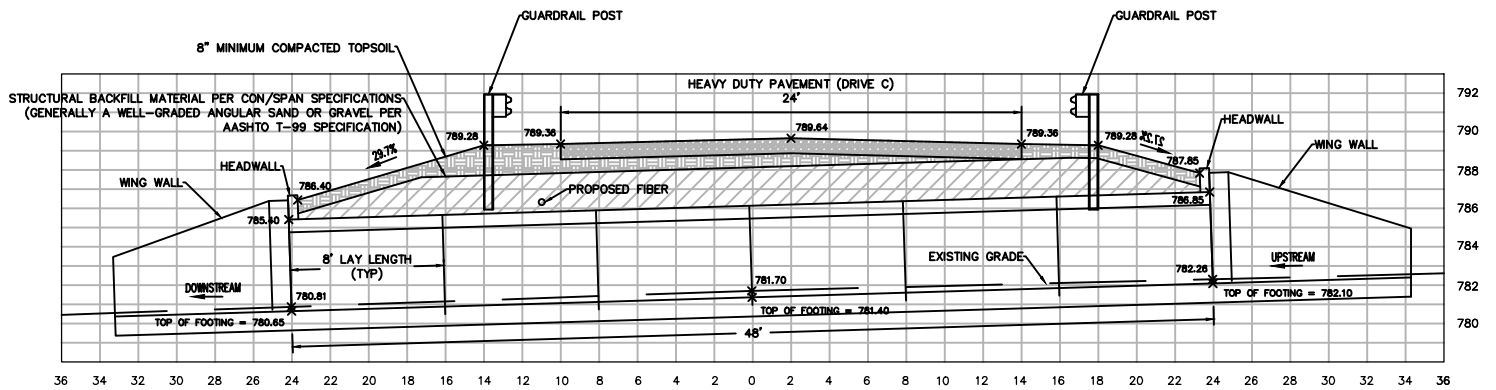
# WATERCOURSE ENCROACHMENT ACCESS DRIVE CULVERT CROSSING (PROFILE VIEW)

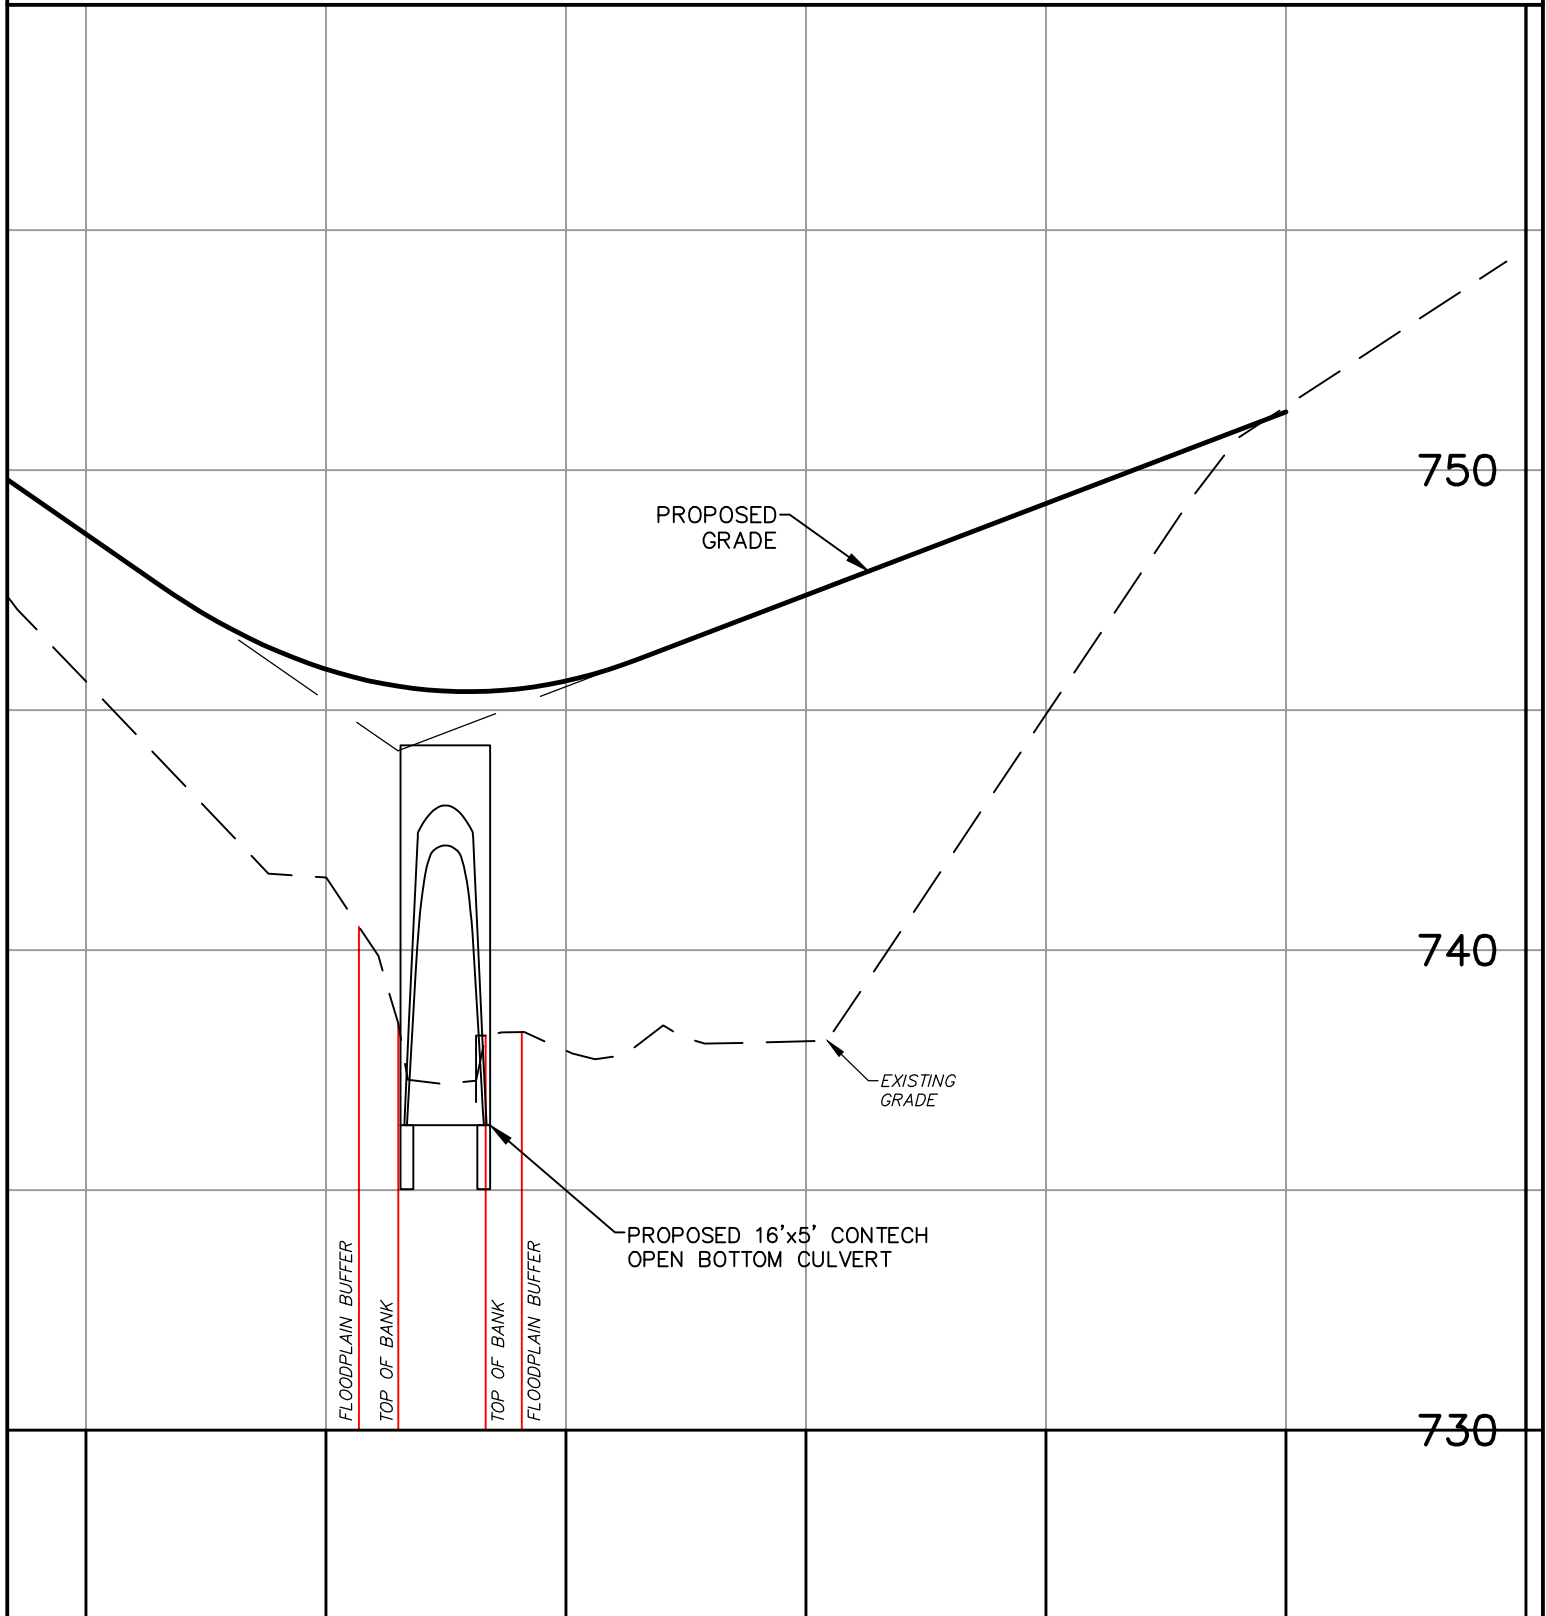
**WATERCOURSE ENCROACHMENT  
PERIMETER PATH  
CULVERT CROSSING  
(CROSS-SECTION VIEW)**

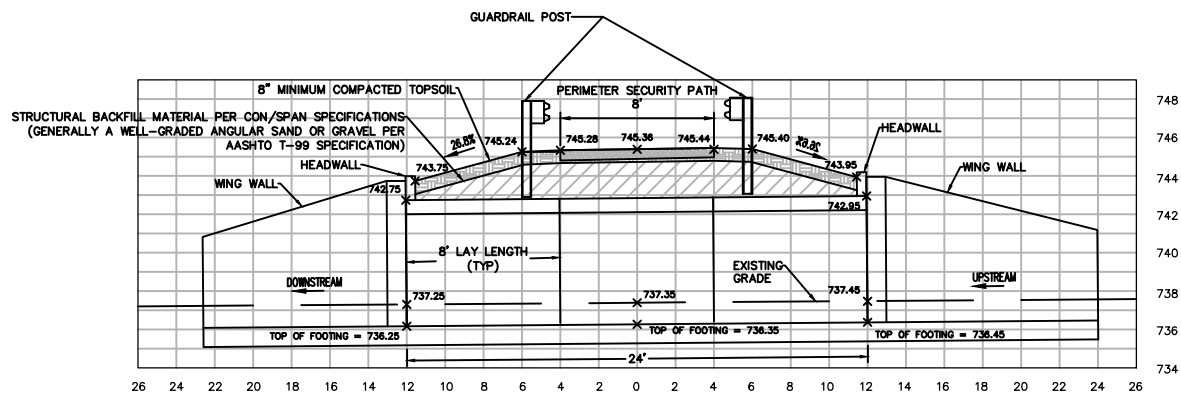
WATERCOURSE ENCROACHMENT  
PERIMETER PATH  
CULVERT CROSSING  
(PROFILE VIEW)

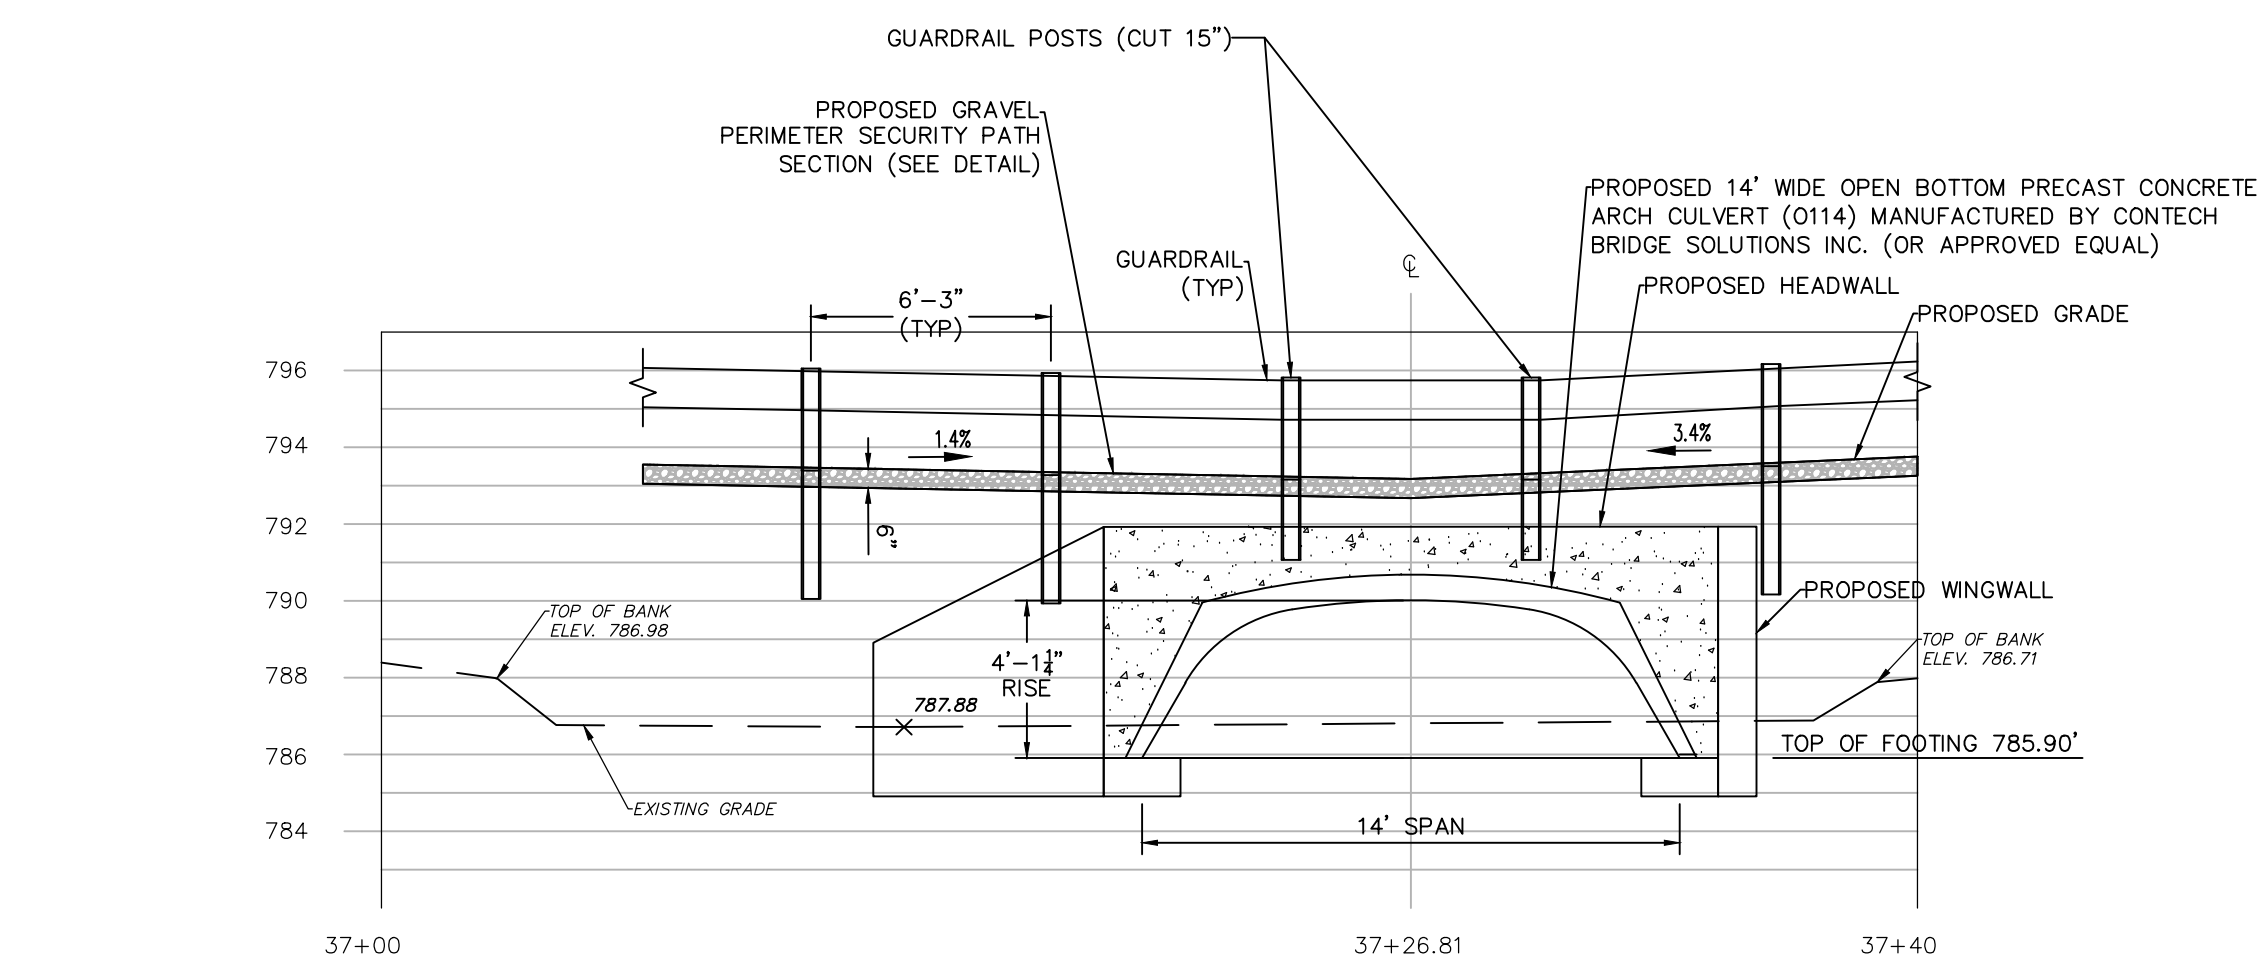
CULVERT 206-207  
PERIMETER PATHWAY CENTERLINE  
(SCALE 1" = 5')

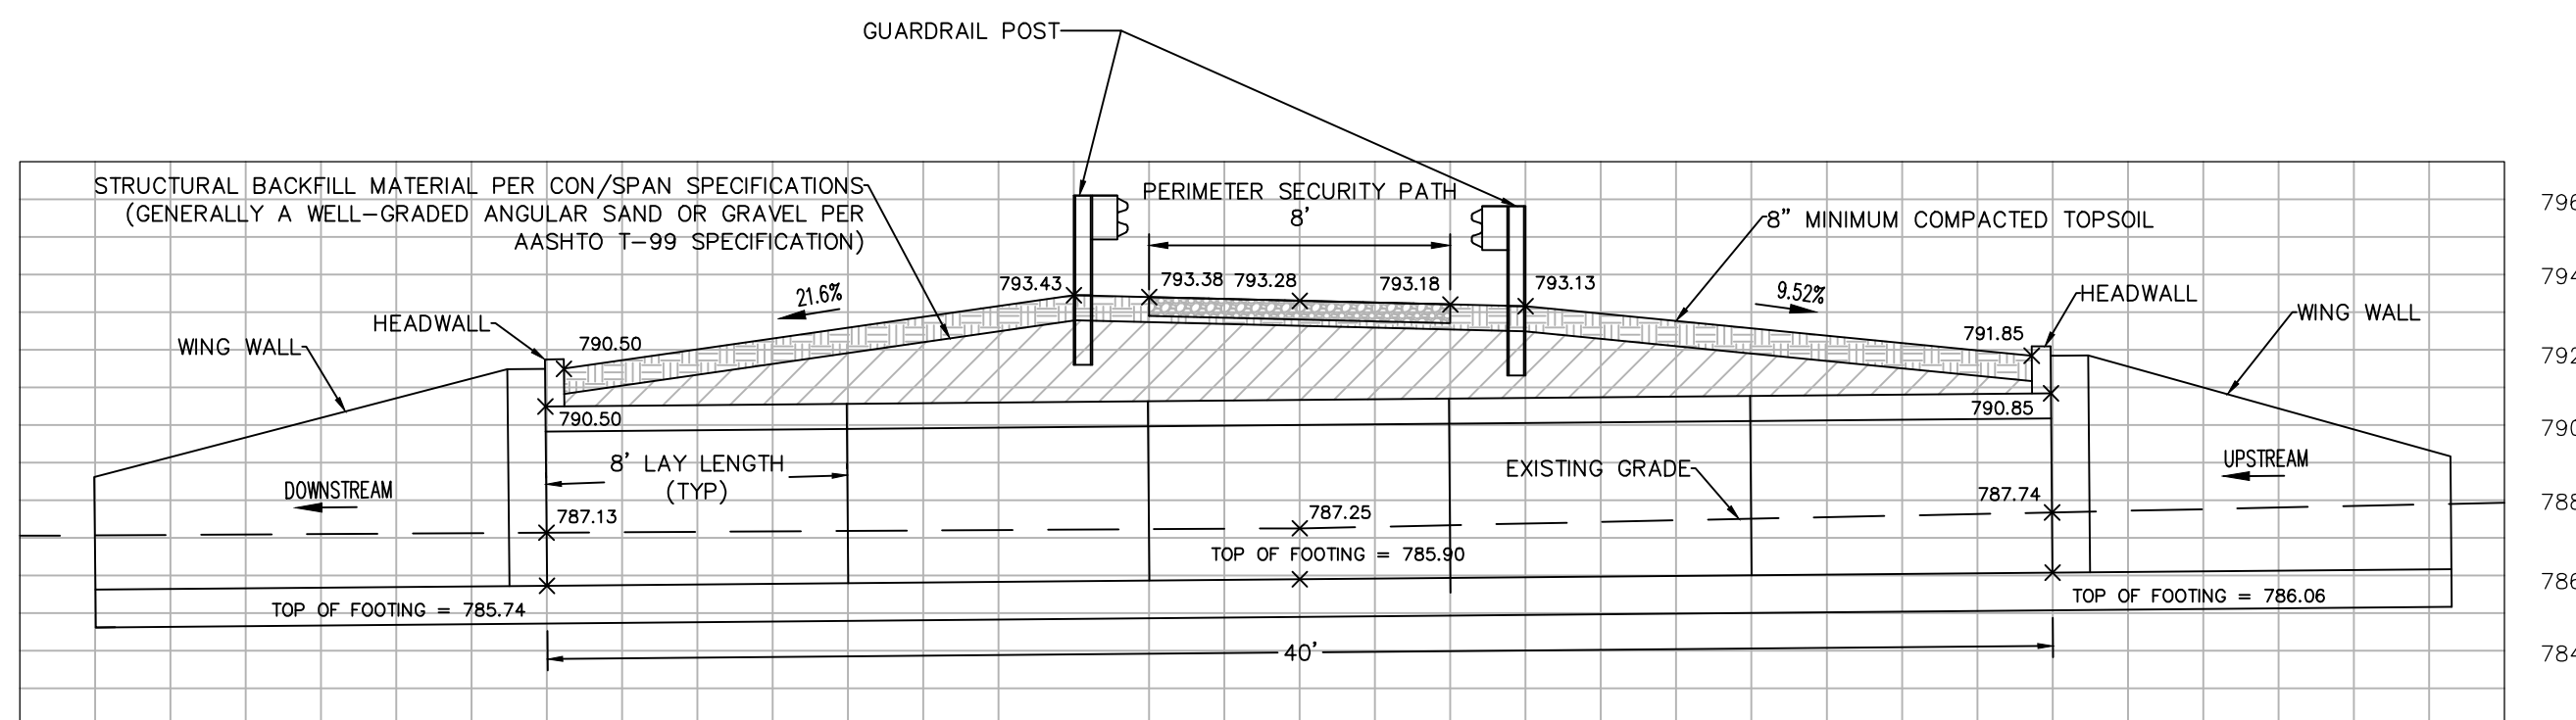
PROFILE CULVERT 206-207  
(SCALE 1" = 5')

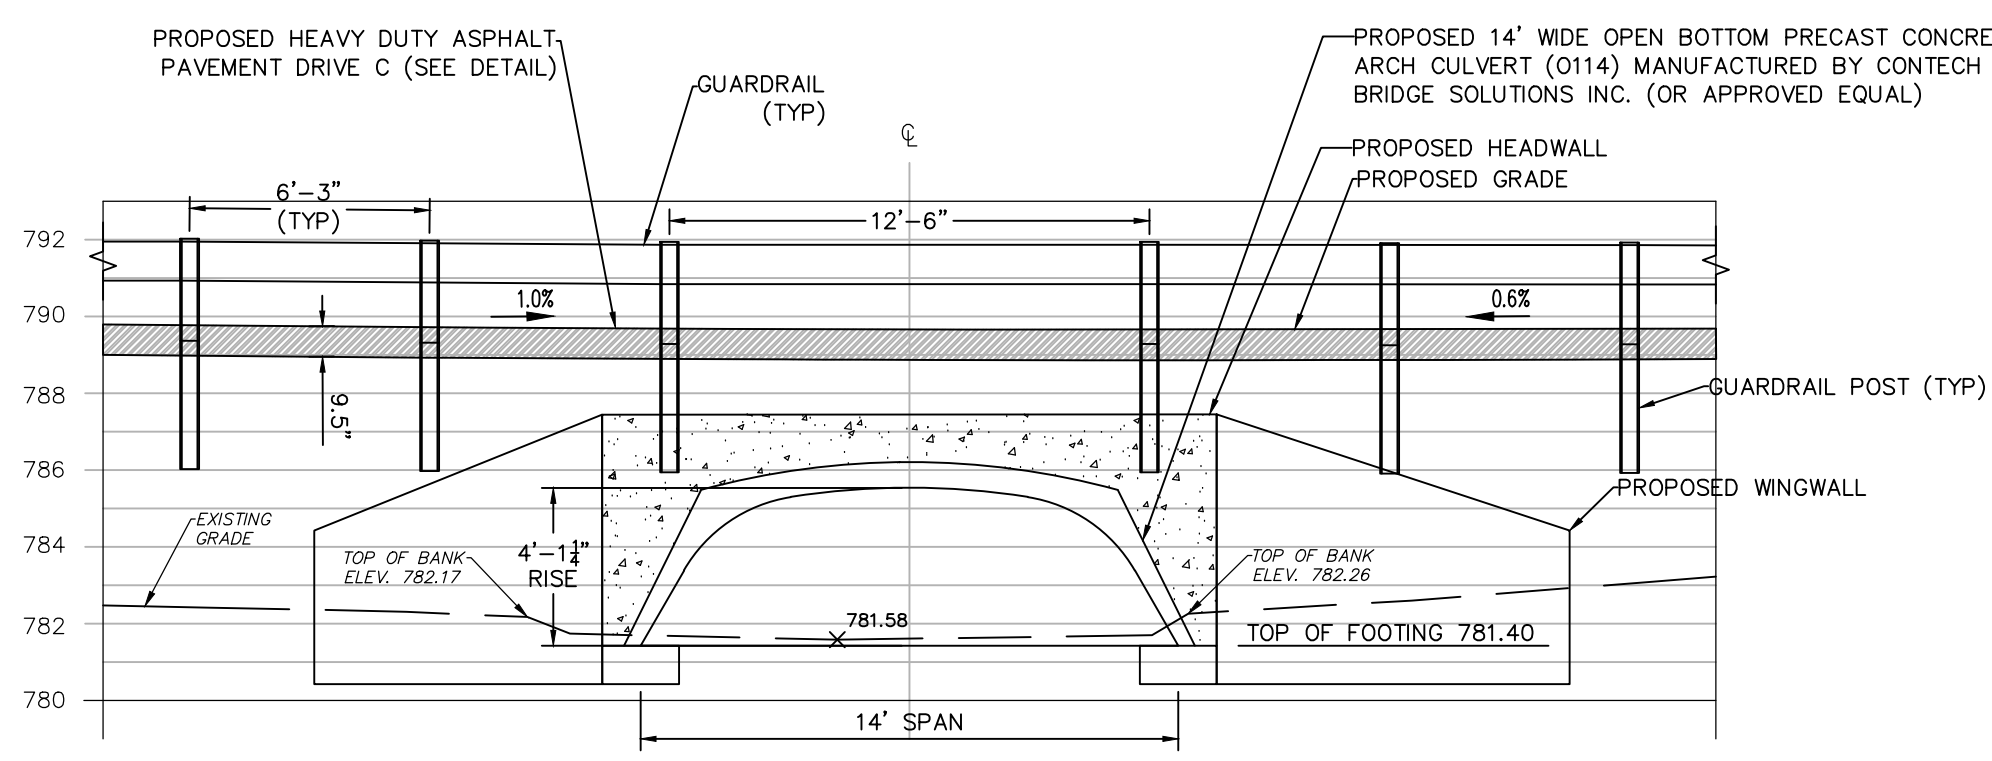
CULVERT 230-231  
DRIVE C CENTERLINE  
(SCALE 1" = 4')

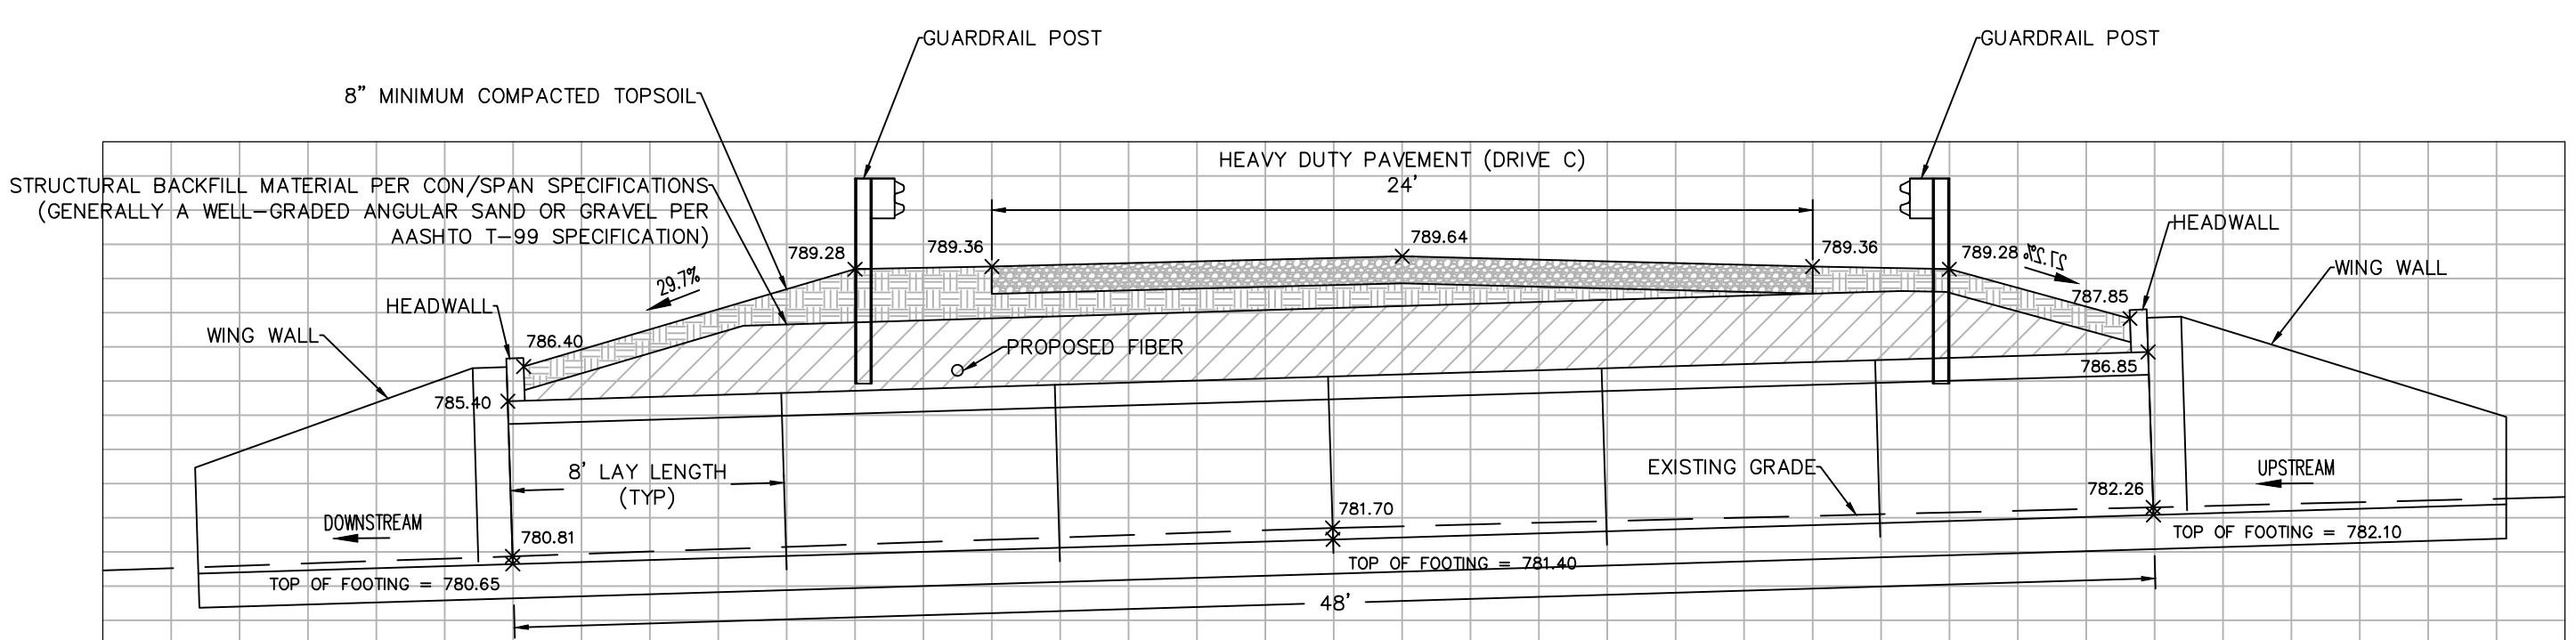
PROFILE CULVERT 230-231  
(SCALE 1" = 5')

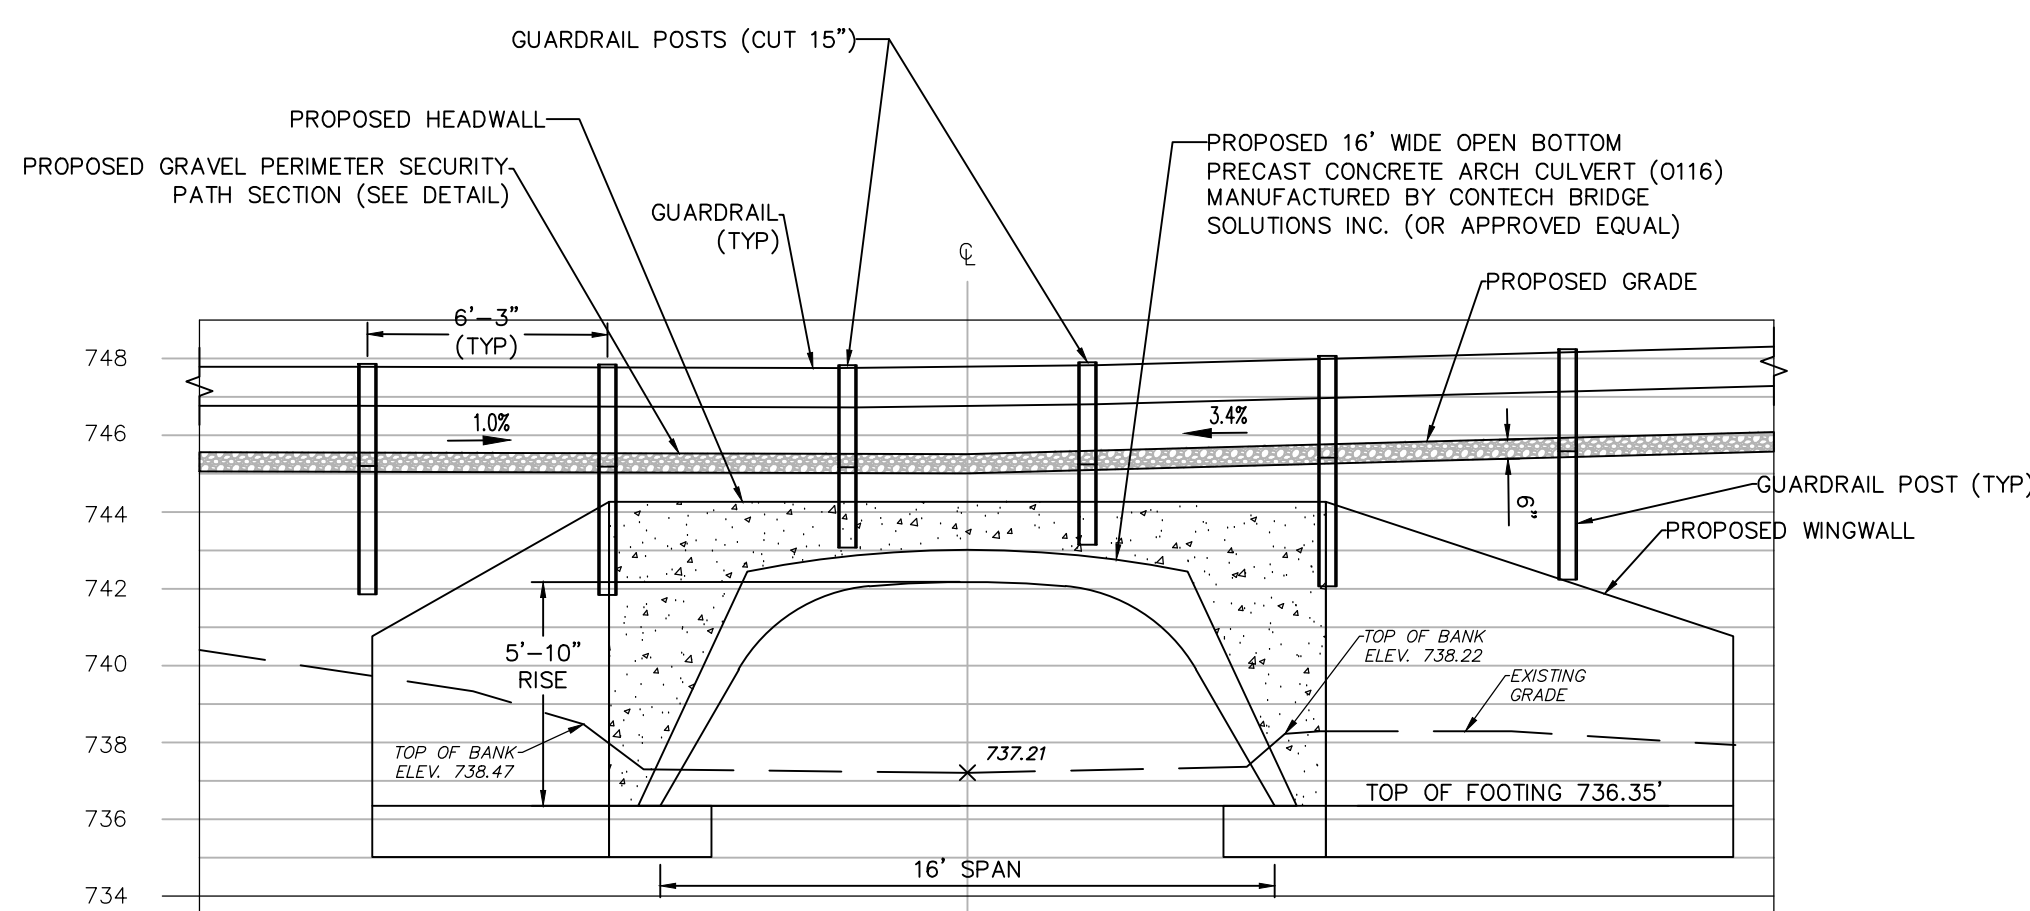
CULVERT 212-213  
PERIMETER PATHWAY CENTERLINE  
(SCALE 1" = 5')

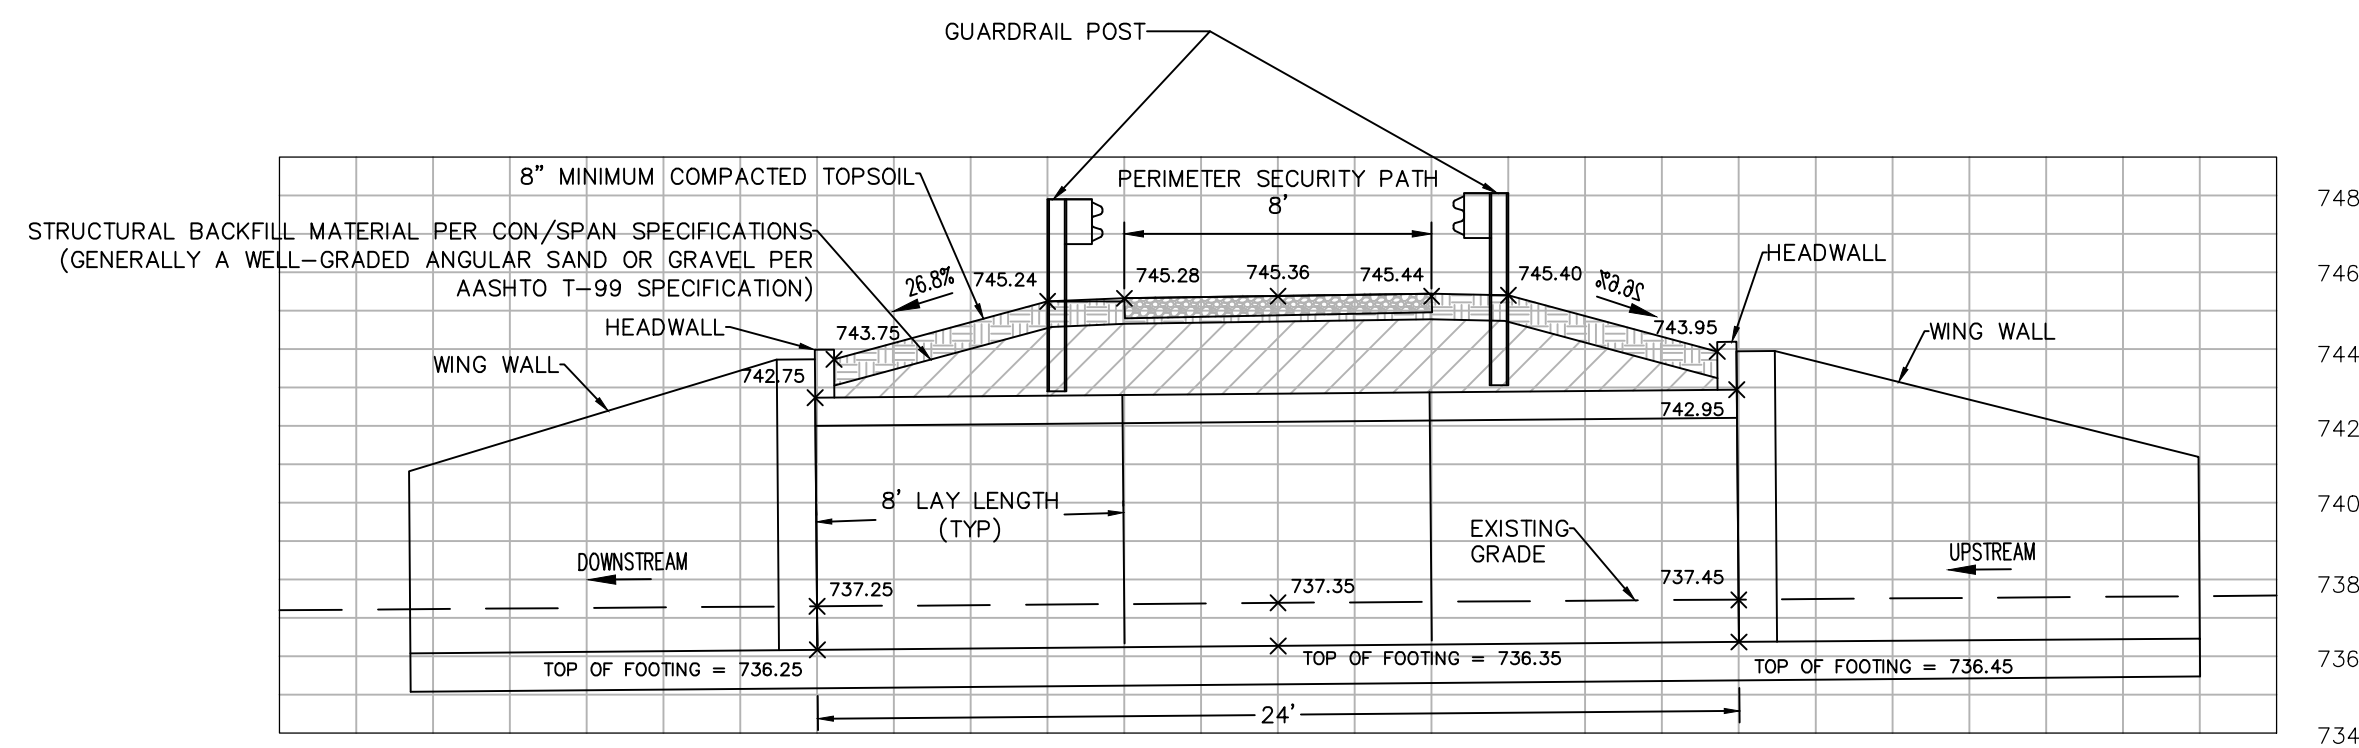
PROFILE CULVERT 212-213  
(SCALE 1" = 5')

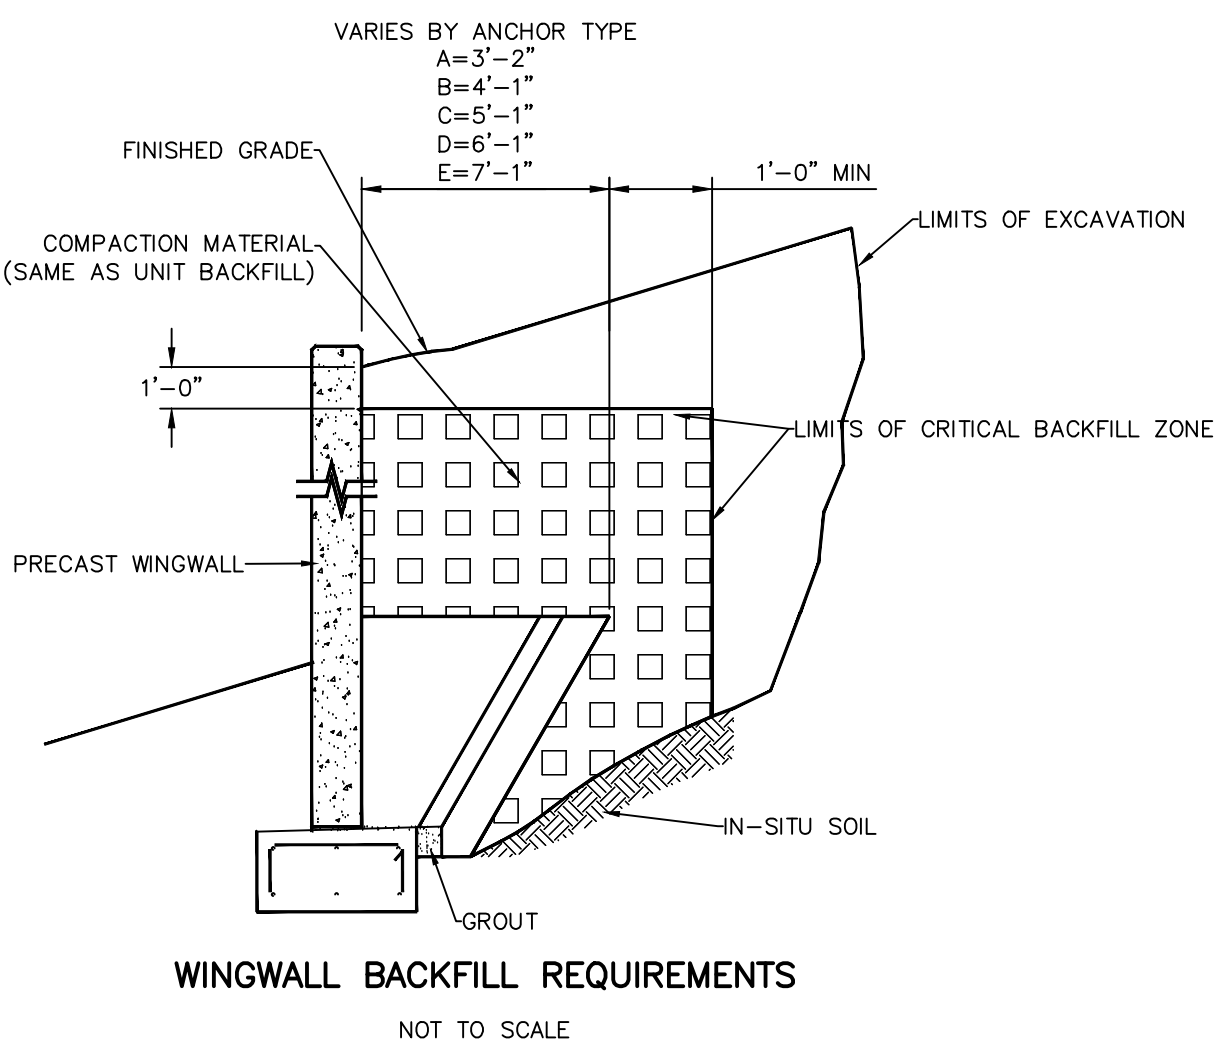
WINGWALL BACKFILL REQUIREMENTS  
NOT TO SCALE

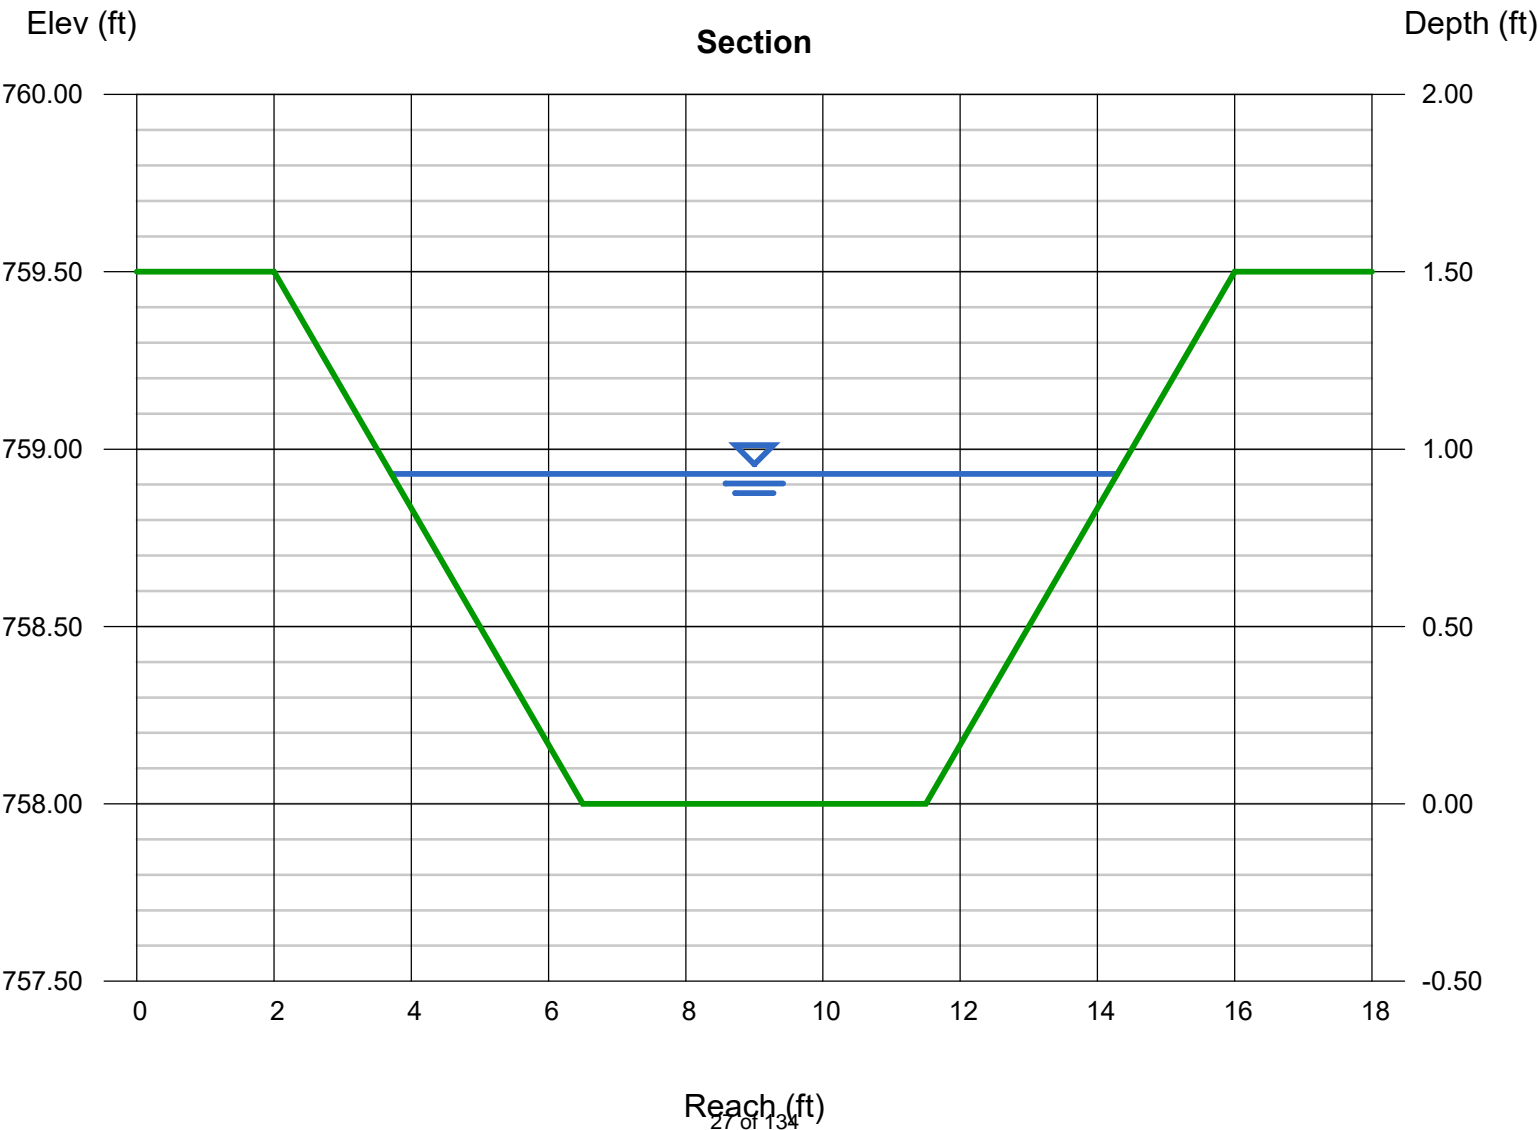
## CHANNEL DESIGN DATA

Depth (ft) = 0.93  
Q (cfs) = 39.55  
Area (sqft) = 7.24  
Velocity (ft/s) = 5.46  
Wetted Perim (ft) = 10.88  
Crit Depth, Yc (ft) = 1.02  
Top Width (ft) = 10.58  
EGL (ft) = 1.39

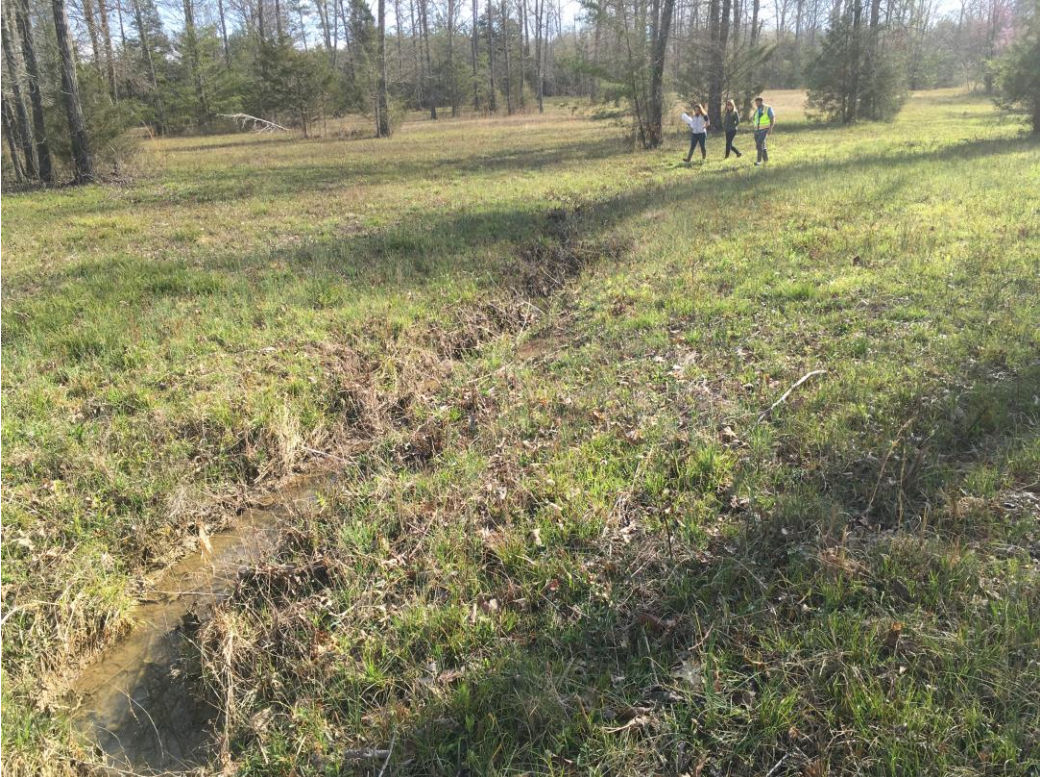
<b>Client Name:</b> TVA		<b>Site Location:</b> Meigs County Project	<b>Project No.</b>
<b>Photo No.</b> 1	<b>Date:</b> 04042019

<b>Direction Photo Taken:</b>  Northeast			
<b>Description:</b>  Upper portion of SMZ 02 SQT assessment reach

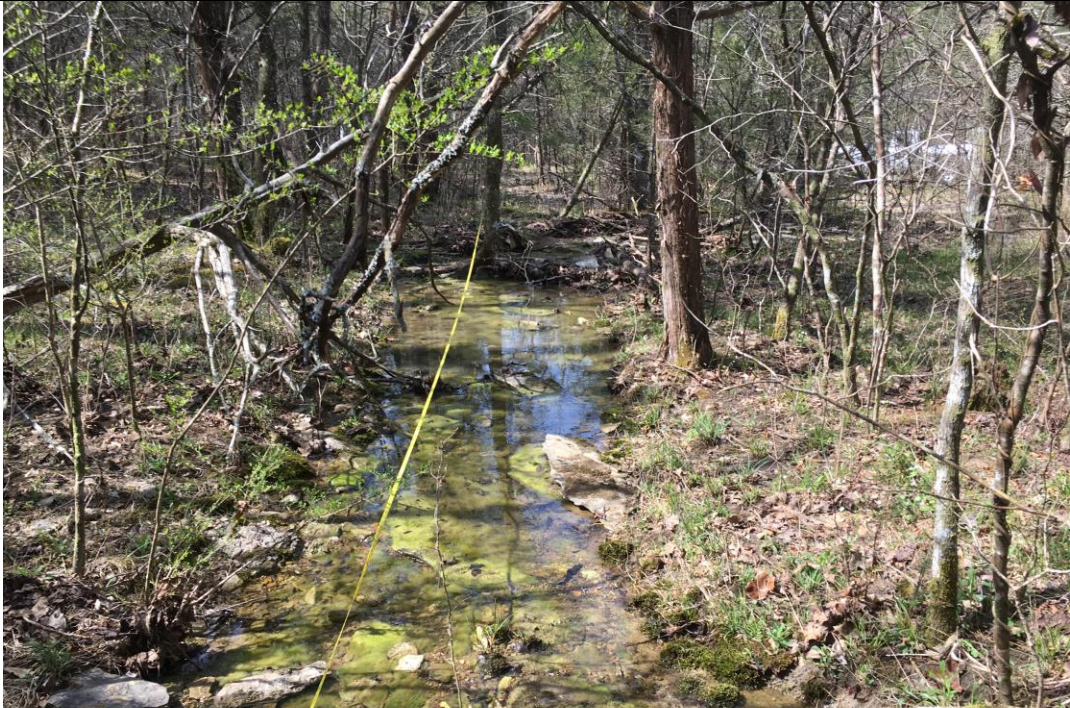
<b>Client Name:</b> TVA		<b>Site Location:</b>	<b>Project No.</b>
<b>Photo No.</b> 5	<b>Date:</b> April 2019

<b>Direction Photo Taken:</b>  Facing south			
<b>Description:</b>  Lower portion of SMZ 03 SQT assessment reach			
<b>Photo No.</b> 6	<b>Date:</b> April 2019

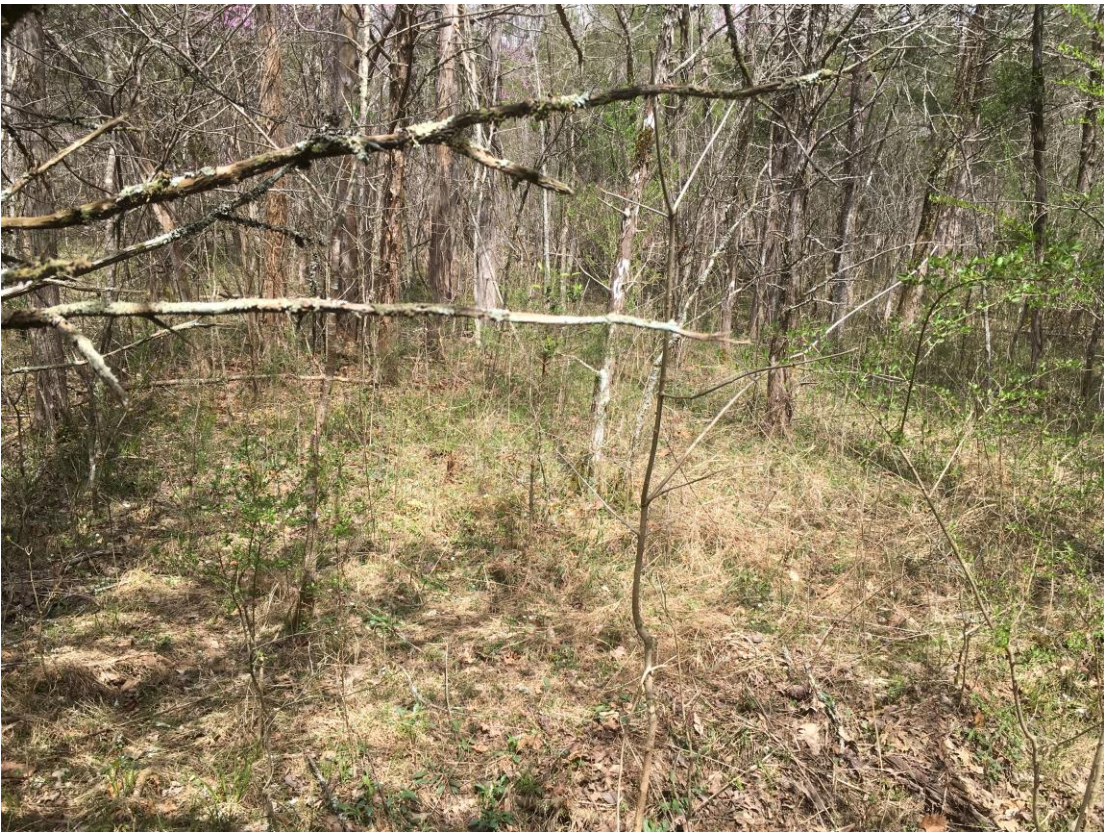
<b>Direction Photo Taken:</b>  west			
<b>Description:</b>  Riparian area of SMZ 03 RB

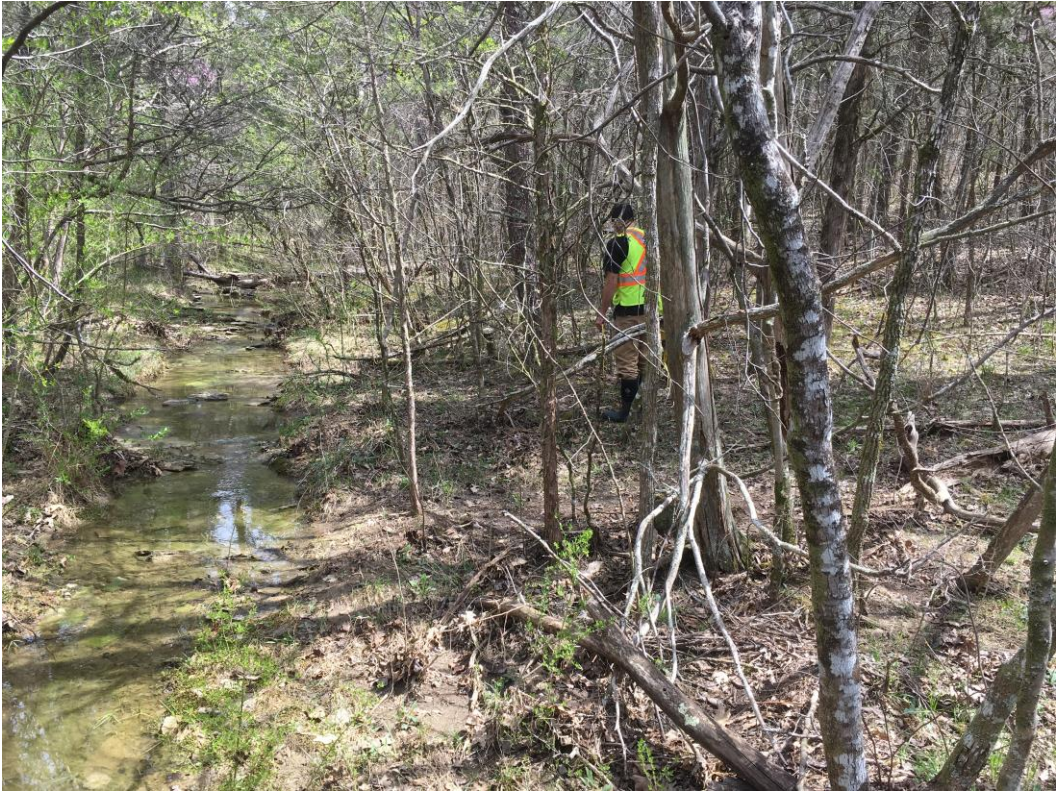
<b>Client Name:</b> TVA		<b>Site Location:</b>	<b>Project No.</b>
<b>Photo No.</b> 7	<b>Date:</b> April 2019

<b>Direction Photo Taken:</b>  Facing north			
<b>Description:</b>  Riparian area of SMZ 03 LB adjacent to riffle cross-section
