## Appendix B Natural Resources Field Review

**RE:** Summary of Environmental Features for the Silicon Ranch McKellar Solar Farm,

Jackson, Madison County, Tennessee

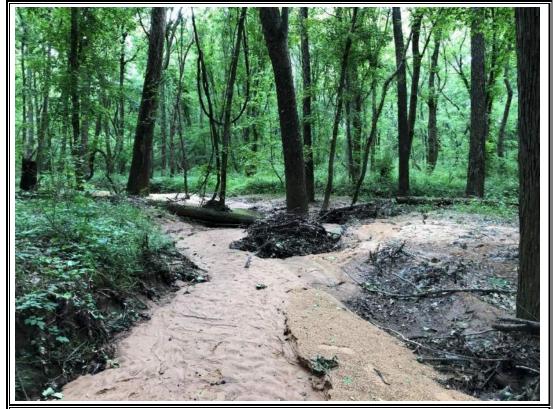
By: N. Carmean Date: May 11, 2020 Feature: STR-1a Lat: 35.589058, Long: -88.935230

Looking downstream within the channel of STR-1a (intermittent portion). Note the strong presence of substrate sorting, wrack lines and active floodplain.

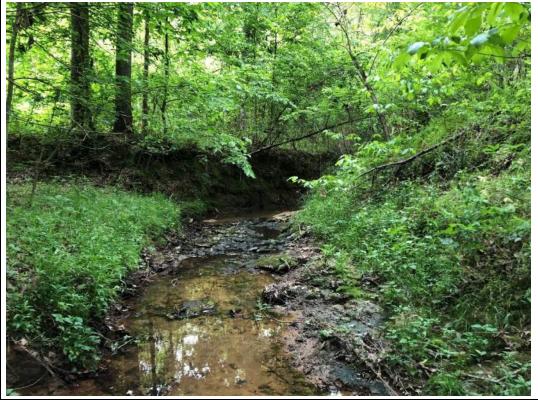
Photo: 2

By: N. Carmean Date: May 11, 2020 Feature: STR-1b Lat: 35.590237, Long: -88.940648

Looking upstream within the channel of STR-1b (perennial portion). Note the strong presence of substrate sorting and now the presence of surface water within the channel.

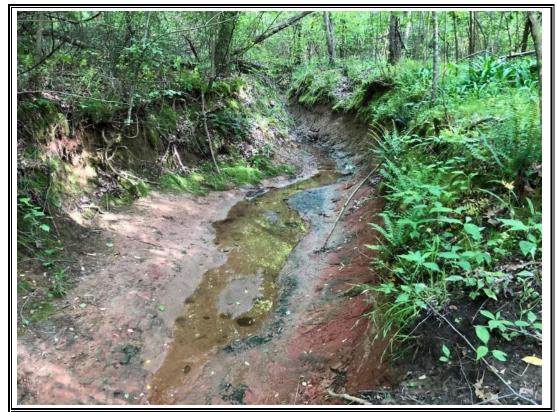
By: N. Carmean Date: May 11, 2020 Feature: STR-2 Lat: 35.586993, Long: -88.939448

Looking downstream within the channel of STR-2. Note the strong presence of a defined bed and bank, an OHWM, and surface water.

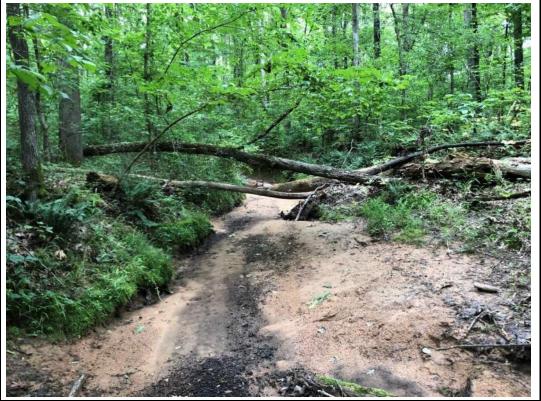
Photo: 4

By: N. Carmean Date: May 29, 2020 Feature: STR-3 Lat: 35.580689, Long: -88.935390

Looking downstream within the channel of STR-3. Note the strong presence of a defined bed and bank, an OHWM, and substrate sorting.

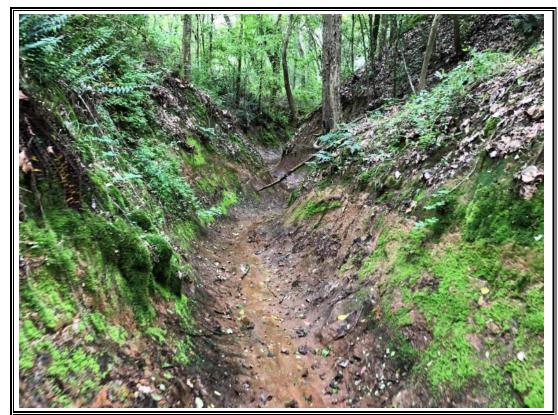
By: N. Carmean Date: May 29, 2020 Feature: STR-4 Lat: 35.576969, Long: -88.938232

Looking downstream within the channel of STR-4. Note the strong presence of a defined bed and bank, an OHWM, and substrate sorting.

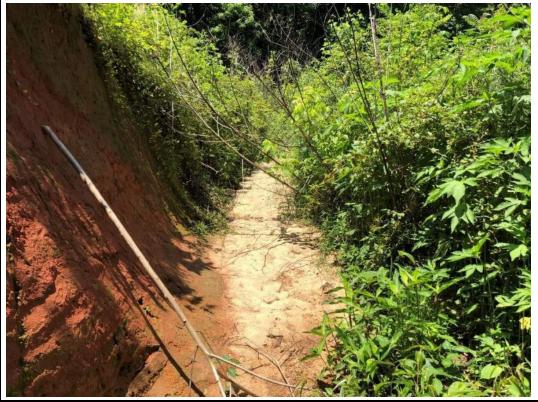
Photo: 6

By: N. Carmean Date: May 29, 2020 Feature: STR-5 Lat: 35.582093, Long: -88.933273

Looking downstream within the channel of STR-5. Note the presence of a defined bed and bank, an OHWM, and substrate sorting.

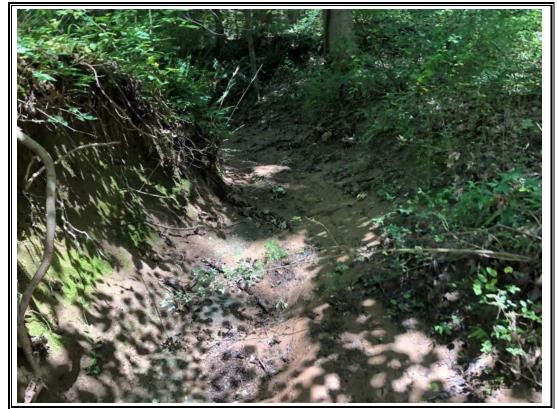
By: N. Carmean Date: May 29, 2020 Feature: STR-6 Lat: 35.582331, Long: -88.932523

Looking upstream within the channel of STR-6. Note the presence of a defined bed and bank, an OHWM, and hydric soils in the channel.

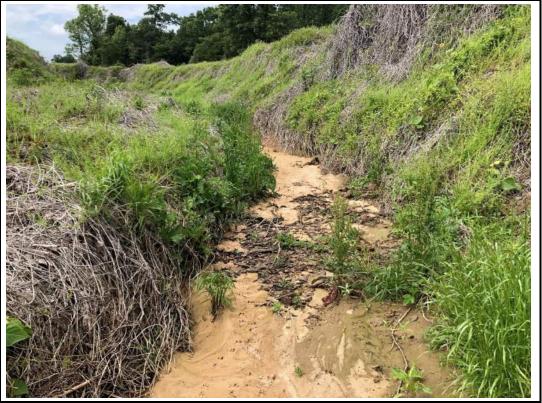
Photo: 8

By: N. Carmean Date: May 28, 2020 Feature: STR-7a Lat: 35.567761, Long: -88.929945

Looking downstream within the channel of STR-7a. Note the presence of a defined bed and bank, an OHWM, and FACW vegetation in the channel, as well as surface water.

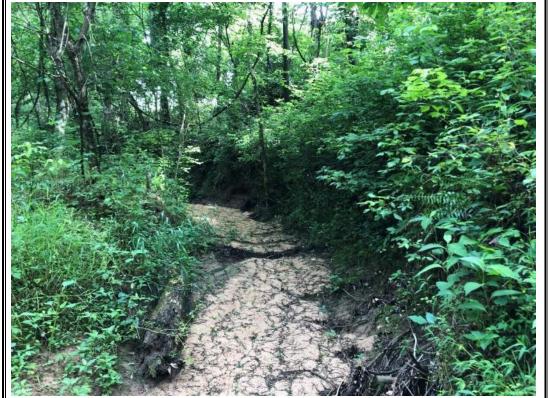
Photo: 9 By: N. Carmean Date: May 28, 2020 Feature: STR-7b

Looking upstream within the channel of STR-7b. Note the presence of a defined bed and bank, an OHWM, and substrate sorting within the channel.

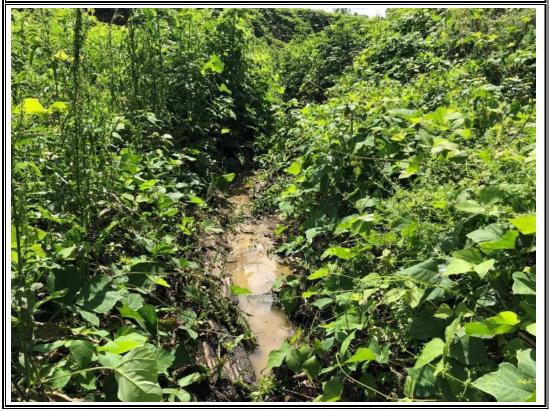
Photo: 10 By: N. Carmean Date: May 28, 2020 Feature: STR-8 Lat: 35.568231, Long: -88.930239

Looking upstream within the channel of STR-8. Note the presence of a defined bed and bank, surface water, and minimal vegetation in the channel.

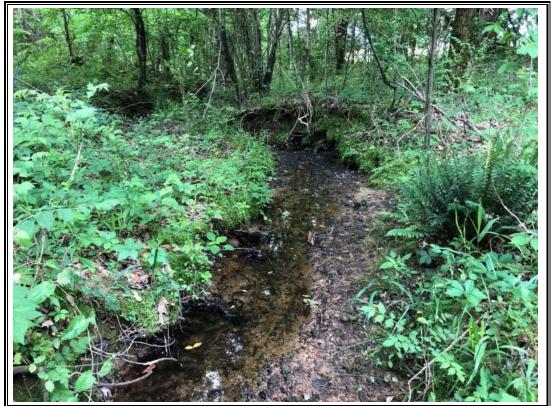
Photo: 11 By: N. Carmean Date: May 14, 2020 Feature: STR-9 Lat: 35.568231, Long: -88.930239

Looking downstream within the channel of STR-9. Note the presence of a defined bed and bank, surface water, and good substrate sorting.

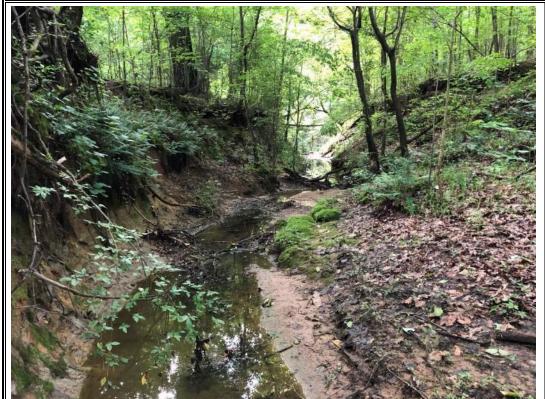
Photo: 12 By: N. Carmean Date: May 28, 2020 Feature: STR-10 Lat: 35.576296, Long: -88.923614

Looking downstream within the channel of STR-10. Note the presence of a defined bed and bank, an OHWM, surface water, and substrate sorting.

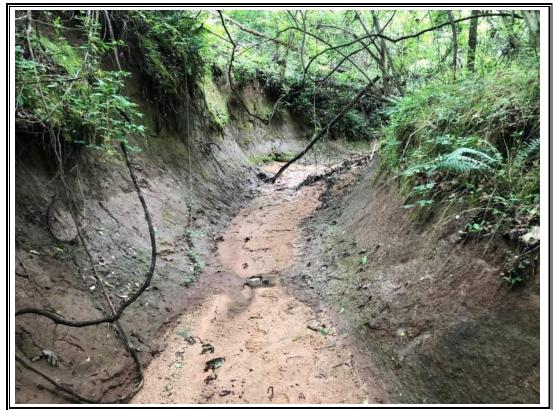
Photo: 13 By: N. Carmean Date: May 28, 2020 Feature: STR-11b Lat: 35.570190, Long: -88.952256

Looking downstream within the channel of STR-11b. Note the presence of a defined bed and bank, an OHWM, and substrate sorting.

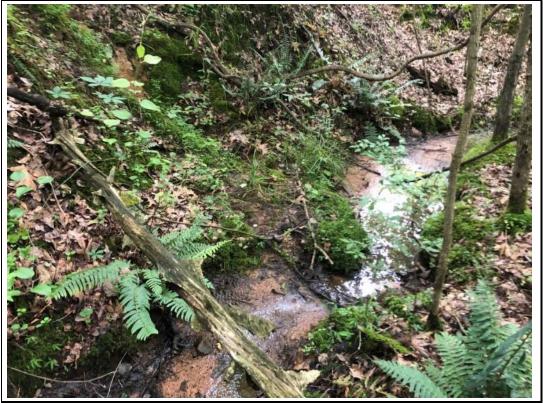
Photo: 14 By: N. Carmean Date: May 28, 2020 Feature: STR-12 Lat: 35.567475, Long: -88.952024

Looking downstream within the channel of STR-12. Note the presence of a defined bed and bank, an OHWM, iron reducing bacteria, and a presence of surface water.

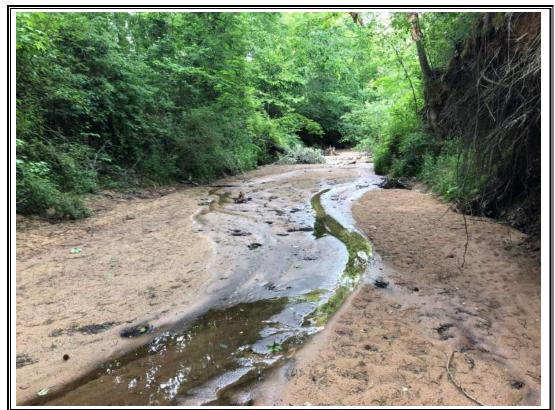
Photo: 15 By: N. Carmean Date: May 28, 2020 Feature: STR-13 (Cub Creek) Lat: 35.568279, Long: -88.953964

Looking upstream within the channel of STR-13 (Cub Creek). Note the presence of a defined bed and bank, an OHWM, and a presence of surface water.

STR-13 (Cub Creek) and the lower portion of STR-1(b) were determined to be perennial streams due to the presence of fish that were not mosquito fish. These streams were observed with minimal surface flow and stream beds of saturated sand and clay. The remaining delineated stream features (STRs-1a thru 12 and 14) were observed as intermittent with varying channel substrates. STR-1a and the lower portion of STR-3 were observed with a sand bottom, underlain with clay, and the remaining streams were observed with hard clay and silty-clay-loam substrates. All the intermittent streams were observed with a connection to the groundwater table through observable seepages, moderate to strong indicators of substrate sorting, and some were observed with a presence of amphibian larvae and adult frogs.

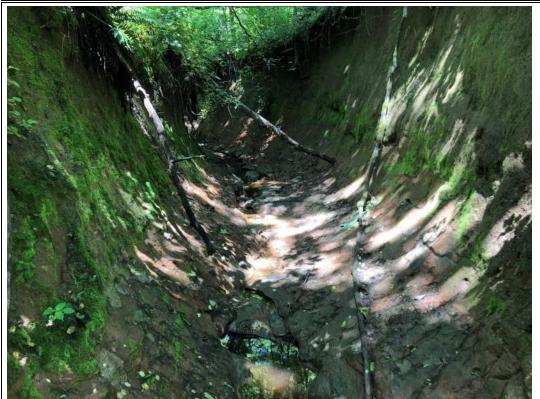
Photo: 16 By: N. Carmean Date: May 28, 2020 Feature: STR-14 Lat: 35.568347, Long: -88.924392

Looking upstream within the channel of STR-14. Note the presence of a defined bed and bank, an OHWM, and some substrate stripping of the clay.

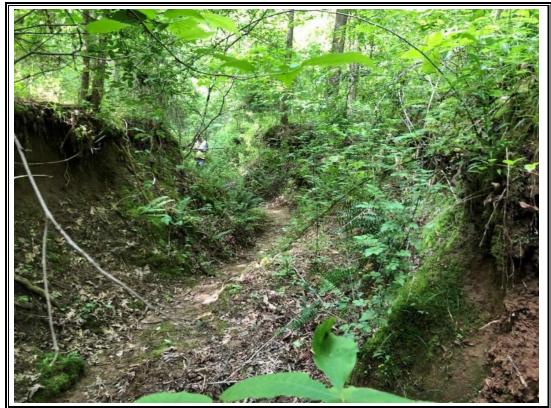
Photo: 17 By: N. Carmean Date: May 11, 2020 Feature: WWC-1 Lat: 35.589967, Long: -88.941744

Looking upstream within the channel of WWC-1. Note the presence of a weak bed and bank, some substrate sorting, and some wrack lines in the channel.

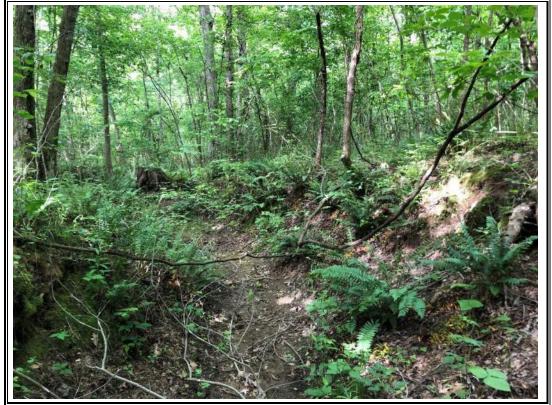
Photo: 18 By: N. Carmean Date: May 11, 2020 Feature: WWC-2 Lat: 35.590077, Long: -88.941923

Looking upstream within the channel of WWC-2. Note the presence of a weak bed and bank, and a moderate presence of fibrous roots.

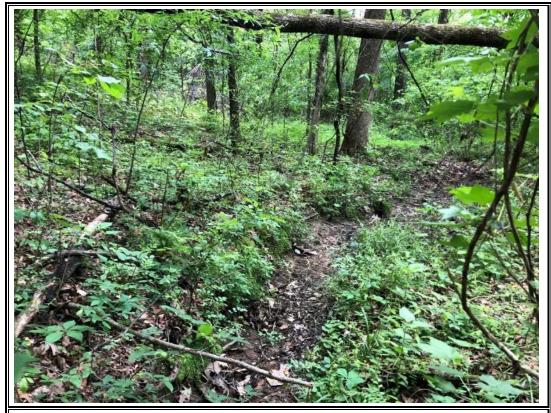
Photo: 19 By: N. Carmean Date: May 12, 2020 Feature: WWC-3 Lat: 35.584041, Long: -88.942811

Looking downstream within the channel of WWC-3. Note the presence of a weak bed and bank, and a moderate presence of leaf litter in the channel.

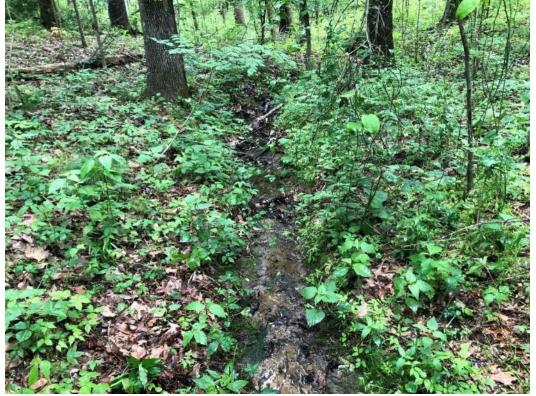
Photo: 20 By: N. Carmean Date: May 12, 2020 Feature: WWC-4 Lat: 35.582745, Long: -88.943114

Looking downstream within the channel of WWC-4. Note the presence of a semimoderate bed and bank, and a presence of leaf litter in the channel.

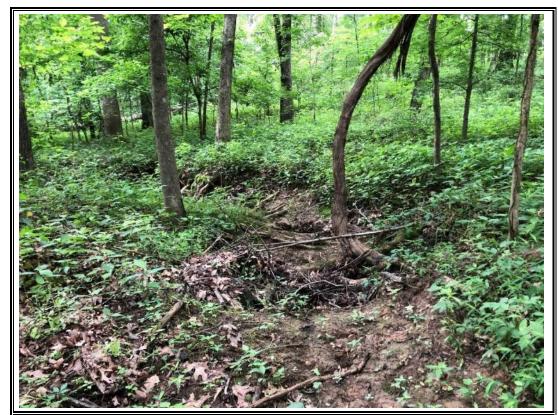
Photo: 21 By: N. Carmean Date: May 29, 2020 Feature: WWC-5 Lat: 35.582864, Long: -88.943275

Looking downstream within the channel of WWC-5. Note the presence of a weak bed and bank, little substrate sorting, wrack lines and vegetation in the channel.

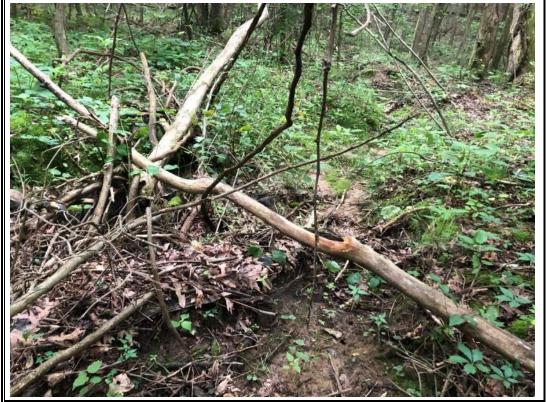
Photo: 22 By: N. Carmean Date: May 29, 2020 Feature: WWC-6 Lat: 35.581099, Long: -88.941358

Looking upstream within the channel of WWC-6. Note the presence of a minimal bed and bank, no substrate sorting, wrack lines and vegetation in the channel.

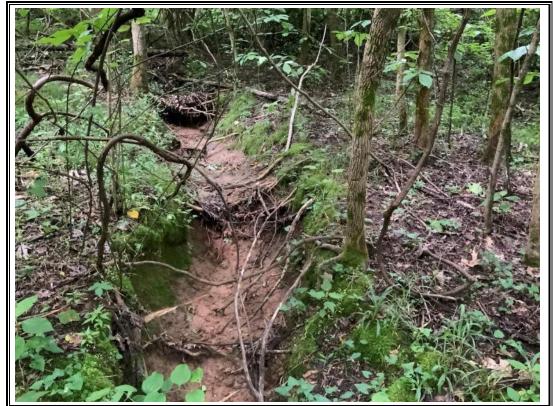
Photo: 23 By: F. Amatucci Date: May 29, 2020 Feature: WWC-7 Lat: 35.582374, Long: -88.939910

Looking upstream within the channel of WWC-7. Note the presence of a moderate bed and bank, some substrate sorting, and wrack lines in the channel.

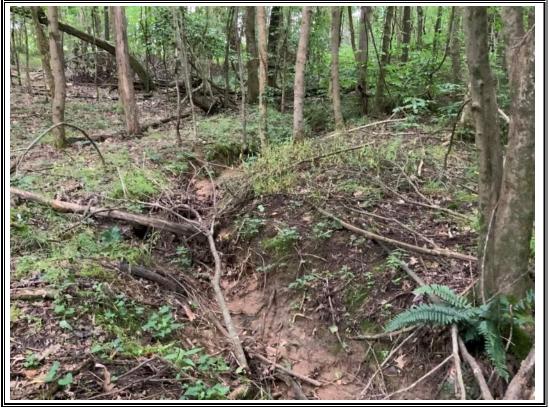
Photo: 24 By: F. Amatucci Date: May 29, 2020 Feature: WWC-8 Lat: 35.582614, Long: -88.939288

Looking upstream within the channel of WWC-8. Note the presence of a weak bed and bank, some substrate sorting, and some wrack lines in the channel.

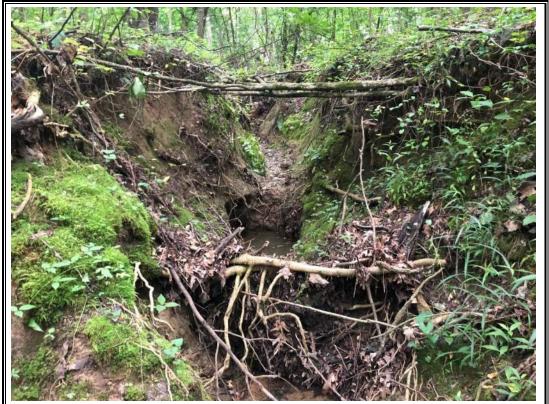
Photo: 25 By: N. Carmean Date: May 29, 2020 Feature: WWC-9 Lat: 35.582614, Long: -88.939288

Looking upstream within the channel of WWC-9. Note the presence of a moderate bed and bank, some substrate sorting, moderate wrack lines in the channel, and some headcuts.

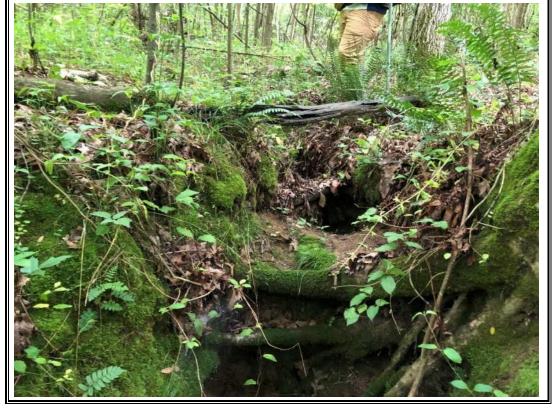
Photo: 26 By: N. Carmean Date: May 29, 2020 Feature: WWC-10 Lat: 35.586453, Long: -88.939803

Looking upstream within the channel of WWC-10. Note the presence of a semi-moderate bed and bank, some substrate sorting, moderate wrack lines in the channel, and some headcuts.

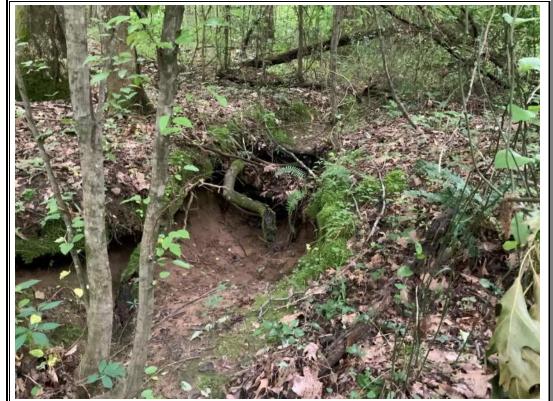
Photo: 27 By: F. Amatucci Date: May 29, 2020 Feature: WWC-11 Lat: 35.588013, Long: -88.939720

Looking upstream within the channel of WWC-11. Note the presence of a semi-moderate bed and bank, little substrate sorting, moderate wrack lines in the channel, and some headcuts.

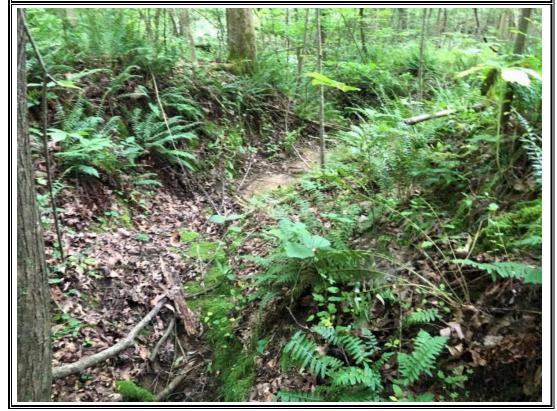
Photo: 28 By: N. Carmean Date: May 29, 2020 Feature: WWC-12 Lat: 35.588372, Long: -88.939084

Looking upstream within the channel of WWC-12. Note the presence of a semi-moderate bed and bank, little substrate sorting, leaf litter in the channel, and some headcuts.

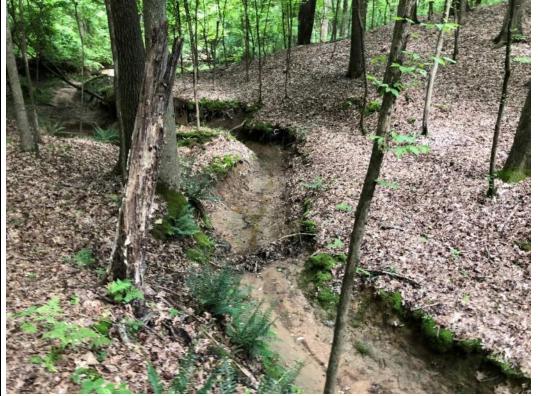
Photo: 30 By: N. Carmean Date: May 29, 2020 Feature: WWC-14 Lat: 35.587594, Long: -88.935109

Looking downstream within the channel of WWC-14. Note the presence of a moderate bed and bank, a medium sized headcut, and moderate substrate sorting.

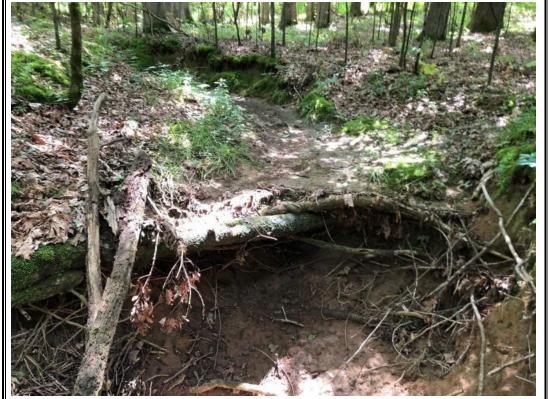
Photo: 31 By: N. Carmean Date: May 29, 2020 Feature: WWC-15 Lat: 35.586264, Long: -88.936330

Looking upstream within the channel of WWC-15. Note the presence of a moderate bed and bank, a medium sized headcut, and moderate substrate sorting.

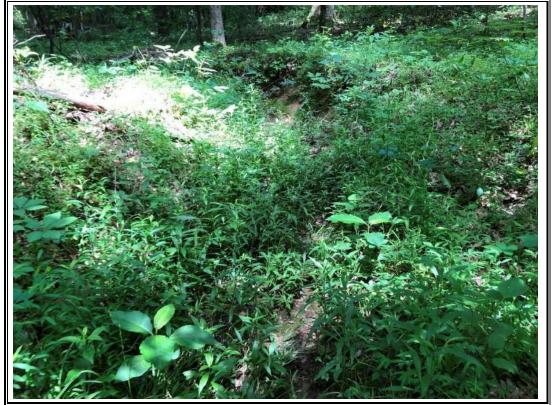
Photo: 32 By: N. Carmean Date: May 29, 2020 Feature: WWC-16 Lat: 35.586247, Long: -88.936715

Looking downstream within the channel of WWC-16. Note the presence of a weak bed and bank, minimal sorting, and vegetation in the channel.

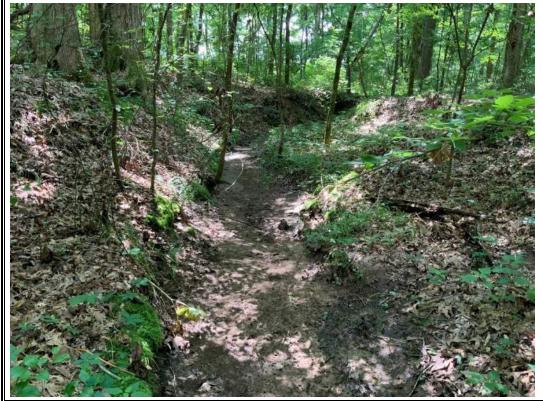
Photo: 34 By: F. Amatucci Date: May 29, 2020 Feature: WWC-18 Lat: 35.582713, Long: -88.935499

Looking upstream within the channel of WWC-18. Note the presence of a moderate bed and bank, with weak sorting, and some vegetation in the channel.

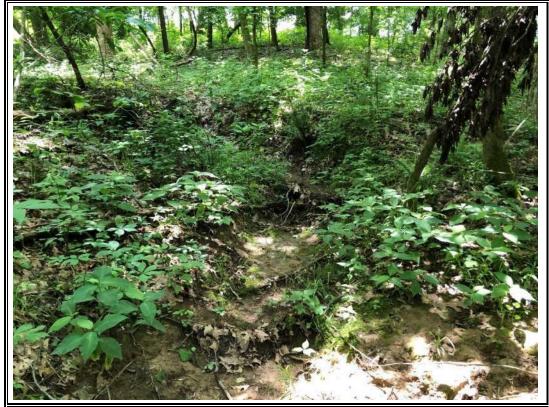
Photo: 35 By: N. Carmean Date: May 29, 2020 Feature: WWC-19 Lat: 35.582694, Long: -88.935674

Looking upstream within the channel of WWC-19. Note the presence of a weak bed and bank, with weak sorting, and some vegetation in the channel.

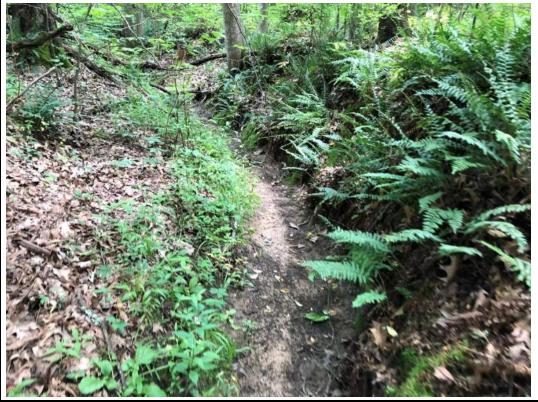
Photo: 36 By: N. Carmean Date: May 29, 2020 Feature: WWC-20 Lat: 35.582022, Long: -88.932376

Looking upstream within the channel of WWC-20. Note the presence of a moderate bed and bank, with moderate sorting, and some vegetation in the channel.

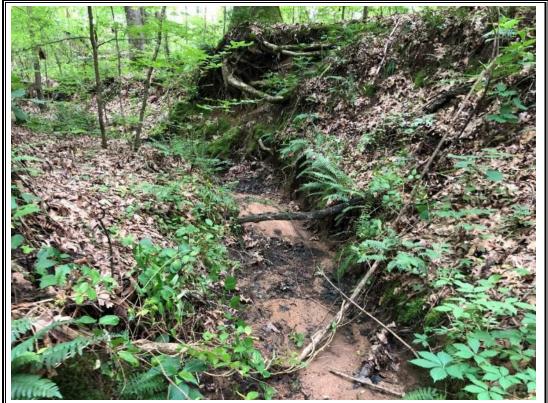
Photo: 37 By: N. Carmean Date: May 29, 2020 Feature: WWC-21 Lat: 35.580342, Long: -88.935985

Looking upstream within the channel of WWC-21. Note the presence of a semi-strong bed and bank, with moderate sorting, presence of wrack lines, and some vegetation in the channel.

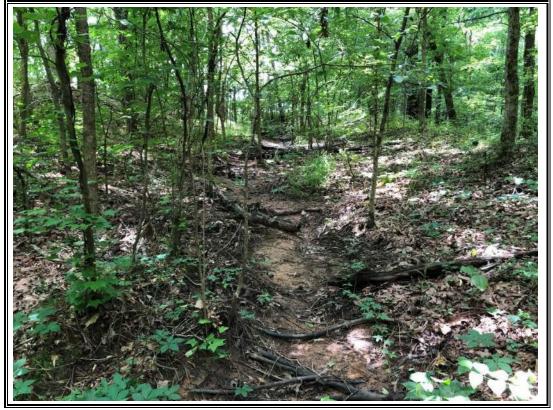
Photo: 38 By: N. Carmean Date: May 29, 2020 Feature: WWC-22 Lat: 35.579538, Long: -88.935579

Looking upstream within the channel of WWC-22. Note the presence of a weak bed and bank, vegetation and fibrous roots in channel.

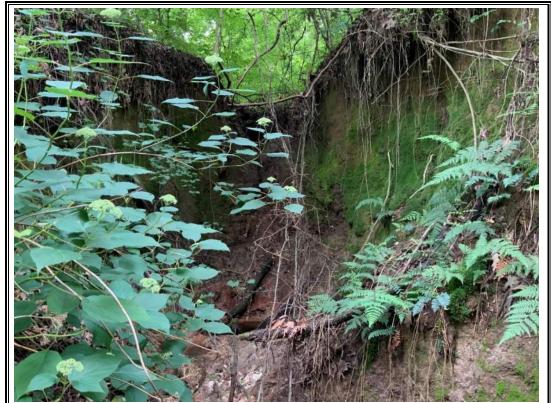
Photo: 39 By: F. Amatucci Date: May 29, 2020 Feature: WWC-23 Lat: 35.577945, Long: -88.937124

Looking upstream within the channel of WWC-23. Note the presence of a moderate headcut and semi-moderate bed and bank.

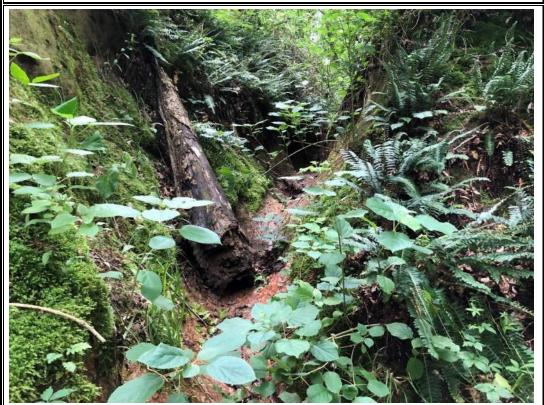
Photo: 40 By: N. Carmean Date: May 29, 2020 Feature: WWC-24 Lat: 35.577877, Long: -88.936981

Looking upstream within the channel of WWC-24. Note the presence of a moderate headcut and semi-moderate bed and bank.

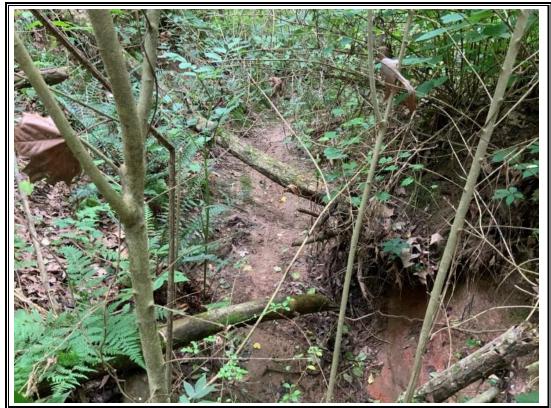
Photo: 41 By: F. Amatucci Date: May 29, 2020 Feature: WWC-25 Lat: 35.576288, Long: -88.937335

Looking downstream within the channel of WWC-25. Note the presence of a moderate bed and bank, some substrate sorting, and wrack lines in the channel.

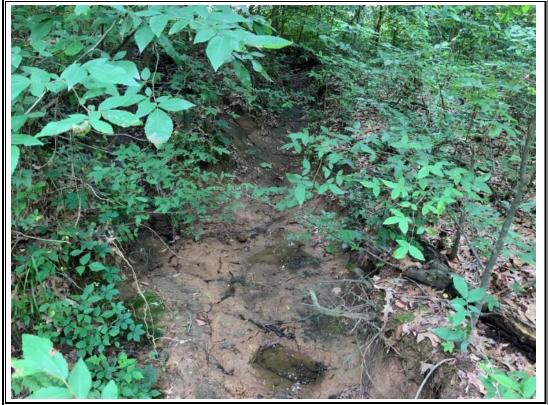
Photo: 42 By: F. Amatucci Date: May 29, 2020 Feature: WWC-26 Lat: 35.575923, Long: -88.937450

Looking upstream within the channel of WWC-26. Note the presence of a moderate bed and bank, some substrate sorting, and wrack lines in the channel.

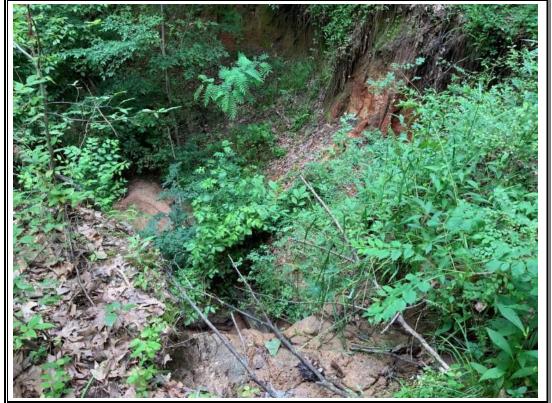
**Photo:** 43 **By:** F. Amatucci **Date:** May 29, 2020 **Feature:** WWC-27 **Lat:** 35.575865, **Long:** -88.937494

Looking downstream within the channel of WWC-27. Note the presence of a moderate bed and bank, some substrate sorting, and very large headcut.

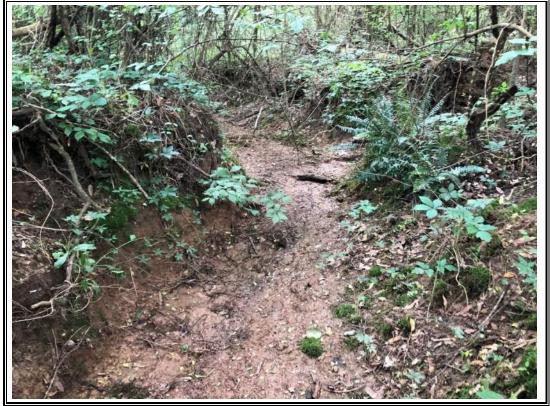
Photo: 44 By: N. Carmean Date: May 29, 2020 Feature: WWC-28 Lat: 35.576647, Long: -88.939445

Looking downstream within the channel of WWC-28. Note the presence of a moderate bed and bank, some substrate sorting, and wrack lines in the channel.

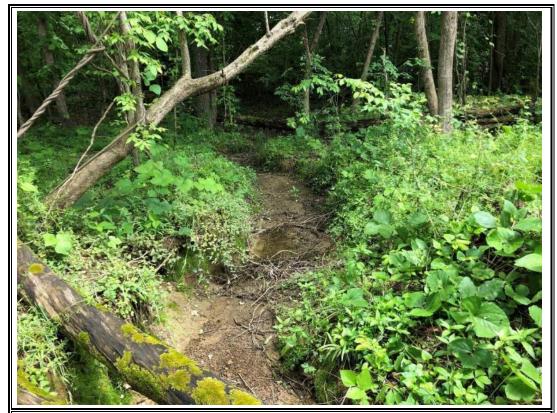
Photo: 45 By: N. Carmean Date: May 13, 2020 Feature: WWC-29 Lat: 35.574321, Long: -88.927595

Looking downstream within the channel of WWC-29a. Note the presence of a moderate bed and bank, some substrate sorting, and wrack lines in the channel.

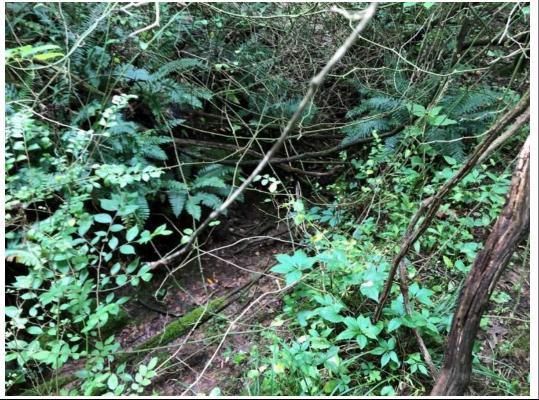
Photo: 46 By: N. Carmean Date: May 28, 2020 Feature: WWC-30 Lat: 35.575981, Long: -88.922960

Looking upstream within the channel of WWC-30. Note the presence of a moderate bed and bank, some substrate sorting, and groundwater seepage in the channel.

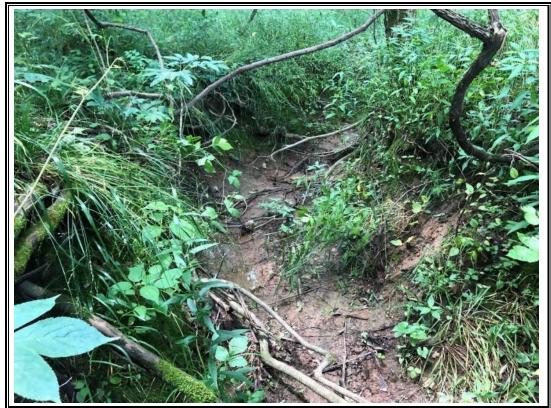
Photo: 47 By: N. Carmean Date: May 28, 2020 Feature: WWC-31 Lat: 35.572497, Long: -88.920632

Looking upstream within the channel of WWC-31. Note the presence of a moderate bed and bank and vegetation in the thalwag.

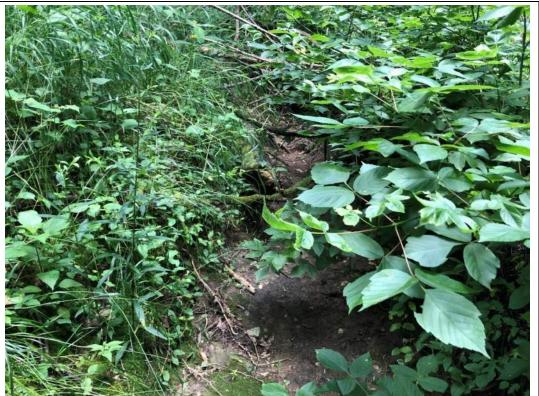
Photo: 48 By: N. Carmean Date: May 28, 2020 Feature: WWC-32 Lat: 35.572387, Long: -88.920702

Looking upstream within the channel of WWC-32. Note the presence of a weak bed and bank and vegetation in the thalwag.

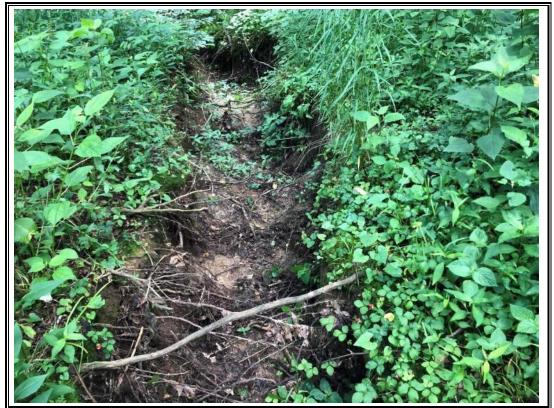
Photo: 49 By: N. Carmean Date: May 28, 2020 Feature: WWC-33 Lat: 35.572486, Long: -88.919800

Looking upstream within the channel of WWC-33. Note the presence of a moderate bed and bank and vegetation in the thalwag.

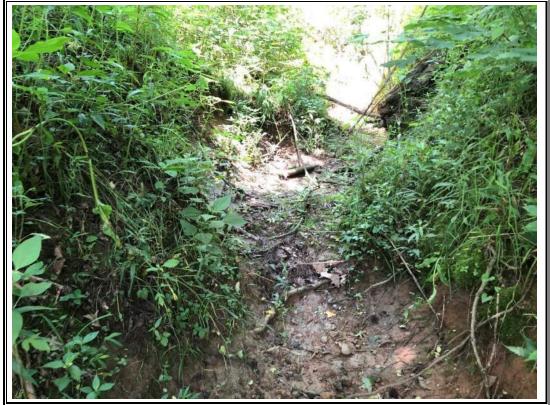
Photo: 50 By: F. Amatucci Date: May 28, 2020 Feature: WWC-34 Lat: 35.569562, Long: -88.924569

Looking upstream within the channel of WWC-34. Note the presence of a weak bed and bank and vegetation in the thalwag.

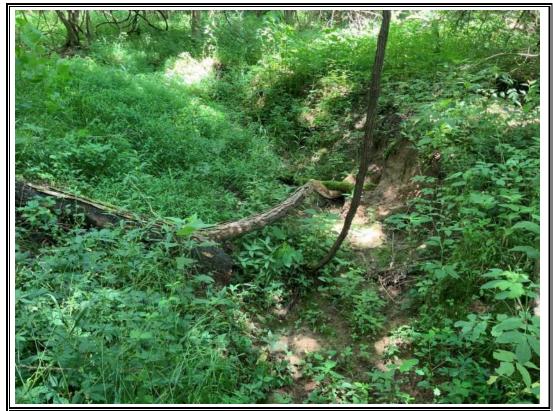
Photo: 51 By: F. Amatucci Date: May 28, 2020 Feature: WWC-35 Lat: 35.569298, Long: -88.924454

Looking downstream within the channel of WWC-35. Note the presence of a weak bed and bank and vegetation in the thalwag.

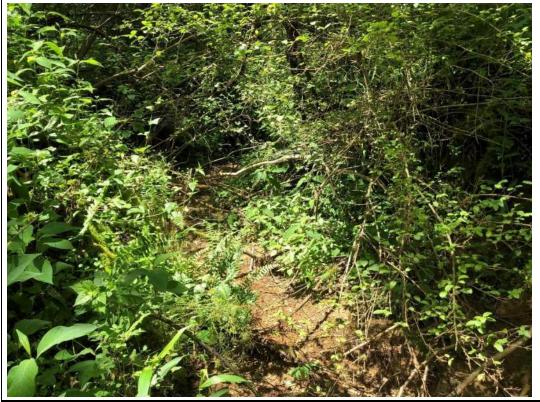
Photo: 52 By: N. Carmean Date: May 28, 2020 Feature: WWC-36 Lat: 35.566803, Long: -88.928135

Looking upstream within the channel of WWC-36. Note the presence of a weak bed and bank and vegetation in the thalwag.

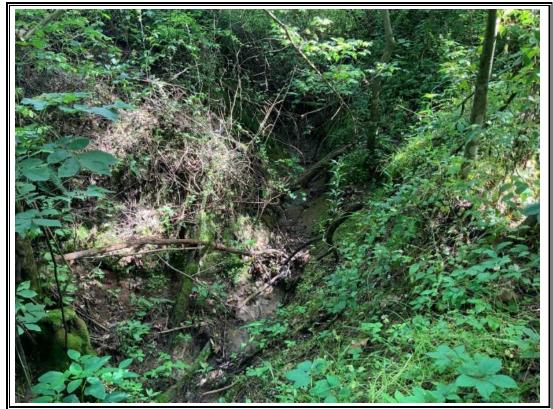
Photo: 53 By: F. Amatucci Date: May 28, 2020 Feature: WWC-37 Lat: 35.566942, Long: -88.928549

Looking downstream within the channel of WWC-37. Note the presence of a moderate bed and bank and a moderate quantity of wrack lines.

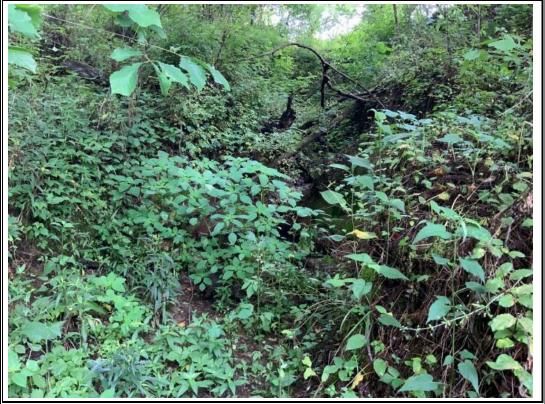
Photo: 54 By: F. Amatucci Date: May 28, 2020 Feature: WWC-38 Lat: 35.568917, Long: -88.930152

Looking upstream within the channel of WWC-38. Note the presence of a weak bed and bank and FACW/FAC vegetation in the thalwag.

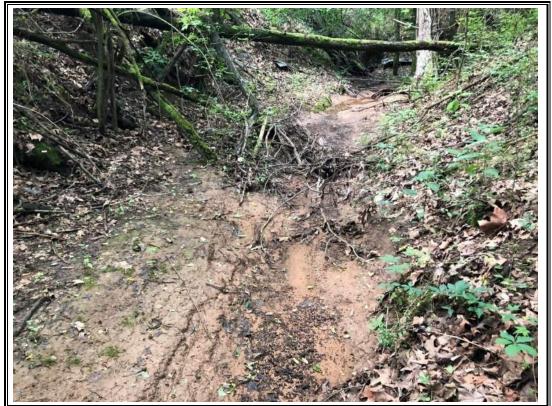
Photo: 55 By: N. Carmean Date: May 28, 2020 Feature: WWC-39 Lat: 35.568017, Long: -88.934943

Looking upstream within the channel of WWC-39. Note the presence of a moderate bed and bank, some substrate sorting, and a mild presence of wrack lines.

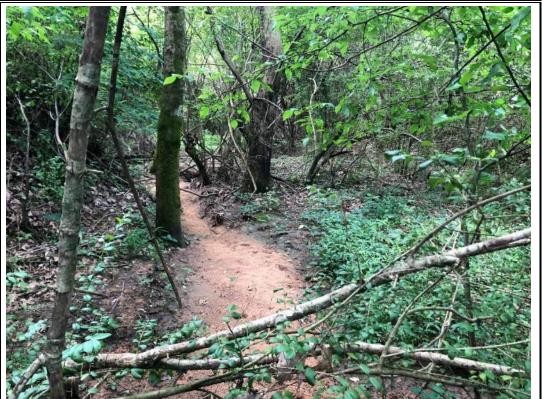
Photo: 56 By: N. Carmean Date: May 28, 2020 Feature: WWC-40 Lat: 35.568737, Long: -88.934397

Looking upstream within the channel of WWC-40. Note the presence of a moderate bed and bank, some substrate sorting, and a mild presence of wrack lines.

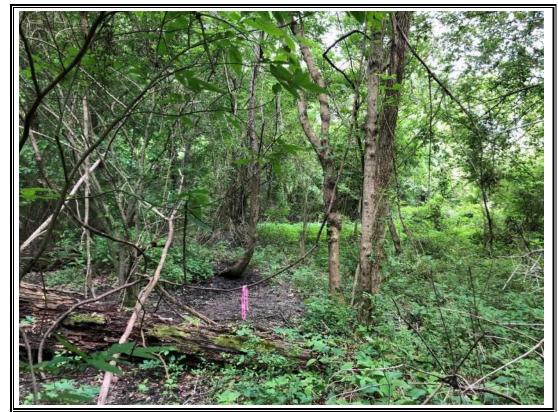
Photo: 57 By: N. Carmean Date: May 14, 2020 Feature: WWC-41 Lat: 35.571328, Long: -88.933576

Looking downstream within the channel of WWC-41 between WTL-13b and 13a. Note the presence of a minimal bed and bank, and hydric soils.

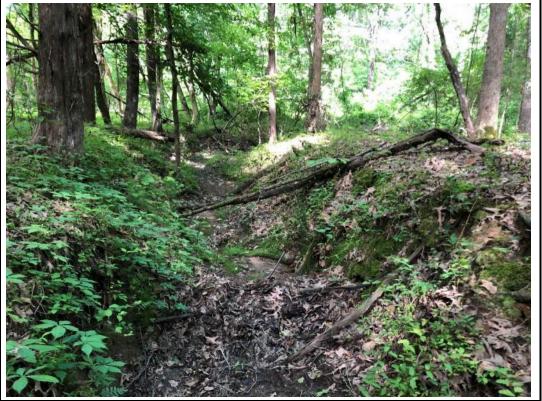
Photo: 58 By: N. Carmean Date: May 14, 2020 Feature: WWC-42 Lat: 35.570187, Long: -88.945580

Looking upstream within the channel of WWC-42 prior to a large headcut. Note the presence of a moderate bed and bank, wrack lines, and some vegetation within the thalwag.

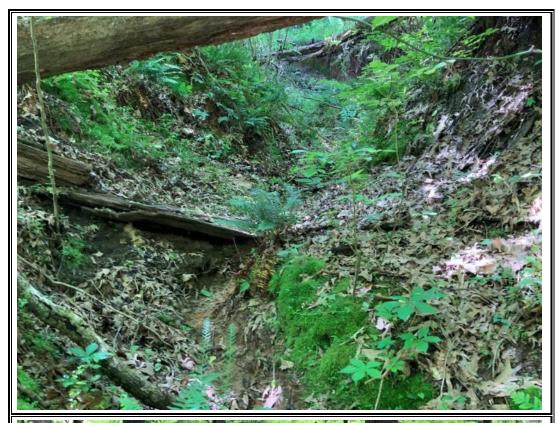
Photo: 59 By: F. Amatucci Date: May 14, 2020 Feature: WWC-43 Lat: 35.570090, Long: -88.946131

Looking upstream within the channel of WWC-43 prior to a large headcut. Note the presence of a weak bed and bank and leaf litter in the channel.

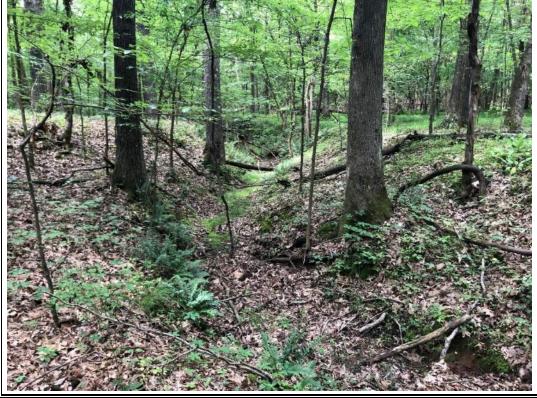
Photo: 60 By: N. Carmean Date: May 28, 2020 Feature: WWC-44 Lat: 35.569909, Long: -88.948636

Looking downstream within the channel of WWC-44. Note the presence of a weak bed and bank and a dominance of leaf litter in the channel. Feature is likely a relic channel prior to the creation of farm pond WTL-14.

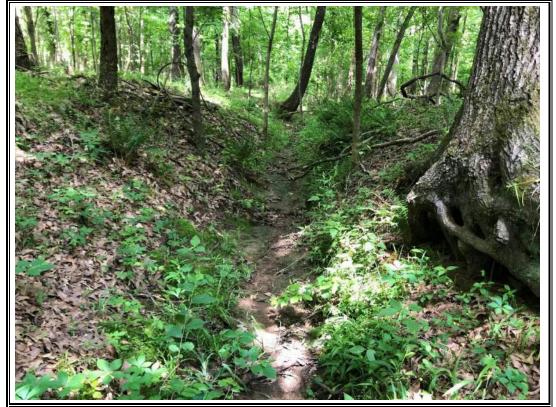
Photo: 61 By: N. Carmean Date: May 14, 2020 Feature: WWC-45 Lat: 35.570408, Long: -88.950158

Looking upstream within the channel of WWC-45. Note the presence of a weak bed and bank and FACU/FAC vegetation within the thalwag.

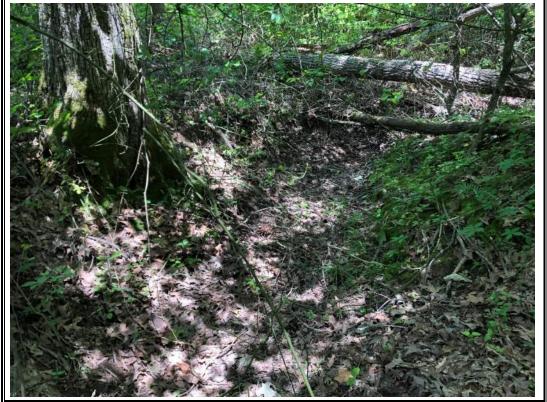
Photo: 62 By: N. Carmean Date: May 14, 2020 Feature: WWC-46 Lat: 35.568652, Long: -88.945392

Looking upstream within the channel of WWC-46. Note the presence of a weak bed and bank and FACU/FAC vegetation and a strong presence of leaf litter within the channel.

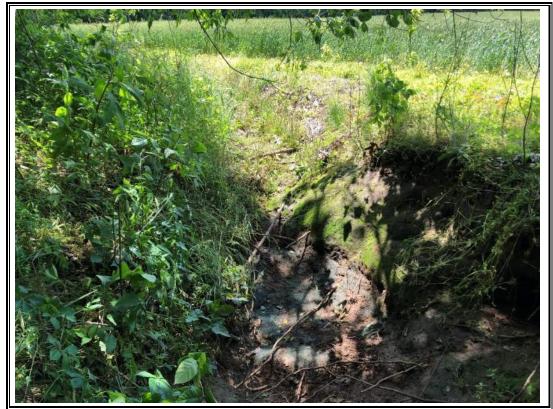
Photo: 63 By: N. Carmean Date: May 14, 2020 Feature: WWC-47 Lat: 35.568766, Long: -88.946097

Looking upstream within the channel of WWC-47. Note the presence of a weak bed and bank and FACU/FAC vegetation within the thalwag.

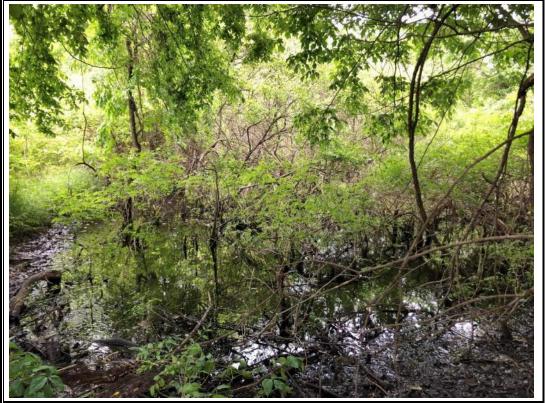
Photo: 64 By: N. Carmean Date: May 12, 2020 Feature: WTL-1 Lat: 35.583486, Long: -88.937663

Representative conditions of WTL-1. Note the potential presence of being a historic farm pond that has become overgrown.

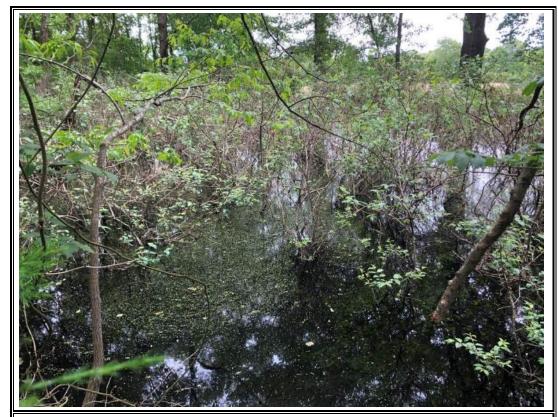
Photo: 65 By: N. Carmean Date: May 12, 2020 Feature: WTL-2 Lat: 35.577779, Long: -88.941487

Representative conditions of WTL-2. Note the potential presence of being a historic farm pond that has become overgrown.

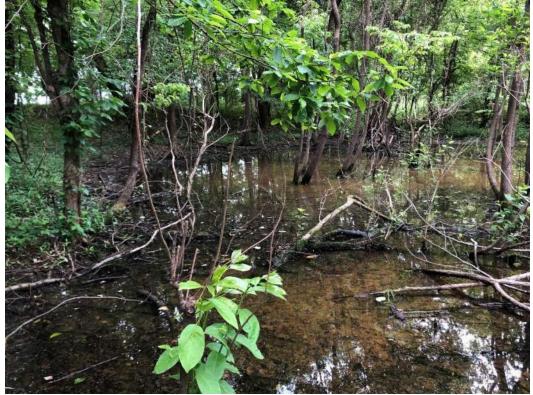
Photo: 66 By: N. Carmean Date: May 12, 2020 Feature: WTL-3 Lat: 35.580655, Long: -88.941943

Representative conditions of WTL-3. Note the potential presence of being a historic farm pond that has become overgrown.

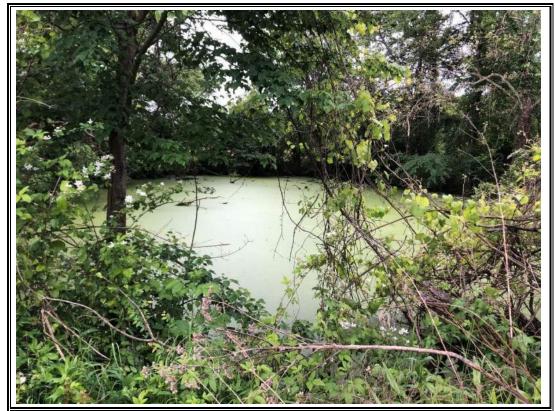
Photo: 67 By: N. Carmean Date: May 12, 2020 Feature: WTL-4 Lat: 35.584285, Long: -88.942462

Representative conditions of WTL-4. Note the potential presence of being a historic farm pond.

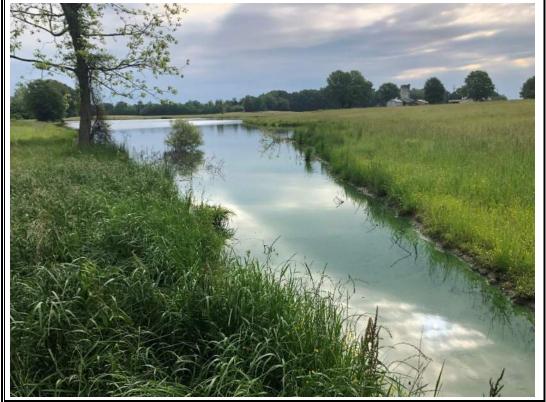
Photo: 68 By: N. Carmean Date: May 12, 2020 Feature: WTL-5 Lat: 35.573909, Long: -88.938316

Representative conditions of WTL-5. Note the presence of being a farm pond with a PEM fringe.

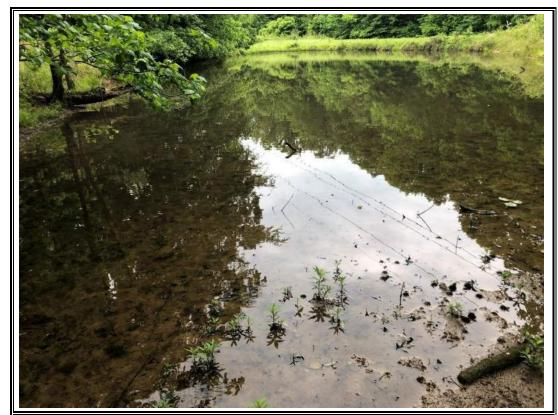
Photo: 69 By: N. Carmean Date: May 13, 2020 Feature: WTL-6 Lat: 35.581566, Long: -88.933498

Representative conditions of WTL-6. Note the presence of being a farm pond with a PFO fringe.

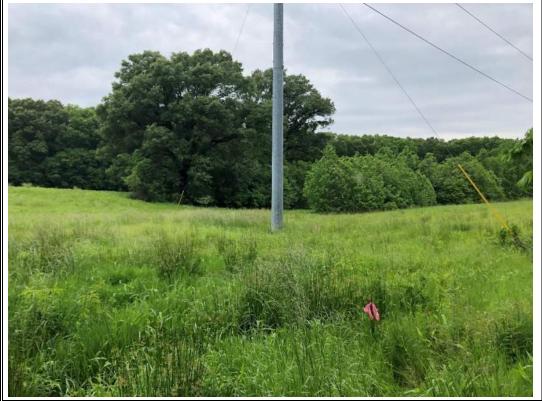
Photo: 70 By: N. Carmean Date: May 13, 2020 Feature: WTL-7 Lat: 35.579945, Long: -88.933053

Representative conditions of WTL-7. Note the wetland is a PEM feature in the electric utility Right-of-Way.

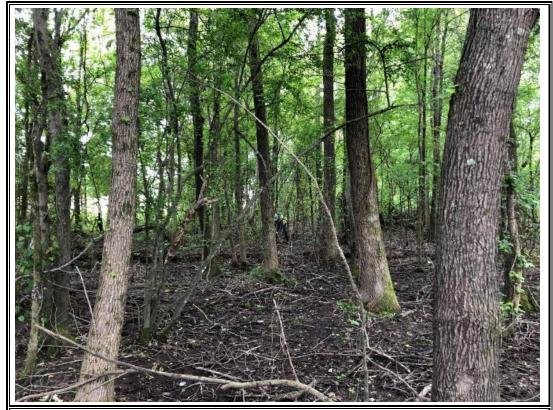
Photo: 71 By: N. Carmean Date: May 13, 2020 Feature: WTL-8 Lat: 35.573688, Long: -88.929620

Representative conditions of WTL-8. Note the wetland is a PFO feature.

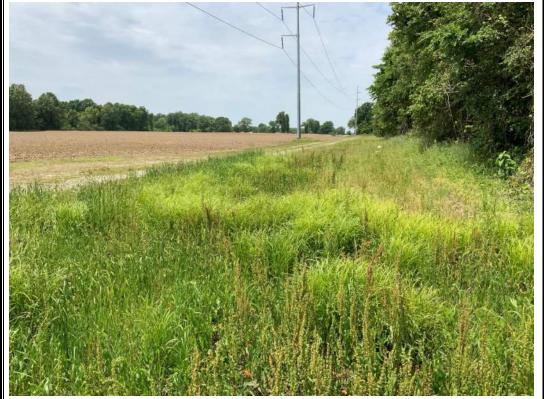
Photo: 72 By: F. Amatucci Date: May 13, 2020 Feature: WTL-9 Lat: 35.573554, Long: -88.928754

Representative conditions of WTL-9. Note the wetland is a PEM feature in the electric utility Right-of-Way.

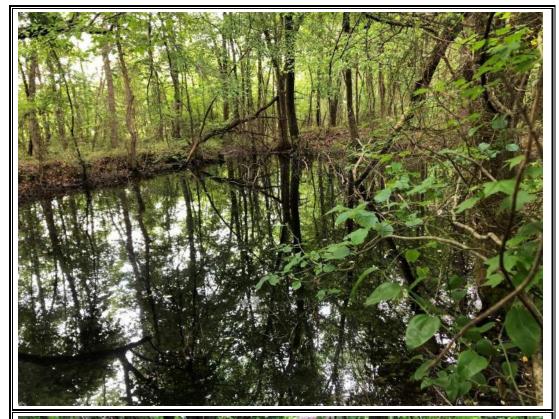
Photo: 73 By: N. Carmean Date: May 13, 2020 Feature: WTL-10a Lat: 35.57294, Long: -88.9237813

Representative conditions of WTL-10a. Note the potential presence of being a historic farm pond that has become overgrown.

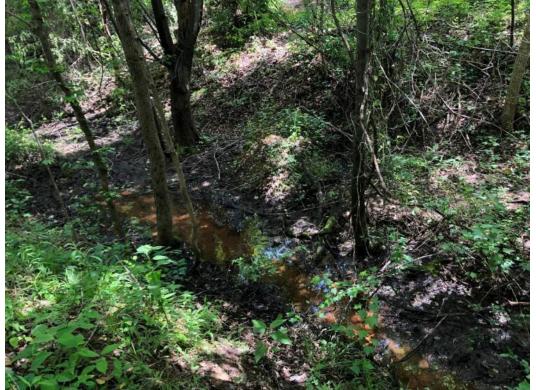
Photo: 74 By: N. Carmean Date: May 13, 2020 Feature: WTL-10b Lat: 35.572964, Long: -88.922921

Representative conditions of WTL-10b. Note the presence of ground water seepage from a berm wall to create a linear wetland feature.

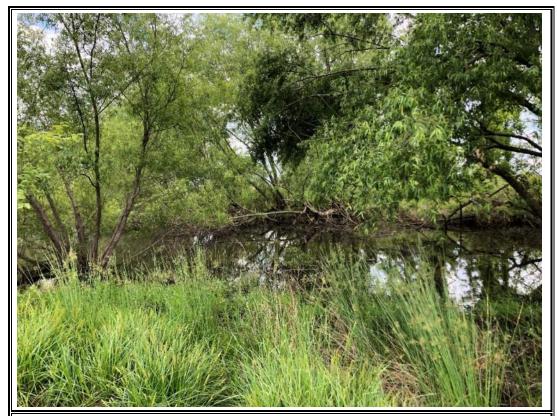
Photo: 75 By: N. Carmean Date: May 13, 2020 Feature: WTL-11 Lat: 35.567558, Long: -88.937630

Representative conditions of WTL-11. Note the presence of being a farm pond with a PEM and PFO fringe.

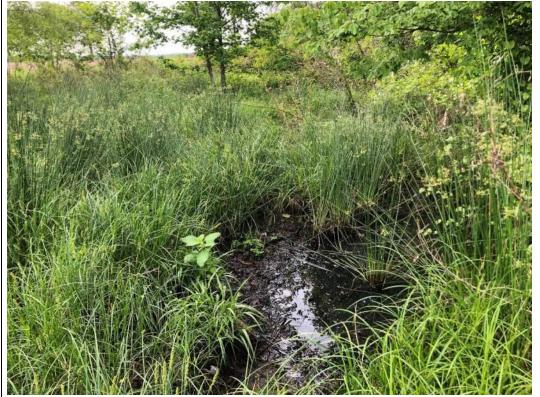
Photo: 76 By: N. Carmean Date: May 14, 2020 Feature: WTL-12 Lat: 35.571323, Long: -88.931008

Representative conditions of WTL-12. Note the wetland is a PFO feature.

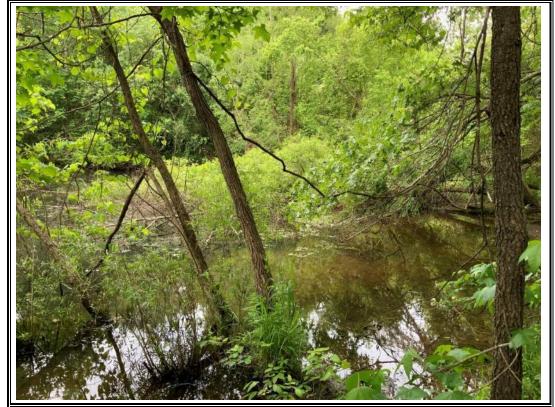
Photo: 77 By: F. Amatucci Date: May 14, 2020 Feature: WTL-13a Lat: 35.571384, Long: -88.932894

Representative conditions of WTL-13. Note the presence of being a farm pond with a PFO fringe.

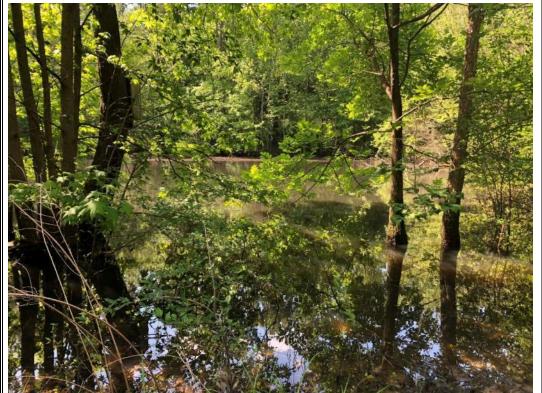
Photo: 78 By: F. Amatucci Date: May 14, 2020 Feature: WTL-14 Lat: 35.568239, Long: -88.948255

Representative conditions of WTL-14. Note the presence of being a farm pond with a PFO fringe.

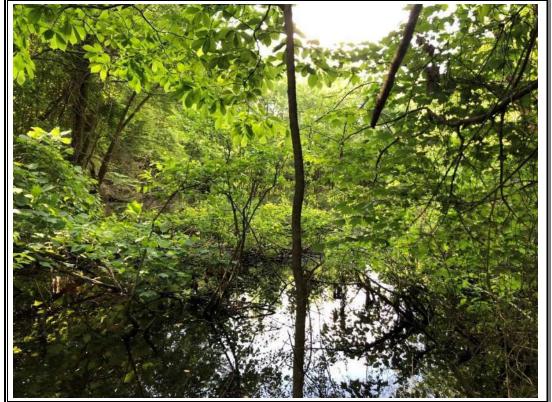
Photo: 79 By: N. Carmean Date: May 28, 2020 Feature: WTL-15a Lat: 35.575168, Long: -88.923614

Representative conditions of WTL-15a. Note the presence of being a farm pond with a PFO fringe.

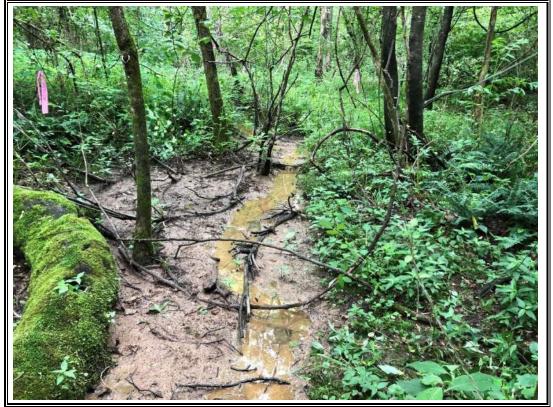
Photo: 80 By: N. Carmean Date: May 28, 2020 Feature: WTL-15b Lat: 35.575375, Long: -88.923061

Representative conditions of WTL-15b. Note the presence of iron oxidizing bacteria coming from seepages within the wetland.
