## Appendix B Natural Resources Field Review

**RE:** Summary of Environmental Features for the Silicon Ranch McKellar Solar Farm,

Jackson, Madison County, Tennessee

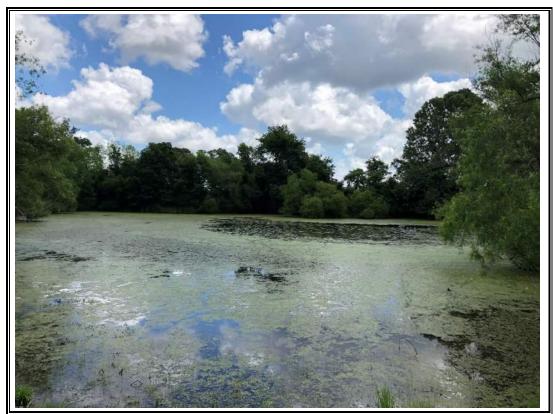
Photo:81 By: N. Carmean Date: May 28, 2020 Feature: WTL-16

Representative conditions of WTL-16. Note the potential presence of being a historic farm pond.

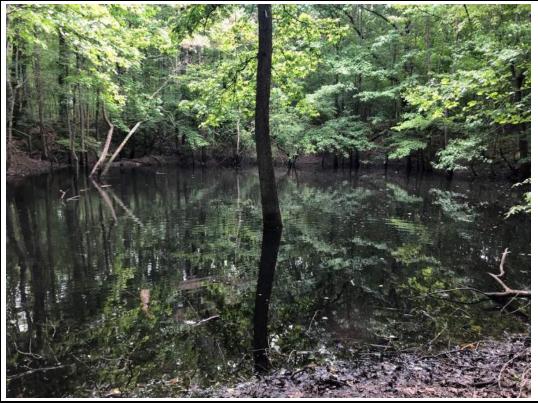
Photo:82 By: N. Carmean Date: May 28, 2020 Feature: WTL-17 Lat: 35.567993, Long: -88.951945

Representative conditions of WTL-17. Note the potential presence of being a duck hunting pond with a PFO fringe.

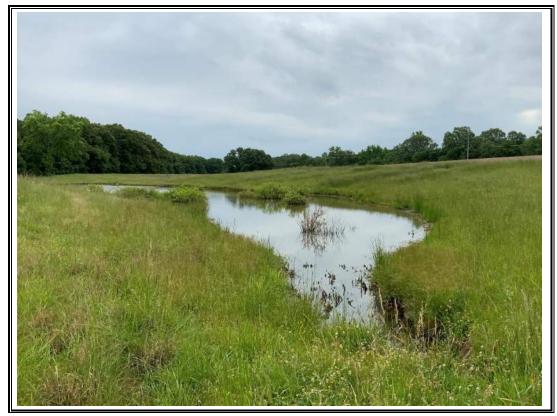
**Photo:** 83

**By:** F. Amatucci **Date:** May 29, 2020 **Feature:** WTL-18 **Lat:** 35.577651, **Long:** -88.935320

Representative conditions of WTL-18. Note the presence of being a farm pond with a PEM/PSS fringe.

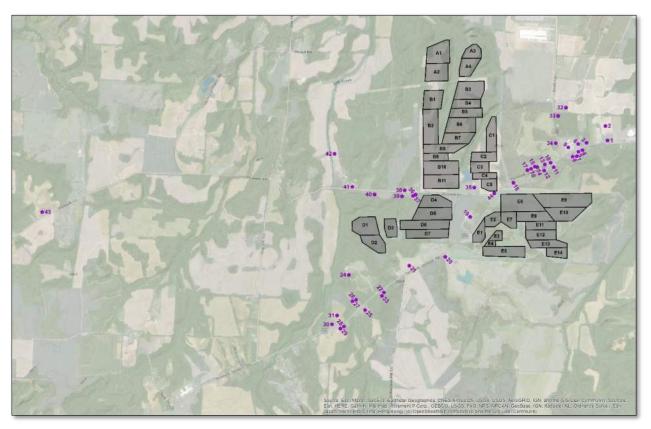
Figure 4: Discrete observation point receptors (purple points)

The SGHAT assessed the potential for glare occurrences at 44 discrete observation point receptors (purple points, *Figure 4*). Each observation point was assessed at an eight-foot first story viewing height and a 16-foot second story viewing height. The SGHAT results do not predict glare occurrences for any of the 44 observation points at either viewing height as a result of single-axis tracking arrays.

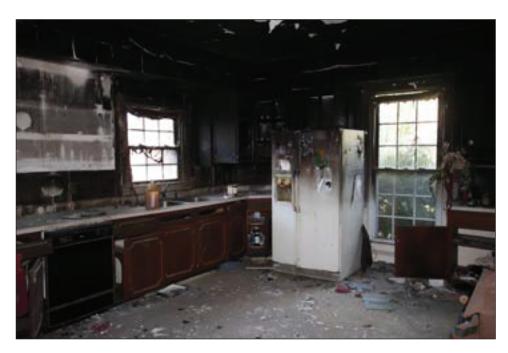
Figure 4.13. Example of MD-IP-2 interior fire damage within the north wing kitchen (view to the northeast).

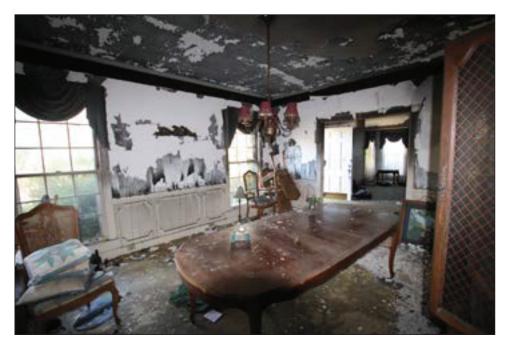
Figure 4.14. Example of MD-IP-2 interior fire damage within the central block dining room (view to the southeast).

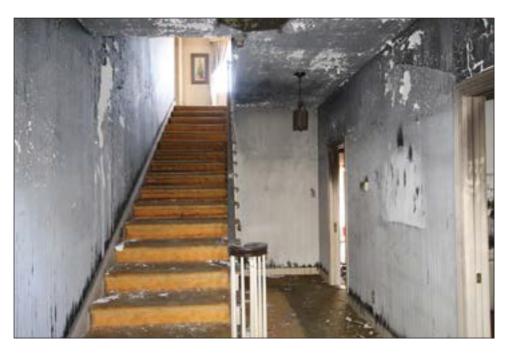
Figure 4.15. Example of MD-IP-2 interior fire damage within the central hallway (view to the west).

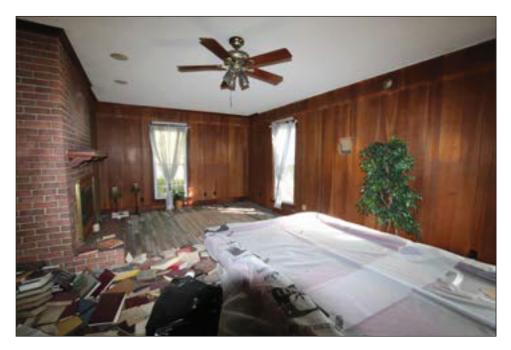
Figure 4.16. MD-IP-2 south wing. Note the removal of custom wall trim and some baseboards (view to the southeast)..

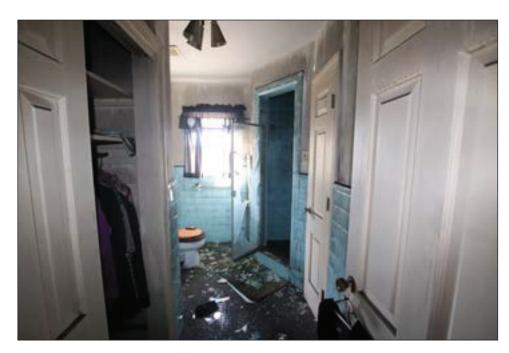
Figure 4.17. Example of smoke damage and vandalism at MD-IP-2 upstairs bathroom (view to the west).

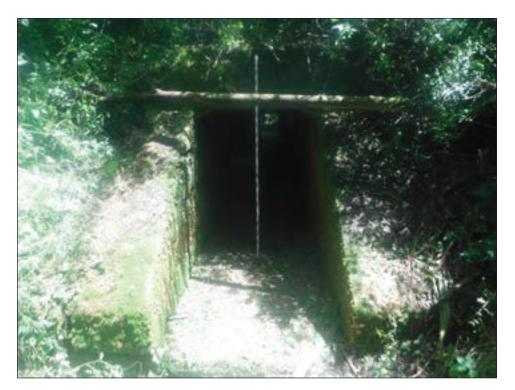
Figure 5.22. Culvert 1 within 40MD267, constructed of concrete (view to the northwest).

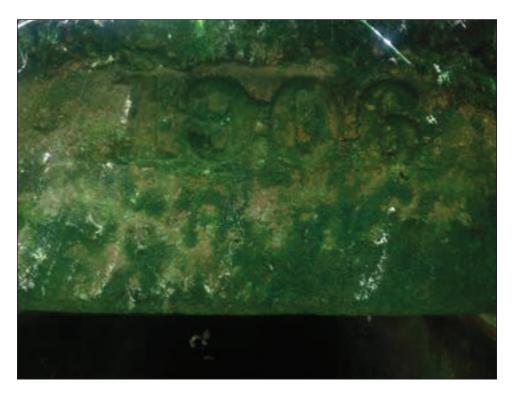
Figure 5.23. A date of "1906" stamped into the concrete of Culvert 1 on 40MD267 (view to the southeast).

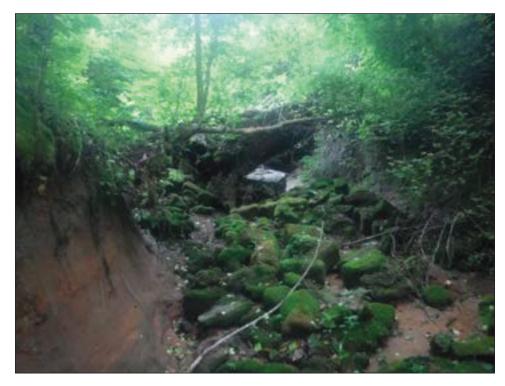
Figure 5.25. Pile of limestone blocks dumped into the drainage associated with Culvert 2 on 40MD267 (view to the northeast).

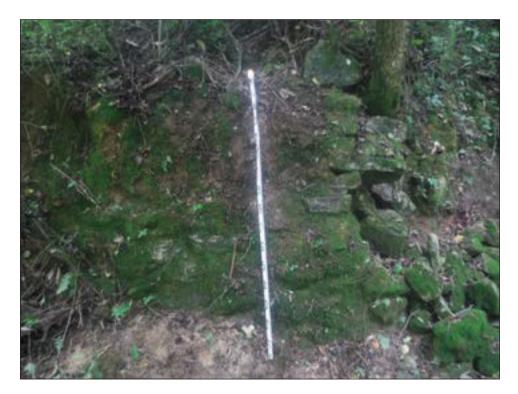
Figure 5.26. Limestone retaining wall along the bank of  $40\mathrm{MD}267$  (view to the southeast).

The integrity of the portion of the railroad within the survey area has been heavily impacted through the removal of the original track infrastructure. Furthermore, the rail bed has been disturbed by the growth of hardwood tree and agriculture. It is TVAR's opinion that the resource within the survey area offers little research potential regarding the area's local or regional history, and accordingly, TVAR recommends that it would not impact the site's overall eligibility for inclusion on the NRHP. No further archaeological investigation of this resource within the survey area is warranted in connection with the proposed project.

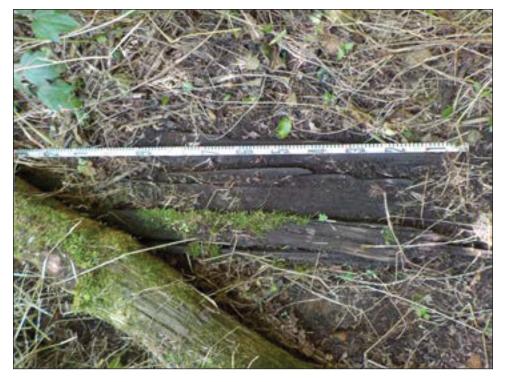
Figure 5.27. Loose, rotted railroad tie observed near 40MD267 (view to the northwest).

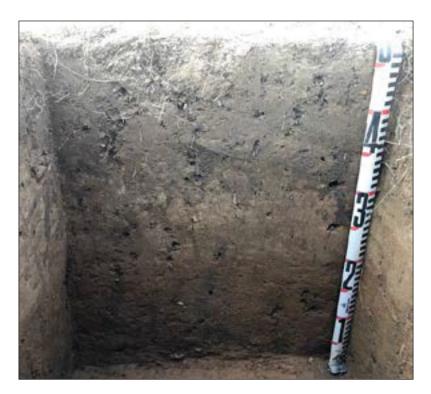
Figure 5.31. Southern profile of Shovel Test 3181 on 40MD268.

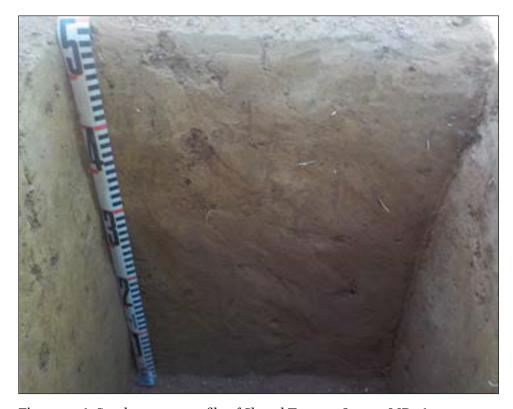
Figure 5.36. Southwestern profile of Shovel Test 3428 on 40MD269.

A total of 19 shovel tests were excavated during the investigation of the site within the survey area, 8 of which yielded artifacts (n=21) from a maximum depth of 50 cmbs. An additional three artifacts were collected from the ground surface in the northern extent of the site. The site encompasses 4,636 m². Memphis silt loam (MeB) is mapped throughout the identified portion of the site. Shovel Test 3428 produced a profile representative of those observed during the testing of 40MD269, consisting of a light yellowish brown (10YR 6/4) silty clay loam plowzone (0 to 23 cmbs) over a yellowish brown (10YR 5/6) silty clay loam (23 to 50 cmbs) (Figure 5.36). The artifacts recovered during TVAR's investigation of 40MD269 are listed below.

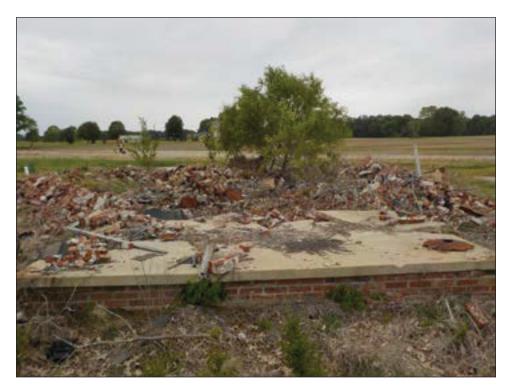
Figure 5.40. Brick foundation and rubble in the location of a structure mapped on 40MD270 (view to the west).

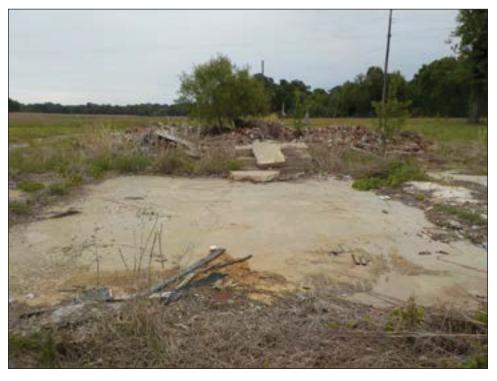
Figure 5.41. Concrete slab attached to brick foundation and rubble in the location of the structure mapped on 40MD270 (view to the east).

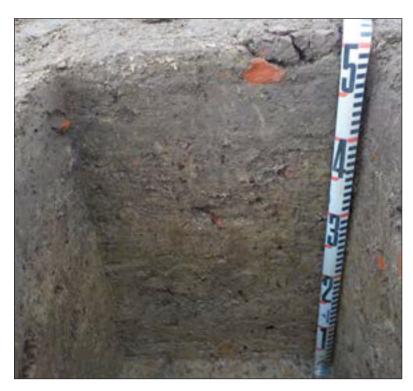
Figure 5.43. Eastern profile of Shovel Test 3234 on 40MD270.

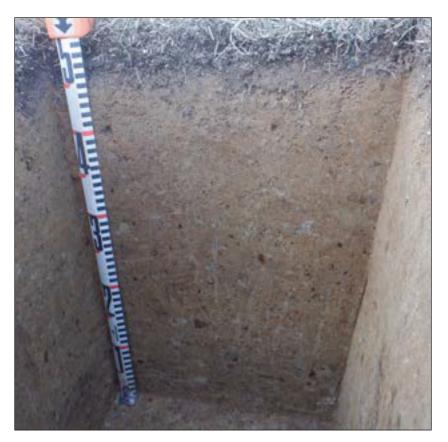
Figure 5.44. Western profile of Shovel Test 8119 on 40MD270.

A total of 92 shovel tests were excavated during TVAR's investigation of this site, 38 of which yielded artifacts (n=352) from a maximum depth of 45 cmbs. An additional eight artifacts were collected from the ground surface. Grenada (GrB) and Loring (LoB) silt loams are mapped at the site. Shovel Test 3234 produced a profile representative of those observed throughout the eastern extent of 40MD270 where Loring silt loam was mapped, consisting of a grayish brown (10YR 5/2) silt loam plow zone (0 to 15 cmbs), a mottled pale brown (10YR 6/3) silt loam with mineral concretions (15 to 35 cmbs), and a mottled light gray (10YR 7/2) silty clay loam with mineral concretions (35 to 50 cmbs) (Figure 5.43). Shovel Test 8182 produced a profile representative of those observed in the western extent of 40MD270 where Grenada silt loam was mapped, consisting of a dark grayish brown (10YR 4/2) silt loam plow zone (0 to 7 cmbs), a yellowish brown (10YR 5/4) silty clay loam (7 to 21 cmbs), and a mottled yellowish brown (10YR 5/6) silty clay (21 to 50 cmbs) (Figure 5.44). The artifacts recovered during TVAR's investigation of 40MD270 are listed below.

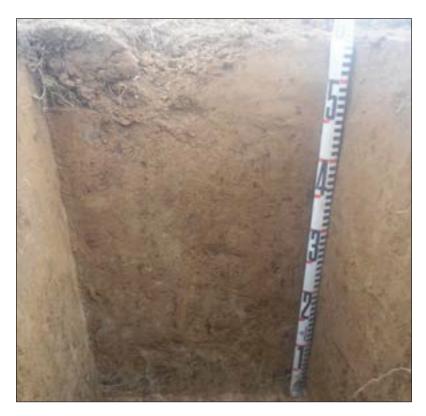
Figure 5.51. Northern profile of Shovel Test 225 on 40MD271.

lowish brown (10YR 5/6) silty clay plowzone (0 to 29 cmbs), a mottled brownish yellow (10YR 6/6) silty clay loam (29 to 43 cmbs), and a mottled very pale brown (10YR 7/3) silt loam (43 to 55 cmbs) (Figure 5.51). Notably, Shovel Test 1886, which was excavated in the mapped location of the western structure, produced a profile consisting of a yellowish brown (10YR 5/6) silty clay loam plowzone (0 to 9 cmbs), a mottled brown (10YR 5/3) silty clay loam (9 to 20), a mottled yellowish brown (10YR 5/6) silty clay loam plowzone (20 to 26 cmbs), and a mottled dark yellowish brown (10YR 4/6) silty clay (26 to 50 cmbs) (Figure 5.52). The second stratum of the test, extending from 9 to 20 cmbs, consisted of a dark soil that produced glass and brick fragments. Considering the location of the test, this stratum likely represents the remnants of a burn pile created during or after the demolition of the structure, which was subsequently flatted and spread by plowing. Artifacts recovered during TVAR's investigation of 40MD271 are listed below.

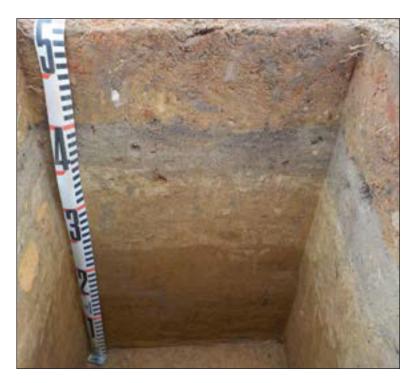
Figure 5.52. Southern profile of Shovel Test 1886 on 40MD271.

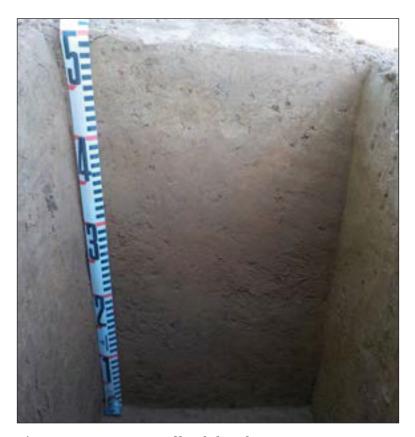
Figure 5.55. Western profile of Shovel Test 5080 on 40MD272.

A total of 30 tests were excavated during TVAR's investigation of this site, one of which yielded one piece of mortar from 0 to 5 cmbs. An additional 17 artifacts were collected from the ground surface as a representative sample of the artifacts observed, and the site's boundary represents the areal extent of the observed surface scatter. The site encompasses 4,571 m². Loring silt loam (LoB3) is mapped across the site. Shovel Test 5080 produced a profile representative of those observed during the testing of 40MD272, consisting of a weak red (10YR 5/4) silty clay loam plow zone (0 to 19 cmbs) underlain by a red (10YR 4/6) silty clay (19 to 50 cmbs) (Figure 5.55). The artifacts recovered during TVAR's investigation of 40MD272 are listed below.

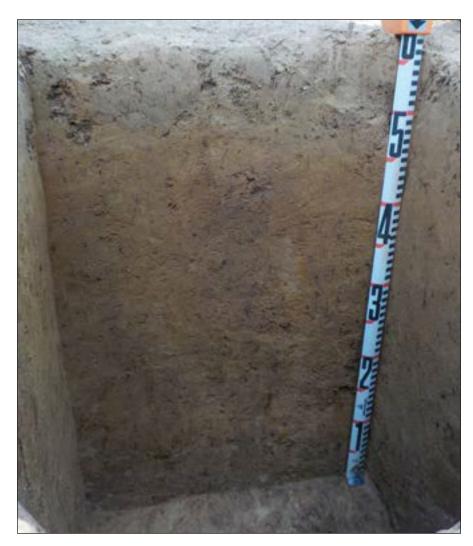
Figure 5.58. Southern profile of Shovel Test 7549 on 40MD273.

Site 40MD273, a Woodland artifact scatter with a minor historic component, was identified in a soy field on a low hill (Figures 5.56 and 5.57). The site is located 285 m east of an unnamed tributary of Cub Creek. During the initial visit to this location by TVAR surface visibility was excellent (approximately 60 percent visibility). A total of 17 tests were excavated during TVAR's investigation of this site, two of which yielded artifacts (n=7) from the first 10 cm of deposits. An additional 48 artifacts were collected from the ground surface as a representative sample of artifacts observed there, and the site's boundary includes the areal extent of the observed surface scatter. The site encompasses 1,477 m². Memphis silt loam (MeB) is mapped across the site. Shovel Test 7549 produced a profile representative of those observed during the testing of 40MD273, consisting of a pale red (10YR 6/4) silt loam plow zone (0 to 13 cmbs), over a brown (7.5YR 5/4) silty clay loam (13 to 19 cmbs), underlain by brown (7.5YR 4/4) silty clay loam (19 to 57 cmbs) (Figure 5.58). The artifacts recovered during TVAR's investigation of 40MD273 are listed below.

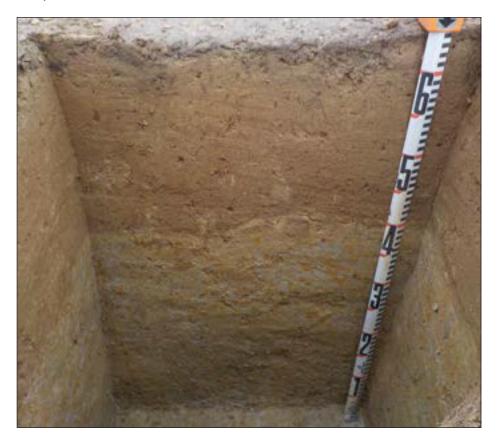
Figure 5.63. Eastern profile of Shovel Test 1000 on 40MD274.

A total of 30 tests were excavated during TVAR's investigation of the site, 14 of which yielded artifacts (n=41) from a maximum depth of 50 cmbs. Two additional artifacts were collected from the ground surface. The site was delineated to the south, east, and west; however, due to the constraints of the survey area, the full extent of 40MD274 could not be fully defined during the current investigation. The identified portion of the site within the survey area encompasses 8,160 m². Loring (LoB) and Calhoun (Ca) silt loams are mapped at the site. Shovel Test 1000 produced a profile representative of those observed during testing of 40MD274, consisting of a dark yellowish brown (10YR 4/4) silty clay loam plowzone (0 to 22 cmbs) and a mottled light yellowish brown (10YR 6/4) silty clay (22 to 62 cmbs) (Figure 5.63). Artifacts recovered during TVAR's investigation of 40MD274 are listed below.

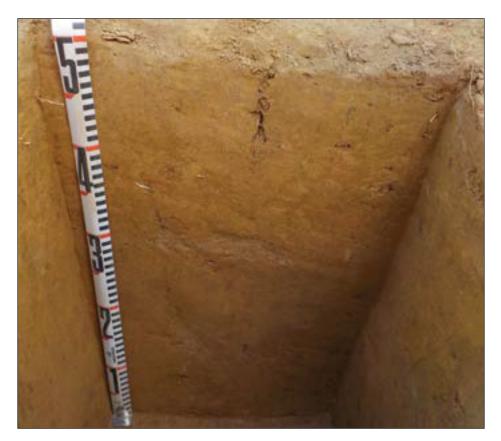
Figure 5.67. Southeastern profile of Shovel Test 1572 on 40MD275.

clay with mineral concretions (43 to 70 cmbs) (Figure 5.67). The artifacts recovered during TVAR's investigation of 40MD275 are listed below.

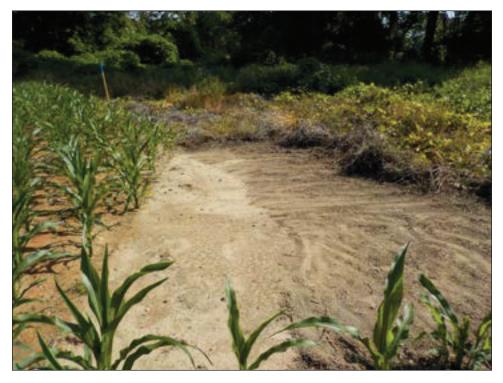
Figure 5.71. Concrete slab along the southwestern boundary of  $40\mathrm{MD}276$  in a corn field (view to the north).

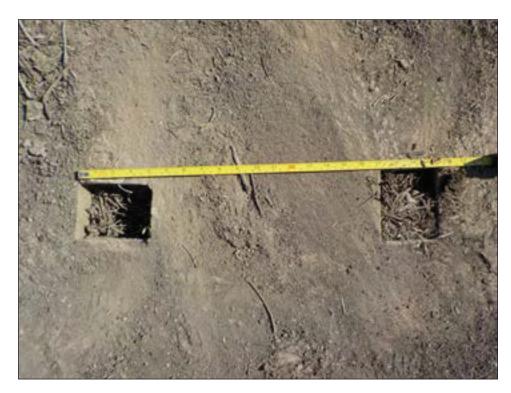
Figure 5.72. Square post holes molded into the concrete slab along the southwestern boundary of 40MD276 in a corn field (view to the north).

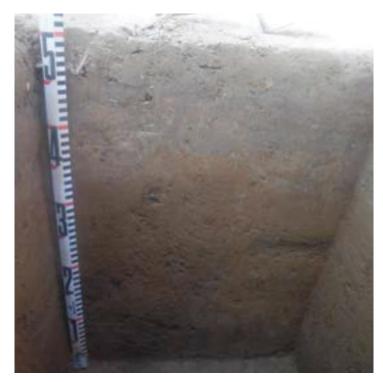
Figure 5.73. Southwestern profile of Shovel Test 1657 on 40MD276.

A total of 30 tests were excavated during TVAR's investigation of this site, two of which yielded artifacts (n=6) from a maximum depth of 15 cmbs. An additional eight artifacts were collected from the ground surface as a representative sample of the artifacts observed, and the site's boundary represents the areal extent of the observed surface scatter. The site encompasses 3,970 m². Memphis silt loam (MeB2) is mapped across the site. Shovel Test 1657 produced a profile representative of those observed during the testing of 40MD276, consisting of a dark yellowish brown (10YR 3/4) silty clay loam (0 to 22 cmbs) underlain by a dark yellowish brown (10YR 3/6) silty clay (22 to 50 cmbs) (Figure 5.73). The artifacts recovered during TVAR's investigation of 40MD276 are listed below.

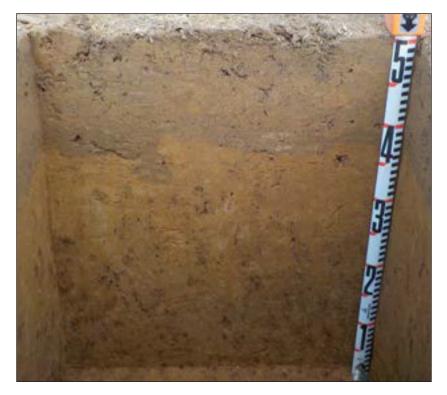
Figure 5.76. Eastern profile of Shovel Test 2540 on 40MD277.

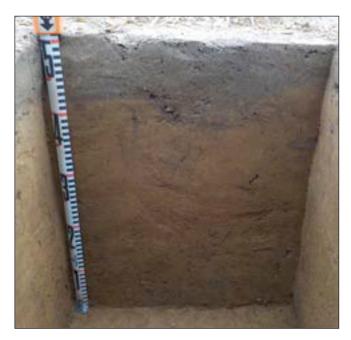
Figure 5.80. Eastern profile of Shovel Test 2534 on 40MD278.

Site 40MD278, a historic scatter, was identified on a hill slope adjacent to Womack Lane and 271 northeast of an unnamed tributary of Cub Creek (Figure 5.78). At the time of TVAR's investigation, the site was located in a harvested wheat field that had been replanted with soy (Figure 5.79). A total of 26 shovel tests were excavated during TVAR's investigation of this site, 10 of which yielded artifacts (n=63) from a maximum depth of 20 cmbs. The site encompasses 4,372 m². Memphis silt loam (MeB) is mapped throughout the site. Shovel Test 2534 produced a profile representative of those observed during testing of 40MD278, consisting of a weak red (10YR 4/3) silty clay loam plow zone (0 to 9 cmbs) underlain by a strong brown (7.5YR 5/6) silty clay (9 to 50 cmbs) (Figure 5.80).

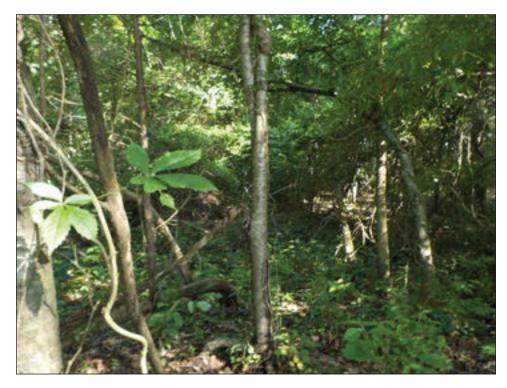
Figure 5.84. Northwestern extent of  $40\mathrm{MD}279$  in a hardwood forest (view to the west).

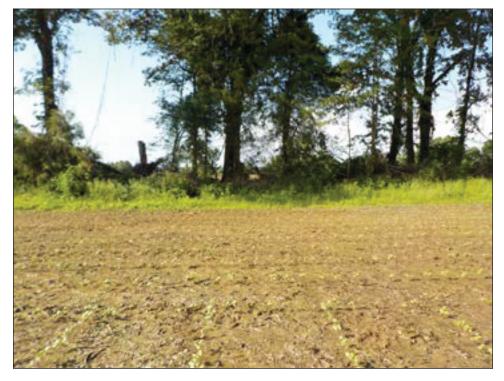
Figure 5.85. Fenceline along the edge of the agricultural field on  $40\mathrm{MD}279$  (view to the south).

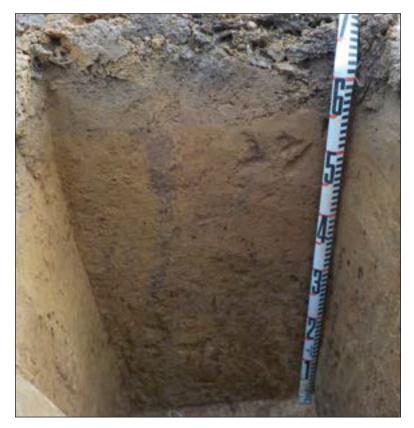
Figure 5.87. Northern profile of Shovel Test 1359 on 40MD279.

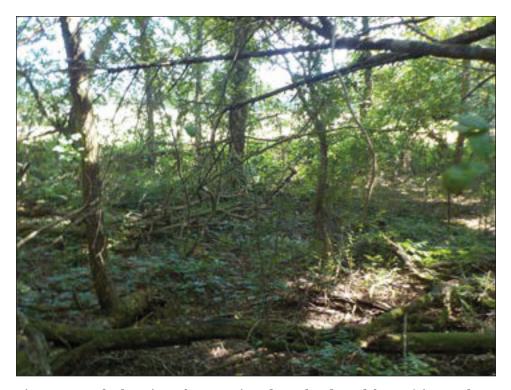
Figure 5.89. The location of NSCR 1 in a dense hardwood forest (view to the north).

Non-Site Cultural Resource 1, a historic scatter, was identified along a hill top 40 m northeast of Denmark-Jackson Road and 197 m west of a pond formed by impounding an unnamed tributary of Johnson Creek (Figure 5.88). At the time of TVAR's survey, the resource was located in a band of dense hardwood trees between two fields (Figure 5.89). A light scatter of glass was observed among the leaves on the ground surface of the resource.

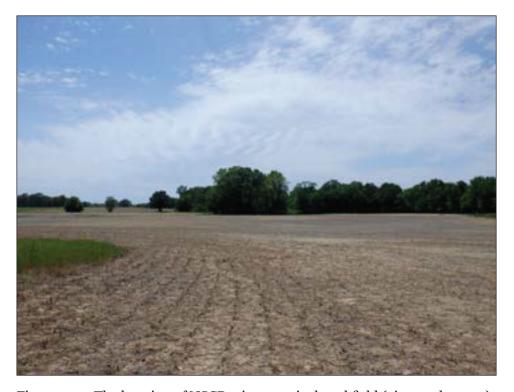
Figure 5.92. The location of NSCR 2 in an agricultural field (view to the west).

Non-Site Cultural Resource 2, a historic scatter, was identified along a hill top 210 m north of Denmark-Jackson Road (Figure 5.91). The resource is situated 172 m east of a pond formed by impounding an unnamed tributary of Cub Creek. At the time of TVAR's survey, the resource spanned an agricultural field, the lawn of an abandoned house (MD-IP-2), and a stand of hardwood trees (Figure 5.92). No structures are visible in the vicinity of the resource on the 1877 map of Madison County, USGS aerial imagery taken in 1947, or the USGS 1959 and Westover 7.5-minute topographic quadrangle. One structure is depicted within the southern boundary of NSCR 2 on the 1959 (Photorevised 1981) Westover 7.5-minute topographic quadrangle. TVAR's assessment of architectural resource MD-IP-2 indicates it was constructed ca. 1964. This structure was still present at the time of TVAR's survey, though it was not occupied and was overgrown by vines (Figure 5.93). As discussed in Chapter 4, TVAR recommends that MD-IP-2 is ineligible for listing on the NRHP. A wire animal enclosure associated with the structure was located within a stand of hardwood trees growing to the east of the structure, in the eastern extent of the resource (Figure 5.94).

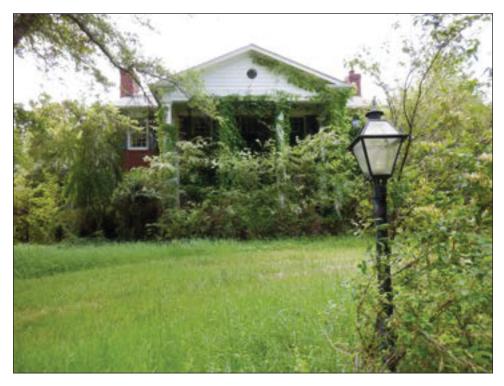
Figure 5.93. Abandoned brick house on NSCR 2 (view to the west).

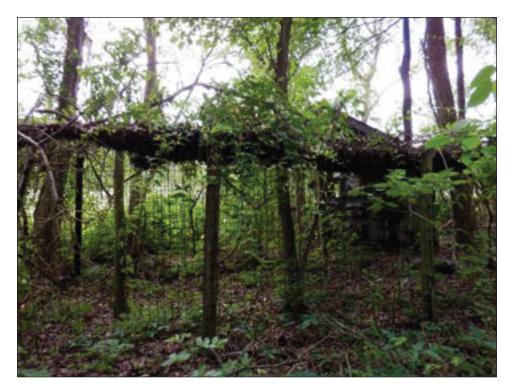
Figure 5.94. Overgrown wire animal enclosure on NSCR 2 under hardwood trees (view to the north).

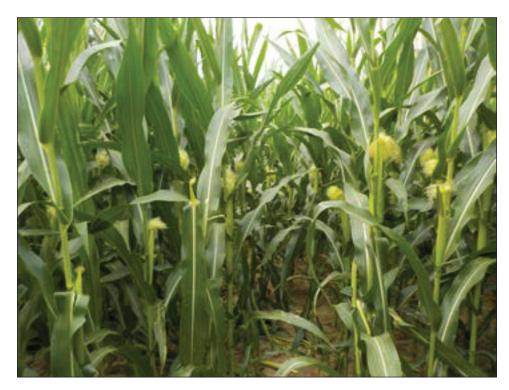
Figure 5.95. The location of NSCR 3 in a corn field (view to the south).

Non-Site Cultural Resource 3, a historic scatter, was identified along a hill top adjacent to Denmark-Jackson Road (see Figure 5.64). The resource is situated 20 m northwest of an unnamed tributary of Johnson Creek. At the time of TVAR's survey, the resource was located in a corn field, and the remnants of a gravel road disturbed by plowing were observed in the northwestern extent of the resource along Denmark-Jackson Road (Figures 5.95 and 5.96). Surface visibility was clear (approximately 50 percent visibility) beneath the corn, and a broad scatter of historic artifacts was observed across the resource's surface. No artifacts were collected during the survey, as all observed surface materials appeared to be near modern in age.

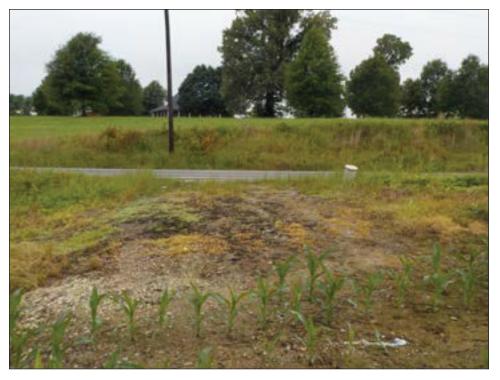
Figure 5.96. The remains of a plowed down gravel road in the western extent of NSCR 3 (view to the west).

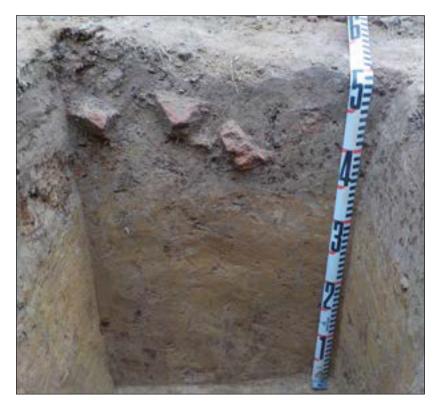
Figure 5.97. Southeastern profile of Shovel Test 1556 on NSCR 3, with brick fragments visible in Stratum I.

A total of 36 tests were excavated during TVAR's investigation of the resource, two of which yielded artifacts (n=22) from a maximum depth of 40 cmbs. The resource encompasses 15,901 m², which includes the full areal extent of the artifact scatter observed at NSCR 3. Notably, the boundary of site 40MD275 intersects the northern boundary of NSCR 3. It was determined that the two assemblages merited separate site numbers due to the distinct concentrations of lithic and historic artifacts recovered from the respective resources. Memphis (MeB2) and Lexington (LeC3) silt loams are mapped at the site. Shovel Test 1556 produced a profile representative of those observed during testing of NSCR 3, consisting of a brown (10YR 5/3) silt loam plowzone (0 to 17 cmbs) underlain by a yellowish brown (10YR 5/6) silty clay loam (17 to 35 cmbs) (Figure 5.97). Brick fragments were present throughout the first stratum, and are visible in the profile of the test. Artifacts recovered during TVAR's investigation of NSCR 3 are listed below.

```
Shovel Test 1556 (0-15 cmbs)
5 91.79 g brick fragment
Shovel Test 1556 (15-30 cmbs)
3 4.16 g ferrous metal wire nail fragment
4 142.51 g brick fragment
Shovel Test 1556 (30-40 cmbs)
8 12.27 g brick fragment
Shovel Test 1561 (0-10 cmbs)
2 0.56 g clear container glass
```

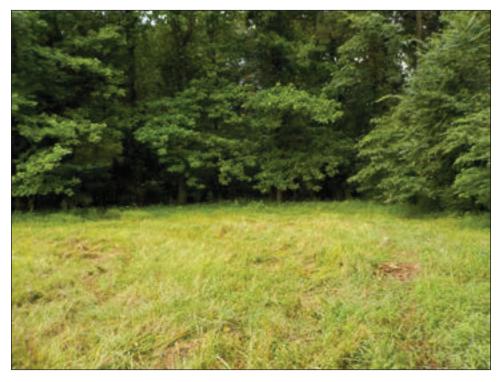
Figure 5.99. The eastern extent of NSCR 4 in an agricultural field alongside a hardwood forest (view to the southwest).

Non-Site Cultural Resource 4, a historic scatter, was identified along a hill slope 204 m south of Womack Lane and 166 m east of an unnamed tributary of Cub Creek (Figure 5.98). At the time of TVAR's investigation, the resource spanned the border of an agricultural field and a hardwood forest (Figures 5.99 and 5.100). No structures are visible in the vicinity of the resource on the 1877 map of Madison County, Tennessee, the USGS 1959 or 1959 (Photorevised 1981) Westover 7.5-minute topographic quadrangles, or USGS aerial imagery taken in 1947.

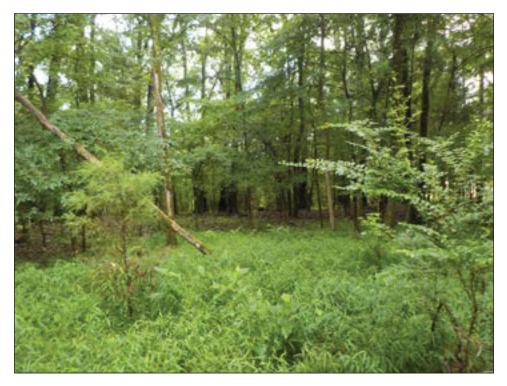
Figure 5.100. The western extent of NSCR 4 in a hardwood forest (view to the northwest).

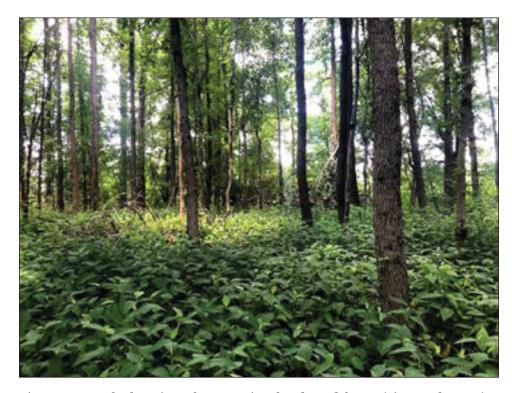
Figure 5.102. The location of NSCR 5 in a hardwood forest (view to the east).

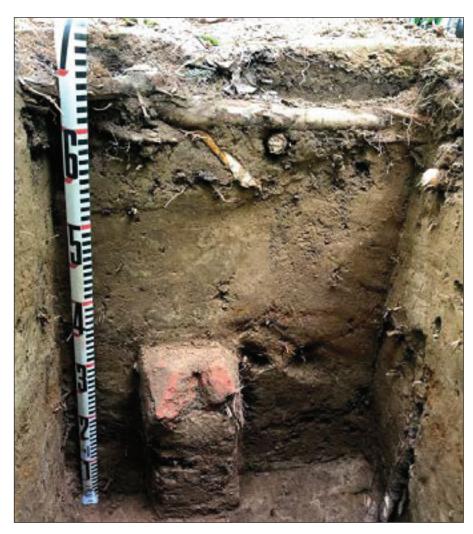
Figure 5.103. Southern profile of Shovel Test 5175 on NSCR 5, with a brick fragment at 40 cmbs.

Eleven shovel tests were excavated during TVAR's investigation of the resource, 3 of which yielded artifacts (n=30) from a maximum depth of 70 cmbs. The resource encompasses 2,180 m². Memphis silt loam (MeB2) is mapped across NSCR 5. Shovel Test 5175 produced a profile representative of those observed during testing of NSCR 5, consisting of a pale brown (10YR 6/3) silty loam (0 to 29 cmbs), a mottled yellowish brown (10YR 5/8) silty clay loam (29 to 48 cmbs), and a yellowish brown (10YR 5/6) silty clay loam (48 to 70 cmbs) (Figure 5.103). Brick fragments were present throughout the second and third strata, and a brick was present in the southern profile at approximately 45 cmbs. The artifacts recovered during TVAR's investigation of NSCR 5 are listed below.

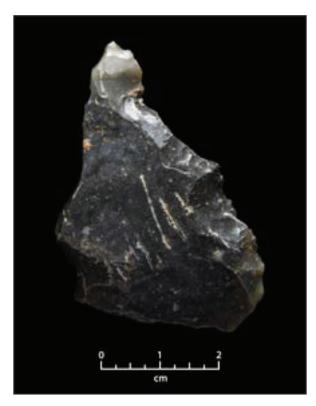
Figure 6.2. Debitage with unifacial retouch produced from St. Louis chert.

Retouched debitage is a category for debitage specimens that display flake scars indicative of retouch along edges. The retouched debitage is sorted on the basis of size grade, raw material type, unifacial or bifacial modification, and edge angle. All edge angles are acute unless otherwise noted as having steep edge angles. Two retouched St. Louis chert debitage specimens were recovered from the survey area. One of the two exhibits unifacial retouch (Figure 6.2) and the other displays both steep angled unifacially retouched and bifacially retouched edges.

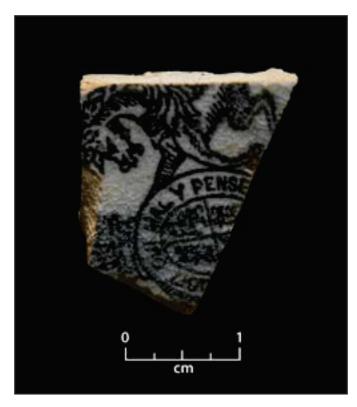
Figure 6.7. Ironstone specimen with a quartered shield royal arms maker mark.

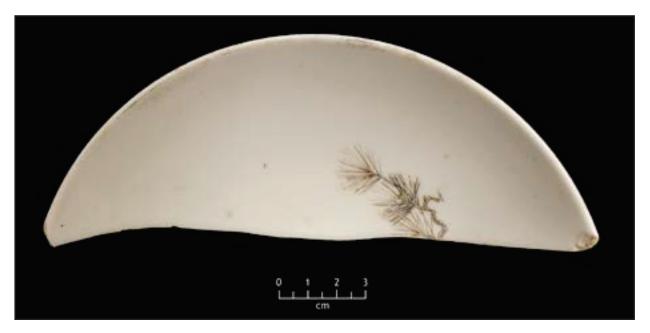
Figure 6.9. Porcelain bowl specimen with a gilded, polychrome floral decal print decoration.

The porcelain bowl specimen has a gilded, polychrome floral decal print decoration (Figure 6.9). Gilding is a decorative technique involving gold added to a medium that is then hand painted onto ceramic surfaces. Perfected in Germany on porcelain and finely enameled earthenware ca. 1723, the process consisted of grinding gold into a medium which was then applied on top of the glaze and burnished after firing. During the nineteenth century, the process changed with the development of "liquid bright gold" in 1836. This method involved dissolving gold with acids and then combining it with other chemicals to form a solution that could be fired with enamel colors. Liquid gold gilding was introduced to English Staffordshire potters by 1870, at which time it began to increase in popularity during the late nineteenth century. Gilding is still used to decorate tableware today. One popular gilding method often consisted of thin bands of gold hand painted onto rims, handles, or other surfaces, or to outline hand-painted or transfer-printed decorations (Miller 1991).

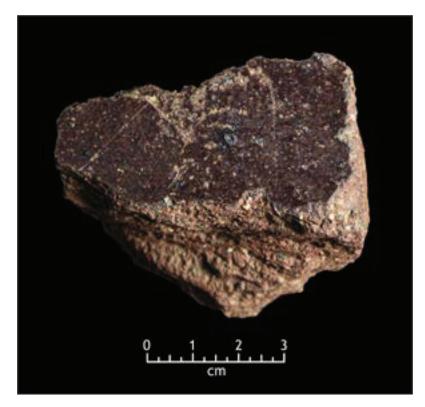
Figure 6.10. Terracotta drainage pipe fragment.

Terracotta is often used as a synonym for coarse earthenware. The use of terracotta can be traced back as far as 1400 B.C. in Babylonia, and the type is still produced today. The mid-eighteenth century marks the beginning of mass-produced terracotta architectural materials in England, and American terracotta was used in architecture as early as 1850 (Fidler 1983; Tunick 2001). Terracotta is commonly used in architecture as roofing tiles, water pipes, and bricks, and it is also used for flower pots (Tunick 2001, Smith and Rogers 2011). Four terracotta specimens were recovered from the survey area, two of which were further identified as drainage pipe fragment with a lead/manganese glaze (n=1) and tile fragment (n=1) specimens (Figure 6.10).

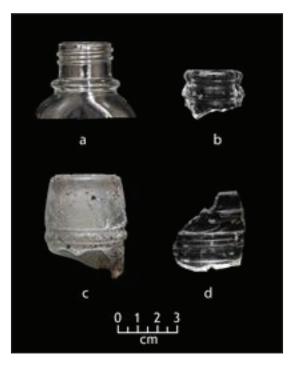
Figure 6.13. Clear finish specimens: (a) small external thread; (b) crown; (c) brandy; (d) large external thread.

A small external thread finish is characterized by the presence of a raised ridge or ridges running around the outside surface of the finish, onto which a cap was tightened and sealed (Figure 6.13a). These ridges can either be one continuous piece, several interrupted pieces, or lugs, which are like interrupted pieces, only shorter, higher, and thicker. Small external thread finishes date as far back as the mid-1870s on liquor bottles and became the dominant finish type by the 1930s (Lindsey 2010h).

One of the nine clear bottle examples is a small external thread finish with "5" embossing. Another one of the nine clear bottle examples is a crown finish with machine mold seams (Figure 6.13b). A crown finish is usually a two-part finish that includes a narrow, bead-like upper part that held the cap closure onto a rounded or flattened lower part. It is the most commonly found finish on soda, mineral water, and beer bottles. Even though this finish was patented in 1892, it did not gain popularity until the early twentieth century (Lindsey 2010h).

The remaining clear bottle example is a brandy finish (Figure 6.13c). The brandy finish is a two-part finish that is a combination of an oil finish on top and a bead finish below. It is flat on top, flares from top to bottom, and has a narrow, rounded ring at the base. It can also be called a wine finish, tapered top with ring, or tapered brandy finish, among other names. The brandy finish was commonly used on applied, tooled, and machine-made bottles for liquor, medicine, and other fluids. The brandy finish was prevalent from the 1860s to the 1920s (Lindsey 2010h).

Nine clear jar examples were recovered from the survey area, all of which are large external thread finish specimens (Figure 6.13d). Three of the nine examples have machine mold seams only. One of the nine jar examples is a cup-bottom base with machine mold seams, stippling, and "7 Owens-Illinois Glass Company maker mark 8"/"6"/"DURAGLAS"/"C 2933" embossing. Duraglas containers were produced by the Owens-Illinois Glass Company from 1940 to 1963 (Lockhart and Hoenig 2015).

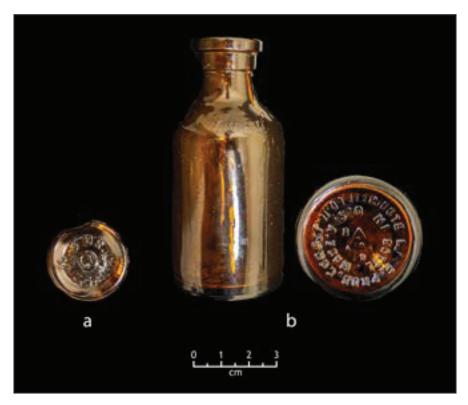
Figure 6.14. Amber container glass maker mark specimens: (a) Armstrong Cork Company; (b) Whitall Tatum & Company with reinforced extract finish.

Seven amber bottle/jar examples were recovered from the survey area. Five of the seven were identified by machine mold seams alone, two of which have a stippled design (n=1) and stippling (n=1). One of the seven amber bottle/jar examples is a cup-bottom base with machine mold seams and "6 DR."/"28 Armstrong Cork Company maker mark 50"/"U.S.A." embossing (Figure 6.14a). The Armstrong Cork Company acquired Whitall Tatum & Co. and Hart Glass Mfg. Co. in 1938 (Lockhart et al. 2013). The date code mark present on this specimen indicates it was produced in 1950 (Lockhart et al. 2013). The remaining amber bottle/jar example is an undifferentiated finish.

The remaining amber bottle specimen is a reinforced extract finish with "LYSOL"/"L.&F. PROD. CORP."/"BLOOMFIELD N.J."/"BOTTLE MADE"/"IN U.S.A."/"Whitall Tatum & Company maker mark" embossing (Figure 6.14b). The Whitall Tatum and Company was operated under several variations of the name as early as 1836. The company was incorporated and purchased by the Armstrong Cork Company in 1938, but continued to operate until 1969. The mark present on this specimen indicates a manufacture date of between 1924 and 1938 (Lockhart et al. 2006). The reinforced extract finish is primarily found on druggist and medicine bottles between 1900 and the early 1920s (Lindsey 2010h).

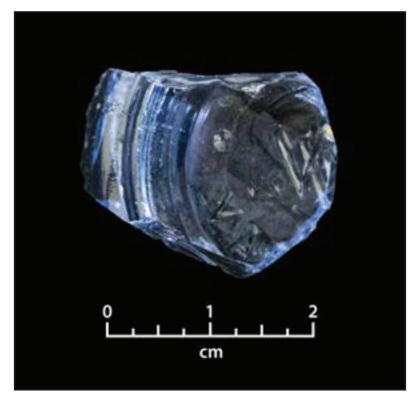
Figure 6.16. Cobalt blue Vicks Vaporub maker mark.

Cobalt blue-colored glass was produced by adding cobalt oxide to the glass. All types of bottles were manufactured using this process ranging from food and beverage containers to ink wells. Bottles of this color commonly date from the 1840s to the 1930s (Lindsey 2010a). Four cobalt blue container glass examples were recovered from the survey area, one of which was further identified as a bottle/jar specimen. This specimen is a cup-bottom base with machine mold seams and "VA..."/"Vicks Vaporub maker mark" embossing (Figure 6.16). Lunsford Richardson began selling medicines under the "Vick's" name starting in the 1890s. By 1905, Richardson created the Vick Family Remedies Company and began selling his products throughout North Carolina; the product is still sold today. The mark present on this specimen indicates it was manufactured between 1921 and 1956 (Whitten 2016).

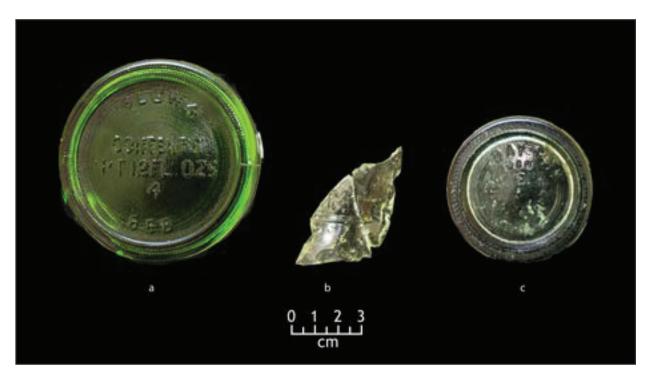
Figure 6.17. Green and light green container glass maker marks: (a) Laurens Glass Works; (b) Lime Cola Company; (c) Chattanooga Glass Company.

The remaining green bottle/jar example is a cup-bottom base with machine mold seams, stippling, stippled design, and "6 Laurens Glass Works maker mark 4"/"CONTENTS"/"1 PT 12 FL. OZS"/"4"/"658" embossing. Incorporated in 1910 in Laurens, South Carolina, Laurens Glass Works became a successful southern bottle and jar producer specializing in soda bottles, namely Coca-Cola hobble-skirt bottles. The company later opened branch plants in Henderson, North Carolina, and Ruston, Louisiana, in the late 1950s and early 1960s, respectively. In 1968, Indian Head Container Corporation purchased Laurens Glass Works and continued producing under the Laurens name. Ball-InCon acquired the plants in 1987 and continued operating for nearly a decade before closing in 1996. The date code mark present on this specimen indicates it was produced in 1964 (Figure 6.17a) (Lockhart et al. 2017).

green bottle/jar example was identified by machine mold seams only. The light green bottle example is a crown finish with machine mold seams and an applied color label. Tow light green soda bottle examples were recovered from the survey area, one of which was identified by machine mold seams and "LIM..." embossing only (Figure 6.17b). This specimen is a Lime Cola soda bottle. The El Paso Real Juice Company bottled Lime Cola and operated from 1935 to 1942. Lime Cola bottles have both applied color label and embossed styles. Due to the range of Lime Cola container styles, this specimen must be dated to entirety of the El Paso Real Juice Company. Thus, this specimen was produced between 1935 and 1942 (Lockhart 2010:13).

The remaining light green soda bottle example is a cup-bottom base Coca-Cola bottle with a crown finish, machine mold seams, an applied color label, and "BAY CITY MICH"/"BOTTLE TRADE MARK"/"Chattanooga Glass Company maker mark" embossing (Figure 6.17c). The Chattanooga Bottle and Glass Manufacturing Company was founded in 1901, changed its name to the Chattanooga Glass Company in 1930, and eventually merged with the Anchor Hocking Glass Corporation in 1987. The mark found on this specimen dates from 1927 to 1987 (Lockhart et al. 2014). However, according to Lockhart and Porter (2010), Coca-Cola bottles began using an applied color label in 1955. However, in 1963, Coca-Cola bottles switch to embossed script on one side and Coke on the reversal. Therefore, this specimen was produced between 1963 and 1987.

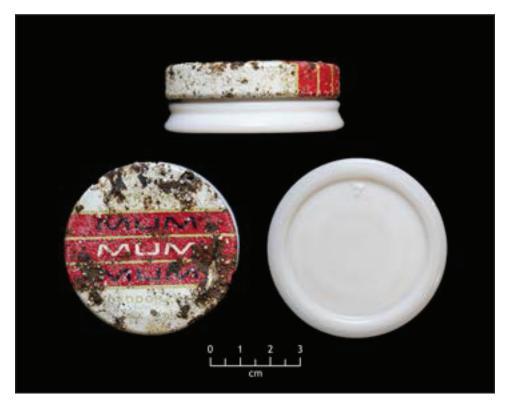
Figure 6.18. Milk Mum cream deodorant jar with ferrous metal screw cap closure.

the 1890s to the mid-twentieth century. Milk glass would not be commonly found on sites with occupations entirely prior to the 1870s (Lindsey 2010a). Four milk container glass examples were recovered from the survey area, three of which were further identified as bottle/jar (n=1) and jar (n=2) specimens. The milk bottle/jar example was identified by machine mold seams only.

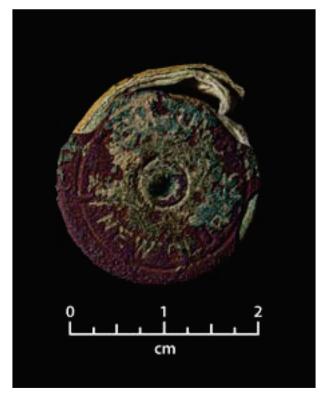
Figure 6.20. Cuprous 12 gauge shotgun shell head with "REM U.M.C. Co."/"No. 12"/"NEW CLUB" headstamp.

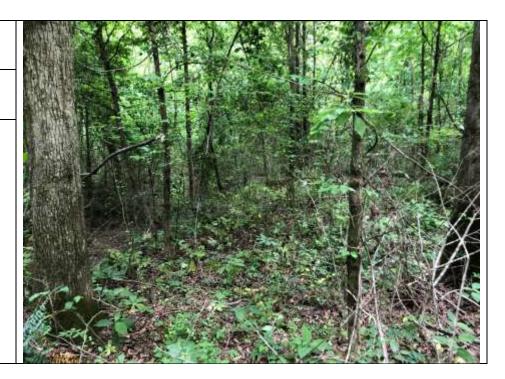
Photograph: 1

Typical view of the wooded part of the northern portion of the site.

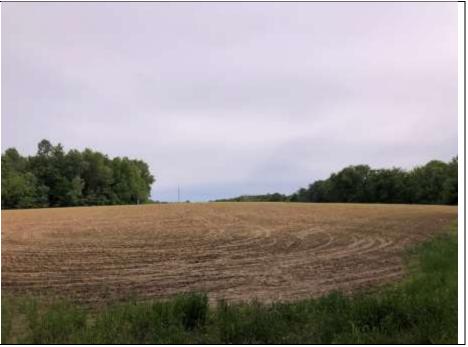
Photograph: 2

Typical view of cultivated area at northeastern parcel.

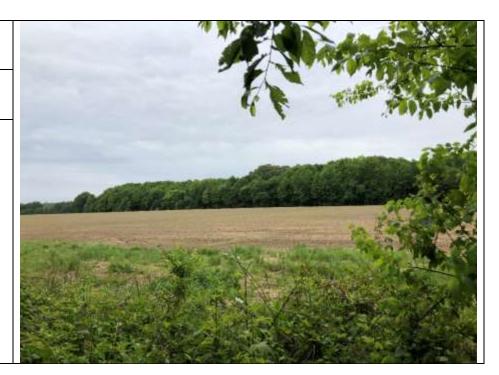
Photograph: 3

Typical view of cultivated area of northwestern parcel.

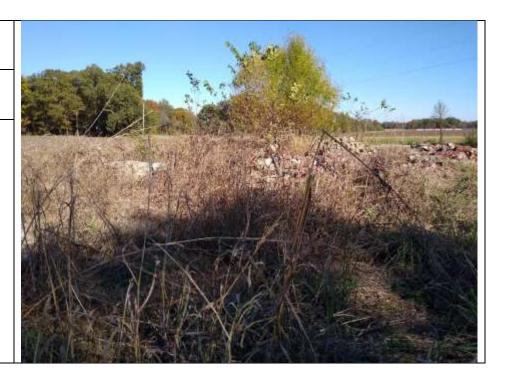
Photograph: 4

View of rubble remnants from house fire at the intersection of Denmark Jackson Road and Womack Lane.

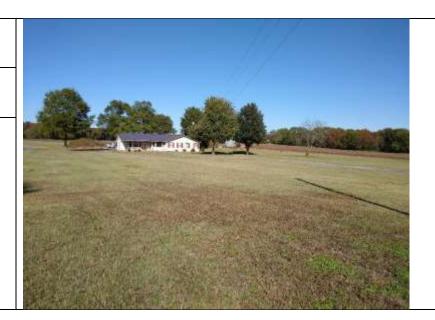
Photograph: 6

View of residential dwelling onsite at Womack Lane.

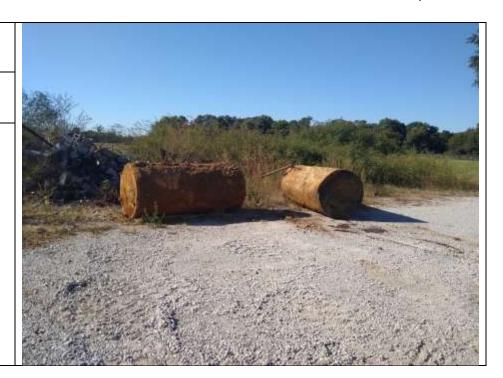
Photograph: 8

View of the two tanks prior to disposal that were removed from the beside the barn off Womack Lane.

Five 500-gallon USTs have been removed from the site. As shown in Figure 2, two tanks were located on the portion of the site the east of Denmark Jackson Road, two tanks were located near the barn off Womack Lane, and one tank was located near the abandoned house near the central portion of the site. During removal of the USTs, field screening was completed with a photoionization detector for all samples. Samples were collected from the tank pit (excavated material) and from beneath each end of the tank. Laboratory analysis based on the analysis laid out by TDEC Division of Underground Storage Tanks (DUST) UST Closure Assessment Guidelines was done by Pace Analytical. As shown on Table 1, with the exception of Extractable Petroleum Hydrocarbons (EPH), there were no exceedances in the samples collected. EPH is used as a soil screening tool in the event that monitoring wells are needed, as EPH can detect old constituents which have degraded below regulated levels otherwise. As no other results were above TDEC DUST UST Closure levels and no groundwater was encountered during excavation, no monitoring wells were installed. For those reasons it is our opinion that the EPH exceedances are not a concern relative to the site. There was no evidence of additional

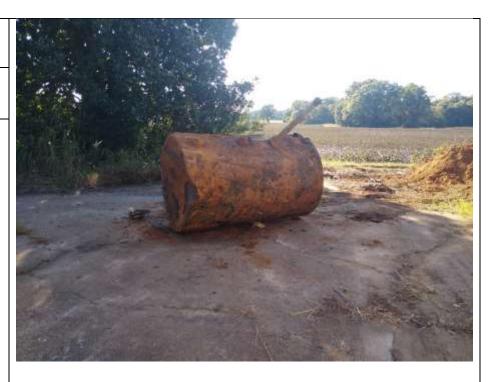
Photograph: 9

View of the tank removed from beside the garage near the central portion of the site prior to disposal.

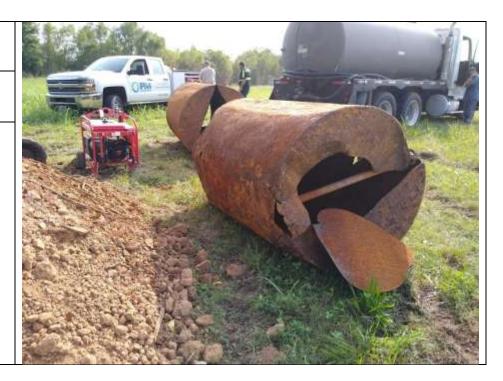
**Description:** Photograph: 10

View of the two USTs from the eastern portion of the site after removal and cleaning, prior to disposal.
