Appendix C – Wetlands Survey

Subject: Wetland Boundary Field Determination

Waverly, Tennessee

GS&P Project No. 29856.00

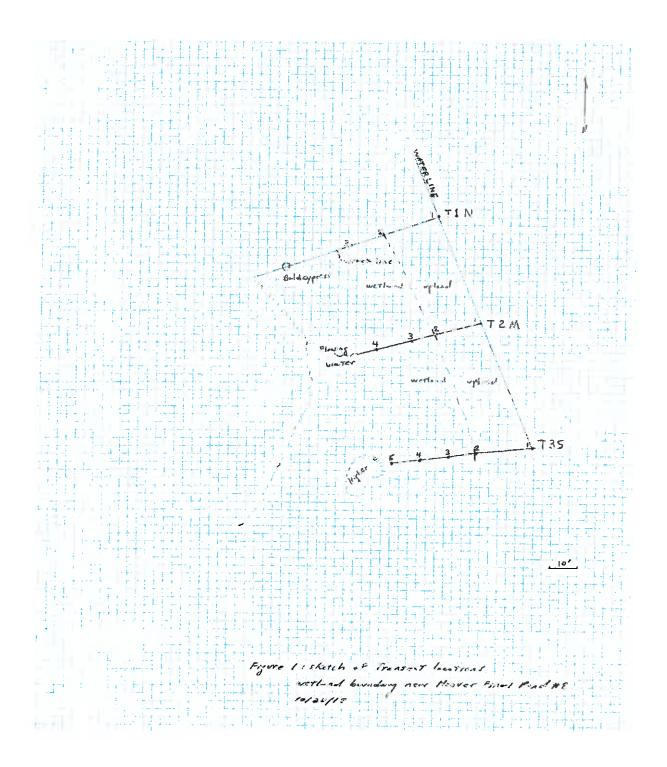
Figure 1: Three short transects were laid out downslope of the existing water line route.

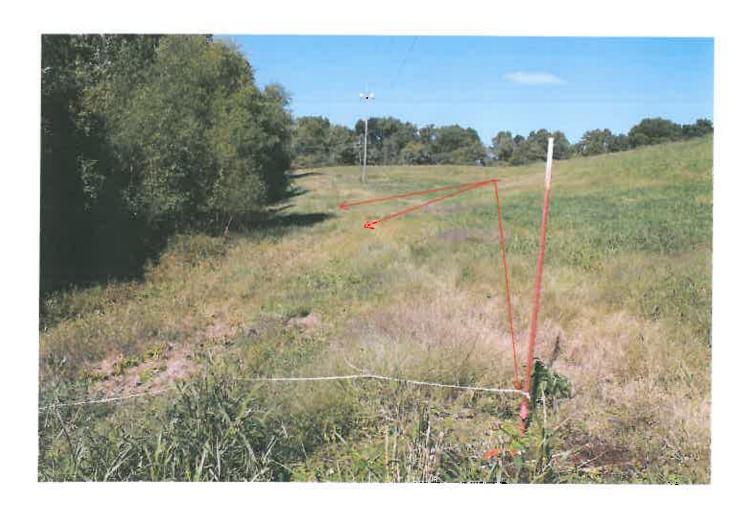
Figure 2: Photo looking from south-southeast along water line route. Arrows denote Transect Initial Points matching the sketch in Figure 1. Foreground is T3S Point 1

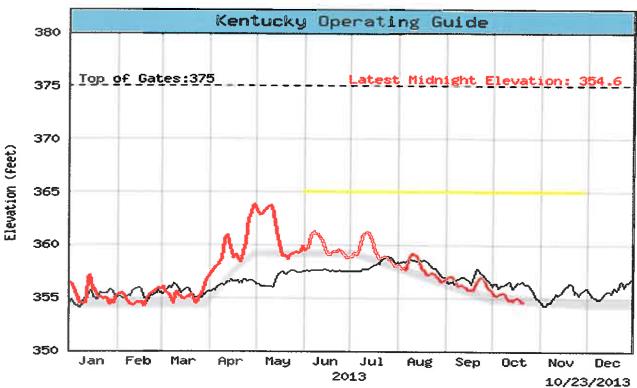
Figure 3: Kentucky Lake level in area of transects 10/22/13 compared to midnight elevation 10/23/13 (red line); Target yearly levels denoted by black line.

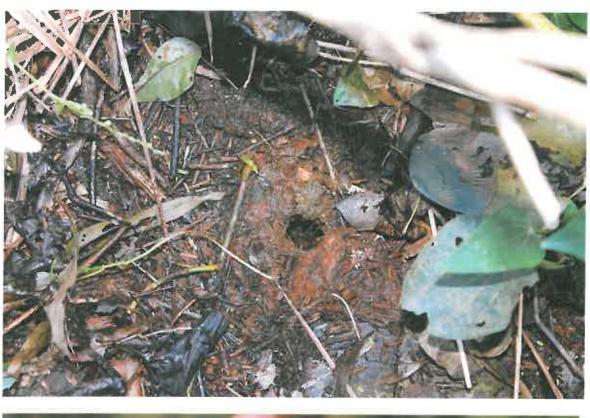
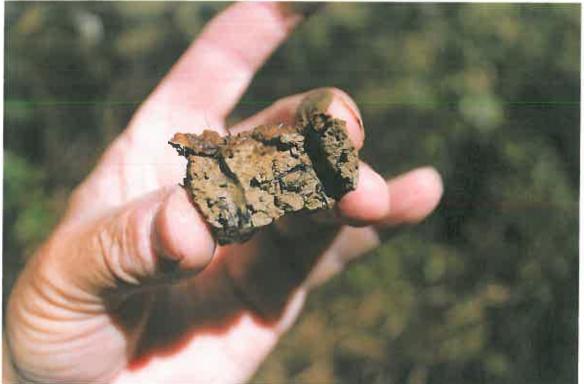
Figure 4: Representative soil at end of T1N transect and water near surface in soil boring.

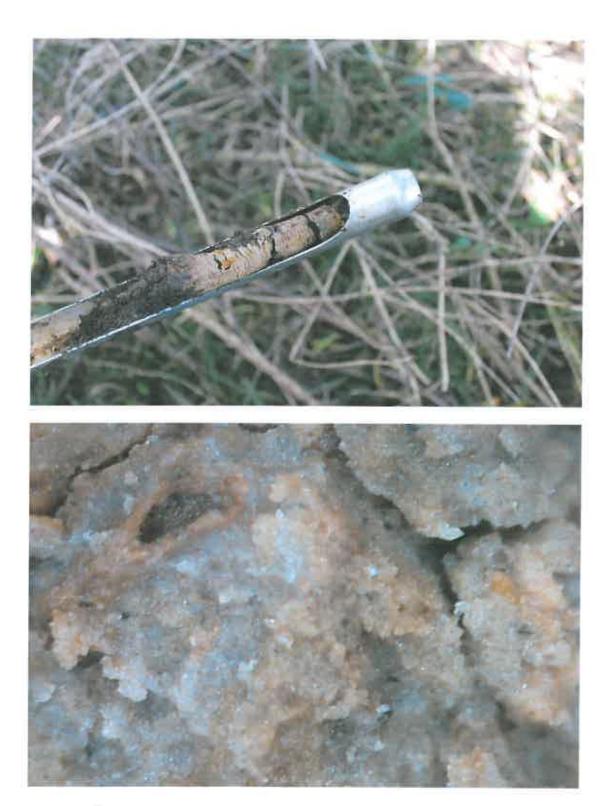
Figure 5: Representative soil at Point 2, T3S transect and microphotograph of rootlet cast formed by iron mineralization.
