## Appendix A Adamsville Solar Public Comments and Responses

# Appendix B Summary of the Environmental Features for the Adamsville Solar Project

## SUMMARY OF ENVIRONMENTAL FEATURES FOR THE

## ADAMSVILLE SOLAR PROJECT

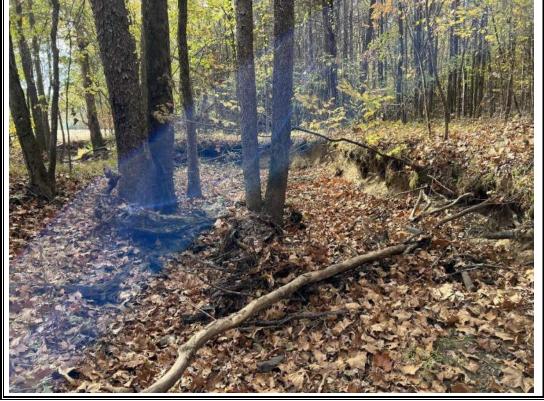
Photo: 2

Feature: STR-1 Lat: 35.265430 Long: -88.366833

Representative conditions of STR-1, facing upstream at beginning of reach.

STR-1 was observed as an intermittent stream that enters the project study area from the north and flows through a culvert into the northeastern portion of the project study area. While no perceivable flow was observed throughout the evaluated reach, continuous bed and bank was moderately strong, as well as a presence of hydric soils on the channel bottom, indicating a potential intermittent stream. The channel bottom is composed of clay with recent overlying deposits of sand, cobble, and gravel. Other than some remnant caddisfly casings, there was no evidence of aquatic life observed within the feature at the time of the site visit. STR-1 is assumed to be jurisdictional to TDEC and the USACE.

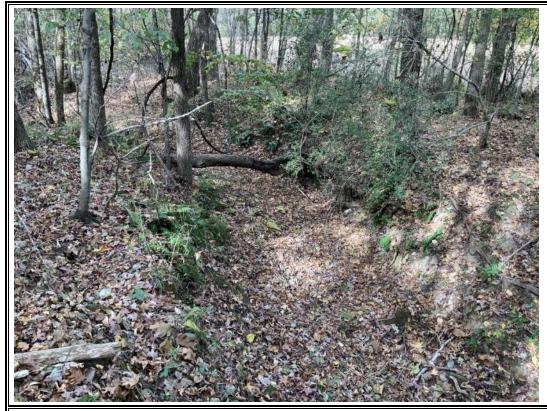
Photo: 3 By: F. Amatucci

Feature: STR-1 Lat: 35.264957 Long: -88.366644

Representative conditions of STR-1, facing downstream near mid reach.

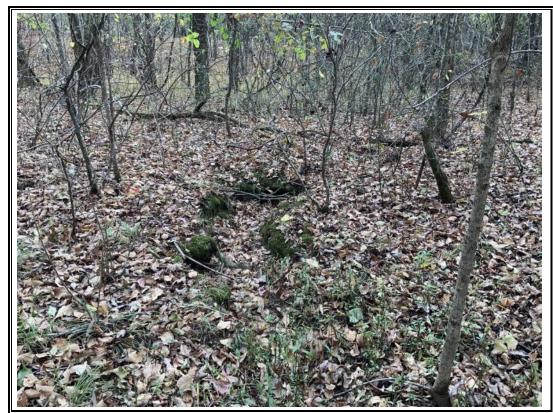
**Photo:** 5 **By:** F. Amatucci

Feature: STR-2 Lat: 35.261491 Long: -88.368628

Representative conditions of STR-2, facing downstream at end of reach before leaving property study area to the east.

STR-2 was observed as an intermittent stream that enters the project study area from the north into the northcentral portion of the project study area. While no perceivable flow was observed throughout the evaluated reach, continuous bed and bank was moderately strong, as well as a presence of hydric soils on the channel bottom, indicating a potential intermittent stream. The stream channel bottom is composed of clay with some deposition of sand and silt as bars and benches. Other than some remnant caddisfly casings, there was no evidence of aquatic life observed within the feature at the time of the site visit. The stream transitions to a potentially perennial stream after the confluence with STR-4 at end of reach before leaving the project study area to the east. STR-2 is assumed to be jurisdictional to TDEC and the USACE.

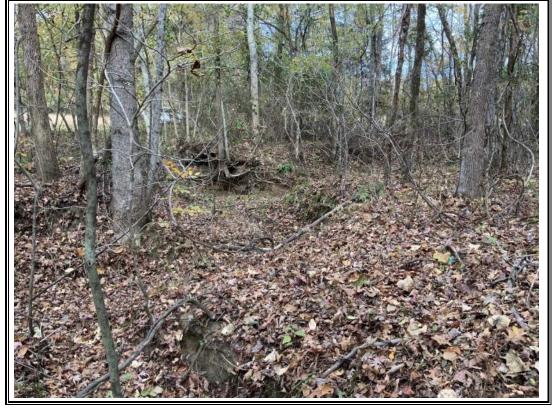
Photo: 6

Representative conditions of STR-3, facing downstream at start of reach downslope

of WTL-1.

STR-3 was observed as an intermittent stream that starts downslope of wetland (WTL) WTL-1 in the eastern central portion of the project study area. The feature potentially originates from groundwater seepage below the berm of WTL-1 and conveys excess surface water to the

confluence with STR-2. While no perceivable flow was observed throughout the evaluated reach, continuous bed and bank was moderate, as well as a presence of hydric soils on the channel bottom, indicating a potential intermittent stream. The stream channel bottom is composed of silt and sand with observed presence of substrate sorting. STR-3 is assumed to be jurisdictional to TDEC and the USACE.

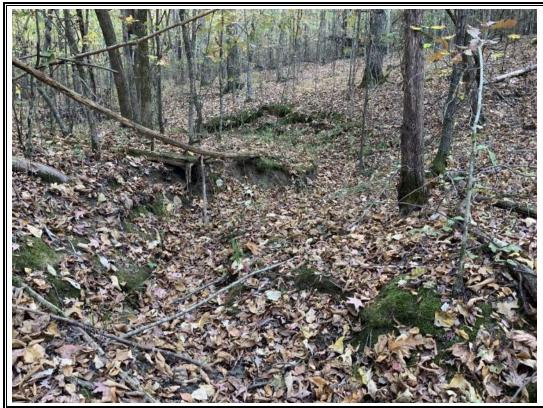
Photo: 7 By: F. Amatucci

Representative conditions of STR-3, facing downstream at end of reach before confluence with STR-2.

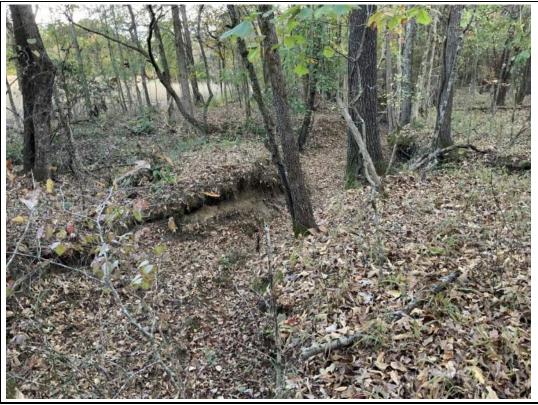
Photo: 8

Representative conditions of STR-4, facing downstream at start of reach after headcut that marks transition from EPH-3.

STR-4 was observed as an intermittent stream that starts at a headcut immediately offsite in the northwestern portion of the project study area. STR-4 conveys excess surface water to the confluence with STR-2. While no perceivable flow was observed throughout the evaluated reach, continuous bed and bank was moderately present, as well as a presence of hydric soils on the channel bottom, indicating a potential intermittent stream. The stream channel bottom is composed of sand and silt with some depositional bars and benches and observed sorting. There was no aquatic life observed within the feature at the time of the site visit. STR-4 is assumed to be jurisdictional to TDEC and the USACE.

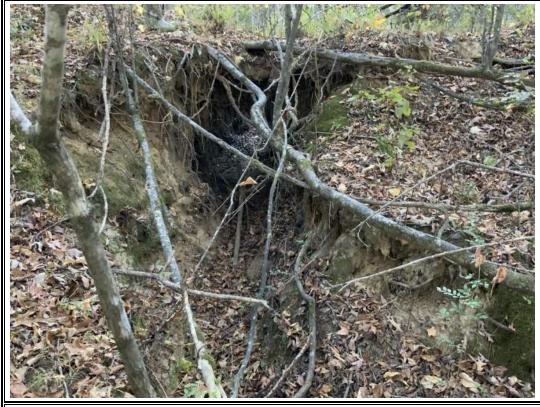
Photo: 9

Representative conditions of STR-4 at mid reach, becomes more incised before eventually confluence with STR-2.

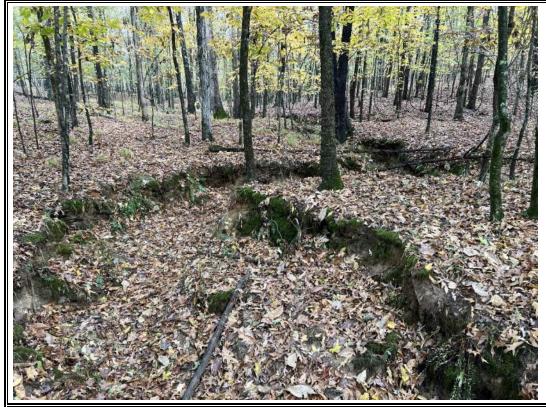
**Photo:** 11 **By:** F. Amatucci

Representative conditions of STR-5, facing downstream mid reach before confluence with STR-4.

STR-5 was observed as an intermittent stream that begins at an eroded berm wall of pond (P) P-2 within the northwestern portion of the project study area. STR-5 conveys excess surface water to the confluence with STR-4. The stream may also be affiliated with a potential groundwater seep. While no perceivable flow was observed throughout the evaluated reach, continuous bed and bank was moderately present, as well as a presence of hydric soils on the channel bottom, indicating a potential intermittent stream. The stream channel bottom is composed of sand and silt, with some recent alluvial deposits. There was no aquatic life observed within the feature at the time of the site visit. STR-5 is assumed to be jurisdictional to TDEC and the USACE.

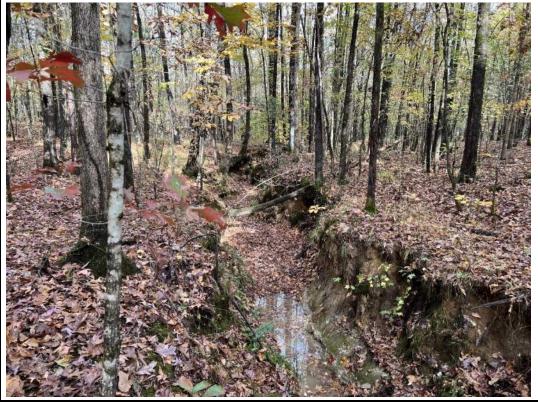
Photo: 12 By: F. Amatucci

Representative conditions of STR-6, facing downstream at start of reach after headcut that marks transition from EPH-8.

STR-6 was observed as an intermittent stream that likely conveys excess surface water from the surrounding upland area into STR-4 in the northcentral portion of the project study area. While no perceivable flow was observed throughout the evaluated reach, continuous bed and bank was moderately present, as well as a presence of hydric soils on the channel bottom, indicating a potential intermittent stream. The stream channel bottom is composed of sand and silt, with observed sorting and some recent alluvial deposits. There was no aquatic life observed within the feature at the time of the site visit. STR-6 is assumed to be jurisdictional to TDEC and the USACE.

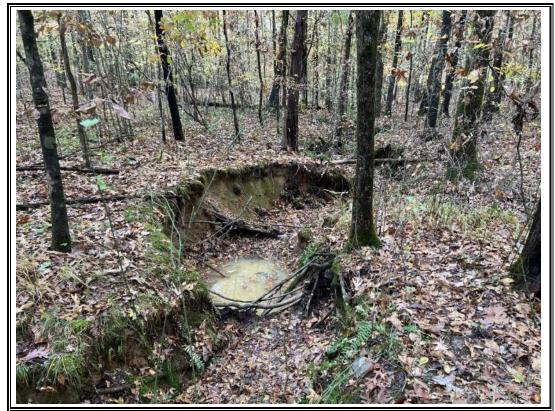
**Photo:** 13 **By:** F. Amatucci

Representative conditions of STR-6, facing downstream mid reach before eventual confluence with STR-4.

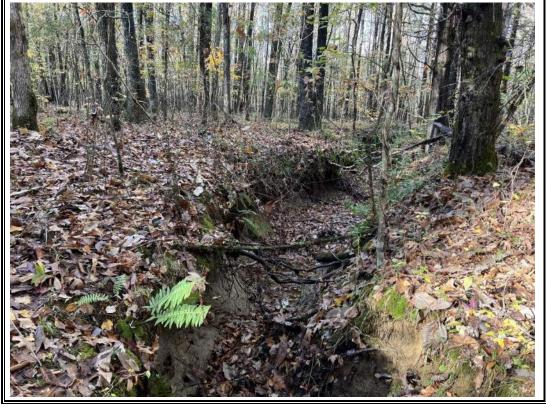
Photo: 14 By: F. Amatucci

Representative conditions of STR-7, facing downstream at start of reach after headcut that marks transition from EPH-10.

STR-7 was observed as an intermittent stream that is likely affiliated with a potential groundwater seep at a moderate headcut. The feature likely conveys excess surface water from the surrounding upland area to the confluence with STR-6 in the northcentral portion of the project study area. While no perceivable flow was observed throughout the evaluated reach, continuous bed and bank was moderately present, as well as a presence of hydric soils on the channel bottom, indicating a potential intermittent stream. The stream channel bottom is composed of sand and silt with some depositional bars and benches, as well as recent alluvial deposits. STR-7 is assumed to be jurisdictional to TDEC and the USACE.

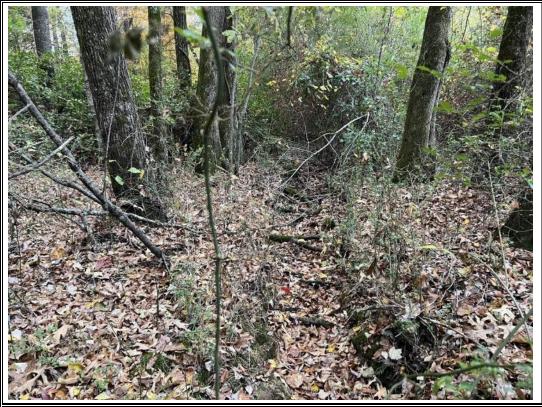
**Photo:** 15 **By:** F. Amatucci

Representative conditions of STR-7, facing downstream at end of reach before confluence with STR-6.

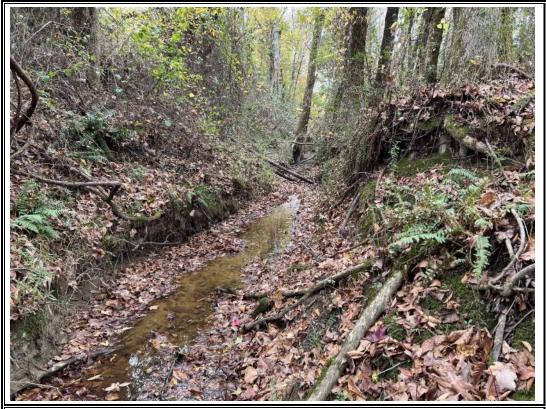
Photo: 17 By: F. Amatucci

Representative conditions of STR-8, facing downstream at end of reach after flowing through culvert outlet and leaving project study area to the south.

STR-8 was observed as an intermittent stream in the eastern portion of the project study area. The feature likely drains excess surface water from WTL-4a. Further downslope the channel dissipates within WTL-4b and reforms at the downslope end of the same wetland feature. While no perceivable flow was observed throughout the evaluated reach, continuous bed and bank was semi-moderately present and there was a presence of hydric soils on the channel bottom, indicating a potential intermittent stream. The stream channel bottom is composed of sand and silt with some depositional bars and benches, as well as recent alluvial deposits. There was no aquatic life observed within the feature at the time of the site visit. STR-8 is assumed to be jurisdictional to TDEC and the USACE.

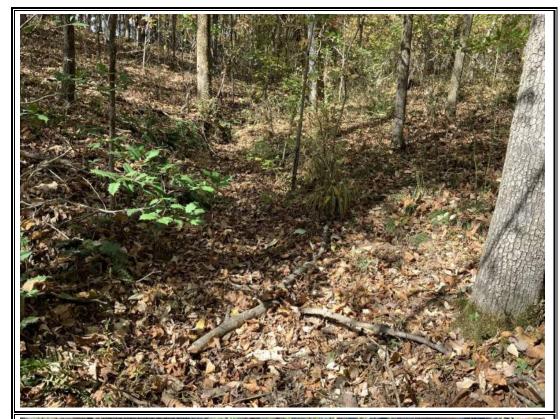
**Photo:** 19 **By:** F. Amatucci

Representative conditions of STR-9, facing downstream at end of reach after culvert outlet and leaving project study area to the east.

STR-9 (Stratton Branch) was observed as an intermittent stream that begins from the overflow of farm pond P-6 in the southern portion of the project study area. While no perceivable flow was observed throughout the evaluated reach, continuous bed and bank was moderately strong, as well as a presence of hydric soils on the channel bottom, indicating a potential intermittent stream. The stream channel bottom is composed of moderately sorted sand and silt with depositional bars and benches, as well as recent alluvial deposits. STR-9 is assumed to be jurisdictional to TDEC and the USACE.

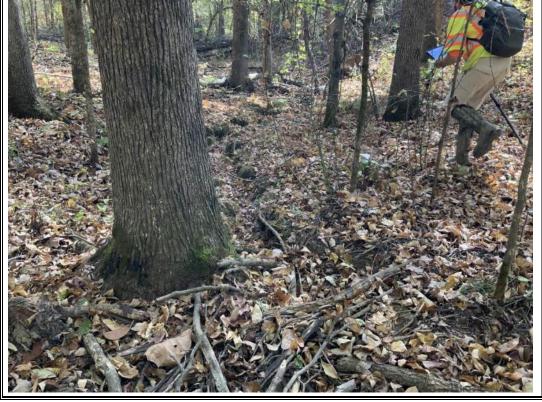
Photo: 20 By: F. Amatucci

Representative conditions of EPH-1, facing upstream at beginning of reach.

EPH-1 was observed as an ephemeral stream to the USACE and as a wet weather conveyance (WWC) to TDEC in the northeastern portion of the project study area. The feature displayed a weak-moderate bed and bank throughout most of the feature, as well as a slight presence of riffle-pool sequences, and is within a natural upland drainage valley. No surface water or saturation was present within the reach during the site visit, and no hydric soils were observed within the channel. A slight presence of Japanese stiltgrass (*Microstegium vimineum*) was observed within the channel, as well as fibrous roots of terrestrial plants. EPH-1 was observed with a channel bottom of sand and silt. EPH-1 is non-jurisdictional to the USACE, and is non-jurisdictional to TDEC, as a WWC.

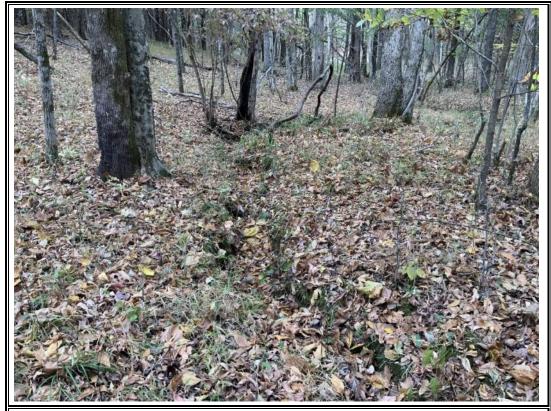
Photo: 21 By: F. Amatucci

Representative conditions of EPH-1, facing downstream mid reach before leaving property study area to the south.

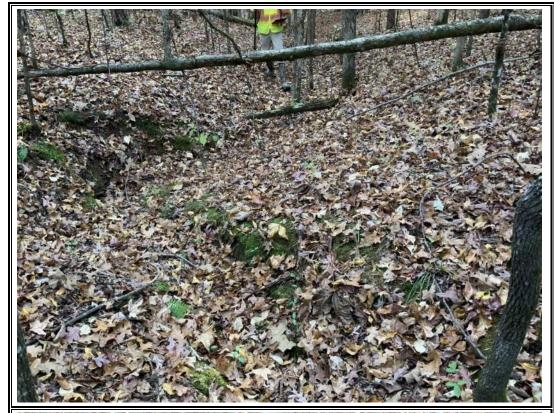
**Photo:** 23 **By:** F. Amatucci

Representative conditions of EPH-2, facing downstream at end of reach before dissipating into WTL-1.

EPH-2 was observed as an ephemeral stream to the USACE and as a WWC to TDEC in the northern portion of the project study area, which directly drains into relic farm pond wetland WTL-1. The feature displayed a semi-moderate bed and bank, as well as two or more ordinary highwater mark (OHWM) indicators such as vegetative cut lines and wrack lines. No surface water or saturation was present within the reach during the site visit, and no hydric soils were observed within the channel. A slight presence of longleaf wood oats was observed within the channel, as well as fibrous roots of terrestrial plants. EPH-2 was observed with a channel bottom of sand and clay. EPH-2 is non-jurisdictional to the USACE, and is non-jurisdictional to TDEC, as a WWC.

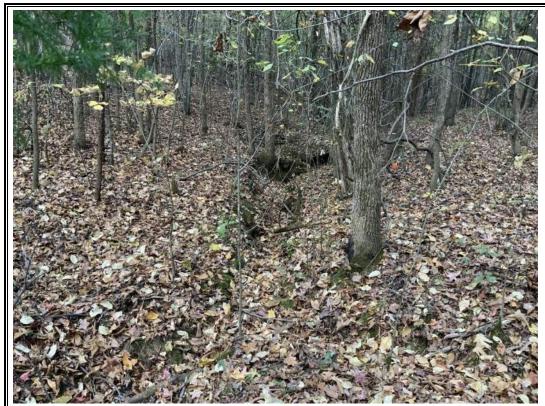
Photo: 25 By: F. Amatucci

Representative conditions of EPH-4, facing upstream at end of reach before confluence with EPH-3.

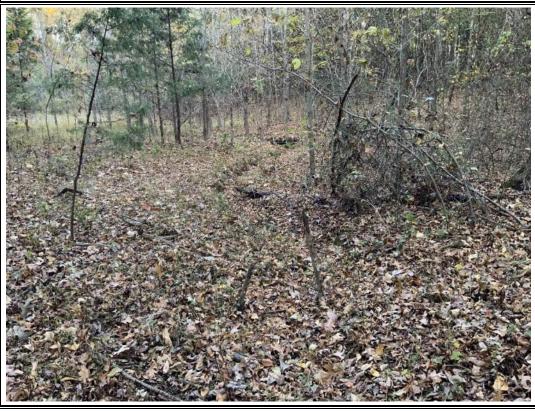
Photo: 26 By: F. Amatucci

Representative conditions of EPH-5, facing downstream at start of reach after entering the property study limits from the west.

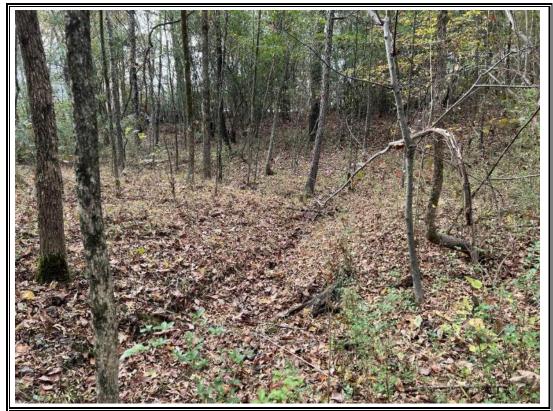
Photo: 27 By: F. Amatucci

Representative conditions of EPH-5, facing downstream at end of reach before dissipating into P-2.

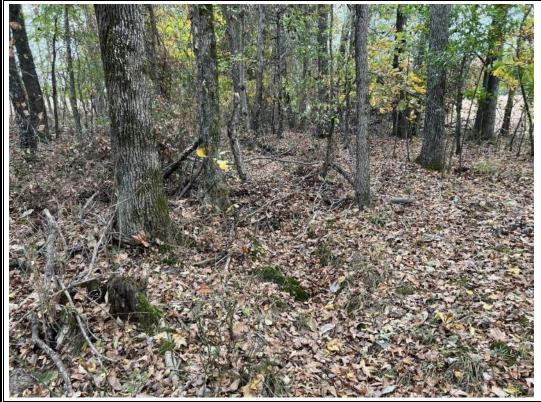
**Photo:** 29 **By:** F. Amatucci

Representative conditions of EPH-6, facing downstream at end of reach before leaving property study area to the south.

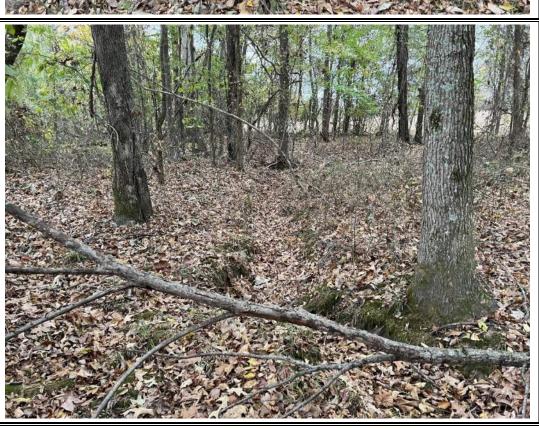
Photo: 30

Representative conditions of EPH-7, facing downstream at start of reach.

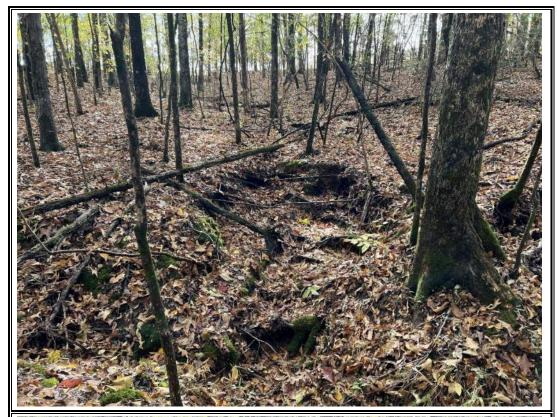
**Photo:** 31 **By:** F. Amatucci

Representative conditions of EPH-7, facing downstream at end of reach before dissipating into WTL-4.

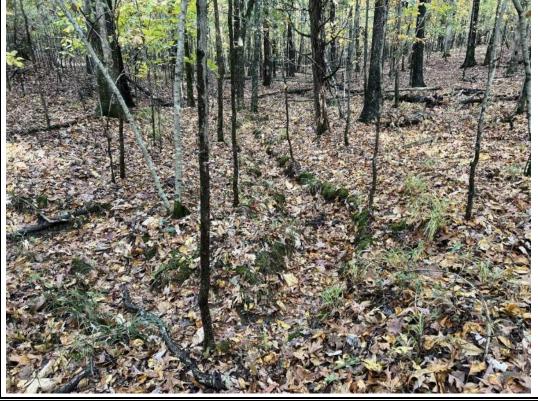
Photo: 32 By: F. Amatucci

Representative conditions of EPH-8, facing upstream at beginning of reach.

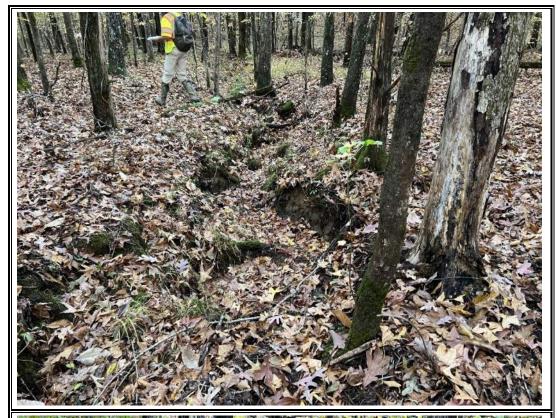
**Photo:** 33 **By:** F. Amatucci

Representative conditions of EPH-8, facing downstream at end of reach before transition into STR-6.

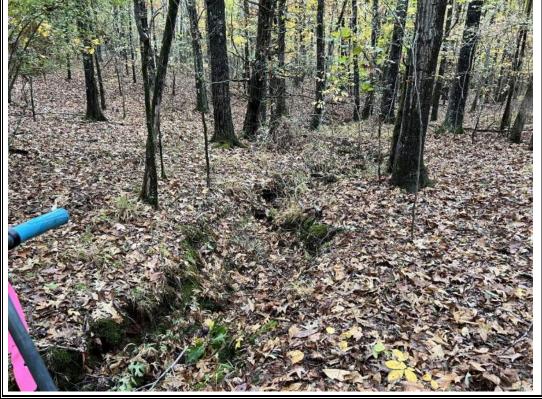
Photo: 34 By: F. Amatucci

Representative conditions of EPH-9, facing upstream at beginning of reach.

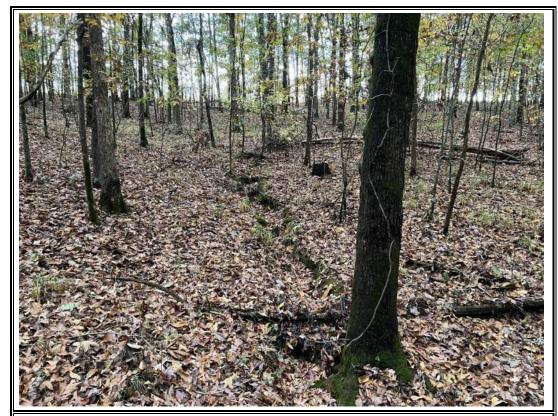
**Photo:** 35 **By:** F. Amatucci

Representative conditions of EPH-9, facing downstream at end of reach before confluence with EPH-10.

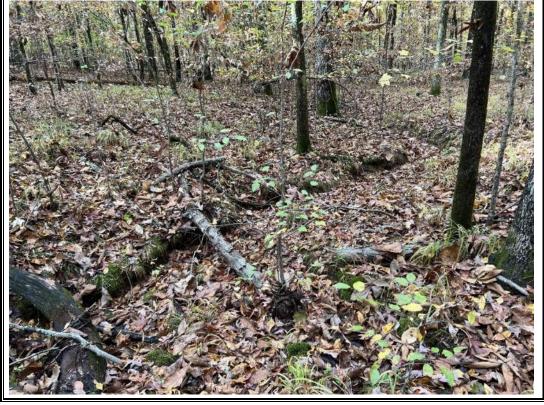
Photo: 36 By: F. Amatucci

Representative conditions of EPH-10, facing upstream at beginning of reach.

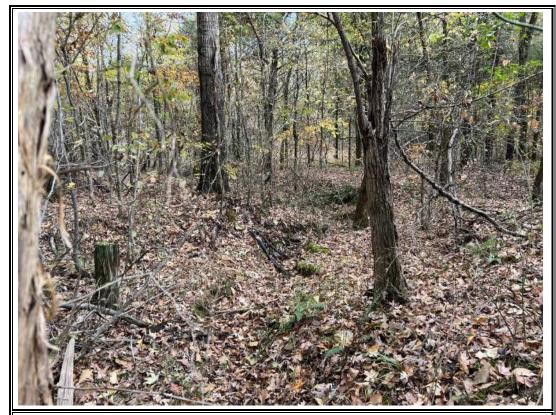
**Photo:** 37 **By:** F. Amatucci

Representative conditions of EPH-10, facing downstream at end of reach before transition into STR-7.

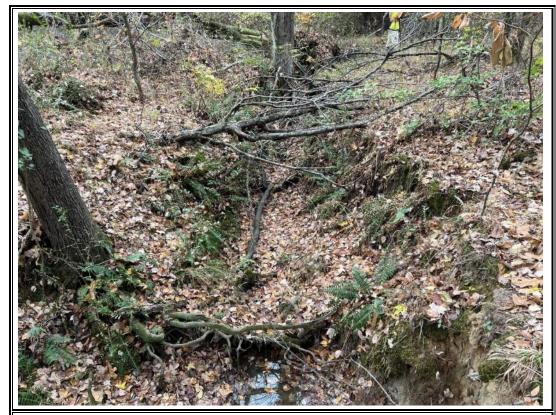
Photo: 39 By: F. Amatucci

Representative conditions of EPH-11, facing upstream at end of reach before confluence with STR-4.

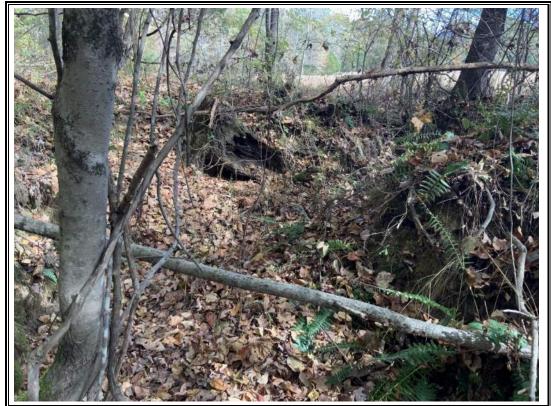
Photo: 41 By: F. Amatucci

Representative conditions of EPH-12, facing downstream at end of reach before confluence with Stratton Branch.

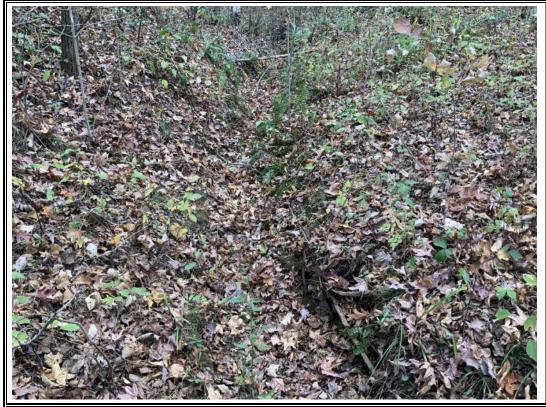
**Photo:** 43 **By:** F. Amatucci

Representative conditions of ES-2, facing downslope mid reach before confluence with STR-1.

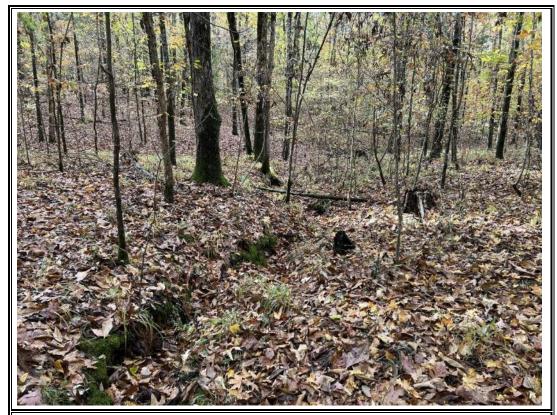
Photo: 45 By: F. Amatucci

Representative conditions of ES-4, facing upslope mid reach.

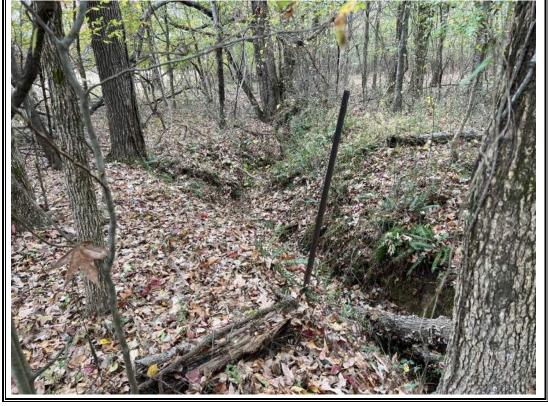
Photo: 46 By: F. Amatucci

Representative conditions of ES-5, facing downslope at beginning of reach before eventual confluence with EPH-10.

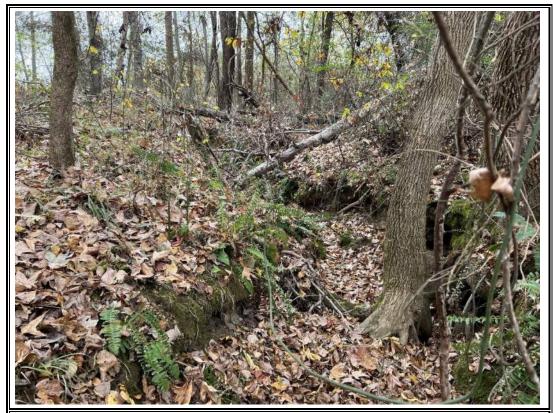
Photo: 47 By: F. Amatucci

Representative conditions of ES-6, facing upslope at end of reach before confluence with Stratton Branch.

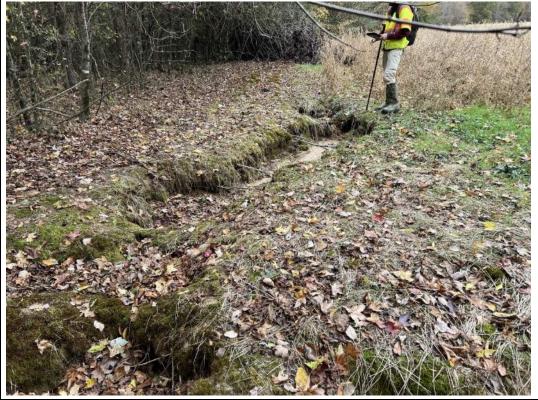
Photo: 48 By: F. Amatucci

Representative conditions of ES-7, facing upslope at end of reach before confluence with Stratton Branch.

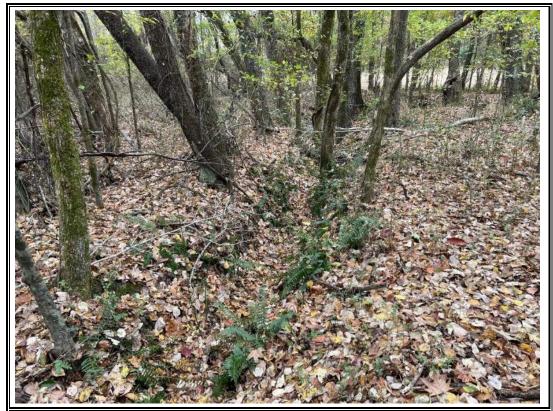
Photo: 49 By: F. Amatucci

Representative conditions of ES-8, facing upslope at start of reach before going subterranean.

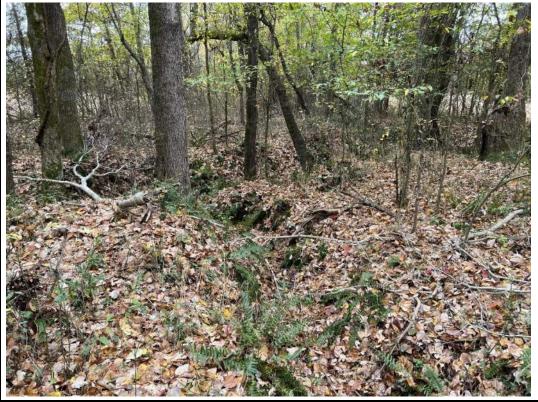
Photo: 50 By: F. Amatucci

Representative conditions of ES-9, facing downslope mid reach before eventual confluence with Stratton Branch.

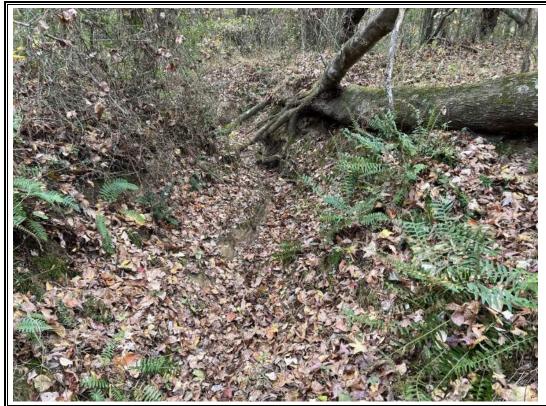
**Photo:** 51 **By:** F. Amatucci

Representative conditions of ES-10, facing downslope at end of reach before confluence with ES-9.

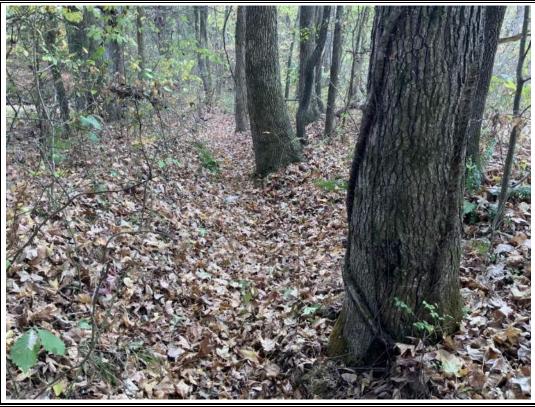
Photo: 52 By: F. Amatucci

Representative conditions of ES-11, facing downslope at end of reach before confluence with Stratton Branch.

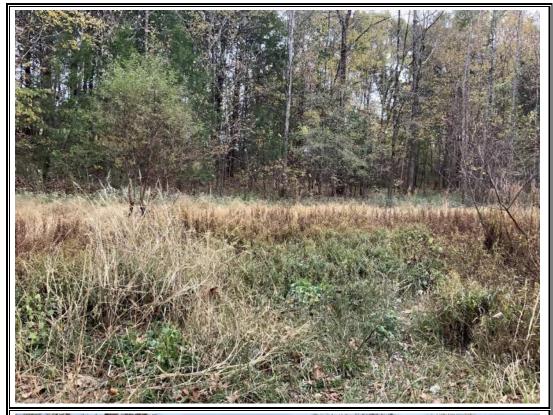
Photo: 53 By: F. Amatucci

Representative conditions of D-1, manmade drainage ditch.

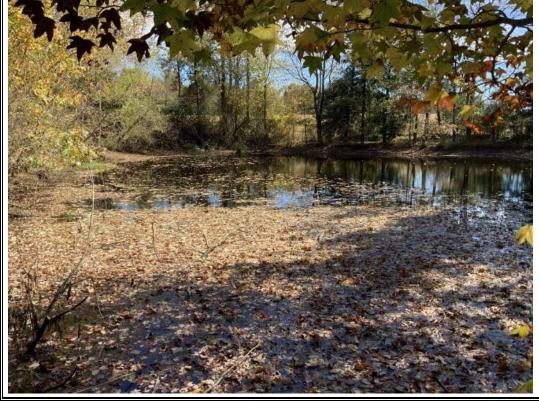
**Photo**: 58

Representative conditions of floodplain WTL-5, adjacent to offsite pond.

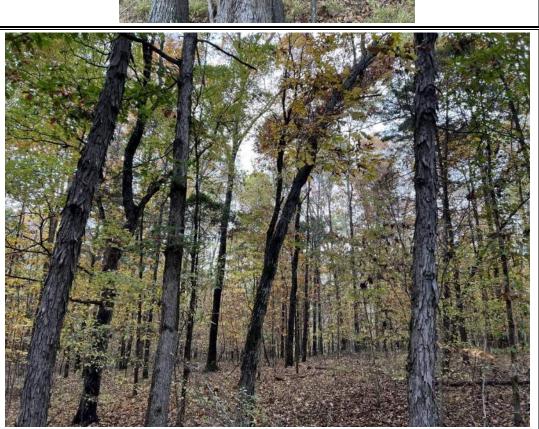
Photo: 80

Potential bat roost location with multiple shagbark hickory trees with exfoliating bark observed within project study area.
