**SR PURYEAR SOLAR
FINAL ENVIRONMENTAL ASSESSMENT
Henry County, Tennessee**

Tennessee Valley Authority
Knoxville, Tennessee

Silicon Ranch

Barge Design Solutions, Inc.

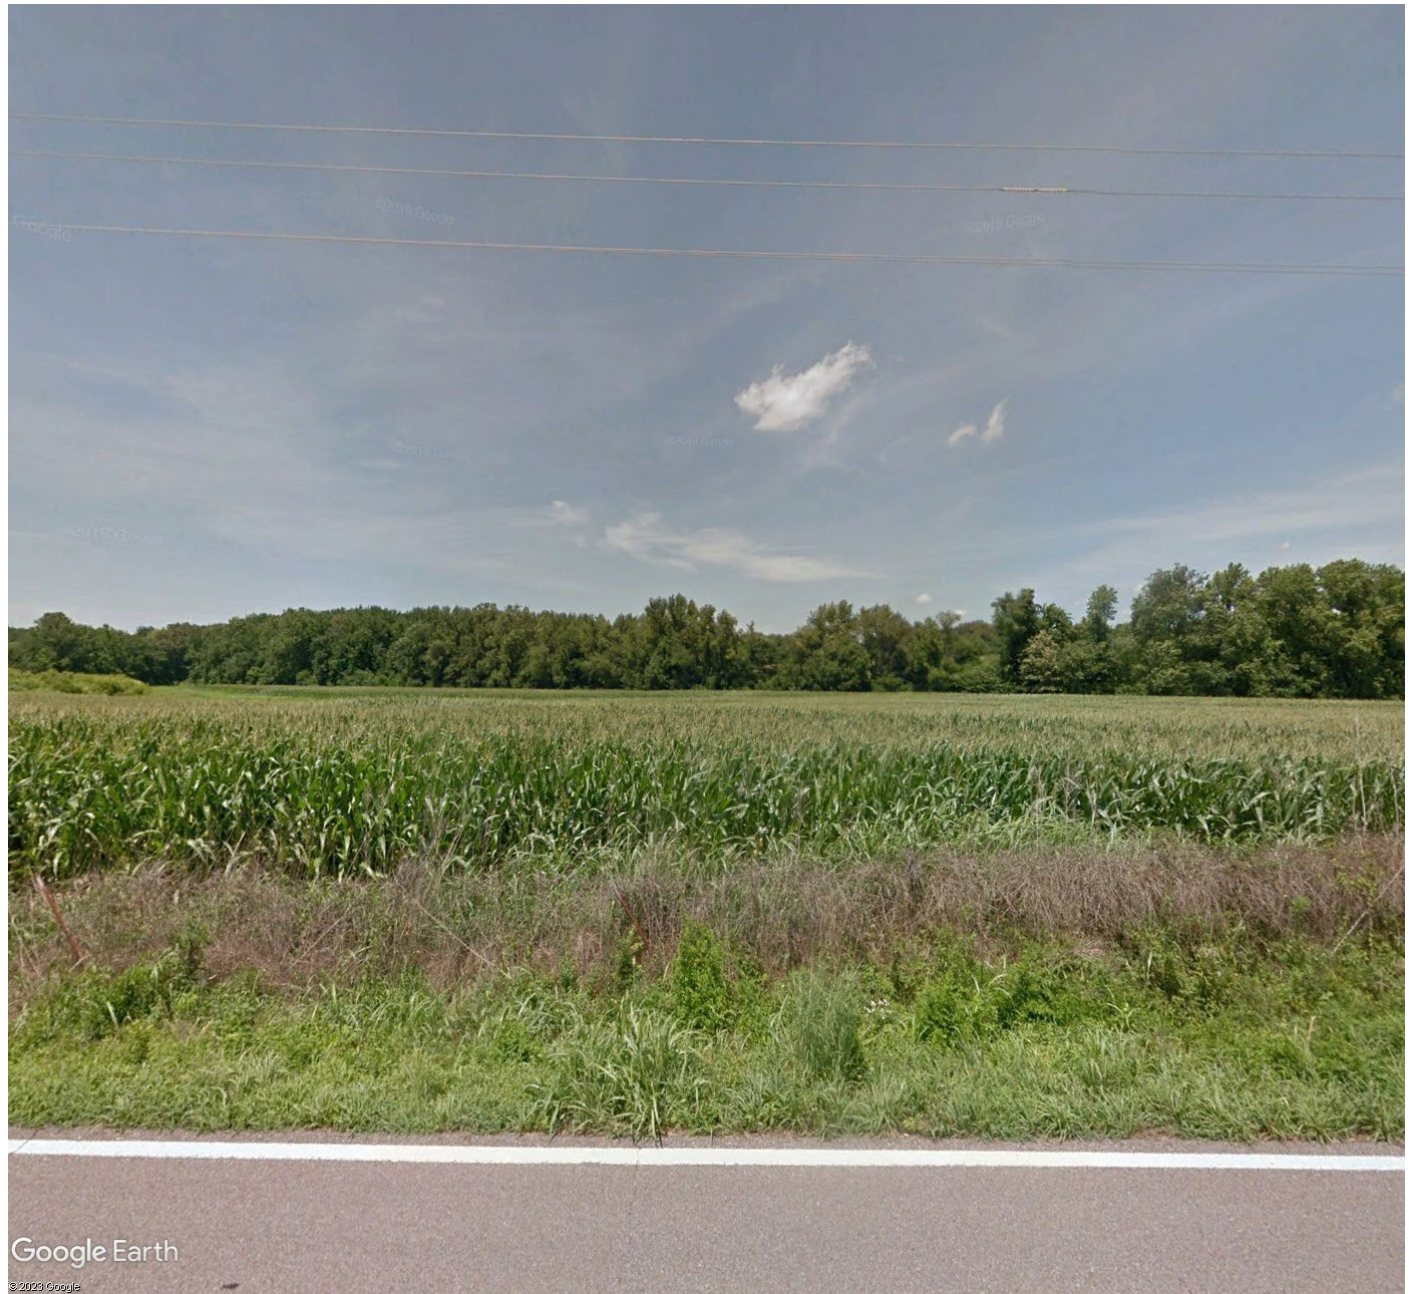
Photo 3.5-1. Agricultural field and tree line near East Fork Clarks River

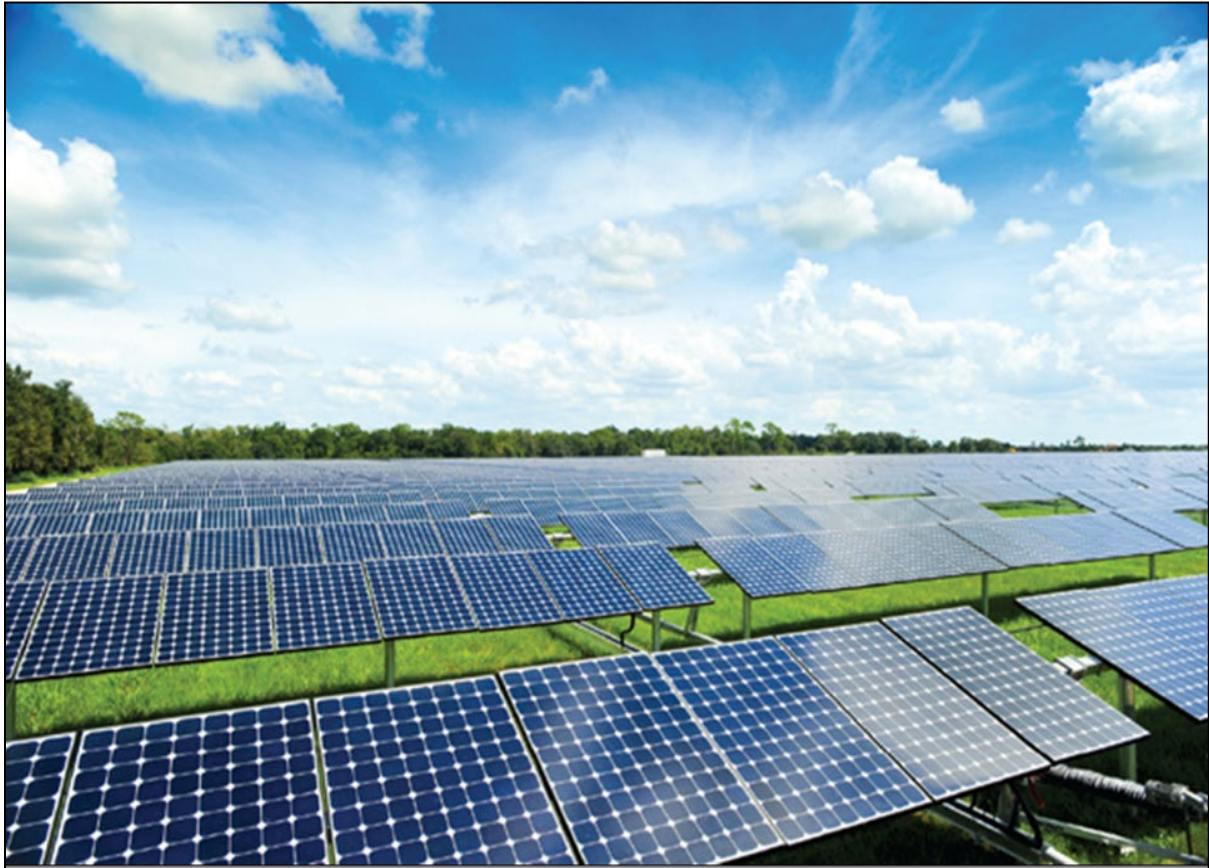
Photo 3.5-6. Single-axis, tracking photovoltaic system with panels close to maximum tilt

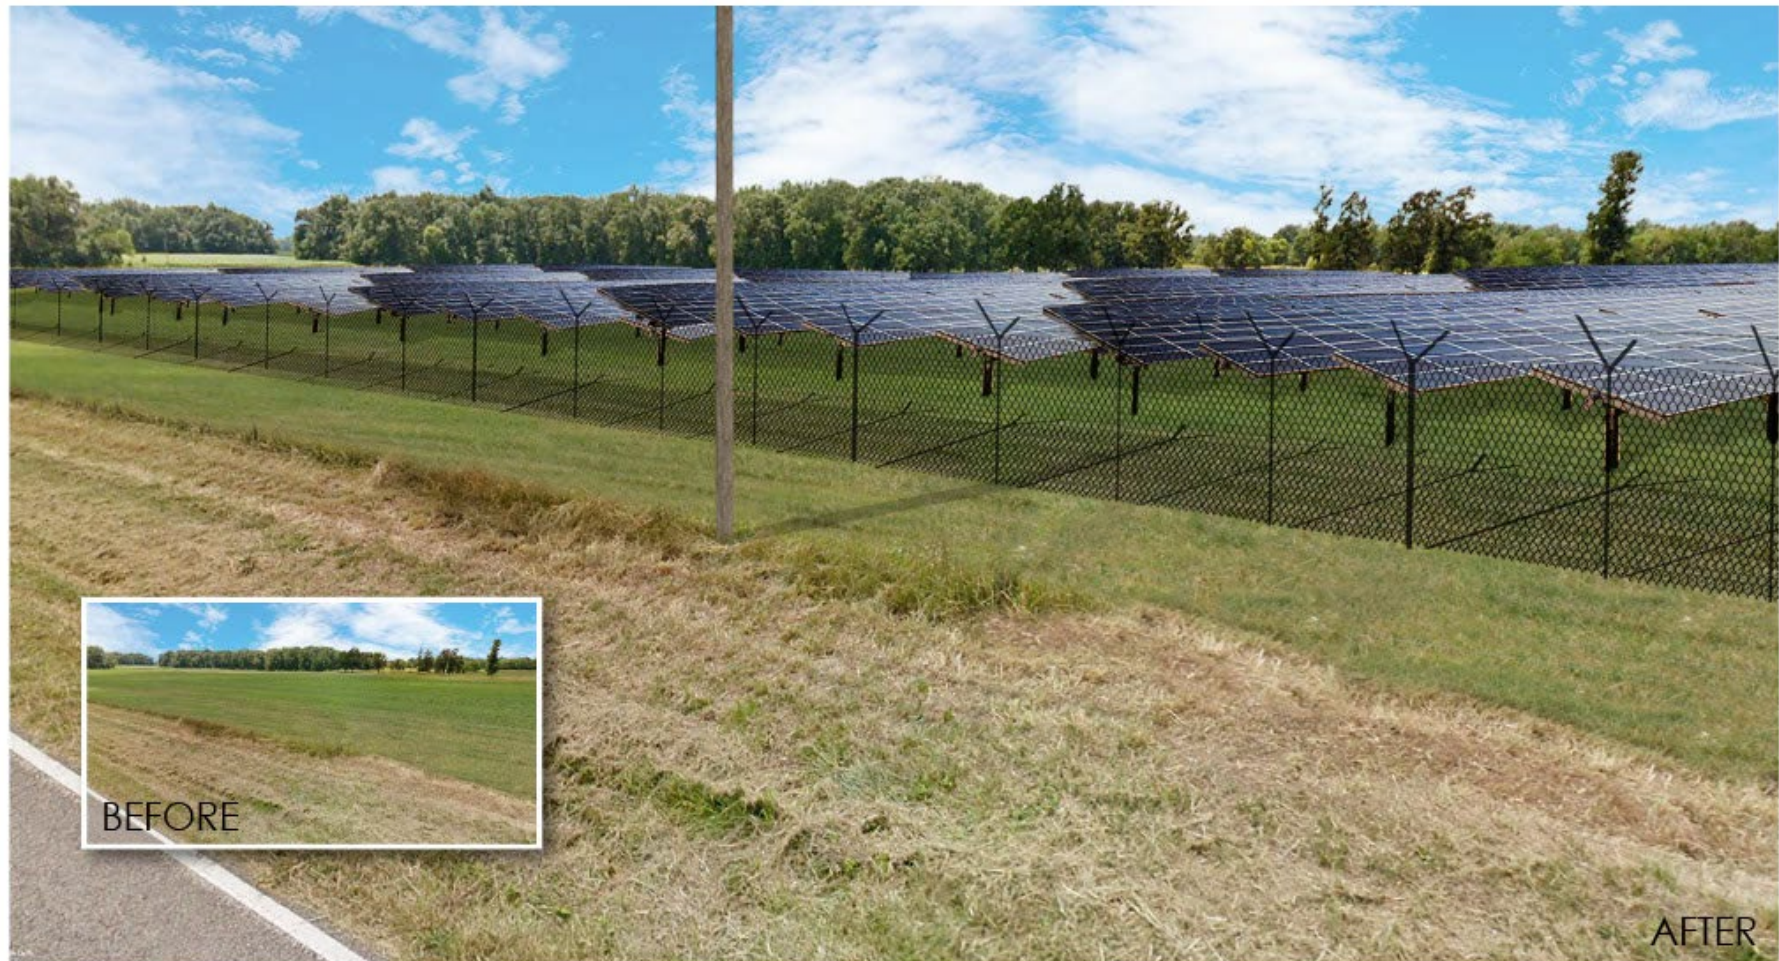
PURYEAR SOLAR FARM - View 1
Puryear, Tennessee July 2023

Photo 3.5-7. Viewshed 1 pre- and post-construction

Photos 3.5-7 to 3.5-9 show the appearance of the Project Site from three publicly accessible viewsheds (Figure 3.5-2). The images show the site as it currently looks and a rendering of the site after construction. The view would change from an agricultural view to a more industrial view. Because vegetation would be planted beneath and around the panels and grow to a height of 2 feet, this would reduce the view of seeing the panels. Since there are very few residences in this location, changes to the visual nature of this space would mostly be seen only by those traveling along SR 140 and Old Paris Murray Road. Additionally, SRC may elect to install vegetative barriers in some areas to further reduce the visual impacts of the panels.

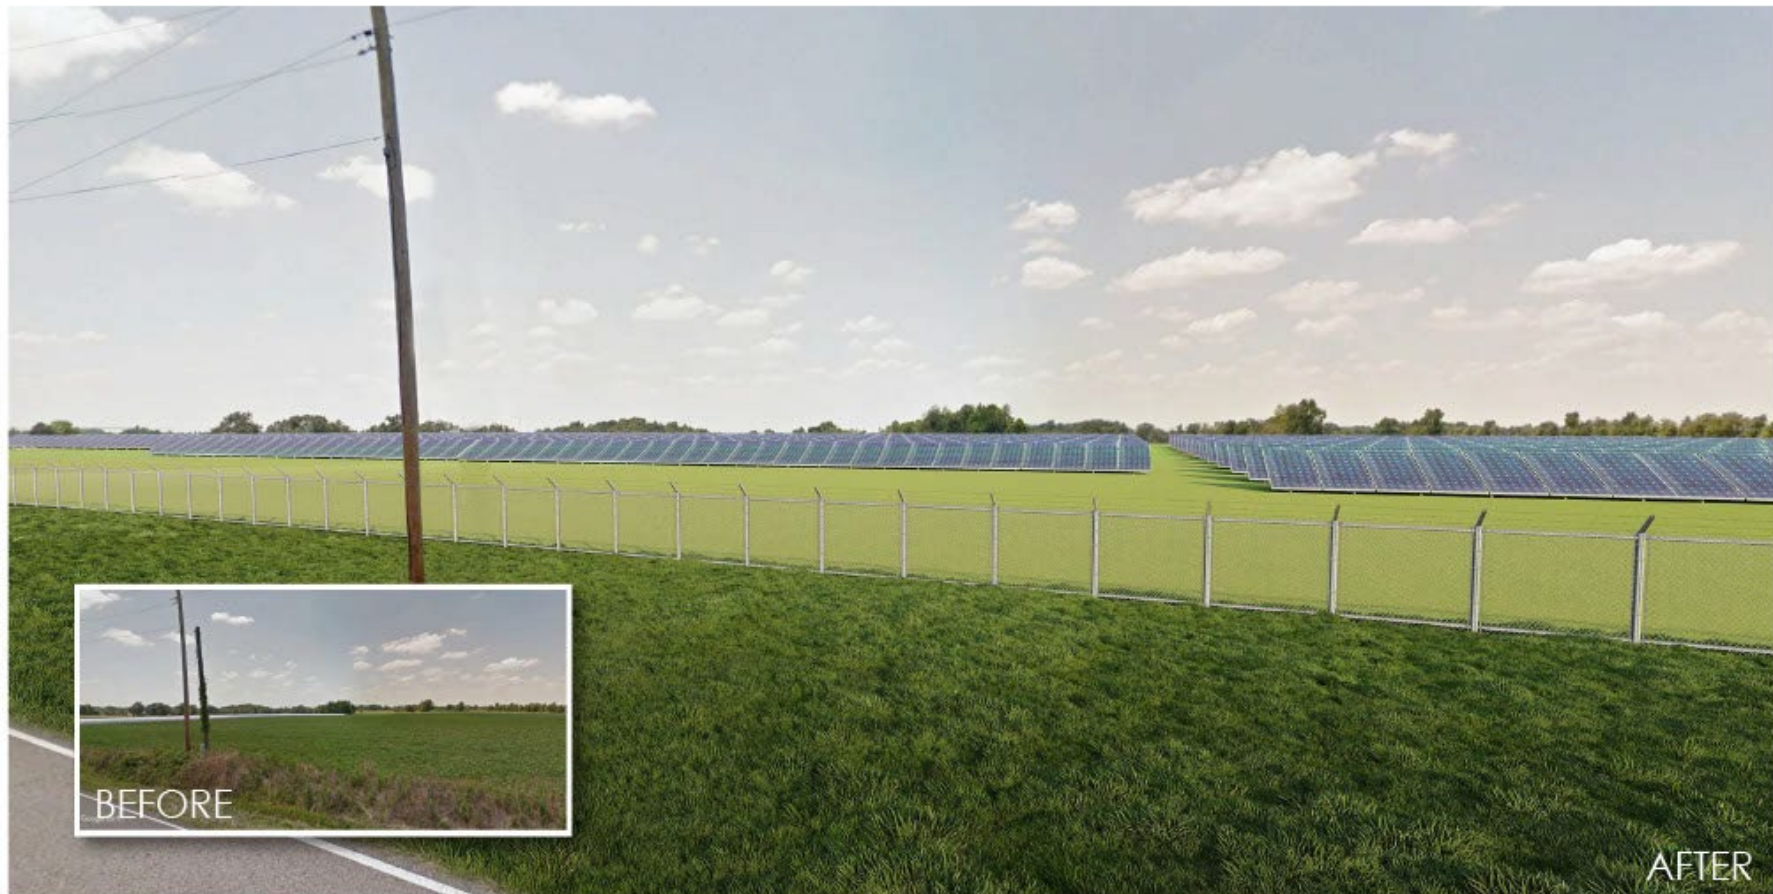
PURYEAR SOLAR FARM - View 2
Puryear, Tennessee July 2023

Photo 3.5-8. Viewshed 2 pre- and post-construction

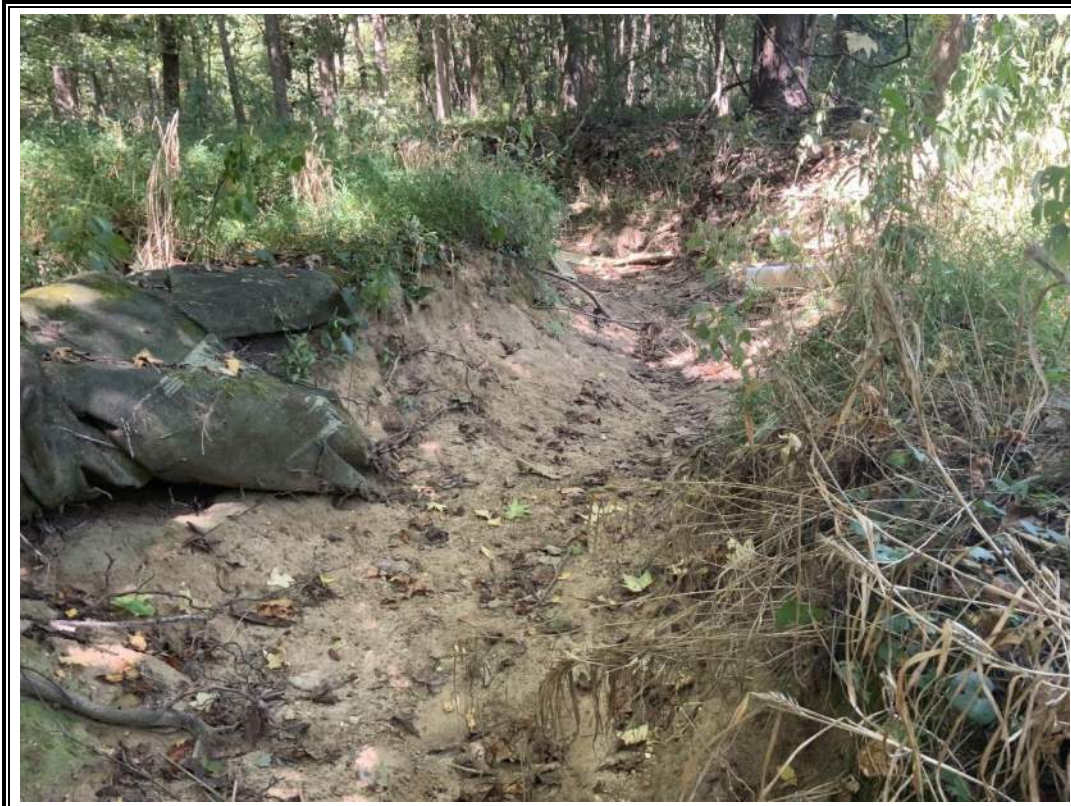
Photo: 1
By: F. Amatucci
Date: September 20, 2022
Feature: STR-1
Lat: 36.453509
Long: -88.307909

Representative conditions of STR-1, facing downstream after transition from EPH-1.

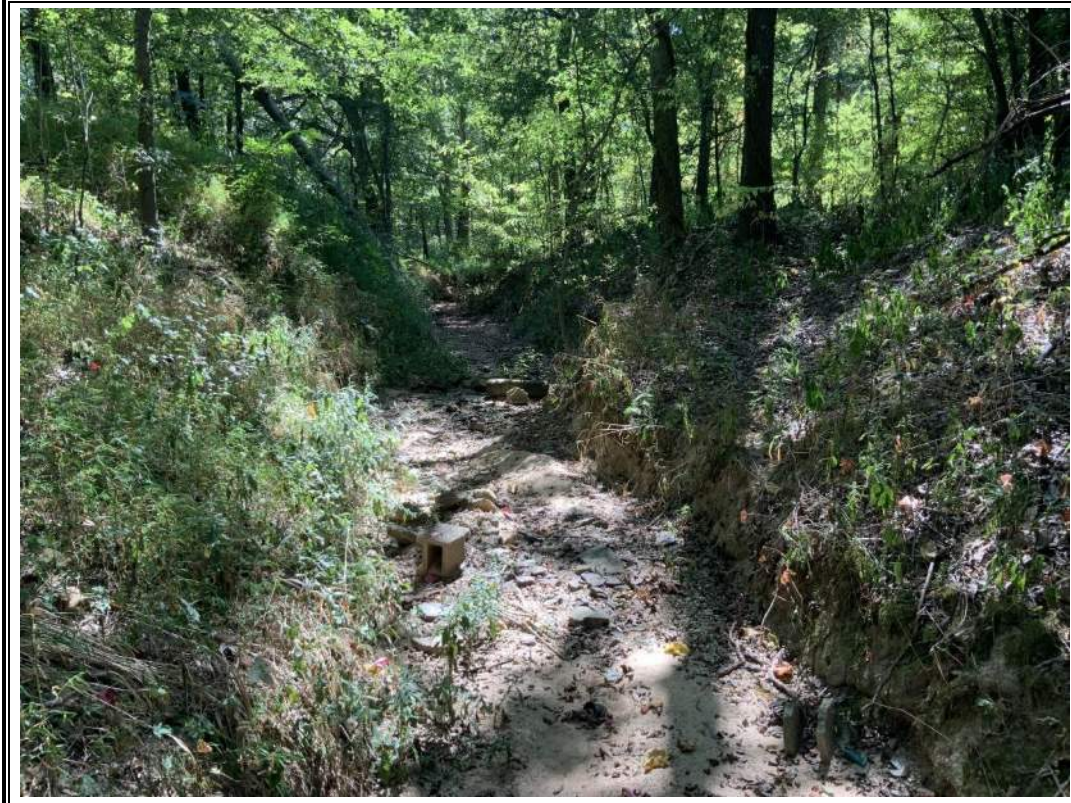
Representative conditions of STR-1, facing upstream at end of reach before flowing out of project study area.

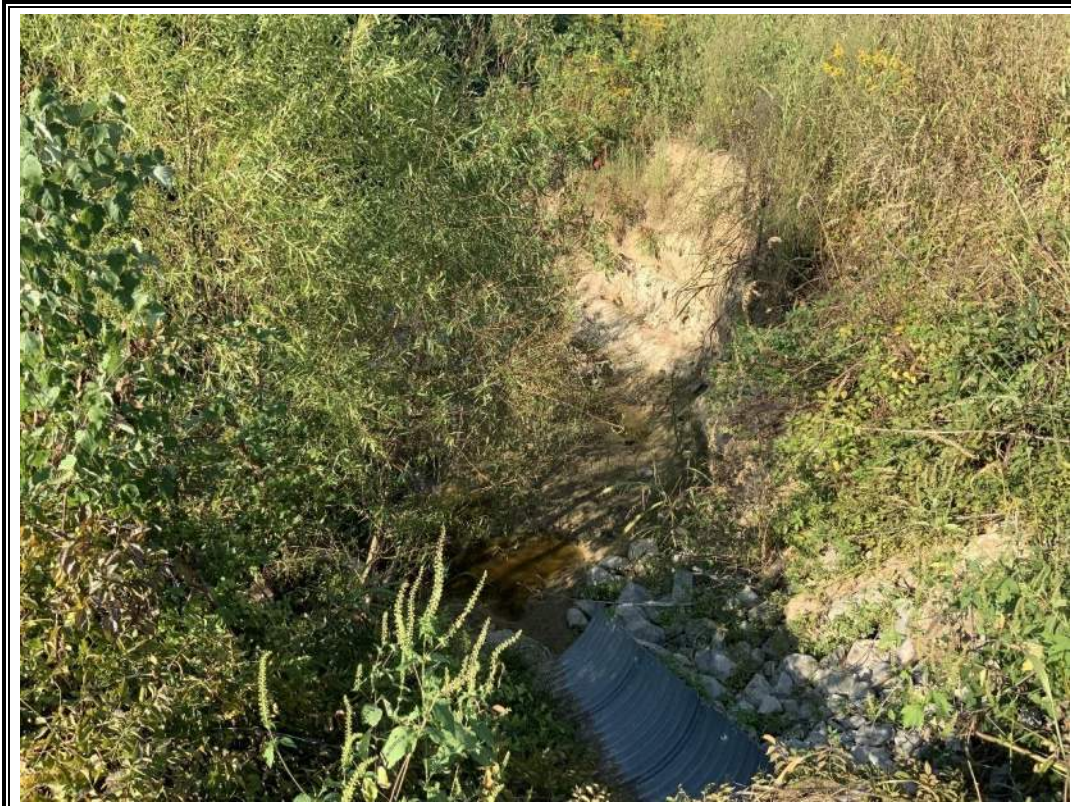
Photo: 3

Representative conditions of STR-2 at beginning of reach, facing downstream from culvert outlet.

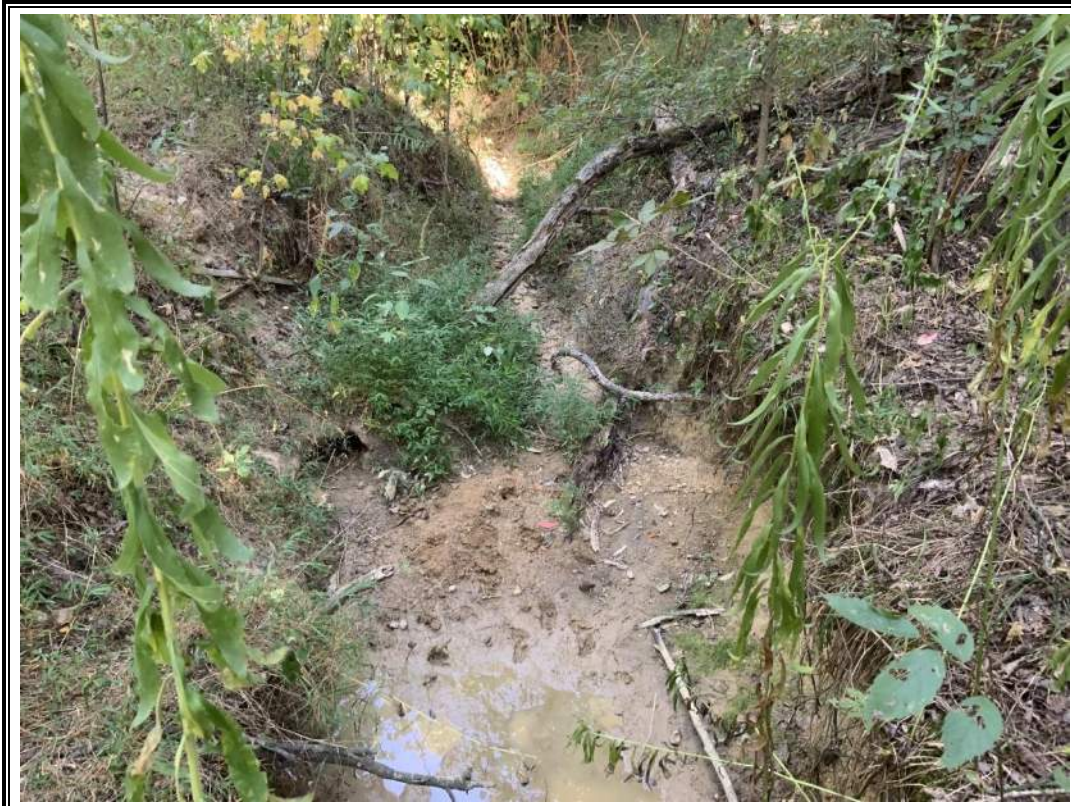
Photo: 5

Representative conditions of STR-3 facing upstream at beginning of reach before transition into EPH-3.

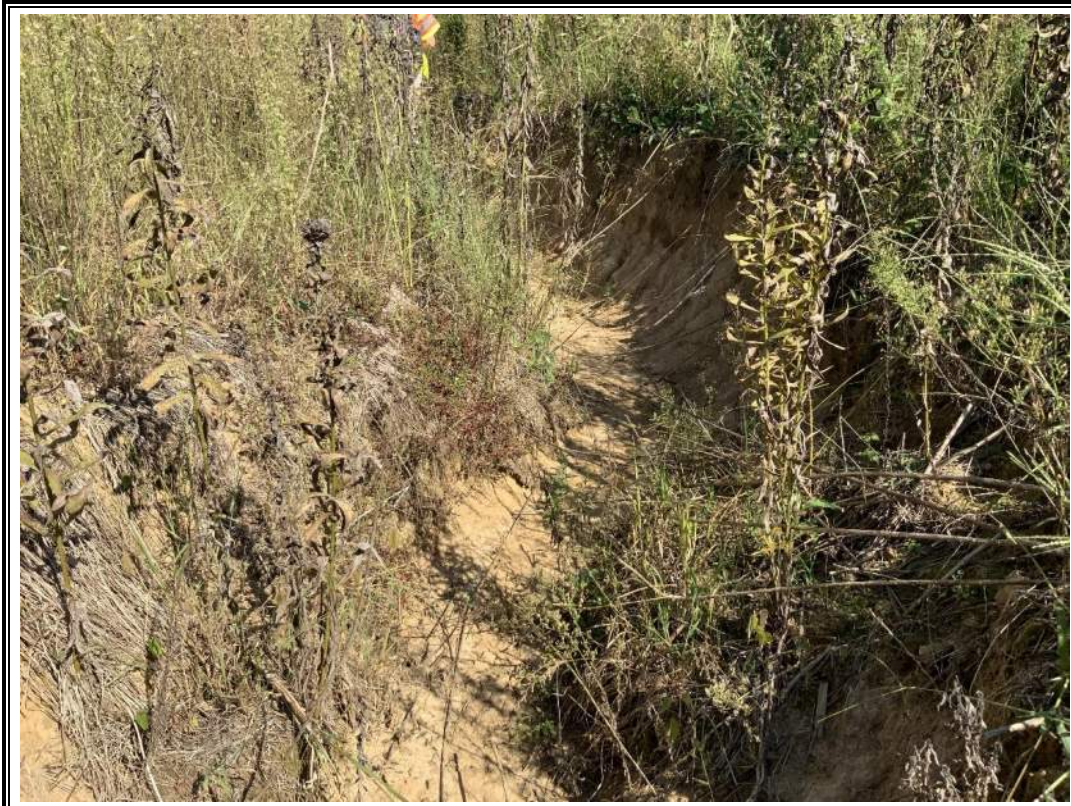
Photo: 7

Representative conditions of STR-4 facing downstream at beginning of reach from P-2.

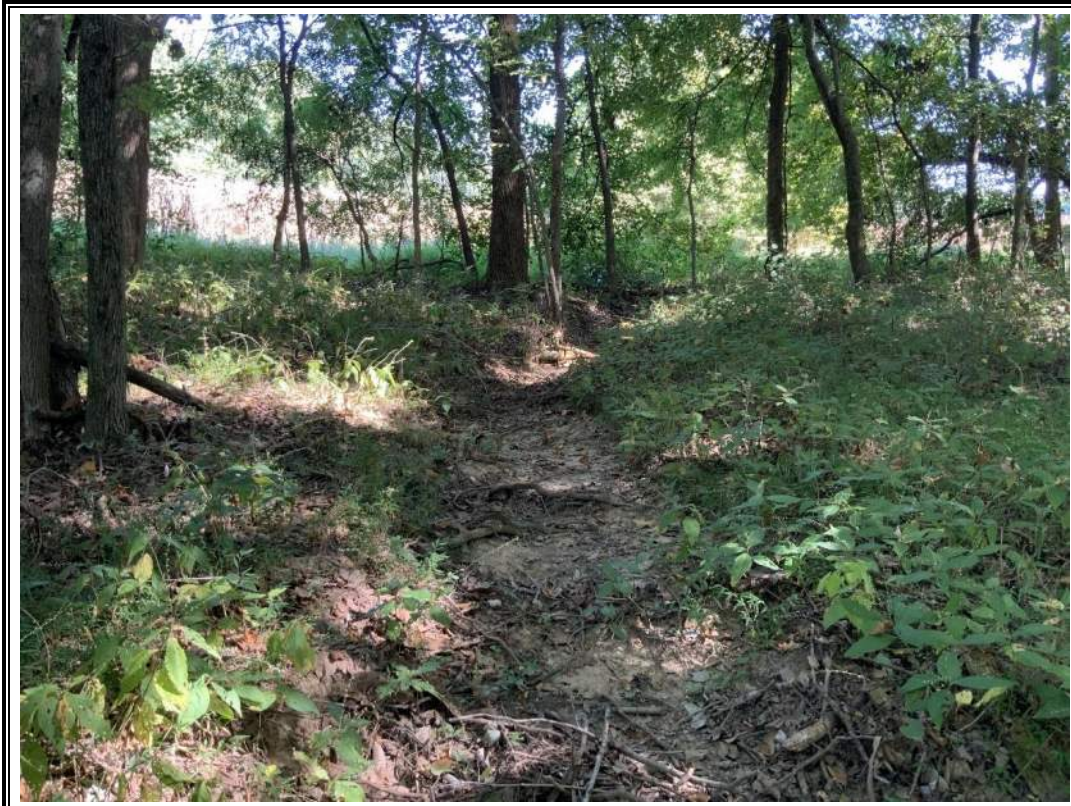
Photo: 9
By: F. Amatucci
Date: September 21, 2022
Feature: STR-5
Lat: 36.445551
Long: -88.314272

Representative conditions of STR-5 mid-reach after forming at bottom of WTL-1.

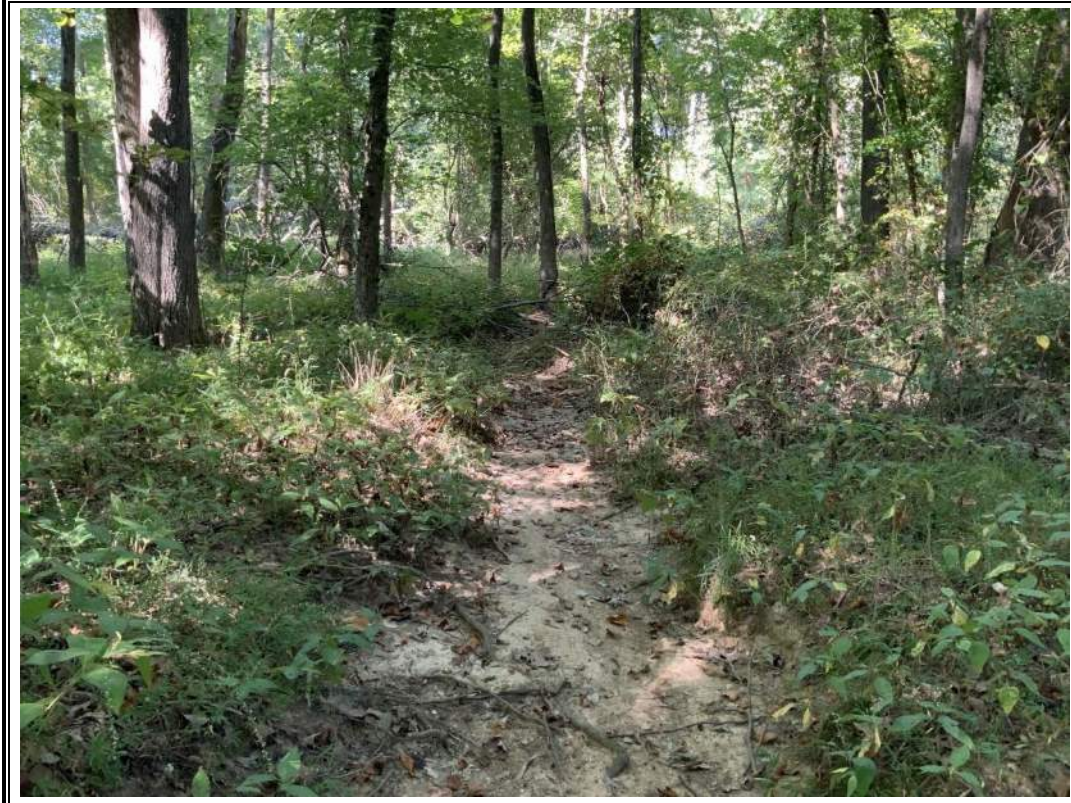
Photo: 10
By: F. Amatucci
Date: September 21, 2022
Feature: STR-5
Lat: 36.445376
Long: -88.314691

Representative conditions of STR-5 at end of reach before dissipating into WTL-2.

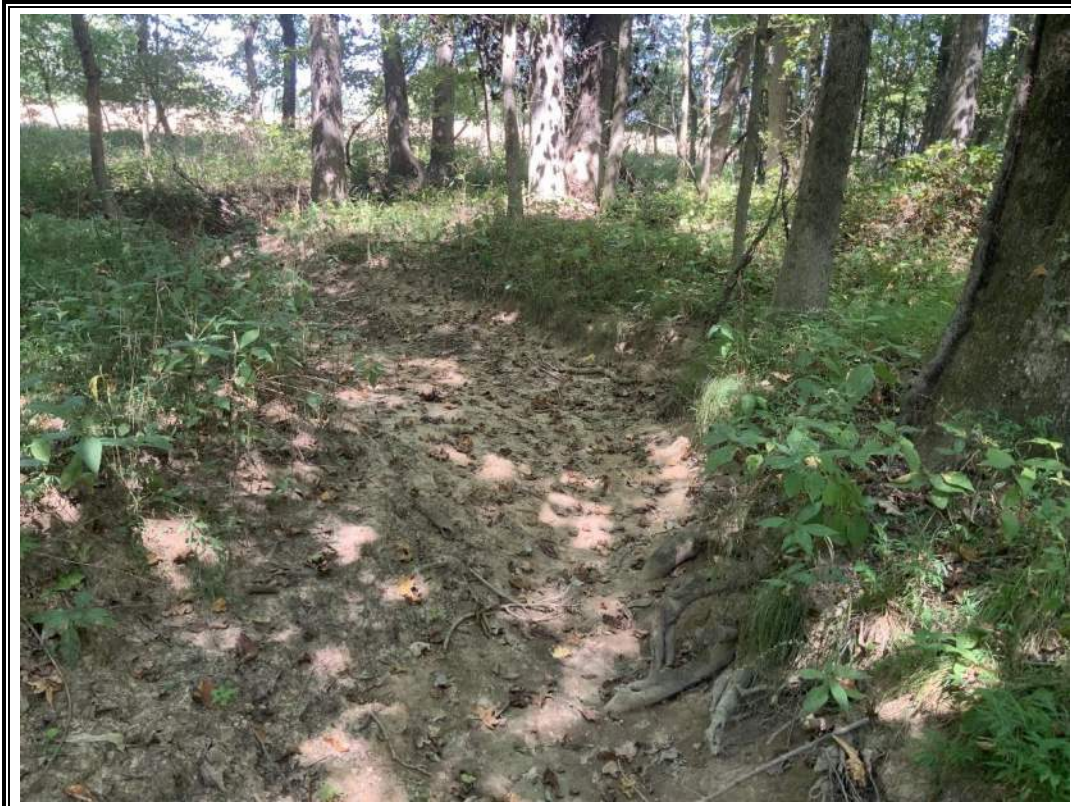
Photo: 11

Representative conditions of STR-6 at beginning of reach, facing upstream before leaving property limits.

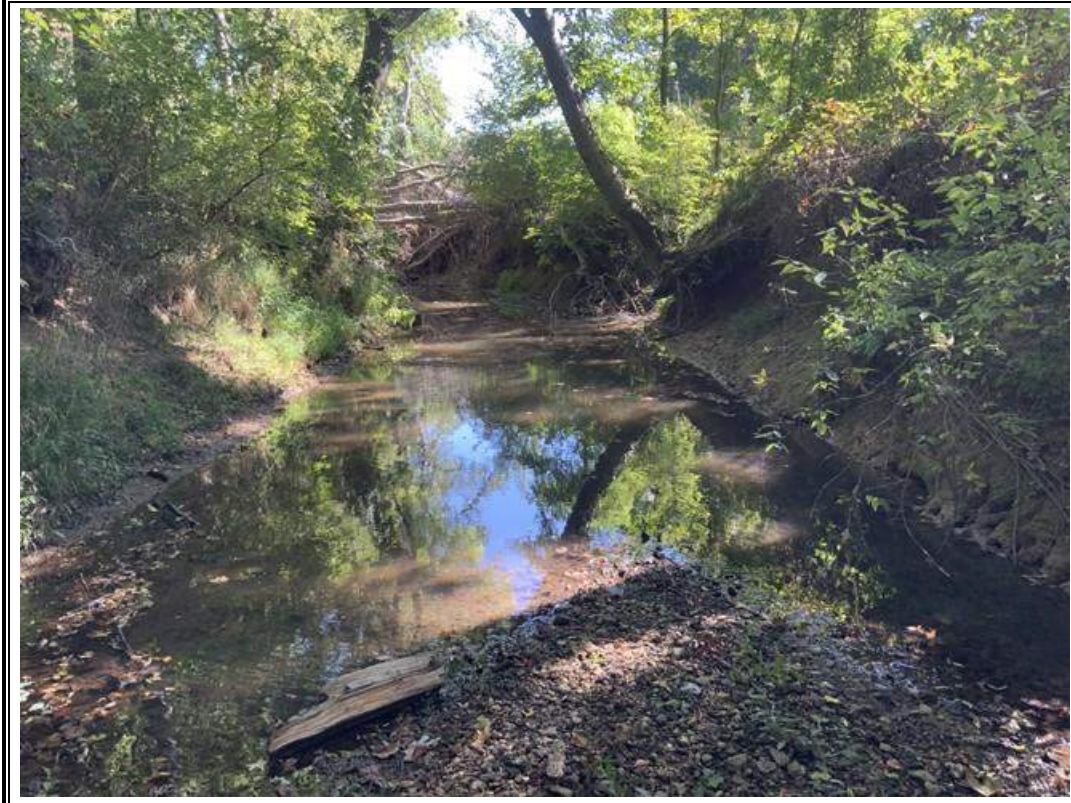
Photo: 14
By: F. Amatucci
Date: September 21, 2022
Feature: STR-7
Lat: 36.445963
Long: -88.316184

Representative conditions of STR-7 at end of reach near confluence with STR-6.

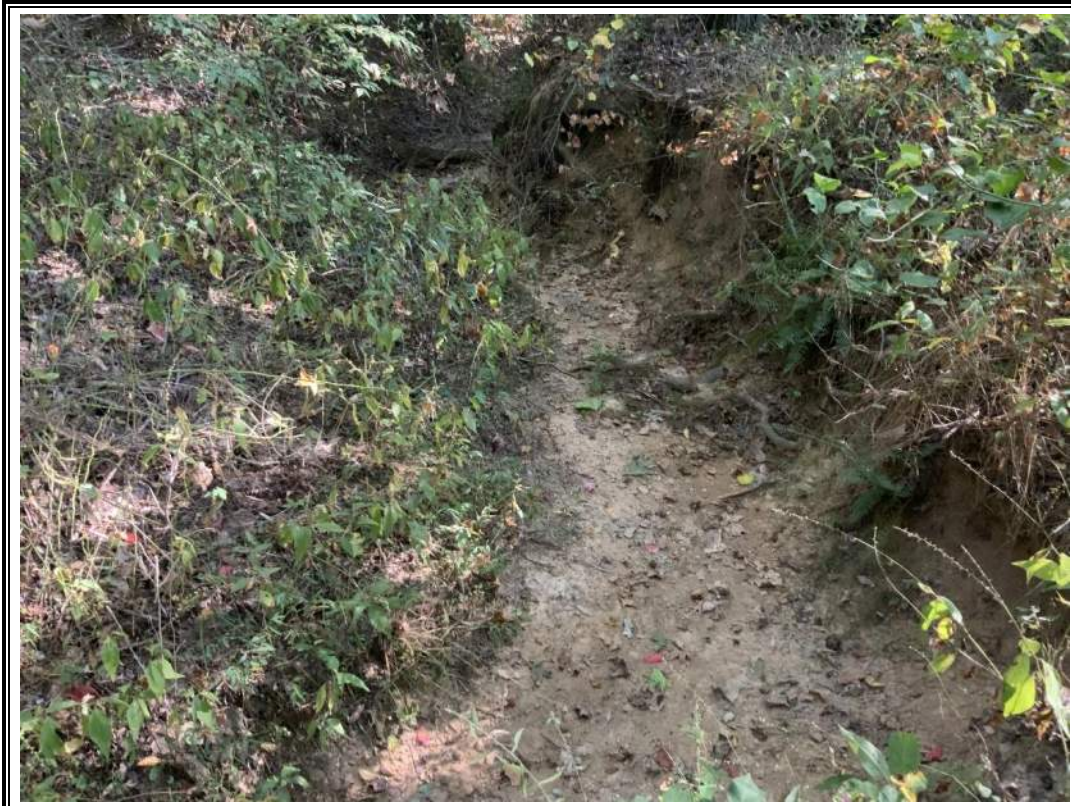
Photo: 15

Representative conditions of STR-7 at mid-reach, facing upstream before leaving property limits.

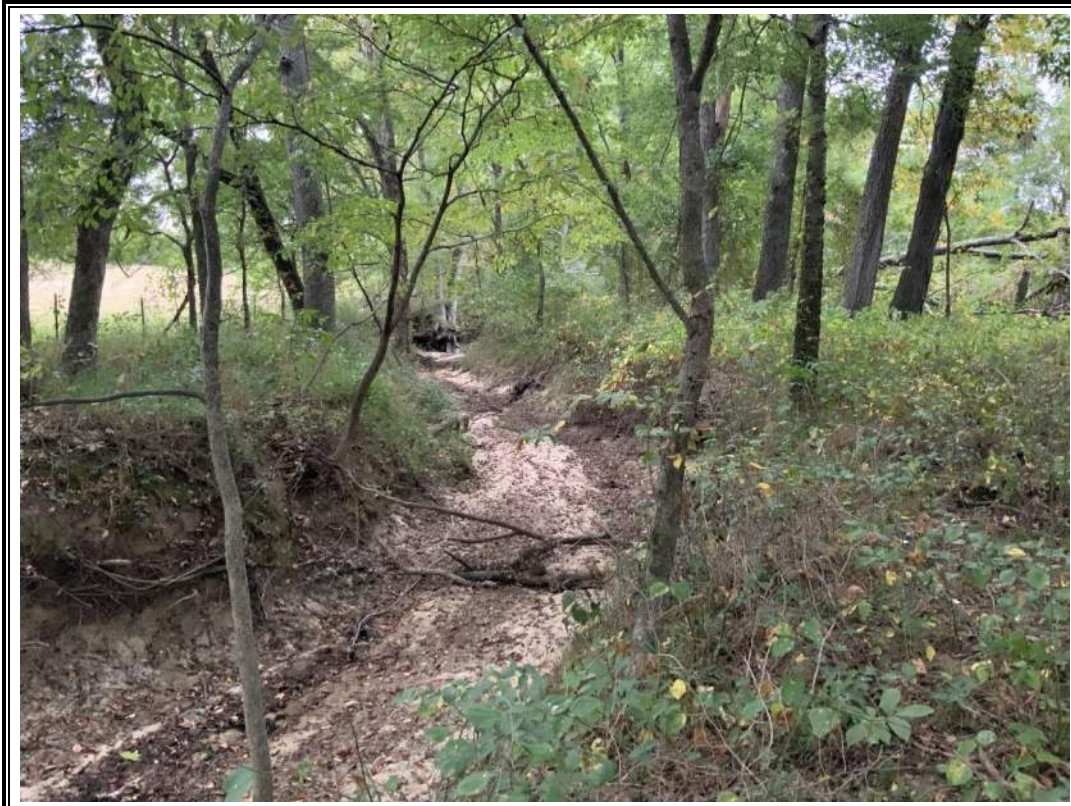
Photo: 17
By: F. Amatucci
Date: September 22, 2022
Feature: STR-9
Lat: 36.444509
Long: -88.319904

Representative conditions of STR-9 at beginning of reach before leaving property limits.

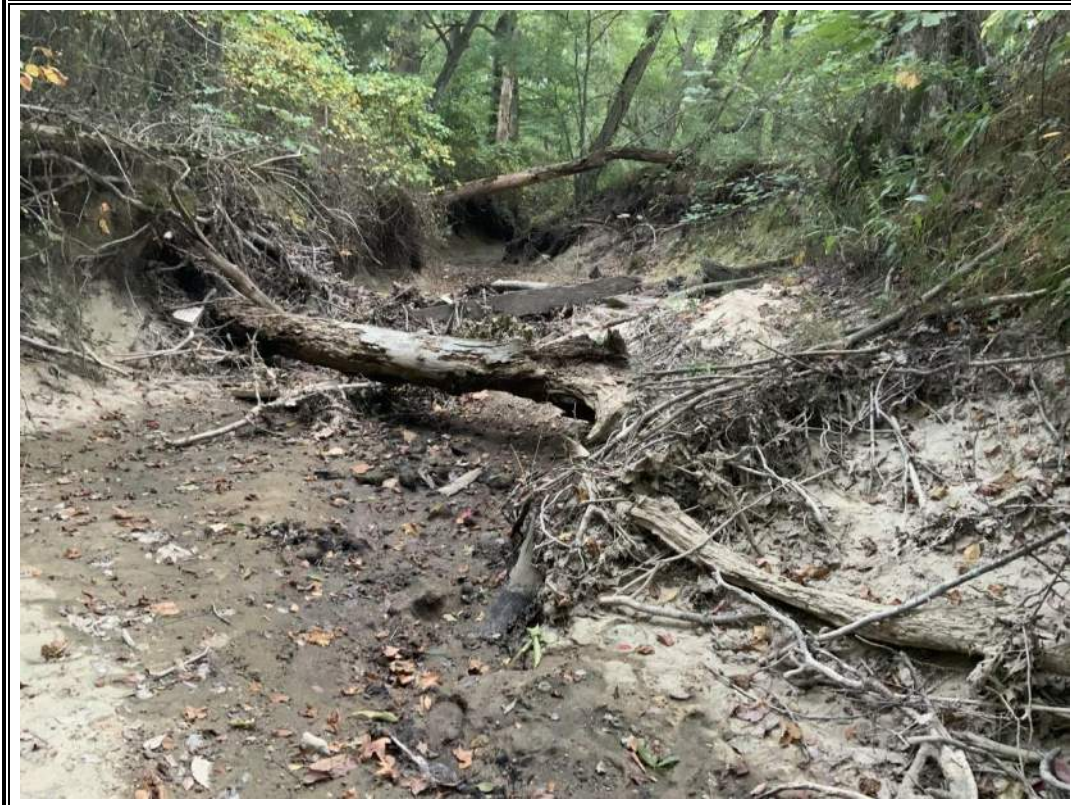
Photo: 18
By: F. Amatucci
Date: September 22, 2022
Feature: STR-9
Lat: 36.445578
Long: -88.319126

Representative conditions of STR-9 at end of reach near confluence with EPH-6 before leaving property limits.

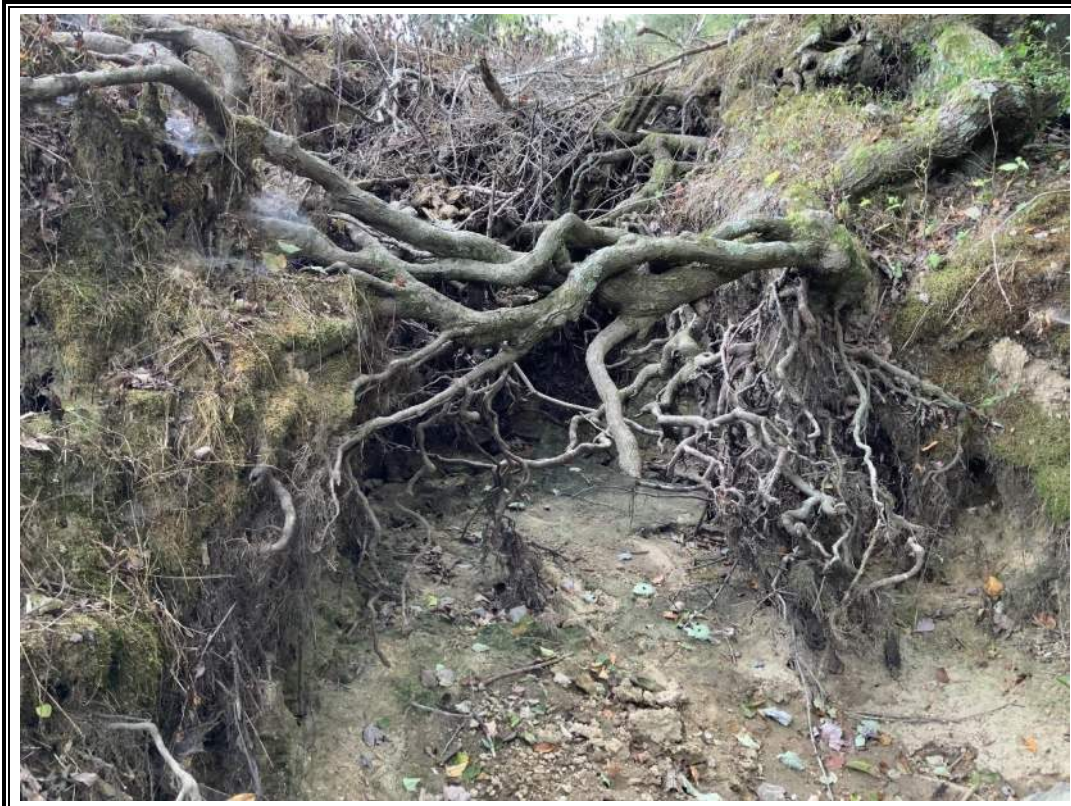
Photo: 19
By: F. Amatucci
Date: September 22, 2022
Feature: STR-10
Lat: 36.441538
Long: -88.300116

Representative conditions of STR-10 at beginning of reach, begins at moderate headcut after transition from EPH-9.

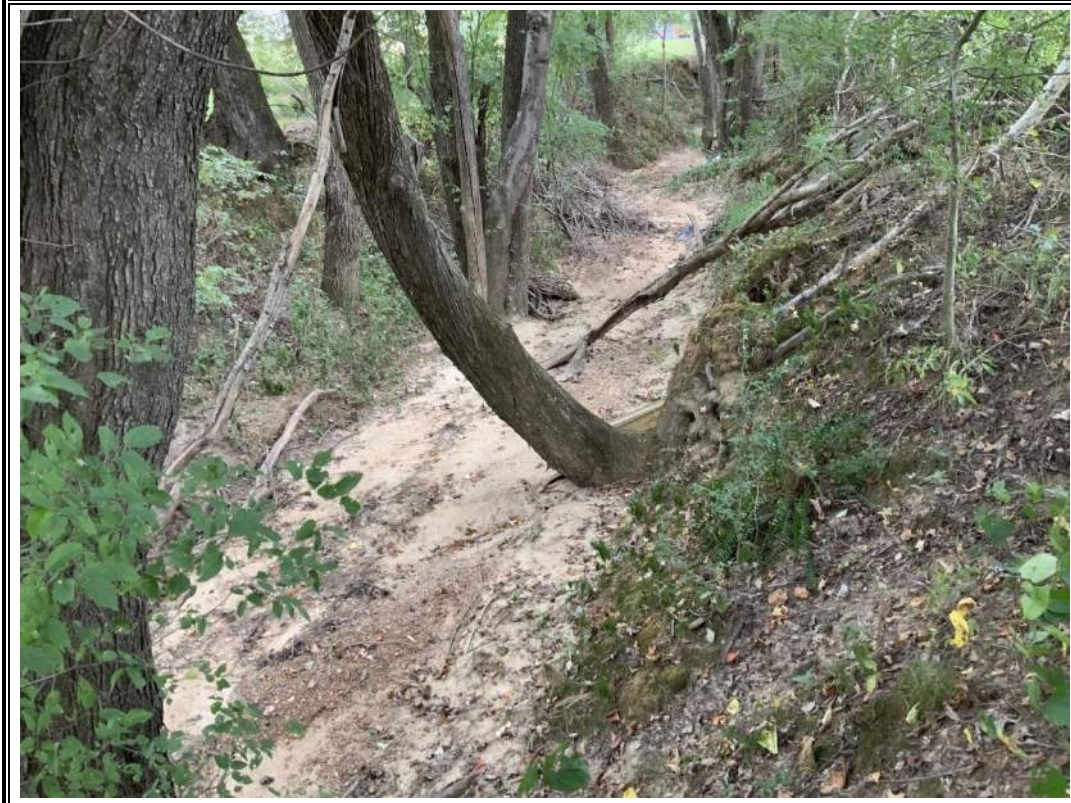
Photo: 20
By: F. Amatucci
Date: September 22, 2022
Feature: STR-10
Lat: 36.440701
Long: -88.302991

Representative conditions of STR-10 near end of reach before entering culver inlet.

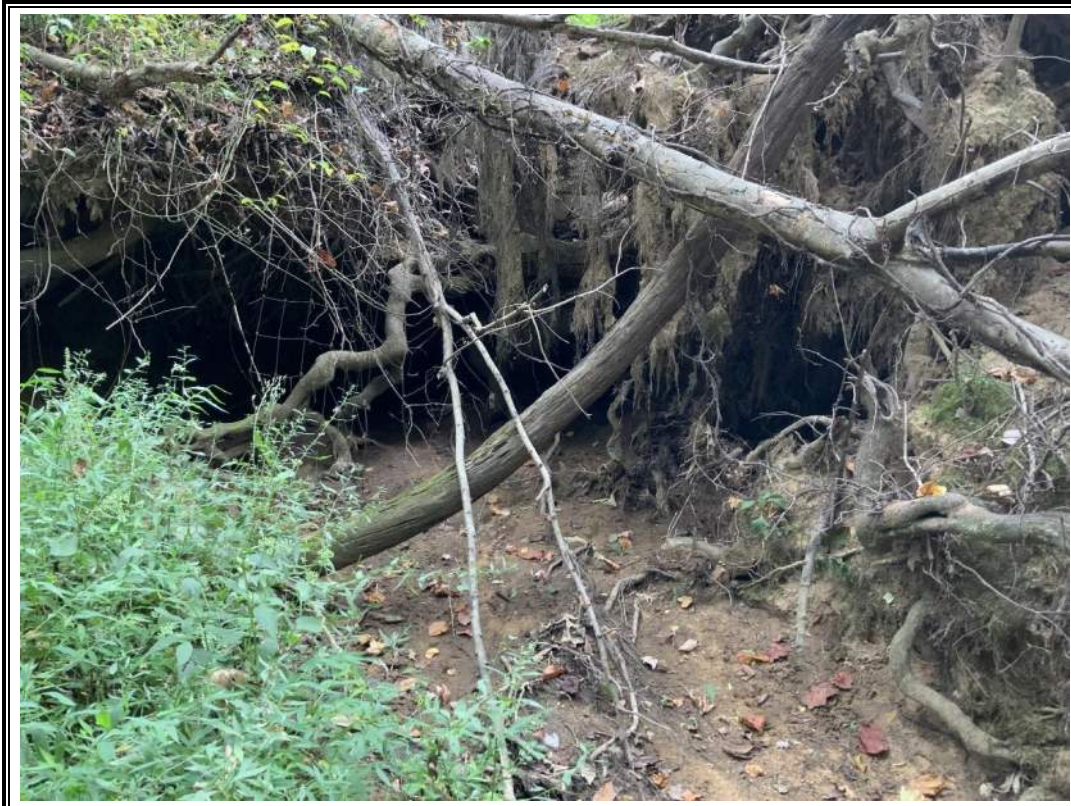
Photo: 21
By: F. Amatucci
Date: September 22, 2022
Feature: STR-11
Lat: 36.441718
Long: -88.300966

Representative conditions of STR-11 at beginning of reach after transitioning from EPH-8.

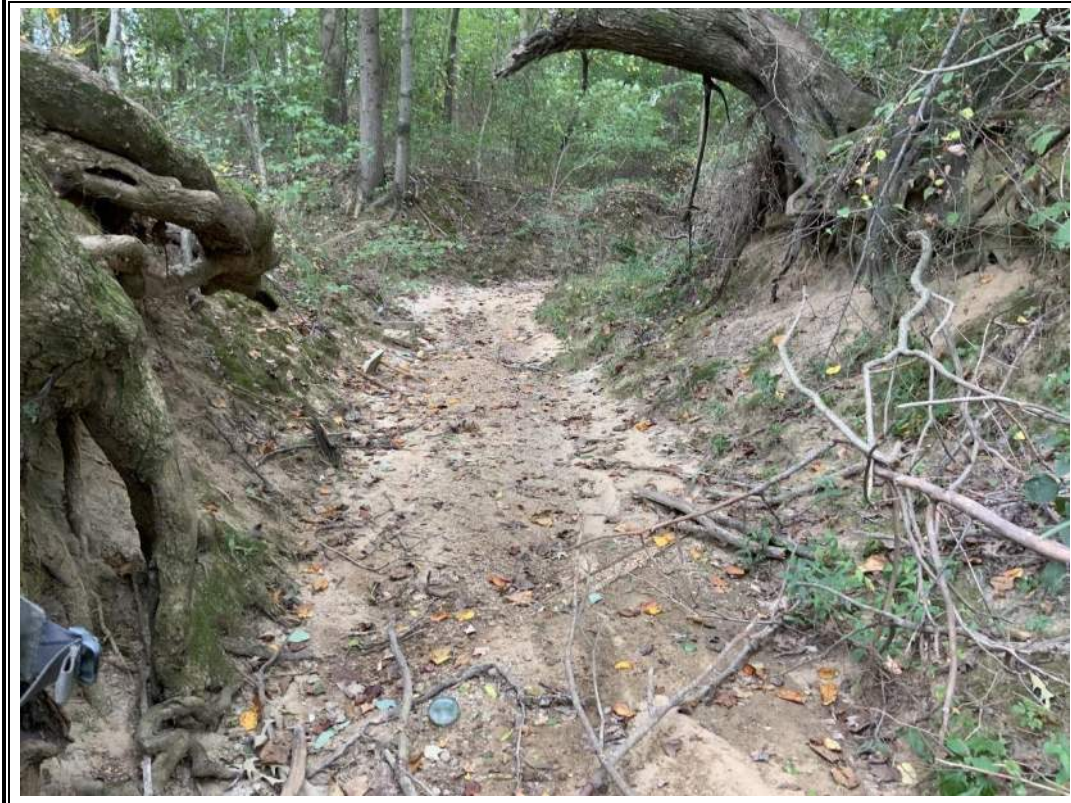
Photo: 22
By: F. Amatucci
Date: September 22, 2022
Feature: STR-11
Lat: 36.441570
Long: -88.300961

Representative conditions of STR-11 at end of reach before confluence with STR-10.

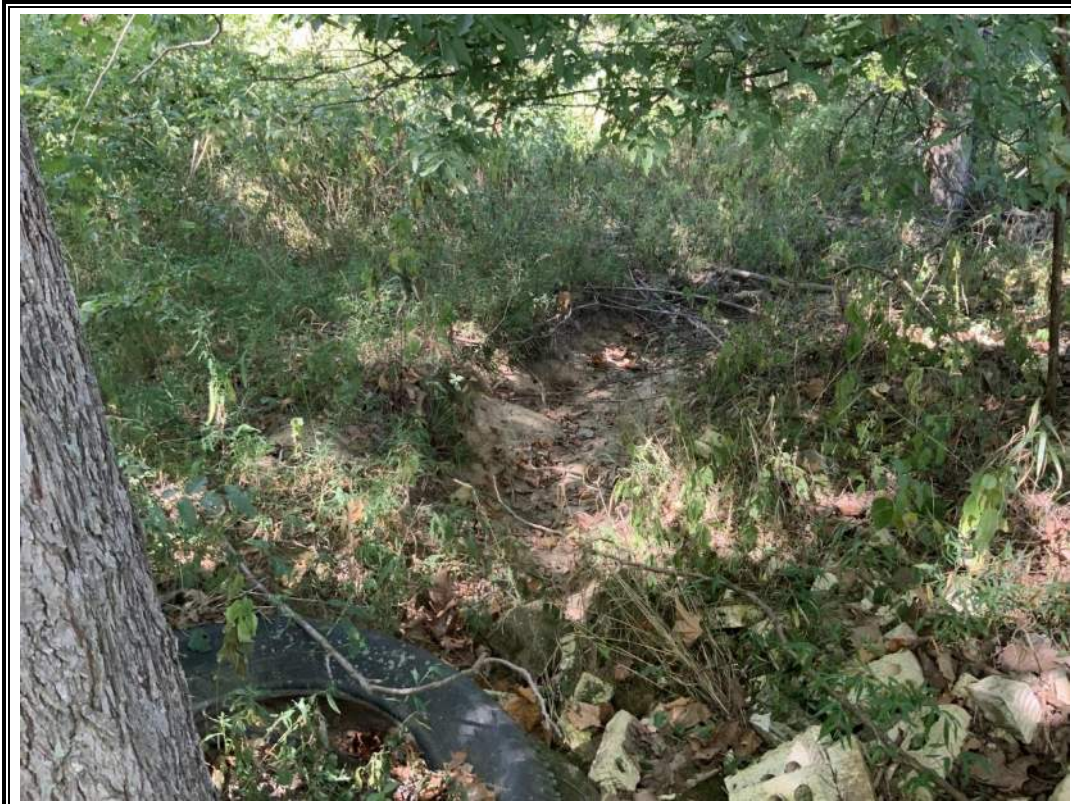
Photo: 23
By: F. Amatucci
Date: September 20, 2022
Feature: EPH-1
Lat: 36.452990
Long: -88.306954

Representative conditions of EPH-1 beginning of reach facing downstream.

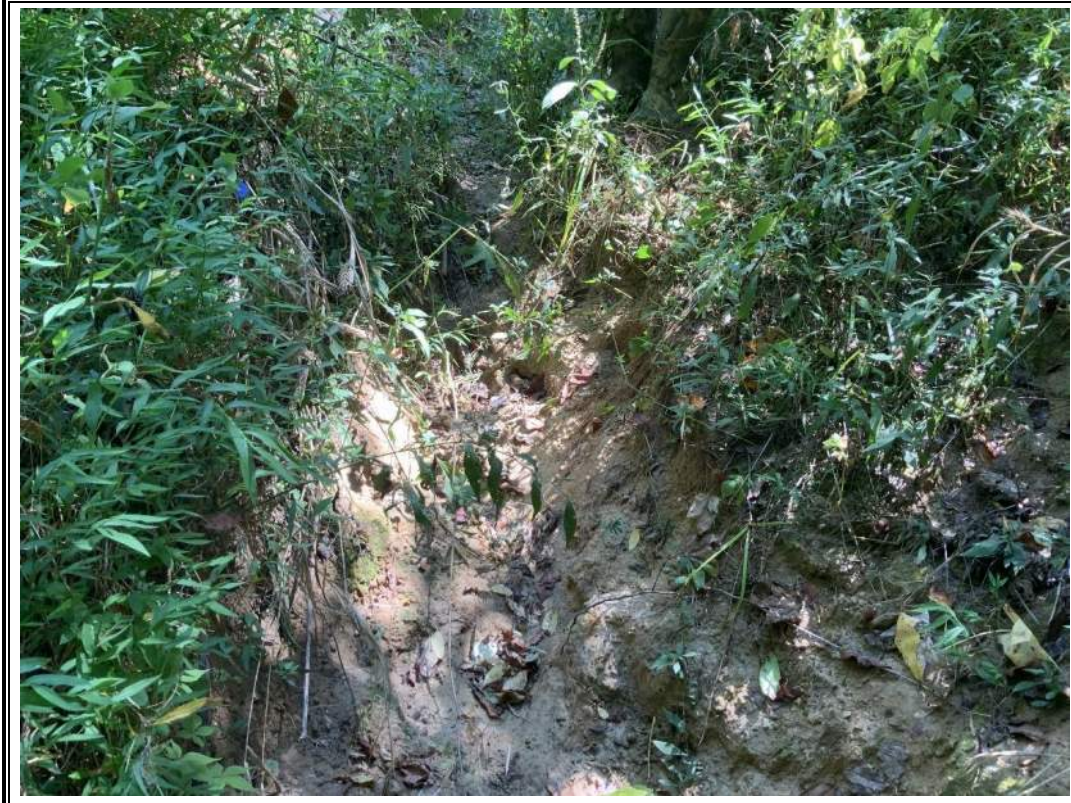
Photo: 24
By: F. Amatucci
Date: September 20, 2022
Feature: EPH-1
Lat: 36.453510
Long: -88.307864

Representative conditions of EPH-1 at end of reach, facing upstream before transition into STR-1.
