**SR PURYEAR SOLAR
FINAL ENVIRONMENTAL ASSESSMENT
Henry County, Tennessee**

Tennessee Valley Authority
Knoxville, Tennessee

Silicon Ranch

Barge Design Solutions, Inc.

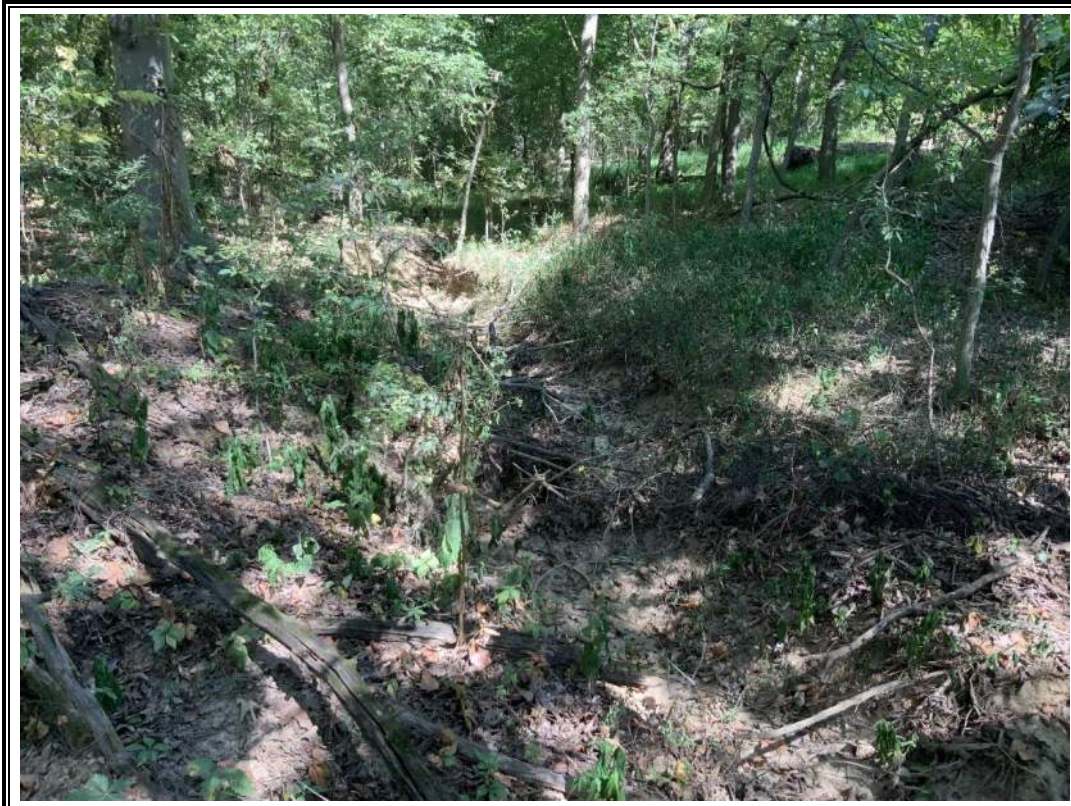
Photo: 25
By: F. Amatucci
Date: September 20, 2022
Feature: EPH-2
Lat: 36.452844
Long: -88.308641

Representative conditions of EPH-2 at beginning of reach, facing downstream after entering property limits.

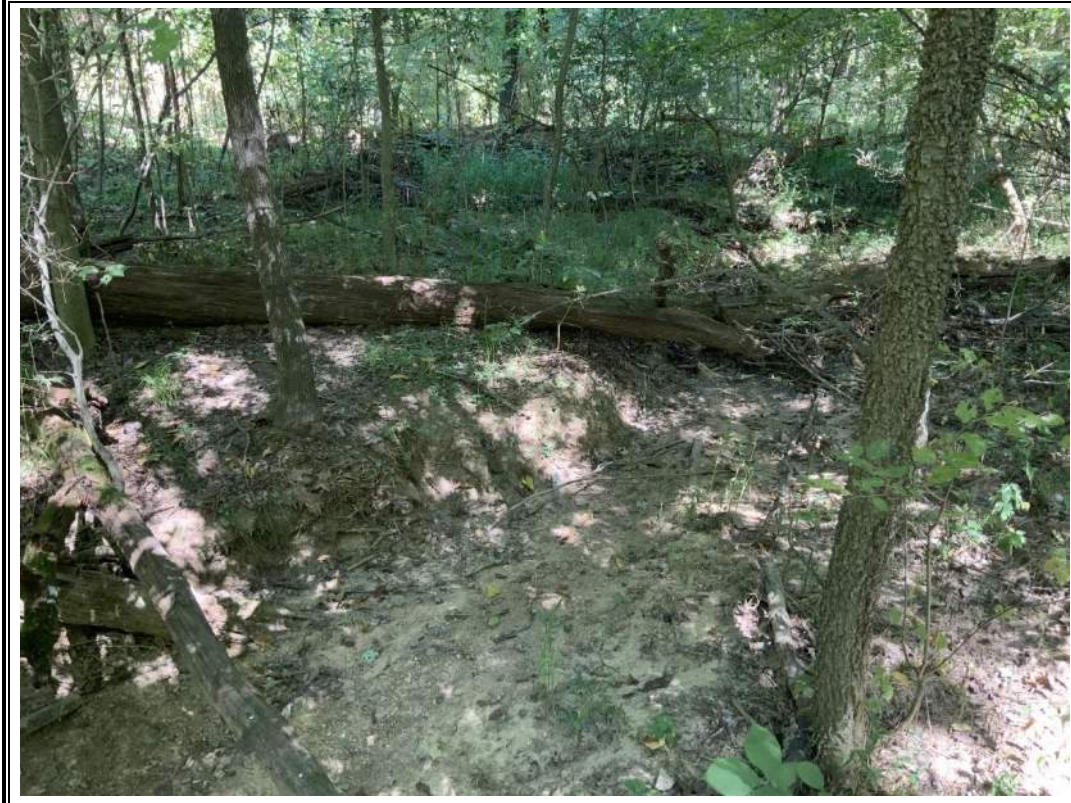
Photo: 26
By: F. Amatucci
Date: September 20, 2022
Feature: EPH-2
Lat: 36.453291
Long: -88.308433

Representative conditions of EPH-2 near end of reach before confluence with STR-1.

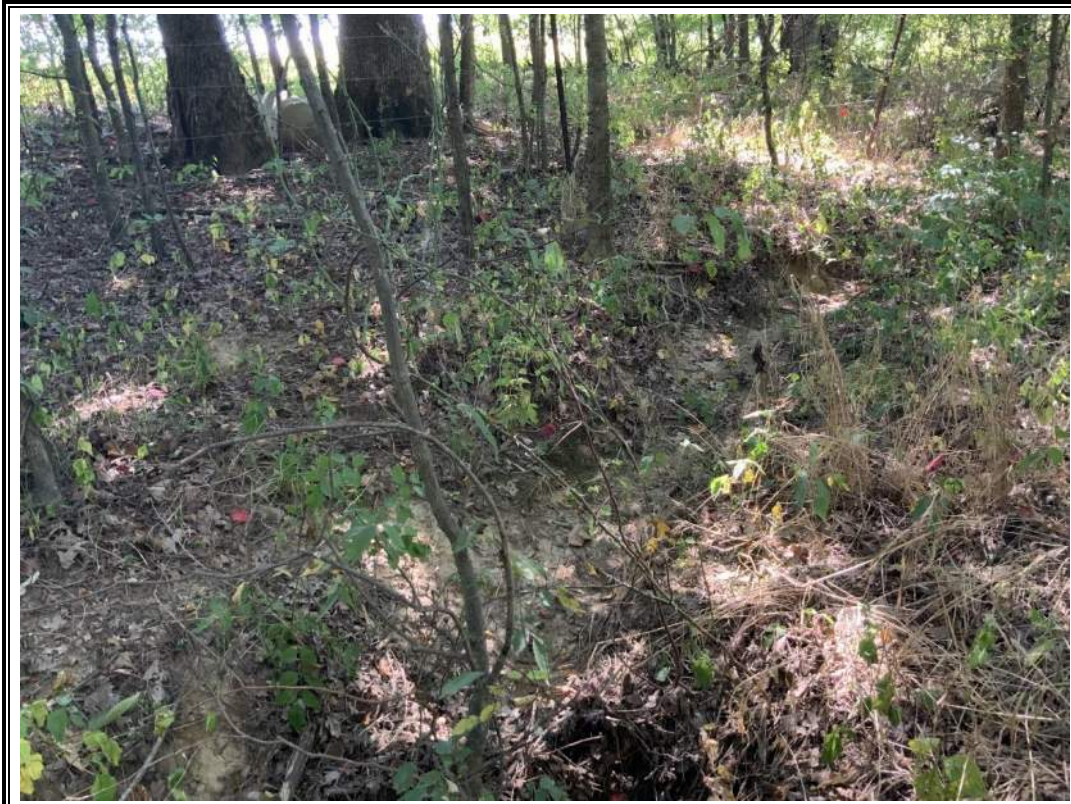
Photo: 27
By: F. Amatucci
Date: September 20, 2022
Feature: EPH-3
Lat: 36.455032
Long: -88.301540

Representative conditions of EPH-3 at beginning of reach facing upstream.

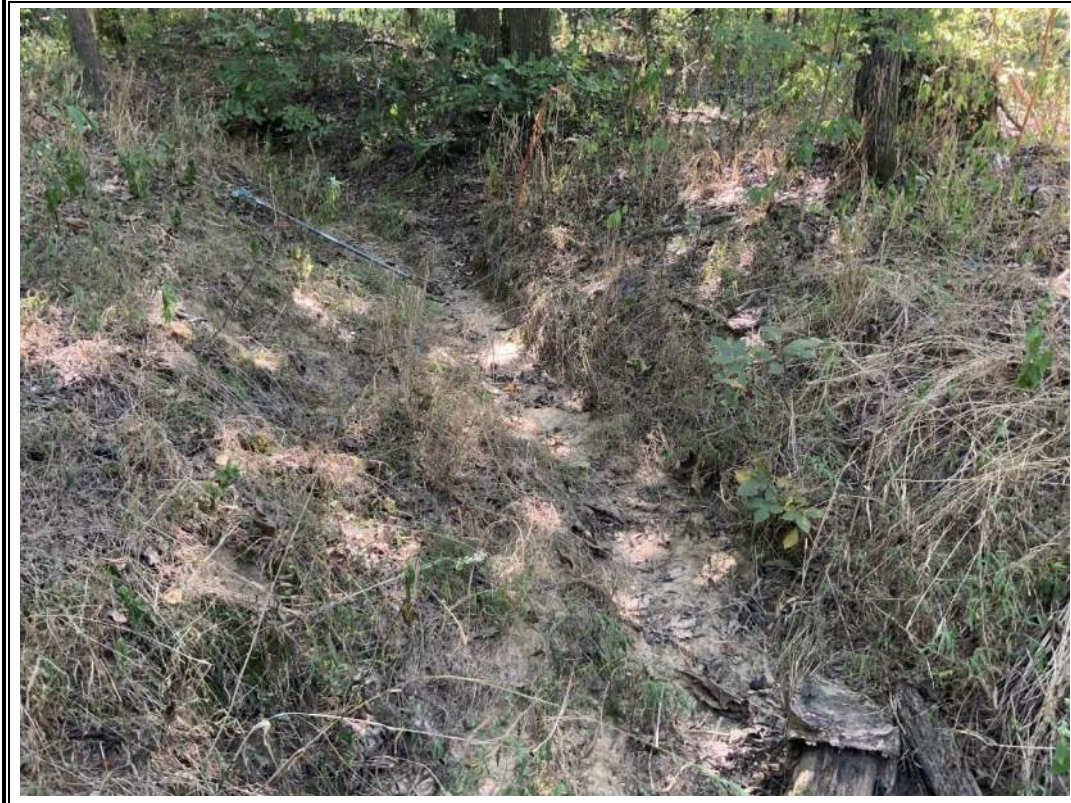
Photo: 28
By: F. Amatucci
Date: September 20, 2022
Feature: EPH-3
Lat: 36.455276
Long: -88.301521

Representative conditions of EPH-3 near end of reach, facing upstream before transition into STR-3.

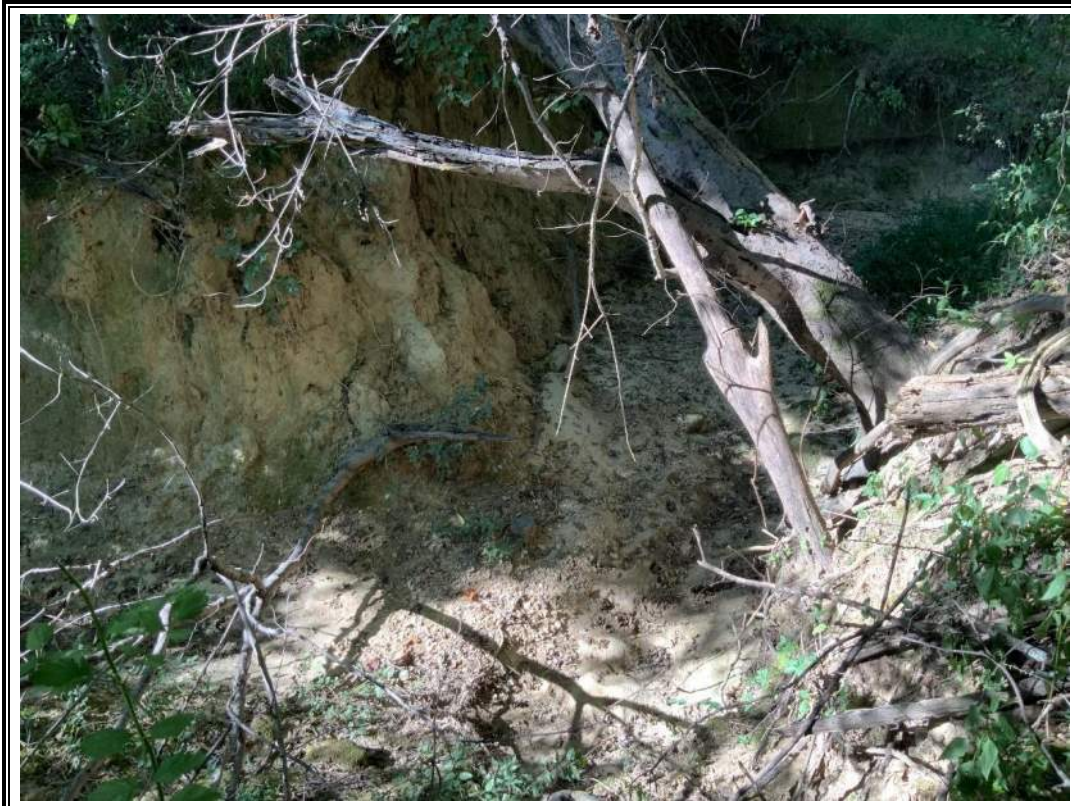
Photo: 29
By: F. Amatucci
Date: September 20, 2022
Feature: EPH-4
Lat: 36.453201
Long: -88.299290

Representative conditions of EPH-4 at beginning of reach facing downstream.

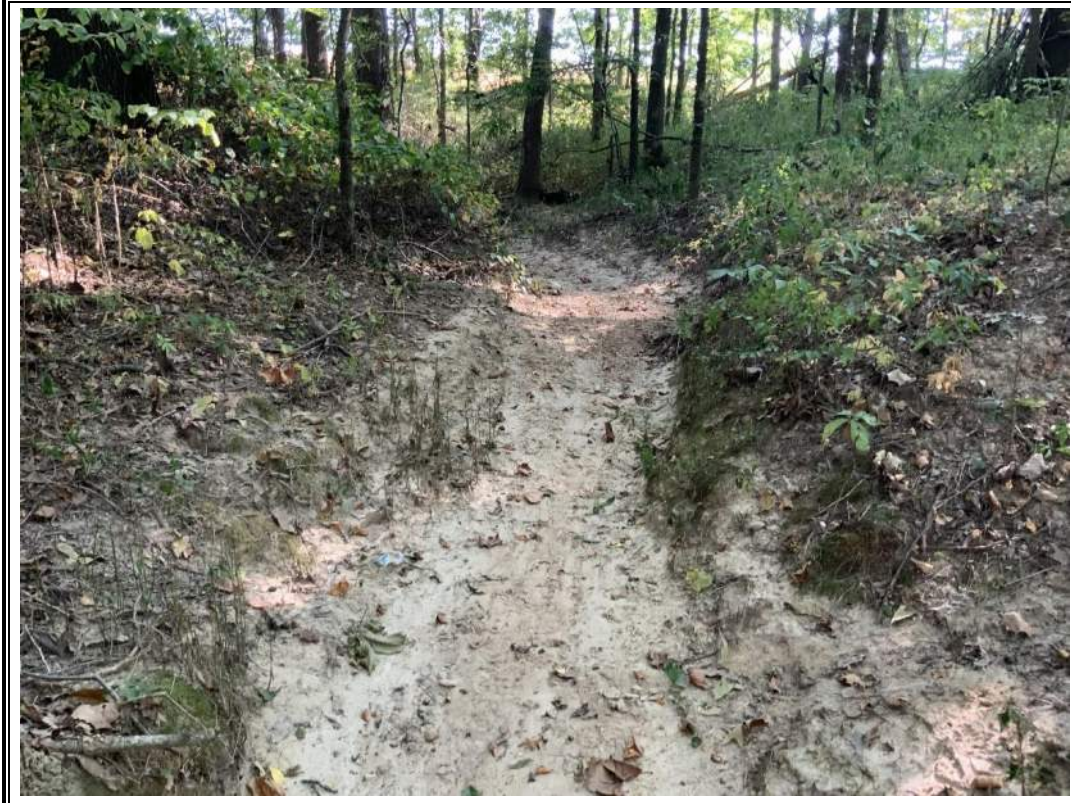
Photo: 30
By: F. Amatucci
Date: September 20, 2022
Feature: EPH-4
Lat: 36.453786
Long: -88.298962

Representative conditions of EPH-4 at end of reach before confluence with STR-2.

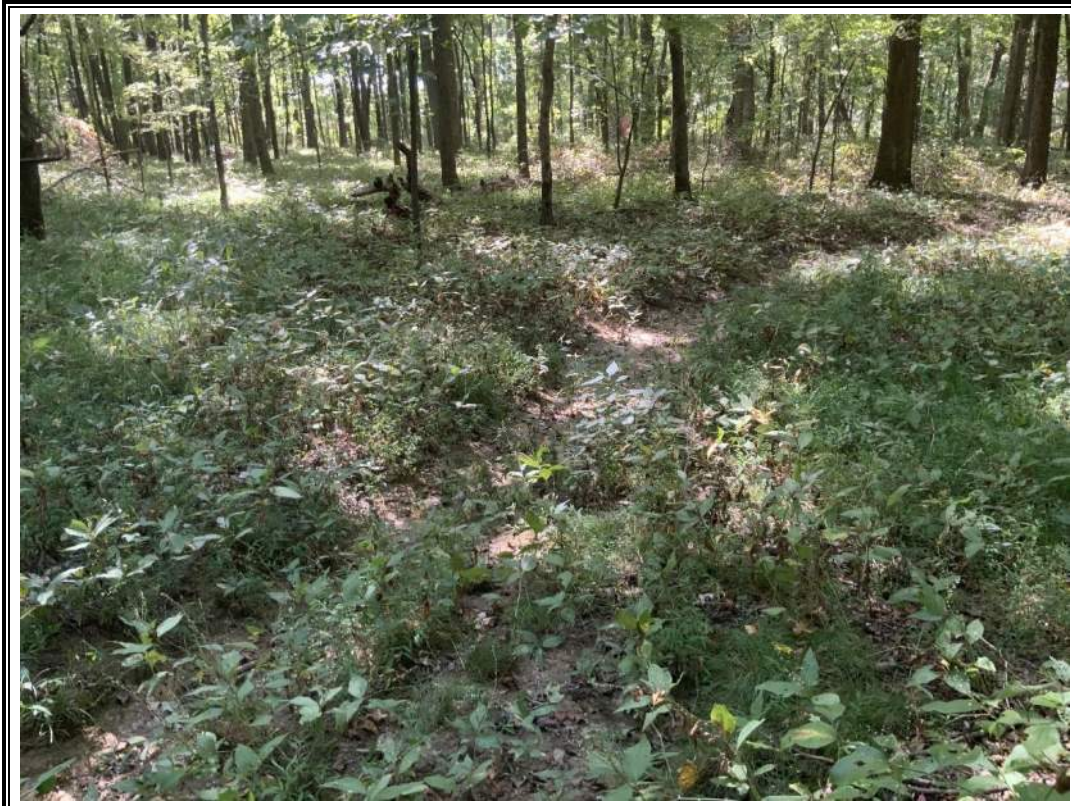
Photo: 31
By: F. Amatucci
Date: September 21, 2022
Feature: EPH-5
Lat: 36.446949
Long: -88.315475

Representative conditions of EPH-5 at beginning of reach facing downstream after beginning at WTL-3.

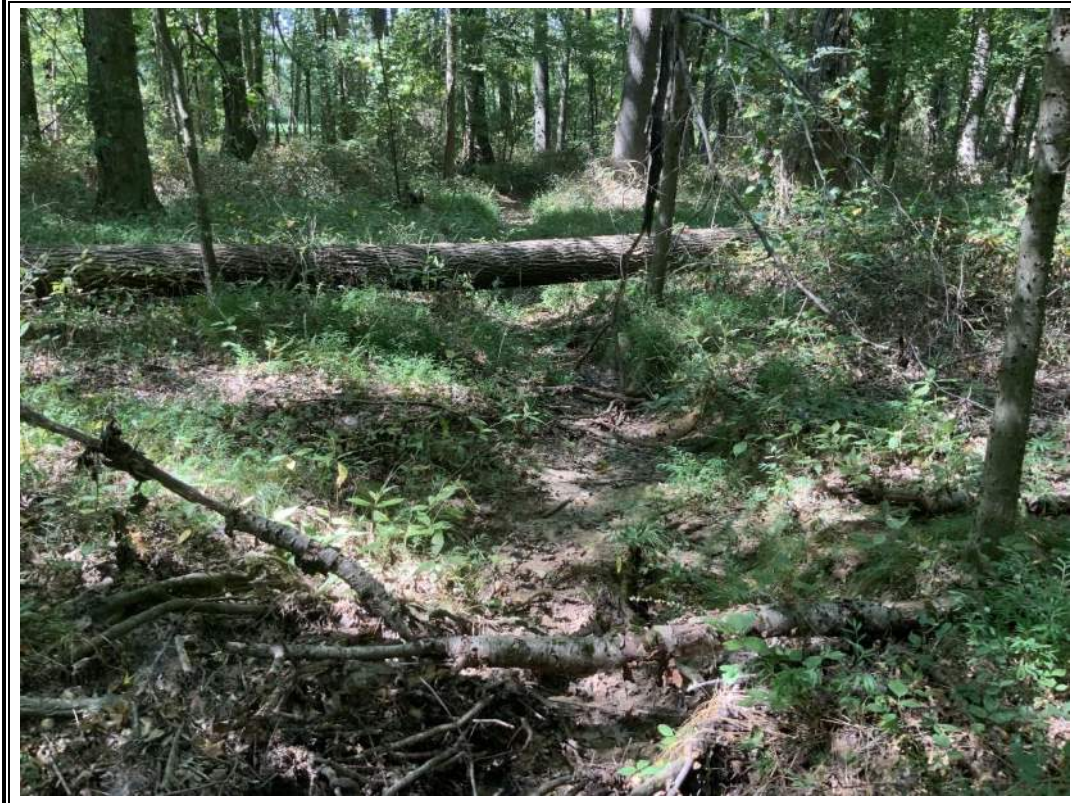
Photo: 32
By: F. Amatucci
Date: September 21, 2022
Feature: EPH-5
Lat: 36.447274
Long: -88.315688

Representative conditions of EPH-5 at end of reach, facing downstream before leaving property limits and dissipating into offsite wetland.

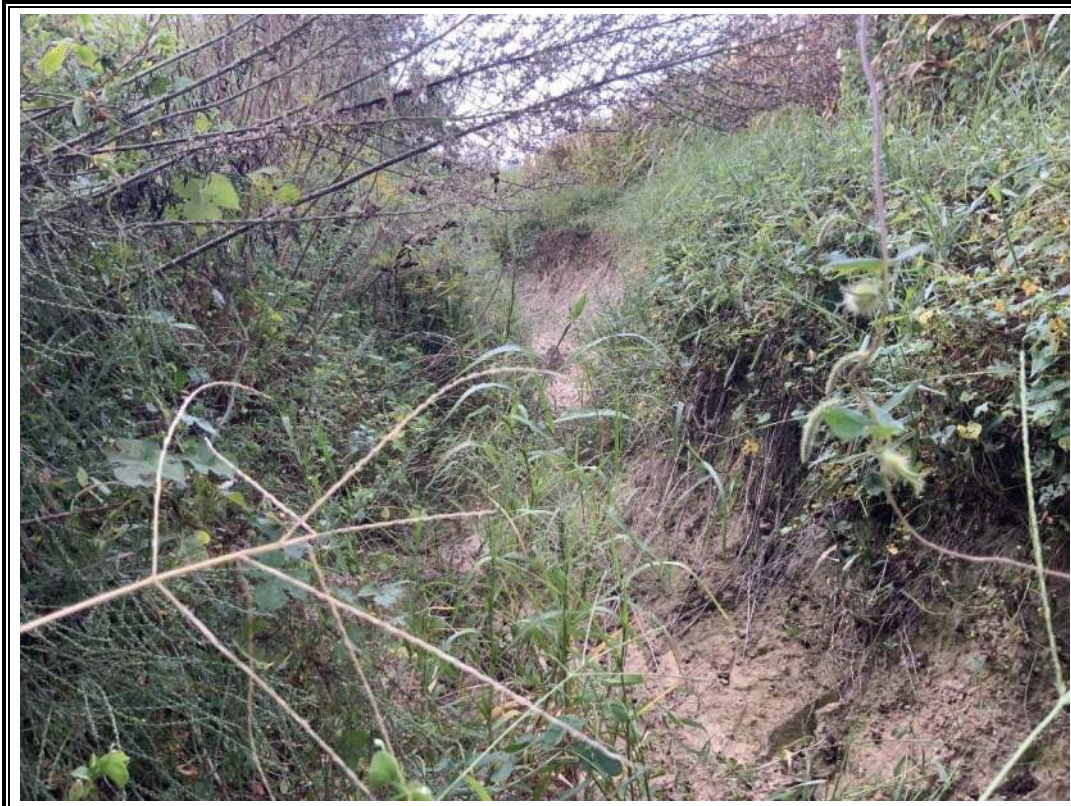
Photo: 33

Representative conditions of EPH-6 at beginning of reach after culvert outfall.

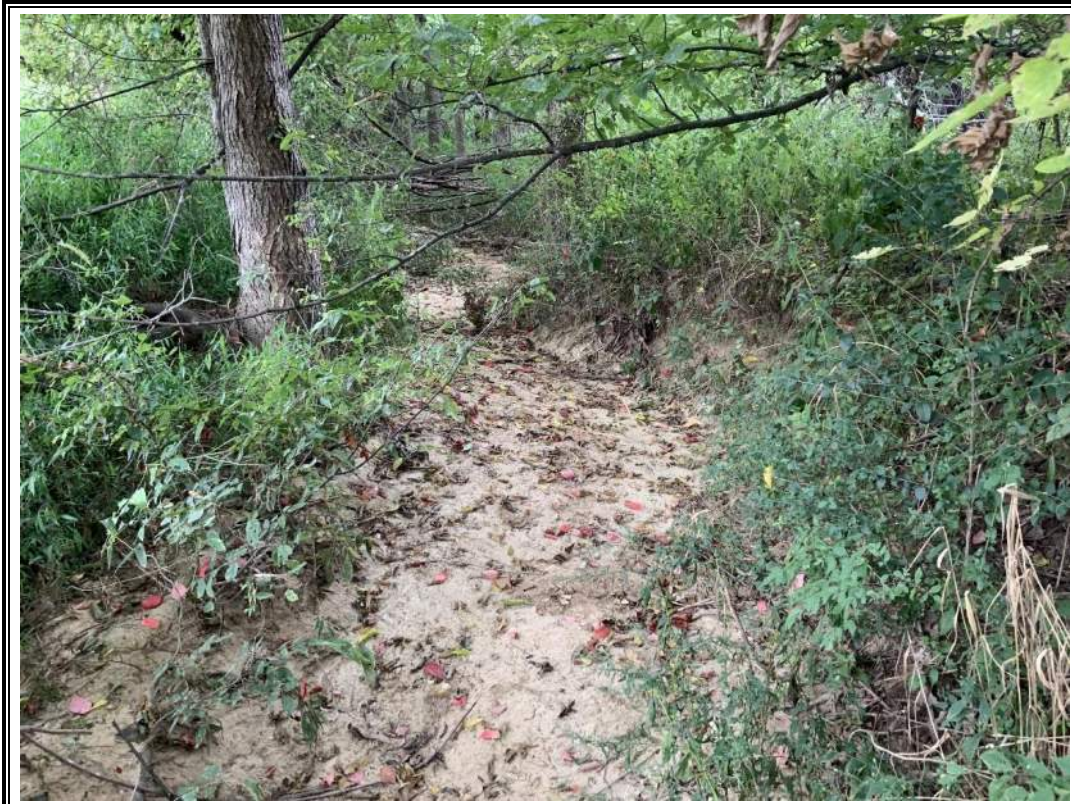
Photo: 35
By: F. Amatucci
Date: September 22, 2022
Feature: EPH-7
Lat: 36.444101
Long: -88.304215

Representative conditions of EPH-7 mid-reach near confluence with two erosional swales.

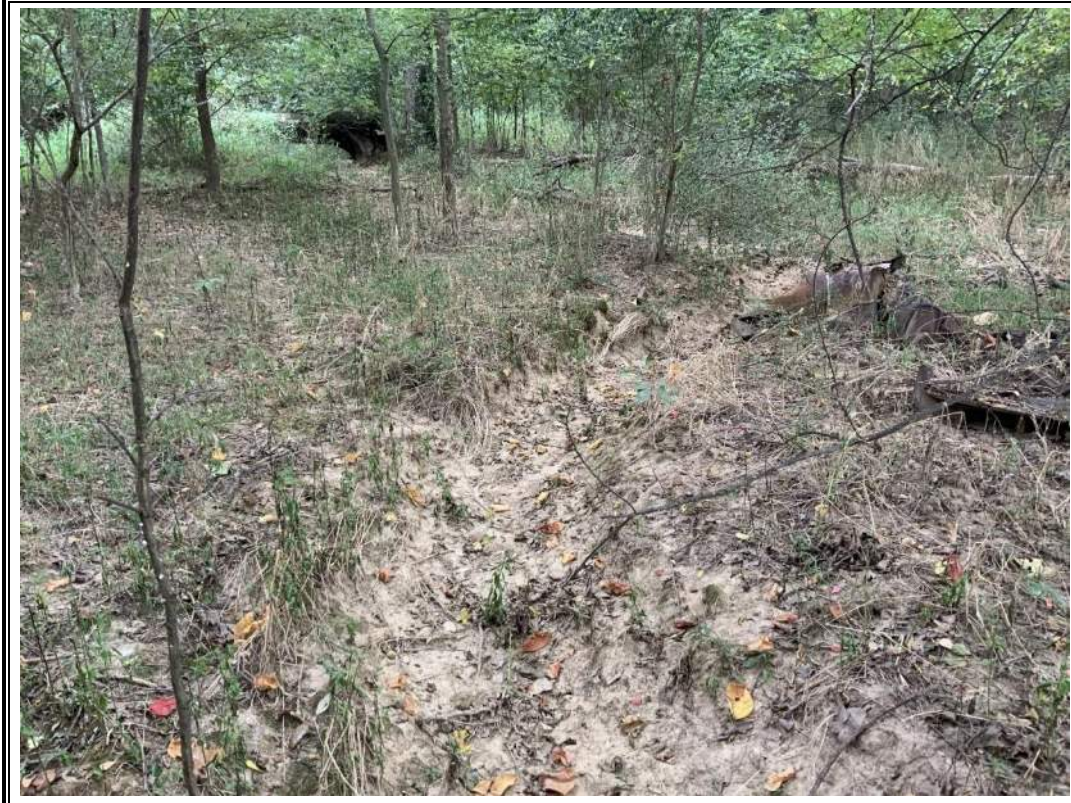
Photo: 36
By: F. Amatucci
Date: September 22, 2022
Feature: EPH-7
Lat: 36.443141
Long: -88.305020

Representative conditions of EPH-7 mid-reach, facing downstream before entering agriculture field.

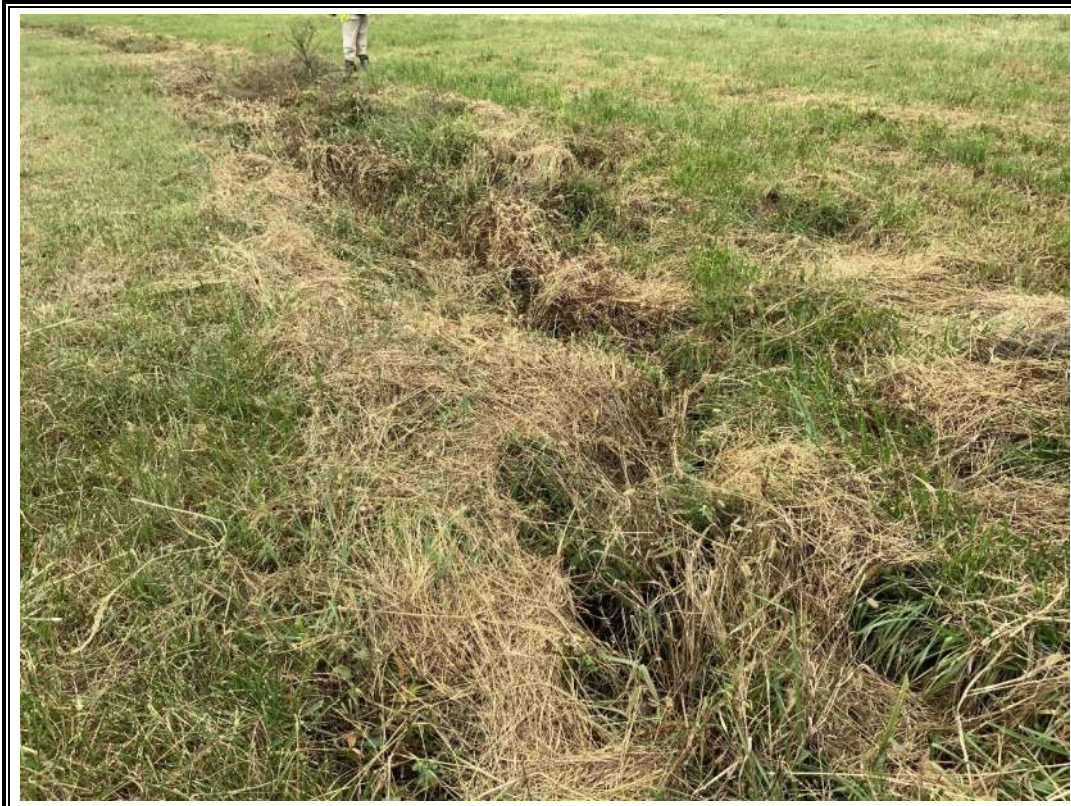
Photo: 37
By: F. Amatucci
Date: September 22, 2022
Feature: EPH-8
Lat: 36.444253
Long: -88.300739

Representative conditions of EPH-8 at beginning of reach, facing downstream.

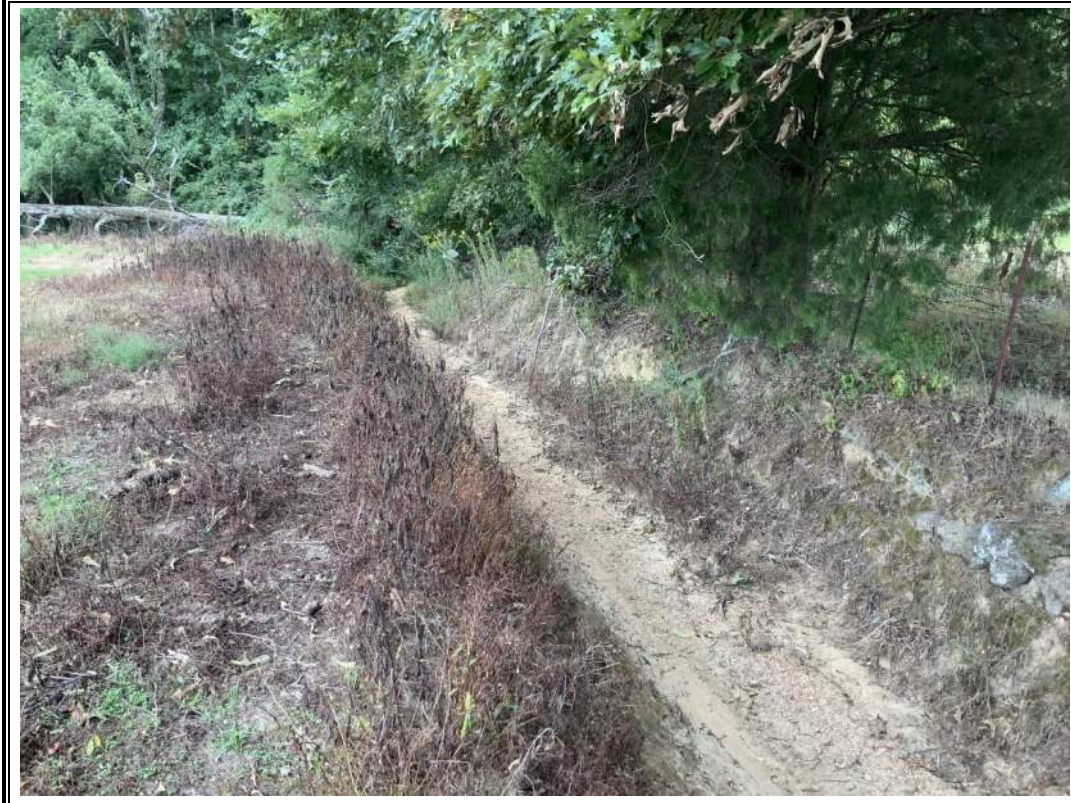
Photo: 38
By: F. Amatucci
Date: September 22, 2022
Feature: EPH-8
Lat: 36.442403
Long: -88.300951

Representative conditions of EPH-8 at mid-reach, facing downstream before eventual transition into STR-11.

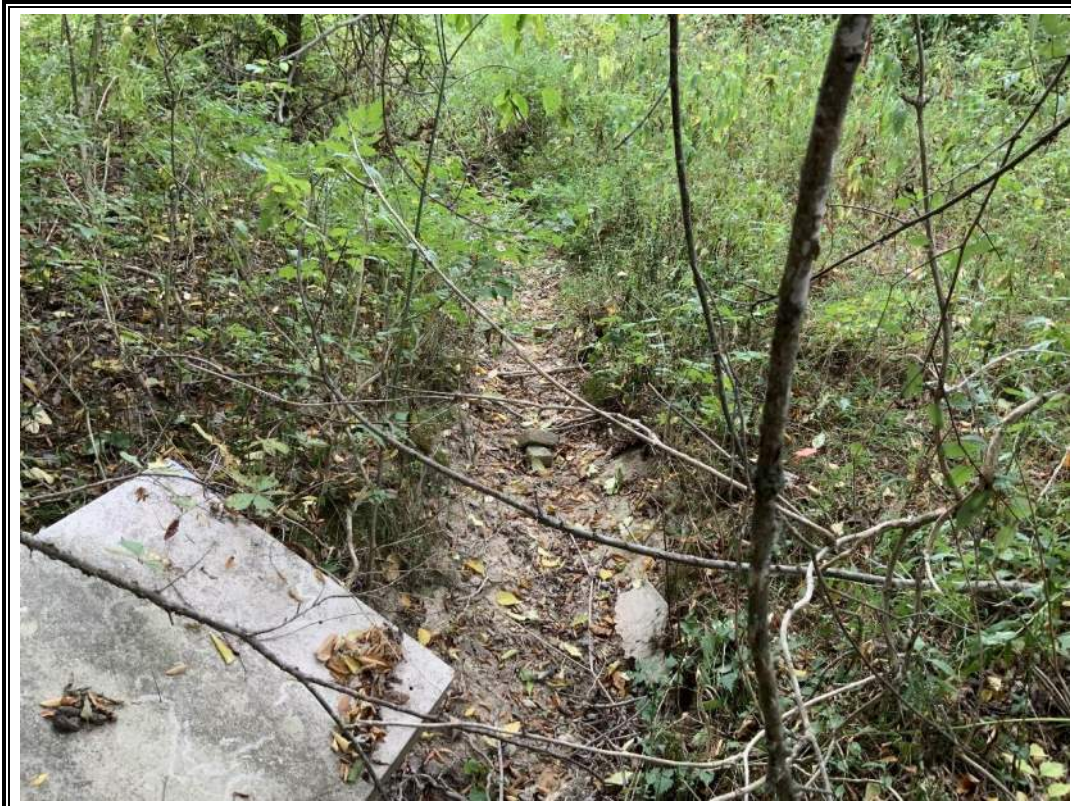
Photo: 39
By: F. Amatucci
Date: September 22, 2022
Feature: EPH-9
Lat: 36.441120
Long: -88.299178

Representative conditions of EPH-9 at beginning of reach, forming at the bottom of WTL-7.

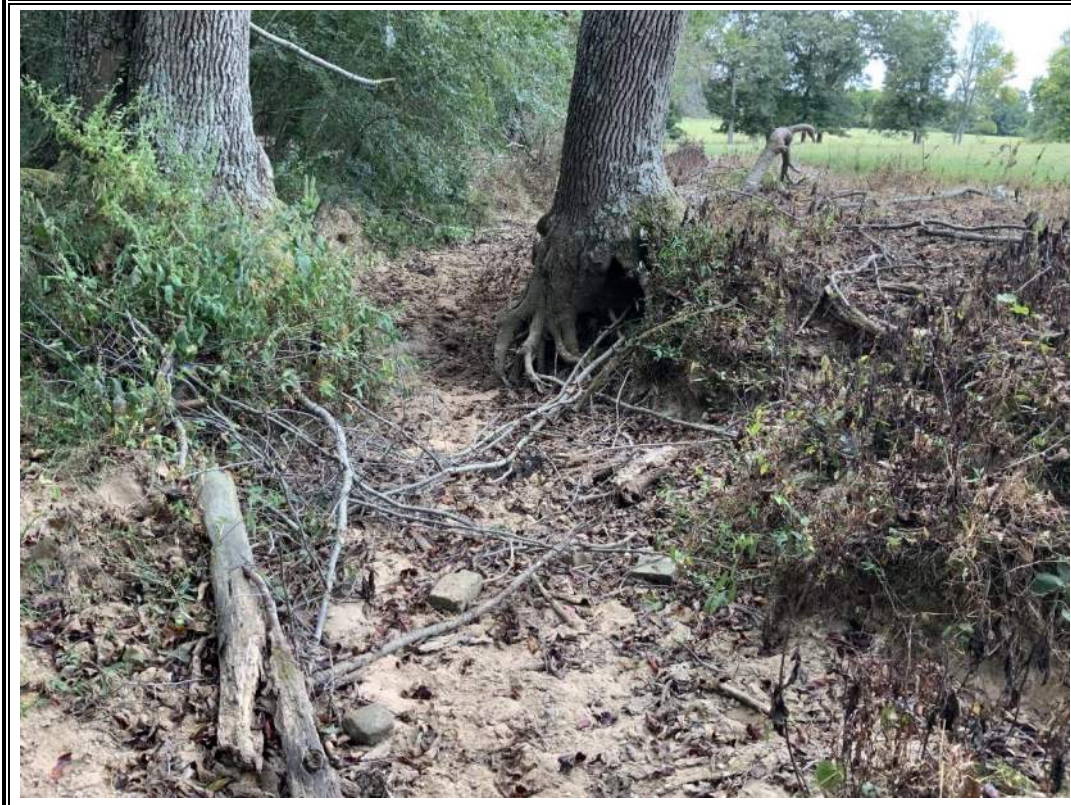
Photo: 40
By: F. Amatucci
Date: September 22, 2022
Feature: EPH-9
Lat: 36.441463
Long: -88.299950

Representative conditions of EPH-9 at end of reach, facing downstream before transition into STR-10.

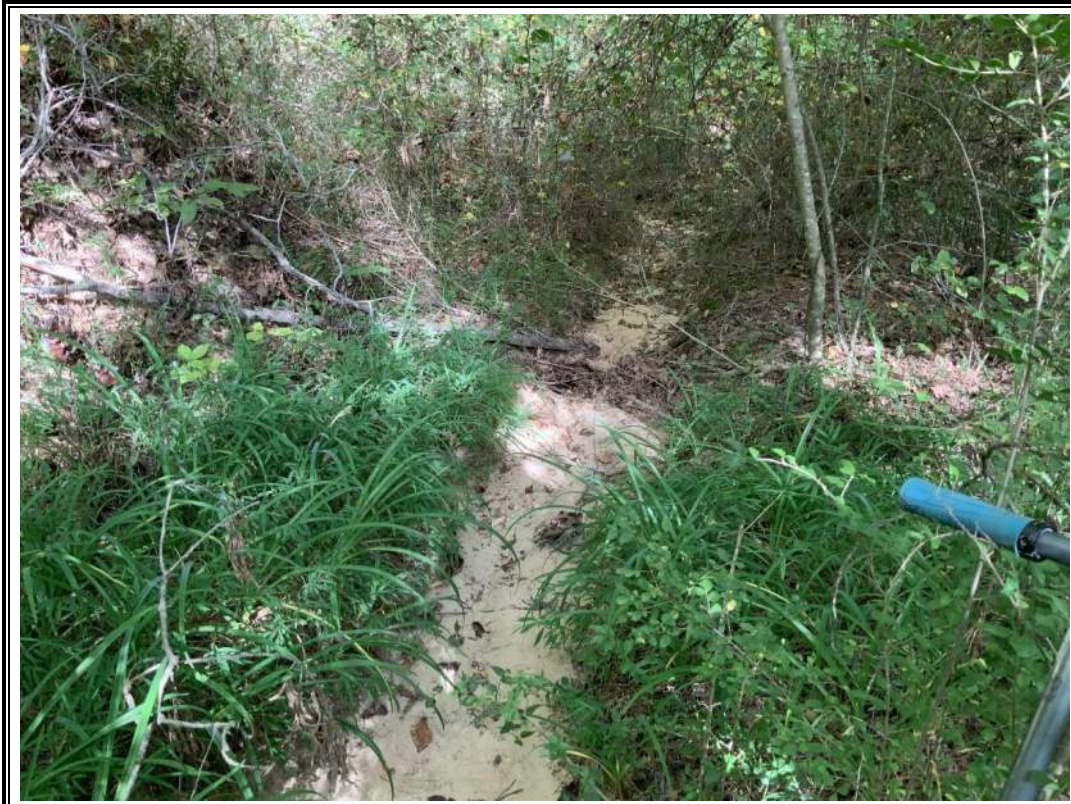
Photo: 41

Representative conditions of EPH-10 at beginning of reach, facing upstream into valley.

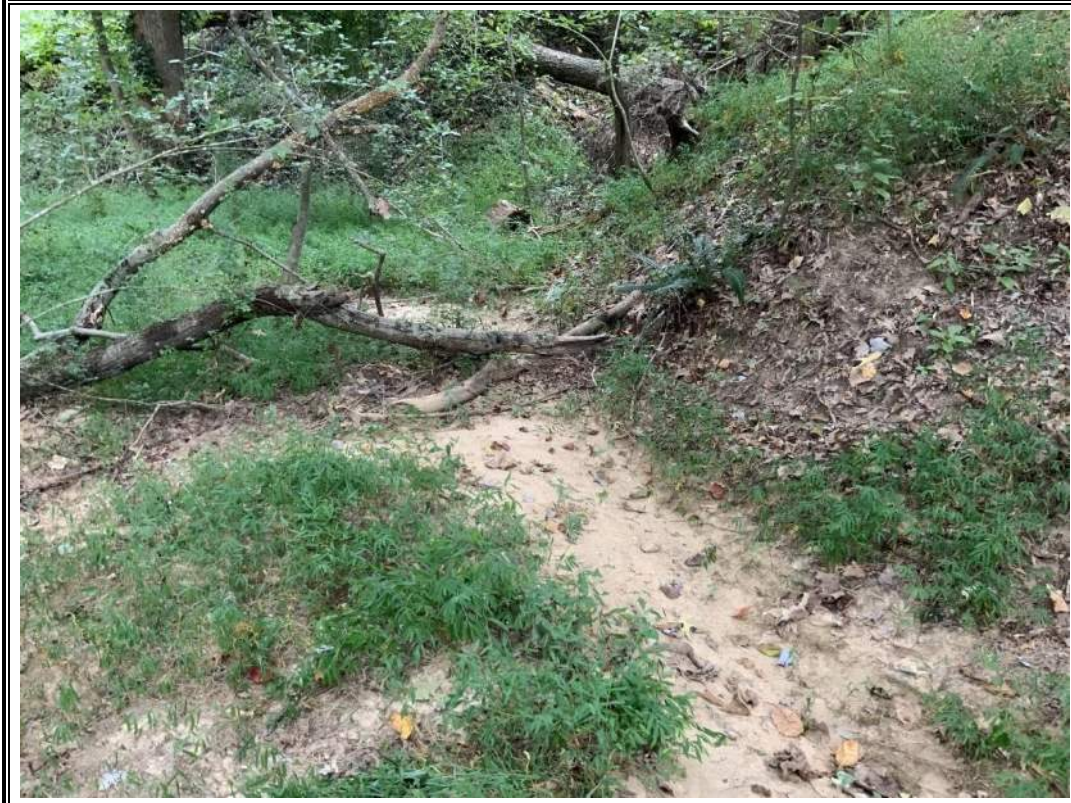
Photo: 42

Representative conditions of EPH-10 at end of reach, facing downstream before leaving property limits.

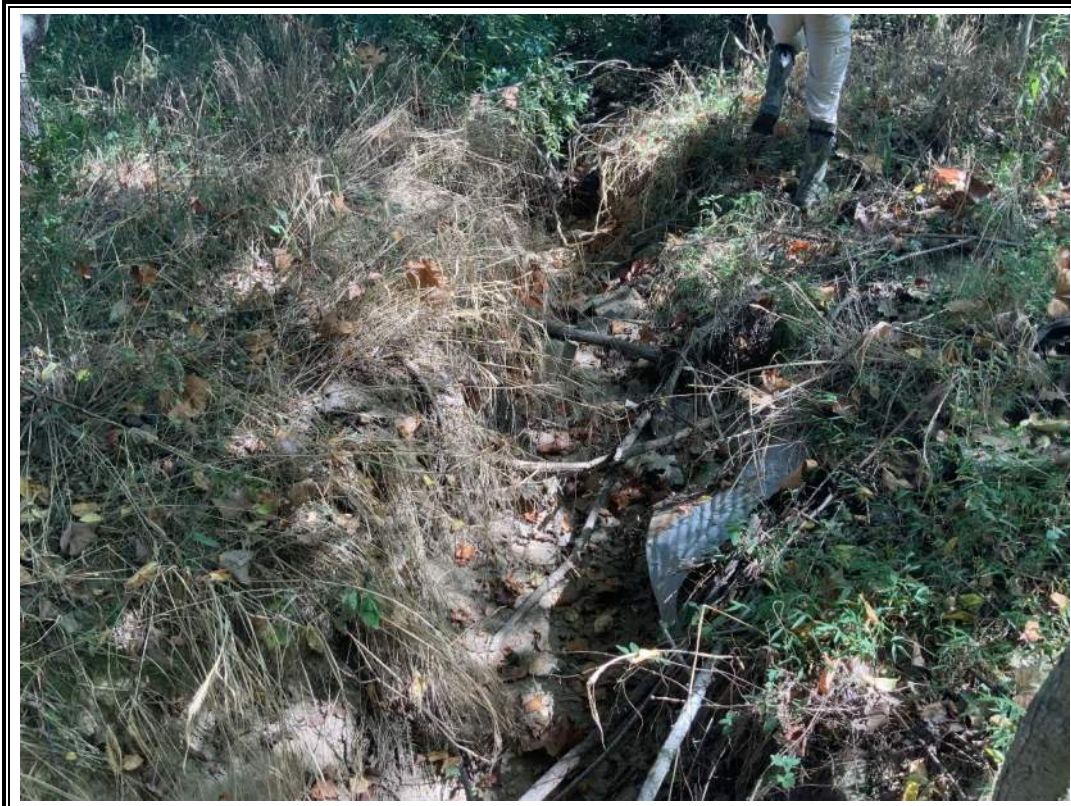
Photo: 43
By: F. Amatucci
Date: September 20, 2022
Feature: ES-1
Lat: 36.453360
Long: -88.307257

Representative conditions of ES-1 at mid-reach, facing upstream before confluence with EPH-1.

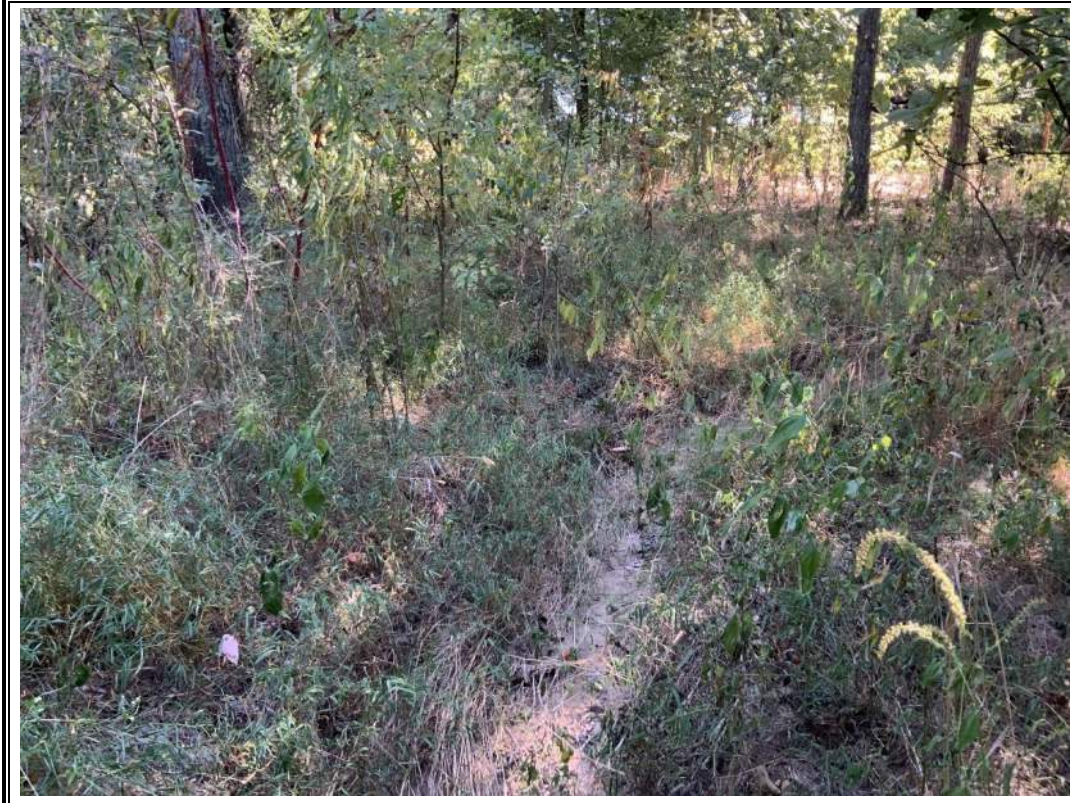
Photo: 44
By: F. Amatucci
Date: September 20, 2022
Feature: ES-2
Lat: 36.455463
Long: -88.301556

Representative conditions of ES-2 at mid-reach before confluence with STR-4.

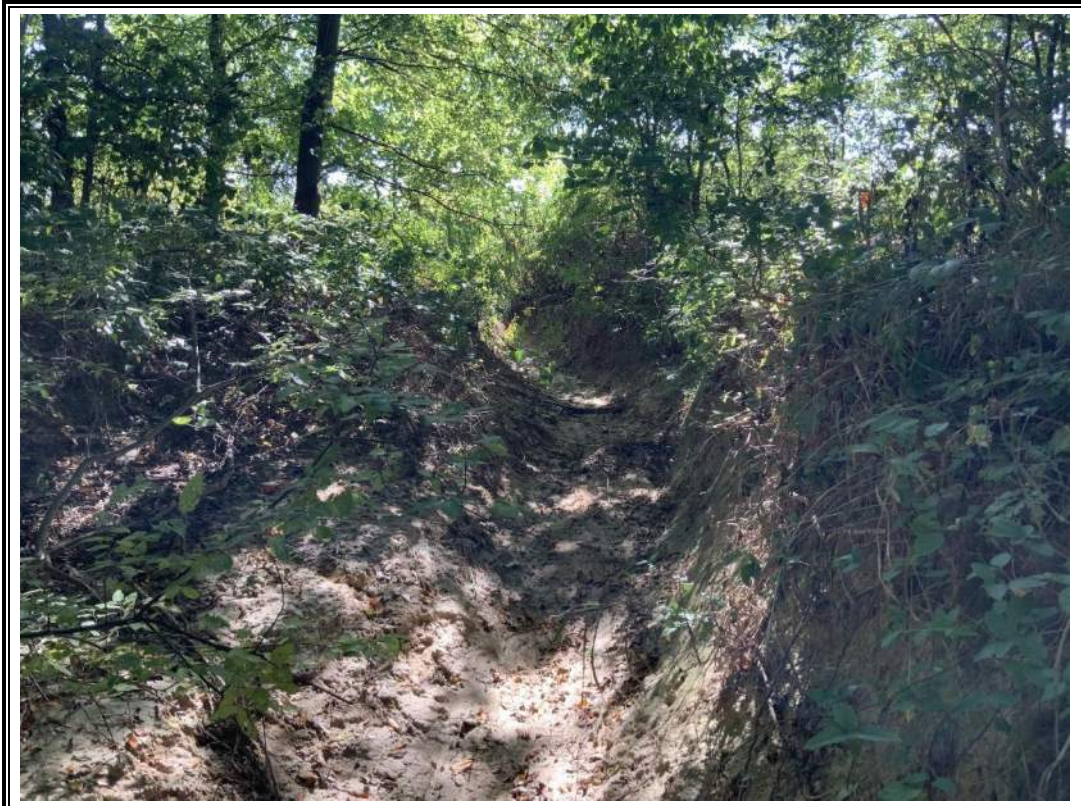
Photo: 45
By: F. Amatucci
Date: September 20, 2022
Feature: ES-3
Lat: 36.454810
Long: -88.299689

Representative conditions of ES-3 at end of reach, facing upstream before confluence with STR-2.

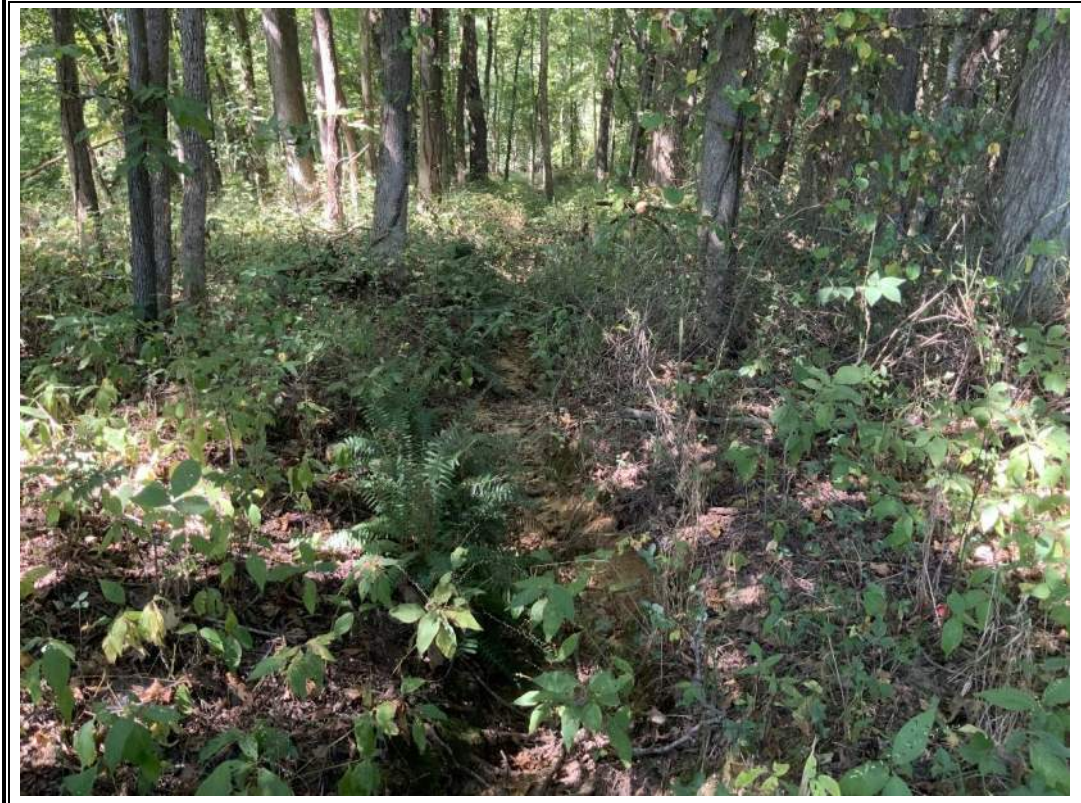
Photo: 46
By: F. Amatucci
Date: September 21, 2022
Feature: ES-4
Lat: 36.445409
Long: -88.314287

Representative conditions of ES-4 near end of reach before confluence with STR-5.

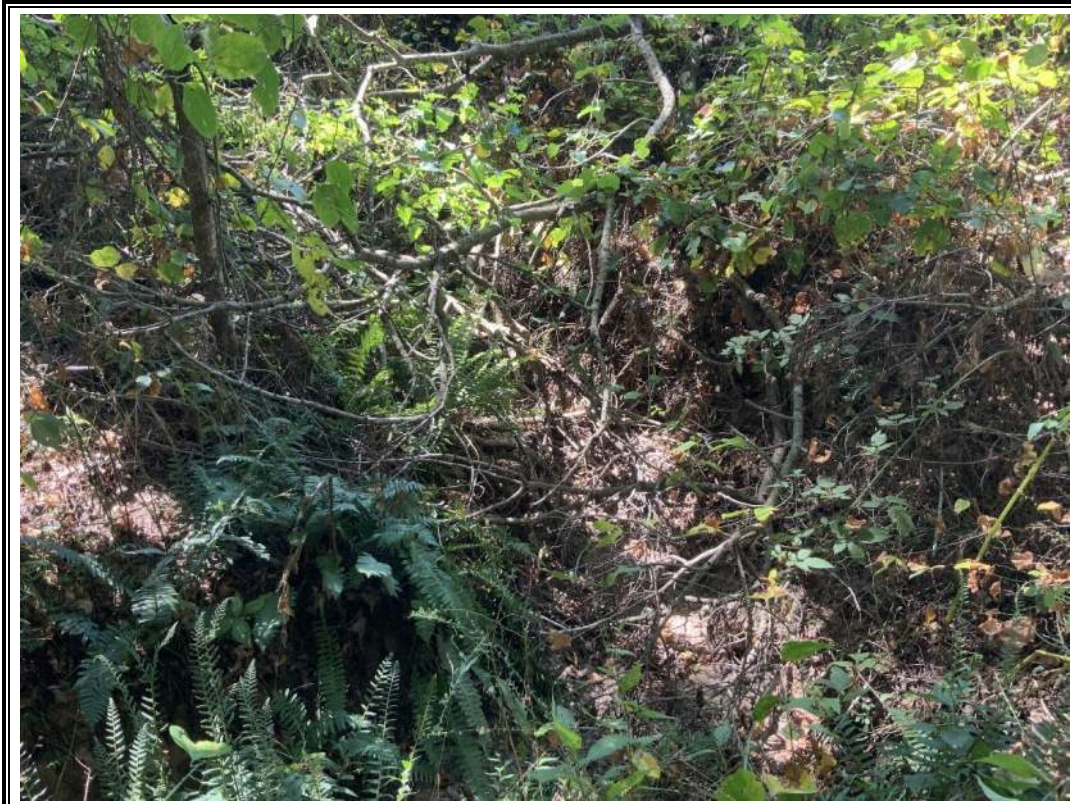
Photo: 47
By: F. Amatucci
Date: September 21, 2022
Feature: ES-5
Lat: 36.445683
Long: -88.315795

Representative conditions of ES-5 near end of reach, facing downstream before confluence with STR-7.

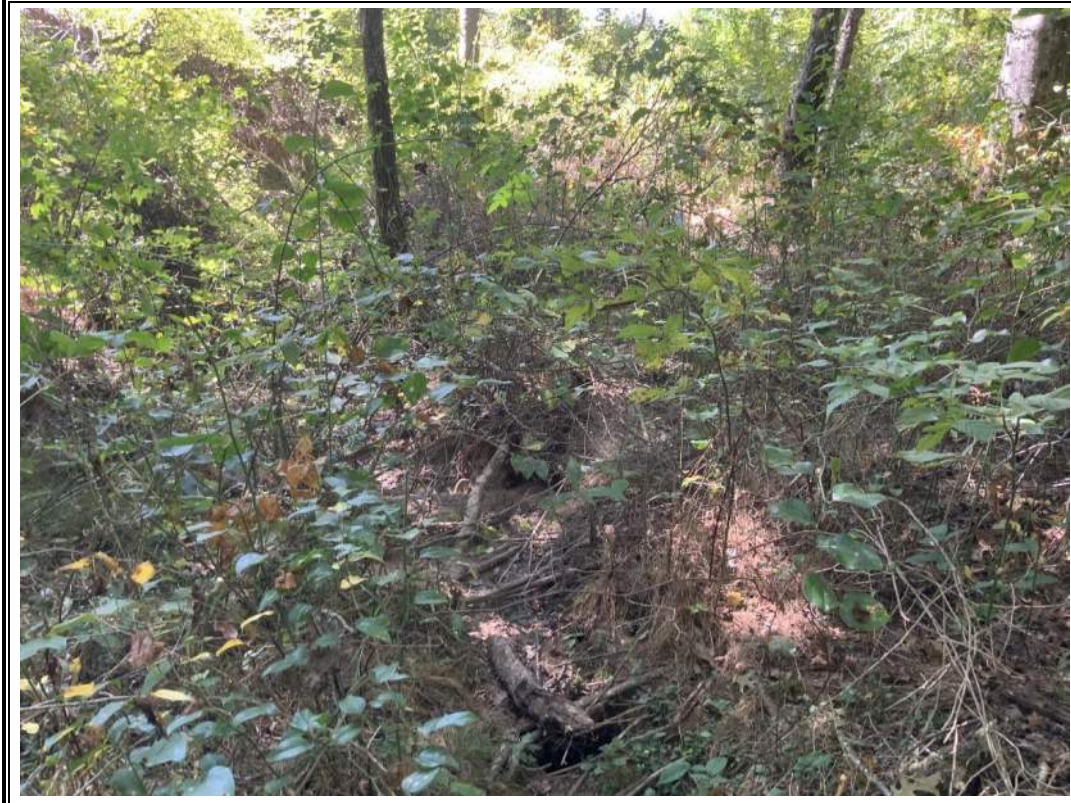
Photo: 48
By: F. Amatucci
Date: September 21, 2022
Feature: ES-6
Lat: 36.445845
Long: -88.316036

Representative conditions of ES-6 near end of reach, facing downstream before confluence with STR-7.

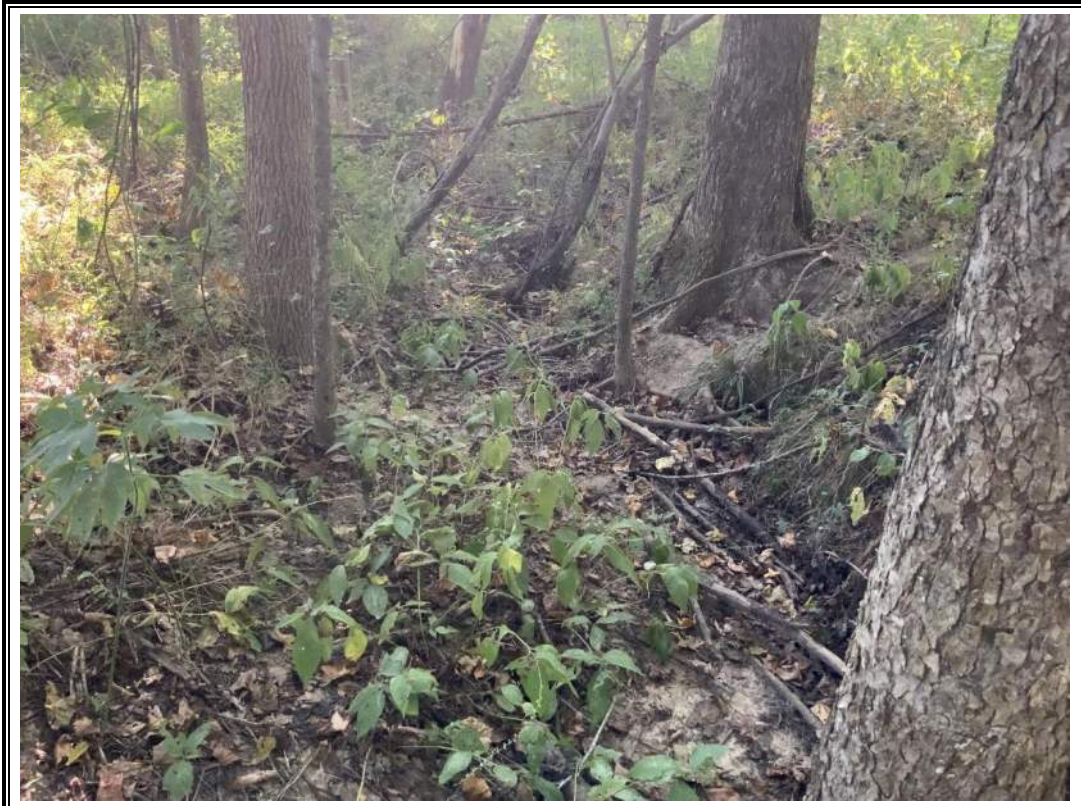
Photo: 49
By: F. Amatucci
Date: September 21, 2022
Feature: ES-7
Lat: 36.444257
Long: -88.314270

Representative conditions of ES-7 near end of reach, facing upstream before confluence with STR-7.

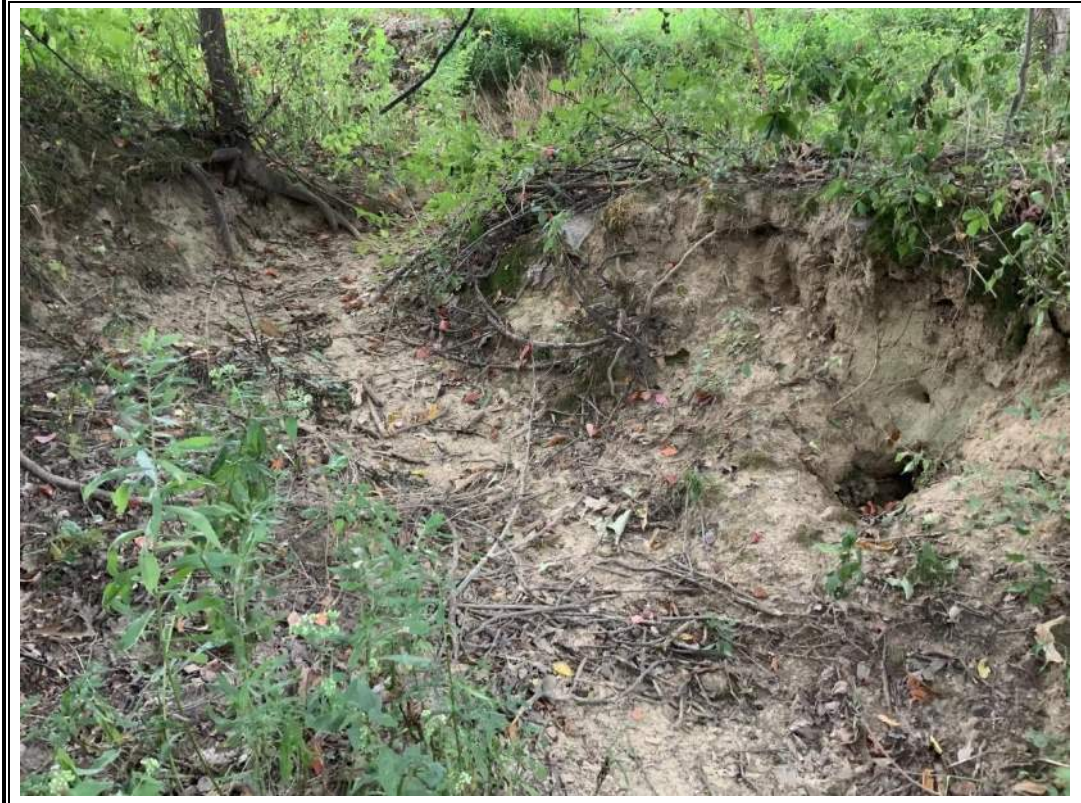
Photo: 50
By: F. Amatucci
Date: September 22, 2022
Feature: ES-8
Lat: 36.443848
Long: -88.304328

Representative conditions of ES-8 near end of reach, facing downstream before confluence with EPH-7.
