**SR PURYEAR SOLAR
FINAL ENVIRONMENTAL ASSESSMENT
Henry County, Tennessee**

Tennessee Valley Authority
Knoxville, Tennessee

Silicon Ranch

Barge Design Solutions, Inc.

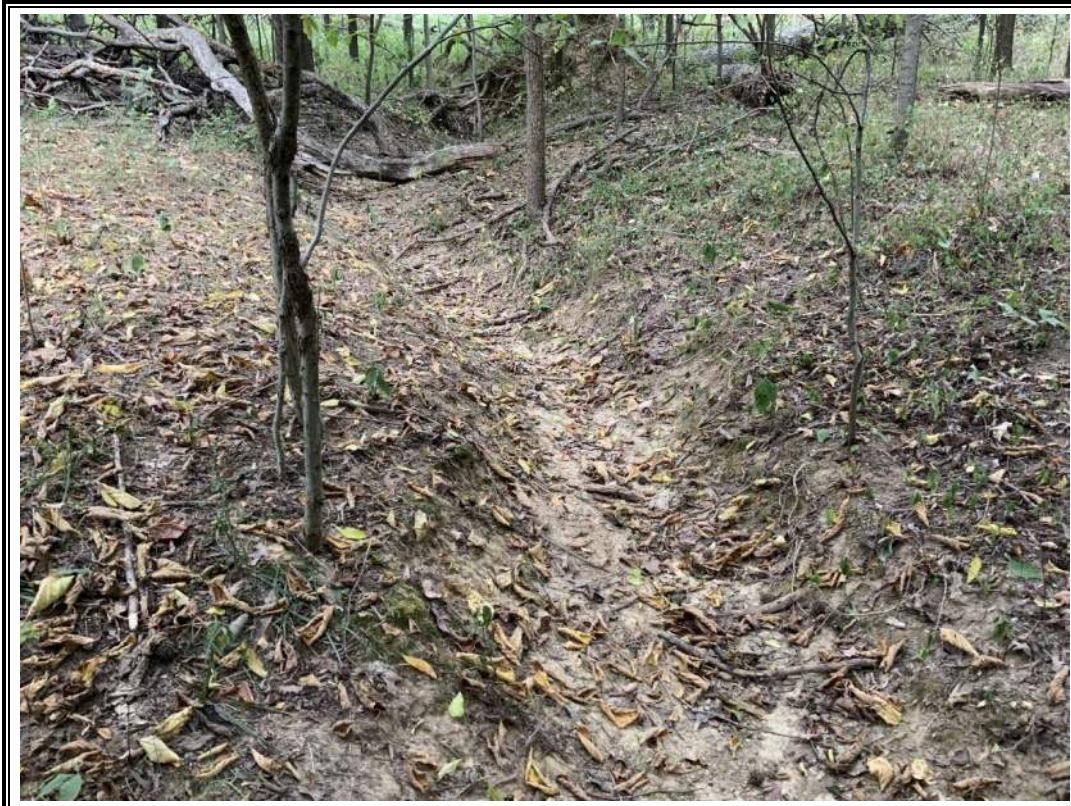
Photo: 51
By: F. Amatucci
Date: September 22, 2022
Feature: ES-9
Lat: 36.443730
Long: -88.304519

Representative conditions of ES-9 near end of reach before confluence with EPH-7.

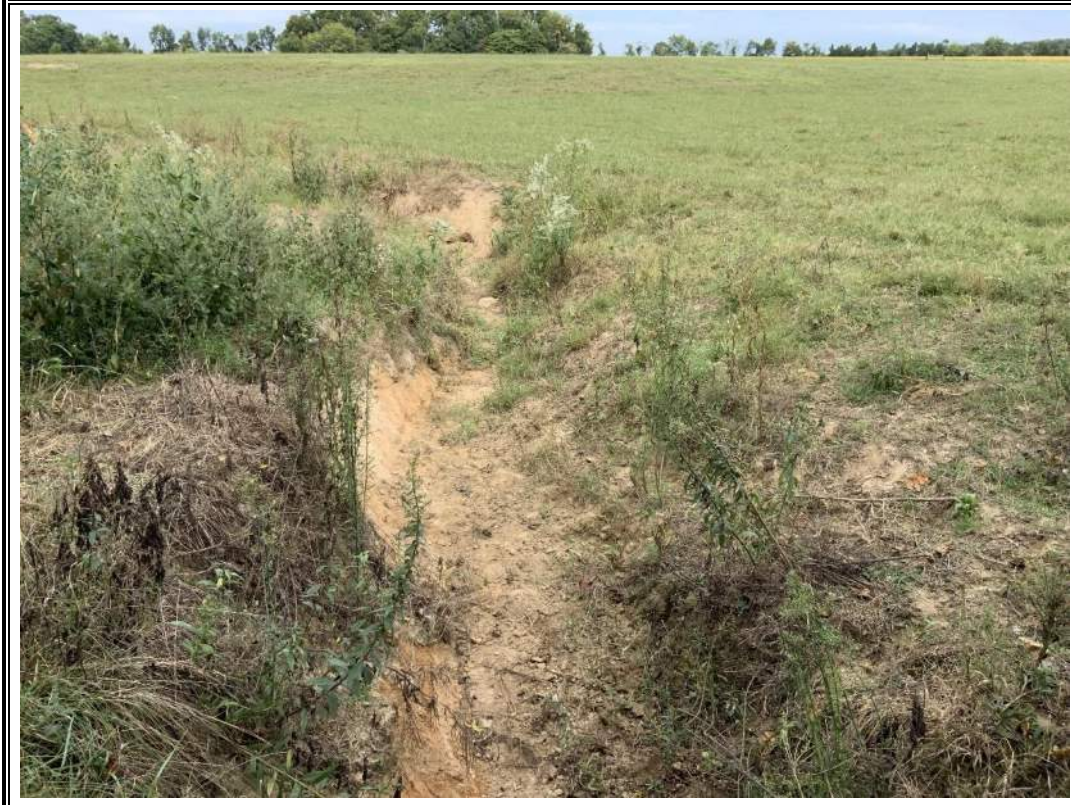
Photo: 52
By: F. Amatucci
Date: September 22, 2022
Feature: ES-10
Lat: 36.441588
Long: -88.297518

Representative conditions of ES-10 mid-reach before dissipating into WTL-7.

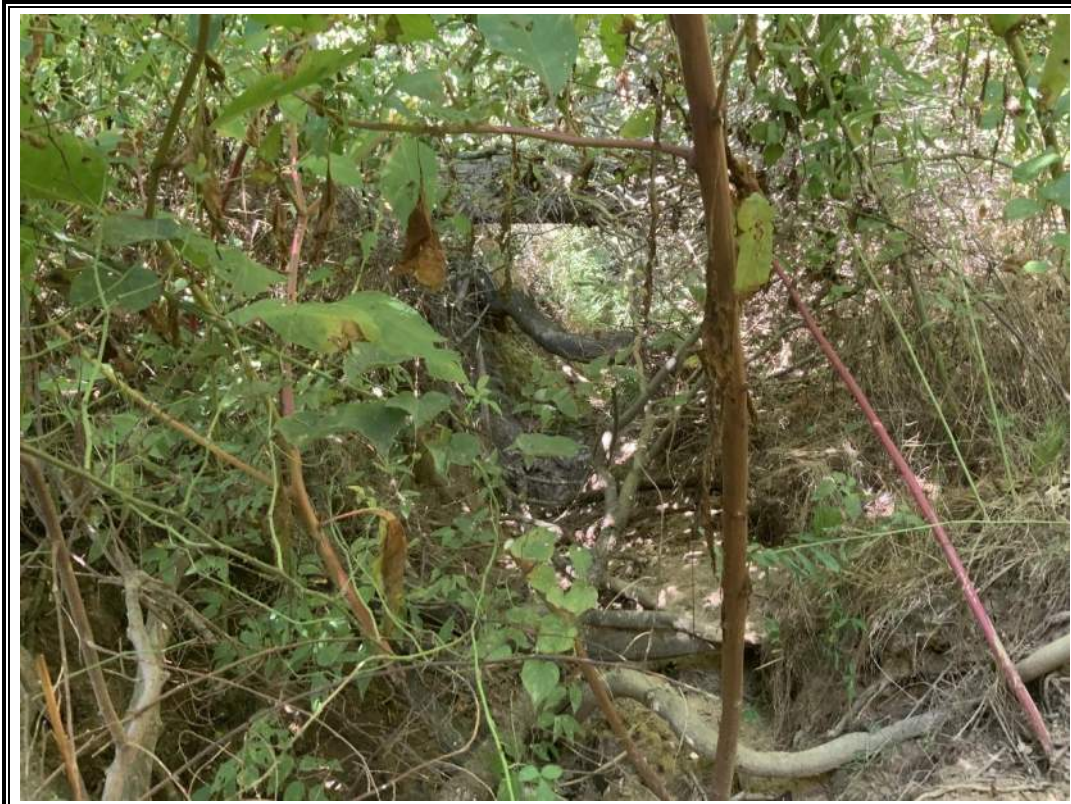
Photo: 53

Representative conditions of D-1 at end of reach, facing upstream before confluence with STR-7.

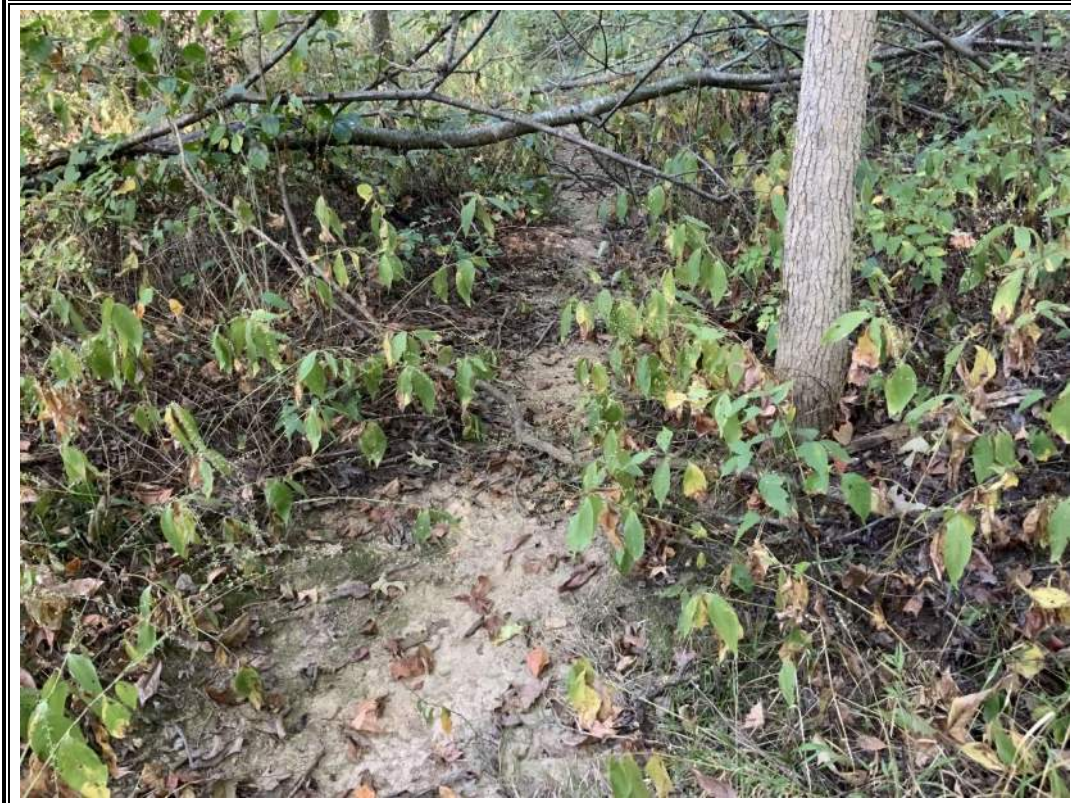
Photo: 54

Representative conditions of UDF-1 mid-reach facing downslope.

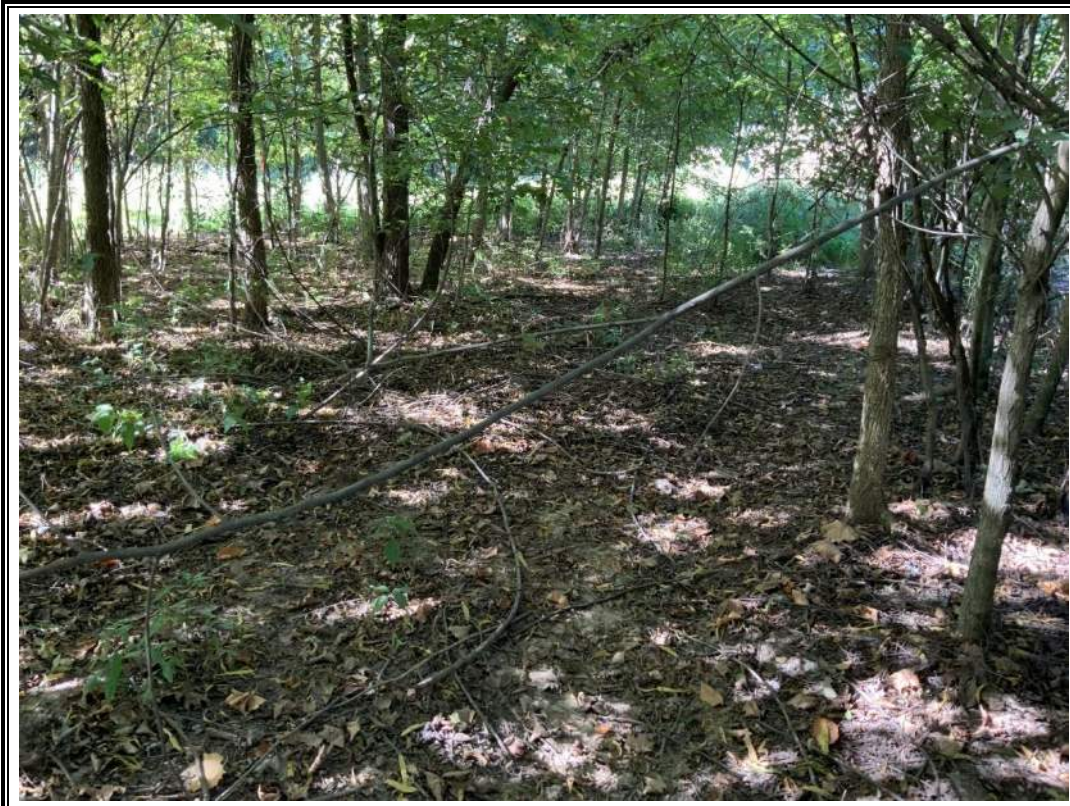
Photo: 55
By: F. Amatucci
Date: September 21, 2022
Feature: WTL-1
Lat: 36.446343
Long: -88.313457

Representative conditions of WTL-1 facing downslope before draining into STR-5.

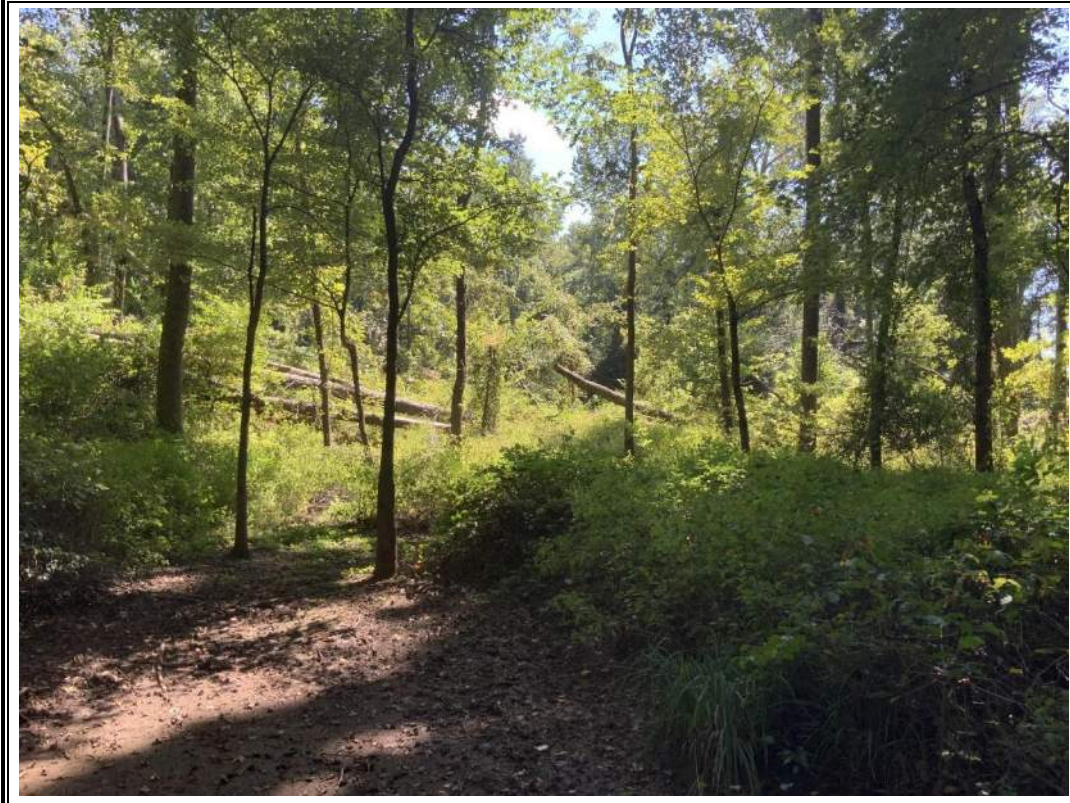
Photo: 56
By: F. Amatucci
Date: September 21, 2022
Feature: WTL-2
Lat: 36.445698
Long: -88.315024

Representative conditions of floodplain WTL-2.

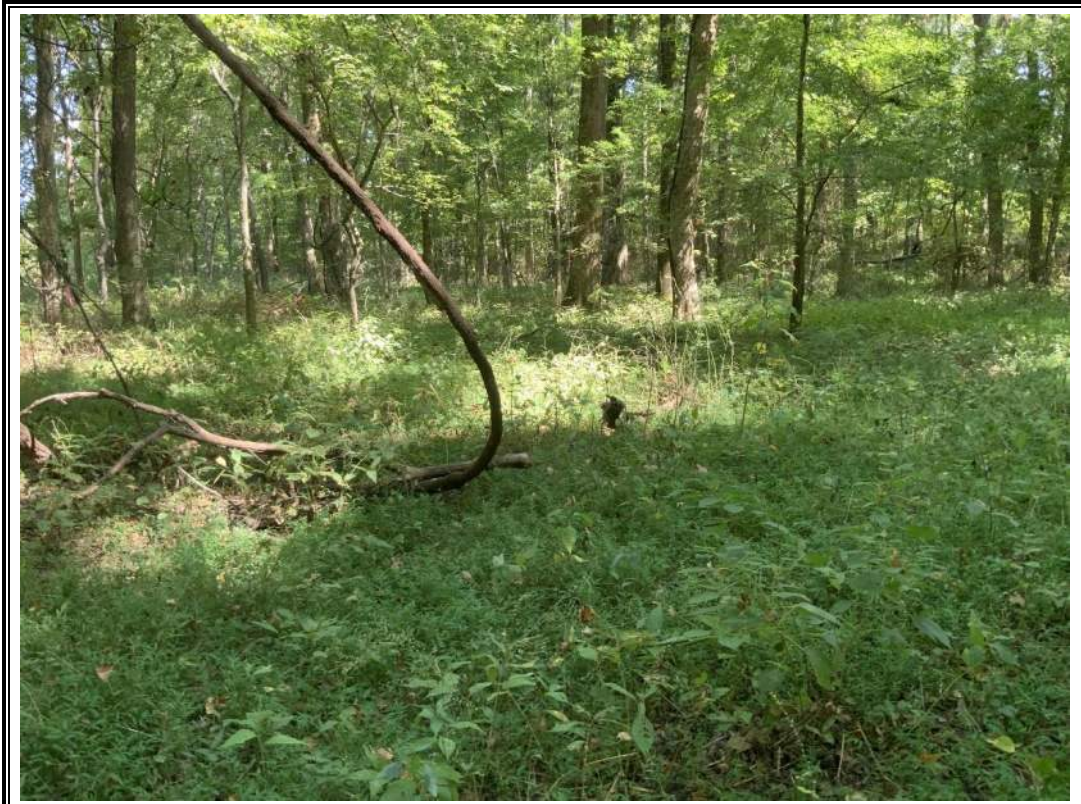
Photo: 57
By: F. Amatucci
Date: September 21, 2022
Feature: WTL-3
Lat: 36.446842
Long: -88.315317

Representative conditions of WTL-3 before draining into EPH-5.

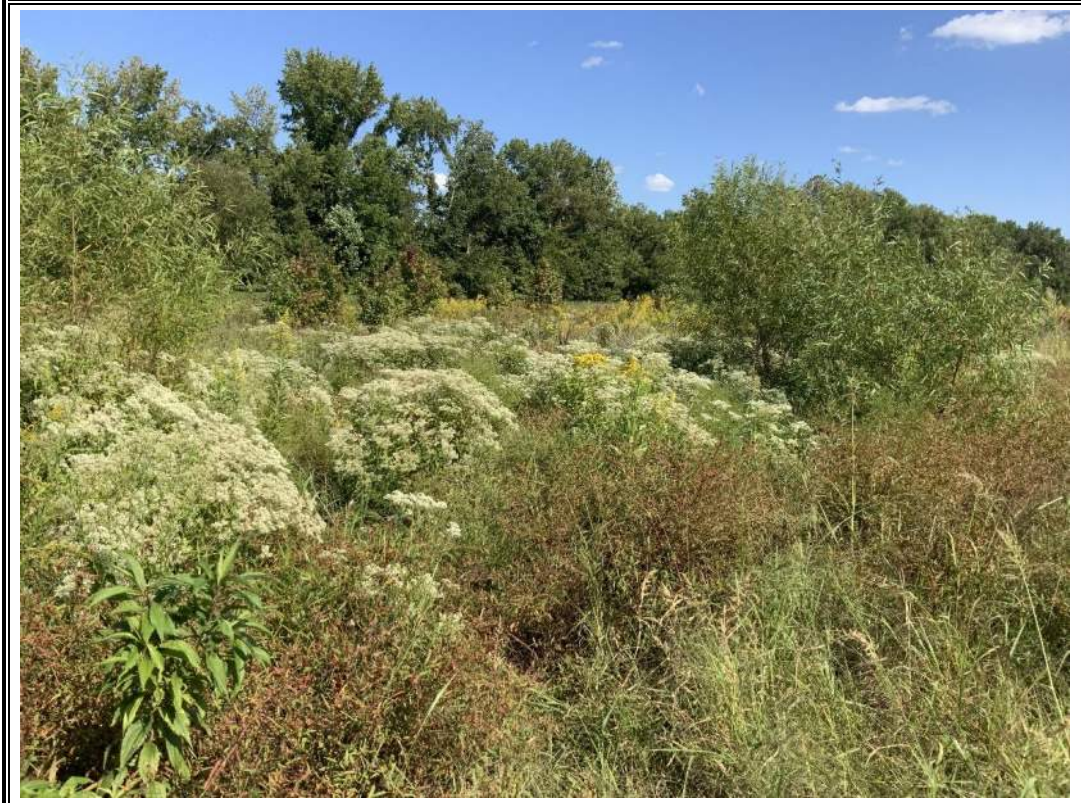
Photo: 58
By: F. Amatucci
Date: September 21, 2022
Feature: WTL-4
Lat: 36.443708
Long: -88.315054

Representative conditions of emergent portion of WTL-4.

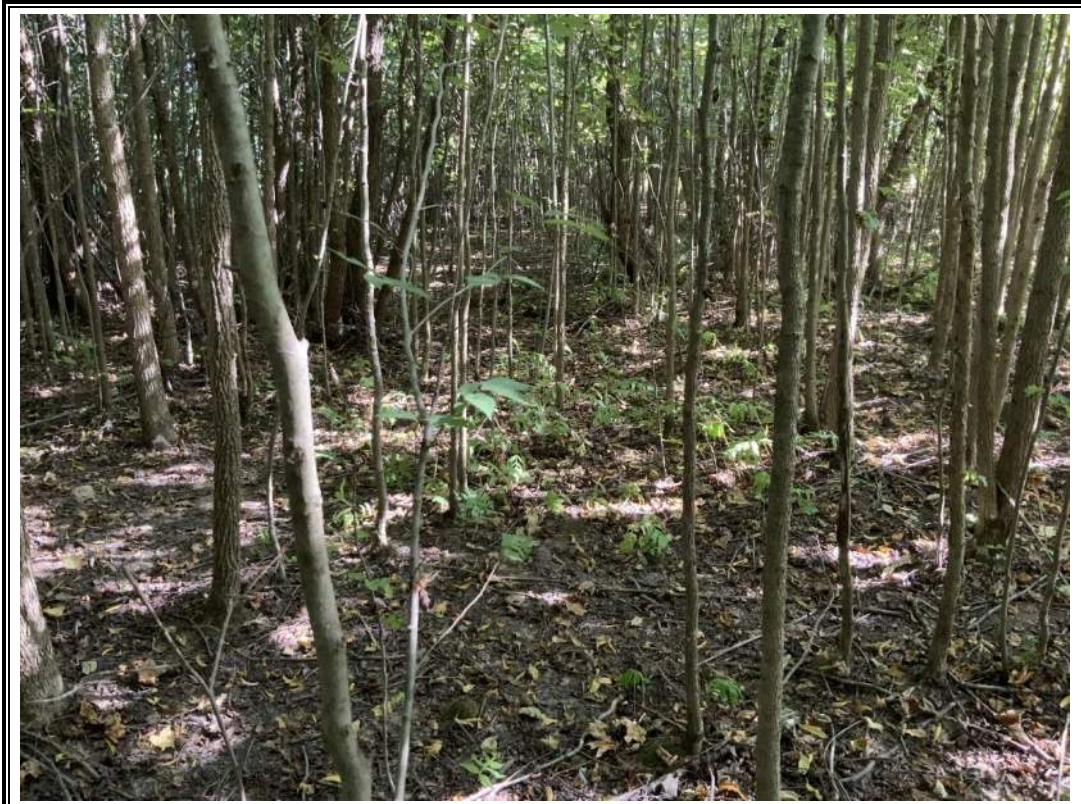
Photo: 59

Representative conditions of forested portion of WTL-4.

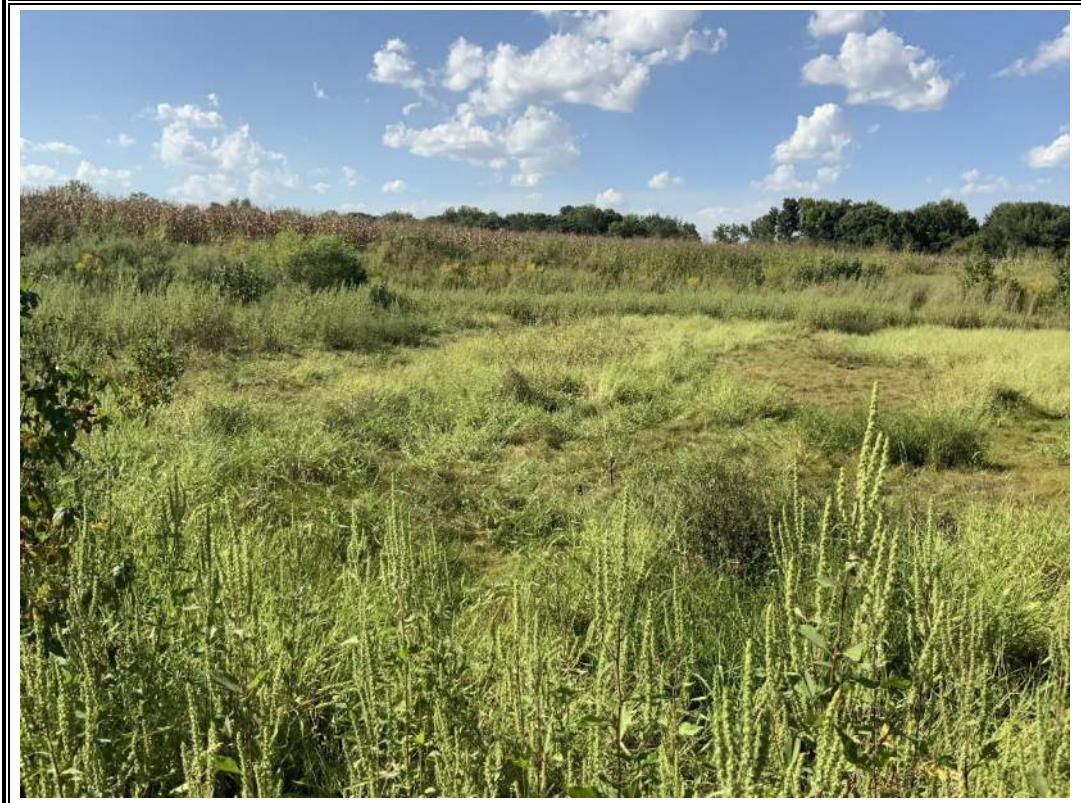
Photo: 60

Representative conditions of depressional WTL-5, relic farm pond.

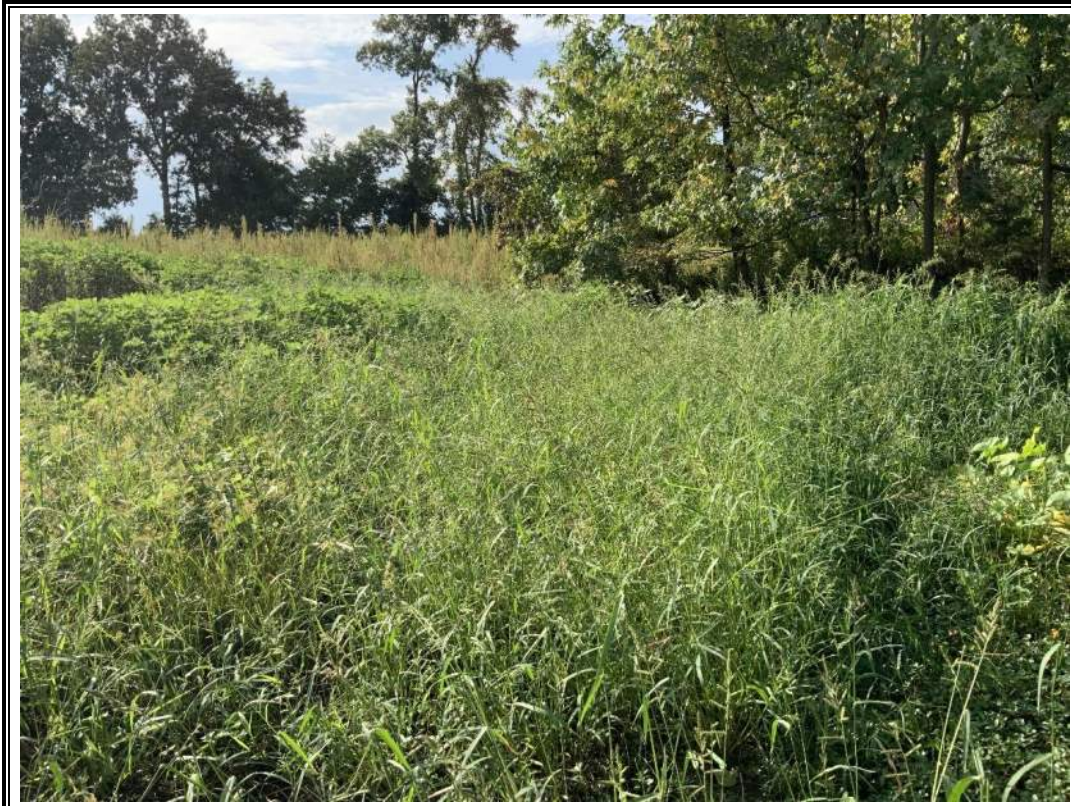
Photo: 61
By: F. Amatucci
Date: September 22, 2022
Feature: WTL-6
Lat: 36.445833
Long: -88.303028

Representative conditions of depressional WTL-6, relic farm pond.

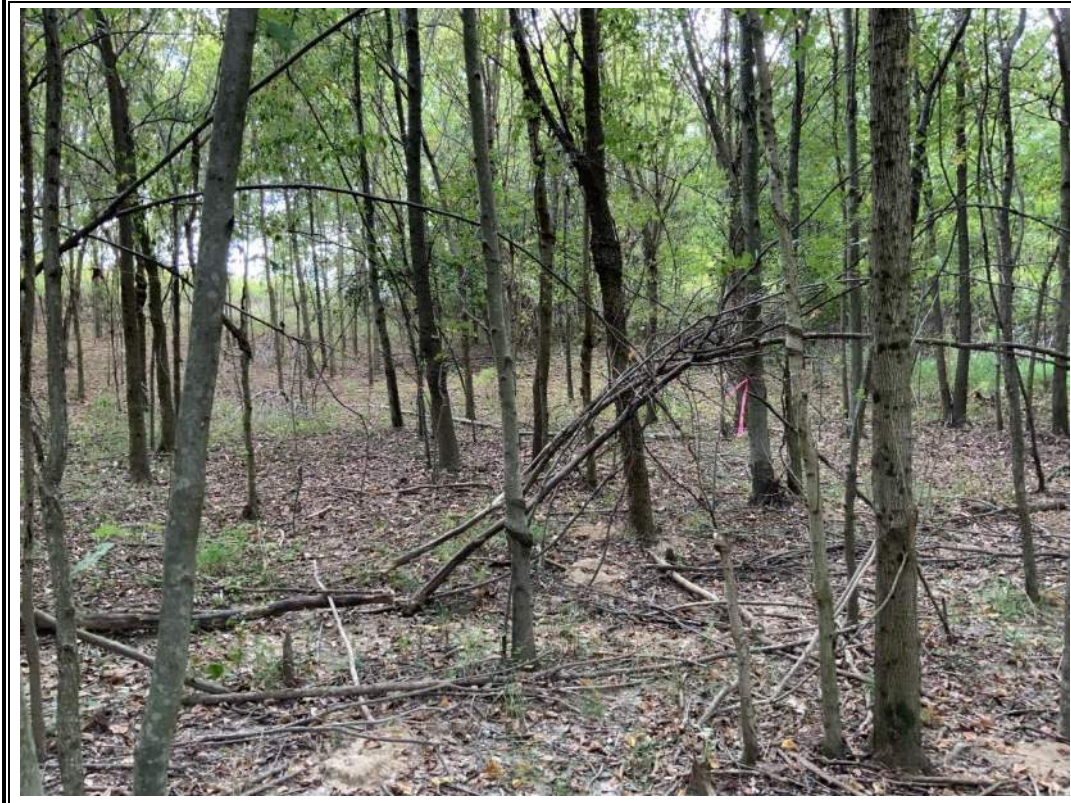
Photo: 62
By: F. Amatucci
Date: September 22, 2022
Feature: WTL-7
Lat: 36.441109
Long: -88.298613

Representative conditions of WTL-7 facing downslope before draining into EPH-9.

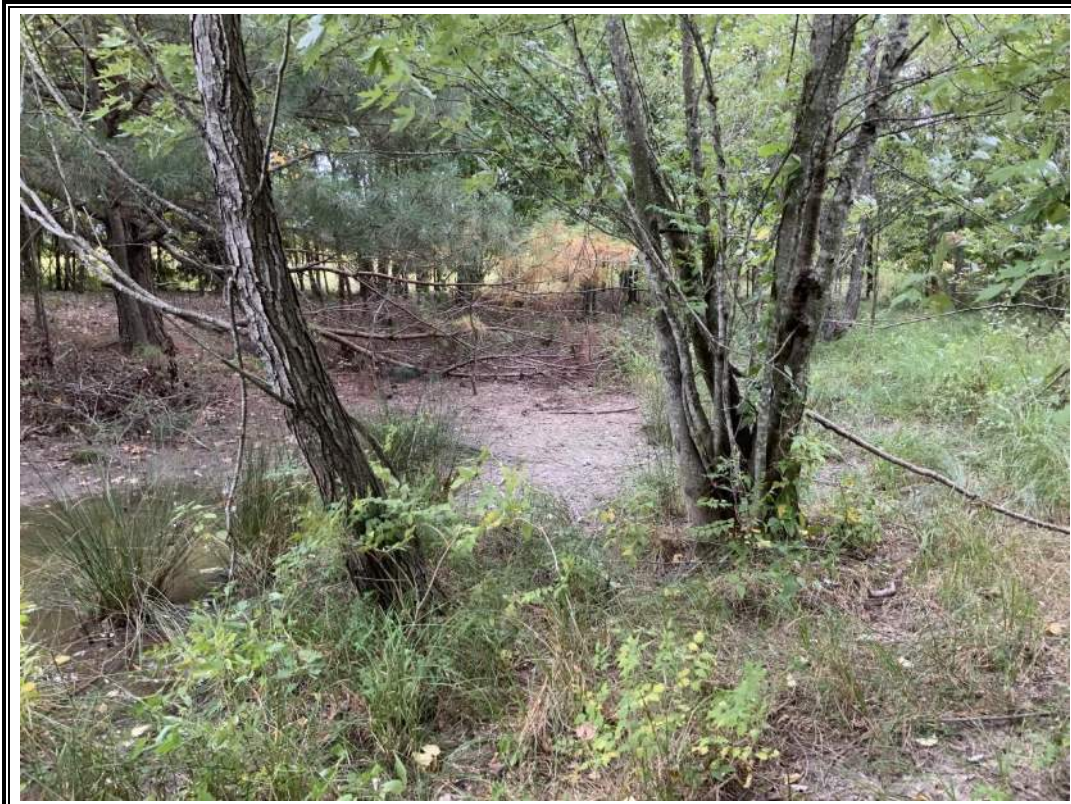
Photo: 63
By: F. Amatucci
Date: September 22, 2022
Feature: WTL-8
Lat: 36.439989
Long: -88.295782

Representative conditions of WTL-8, fringe wetland to P-12.

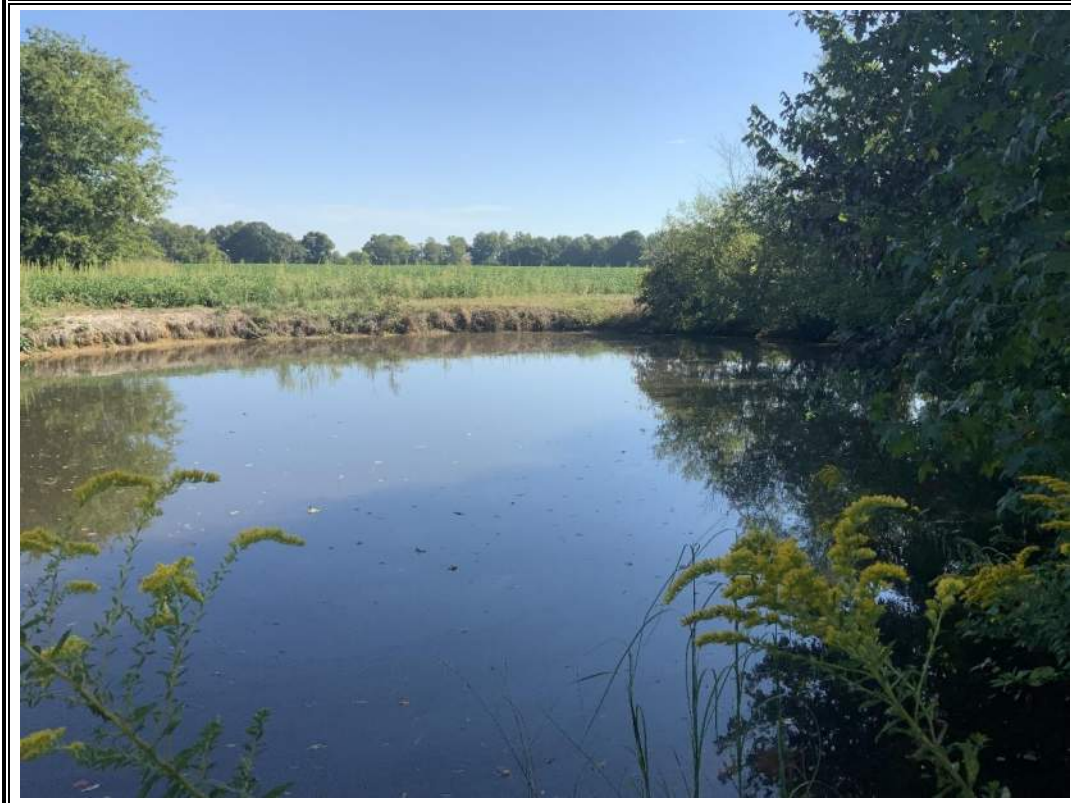
Photo: 64
By: F. Amatucci
Date: September 20, 2022
Feature: P-1
Lat: 36.452776
Long: -88.303313

Representative conditions of farm pond P-1.

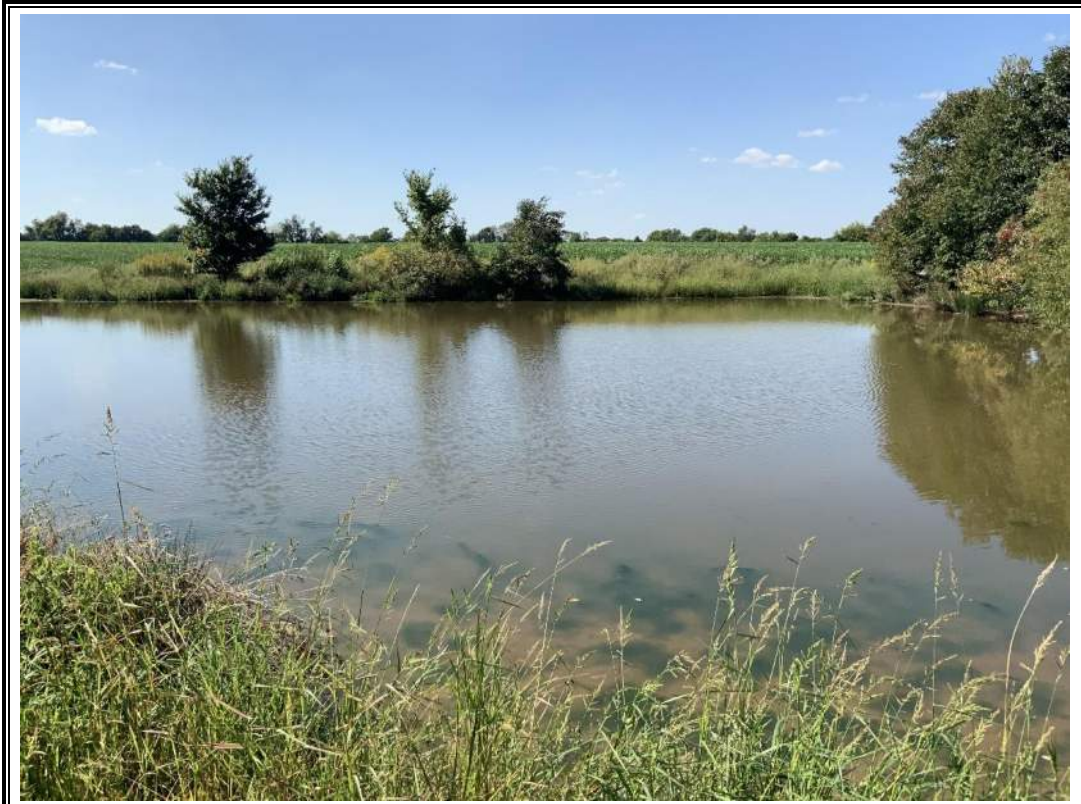
Photo: 65
By: F. Amatucci
Date: September 20, 2022
Feature: P-2
Lat: 36.455505
Long: -88.302763

Representative conditions of farm pond P-2.

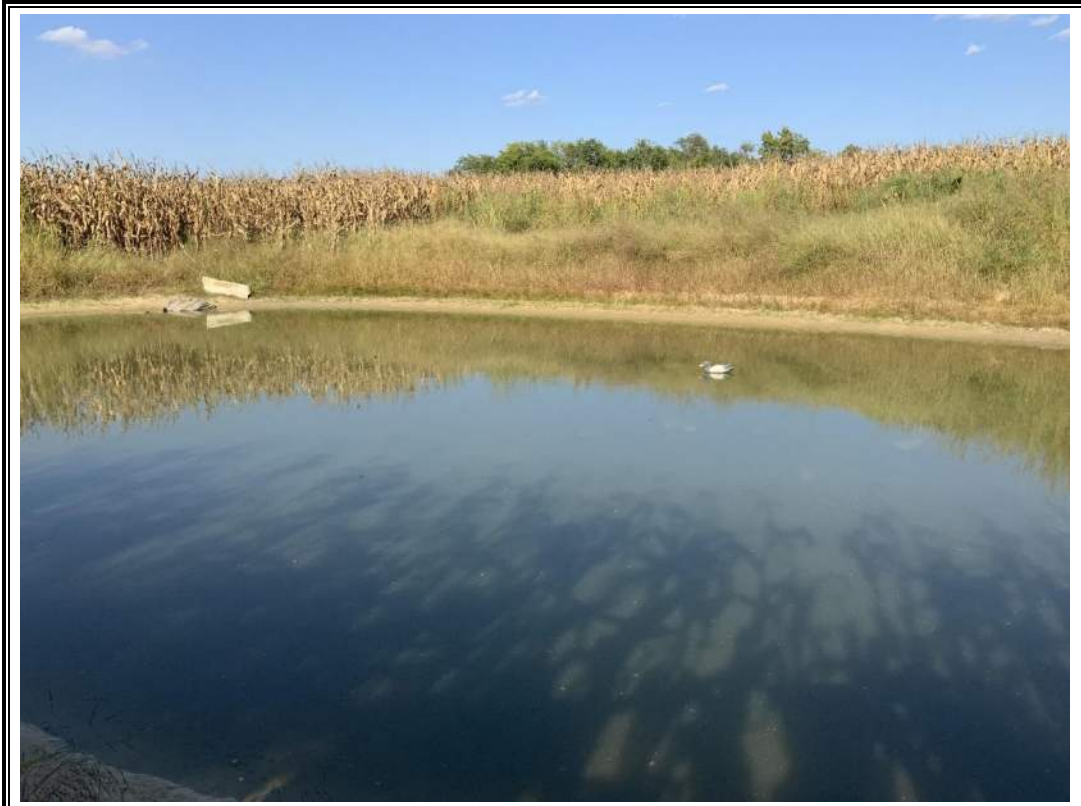
Photo: 67
By: F. Amatucci
Date: September 20, 2022
Feature: P-4
Lat: 36.451544
Long: -88.296563

Representative conditions of farm pond P-4.

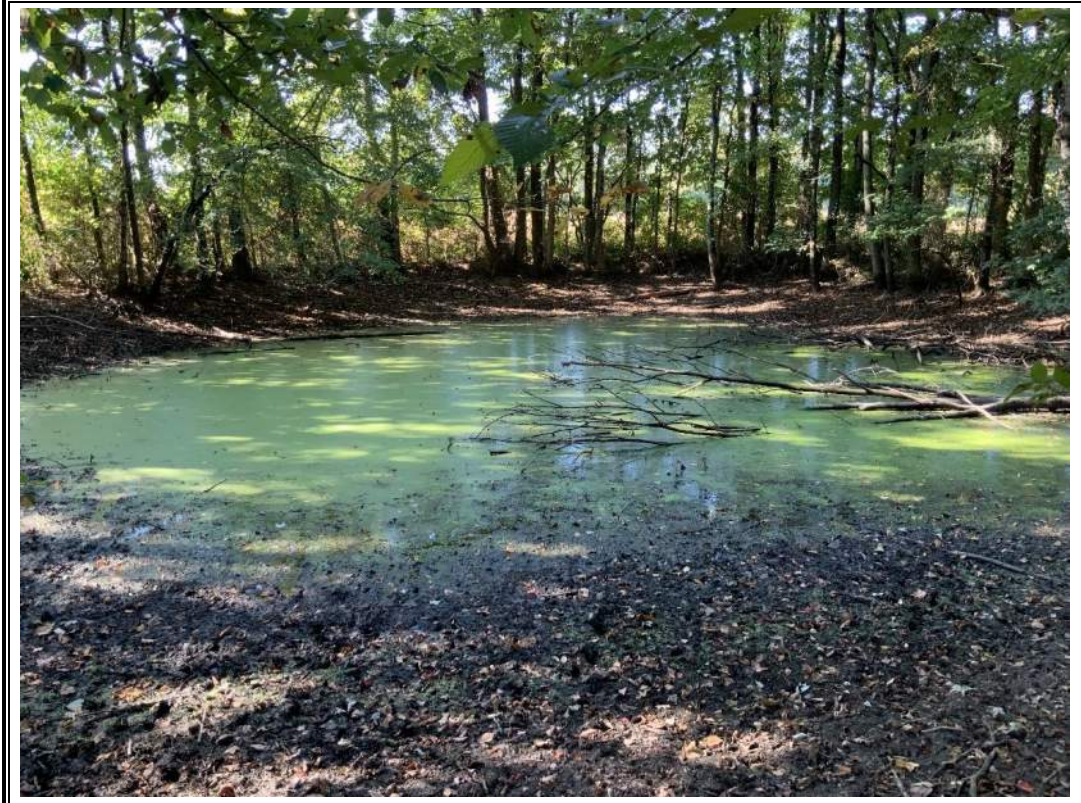
Photo: 68
By: F. Amatucci
Date: September 21, 2022
Feature: P-6
Lat: 36.446685
Long: -88.312390

Representative conditions of farm pond P-6.

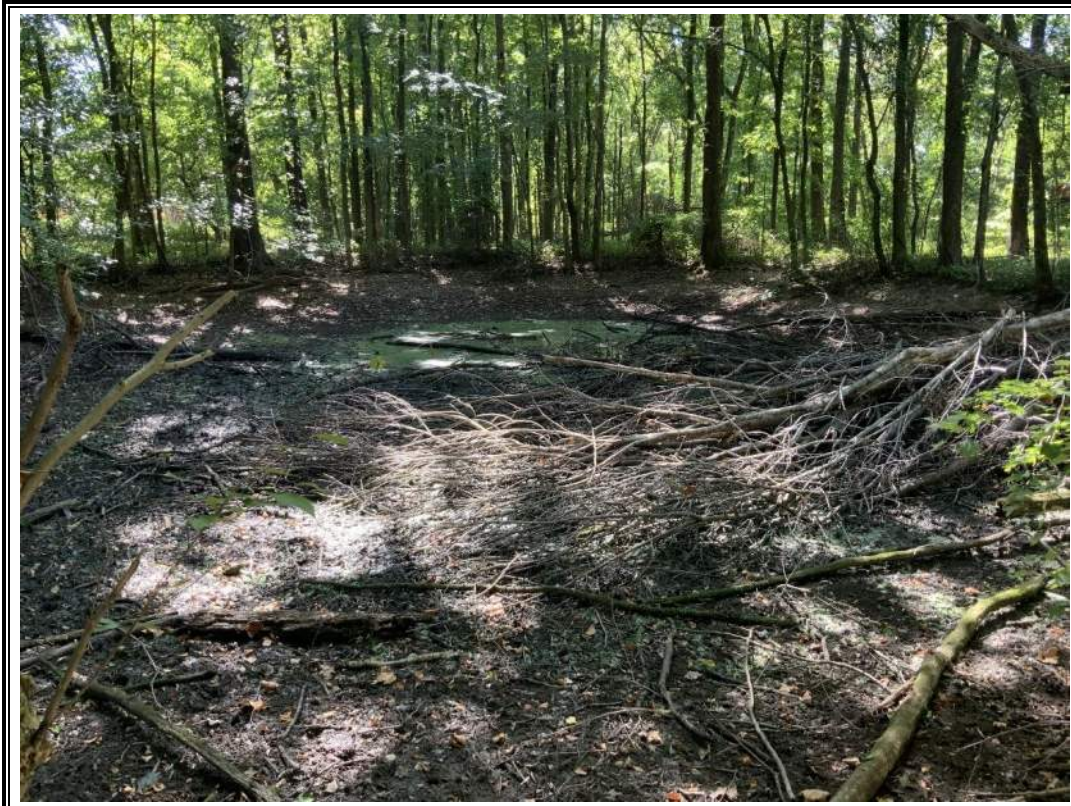
Photo: 69
By: F. Amatucci
Date: September 21, 2022
Feature: P-7
Lat: 36.445152
Long: -88.314391

Representative conditions of farm pond P-7.

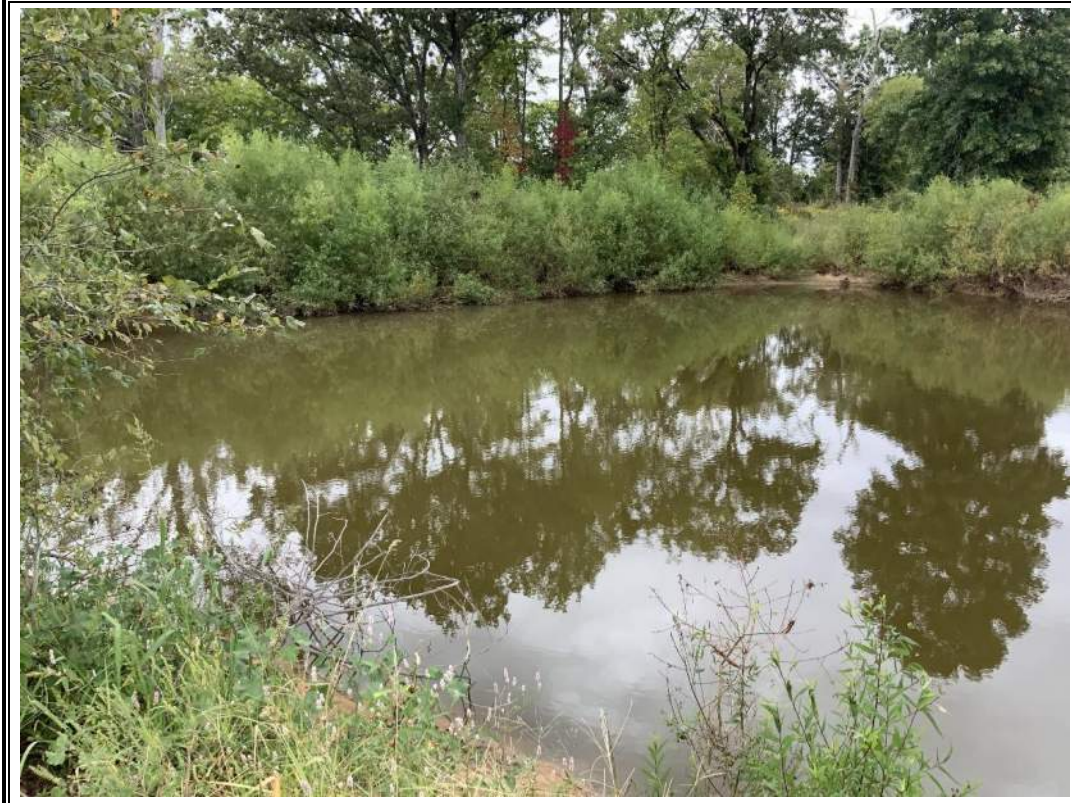
Photo: 70
By: F. Amatucci
Date: September 22, 2022
Feature: P-8
Lat: 36.442592
Long: -88.307931

Representative conditions of farm pond P-8.

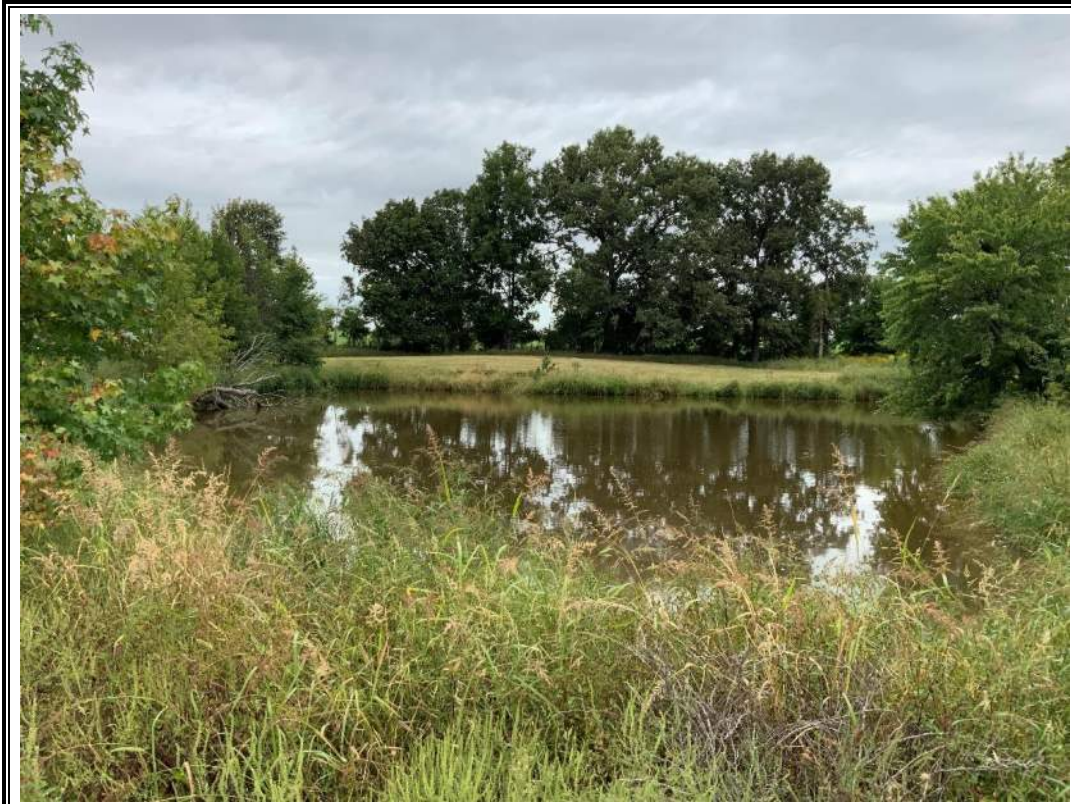
Photo: 71
By: F. Amatucci
Date: September 22, 2022
Feature: P-9
Lat: 36.444728
Long: -88.300209

Representative conditions of farm pond P-9.

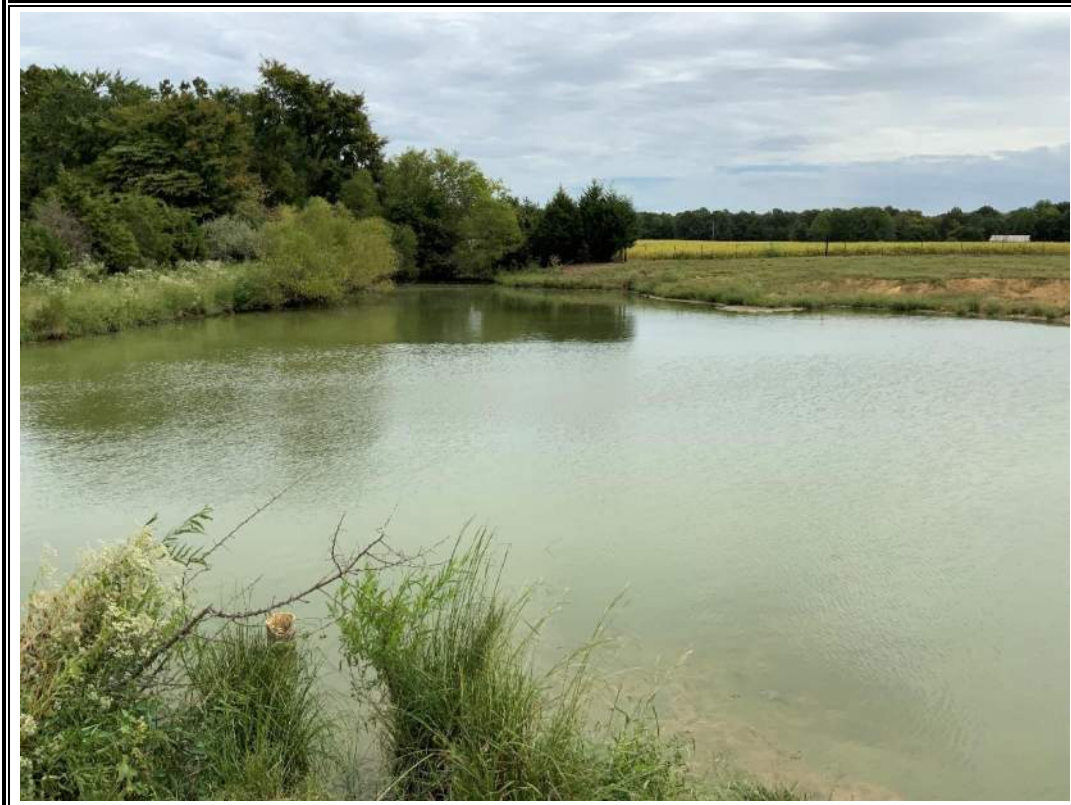
Photo: 72
By: F. Amatucci
Date: September 22, 2022
Feature: P-10
Lat: 36.443472
Long: -88.298525

Representative conditions of farm pond P-10.

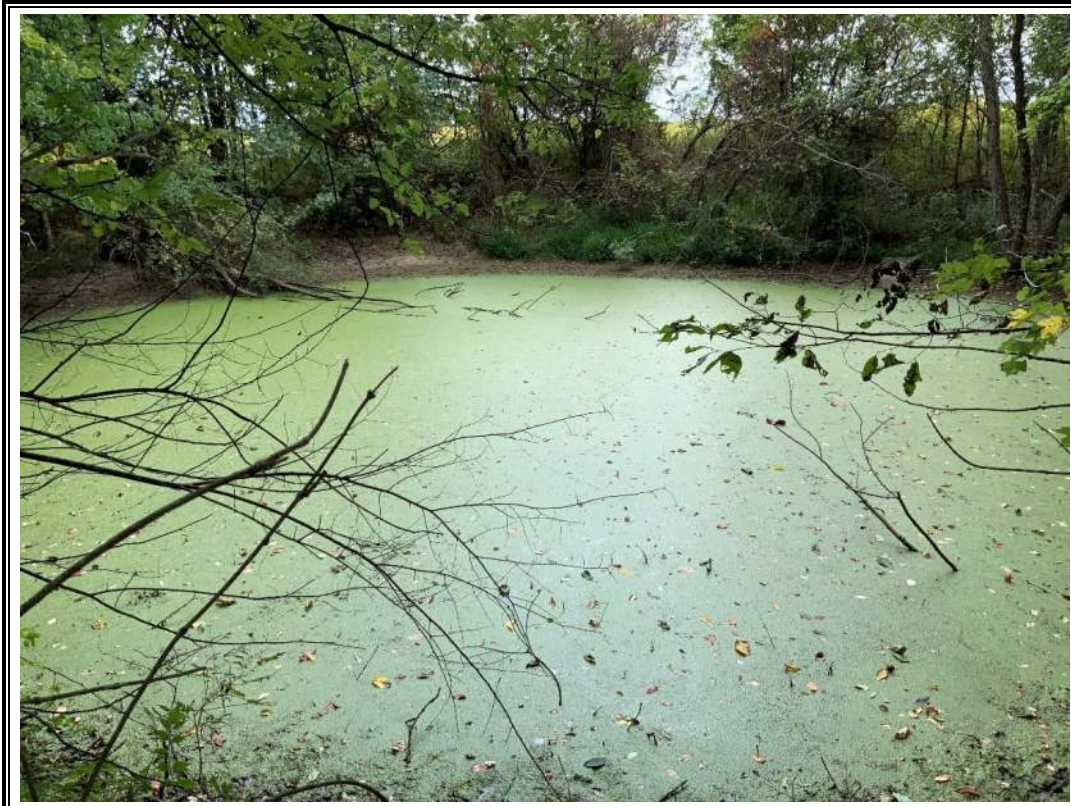
Photo: 73

Representative conditions of farm pond P-11.

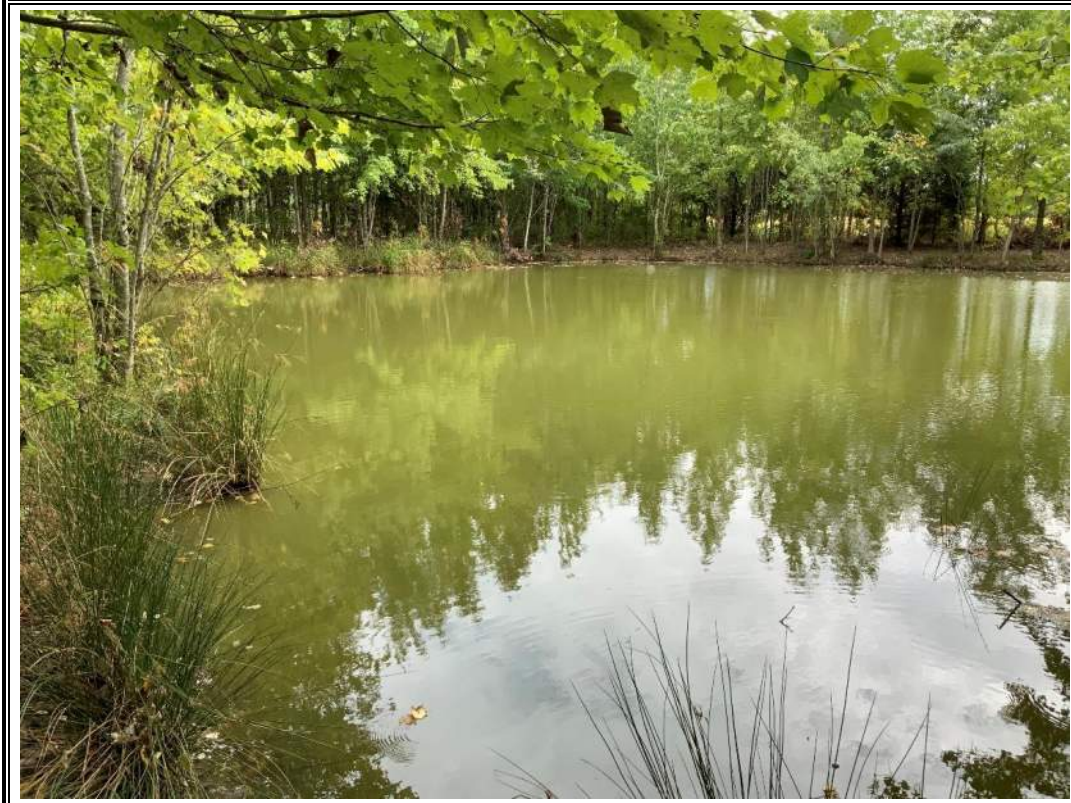
Photo: 74

Representative conditions of farm pond P-12, adjacent to fringe wetland WTL-8.

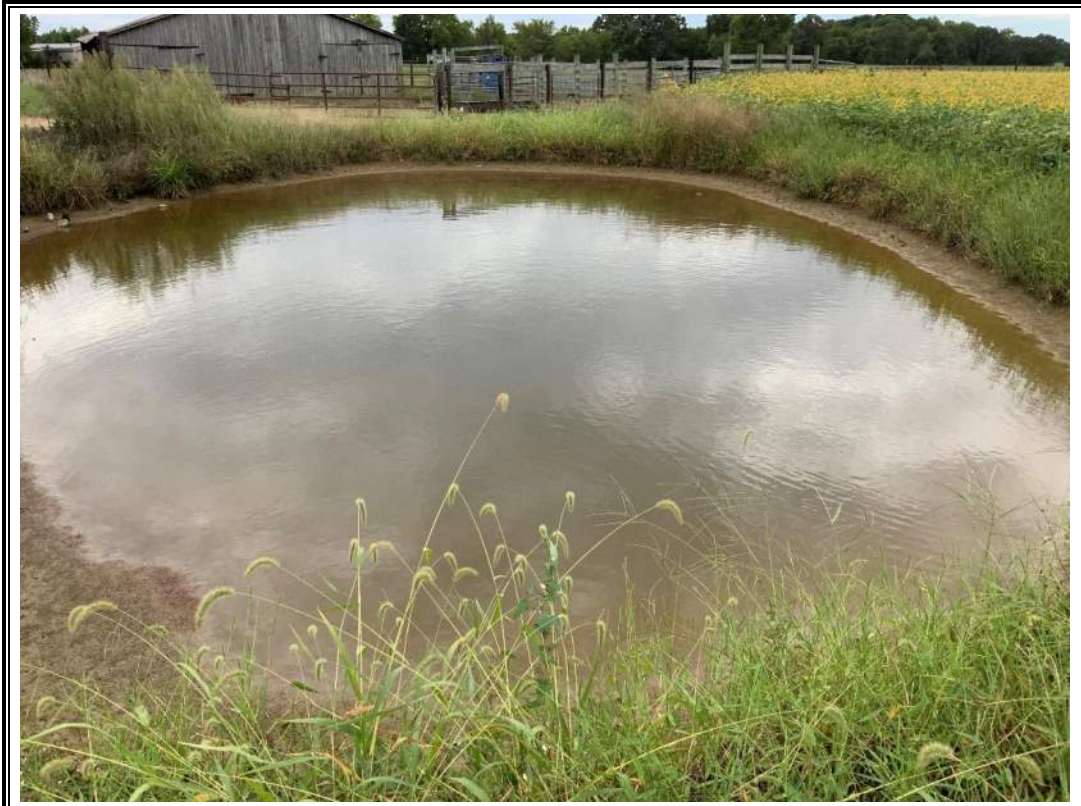
Photo: 75
By: F. Amatucci
Date: September 22, 2022
Feature: P-13
Lat: 36.442887
Long: -88.294656

Representative conditions of farm pond P-13, adjacent to roadway.

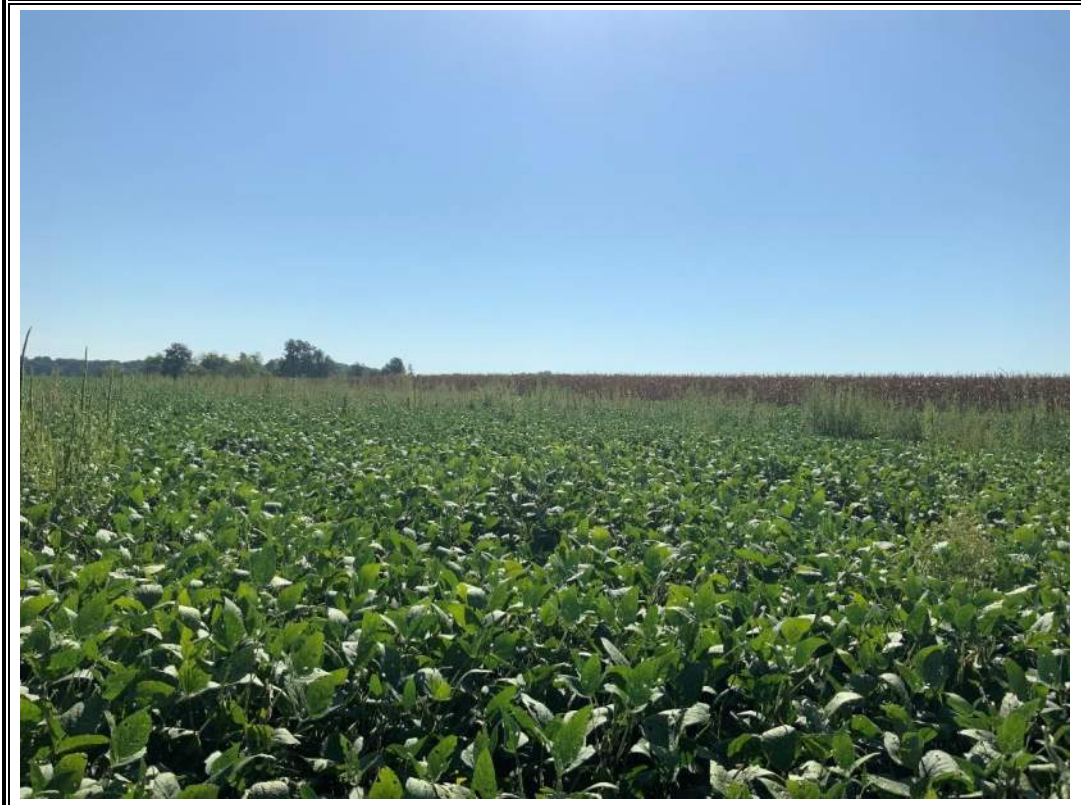
Photo: 76
By: F. Amatucci
Date: September 20, 2022
Feature: Cropland
Lat: 36.452092
Long: -88.303009

Representative cropland vegetative community observed within project study area.
