**SR PURYEAR SOLAR
FINAL ENVIRONMENTAL ASSESSMENT
Henry County, Tennessee**

Tennessee Valley Authority
Knoxville, Tennessee

Silicon Ranch

Barge Design Solutions, Inc.

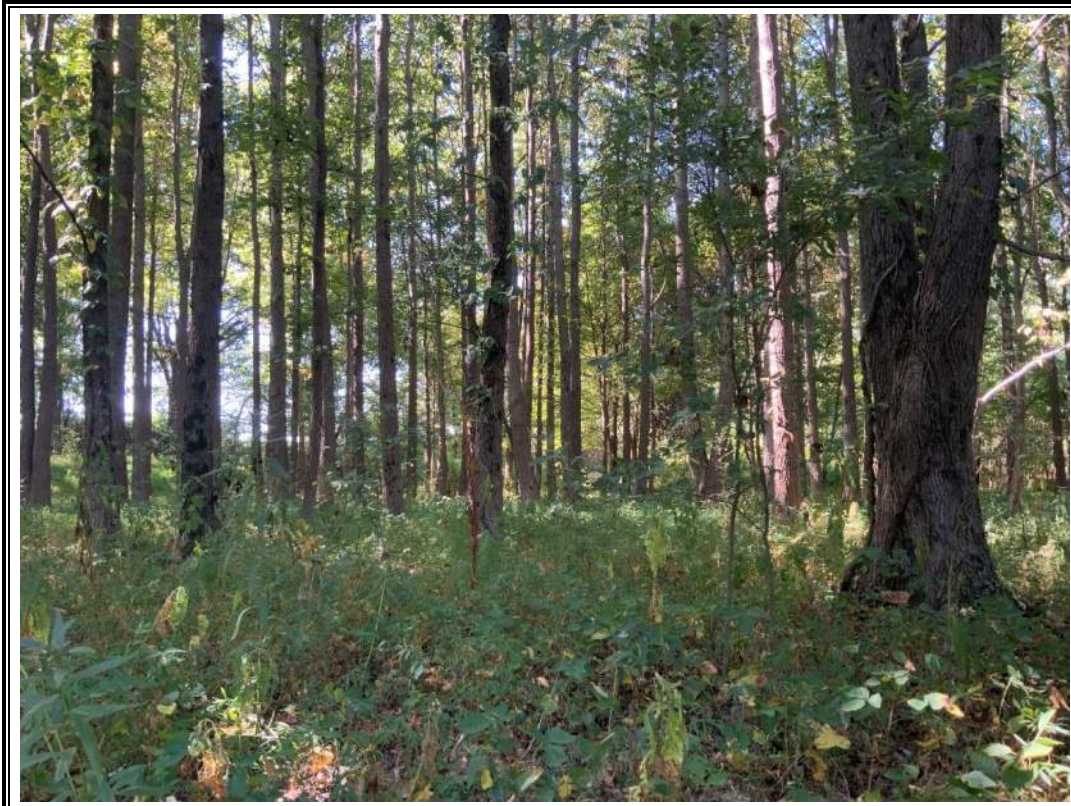
Photo: 77

Representative semi-mature riparian forest vegetative community observed within project study area.

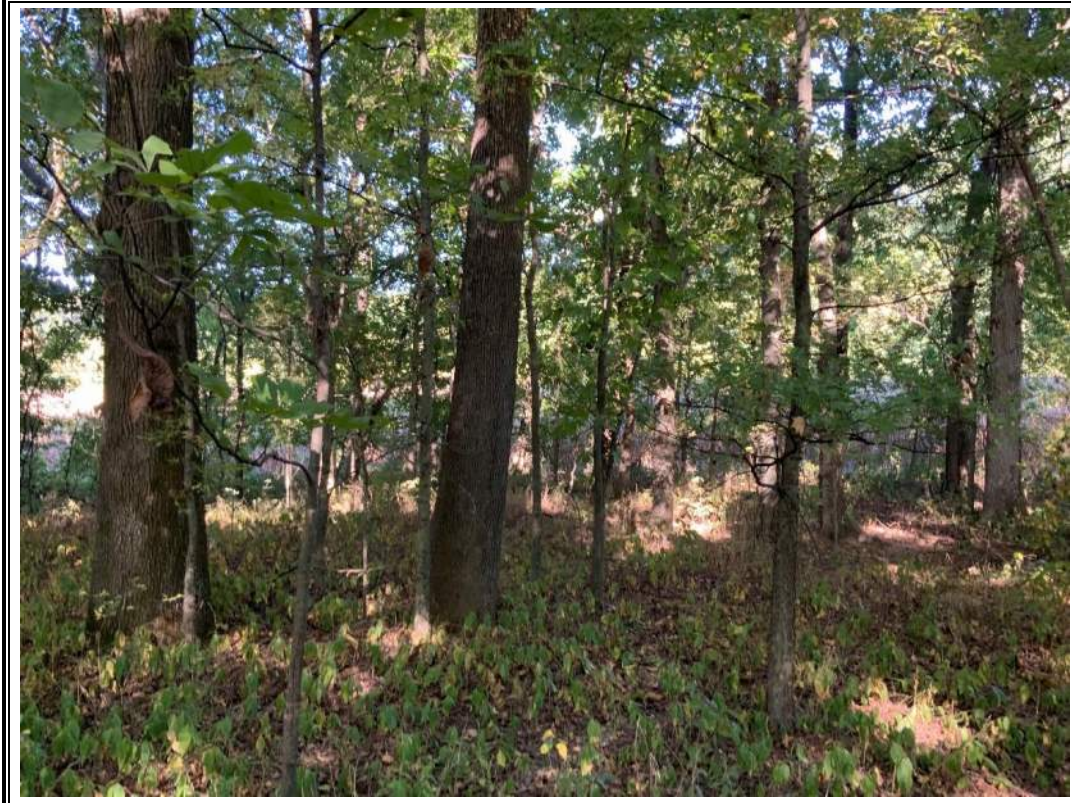
Photo: 78

Representative mixed growth hardwood forest vegetative community observed within project study area.

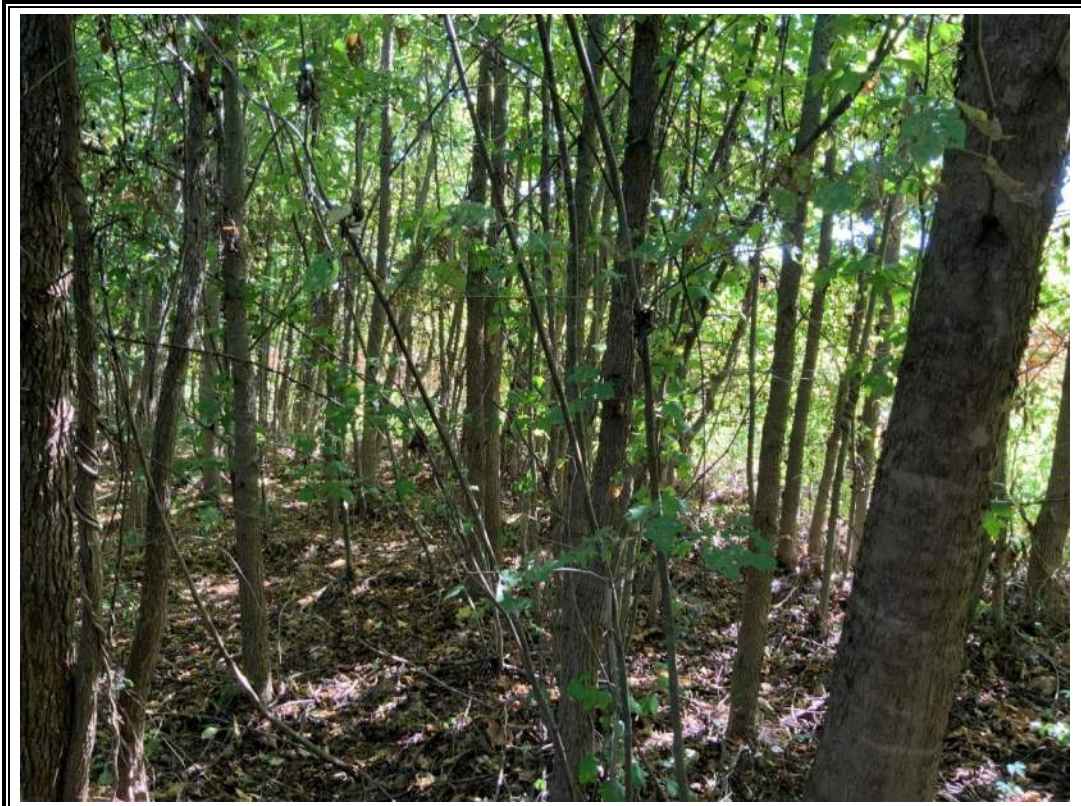
Photo: 79

Representative successional hardwood forest vegetative community observed within project study area.

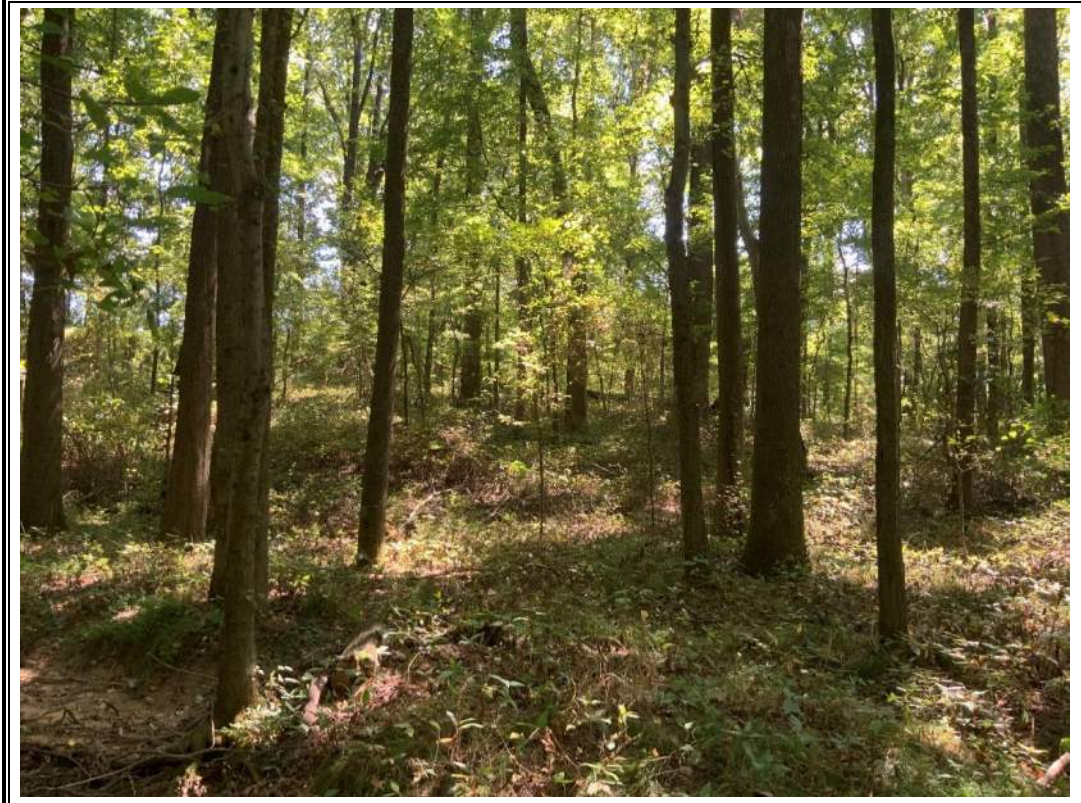
Photo: 80

Representative mature riparian forest vegetative community observed within project study area.

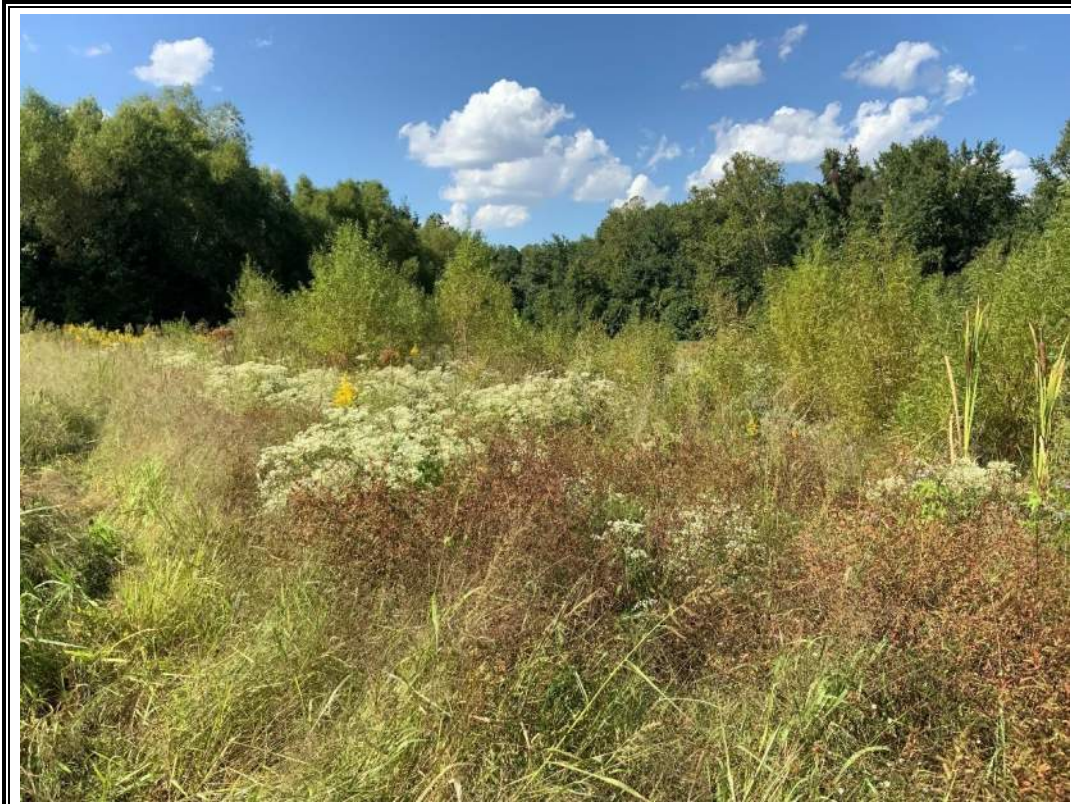
Photo: 81
By: F. Amatucci
Date: September 21, 2022
Feature: Shallow Emergent Marsh
Lat: 36.443780
Long: -88.314995

Representative shallow emergent marsh vegetative community observed within project study area.

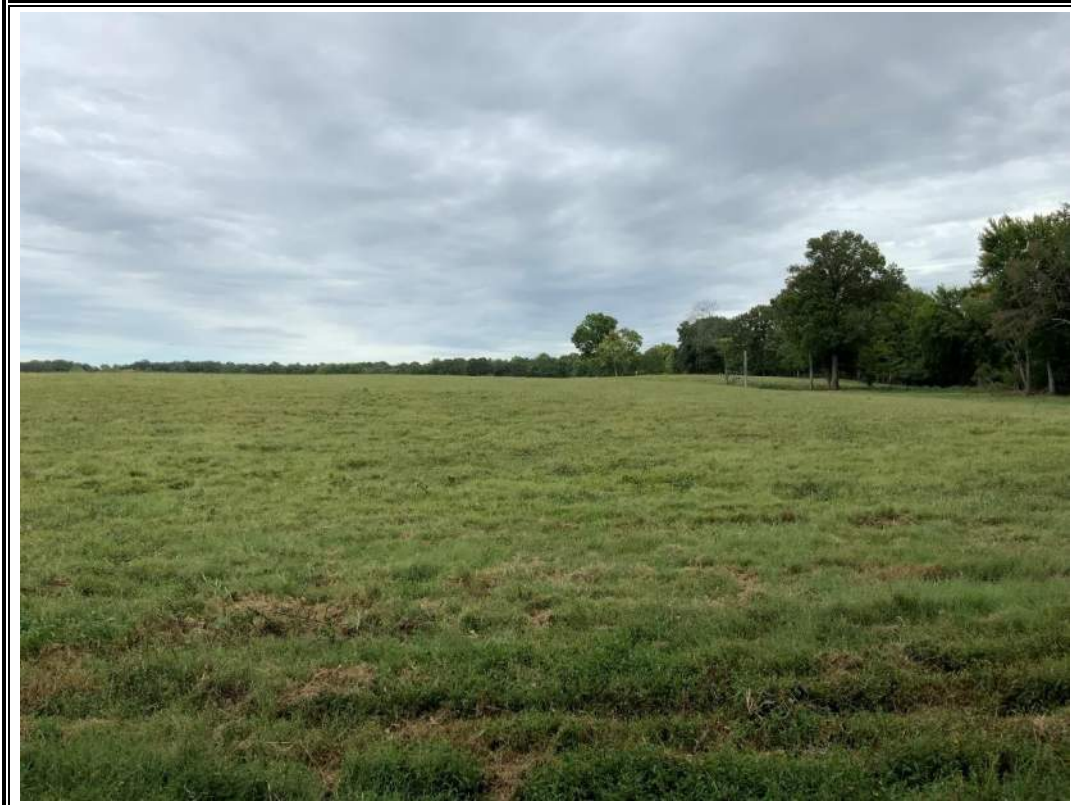
Photo: 82
By: F. Amatucci
Date: September 22, 2022
Feature: Pastureland (Cattle)
Lat: 36.442526
Long: -88.300671

Representative pastureland (cattle) vegetative community observed within project study area.

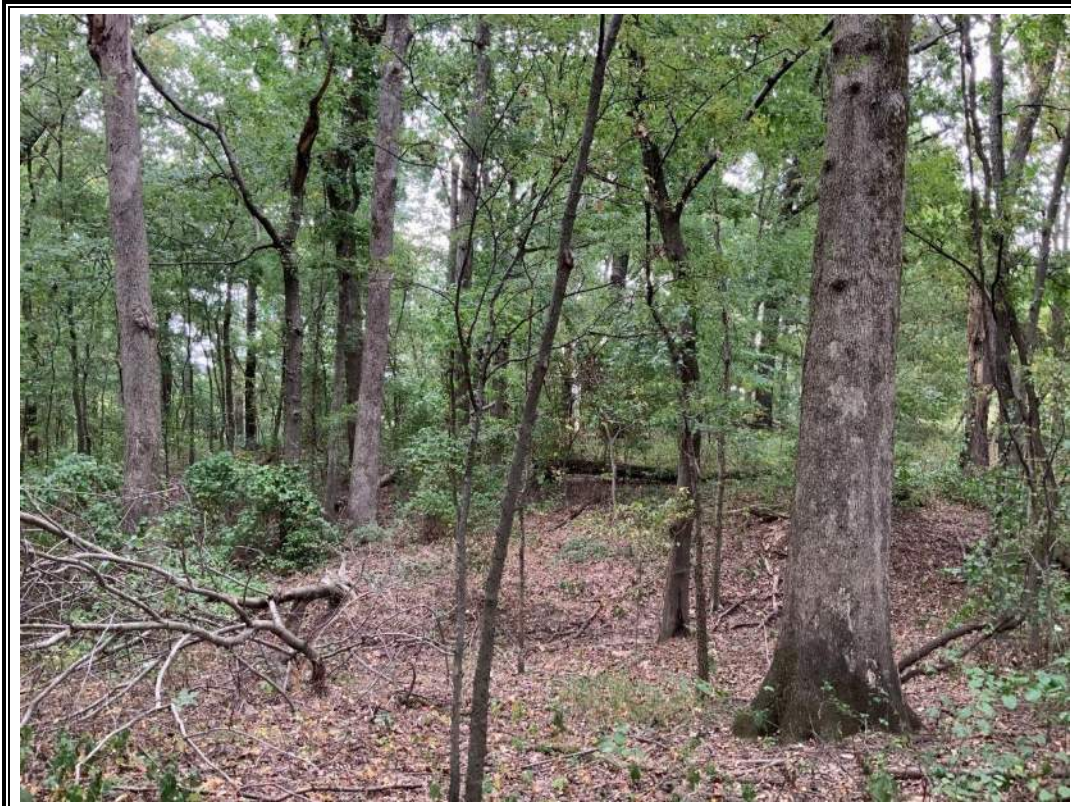
Photo: 83

Representative mature oak-hickory forest vegetative community observed within project study area.

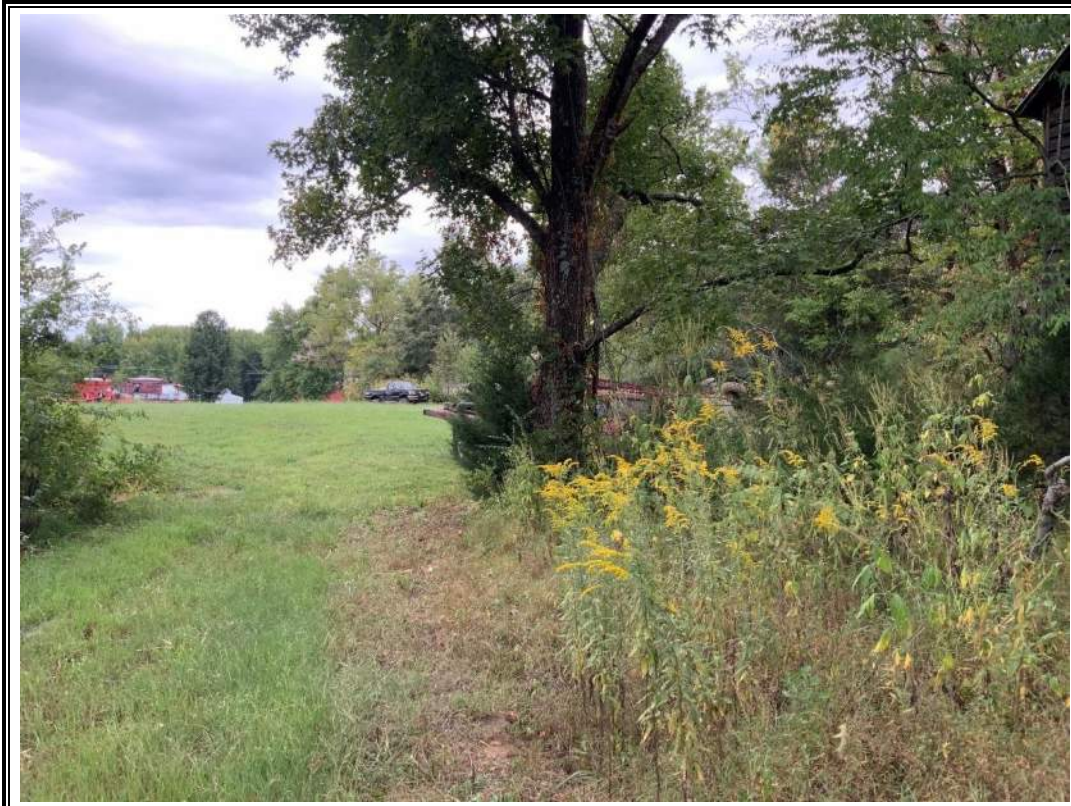
Photo: 85

Representative residential vegetative community observed within project study area.

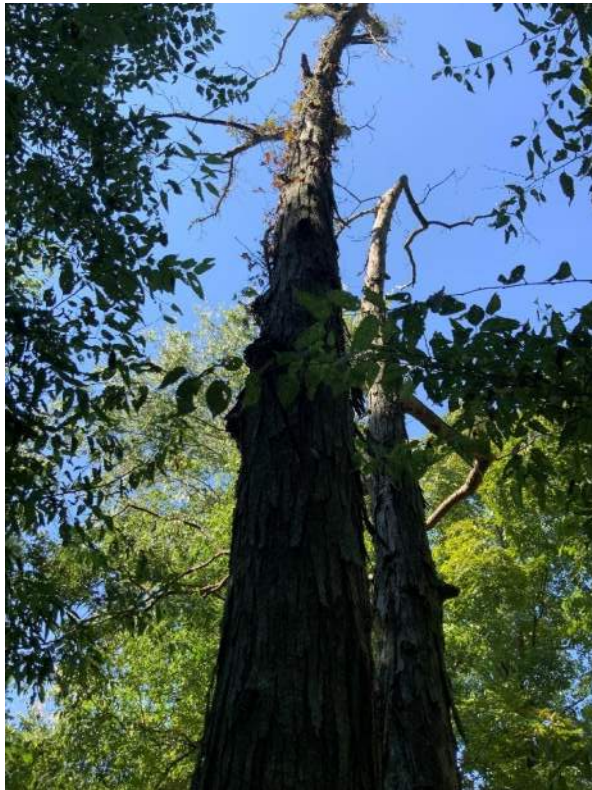
Photo: 87

Potential bat roost tree observed a living shagbark hickory, 20 inches in diameter, approximately 85 percent exfoliating bark, high solar exposure, and with suitable habitat 15 plus feet above the ground.

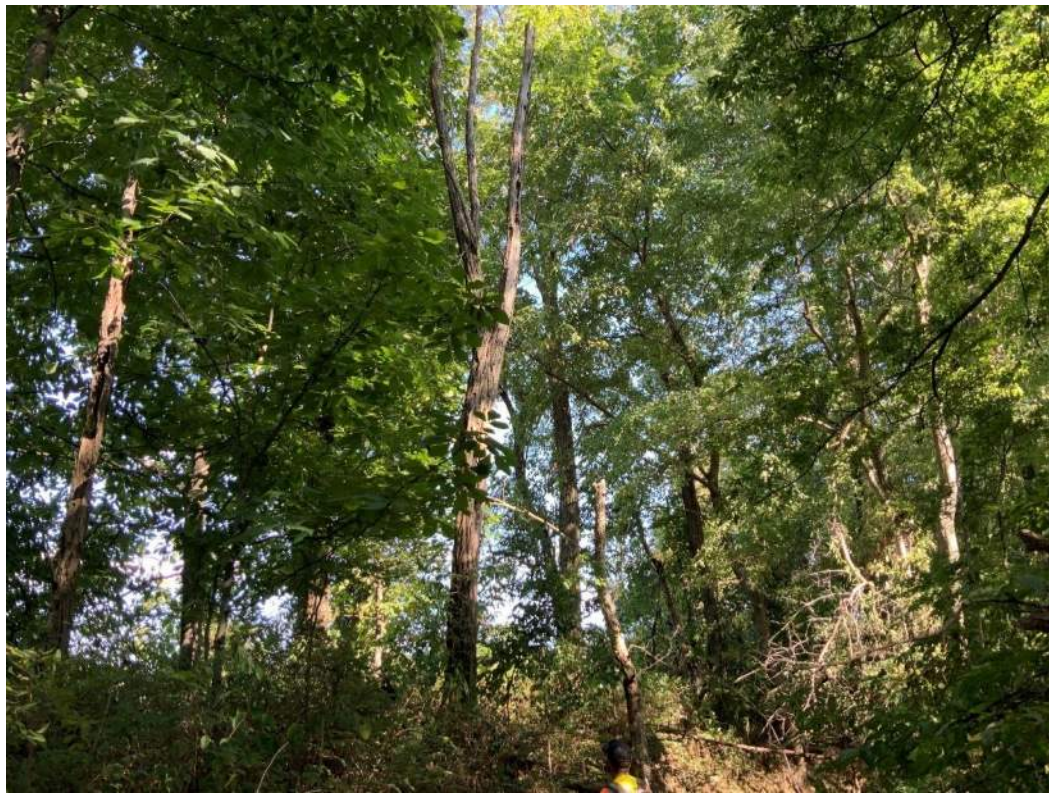
Photo: 90
By: F. Amatucci
Date: September 20, 2022
Feature: PRT-5
Lat: 36.454856
Long: -88.299593

Potential bat roost tree observed as dead, 18 inches in diameter, with crack and crevice holes in upper limbs, little solar exposure, and with suitable habitat 30 plus feet above the ground.

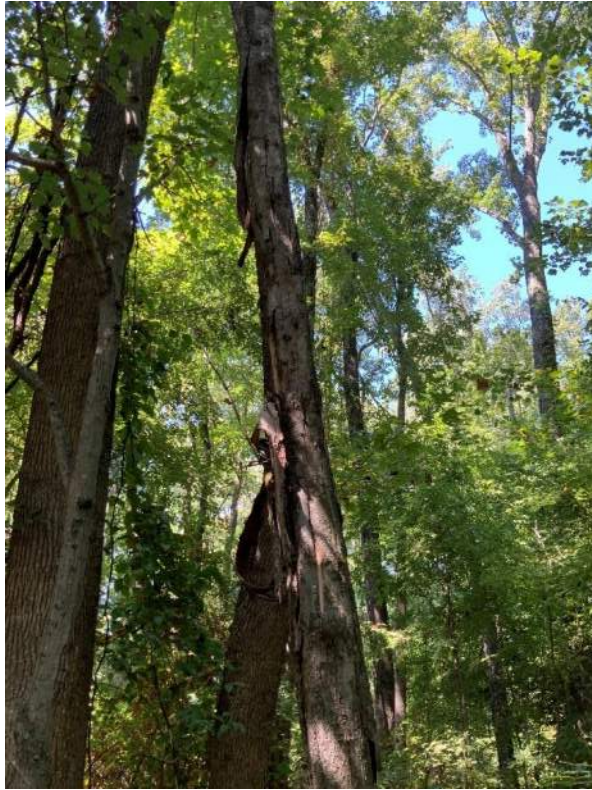
Photo: 91
By: F. Amatucci
Date: September 21, 2022
Feature: PRT-6
Lat: 36.444750
Long: -88.314635

Potential bat roost tree observed as dead, 10 inches in diameter, approximately 10 percent exfoliating bark, some binding vines limiting access, slight solar exposure, and with suitable habitat 15 plus feet above the ground.

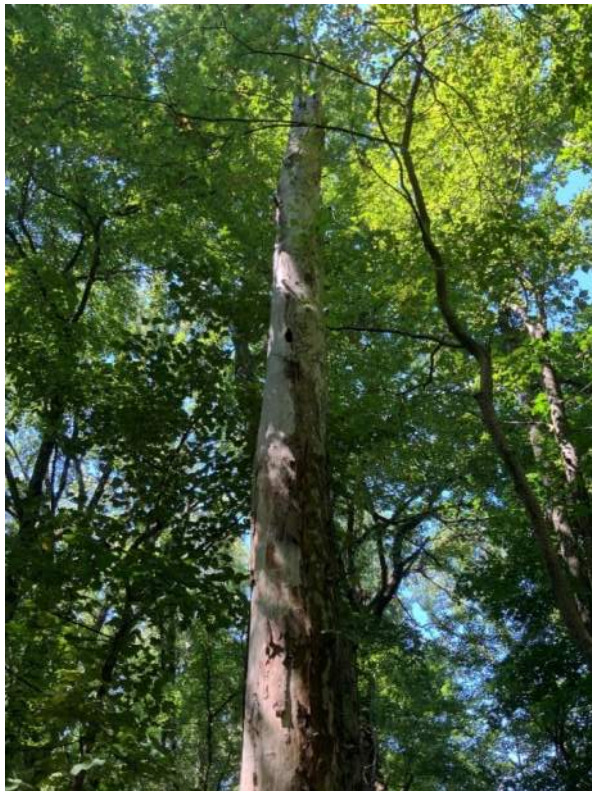
Photo: 92
By: F. Amatucci
Date: September 21, 2022
Feature: PRT-8
Lat: 36.447105
Long: -88.314483

Potential bat roost tree observed as dead, 28 inches in diameter, some presence of relic woodpecker holes that could be utilized, slight solar exposure, and with suitable habitat 15 plus feet above the ground.

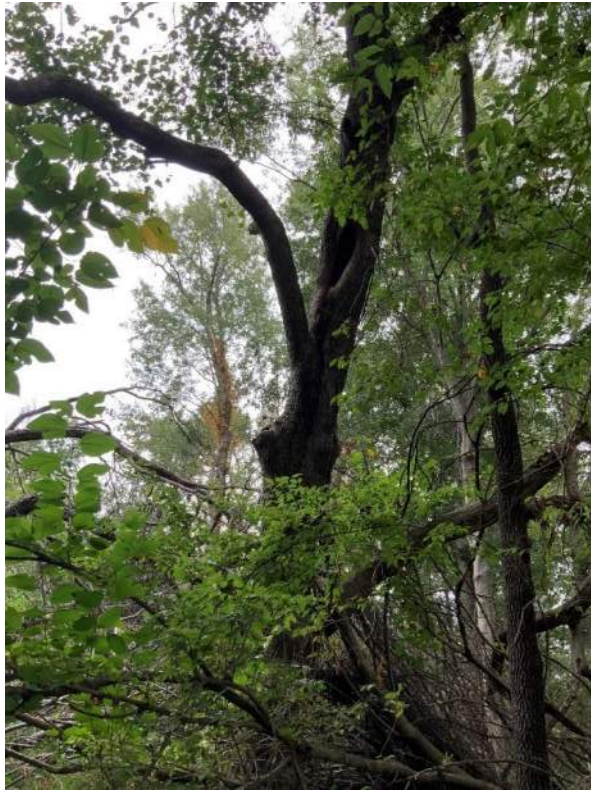
Photo: 93

Potential bat roost tree observed in a living red maple, 24 inches in diameter, with a large hole in the tree, moderate solar exposure, and with suitable habitat 20 plus feet above the ground.

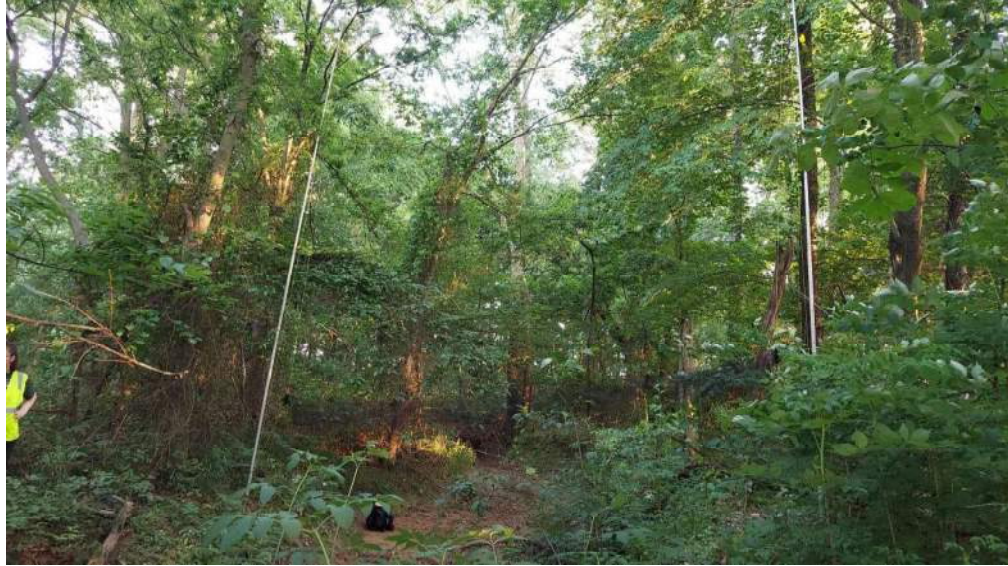
Net Site 1, Net A

Net Coordinates		
Unit	Latitude	Longitude
A	36.444367	-88.314486
B	36.445232	-88.314346
C	36.445385	-88.313847
