**APPENDIX G –
CCR MATERIAL INVESTIGATIONS**

**Appendix G.1 - Technical
Evaluation of Geotechnical and
CCR Material Characteristics Data**

TDEC Commissioner's Order:
Environmental Assessment Report
Cumberland Fossil Plant
Cumberland, Tennessee

Stantec Consulting Services Inc.
Lexington, Kentucky

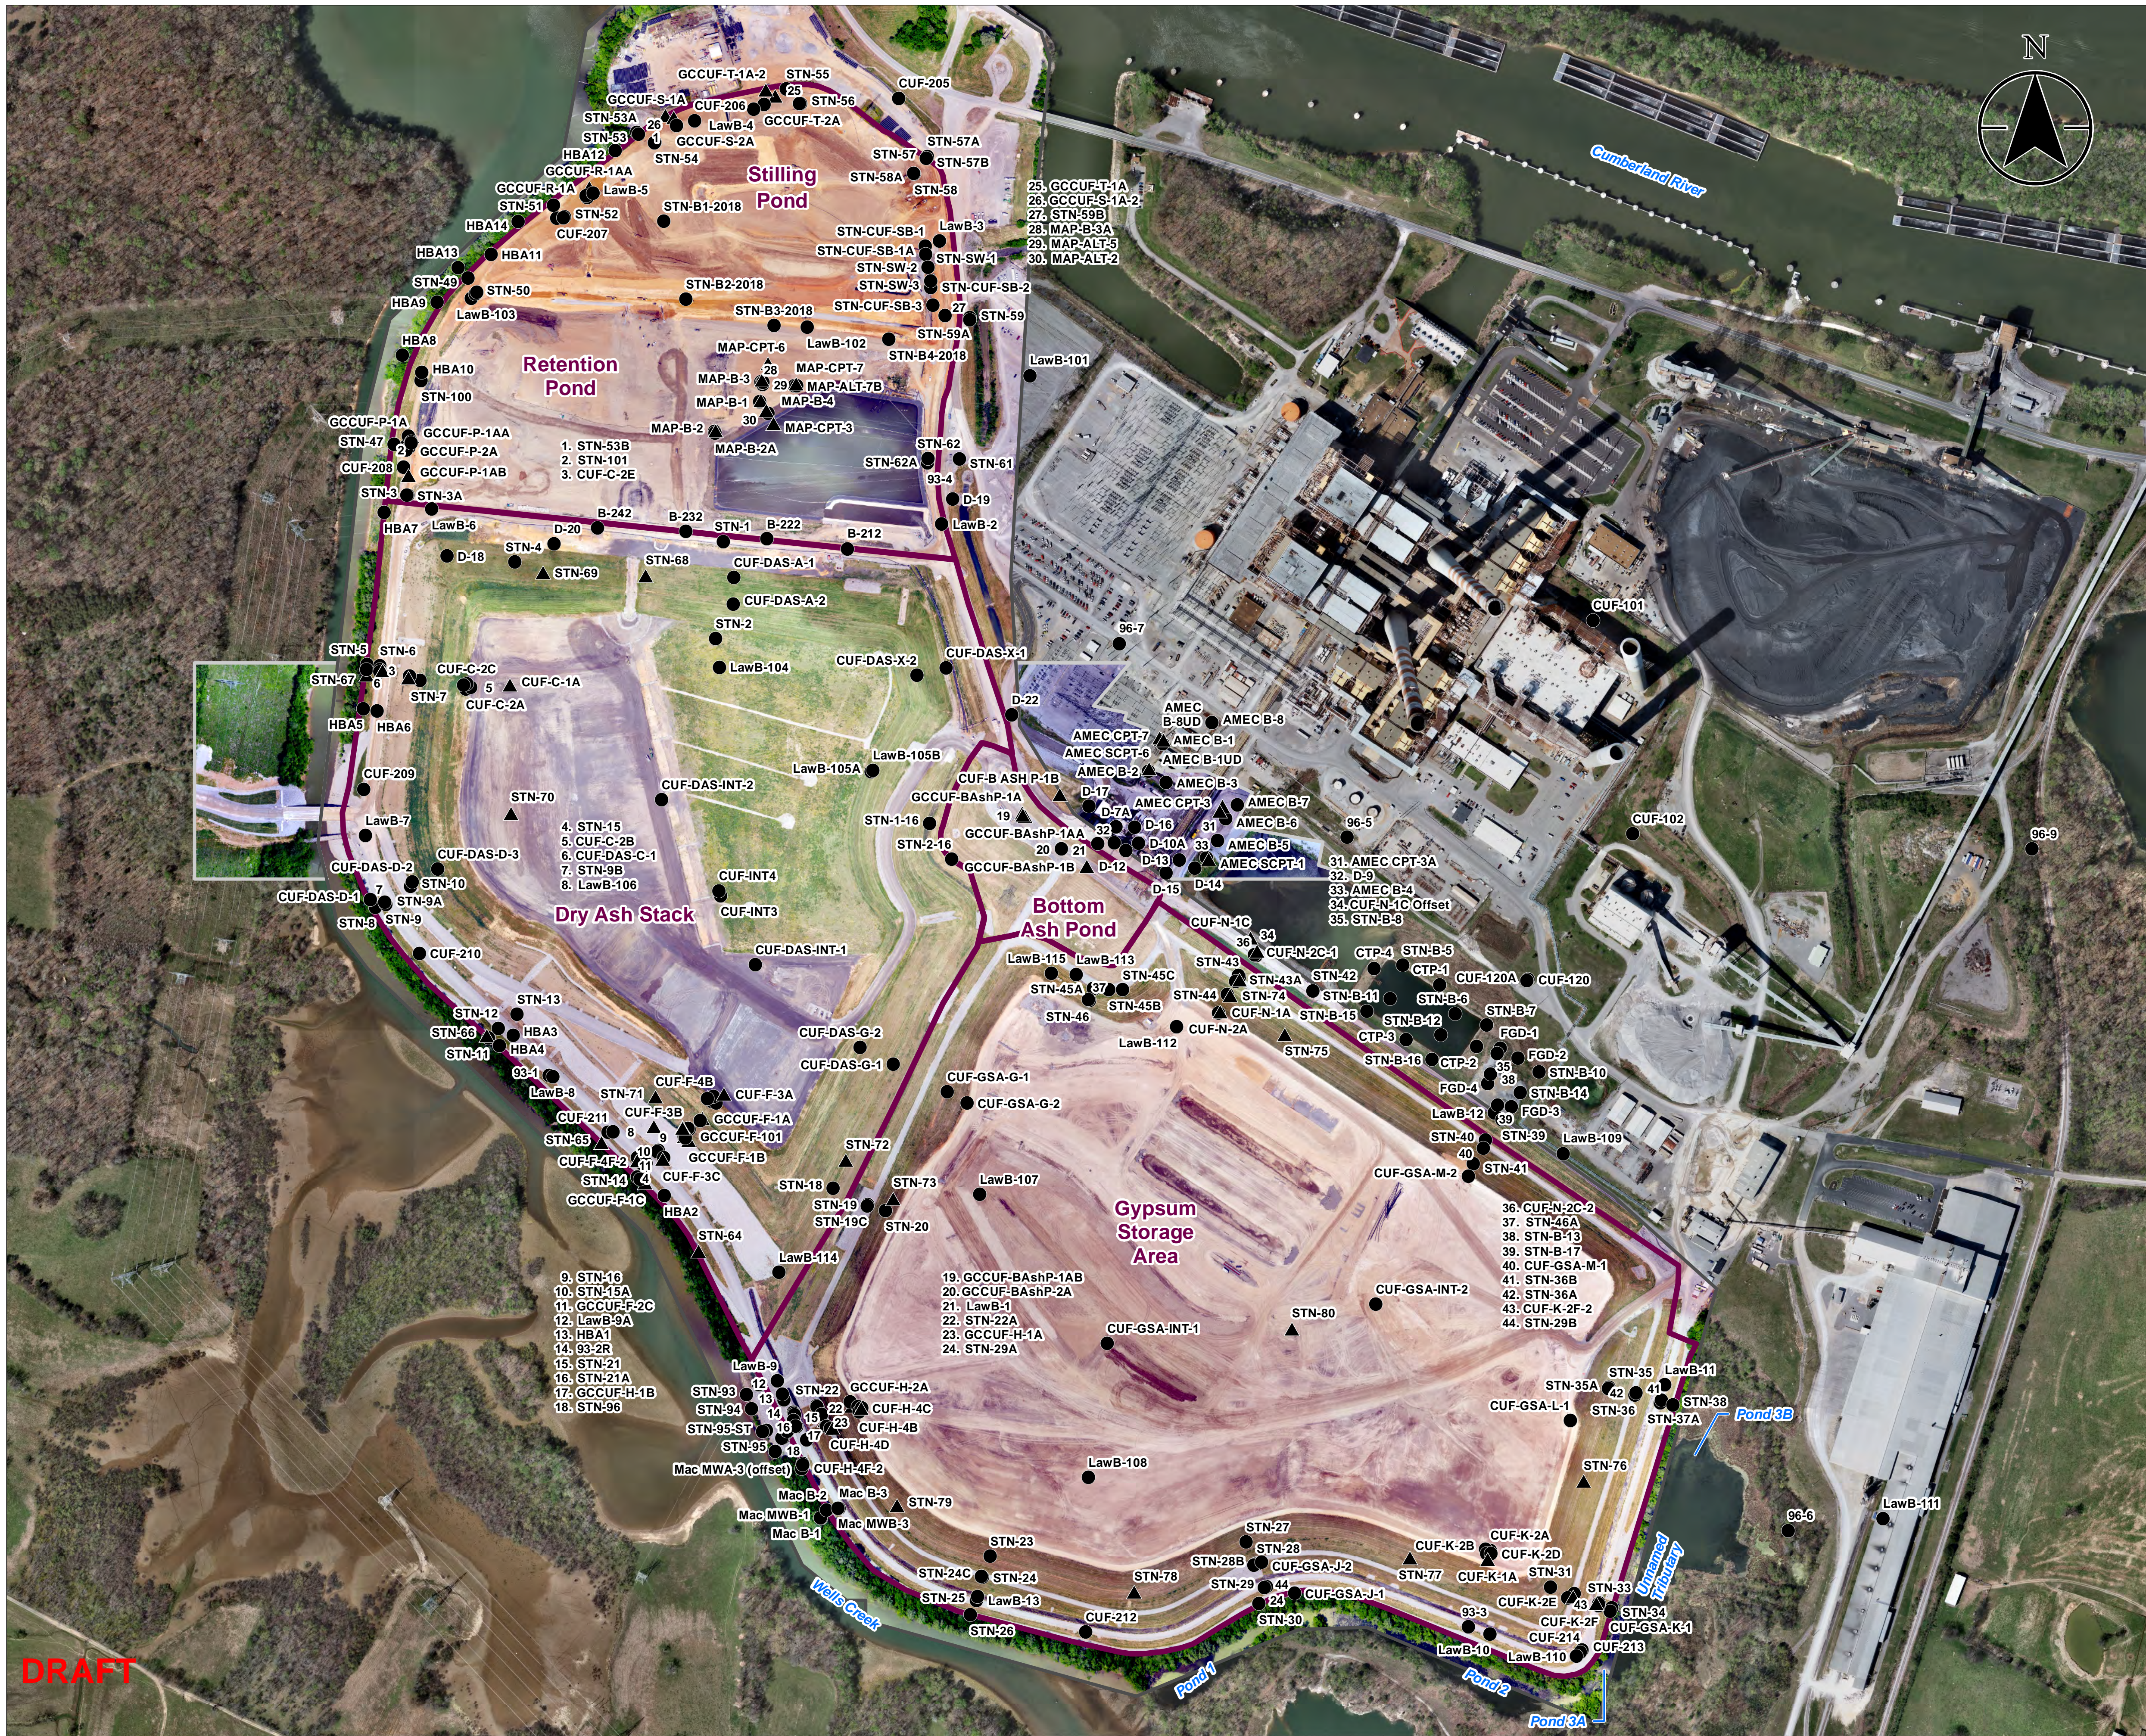
Exhibit No.
G.1-1

Title
Historical Boring and CPT Locations

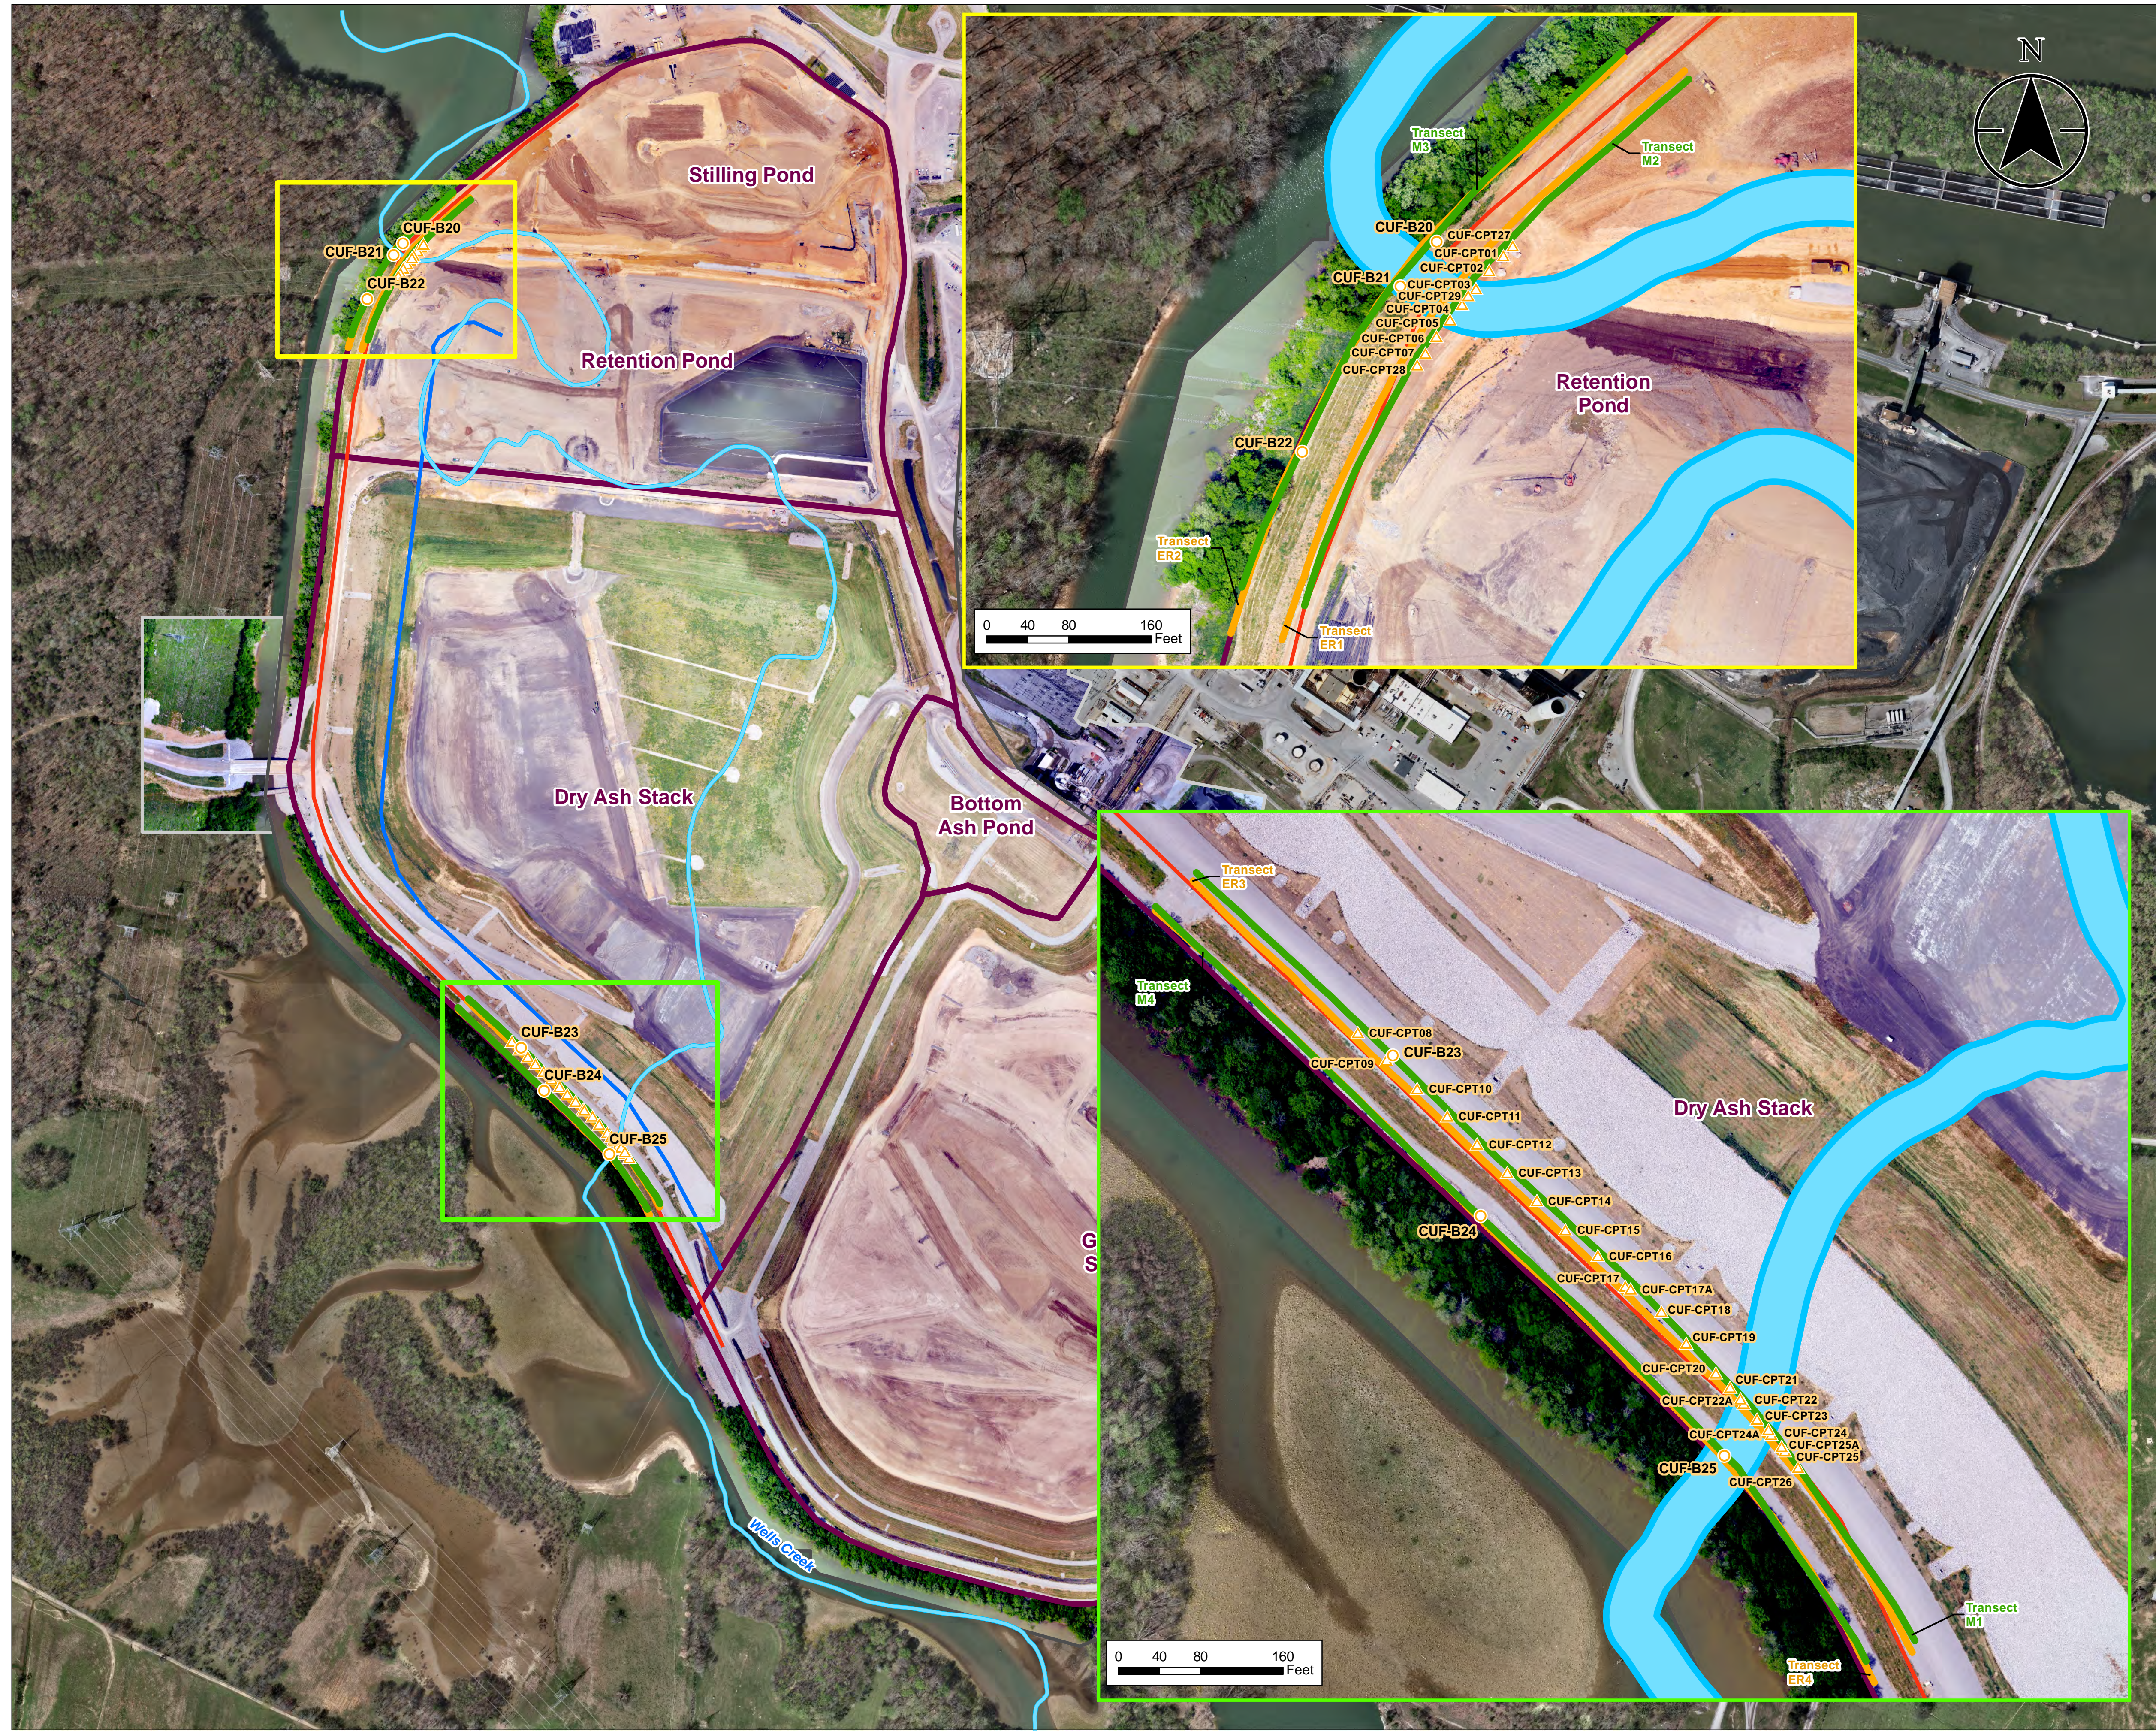
Exhibit No. **G.1-3**
 Title **Cone Penetration Testing, Surface Geophysical Surveys, and Supplemental Geotechnical Borings**
 Client/Project Tennessee Valley Authority
 Cumberland Fossil (CUF) Plant TDEC Order

- Notes**
1. Coordinate System: NAD 1983 StatePlane Tennessee FIPS 4100 Feet
 2. Imagery Provided by Tuck Mapping (c. 2017) and TVA (5/21/2021 and 5/12/2022)
 3. Location of performed CPTs were surveyed by the RLS Group on 04/29/2019. The location of the geotechnical borings were surveyed by DDS Engineering on 09/22/2020 and 12/01/2020.
 4. Electrical Resistivity Imaging (ERI) and Multichannel Analysis of Surface Waves (MASW) surveys were conducted by ARM Geophysics at the transect locations along the raised dike crest and the remnant starter dike crest. Transect locations were based on handheld GPS coordinates by ARM Geophysics at the time of the surveys.

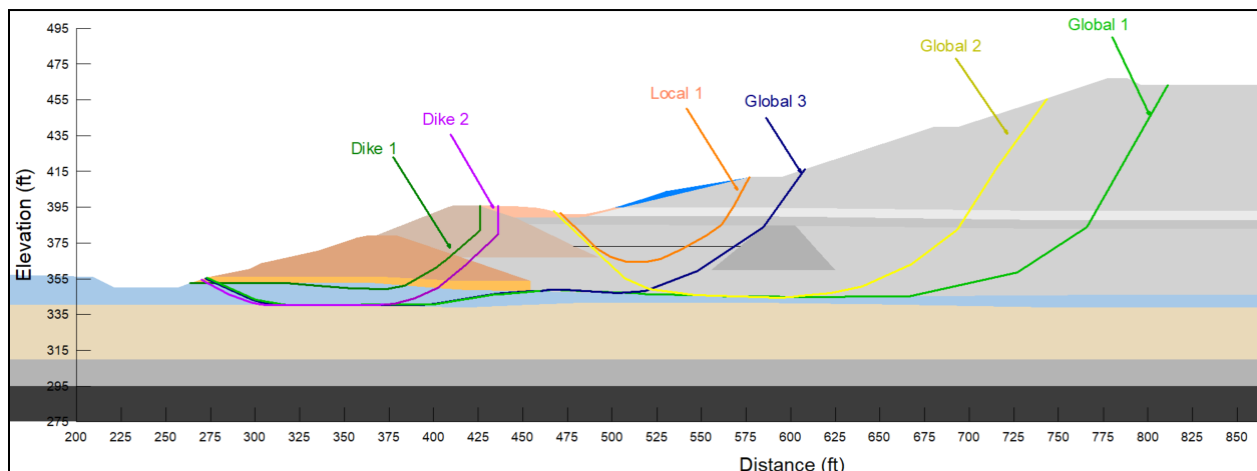
Figure 3. Convention used to Label Slip Surfaces

Geocomp performed two-dimensional non-linear ground amplification analyses as well as static, pseudo-static, and post-earthquake slope stability analyses for the three selected cross sections. Cross Section C-C' at DFAS was evaluated for existing conditions. Cross Section F-F', which showed the lowest FOS for static loading among other sections analyzed in prior assessments, was evaluated for the existing and future stacking conditions. Cross section JK-JK' at GDC was evaluated for proposed regraded Dike 3. The ground amplification analyses were performed using the finite element software OpenSees. For Cross Sections C-C' and F-F', the amplification analysis results conducted in 2019 assessment were utilized because the geometry change related to new buttress with respect to the complete geometry of the cross section was not significant for seismic considerations. For a new and hybrid Cross Section JK-JK', updated amplification analyses were conducted to determine the displacement compatible pseudo-static coefficients. All slope stability analyses were performed using the commercial limit equilibrium analysis software Slope/W by Geoslope International with the Spencer method. Figure 3 shows the slip surface convention used for presenting the stability results.

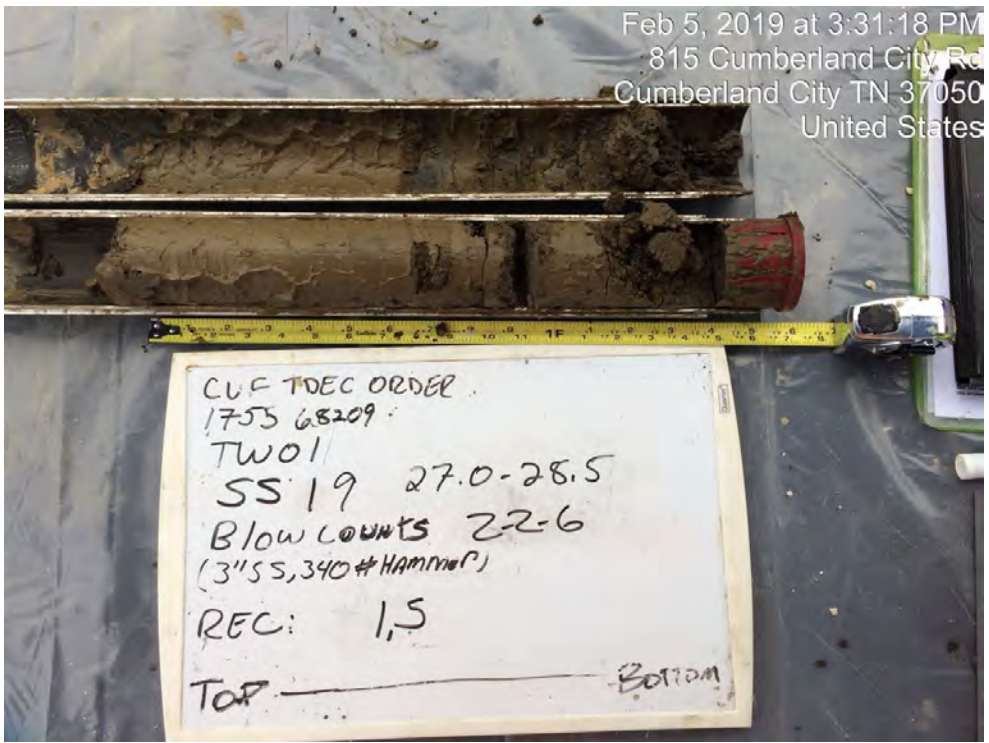
Photograph ID: 19

Feb 5, 2019 at 3:31:18 PM 815 Cumberland City Rd Cumberland City TN 37050 United States
Photo Location: CUF-TW01		
Photo Date: 2/5/2019		
Comments: Interval (27.0-28.5 feet).

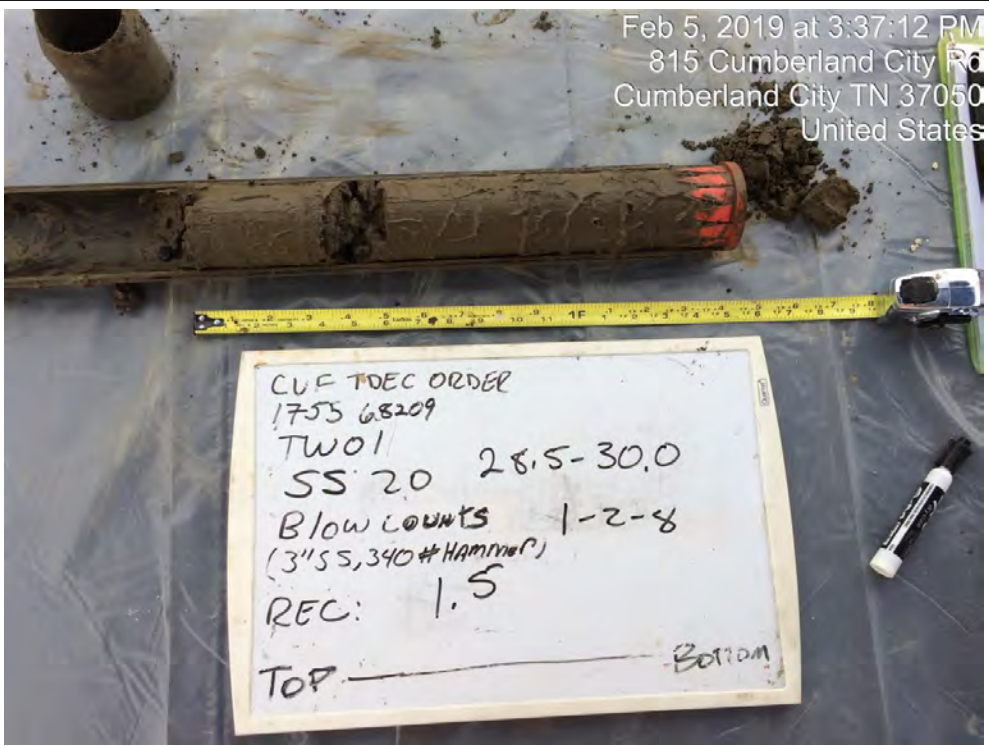
Photograph ID: 20

Feb 5, 2019 at 3:37:12 PM 815 Cumberland City Rd Cumberland City TN 37050 United States
Photo Location: CUF-TW01		
Photo Date: 2/5/2019		
Comments: Interval (28.5-30.0 feet).

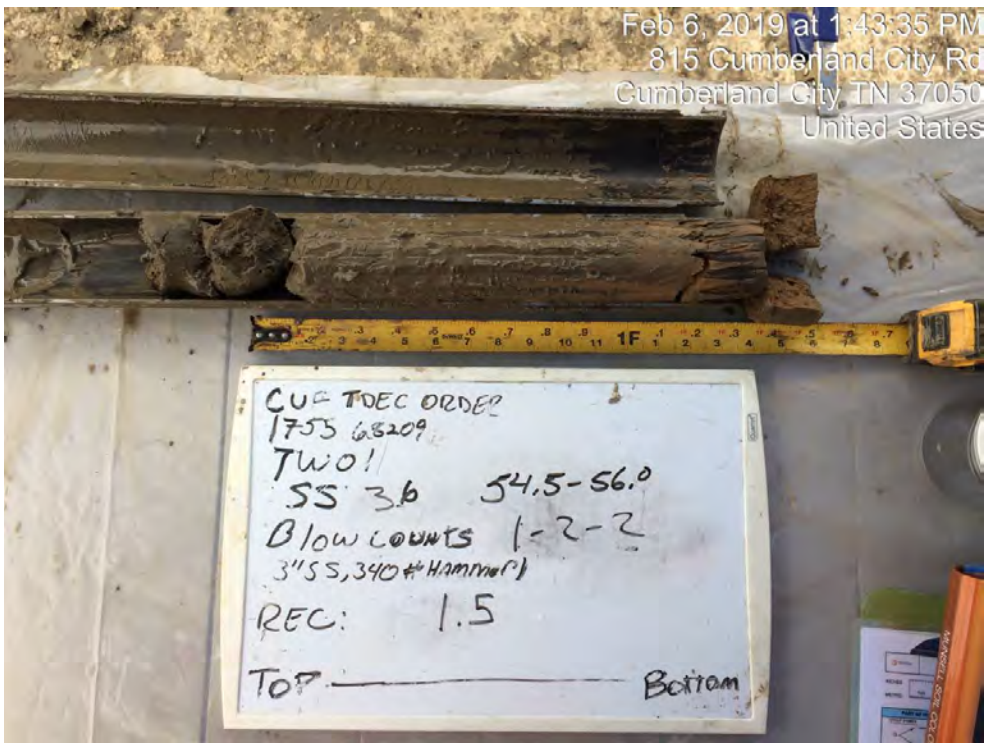
Photograph ID: 38

Photo Location: CUF-TW01	
Photo Date: 2/6/2019	
Comments: Interval (54.5-56.0 feet).

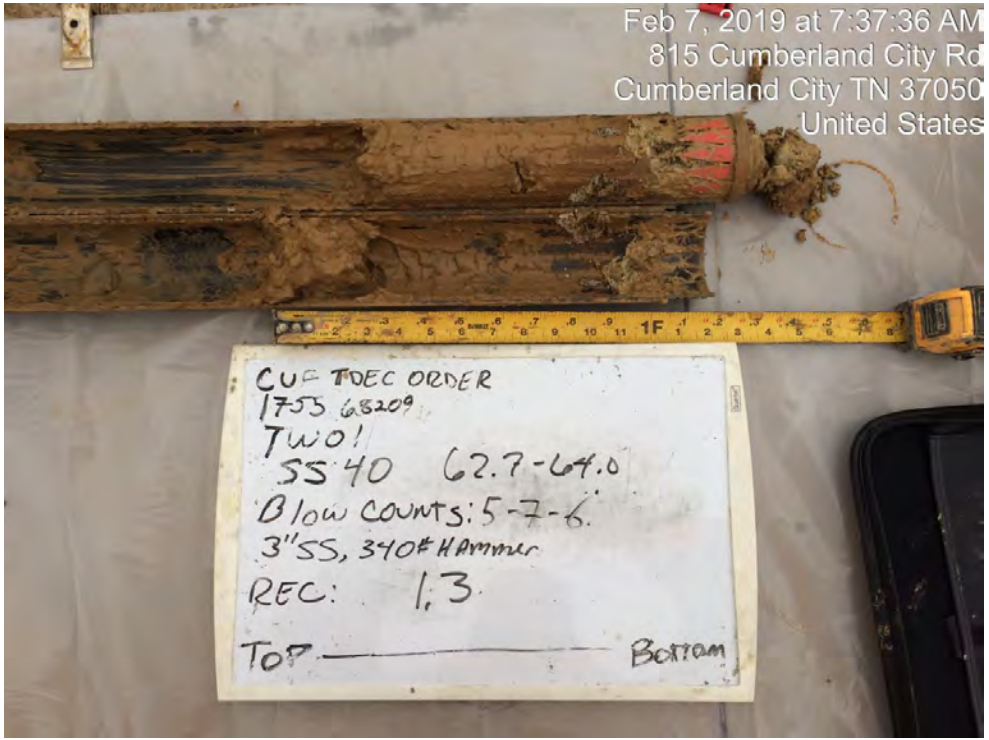
Photograph ID: 44

Photo Location: CUF-TW01	
Photo Date: 2/7/2019	
Comments: Interval (62.7-64.0 feet).

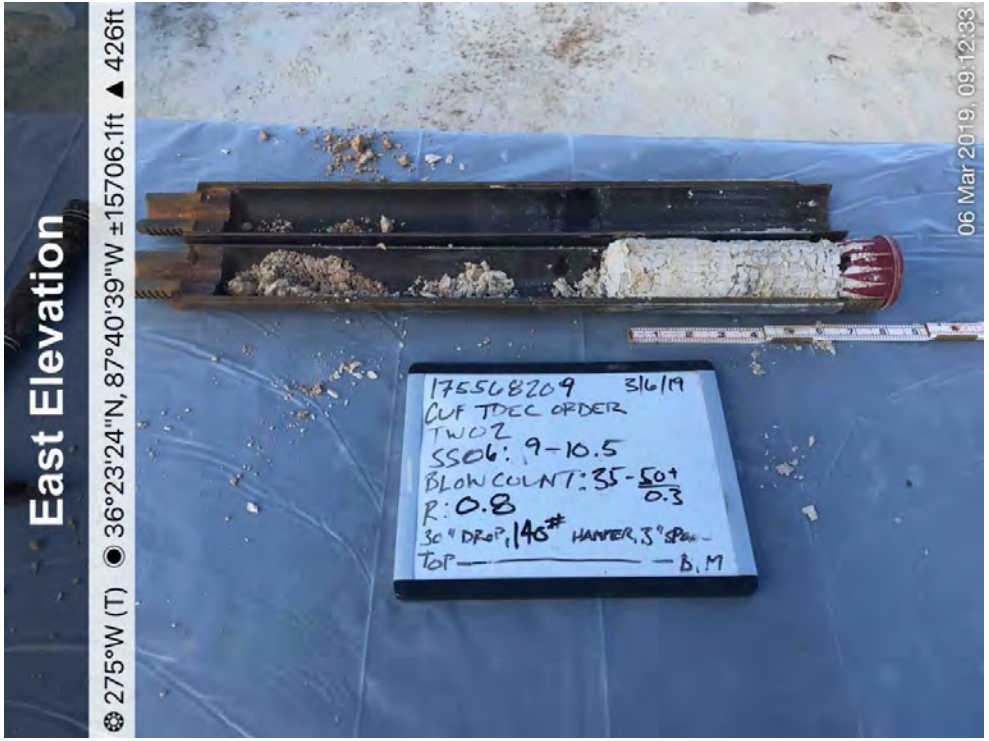
<p>Photograph ID: 55</p> <p>Photo Location: CUF-TW02</p> <p>Photo Date: 3/6/2019</p> <p>Comments: Interval (9.0-9.8 feet). Interval shown on white board should be 9.0-9.8 feet. Sampler refusal at 9.8 feet.</p>

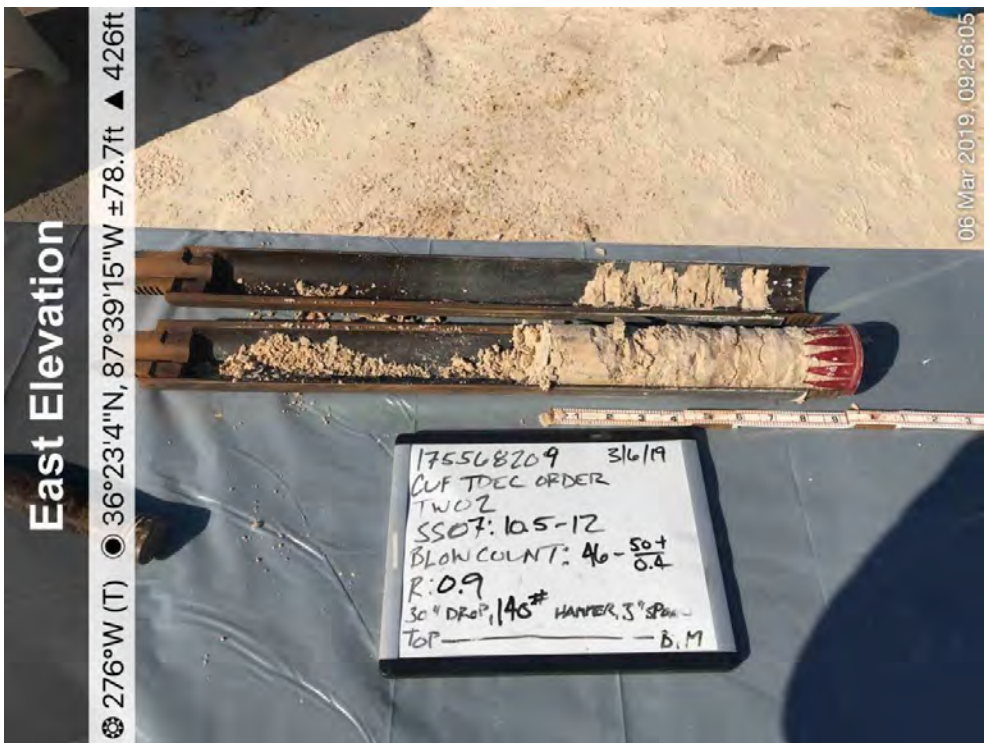
<p>Photograph ID: 56</p> <p>Photo Location: CUF-TW02</p> <p>Photo Date: 3/6/2019</p> <p>Comments: Interval (10.5-11.4 feet). Interval shown on white board should be 10.5-11.4. Sampler refusal at 11.4 feet.</p>

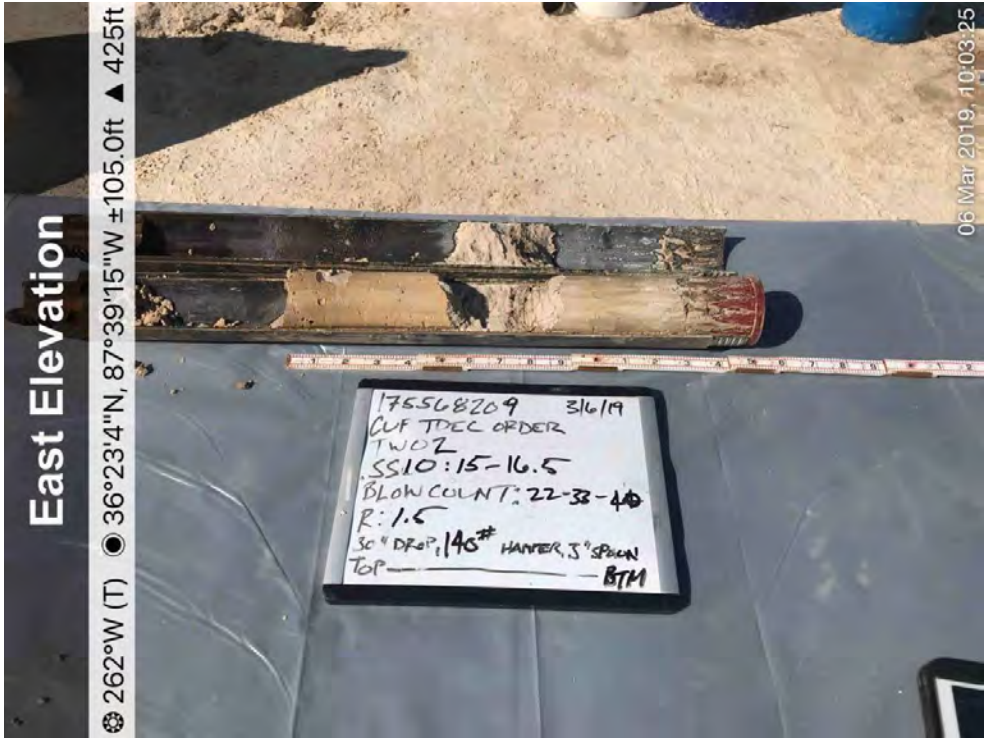
<p>Photograph ID: 59</p> <p>Photo Location: CUF-TW02</p> <p>Photo Date: 3/6/2019</p> <p>Comments: Interval (15.0-16.5 feet). Interval shown on white board should be 15.0-16.5. Blowcount shown on white board is 22-33-40.</p>

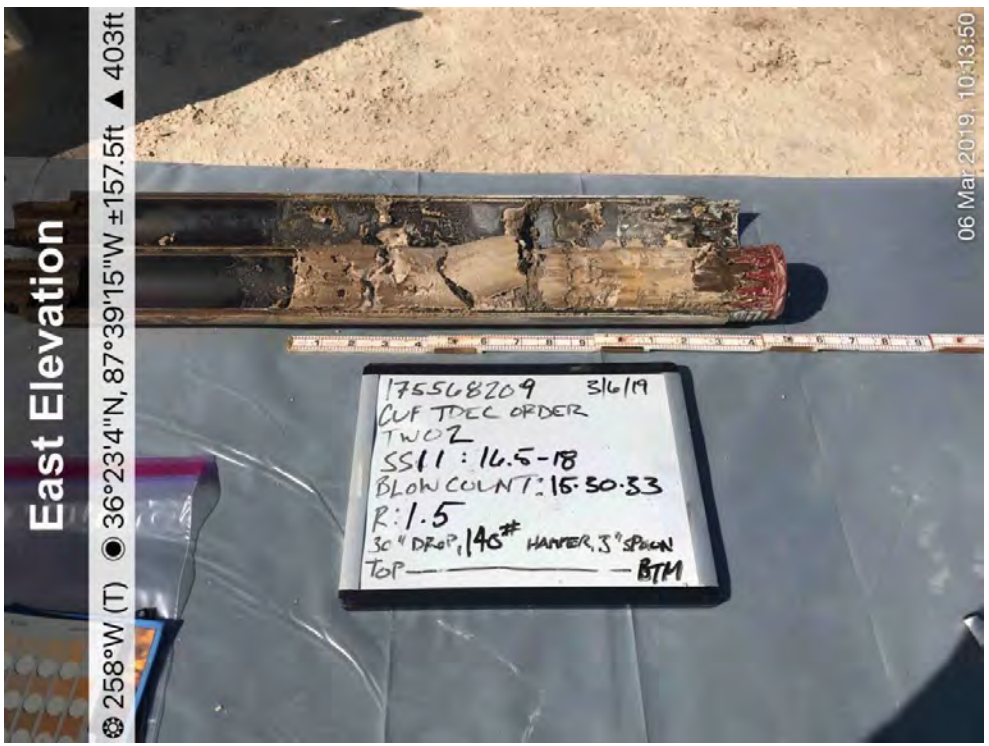
<p>Photograph ID: 60</p> <p>Photo Location: CUF-TW02</p> <p>Photo Date: 3/6/2019</p> <p>Comments: Interval (16.5-18.0 feet). Interval shown on white board should be 16.5-18.0.</p>

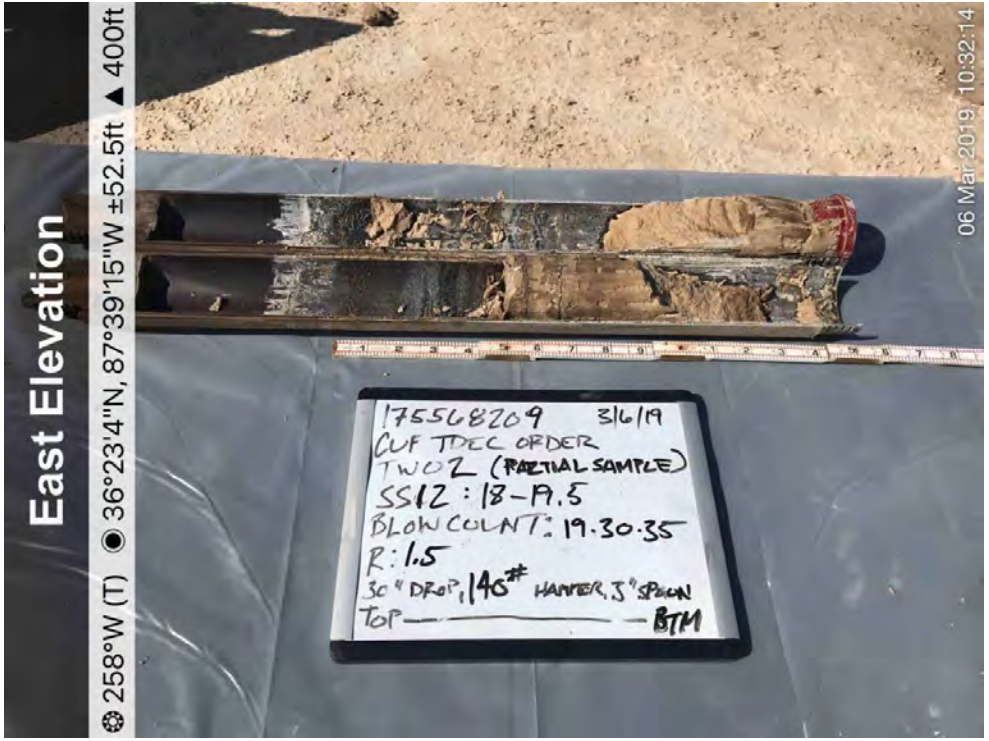
<p>Photograph ID: 61</p> <p>Photo Location: CUF-TW02</p> <p>Photo Date: 3/6/2019</p> <p>Comments: Interval (18.0-19.5 feet). Interval shown on white board should be 18.0-19.5.</p>

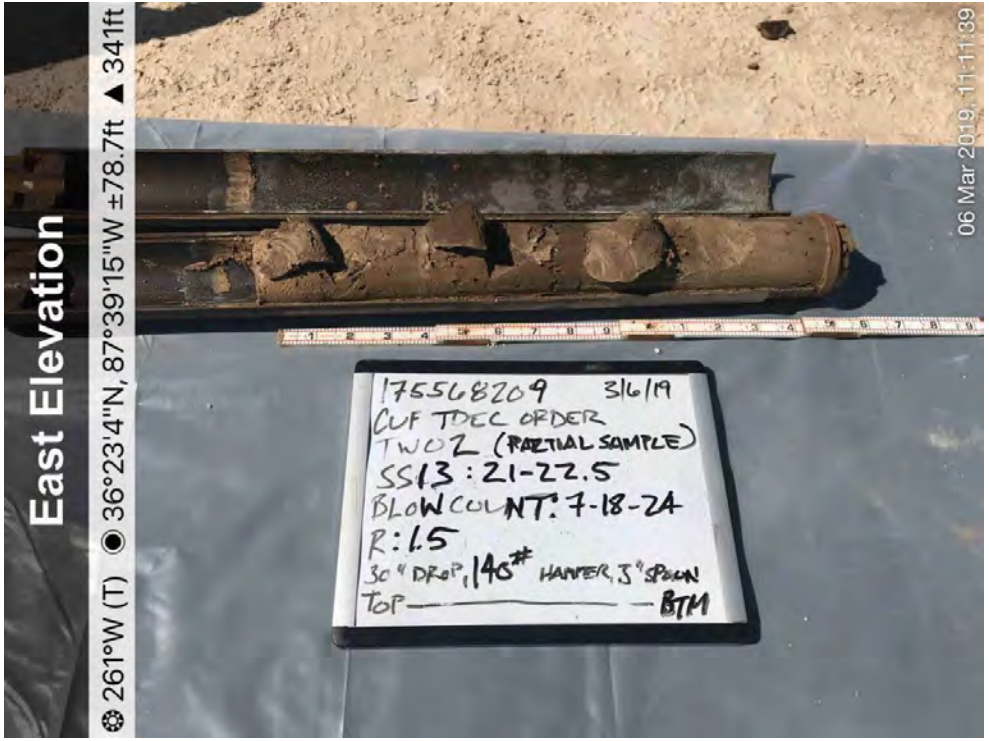
<p>Photograph ID: 63</p> <p>Photo Location: CUF-TW02</p> <p>Photo Date: 3/6/2019</p> <p>Comments: Interval (21.0-22.5 feet). Interval shown on white board should be 21.0-22.5.</p>

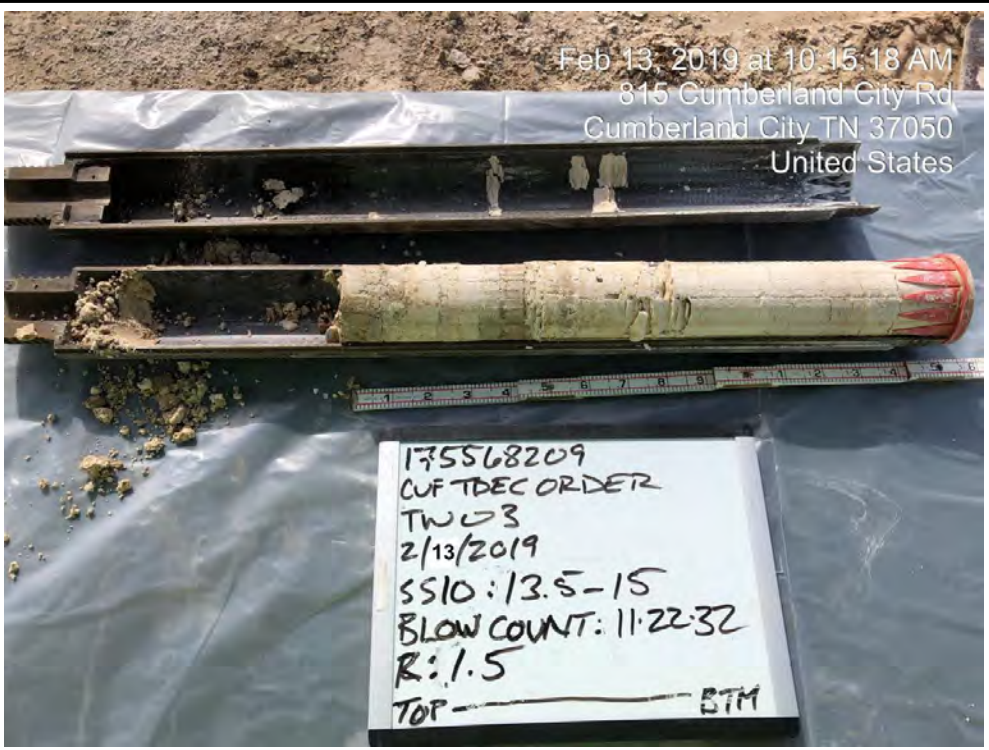
Photograph ID: 76

Photo Location: CUF-TW03	
Photo Date: 2/13/2019	
Comments: Interval (13.5-15.0 feet). Interval shown on white board should be 13.5-15.0.

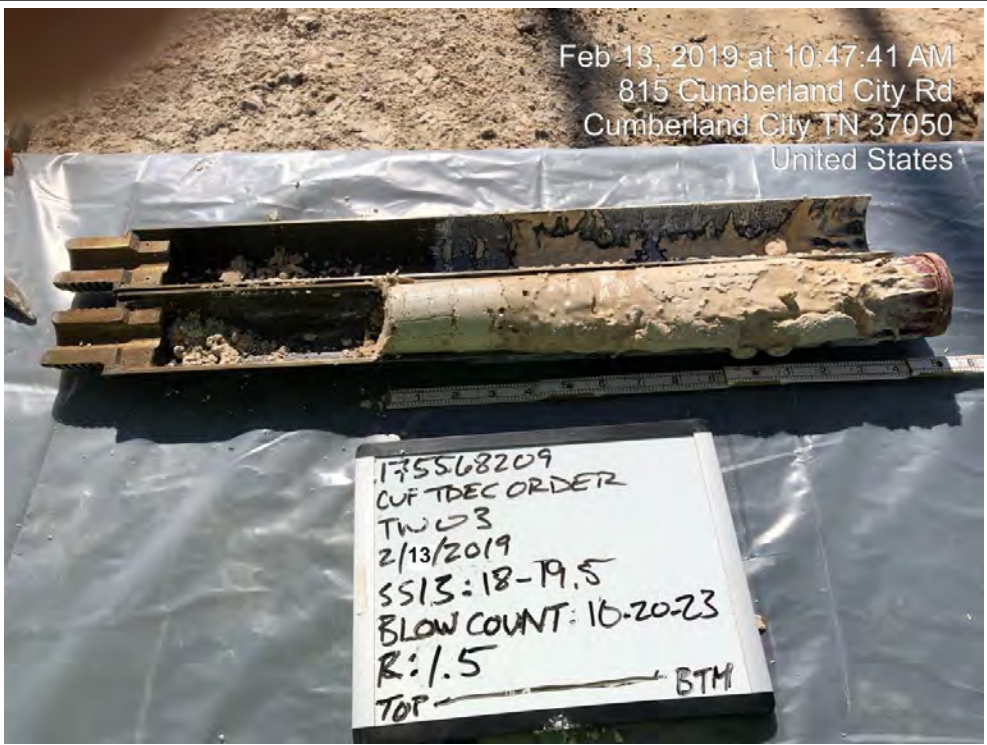
Photograph ID: 79	Feb 13, 2019 at 10:47:41 AM 815 Cumberland City Rd Cumberland City TN 37050 United States
Photo Location: CUF-TW03	
Photo Date: 2/13/2019	
Comments: Interval (18.0-19.5 feet). Interval shown on white board should be 18.0-19.5.

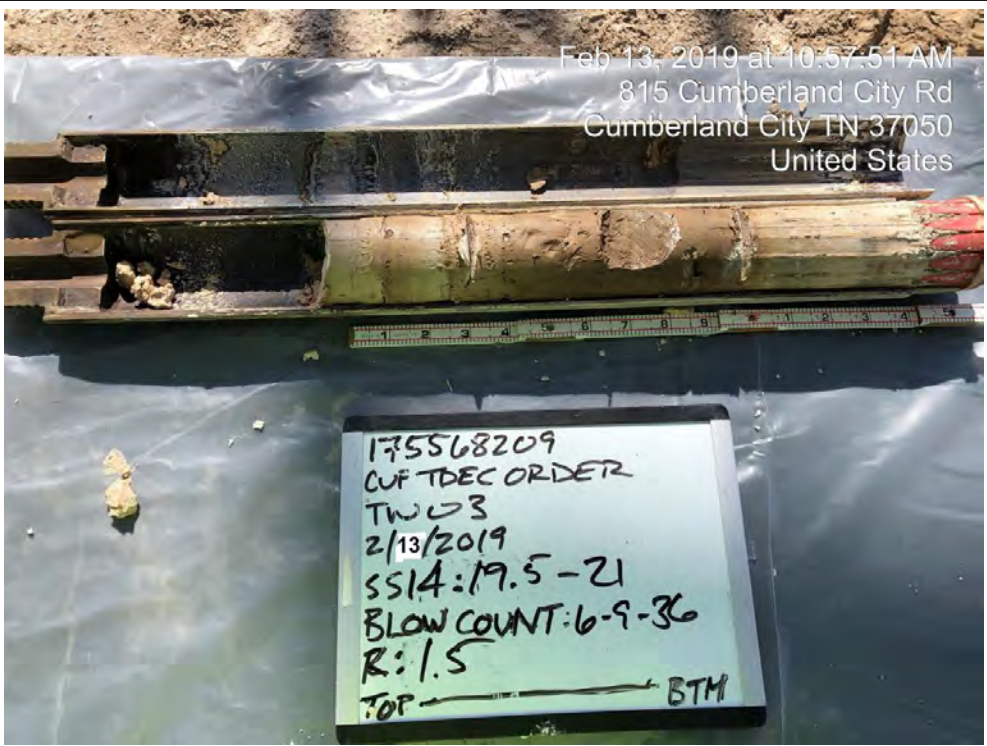
Photograph ID: 80	Feb 13, 2019 at 10:57:51 AM 815 Cumberland City Rd Cumberland City TN 37050 United States
Photo Location: CUF-TW03	
Photo Date: 2/13/2019	
Comments: Interval (19.5-21.0 feet). Interval shown on white board should be 19.5-21.0.

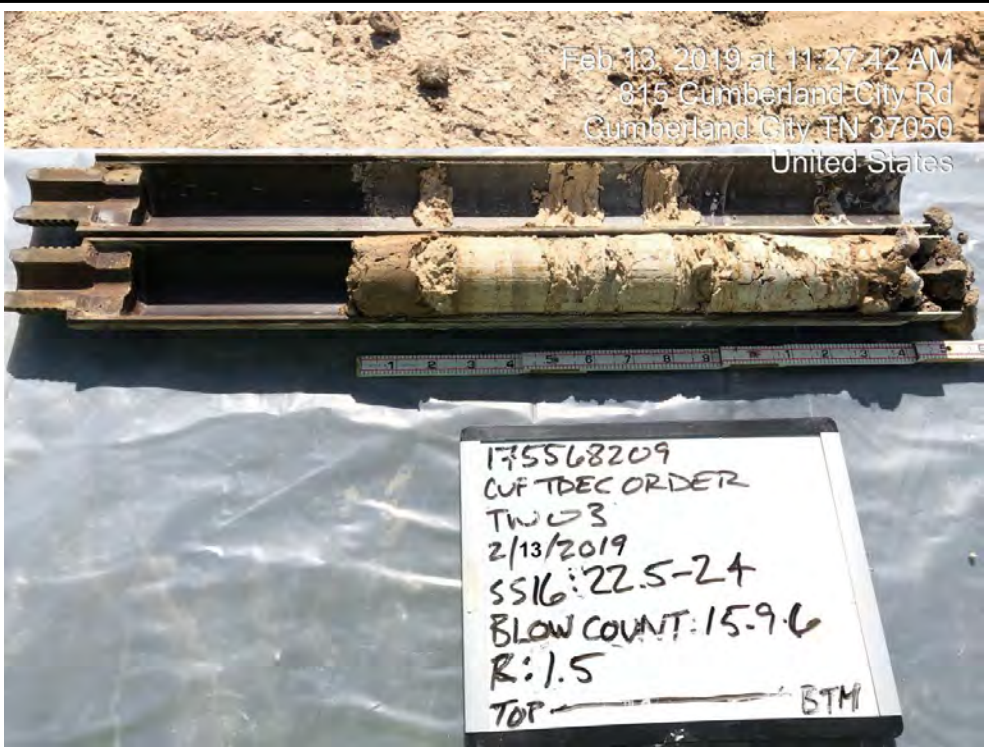
Photograph ID: 82

Photo Location: CUF-TW03	
Photo Date: 2/13/2019	
Comments: Interval (22.5-24.0 feet). Interval shown on white board should be 22.5-24.0.

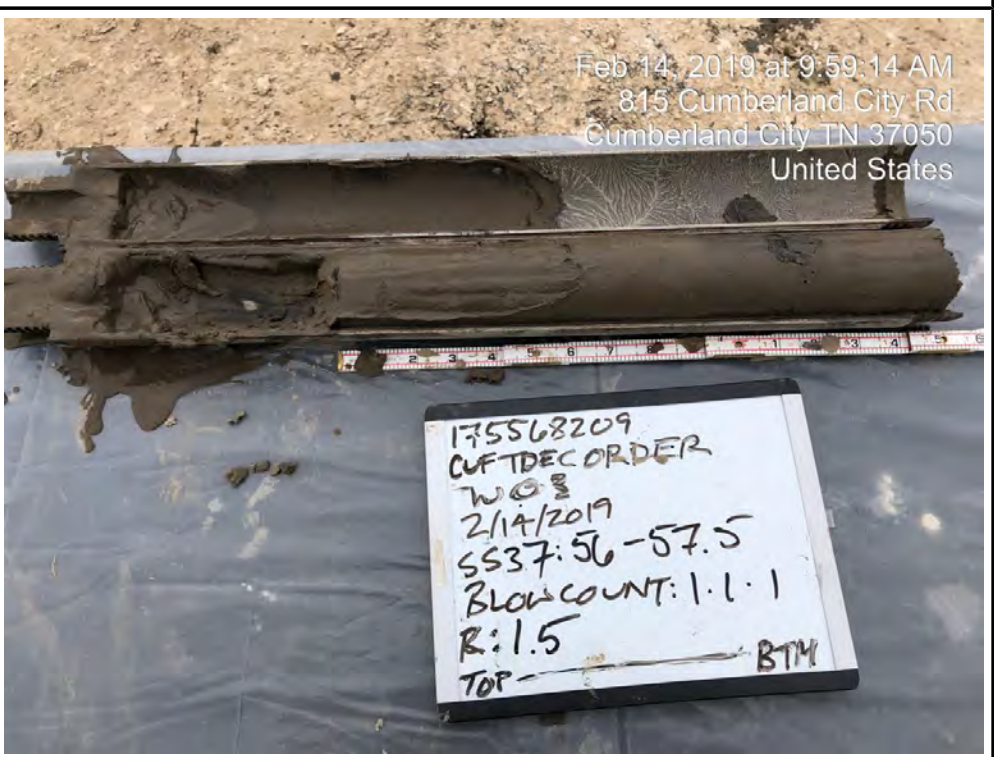
Photograph ID: 104

Photo Location: CUF-TW03	
Photo Date: 2/14/2019	
Comments: Interval (56.0-57.5 feet). Interval shown on white board should be 56.0-57.5.

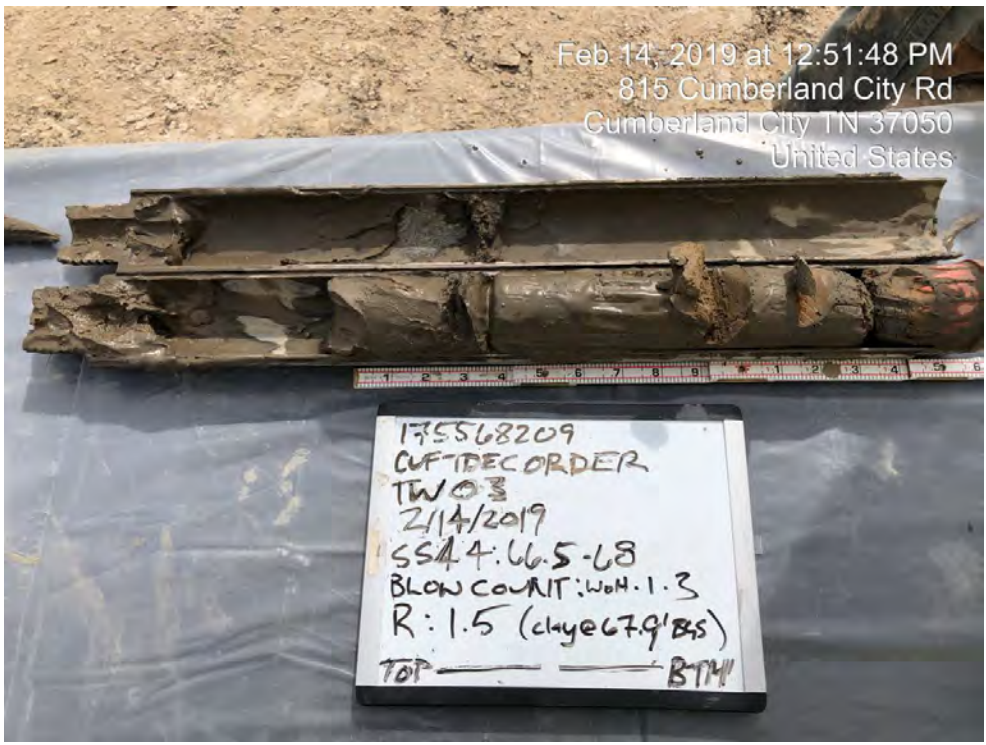
Photograph ID: 111

Photo Location: CUF-TW03	
Photo Date: 2/14/2019	
Comments: Interval (66.5-68.0 feet). Interval shown on white board should be 66.5-68.0. WOH on white board is the same as WH on the boring log.

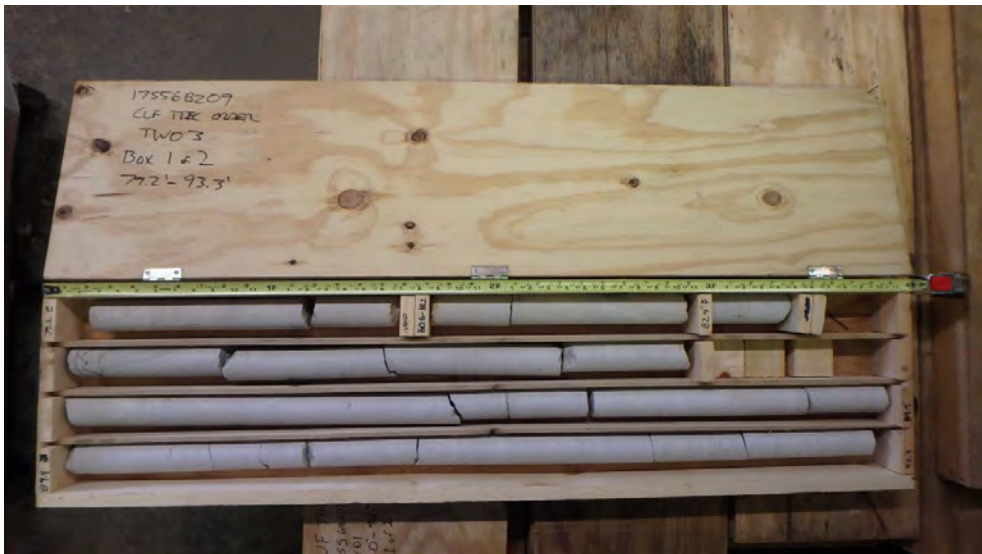
Photo Location: CUF-TW03			
Photo Date: 2/18/2019			
Comments: Interval (79.2-93.3 feet).			
Photograph ID: 118

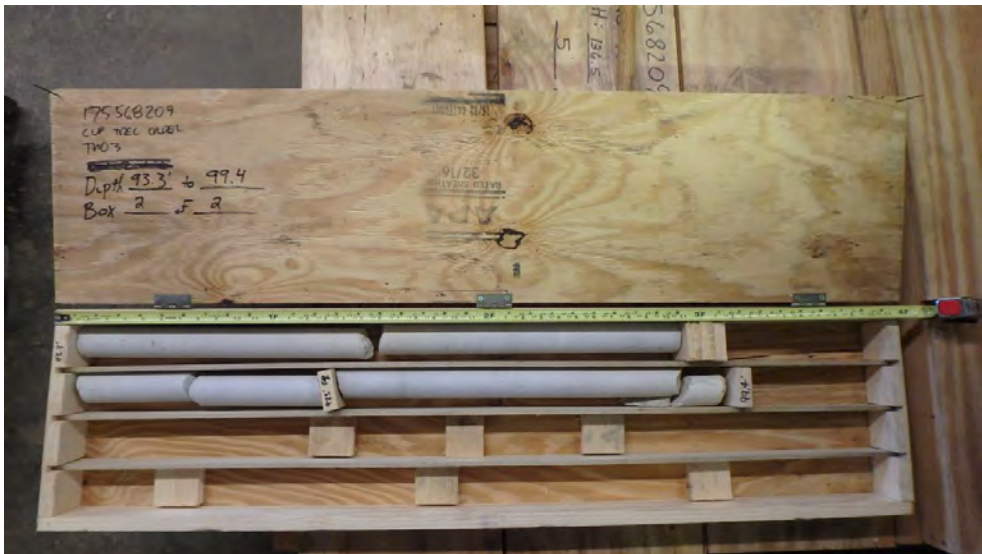
Photo Location: CUF-TW03			
Photo Date: 2/19/2019			
Comments: Interval (93.3-99.4 feet).
