**APPENDIX G –
CCR MATERIAL INVESTIGATIONS**

**Appendix G.1 - Technical
Evaluation of Geotechnical and
CCR Material Characteristics Data**

TDEC Commissioner's Order:
Environmental Assessment Report
Cumberland Fossil Plant
Cumberland, Tennessee

Stantec Consulting Services Inc.
Lexington, Kentucky

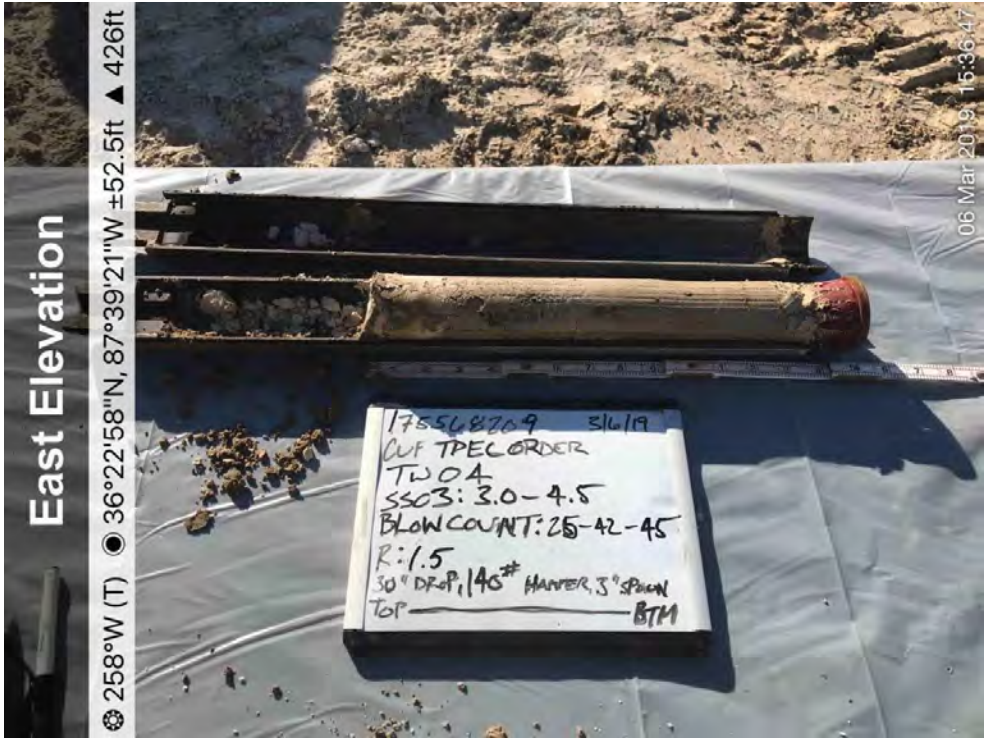
<p>Photograph ID: 121</p> <p>Photo Location: CUF-TW04</p> <p>Photo Date: 3/6/2019</p> <p>Comments: Interval (3.0-4.5 feet). Blowcount shown on white board is 25-42-45.</p>

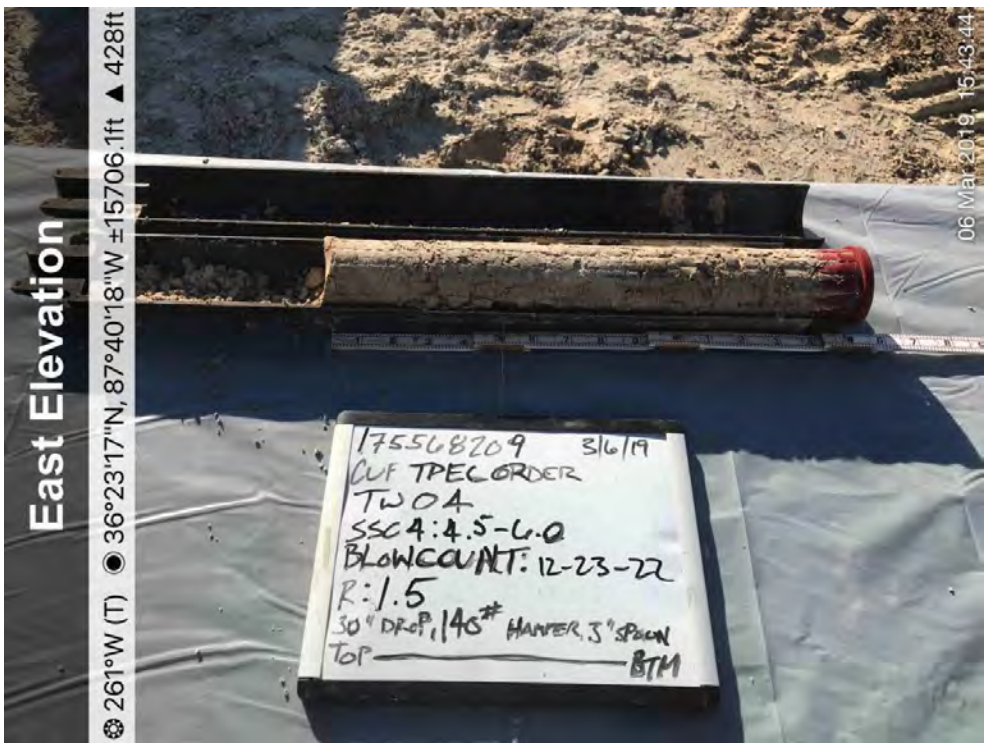
<p>Photograph ID: 122</p> <p>Photo Location: CUF-TW04</p> <p>Photo Date: 3/6/2019</p> <p>Comments: Interval (4.5-6.0 feet).</p>

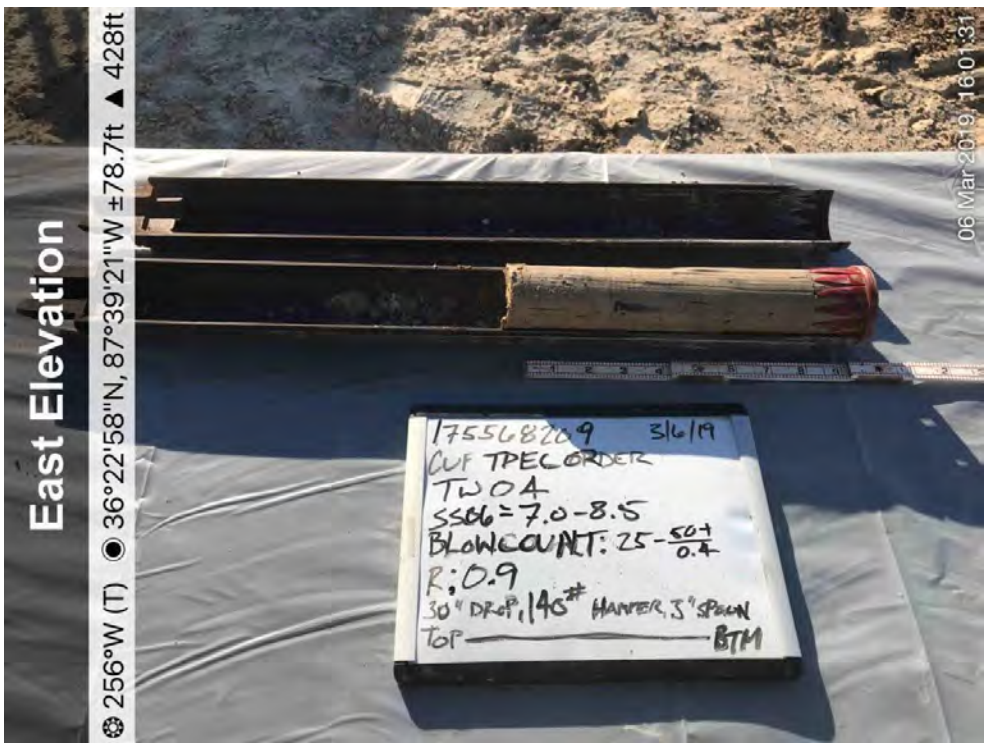
<p>Photograph ID: 124</p> <p>Photo Location: CUF-TW04</p> <p>Photo Date: 3/6/2019</p> <p>Comments: Interval (7.0-7.9 feet). Interval shown on white board should be 7.0-7.9. Sampler refusal at 7.9 feet.</p>

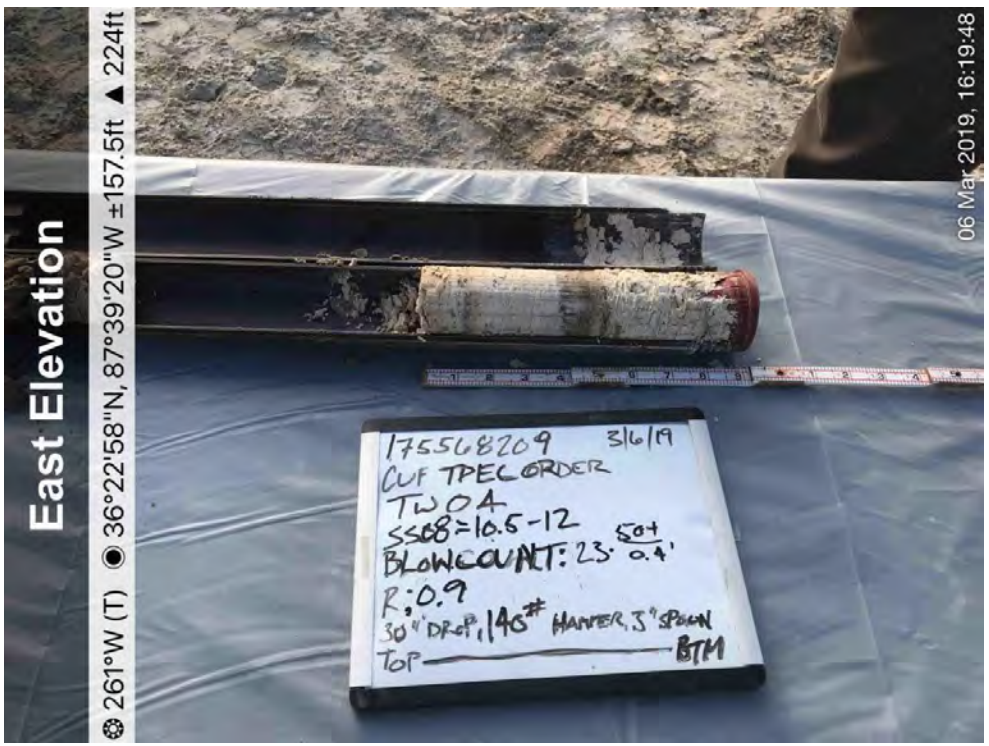
<p>Photograph ID: 126</p> <p>Photo Location: CUF-TW04</p> <p>Photo Date: 3/6/2019</p> <p>Comments: Interval (10.5-11.4 feet). Interval shown on white board should be 10.5-11.4. Sampler refusal at 11.4 feet.</p>

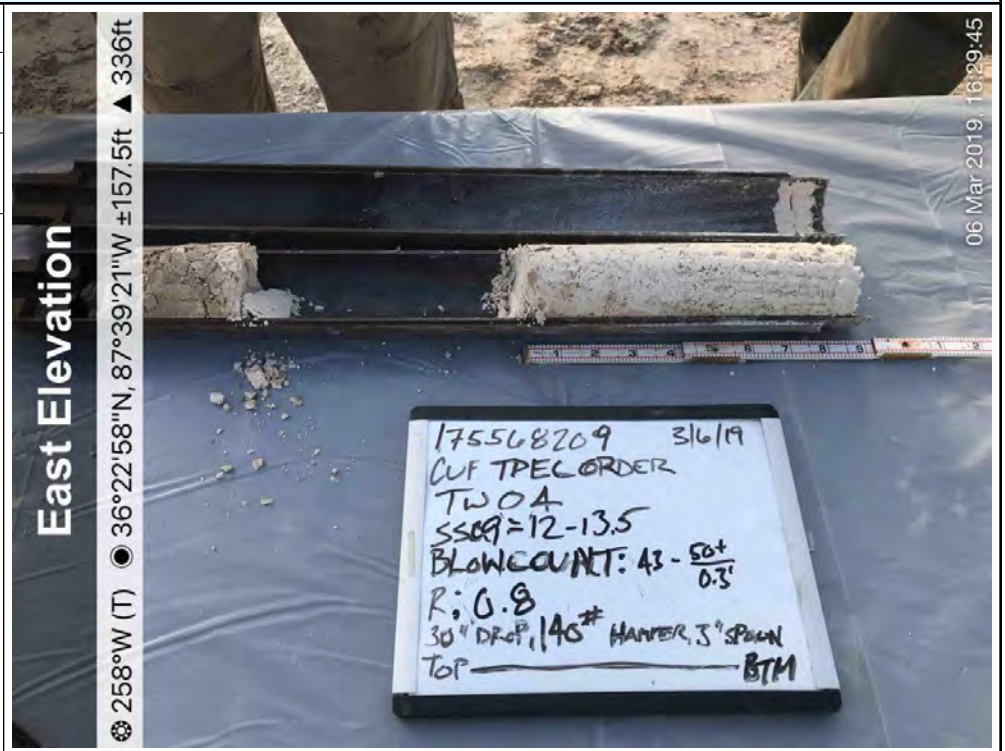
Comments:
Interval (12.0-12.8 feet). Interval shown on white board should be 12.0-12.8. Sampler refusal at 12.8 feet.

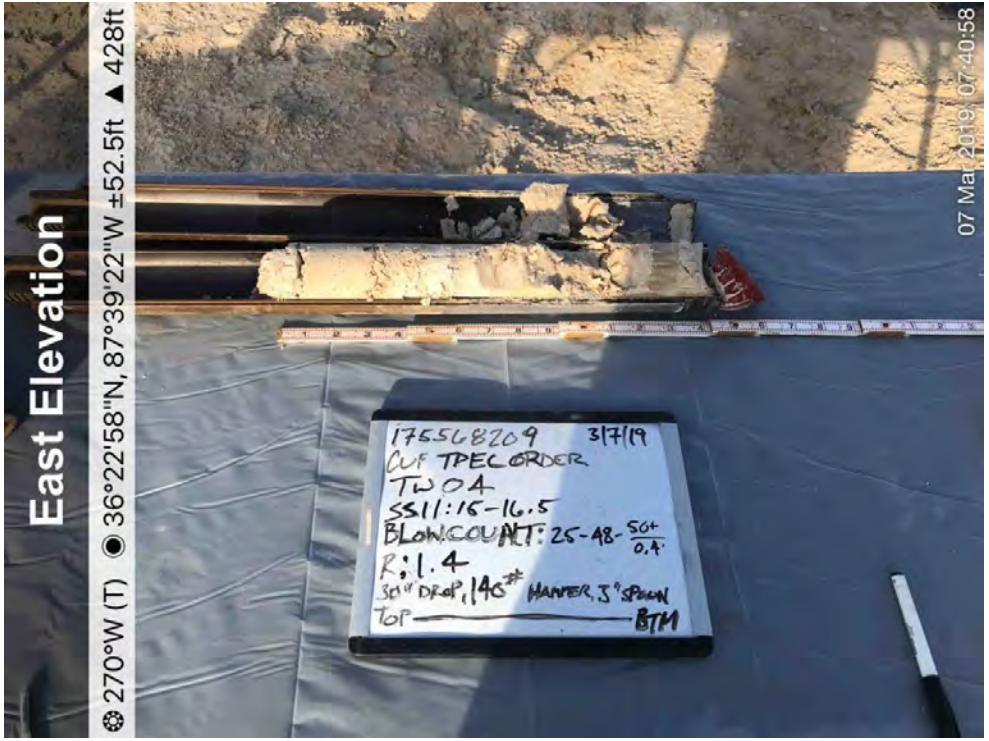
<p>Photograph ID: 129</p> <p>Photo Location: CUF-TW04</p> <p>Photo Date: 3/7/2019</p> <p>Comments: Interval (15.0-16.4 feet). Interval shown on white board should be 15.0-16.4. Sampler refusal at 16.4 feet.</p>

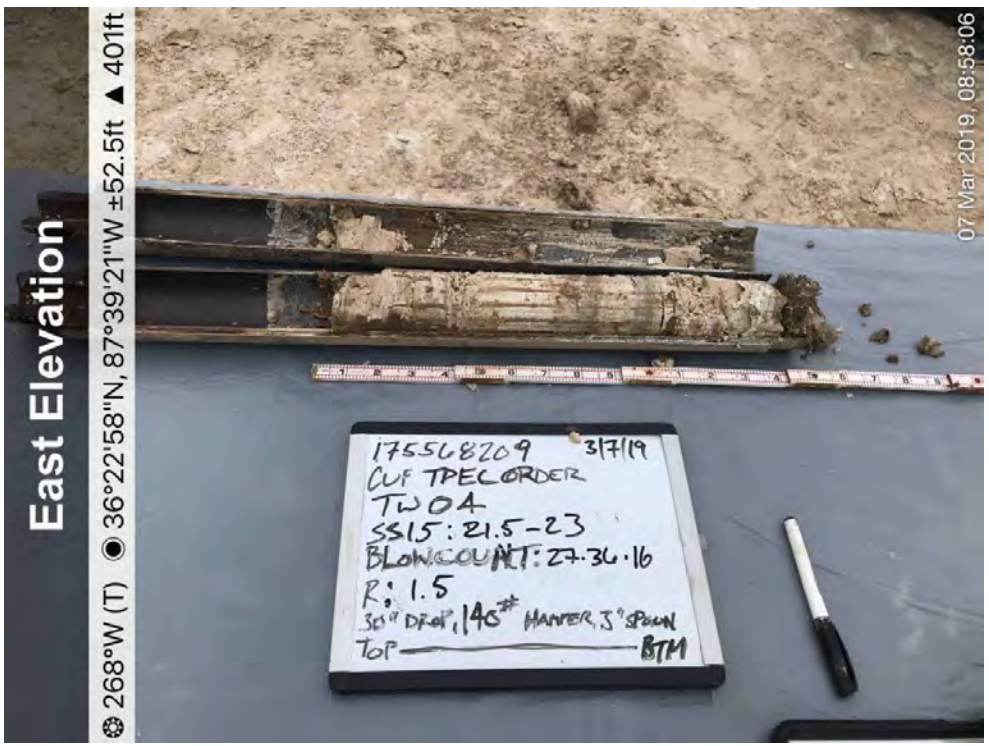
<p>Photograph ID: 134</p> <p>Photo Location: CUF-TW04</p> <p>Photo Date: 3/7/2019</p> <p>Comments: Interval (21.5-23.0 feet). Interval shown on white board should be 21.5-23.0.</p>

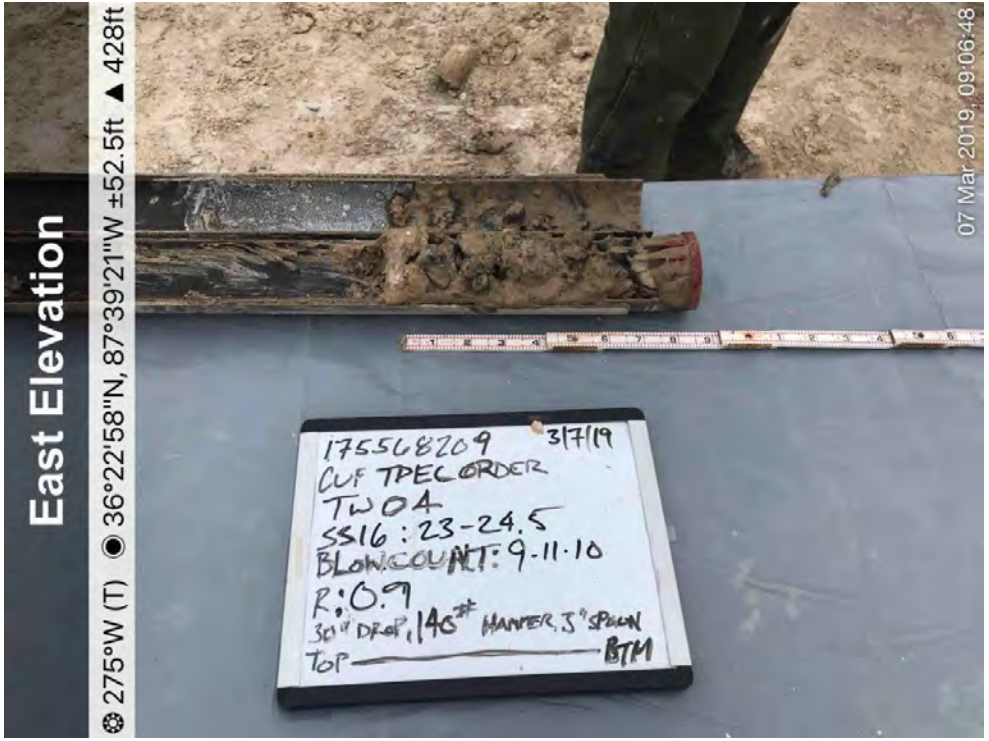
<p>Photograph ID: 135</p> <p>Photo Location: CUF-TW04</p> <p>Photo Date: 3/7/2019</p> <p>Comments: Interval (23.0-24.5 feet). Interval shown on white board should be 23.0-24.5.</p>

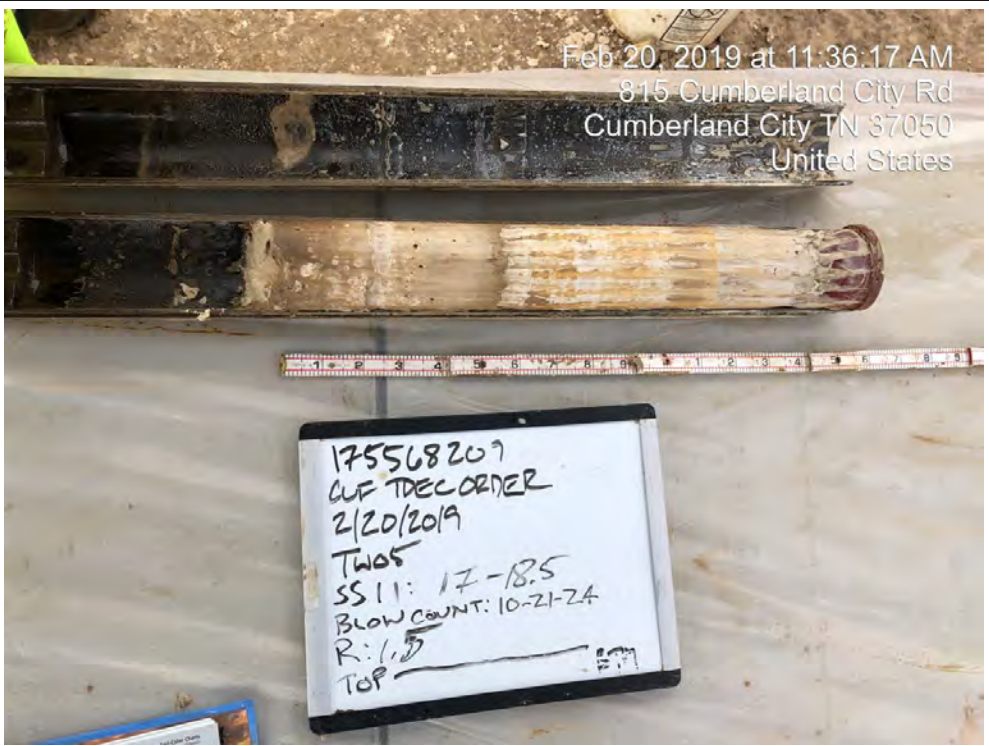
Photograph ID: 148

Photo Location: CUF-TW05	
Photo Date: 2/20/2019	
Comments: Interval (17.0-18.5 feet). Interval shown on white board should be 17.0-18.5.

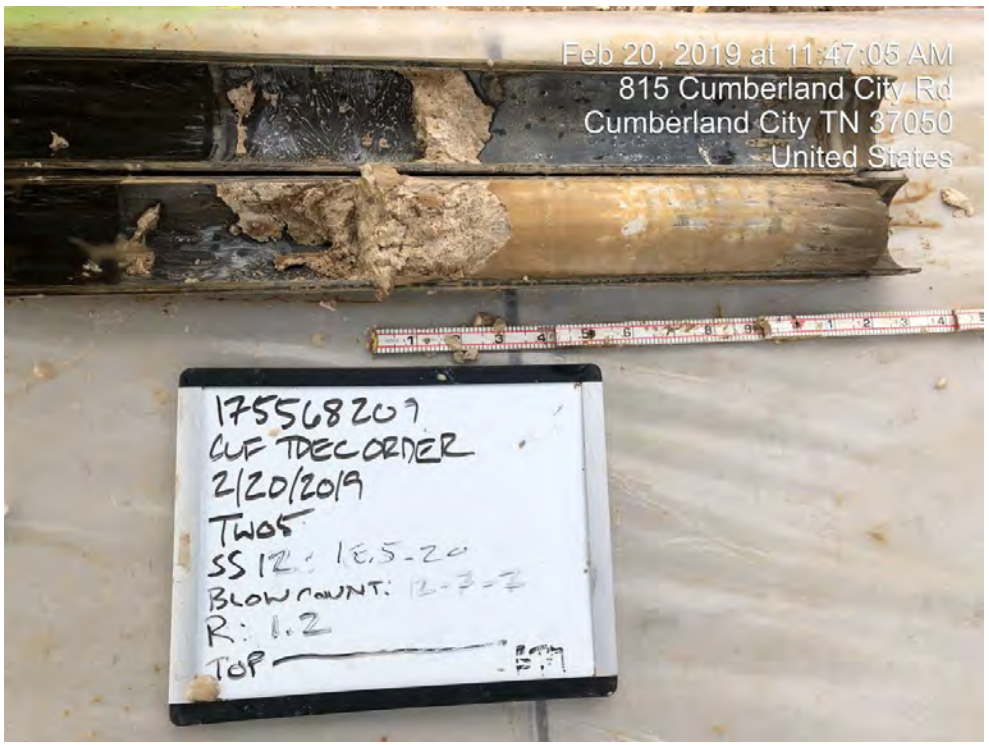
Photograph ID: 149

Photo Location: CUF-TW05	
Photo Date: 2/20/2019	
Comments: Interval (18.5-20.0 feet). Interval shown on white board should be 18.5-20.0. Blowcount shown on white board is 12-7-7.

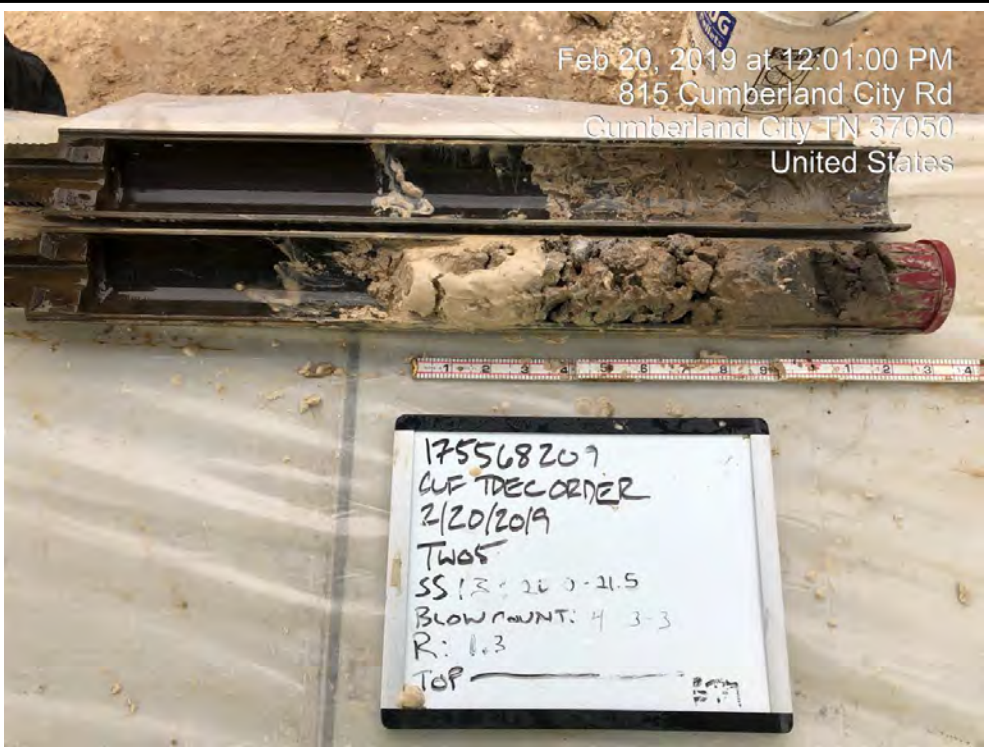
Photograph ID: 150

Photo Location: CUF-TW05	
Photo Date: 2/20/2019	
Comments: Interval (20.0-21.5 feet). Interval shown on white board is 20.0-21.5. Blow count shown on white board is 4-3-3.

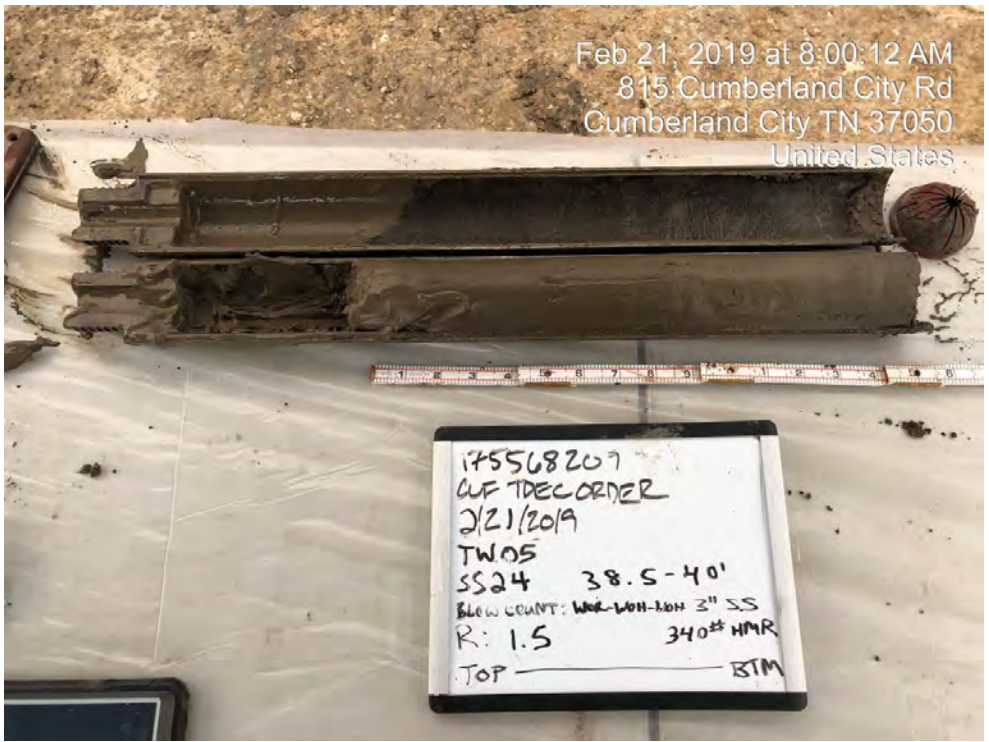
Photograph ID: 162	Feb 21, 2019 at 8:00:12 AM 815 Cumberland City Rd Cumberland City TN 37050 United States
Photo Location: CUF-TW05	
Photo Date: 2/21/2019	
Comments: Interval (38.5-40.0 feet). Interval shown on white board should be 38.5-40.0. WOR and WOH on white board are the same as WR and WH, respectively, on the boring log.

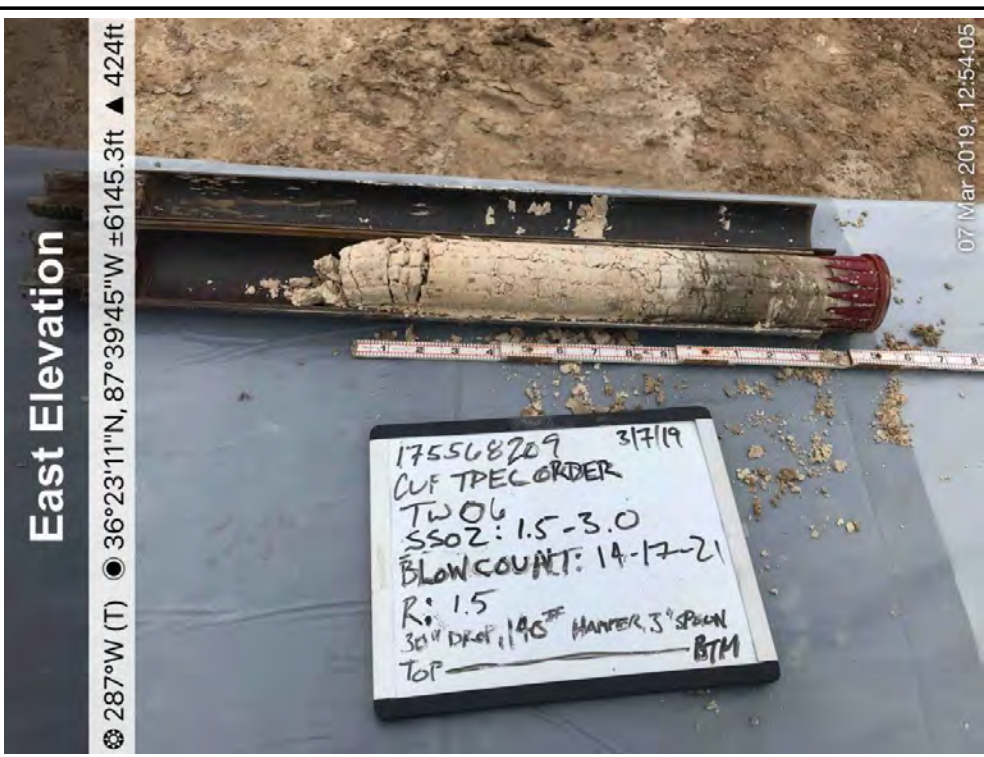
Photograph ID: 186

Photo Location: CUF-TW06	
Photo Date: 3/7/2019	
Comments: Interval (1.5-3.0 feet).

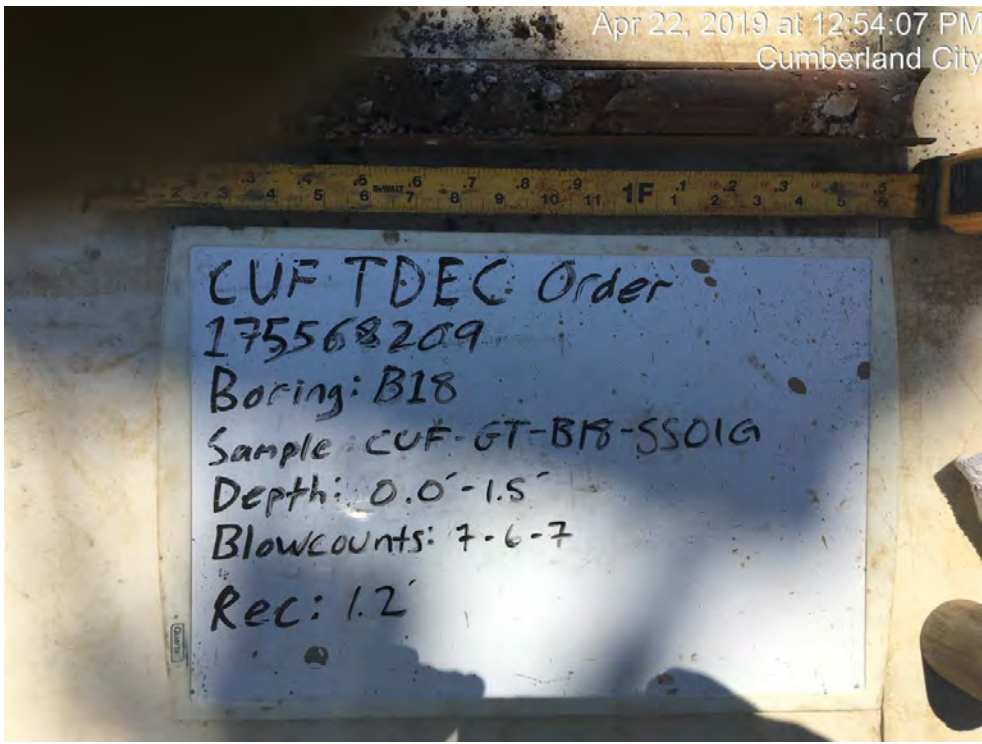
Client:	Tennessee Valley Authority	Project:	CUF TDEC Order
Site Name:	Cumberland Fossil (CUF) Plant	Site Location:	Cumberland City, Tennessee
Photograph ID: 199

<p style="text-align: right;">Apr 22, 2019 at 12:54:07 PM Cumberland City</p>		
Photo Location: CUF-B18			
Photo Date: 4/22/2019			
Comments: Interval (0.0-1.5 feet).			
Photograph ID: 200

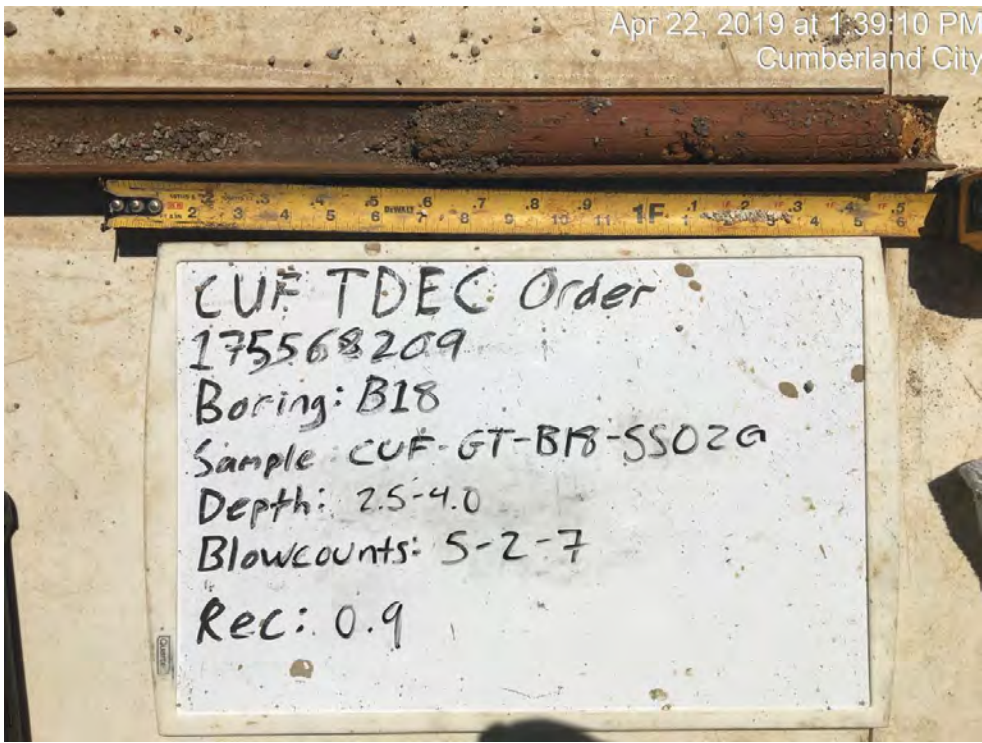
<p style="text-align: right;">Apr 22, 2019 at 1:39:10 PM Cumberland City</p>		
Photo Location: CUF-B18			
Photo Date: 4/22/2019			
Comments: Interval (2.5-4.0 feet).

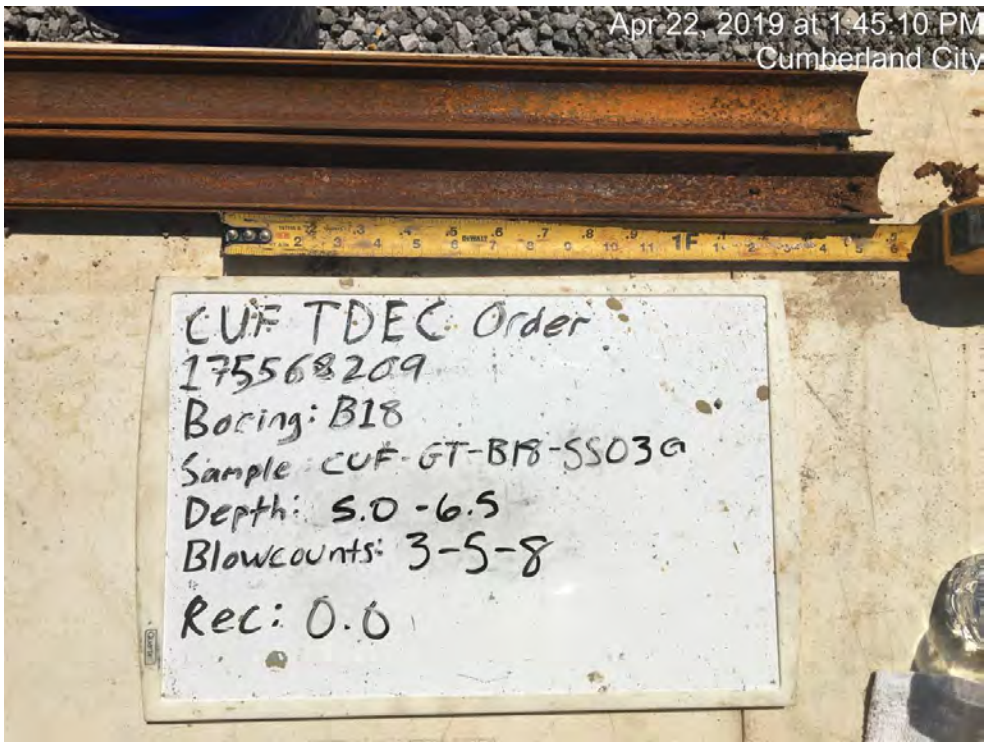
Photograph ID: 201

Photo Location: CUF-B18	
Photo Date: 4/22/2019	
Comments: Interval (5.0-6.5 feet).

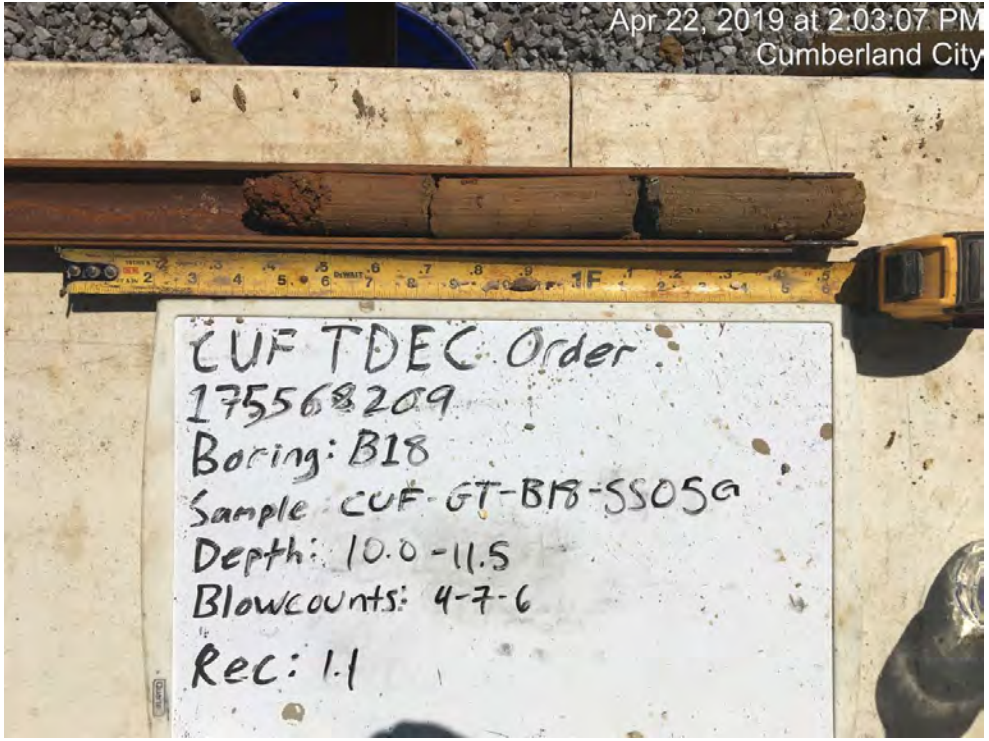
Photograph ID: 203

Photo Location: CUF-B18	
Photo Date: 4/22/2019	
Comments: Interval (10.0-11.5 feet).

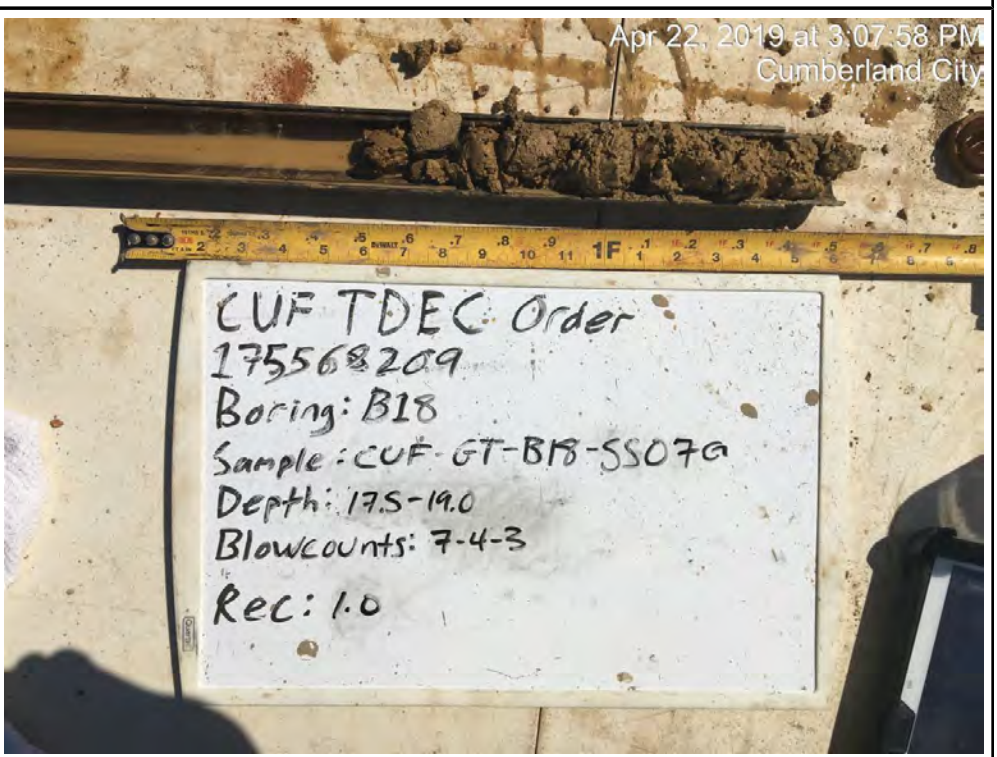
Photograph ID: 206

Photo Location: CUF-B18	
Photo Date: 4/22/2019	
Comments: Interval (17.5-19.0 feet).

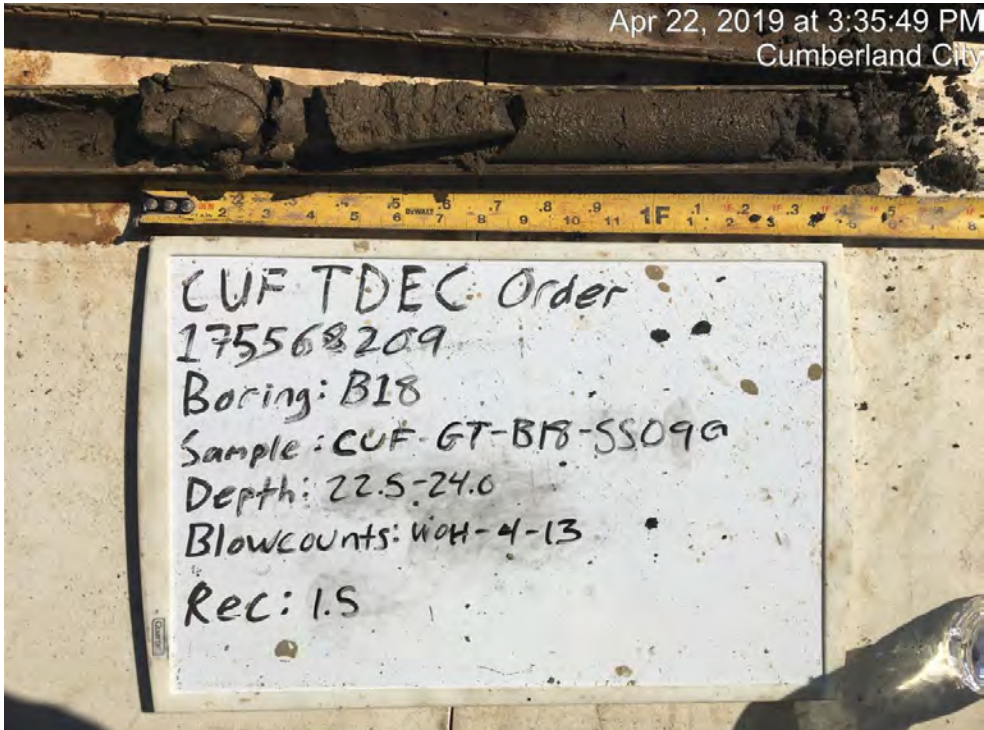
Photograph ID: 208

Photo Location: CUF-B18	
Photo Date: 4/22/2019	
Comments: Interval (22.5-24.0 feet). WOH on white board is the same as WH on the boring log.

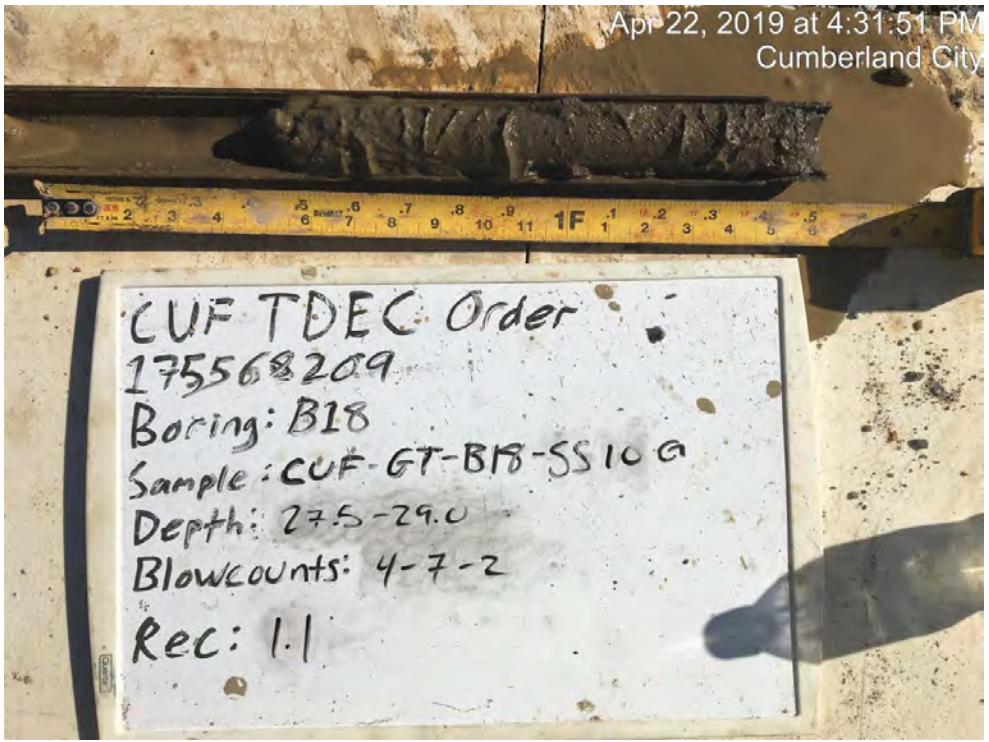
Photograph ID: 210

Photo Location: CUF-B18	
Photo Date: 4/22/2019	
Comments: Interval (27.5-29.0 feet).

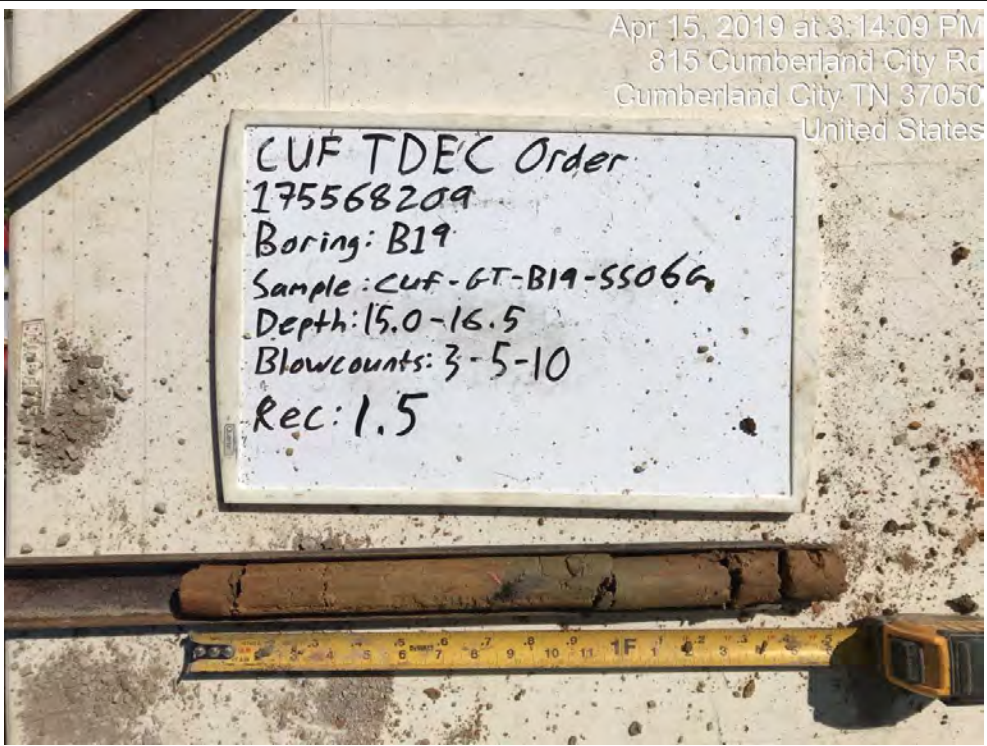
Photograph ID: 226

<p>Apr 15, 2019 at 3:14:09 PM 815 Cumberland City Rd Cumberland City TN 37050 United States</p> <p>CUF TDEC Order 175568209 Boring: B19 Sample: CUF-GT-B19-SS066 Depth: 15.0-16.5 Blowcounts: 3-5-10 Rec: 1.5</p>
Photo Location: CUF-B19	
Photo Date: 4/15/2019	
Comments: Interval (15.0-16.5 feet).

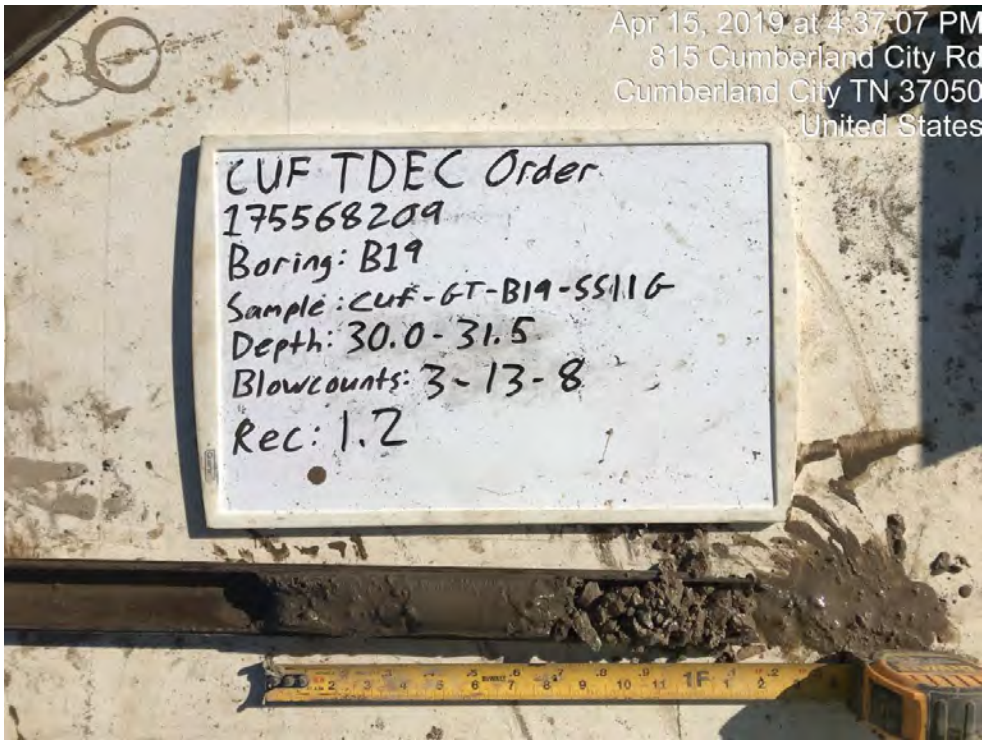
Photograph ID: 232

Photo Location: CUF-B19	
Photo Date: 4/15/2019	
Comments: Interval (30.0-31.5 feet). Blowcount shown on white board should be 3-8-13.

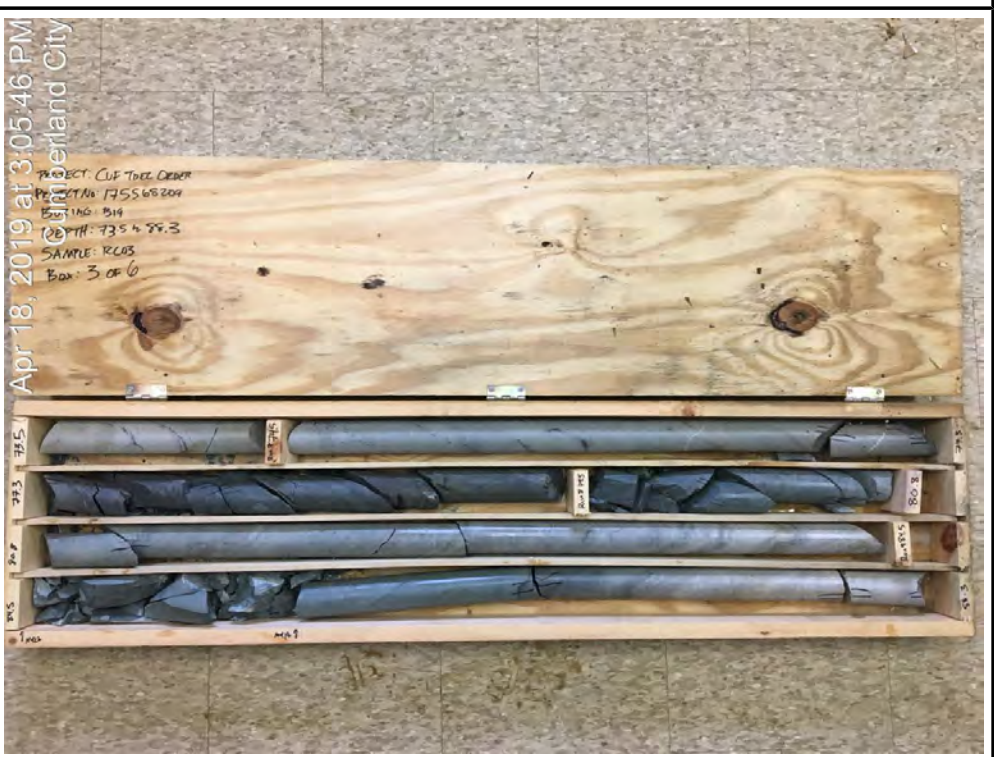
Photograph ID: 240

Photo Location: CUF-B19	
Photo Date: 4/17/2019	
Comments: Interval (73.5-88.3 feet). Metadata date reflects the date the photo was taken, not the date the core was drilled.

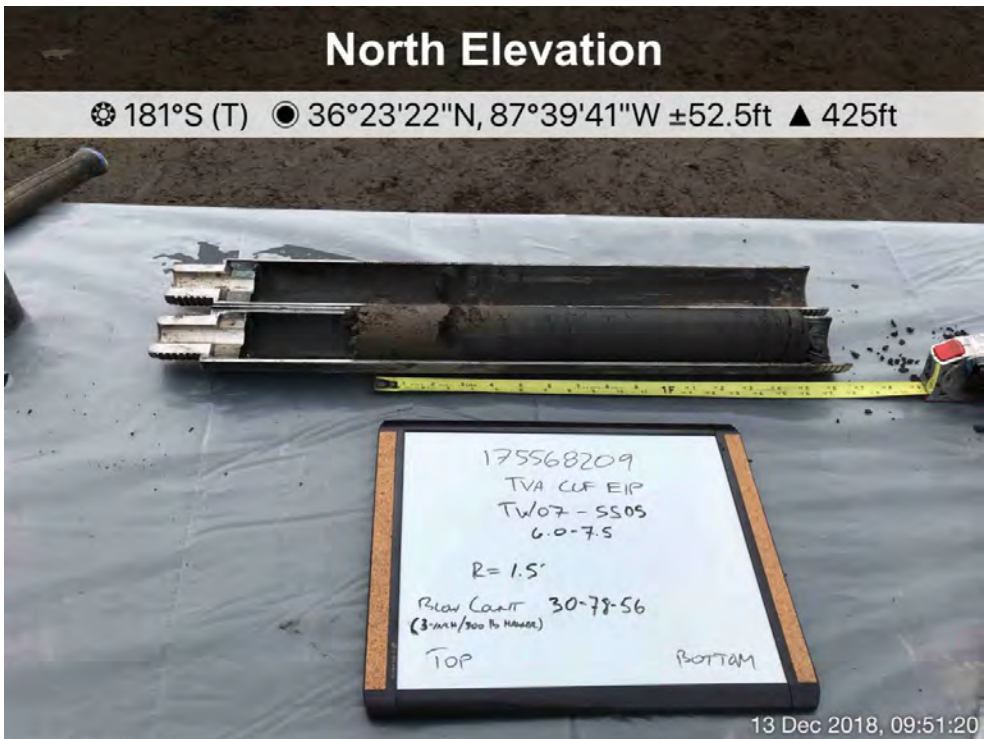
Photograph ID: 5

Photo Location: CUF-TW07	
Photo Date: 12/13/2018	
Comments: Interval (6.0-7.5 feet).

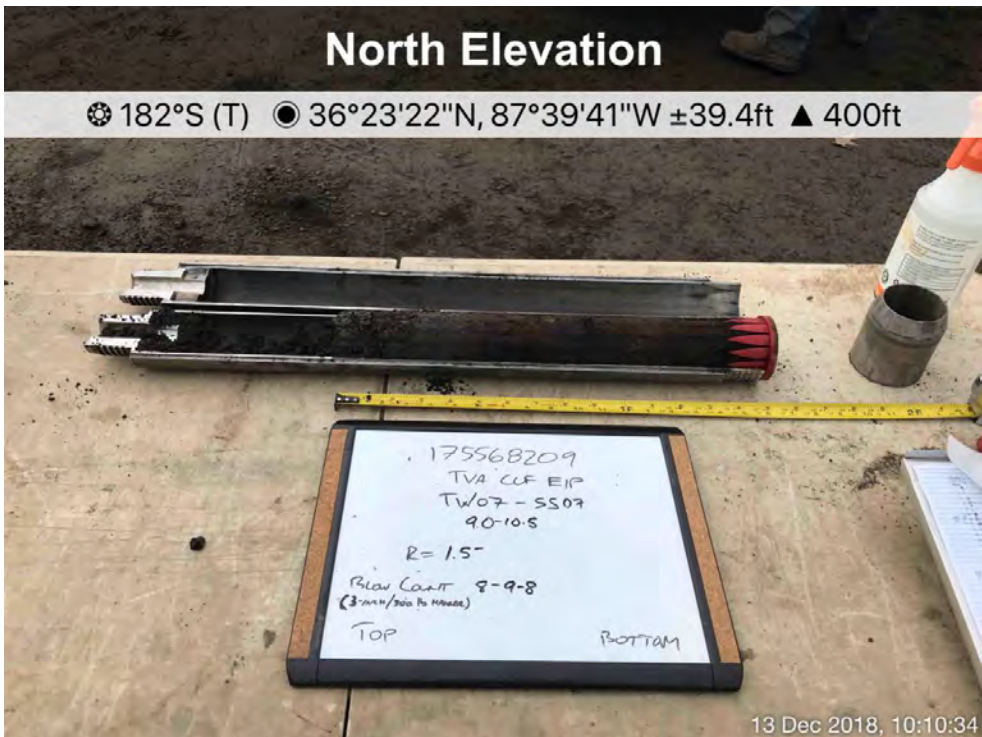
Photograph ID: 7

Photo Location: CUF-TW07	
Photo Date: 12/13/2018	
Comments: Interval (9.0-10.5 feet).

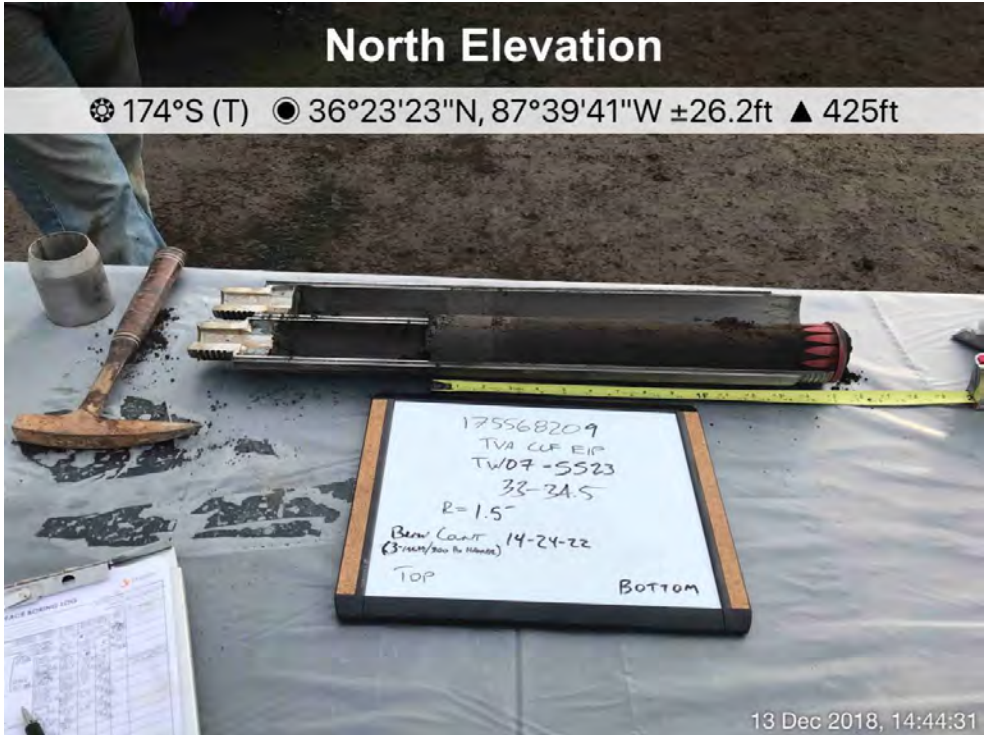
Photograph ID: 23

Photo Location: CUF-TW07	
Photo Date: 12/13/2018	
Comments: Interval (33.0-34.5 feet). Interval shown on white board should be 33.0-34.5 feet.

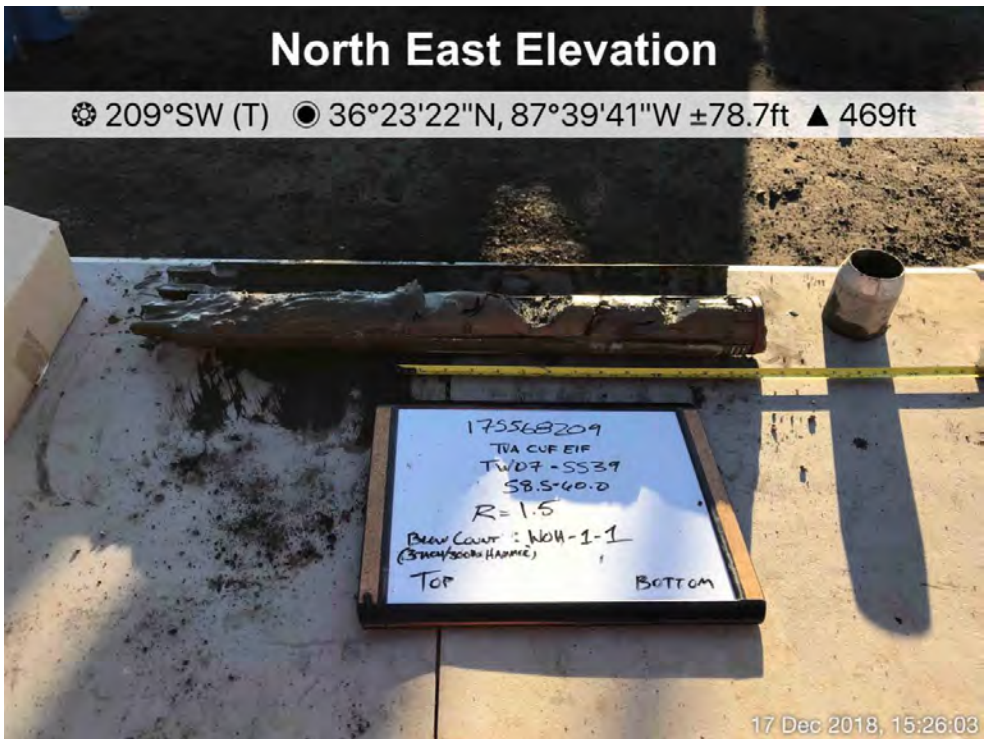
Photograph ID: 39

Photo Location: CUF-TW07	
Photo Date: 12/17/2018	
Comments: Interval (58.5-60.0 feet). WOH on white board is the same as WH on the boring log.

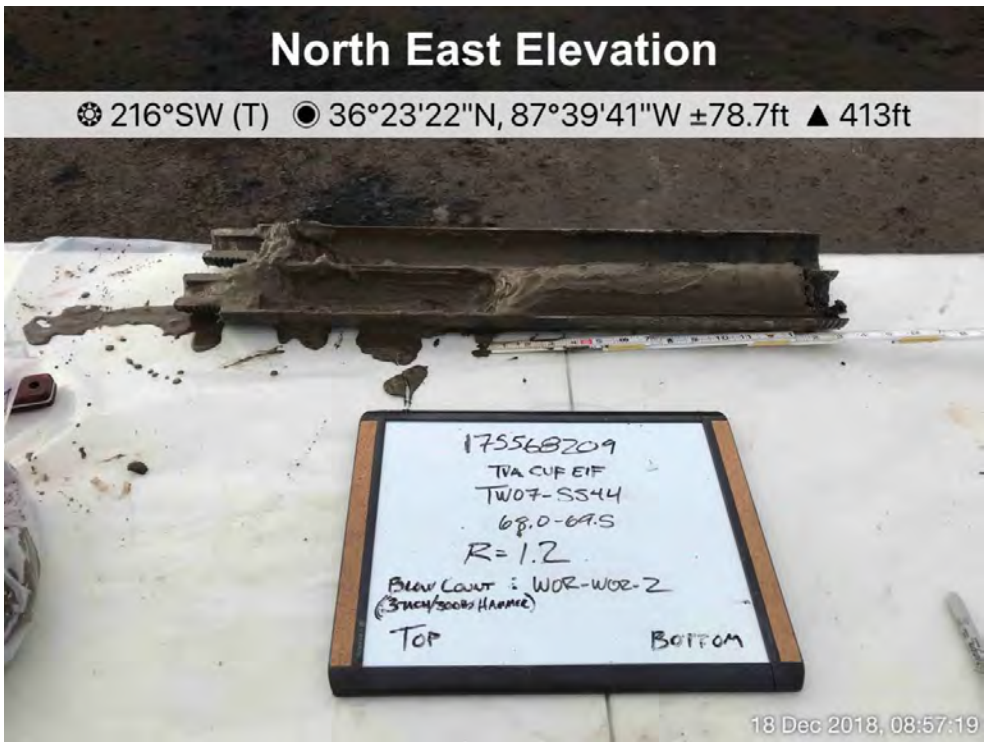
Photograph ID: 45

Photo Location: CUF-TW07	
Photo Date: 12/18/2018	
Comments: Interval (68.0-69.5 feet). WOR on white board is the same as WR on the boring log.

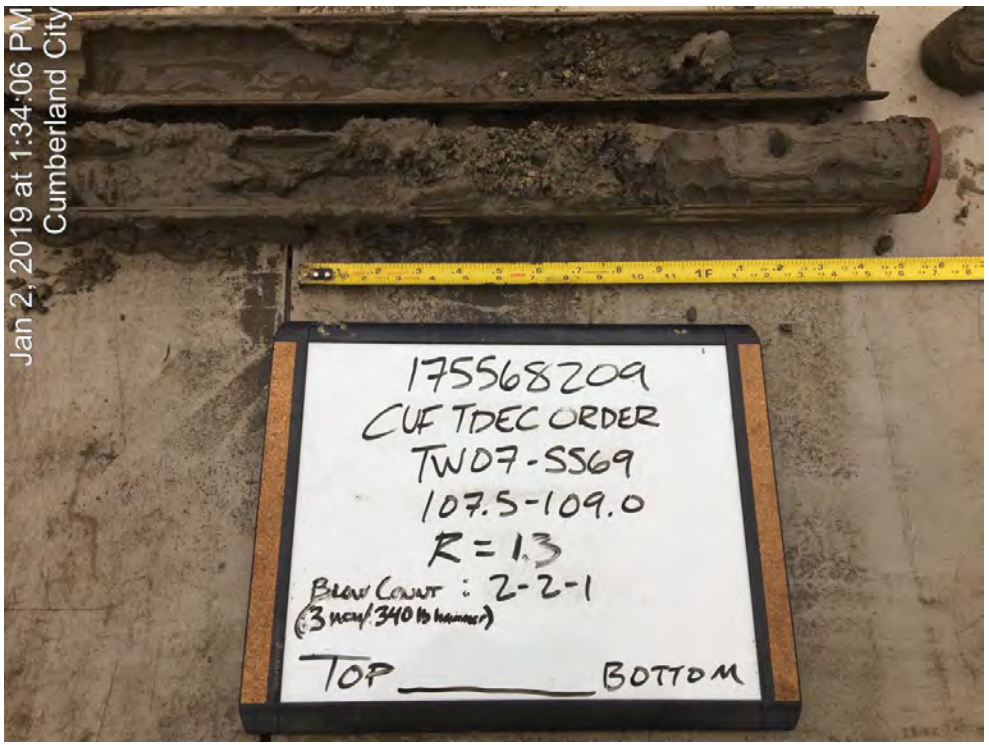
Photograph ID: 71	Jan 2, 2019 at 1:34:06 PM Cumberland City

Photo Location: CUF-TW07		
Photo Date: 1/2/2019		
Comments: Interval (107.5-109.0 feet).
