**APPENDIX G –
CCR MATERIAL INVESTIGATIONS**

**Appendix G.1 - Technical
Evaluation of Geotechnical and
CCR Material Characteristics Data**

TDEC Commissioner's Order:
Environmental Assessment Report
Cumberland Fossil Plant
Cumberland, Tennessee

Stantec Consulting Services Inc.
Lexington, Kentucky

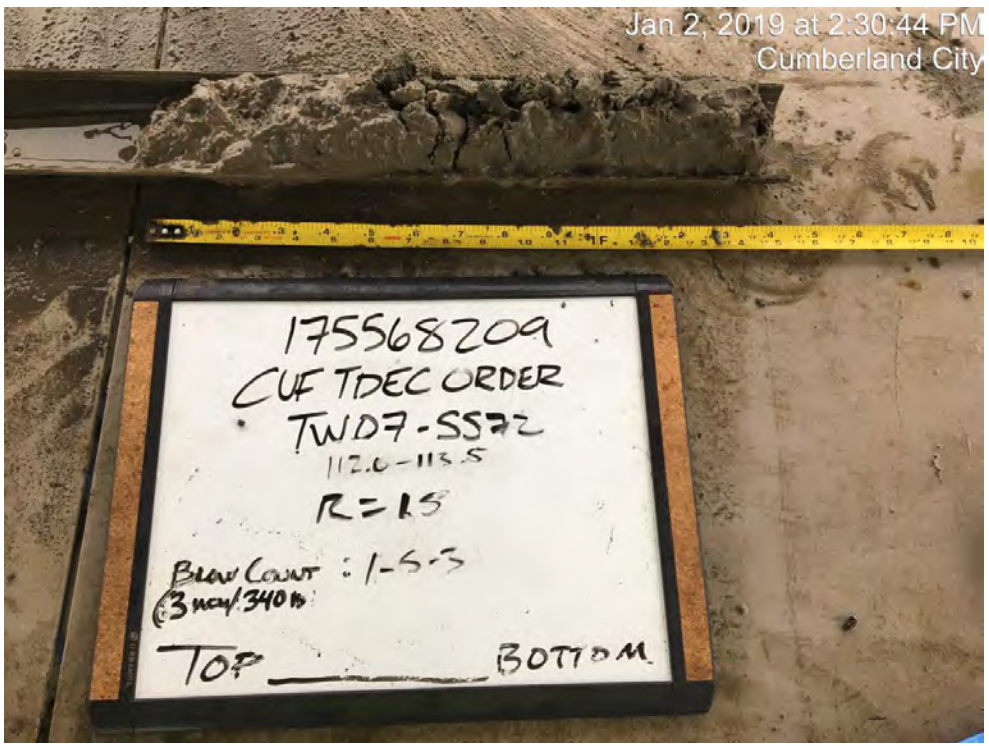
<p>Photograph ID: 74</p> <p>Photo Location: CUF-TW07</p> <p>Photo Date: 1/2/2019</p> <p>Comments: Interval (112.0-113.5 feet).</p>	<p style="text-align: right;">Jan 2, 2019 at 2:30:44 PM Cumberland City</p>

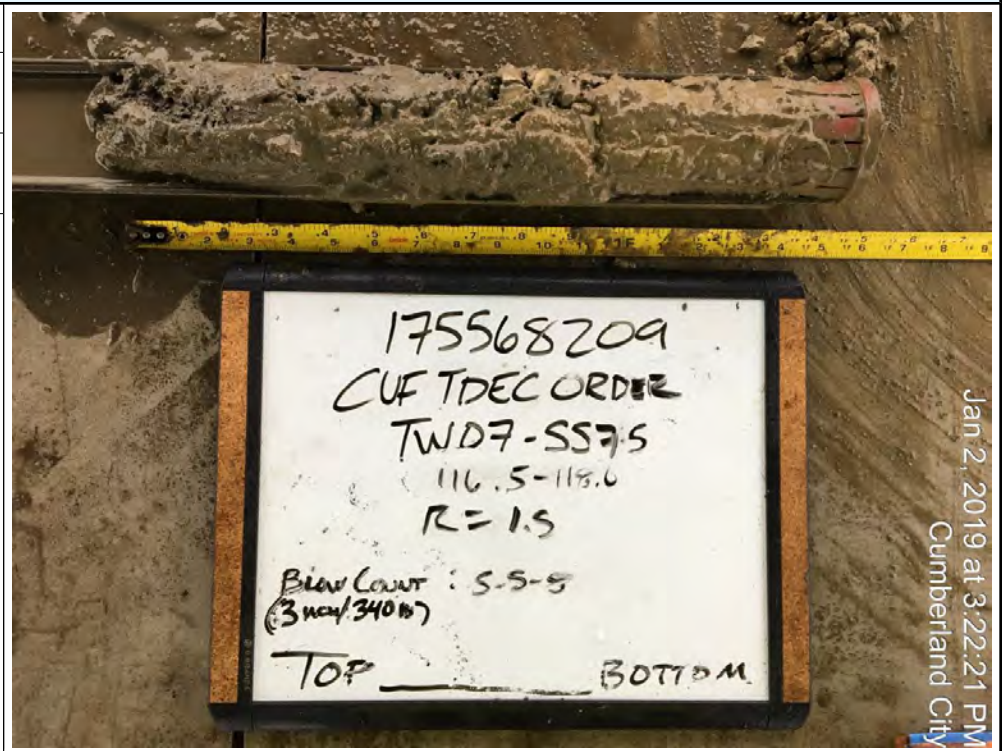
Comments:
Interval (116.5-118.0 feet).
Blow count on white board is 5-5-8.

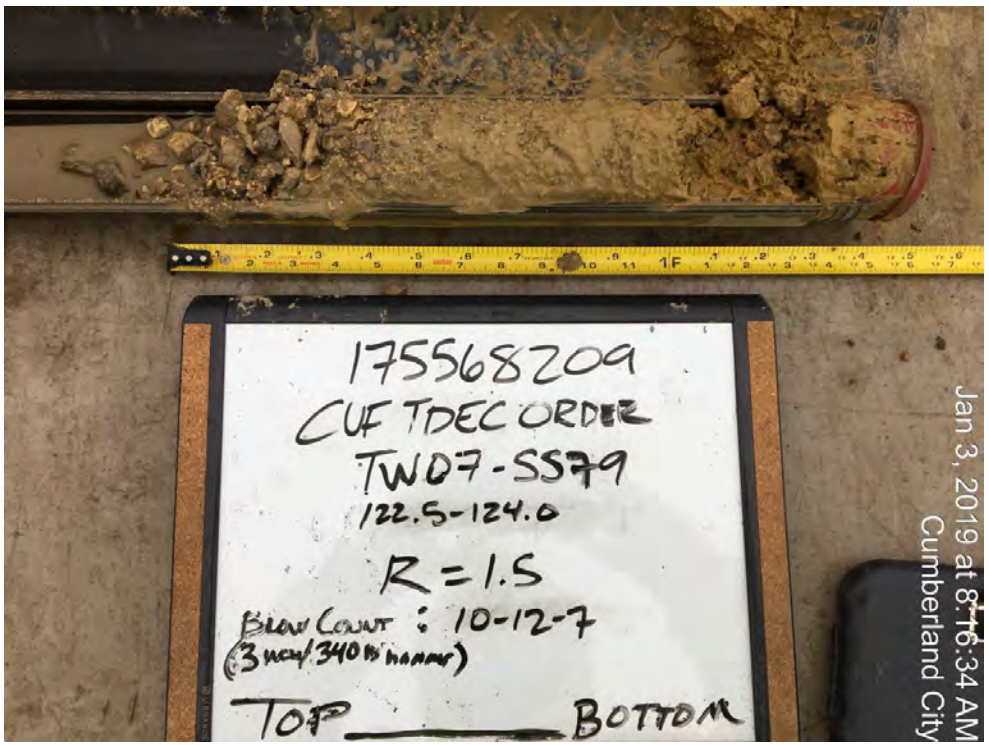
Photograph ID: 81

Photo Location: CUF-TW07	
Photo Date: 1/3/2019	
Comments: Interval (122.5-124.0 feet).

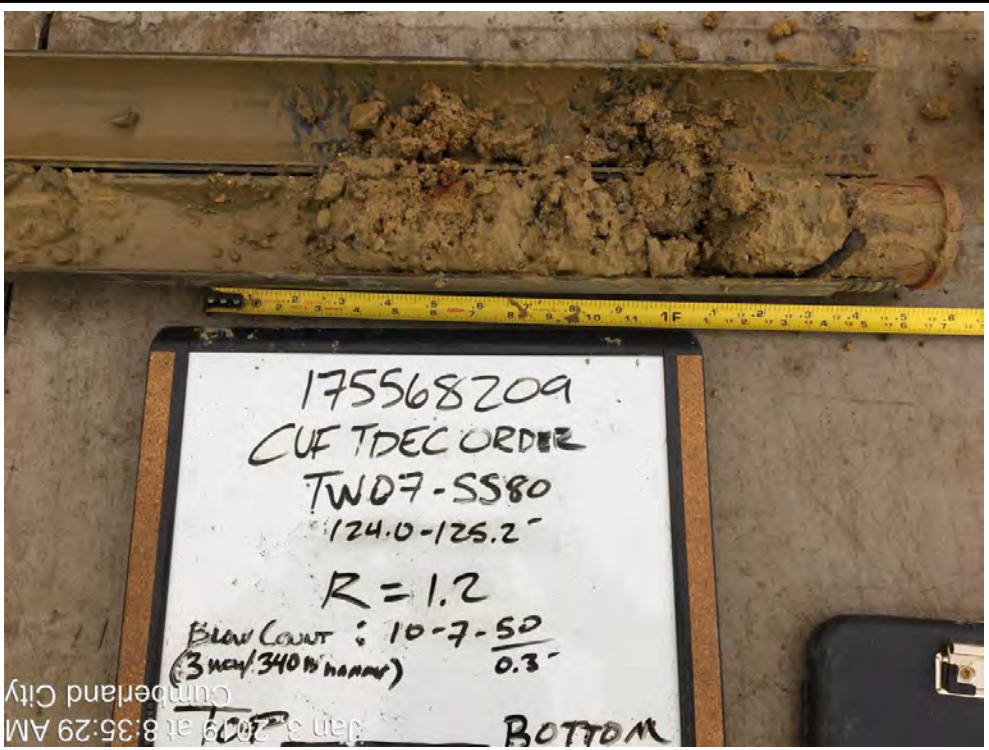
Photograph ID: 82

Photo Location: CUF-TW07	
Photo Date: 1/3/2019	
Comments: Interval (124.0-125.2 feet). Sampler refusal at 125.2 feet.

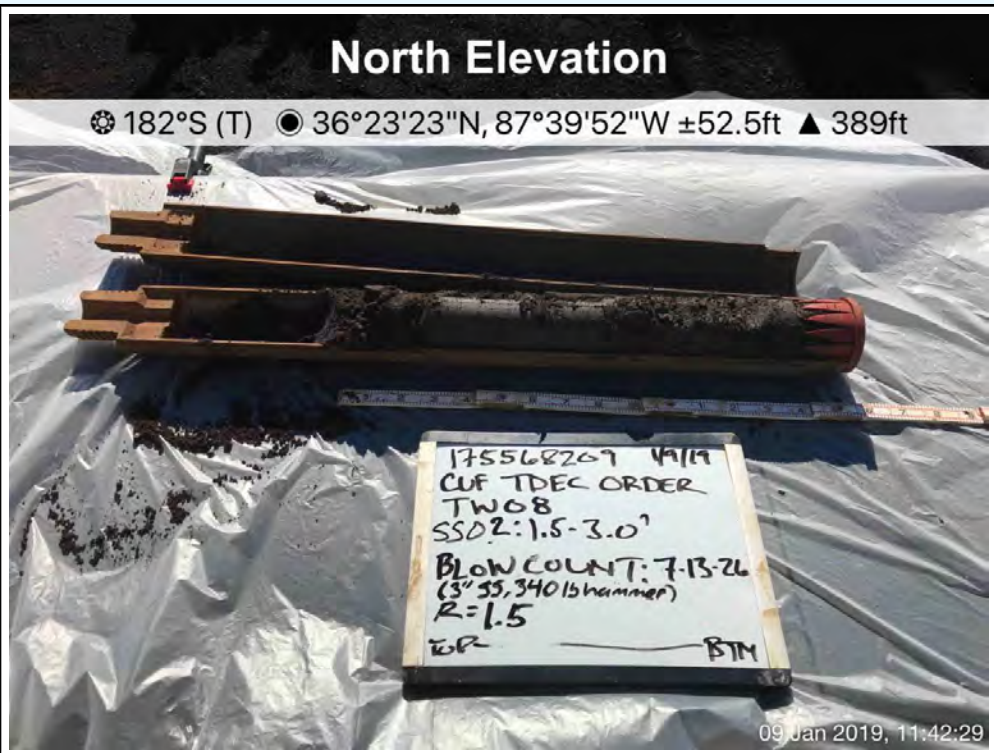
Photograph ID: 85
Photo Location: CUF-TW08
Photo Date: 1/9/2019
Comments: Interval (1.5-3.0 feet).

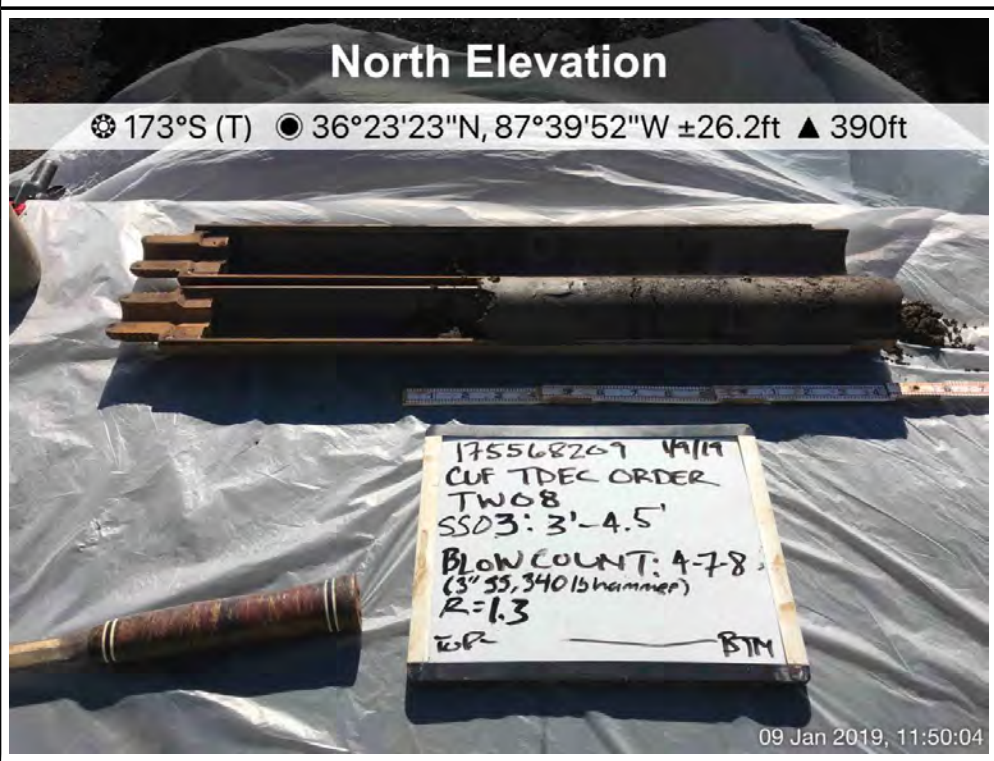
Photograph ID: 86
Photo Location: CUF-TW08
Photo Date: 1/9/2019
Comments: Interval (3.0-4.5 feet). Interval shown on white board should be 3.0-4.5 feet.

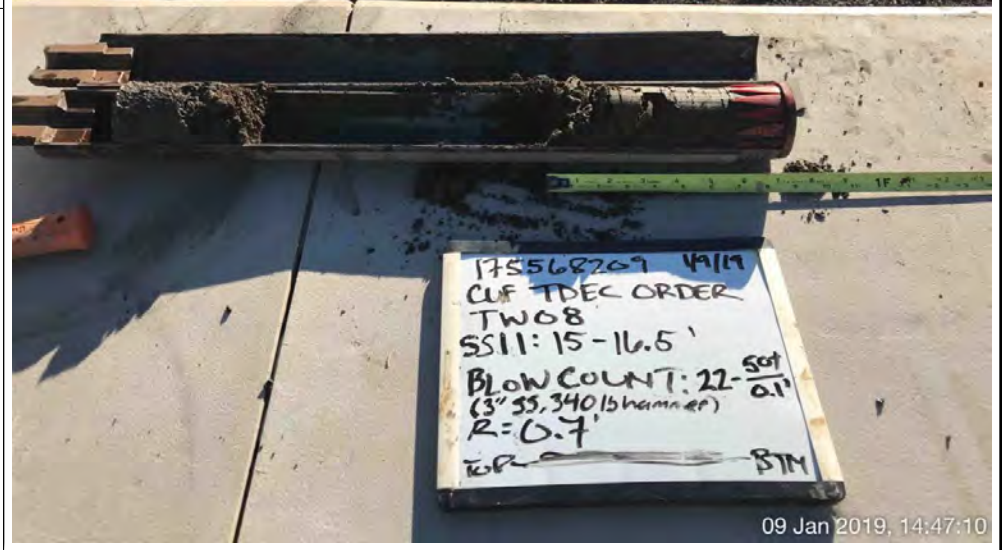
Comments:
Interval (15.0-15.6 feet). Interval shown on white board should be 15.0-15.6 feet. Recovery on whiteboard should be 0.6. Sampler refusal at 15.6 feet.

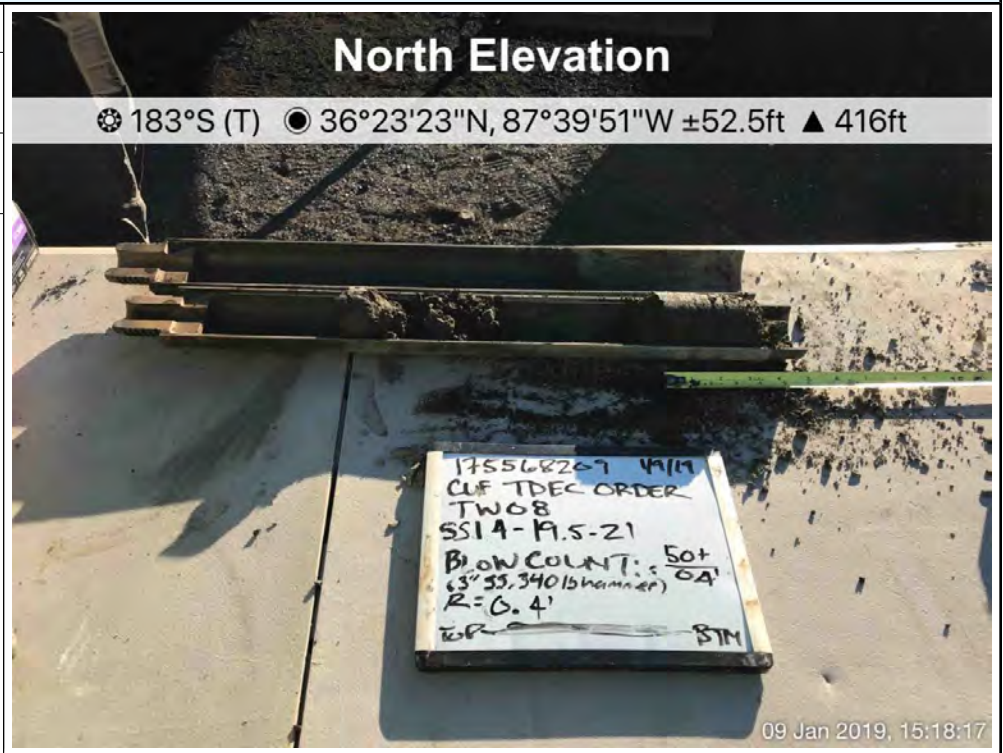
Comments:
Interval (19.5-19.9 feet).
Interval on white board should be 19.5-19.9 feet.

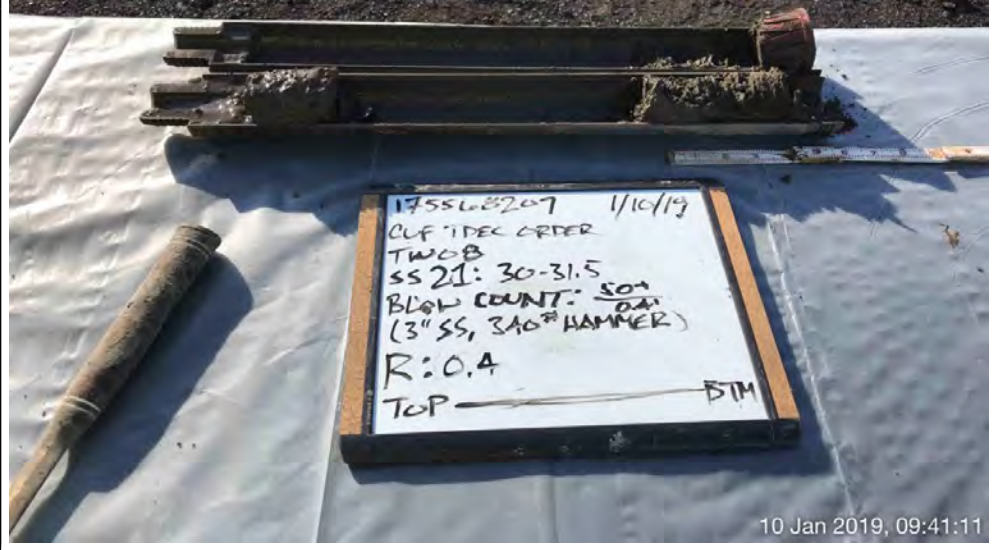
Comments:
Interval (30.0-30.4 feet).
Project number shown on white board is 175568209.
Interval shown on white board should be 30.0-30.4.
Sampler refusal at 30.4 feet.

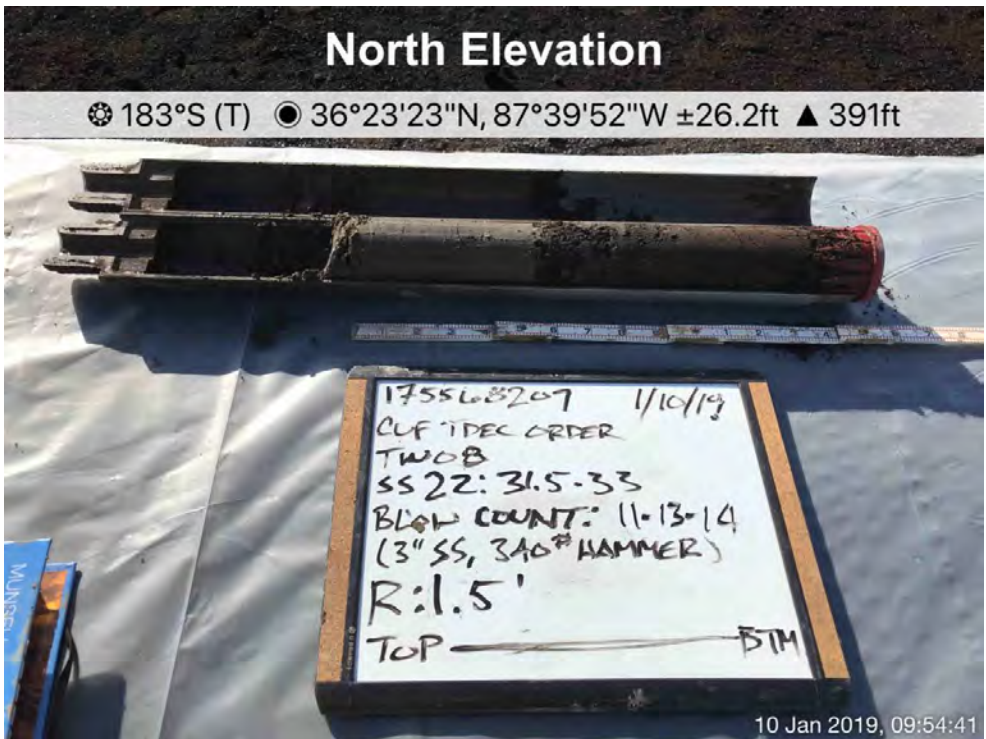
Photograph ID: 105

<p>North Elevation</p> <p>☉ 183°S (T) ● 36°23'23"N, 87°39'52"W ±26.2ft ▲ 391ft</p> <p>10 Jan 2019, 09:54:41</p>
Photo Location: CUF-TW08	
Photo Date: 1/10/2019	
Comments: Interval (31.5-33.0 feet). Project number shown on white board is 175568209. Interval shown on white board should be 31.5-33.0 feet.

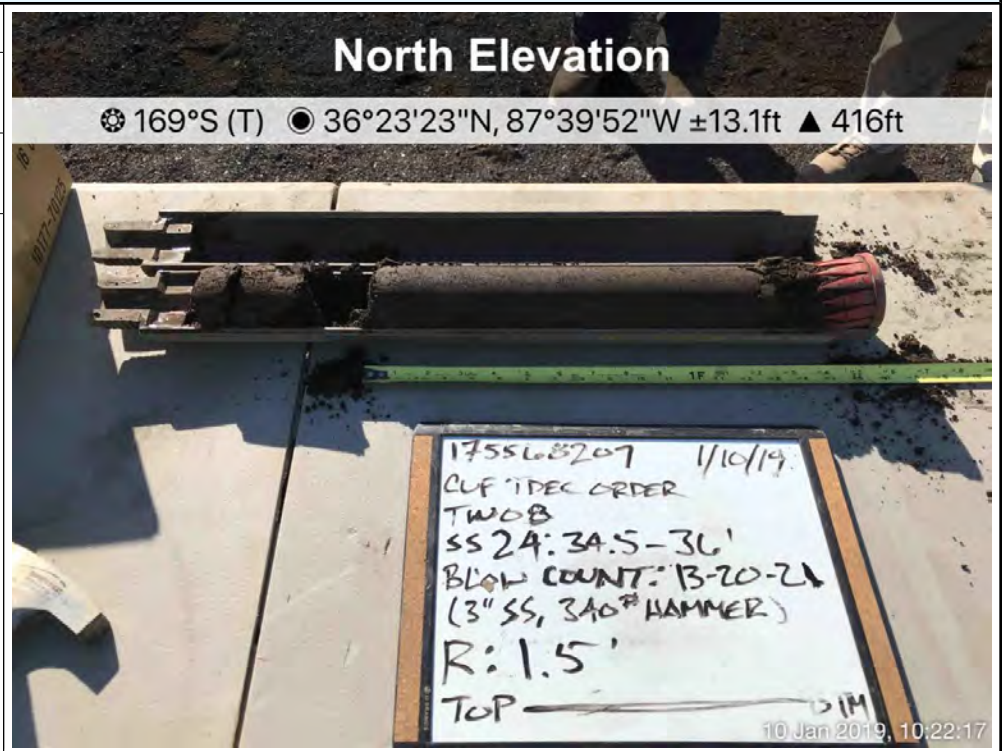
Comments:
Interval (34.5-36.0 feet).
Project number shown on white board is 175568209. Interval shown on white board should be 34.5-36.0 feet.

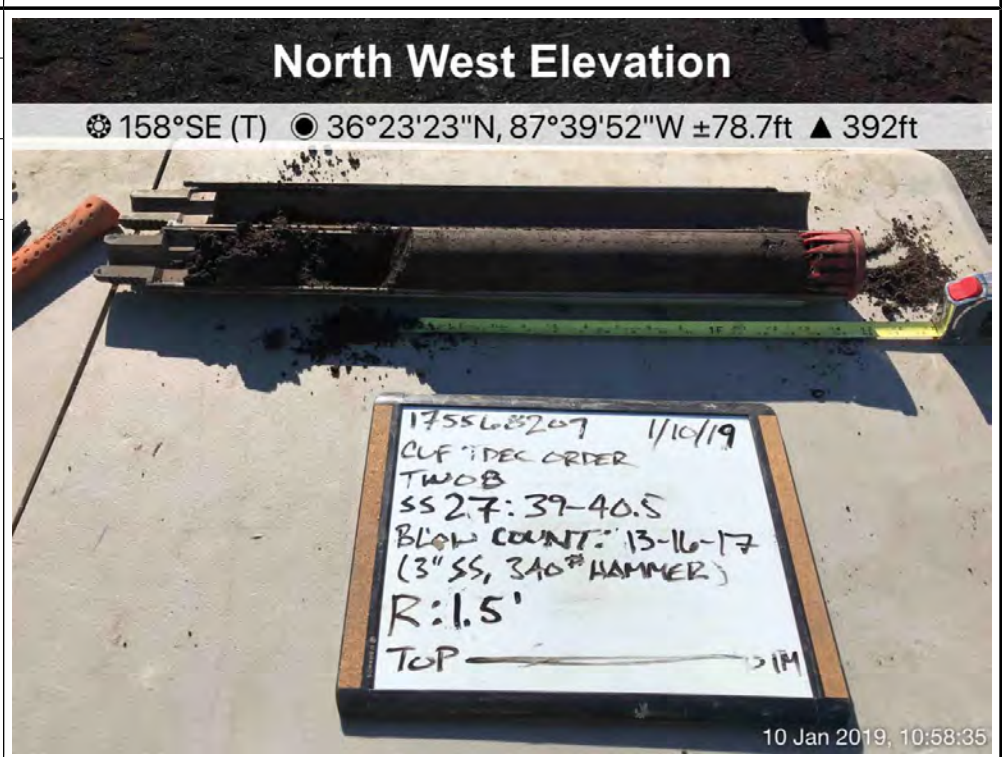
Photograph ID: 110
Photo Location: CUF-TW08
Photo Date: 1/10/2019
Comments: Interval (39.0-40.5 feet). Project number shown on white board is 175568209. Interval shown on white board should be 39.0-40.5 feet.

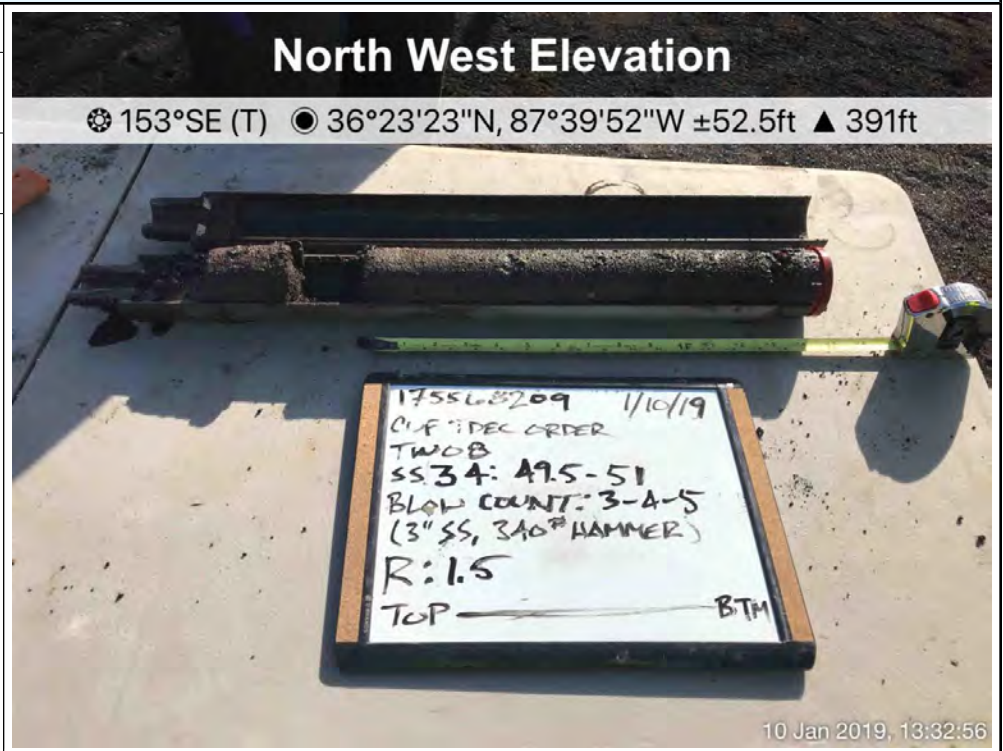
Comments:
Interval (49.5-51.0 feet).
Interval shown on white board should be 49.5-51.0 feet.

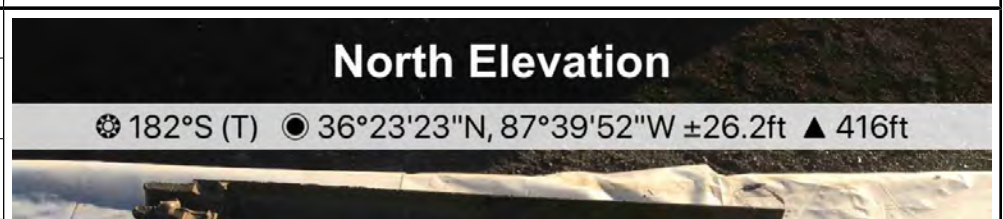
Comments:
Interval (63.0-64.5 feet). Interval shown on white board should be 63.0-64.5 feet. WOR and WOH on white board are the same as WR and WH, respectively, on the boring log.

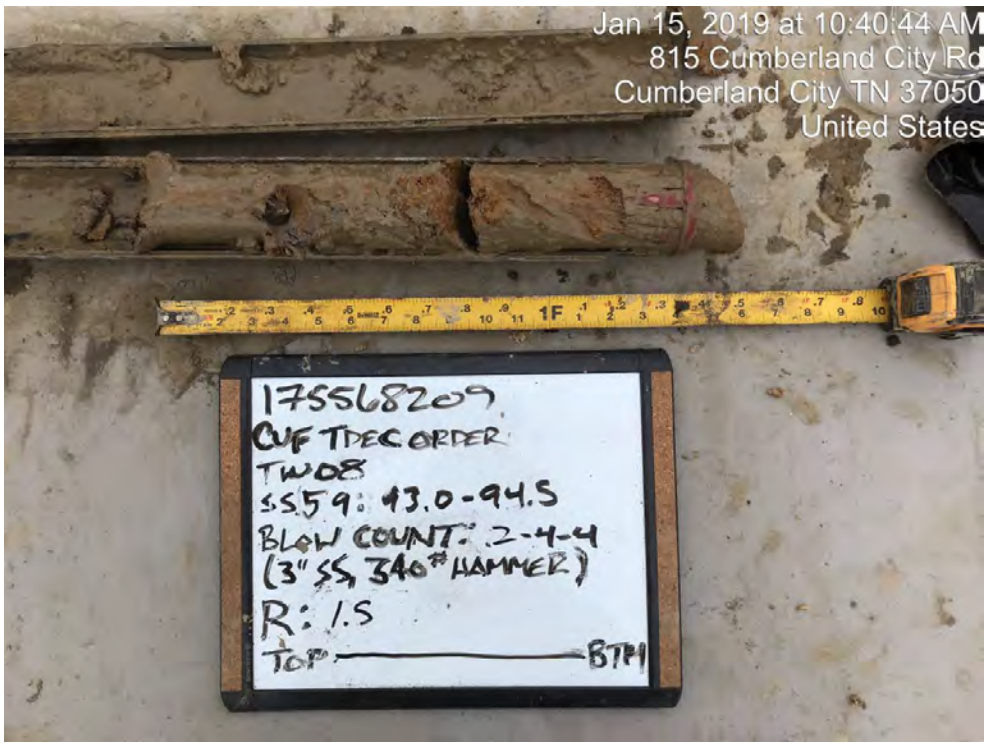
Photograph ID: 145

Jan 15, 2019 at 10:40:44 AM 815 Cumberland City Rd Cumberland City TN 37050 United States
Photo Location: CUF-TW08		
Photo Date: 1/15/2019		
Comments: Interval (93.0-94.5 feet).

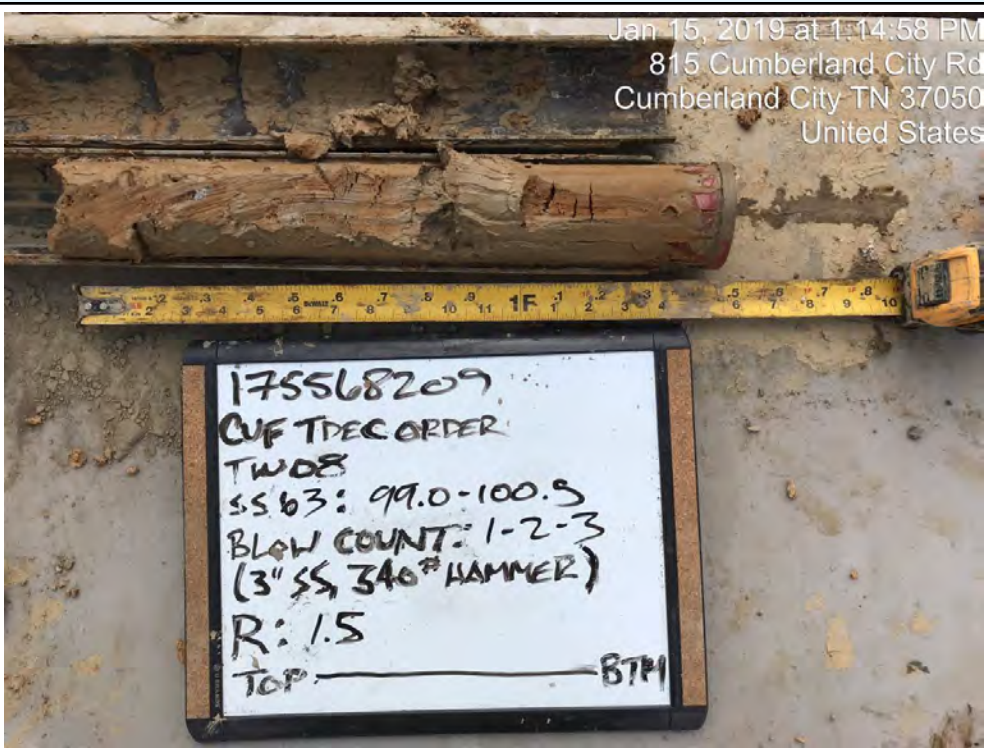
Photograph ID: 149

Jan 15, 2019 at 1:14:58 PM 815 Cumberland City Rd Cumberland City TN 37050 United States
Photo Location: CUF-TW08		
Photo Date: 1/15/2019		
Comments: Interval (99.0-100.5 feet).

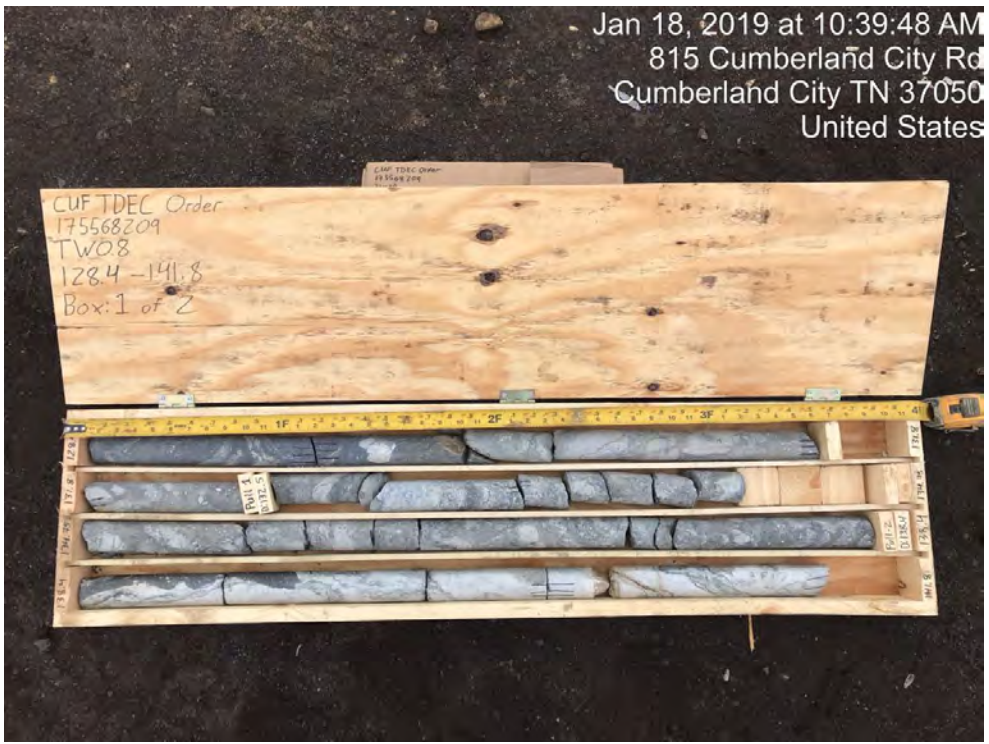
Photo Location: CUF-TW08			
Photo Date: 1/18/2019			
Comments: Interval (128.4-141.8 feet).			
Photograph ID: 170

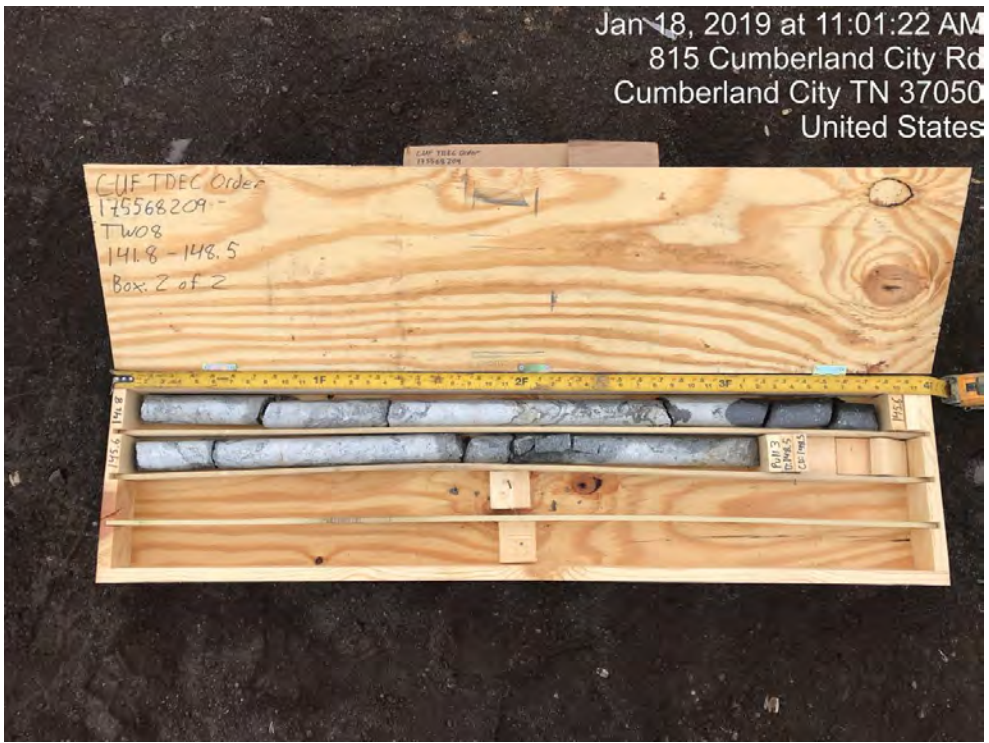
Photo Location: CUF-TW08			
Photo Date: 1/18/2019			
Comments: Interval (141.8-148.5 feet).

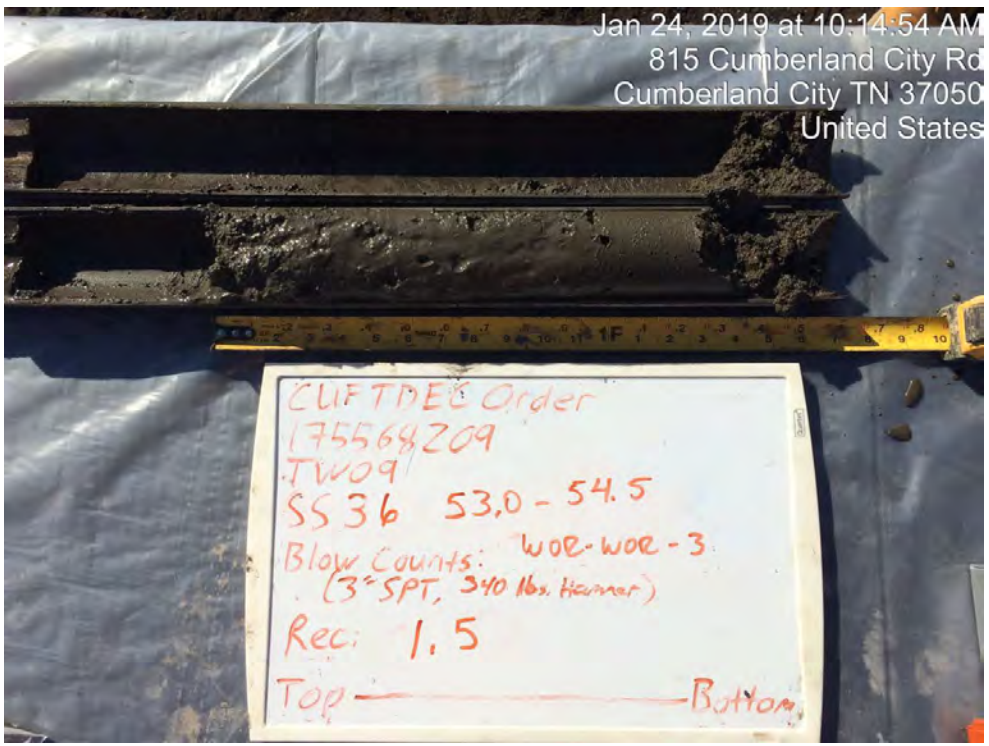
Photograph ID: 206

Jan 24, 2019 at 10:14:54 AM
Photo Location: CUF-TW09		815 Cumberland City Rd
Photo Date: 1/24/2019		Cumberland City TN 37050
Comments: Interval (53.0-54.5 feet). WOR on white board is the same as WR on the boring log.		United States

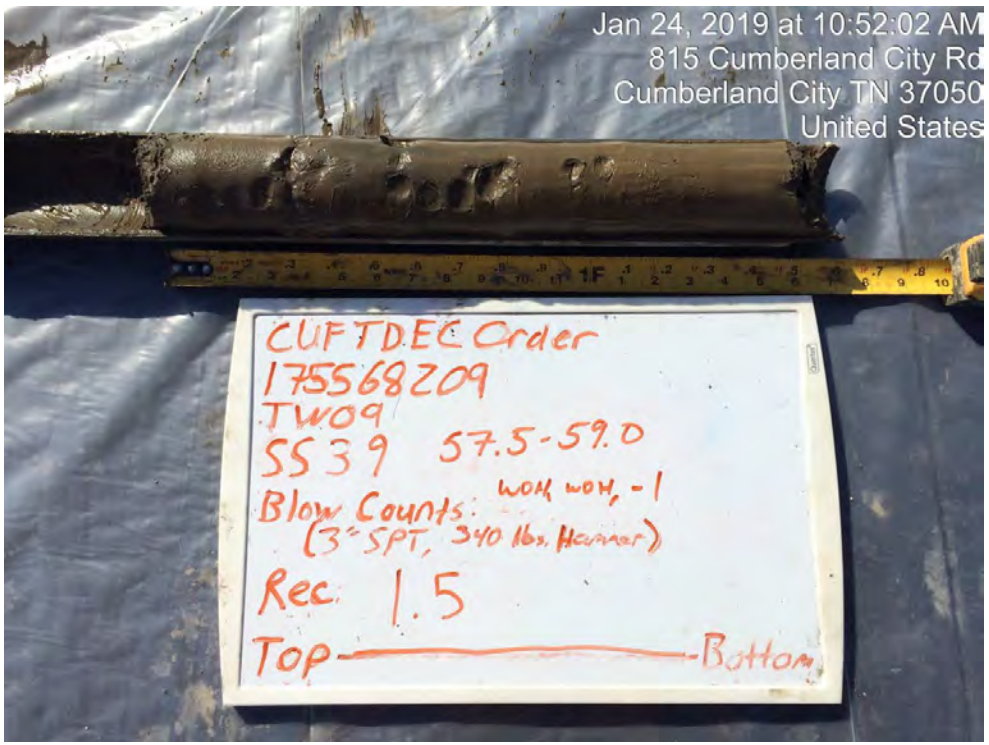
Photograph ID: 209

<p>Jan 24, 2019 at 10:52:02 AM 815 Cumberland City Rd Cumberland City TN 37050 United States</p>
Photo Location: CUF-TW09	
Photo Date: 1/24/2019	
Comments: Interval (57.5-59.0 feet). WOH on white board is the same as WH on the boring log.

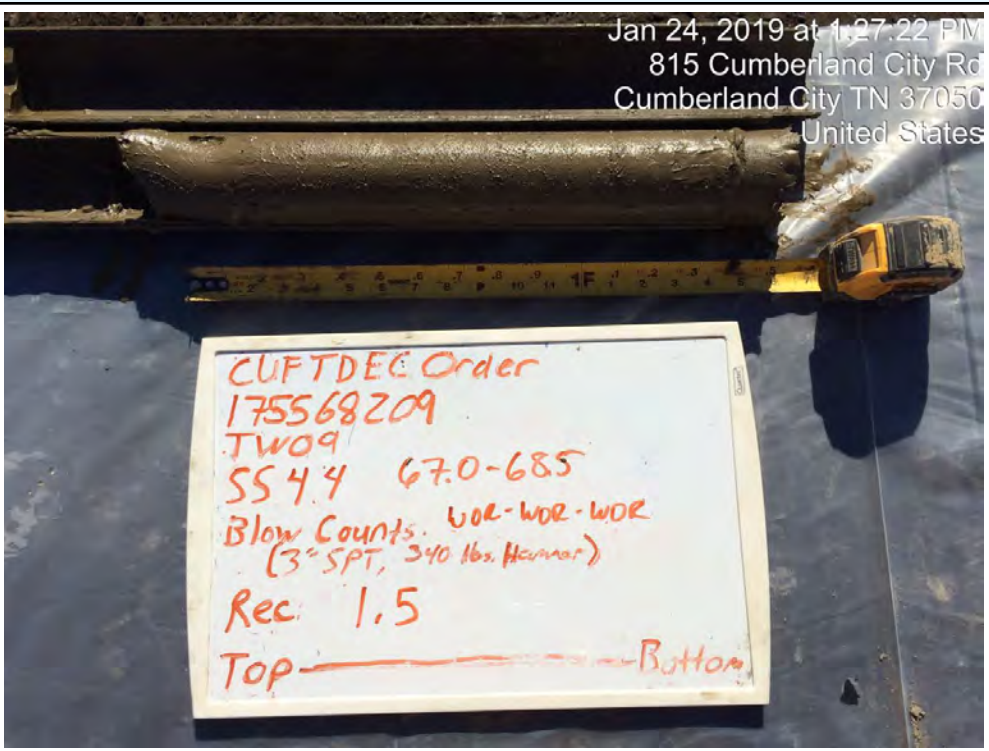
Photograph ID: 215	Jan 24, 2019 at 1:27:22 PM 815 Cumberland City Rd Cumberland City TN 37050 United States
Photo Location: CUF-TW09	
Photo Date: 1/24/2019	
Comments: Interval (67.0-68.5 feet). WOR on white board is the same as WR on the boring log.

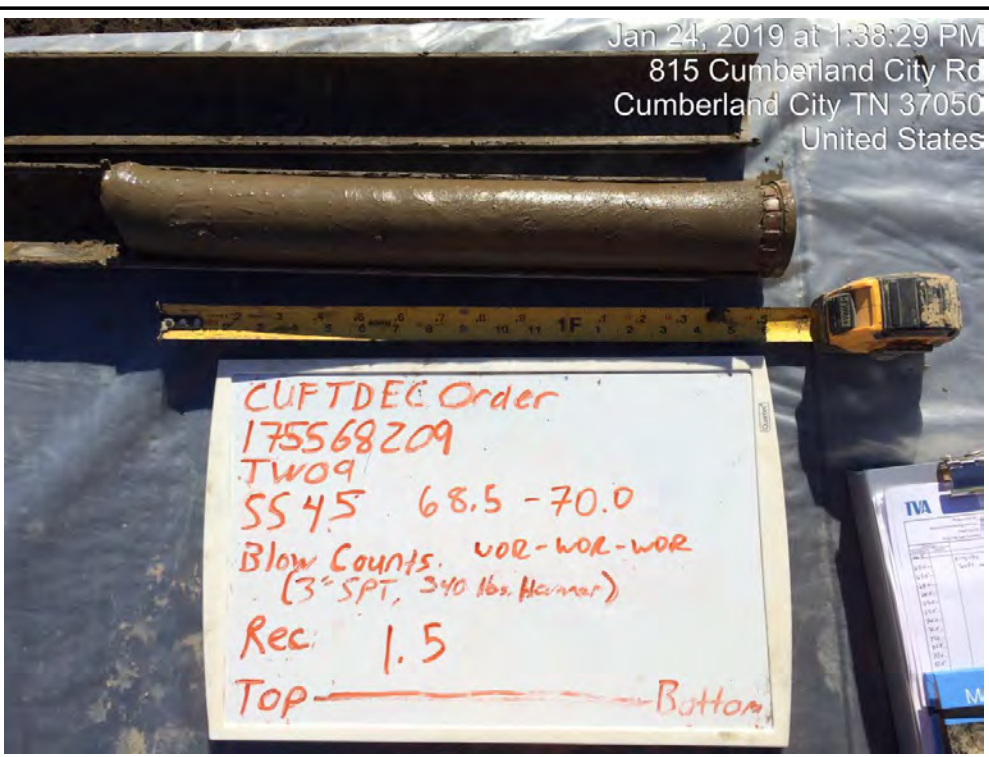
Photograph ID: 216	Jan 24, 2019 at 1:38:29 PM 815 Cumberland City Rd Cumberland City TN 37050 United States
Photo Location: CUF-TW09	
Photo Date: 1/24/2019	
Comments: Interval (68.5-70.0 feet). WOR on white board is the same as WR on the boring log.

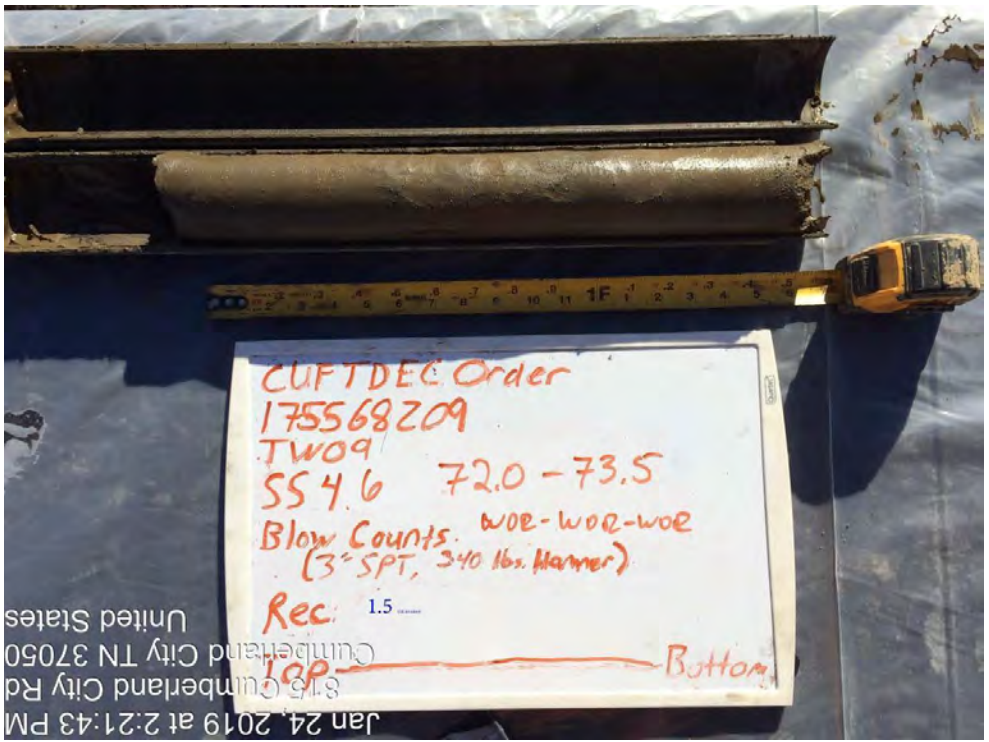
Photograph ID: 218

Photo Location: CUF-TW09	
Photo Date: 1/24/2019	
Comments: Interval (72.0-73.5 feet). WOR on white board is the same as WR on the boring log.

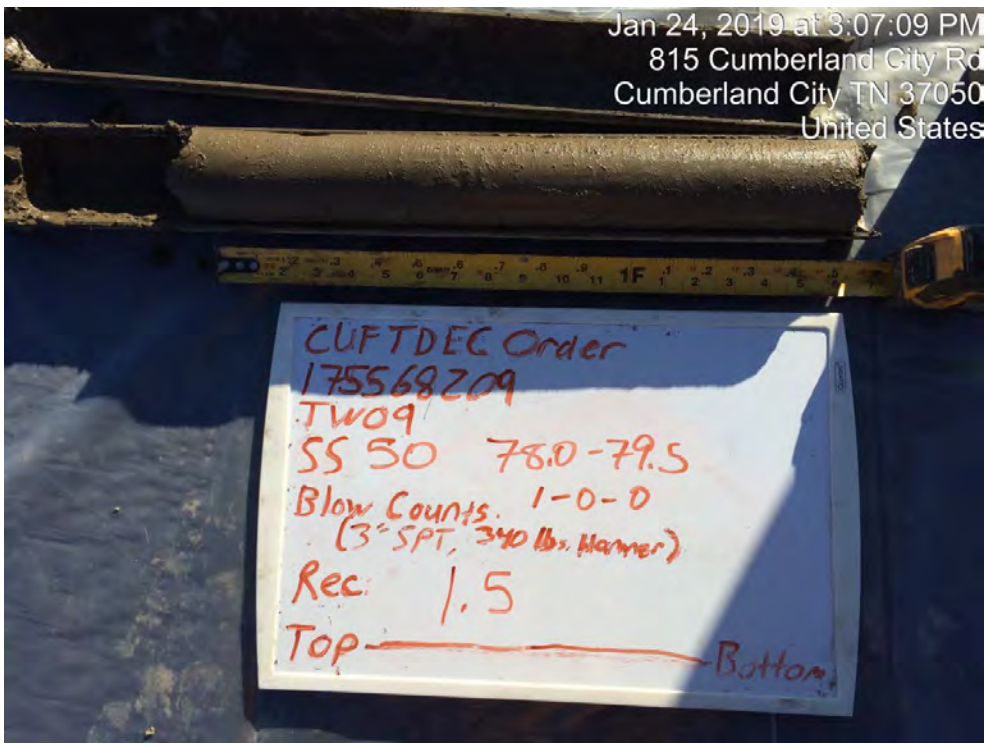
Photograph ID: 222

<p>Jan 24, 2019 at 3:07:09 PM 815 Cumberland City Rd Cumberland City TN 37050 United States</p>
Photo Location: CUF-TW09	
Photo Date: 1/24/2019	
Comments: Interval (78.0-79.5 feet). Blowcount on white board should be 1-WH-WH.

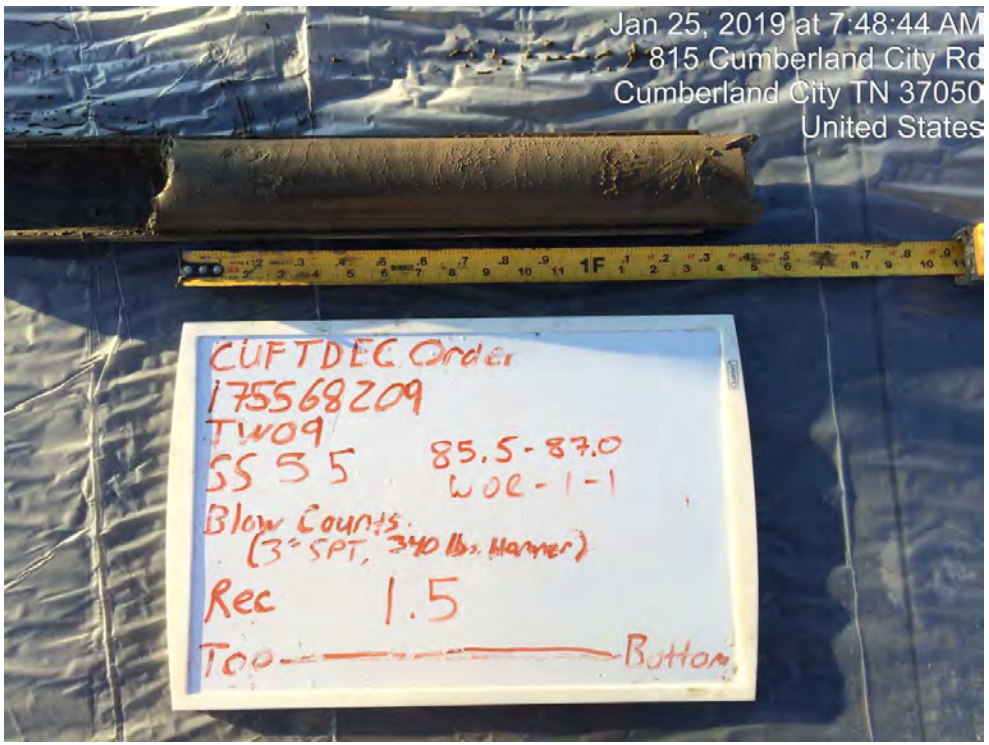
Photograph ID: 227

<p>Jan 25, 2019 at 7:48:44 AM 815 Cumberland City Rd Cumberland City TN 37050 United States</p>
Photo Location: CUF-TW09	
Photo Date: 1/25/2019	
Comments: Interval (85.5-87.0 feet). WOR on white board is the same as WR on the boring log.

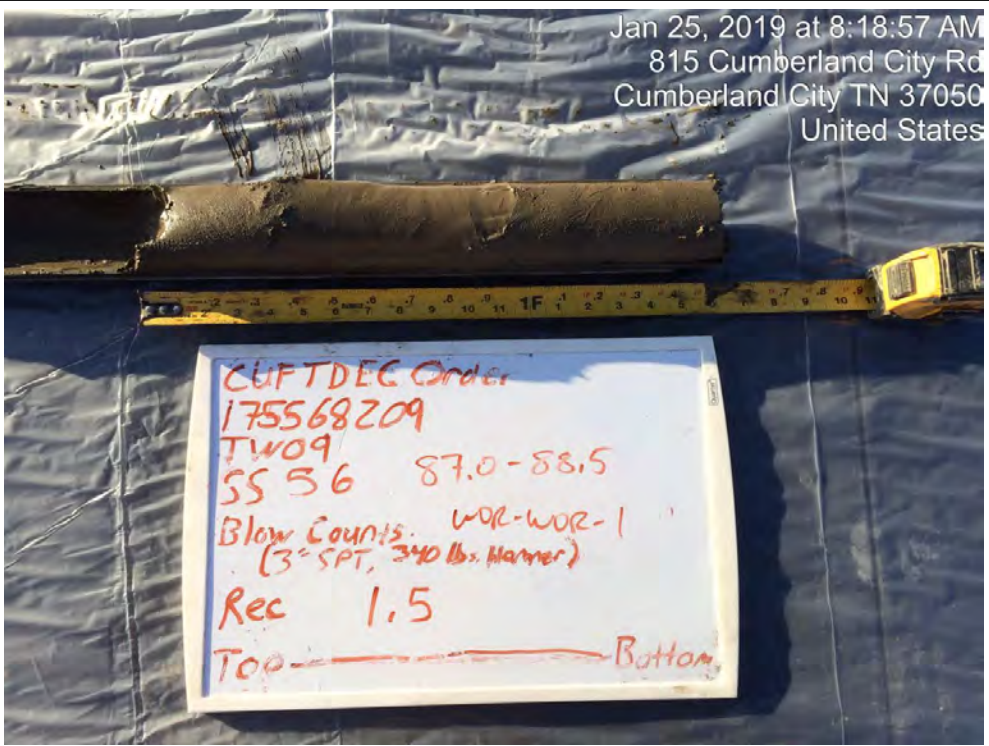
Photograph ID: 228

<p>Jan 25, 2019 at 8:18:57 AM 815 Cumberland City Rd Cumberland City TN 37050 United States</p>
Photo Location: CUF-TW09	
Photo Date: 1/25/2019	
Comments: Interval (87.0-88.5 feet). WOR on white board is the same as WR on the boring log.

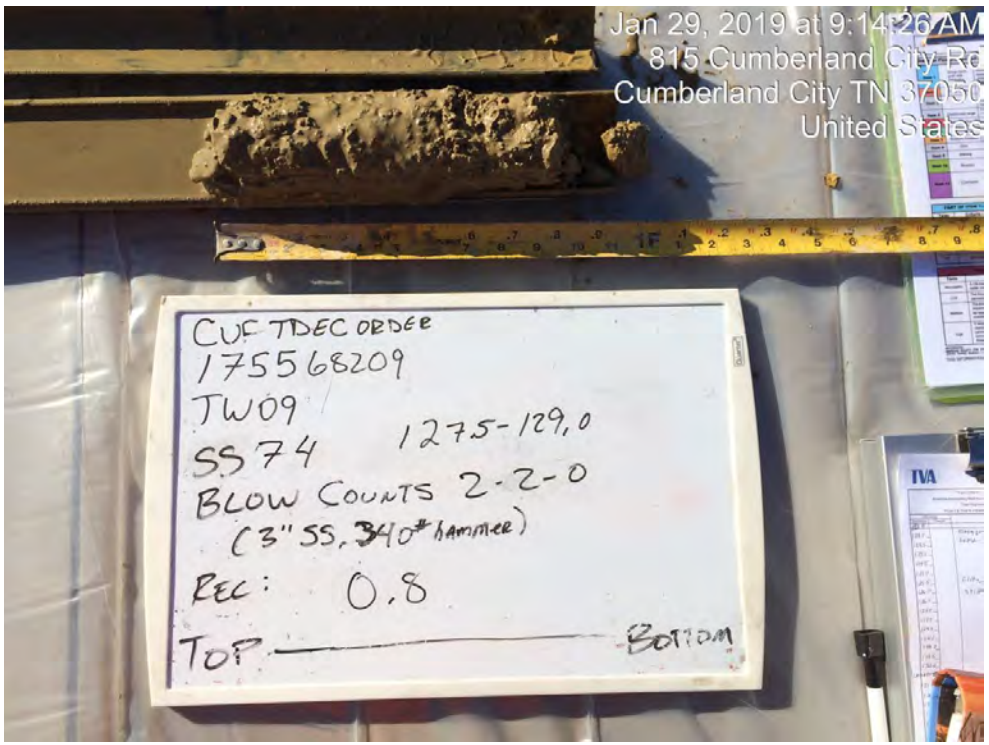
Photograph ID: 247

<p>Jan 29, 2019 at 9:14:26 AM 815 Cumberland City Rd Cumberland City TN 37050 United States</p>
Photo Location: CUF-TW09	
Photo Date: 1/29/2019	
Comments: Interval (127.5-129.0 feet). Blowcount on white board should be 2-2-WH.

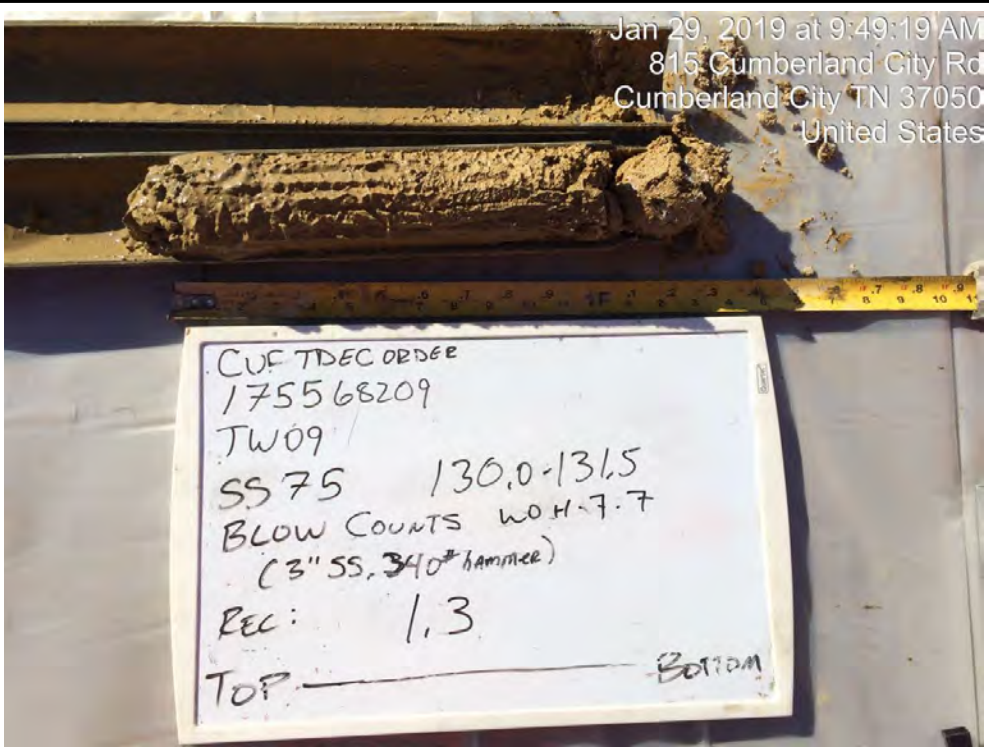
Photograph ID: 248

<p>Jan 29, 2019 at 9:49:19 AM 815 Cumberland City Rd Cumberland City TN 37050 United States</p>
Photo Location: CUF-TW09	
Photo Date: 1/29/2019	
Comments: Interval (130.0-131.5 feet). WOH on white board is the same as WH on the boring log.

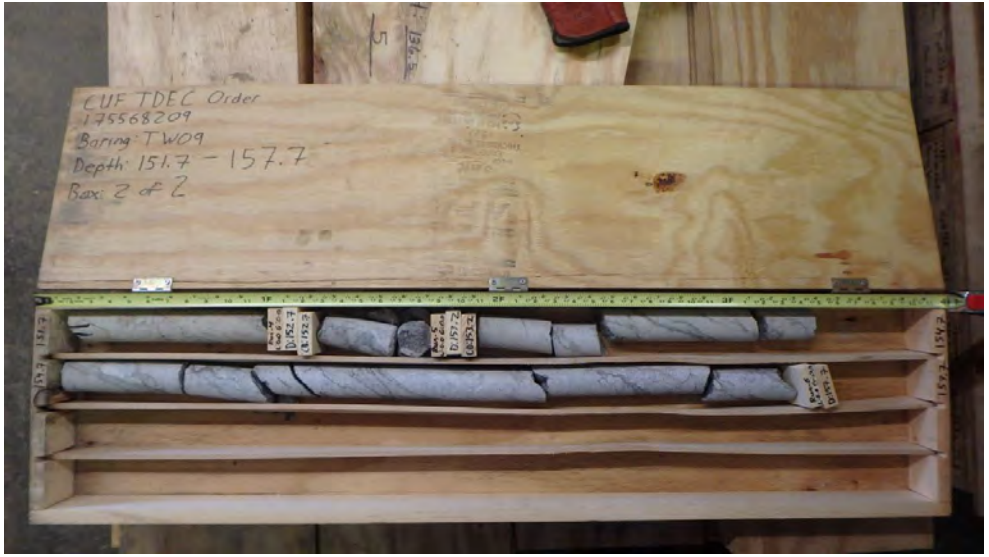
Photo Location: CUF-TW09			
Photo Date: 2/4/2019			
Comments: Interval (151.7-157.7 feet).

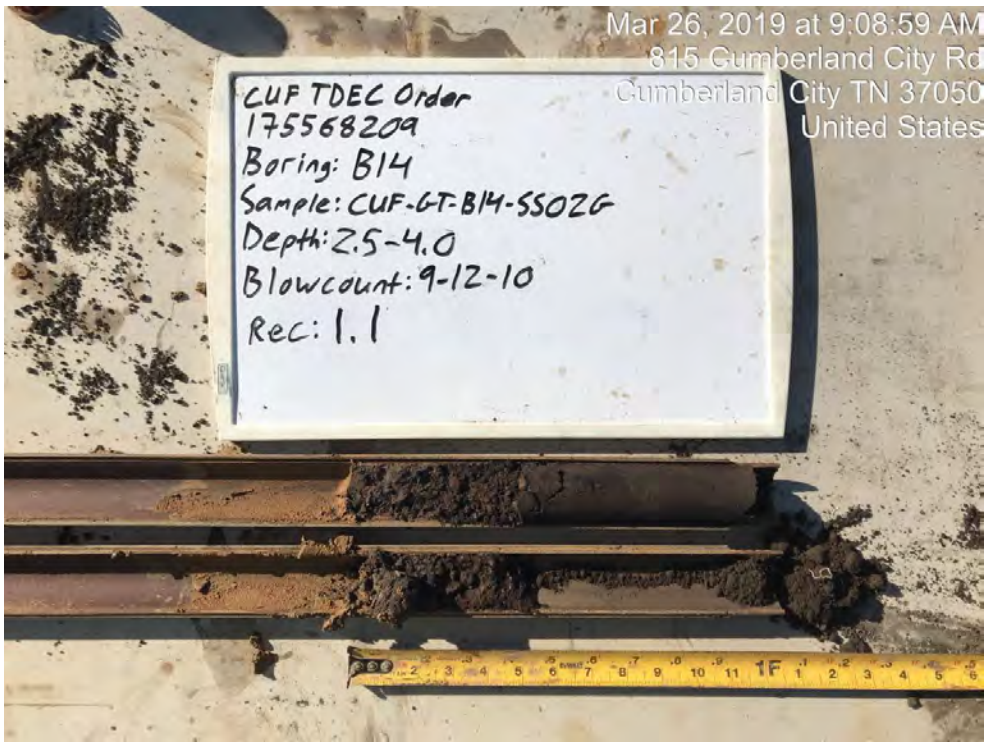
<p style="text-align: right; color: gray; font-size: small;">Mar 26, 2019 at 9:08:59 AM 815 Cumberland City Rd Cumberland City TN 37050 United States</p>		
Photo Location: CUF-B14			
Photo Date: 3/26/2019			
Comments: Interval (2.5-4.0 feet).
