**APPENDIX G –
CCR MATERIAL INVESTIGATIONS**

**Appendix G.1 - Technical
Evaluation of Geotechnical and
CCR Material Characteristics Data**

TDEC Commissioner's Order:
Environmental Assessment Report
Cumberland Fossil Plant
Cumberland, Tennessee

Stantec Consulting Services Inc.
Lexington, Kentucky

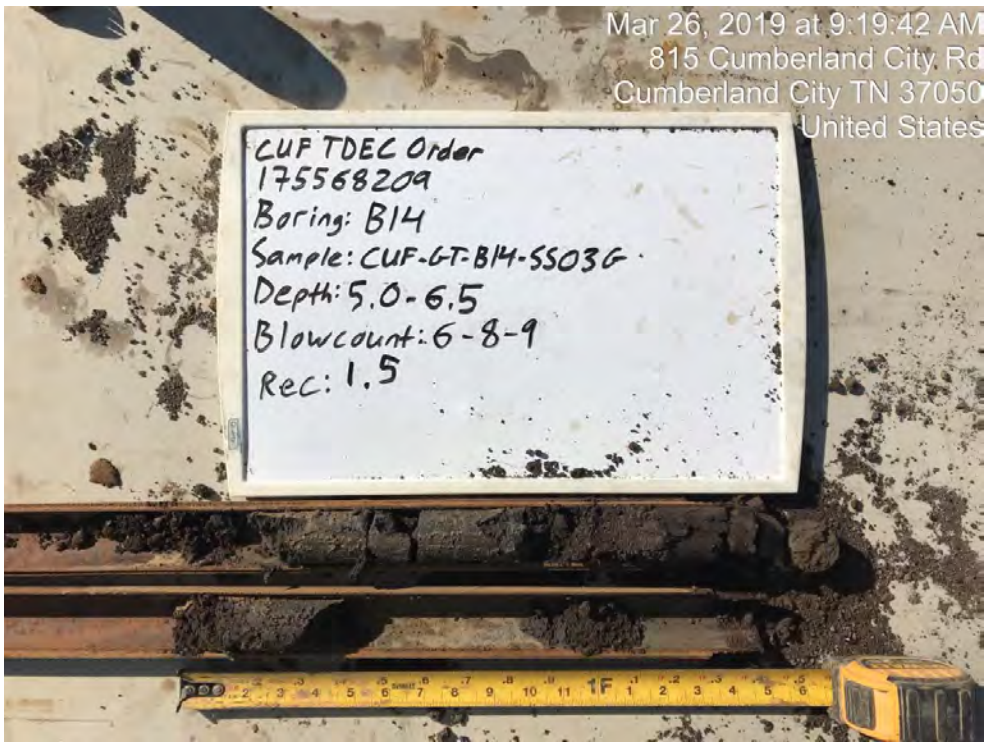
<p style="text-align: right;">Mar 26, 2019 at 9:19:42 AM 815 Cumberland City Rd Cumberland City TN 37050 United States</p>		
Photo Location: CUF-B14			
Photo Date: 3/26/2019			
Comments: Interval (5.0-6.5 feet).			
Photograph ID: 4

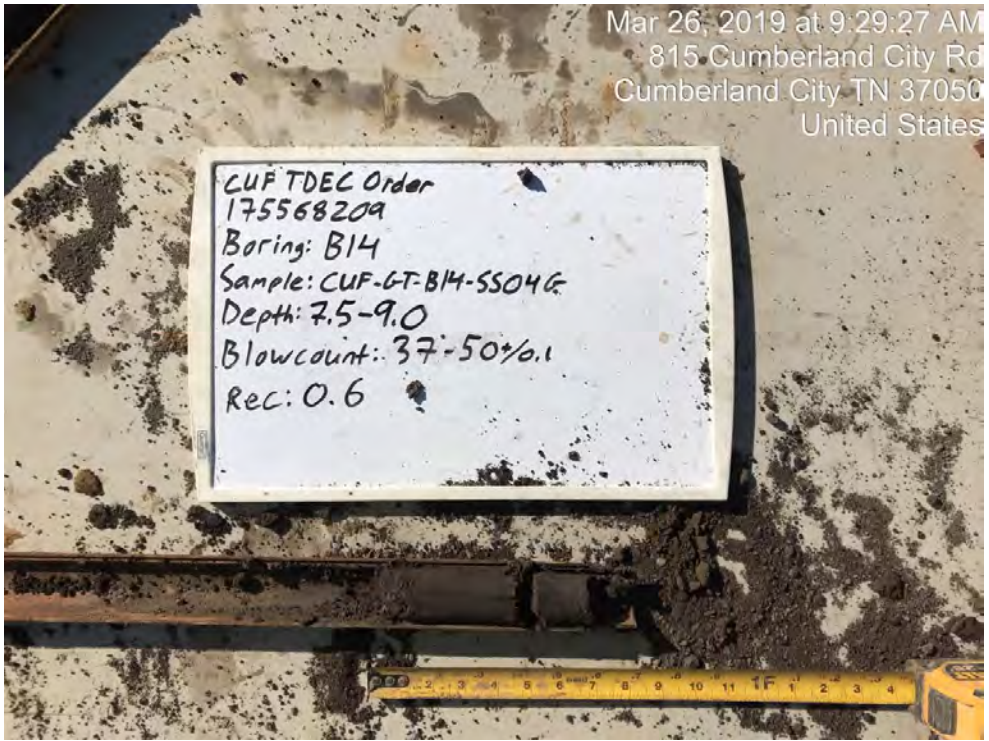
<p style="text-align: right;">Mar 26, 2019 at 9:29:27 AM 815 Cumberland City Rd Cumberland City TN 37050 United States</p>		
Photo Location: CUF-B14			
Photo Date: 3/26/2019			
Comments: Interval (7.5-8.1 feet). Interval shown on white board should be 7.5-8.1 feet. Sampler refusal at 8.1 feet.

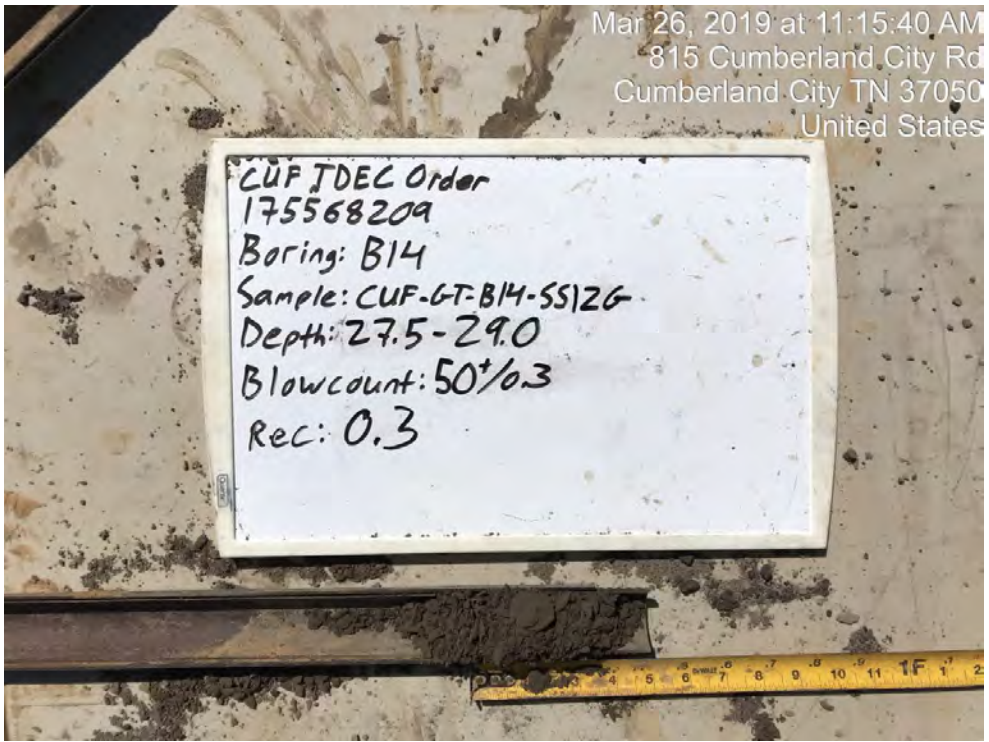
Photograph ID: 12

Photo Location: CUF-B14	
Photo Date: 3/26/2019	
Comments: Interval (27.5-27.8 feet). Interval shown on white board should be 27.5-27.8 feet. Sampler refusal at 27.8 feet.

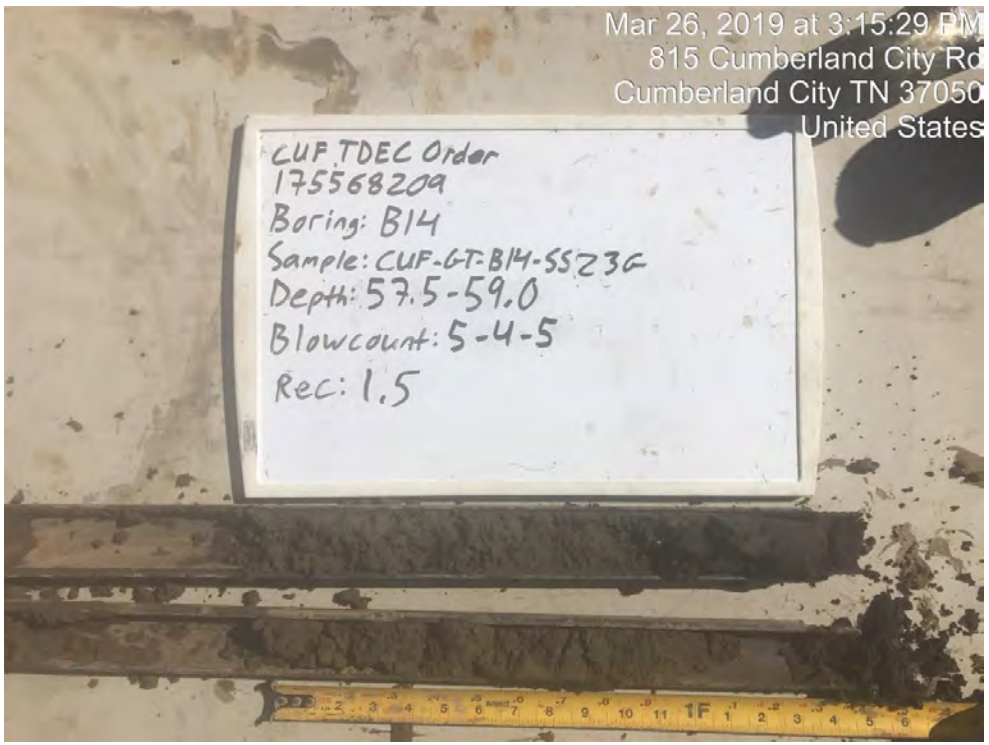
Photograph ID: 25

Photo Location: CUF-B14	
Photo Date: 3/26/2019	
Comments: Interval (57.5-59.0 feet).

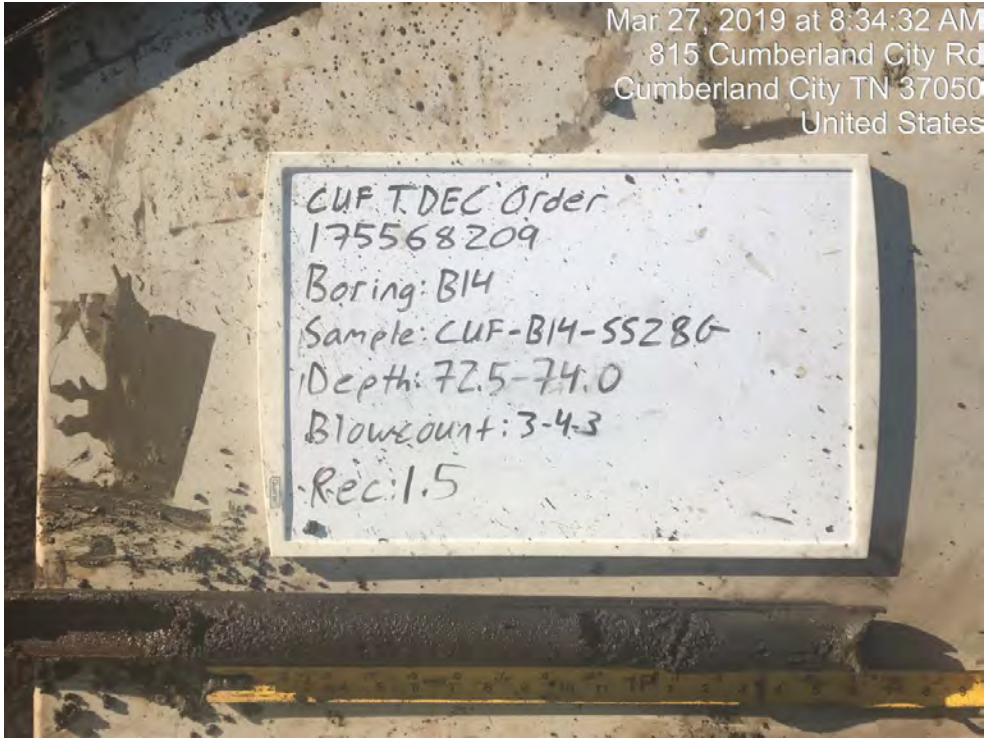
Photograph ID: 31

Mar 27, 2019 at 8:34:32 AM 815 Cumberland City Rd Cumberland City TN 37050 United States
Photo Location: CUF-B14		
Photo Date: 3/27/2019		
Comments: Interval (72.5-74.0 feet).

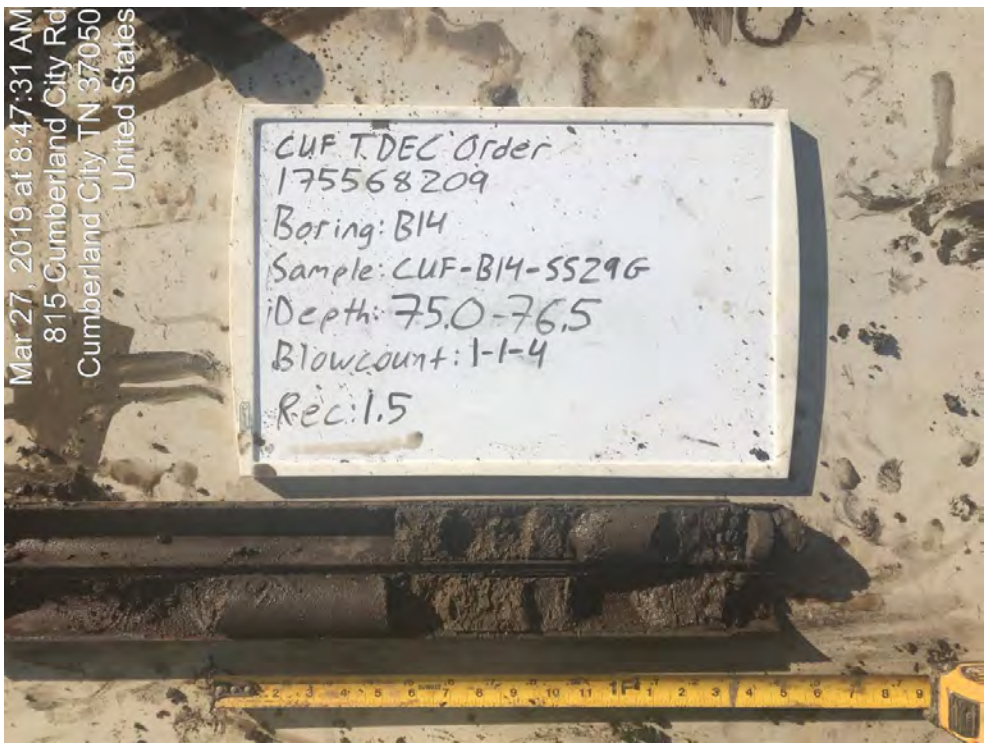
Photograph ID: 32

Mar 27, 2019 at 8:47:31 AM 815 Cumberland City Rd Cumberland City TN 37050 United States
Photo Location: CUF-B14		
Photo Date: 3/27/2019		
Comments: Interval (75.0-76.5 feet).

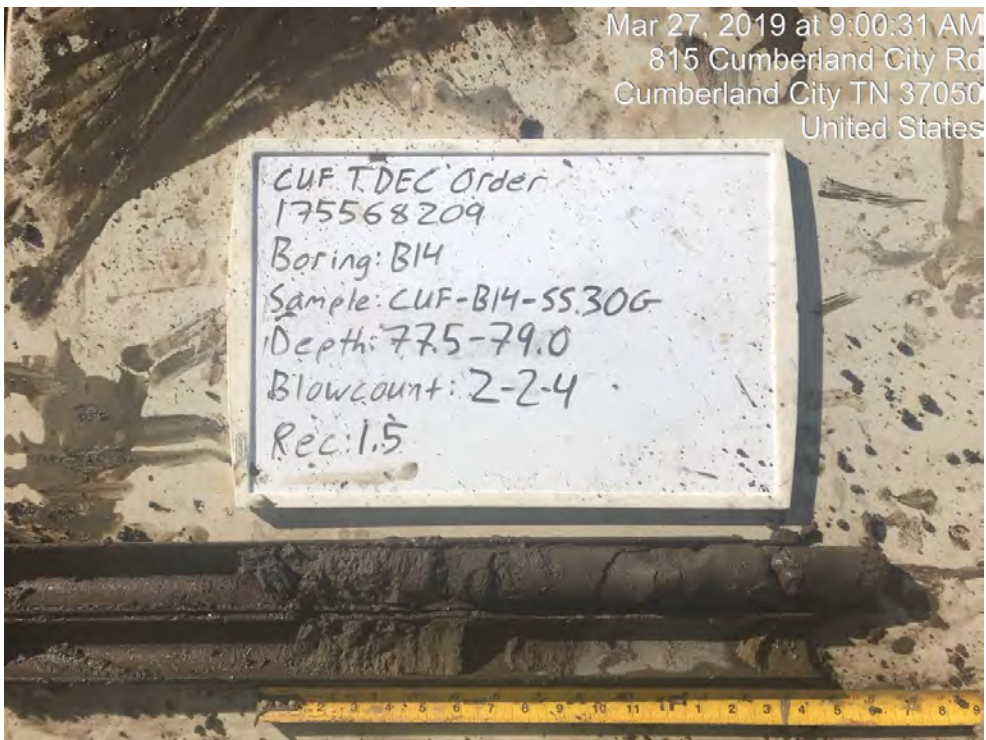
<p>Mar 27, 2019 at 9:00:31 AM 815 Cumberland City Rd Cumberland City TN 37050 United States</p>		
Photo Location: CUF-B14			
Photo Date: 3/27/2019			
Comments: Interval (77.5-79.0 feet).			
Photograph ID: 34	<p style="text-align: center;">No Photo Applicable</p>		
Photo Location: CUF-B14			
Photo Date: 3/27/2019			
Comments: Photo of interval (80.0-81.4 feet) unavailable because sample collected with shelby tube. Sampler refusal at 81.4 feet.

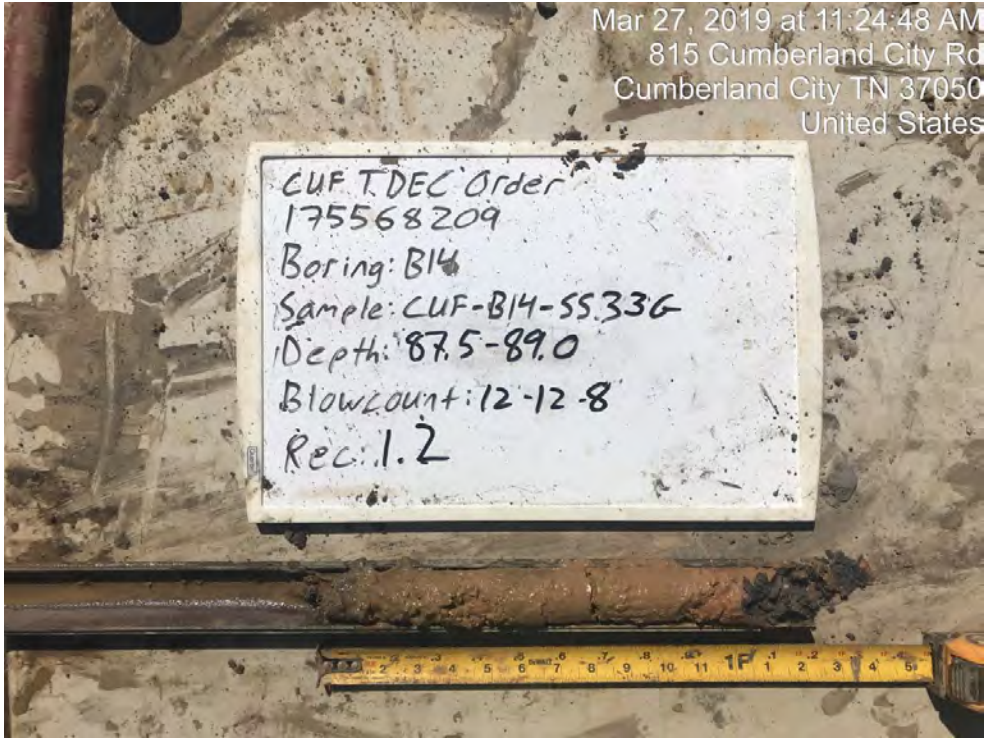
Photograph ID: 37	Mar 27, 2019 at 11:24:48 AM 815 Cumberland City Rd Cumberland City TN 37050 United States
Photo Location: CUF-B14	
Photo Date: 3/27/2019	
Comments: Interval (87.5-89.0 feet).

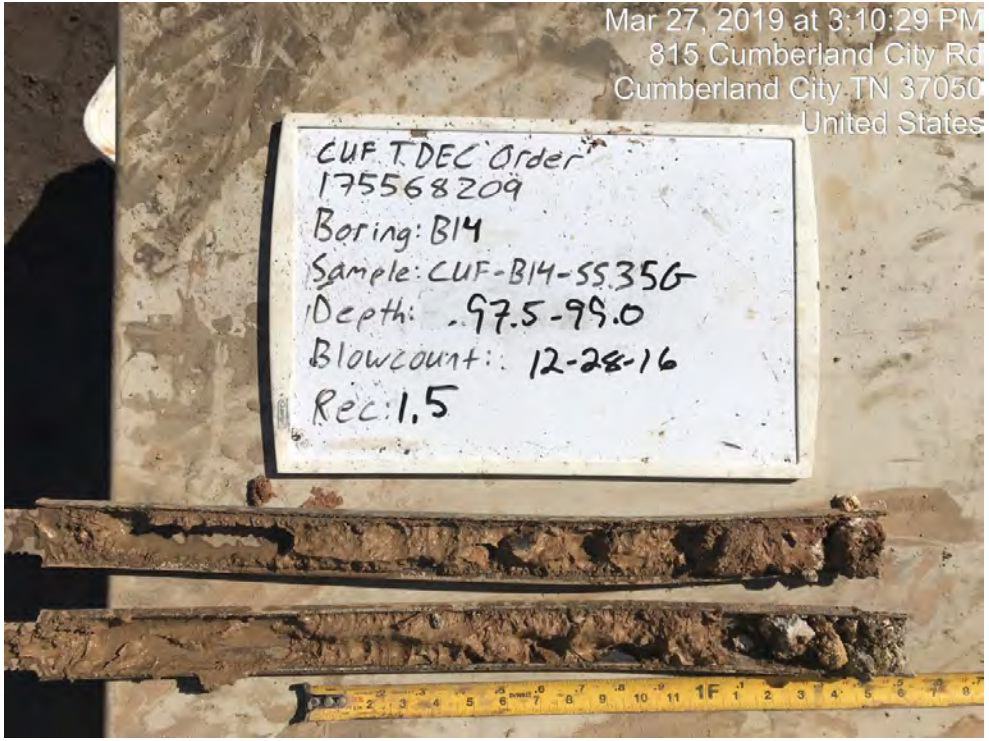
Photograph ID: 41

Photo Location: CUF-B14	
Photo Date: 3/27/2019	
Comments: Interval (97.5-99.0 feet). Sample identifier on white board should be SS36.

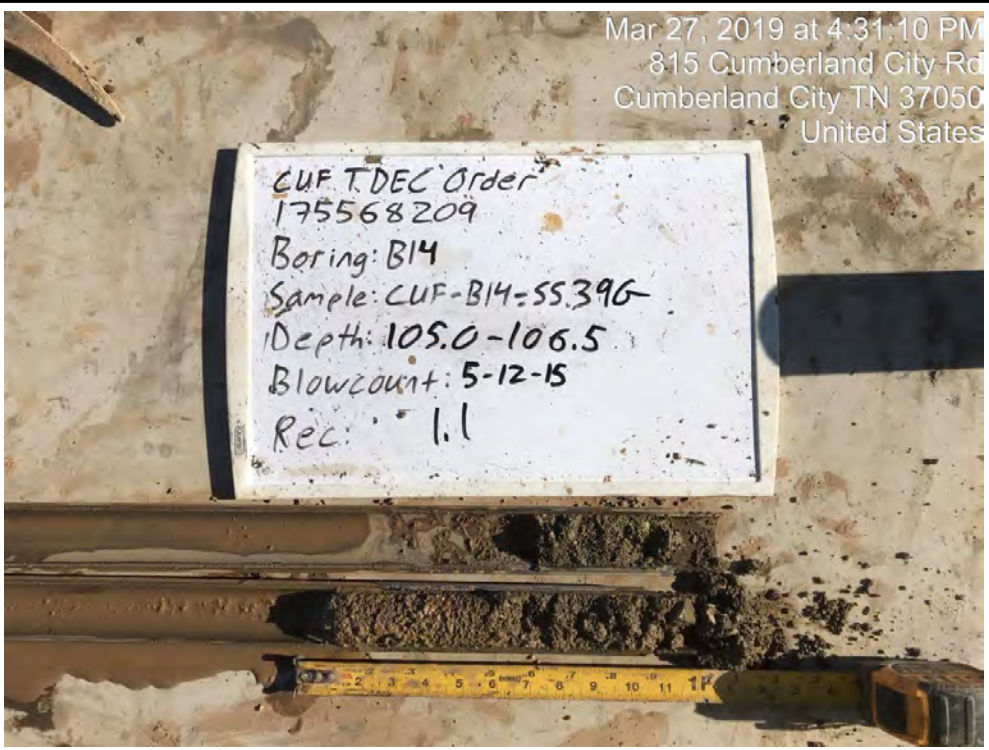
Photograph ID: 44

Mar 27, 2019 at 4:31:10 PM 815 Cumberland City Rd Cumberland City TN 37050 United States
Photo Location: CUF-B14		
Photo Date: 3/27/2019		
Comments: Interval (105.0-106.5 feet).

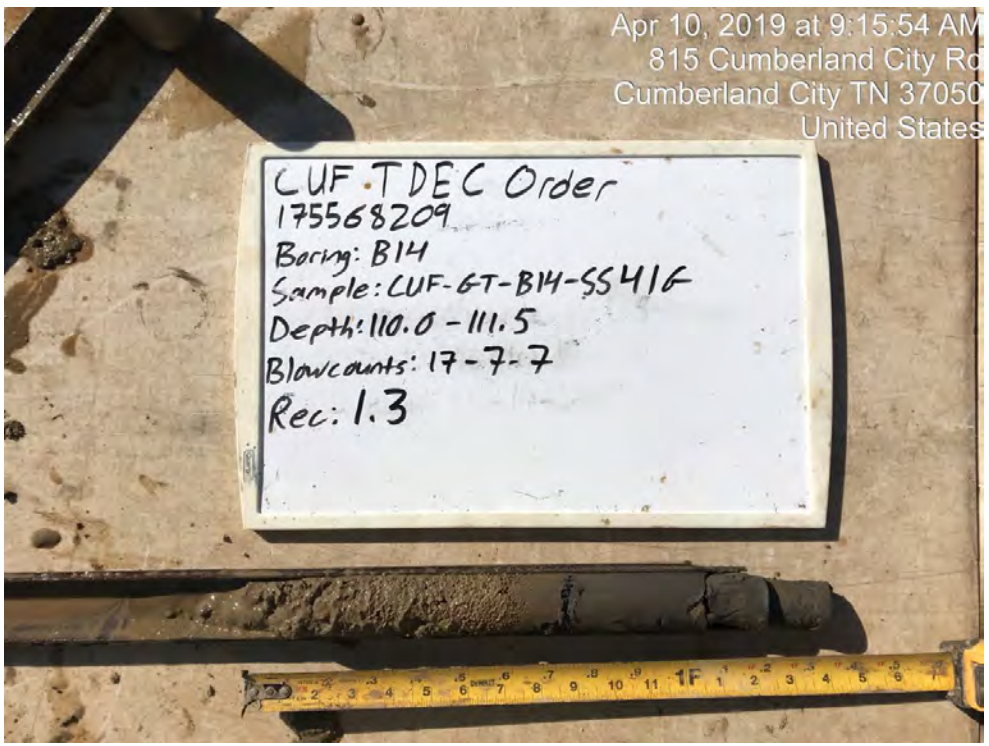
Photograph ID: 46

Photo Location: CUF-B14	
Photo Date: 4/10/2019	
Comments: Interval (100.0-111.5 feet).

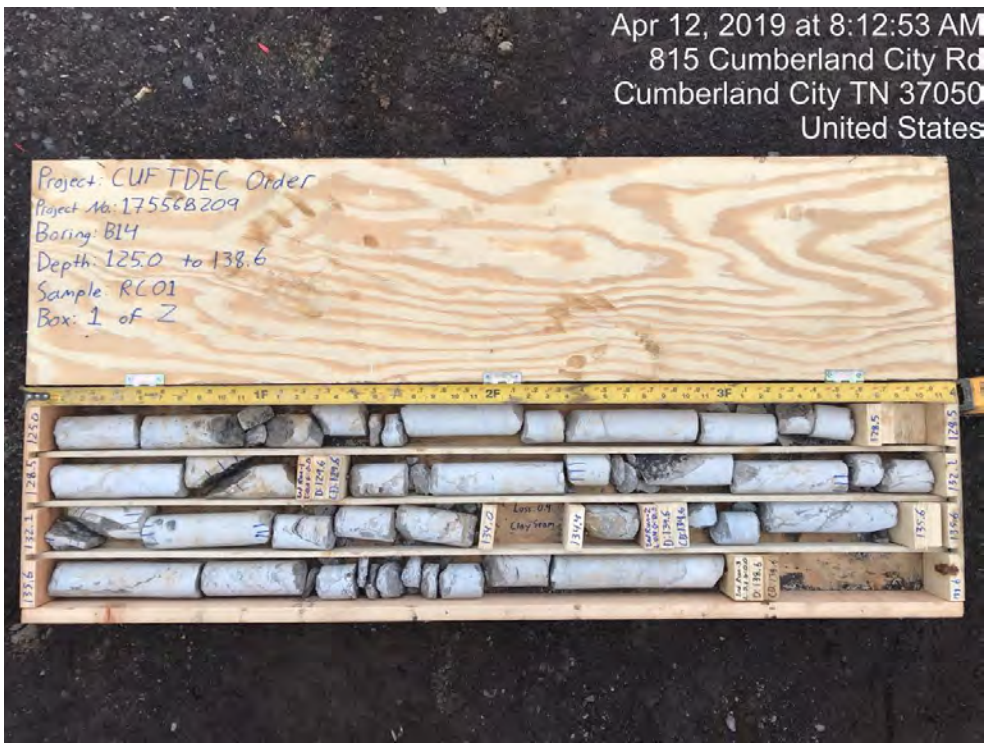
Photograph ID: 52

Apr 12, 2019 at 8:12:53 AM 815 Cumberland City Rd Cumberland City TN 37050 United States
Photo Location: CUF-B14		
Photo Date: 4/12/2019		
Comments: Interval (125.0-138.6 feet). Metadata date reflects the date the photo was taken, not the date the core was drilled.

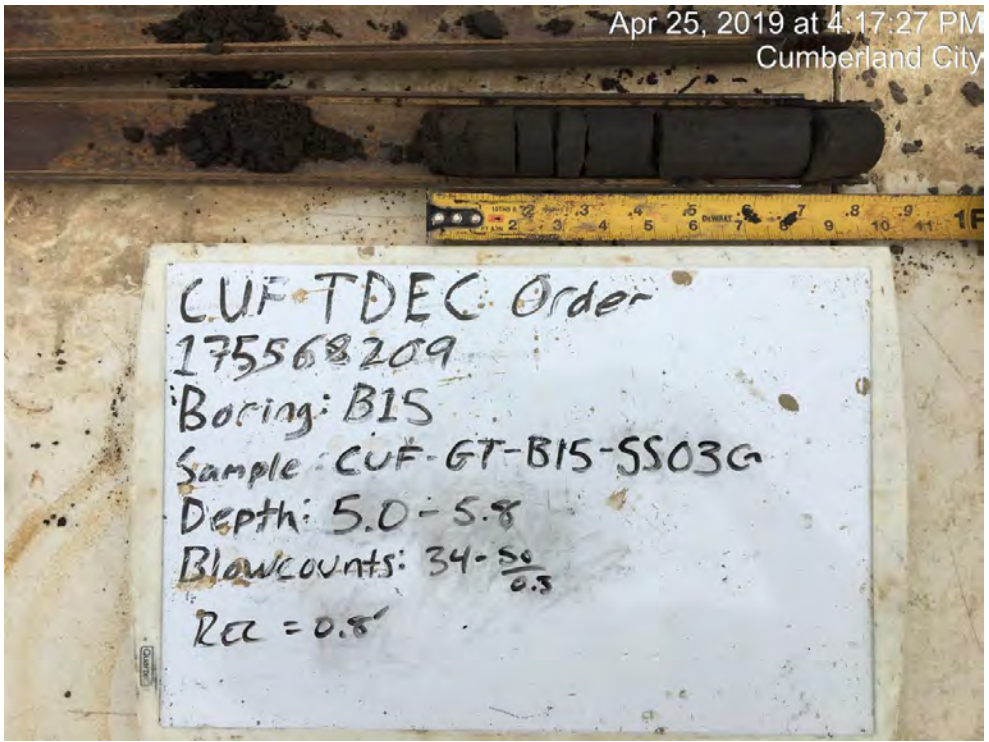
Photograph ID: 56

Photo Location: CUF-B15	
Photo Date: 4/25/2019	
Comments: Interval (5.0-5.8 feet). Sampler refusal at 5.8 feet.

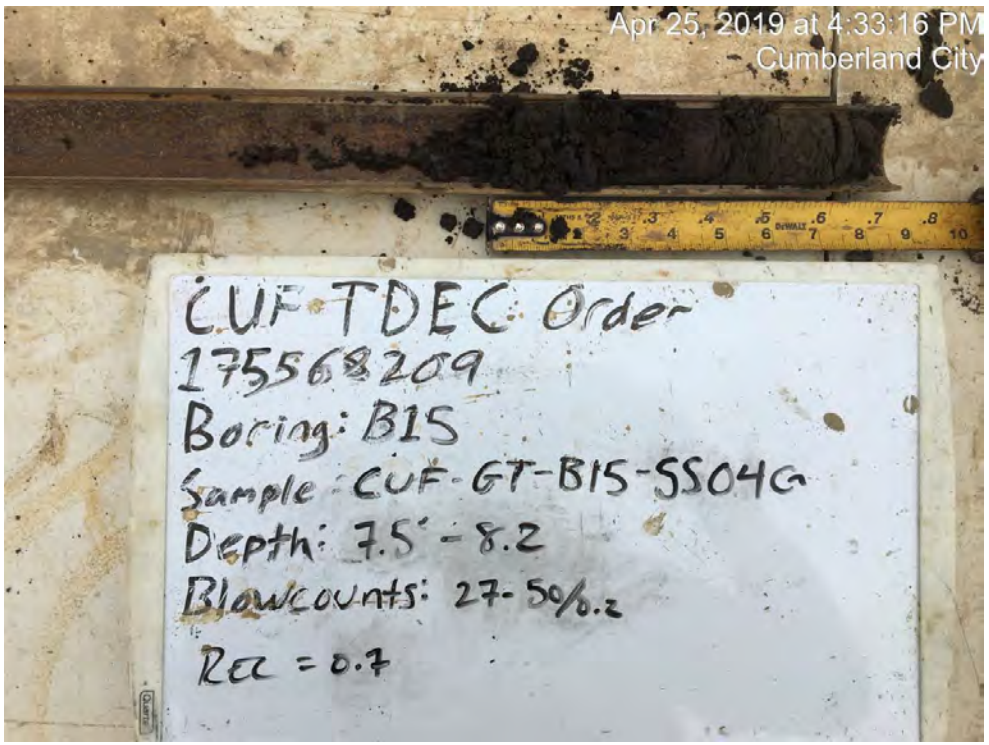
Photograph ID: 57

Photo Location: CUF-B15	
Photo Date: 4/25/2019	
Comments: Interval (7.5-8.2 feet). Sampler refusal at 8.2 feet.

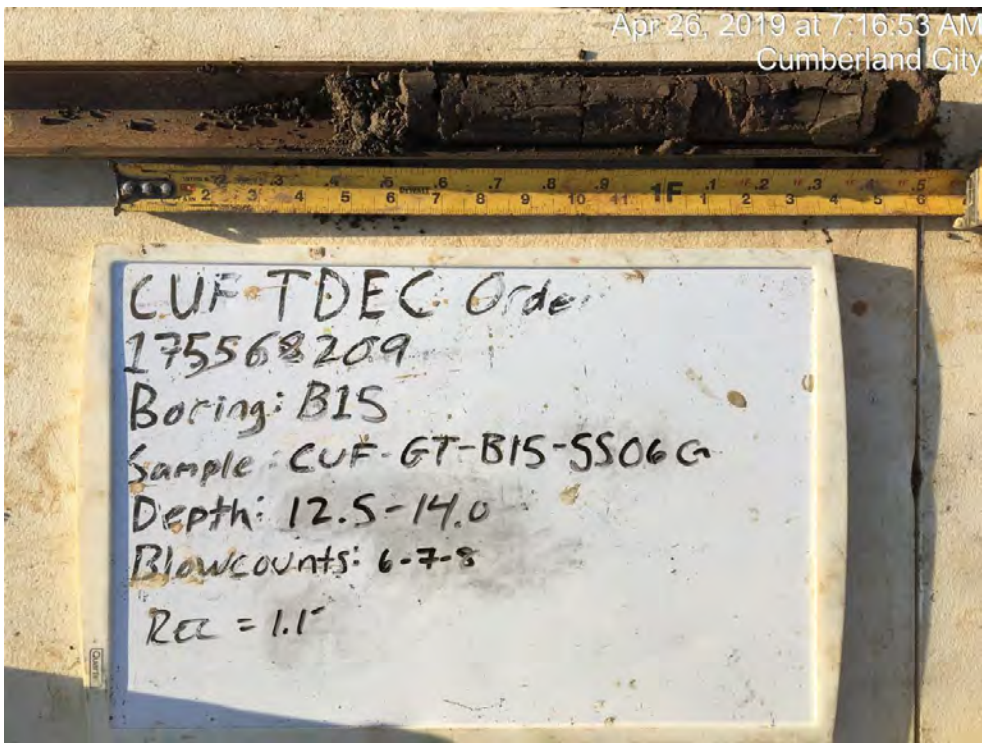
Photo Location: CUF-B15			
Photo Date: 4/26/2019			
Comments: Interval (12.5-14.0 feet).			
Photograph ID: 60	<p style="text-align: center;">No Photo Applicable</p>		
Photo Location: CUF-B15			
Photo Date: 4/26/2019			
Comments: Photo of interval (15.0-15.8 feet) unavailable because sample collected with shelby tube. Sampler refusal at 15.8 feet.

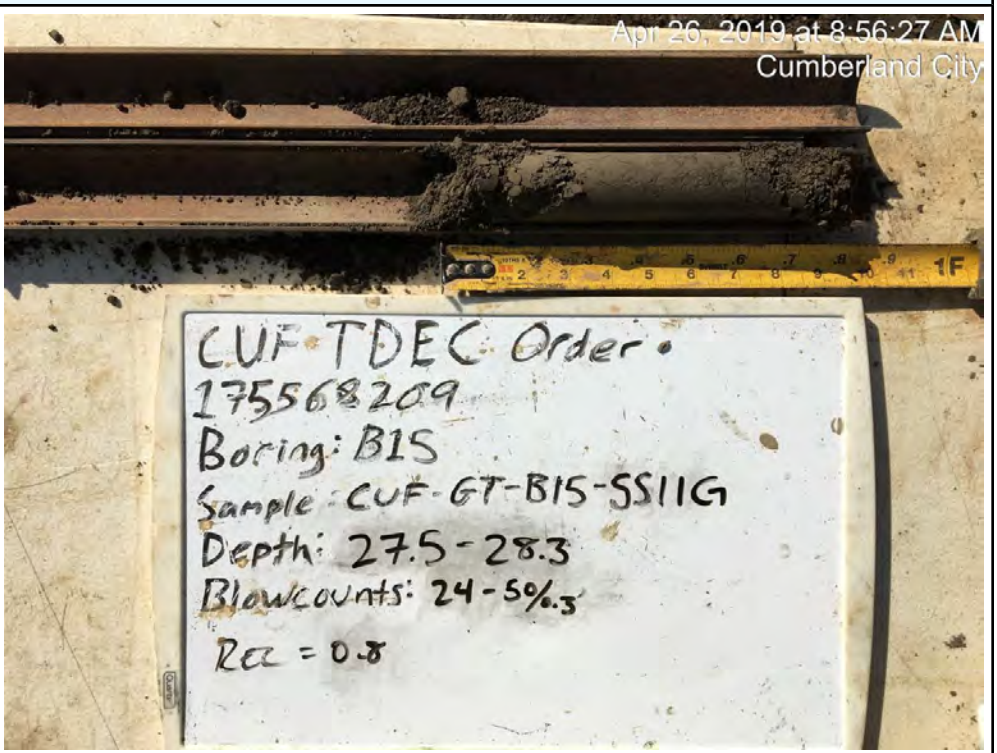
Photograph ID: 65

Photo Location: CUF-B15	
Photo Date: 4/26/2019	
Comments: Interval (27.5-28.3 feet). Sampler refusal at 28.3 feet.

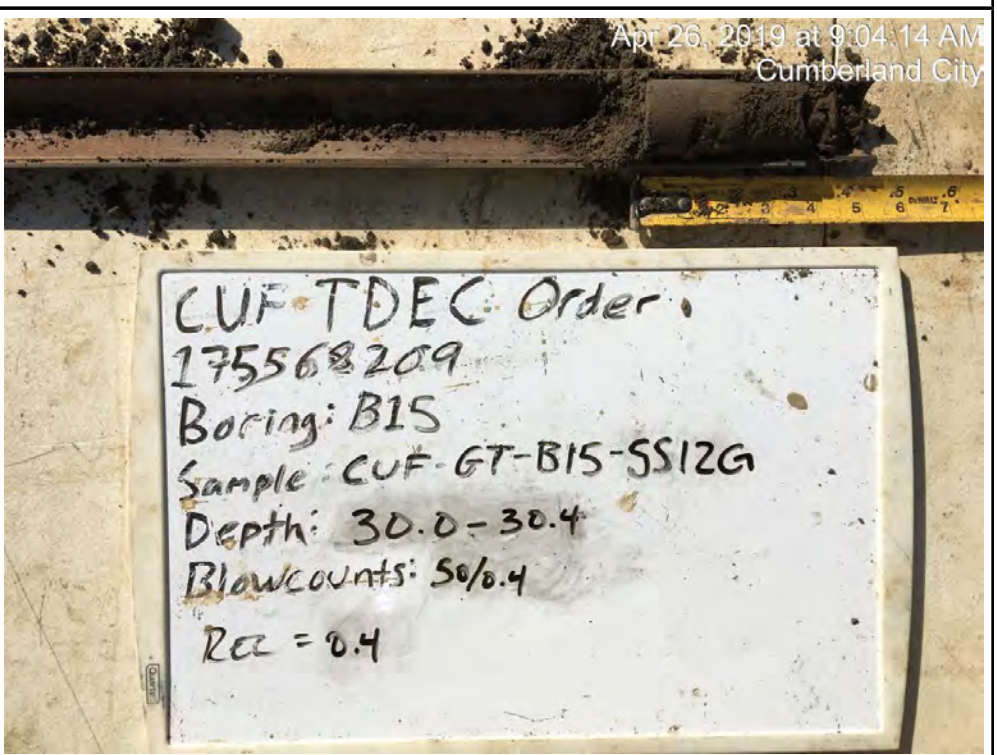
Photograph ID: 66

Photo Location: CUF-B15	
Photo Date: 4/26/2019	
Comments: Interval (30.0-30.4 feet). Sampler refusal at 30.4 feet.

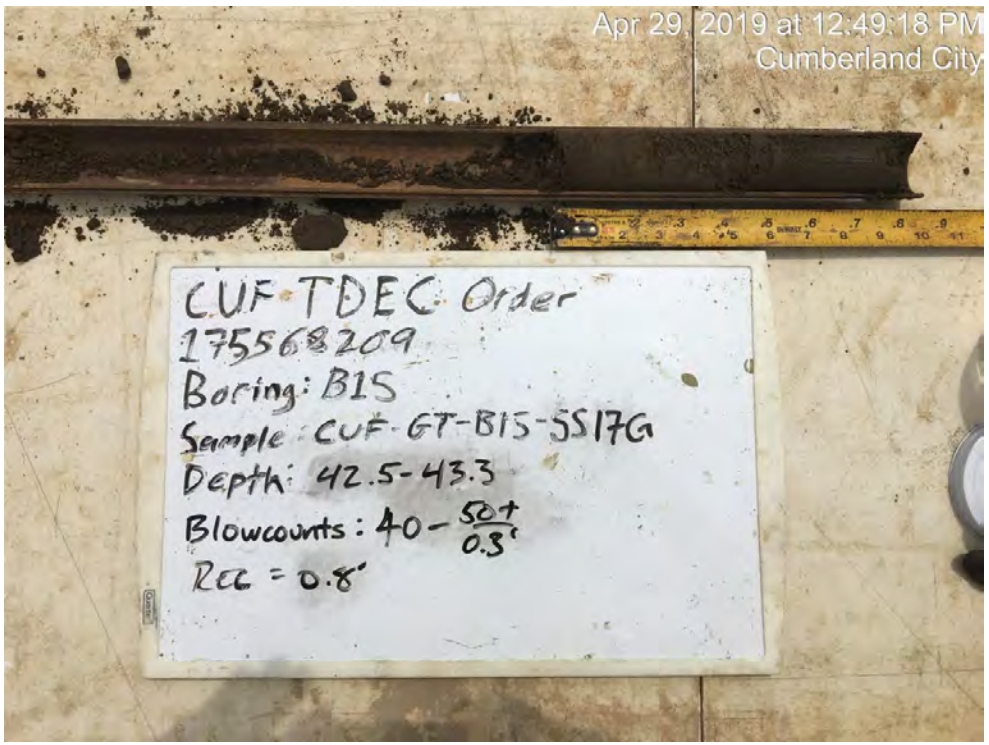
Photograph ID: 71

Photo Location: CUF-B15	
Photo Date: 4/29/2019	
Comments: Interval (42.5-43.3 feet). Sampler refusal at 43.3 feet.

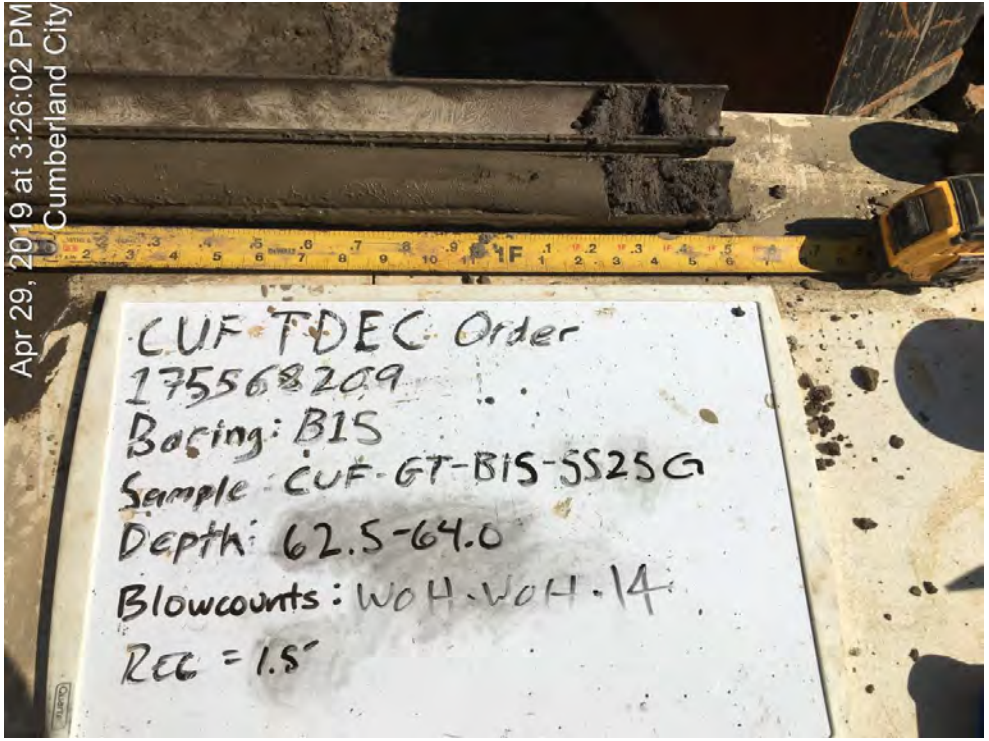
Photograph ID: 79

Photo Location: CUF-B15	
Photo Date: 4/29/2019	
Comments: Interval (62.5-64.0 feet). WOH on white board is the same as WH on the boring log.

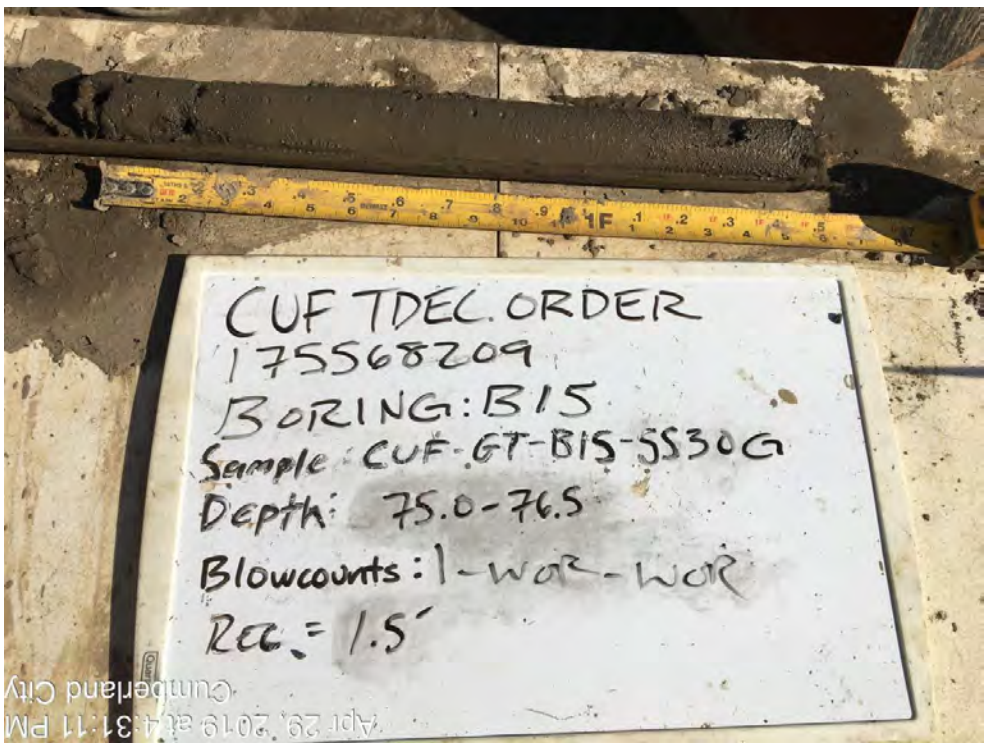
Photograph ID: 84

<p>Apr 29, 2019 at 4:31:11 PM Cumberland City</p>
Photo Location: CUF-B15	
Photo Date: 4/29/2019	
Comments: Interval (75.0-76.5 feet). WOR on white board is the same as WR on the boring log.

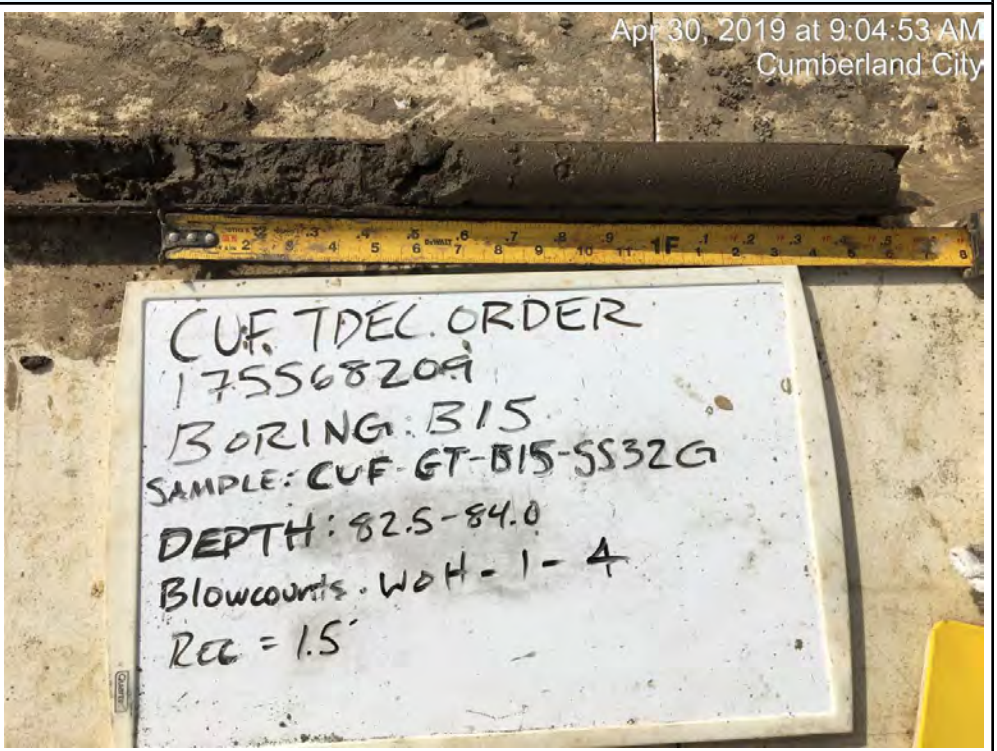
Photograph ID: 87

Photo Location: CUF-B15	
Photo Date: 4/30/2019	
Comments: Interval (82.5-84.0 feet). WOH on white board is the same as WH on the boring log.

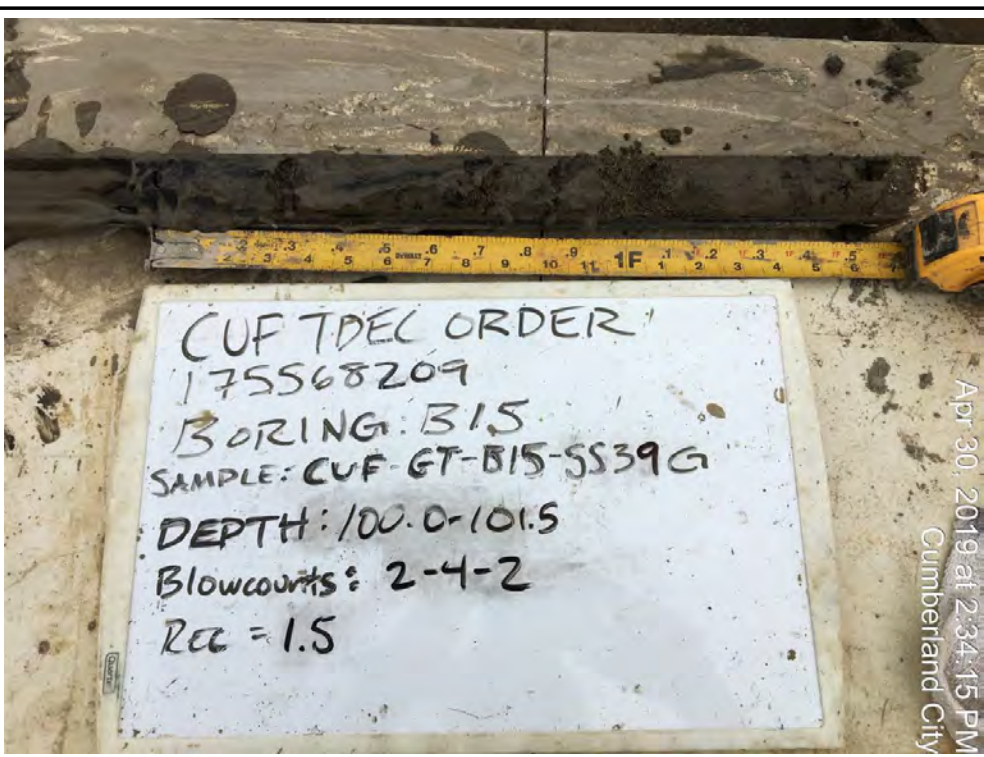
Photograph ID: 94

Photo Location: CUF-B15	
Photo Date: 4/30/2019	
Comments: Interval (100.0-101.5 feet).

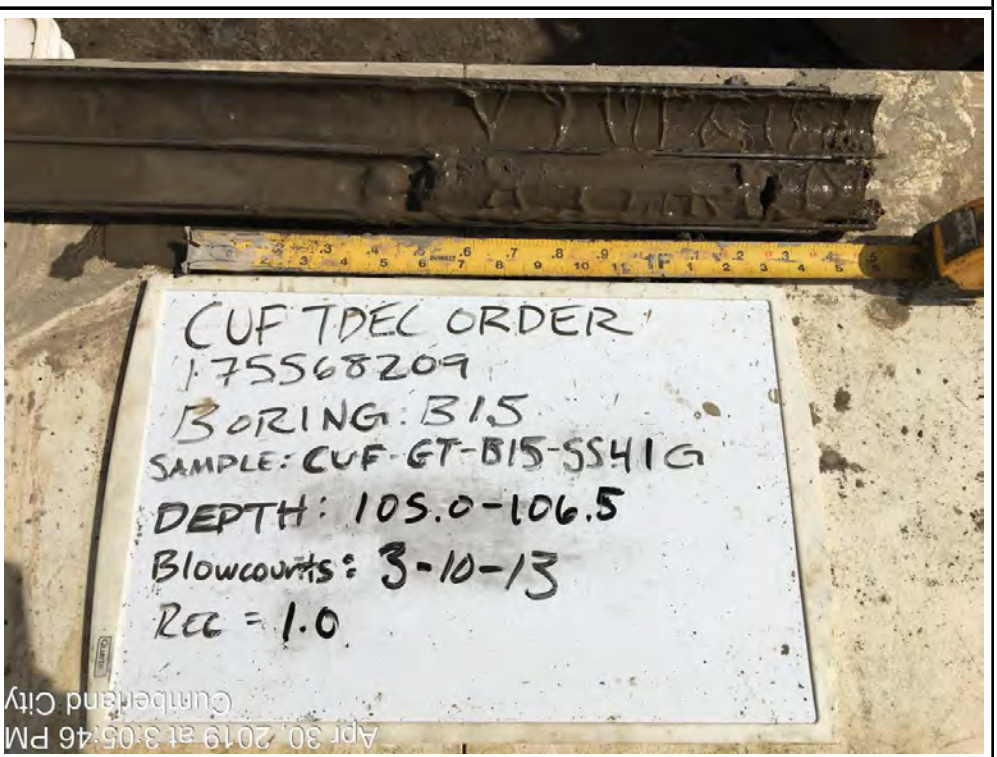
Photograph ID: 96

Photo Location: CUF-B15	
Photo Date: 4/30/2019	
Comments: Interval (105.0-106.5 feet).

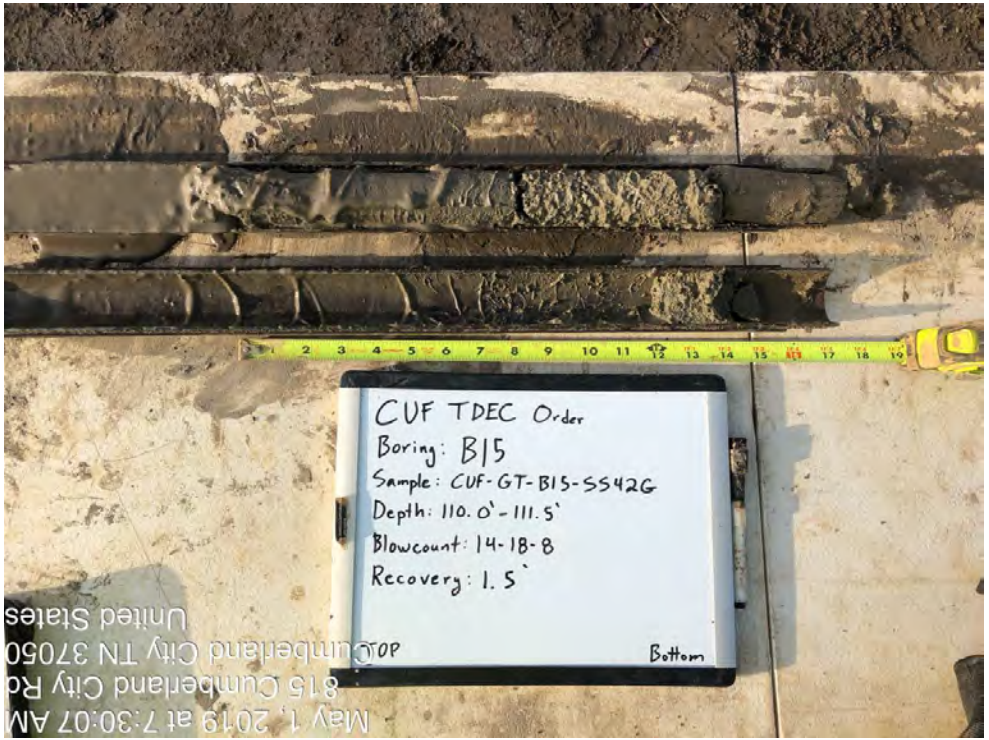
Photograph ID: 98

Photo Location: CUF-B15	
Photo Date: 5/1/2019	
Comments: Interval (110.0-111.5 feet).

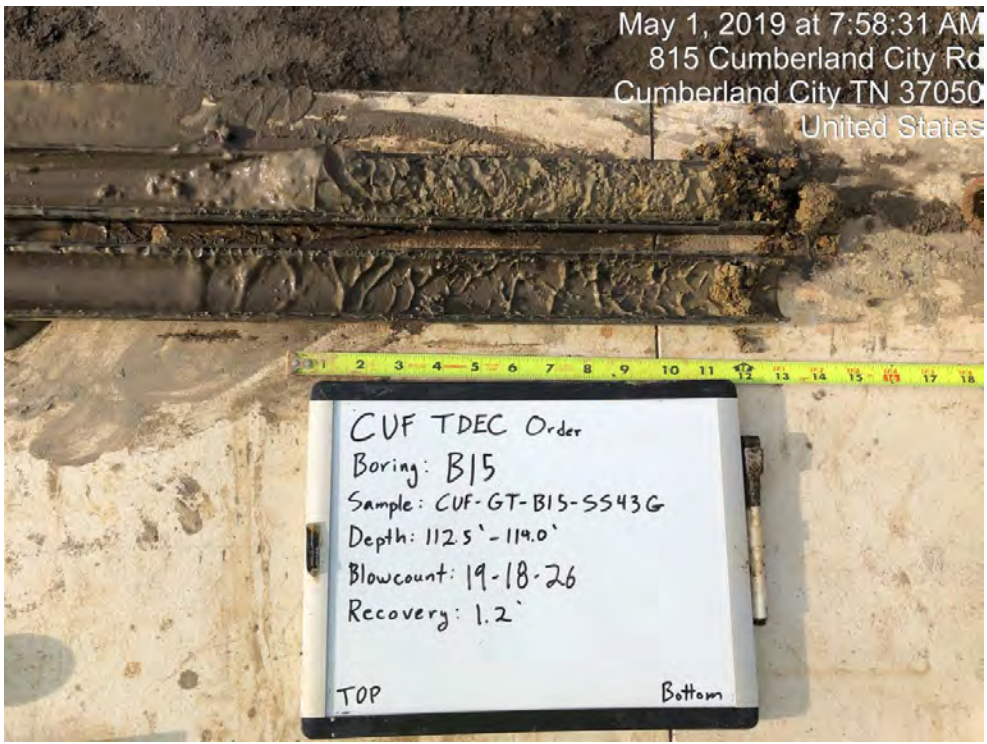
<p>May 1, 2019 at 7:58:31 AM 815 Cumberland City Rd Cumberland City TN 37050 United States</p>		
Photo Location: CUF-B15			
Photo Date: 5/1/2019			
Comments: Interval (112.5-114.0 feet).			
Photograph ID: 100

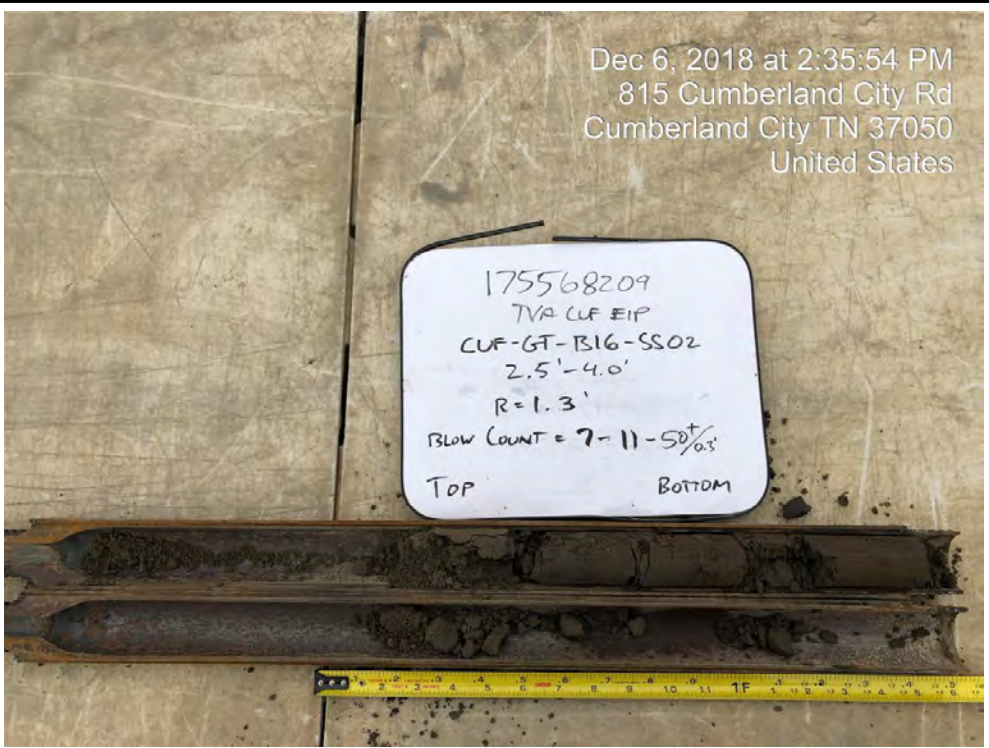
Photograph ID: 106

Photo Location: CUF-B16	
Photo Date: 12/6/2018	
Comments: Interval (2.5-3.8 feet). Interval shown on white board should be 2.5-3.8 feet. Sampler refusal at 3.8 feet.

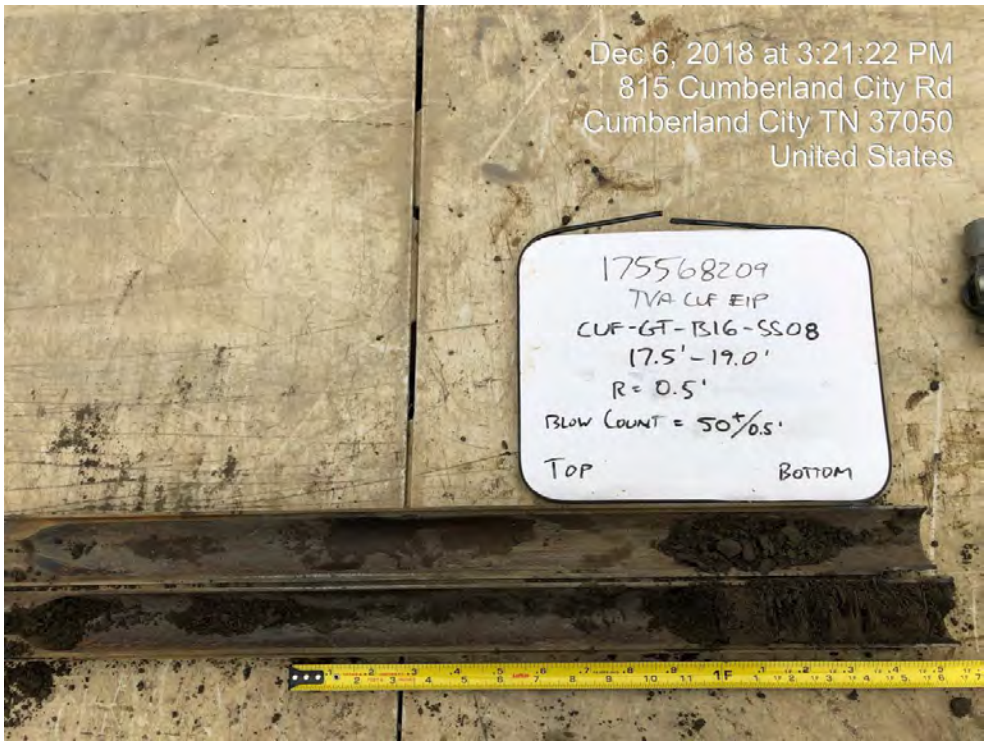
Photograph ID: 112	Dec 6, 2018 at 3:21:22 PM 815 Cumberland City Rd Cumberland City TN 37050 United States
Photo Location: CUF-B16	
Photo Date: 12/6/2018	
Comments: Interval (17.5-18.0 feet). Interval shown on white board should be 17.5-18.0 feet. Sampler refusal at 18.0 feet.

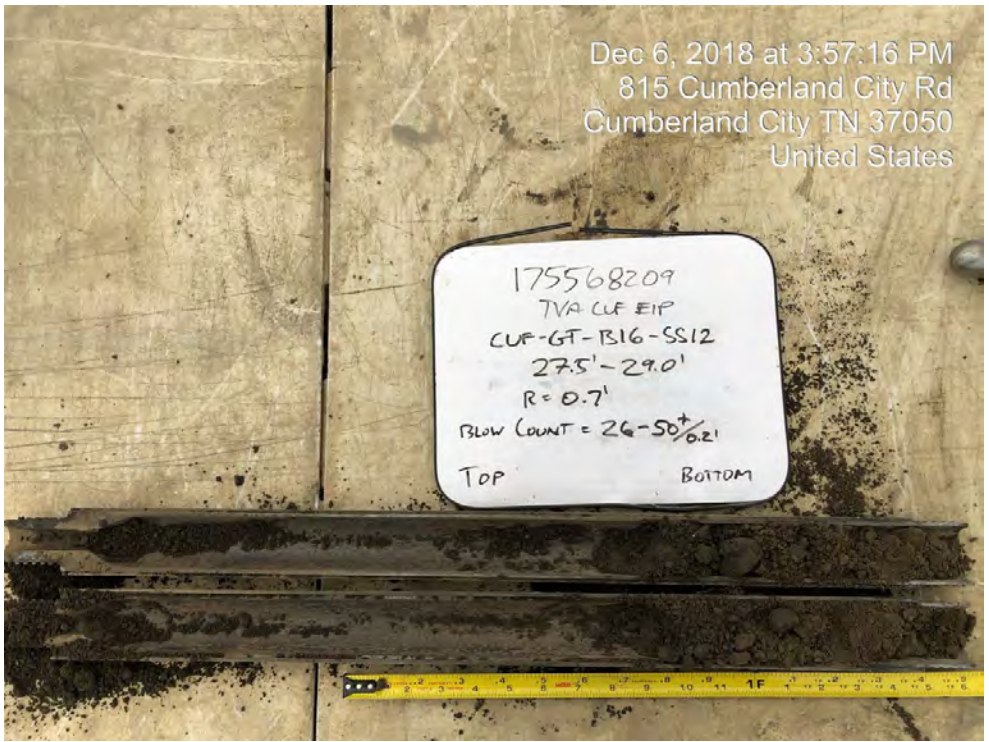
Photograph ID: 116	Dec 6, 2018 at 3:57:16 PM 815 Cumberland City Rd Cumberland City TN 37050 United States
Photo Location: CUF-B16	
Photo Date: 12/6/2018	
Comments: Interval (27.5-28.2 feet). Interval shown on white board should be 27.5-28.2 feet. Sampler refusal at 28.2 feet.

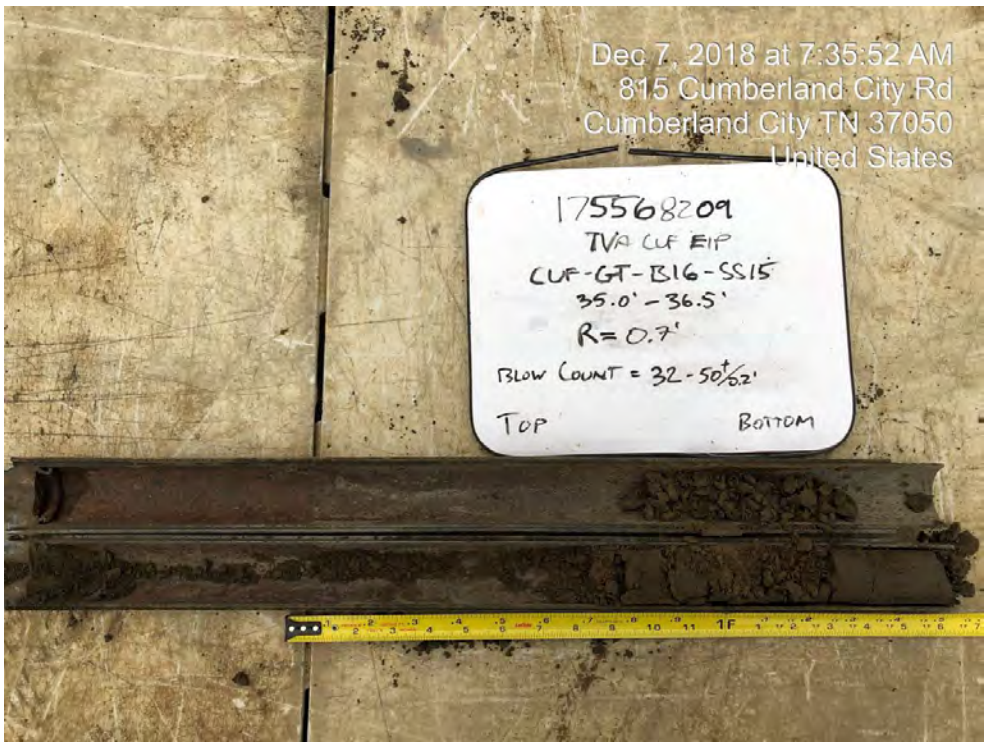
Photograph ID: 119

Photo Location: CUF-B16	
Photo Date: 12/7/2018	
Comments: Interval (35.0-35.7 feet). Interval shown on white board should be 35.0-35.7 feet. Sampler refusal at 35.7 feet.
