**APPENDIX G –
CCR MATERIAL INVESTIGATIONS**

**Appendix G.1 - Technical
Evaluation of Geotechnical and
CCR Material Characteristics Data**

TDEC Commissioner's Order:
Environmental Assessment Report
Cumberland Fossil Plant
Cumberland, Tennessee

Stantec Consulting Services Inc.
Lexington, Kentucky

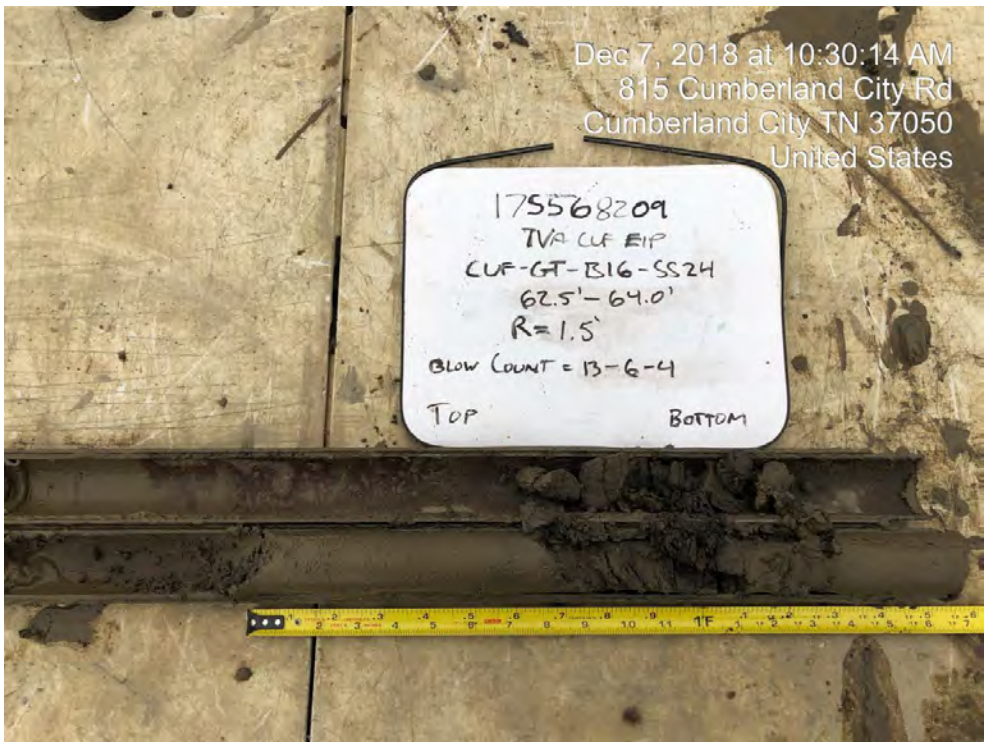
Photograph ID: 129	Dec 7, 2018 at 10:30:14 AM 815 Cumberland City Rd Cumberland City TN 37050 United States
Photo Location: CUF-B16	
Photo Date: 12/7/2018	
Comments: Interval (62.5-64.0 feet).

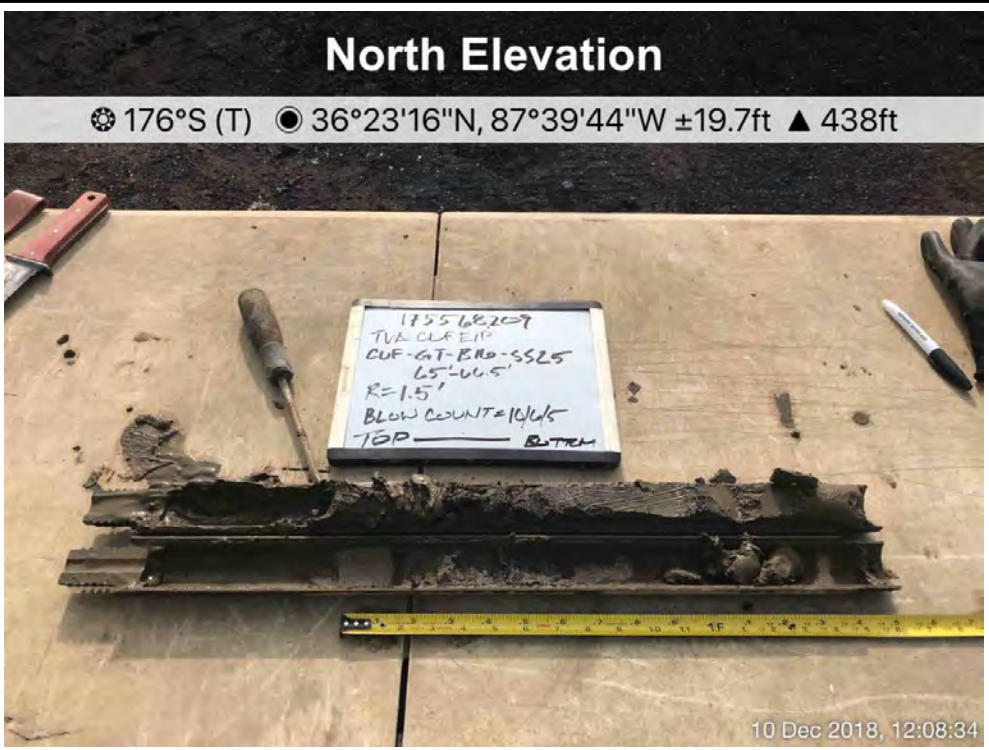
438ft </p>
Photo Location: CUF-B16	
Photo Date: 12/10/2018	
Comments: Interval (65.0-66.5 feet). Interval shown on white board should be 65.0-66.5 feet.

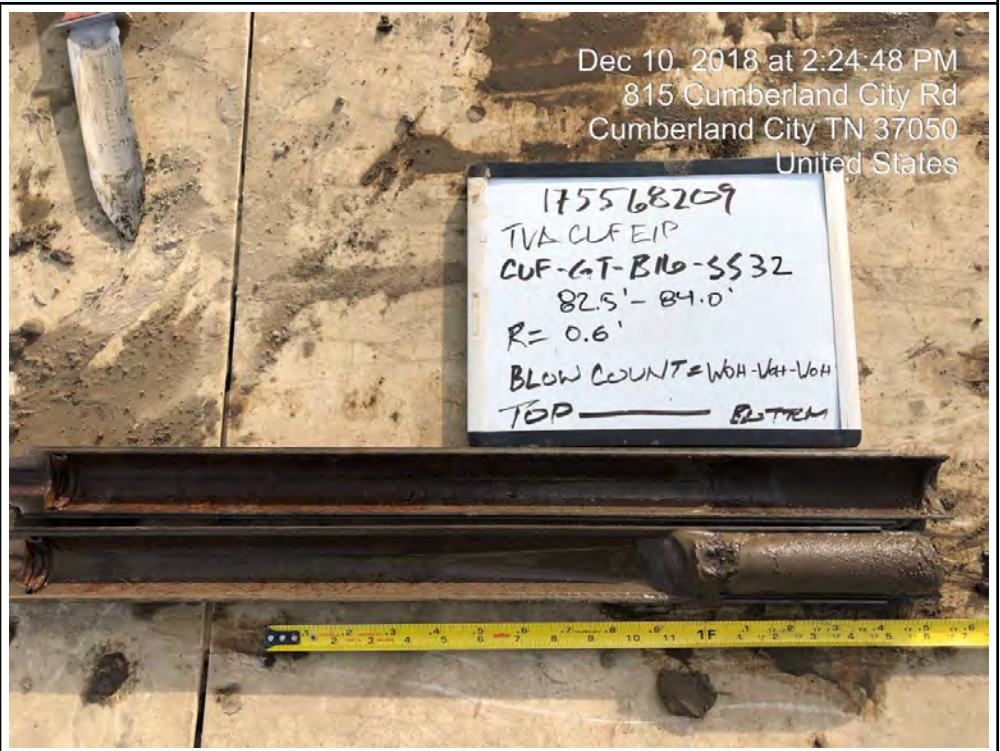
Comments:
Interval (82.5-84.0 feet).
WOH on white board is the same as WH on the boring log.

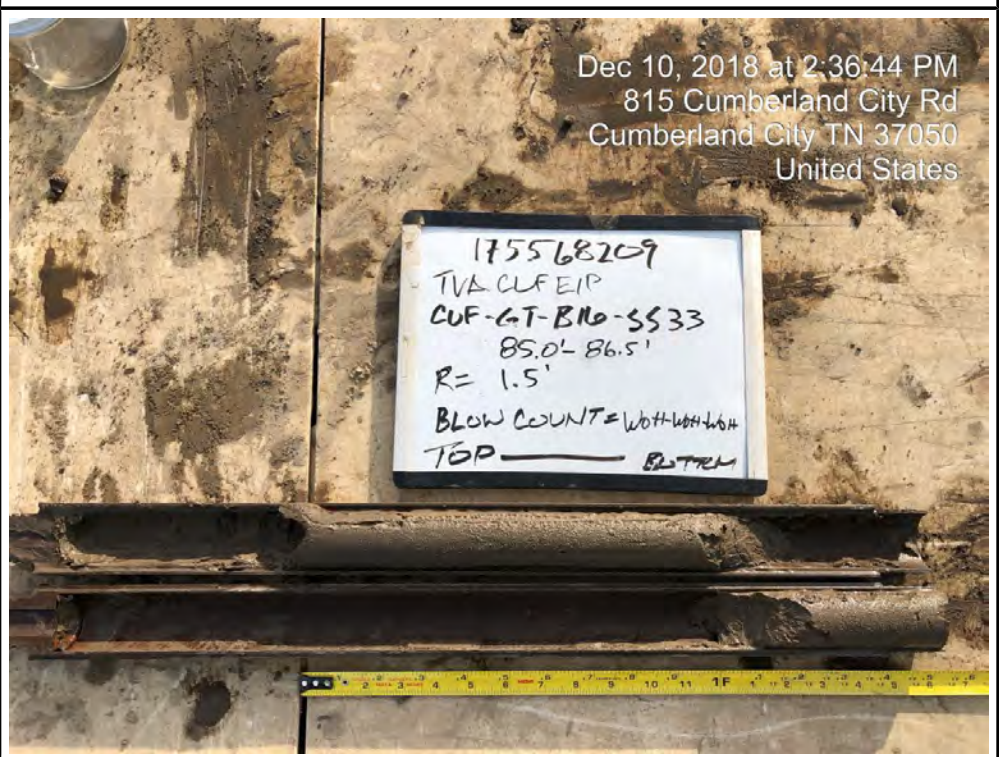
Photograph ID: 138

Comments:
Interval (85.0-86.5 feet).
WOH on white board is the same as WH on the boring log.

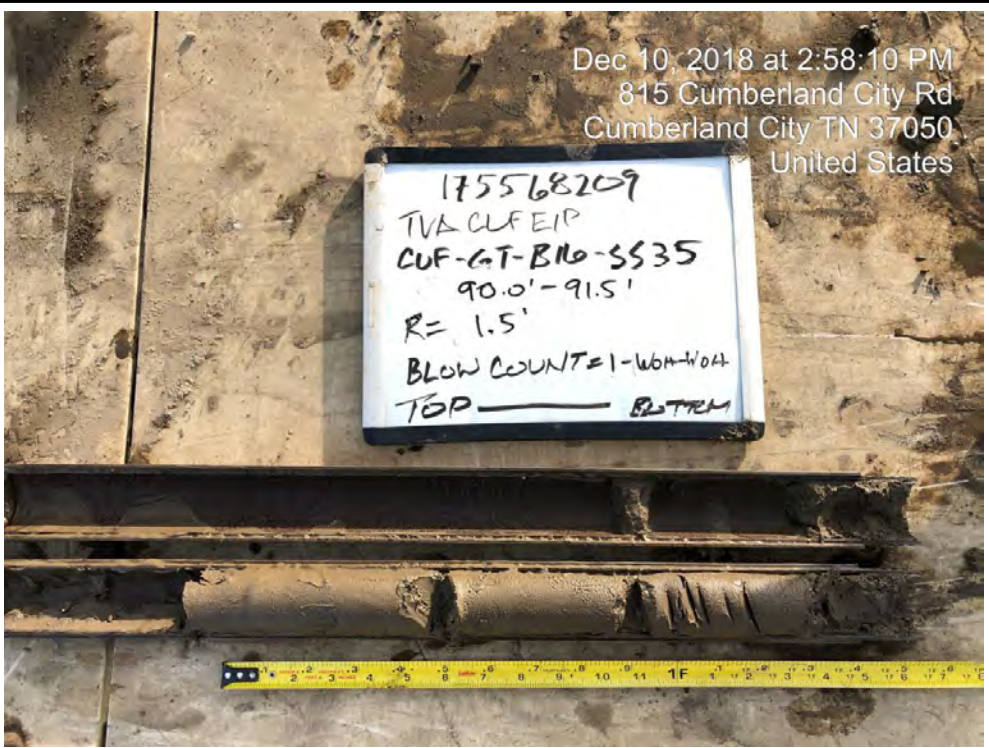
Photograph ID: 140

Photo Location: CUF-B16	
Photo Date: 12/10/2018	
Comments: Interval (90.0-91.5 feet). WOH on white board is the same as WH on the boring log.

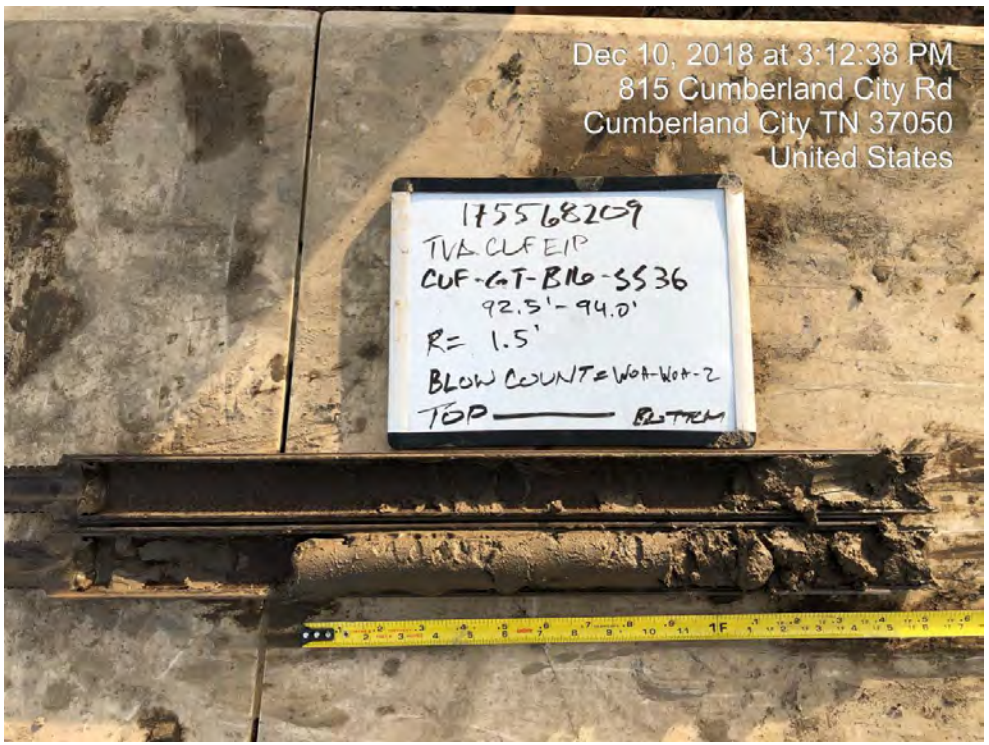
Photograph ID: 141	Dec 10, 2018 at 3:12:38 PM 815 Cumberland City Rd Cumberland City TN 37050 United States
Photo Location: CUF-B16	
Photo Date: 12/10/2018	
Comments: Interval (92.5-94.0 feet). WOH on white board is the same as WH on the boring log.

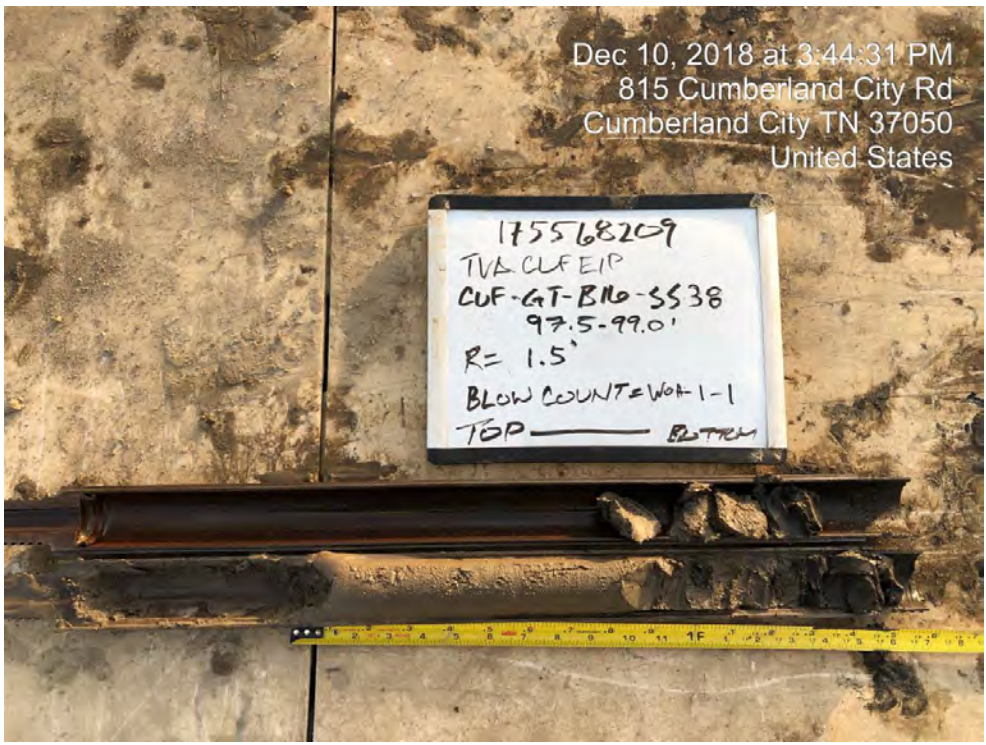
Photograph ID: 143

Photo Location: CUF-B16	
Photo Date: 12/10/2018	
Comments: Interval (97.5-99.0 feet). WOH on white board is the same as WH on the boring log.

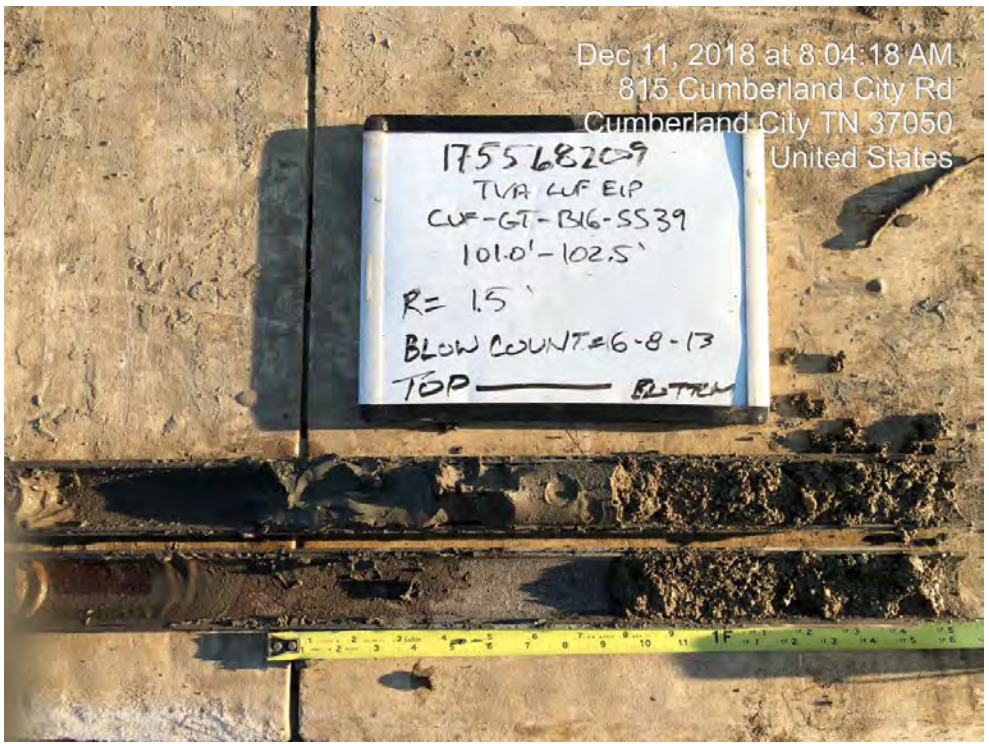
Client:	Tennessee Valley Authority	Project:	CUF TDEC Order
Site Name:	Cumberland Fossil (CUF) Plant	Site Location:	Cumberland City, Tennessee
Photograph ID: 145

Photo Location: CUF-B16			
Photo Date: 12/11/2018			
Comments: Interval (101.0-102.5 feet).			
Photograph ID: 146

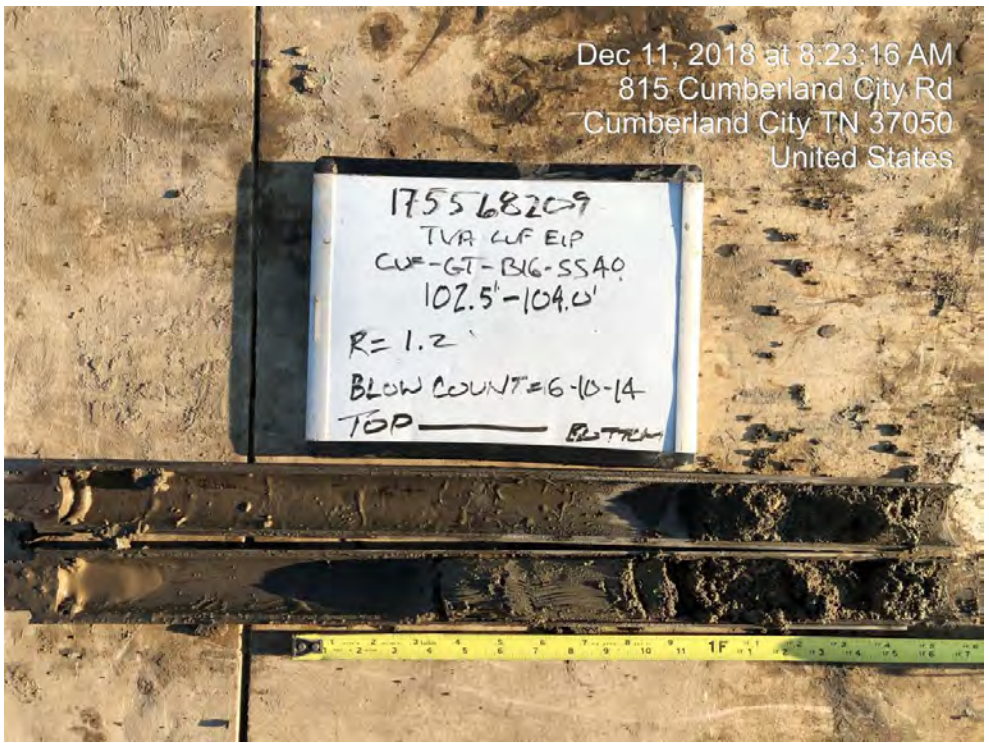
Photo Location: CUF-B16			
Photo Date: 12/11/2018			
Comments: Interval (102.5-104.0 feet).

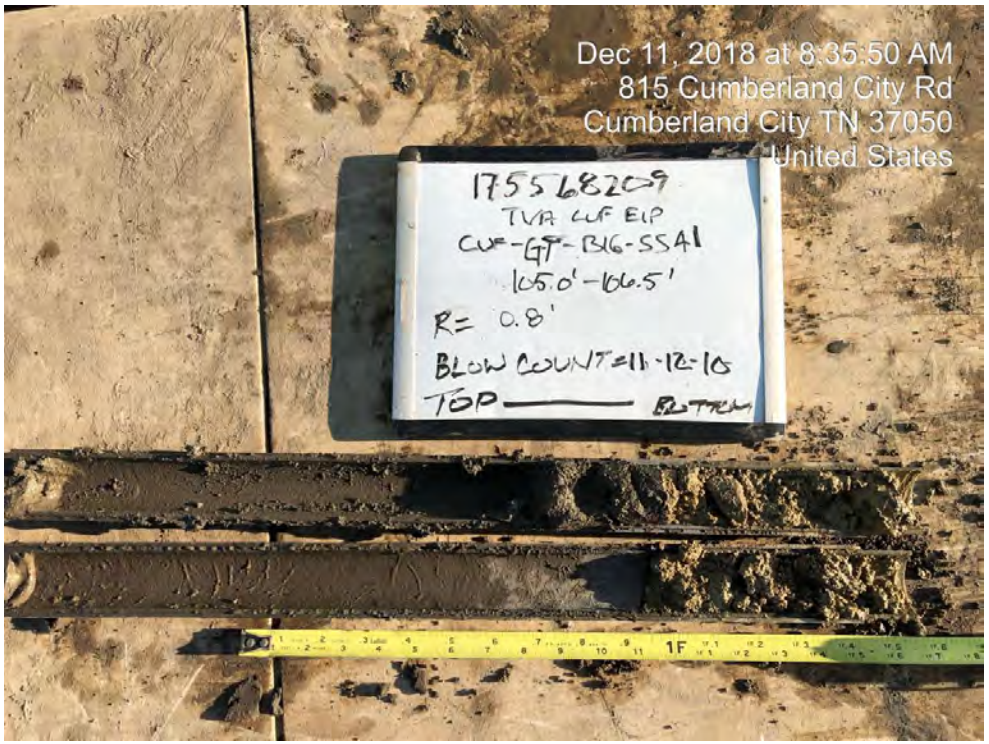
Client:	Tennessee Valley Authority	Project:	CUF TDEC Order
Site Name:	Cumberland Fossil (CUF) Plant	Site Location:	Cumberland City, Tennessee
Photograph ID: 147

Photo Location: CUF-B16			
Photo Date: 12/11/2018			
Comments: Interval (105.0-106.5 feet).			
Photograph ID: 148	<p style="text-align: center;">No Photo Applicable</p>		
Photo Location: CUF-B16			
Photo Date: 12/11/2018			
Comments: Photo of interval (107.5-109.5 feet) unavailable because sample collected with shelby tube.

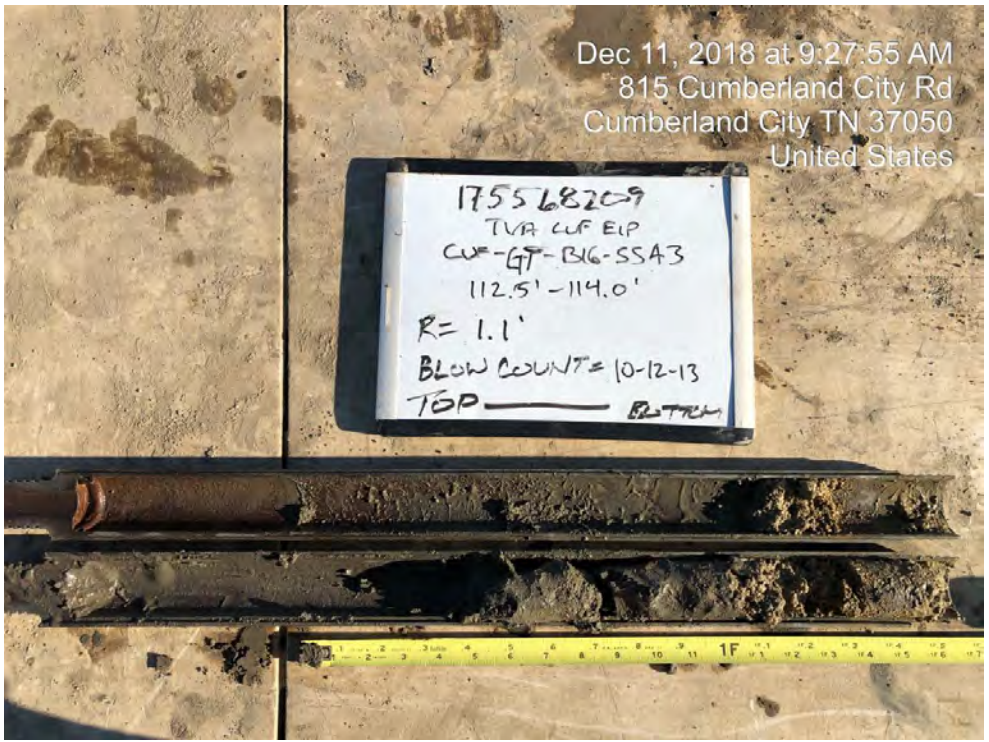
Photograph ID: 150

<p>Dec 11, 2018 at 9:27:55 AM 815 Cumberland City Rd Cumberland City TN 37050 United States</p> <p>175568209 TVA CUF EIP CUF-GT-BIG-SSA3 112.5' - 114.0' R = 1.1' BLOW COUNT = 10-12-13 TOP _____ BOTTOM</p>
Photo Location: CUF-B16	
Photo Date: 12/11/2018	
Comments: Interval (112.5-114.0 feet).

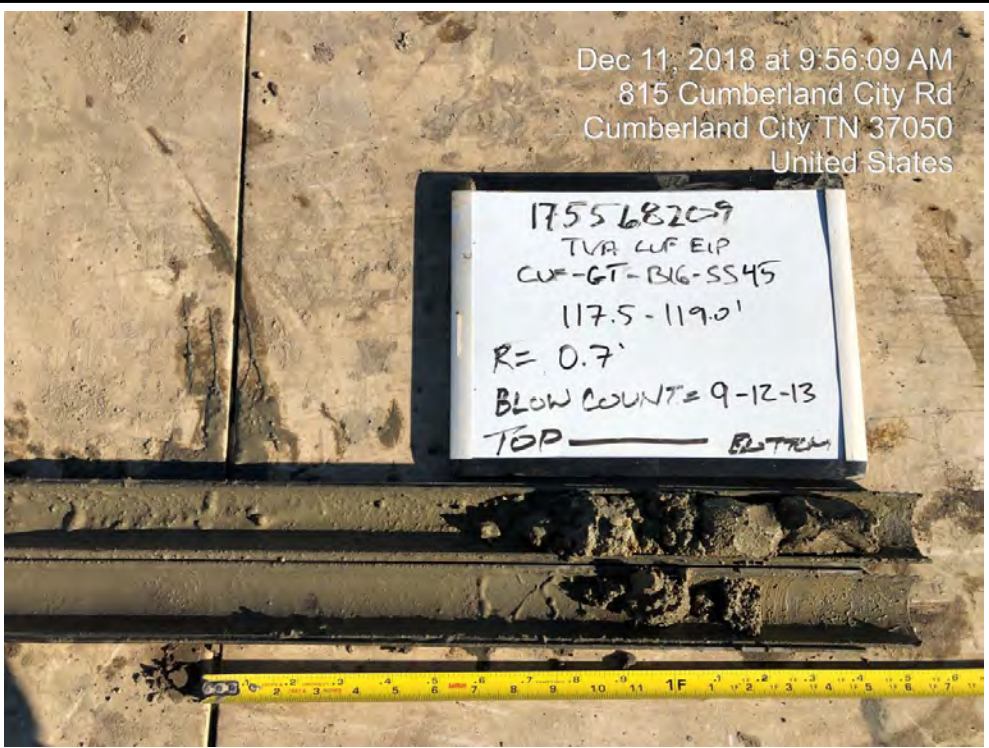
Photograph ID: 152

Photo Location: CUF-B16	
Photo Date: 12/11/2018	
Comments: Interval (117.5-119.0 feet).

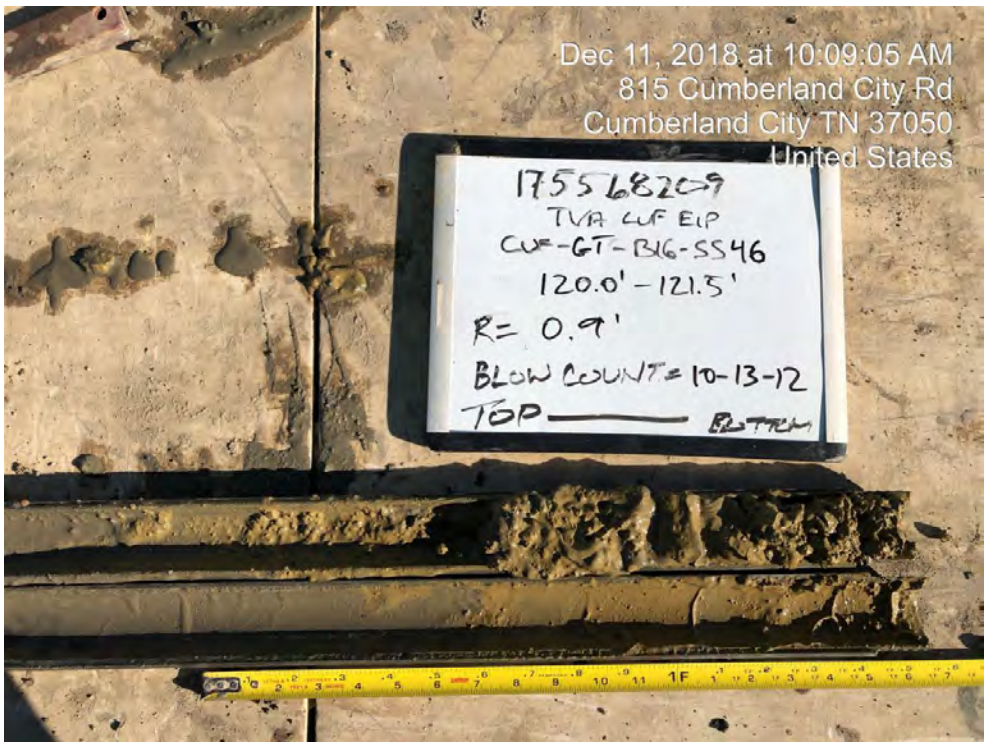
Photograph ID: 153

Photo Location: CUF-B16	
Photo Date: 12/11/2018	
Comments: Interval (120.0-121.5 feet).

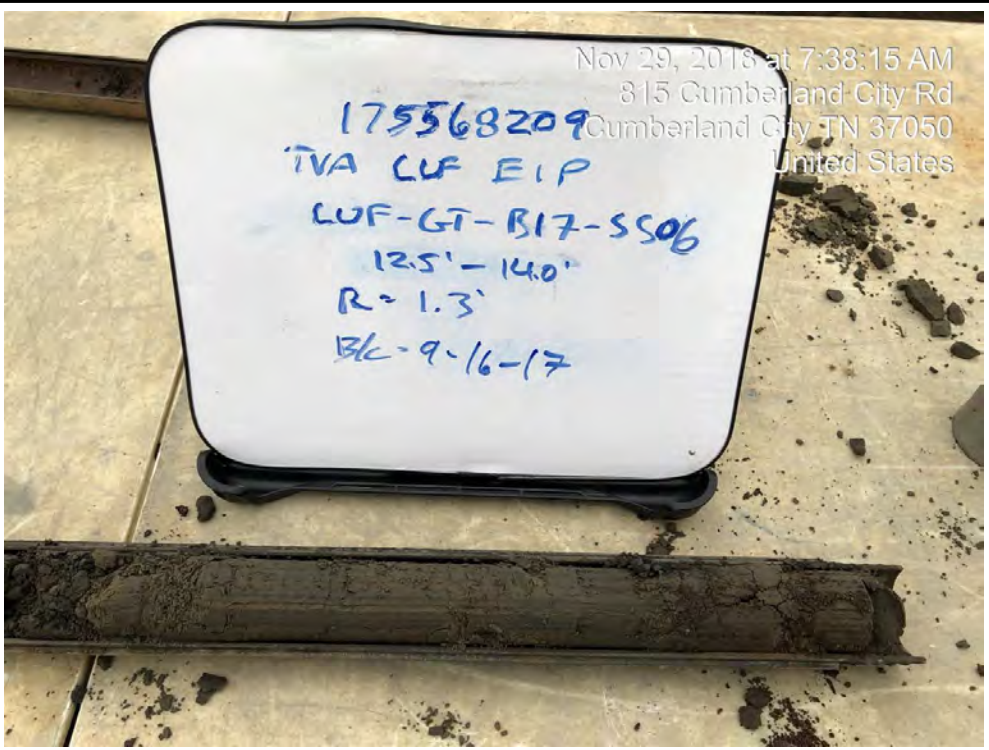
Photograph ID: 162

<p>Nov 29, 2018 at 7:38:15 AM 815 Cumberland City Rd Cumberland City TN 37050 United States</p> <p>175568209 TVA CUF EIP LUF-GT-B17-SS06 12.5'-14.0' R=1.3' Blc-9-16-17</p>
Photo Location: CUF-B17	
Photo Date: 11/29/2018	
Comments: Interval (12.5-14.0 feet).

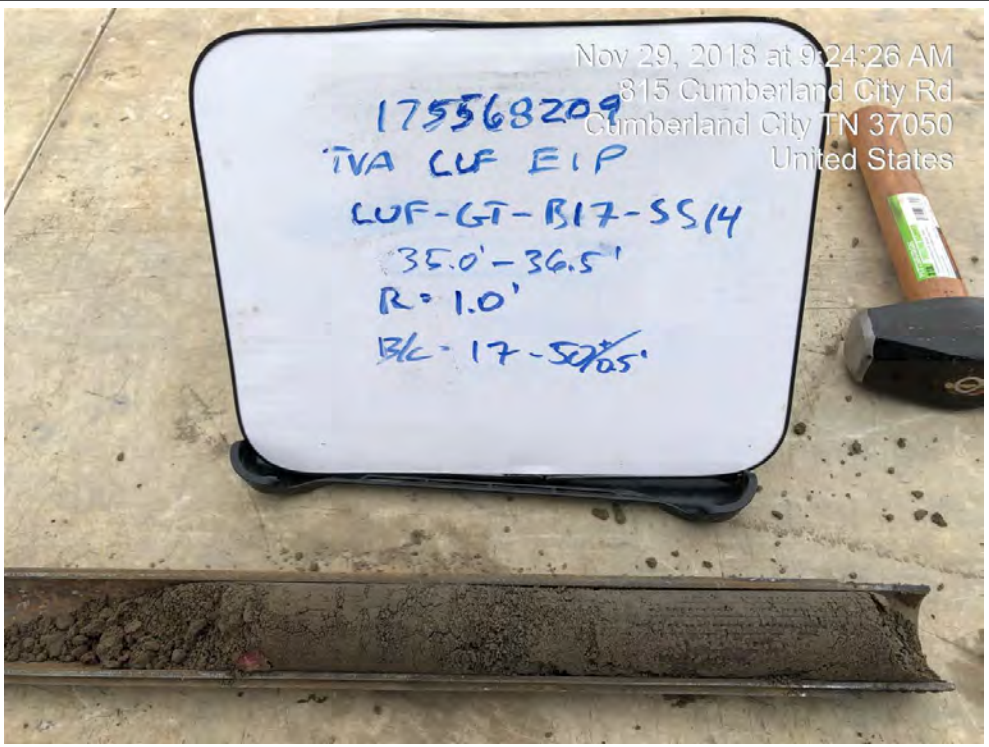
Photograph ID: 171

Photo Location: CUF-B17	
Photo Date: 11/29/2018	
Comments: Interval (35.0-36.0 feet). Interval shown on white board should be 35.0-36.0 feet. Blow count shown on white board should be 17-50. Sampler refusal at 36.0 feet.

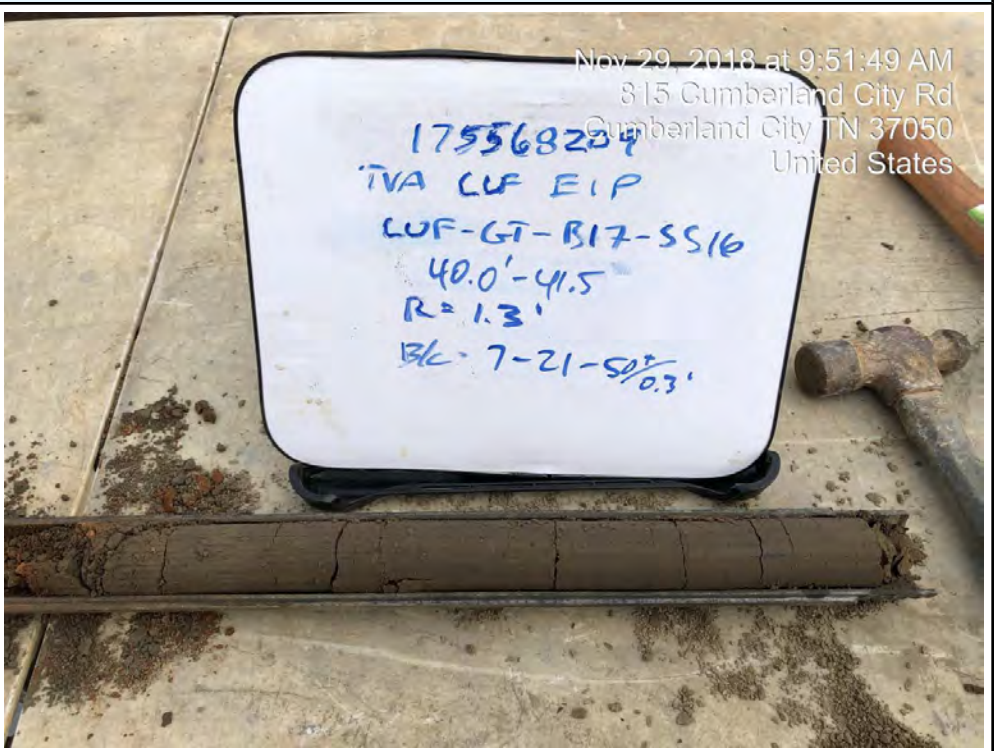
Photograph ID: 173

Photo Location: CUF-B17	
Photo Date: 11/29/2018	
Comments: Interval (40.0-41.3 feet). Interval shown on white board should be 40.0-41.3 feet. Sampler refusal at 41.3 feet.

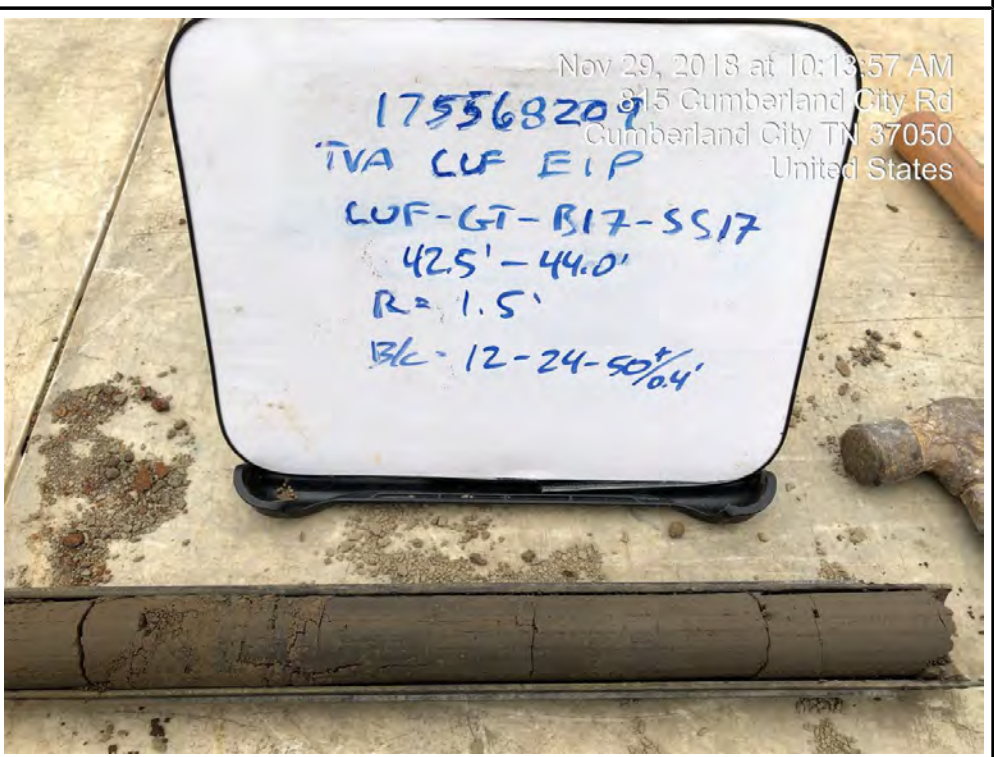
Photograph ID: 174

Photo Location: CUF-B17	
Photo Date: 11/29/2018	
Comments: Interval (42.5-43.9 feet). Interval shown on white board should be 42.5-43.9 feet. Recovery on white board should be 1.4 feet. Sampler refusal at 43.9 feet.

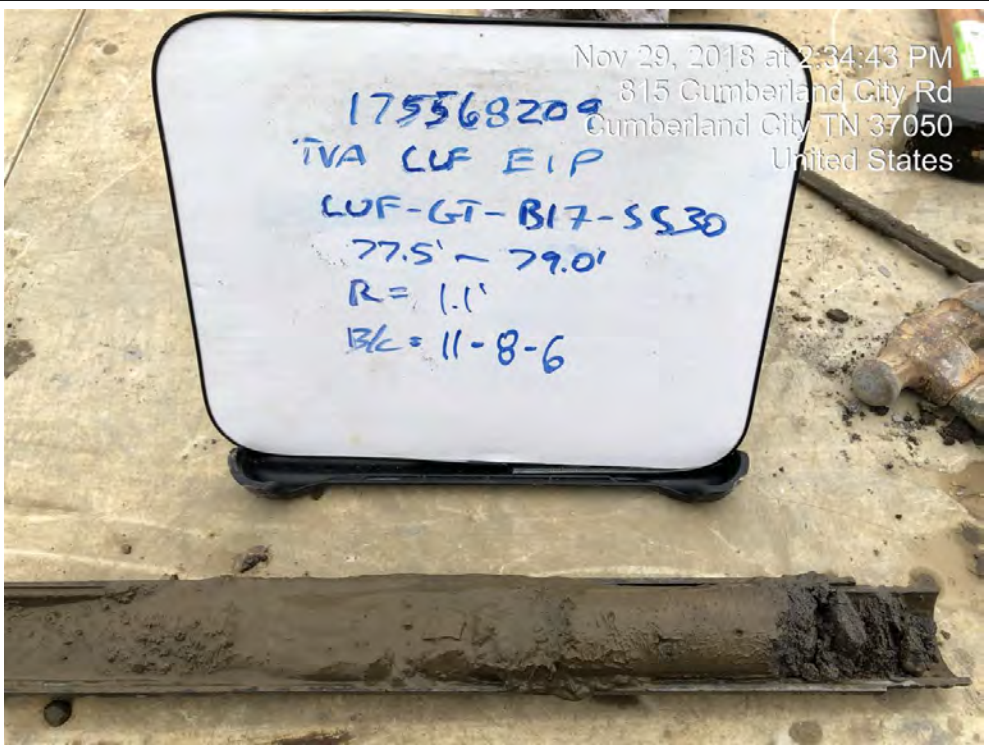
Photograph ID: 188

<p>Nov 29, 2018 at 2:34:43 PM 815 Cumberland City Rd Cumberland City TN 37050 United States</p> <p>175568209 TVA CUF EIP CUF-GT-B17-SS30 77.5' - 79.0' R = 1.1 Blk = 11-8-6</p>
Photo Location: CUF-B17	
Photo Date: 11/29/2018	
Comments: Interval (77.5-79.0 feet).

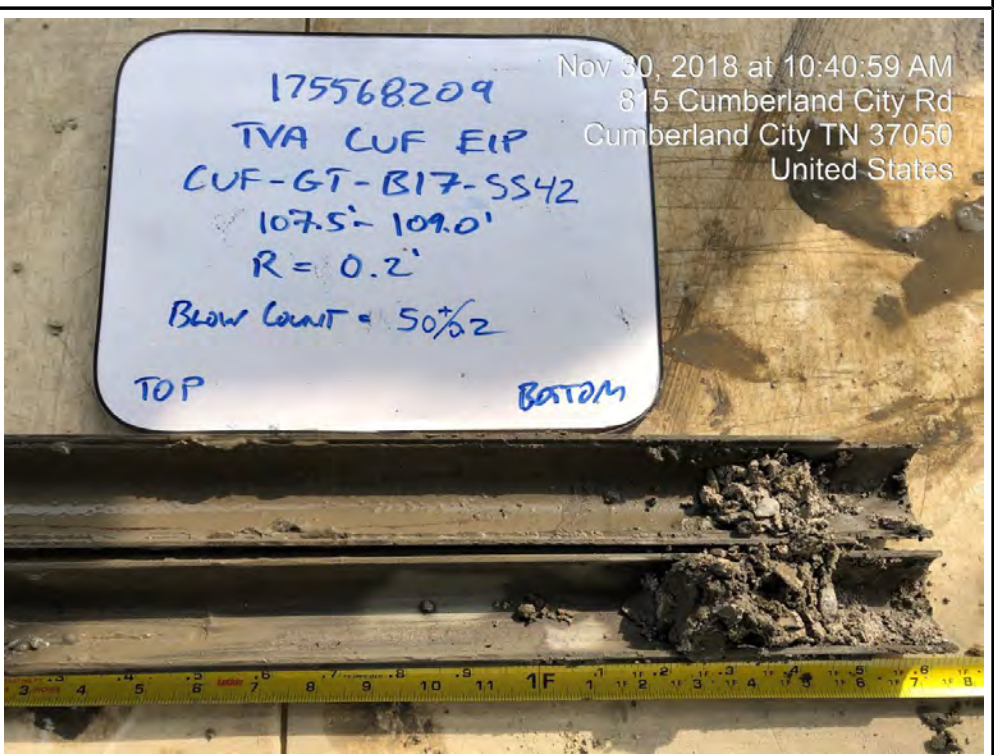
Photograph ID: 200

Photo Location: CUF-B17	
Photo Date: 11/30/2018	
Comments: Interval (107.5-107.7 feet). Interval shown on white board should be 107.5-107.7 feet.

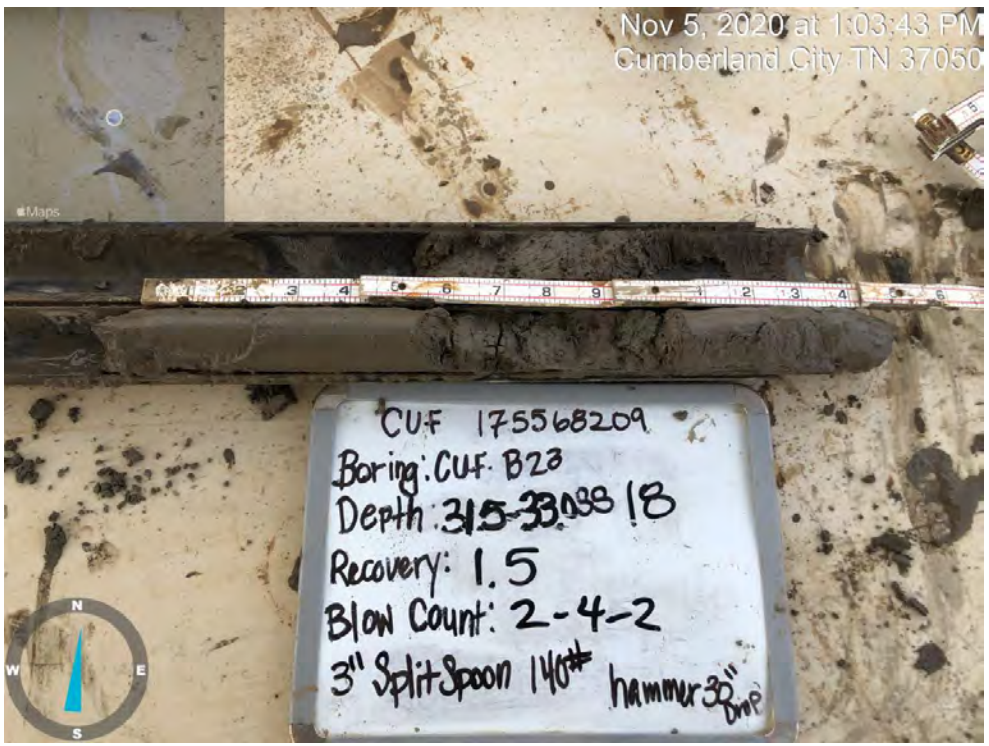
Photograph ID: 220

Photo Location: CUF-B23	
Photo Date: 11/5/2020	
Comments: Interval (31.5-33.0 feet). Split spoon size on white board should be 2".

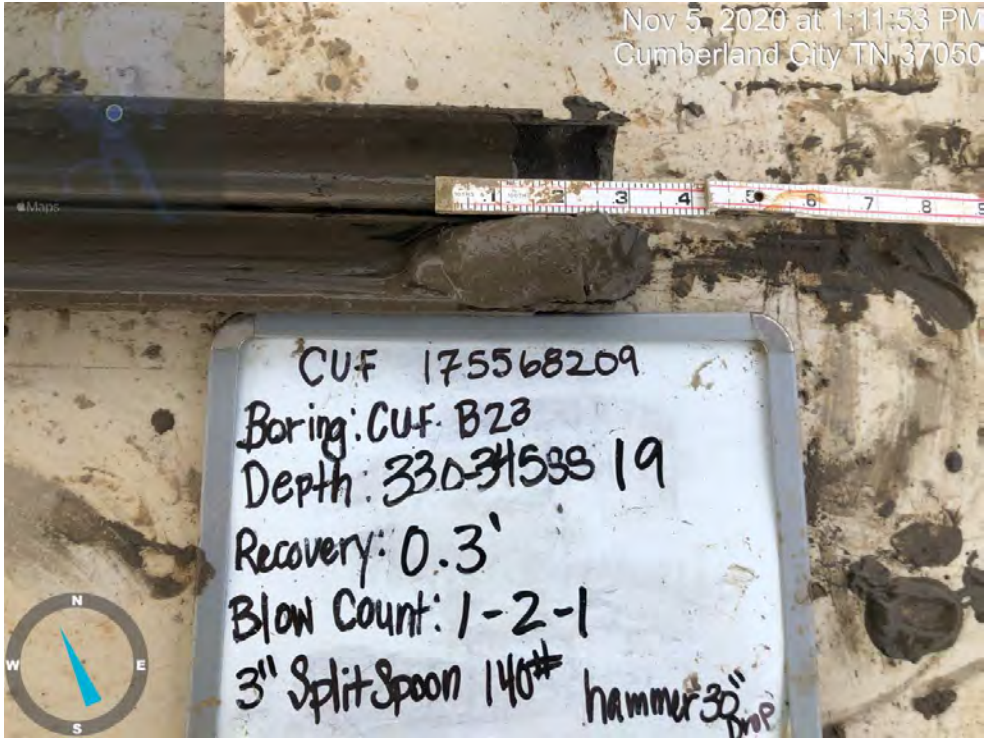
Photograph ID: 221

Photo Location: CUF-B23	
Photo Date: 11/5/2020	
Comments: Interval (33.0-34.5 feet). Split spoon size on white board should be 2". Blow count on white board should be 2-3-2. Recovery on white board should be 0.4'.

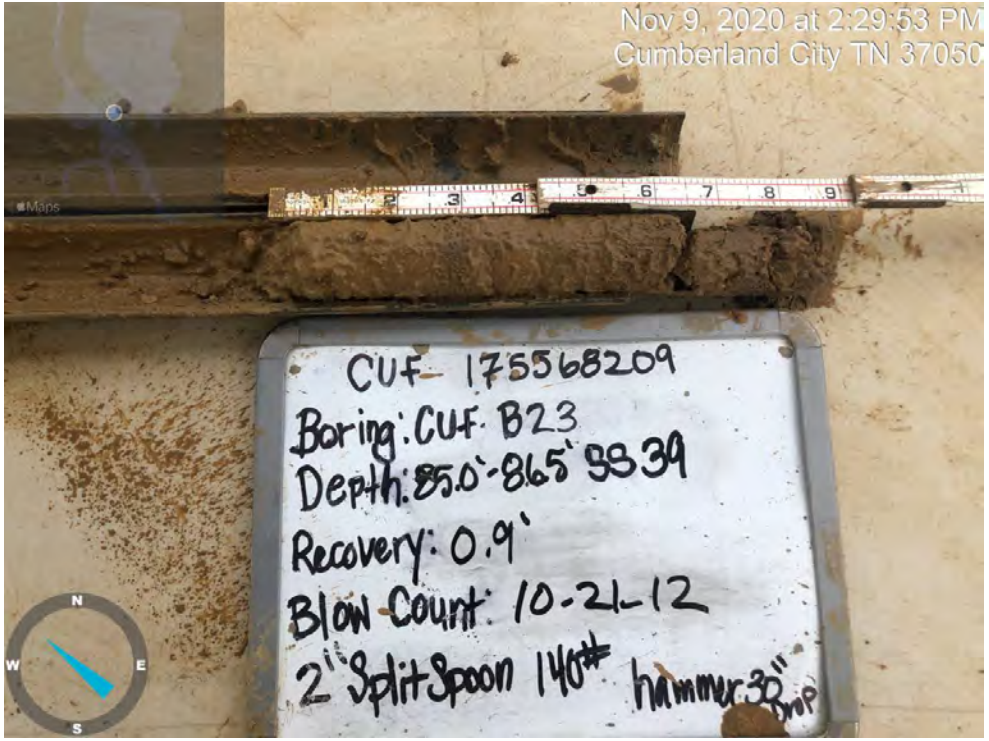
Photograph ID: 241

Photo Location: CUF-B23	
Photo Date: 11/9/2020	
Comments: Interval (85.0-86.5 feet)

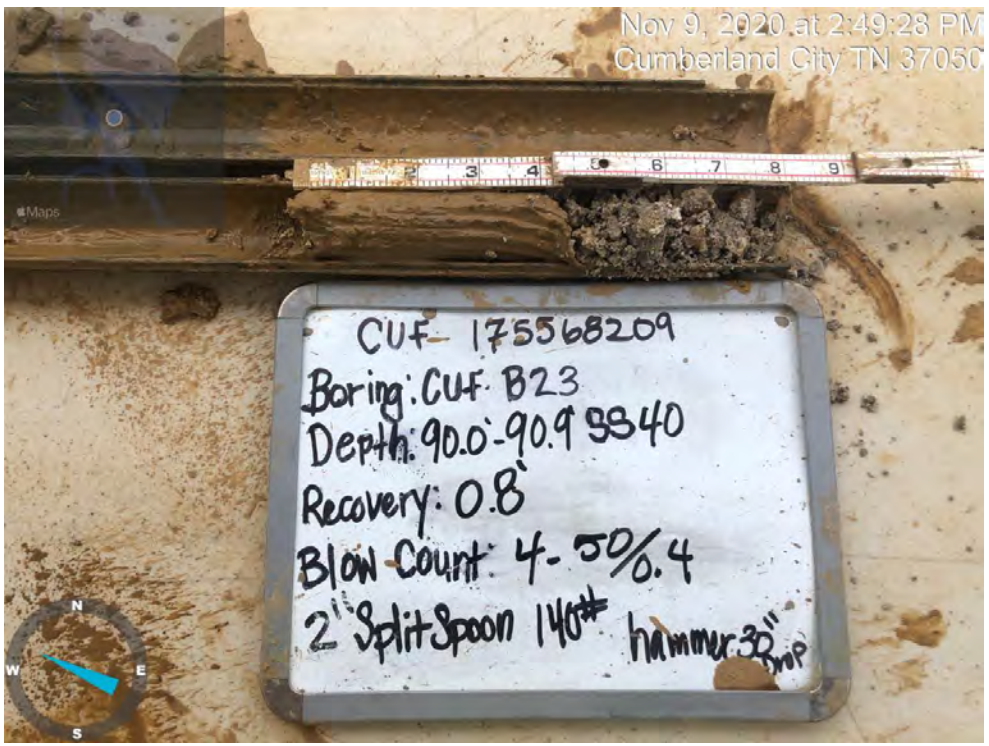
Photograph ID: 242

Photo Location: CUF-B23	
Photo Date: 11/9/2020	
Comments: Interval (90.0-90.9 feet)

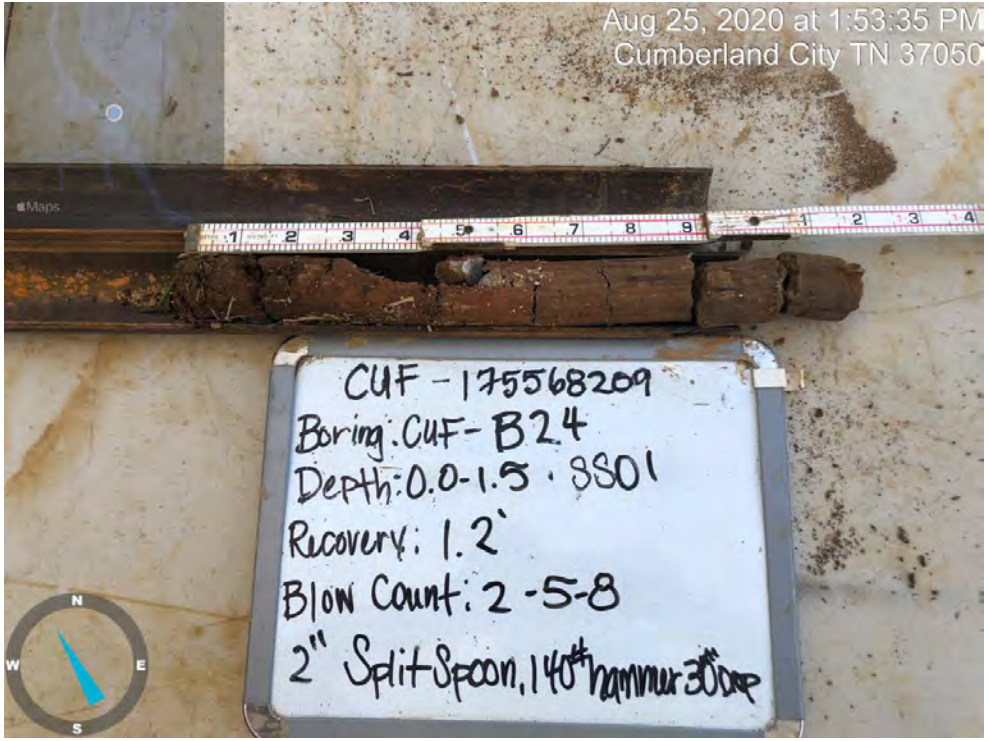
Photograph ID: 243

Photo Location: CUF-B24	
Photo Date: 8/25/2020	
Comments: Interval (0.0-1.5 feet)

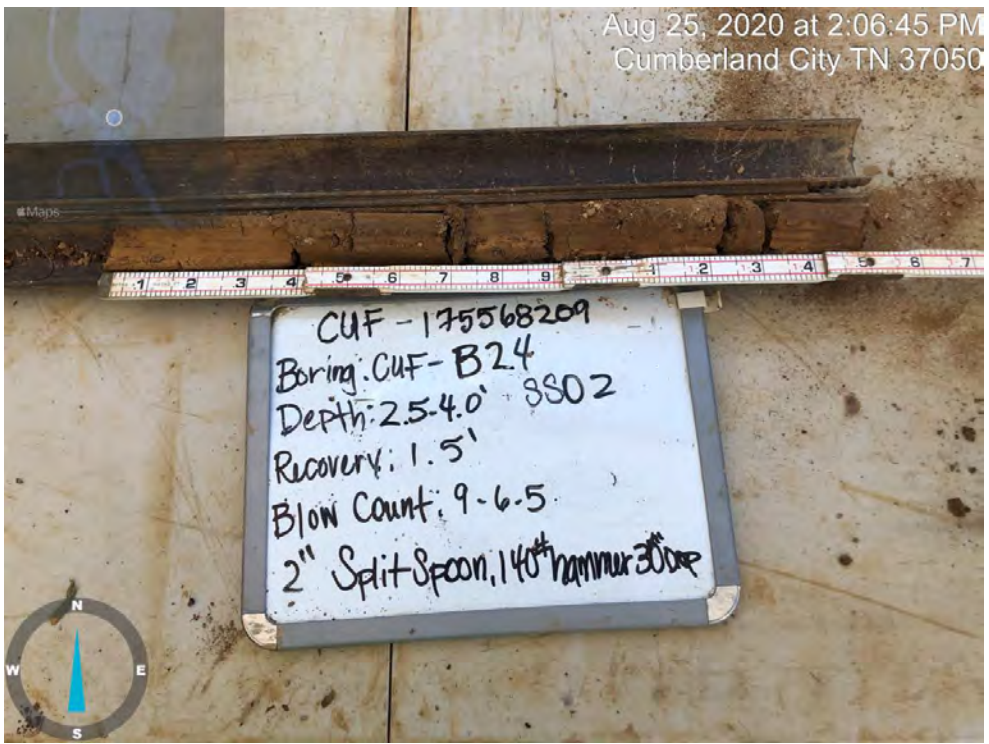
Photograph ID: 244

Photo Location: CUF-B24	
Photo Date: 8/25/2020	
Comments: Interval (2.5-4.0 feet)

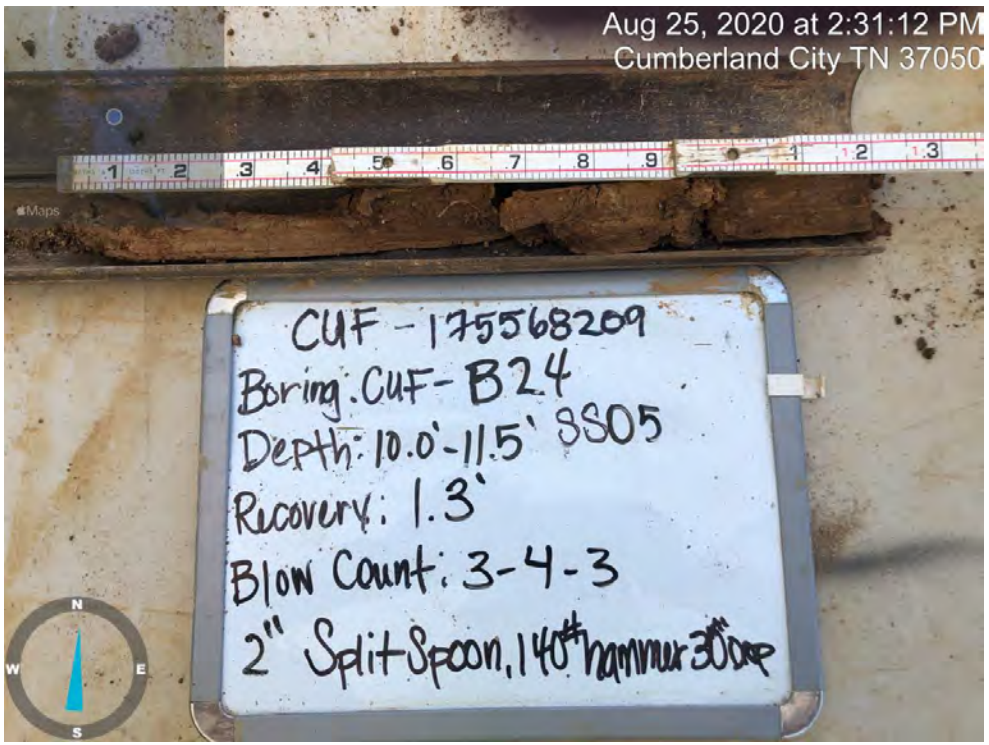
Photograph ID: 247

Photo Location: CUF-B24	
Photo Date: 8/25/2020	
Comments: Interval (10.0-11.5 feet)

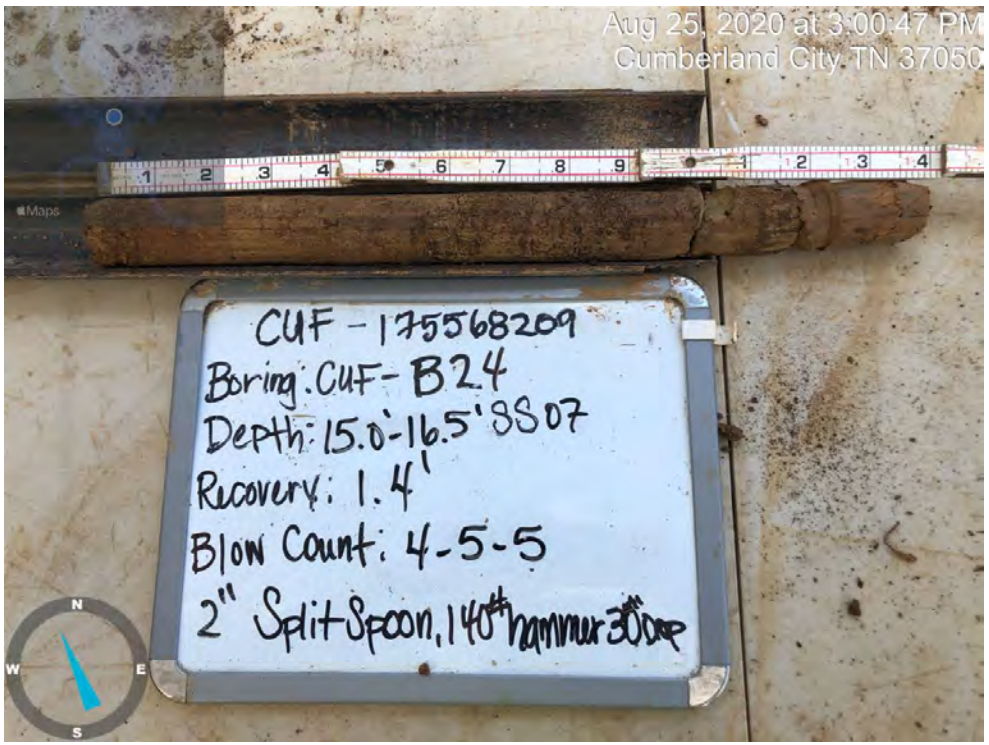
Photograph ID: 249

<p style="text-align: right;">Aug 25, 2020 at 3:00:47 PM Cumberland City TN 37050</p>
Photo Location: CUF-B24	
Photo Date: 8/25/2020	
Comments: Interval (15.0-16.5 feet)

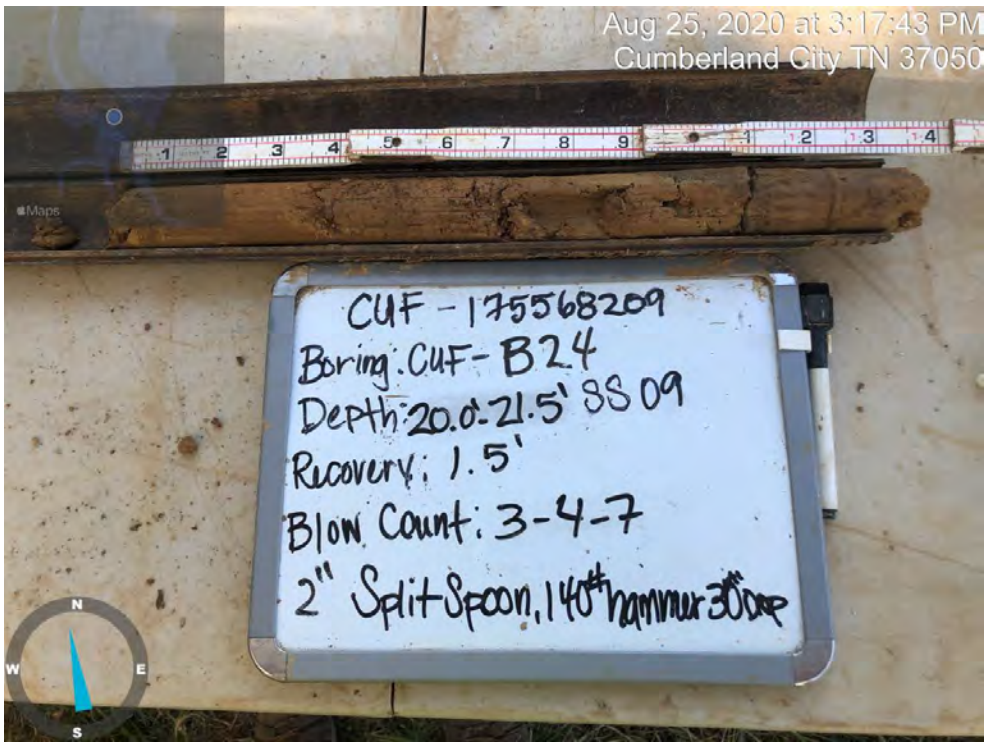
Photograph ID: 251

Photo Location: CUF-B24	
Photo Date: 8/25/2020	
Comments: Interval (20.0-21.5 feet)

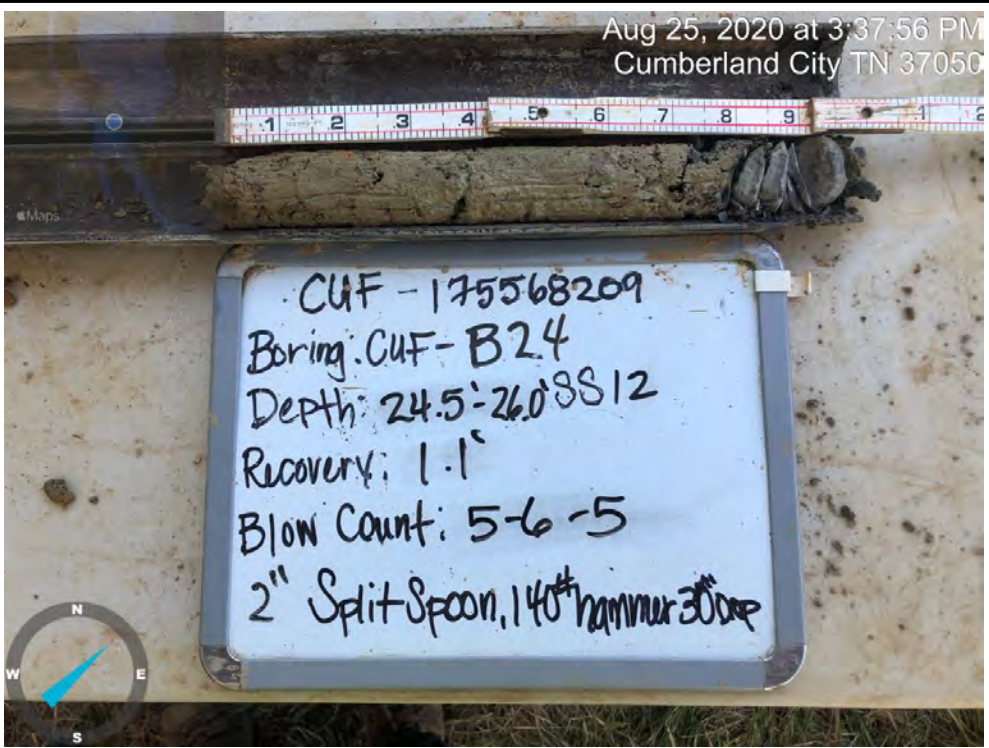
Photograph ID: 254

Photo Location: CUF-B24	
Photo Date: 8/25/2020	
Comments: Interval (24.5-26.0 feet)
