**APPENDIX G –
CCR MATERIAL INVESTIGATIONS**

**Appendix G.1 - Technical
Evaluation of Geotechnical and
CCR Material Characteristics Data**

TDEC Commissioner's Order:
Environmental Assessment Report
Cumberland Fossil Plant
Cumberland, Tennessee

Stantec Consulting Services Inc.
Lexington, Kentucky

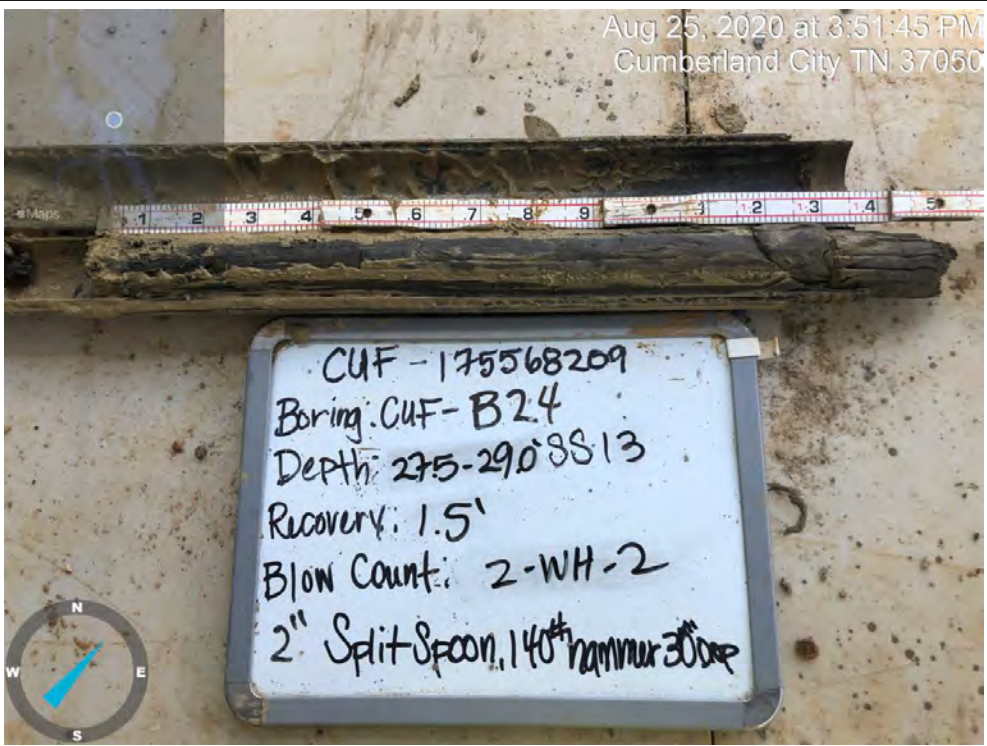
Photograph ID: 256

Photo Location: CUF-B24	
Photo Date: 8/25/2020	
Comments: Interval (27.5-29.0 feet). Sample identifier shown on white board should be SS14.

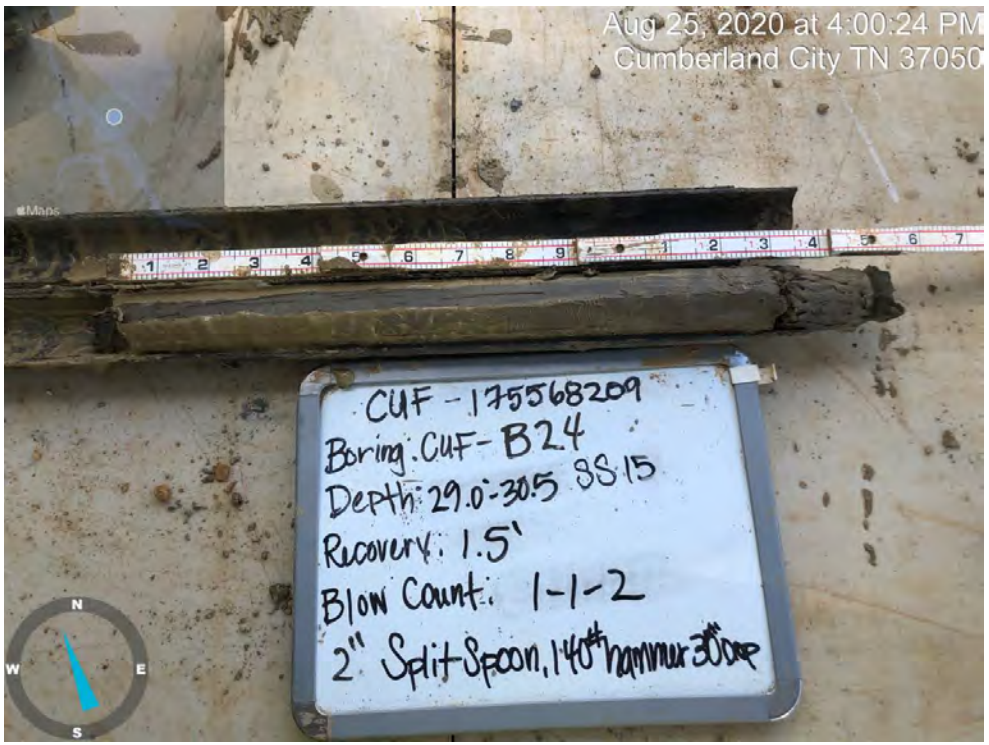
Photograph ID: 257

Photo Location: CUF-B24	
Photo Date: 8/25/2020	
Comments: Interval (29.0-30.5 feet)

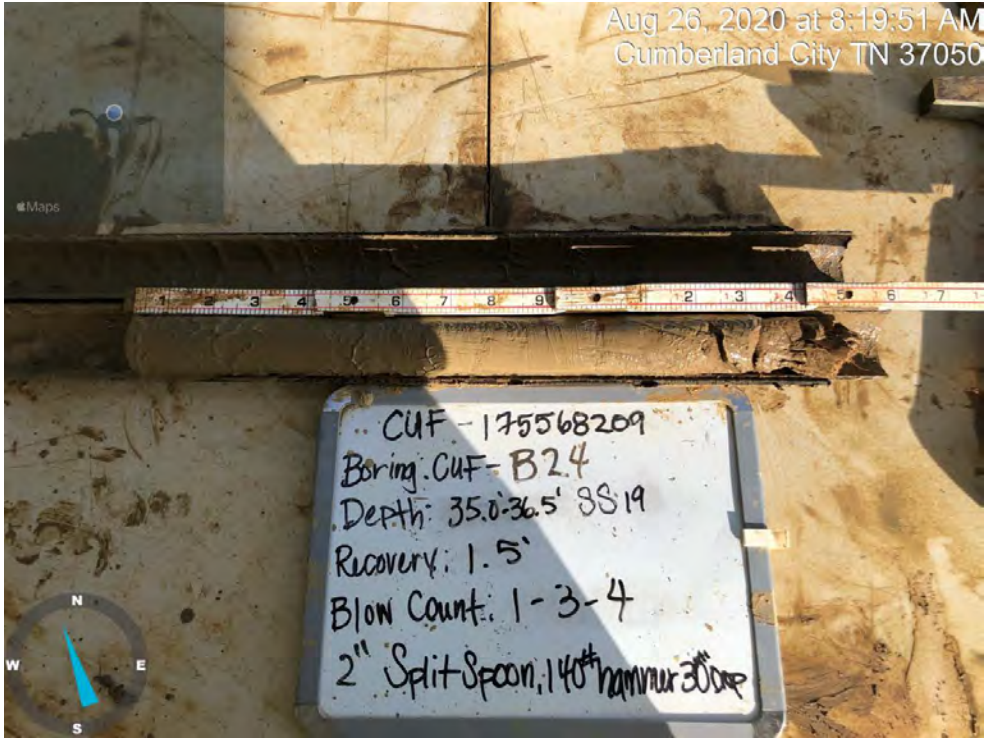
Photograph ID: 261

Photo Location: CUF-B24	
Photo Date: 8/26/2020	
Comments: Interval (35.0-36.5 feet)

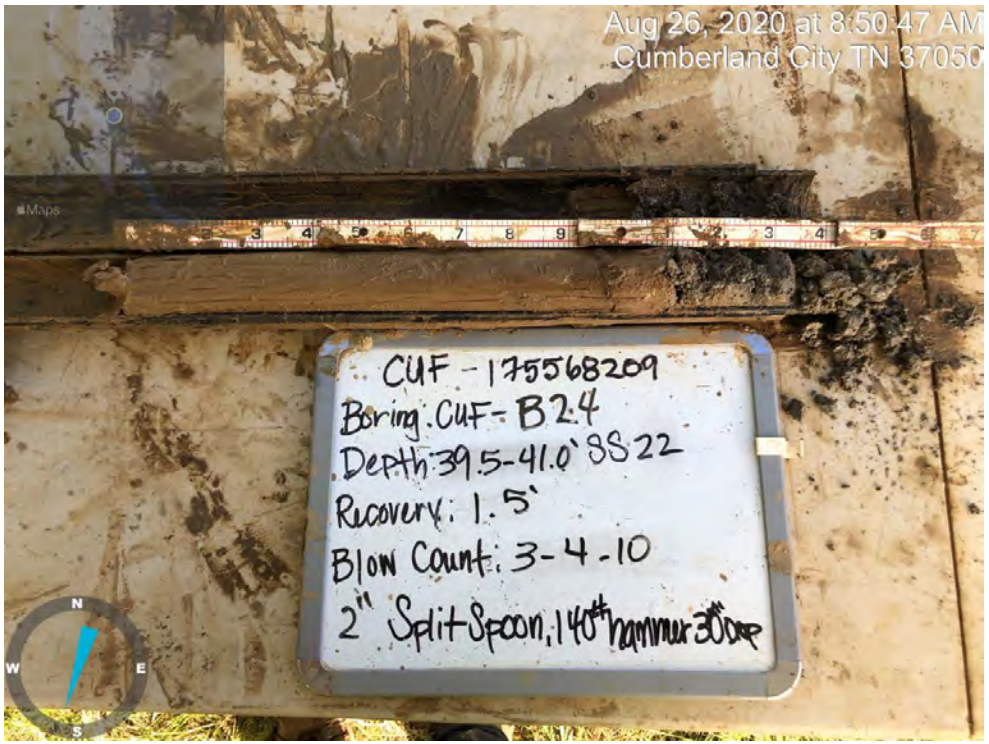
Photograph ID: 264

Photo Location: CUF-B24	
Photo Date: 8/26/2020	
Comments: Interval (39.5-41.0 feet)

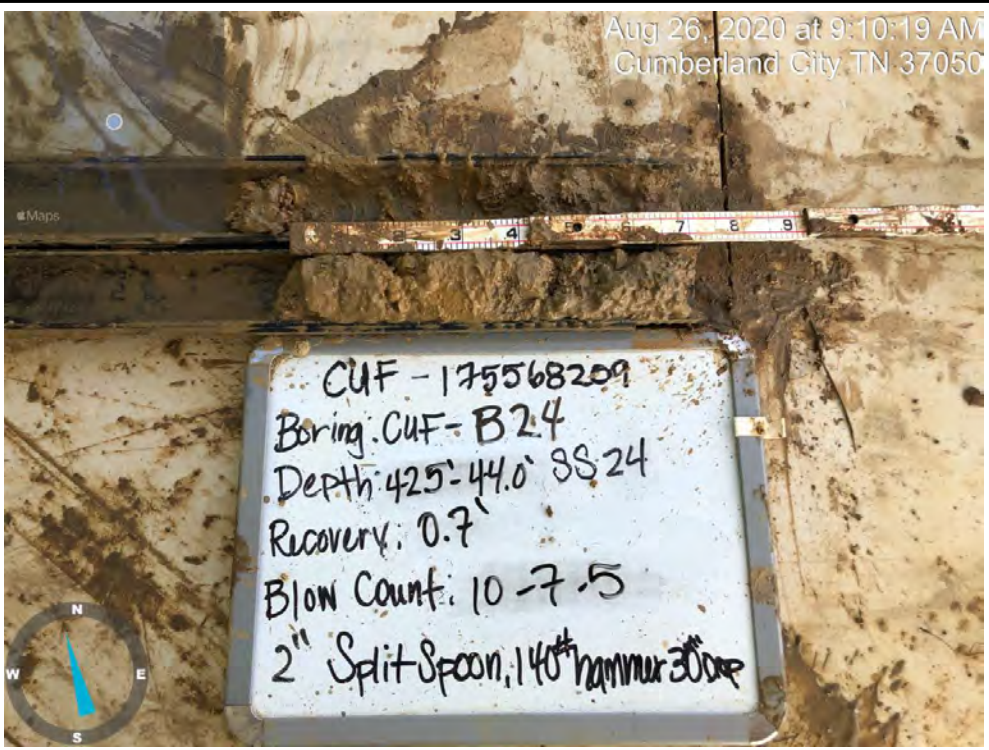
Photograph ID: 266

Photo Location: CUF-B24	
Photo Date: 8/26/2020	
Comments: Interval (42.5-44.0 feet)

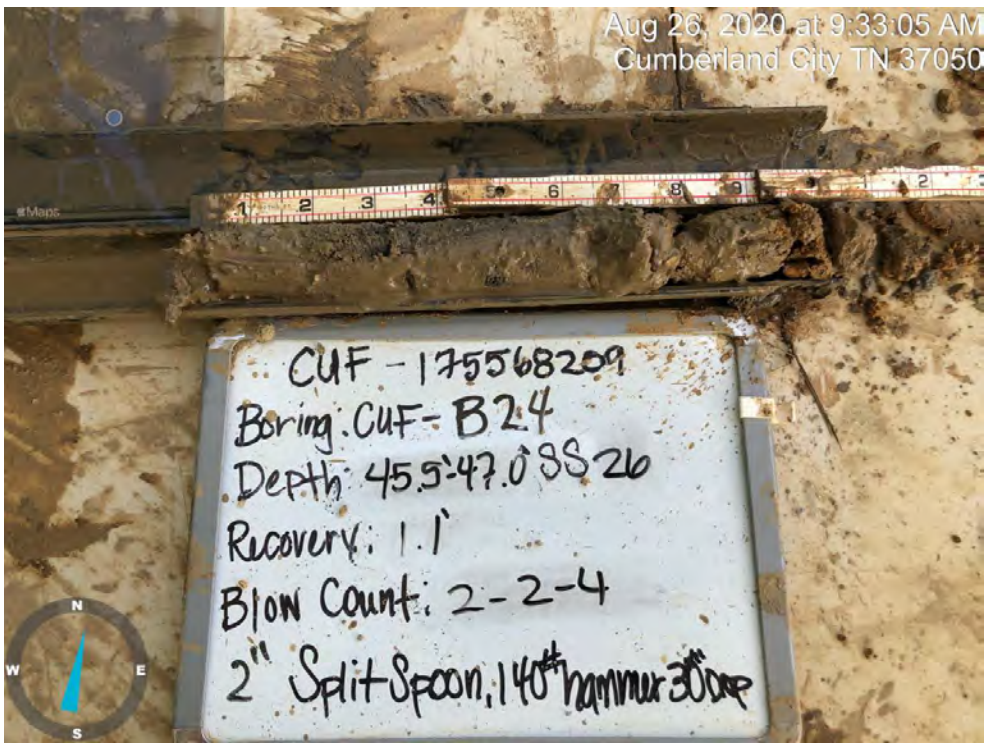
Photograph ID: 268

Photo Location: CUF-B24	
Photo Date: 8/26/2020	
Comments: Interval (45.5-47.0 feet)

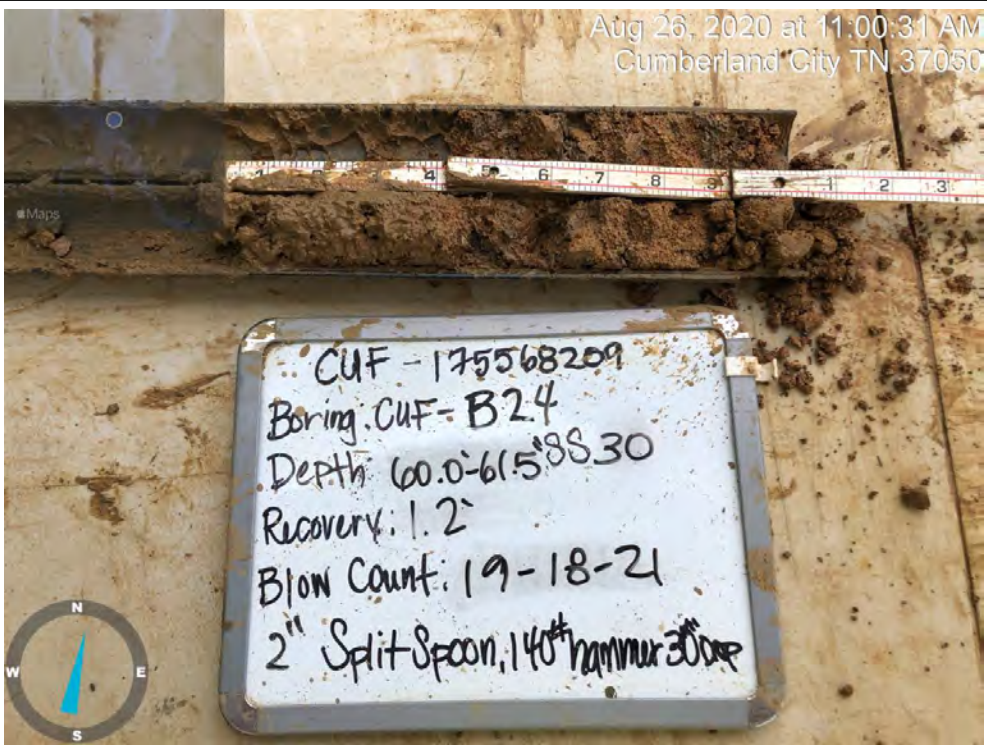
Photograph ID: 272

Photo Location: CUF-B24	
Photo Date: 8/26/2020	
Comments: Interval (60.0-61.5 feet)

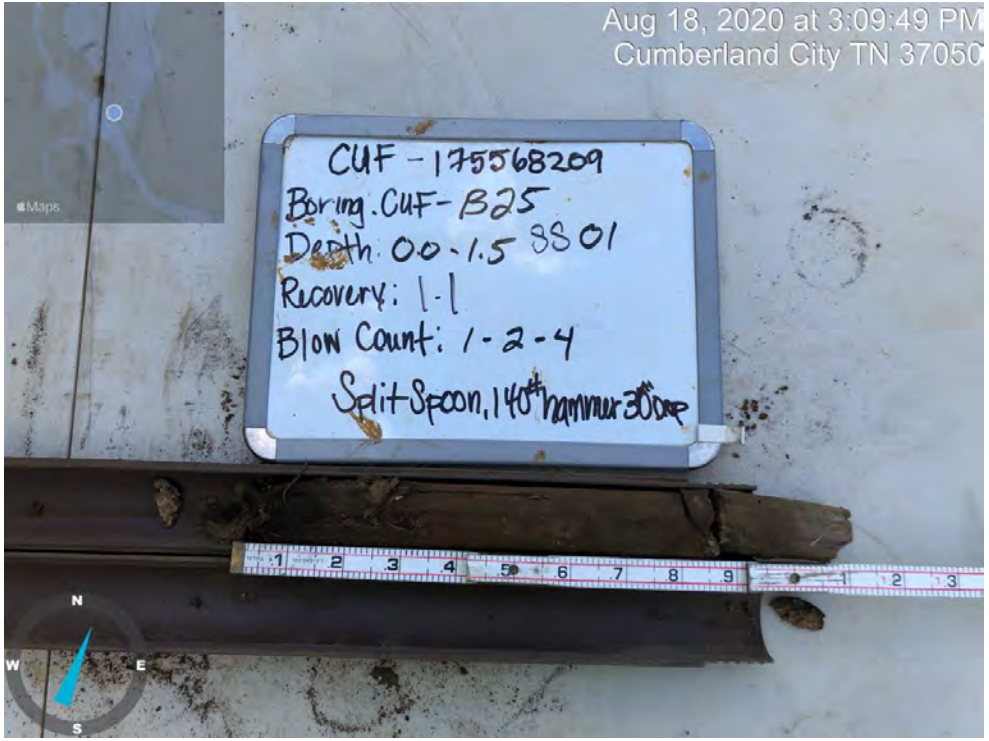
Photograph ID: 275

Aug 18, 2020 at 3:09:49 PM Cumberland City TN 37050
Photo Location: CUF-B25		
Photo Date: 8/18/2020		
Comments: Interval (0.0-1.5 feet)

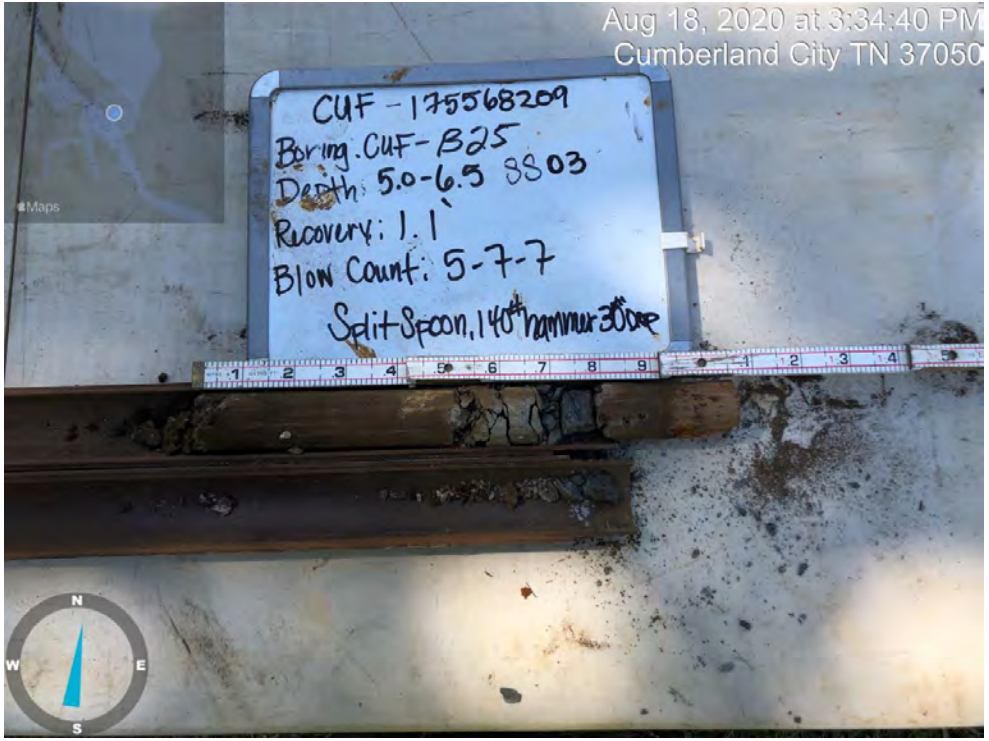
Photograph ID: 277

Photo Location: CUF-B25	
Photo Date: 8/18/2020	
Comments: Interval (5.0-6.5 feet)

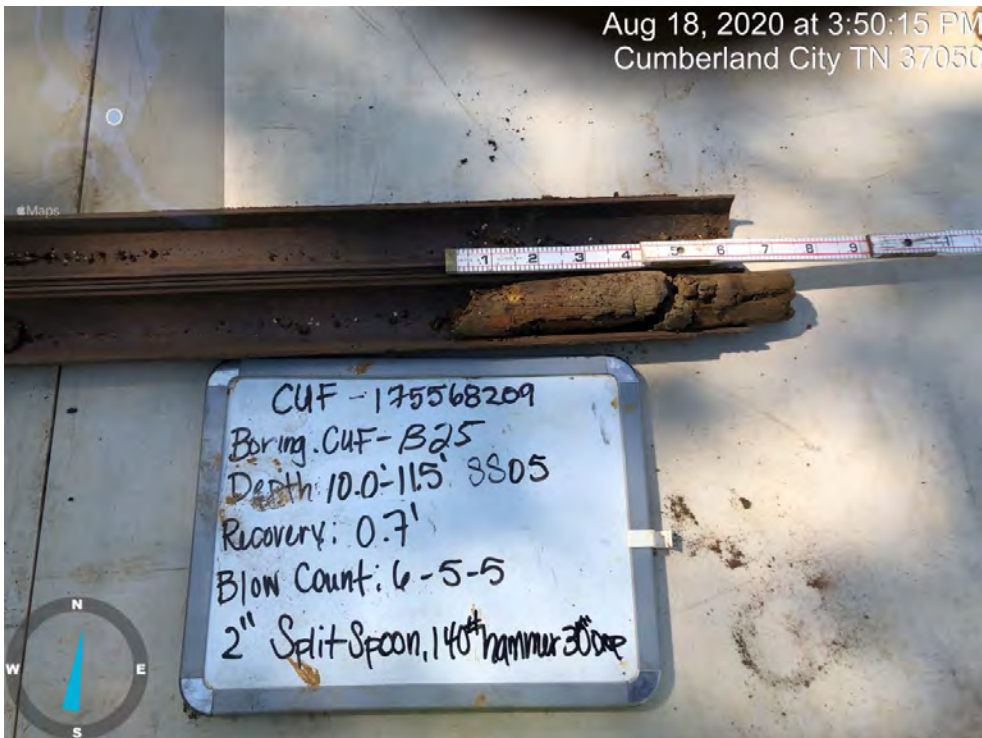
<p>Client: Tennessee Valley Authority</p> <p>Site Name: Cumberland Fossil (CUF) Plant</p>	<p>Project: CUF TDEC Order</p> <p>Site Location: Cumberland City, Tennessee</p>
<p>Photograph ID: 279</p> <p>Photo Location: CUF-B25</p> <p>Photo Date: 8/18/2020</p> <p>Comments: Interval (10.0-11.5 feet)</p>

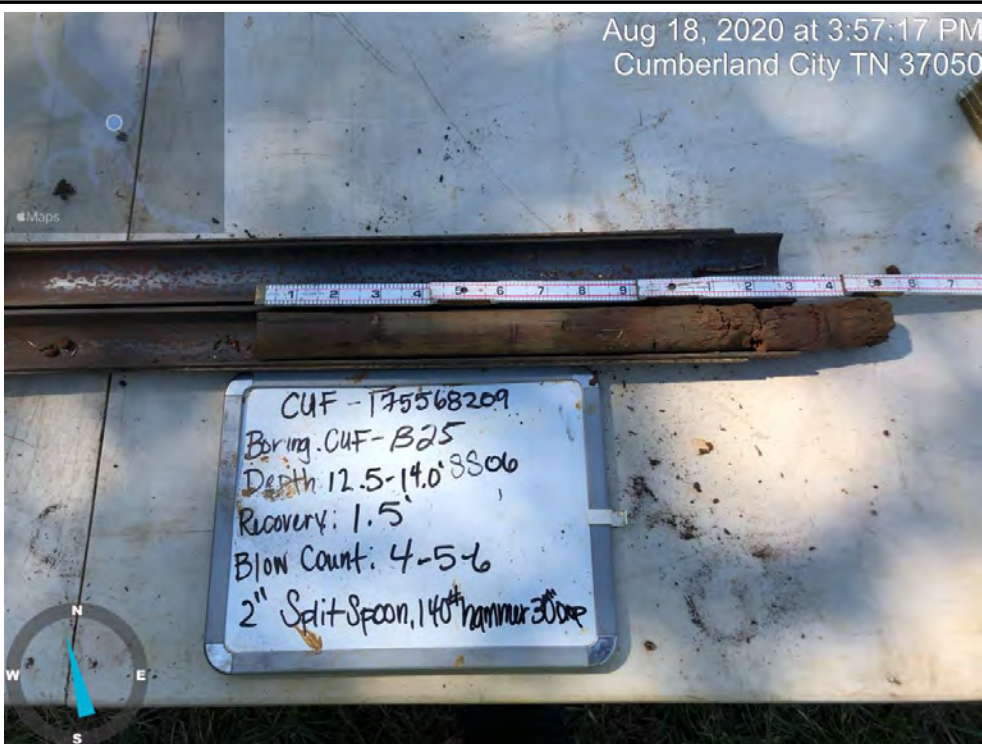
<p>Aug 18, 2020 at 3:50:15 PM Cumberland City TN 37050</p>
<p>Photograph ID: 280</p> <p>Photo Location: CUF-B25</p> <p>Photo Date: 8/18/2020</p> <p>Comments: Interval (12.5-14.0 feet)</p>

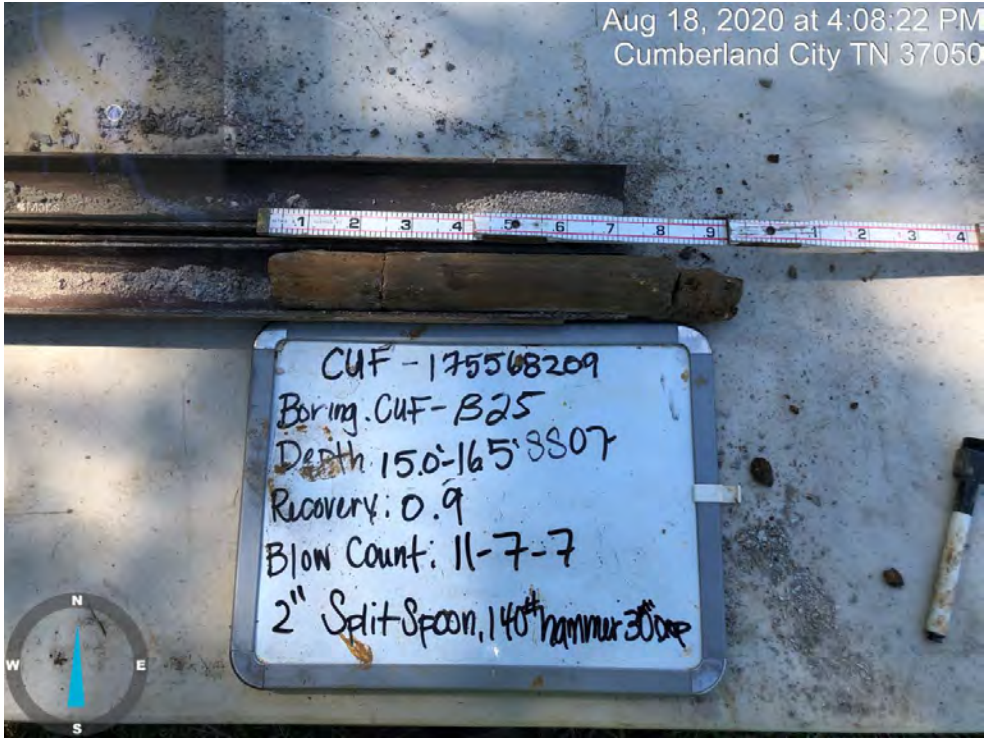
Photograph ID: 281

Photo Location: CUF-B25	
Photo Date: 8/18/2020	
Comments: Interval (15.0-16.5 feet)

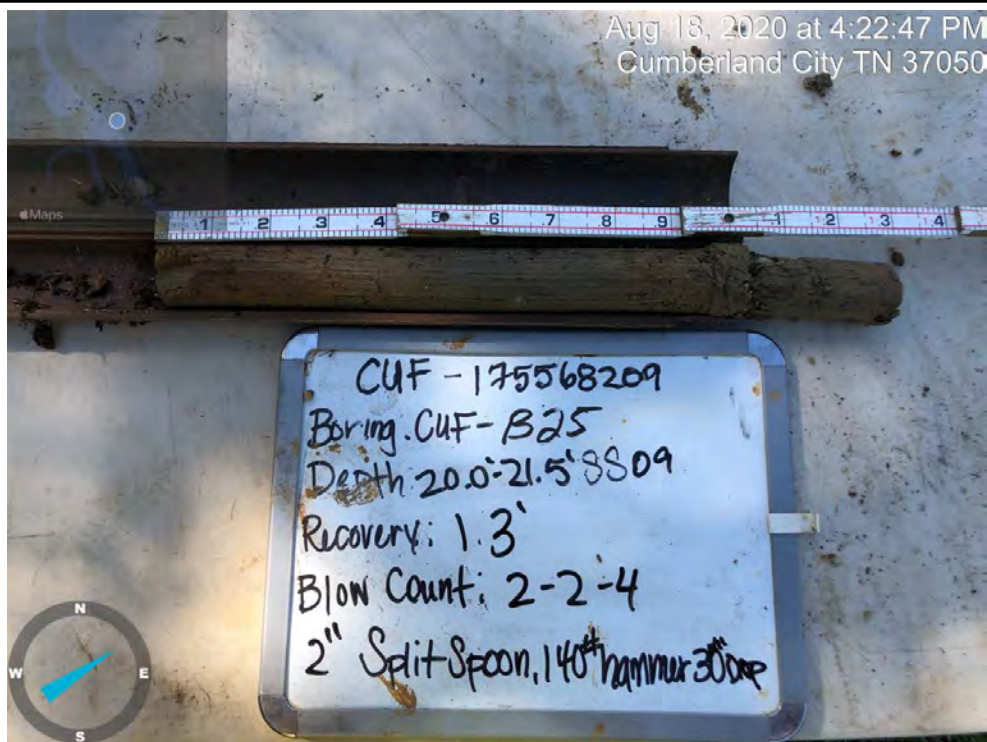
<p>Client: Tennessee Valley Authority</p> <p>Site Name: Cumberland Fossil (CUF) Plant</p>	<p>Project: CUF TDEC Order</p> <p>Site Location: Cumberland City, Tennessee</p>
<p>Photograph ID: 283</p> <p>Photo Location: CUF-B25</p> <p>Photo Date: 8/18/2020</p> <p>Comments: Interval (20.0-21.5 feet)</p>

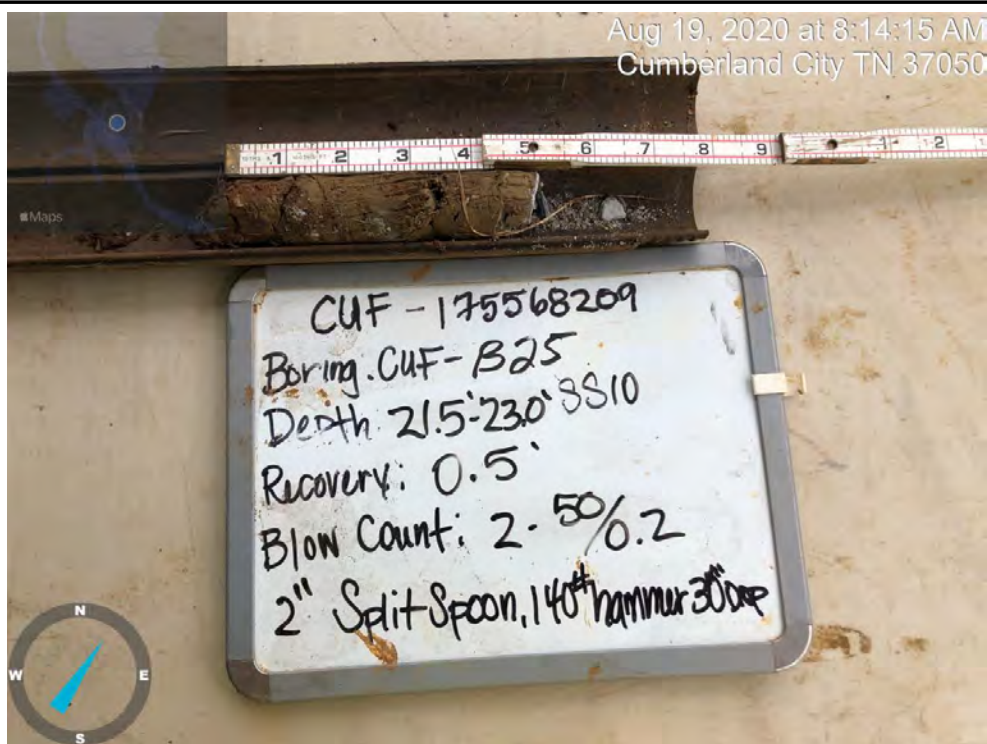
<p>Aug 18, 2020 at 4:22:47 PM Cumberland City TN 37050</p>
<p>Photograph ID: 284</p> <p>Photo Location: CUF-B25</p> <p>Photo Date: 8/19/2020</p> <p>Comments: Interval (21.5-22.2 feet). Interval on white board should be 21.5-22.2 feet.</p>

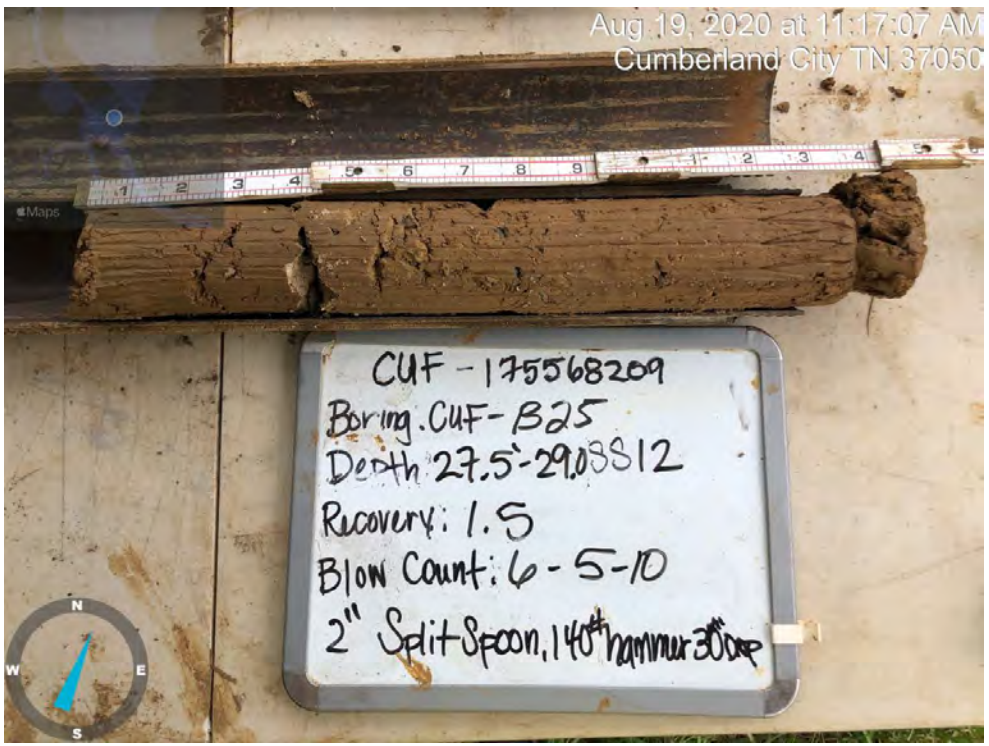
Photograph ID: 286

Photo Location: CUF-B25	
Photo Date: 8/19/2020	
Comments: Interval (27.5-29.0 feet). Blow counts on white board should be 2-3-6.

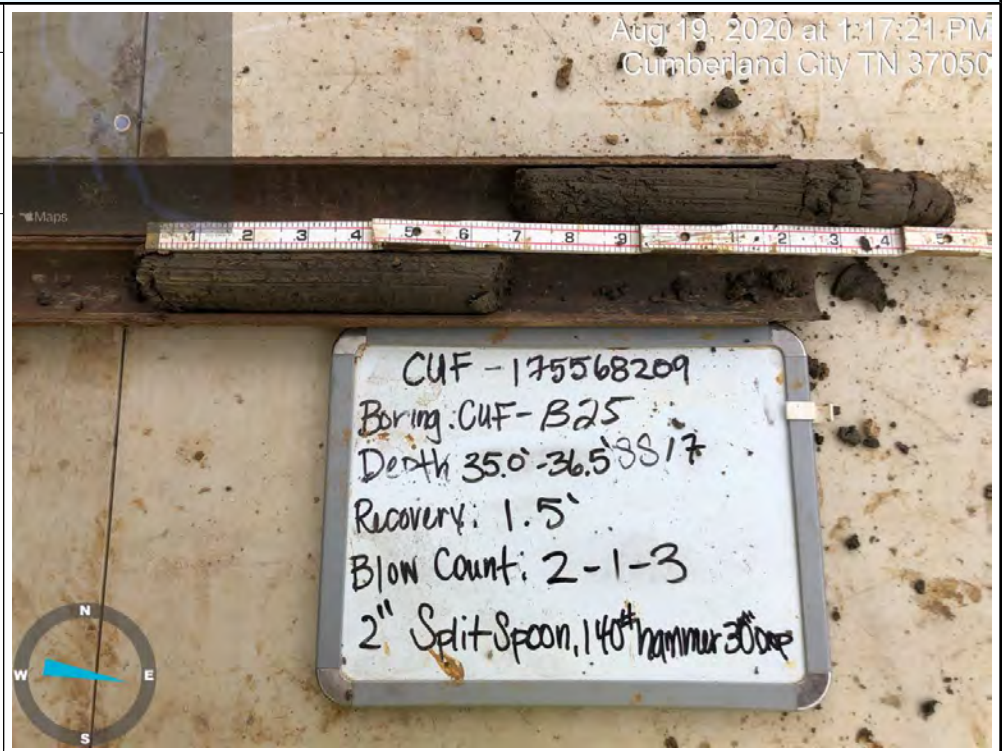
Comments:
Interval (35.0-36.5 feet)

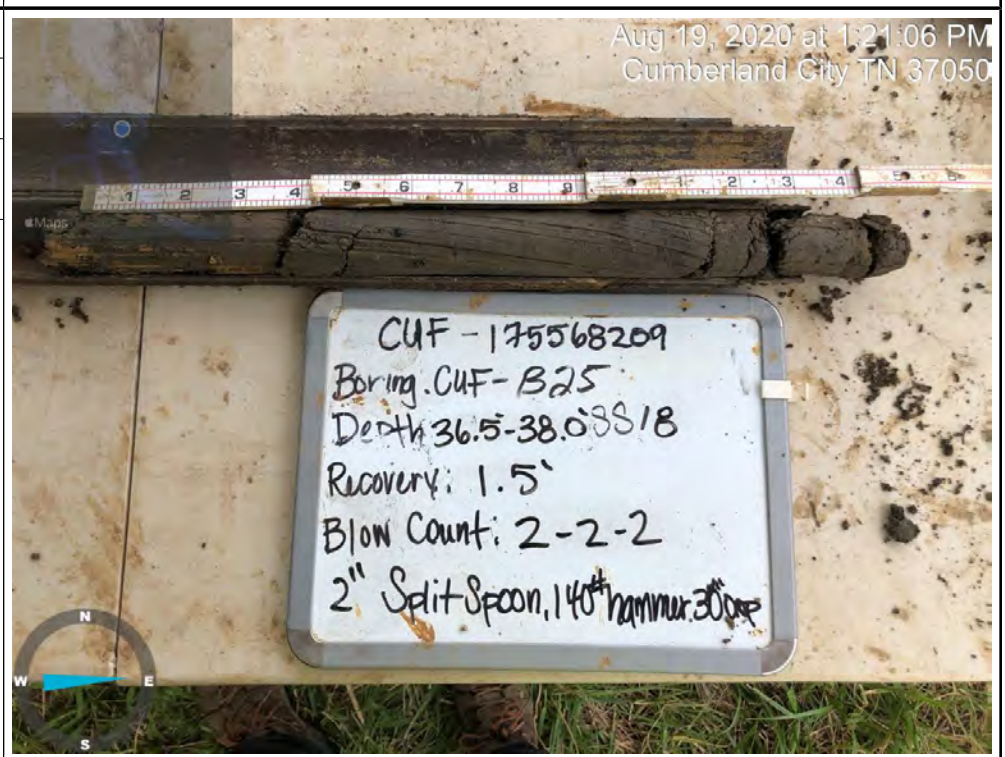
Photograph ID: 292

Comments:
Interval (36.5-38.0 feet)

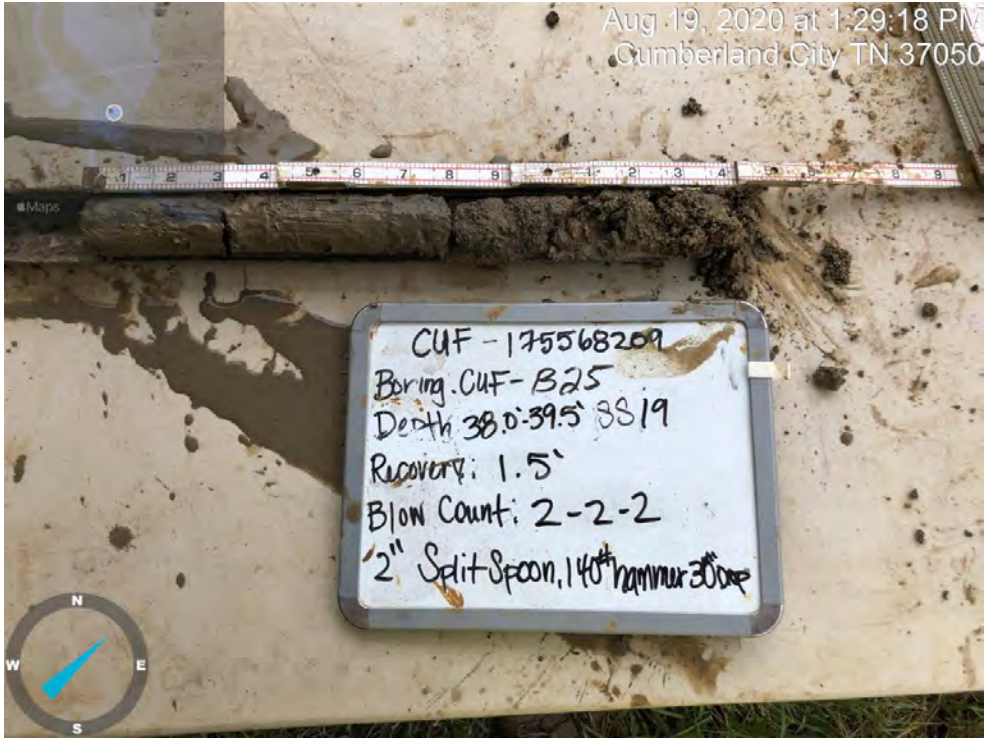
Photograph ID: 293

Photo Location: CUF-B25	
Photo Date: 8/19/2020	
Comments: Interval (38.0-39.5 feet). Blow count on white board should be WH-4-8.

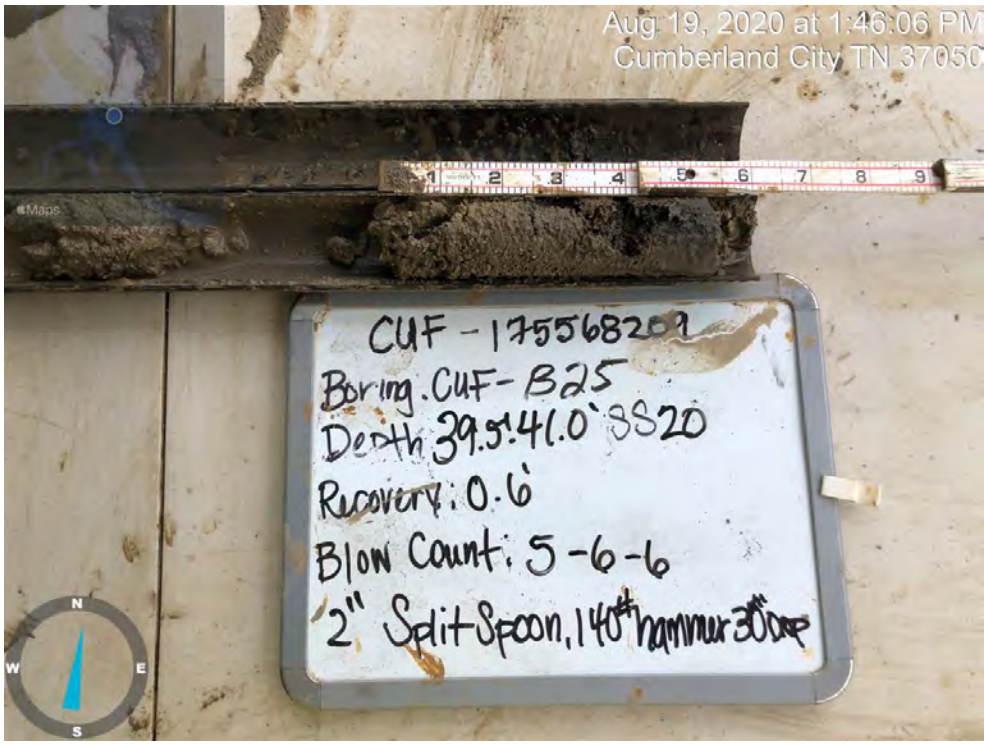
Photograph ID: 294

Photo Location: CUF-B25	
Photo Date: 8/19/2020	
Comments: Interval (39.5-41.0 feet)

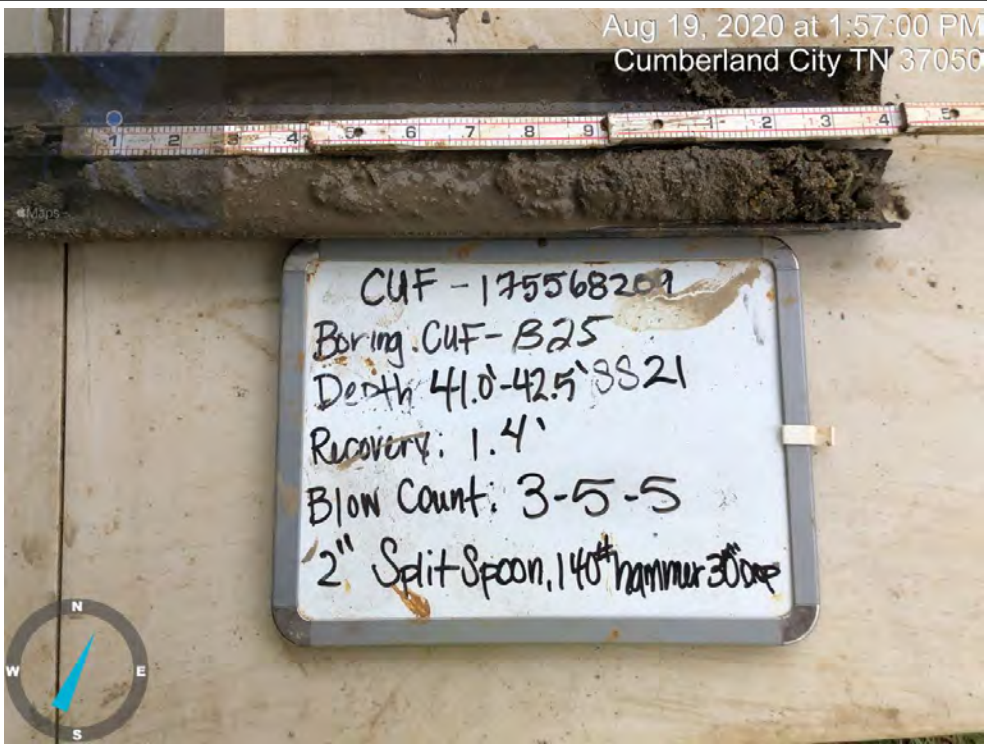
Photograph ID: 295

Photo Location: CUF-B25	
Photo Date: 8/19/2020	
Comments: Interval (41.0-42.5 feet)

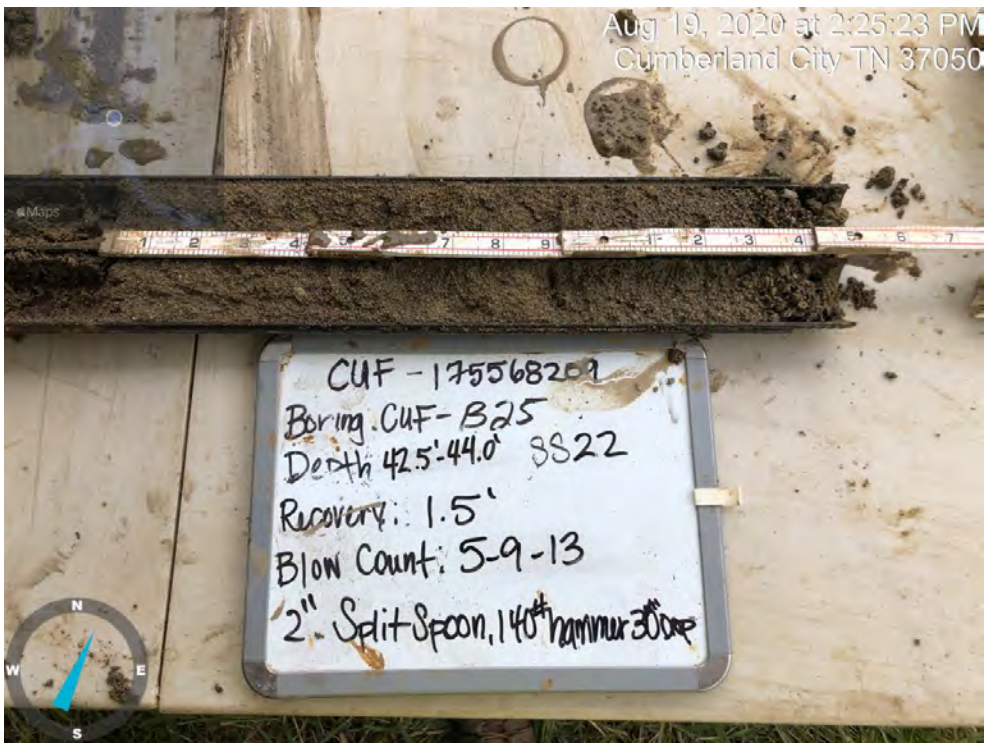
Photograph ID: 296

Photo Location: CUF-B25	
Photo Date: 8/19/2020	
Comments: Interval (42.5-44.0 feet)

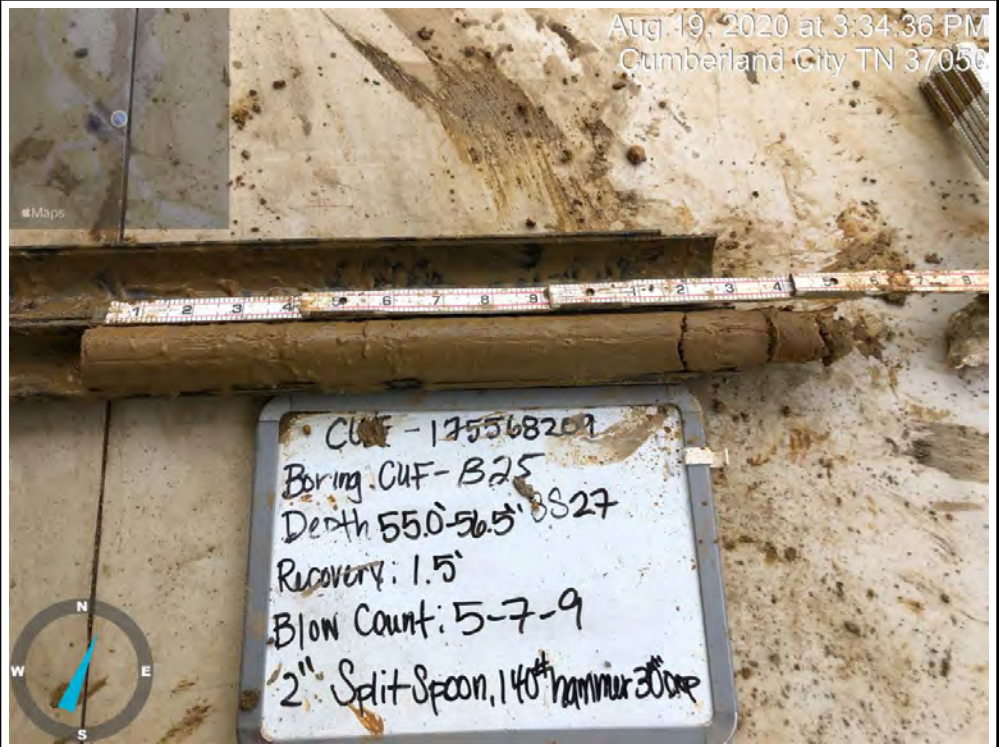
Comments:
Interval (55.0-56.5 feet)

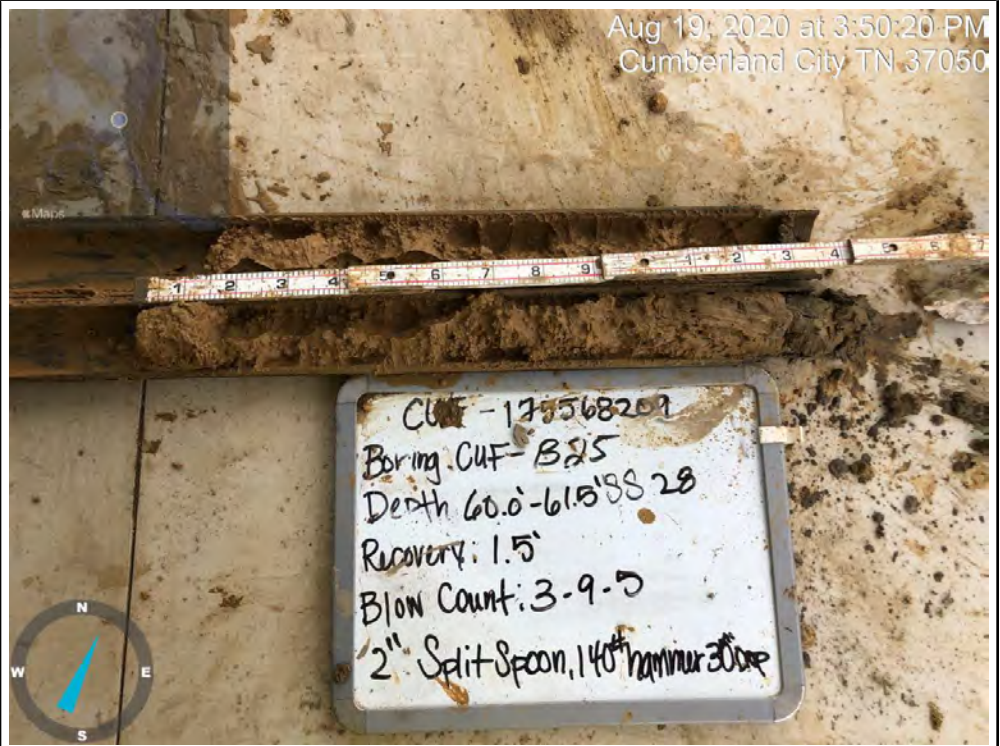
Photograph ID: 302

Comments:
Interval (60.0-61.5 feet)

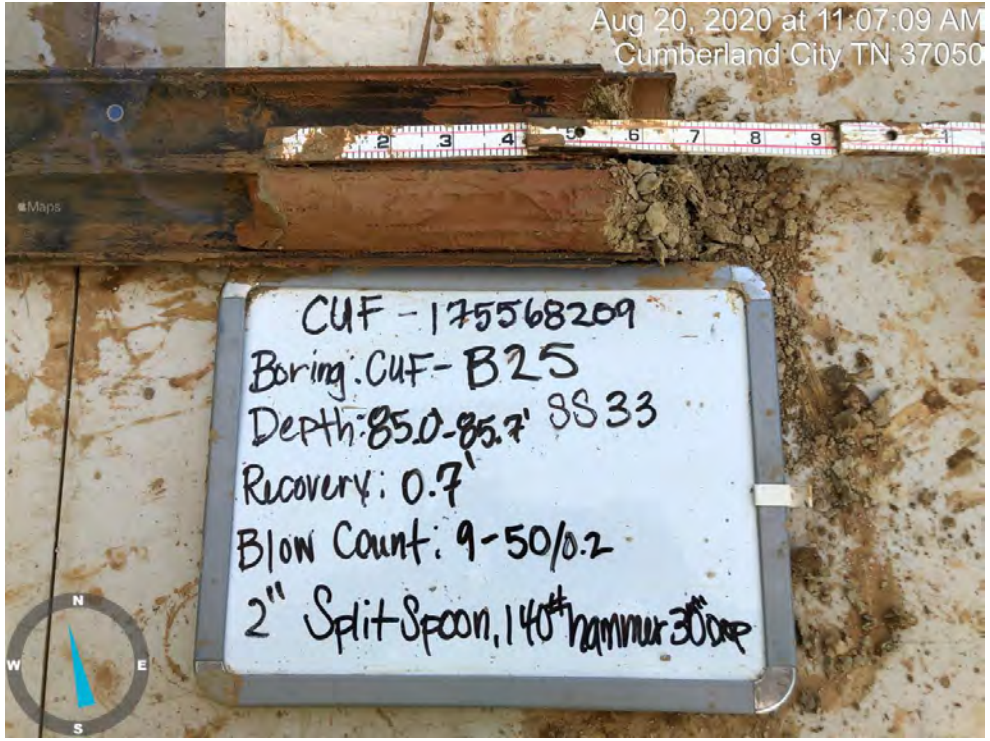
Photograph ID: 307	Aug 20, 2020 at 11:07:09 AM Cumberland City TN 37050
Photo Location: CUF-B25	
Photo Date: 8/20/2020	
Comments: Interval (85.0-85.7 feet)

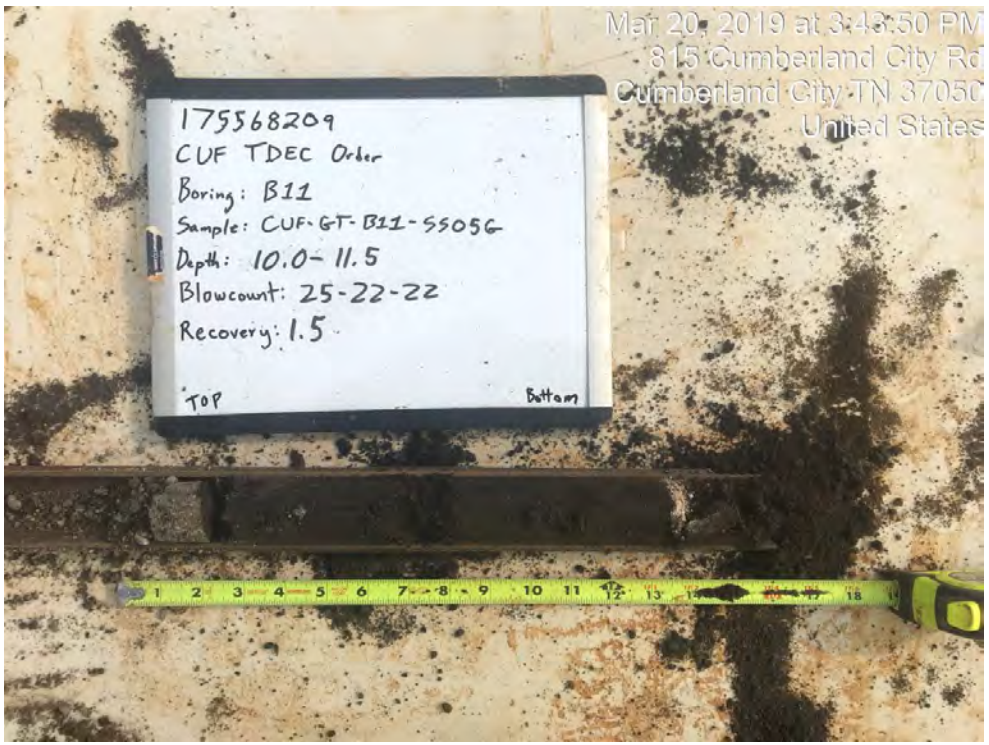
Photograph ID: 5

Photo Location: CUF-B11	
Photo Date: 3/20/2019	
Comments: Interval (10.0-11.5 feet).

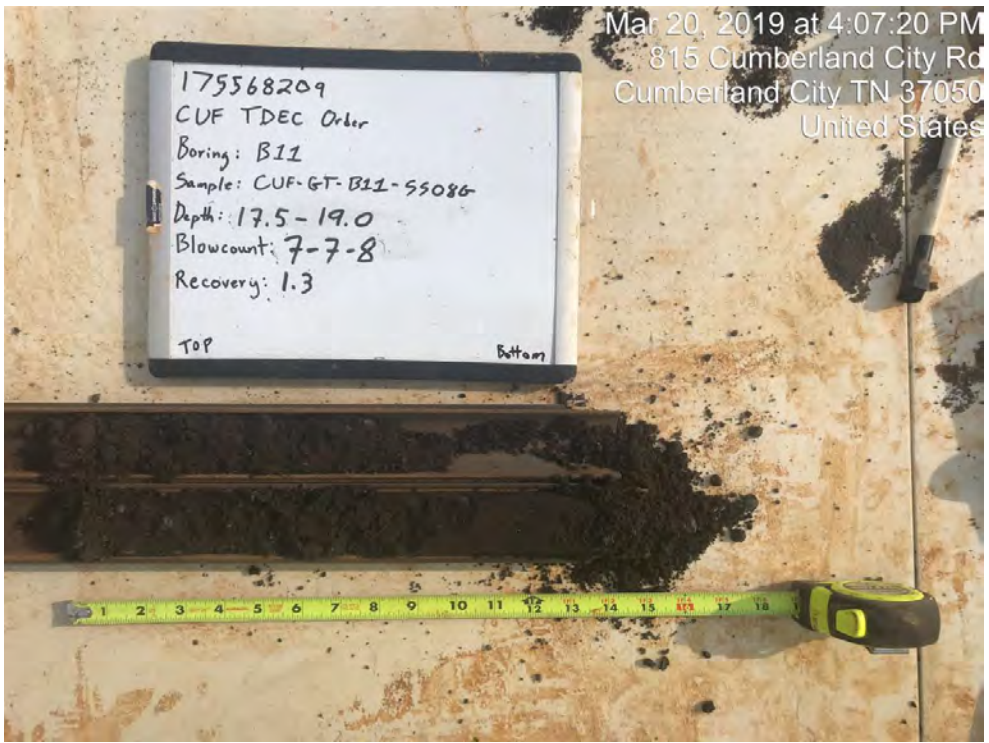
Photo Location: CUF-B11			
Photo Date: 3/20/2019			
Comments: Interval (17.5-19.0 feet).

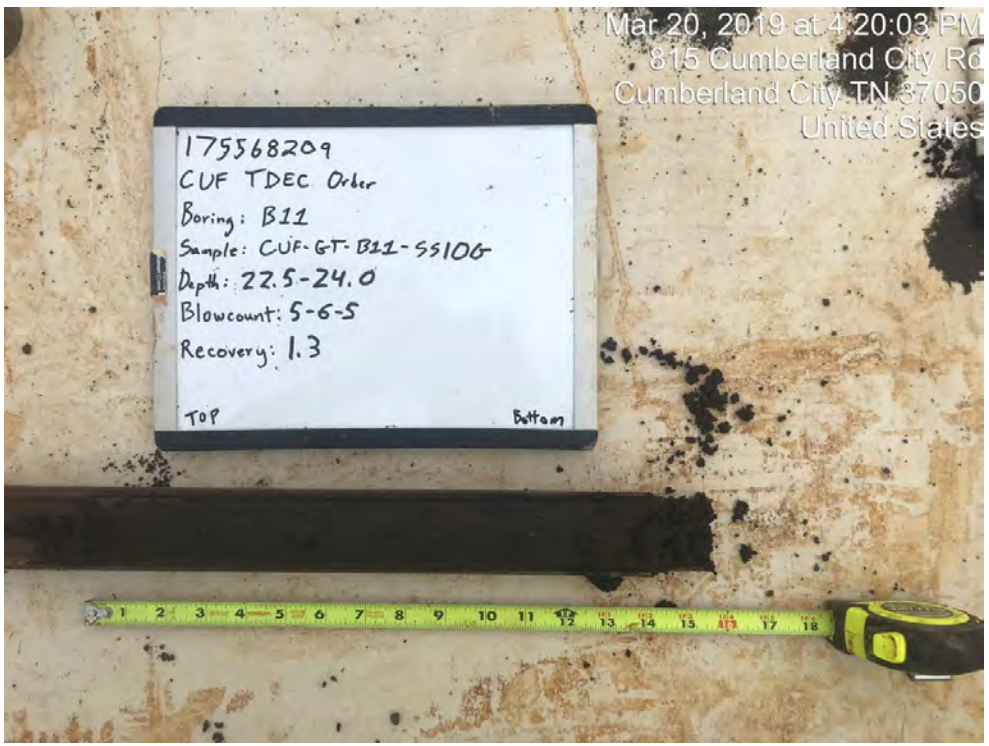
Photograph ID: 10

Mar 20, 2019 at 4:20:03 PM 815 Cumberland City Rd Cumberland City TN 37050 United States
Photo Location: CUF-B11		
Photo Date: 3/20/2019		
Comments: Interval (22.5-24.0 feet).

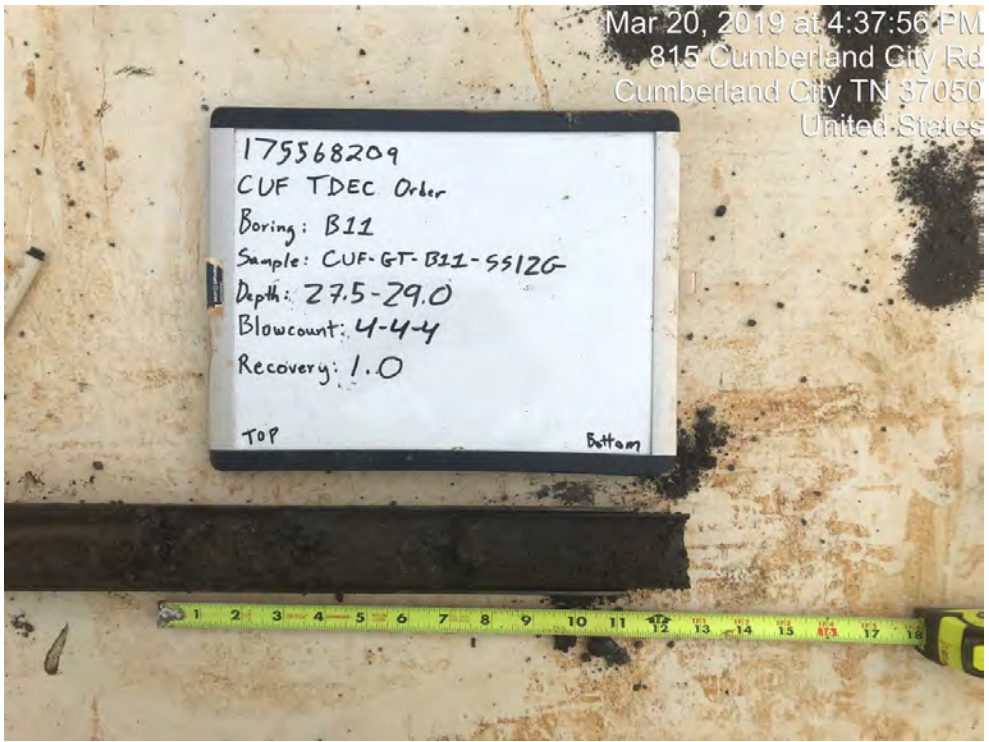
Photograph ID: 12

Mar 20, 2019 at 4:37:56 PM 815 Cumberland City Rd Cumberland City TN 37050 United States
Photo Location: CUF-B11		
Photo Date: 3/20/2019		
Comments: Interval (27.5-29.0 feet).

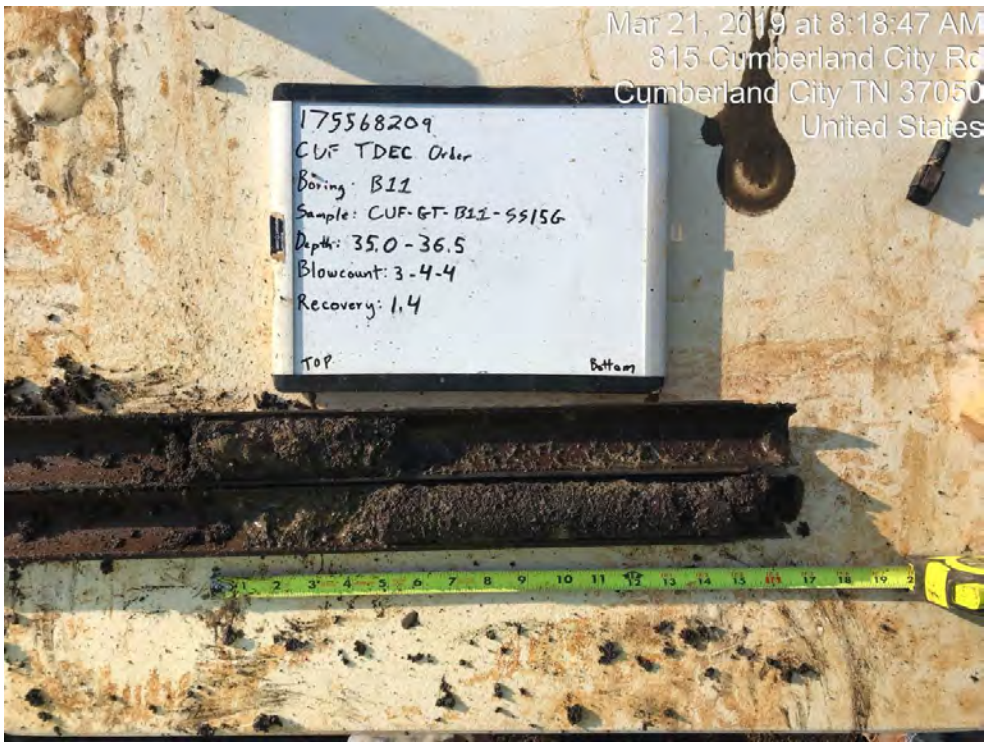
Photograph ID: 15

Photo Location: CUF-B11	
Photo Date: 3/21/2019	
Comments: Interval (35.0-36.5 feet).	
Photograph ID: 16

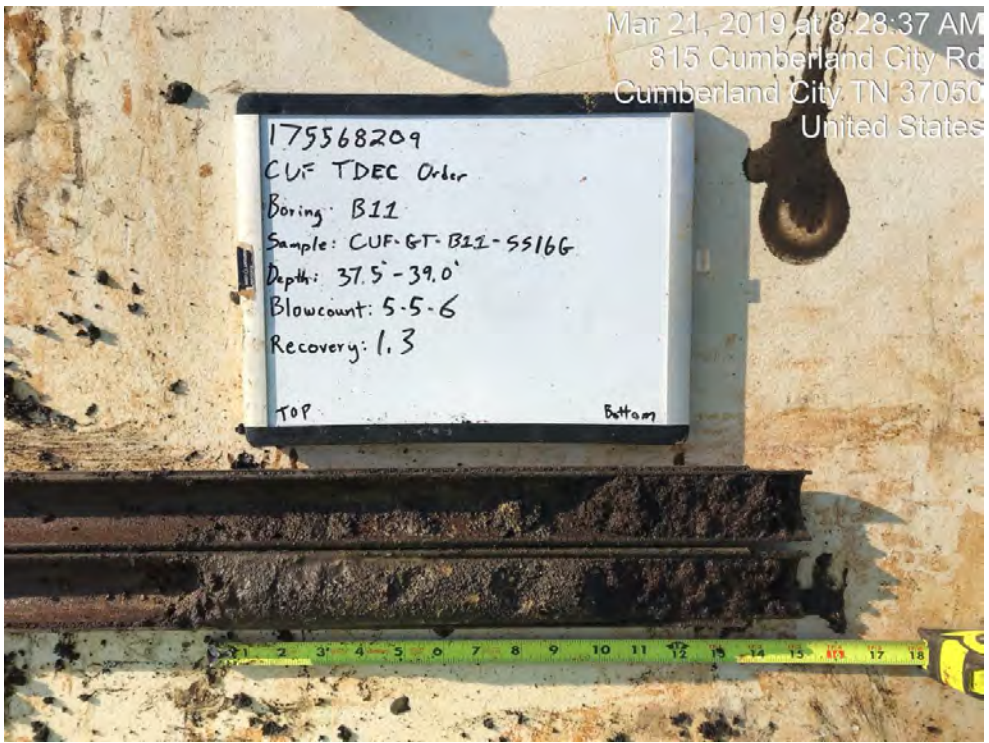
Photo Location: CUF-B11	
Photo Date: 3/21/2019	
Comments: Interval (37.5-39.0 feet).
