**APPENDIX G –
CCR MATERIAL INVESTIGATIONS**

**Appendix G.1 - Technical
Evaluation of Geotechnical and
CCR Material Characteristics Data**

TDEC Commissioner's Order:
Environmental Assessment Report
Cumberland Fossil Plant
Cumberland, Tennessee

Stantec Consulting Services Inc.
Lexington, Kentucky

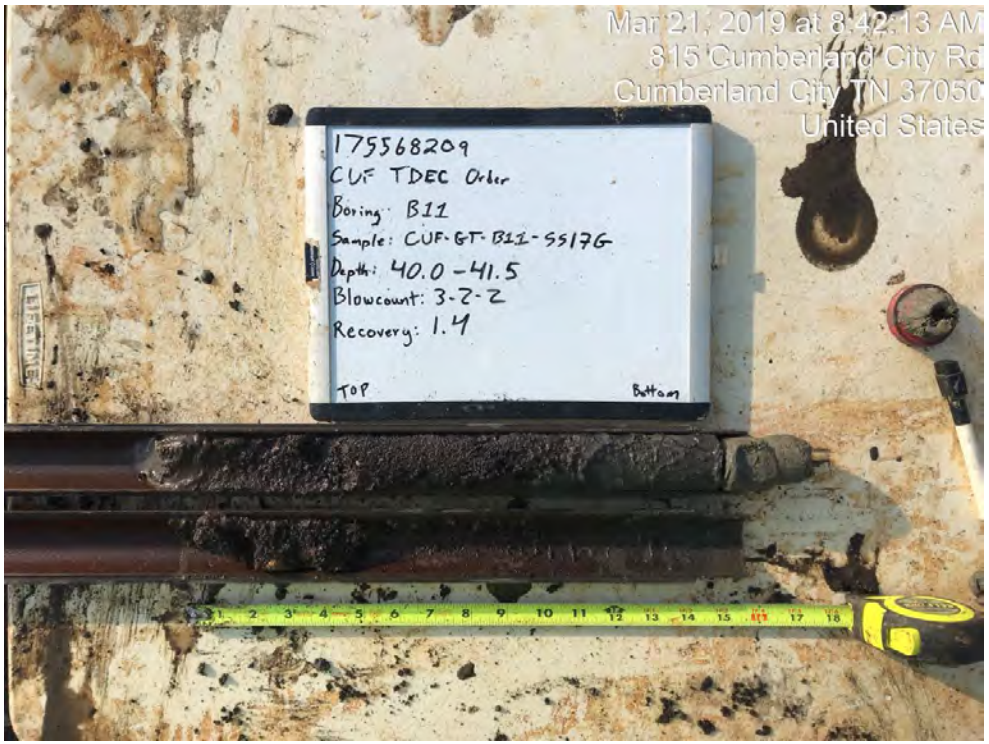
<p>Mar 21, 2019 at 8:42:13 AM 815 Cumberland City Rd Cumberland City TN 37050 United States</p>		
Photo Location: CUF-B11			
Photo Date: 3/21/2019			
Comments: Interval (40.0-41.5 feet).			
Photograph ID: 18	<p style="text-align: center;">No Photo Applicable</p>		
Photo Location: CUF-B11			
Photo Date: 3/21/2019			
Comments: Photo of interval (42.5-44.5 feet) unavailable because sample collected with shelly tube.

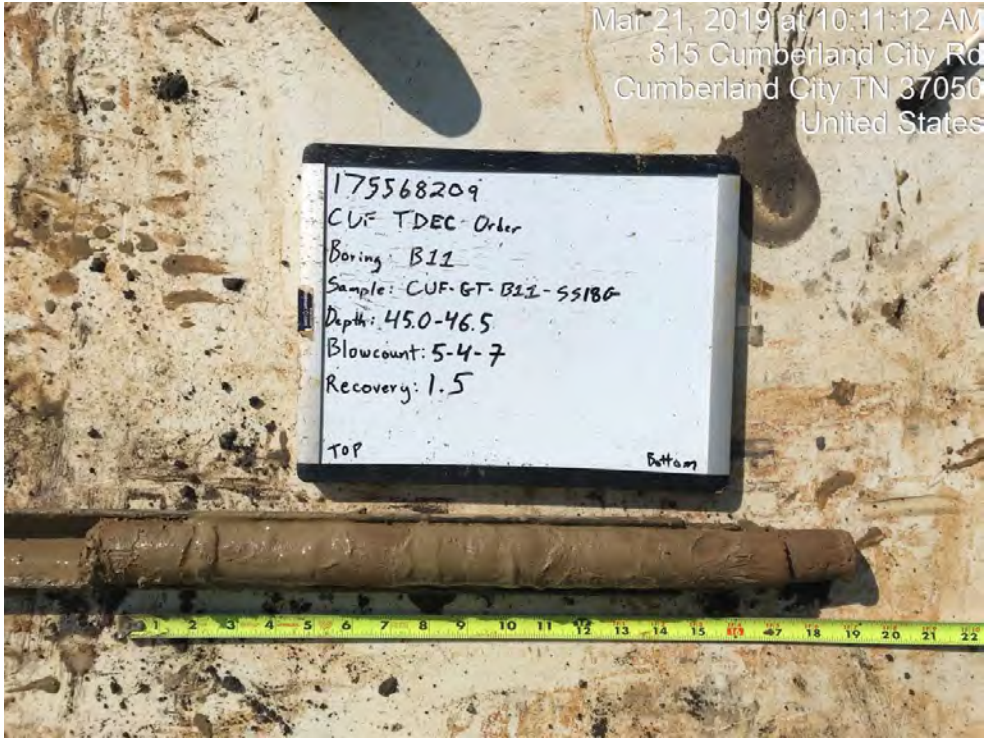
Photograph ID: 19

Photo Location: CUF-B11	
Photo Date: 3/21/2019	
Comments: Interval (45.0-46.5 feet).

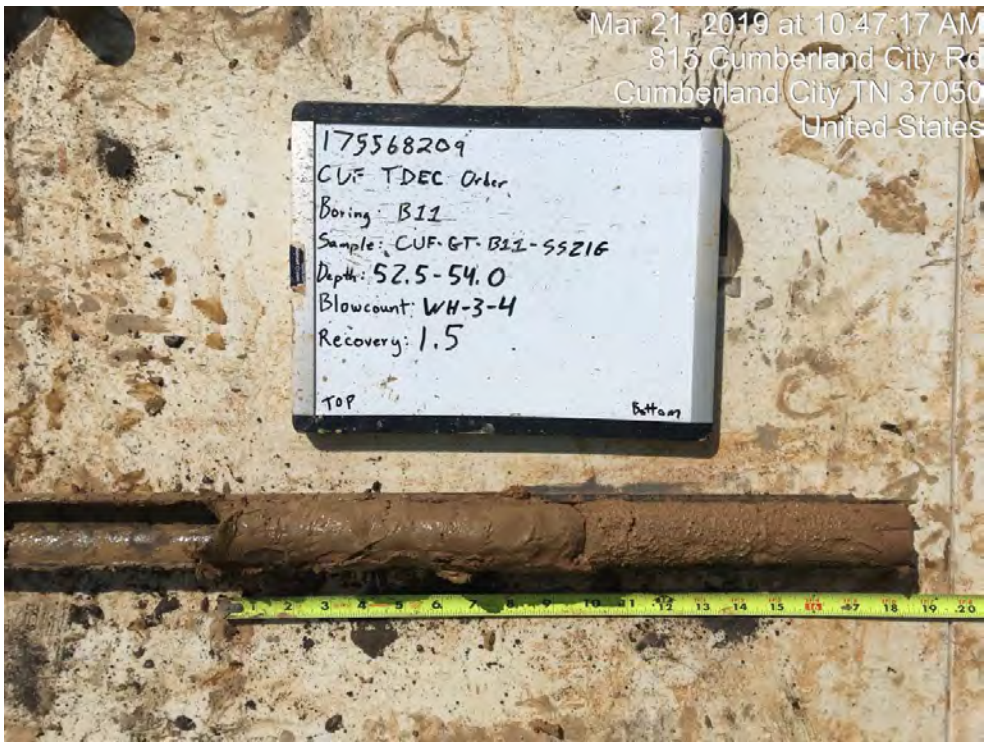
Photo Location: CUF-B11	
Photo Date: 3/21/2019	
Comments: Interval (52.5-54.0 feet).

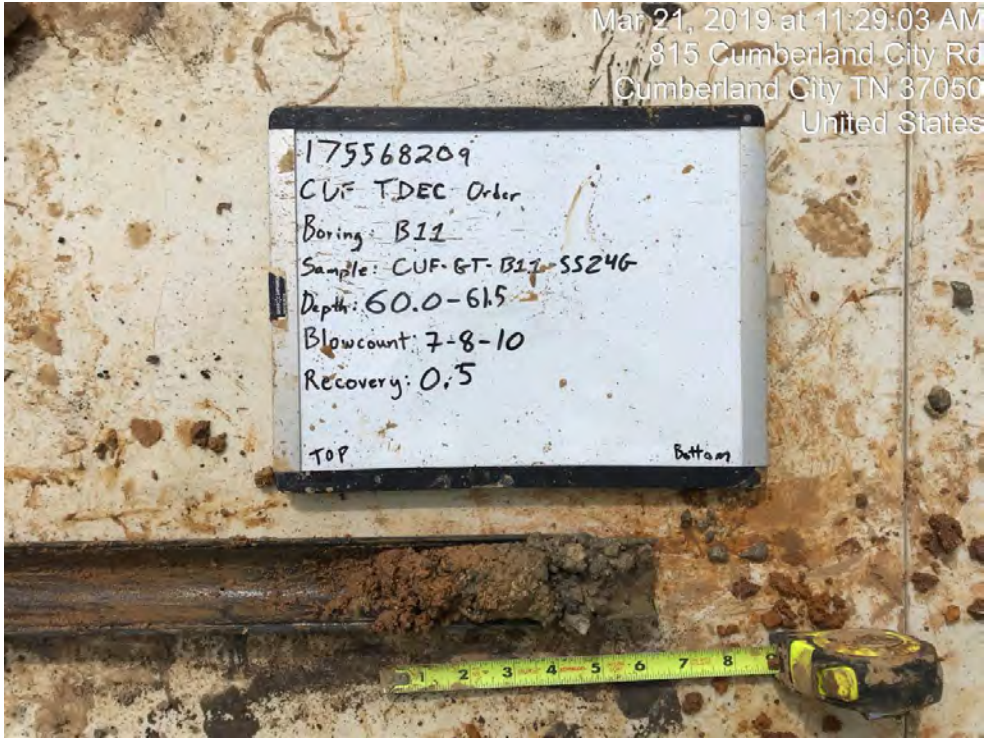
Photograph ID: 25

<p>Mar 21, 2019 at 11:29:03 AM 815 Cumberland City Rd Cumberland City TN 37050 United States</p>
Photo Location: CUF-B11	
Photo Date: 3/21/2019	
Comments: Interval (60.0-61.5 feet).

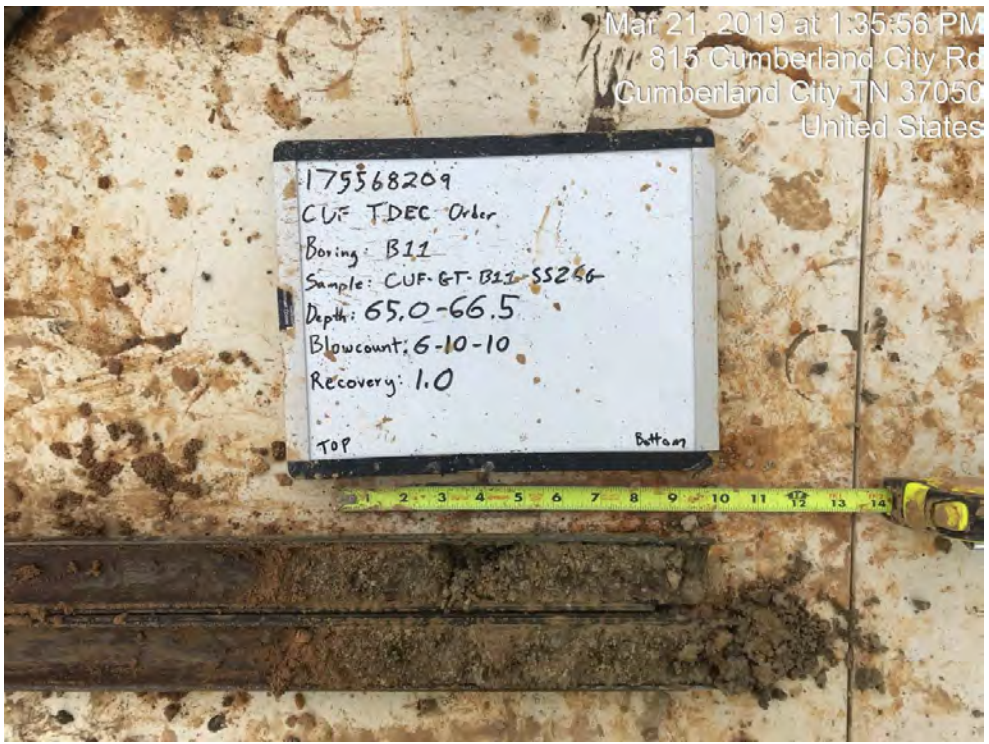
Photograph ID: 27

Photo Location: CUF-B11	
Photo Date: 3/21/2019	
Comments: Interval (65.0-66.5 feet).

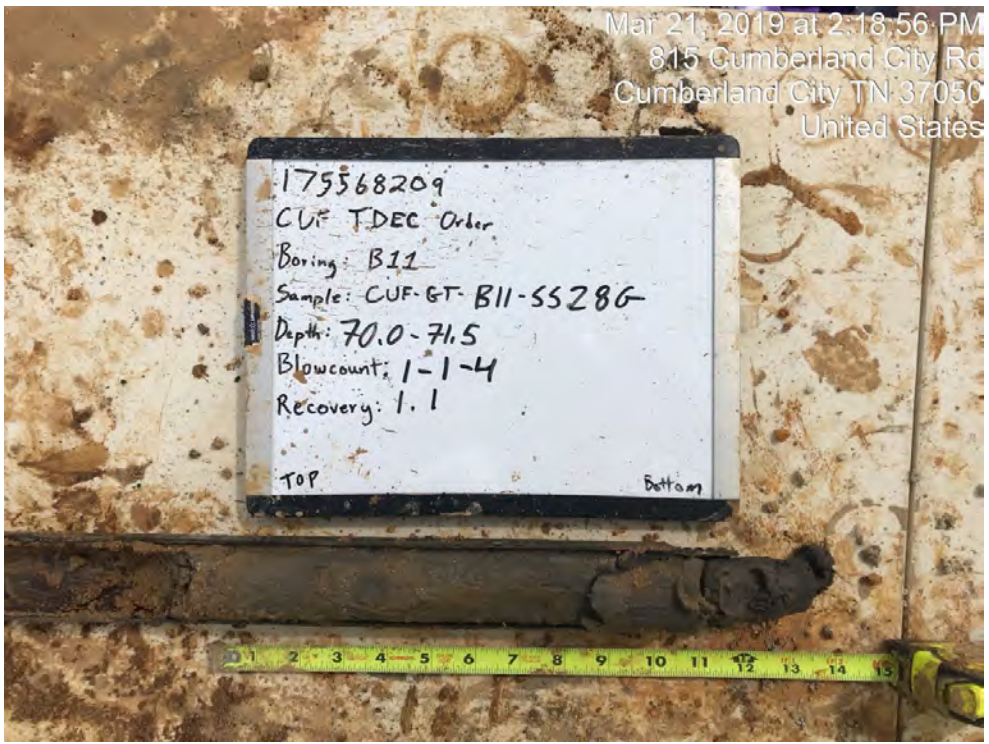
<p>Mar 21, 2019 at 2:18:56 PM 815 Cumberland City Rd Cumberland City TN 37050 United States</p>		
Photo Location: CUF-B11			
Photo Date: 3/21/2019			
Comments: Interval (70.0-71.5 feet).			
Photograph ID: 30

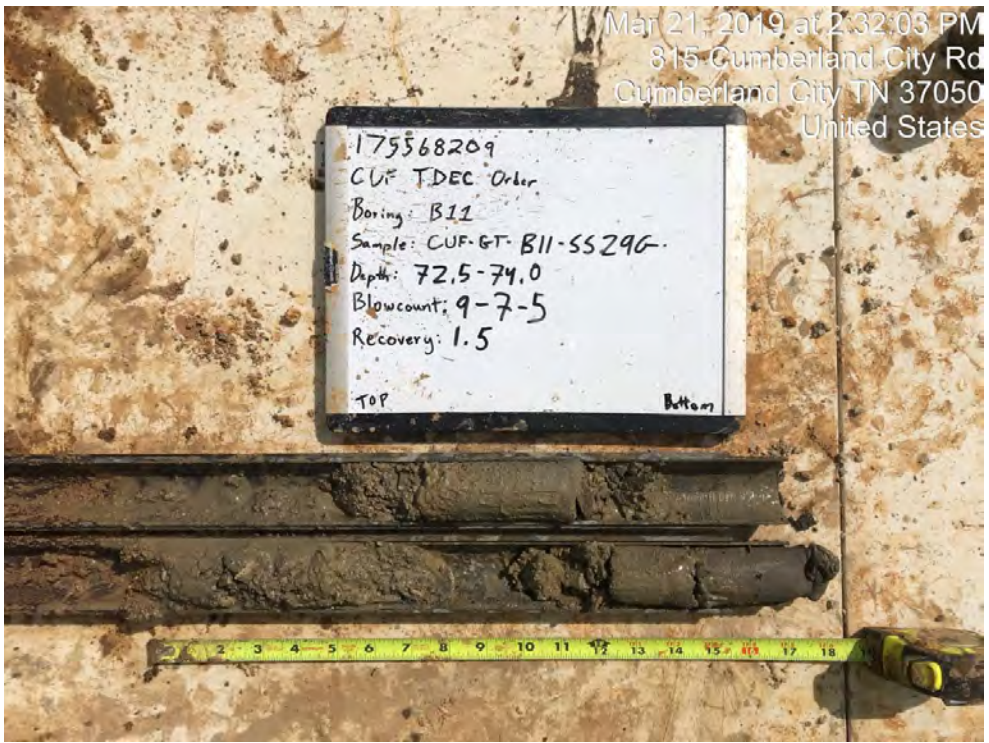
<p>Mar 21, 2019 at 2:32:03 PM 815 Cumberland City Rd Cumberland City TN 37050 United States</p>		
Photo Location: CUF-B11			
Photo Date: 3/21/2019			
Comments: Interval (72.5-74.0 feet).

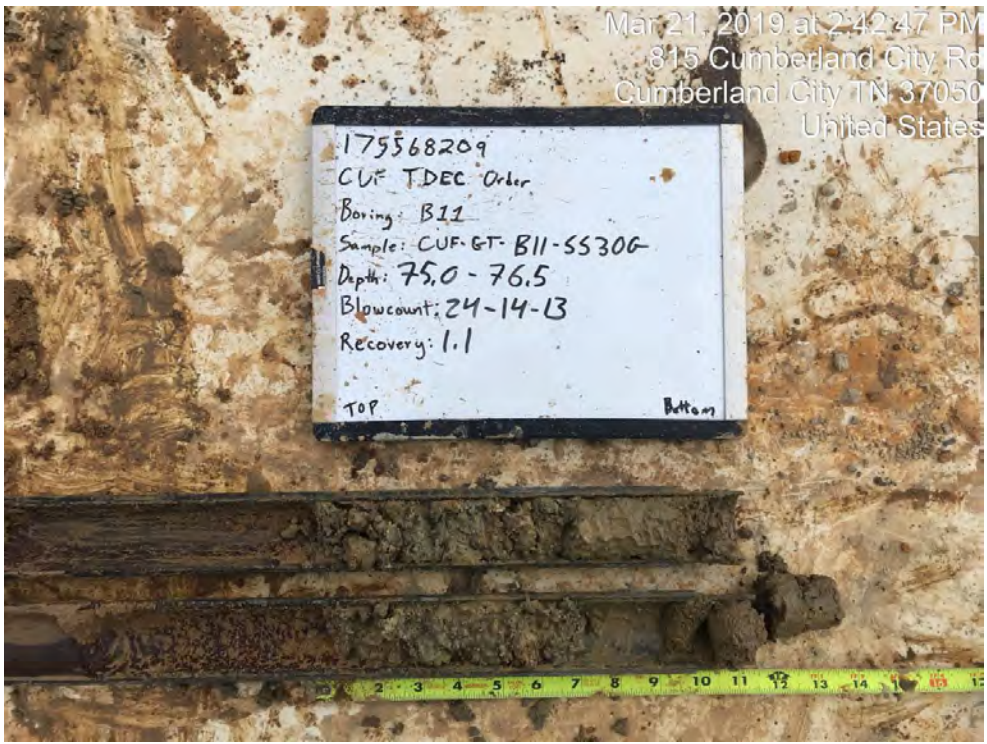
<p>Mar 21, 2019 at 2:42:47 PM 815 Cumberland City Rd Cumberland City TN 37050 United States</p>		
Photo Location: CUF-B11			
Photo Date: 3/21/2019			
Comments: Interval (75.0-76.5 feet).			
Photograph ID: 32

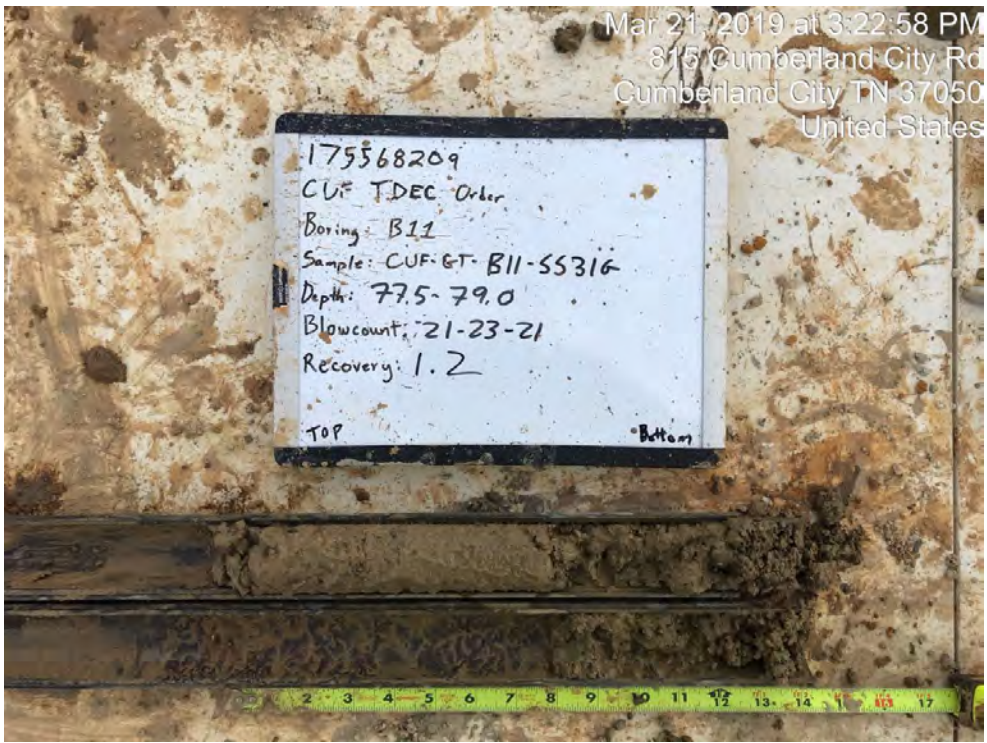
<p>Mar 21, 2019 at 3:22:58 PM 815 Cumberland City Rd Cumberland City TN 37050 United States</p>		
Photo Location: CUF-B11			
Photo Date: 3/21/2019			
Comments: Interval (77.5-79.0 feet).

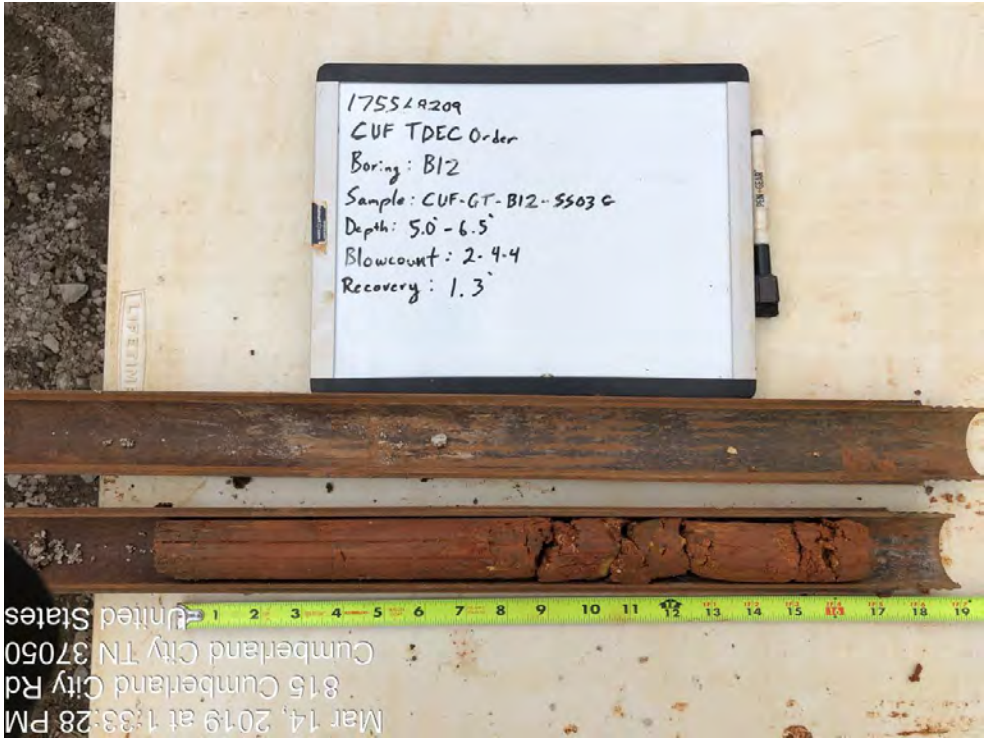
Photograph ID: 39

Photo Location: CUF-B12	
Photo Date: 3/14/2019	
Comments: Interval (5.0-6.5 feet).

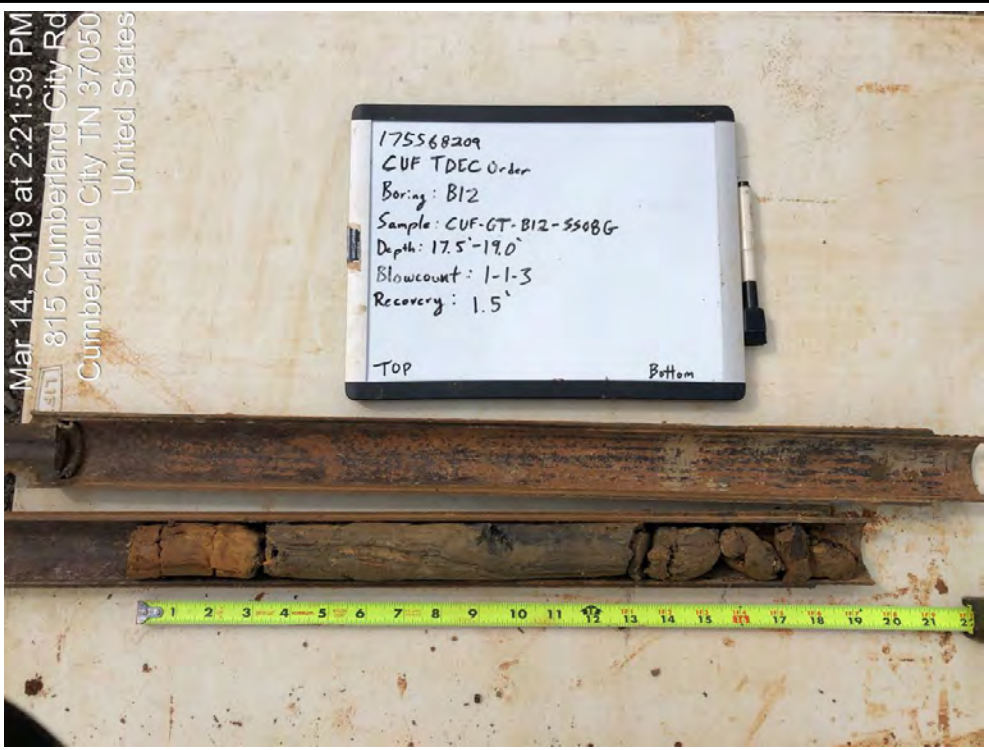
<p>Photograph ID: 44</p> <p>Photo Location: CUF-B12</p> <p>Photo Date: 3/14/2019</p> <p>Comments: Interval (17.5-19.0 feet).</p>

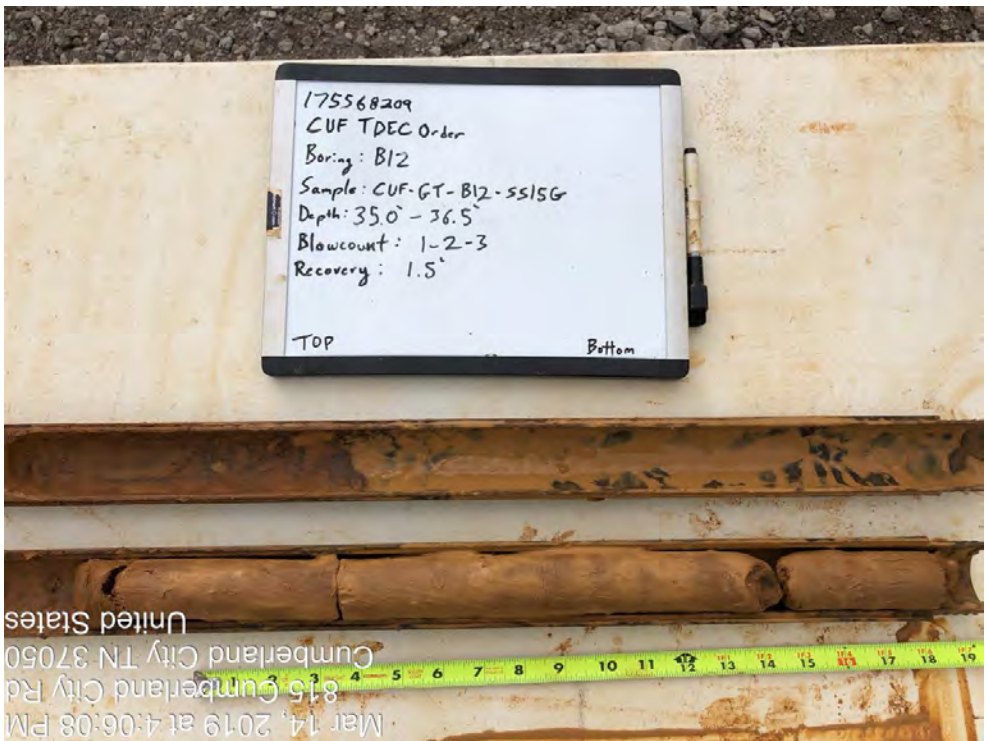
Photograph ID: 51

Photo Location: CUF-B12	
Photo Date: 3/14/2019	
Comments: Interval (35.0-36.5 feet).

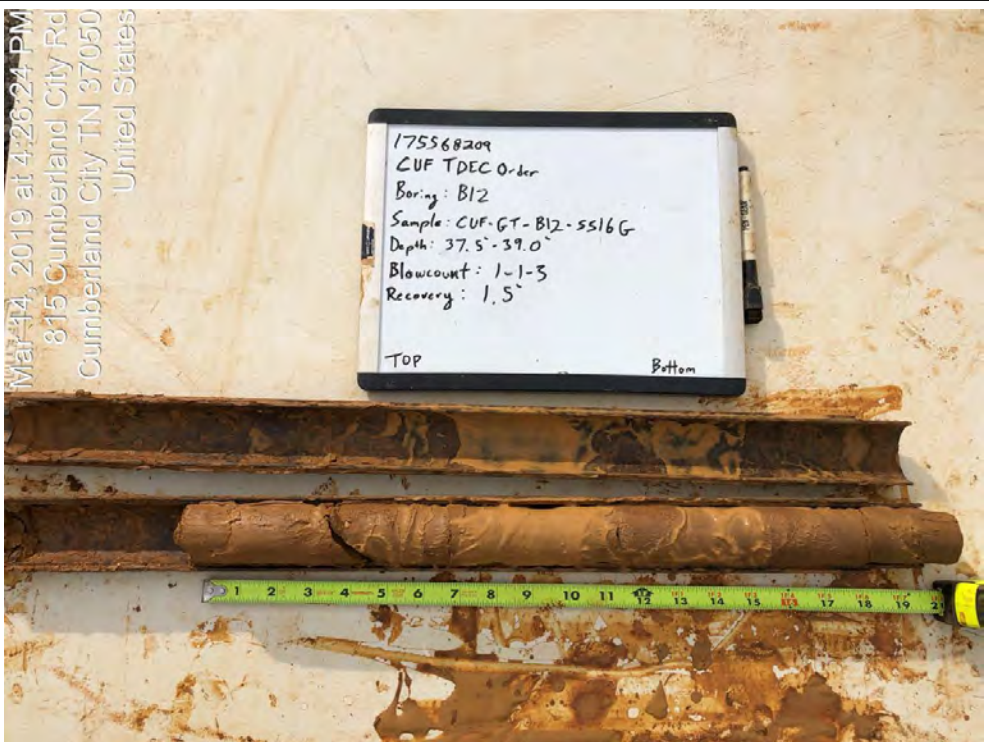
Photograph ID: 52

Photo Location: CUF-B12	
Photo Date: 3/14/2019	
Comments: Interval (37.5-39.0 feet).

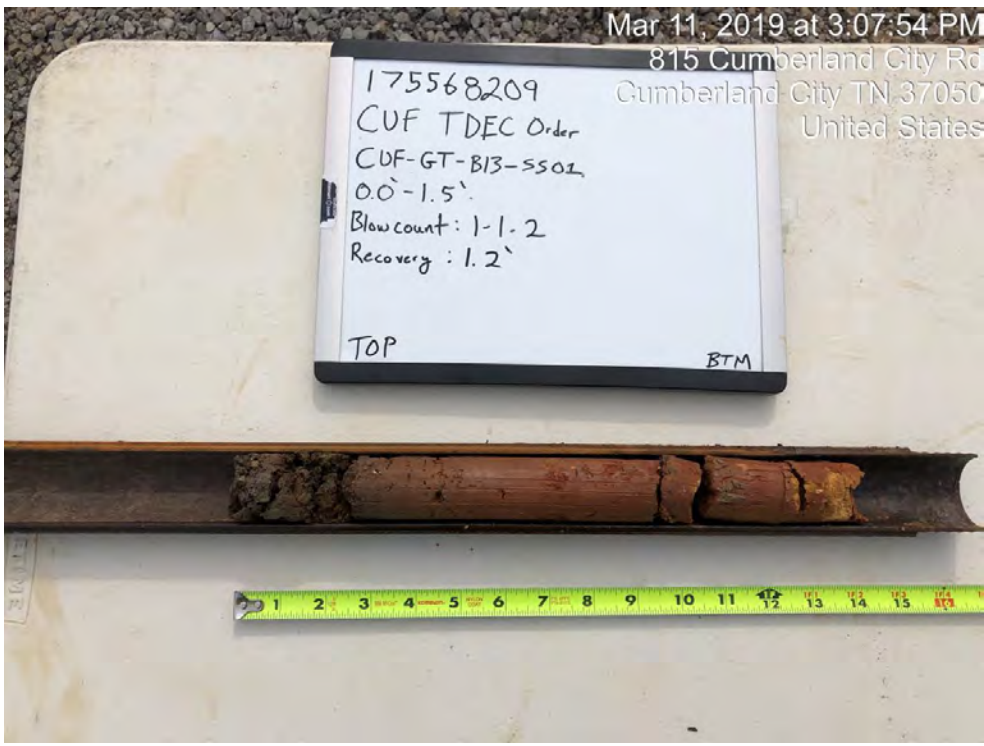
Photograph ID: 60

Photo Location: CUF-B13	
Photo Date: 3/11/2019	
Comments: Interval (0.0-1.5 feet).

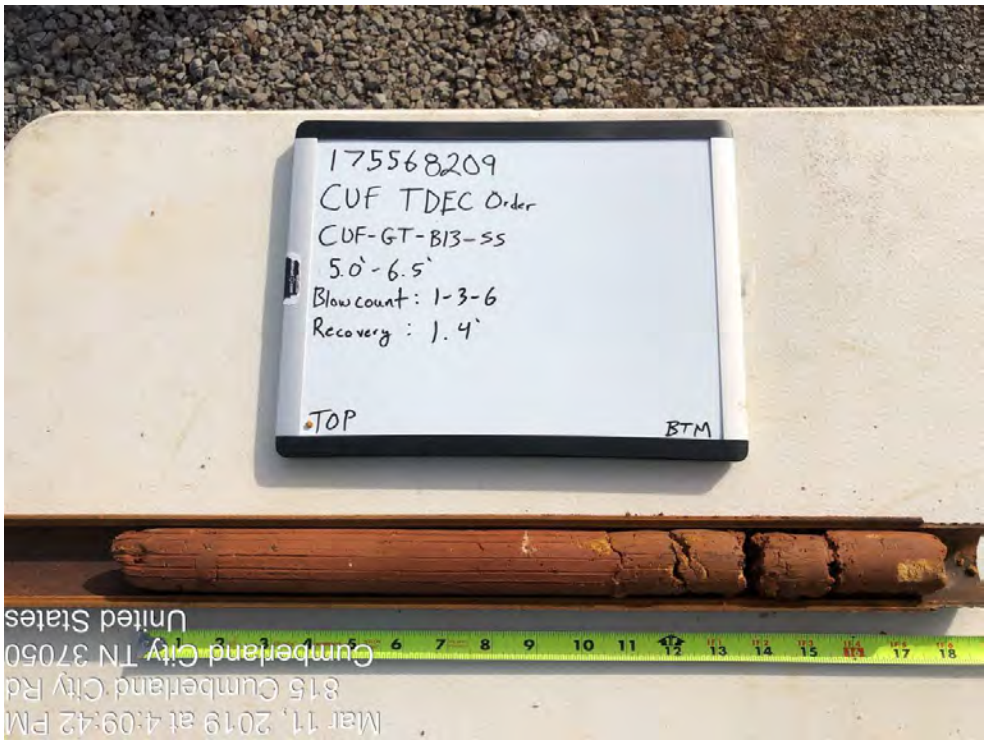
Photograph ID: 62

<p>The photograph shows a whiteboard with handwritten text: '175568209', 'CUF TDEC Order', 'CUF-GT-B13-SS', '5.0'-6.5'', 'Blow count: 1-3-6', 'Recovery: 1.4'', 'TOP' (with a red dot), and 'BTM'. Below the whiteboard is a soil sample in a wooden core, and a yellow ruler is visible at the bottom. The background is a gravel surface.</p>
Photo Location: CUF-B13	
Photo Date: 3/11/2019	
Comments: Interval (5.0-6.5 feet). Sample identifier shown on white board should be SS02.

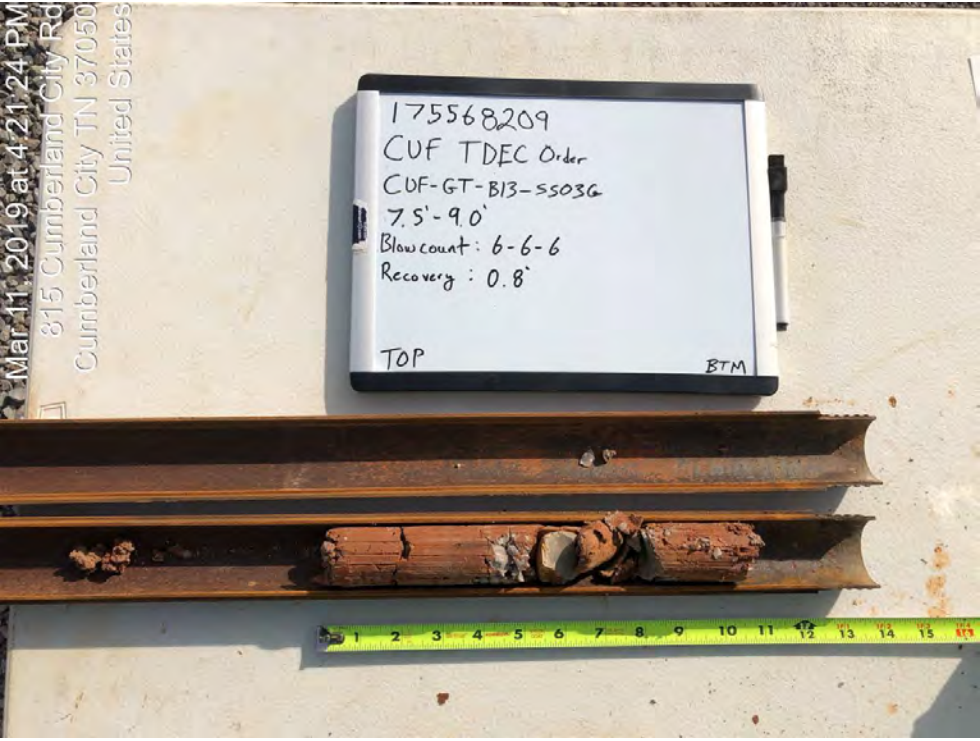
Photograph ID: 63

Photo Location: CUF-B13		
Photo Date: 3/11/2019		
Comments: Interval (7.5-9.0 feet).

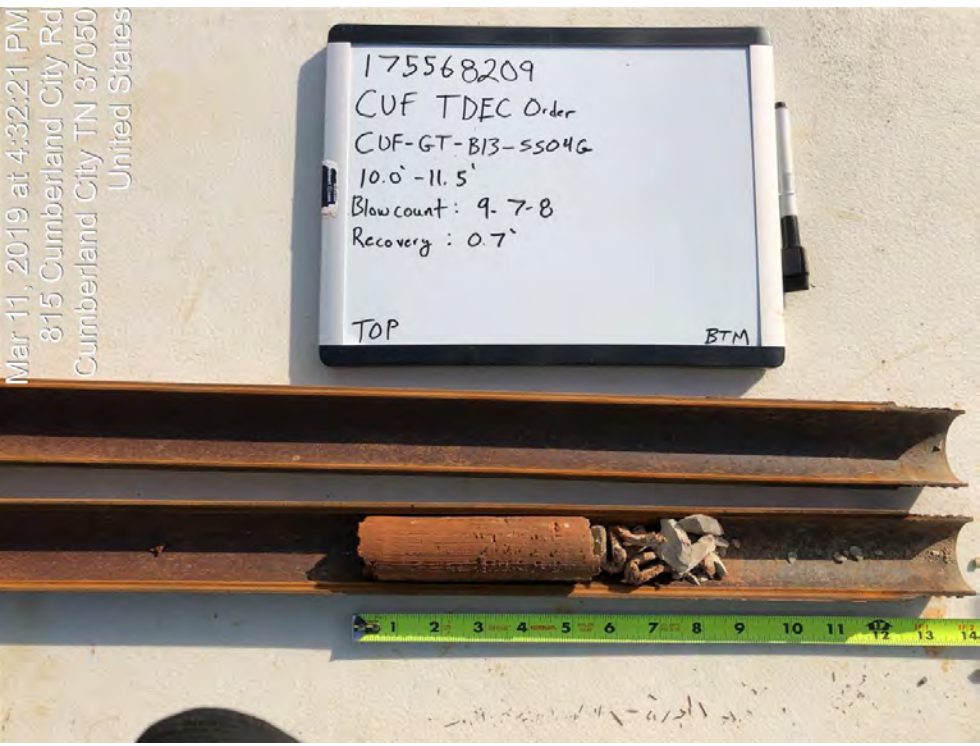
Photograph ID: 64

Photo Location: CUF-B13		
Photo Date: 3/11/2019		
Comments: Interval (10.0-11.5 feet).

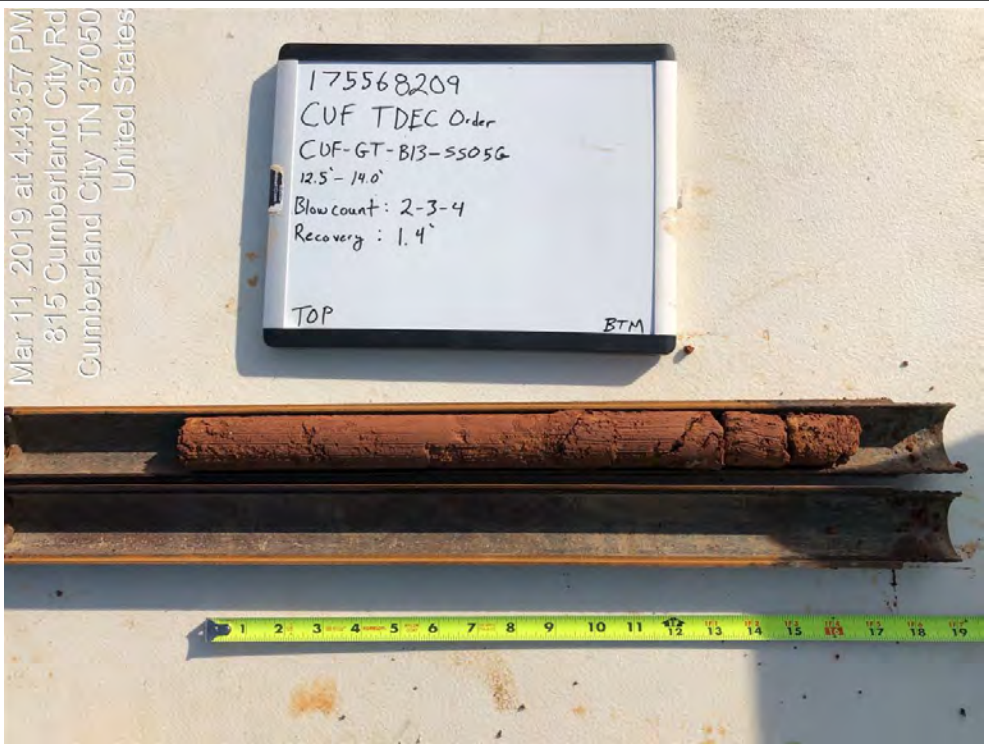
Photo Location: CUF-B13			
Photo Date: 3/11/2019			
Comments: Interval (12.5-14.0 feet).			
Photograph ID: 66

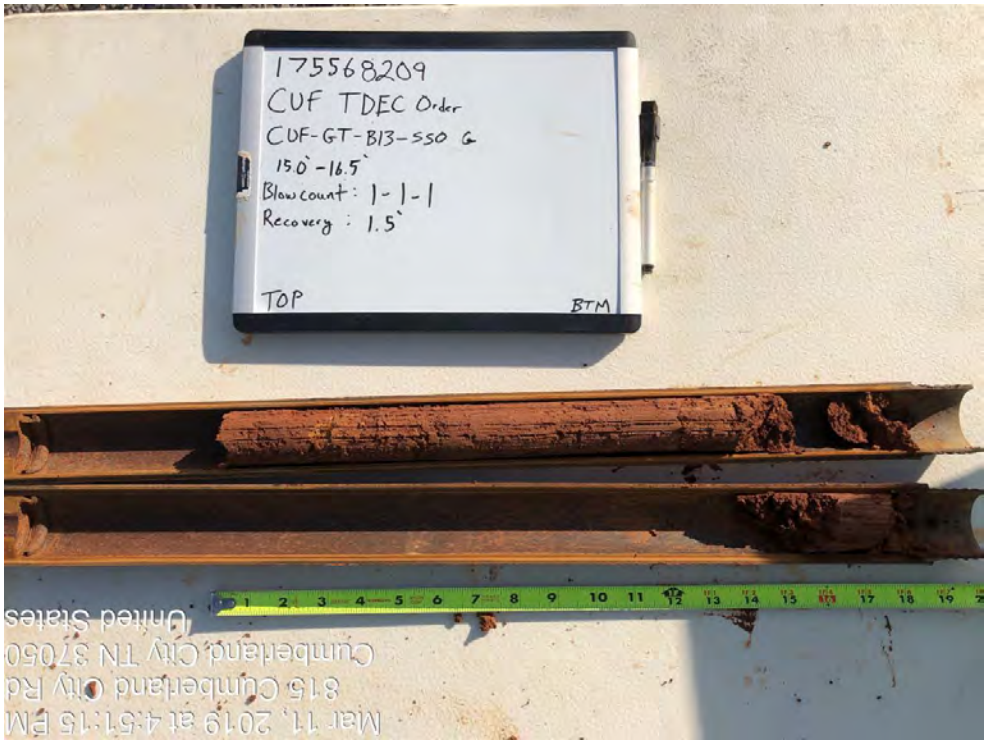
Photo Location: CUF-B13			
Photo Date: 3/11/2019			
Comments: Interval (15.0-16.5 feet). Sample identifier shown on white board should be SS06.

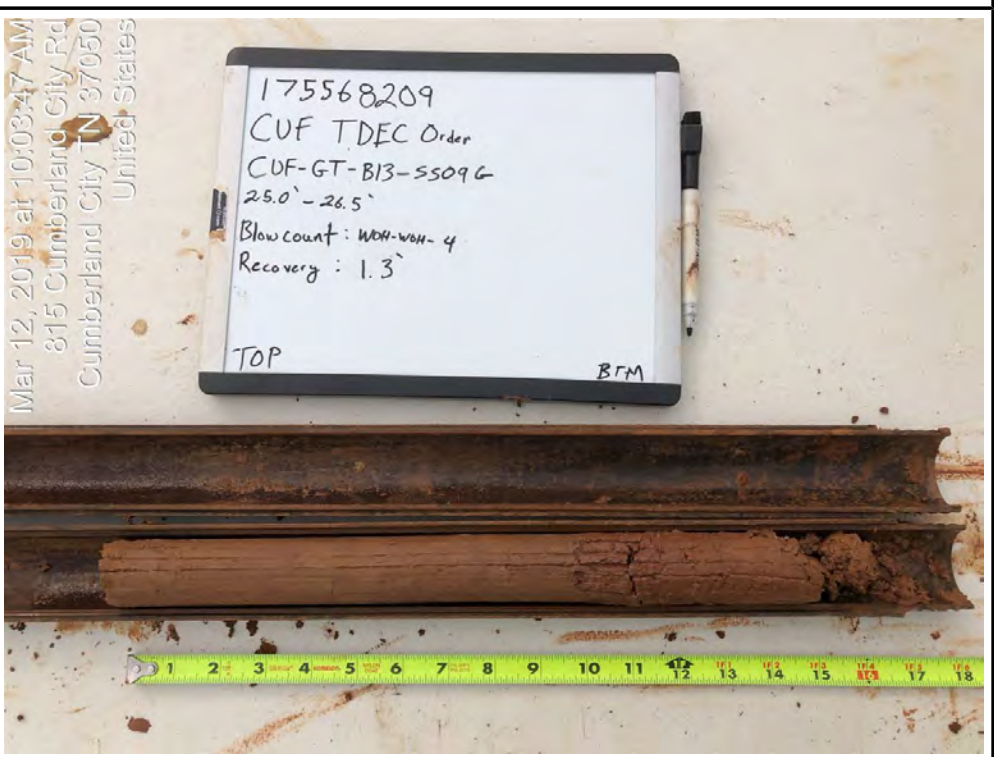
Photograph ID: 70	<div style="font-size: small; text-align: center;"> Mar 12, 2019 at 10:08:47 AM 815 Cumberland City Rd Cumberland City TN 37050 United States </div>

Photo Location: CUF-B13	
Photo Date: 3/12/2019	
Comments: Interval (25.0-26.5 feet). WOH on white board is the same as WH on the boring log.

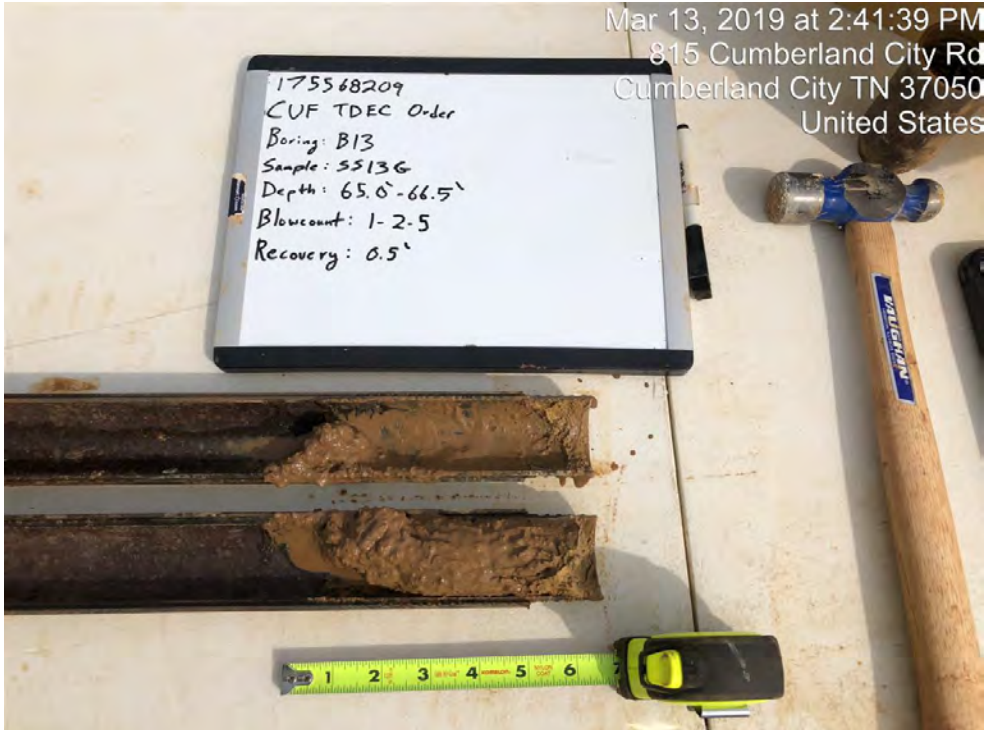
<p>Client: Tennessee Valley Authority</p> <p>Site Name: Cumberland Fossil (CUF) Plant</p>	<p>Project: CUF TDEC Order</p> <p>Site Location: Cumberland City, Tennessee</p>
<p>Photograph ID: 75</p> <p>Photo Location: CUF-B13</p> <p>Photo Date: 3/13/2019</p> <p>Comments: Interval (65.0-66.5 feet).</p>	<p>Mar 13, 2019 at 2:41:39 PM 815 Cumberland City Rd Cumberland City TN 37050 United States</p>

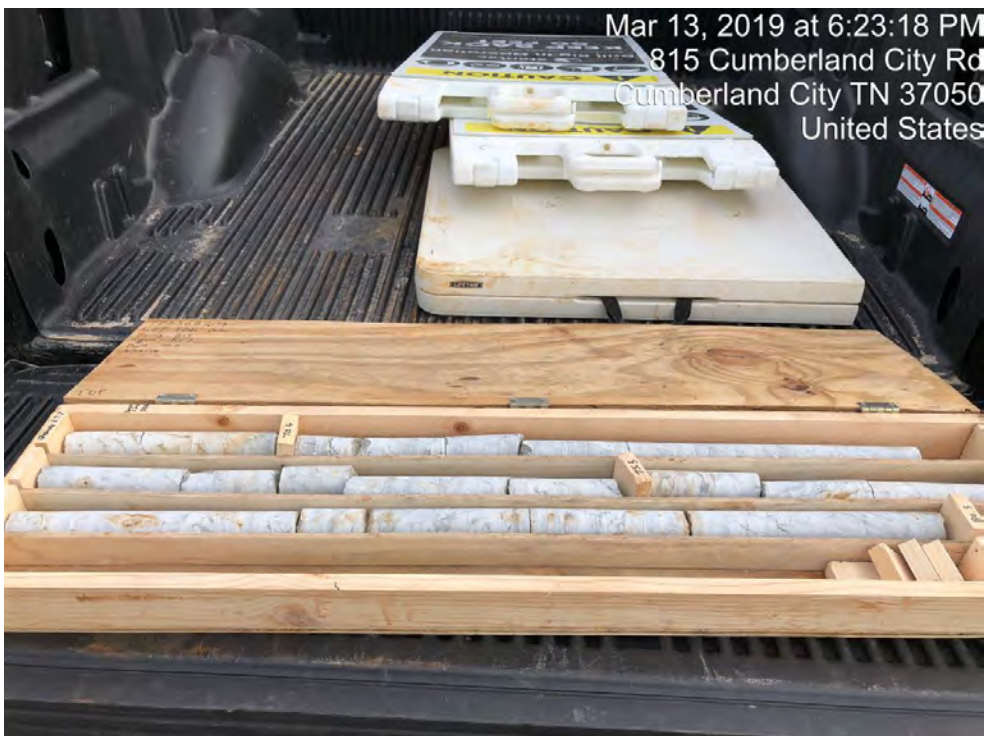
<p>175568209 CUF TDEC Order Boring: B13 Sample: 55136 Depth: 65.0'-66.5' Blowcount: 1-2-5 Recovery: 0.5'</p>
<p>Photograph ID: 76</p> <p>Photo Location: CUF-B13</p> <p>Photo Date: 3/13/2019</p> <p>Comments: Interval (69.7-80.5 feet). Project number, boring identifier, and interval shown on box should be 175568209, B13, and 69.7-80.5 feet, respectively.</p>	<p>Mar 13, 2019 at 6:23:18 PM 815 Cumberland City Rd Cumberland City TN 37050 United States</p>

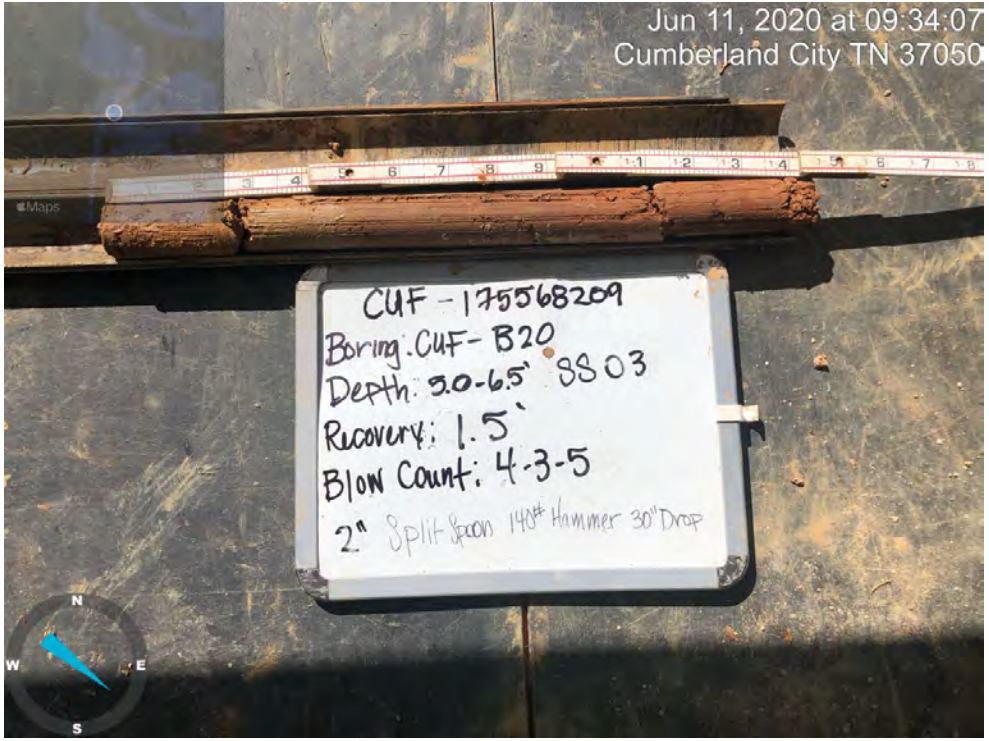
Photograph ID: 79

Photo Location: CUF-B20	
Photo Date: 6/11/2020	
Comments: Interval (5.0-6.5 feet)

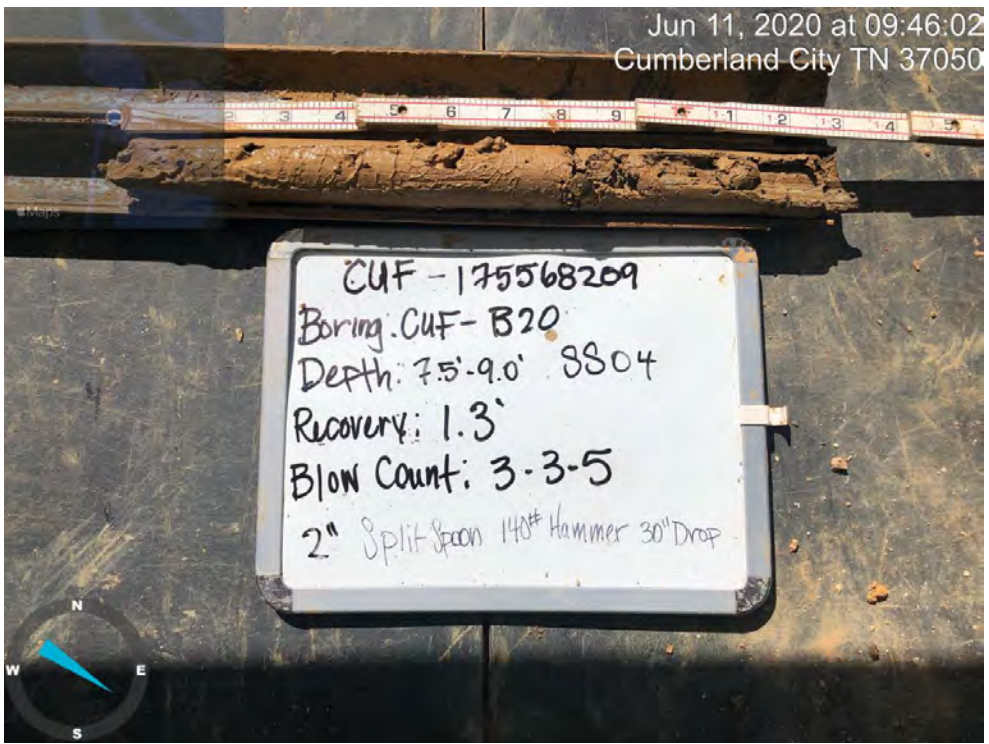
Photograph ID: 80

Photo Location: CUF-B20	
Photo Date: 6/11/2020	
Comments: Interval (7.5-9.0 feet)

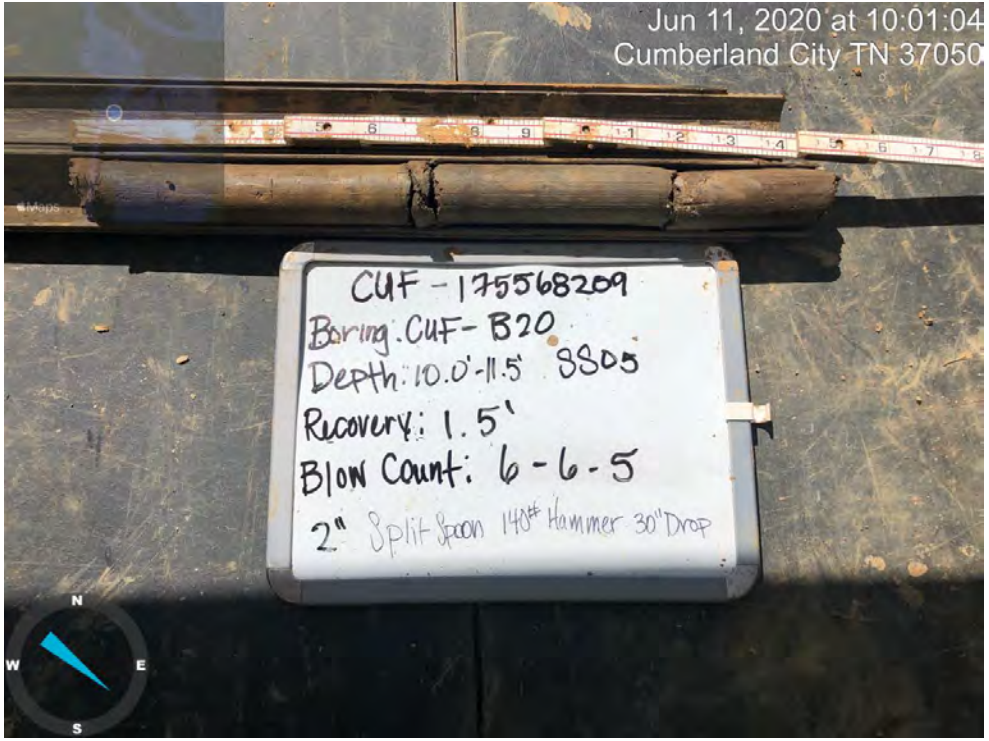
Photograph ID: 81

Photo Location: CUF-B20	
Photo Date: 6/11/2020	
Comments: Interval (10.0-11.5 feet)

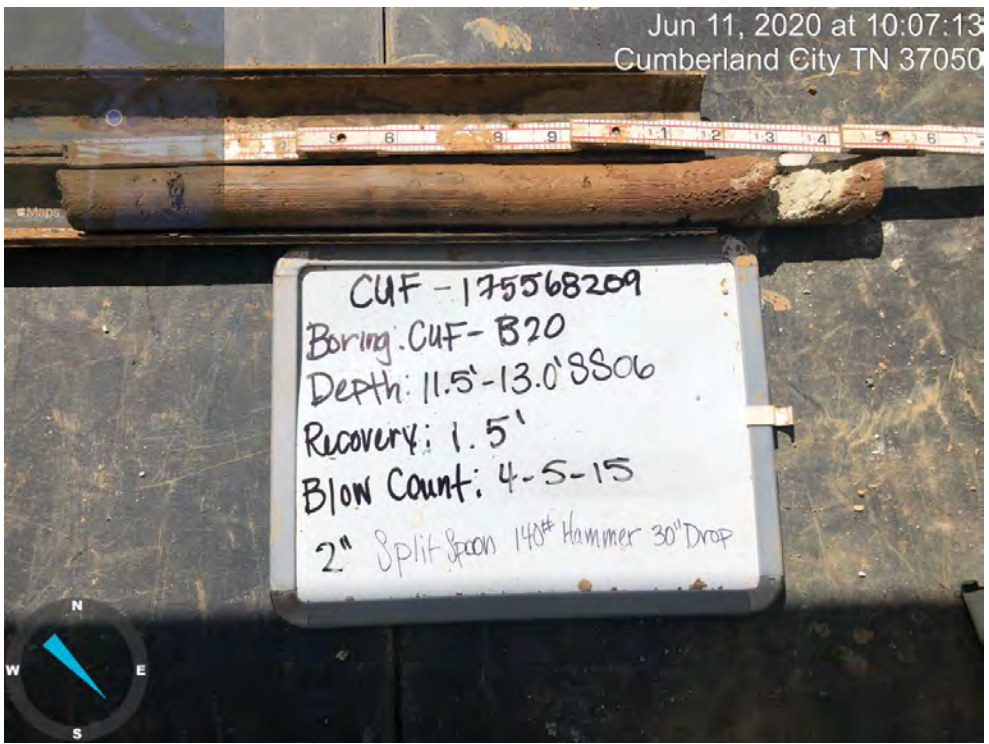
Photograph ID: 82

Photo Location: CUF-B20	
Photo Date: 6/11/2020	
Comments: Interval (11.5-13.0 feet)

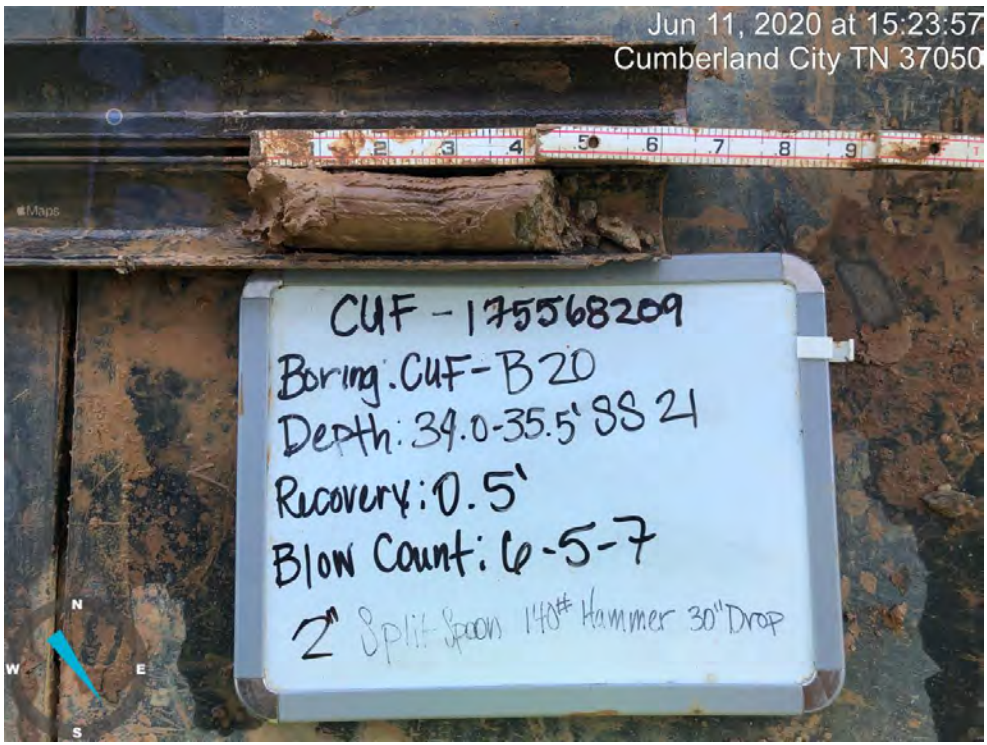
Photograph ID: 97

Photo Location: CUF-B20	
Photo Date: 6/11/2020	
Comments: Interval (34.0-35.5 feet)

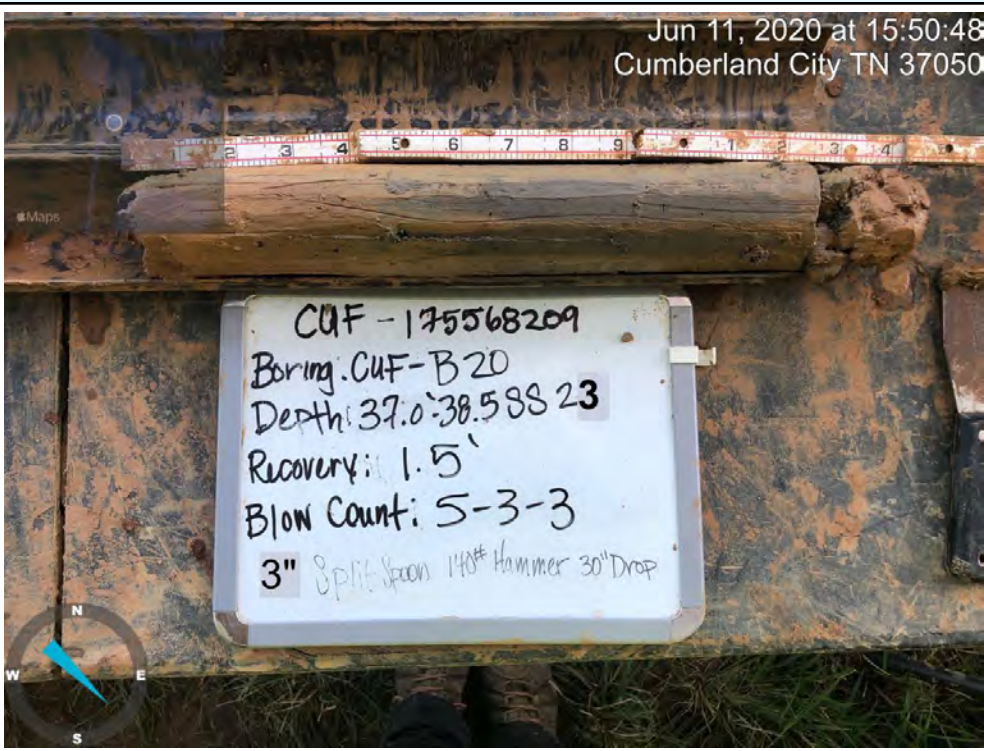
Photograph ID: 99

Photo Location: CUF-B20	
Photo Date: 6/11/2020	
Comments: Interval (37.0-38.5 feet)

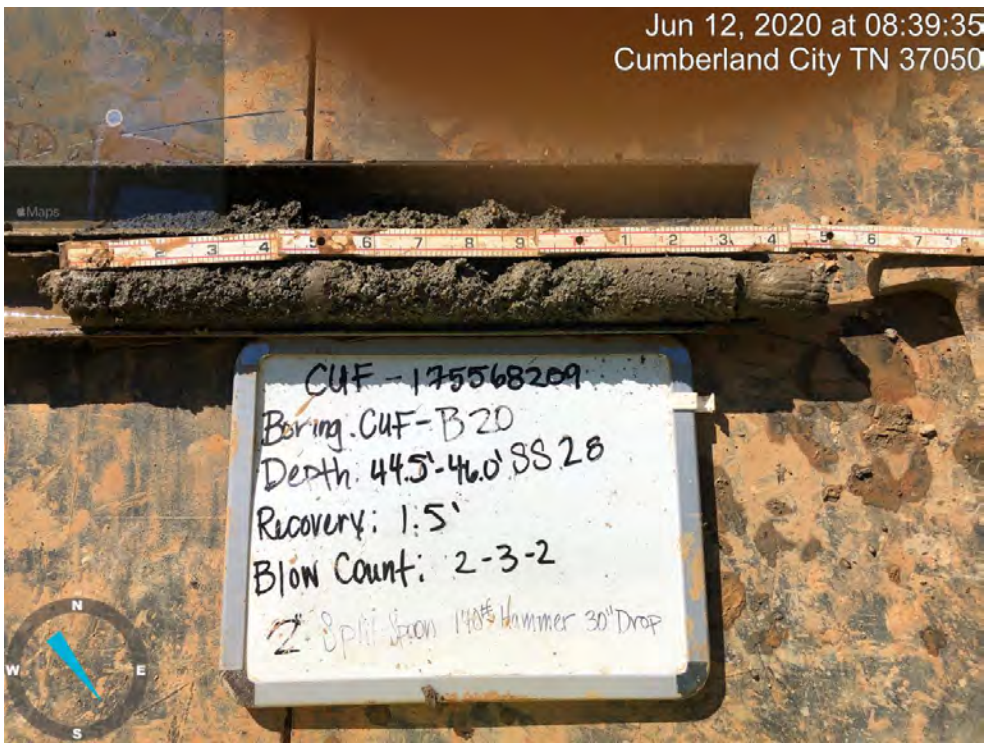
Photograph ID: 104

<p style="text-align: right;">Jun 12, 2020 at 08:39:35 Cumberland City TN 37050</p>
Photo Location: CUF-B20	
Photo Date: 6/12/2020	
Comments: Interval (44.5-46.0 feet)
