**APPENDIX G –
CCR MATERIAL INVESTIGATIONS**

**Appendix G.1 - Technical
Evaluation of Geotechnical and
CCR Material Characteristics Data**

TDEC Commissioner's Order:
Environmental Assessment Report
Cumberland Fossil Plant
Cumberland, Tennessee

Stantec Consulting Services Inc.
Lexington, Kentucky

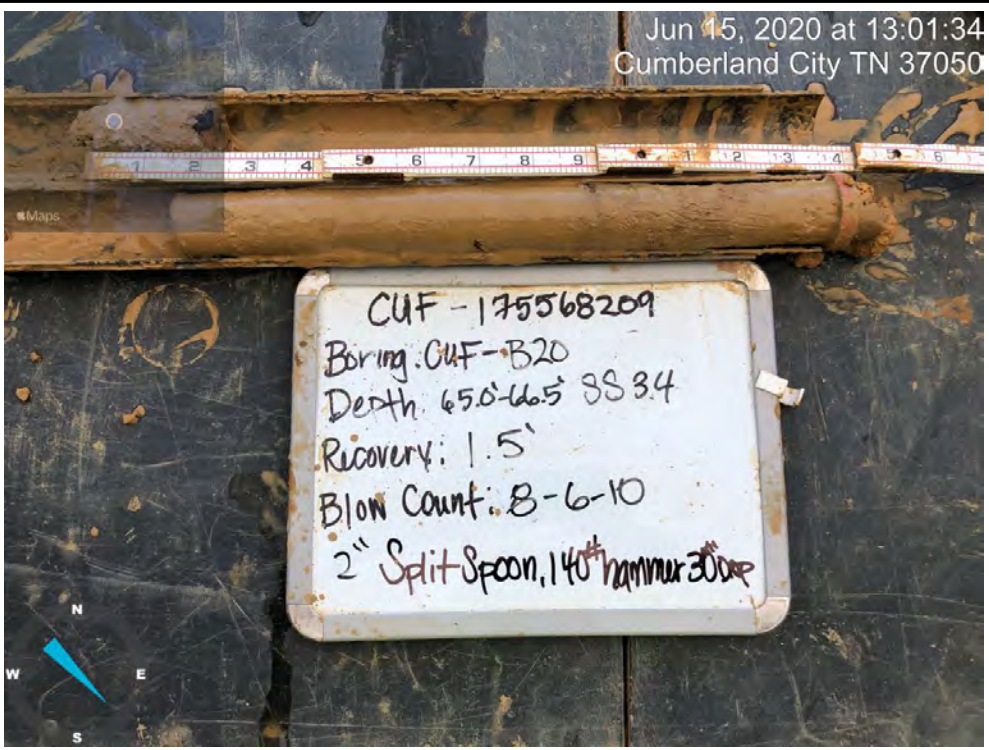
Photograph ID: 110

Photo Location: CUF-B20	
Photo Date: 6/15/2020	
Comments: Interval (65.0-66.5 feet)

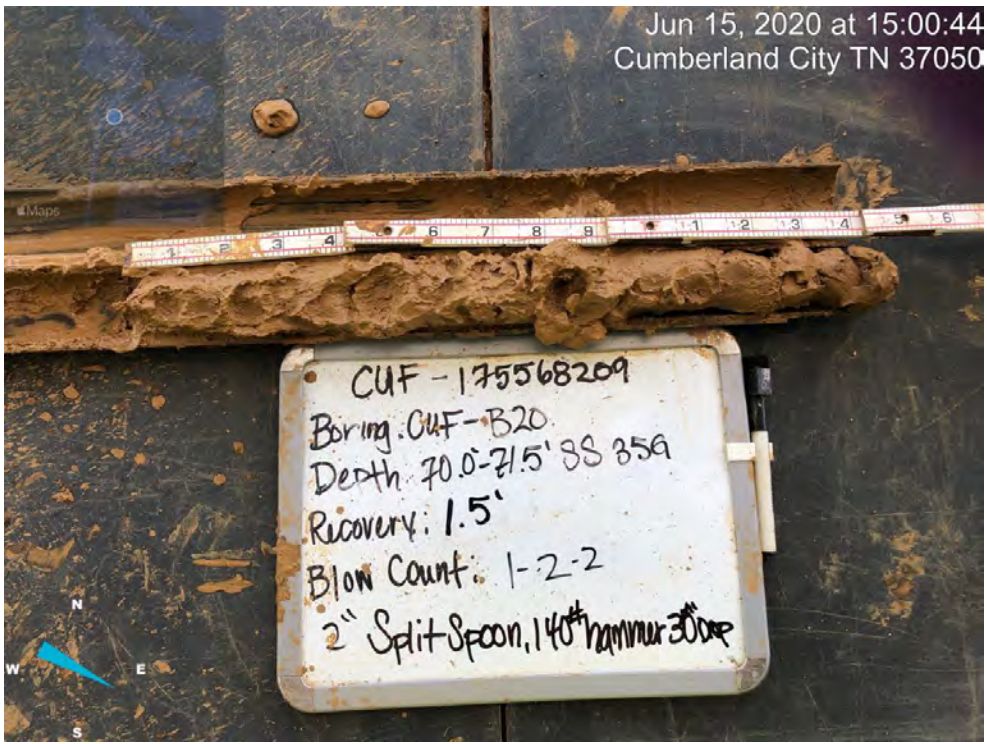
Photo Location: CUF-B20			
Photo Date: 6/15/2020			
Comments: Interval (70.0-71.5 feet)			
Photograph ID: 112

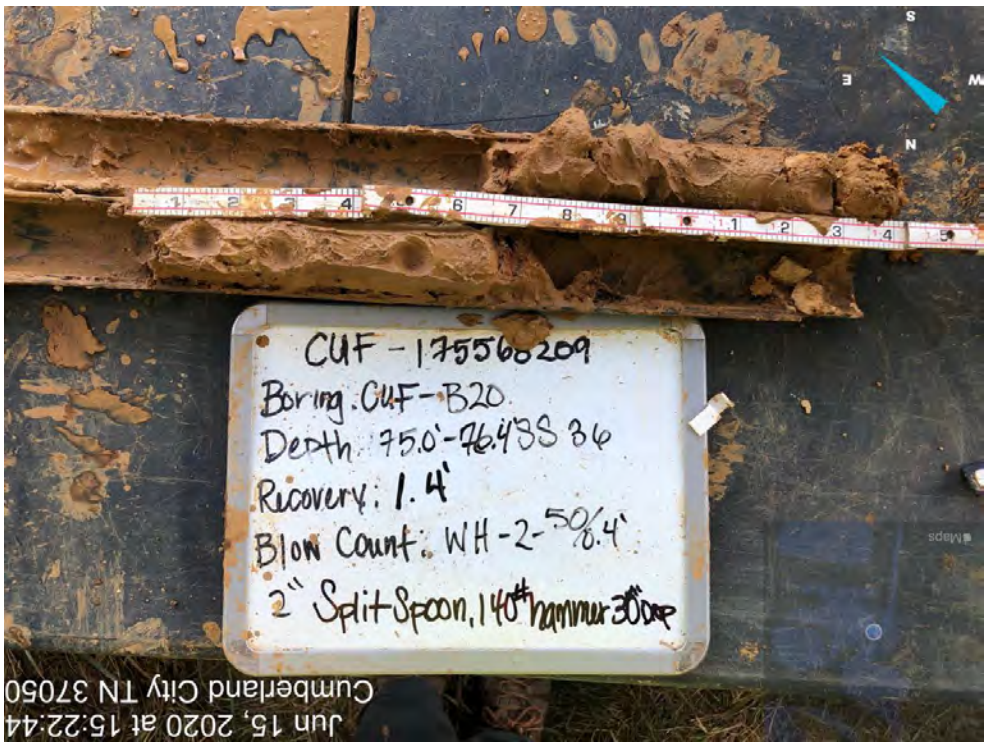
Photo Location: CUF-B20			
Photo Date: 6/15/2020			
Comments: Interval (75.0-76.4 feet)

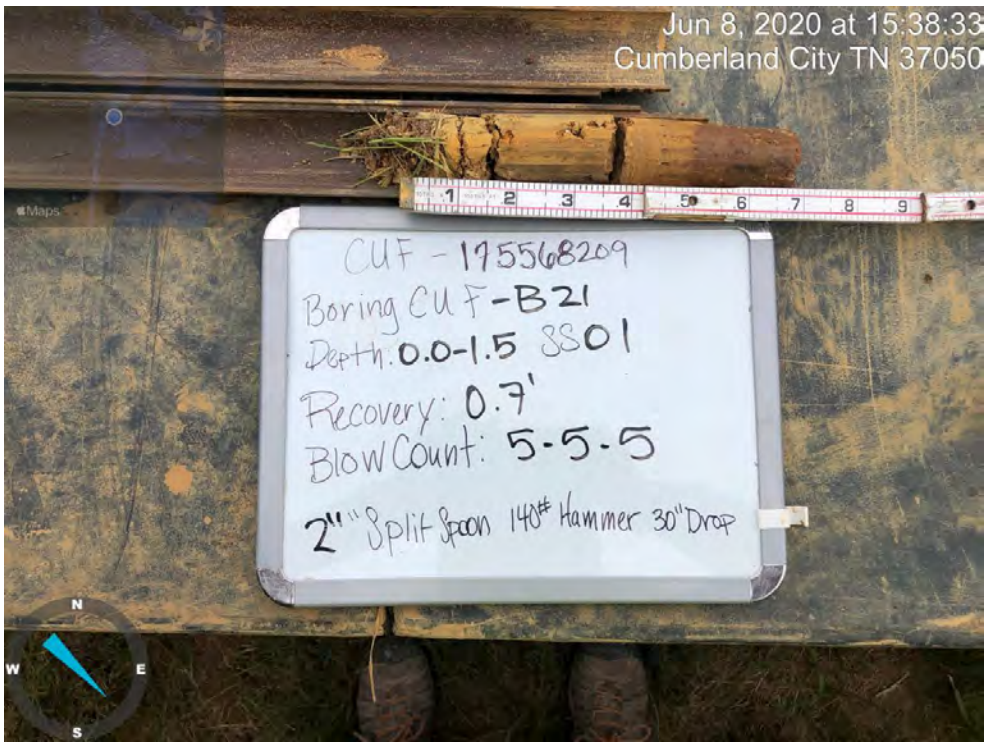
Photograph ID: 113

Photo Location: CUF-B21	
Photo Date: 6/8/2020	
Comments: Interval (0.0-1.5 feet)

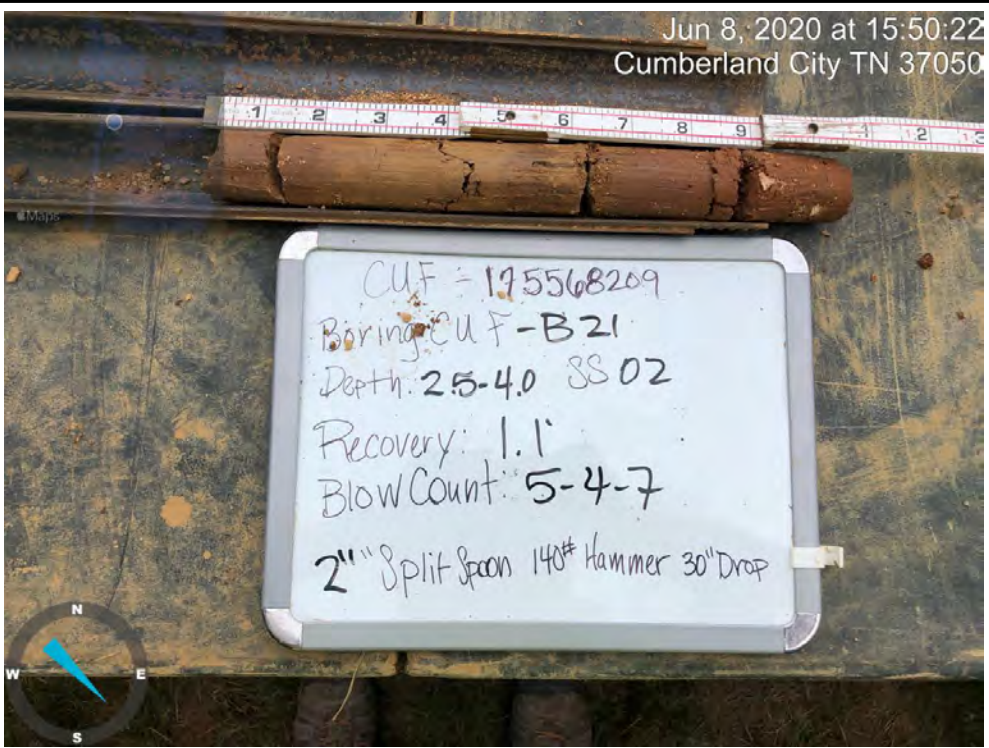
Photograph ID: 114

Photo Location: CUF-B21	
Photo Date: 6/8/2020	
Comments: Interval (2.5-4.0 feet)

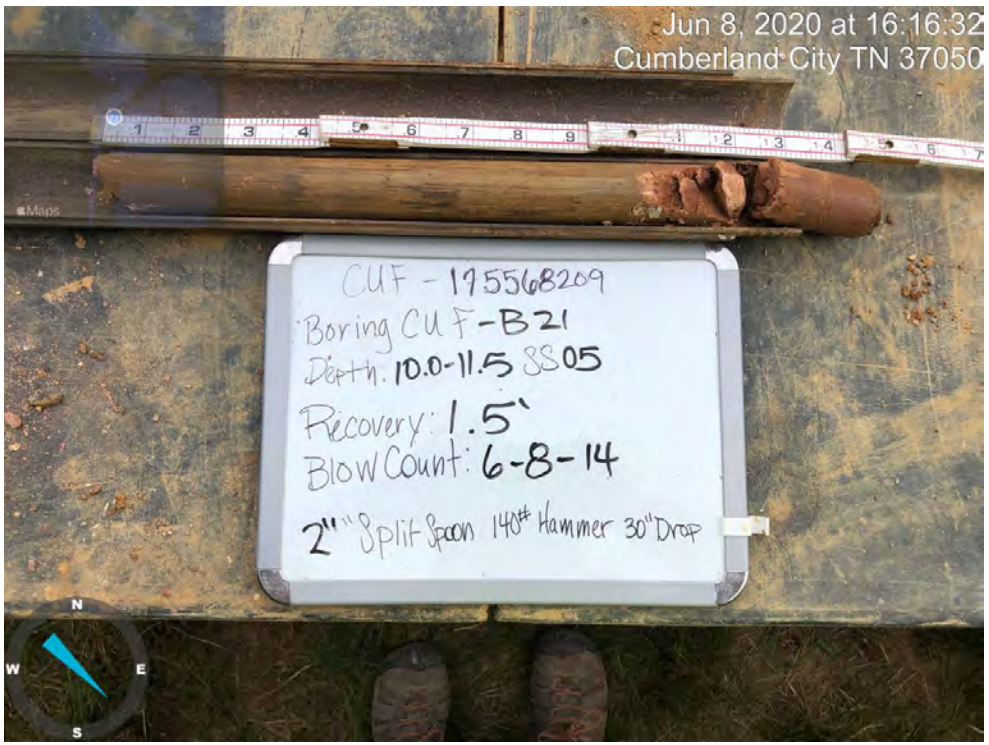
Photograph ID: 117

Photo Location: CUF-B21	
Photo Date: 6/8/2020	
Comments: Interval (10.0-11.5 feet)

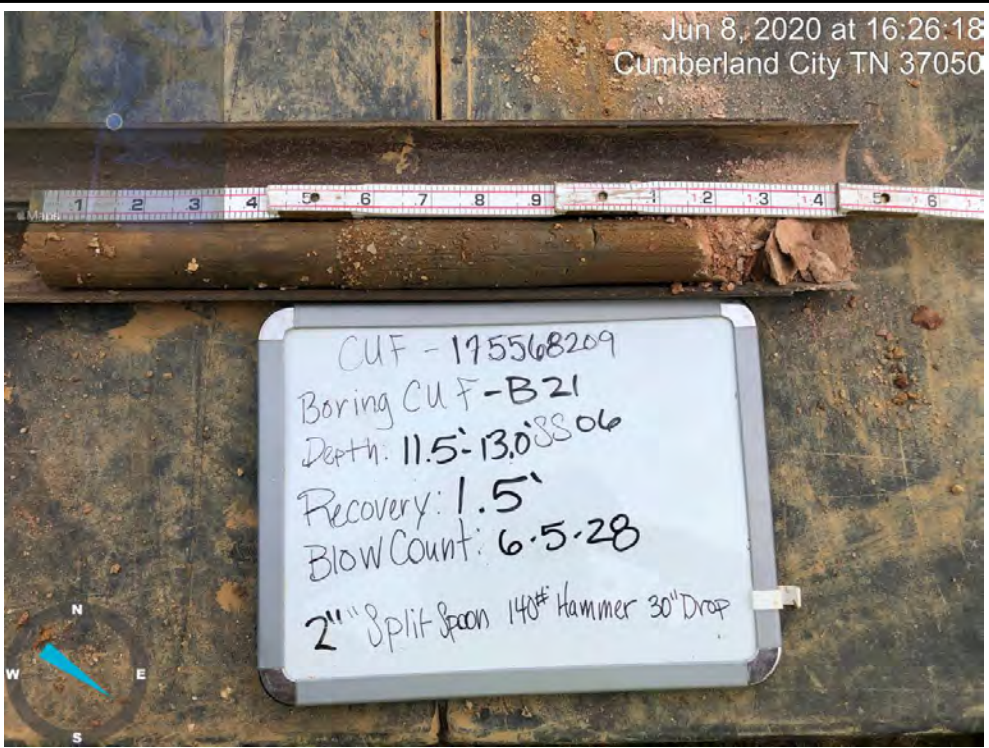
Photograph ID: 118

Photo Location: CUF-B21	
Photo Date: 6/8/2020	
Comments: Interval (11.5-13.0 feet)

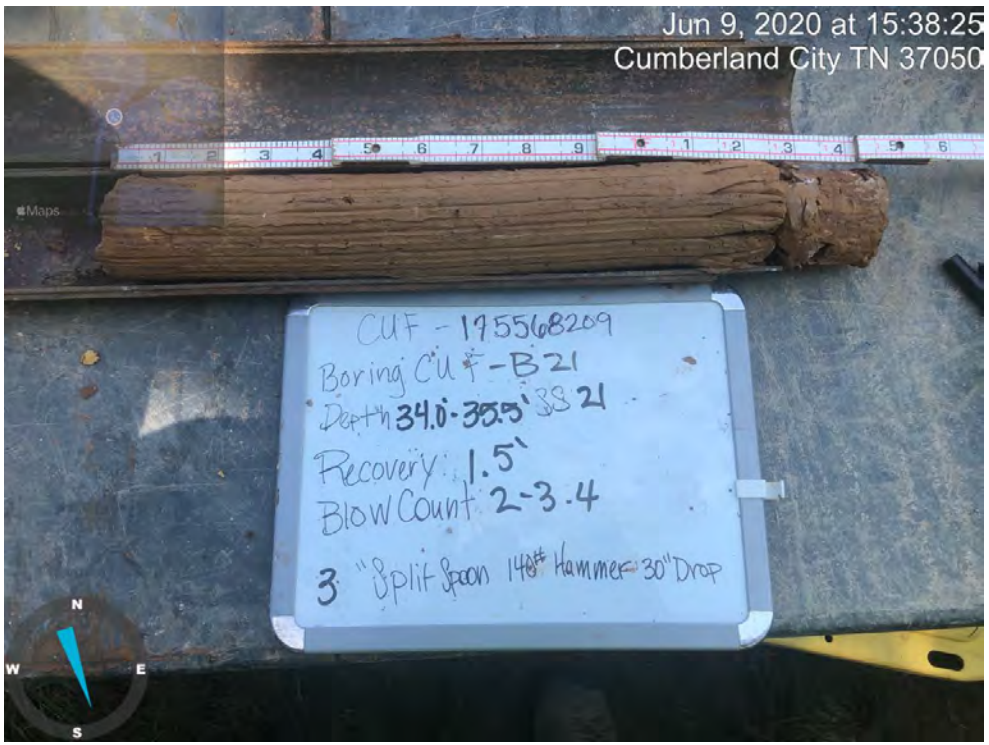
Photograph ID: 133

Photo Location: CUF-B21	
Photo Date: 6/9/2020	
Comments: Interval (34.0-35.5 feet)

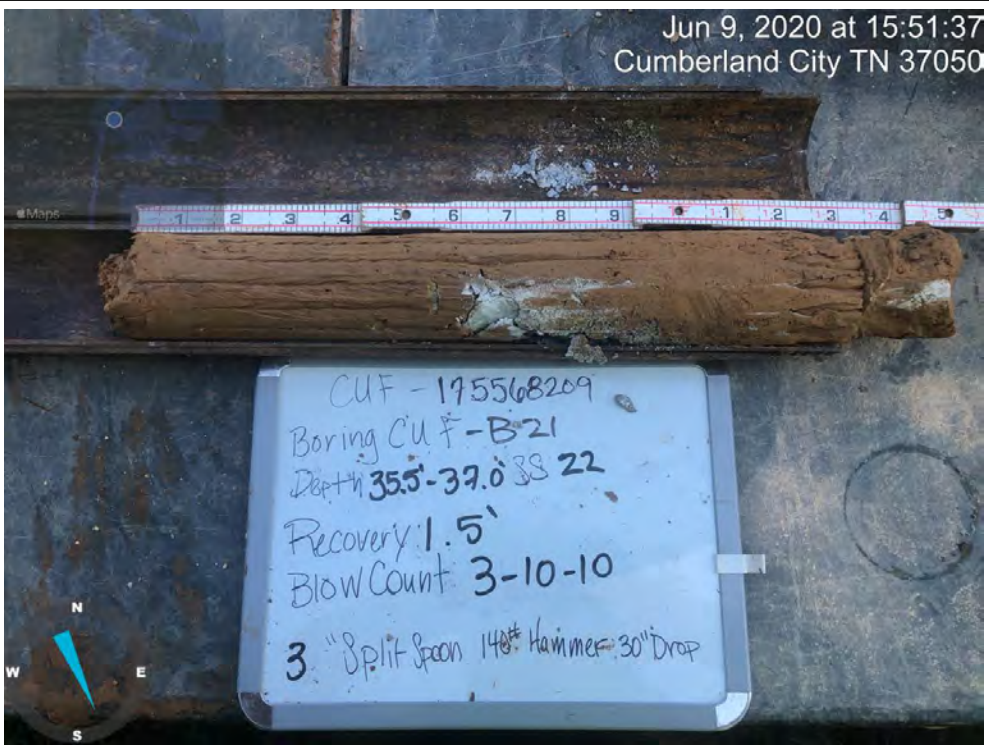
Photograph ID: 134

Photo Location: CUF-B21	
Photo Date: 6/9/2020	
Comments: Interval (35.5-37.0 feet)

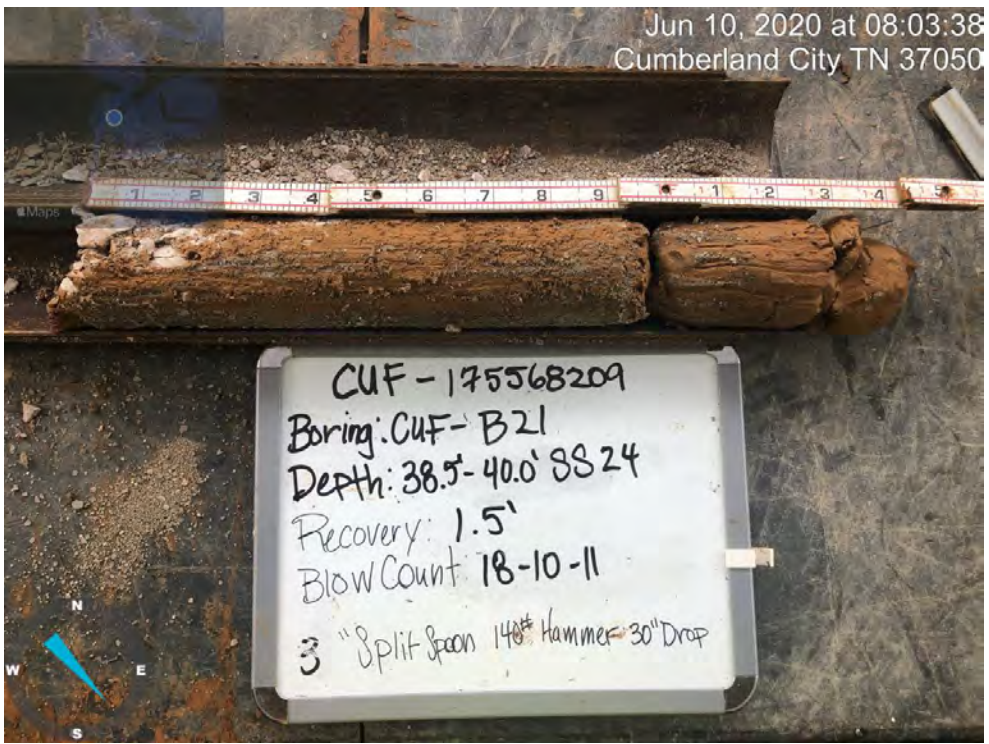
Photograph ID: 136

Photo Location: CUF-B21	
Photo Date: 6/10/2020	
Comments: Interval (38.5-40.0 feet)

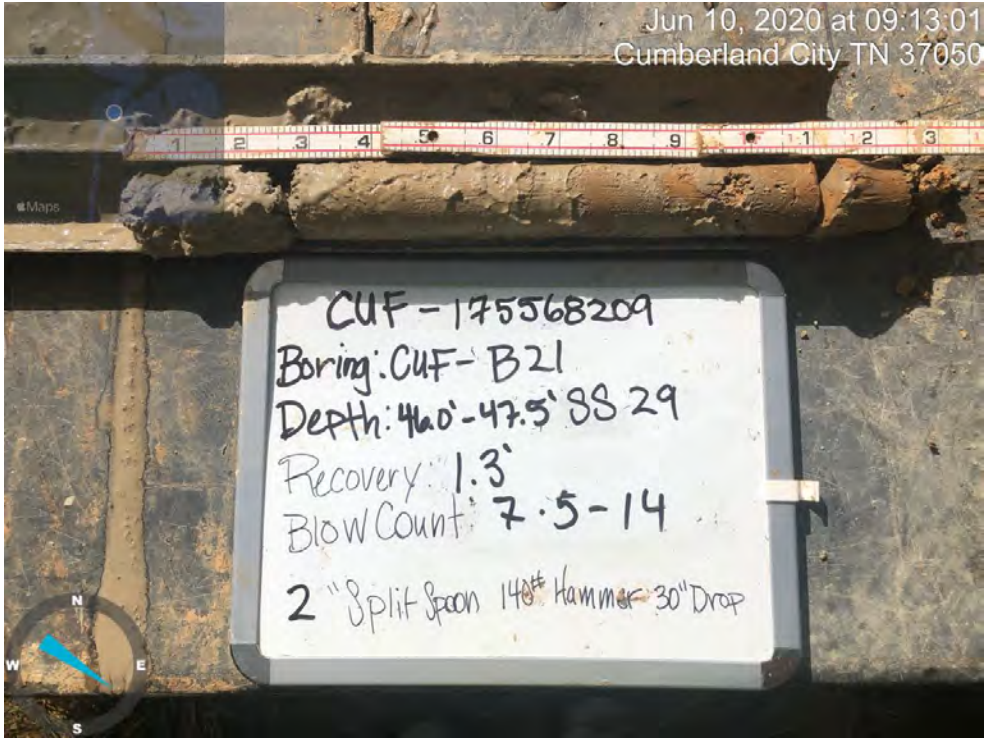
Photograph ID: 141

Photo Location: CUF-B21	
Photo Date: 6/10/2020	
Comments: Interval (46.0-47.5 feet)

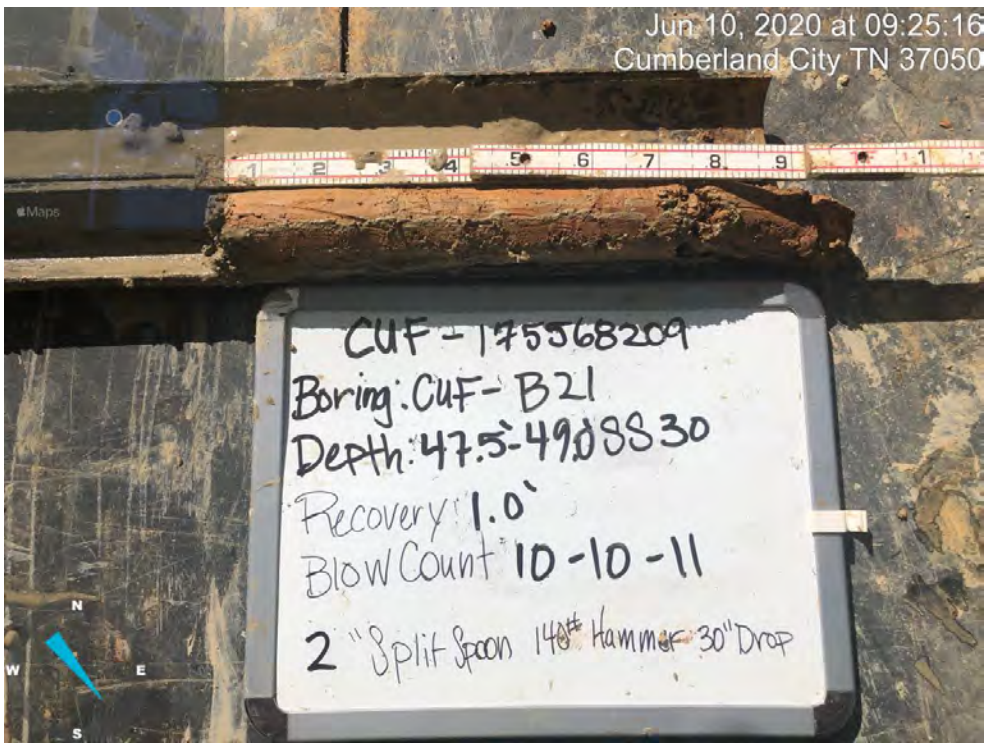
Photograph ID: 142

Photo Location: CUF-B21	
Photo Date: 6/10/2020	
Comments: Interval (47.5-49.0 feet)

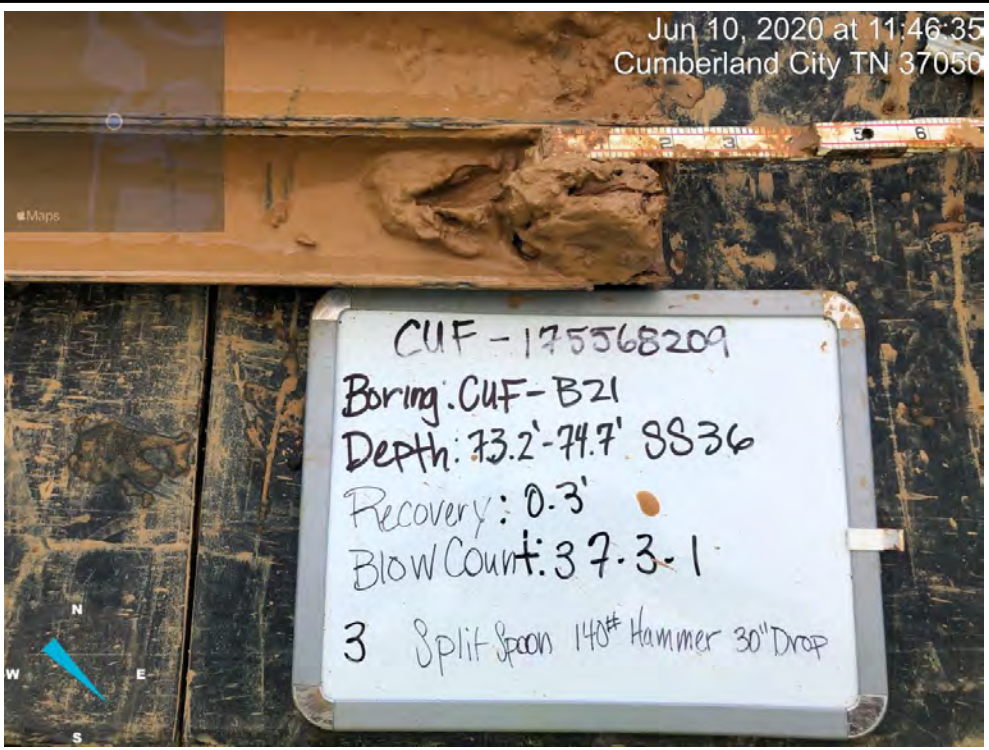
Photograph ID: 148

Photo Location: CUF-B21	
Photo Date: 6/10/2020	
Comments: Interval (73.2-74.7 feet)

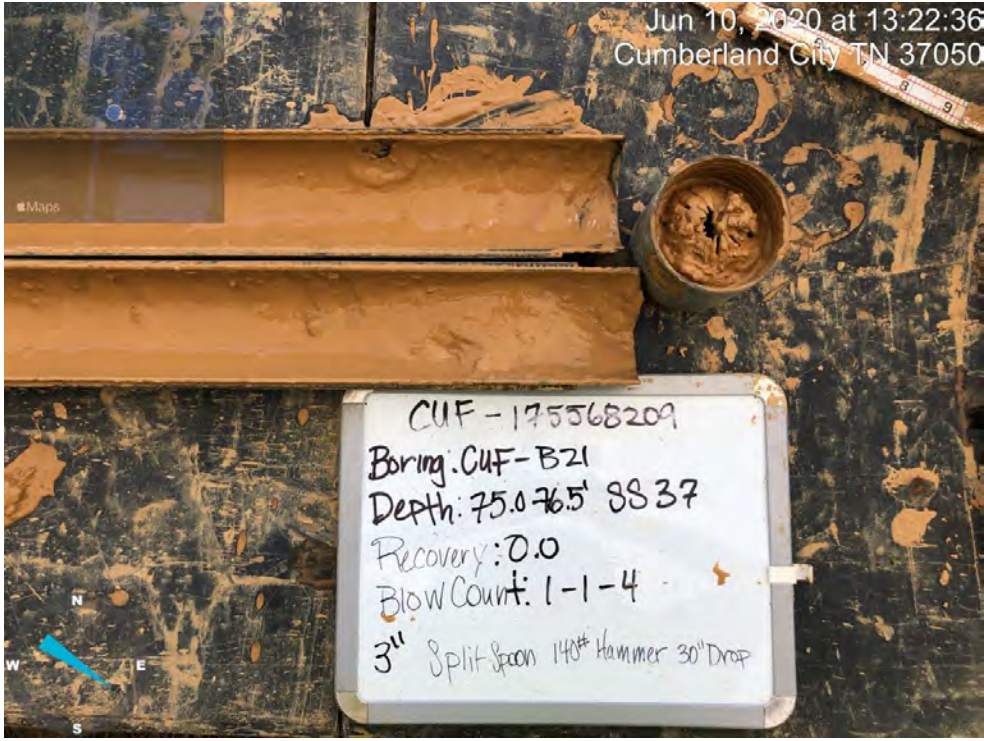
Photograph ID: 149

Photo Location: CUF-B21	
Photo Date: 6/10/2020	
Comments: Interval (75.0-76.5 feet)

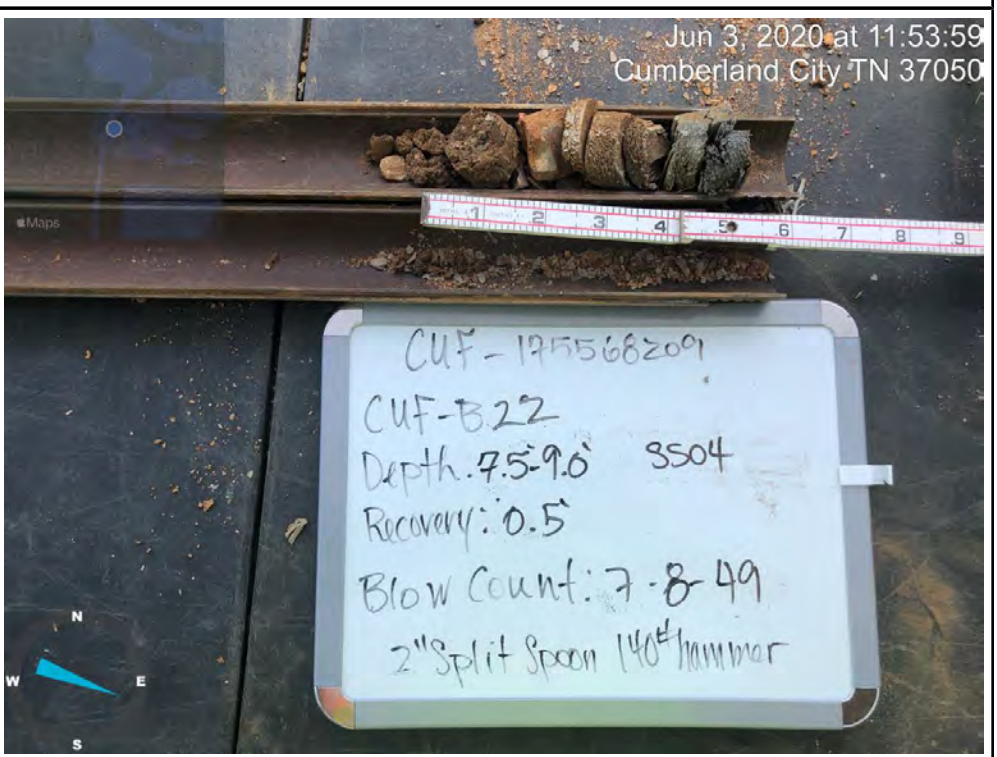
<p>Photograph ID: 154</p> <p>Photo Location: CUF-B22</p> <p>Photo Date: 6/3/2020</p> <p>Comments: Interval (7.5-9.0 feet)</p>

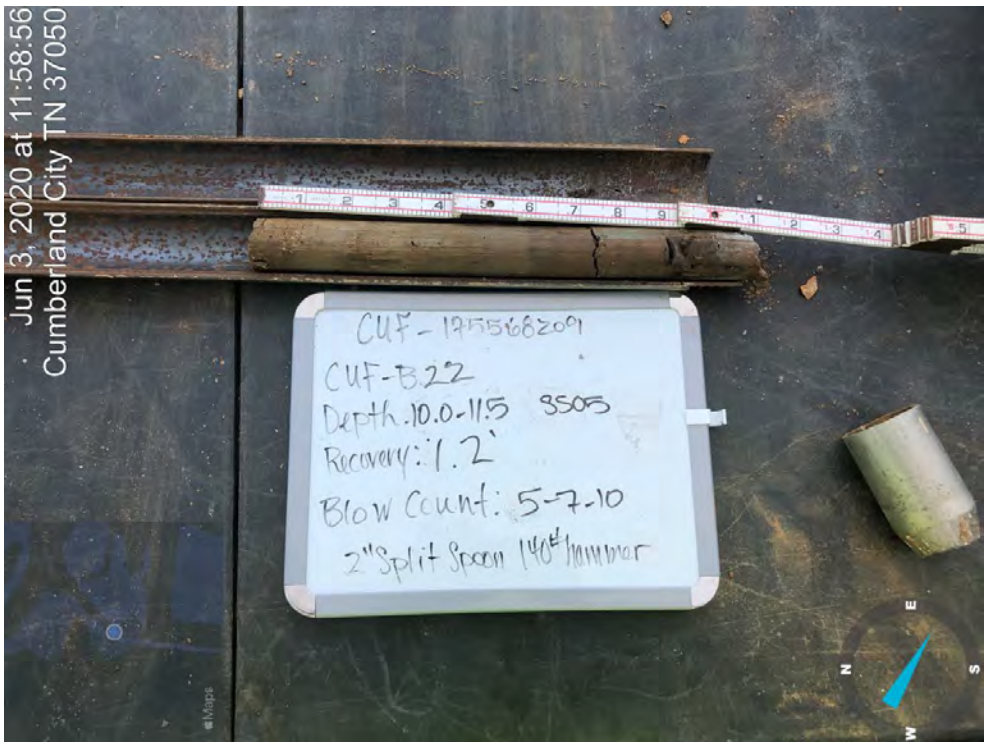
Photograph ID: 155	Jun 3, 2020 at 11:58:56 Cumberland City TN 37050

Photo Location: CUF-B22		
Photo Date: 6/3/2020		
Comments: Interval (10.0-11.5 feet)

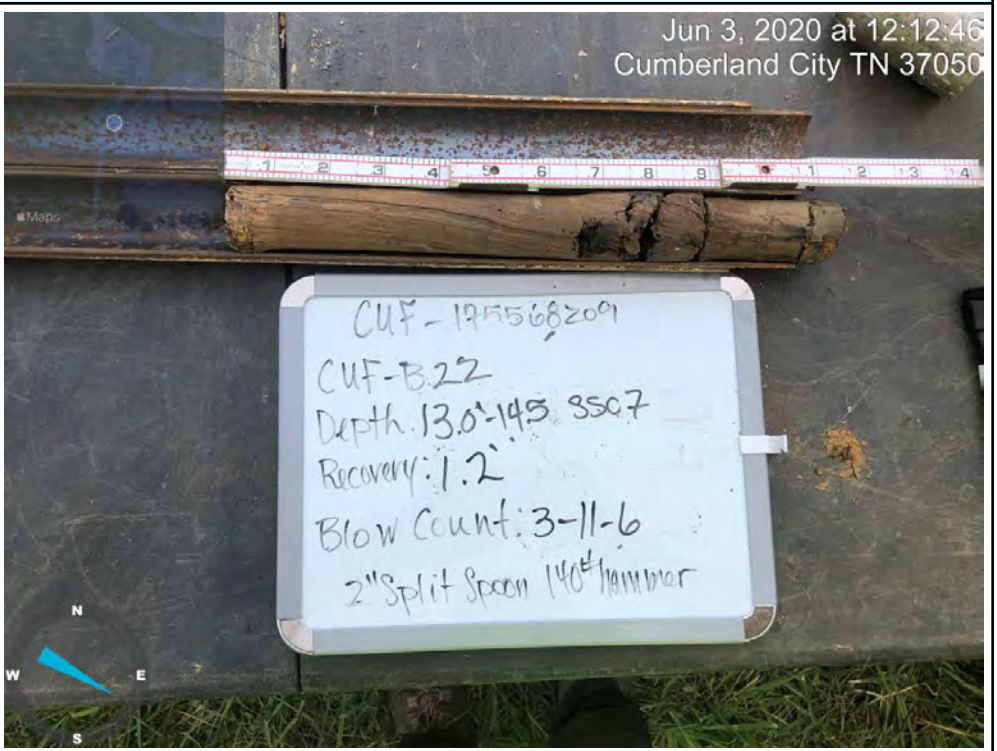
Photograph ID: 157

Photo Location: CUF-B22	
Photo Date: 6/3/2020	
Comments: Interval (13.0-14.5 feet)

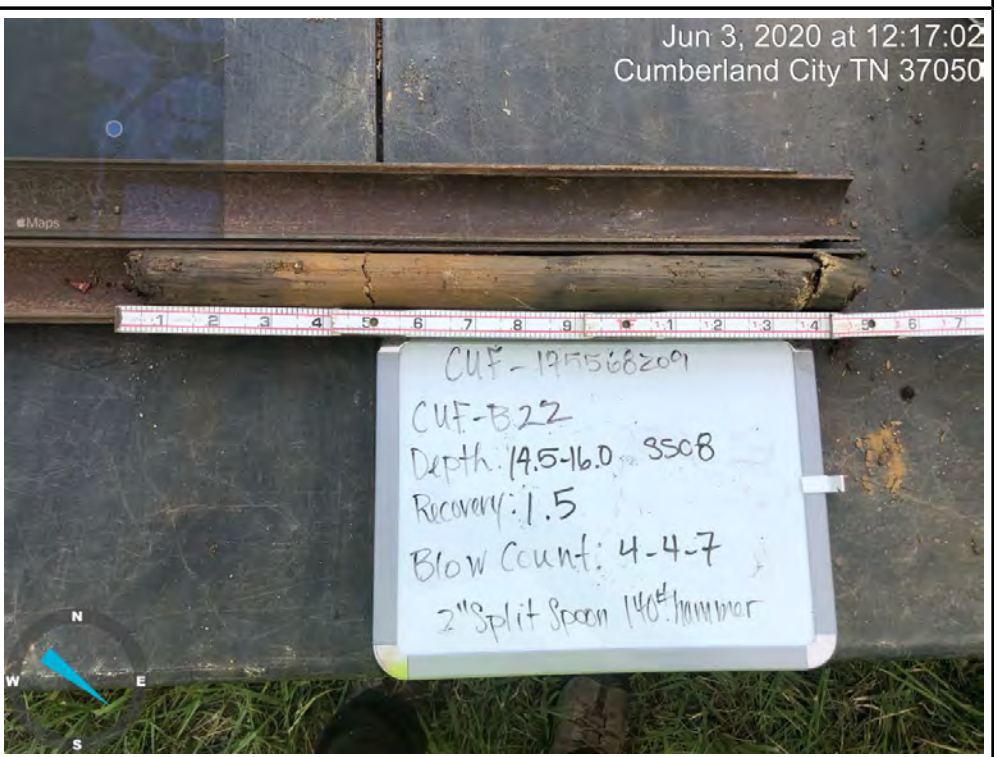
Photograph ID: 158

Photo Location: CUF-B22	
Photo Date: 6/3/2020	
Comments: Interval (14.5-16.0 feet)

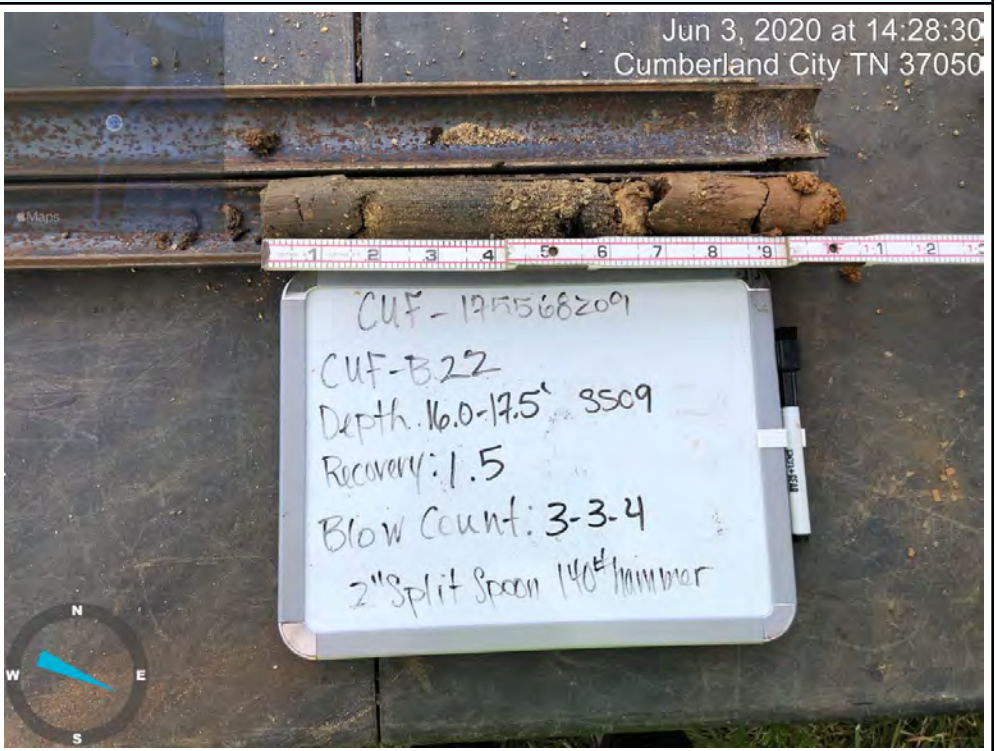
Photograph ID: 159

Photo Location: CUF-B22	
Photo Date: 6/3/2020	
Comments: Interval (16.0-17.5 feet). Recovery on white board should be 1.0'.

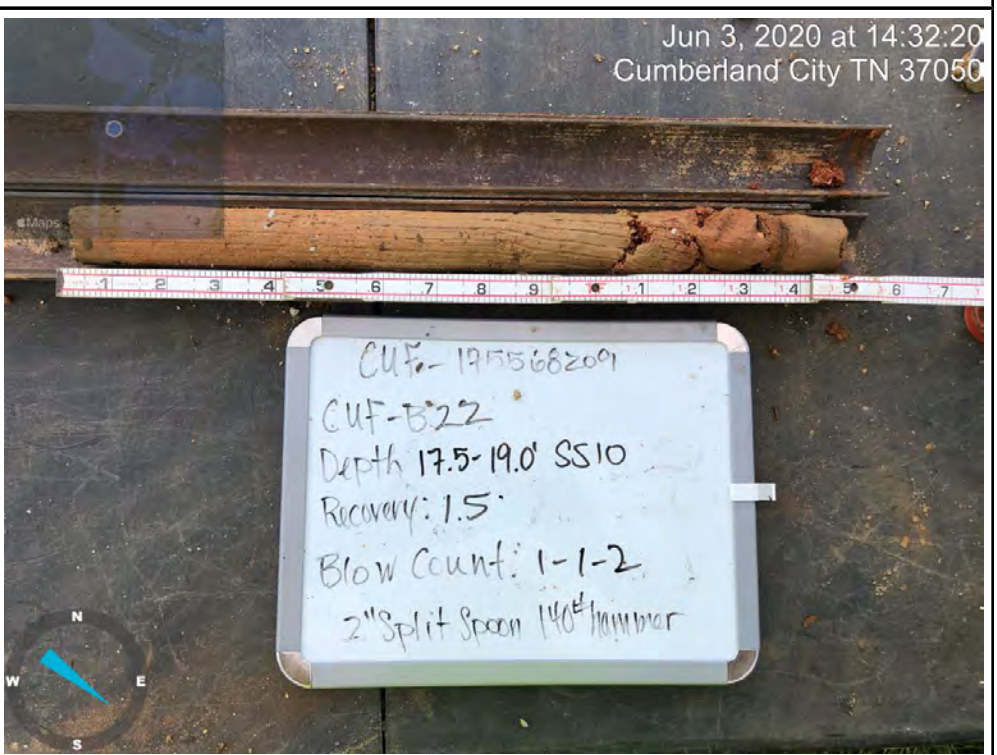
Photograph ID: 160

Photo Location: CUF-B22	
Photo Date: 6/3/2020	
Comments: Interval (17.5-19.0 feet)

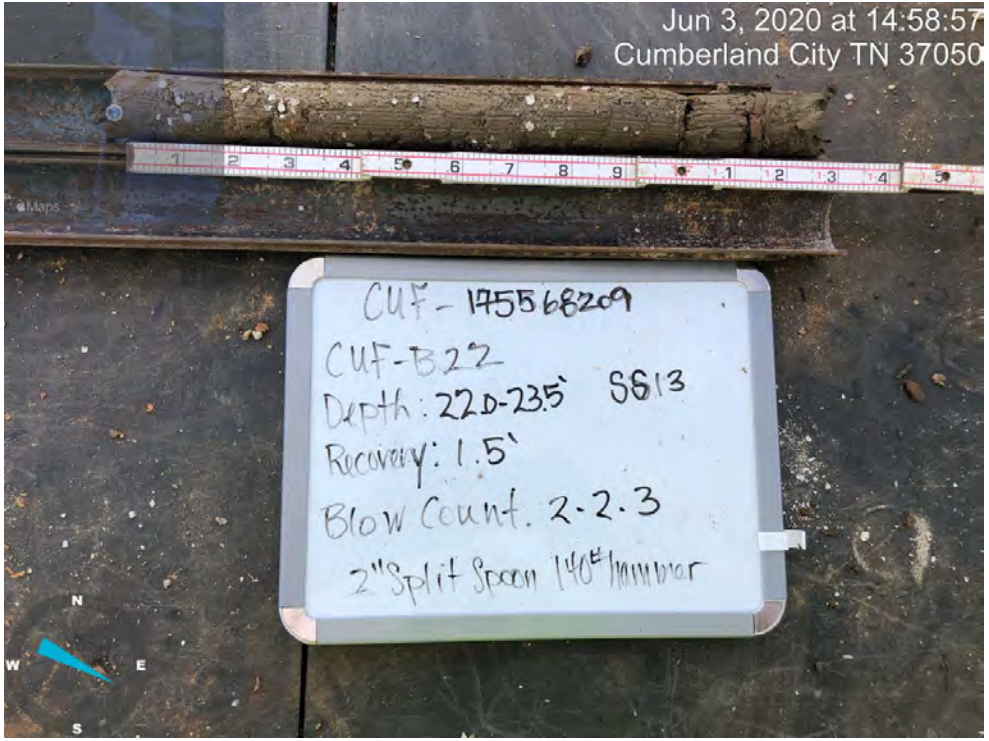
Photograph ID: 163

Photo Location: CUF-B22	
Photo Date: 6/3/2020	
Comments: Interval (22.0-23.5 feet). Recovery on white board should be 1.3'.

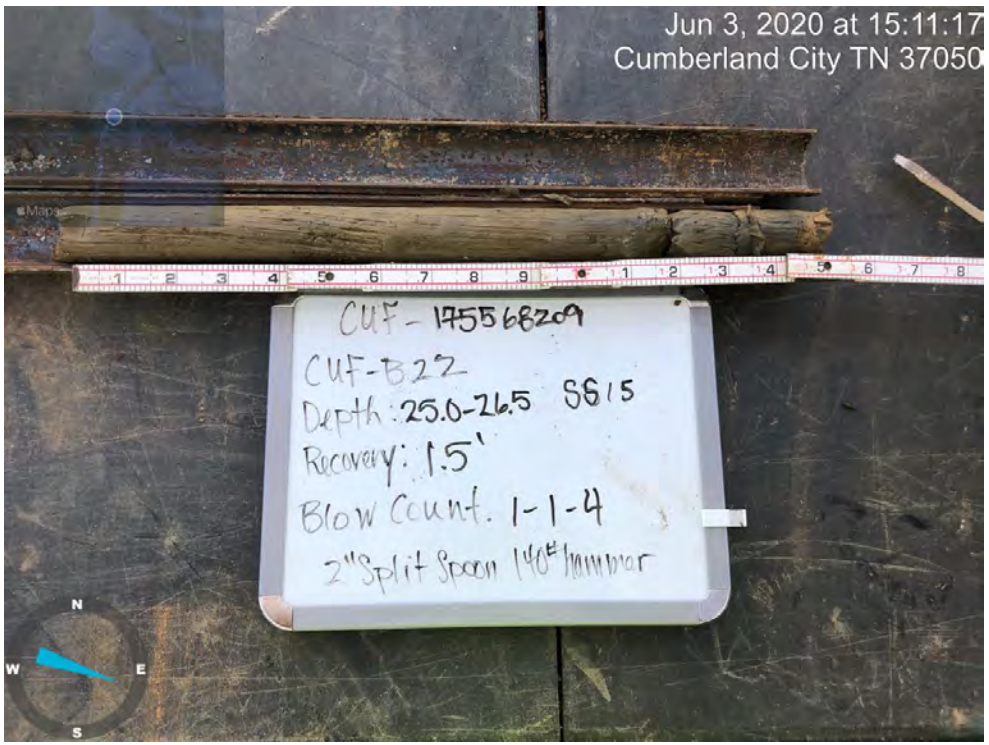
Photograph ID: 165

Photo Location: CUF-B22	
Photo Date: 6/3/2020	
Comments: Interval (25.0-26.5 feet)

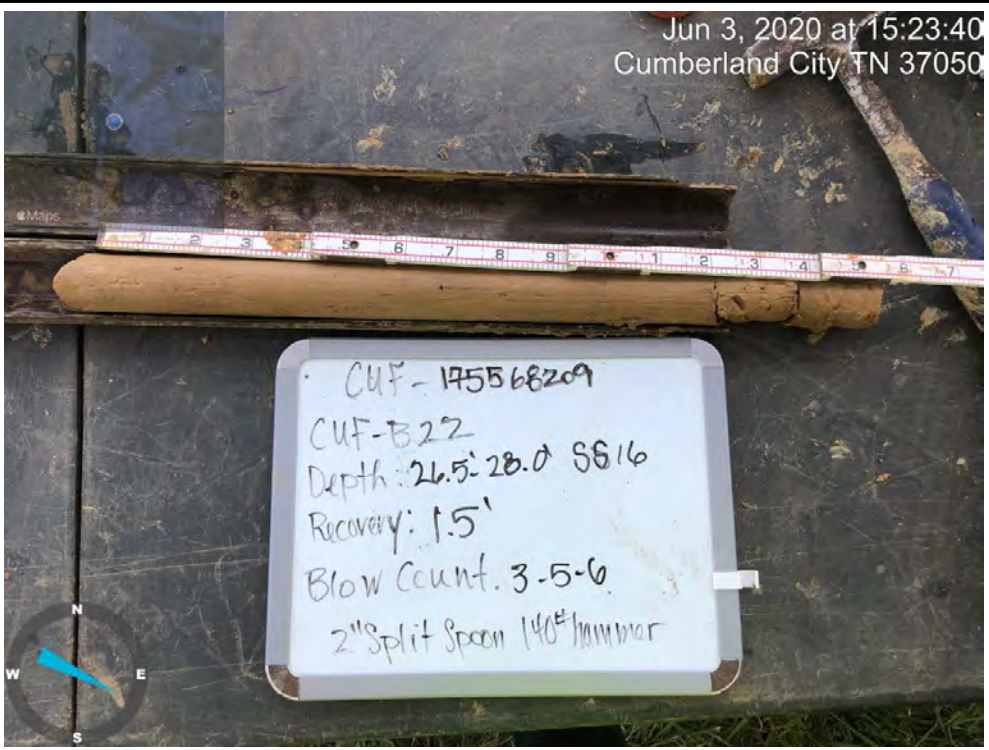
Photograph ID: 166

Photo Location: CUF-B22	
Photo Date: 6/3/2020	
Comments: Interval (26.5-28.0 feet)

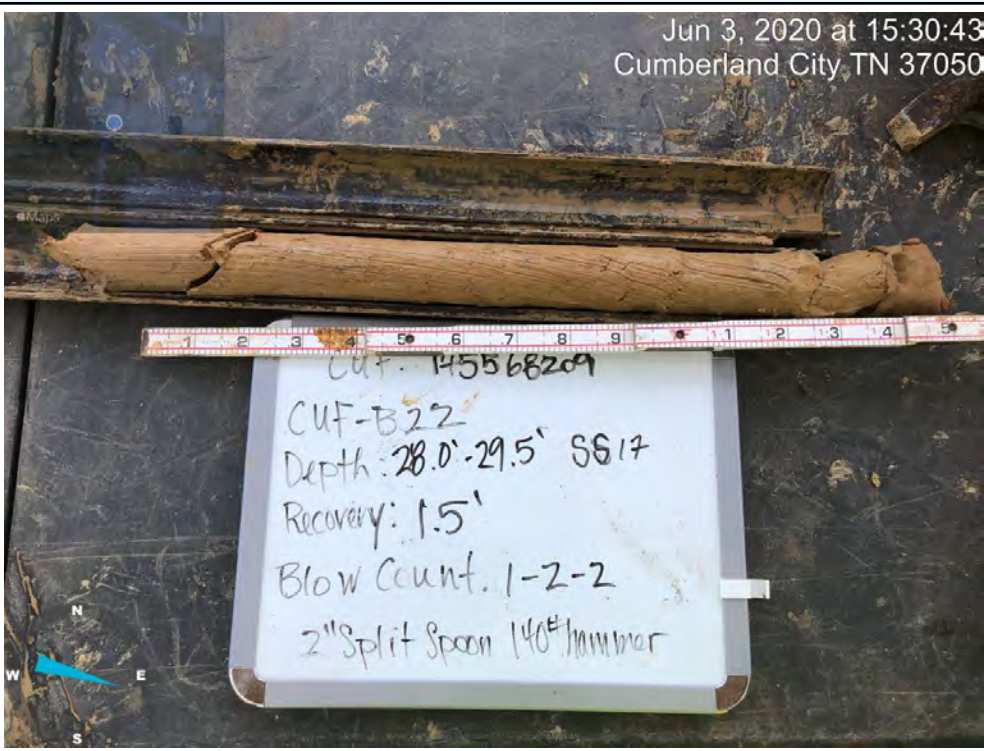
Photograph ID: 167

<p>Jun 3, 2020 at 15:30:43 Cumberland City TN 37050</p> <p>CUF. 145568209 CUF-B22 Depth: 28.0'-29.5' SS17 Recovery: 1.5' Blow Count. 1-2-2 2" Split Spoon 140# Hammer</p>
Photo Location: CUF-B22	
Photo Date: 6/3/2020	
Comments: Interval (28.0-29.5 feet)

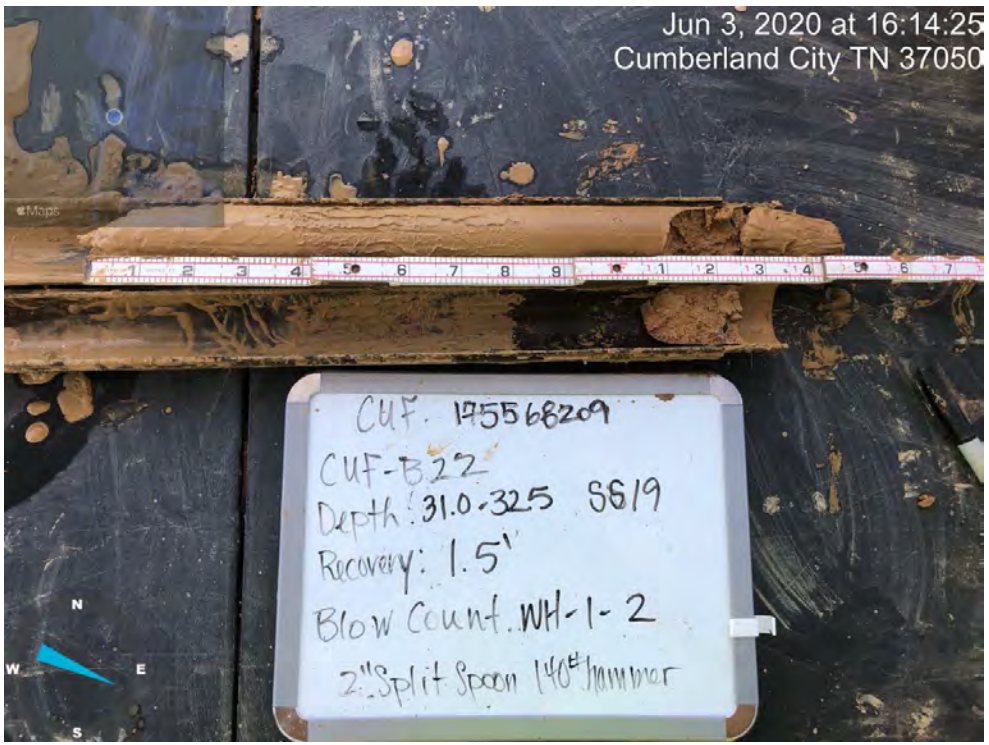
Photograph ID: 169

Photo Location: CUF-B22	
Photo Date: 6/3/2020	
Comments: Interval (31.0-32.5 feet)

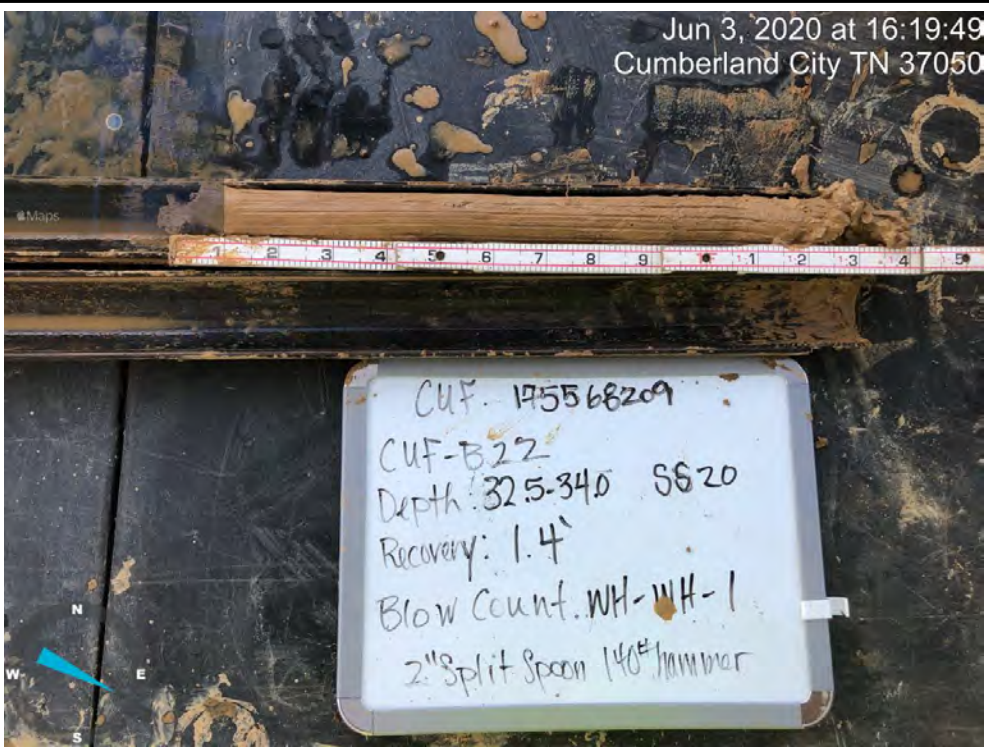
Photograph ID: 170

Photo Location: CUF-B22	
Photo Date: 6/3/2020	
Comments: Interval (32.5-34.0 feet)

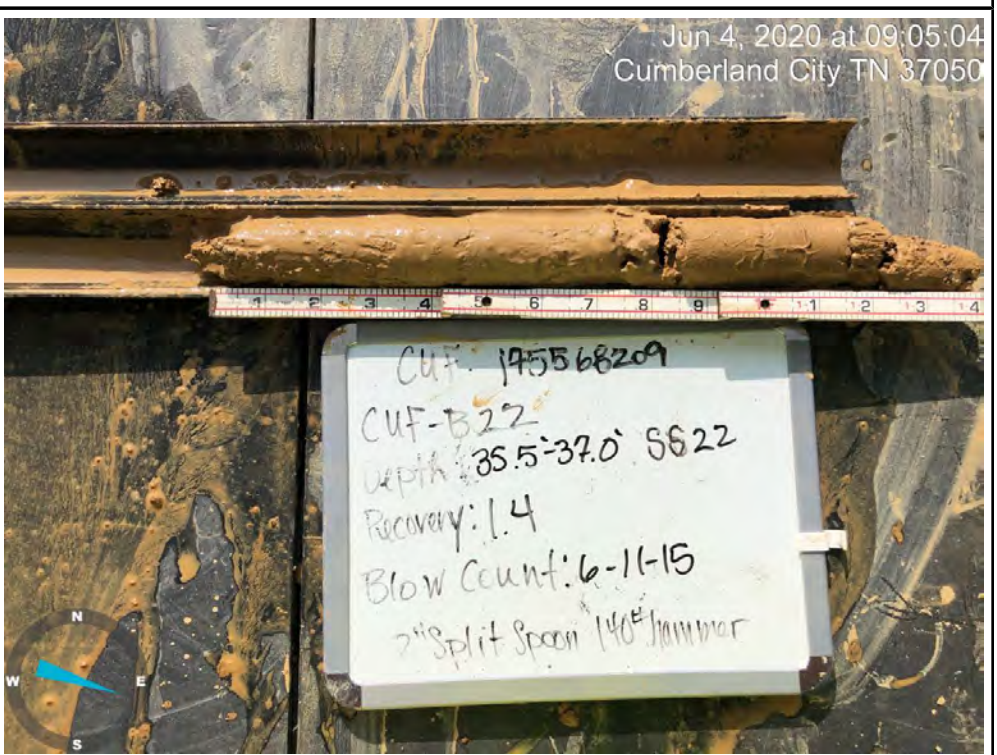
Photograph ID: 172

Photo Location: CUF-B22	
Photo Date: 6/4/2020	
Comments: Interval (35.5-37.0 feet)

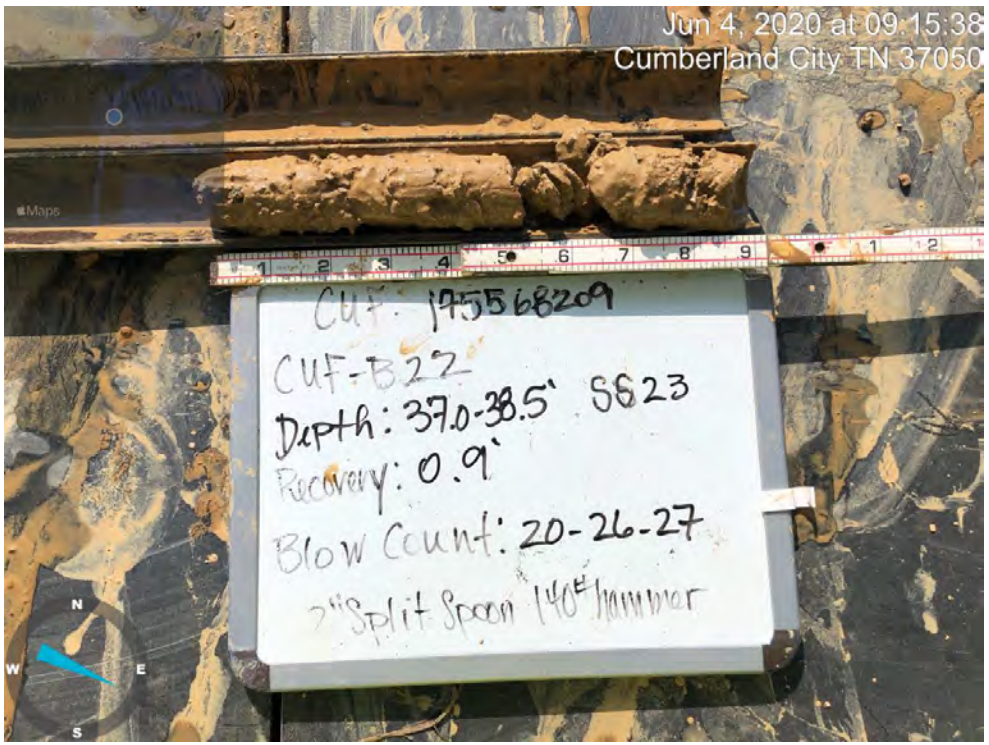
Photograph ID: 173

Photo Location: CUF-B22	
Photo Date: 6/4/2020	
Comments: Interval (37.0-38.5 feet)

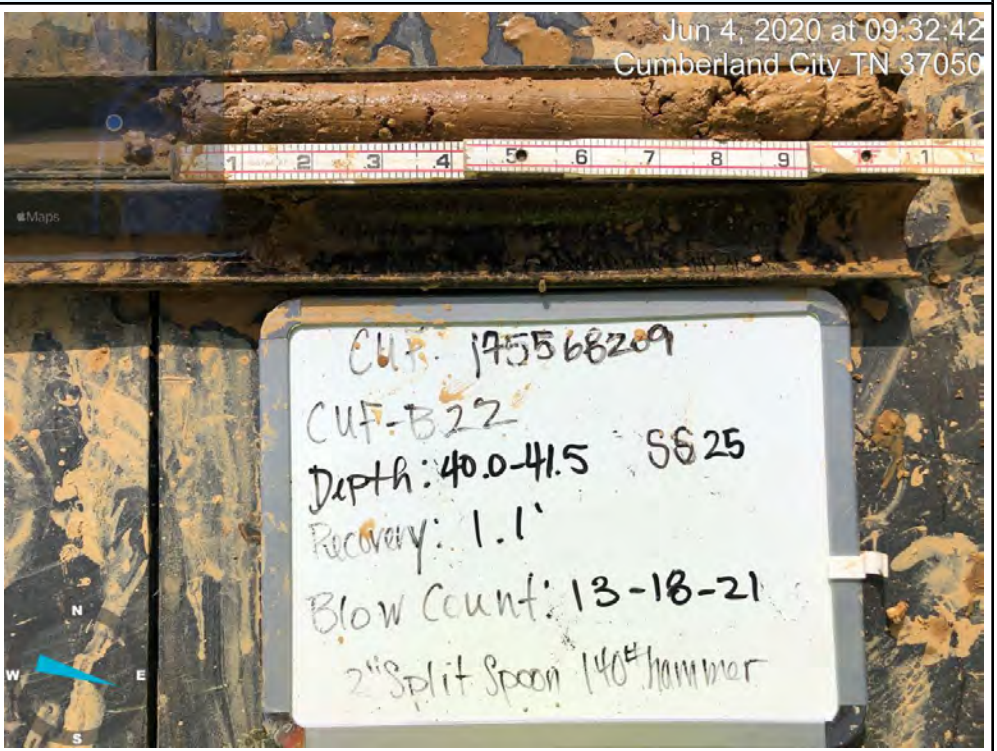
Photograph ID: 175

Photo Location: CUF-B22	
Photo Date: 6/4/2020	
Comments: Interval (40.0-41.5 feet)

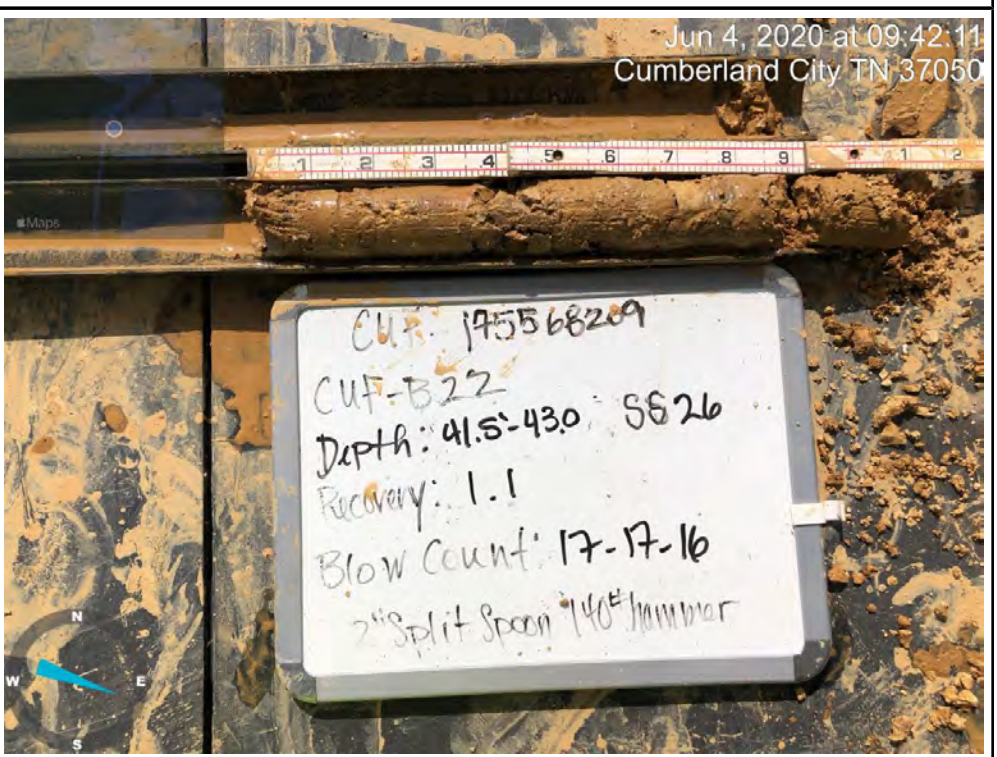
Photograph ID: 176

Photo Location: CUF-B22	
Photo Date: 6/4/2020	
Comments: Interval (41.5-43.0 feet)
