**APPENDIX G –
CCR MATERIAL INVESTIGATIONS**

**Appendix G.1 - Technical
Evaluation of Geotechnical and
CCR Material Characteristics Data**

TDEC Commissioner's Order:
Environmental Assessment Report
Cumberland Fossil Plant
Cumberland, Tennessee

Stantec Consulting Services Inc.
Lexington, Kentucky

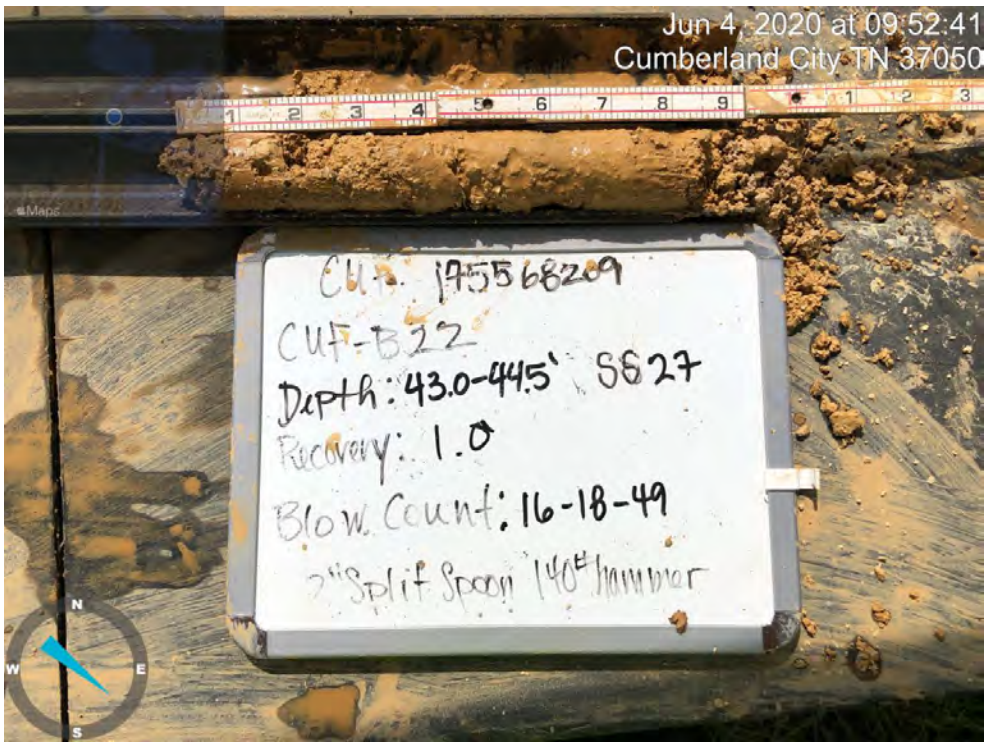
Photograph ID: 177

Photo Location: CUF-B22	
Photo Date: 6/4/2020	
Comments: Interval (43.0-44.5 feet)

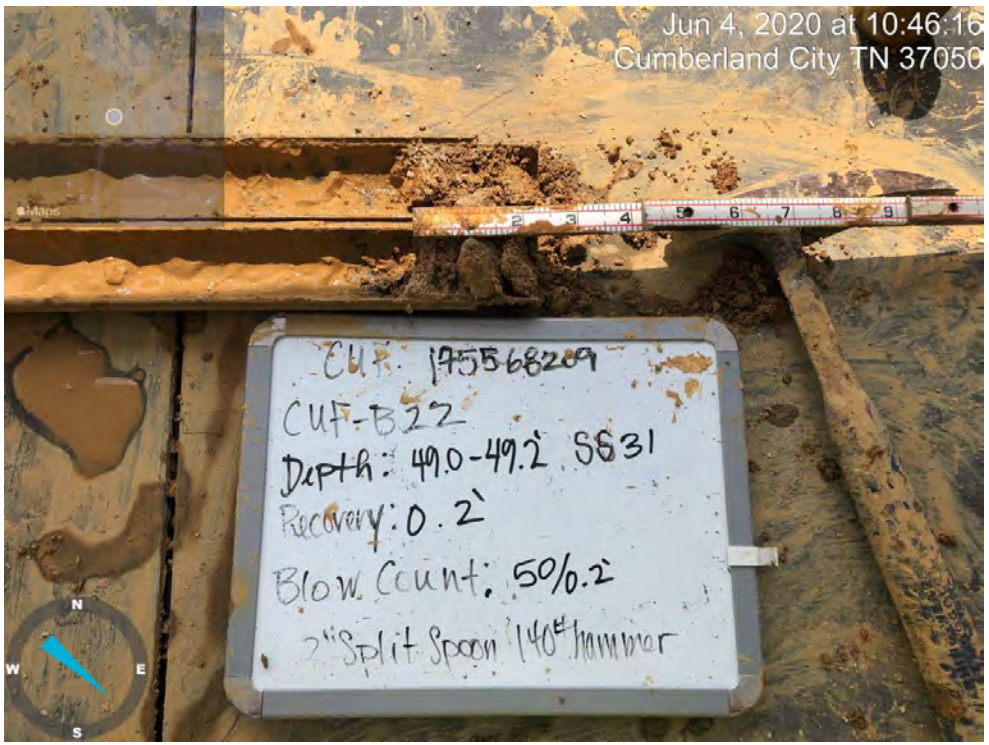
Photograph ID: 181

Photo Location: CUF-B22	
Photo Date: 6/4/2020	
Comments: Interval (49.0-49.2 feet)

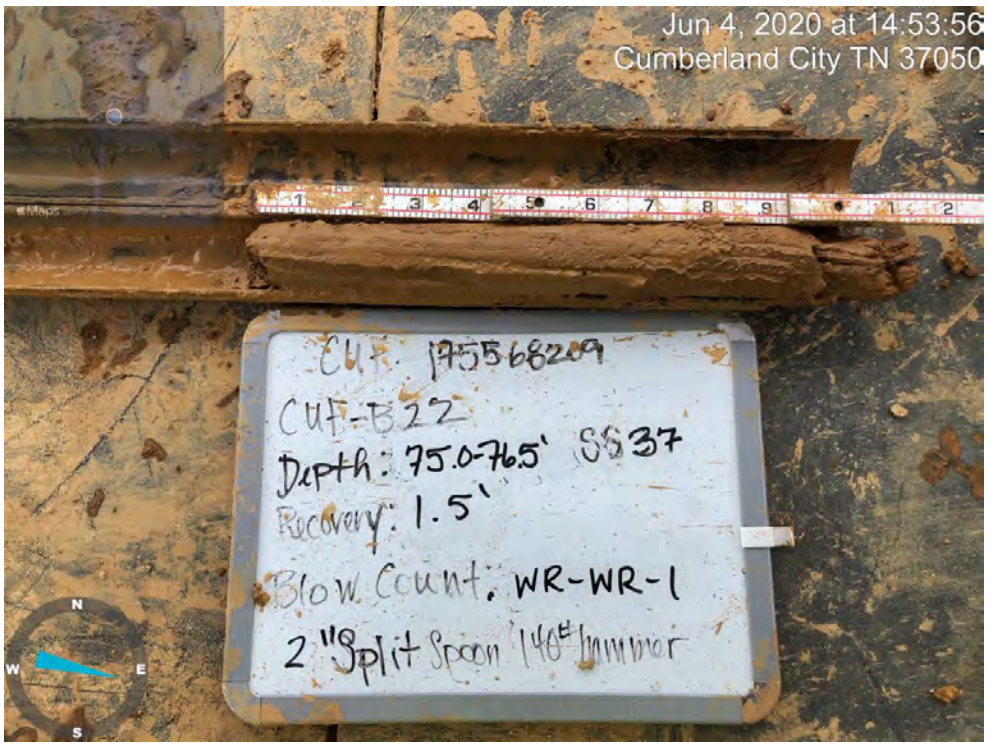
Photograph ID: 187

Photo Location: CUF-B22	
Photo Date: 6/4/2020	
Comments: Interval (75.0-76.5 feet)

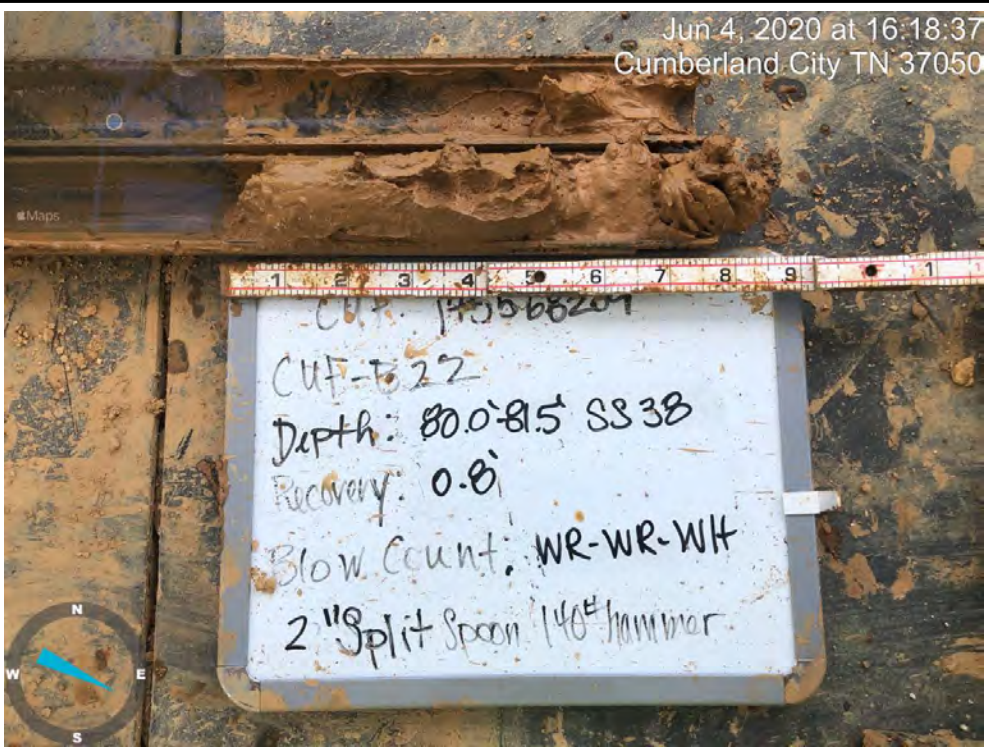
Photograph ID: 188

Photo Location: CUF-B22	
Photo Date: 6/4/2020	
Comments: Interval (80.0-81.5 feet)

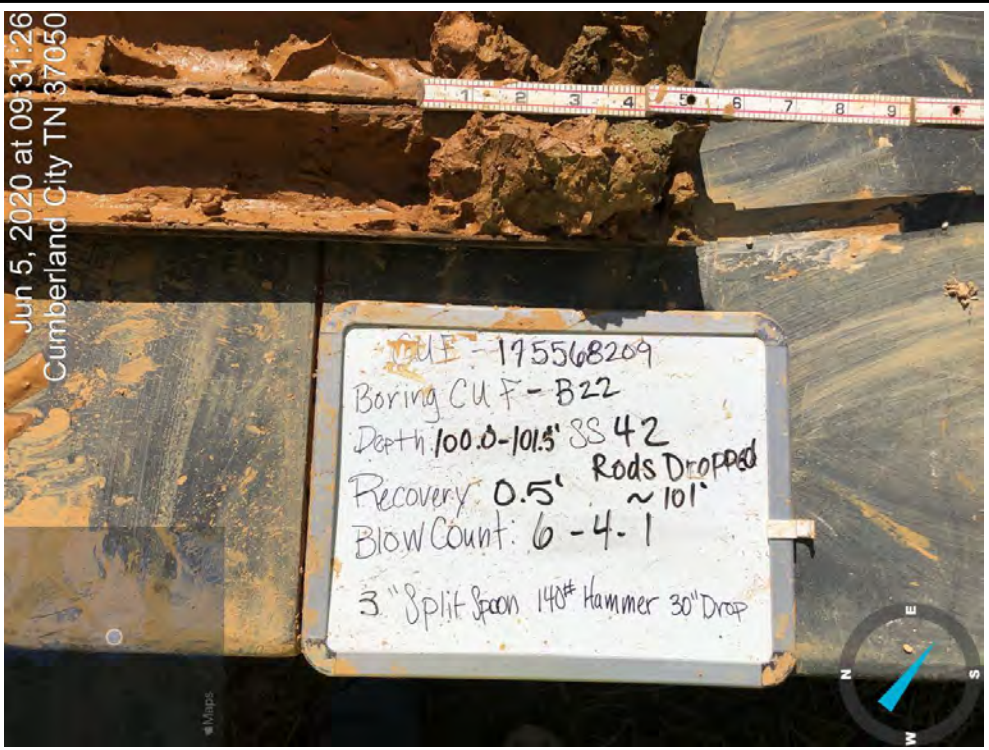
Photograph ID: 192

Photo Location: CUF-B22	
Photo Date: 6/5/2020	
Comments: Interval (100.0-101.5 feet)

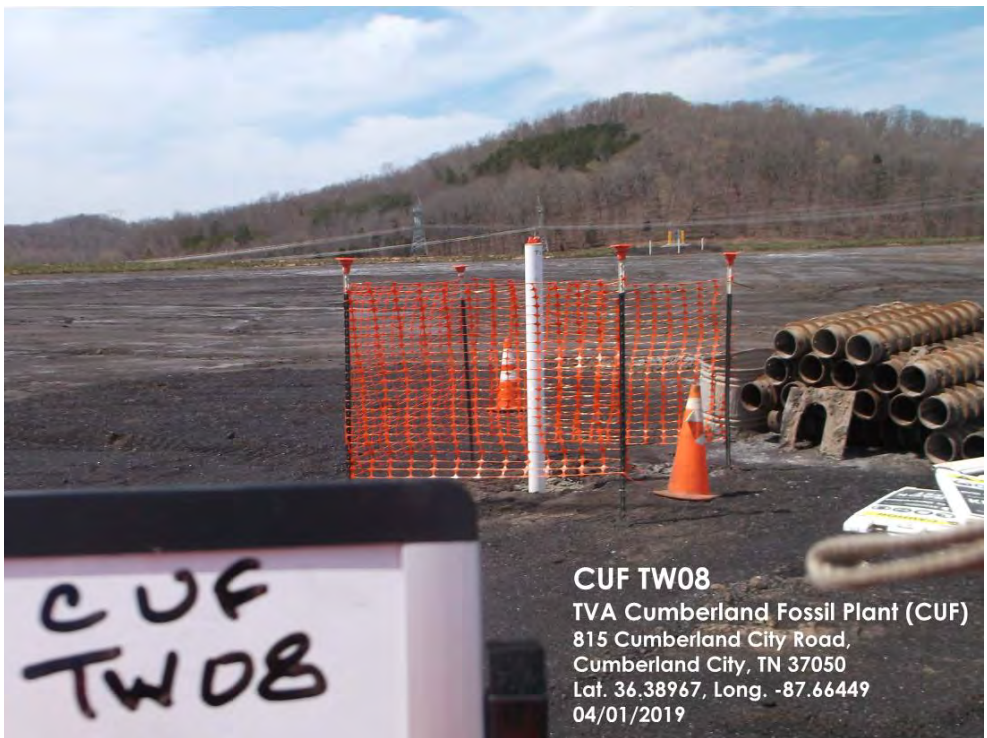
<p>Client: Tennessee Valley Authority</p> <p>Site Name: Cumberland Fossil (CUF) Plant</p>	<p>Project: CUF TDEC Order</p> <p>Site Location: Cumberland City, Tennessee</p>
<p>Photograph ID: 5</p> <p>Photo Location: CUF-TW08</p> <p>Photo Date: 04/01/2019</p> <p>Comments: Surface protection at CUF-TW08, looking west.</p>

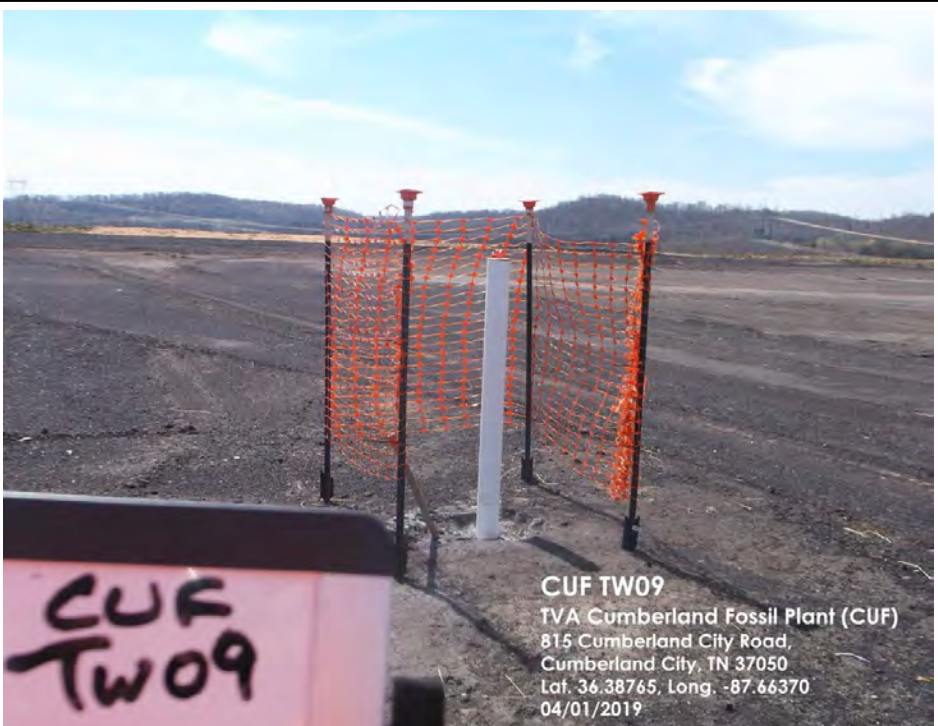
<p>CUF TW08 TVA Cumberland Fossil Plant (CUF) 815 Cumberland City Road, Cumberland City, TN 37050 Lat. 36.38967, Long. -87.66449 04/01/2019</p>
<p>Photograph ID: 6</p> <p>Photo Location: CUF-TW09</p> <p>Photo Date: 04/01/2019</p> <p>Comments: Surface protection at CUF-TW09, looking west.</p>

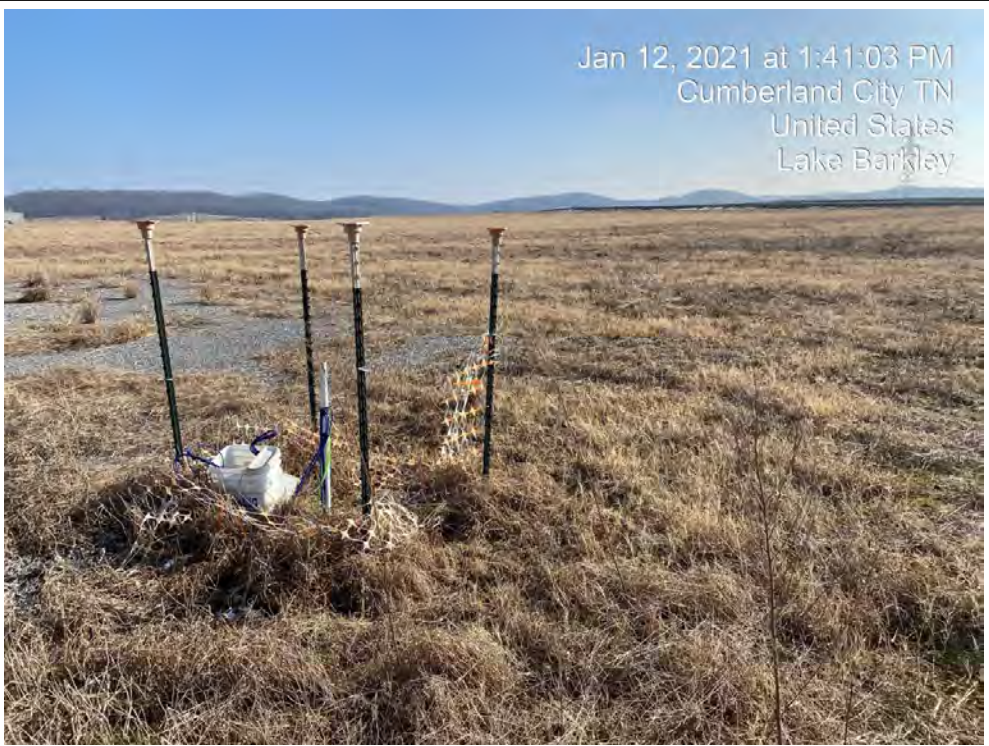
Photograph ID: 8

Photo Location: CUF-B15	
Photo Date: 1/12/2021	
Comments: Typical surface protection for the VWPZ installation at CUF-B15, looking south.

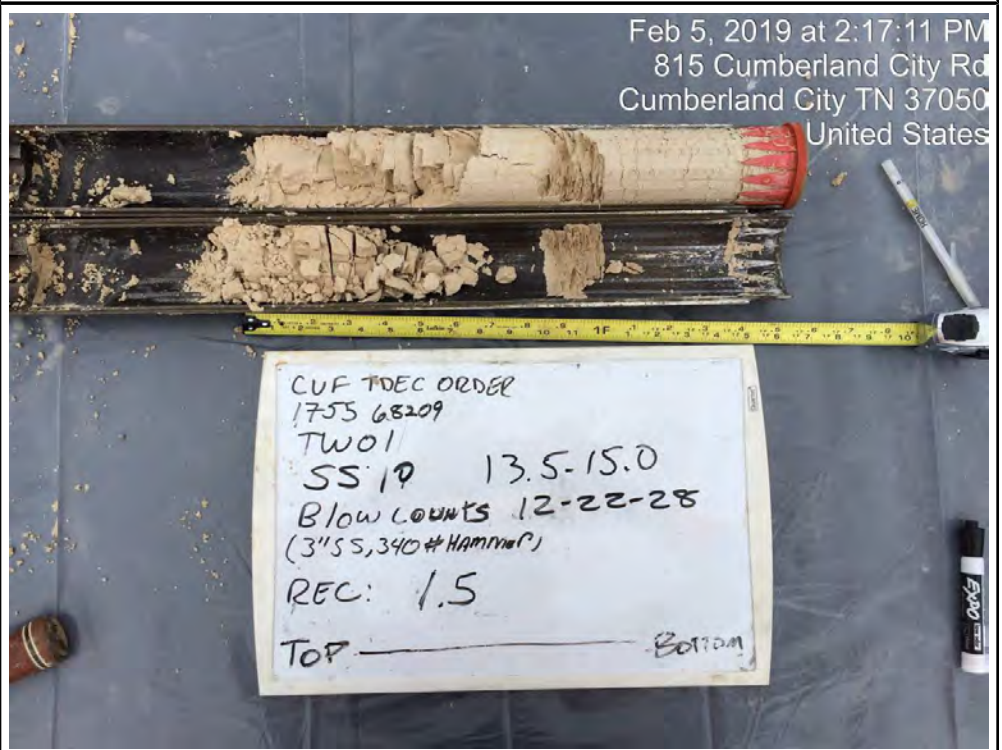
Comments:
Interval (13.5-15.0 feet).

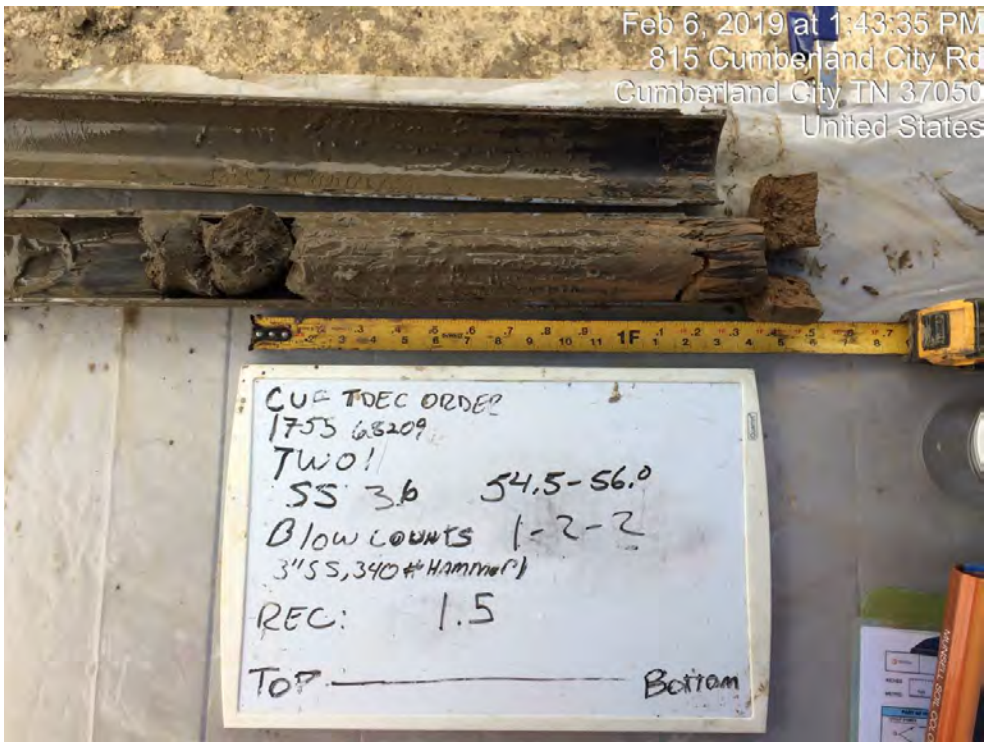
<p style="text-align: right;">Feb 6, 2019 at 1:43:35 PM 815 Cumberland City Rd Cumberland City TN 37050 United States</p>
Photo Location: CUF-TW01	
Photo Date: 2/6/2019	
Comments: Interval (54.5-56.0 feet).

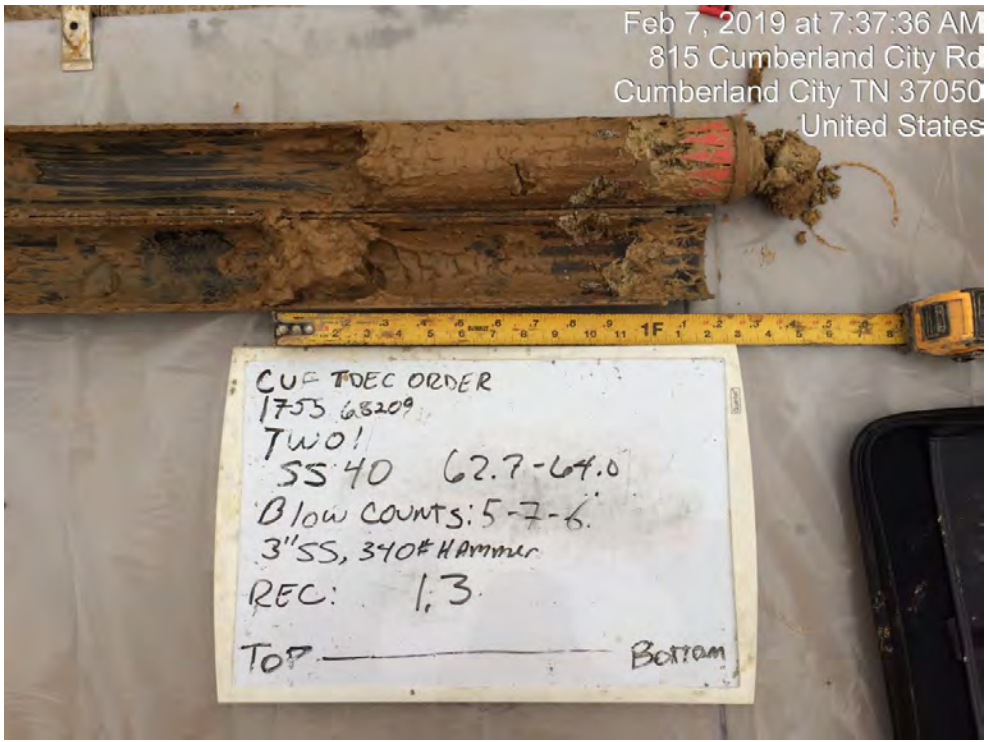
Photograph ID: 44

Photo Location: CUF-TW01	
Photo Date: 2/7/2019	
Comments: Interval (62.7-64.0 feet).

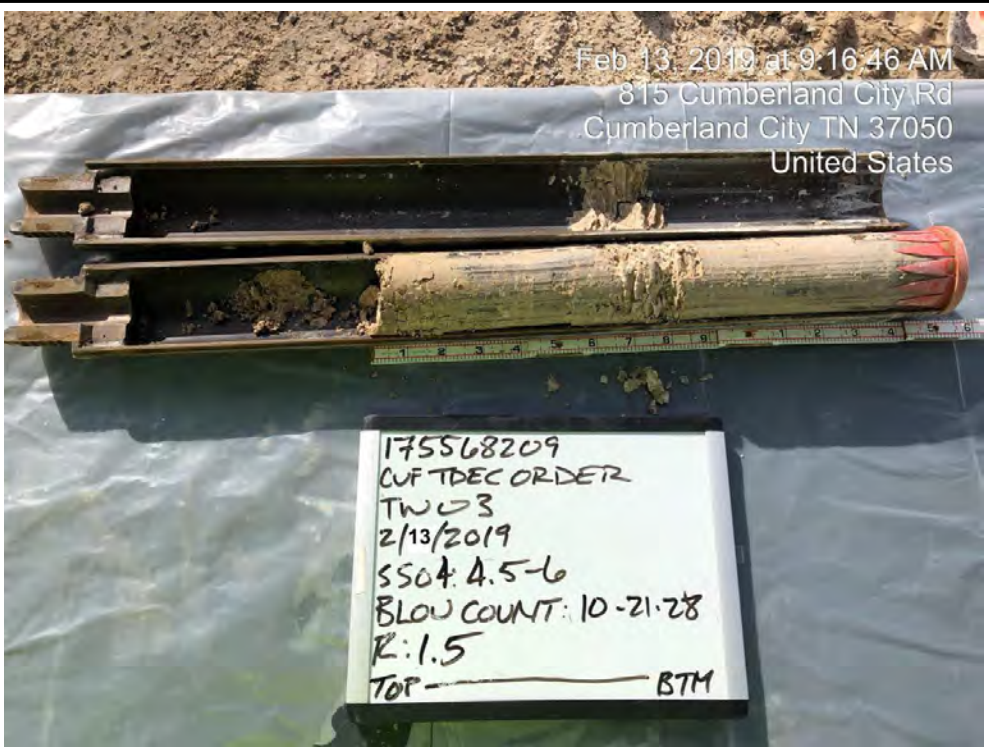
Photograph ID: 70

Photo Location: CUF-TW03	
Photo Date: 2/13/2019	
Comments: Interval (4.5-6.0 feet). Depth interval shown on white board should be 4.5-6.0.

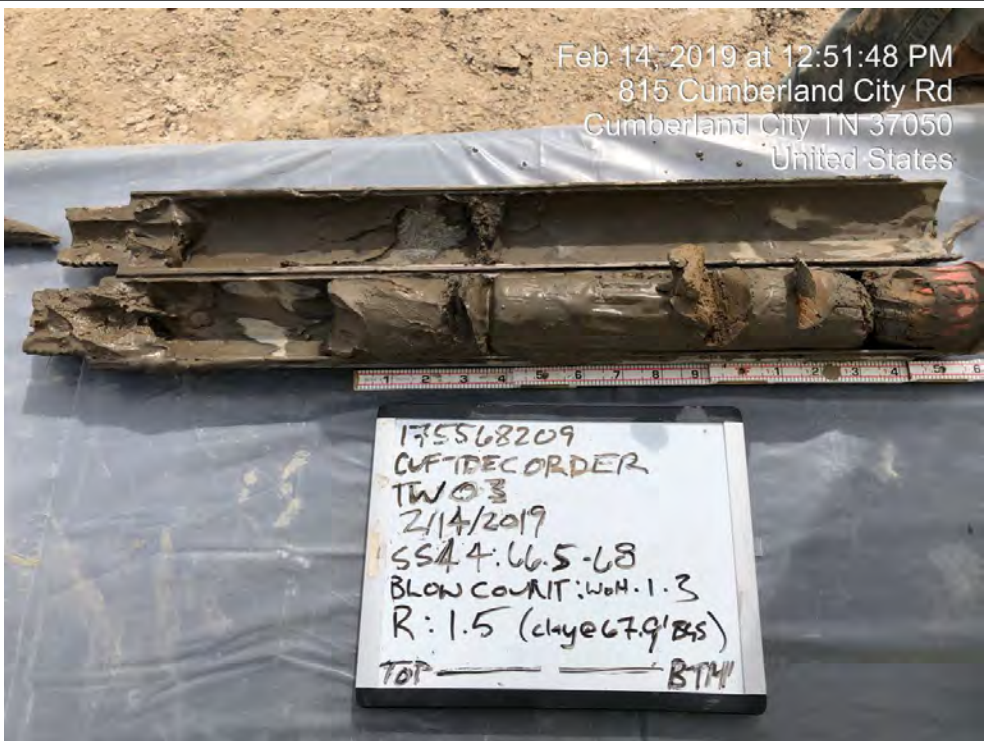
Photograph ID: 111

Photo Location: CUF-TW03	
Photo Date: 2/14/2019	
Comments: Interval (66.5-68.0 feet). Depth interval shown on white board should be 66.5-68.0. WOH on white board is the same as WH on the boring log.

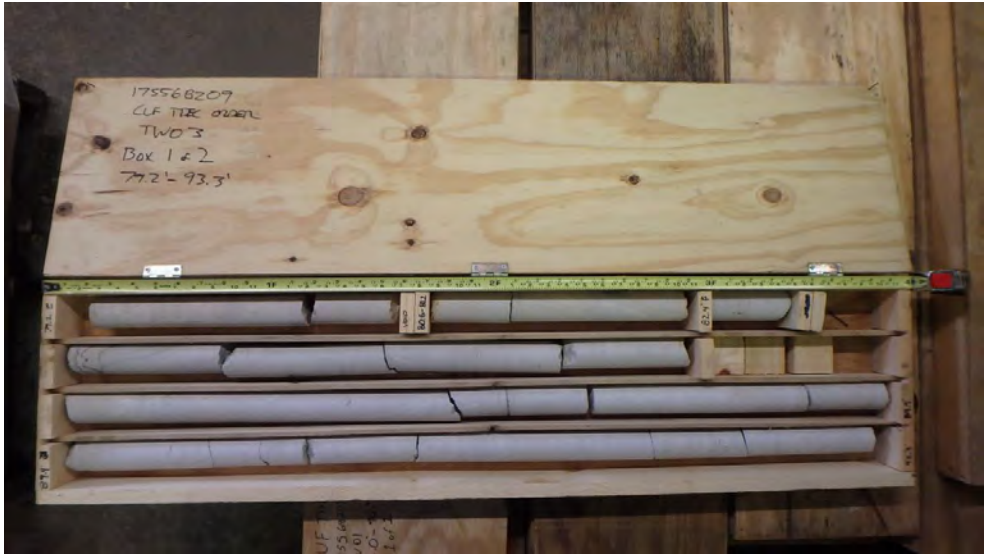
Photo Location: CUF-TW03			
Photo Date: 2/18/2019			
Comments: Interval (79.2-93.3 feet).			
Photograph ID: 118

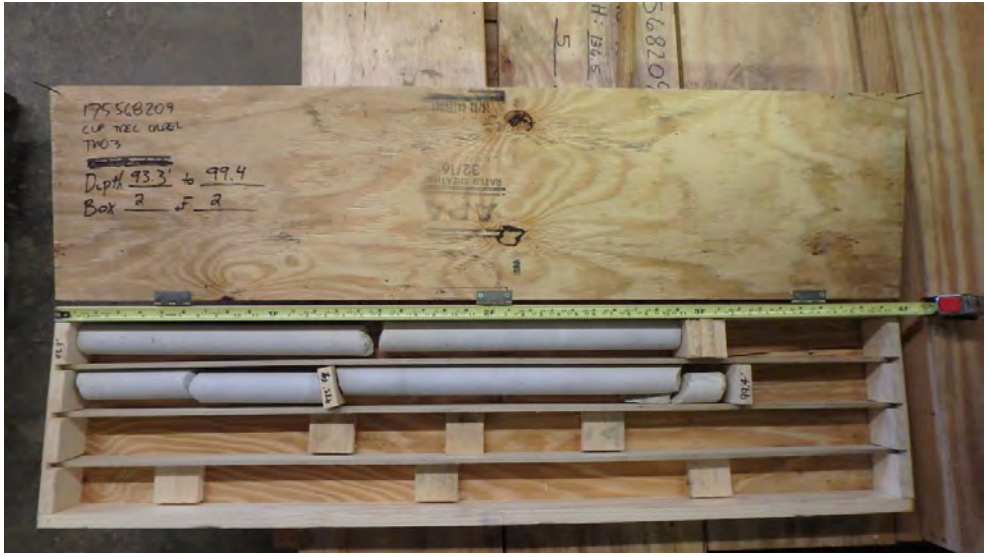
Photo Location: CUF-TW03			
Photo Date: 2/19/2019			
Comments: Interval (93.3-99.4 feet).

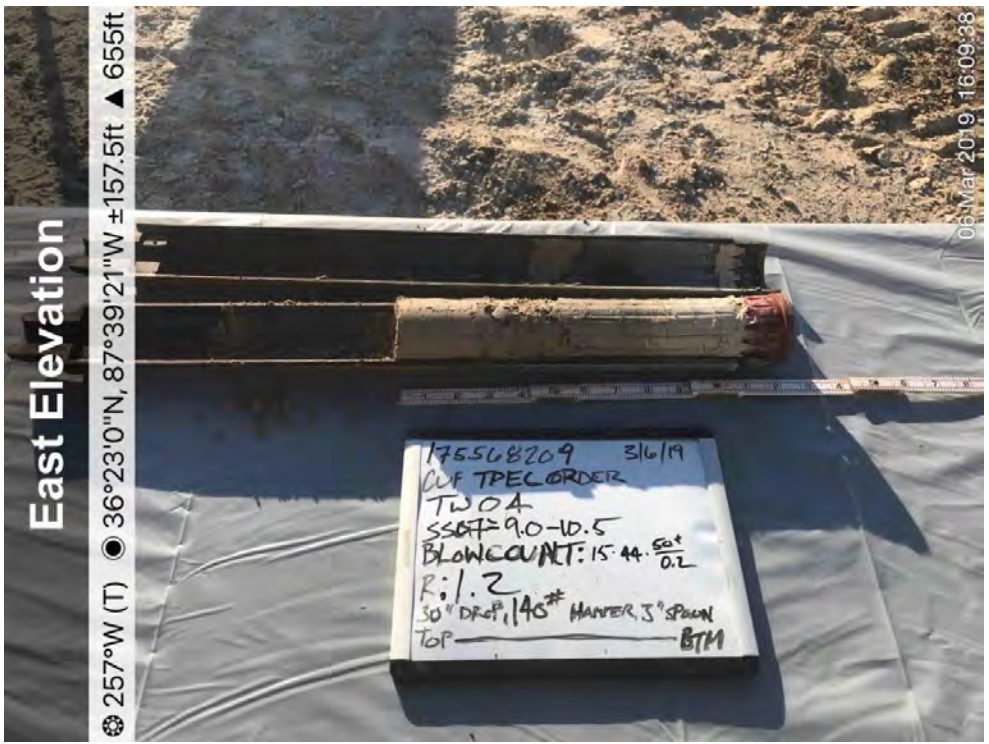
Photo Location: CUF-TW04	
Photo Date: 3/6/2019	
Comments: Interval (9.0-10.2 feet). Depth interval shown on white board should be 9.0-10.2.	
Photograph ID: 126

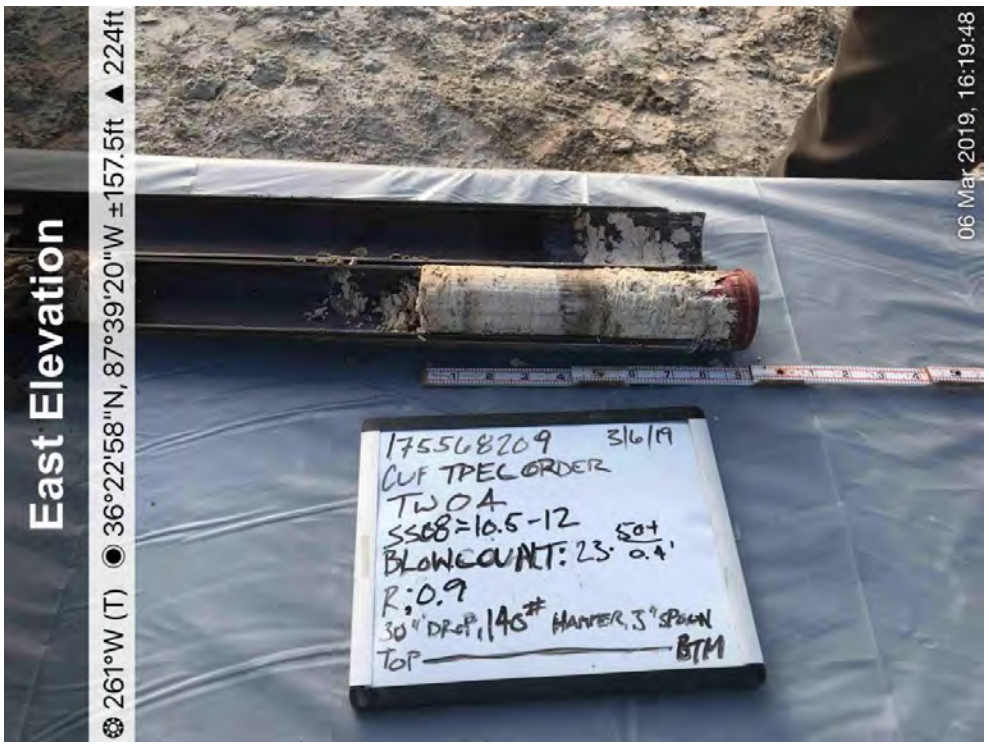
Photo Location: CUF-TW04	
Photo Date: 3/6/2019	
Comments: Interval (10.5-11.4 feet). Depth interval shown on white board should be 10.5-11.4.

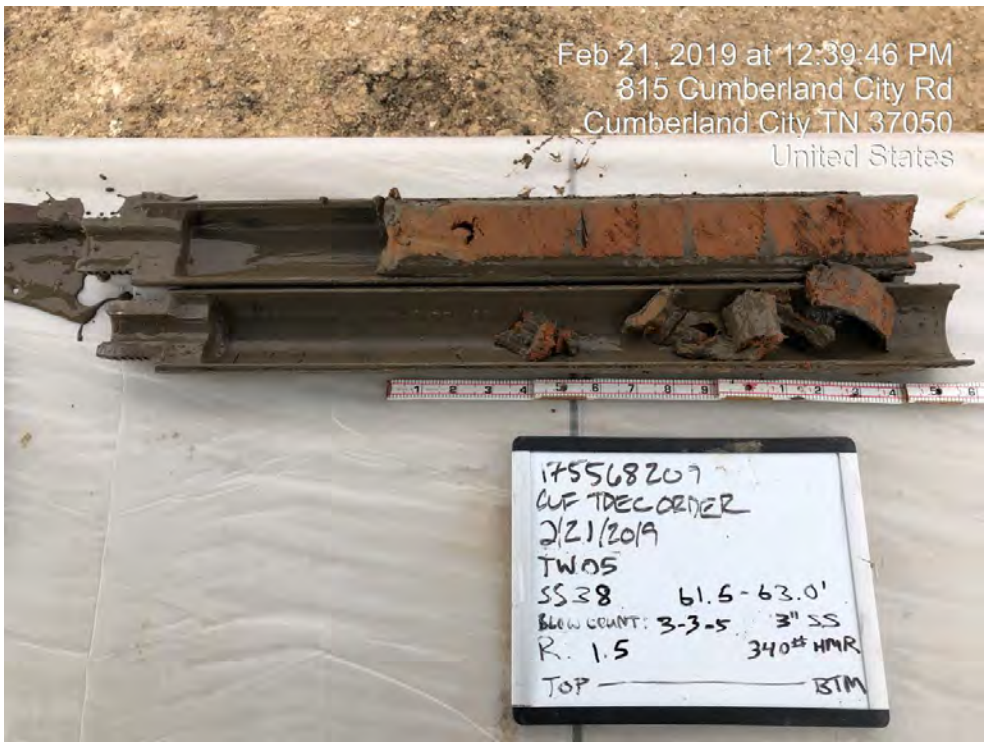
Photograph ID: 178	Feb 21, 2019 at 1:03:53 PM 815 Cumberland City Rd Cumberland City TN 37050 United States
Photo Location: CUF-TW05	
Photo Date: 2/21/2019	
Comments: Interval (63.0-64.5 feet). Depth interval shown on white board should be 63.0-64.5.

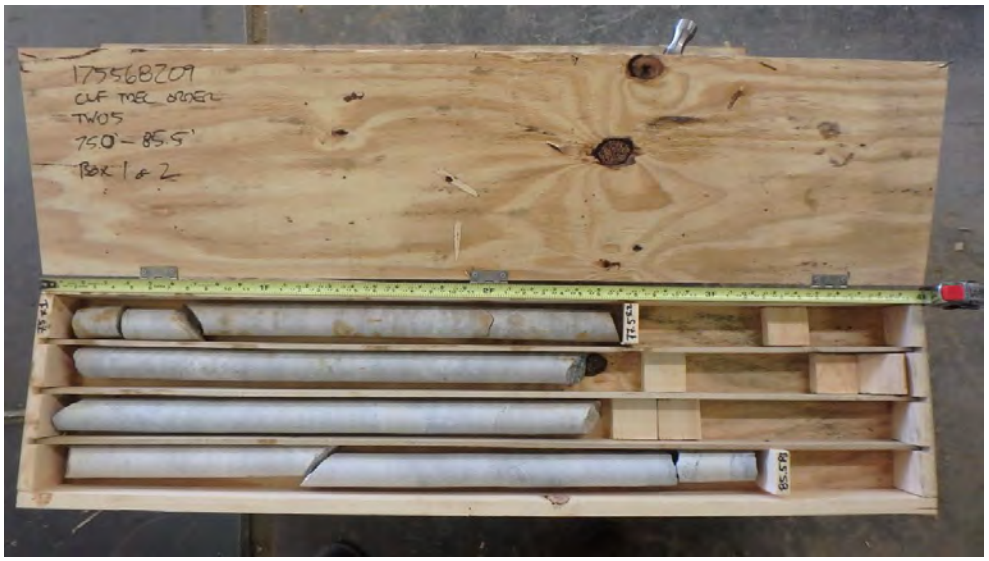
Photo Location: CUF-TW05			
Photo Date: 2/25/2019			
Comments: Interval (75.0-85.5 feet).			
Photograph ID: 184

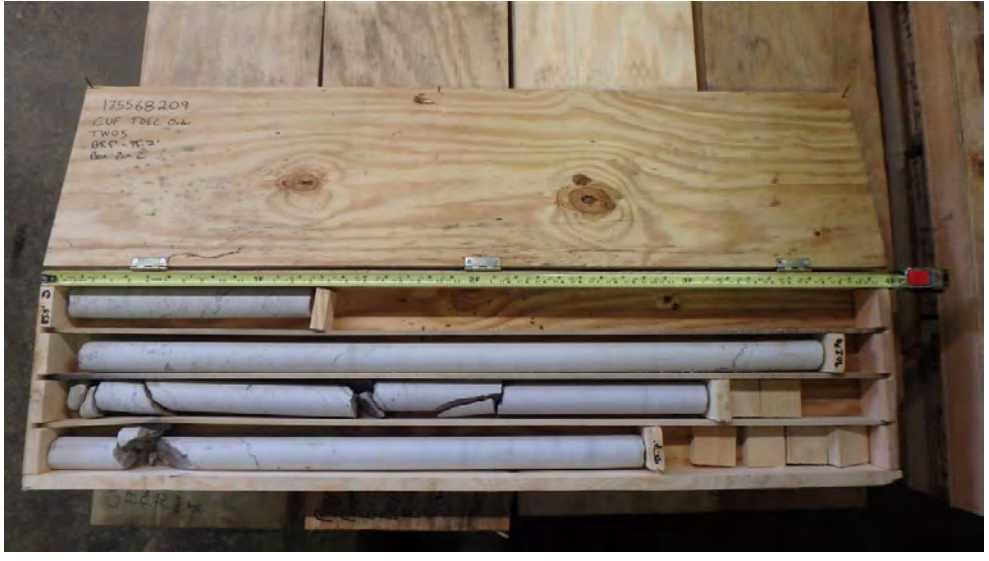
Photo Location: CUF-TW05			
Photo Date: 2/26/2019			
Comments: Interval (85.5-95.7 feet).

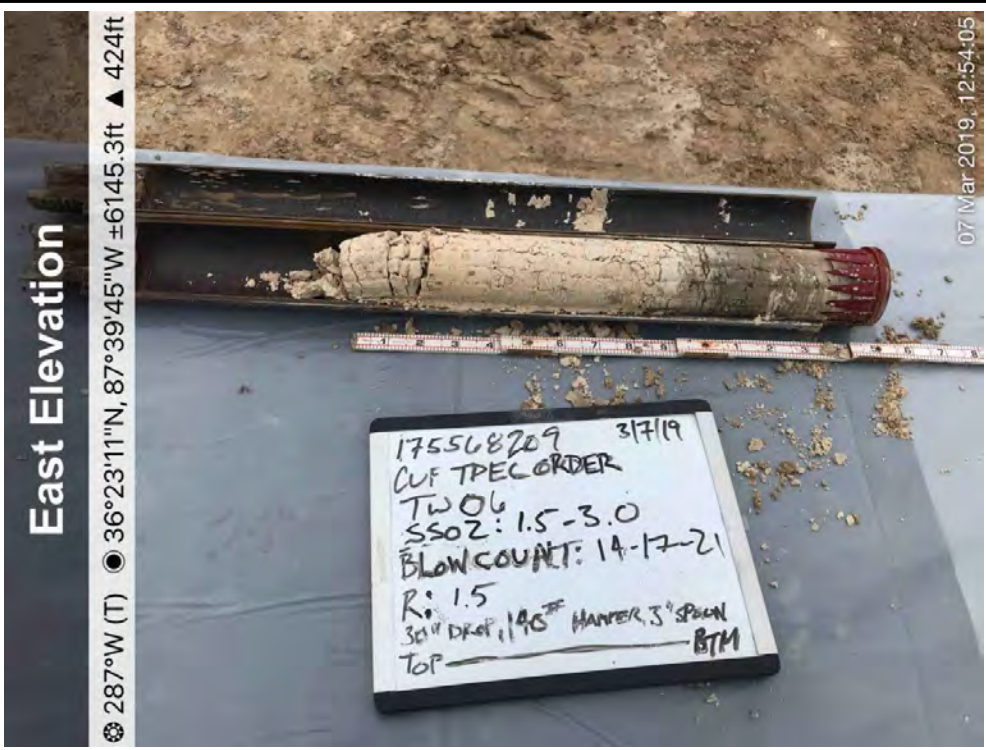
Photo Location: CUF-TW06			
Photo Date: 3/7/2019			
Comments: Interval (1.5-3.0 feet).

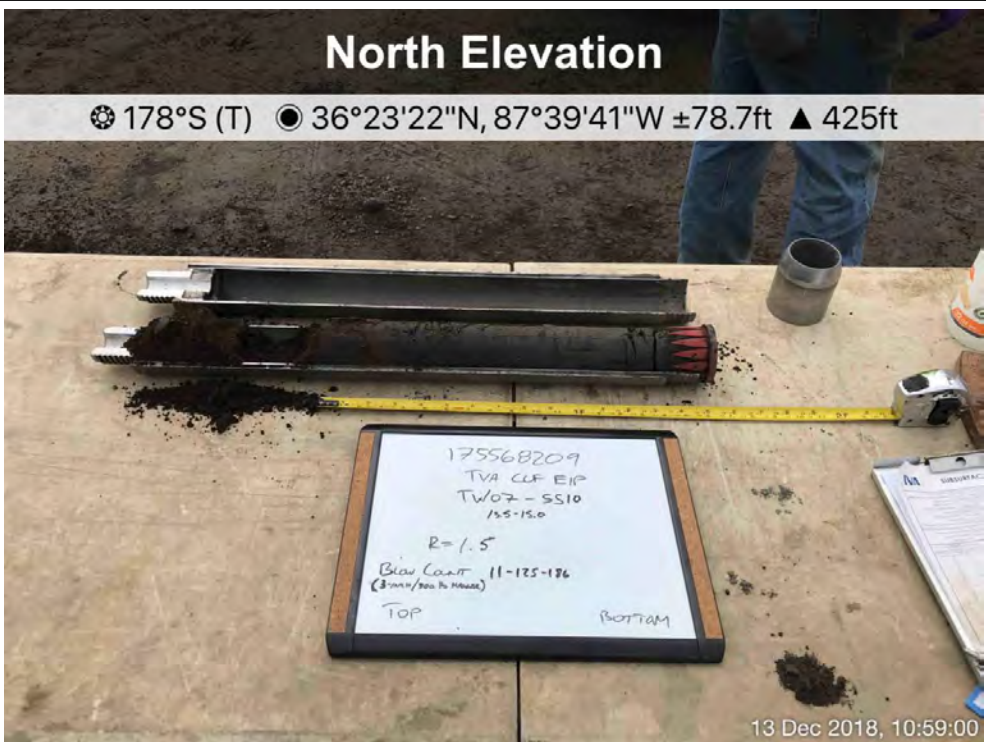
Photo Location: CUF-TW07	
Photo Date: 12/13/2018	
Comments: Interval (13.5-15.0 feet).

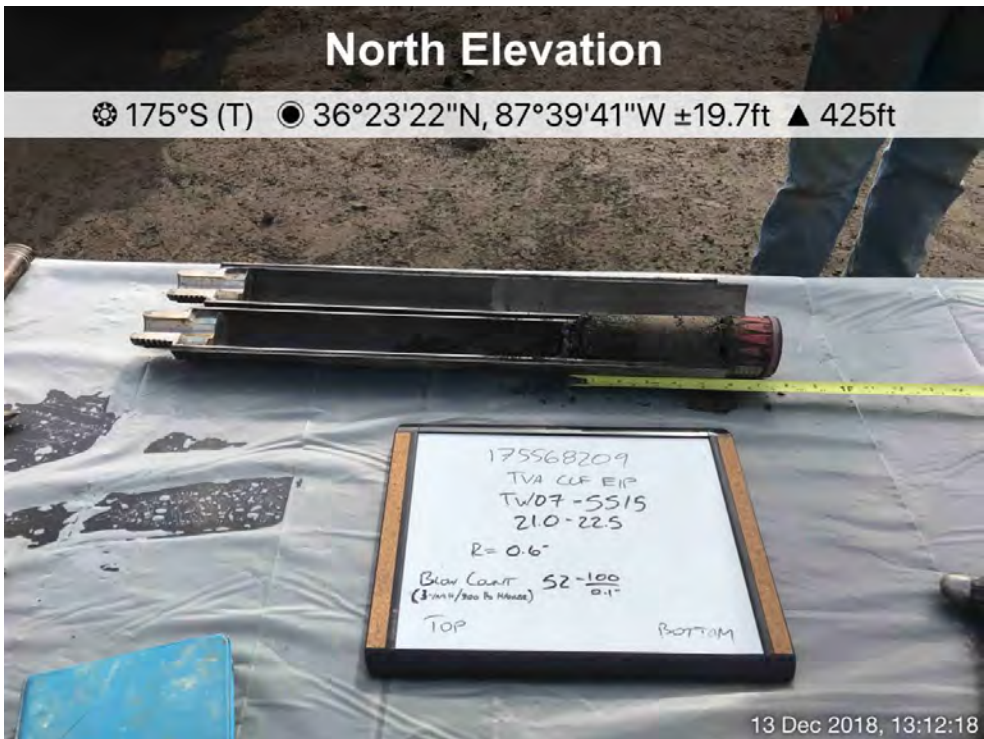
Photograph ID: 29

Photo Location: CUF-TW07	
Photo Date: 12/13/2018	
Comments: Interval (21.0-21.6 feet). Depth interval shown on white board should be 21.0-21.6.

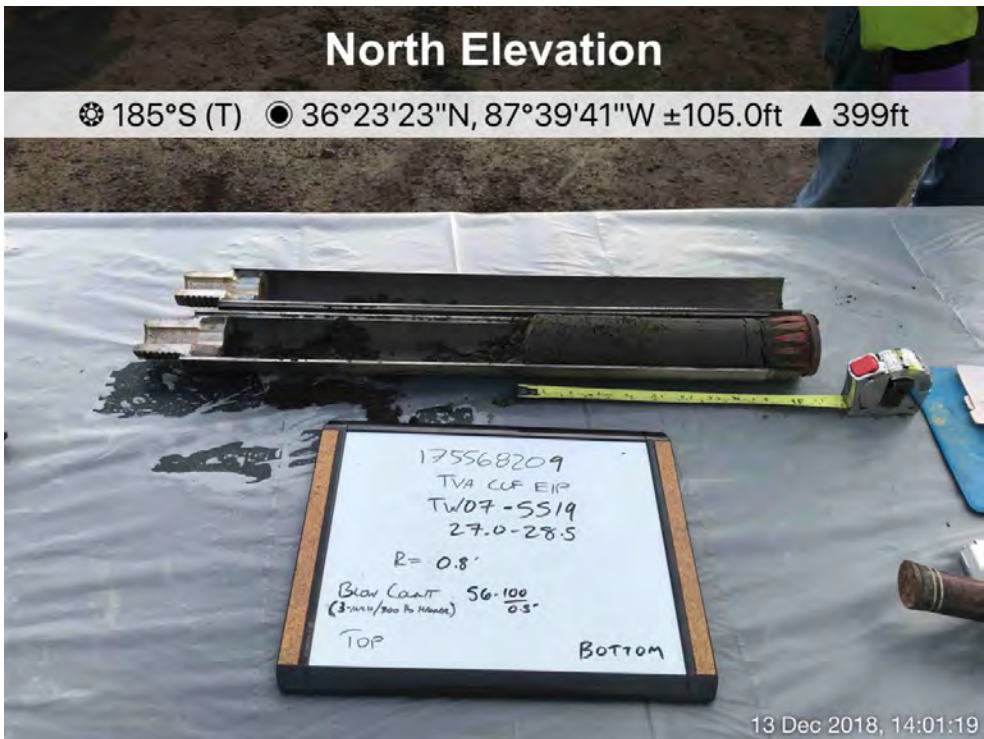
Photograph ID: 33

Photo Location: CUF-TW07	
Photo Date: 12/13/2018	
Comments: Interval (27.0-27.8 feet). Depth interval shown on white board should be 27.0-27.8.

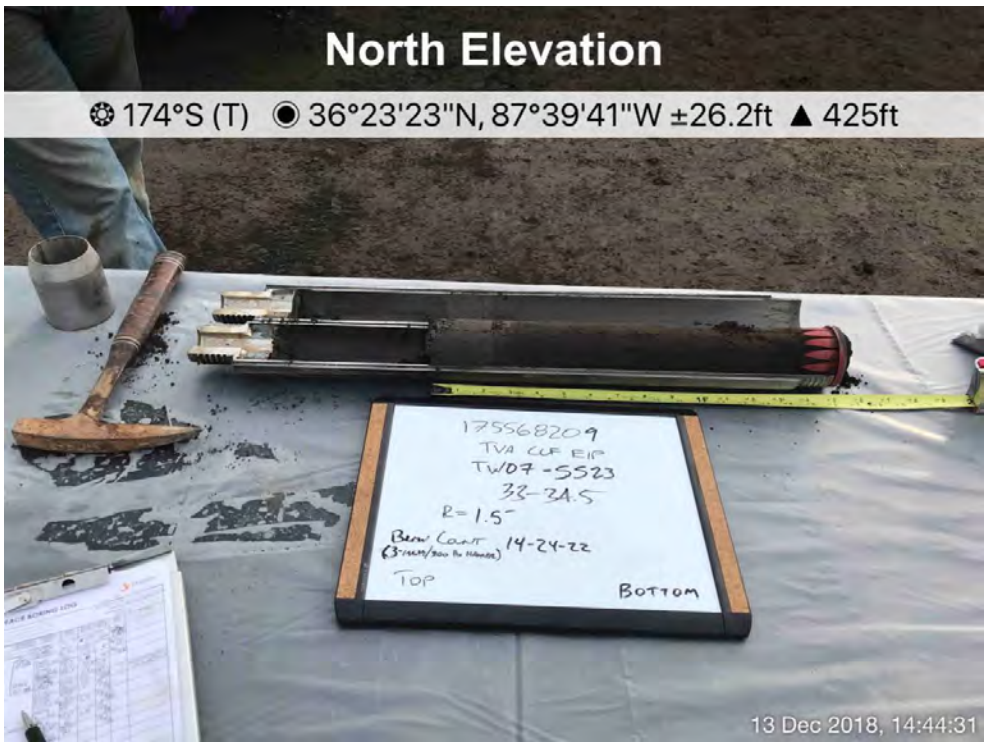
<p>Photograph ID: 37</p> <p>Photo Location: CUF-TW07</p> <p>Photo Date: 12/13/2018</p> <p>Comments: Interval (33.0-34.5 feet). Depth interval shown on white board should be 33.0-34.5.</p>

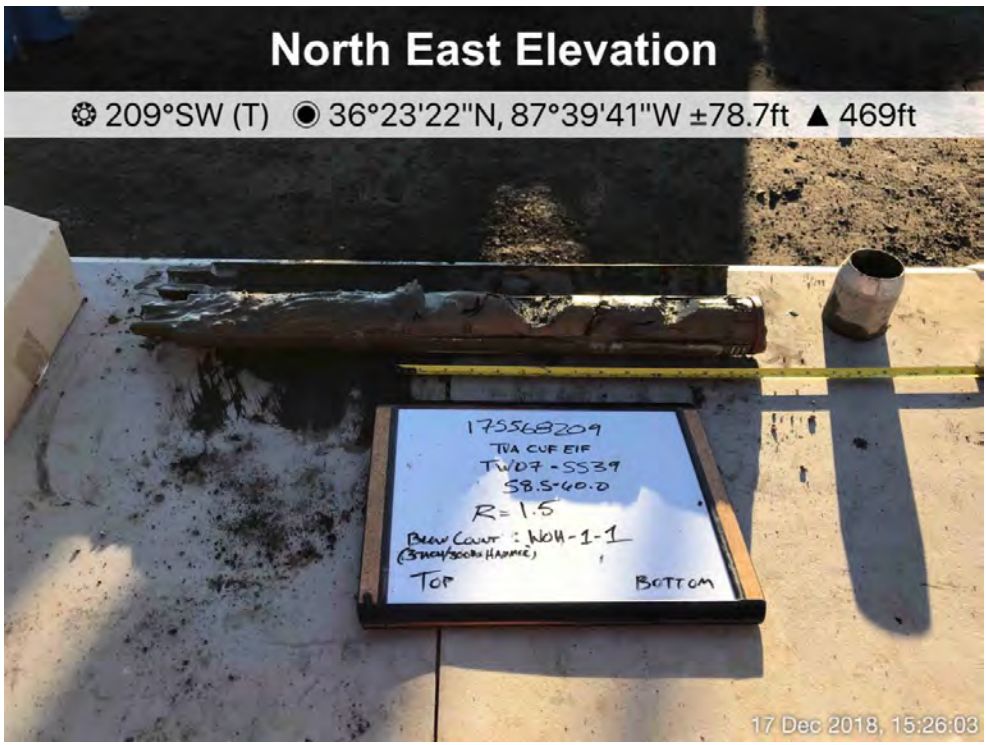
Photograph ID: 53

Photo Location: CUF-TW07	
Photo Date: 12/17/2018	
Comments: Interval (58.5-60.0 feet). WOH on white board is the same as WH on the boring log.

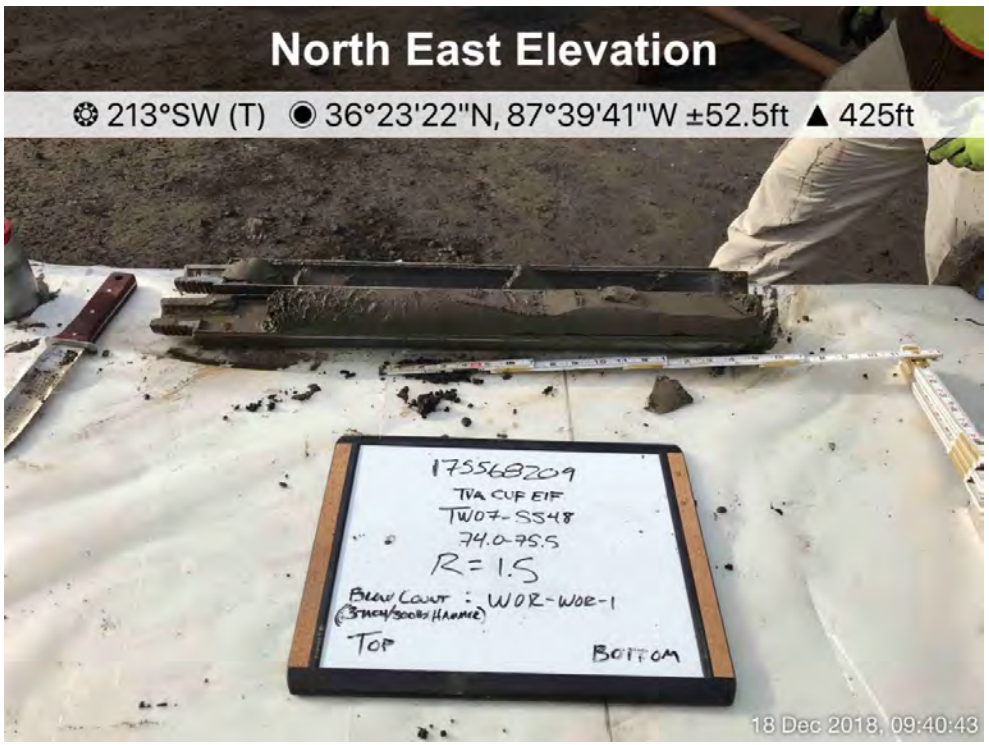
Photograph ID: 63

<p>North East Elevation</p> <p>☉ 213°SW (T) ● 36°23'22"N, 87°39'41"W ±52.5ft ▲ 425ft</p> <p>175568209 TVA CUF EIF TW07-SS48 74.0-75.5 R = 1.5 BLOW COUNT : WOR-WOR-1 (3 inch/500lb HAMMER) TOP BOTTOM</p> <p>18 Dec 2018, 09:40:43</p>
Photo Location: CUF-TW07	
Photo Date: 12/18/2018	
Comments: Interval (74.0-75.5 feet). WOR on white board is the same as WR on the boring log.

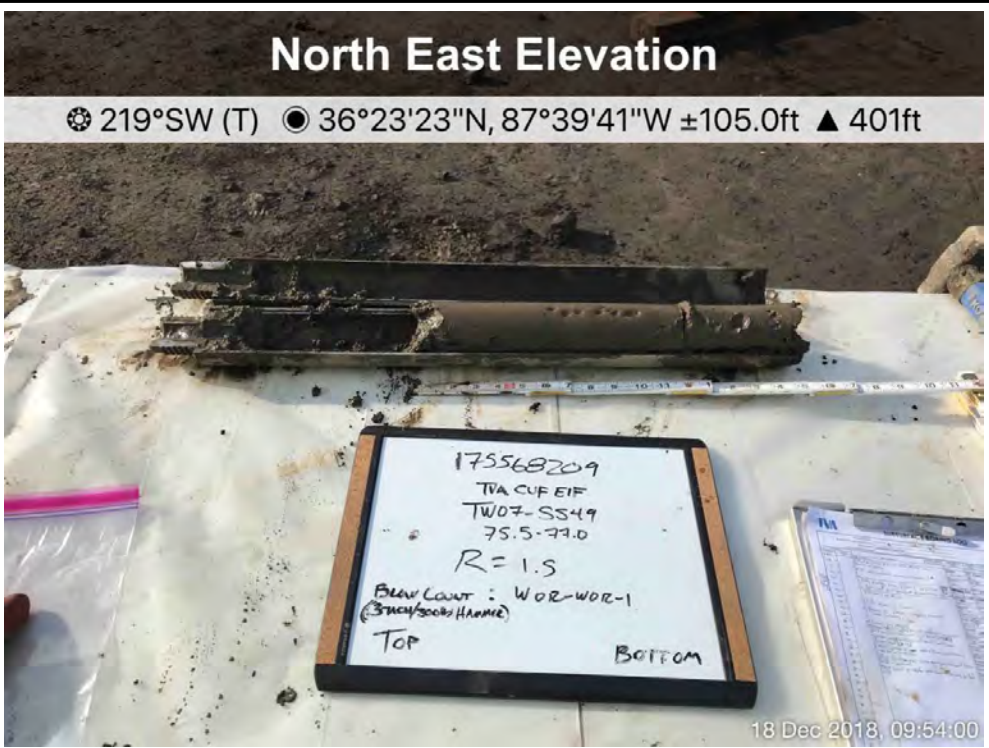
Photograph ID: 64

<p>North East Elevation</p> <p>☉ 219°SW (T) ● 36°23'23"N, 87°39'41"W ±105.0ft ▲ 401ft</p> <p>175568209 TVA CUF EIF TW07-SS49 75.5-77.0 R = 1.5 BLOW COUNT : WOR-WOR-1 (3 inch/500lb HAMMER) TOP BOTTOM</p> <p>18 Dec 2018, 09:54:00</p>
Photo Location: CUF-TW07	
Photo Date: 12/18/2018	
Comments: Interval (75.5-77.0 feet). WOR on white board is the same as WR on the boring log.

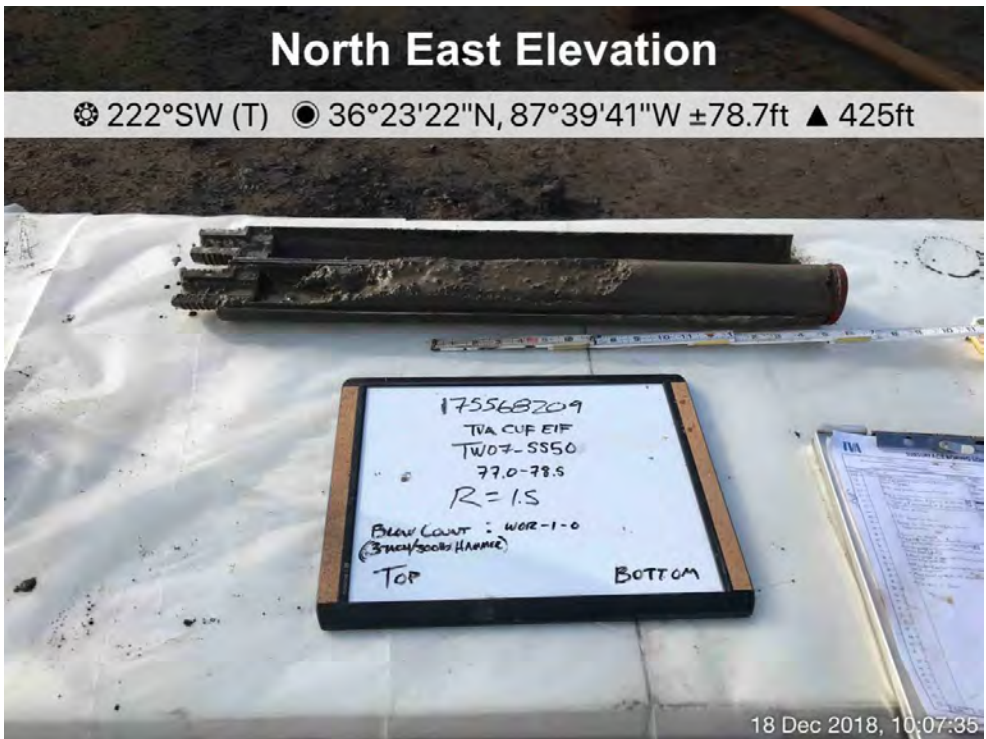
Photograph ID: 65

Photo Location: CUF-TW07	
Photo Date: 12/18/2018	
Comments: Interval (77.0-78.5 feet). Blow count shown on white board should be WR-1-WH.

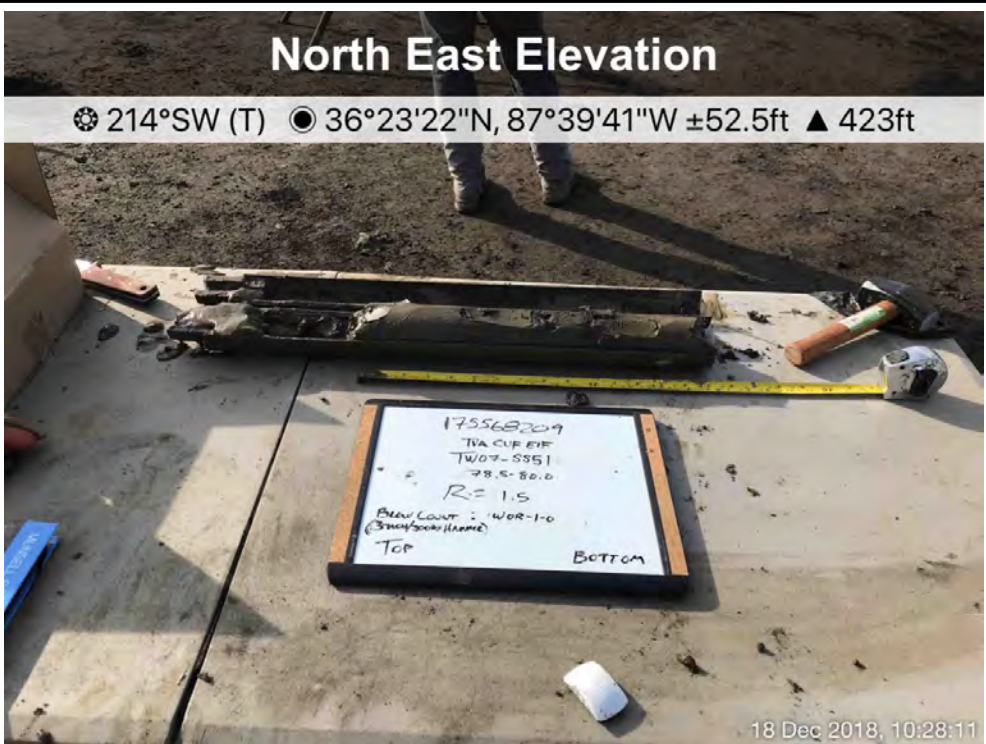
Photograph ID: 66

Photo Location: CUF-TW07	
Photo Date: 12/18/2018	
Comments: Interval (78.5-80.0 feet). Blow count shown on white board should be WR-1-WH.
