**APPENDIX G –
CCR MATERIAL INVESTIGATIONS**

**Appendix G.1 - Technical
Evaluation of Geotechnical and
CCR Material Characteristics Data**

TDEC Commissioner's Order:
Environmental Assessment Report
Cumberland Fossil Plant
Cumberland, Tennessee

Stantec Consulting Services Inc.
Lexington, Kentucky

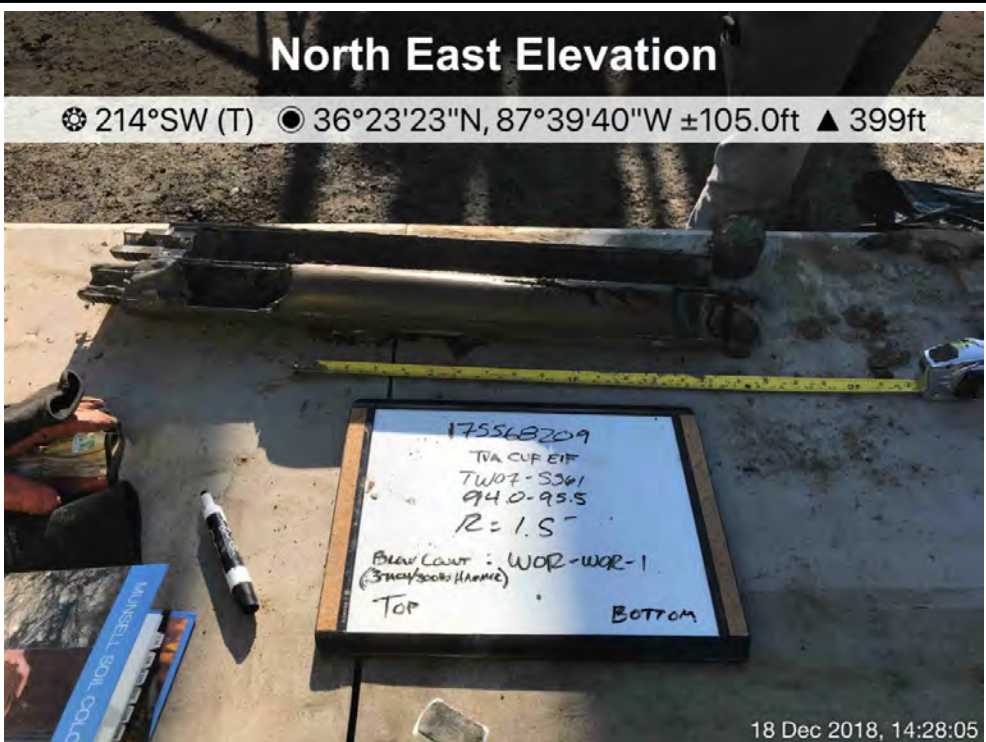
Photograph ID: 76

Photo Location: CUF-TW07	
Photo Date: 12/18/2018	
Comments: Interval (94.0-95.5 feet). WOR on white board is the same as WR on the boring log.

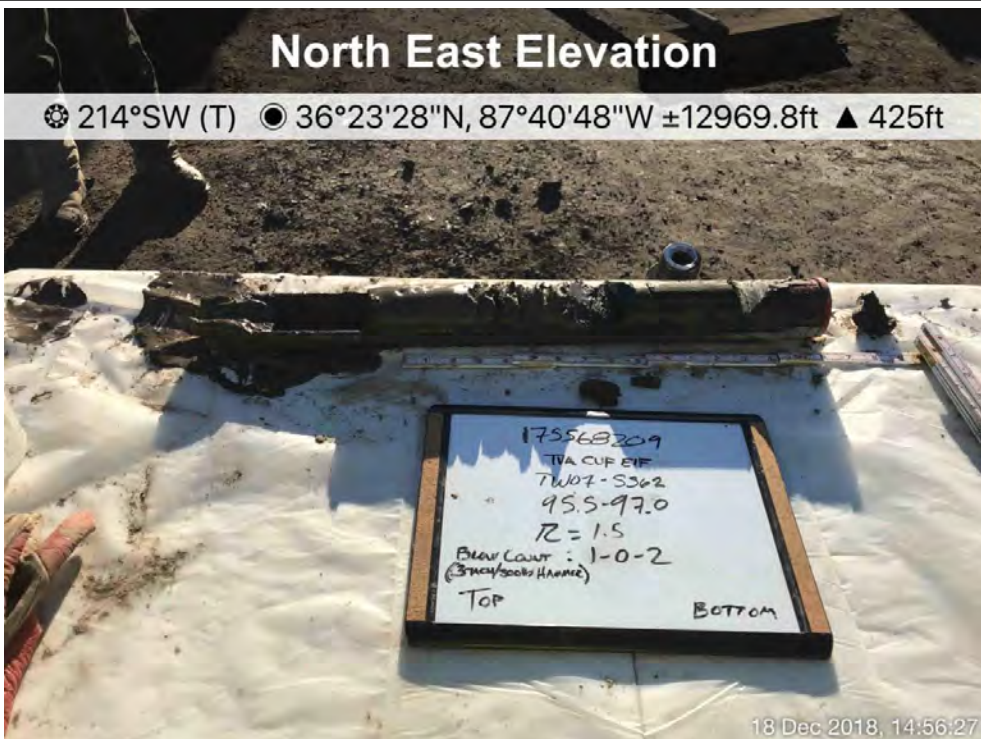
Photograph ID: 77

Photo Location: CUF-TW07	
Photo Date: 12/18/2018	
Comments: Interval (95.5-97.0 feet). Blow count shown on white board should be 1-WH-2.

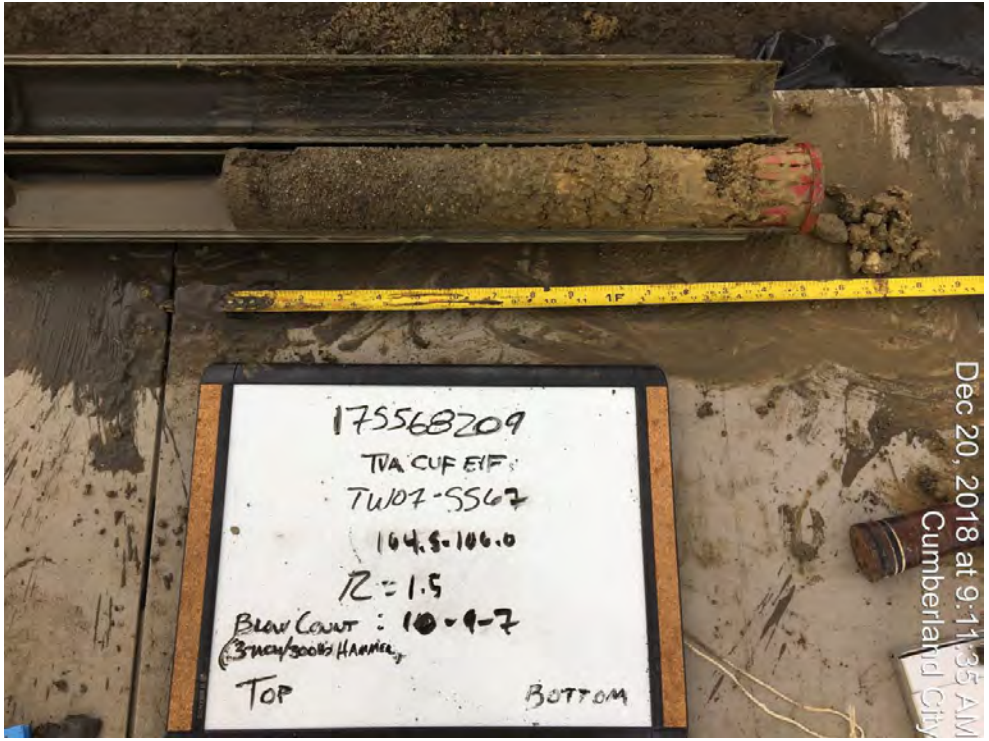
Photograph ID: 83

Photo Location: CUF-TW07	
Photo Date: 12/20/2018	
Comments: Interval (104.5-106.0 feet). Depth interval shown on white board is 104.5-106.0.

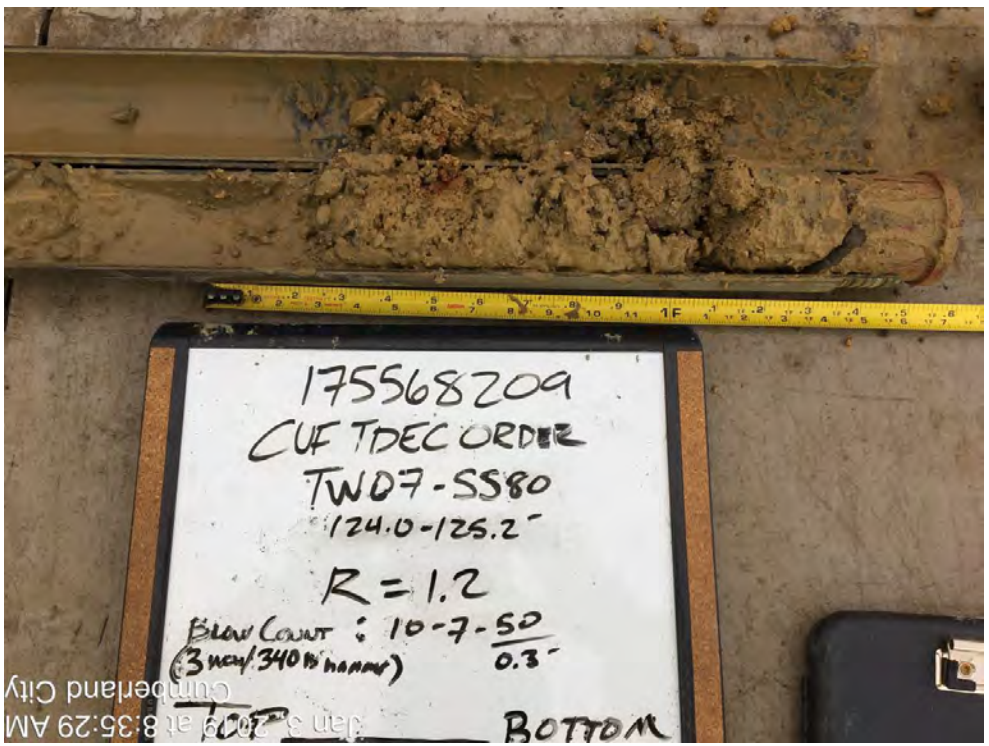
Photograph ID: 96

Photo Location: CUF-TW07	
Photo Date: 1/3/2019	
Comments: Interval (124.0-125.2 feet). Blow count shown on white board should be 10-7-50/2.

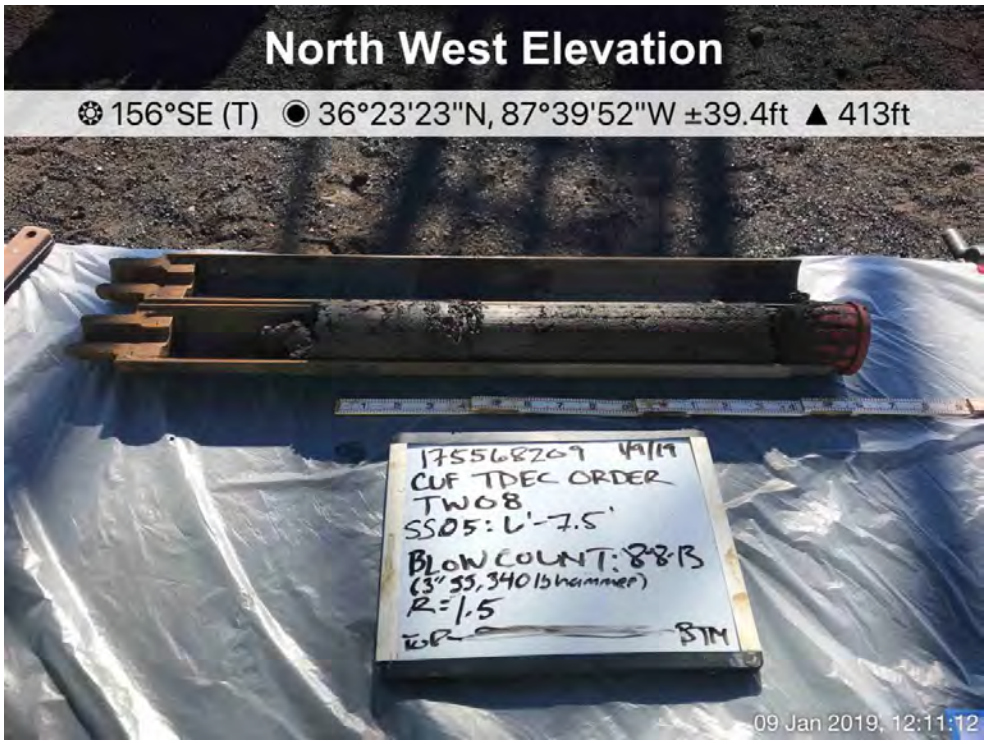
Photograph ID: 102

Photo Location: CUF-TW08	
Photo Date: 1/9/2019	
Comments: Interval (6.0-7.5 feet). Depth interval shown on white board should be 6.0-7.5.

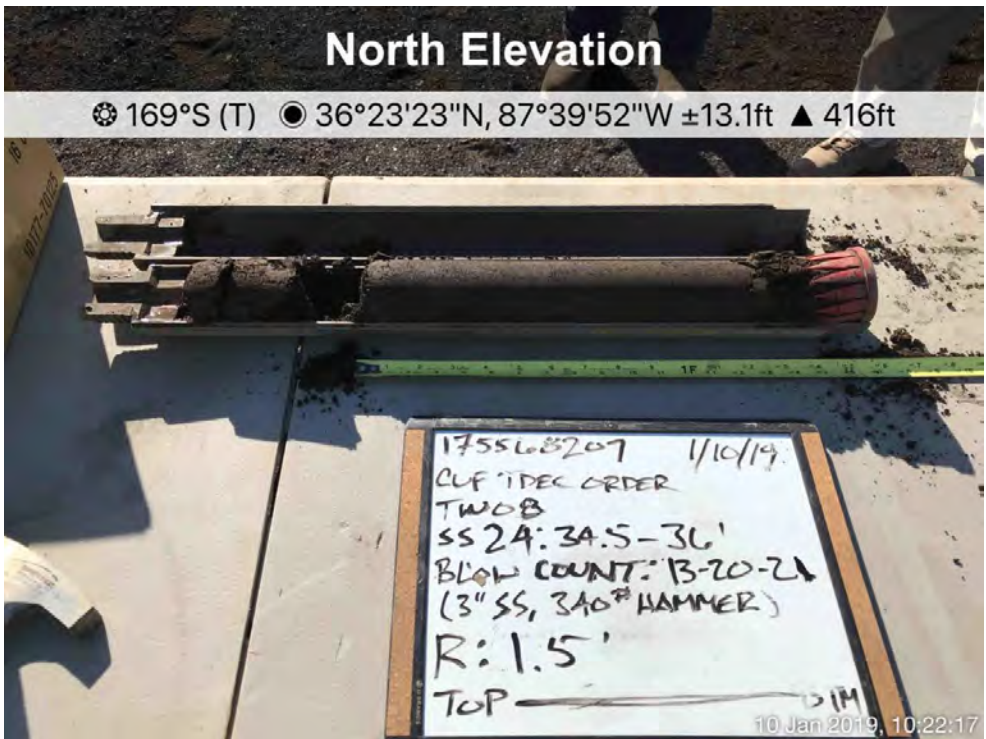
Photograph ID: 121

Photo Location: CUF-TW08	
Photo Date: 1/10/2019	
Comments: Interval (34.5-36.0 feet). Project number shown on white board is 175568209. Depth interval shown on white board should be 34.5-36.0.

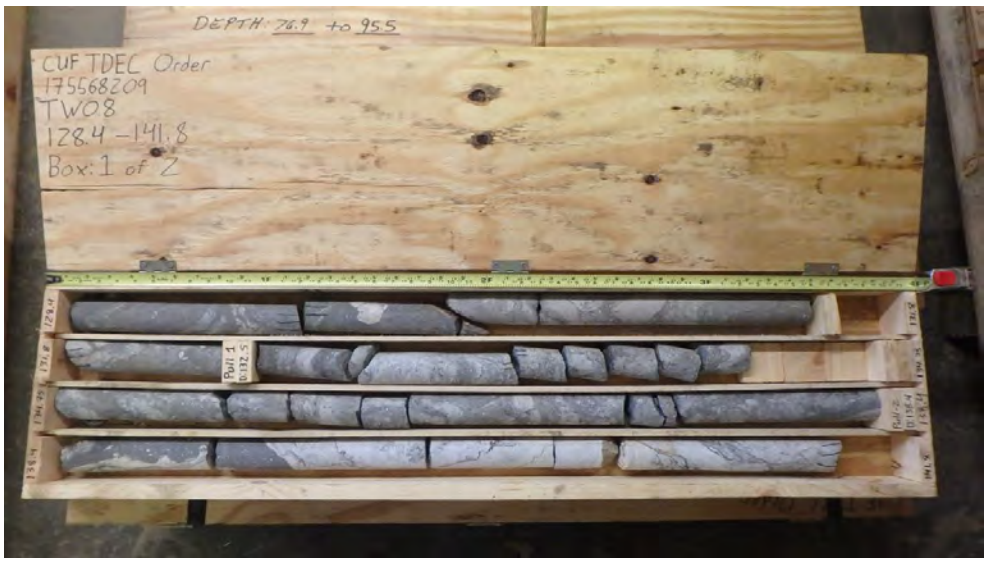
Client:	Tennessee Valley Authority	Project:	TDEC Order
Site Name:	Cumberland Fossil (CUF) Plant	Site Location:	Cumberland City, Tennessee
Photograph ID: 183

Photo Location: CUF-TW08			
Photo Date: 4/4/2019			
Comments: Interval (128.4-141.8 feet).			
Photograph ID: 184

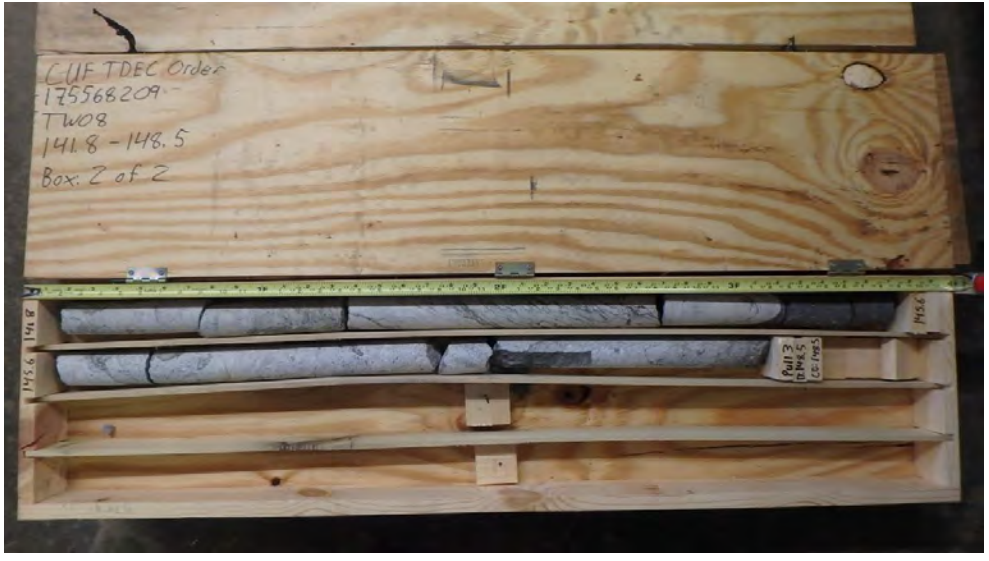
Photo Location: CUF-TW08			
Photo Date: 4/4/2019			
Comments: Interval (141.8-148.5 feet).

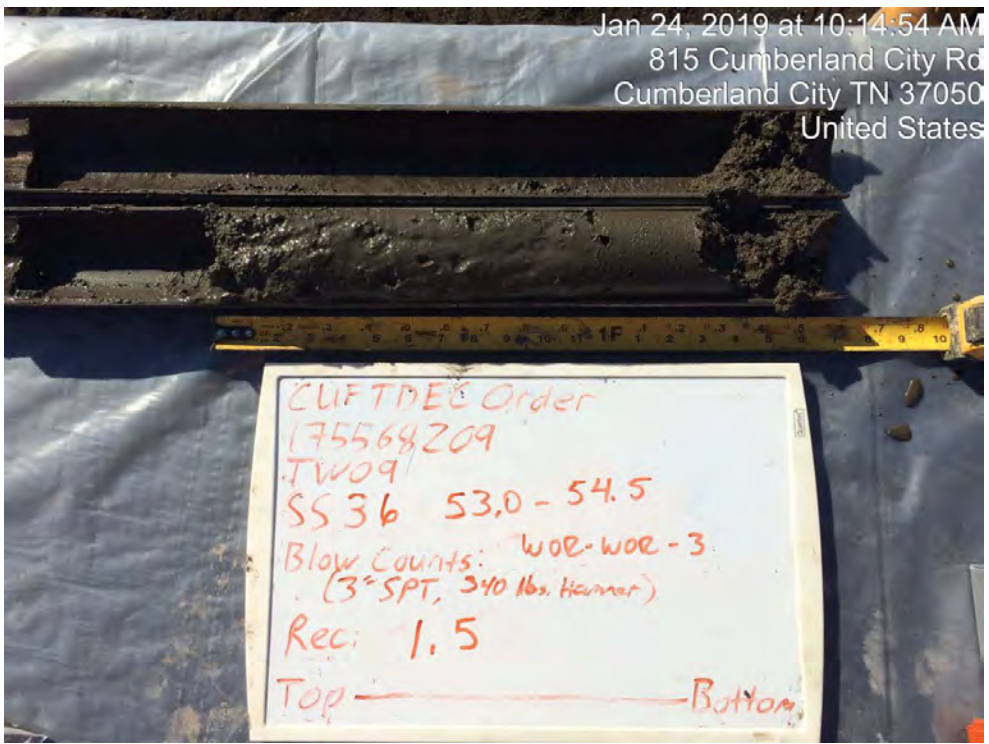
Photograph ID: 36

Jan 24, 2019 at 10:14:54 AM
Photo Location: CUF-TW09		815 Cumberland City Rd
Photo Date: 1/24/2019		Cumberland City TN 37050
Comments: Interval (53.0-54.5 feet). WOR on white board is the same as WR on the boring log.		United States

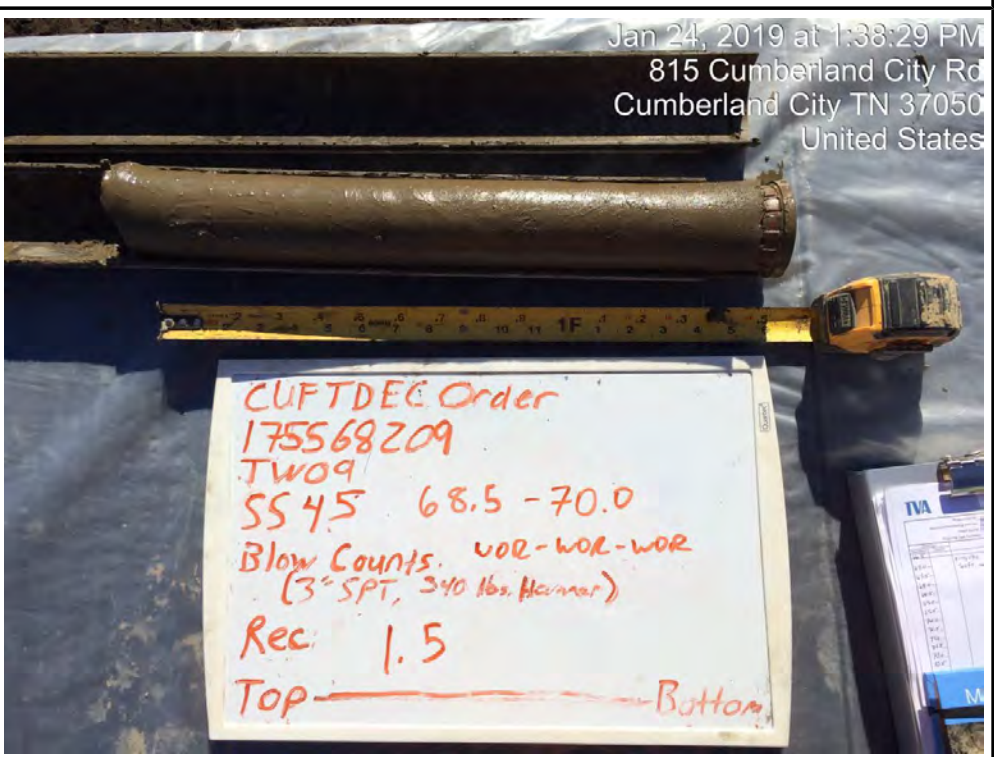
Photograph ID: 46	Jan 24, 2019 at 1:38:29 PM 815 Cumberland City Rd Cumberland City TN 37050 United States
Photo Location: CUF-TW09	
Photo Date: 1/24/2019	
Comments: Interval (68.5-70.0 feet). WOR on white board is the same as WR on the boring log.

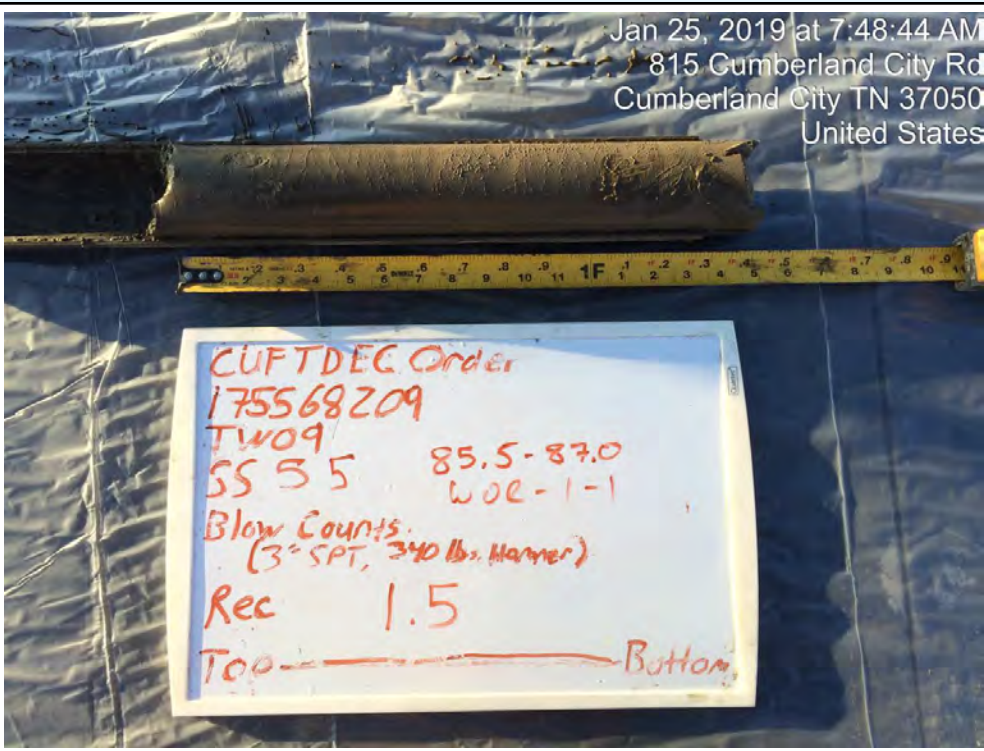
Photograph ID: 57

Photo Location: CUF-TW09	
Photo Date: 1/25/2019	
Comments: Interval (85.5-87.0 feet). WOR on white board is the same as WR on the boring log.

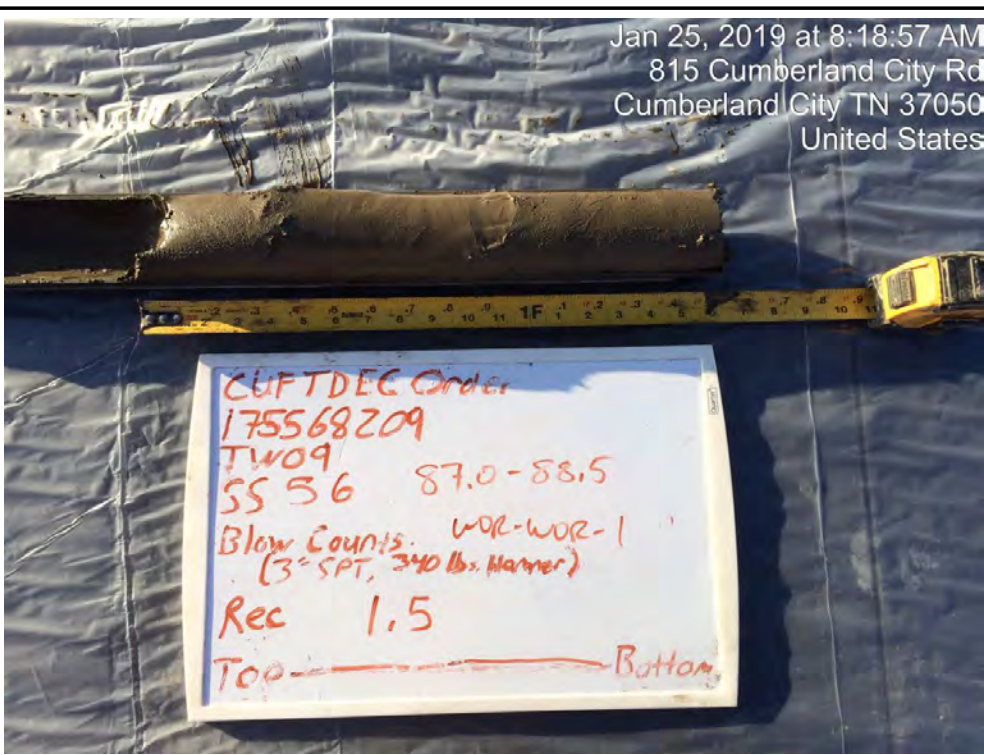
Photograph ID: 58

Photo Location: CUF-TW09	
Photo Date: 1/25/2019	
Comments: Interval (87.0-88.5 feet). WOR on white board is the same as WR on the boring log.

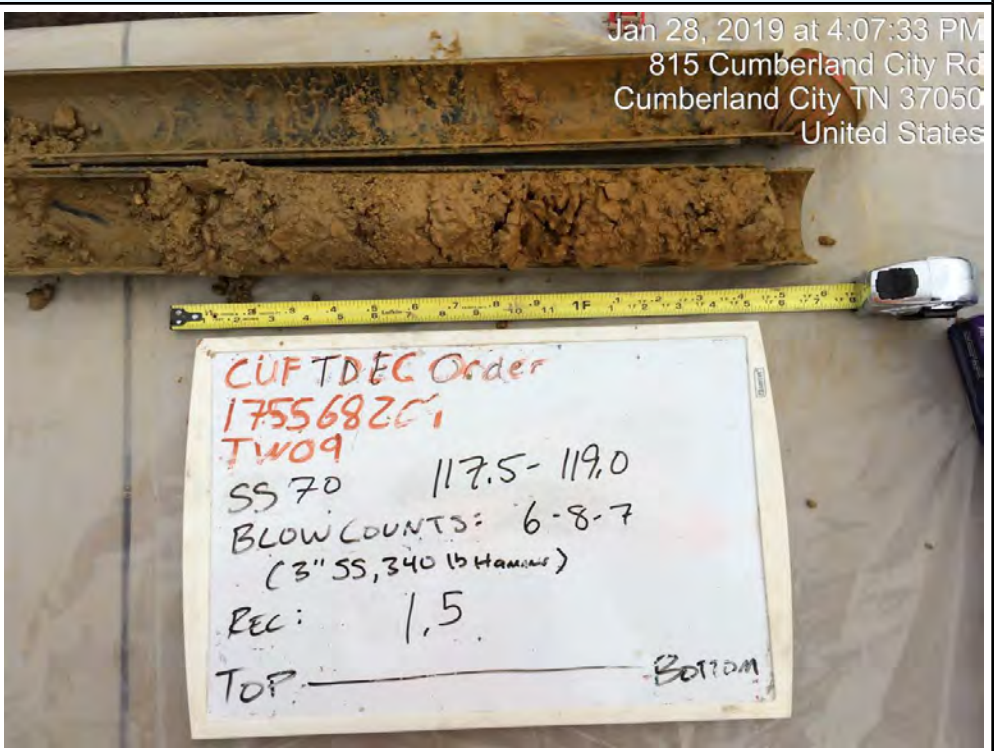
Photograph ID: 73

Photo Location: CUF-TW09	
Photo Date: 1/28/2019	
Comments: Interval (117.5-119.0 feet). Project number shown on white board is 175568209.

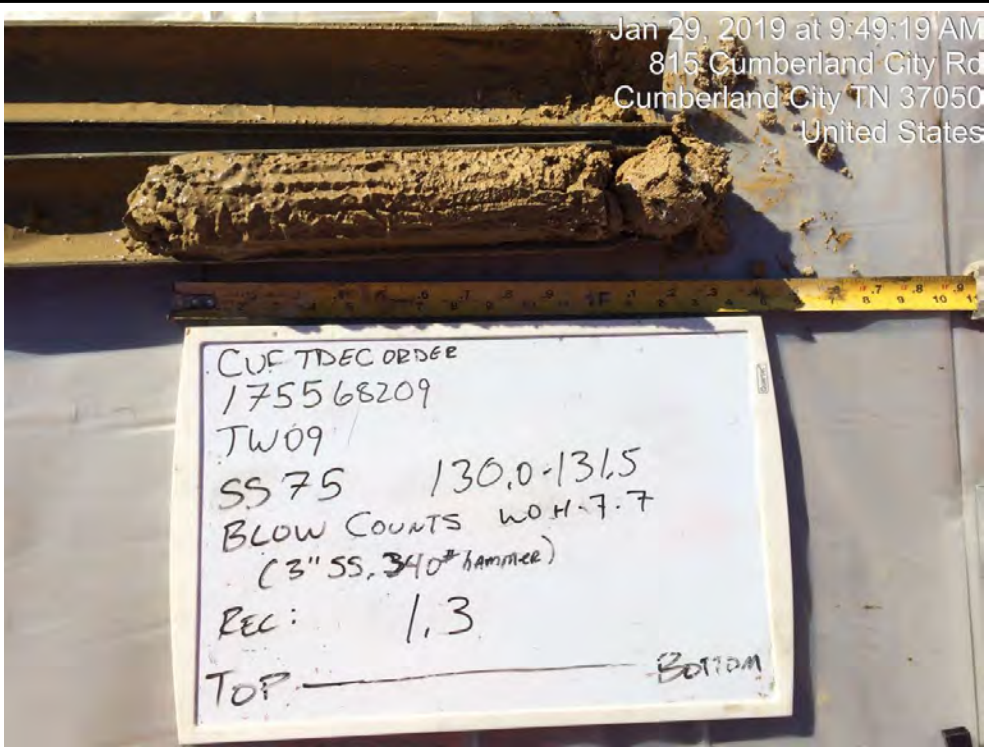
Photograph ID: 78

<p>Jan 29, 2019 at 9:49:19 AM 815 Cumberland City Rd Cumberland City TN 37050 United States</p>
Photo Location: CUF-TW09	
Photo Date: 1/29/2019	
Comments: Interval (130.0-131.5 feet). WOH on white board is the same as WH on the boring log.

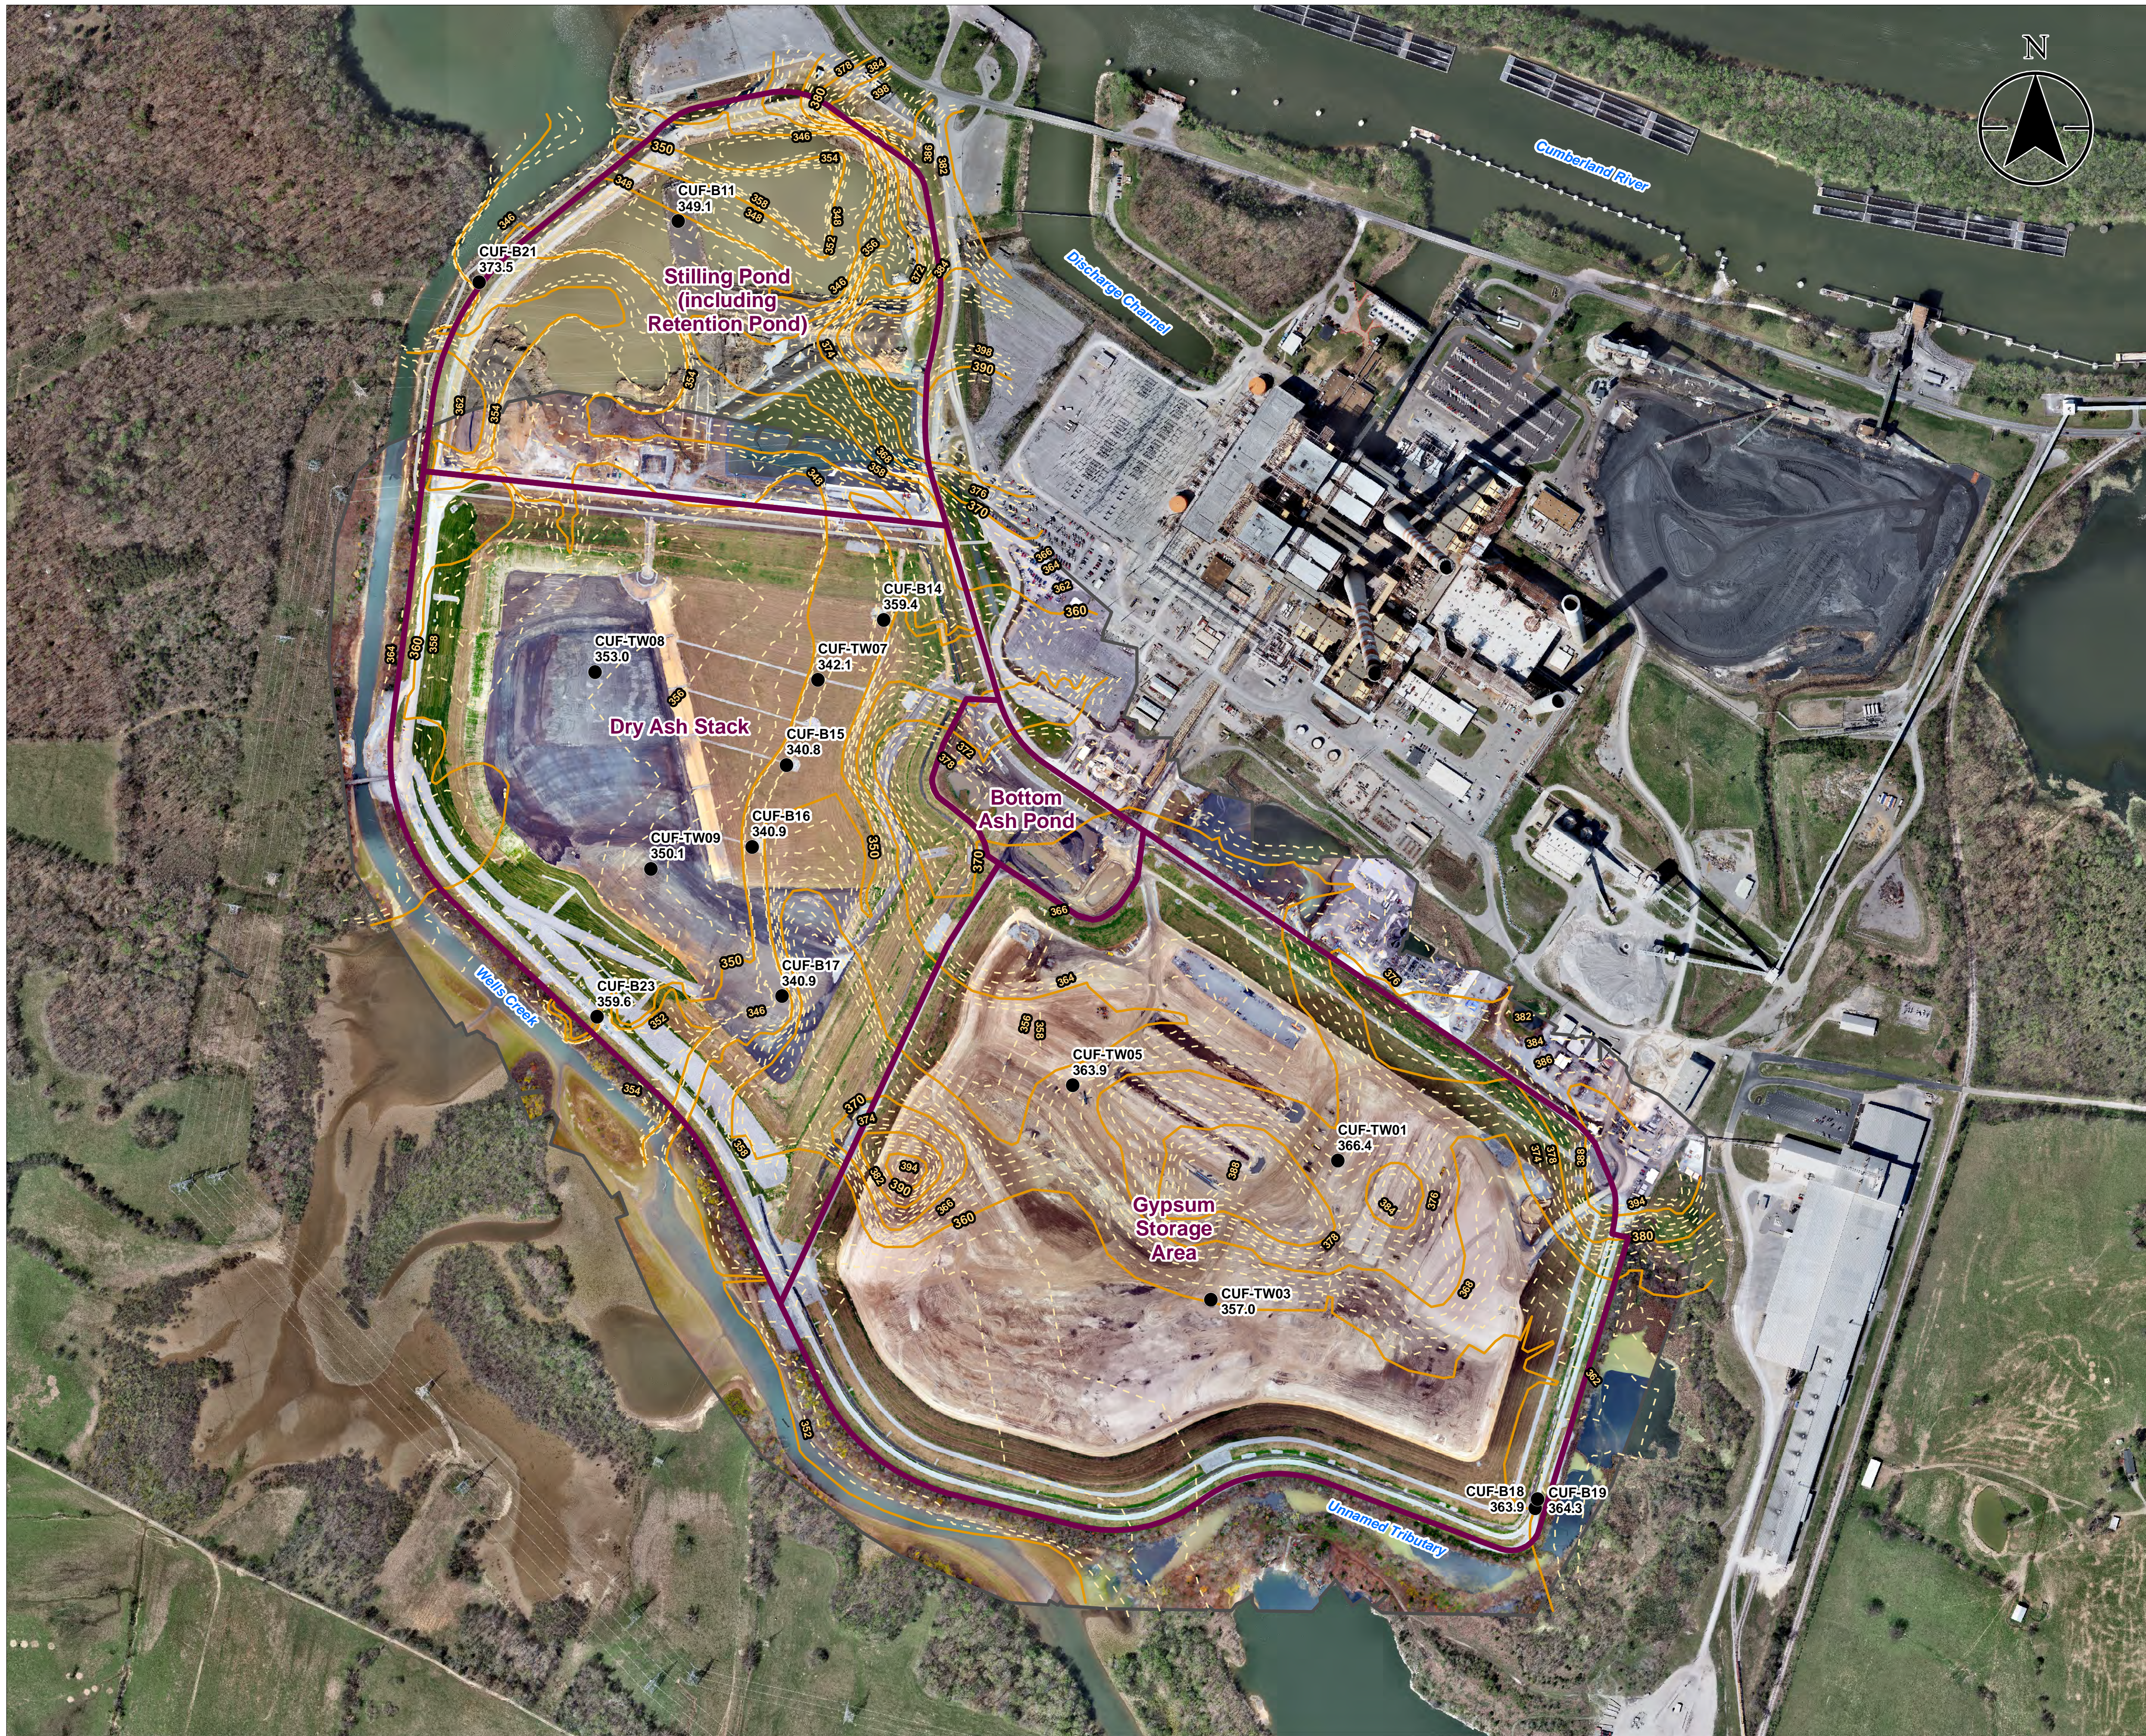
Exhibit No. **A.3**
 Title **Pre-Construction Topography**

- Notes**
1. Coordinate System: NAD 1927 StatePlane Tennessee FIPS 4100
 2. Vertical Datum: NGVD29
 3. Imagery Provided by Tuck Mapping (c. 2017) and TVA (12/11/2019 and 11/09/2020)
 4. Model input data and confirmation data used to model and evaluate the pre-construction surface shown herein are summarized in Table C.1 (Appendix C).

The pre-construction surface was then compared to the top of foundation soil elevation boring data from borings installed as part of the EI. For the purposes of the MQA, it was determined that the difference between the top of foundation soil elevation boring data and the contour data from TVA Drawing 10N212R11 was negligible; therefore, the top of foundation soil elevation boring data was not imported into the pre-construction surface and is designated in herein as confirmation data.

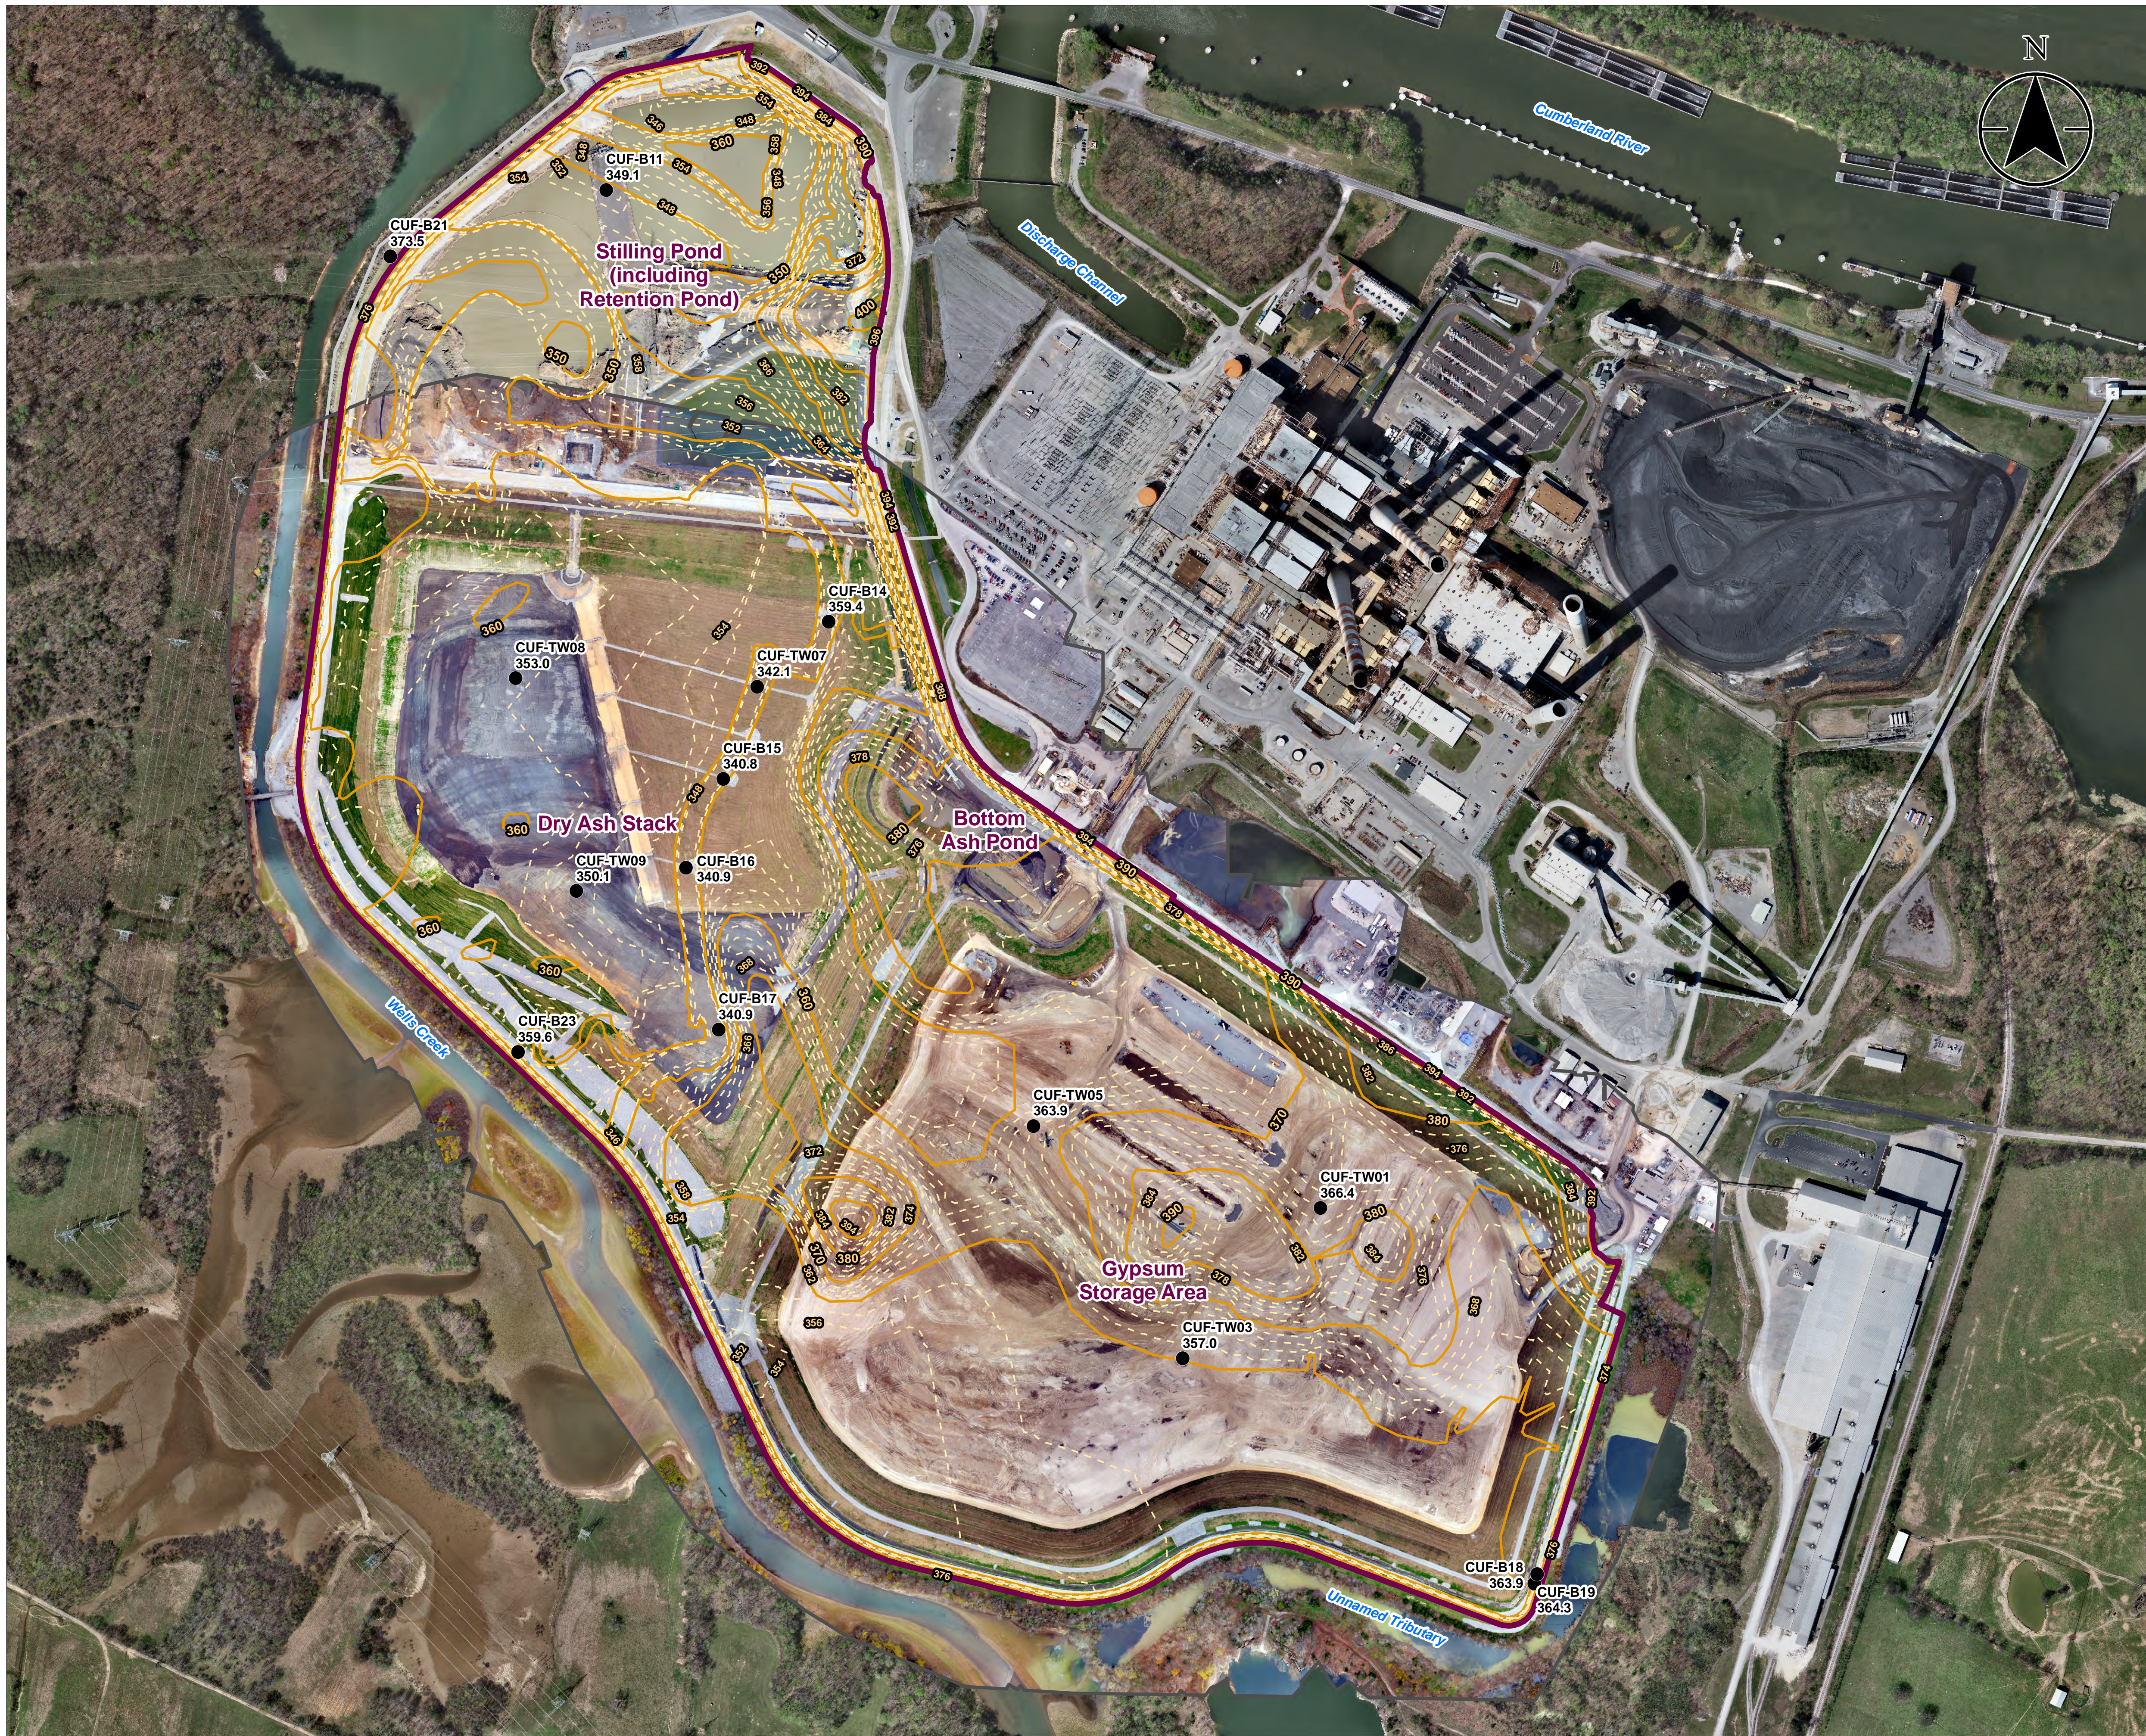
Exhibit No. **A.4**
 Title **Bottom of CCR Material Elevations**

- Notes**
1. Coordinate System: NAD 1927 StatePlane Tennessee FIPS 4100
 2. Vertical Datum: NGVD29
 3. Imagery Provided by Tuck Mapping (c. 2017) and TVA (12/11/2019 and 11/09/2020)
 4. Model input data and confirmation data used to model and evaluate the pre-construction surface shown herein are summarized in Table C.1 (Appendix C).

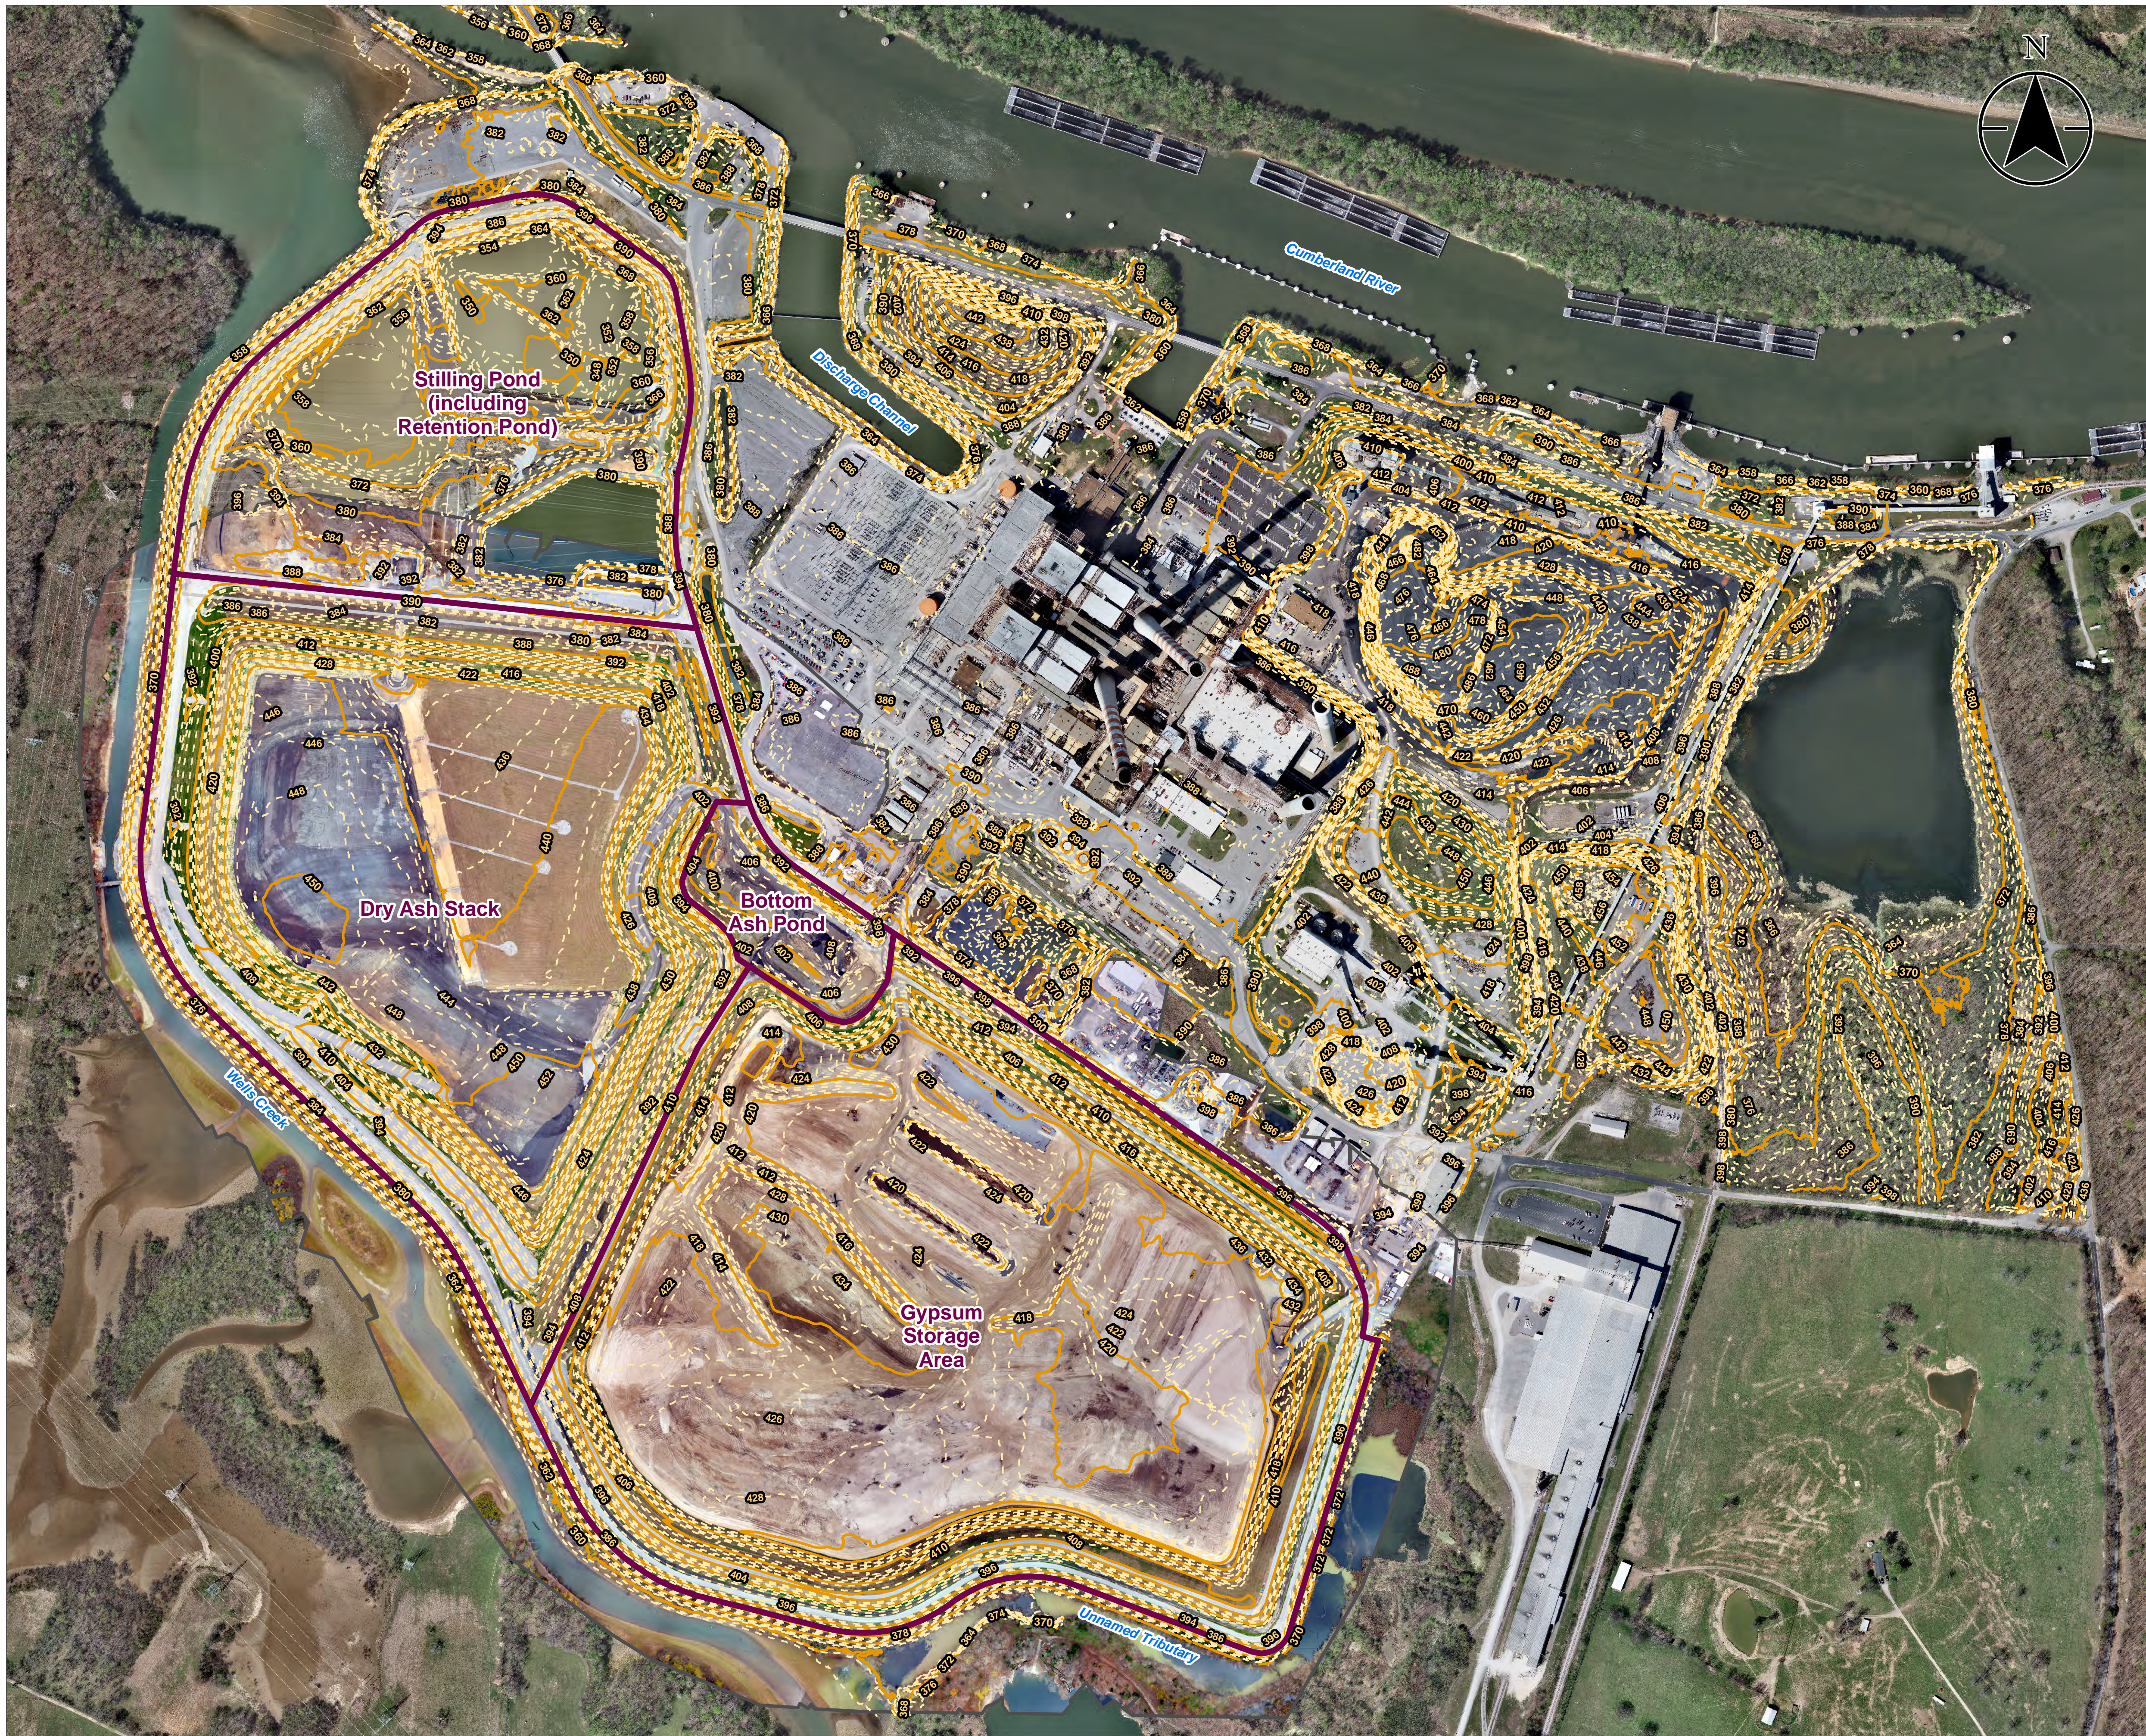
Exhibit No. **A.5**
 Title **Ground Surface Elevations of CCR Units
 2017-2021 Composite Surface**

- Notes**
1. Coordinate System: NAD 1927 StatePlane Tennessee FIPS 4100
 2. Vertical Datum: NGVD29
 3. Imagery Provided by Tuck Mapping (c. 2017) and TVA (12/11/2019 and 11/09/2020)
 4. Contours from the 2017 CUF Plant aerial survey (Tuck 2017), 2021 CUF Plant aerial survey (RLS 2021a and b), and supplemental as-built construction surveys summarized in Table C.2 (Appendix C) were used to model the composite ground surface shown herein.
