**APPENDIX G –
CCR MATERIAL INVESTIGATIONS**

**Appendix G.1 - Technical
Evaluation of Geotechnical and
CCR Material Characteristics Data**

TDEC Commissioner's Order:
Environmental Assessment Report
Cumberland Fossil Plant
Cumberland, Tennessee

Stantec Consulting Services Inc.
Lexington, Kentucky

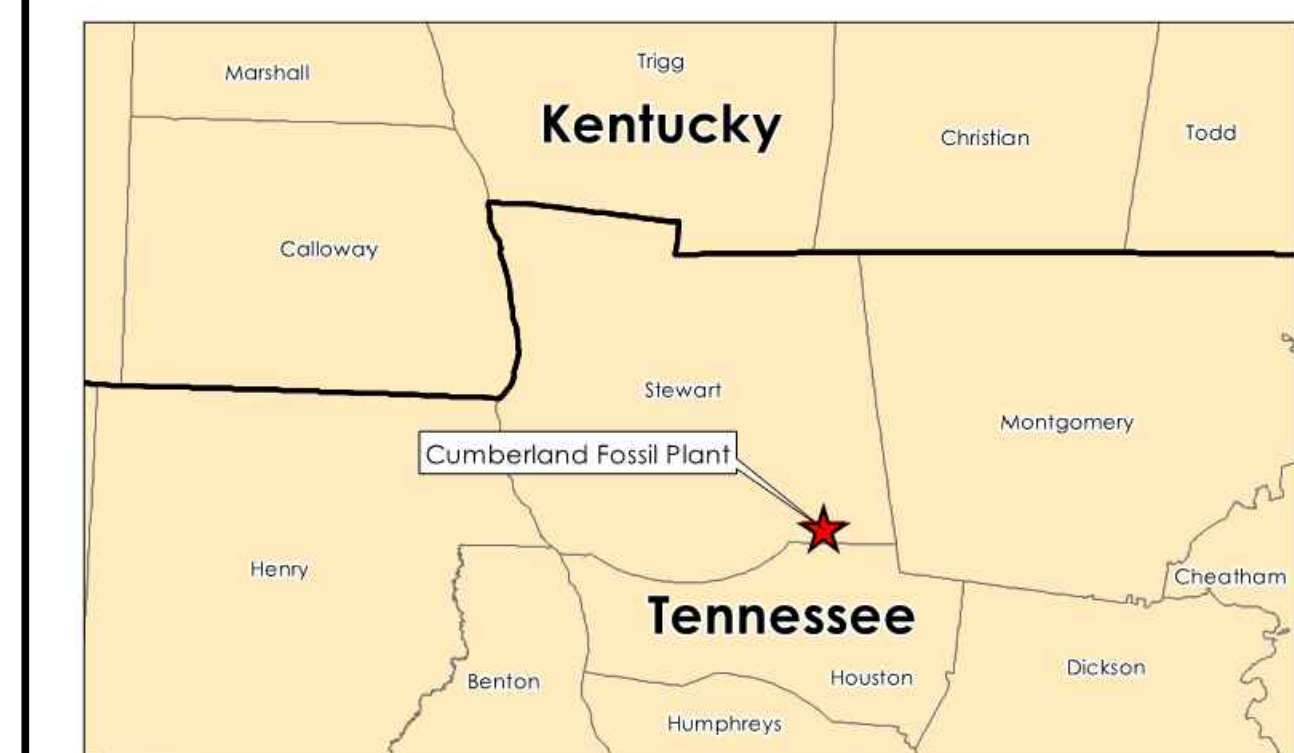
**CUF MATERIAL QUANTITY
CROSS SECTIONS**

1. COORDINATE SYSTEM: NAD 1927 STATEPLANE TENNESSEE FIPS 4100.
2. VERTICAL DATUM: NGVD29.
3. SEE SECTION 4.0 OF THE MATERIAL QUANTITY SAMPLING AND ANALYSIS REPORT FOR DETAILS REGARDING THE METHODOLOGY AND SOURCE DATA USED TO DEVELOP THE THREE-DIMENSIONAL MODELS FROM WHICH THESE CROSS SECTIONS WERE EXTRACTED.
4. THE INFORMATION AND DATA SHOWN HEREIN ARE FURNISHED ONLY FOR PURPOSES OF THE TDEC ORDER AND SHOULD NOT BE USED FOR ANY OTHER PURPOSE. THE ENGINEER OR OWNER WILL NOT BE RESPONSIBLE FOR ANY INTERPRETATION OR CONCLUSION DRAWN BY OTHERS FOR PURPOSES OTHER THAN THE TDEC ORDER.

A cross section location exhibit and 12 representative cross sections are provided as Exhibits A.8 through A.14. The cross-section locations were intentionally selected to capture variations within each CCR management unit. The cross sections are on approximate 800 feet spacing with additional sections taken perpendicular the primary sections. The modeled dikes and surfaces discussed in Section 4.0 are shown on the cross sections. The composite surface summarized in Table C.4 and shown on Exhibit A.15 is also shown on the cross-sections to depict site conditions during the time of the EI; however, this composite surface will not be used to calculate volumes which will be provided in the EAR.
