**Cumberland Fossil Plant  
Seep Sampling and Analysis  
Report**

TDEC Commissioner's Order:  
Environmental Investigation Plan  
Cumberland Fossil Plant  
Cumberland City, Tennessee

April 9, 2021

Stantec Consulting Services Inc.  
Lexington, Kentucky

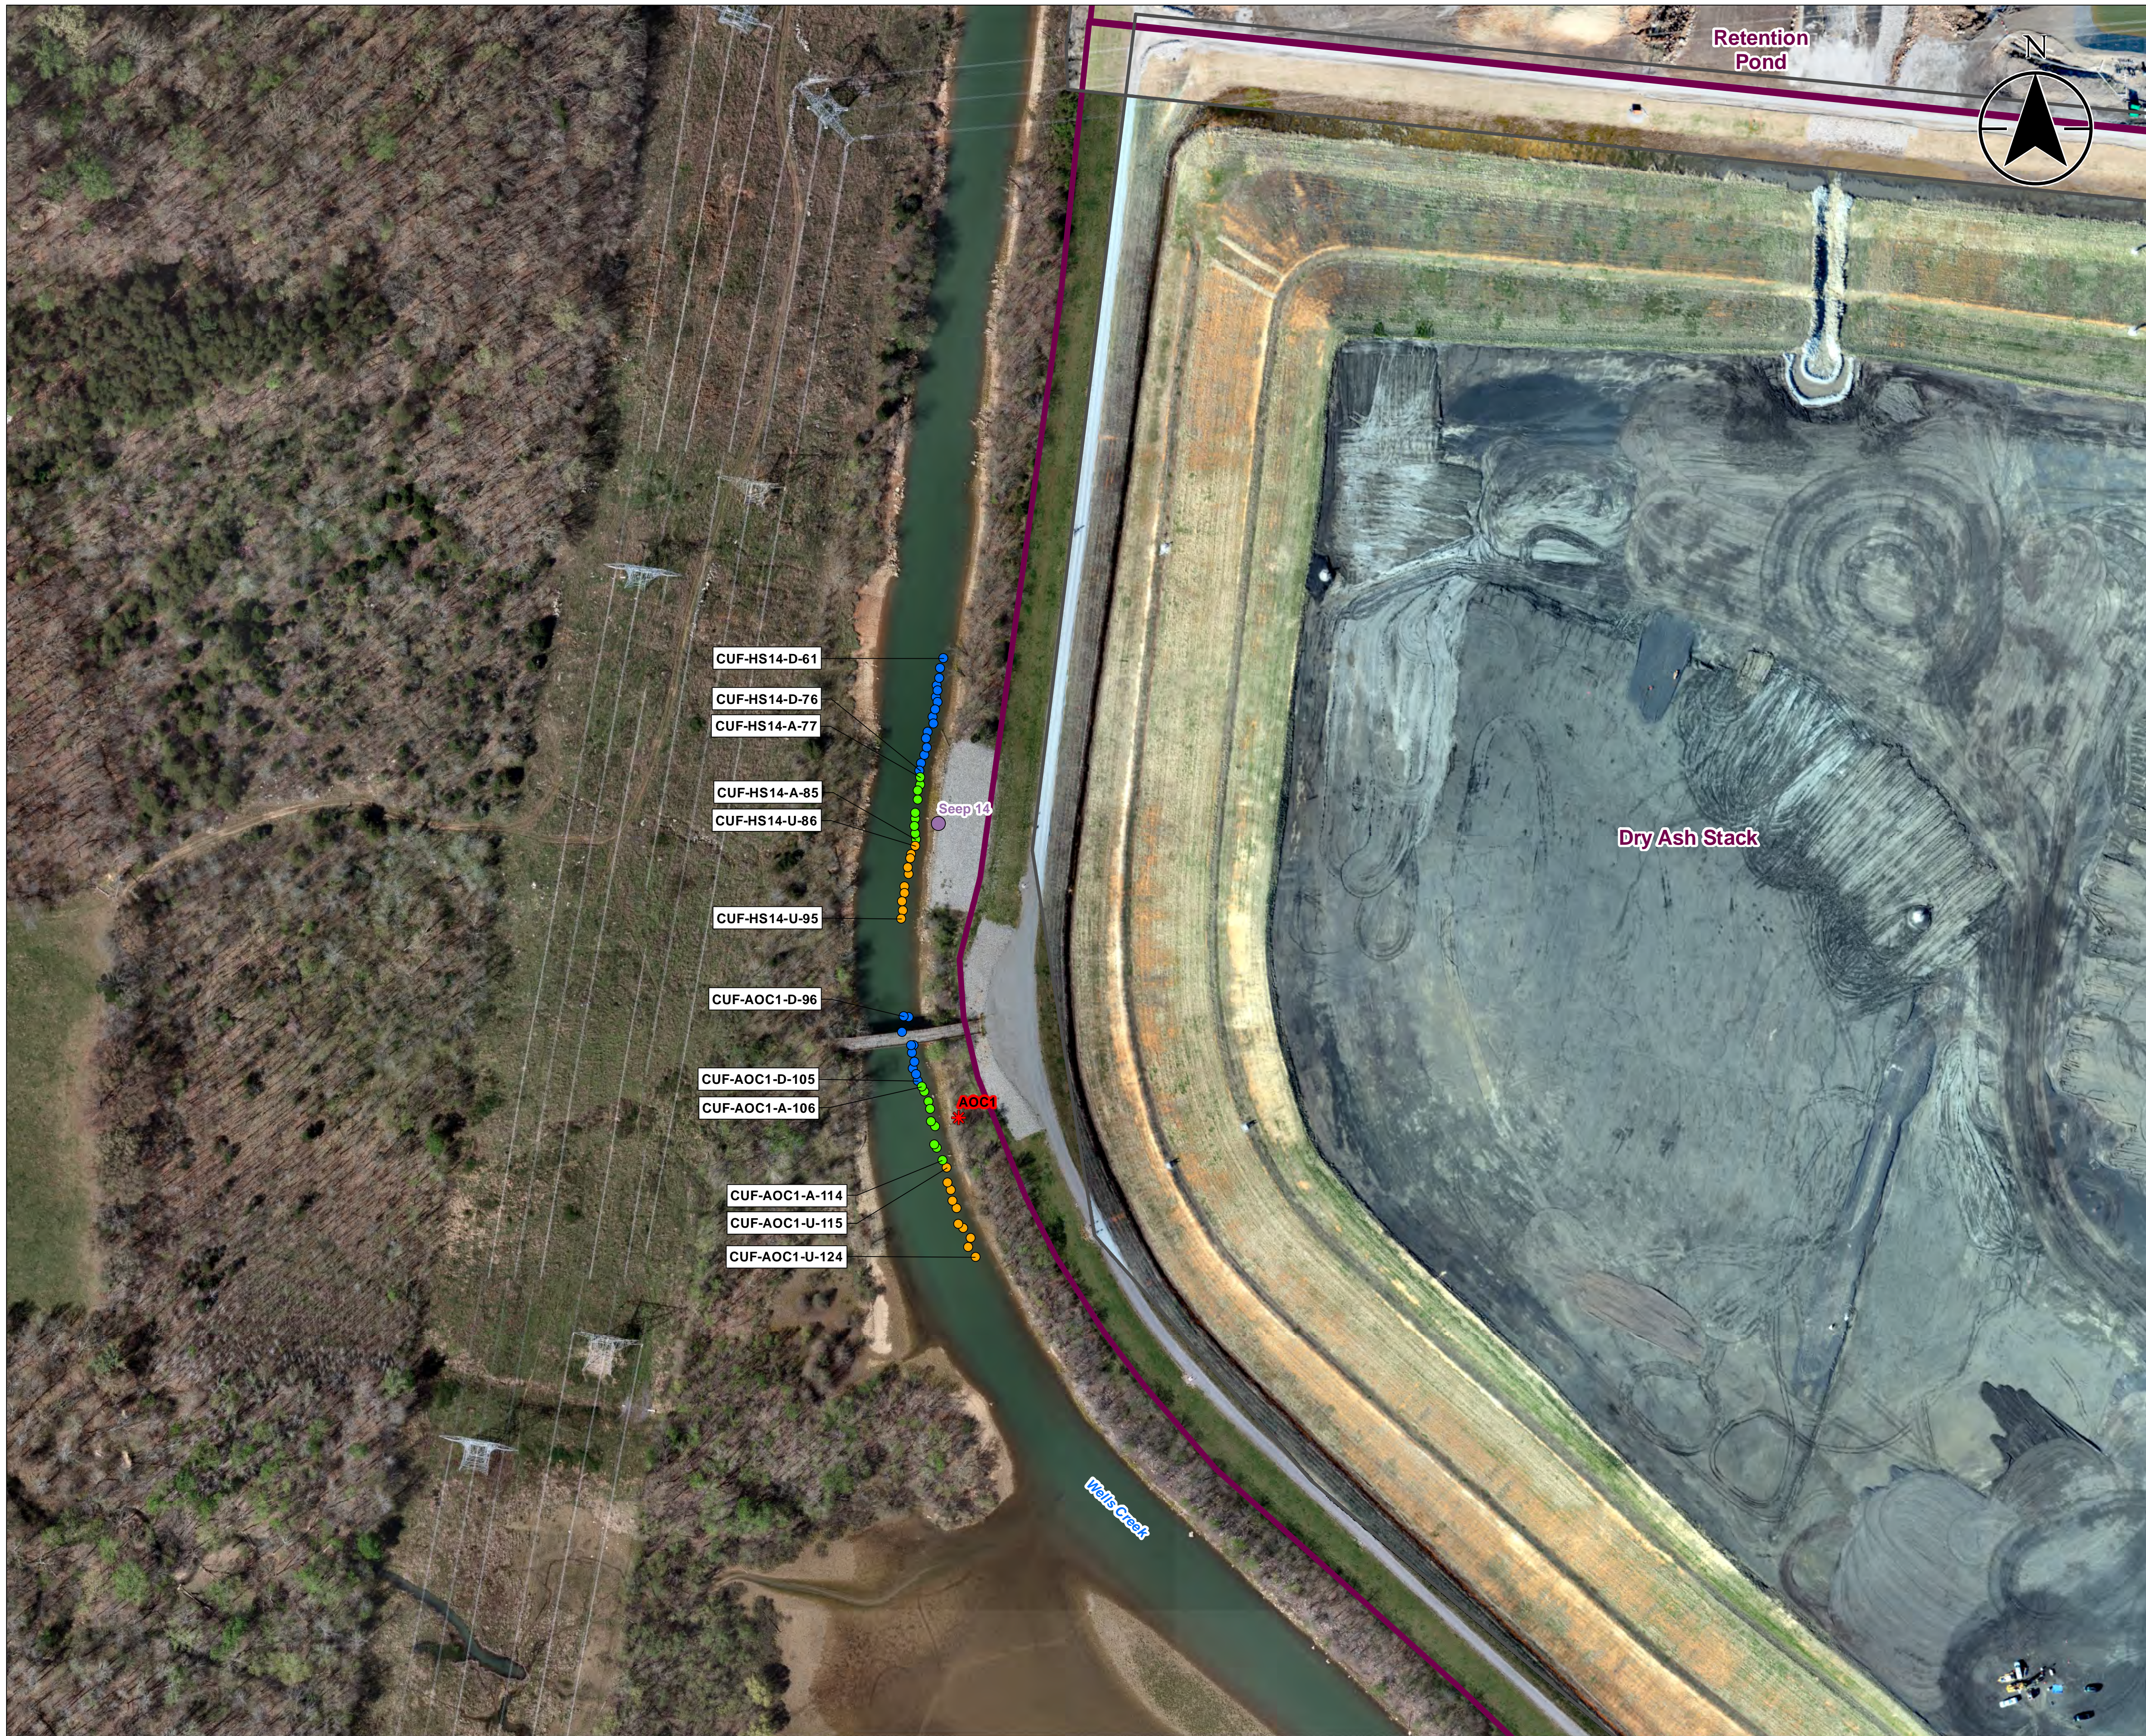
Exhibit No. **A.2**  
 Title **Water Quality Parameter Measurement Locations - Western Detail**

- CUF-HS14-D-61
- CUF-HS14-D-76
- CUF-HS14-A-77
- CUF-HS14-A-85
- CUF-HS14-U-86
- CUF-HS14-U-95
- CUF-AOC1-D-96
- CUF-AOC1-D-105
- CUF-AOC1-A-106
- CUF-AOC1-A-114
- CUF-AOC1-U-115
- CUF-AOC1-U-124

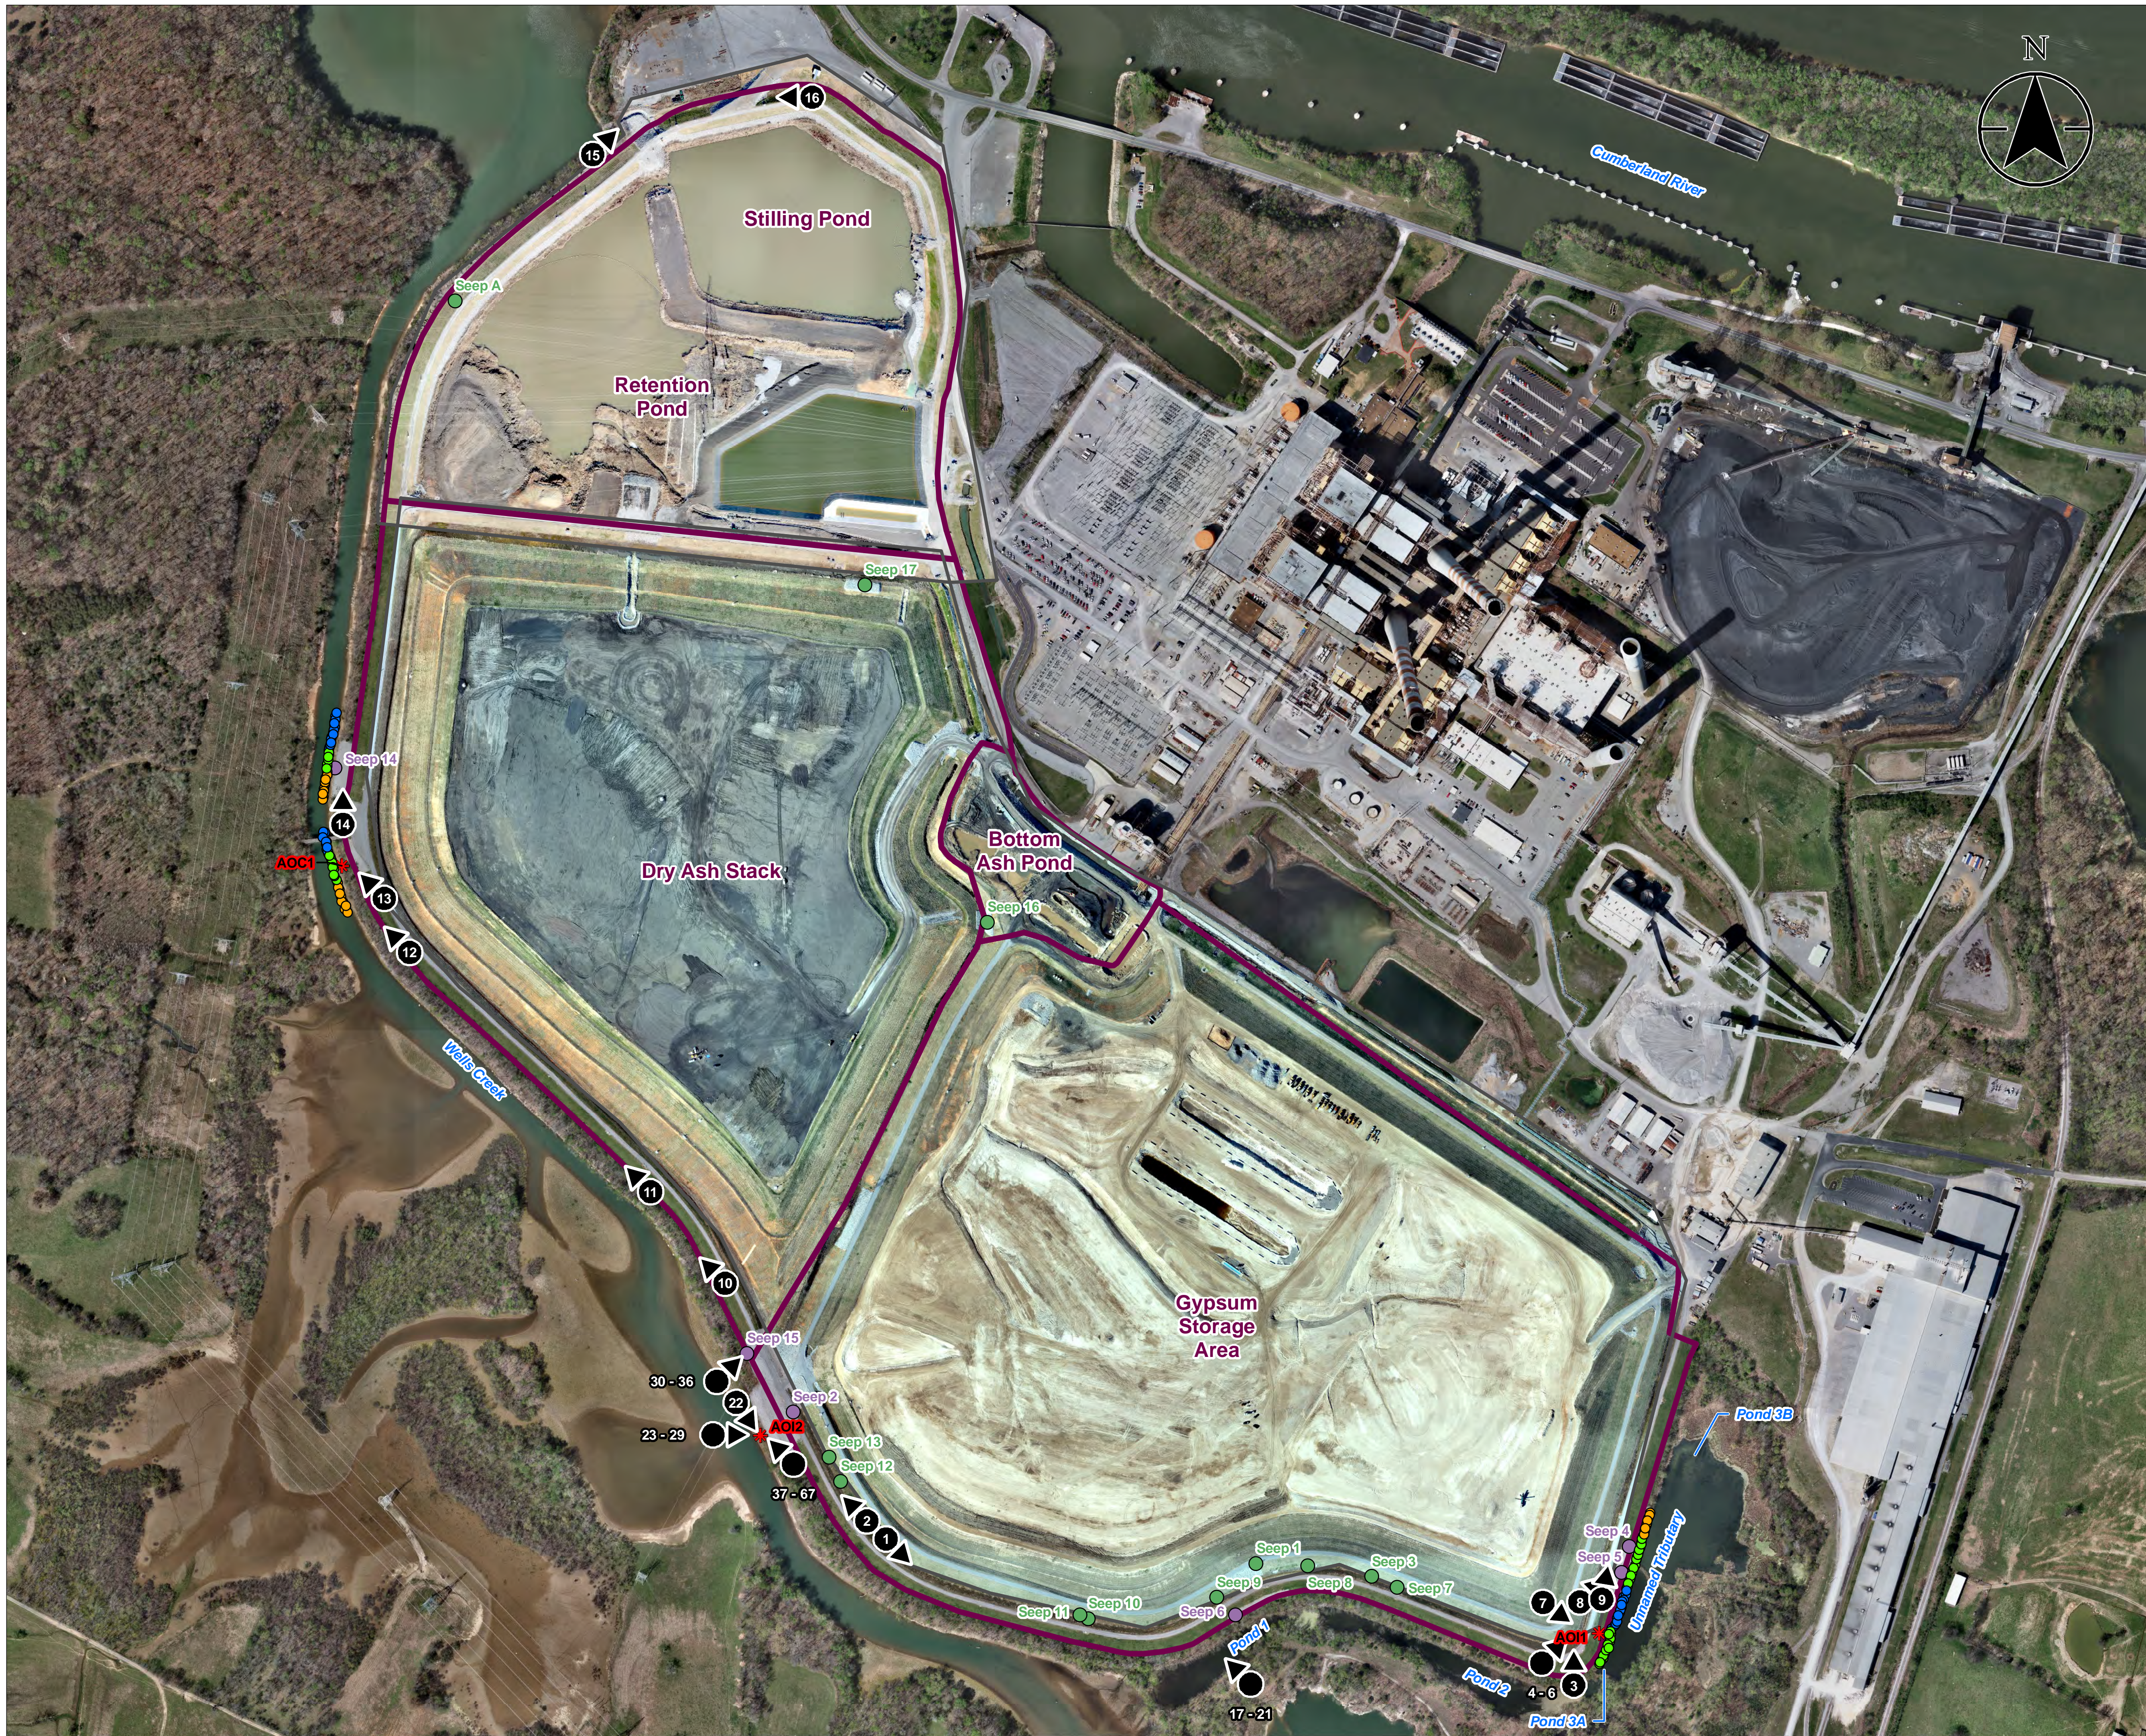
Exhibit No. **C.1**  
 Title **Photographs of Site Conditions**  
 Client/Project  
 Tennessee Valley Authority  
 Cumberland Fossil (CUF) Plant TDEC Order  
 Project Location  
 Stewart County, Tennessee  
 175568209  
 Prepared by MB on 2021-04-05  
 Technical Review by HW on 2021-04-05

- Notes**
1. Coordinate System: NAD 1983 StatePlane Tennessee FIPS 4100 Feet
  2. Imagery Provided by Tuck Mapping (c. 2017) and TVA (3/6/2019 and 12/11/2019)
  3. Photo location arrows with multiple photos identified depict the area and general direction the photos were taken. The direction each photo was taken is further detailed on the photographic log for each photo.

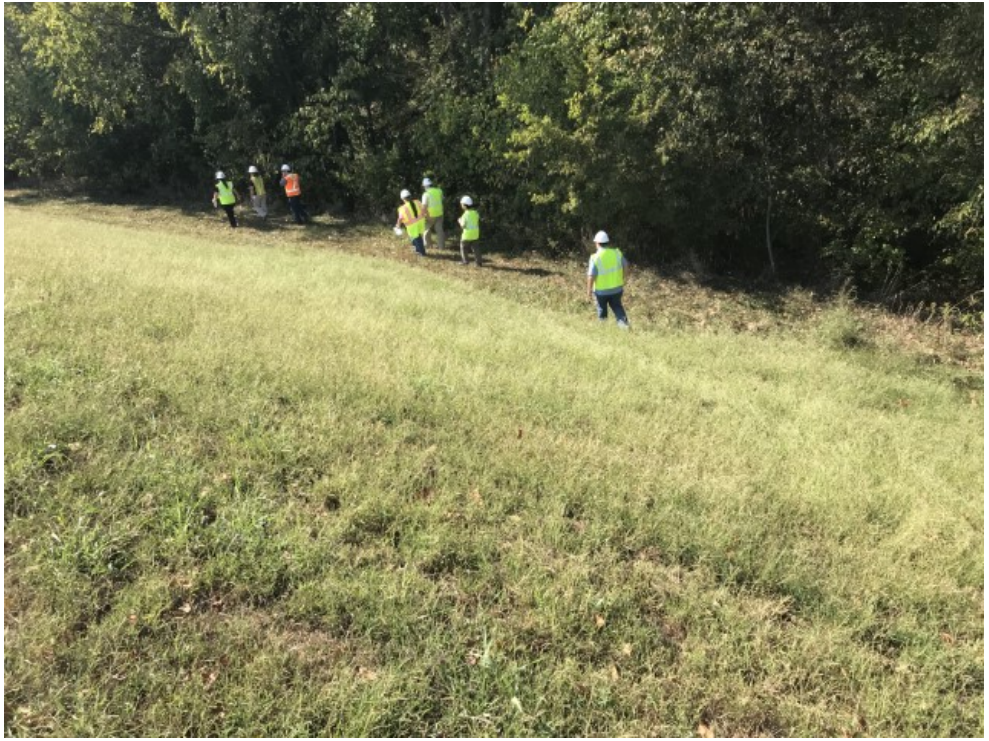
<b>Photo Location:</b> Gypsum Storage Area	
<b>Direction:</b> Southeast	
<b>Photo Date:</b> 10/1/2019	
<b>Comments:</b> Accessible area inspection: View below perimeter ditch, southwest side of Gypsum Storage Area

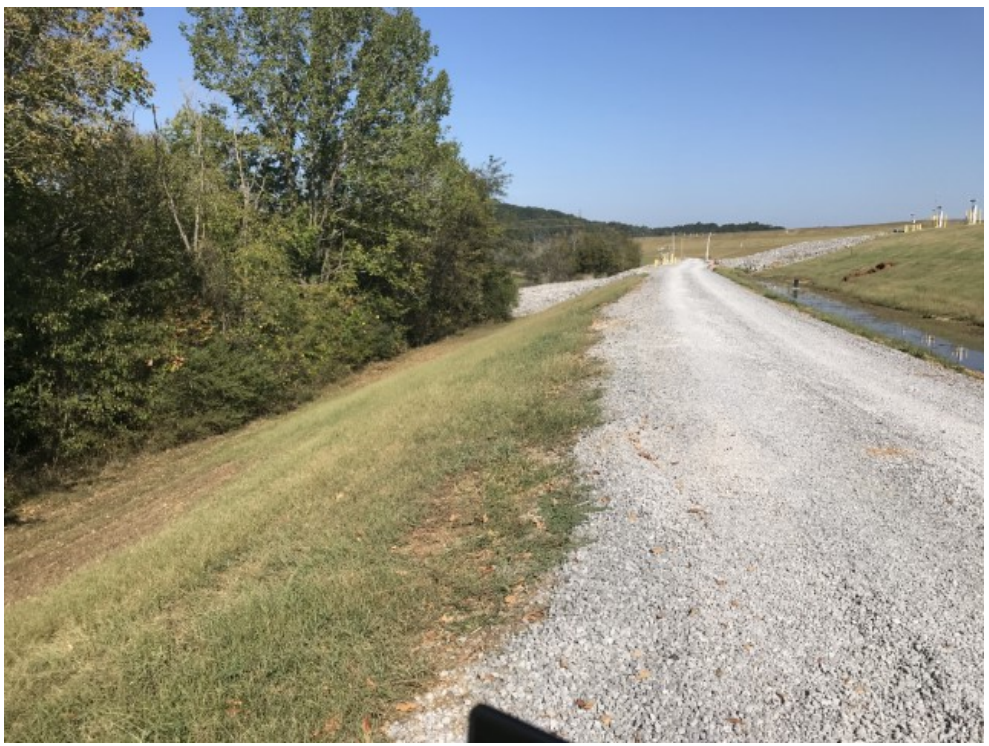
<b>Photo Location:</b> Gypsum Storage Area	
<b>Direction:</b> Northwest	
<b>Photo Date:</b> 10/1/2019	
<b>Comments:</b> Accessible area inspection: View from perimeter ditch access road, southwest side of Gypsum Storage Area

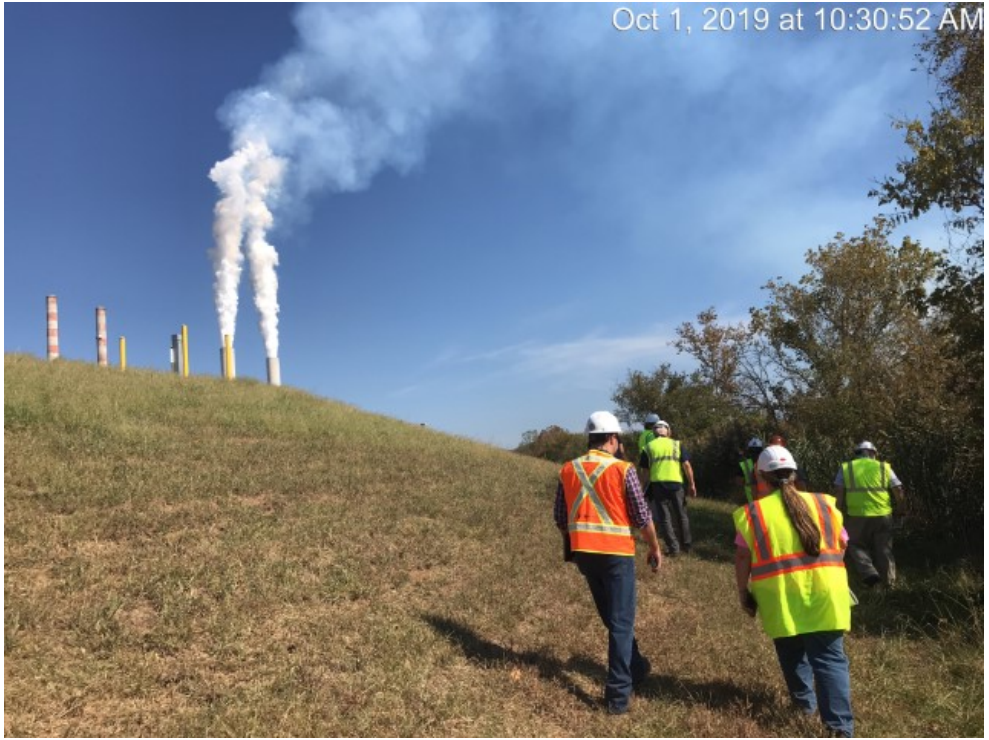
<p style="text-align: right;">Oct 1, 2019 at 10:30:52 AM</p>		
<b>Photo Location:</b>			
Gypsum Storage Area			
<b>Direction:</b>			
North			
<b>Photo Date:</b>			
10/1/2019			
<b>Comments:</b>			
Accessible area inspection: View below perimeter ditch, southeast side of Gypsum Storage Area			
<b>Photograph ID:</b> 4

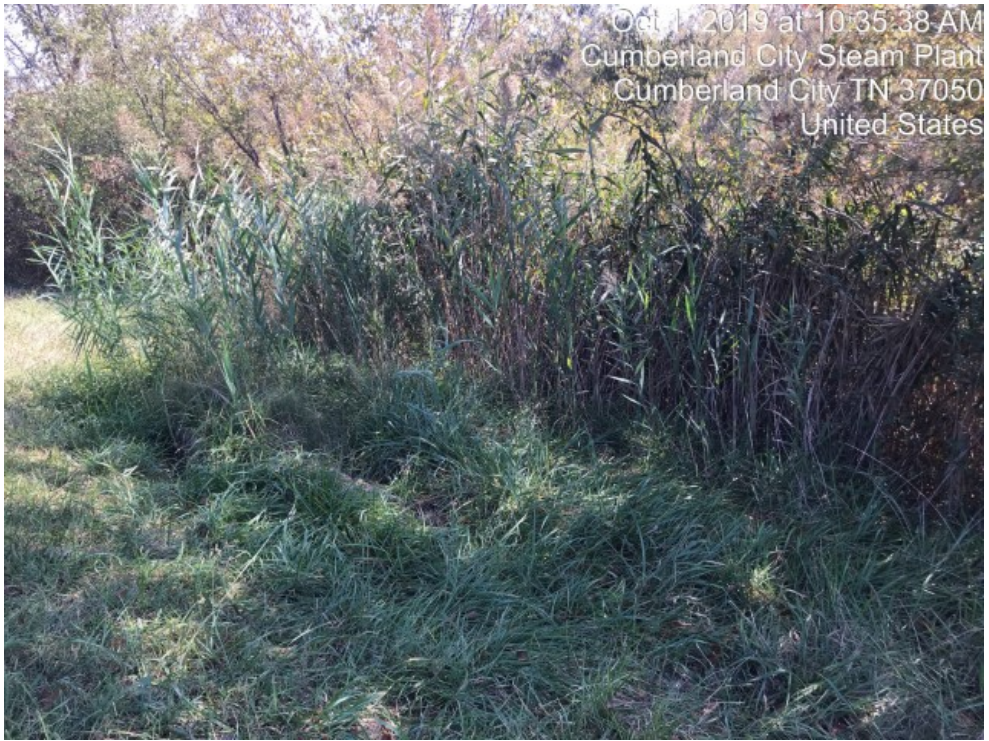
<p style="text-align: right;">Oct 1, 2019 at 10:35:38 AM Cumberland City Steam Plant Cumberland City TN 37050 United States</p>		
<b>Photo Location:</b>			
Area of Interest (AOI) 1			
<b>Direction:</b>			
Northeast			
<b>Photo Date:</b>			
10/1/2019			
<b>Comments:</b>			
Accessible area inspection: AOI 1 identified at change in vegetation (Common Reed); below perimeter ditch, southeast side of Gypsum Storage Area

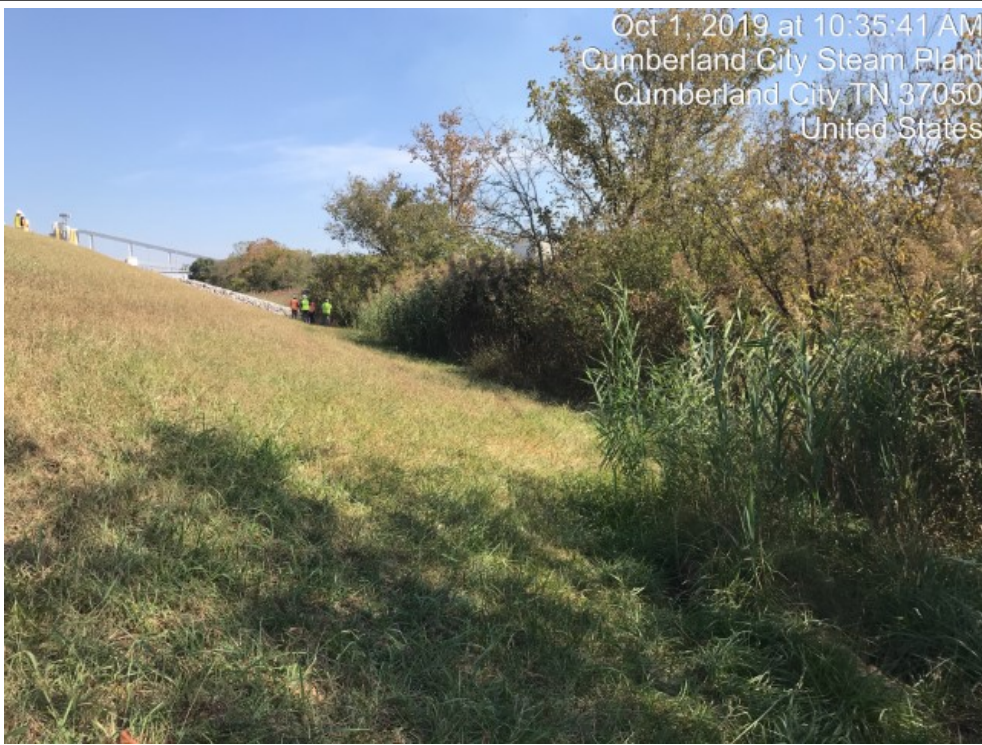
- AOI1 – change in vegetation (common reed) at the southeastern toe of the Gypsum Storage Area; visual observations were obscured due to dense vegetation, but no signs of wetness or discoloration were noted. TDEC requested that water quality measurements be taken adjacent to this location

<p>Oct 1, 2019 at 10:35:41 AM Cumberland City Steam Plant Cumberland City TN 37050 United States</p>
<b>Photo Location:</b> AOI 1/Historical Seeps 4 and 5	
<b>Direction:</b> North	
<b>Photo Date:</b> 10/1/2019	
<b>Comments:</b> Accessible area inspection: below perimeter ditch, southeast side of Gypsum Storage Area; reverse grade filter to the north

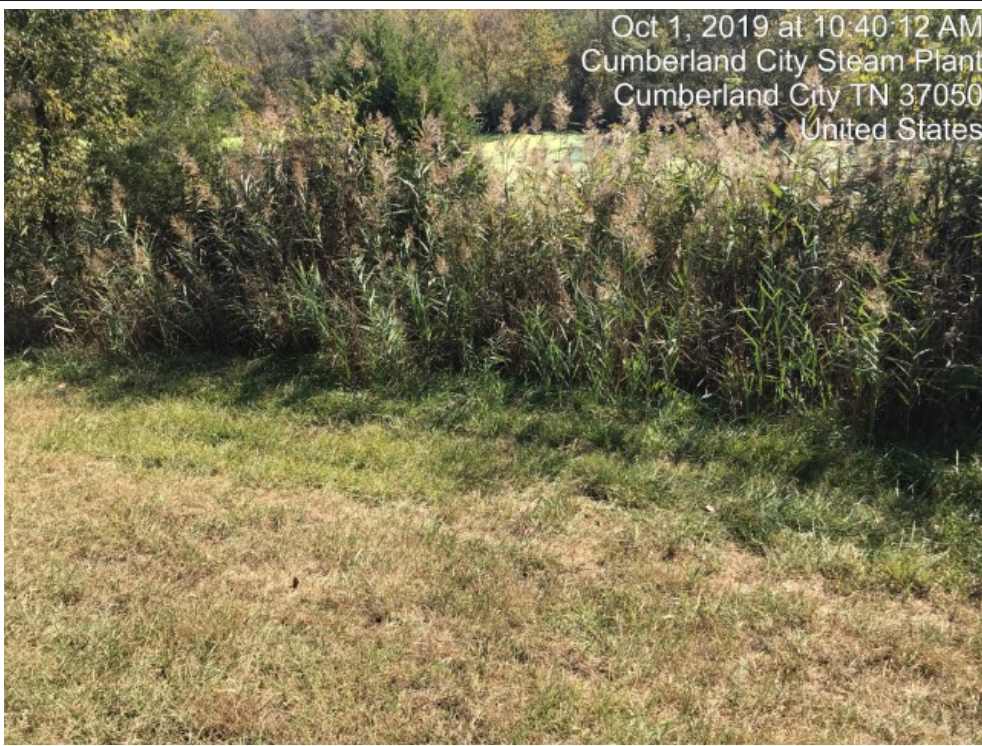
<p>Oct 1, 2019 at 10:40:12 AM Cumberland City Steam Plant Cumberland City TN 37050 United States</p>
<b>Photo Location:</b> AOI 1	
<b>Direction:</b> Northeast	
<b>Photo Date:</b> 10/1/2019	
<b>Comments:</b> Accessible area inspection: below perimeter ditch, southeast side of Gypsum Storage Area; unnamed tributary pond to the northeast

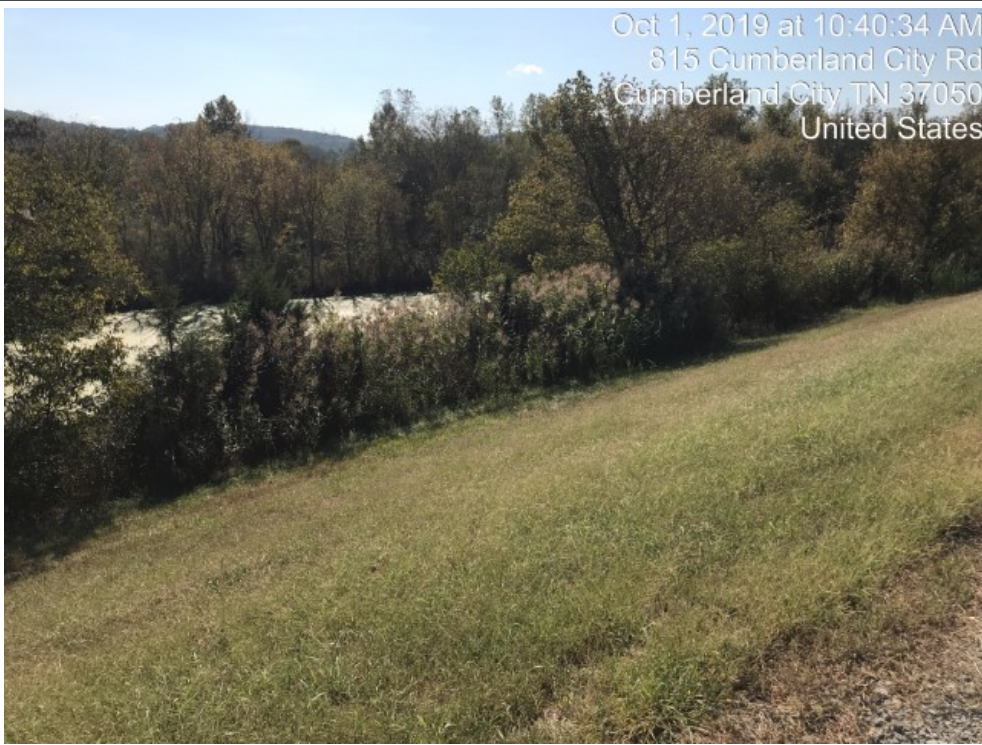
<p>Oct 1, 2019 at 10:40:34 AM 815 Cumberland City Rd Cumberland City TN 37050 United States</p>
<b>Photo Location:</b> AOI 1	
<b>Direction:</b> Southeast	
<b>Photo Date:</b> 10/1/2019	
<b>Comments:</b> Accessible area inspection: below perimeter ditch, southeast side of Gypsum Storage Area; unnamed tributary ponds to the southeast

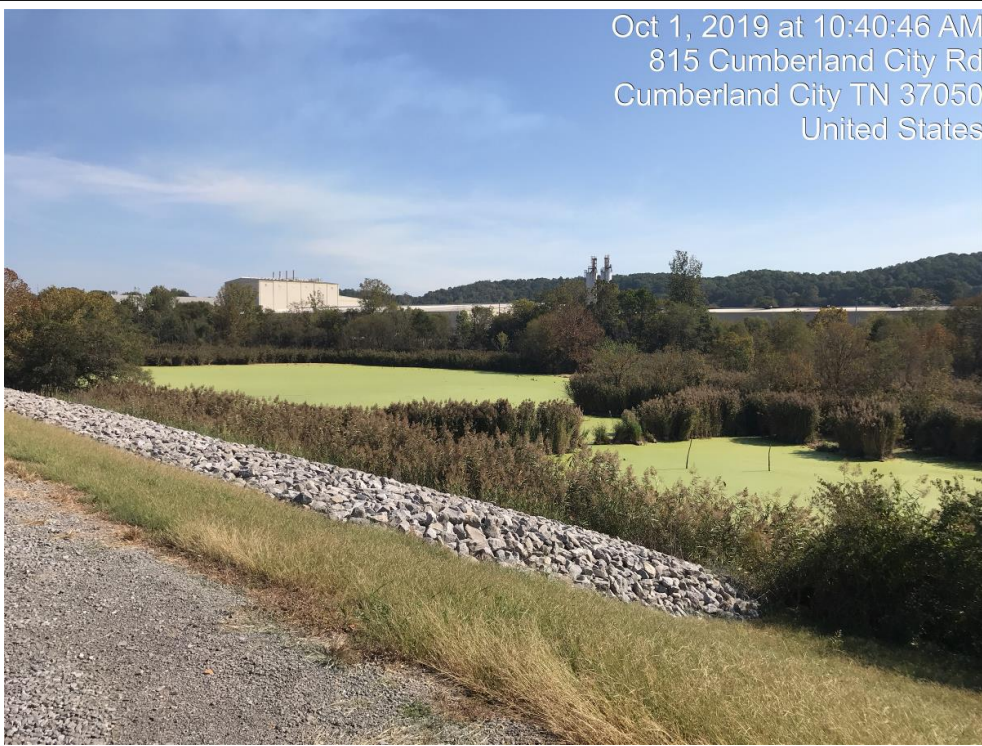
- Historical Seeps 4 and 5 – change in vegetation (common reed) in the riprap area east of the Gypsum Storage Area, located below the perimeter ditch and adjacent to Ponds 3A and 3B of the “Unnamed Tributary” which occasionally discharges to Wells Creek during high flow; no signs of wetness or discoloration were noted

<p>Oct 1, 2019 at 10:40:46 AM 815 Cumberland City Rd Cumberland City TN 37050 United States</p>
<b>Photo Location:</b> Historical Seeps 4 and 5	
<b>Direction:</b> Northeast	
<b>Photo Date:</b> 10/1/2019	
<b>Comments:</b> Accessible area inspection: reverse grade filter; southeast side of Gypsum Storage Area; unnamed tributary ponds to the northeast

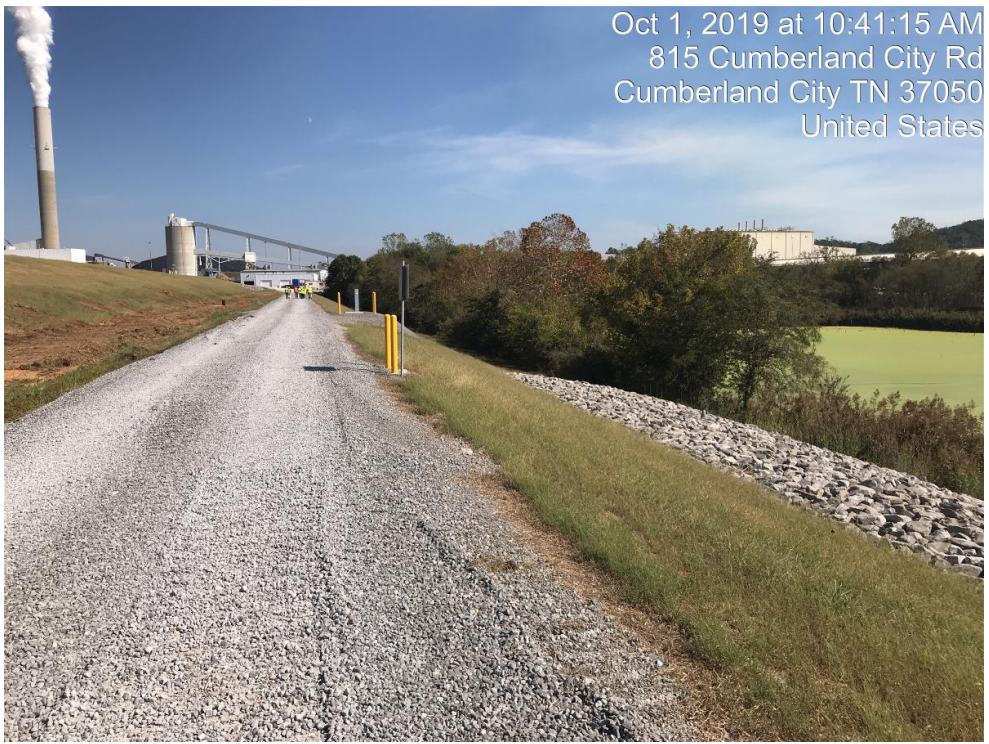
<p>Oct 1, 2019 at 10:41:15 AM 815 Cumberland City Rd Cumberland City TN 37050 United States</p>		
<b>Photo Location:</b> Historical Seeps 4 and 5			
<b>Direction:</b> Northeast			
<b>Photo Date:</b> 10/1/2019			
<b>Comments:</b> Accessible area inspection: reverse grade filter; southeast side of Gypsum Storage Area; unnamed tributary ponds to the northeast			
<b>Photograph ID:</b> 10

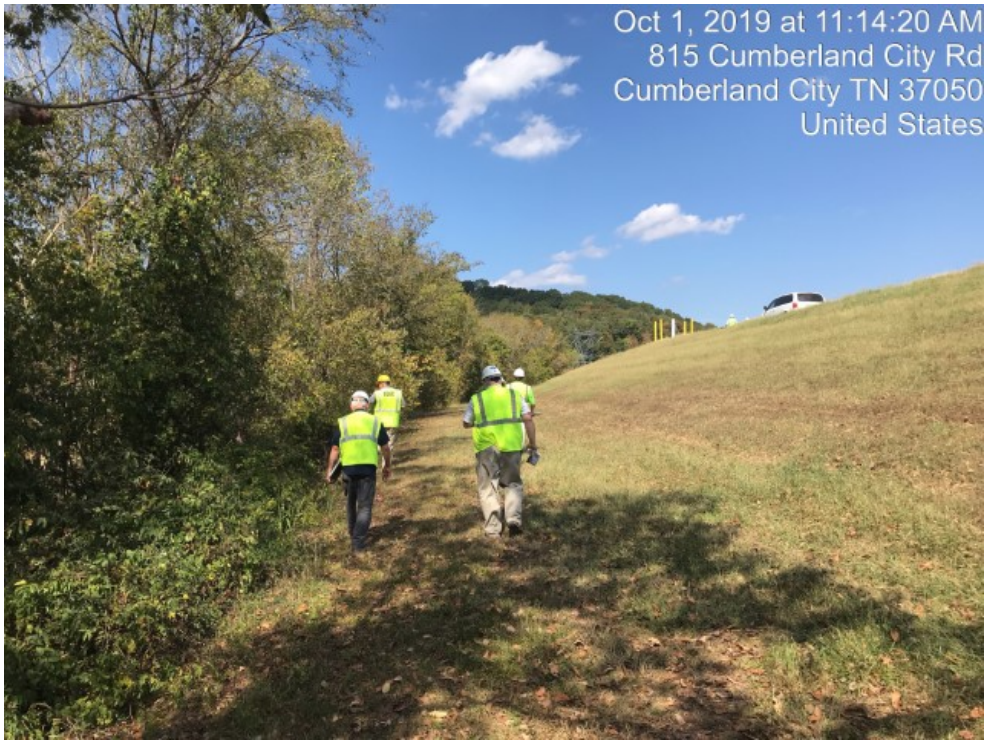
<p>Oct 1, 2019 at 11:14:20 AM 815 Cumberland City Rd Cumberland City TN 37050 United States</p>		
<b>Photo Location:</b> Dry Ash Stack			
<b>Direction:</b> Northwest			
<b>Photo Date:</b> 10/1/2019			
<b>Comments:</b> Accessible area inspection: view below perimeter ditch, south side of Dry Ash Stack

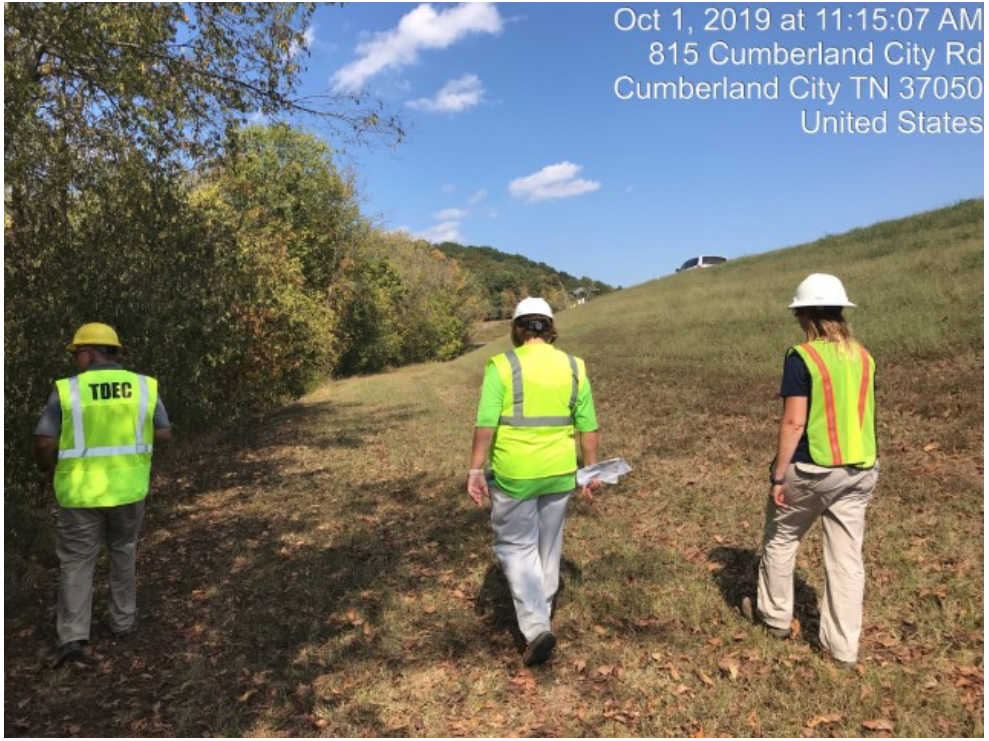
- Historical Seep 14 – riprap area west of Dry Ash Stack, located below the perimeter ditch and adjacent to Wells Creek; no signs of wetness or discoloration were noted

<b>Photograph ID:</b> 12	Oct 1, 2019 at 11:17:14 AM 815 Cumberland City Rd Cumberland City TN 37050 United States
<b>Photo Location:</b> Dry Ash Stack	
<b>Direction:</b> Northwest	
<b>Photo Date:</b> 10/1/2019	
<b>Comments:</b> Accessible area inspection: view of riprap and bridge over Wells Creek to south of Historical Seep 14; below perimeter ditch, west side of Dry Ash Stack

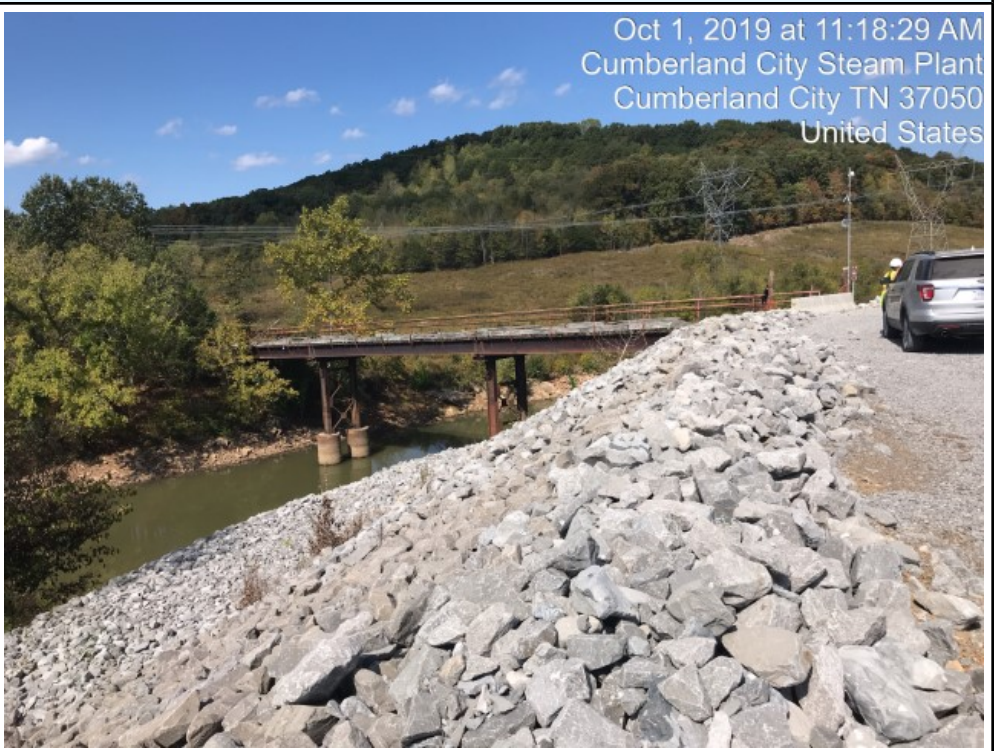
<p style="text-align: right;">Oct 1, 2019 at 11:18:29 AM Cumberland City Steam Plant Cumberland City TN 37050 United States</p>
<b>Photo Location:</b> Historical Area of Concern (AOC) 1	
<b>Direction:</b> Northwest	
<b>Photo Date:</b> 10/1/2019	
<b>Comments:</b> Accessible area inspection: view of riprap and bridge over Wells Creek south of Historical Seep 14; below perimeter ditch, west side of Dry Ash Stack

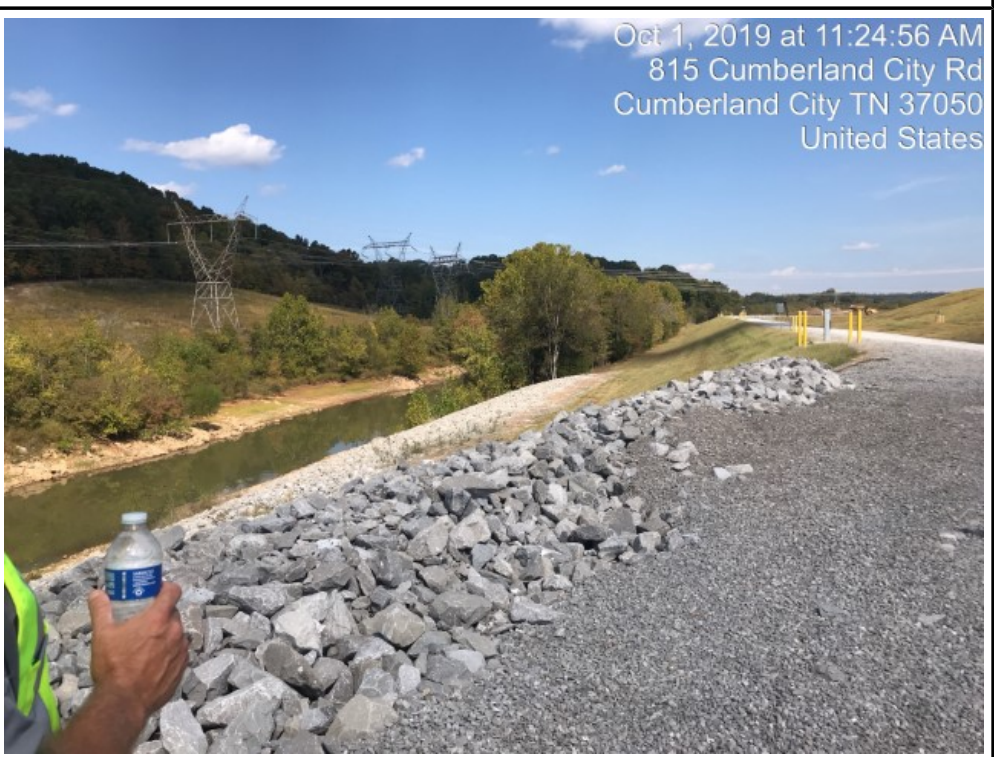
<p style="text-align: right;">Oct 1, 2019 at 11:24:56 AM 815 Cumberland City Rd Cumberland City TN 37050 United States</p>
<b>Photo Location:</b> Historical Seep 14	
<b>Direction:</b> North	
<b>Photo Date:</b> 10/1/2019	
<b>Comments:</b> Accessible area inspection: reverse grade filter; below perimeter ditch, west side of Dry Ash Stack

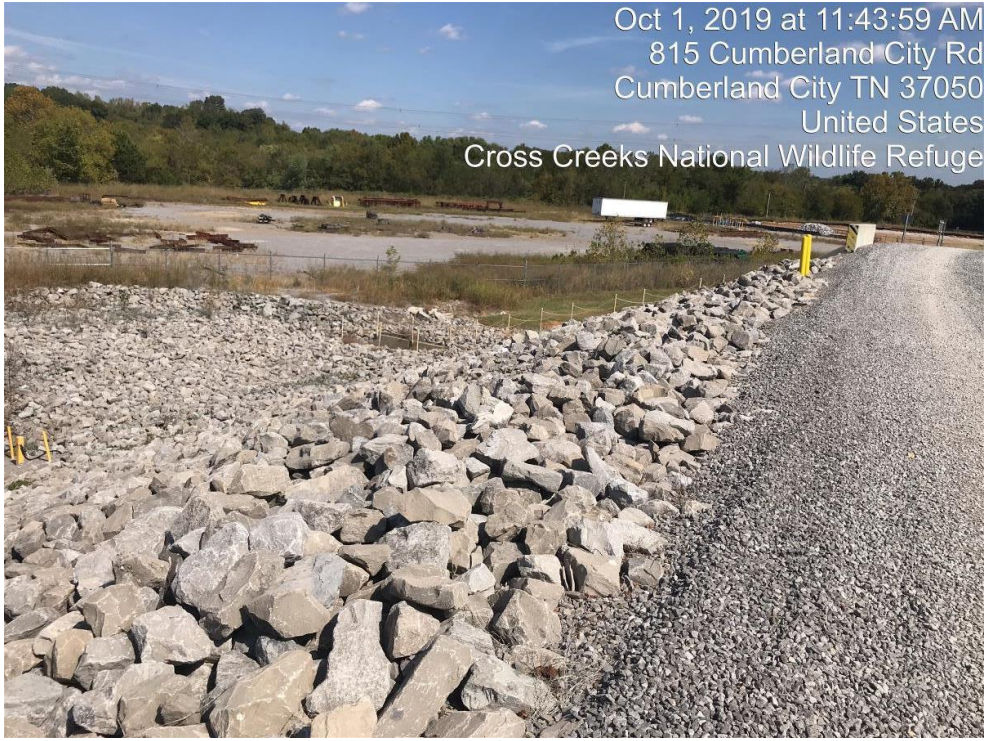
<p>Oct 1, 2019 at 11:43:59 AM 815 Cumberland City Rd Cumberland City TN 37050 United States Cross Creeks National Wildlife Refuge</p>
<b>Photo Location:</b> Stilling Pond	
<b>Direction:</b> Northeast	
<b>Photo Date:</b> 10/1/2019	
<b>Comments:</b> Accessible area inspection: view of outer riprap area at northwest side of Stilling Pond

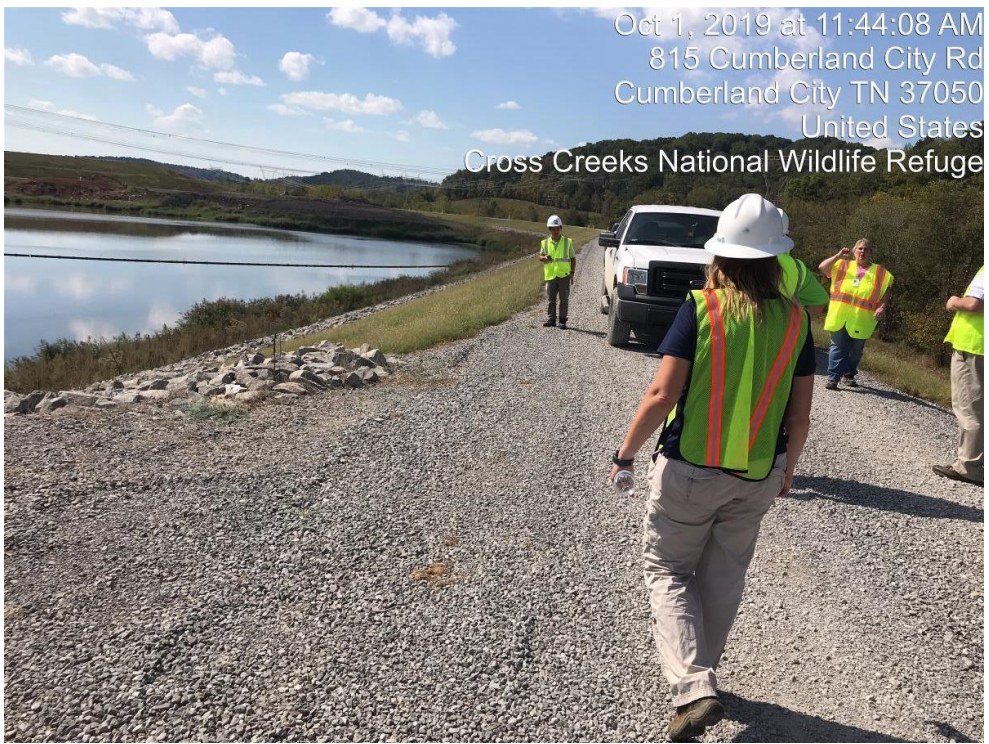
<p>Oct 1, 2019 at 11:44:08 AM 815 Cumberland City Rd Cumberland City TN 37050 United States Cross Creeks National Wildlife Refuge</p>
<b>Photo Location:</b> Stilling Pond	
<b>Direction:</b> West	
<b>Photo Date:</b> 10/1/2019	
<b>Comments:</b> Accessible area inspection: view of outer riprap area at northwest side of Stilling Pond

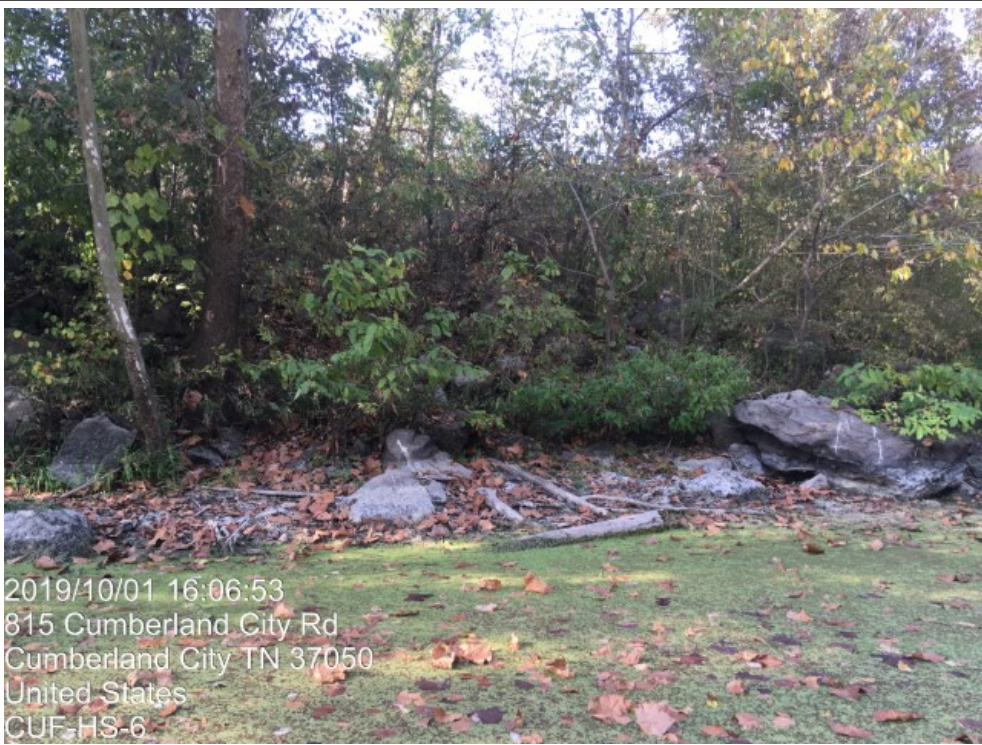
- Historical Seep 6 – riprap area south of the Gypsum Storage Area below the perimeter ditch and adjacent to Pond 1 of the unnamed tributary; no signs of wetness or discoloration were noted

<b>Photo Location:</b> Historical Seep 6	
<b>Direction:</b> Northwest	
<b>Photo Date:</b> 10/1/2019	
<b>Comments:</b> Boat inspection: shoreline below perimeter ditch; south side of Gypsum Storage Area

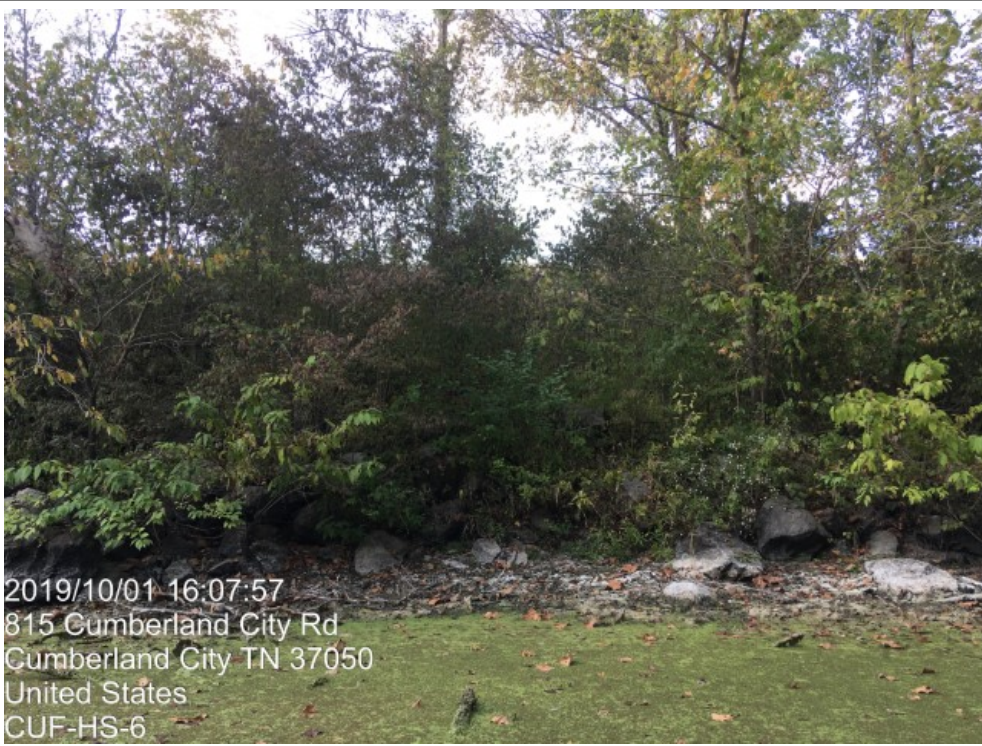
<b>Photo Location:</b> Historical Seep 6	
<b>Direction:</b> Northwest	
<b>Photo Date:</b> 10/1/2019	
<b>Comments:</b> Boat inspection: shoreline below perimeter ditch; south side of Gypsum Storage Area

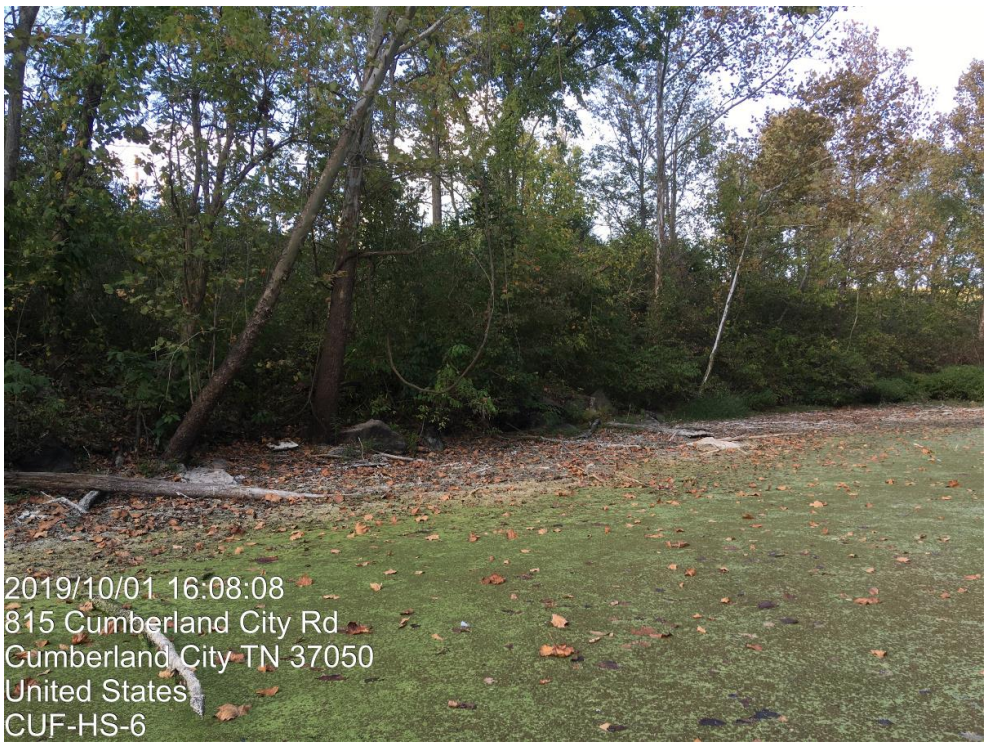
<p>2019/10/01 16:08:08 815 Cumberland City Rd Cumberland City TN 37050 United States CUF-HS-6</p>		
<b>Photo Location:</b> Historical Seep 6			
<b>Direction:</b> North			
<b>Photo Date:</b> 10/1/2019			
<b>Comments:</b> Boat inspection: shoreline below perimeter ditch; south side of Gypsum Storage Area			
<b>Photograph ID:</b> 20
