**Cumberland Fossil Plant  
Seep Sampling and Analysis  
Report**

TDEC Commissioner's Order:  
Environmental Investigation Plan  
Cumberland Fossil Plant  
Cumberland City, Tennessee

April 9, 2021

Stantec Consulting Services Inc.  
Lexington, Kentucky

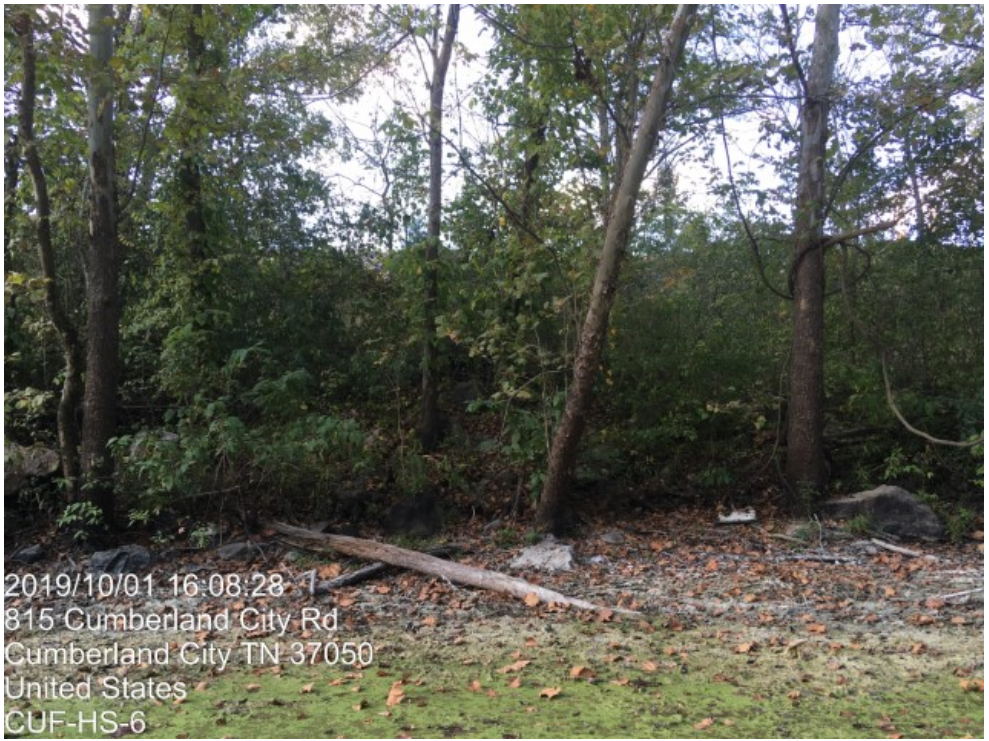
<p>2019/10/01 16:08:28 815 Cumberland City Rd Cumberland City TN 37050 United States CUF-HS-6</p>		
<b>Photo Location:</b> Historical Seep 6			
<b>Direction:</b> North			
<b>Photo Date:</b> 10/1/2019			
<b>Comments:</b> Boat inspection: shoreline below perimeter ditch; south side of Gypsum Storage Area

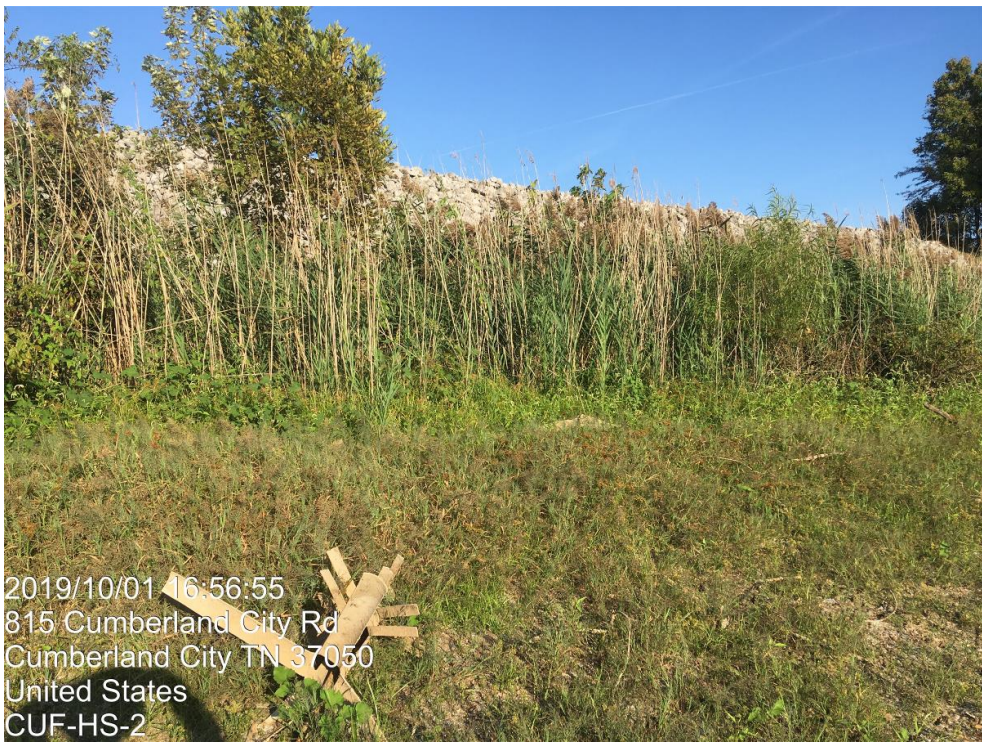
<b>Photo Location:</b> AOI 2/Historical Seep 2	
<b>Direction:</b> East	
<b>Photo Date:</b> 10/1/2019	
<b>Comments:</b> Boat inspection: reverse grade filter; area vegetated with Common Reed; southwest side of Gypsum Storage Area

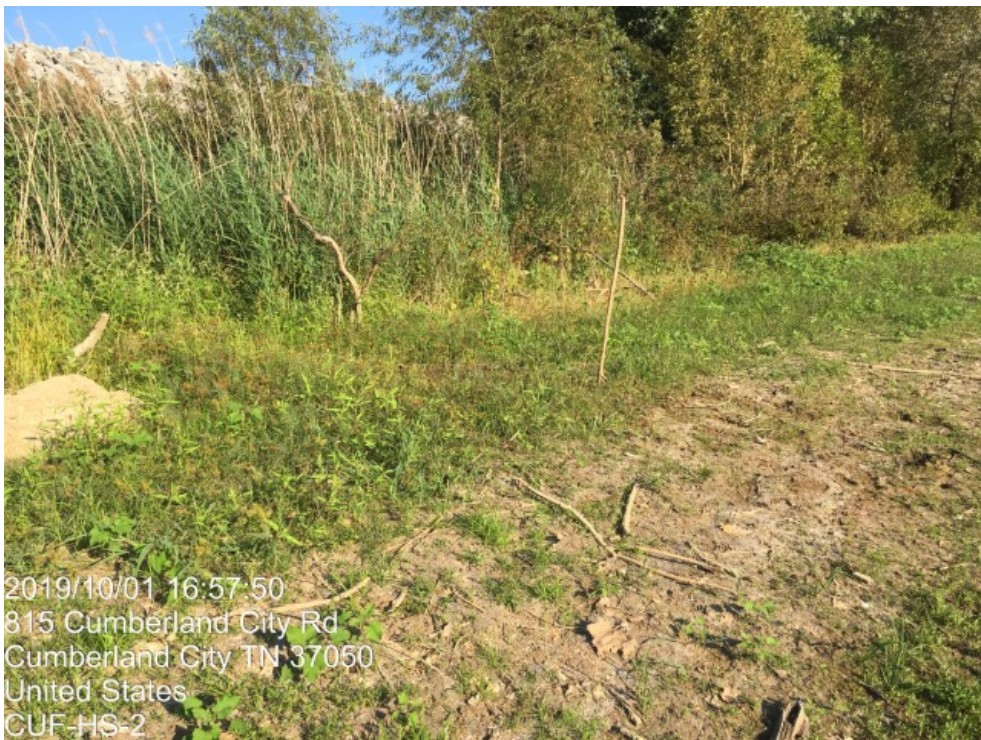
<b>Photo Location:</b> AOI 2/Historical Seep 2			
<b>Direction:</b> Southeast			
<b>Photo Date:</b> 10/1/2019			
<b>Comments:</b> Boat inspection: water flow downslope of reverse grade filter and area vegetated with Common Reed; southeast side of Gypsum Storage Area			
<b>Photograph ID:</b> 26

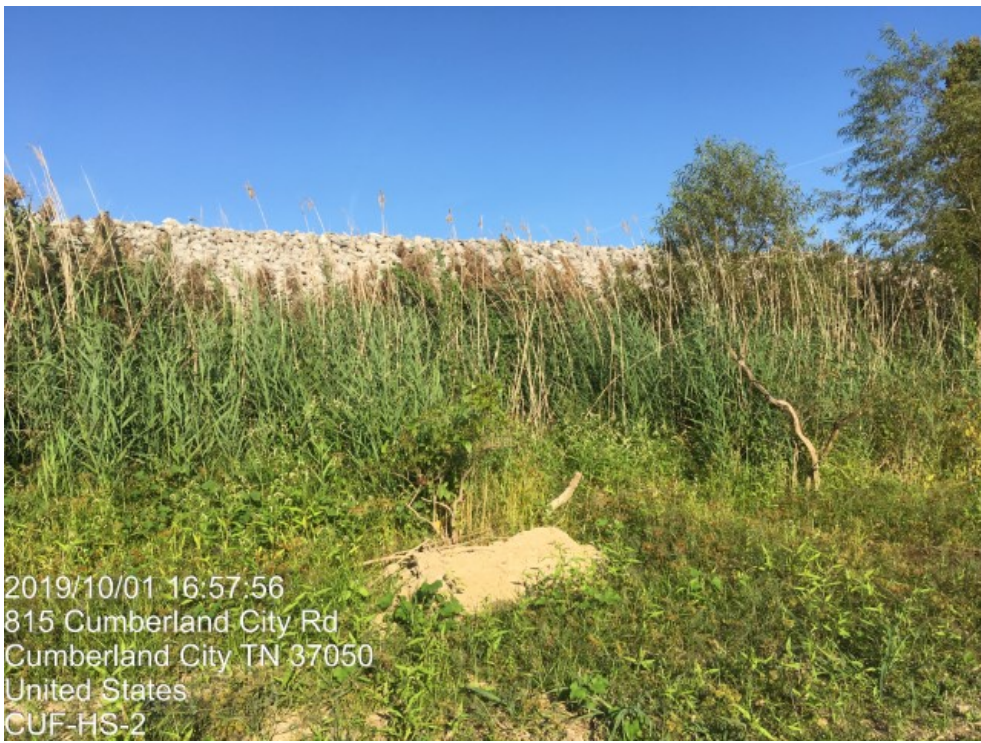
<b>Photo Location:</b> AOI 2/Historical Seep 2			
<b>Direction:</b> East			
<b>Photo Date:</b> 10/1/2019			
<b>Comments:</b> Boat inspection: reverse grade filter; area vegetated with Common Reed; southwest side of Gypsum Storage Area.

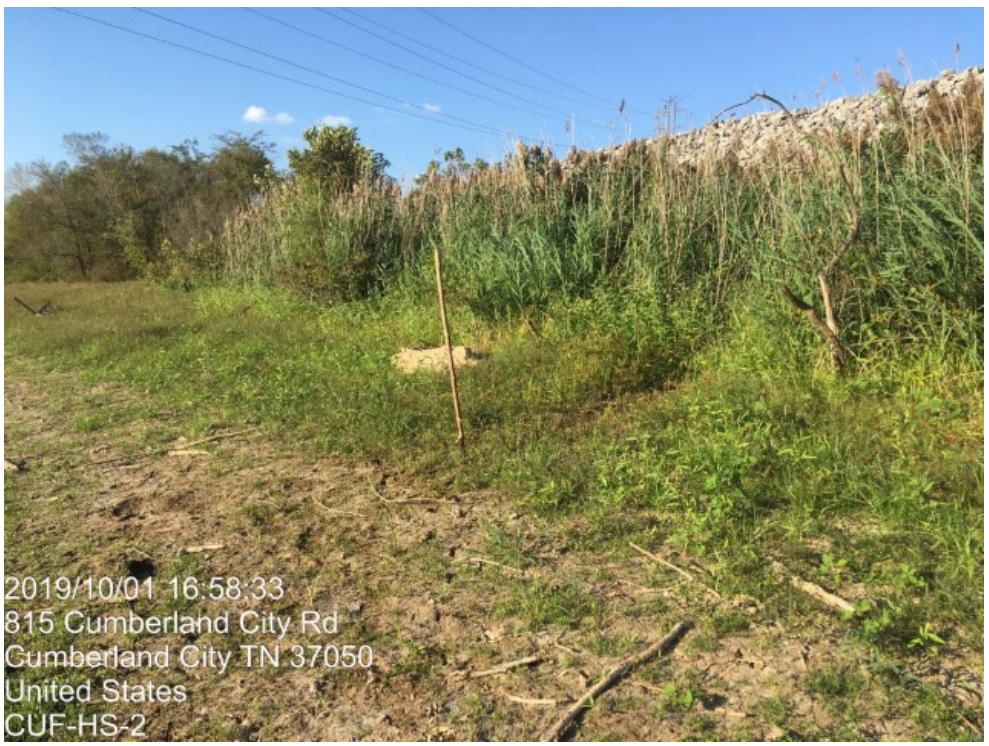
<b>Photo Location:</b> AOI 2/Historical Seep 2	
<b>Direction:</b> Northeast	
<b>Photo Date:</b> 10/1/2019	
<b>Comments:</b> Boat inspection: water flow downslope of reverse grade filter and area vegetated with Common Reed; southeast side of Gypsum Storage Area

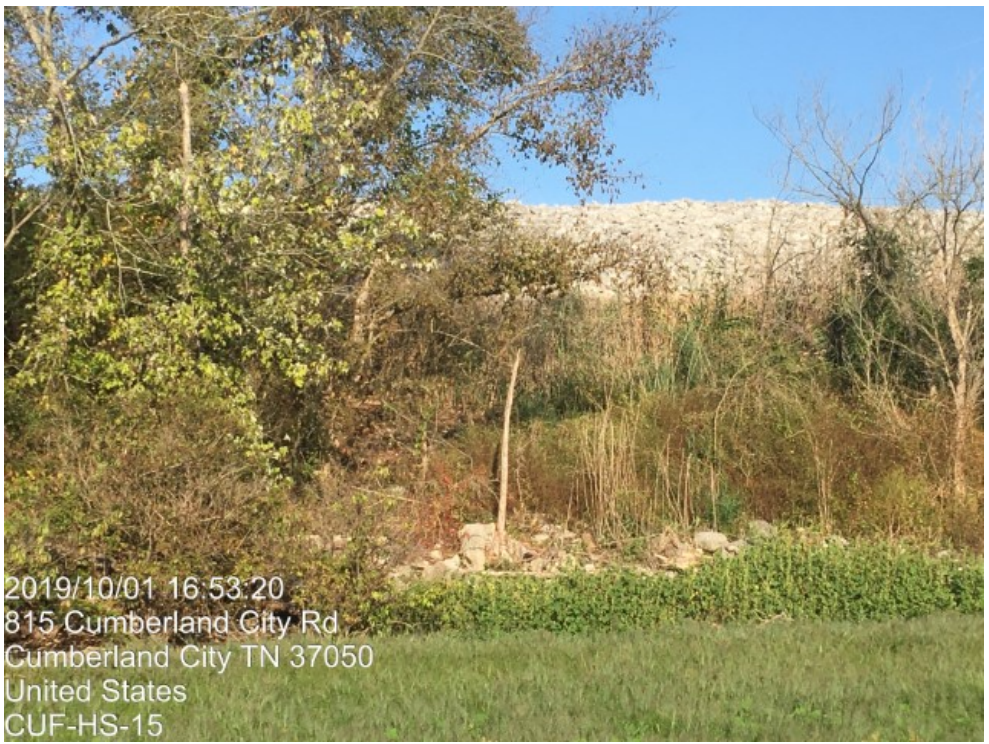
<b>Photo Location:</b> Historical Seep 15			
<b>Direction:</b> Northeast			
<b>Photo Date:</b> 10/1/2019			
<b>Comments:</b> Boat inspection: downslope of reverse grade filter; southern corner of Dry Ash Stack			
	<p>2019/10/01 16:53:20 815 Cumberland City Rd Cumberland City TN 37050 United States CUF-HS-15</p>		
<b>Photograph ID:</b> 32

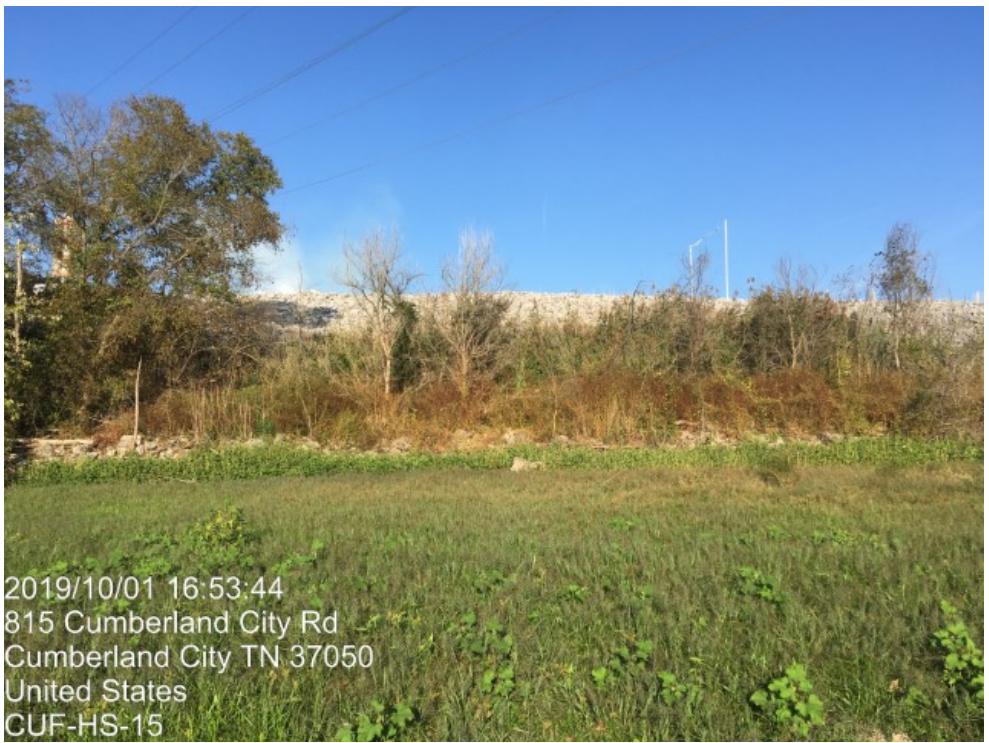
<b>Photo Location:</b> Historical Seep 15			
<b>Direction:</b> Northeast			
<b>Photo Date:</b> 10/1/2019			
<b>Comments:</b> Boat inspection: downslope of reverse grade filter; southern corner of Dry Ash Stack			
	<p>2019/10/01 16:53:44 815 Cumberland City Rd Cumberland City TN 37050 United States CUF-HS-15</p>

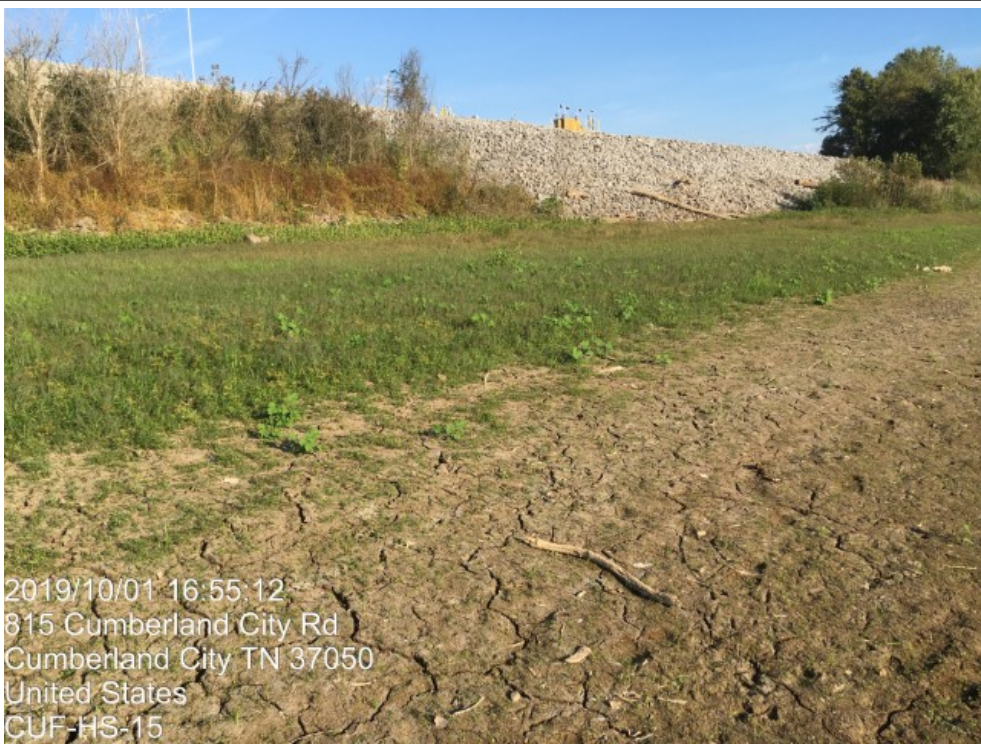
<b>Photo Location:</b> Historical Seep 15	
<b>Direction:</b> East	
<b>Photo Date:</b> 10/1/2019	
<b>Comments:</b> Boat inspection: downslope of reverse grade filter; southern corner of Dry Ash Stack

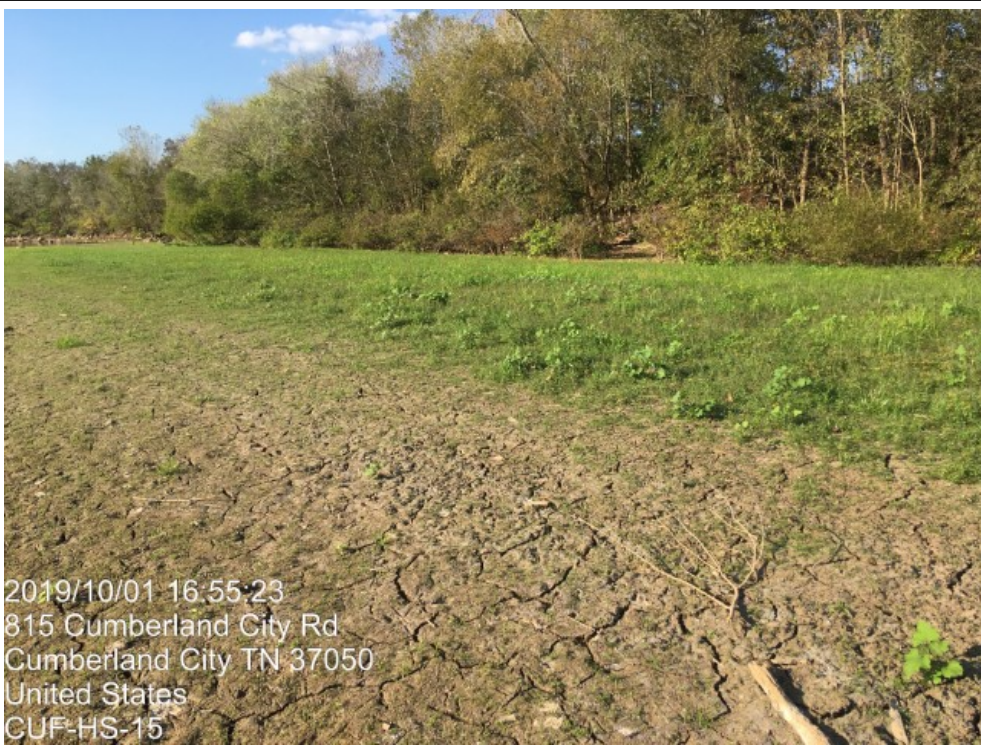
<b>Photo Location:</b> Dry Ash Stack	
<b>Direction:</b> North	
<b>Photo Date:</b> 10/1/2019	
<b>Comments:</b> Boat inspection: shoreline northwest of Historical Seep 15; southern corner of Dry Ash Stack

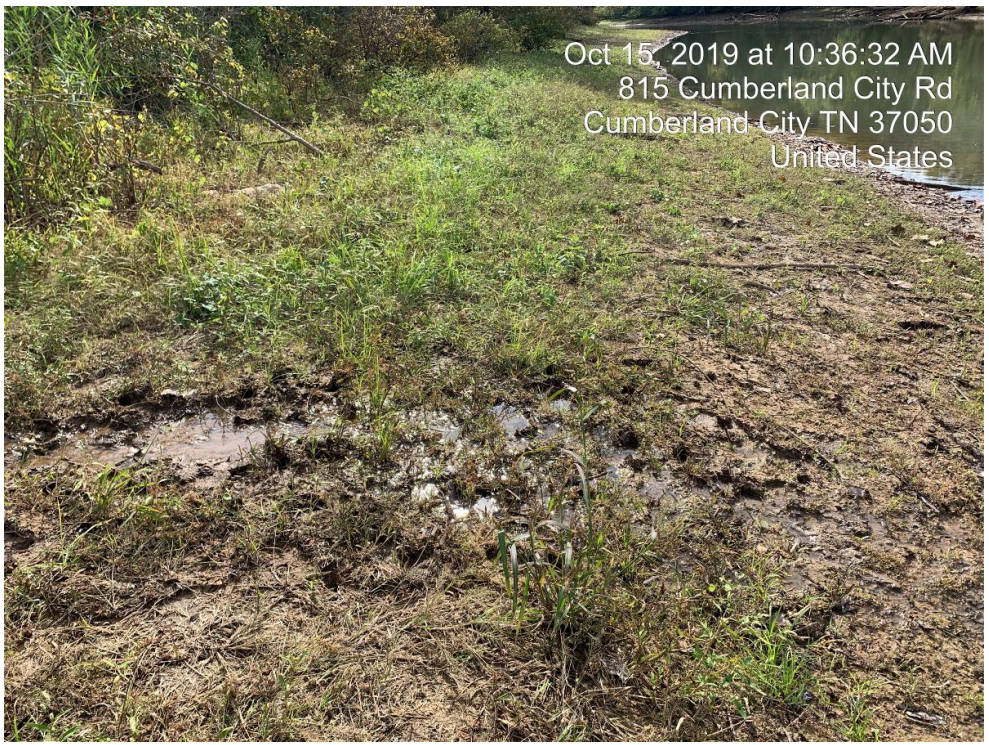
<b>Photo Location:</b> AOI 2	
<b>Direction:</b> Southeast	
<b>Photo Date:</b> 10/15/2019	
<b>Comments:</b> AOI 2 observation; water flow present

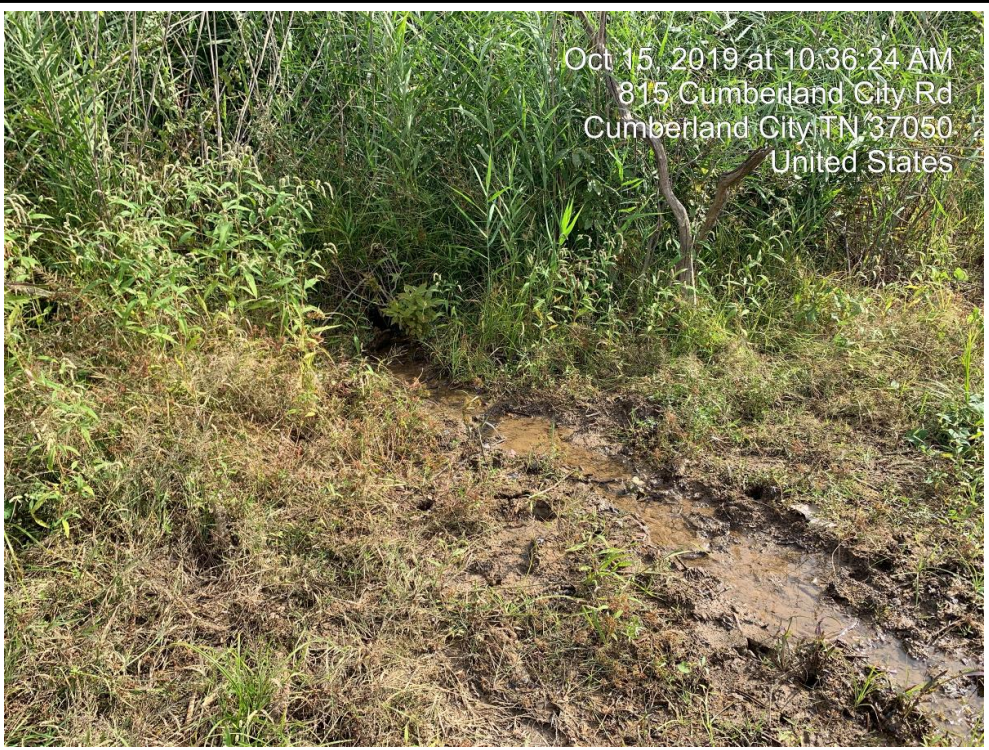
<b>Photo Location:</b> AOI 2	
<b>Direction:</b> East	
<b>Photo Date:</b> 10/15/2019	
<b>Comments:</b> AOI 2 observation; water flow present

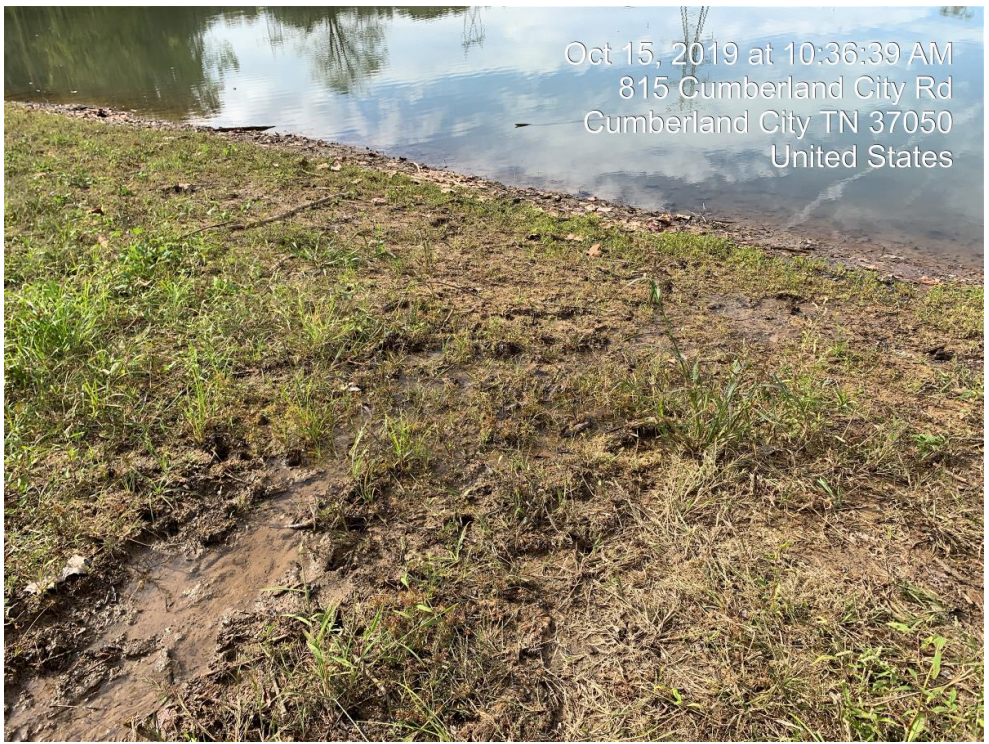
<p>Oct 15, 2019 at 10:36:39 AM 815 Cumberland City Rd Cumberland City TN 37050 United States</p>		
<b>Photo Location:</b> AOI 2			
<b>Direction:</b> Southwest			
<b>Photo Date:</b> 10/15/2019			
<b>Comments:</b> AOI 2 observation; water flow present			
<b>Photograph ID:</b> 42

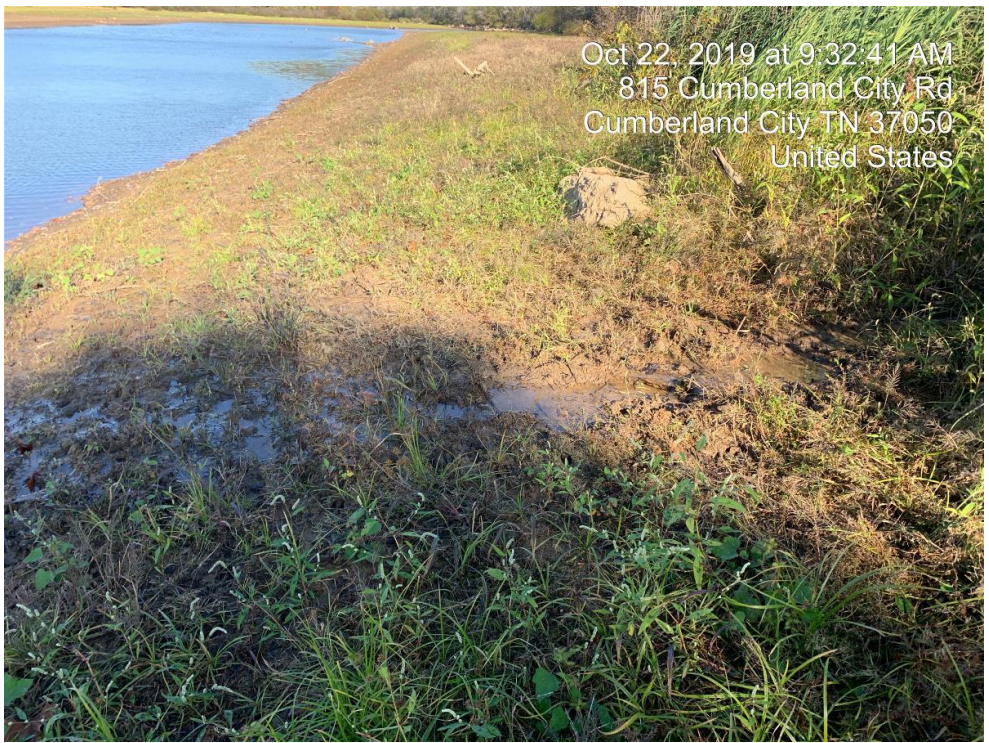
<p>Oct 22, 2019 at 9:32:41 AM 815 Cumberland City Rd Cumberland City TN 37050 United States</p>		
<b>Photo Location:</b> AOI 2			
<b>Direction:</b> Northeast			
<b>Photo Date:</b> 10/22/2019			
<b>Comments:</b> AOI 2 observation; water flow present

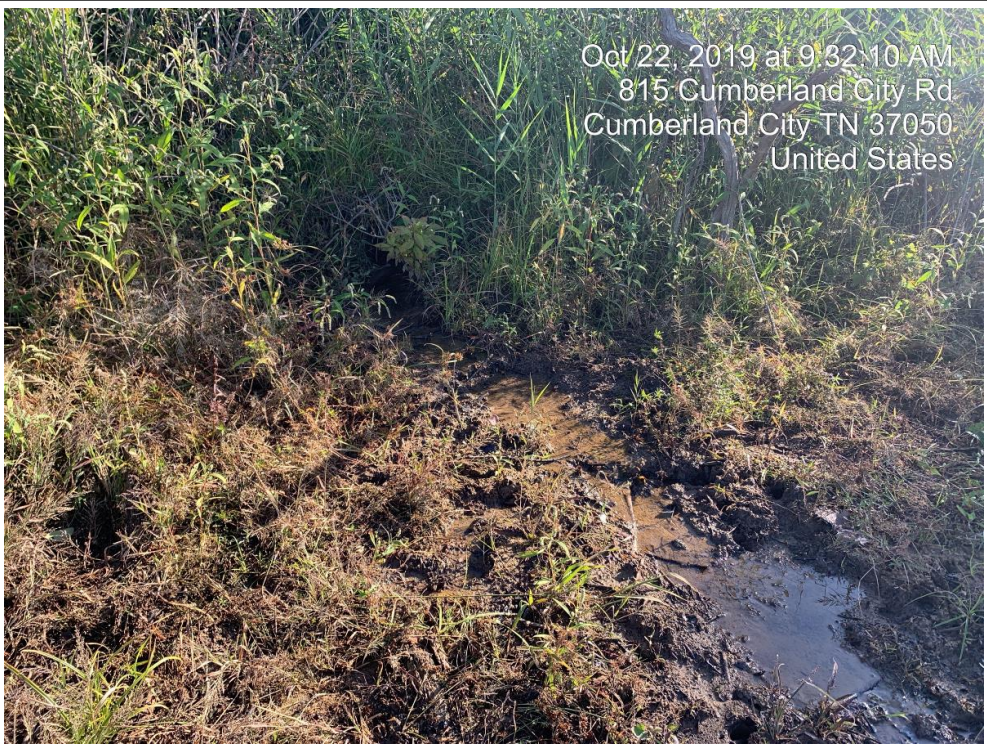
<p>Oct 22, 2019 at 9:32:10 AM 815 Cumberland City Rd Cumberland City TN 37050 United States</p>
<b>Photo Location:</b> AOI 2	
<b>Direction:</b> East	
<b>Photo Date:</b> 10/22/2019	
<b>Comments:</b> AOI 2 observation; water flow present

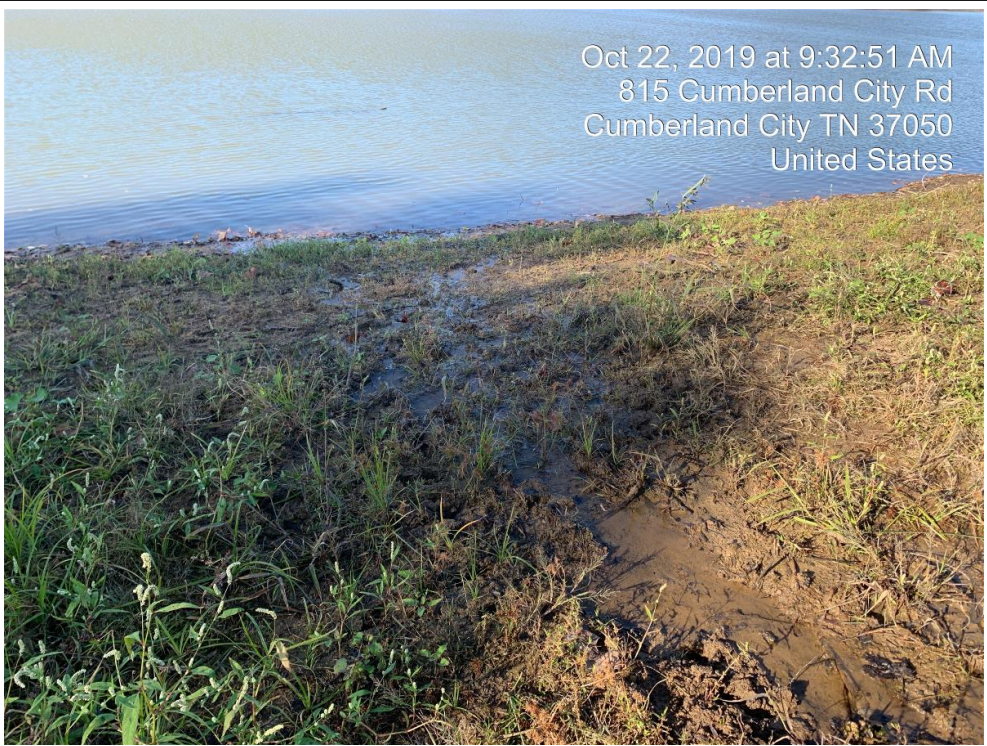
<p>Oct 22, 2019 at 9:32:51 AM 815 Cumberland City Rd Cumberland City TN 37050 United States</p>
<b>Photo Location:</b> AOI 2	
<b>Direction:</b> Southwest	
<b>Photo Date:</b> 10/22/2019	
<b>Comments:</b> AOI 2 observation; water flow present

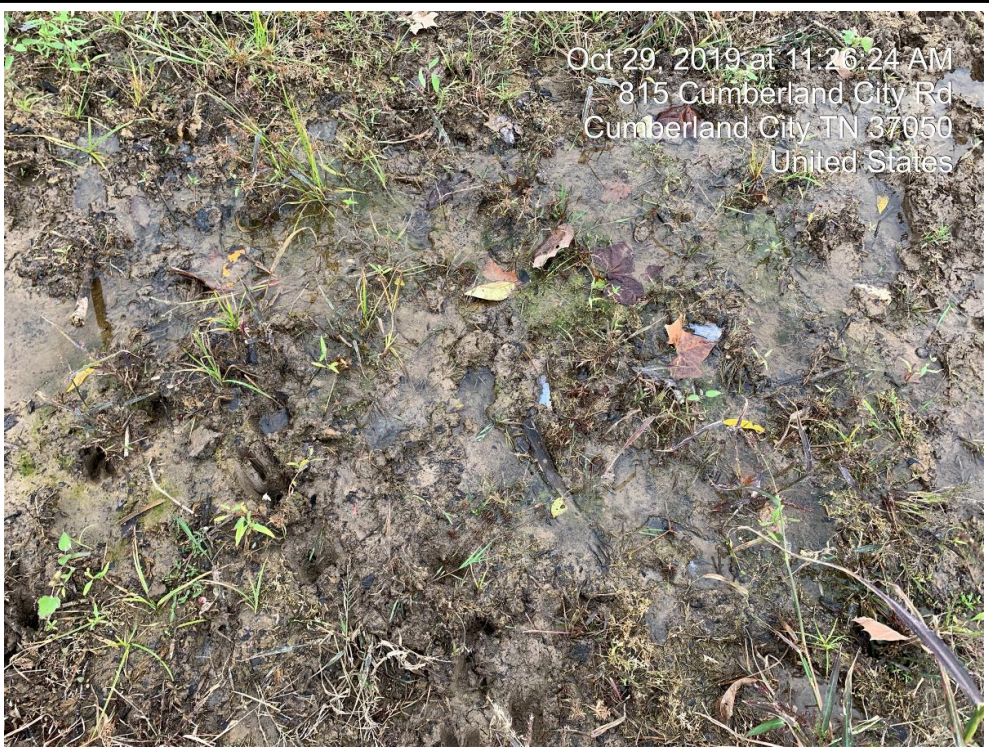
<b>Photo Location:</b> AOI 2	
<b>Direction:</b> East	
<b>Photo Date:</b> 10/29/2019	
<b>Comments:</b> AOI 2 observation; water flow present

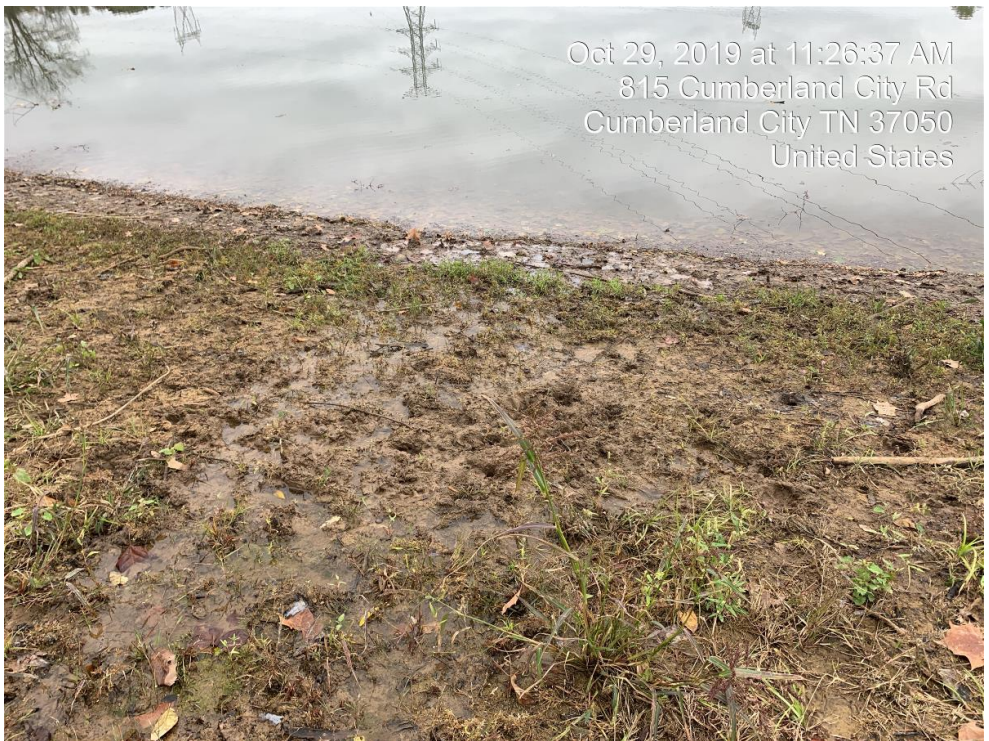
<b>Photo Location:</b> AOI 2	
<b>Direction:</b> Southwest	
<b>Photo Date:</b> 10/29/2019	
<b>Comments:</b> AOI 2 observation; water flow present

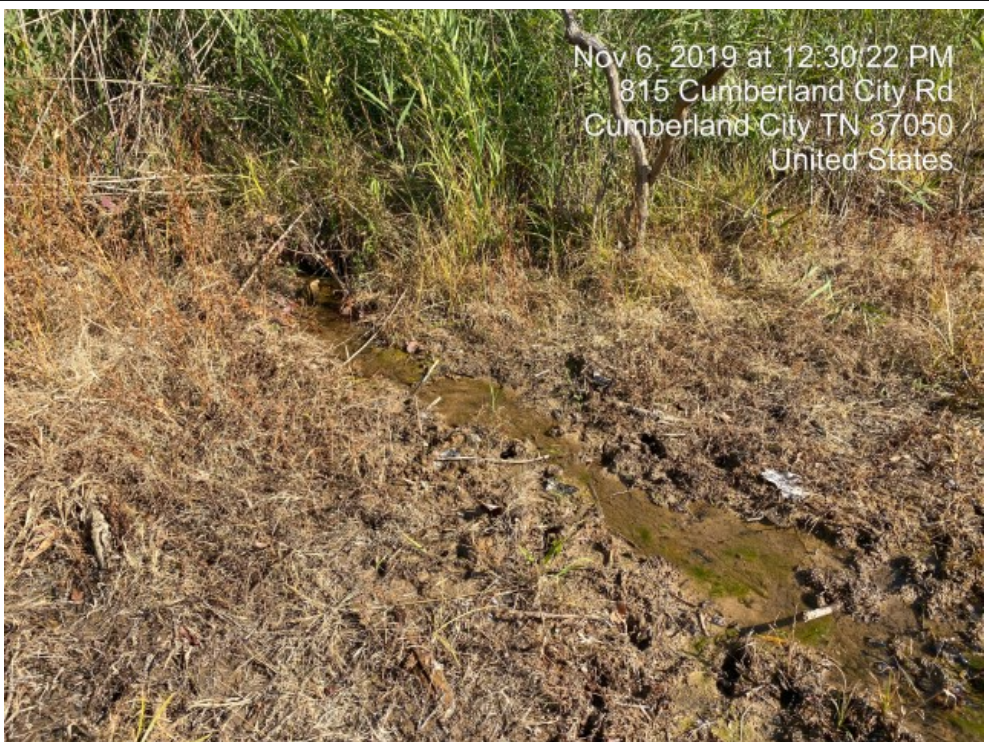
<b>Photo Location:</b> AOI 2	
<b>Direction:</b> East	
<b>Photo Date:</b> 11/6/2019	
<b>Comments:</b> AOI 2 observation; water flow present

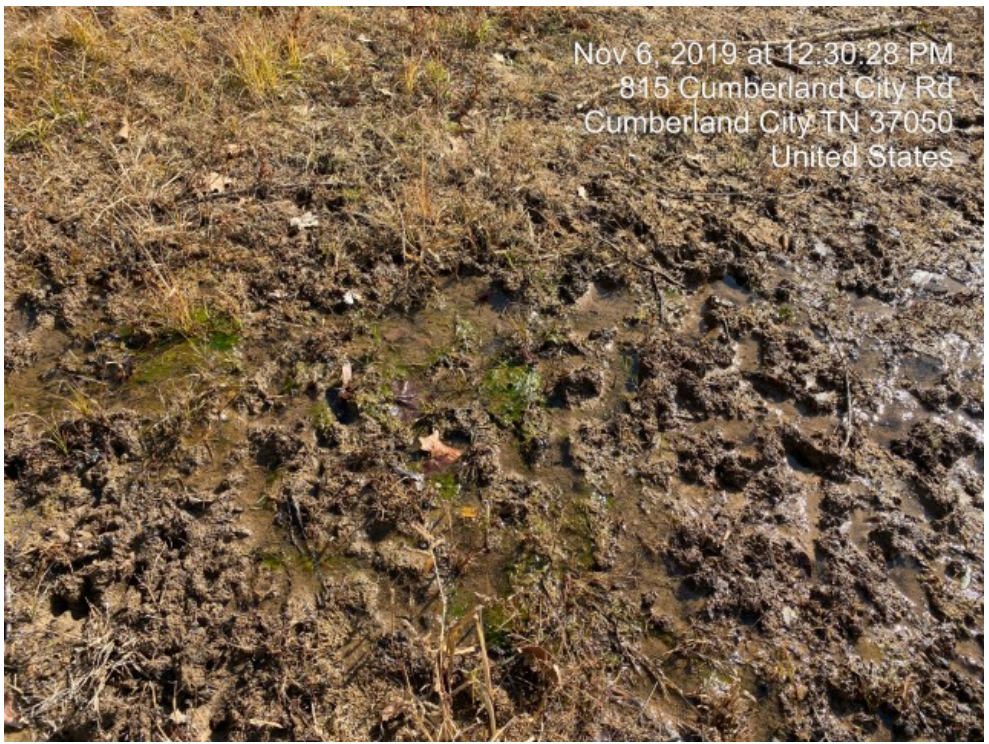
<b>Photo Location:</b> AOI 2			
<b>Direction:</b> East			
<b>Photo Date:</b> 11/6/2019			
<b>Comments:</b> AOI 2 observation; water flow present			
<b>Photograph ID:</b> 50

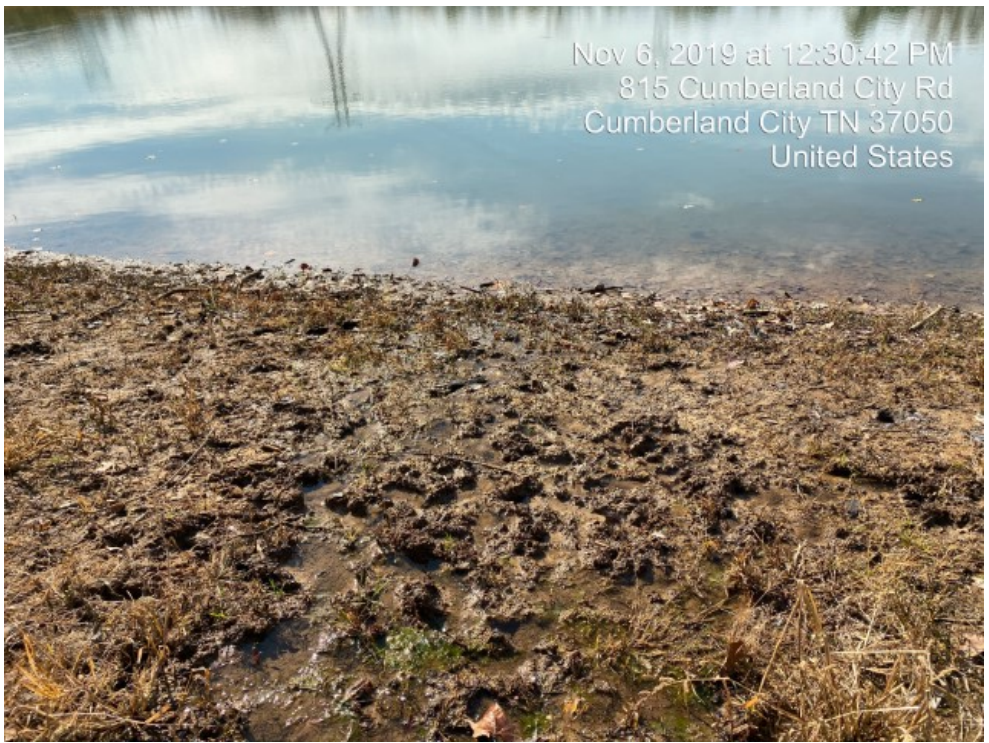
<b>Photo Location:</b> AOI 2			
<b>Direction:</b> Southwest			
<b>Photo Date:</b> 11/6/2019			
<b>Comments:</b> AOI 2 observation; water flow present

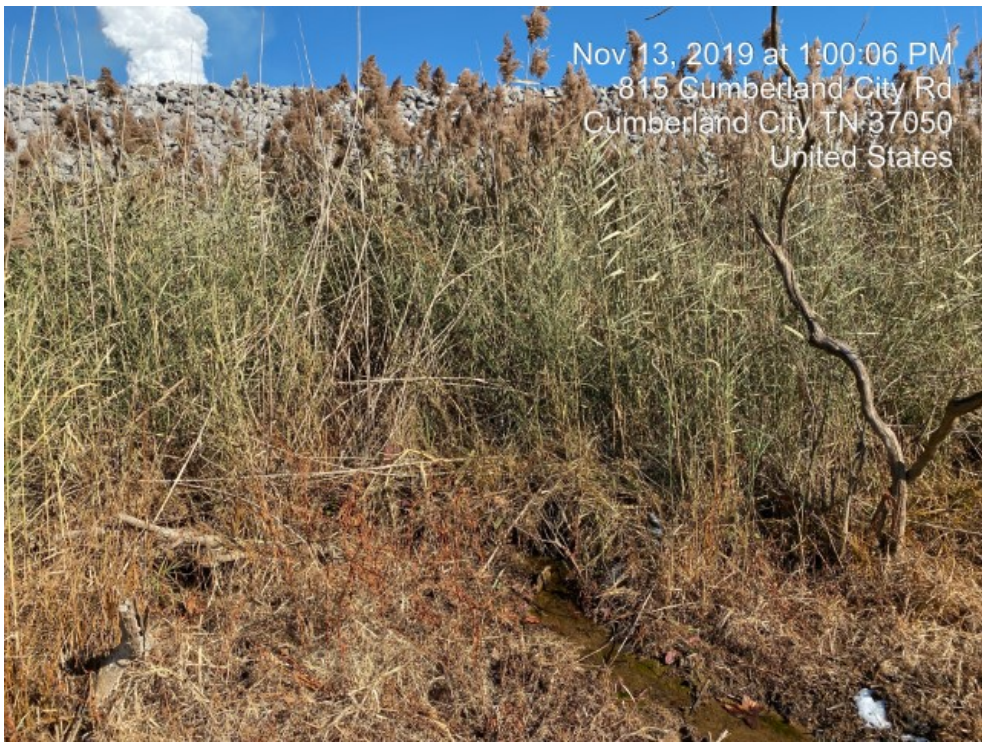
<p>Nov 13, 2019 at 1:00:06 PM 815 Cumberland City Rd Cumberland City TN 37050 United States</p>		
<b>Photo Location:</b> AOI 2			
<b>Direction:</b> Northeast			
<b>Photo Date:</b> 11/13/2019			
<b>Comments:</b> AOI 2 observation; water flow present			
<b>Photograph ID:</b> 52

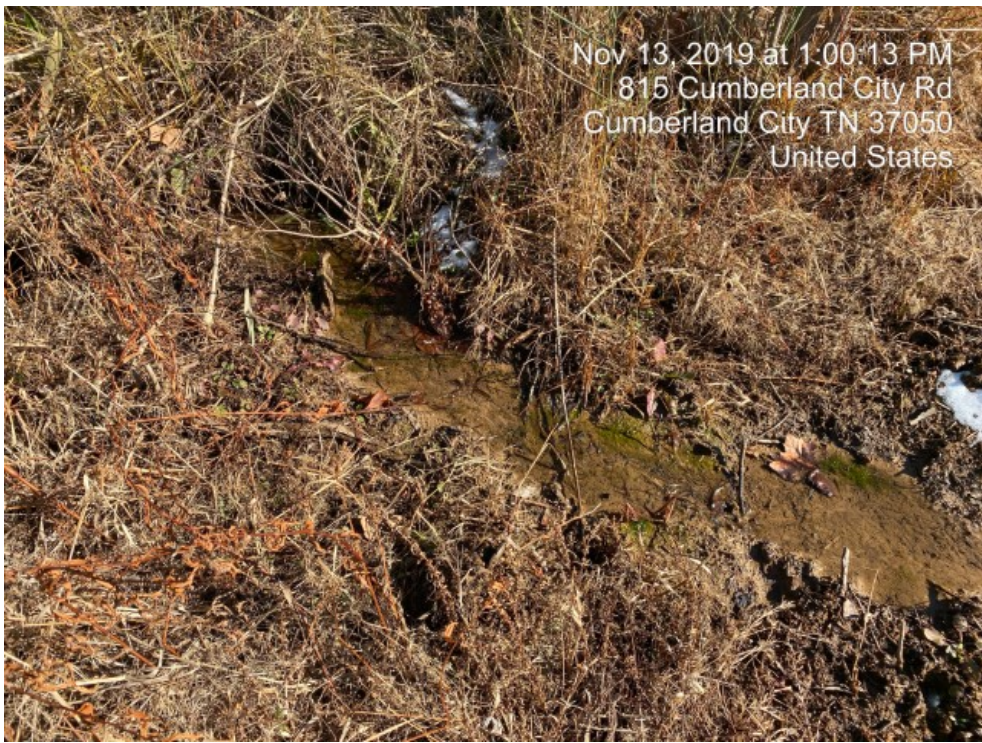
<p>Nov 13, 2019 at 1:00:13 PM 815 Cumberland City Rd Cumberland City TN 37050 United States</p>		
<b>Photo Location:</b> AOI 2			
<b>Direction:</b> East			
<b>Photo Date:</b> 11/13/2019			
<b>Comments:</b> AOI 2 observation; water flow present

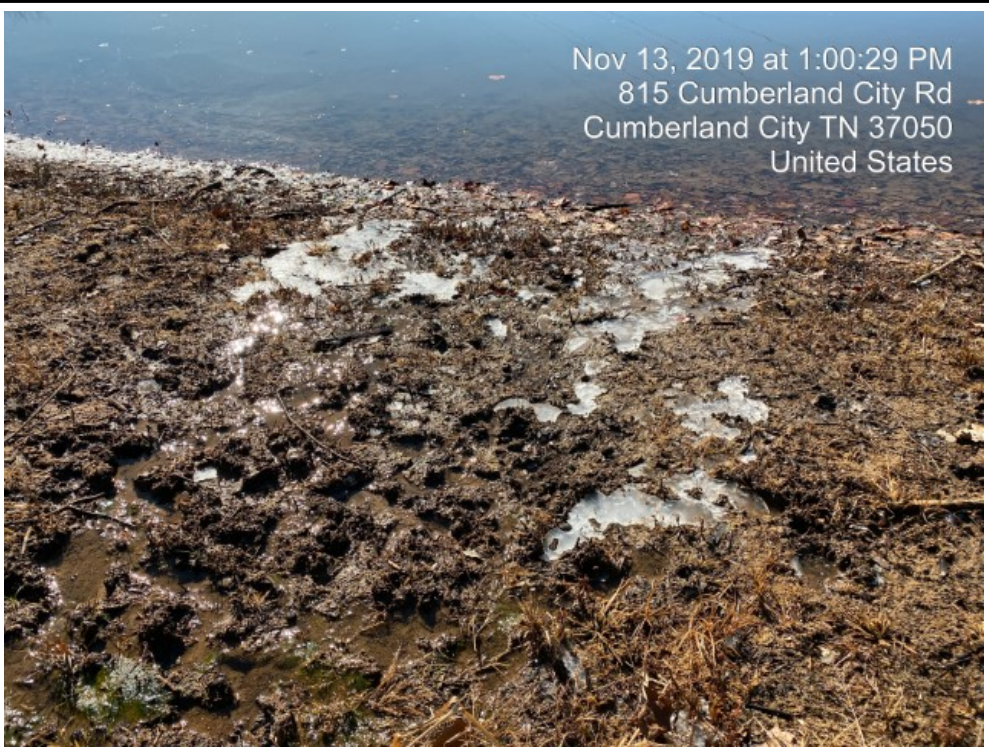
<b>Photo Location:</b> AOI 2	
<b>Direction:</b> Southwest	
<b>Photo Date:</b> 11/13/2019	
<b>Comments:</b> AOI 2 observation; water flow present

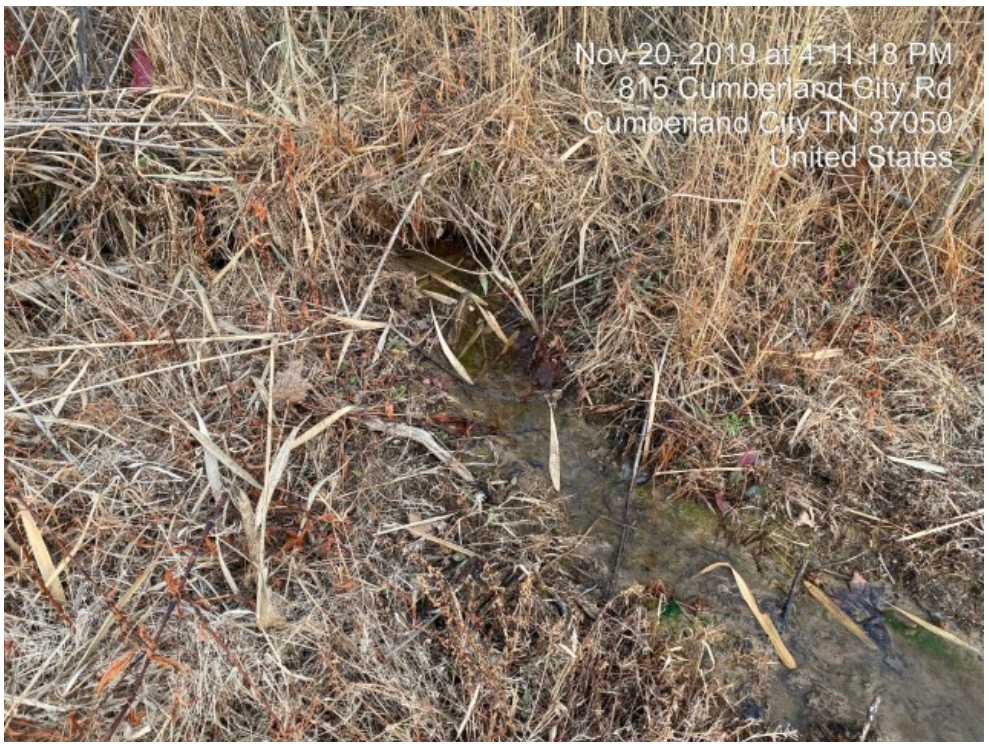
<b>Photo Location:</b> AOI 2			
<b>Direction:</b> Northeast			
<b>Photo Date:</b> 11/20/2019			
<b>Comments:</b> AOI 2 observation; water flow present			
<b>Photograph ID:</b> 56

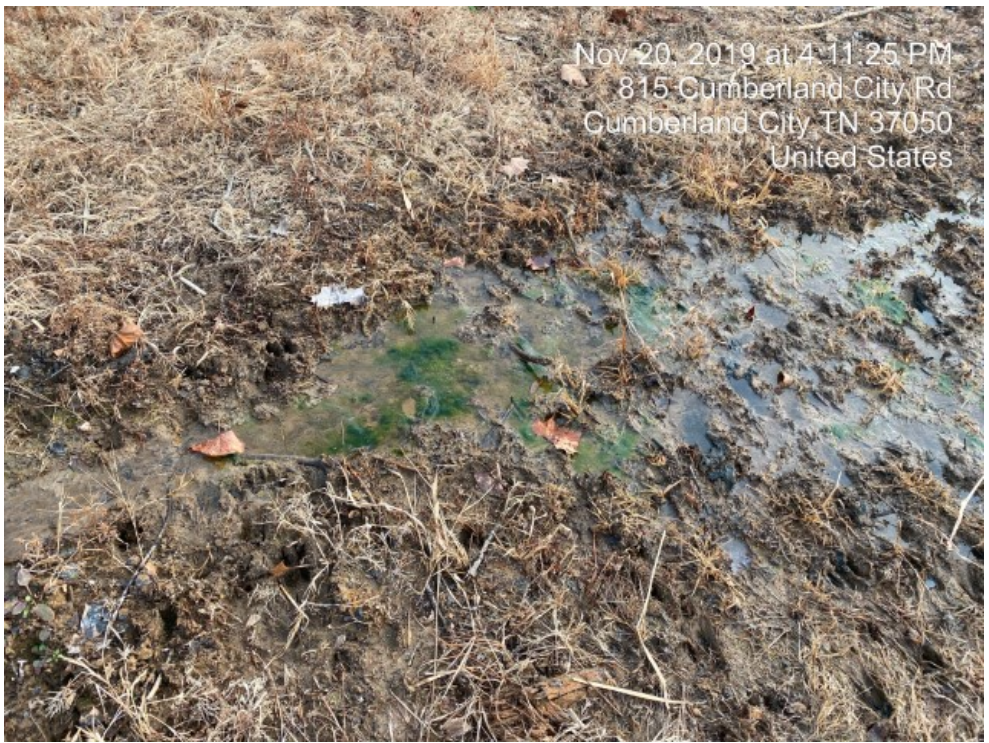
<b>Photo Location:</b> AOI 2			
<b>Direction:</b> East			
<b>Photo Date:</b> 11/20/2019			
<b>Comments:</b> AOI 2 observation; water flow present

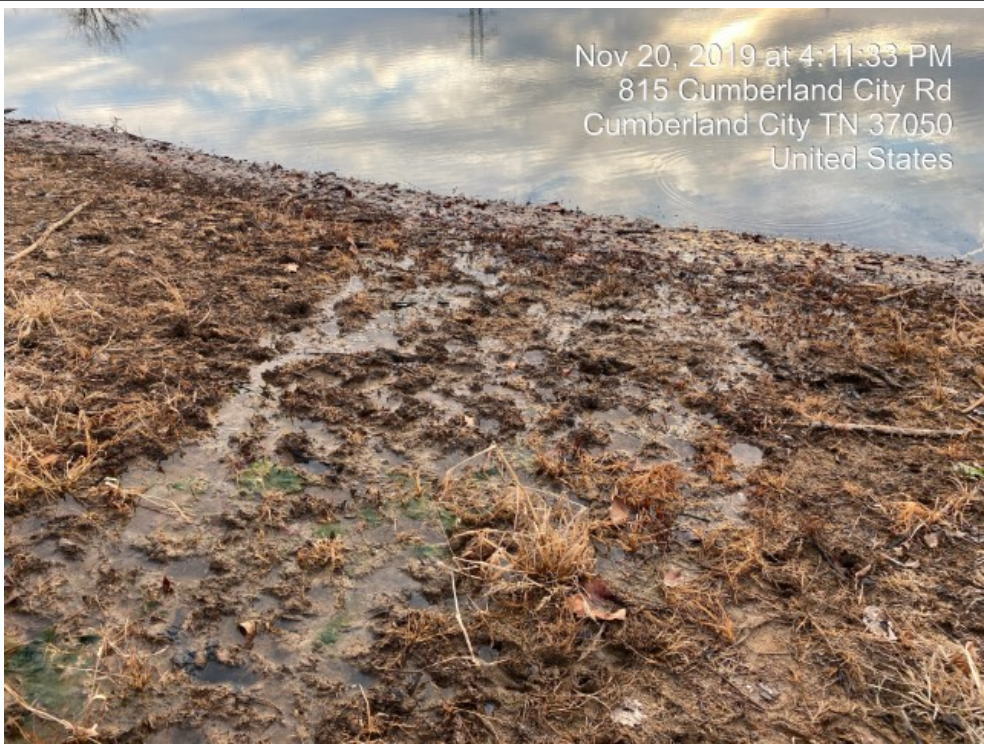
<b>Photo Location:</b> AOI 2			
<b>Direction:</b> Southwest			
<b>Photo Date:</b> 11/20/2019			
<b>Comments:</b> AOI 2 observation; water flow present			
<b>Photograph ID:</b> 58

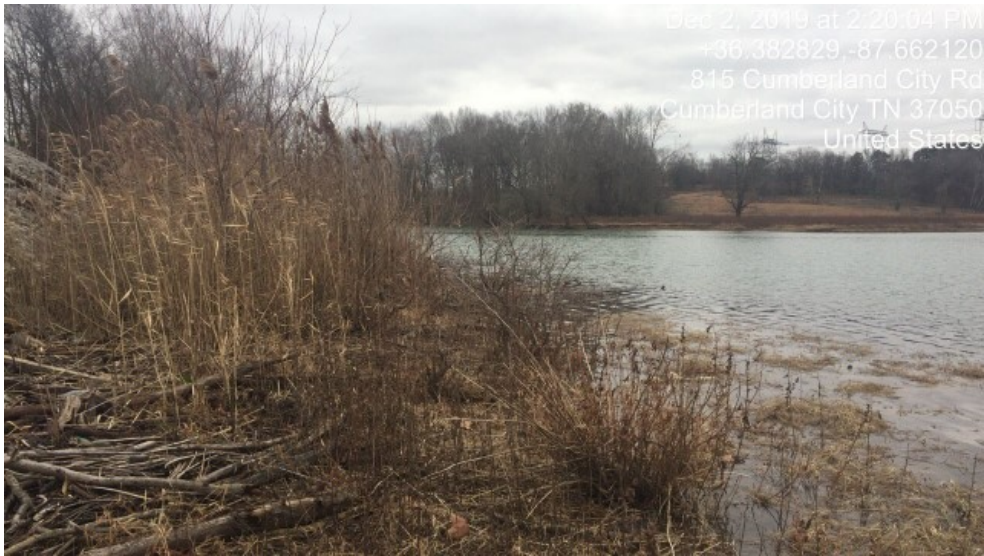
<b>Photo Location:</b> AOI 2			
<b>Direction:</b> Southwest			
<b>Photo Date:</b> 12/2/2019			
<b>Comments:</b> AOI 2 observation; Wells Creek stage above previously observed flow

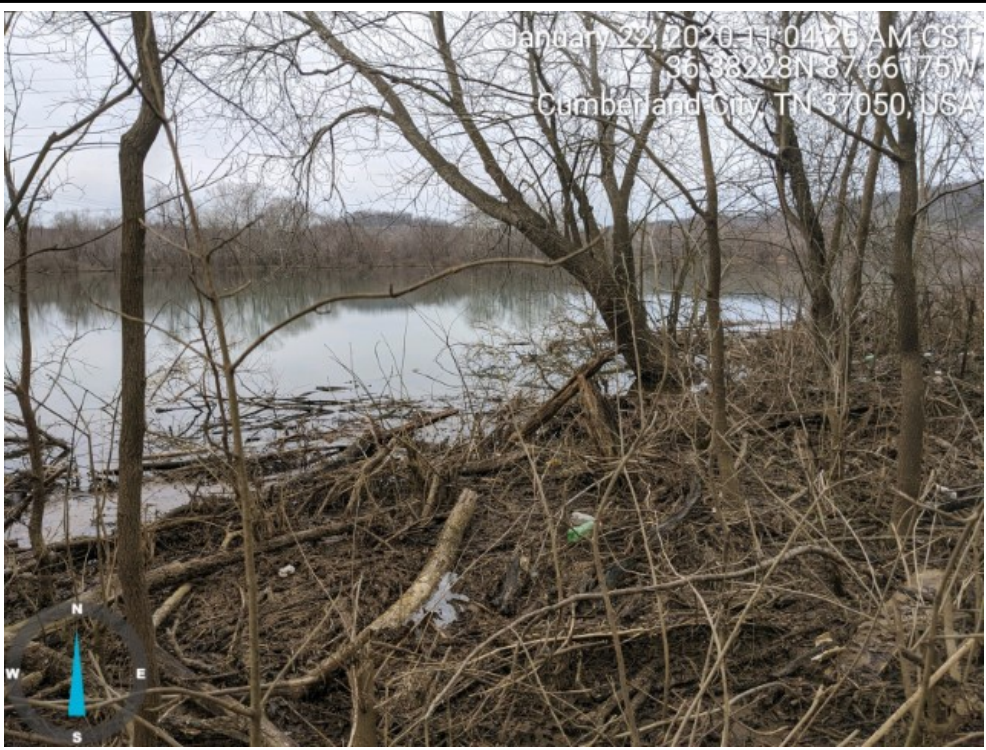
<b>Photo Location:</b> AOI 2	
<b>Direction:</b> North	
<b>Photo Date:</b> 1/22/2020	
<b>Comments:</b> AOI 2 observation; Wells Creek stage above previously observed flow

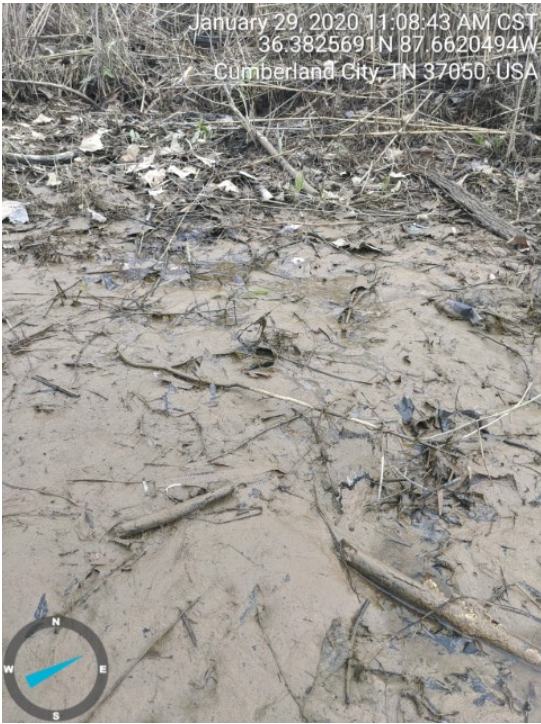
<b>Photo Location:</b> AOI 2			
<b>Direction:</b> Northeast			
<b>Photo Date:</b> 1/29/2020			
<b>Comments:</b> AOI 2 observation; Wells Creek stage above previously observed flow			
<b>Photograph ID:</b> 64
