**Cumberland Fossil Plant  
Seep Sampling and Analysis  
Report**

TDEC Commissioner's Order:  
Environmental Investigation Plan  
Cumberland Fossil Plant  
Cumberland City, Tennessee

April 9, 2021

Stantec Consulting Services Inc.  
Lexington, Kentucky

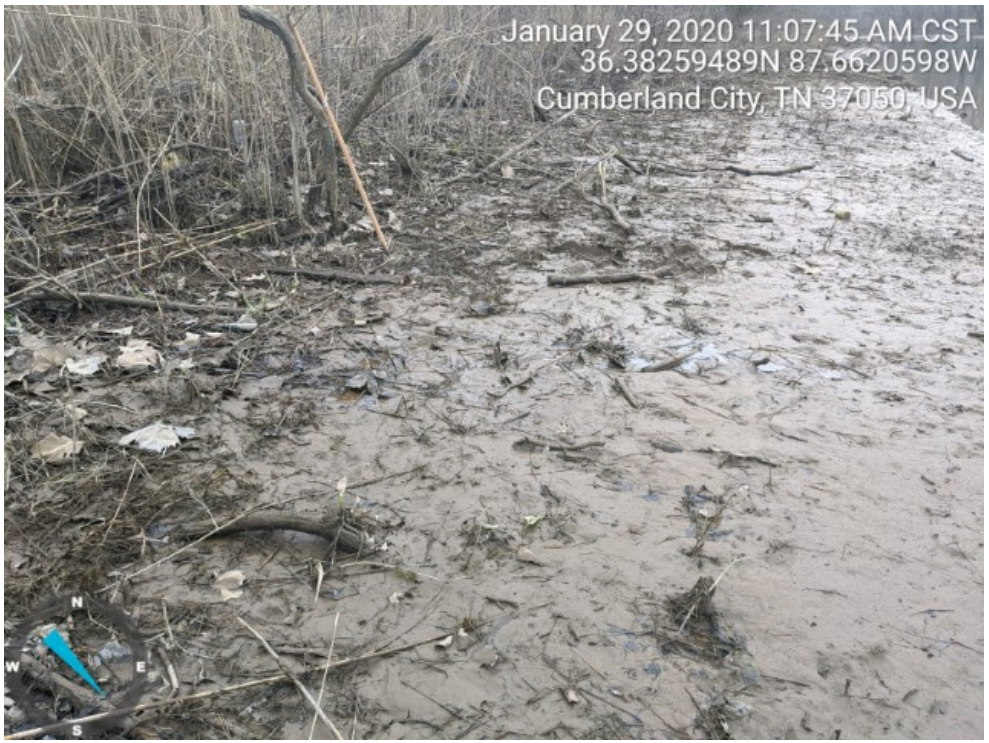
<b>Photo Location:</b> AOI 2			
<b>Direction:</b> Northeast			
<b>Photo Date:</b> 1/26/2020			
<b>Comments:</b> AOI 2 observation; Wells Creek stage above previously observed flow

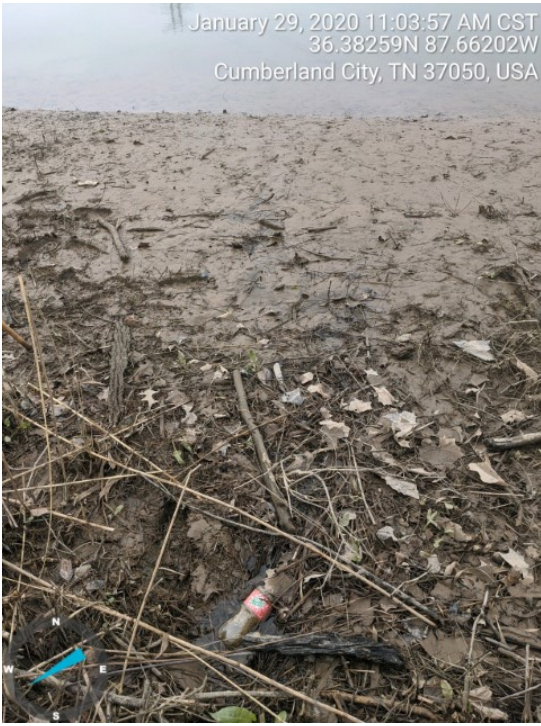
<b>Photo Location:</b> AOI 2			
<b>Direction:</b> Northeast			
<b>Photo Date:</b> 1/29/2020			
<b>Comments:</b> AOI 2 observation; Wells Creek stage above previously observed flow			
<b>Photograph ID:</b> 66

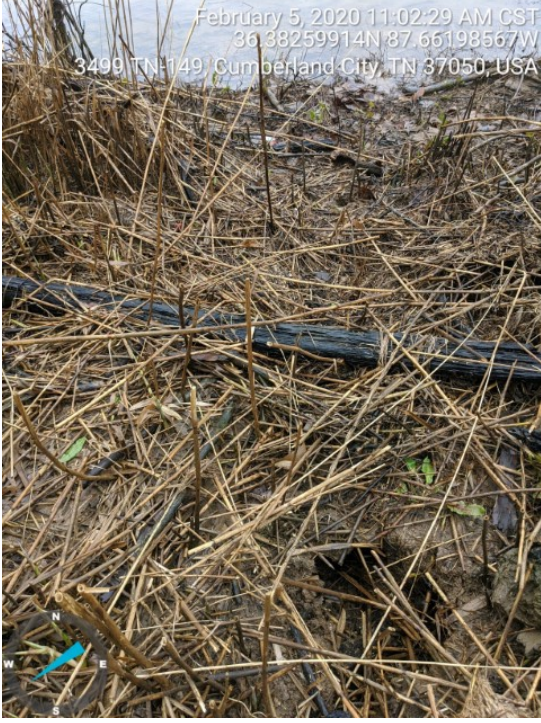
<b>Photo Location:</b> AOI 2			
<b>Direction:</b> Southwest			
<b>Photo Date:</b> 2/5/2020			
<b>Comments:</b> AOI2 monitoring, River stage above previously observed flow.

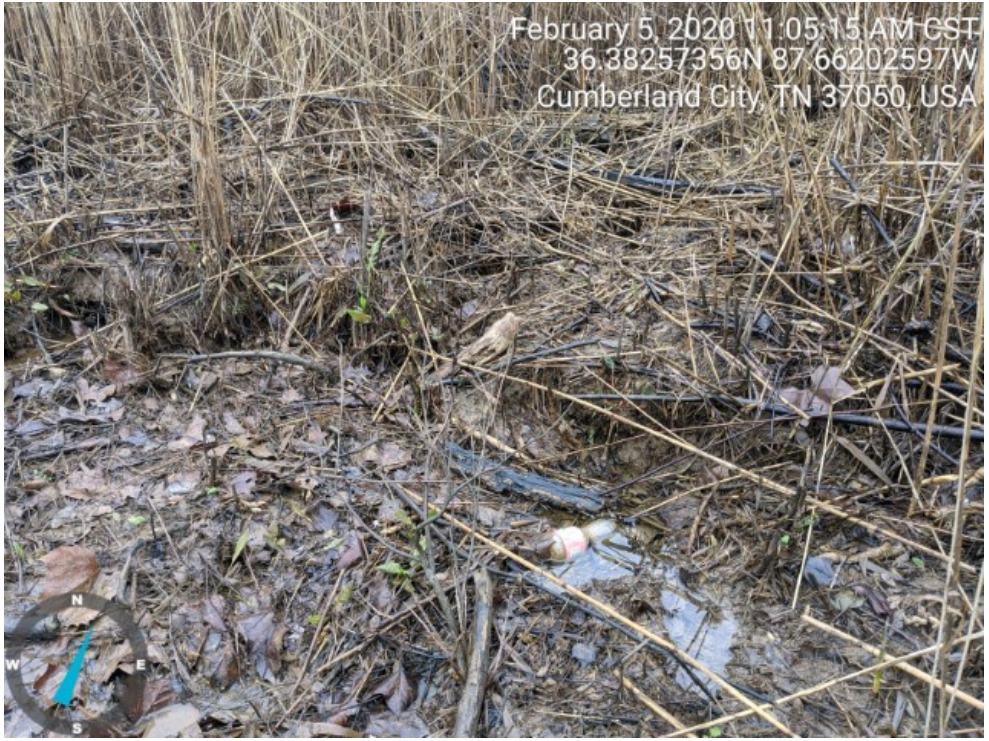
<p>February 5, 2020 11:05:15 AM CST          36.38257356N 87.66202597W          Cumberland City, TN 37050, USA</p>		
<b>Photo Location:</b> AOI 2			
<b>Direction:</b> Northeast			
<b>Photo Date:</b> 2/5/2020			
<b>Comments:</b> AOI 2 observation; Wells Creek stage above previously observed flow
