**Kingston Fossil Plant
Seep Sampling and Analysis
Report**

TDEC Commissioner's Order:
Environmental Investigation Plan
Kingston Fossil Plant
Harriman, Tennessee

June 17, 2020

Stantec Consulting Services Inc.
Lexington, Kentucky

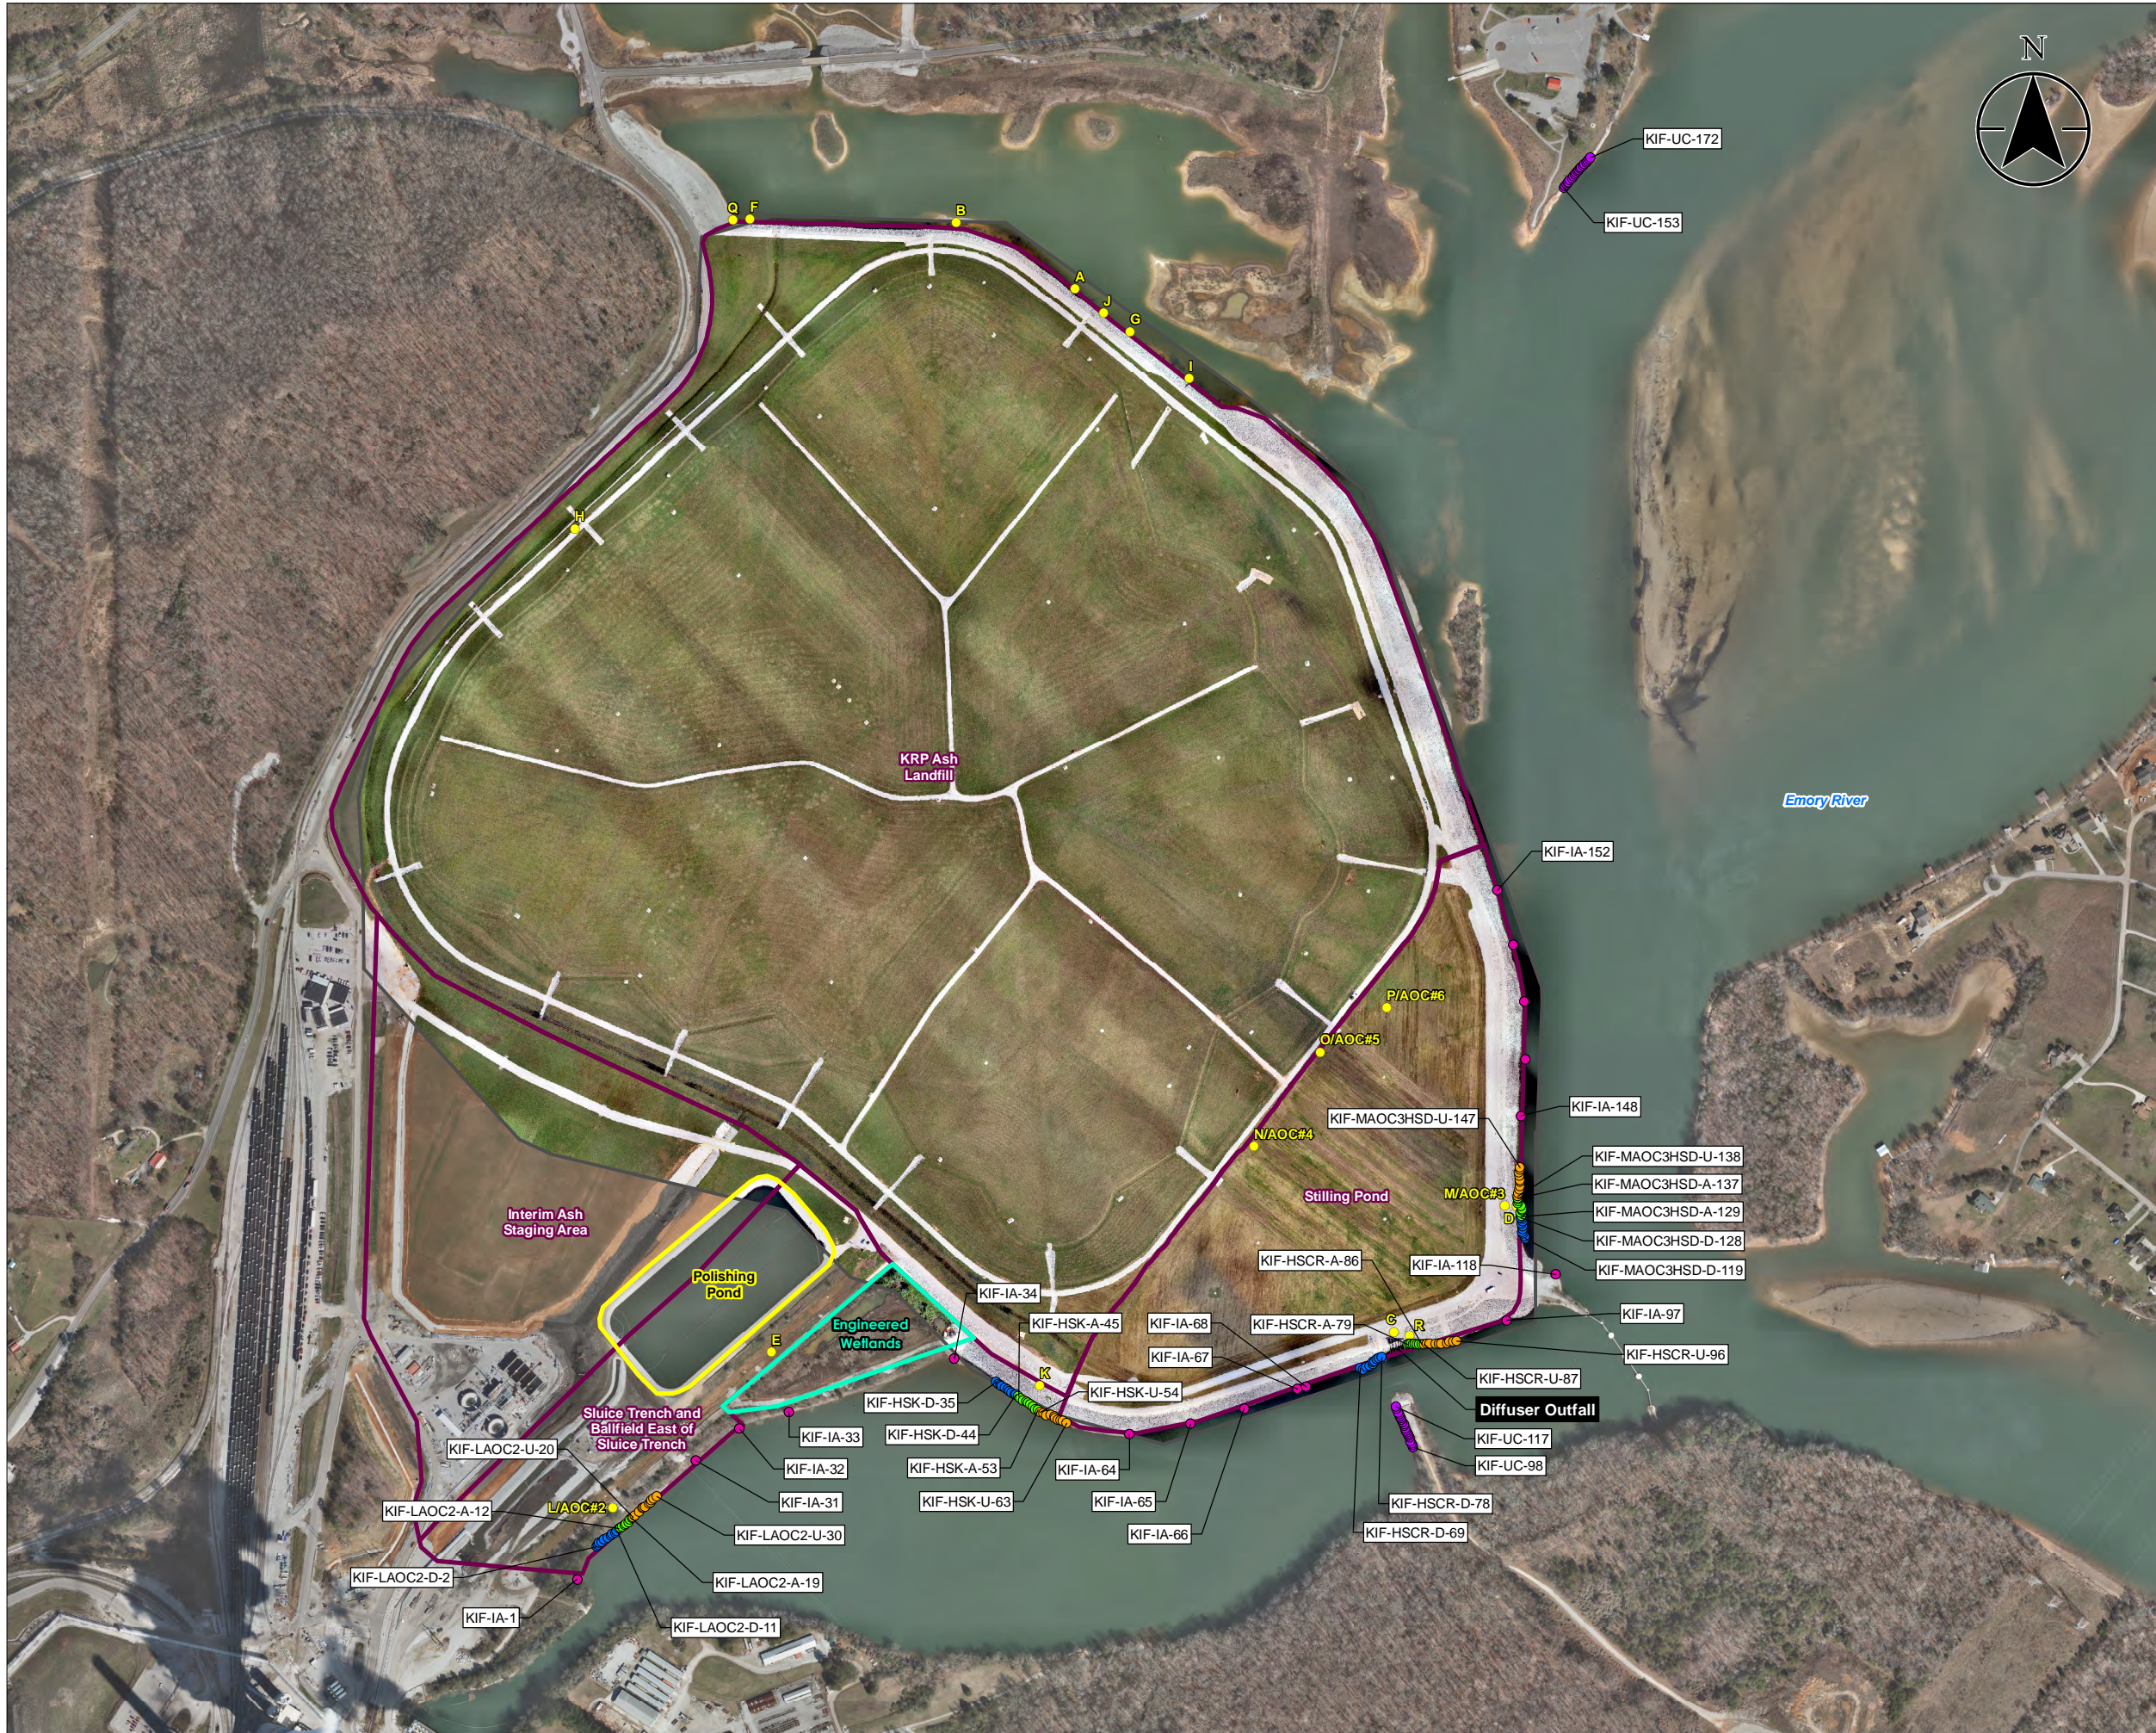
Exhibit No. **A.1**
 Title **Water Quality Parameter Measurement Locations Overview**
 Client/Project
 Tennessee Valley Authority
 Kingston Fossil Plant - TDEC Order
 Project Location
 Roane County, Tennessee
 175668043
 Prepared by DMB on 2020-04-08
 Technical Review by HW on 2020-04-08

Water quality parameters (pH, specific conductance, temperature and DO) were recorded by Stantec FSP at each measurement location. Two control areas were established. The northern control area encompassed measurement locations KIF-UC-153 to KIF-UC-172 and, the southern control area included measurement locations KIF-UC-98 to KIF-UC-117 (Exhibit A.1; Appendix A).

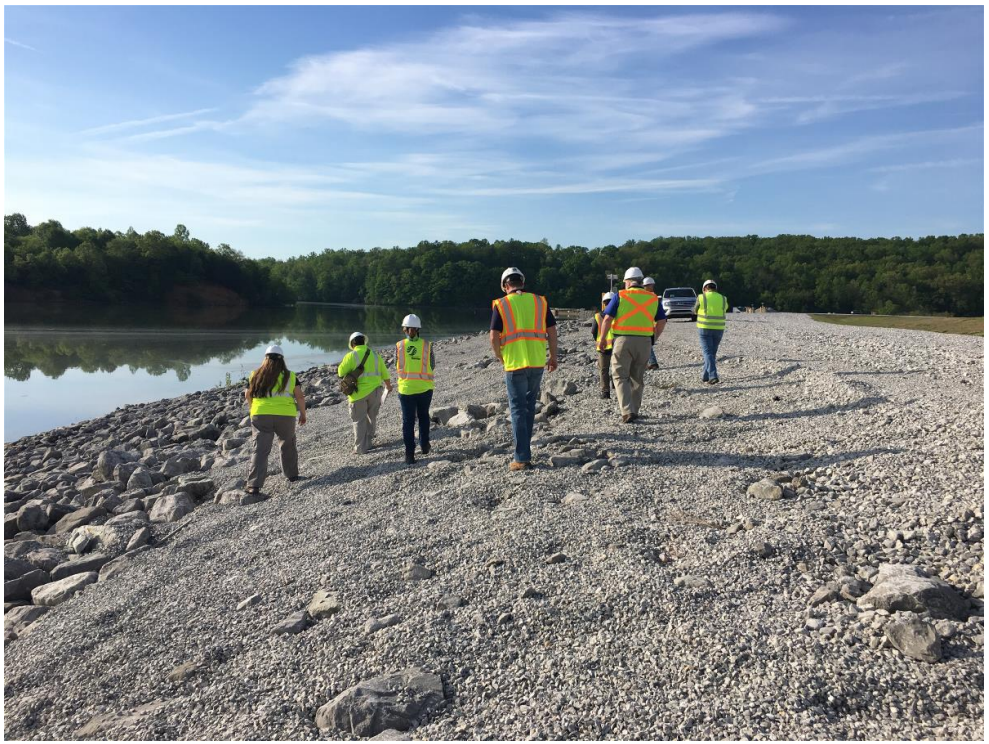
Client:	TVA	Project:	Seep Investigation
Site Name:	Kingston Fossil Plant	Site Location:	Harriman, TN
Photograph ID: 1

Photo Location: Former Stilling Pond			
Direction: South - Southeast			
Survey Date: 4/23/2019			
Comments: TDEC/TVA Inspection			
Photograph ID: 2

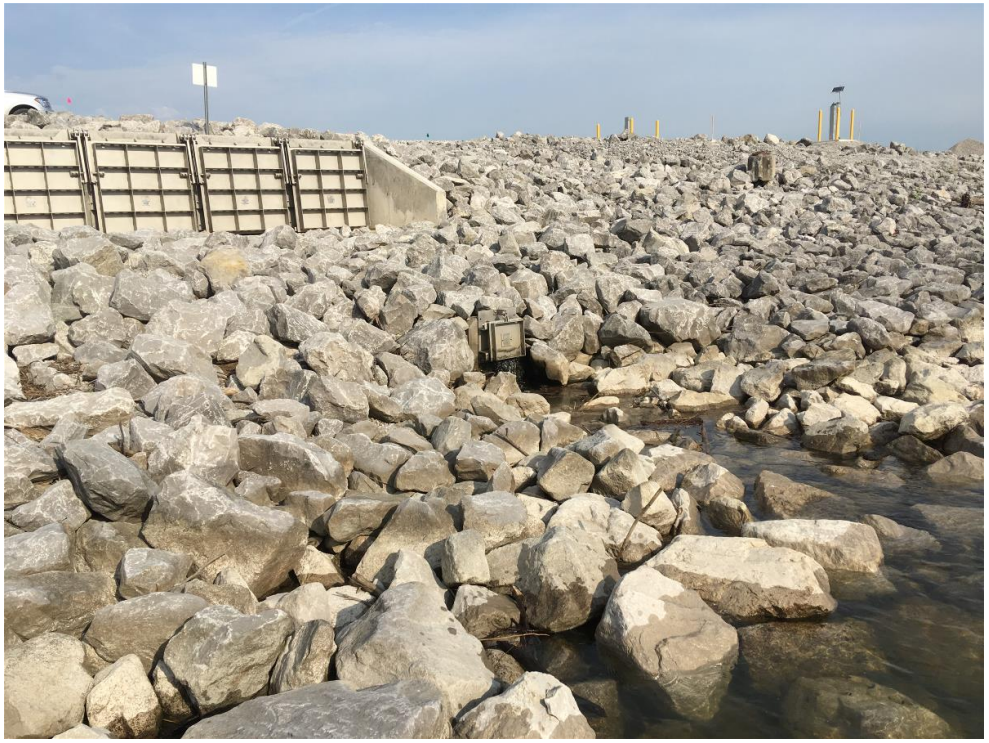
Photo Location: Former Stilling Pond			
Direction: Northwest			
Survey Date: 4/25/2019			
Comments: TDEC/TVA Inspection - Storm water outfall

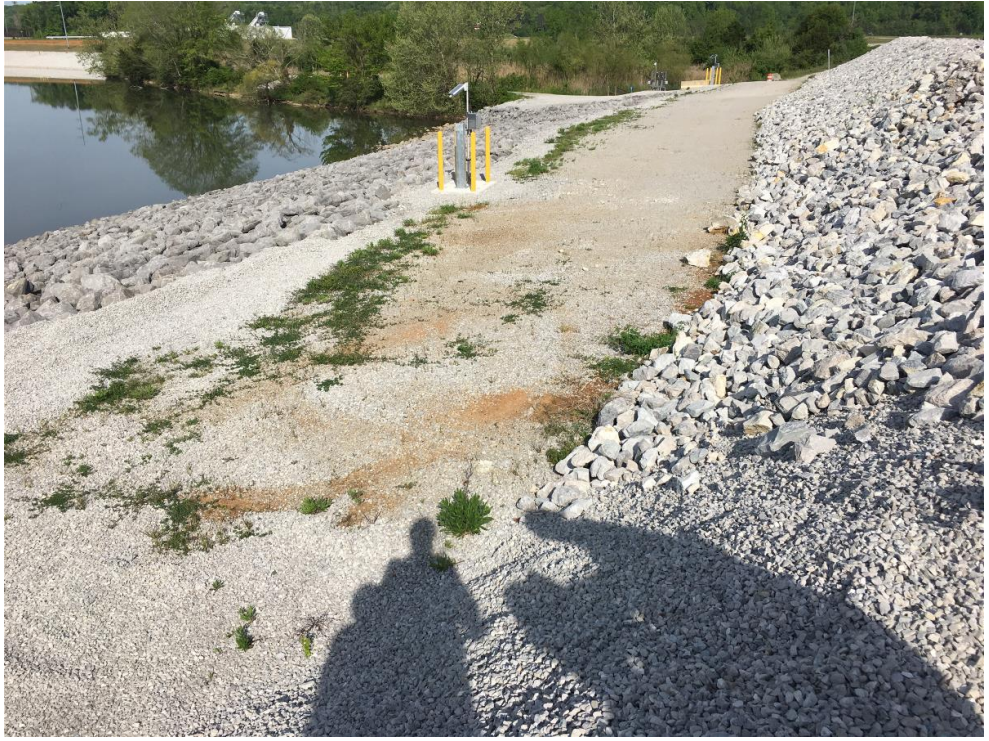
Photo Location: Former Stilling Pond/ KRP Ash Landfill			
Direction: Northwest			
Survey Date: 4/23/2019			
Comments: TDEC/TVA Inspection - Intersection of former Stilling Pond and KRP Landfill.

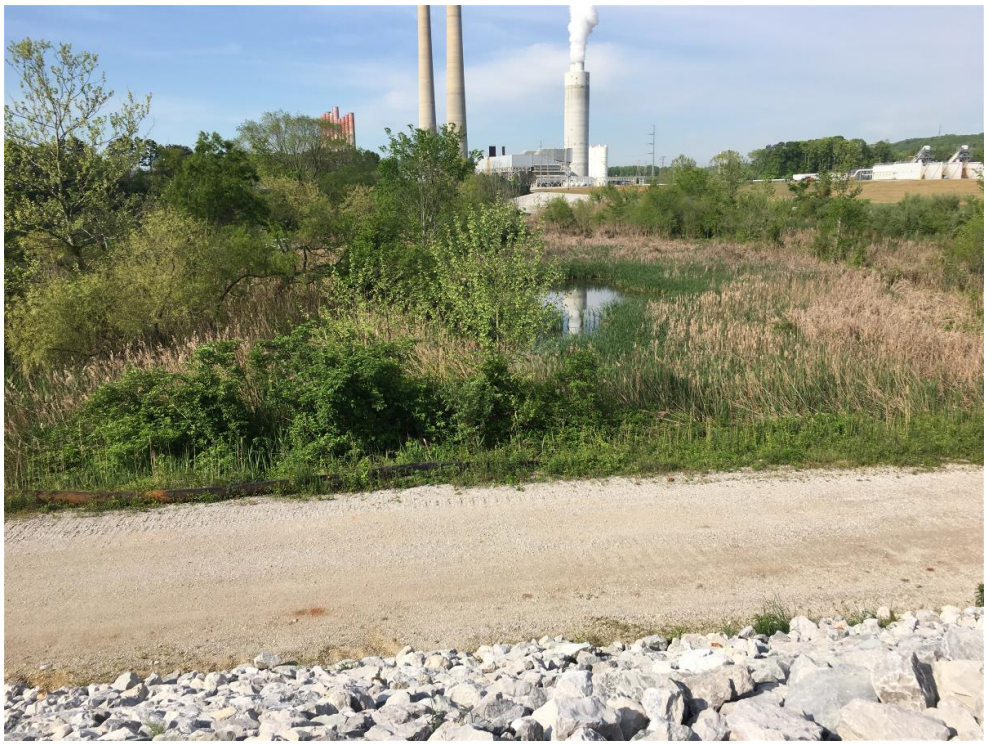
Client:	TVA	Project:	Seep Investigation	
Site Name:	Kingston Fossil Plant	Site Location:	Harriman, TN	
Photograph ID: 5

Photo Location:				Engineered Wetland
Direction:				West
Survey Date:				4/23/2019
Comments:				TDEC/TVA Inspection - NPDES permit area.
Photograph ID: 6

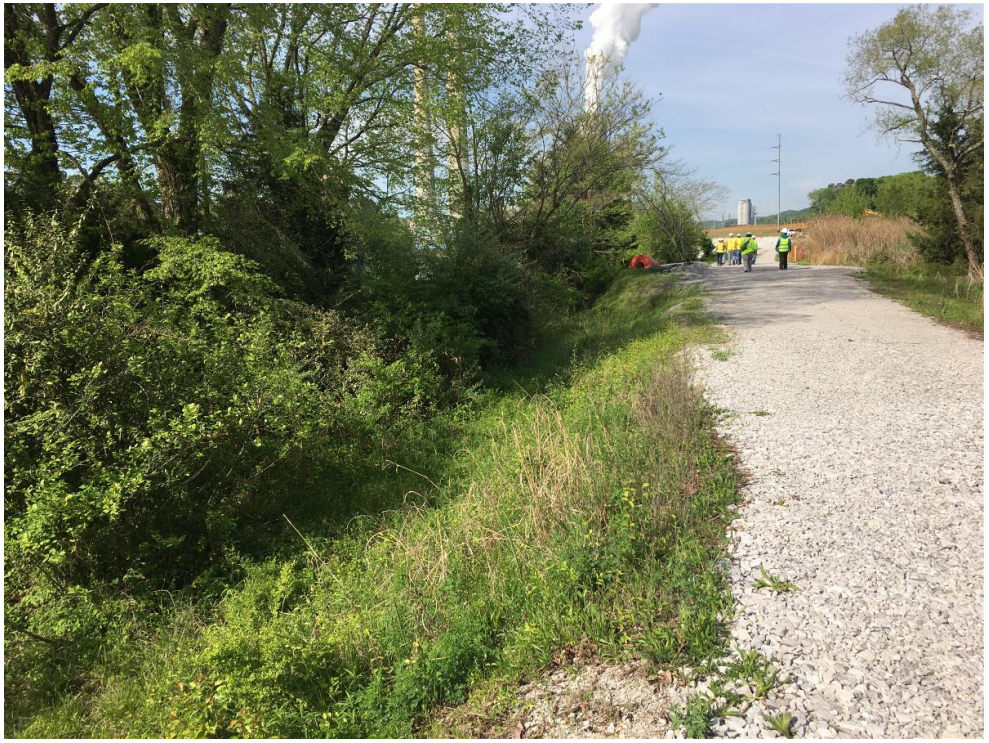
Photo Location:				Engineered Wetland
Direction:				West
Survey Date:				4/23/2019
Comments:				TDEC/TVA Inspection - downslope area on left.

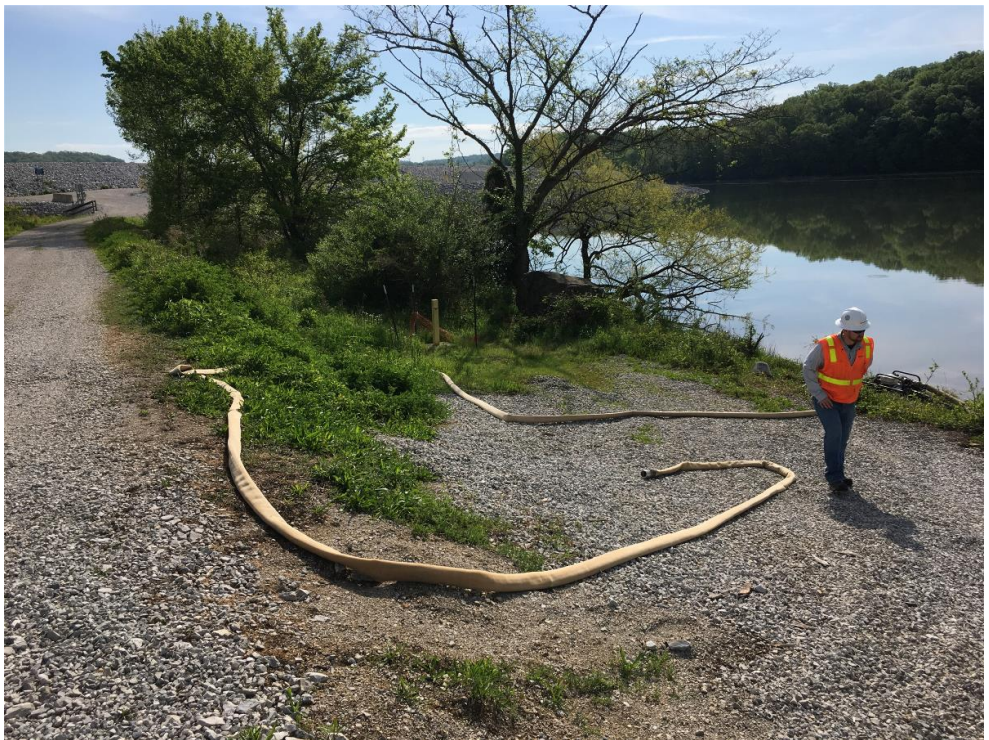
Client:	TVA	Project:	Seep Investigation
Site Name:	Kingston Fossil Plant	Site Location:	Harriman, TN
Photograph ID: 7

Photo Location: Engineered Wetland			
Direction: East			
Survey Date: 4/23/2019			
Comments: TDEC/TVA Inspection - downslope area on right.			
Photograph ID: 8

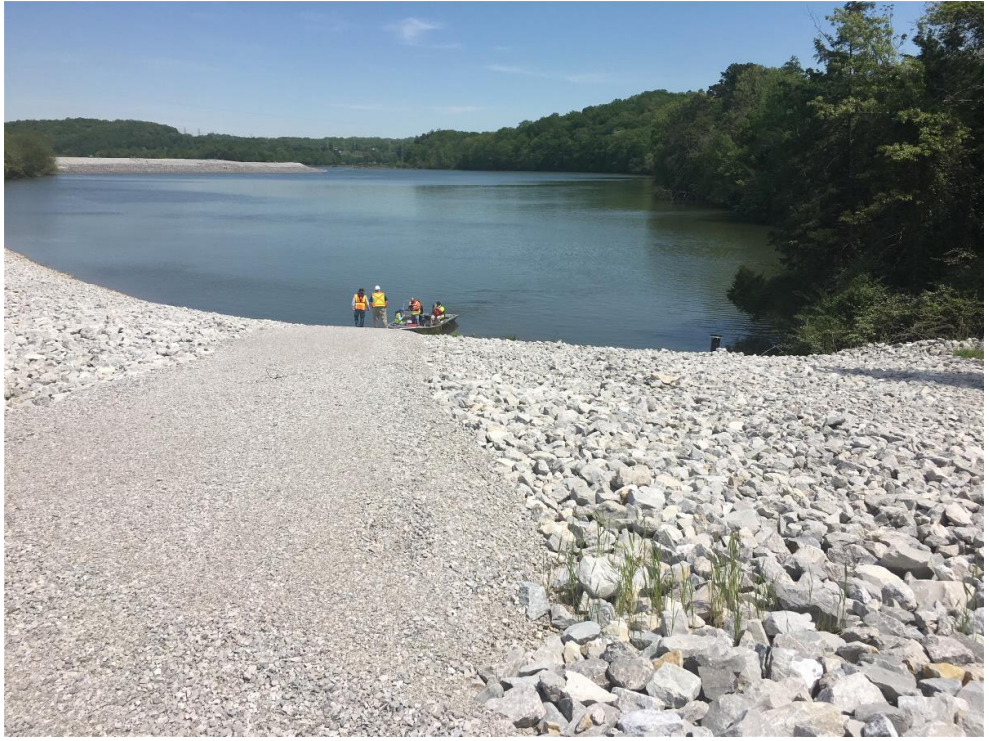
Photo Location: Reverse Grade filter			
Direction: Southeast			
Survey Date: 4/23/2019			
Comments: TDEC/TVA Inspection

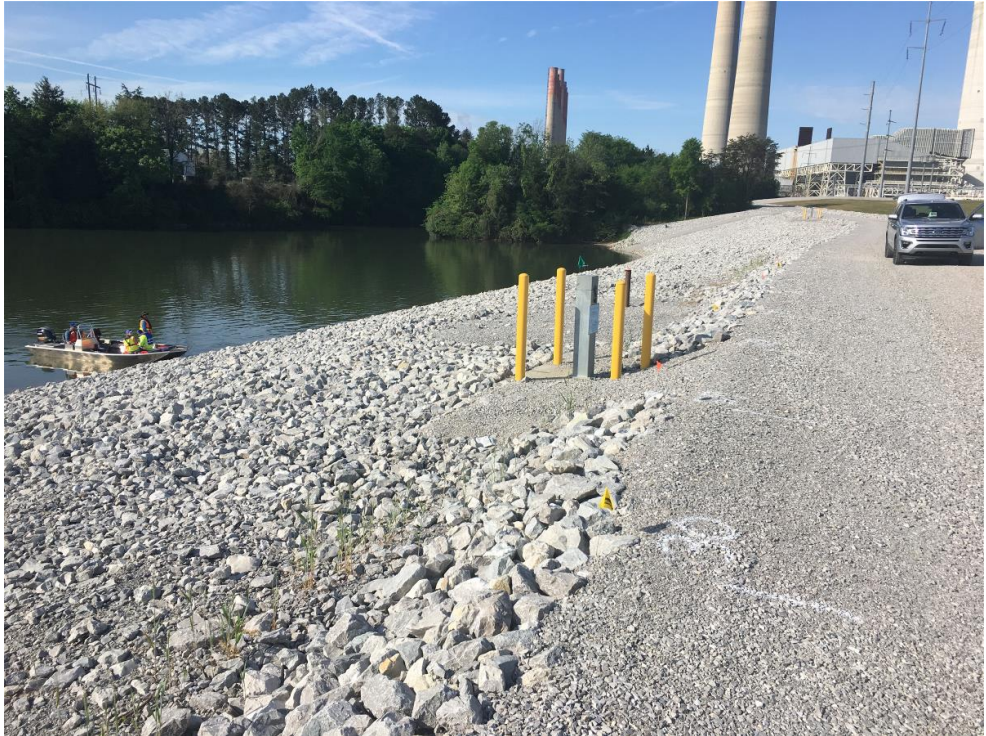
Client:	TVA	Project:	Seep Investigation
Site Name:	Kingston Fossil Plant	Site Location:	Harriman, TN
Photograph ID: 9

Photo Location: Reverse Grade filter			
Direction: Southwest			
Survey Date: 4/24/2019			
Comments: TDEC/TVA Inspection			
Photograph ID: 10

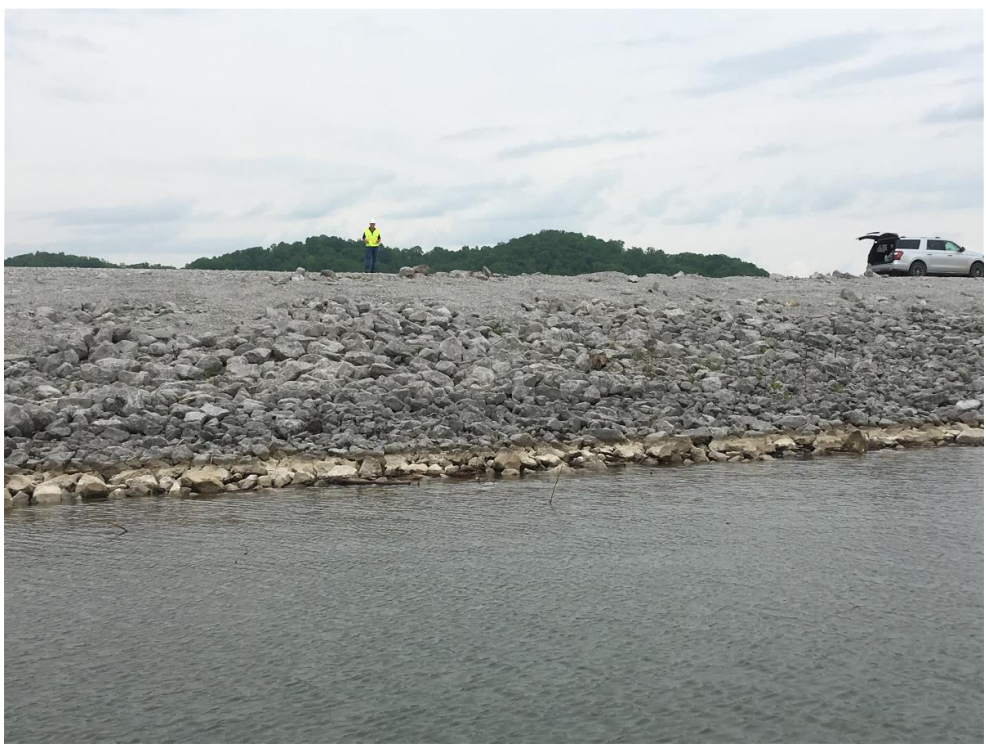
Photo Location: East Bank of Former Stilling Pond			
Direction: North			
Survey Date: 4/25/2019			
Comments: Boat Inspection/Sonde Measurements

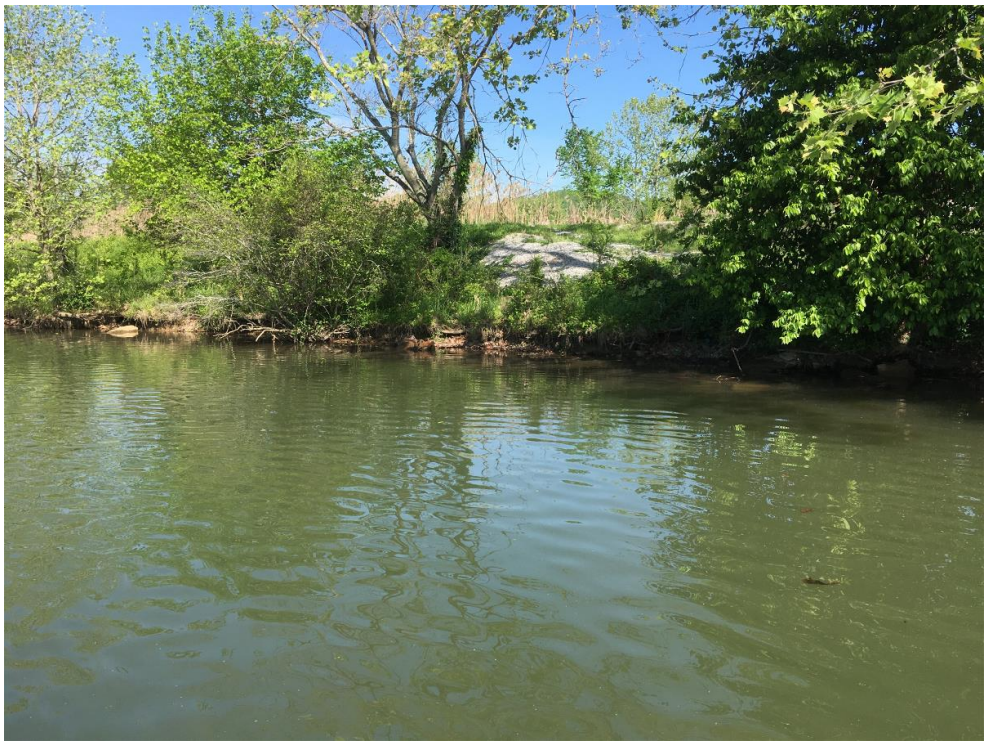
Client:	TVA	Project:	Seep Investigation
Site Name:	Kingston Fossil Plant	Site Location:	Harriman, TN
Photograph ID: 11

Photo Location: Engineered Wetland			
Direction: North			
Survey Date: 4/24/2019			
Comments: Boat Inspection/Sonde Measurements			
Photograph ID: 12

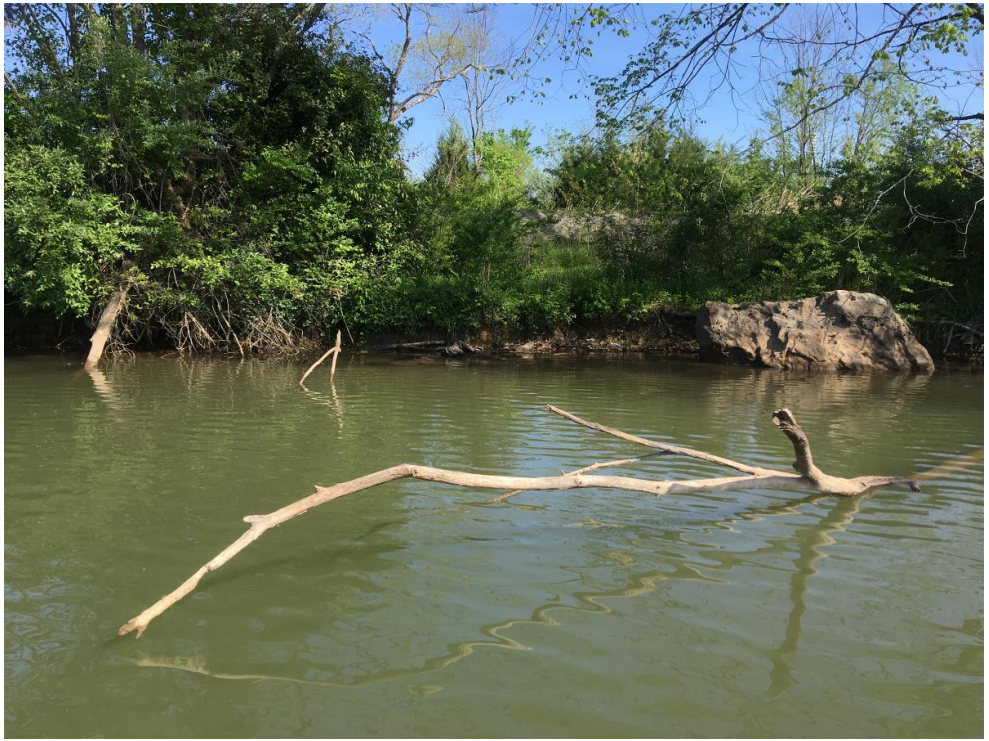
Photo Location: Engineered Wetland			
Direction: North			
Survey Date: 4/24/2019			
Comments: Boat Inspection/Sonde Measurements

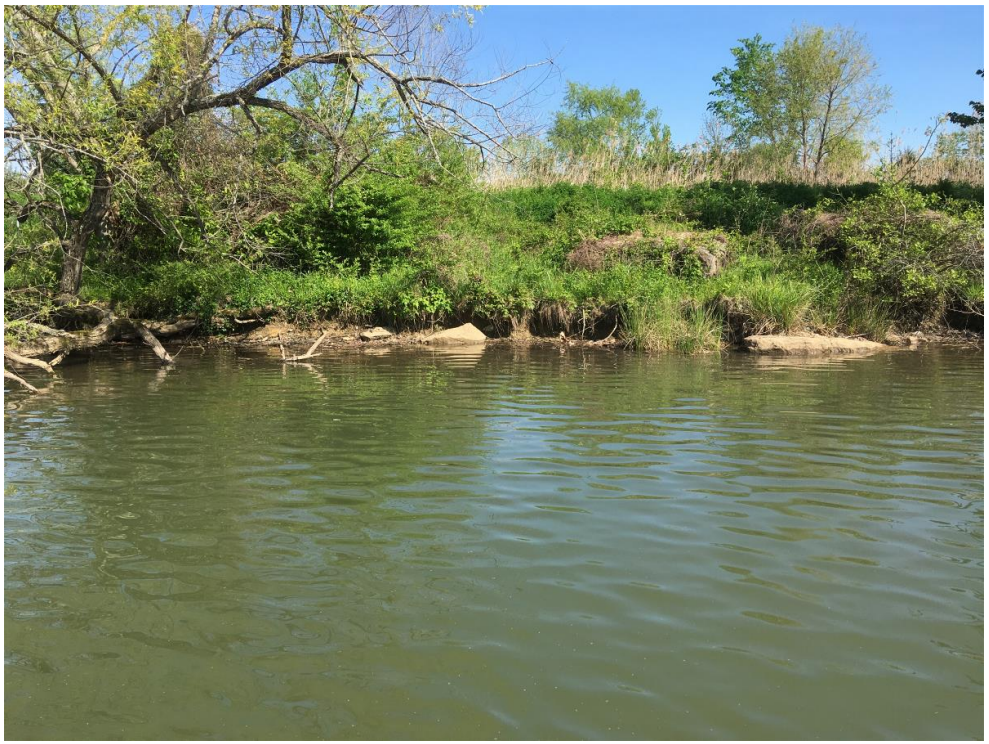
Client:	TVA	Project:	Seep Investigation
Site Name:	Kingston Fossil Plant	Site Location:	Harriman, TN
Photograph ID: 13

Photo Location: Engineered Wetland			
Direction: North			
Survey Date: 4/24/2019			
Comments: Boat Inspection/Sonde Measurements			
Photograph ID: 14
