# Environmental Assessment Report

Watts Bar Fossil Plant Spring City, Tennessee Tennessee Valley Authority

Title of Document: Environmental Assessment Report Watts Bar Fossil Plant

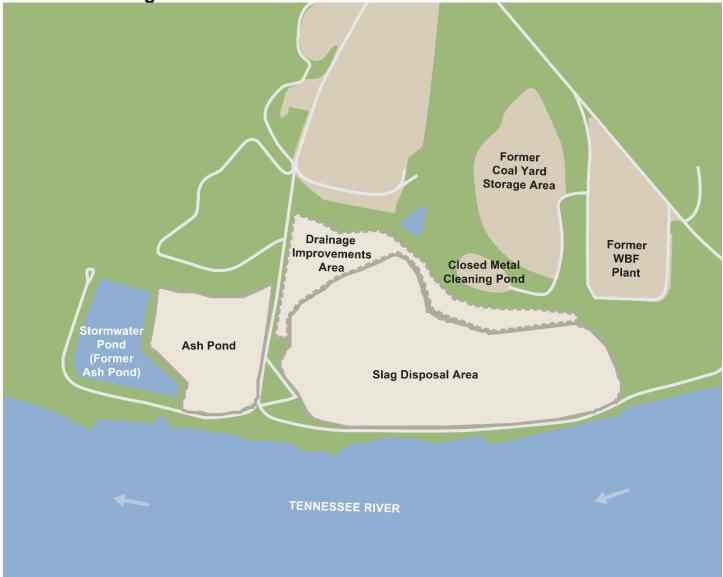
# **WBF CCR Management Units**

On August 6, 2015, the Tennessee Department of Environment and Conservation (TDEC) issued Commissioner's Order No. OGC15-0177 (TDEC Order) to TVA (TDEC 2015, in Appendix A.1). The two closed CCR management units<sup>2</sup> at the WBF Plant included in the TDEC Order are: the Ash Pond and Slag Disposal Area (see below).

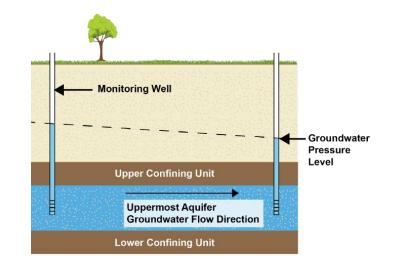
#### **Confined Aquifer**

- Aquifer a geologic formation capable of yielding usable quantities of groundwater
- Confined aquifer an aquifer present between two aquitards when the water level in a well is observed to be above the top of the aquifer due to the confining pressure (see graphic below).

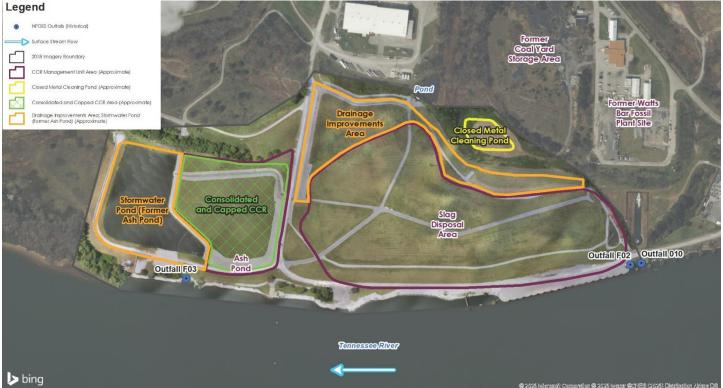
# **WBF Plant Features**

CCR material in the forms of fly ash, bottom ash, and slag were sluiced to the Slag Disposal Area from 1942 to 1957 (TVA 1940). The Slag Disposal Area was formed by a railroad embankment and a natural knoll to the west, stacked CCR material to the east, and a dike and spillway to the south constructed to discharge process water (refer to Exhibit 2-2; TVA 1969). TVA raised this dike using borrow soil material in 1969 to prepare for resuming power generation operations in 1970 (TVA 1973). The borrow material was excavated from the footprint of the future Ash Pond (TVA 1973). During operation of the Slag Disposal Area, process water and CCR material were also sent into the area now identified as the Drainage Improvements Area, which was an extension of the Slag Disposal Area (TVA 1977).

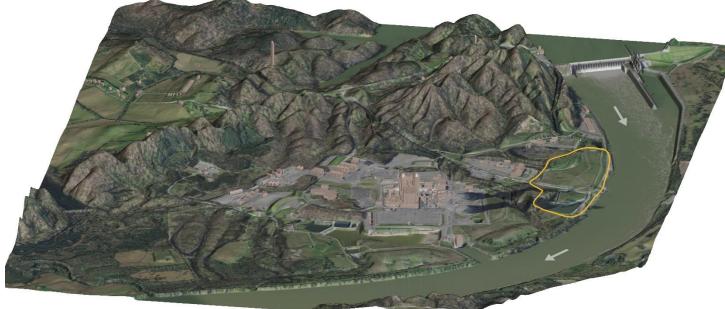
# **WBF** Physiographic Features

Typical surface stream flow direction
Study Area

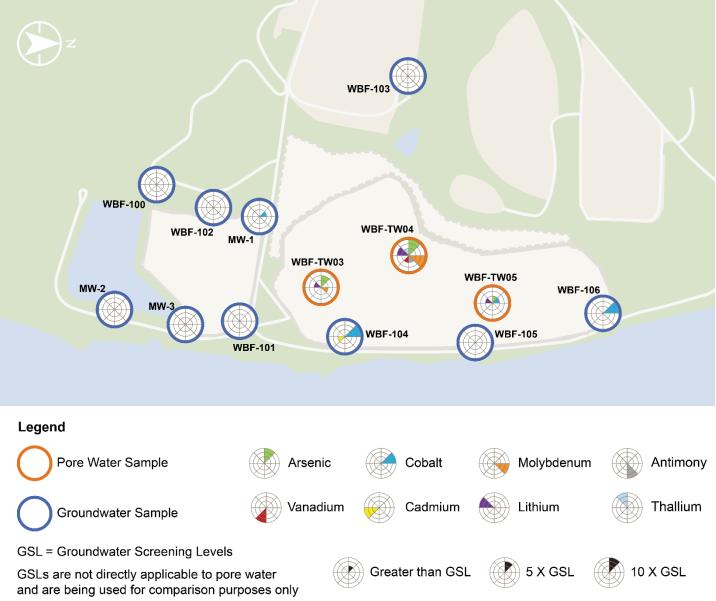
# Pore Water Quality (with Groundwater)

There is a distinct difference between pore water and groundwater quality. As this figure illustrates, many constituents detected above a GSL in pore water samples were below the applicable GSLs in groundwater samples from the same areas.

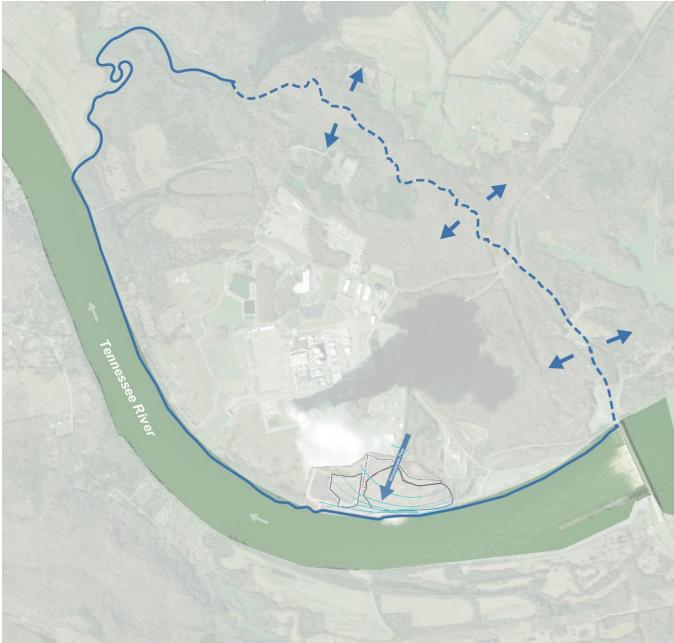
# **Groundwater Flow Directions, Boundaries and Divides**

- Interpolated Groundwater Contour
   Groundwater Contour
   (5 ft interval; elevations are in ft amsl)
- Surface stream that bounds groundwater flow
- ---- Hydrogeological Divide

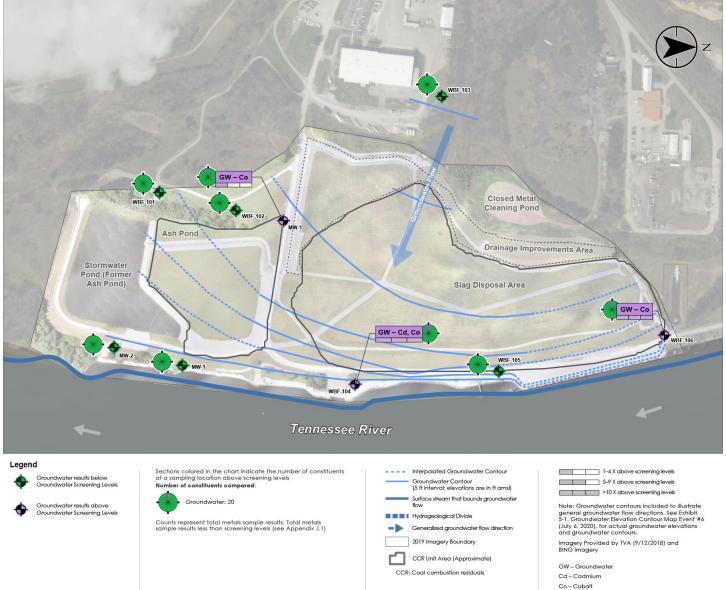
# **Groundwater Findings Near the WBF Plant CCR Management Units**

The figure shows that most constituents were detected below the GSLs. Three wells had constituents with statistically significant concentrations above a GSL.

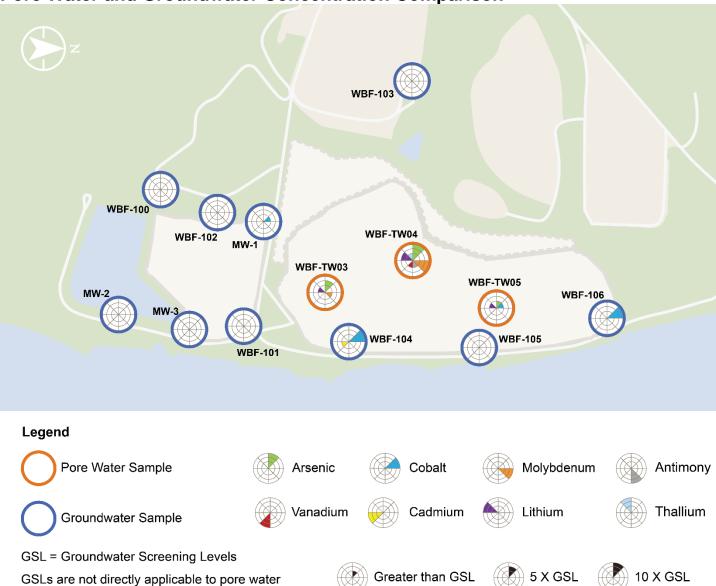
# Pore Water and Groundwater Concentration Comparison

In addition, the quality of pore water was compared to groundwater quality. The following two figures illustrate the difference between pore water quality (symbol with orange outer ring) measured within the CCR management units and groundwater quality (symbol with blue outer ring) measured at the edge of the CCR management units. The first figure is a plan view showing the differences in water quality by comparison of the colors within the symbols. The CCR constituents detected are represented by different colors, as shown in the legend. The relative concentration of the constituent detected compared to the GSLs is represented by the number of colored sections within each slice.

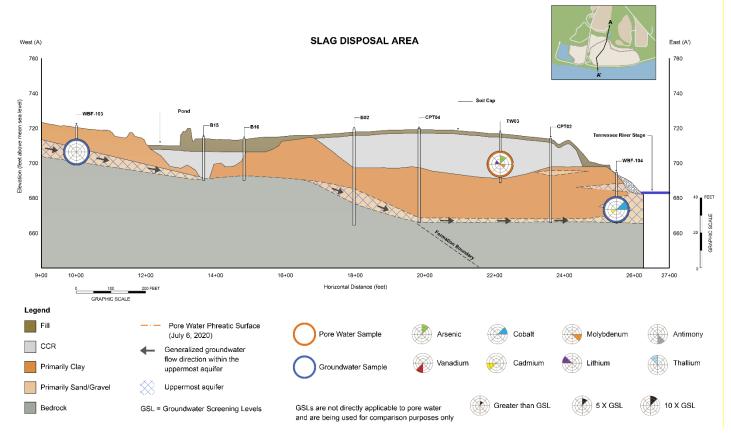
# **Cross Section View of Pore Water and Groundwater Comparison**

The second figure is a cross section through the Slag Disposal Area that also shows the same differences in water quality. These two figures show that generally the constituents detected in downgradient groundwater along the edge of the CCR management units are different than those detected in pore water within the CCR management units. This can be explained by geochemical reactions that can occur as water flows through natural geological materials.

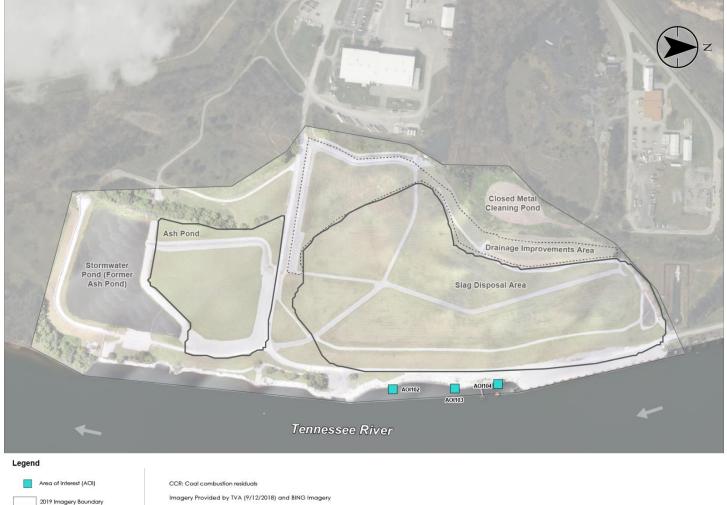
# **WBF** Area of Interest Locations

During the review of the Tennessee River levels and initial EI data within the Slag Disposal Area, TVA observed the phreatic levels within the unit trending with the river levels. Additionally, the phreatic levels were observed to gradually increase in elevation toward a ponded area located west of the Slag Disposal Area. In June 2020, additional multi-level vibrating wire piezometers were installed adjacent to each AOI (AOI02, AOI03, and AOI04) to monitor groundwater levels at the Tennessee River bank. Also, two additional multi-level vibrating wire piezometers were installed to monitor potential influence of the ponded area on the phreatic surface within the Slag Disposal Area. The supplemental investigation procedures and piezometer locations are provided in Appendix G.2. Based on the EI data, and using the supplemental investigation results described above, the three AOIs (AOI02, AOI03, and AOI04) adjacent to the Slag Disposal Area along the Tennessee River bank will be further evaluated in the CARA Plan to determine if corrective actions are needed.

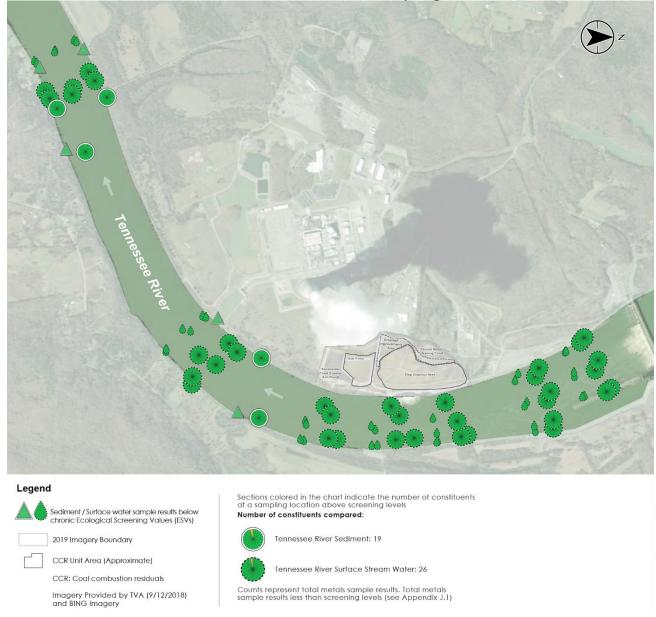
### **Tennessee River Sediment and Surface Stream Sampling Locations**

For the EI, benthic macroinvertebrate community collection was performed in 2019 using a Ponar dredge sampler within the Tennessee River. Sampling transects were established at locations adjacent to and downstream of the WBF Plant CCR management units, as well as upstream of the Watts Bar Dam within the Reservoir. As previously discussed, upstream communities are likely affected by habitat-related stress associated with the impoundment and are not ideal as study controls. The benthic community taxa lists and counts were composited by transect to capture a comprehensive cross section of the existing benthic community in each representative river segment. Community metrics were then used

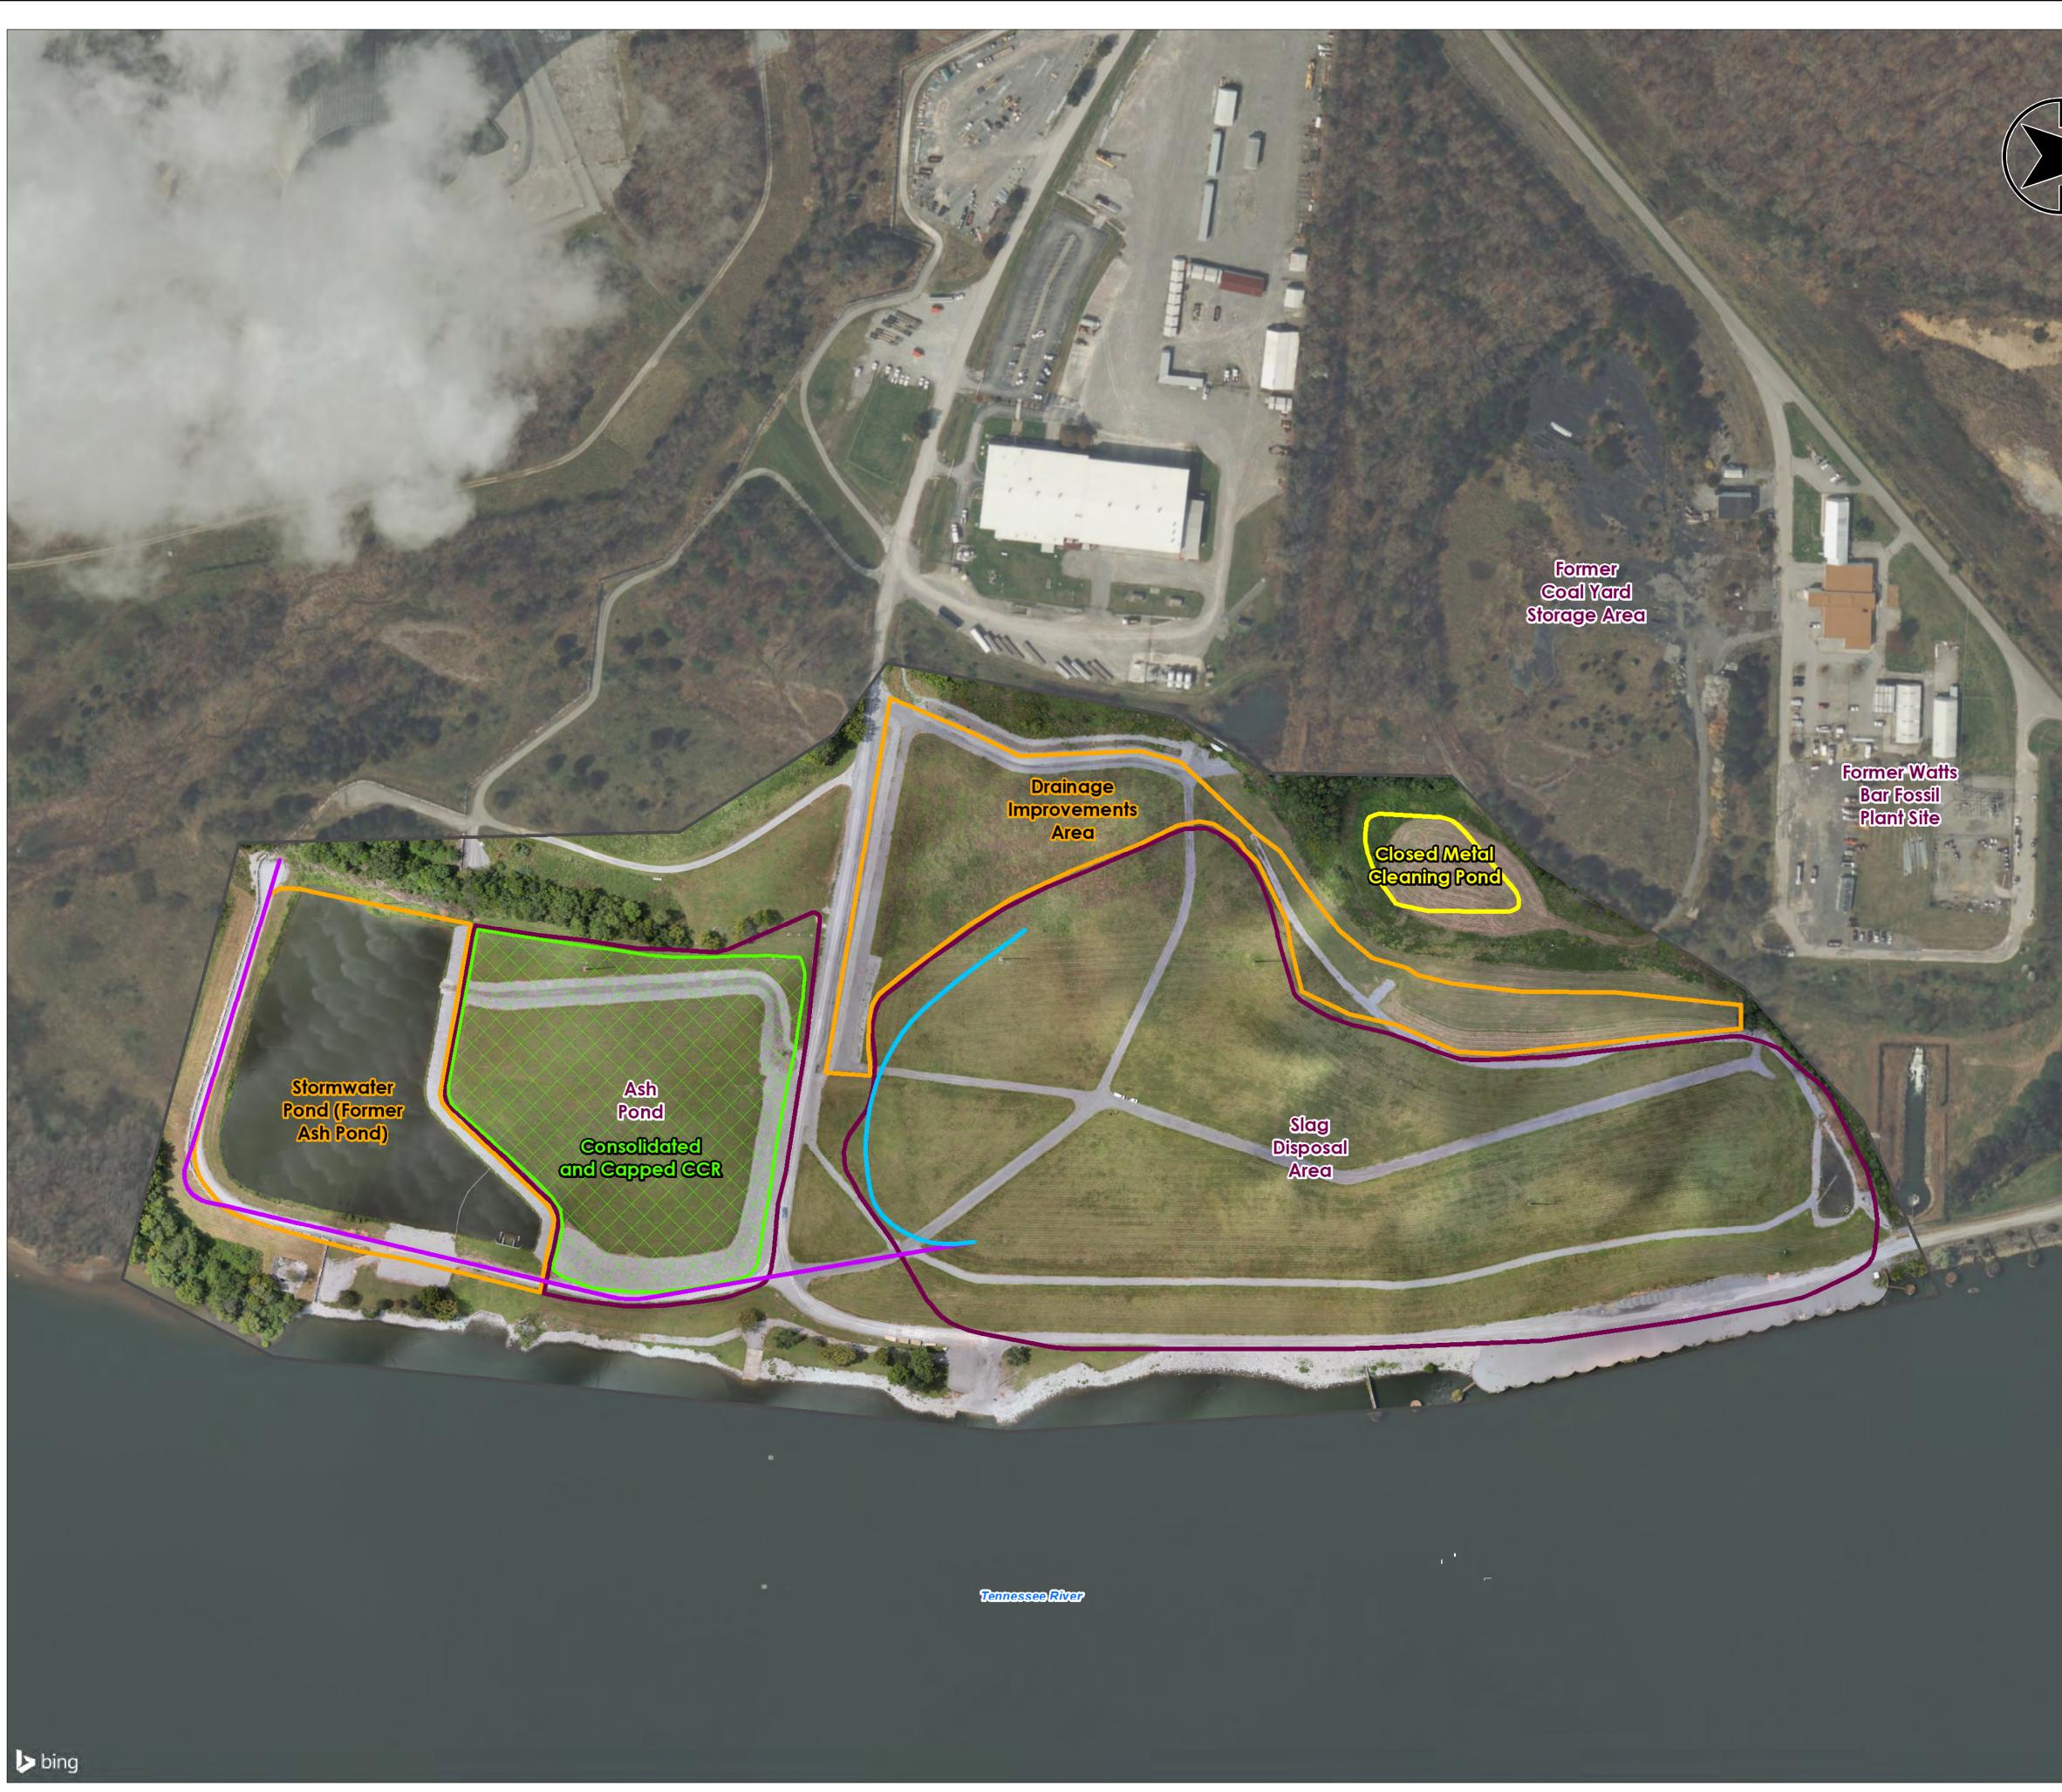
Exhibit No. 2-2

## Title Dike Construction History

- Coordinate System: NAD 1927 StatePlane Tennessee FIPS 4100
   Imagery Provided by TVA (9/12/2018) and BING Imagery
   Dike alignments digitized from TVA Drawing 10W243 R0.

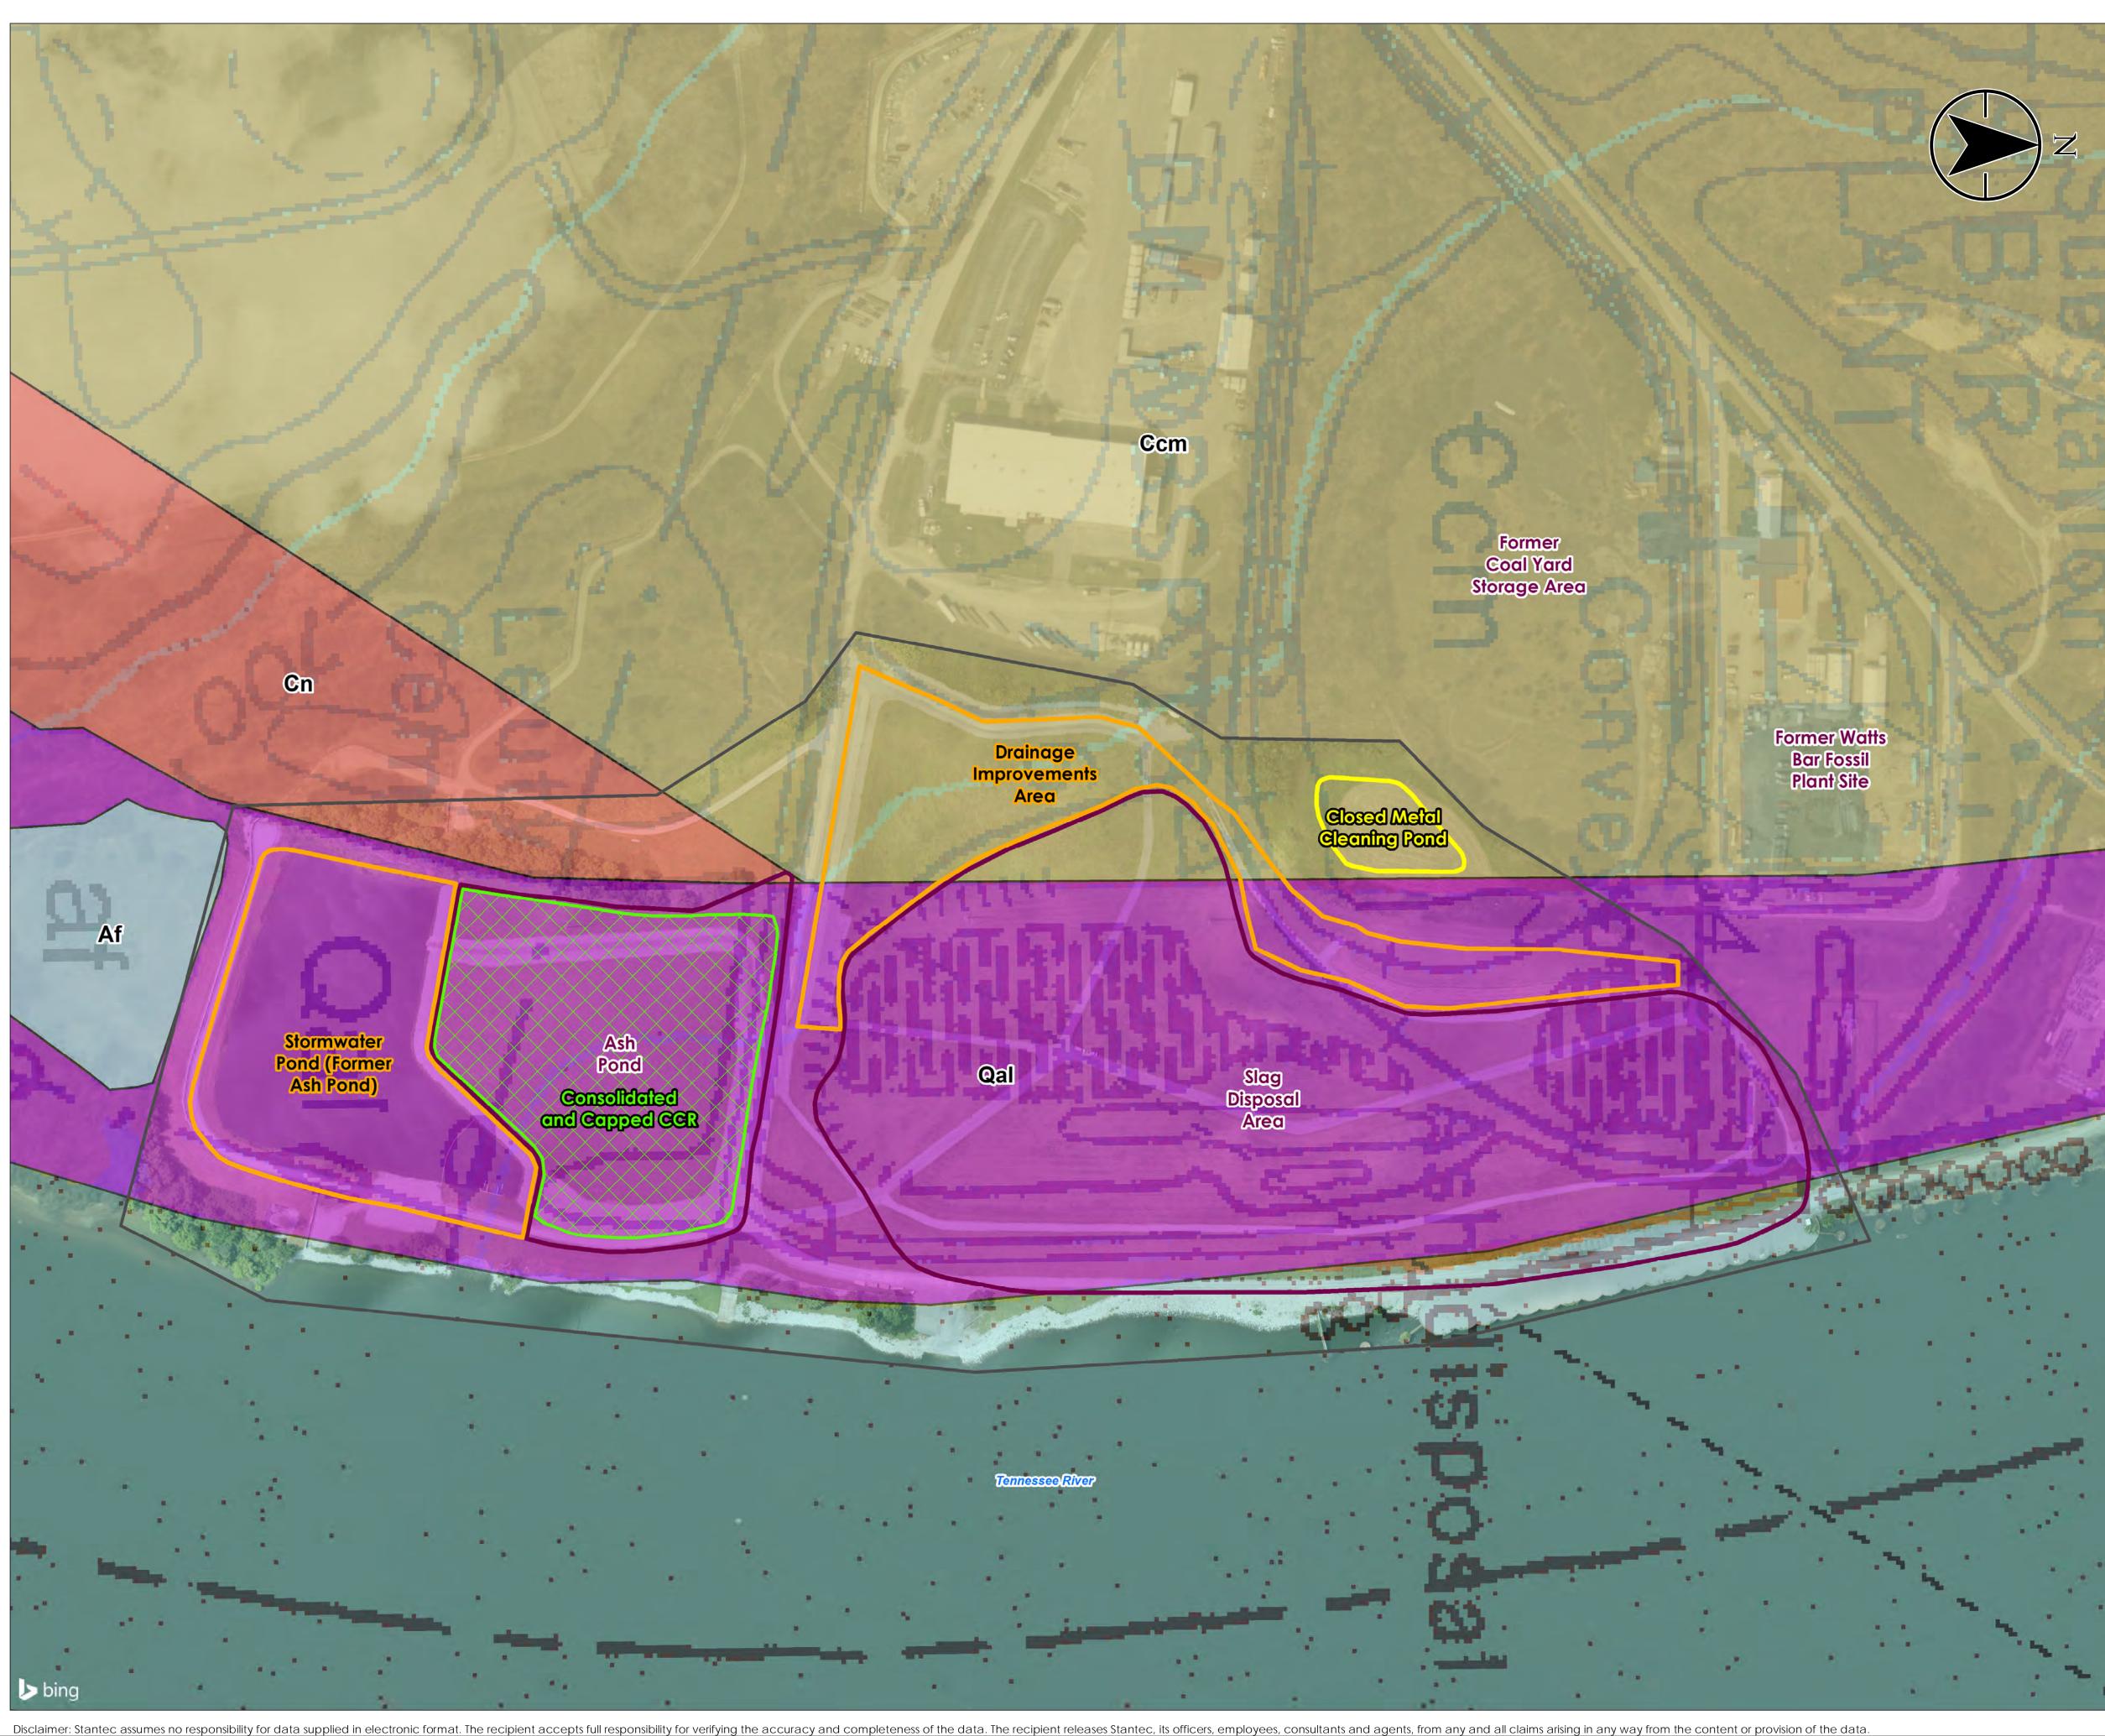
Exhibit No. 2-4

## Title Geologic Map

Exhibit 2-5 provides an overlay of faults and fractures in the vicinity of the WBF Plant. The faults and fractures were mapped as part of the work conducted for the USGS Tennessee Geologic Map (Hardeman et al, 1966).

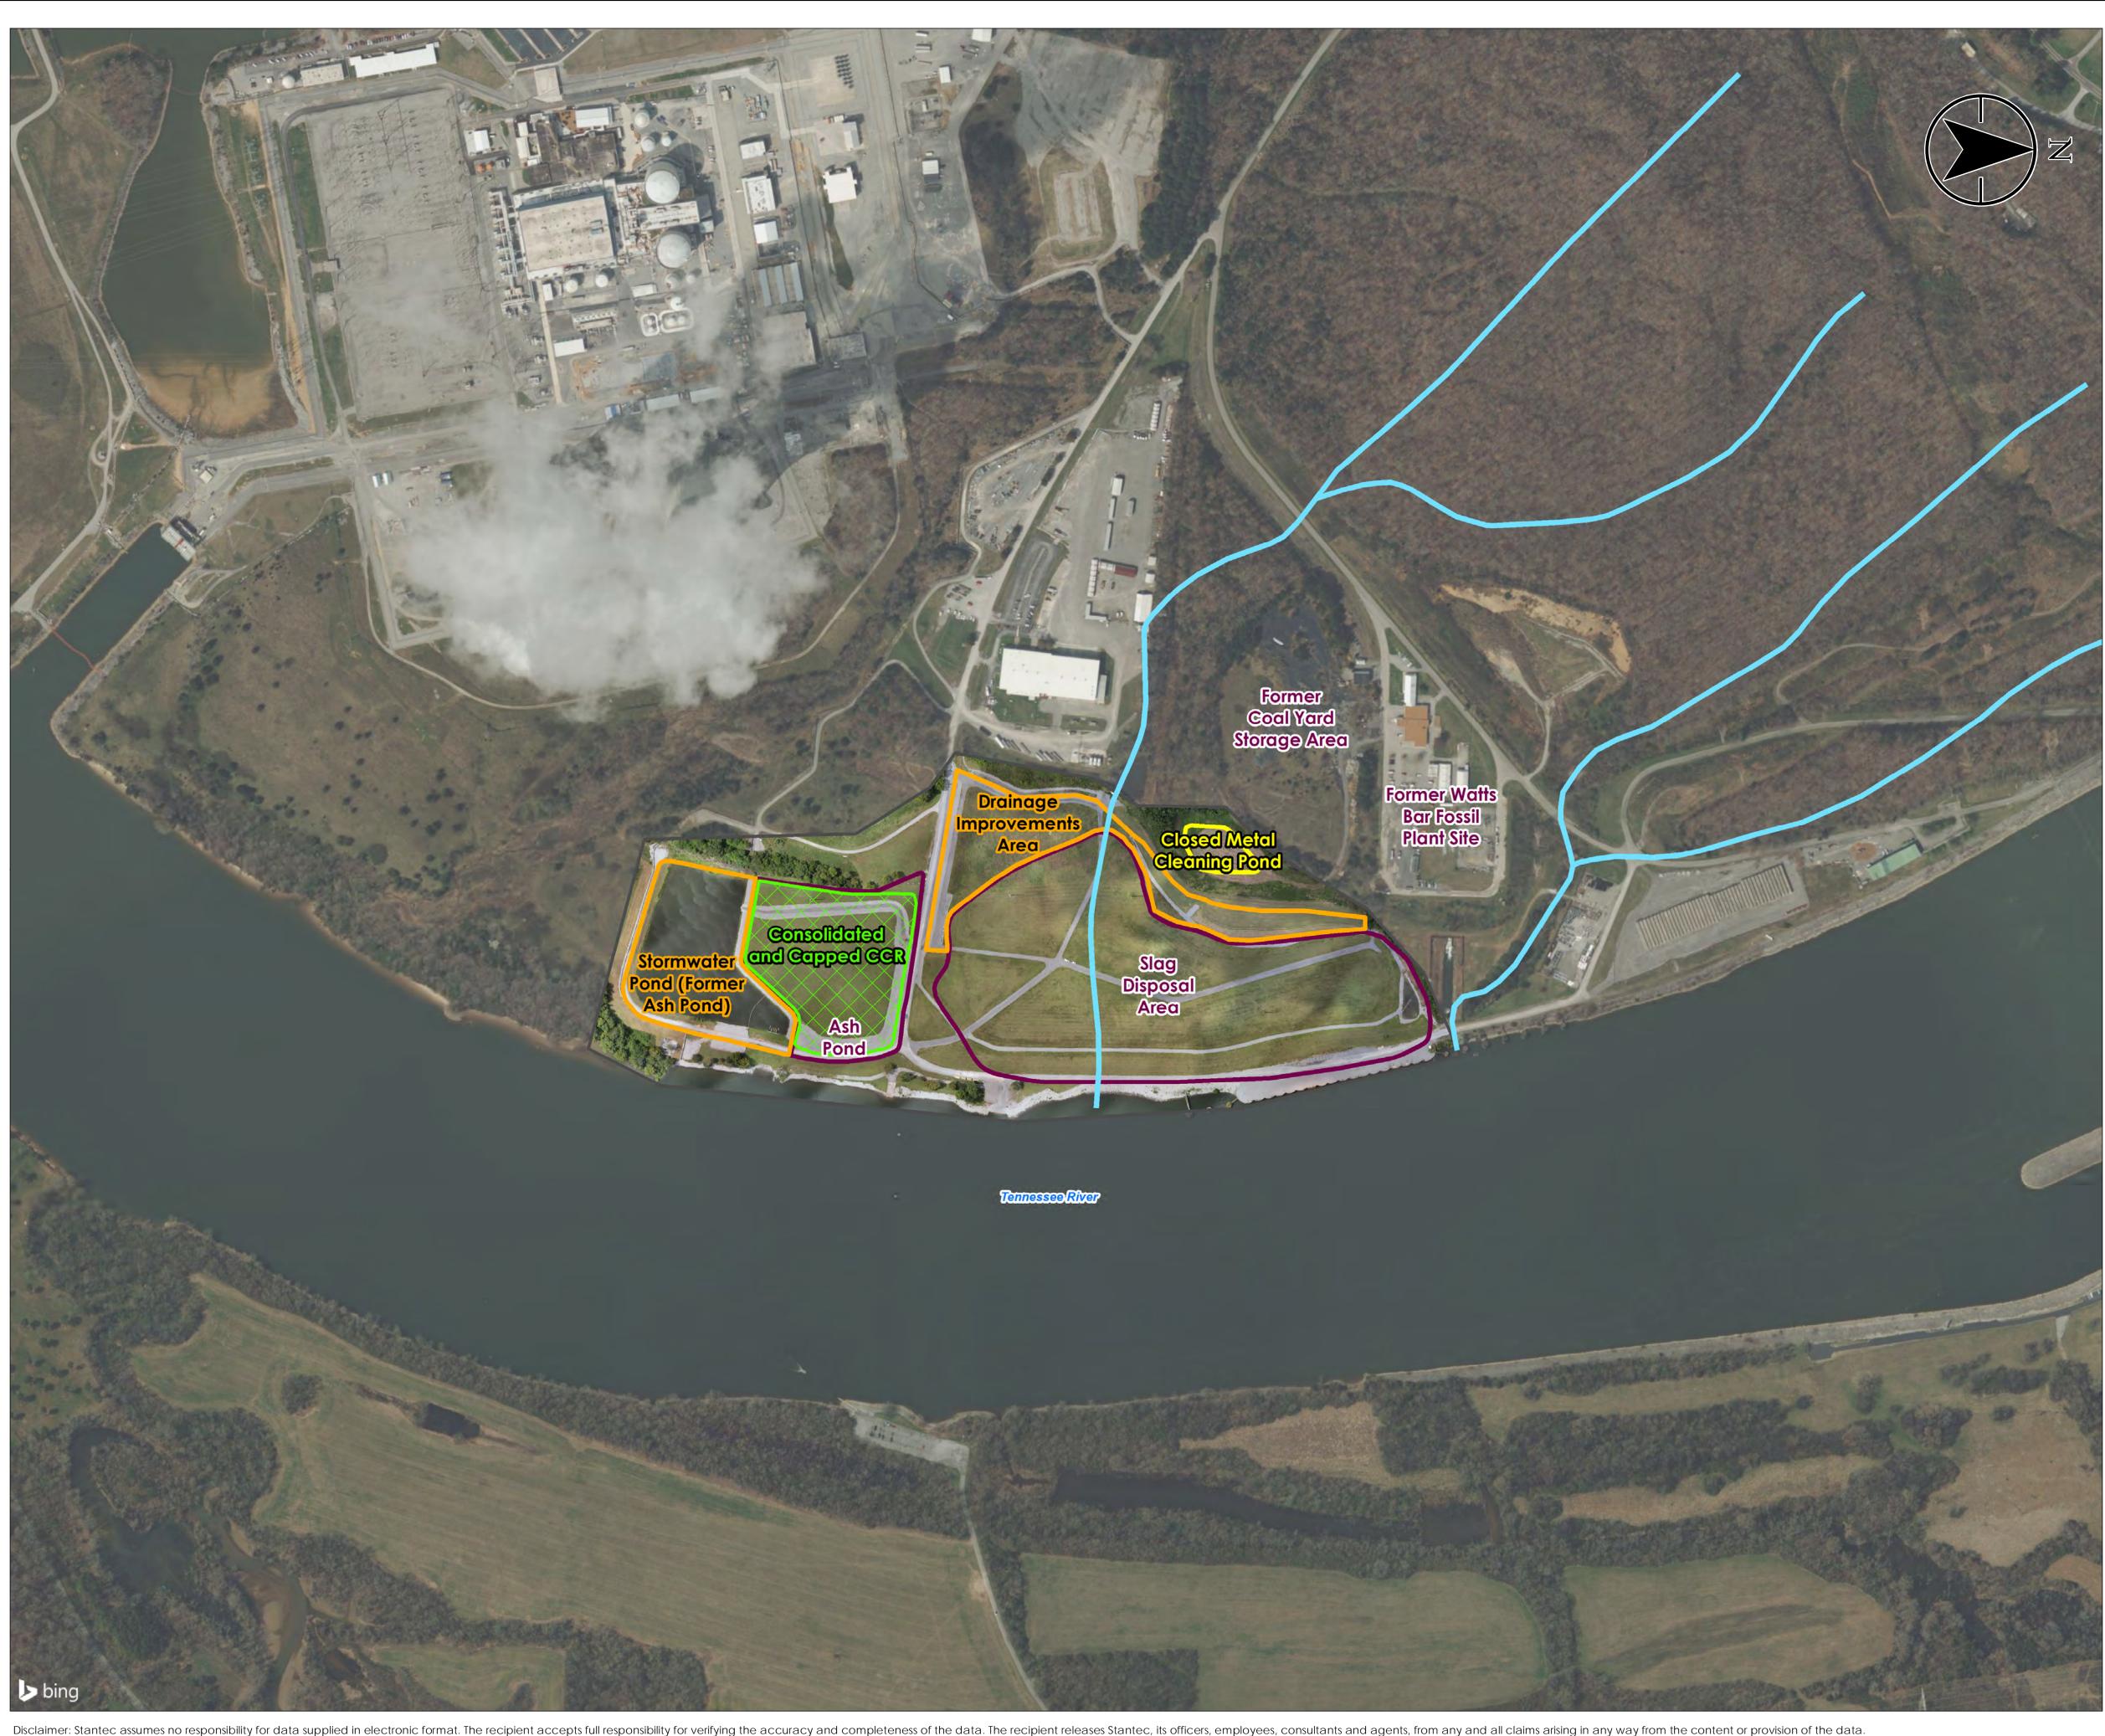
Exhibit No. 2-6

## Title Historic Stream Alignment

- Coordinate System: NAD 1983 StatePlane Tennessee FIPS 4100 Feet
   Imagery Provided by TVA (9/12/2018) and BING Imagery
   Historic stream alignments digitized from Topographic Map USGS TVA, Decatur Quadrangle, 1935

The WBF Plant is located on the south-flowing Tennessee River approximately one mile downstream of TVA Watts Bar Dam and 58 miles upstream of TVA Chickamauga Dam (Exhibit 2-1). Under normal conditions, the Tennessee River flow in the vicinity of the WBF Plant depends primarily upon releases from the Watts Bar Dam. The reservoir upstream of Chickamauga Dam was filled in 1940 (TVA 2022a). The reservoir upstream of Watts Bar Dam was filled in 1942 (TVA 2022b). After the construction of these dams, the WBF Plant was constructed in dry conditions between 1940 and 1945. Prior to the construction of the WBF Plant, a small tributary to the Tennessee River followed an alignment through the Slag Disposal Area (Exhibit 2-6).

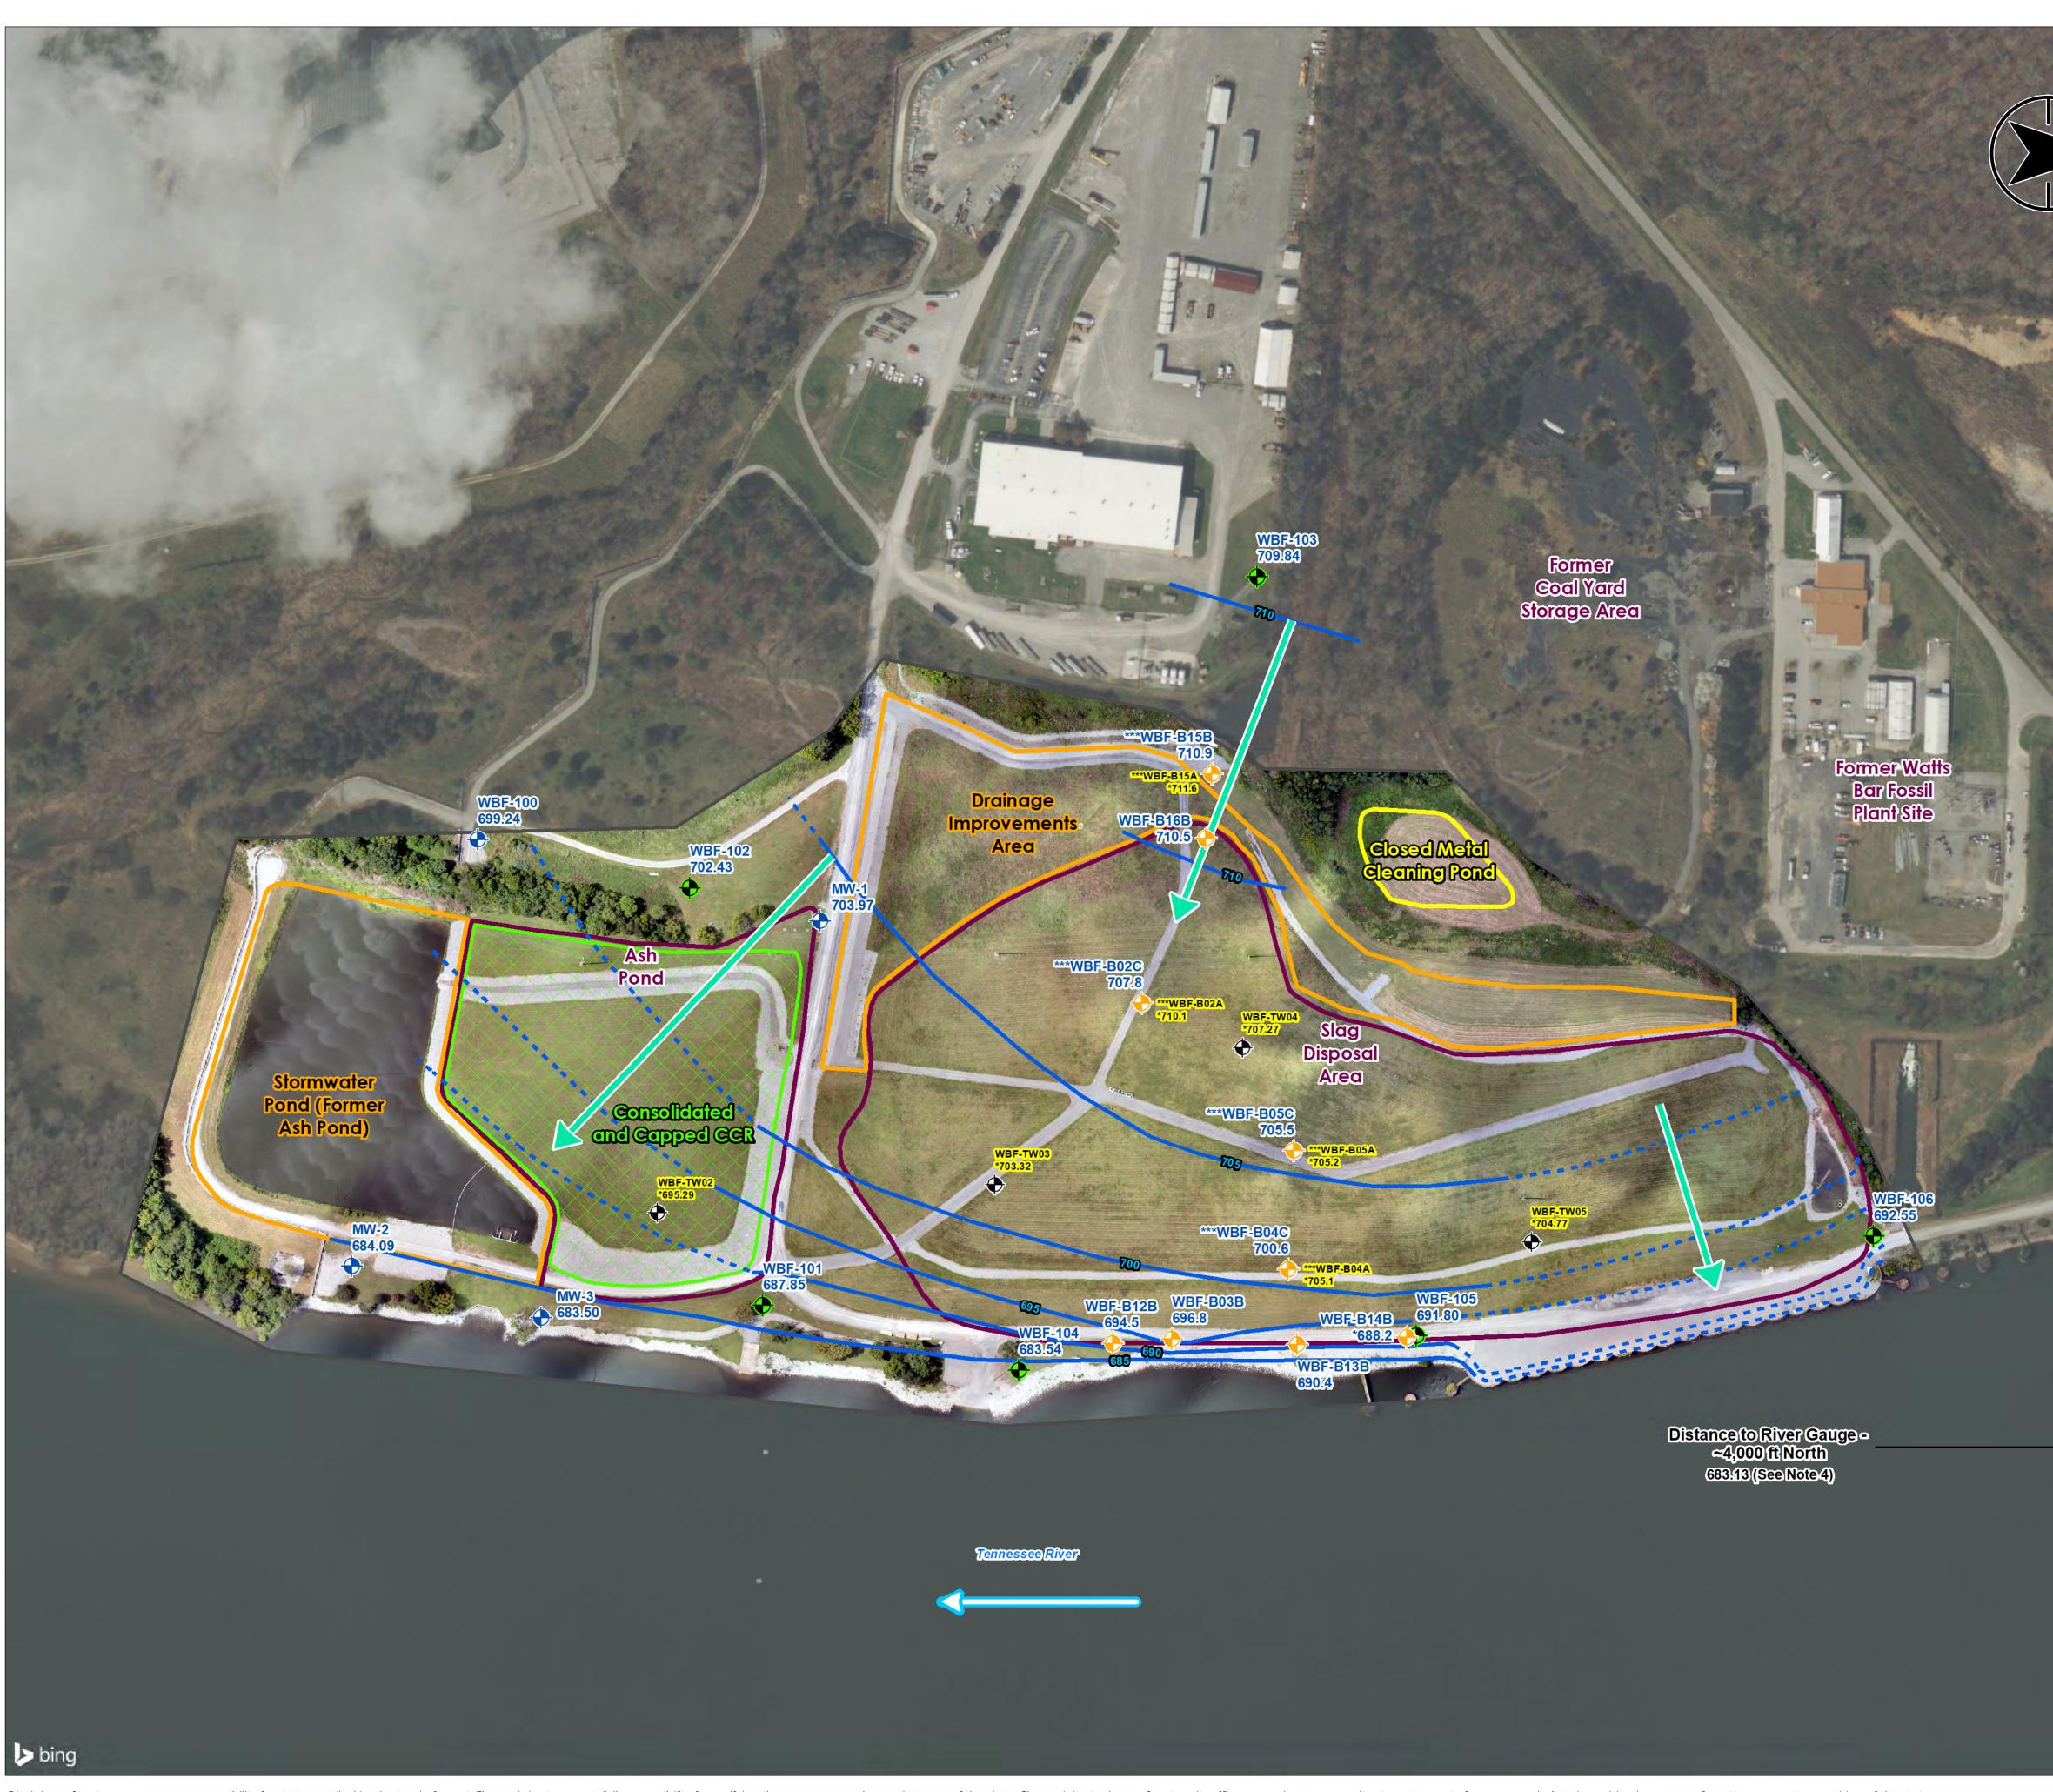
Exhibit No. 5-1

Title Groundwater Elevation Contour Map, Event #6 (July 6, 2020)
