Structural Assessment

Muscle Shoals Reservation
adaptive re-use study

Conditions/Market/Planning/Implementation

July 31, 2009
Revised August 25, 2009

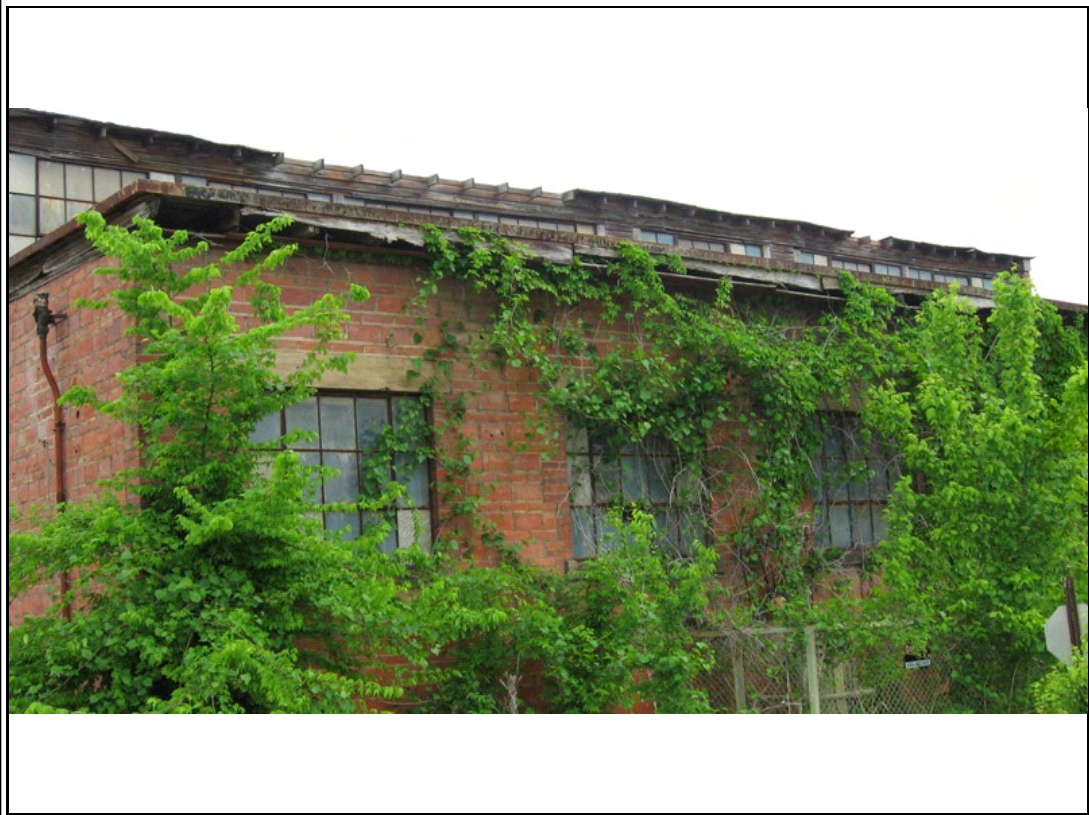
Photograph #: 3

View of clerestory monitor with deteriorated roof structure.
