Tennessee Valley Authority

Cyclic Assessment Report
TVA Muscle Shoals, Alabama
September 16, 2013

Executive Summary

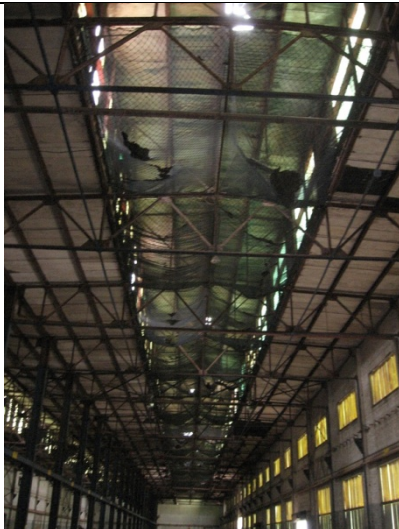
2009 Photo #11: Large holes in deteriorated concrete plank roof deck

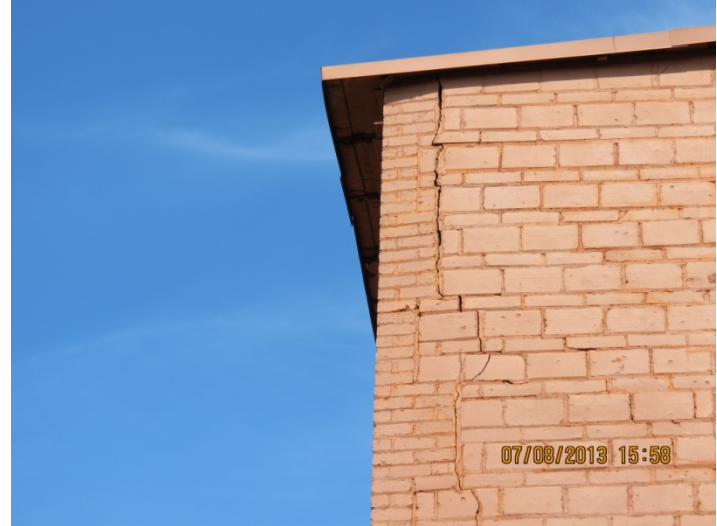
2009 Photo #6: Crack in wall by door opening West end
