# BOOK 2 . CONDITIONS

## Architectural and Historic Assessment

tennessee valley authority

Muscle Shoals Reservation  
adaptive re-use study  
Conditions/Market/Planning/Implementation

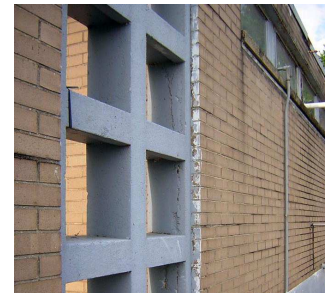
Chimney: Exterior End; Brick  
 Efflorescence through deck at overhangs  
 Serious cracking in masonry; significant repointing required  
 Exterior doors not historic

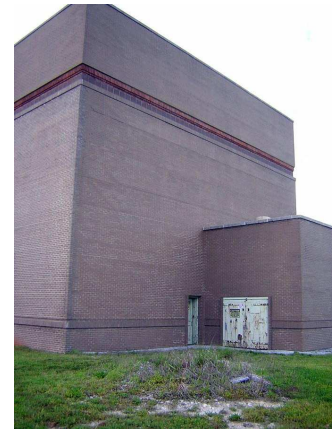
Entire facade covered with new brick  
Original window openings infilled with brick or louvres

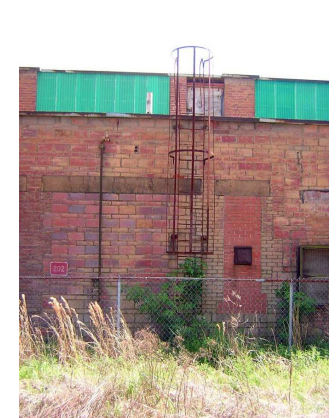
Windows removed at ground level and 1/2 of clerestory

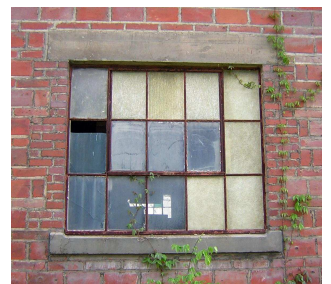
Significant damage to clerestory and roof  
Several sections of roof deck rotten or missing

Several areas of wood ceiling/deck rotten or missing resulting in significant water damage  
Majority of clerestory deck and framing in disrepair

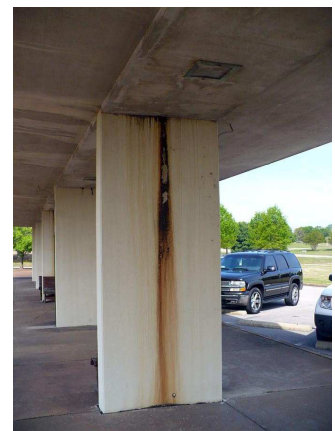
Roof drains appear to be internal and tie in to sewer below building; visible in garage area  
 Cracking in brick sawtooth walls in police garage area  
 Brick infill at Northeast corner not original to building; originally storefront in this area  
 Metal coping and flashing are in disrepair at interior corners of building  
 Bottom window panes are operable  
 Concrete canopy in front of building was originally bus terminal; moderate water damage to concrete

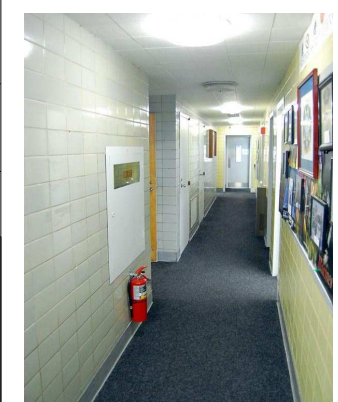
Roof leaks visible at several areas, likely caused by clogged roof drains internal to building  
 Police/Staff offices located off main double-loaded corridor  
 All original interior walls made of glazed tile in various colors  
 Locker/Toilet Rooms feature original marble toilet partitions and window sills  
 Several interior doors appear to be original, most office doors appear to be non-historic

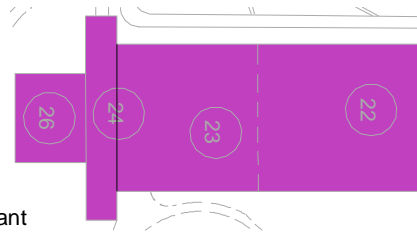
Concrete panels falling from ceiling  
 Extension rust/corrosion in some areas of steel frame  
 Brick paving in certain areas  
 Sliding wood doors and pulley system between main warehouse buildings/spaces.  
 Lower level inaccessible due to environmental hazards

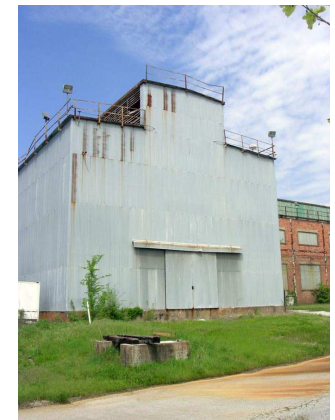
No surviving windows; openings covered with corrugated plastic panels.  
 Louvres at East end of building.  
 Evidence of rust on exposed steel structure.

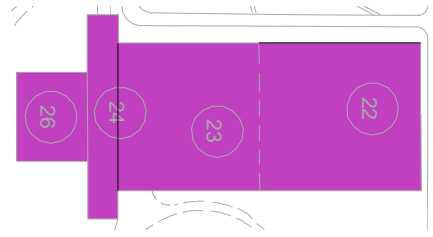
Building Name	24 - L/N Warehouse No. 4	
Period of Construction	1918	
National Register Eligibility	Contributing MSHD, NFDC Context	
Building Height	1 story	
Building Footprint	18,439 SF	
Historic Use   Current Use	Cyanamide Oven Bldg.	Vacant
Potential Use   Adaptability	CR, LI, LO, RE, ST, WH	3

Building Component	Building Material	Condition
Corridors	N/A	
Primary Space	Open, low brick wall divides space	3
Secondary Space	N/A	
Secondary Space	N/A	
Secondary Space	N/A	
Flooring	Concrete; Brick	2
Walls	Exposed corrugated metal at ends and exposed hollow clay tile where abutting adjacent buildings	3
Ceiling	Exposed Beams: Steel; Concrete, panels	3

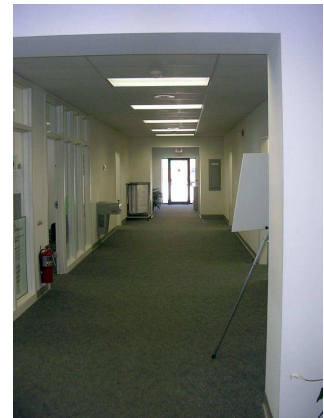
Interior recently renovated for office use, no historic features remain visible

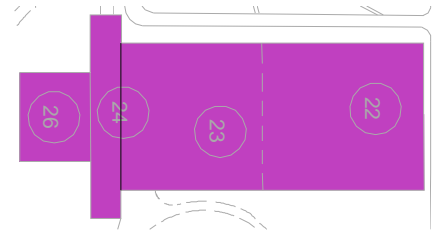
Building Name	26 - Grounds Maintenance Shop	
Period of Construction	1918	
National Register Eligibility	Contributing MSHD, NFDC Context	
Building Height	1 story	
Building Footprint	18,623 SF	
Historic Use   Current Use	Cyanamide Oven Bldg.	Vacant
Potential Use   Adaptability	CR, LI, LO, RE, ST, WH	3

Interior space inaccessible due to environmental hazards  
Severe cracking in areas of concrete floor

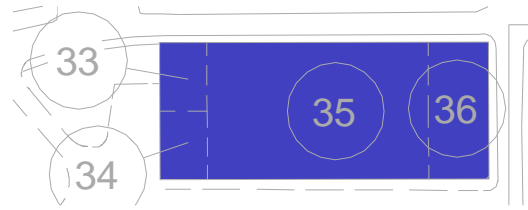
Building Name	35 - Chemical Plant Warehouse	
Period of Construction	1918	
National Register Eligibility	Contributing MSHD, NFDC Context	
Building Height	2 story	
Building Footprint	37,849 SF	
Historic Use   Current Use	Store House	Storage
Potential Use   Adaptability	LI, LO, RE, ST, WH	1

CMU infill at several dock openings on North facade  
 Loading Dock on North side of building has been removed  
 New metal overhead doors have been recently installed in several dock openings  
 West facade shows signs of cracking/bulging; tie plates installed in areas of end walls  
 Storm windows applied to exterior of original steel windows on West side of building

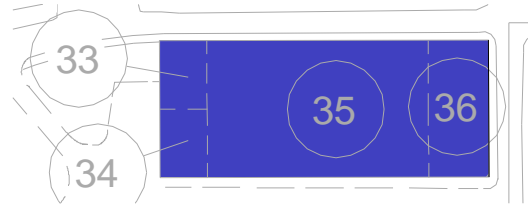
Building Name	35 - Chemical Plant Warehouse	
Period of Construction	1918	
National Register Eligibility	Contributing MSHD, NFDC Context	
Building Height	2 story	
Building Footprint	37,849 SF	
Historic Use   Current Use	Store House	Storage
Potential Use   Adaptability	LI, LO, RE, ST, WH	1

Office area off entry doors is wood framed with original bead board  
 Masonry elevator shaft centrally located  
 Original copper-wrapped interior sliding doors with pulley system; still operable  
 Interior of East wall shows severe cracking/bulging; ties in several areas of end walls.

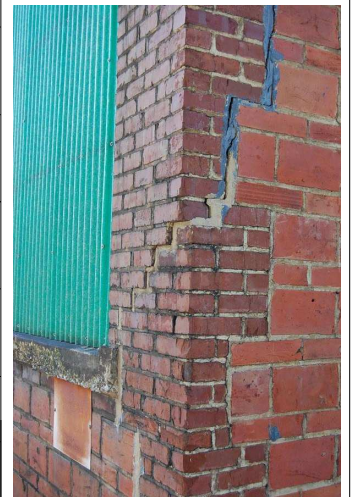
Significant cracking in masonry at West facade  
 Several original openings infilled with hollow clay tile and CMU  
 Erosion of hollow clay tile in areas on East facade  
 Significant cracking and exposed rebar at concrete sills  
 Wood doors on East facade have old cast straps, but don't appear to be original to building  
 New metal overhead doors on East facade at Gas/Diesel Repair Shop

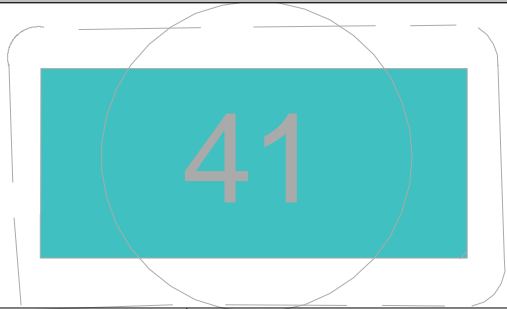
Building Name	41 - Sheet Metal Shop	
Period of Construction	1918	
National Register Eligibility	Contributing MSHD, NFDC Context	
Building Height	1 story	
Building Footprint	6,622 SF	
Historic Use   Current Use	Wood Working Shop	Shop
Potential Use   Adaptability	CR, LI, LO, RE, ST, WH	2

Brick recently replaced at large door opening header on North side  
 Severe cracking at brick quoins around openings; major brick replacement at West Facade  
 Severe spalling and exposed rebar at concrete window sills  
 North facade of building has severe cracking and bulging

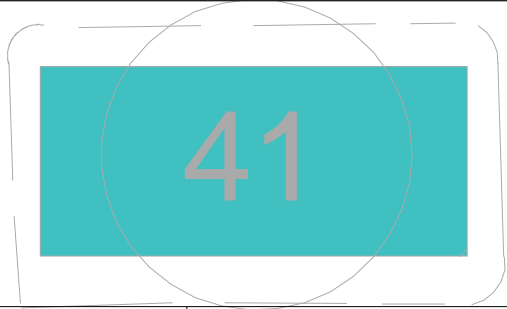
Building Name	41 - Sheet Metal Shop	
Period of Construction	1918	
National Register Eligibility	Contributing MSHD, NFDC Context	
Building Height	1 story	
Building Footprint	6,622 SF	
Historic Use   Current Use	Wood Working Shop	Shop
Potential Use   Adaptability	CR, LI, LO, RE, ST, WH	2

Water infiltration around some roof openings and flashing  
 Entire interior painted, included steel framing, steel windows, and HCT walls  
 Small equipment mezzanine with stair in corner of space

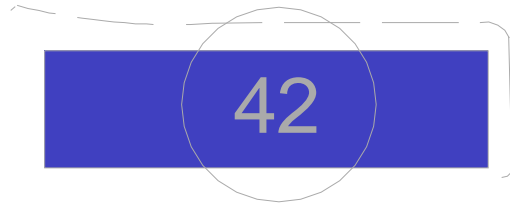
Building Name	42 - Pipe Shop		
Period of Construction	1918		
National Register Eligibility	Contributing MSHD, NFDC Context		
Building Height	1 story		
Building Footprint	10,933 SF		
Historic Use   Current Use	Blacksmith Shop	Shop	
Potential Use   Adaptability	LI, RE, ST, WH	2

CMU infill at large openings on all four sides  
 Major cracking in Hollow Clay Tile at East wall; Wall ties visible at East and West walls  
 Severe settlement/cracking in foundation on all sides  
 Spalling and exposed rebar observed at window/opening sills; sealant bad at sills

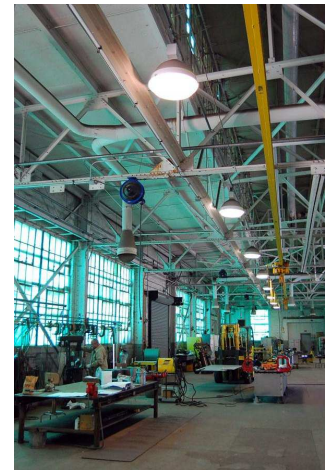
Concrete floors show signs of wear from shop equipment  
 Entire interior painted, including steel frame and steel windows

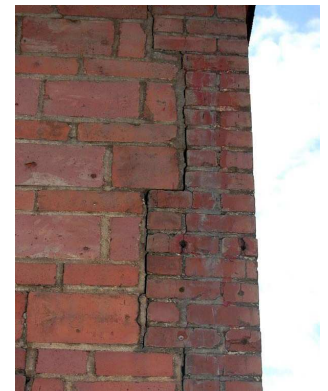
Wood fascia peeling and rotten in certain areas  
 Significant cracking in concrete foundation around building perimeter  
 Steel windows showing rust on exterior  
 Lintels show signs of spalling and pocking

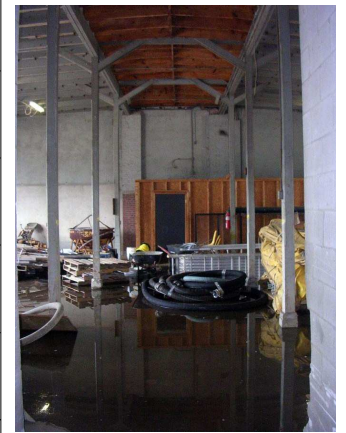
Major roof leak in Locker Room has resulted in standing water for large portion of floor  
East end of building not accessible due to environmental hazard

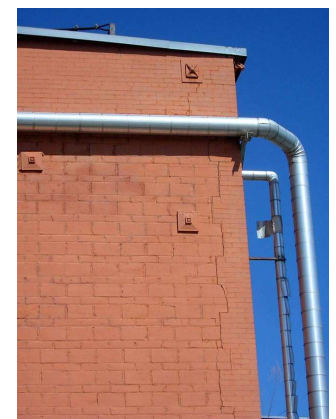
All original steel windows have been removed  
 Concrete window sills vary in condition from good to poor  
 Numerous structural ties at exterior corners of West facade; seperation evident in these areas  
 Brick infill at large area on South facade

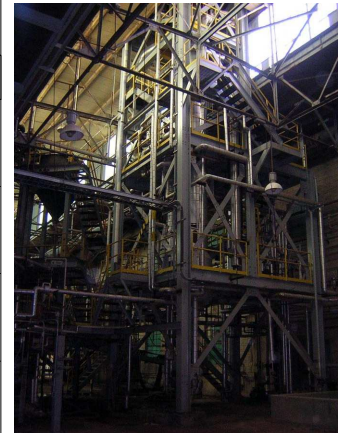
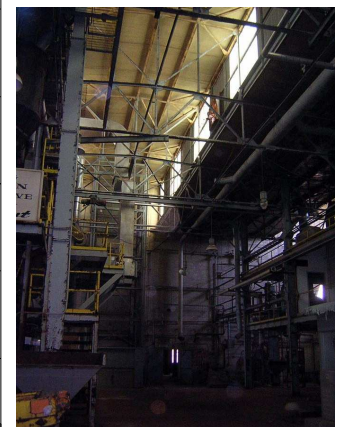
Large Pilot Plant equipment occupying majority of floor space  
 Majority of concrete floor shows severe deterioration  
 Floor has many trenches/grates running length of building  
 Steel stairs and mezzanines provide access to upper levels of process equipment  
 Water piping is damaged and water is flooding portions of this building and addition

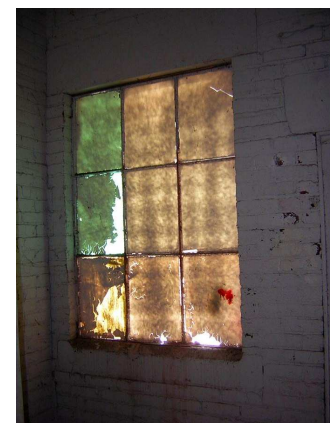
Interior of window sills severely deteriorated  
Interior divided in several smaller storage areas

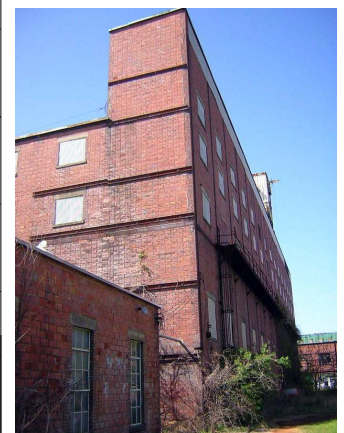
Corrugated metal addition on roof of 3rd story has visible rust and deterioration  
 Areas of catwalk and fire escape on East side of building deteriorated or missing  
 Steel frame exposed on exterior of building on East and West facades  
 Corners of building show signs of cracking and separation in hollow clay tile/brick quoins

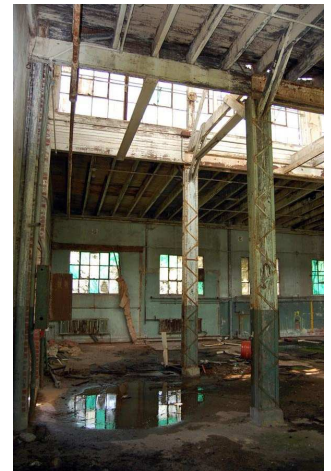
Concrete floor in main interior space in poor condition  
 Wood decking missing or rotten in several areas, recently repaired in other areas  
 Wood joists rotten in several areas  
 Original wood doors between original building and main addition  
 Standing water covering 30% of floor in original building

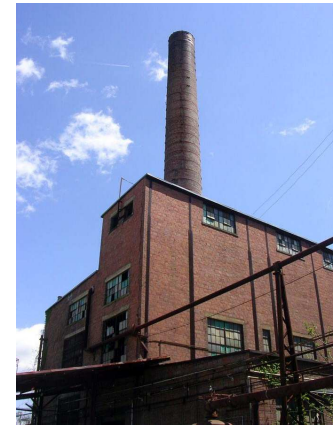
Chimney/Stack made of brick; several areas of disrepair including compression bands  
 Drainage problems at East end of low shed roof  
 Cracking at top corners of building  
 Concrete lintels show some signs of deterioration  
 Several single metal doors around perimeter of building heavily rusted

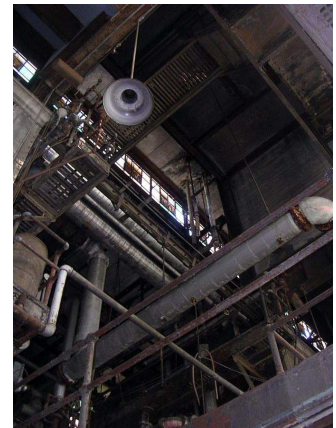
Primary space filled with Boiler Equipment and catwalks  
 Mezzanines and catwalks inaccessible due to severe rust  
 Majority of building inaccessible due to environmental hazard

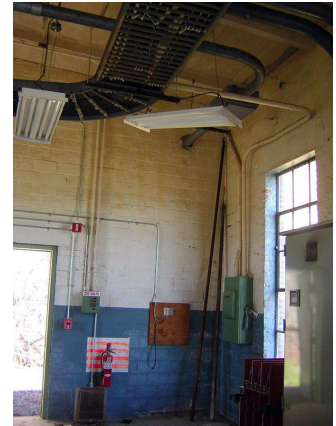
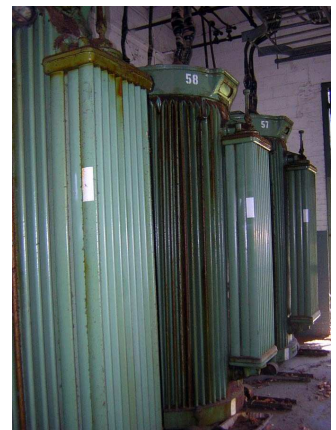
Entire interior of building is painted; paint peeling in some areas  
Interior fire door scrapes concrete floor

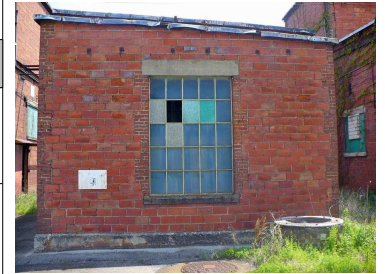
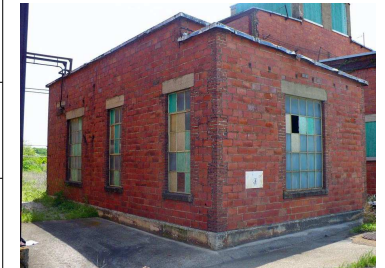
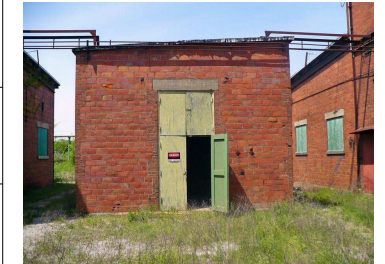
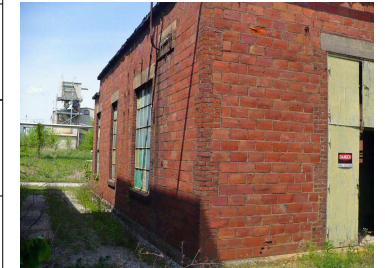
80% of window panes replaced with translucent fiberglass  
 Misc. steel conduit/raceways connected to Buildings 69 & 70  
 Roof has single large ventilation chimney

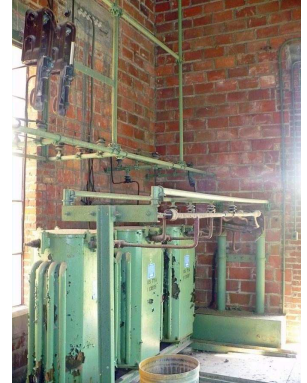
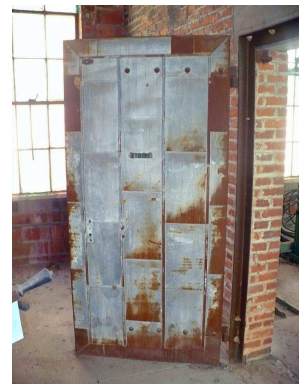
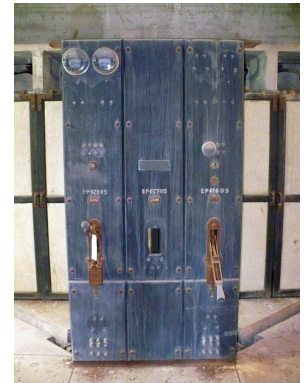
Primary space has floor mounted electrical transformers and equipment  
 Secondary space has switchgear plus transformers in cast in place concrete housings  
 Original tin-covered door in brick wall between interior spaces

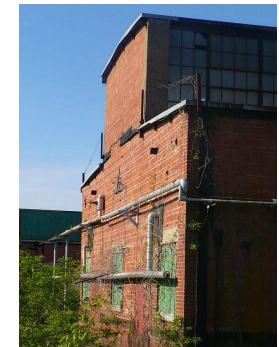
Ventilation/mechanical equipment added on shed roof  
 95% of windows covered by translucent fiberglass  
 Cracking in hollow clay tile at all exterior corners  
 New metal awnings over entry doors

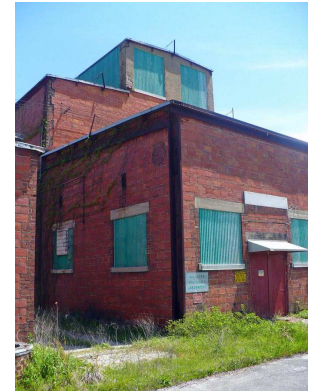
Rear 1/3 of building demolished - slab remains  
 100% of windows covered by translucent fiberglass  
 Cracking in hollow clay tile at all exterior corners  
 New metal awnings over entry doors  
 Ventilation/mechanical equipment added on shed roof

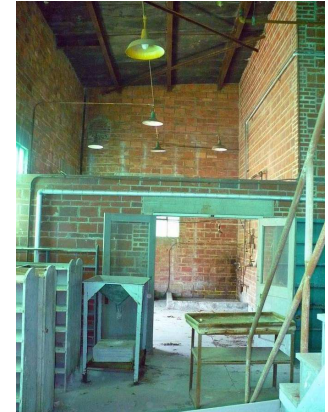
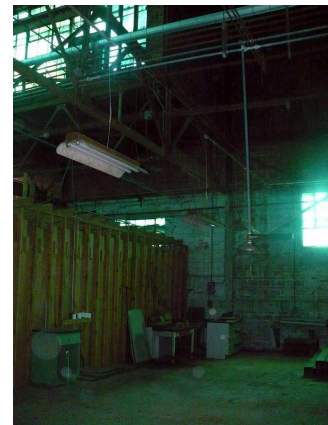
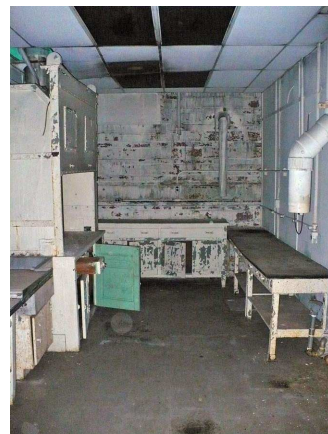
Office and Labs in poor condition - ACT failing due to water infiltration

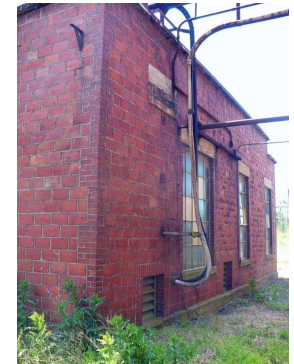
50% of window panes replaced with translucent fiberglass  
 Misc. steel conduit/raceways connected to Buildings 71 & 72  
 Roof has single large ventilation chimney

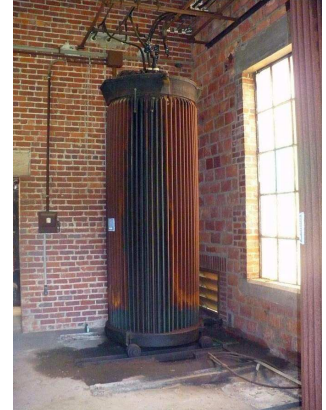
Primary space has floor mounted electrical transformers and equipment  
 Secondary space has switchgear plus transformers in CIP concrete housings  
 Original metal-covered door in brick wall between interior spaces

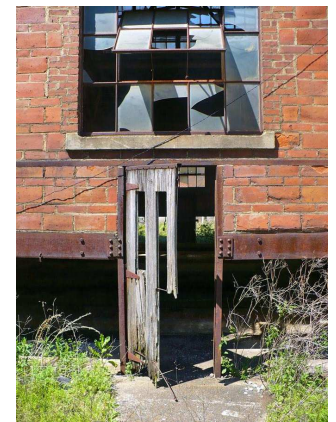
Wood louvres below sill beam - only four or five remain around entire perimeter  
 Visible rust on steel window frames  
 Serious cracking and displacement at upper East facade  
 Metal frame openings at West facade appear to be added - no brick quoining adjacent to openings

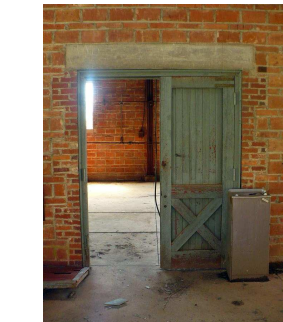
Flues and concrete pad raised about 7" above slab in Catalyzer Room  
 Building still retains much of its interior historic fabric

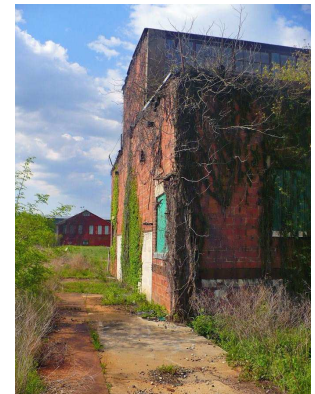
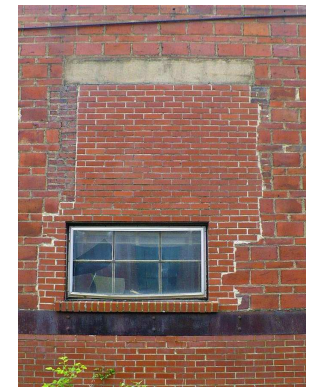
All original ground-level openings infilled with brick, new fixed aluminum windows added  
 New metal awnings over entry doors  
 Cracking in hollow clay tile at all exterior corners  
 40% of clerestory windows covered by translucent fiberglass panels  
 Some CMU infill at exterior walls and doors

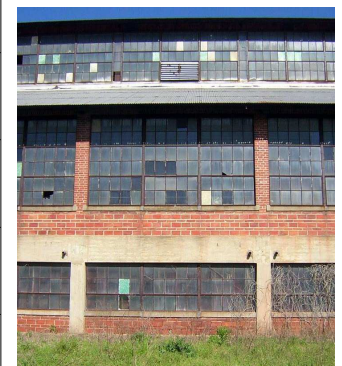
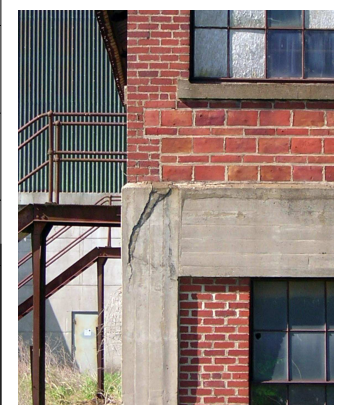
Clerestory consists of steel windows with brick at corners only  
 Concrete mezzanine structure projects onto exterior on East, West, and South facades  
 Historic metal clad sliding door at Loading Dock

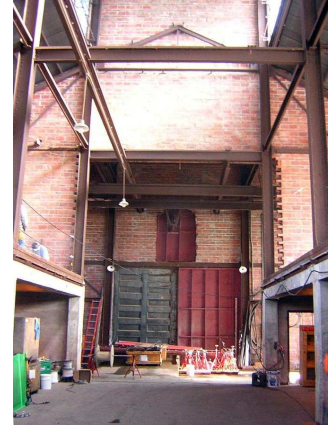
Center bay is open from ground level to Celerestory  
 Mezzanine on each side consists of exposed concrete structural floor and beams  
 Most windows at Clerestory intact and in good condition  
 Concrete structure exposed at ground level, steel structure exposed above

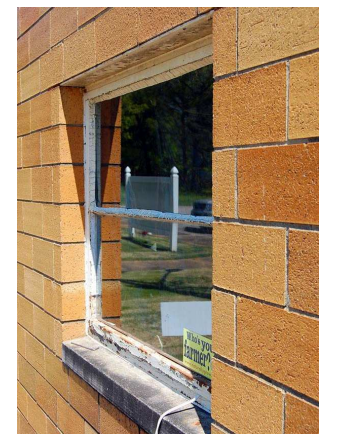
Original metal fascia/flashing intact; small areas of rust visible  
 Porch addition is made of steel frame and bar joists with corrugated plastic panels; paint peeling  
 Window frames rusted through paint; still operable and in very good condition  
 L-shaped awning over front entry has significant amount of rust  
 Greenhouses are in very good condition; all original doors and windows still operable; currently in use

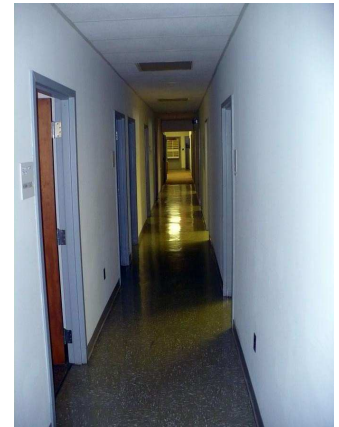
Office area has drywall partitions, carpet, and ACT  
Storage/Shop area has plywood partitions, concrete floors, and ceiling open to framing
