WILSON DAM BRIDGE DECK REFURBISHMENT DRAFT ENVIRONMENTAL ASSESSMENT

Lauderdale and Colbert Counties, Alabama

Prepared by: TENNESSEE VALLEY AUTHORITY Muscle Shoals, Alabama

April 2019

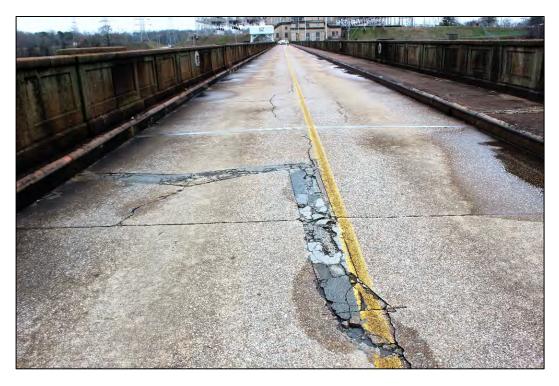
Deterioration of Parapet and Curb

Over the years, the downstream face where the concrete arches interface with the parapet have developed widespread spalls (areas where chips, splinters or fragments are broken off) with efflorescence (whitish powdery substance due to migration of mineral rich water through the porous concrete where it evaporates) and visible water movement. In addition, the sidewalk, curb, and deck have developed widespread cracking.

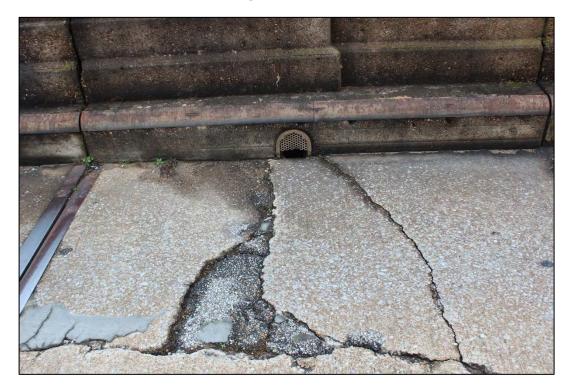
Bridge Deck Cracks

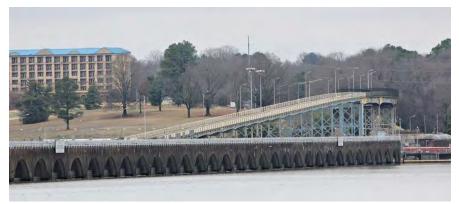
Wilson Dam Bridge Fly-over

In addition, the epoxy overlay with a flint aggregate wearing surface on the fly-over would be replaced. As part of the process, a small, surface preparation milling machine would scarify the surface, the surface would be pressure washed, and then the epoxy would be applied using a trailer mounted mixer/applicator. This epoxy resurfacing would take approximately two weeks with the most time involving surface preparation activities. To replace the six expansion joints, a cut would be made in the concrete a few inches behind the joint and then the joint would be chipped out with small pneumatic hammers. A replacement joint would be set from the bottom and concrete would be poured around the new joint (see Appendix B). Each expansion joints would take approximately a week to replace. To remove the paint/coating on the handrails, an abrasive pressure wash would be used. Operations to remove the expansion joints and prepare the handrails would be fully contained to avoid or minimize releases of materials.

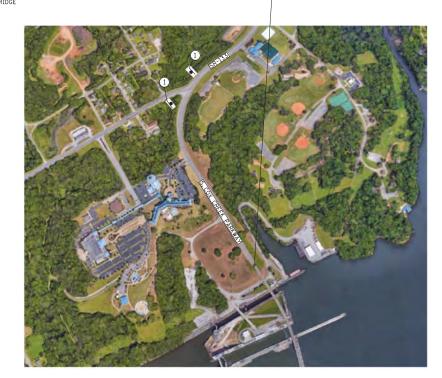
BRIDGE CLOSURE SIGN LOCATIONS - AREA 2

A TOTAL OF FOUR (4) SIGNS ARE REQUIRED. ADDITIONAL MAY BE REQUESTED BY TVA.

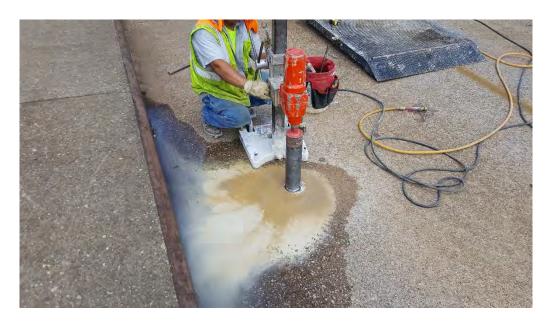
Figure 4: Typical Concrete Coring Setup

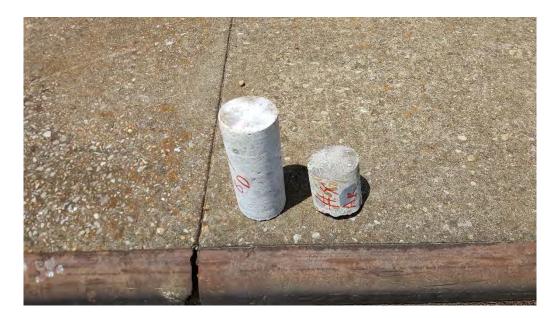
Figure 5: Typical Deck and Arch Samples

As can be seen in Table 3, this deteriorated layer (void) varied in depth from 0.125" to 0.500" for the samples collected. It is believed that the differential settlement along the deck slab is the probable cause of the cracking in the deck. This cracking has allowed water to pass through the deck, where it travels along the construction joint between the arch and the deck, eventually daylighting along the arch face. This passage of water is believed to be the cause of the deterioration of the concrete in the face of the arch.

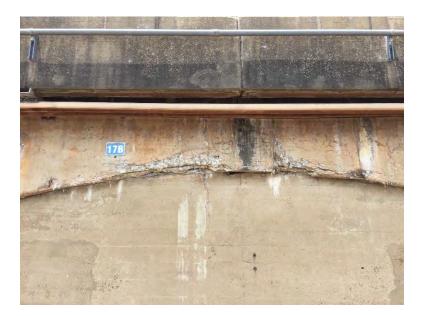
Figure 6: Typical Arch Deterioration

Concrete faces for the arches adjacent to the turnaround, at approximate station 73+55, were visually observed from the turnaround and their areas of deteriorated concrete estimated. Five arches were estimated in all totaling approximately 10% of the project limits. The deteriorated area of those five arches was assumed to be representative of the entire project when calculating repair quantities. Further hands-on inspection of the arch faces by sounding is recommended in future project phases to better quantify the limits of this deterioration. It is also recommended that concrete cores be taken horizontally along the arch for further evaluation.

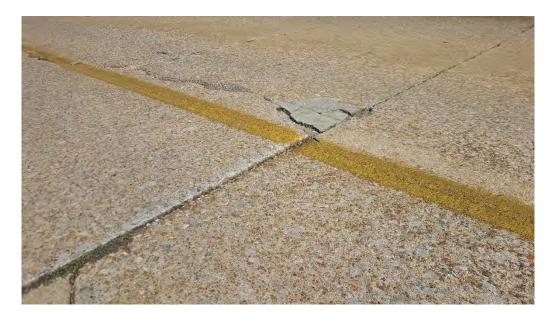
Figure 8: Typical Deck Patching

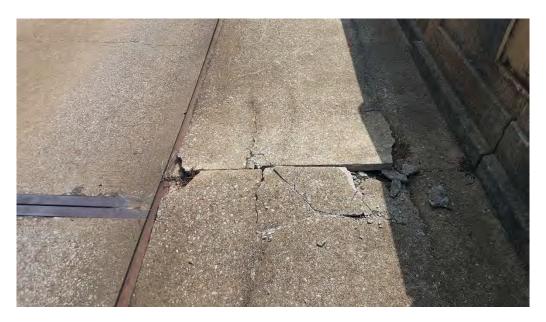
Figure 9: Typical Sidewalk Spall

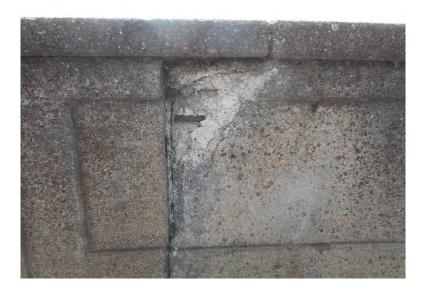
Figure 10: Typical Rail Spall

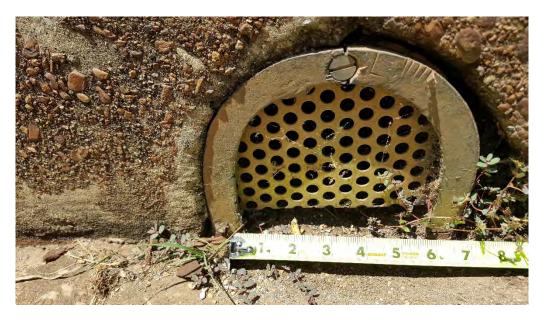
Figure 11: Typical Deck Drain

A hydraulic analysis was performed to see how the existing deck drains will handle a 10-year storm event. The 10-year design frequency is what is required by ALDOT for bridge deck drainage design. Using the FHWA HEC 21 formula for flat bridges, a required inlet spacing of 90' was derived. The spacing of the existing deck drains varies from approximately 46' to 55', so this criteria appears to be met. Due to the structure not having shoulders, the ALDOT criteria of limiting spread to the shoulders could not be met. Therefore, we assumed a maximum allowable spread of one-half of the travel lane, which is allowed by some agencies on lower speed facilities. The calculations can be found in Appendix E. These calculations do not take into consideration the size and flow capacity of the existing deck drains. The capacity of the existing drains could not be verified due to the unique configuration that is no longer typically used, and no published information could be found to confidently determine the existing grate capacities.

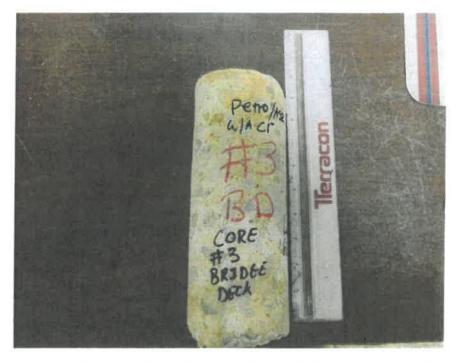
Photo 1: Core #3 from bridge deck (Lab No. 6650), as received.

The cores were generally intact, with the exception of Core #3 from the bridge deck, which was cored over a full-depth fracture and Core #3 from the arch, which had subparallel fractures associated with freeze-thaw damage. The fracture in Core #3 from the bridge was stained black and also exhibited filmy deposits of white calcium carbonate. The bottom surface of Core #3 and Core #5 from the arch exhibited calcium carbonate deposits around aggregates.

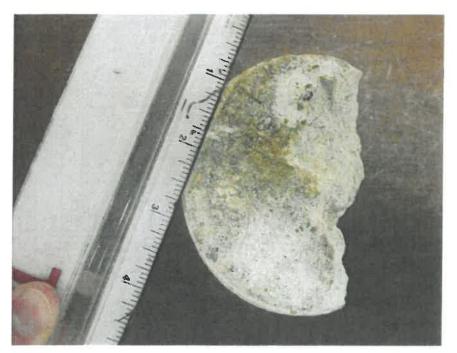
Photo 2: Top surface of Core #3 from bridge deck.

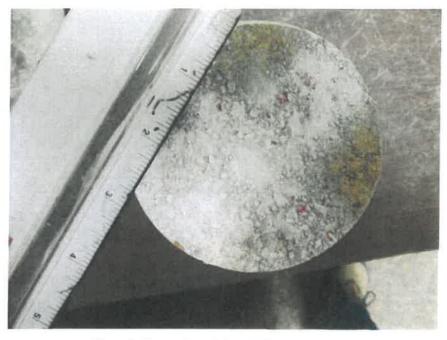
Photo 5: Top surface of Core #4 from bridge deck.

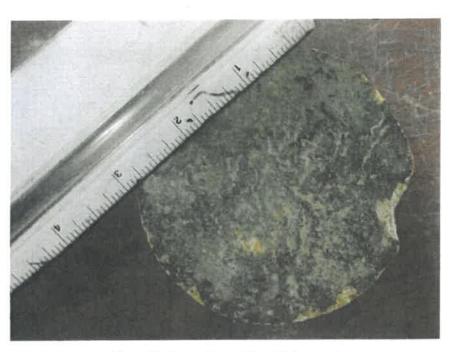
Photo 13: Top surface of Core #4 from arch

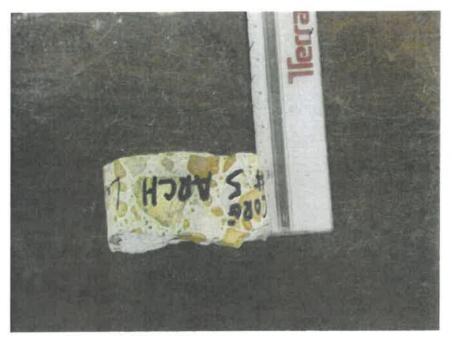
Photo 14: Core #5 from arch (Lab No. 6655), as received

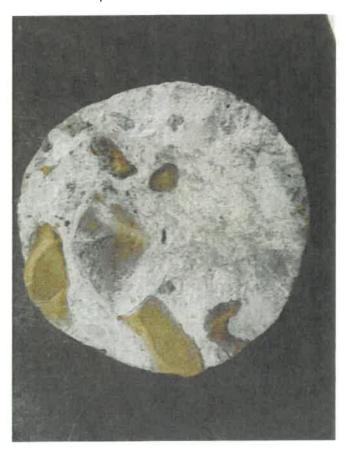
Photo 16: Bottom surface of Core #5 arch from arch showing possible calcium deposits (faint white)

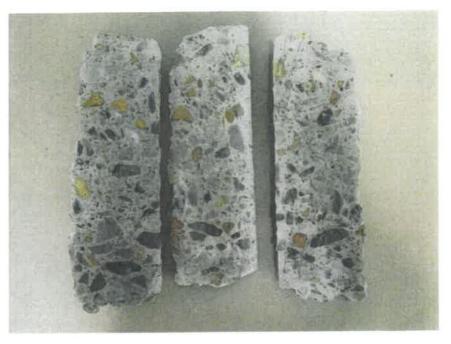
Photo 17: Longitudinally sawn sections of Core #3 from bridge deck. No fractures are apparent.

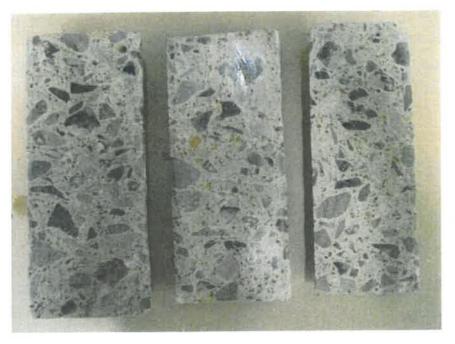
Photo 18: Longitudinally sawn sections of Core #4 from bridge deck. No fractures are apparent.

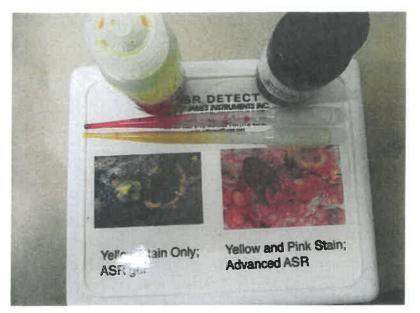
Photo 23: Los Alamos stains used.

Sawn sections were stained using proprietary Los Alamos stains to further detect the presence of ASR. Phenolphthalein stain was also applied to sawn surfaces of the cores. Phenolphthalein is a pH indicator which turns from colorless to magenta at about a pH of 9-10. When the stain remains colorless after application, the concrete is usually carbonated and maintains a pH below 9.

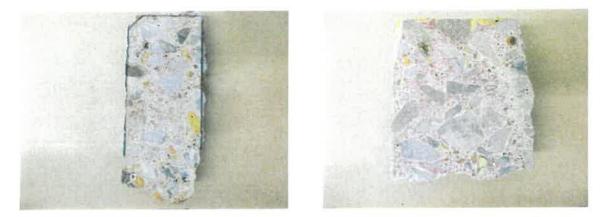
Photo 27: Sawn surfaces of Core #3 from bridge deck (Lab No. 6650) (left) and Core #4 from bridge deck (Lab No. 6651) (right) after application of phenolphthalein stain. Areas not stained magenta are carbonated.

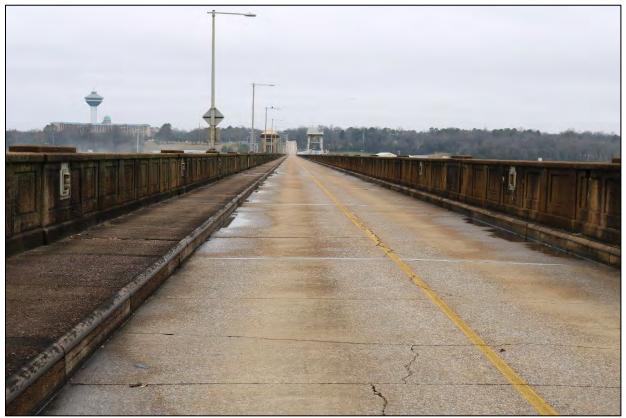
Figure 2. Overview of the deck of Wilson Bridge, facing north, toward Florence, AL.

The original wearing surface of the bridge was comprised of brick pavers, which were removed in the late 1950s and replaced with a concrete deck when the additional steel superstructure viaduct was constructed over the lock. The arch appears to be constructed of mass unreinforced concrete. The bridge deck also appears to be unreinforced (Figure 2).

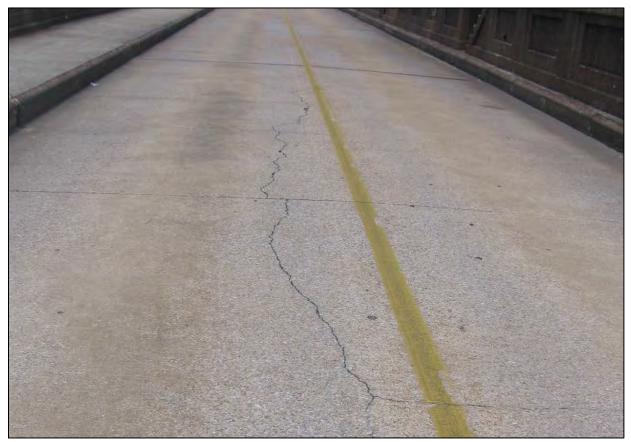
Figure 3. Longitudinal deck crack.

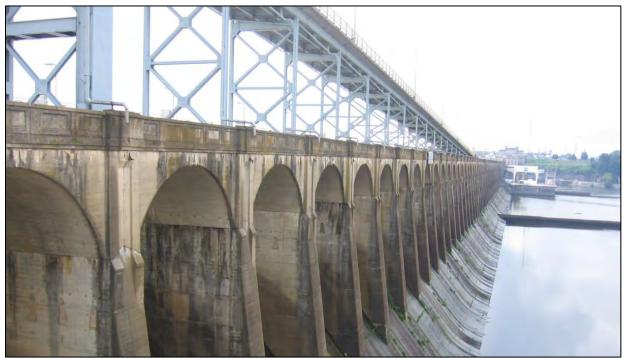
Figure 4. Downstream face of the dam and bridge from the lock wall.

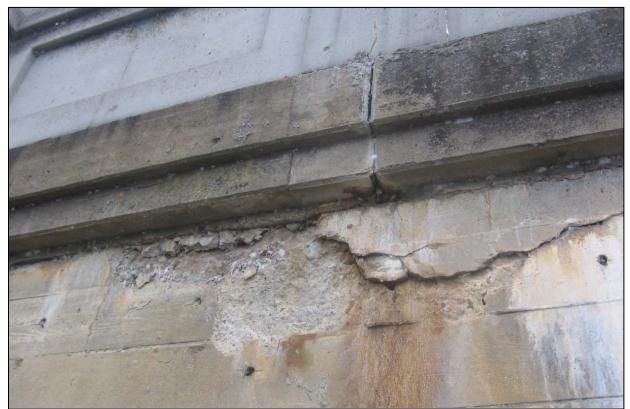
Figure 5. Typical spalling at parapet concrete arch interface

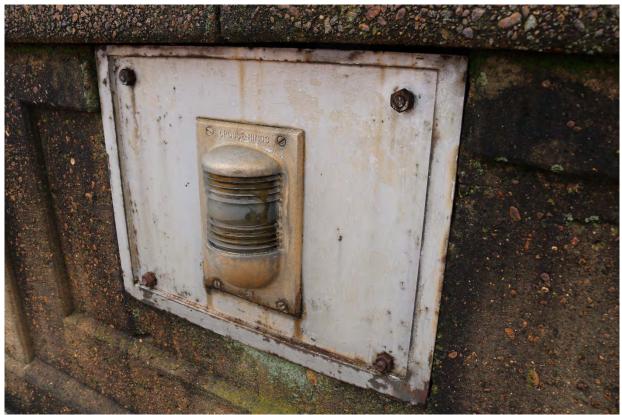
Figure 8. Historic light fixture on the interior of the bridge railing to be removed and reinstalled.

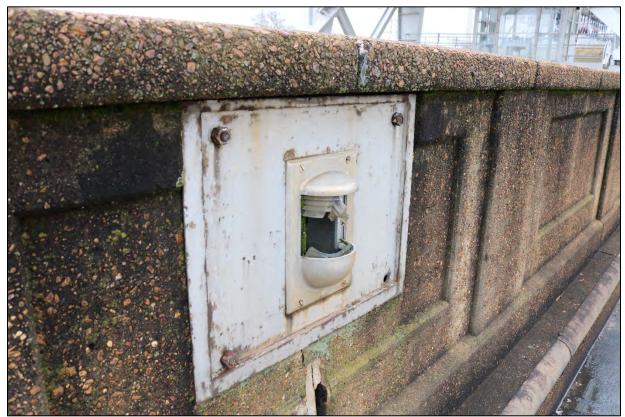
Figure 9. Damaged historic light fixture on the interior of the bridge railing to be removed and reinstalled.

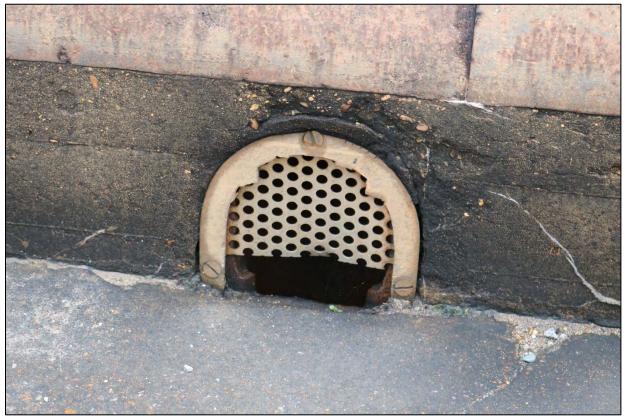
Figure 10. Historic desk drain at the base of the curb at its intersection with the deck.

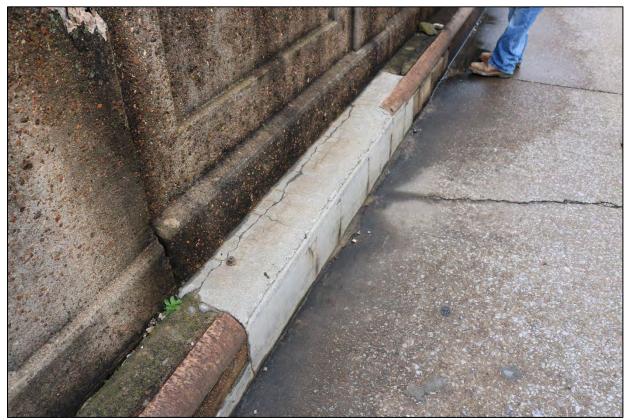
Figure 11. Previous repair flanked by existing steel at curb; sections like this will be repaired to feature new steel curb that matches the profile of the existing curb.

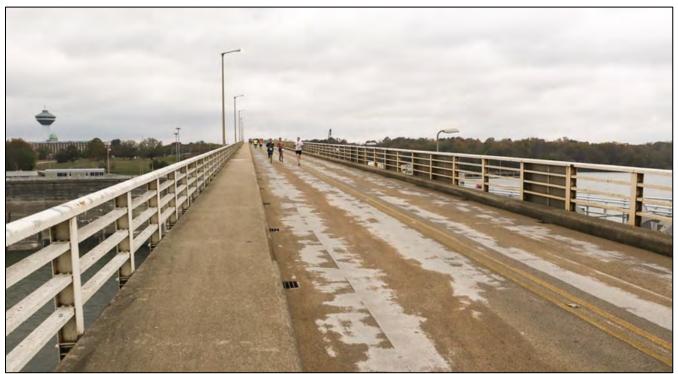
Figure 3. Overview of deterioration of epoxy overlay and the coatings on the handrails (werunracephotos.com).
