SUMMARY OF ENVIRONMENTAL FEATURES FOR THE

ADAMSVILLE SOLAR PROJECT

ADAMSVILLE, MCNAIRY & HARDIN COUNTIES, TENNESSEE

36095-17 TVA# 412154 September 2023

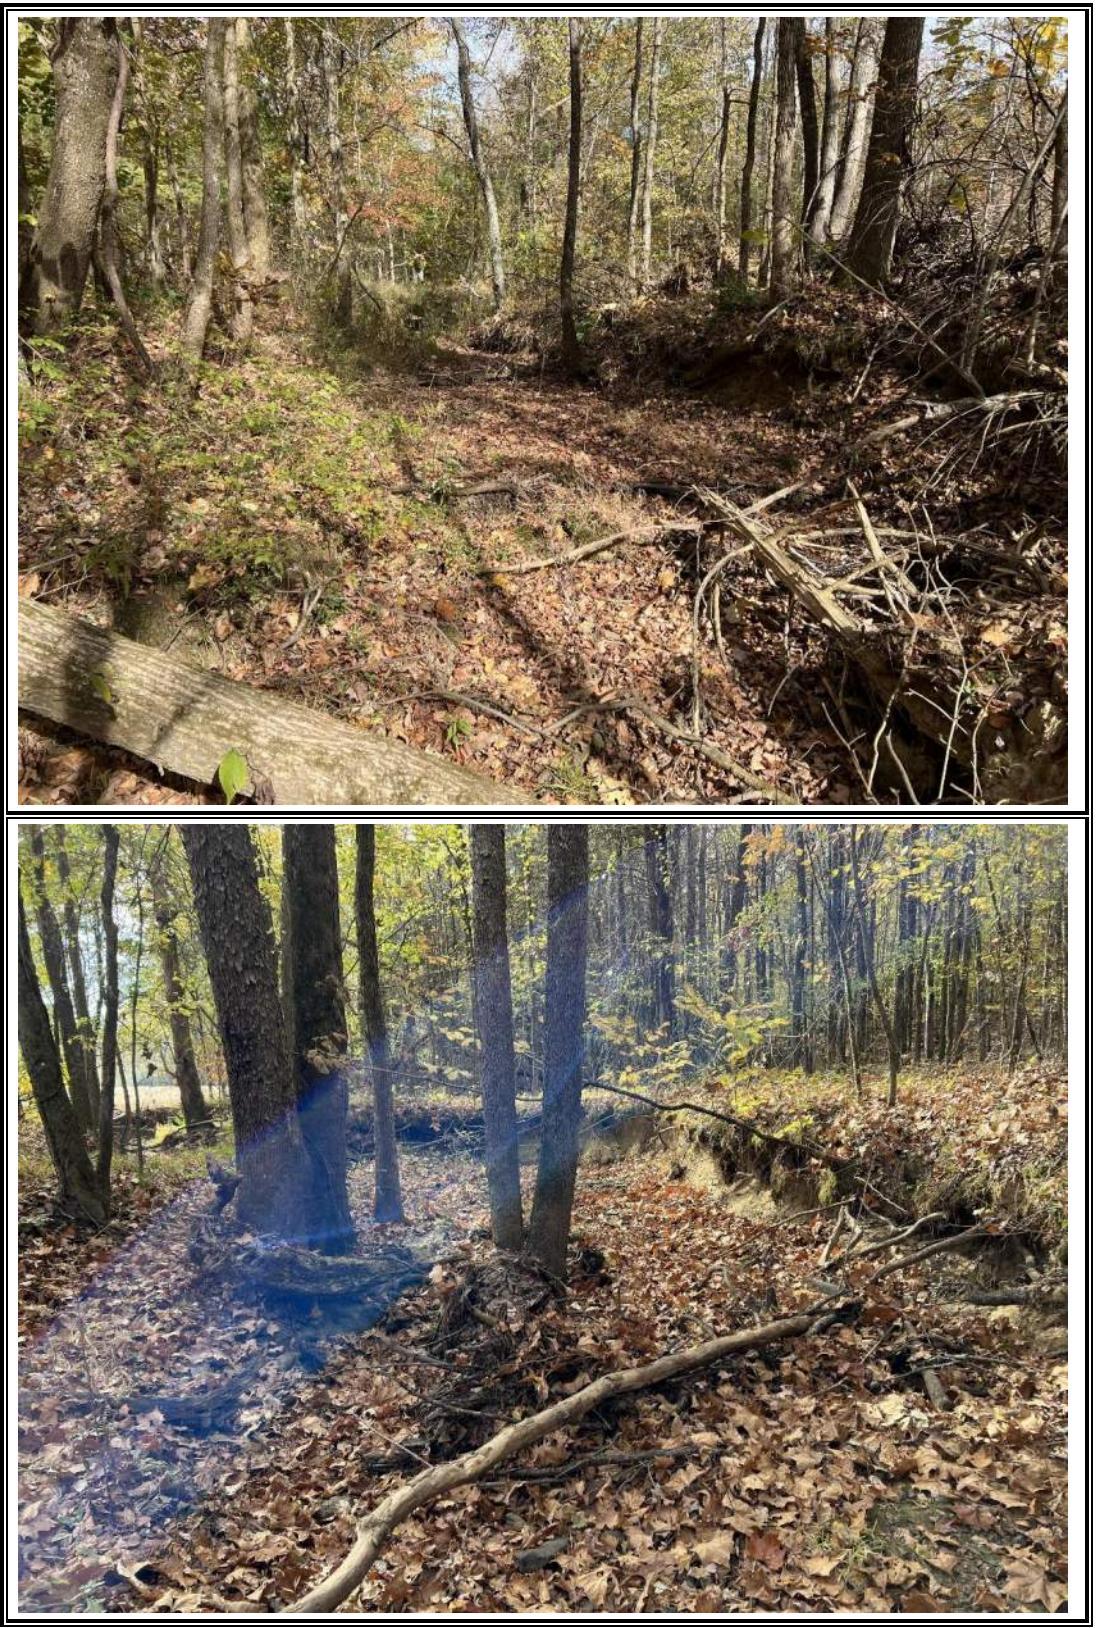
Photo: 1 By: F. Amatucci Date: October 24, 2022 Feature: STR-1 Lat: 35.265430 Long: -88.366833

STR-1 was observed as an intermittent stream that enters the project study area from the north and flows through a culvert into the northeastern portion of the project study area. While no perceivable flow was observed throughout the evaluated reach, continuous bed and bank was moderately strong, as well as a presence of hydric soils on the channel bottom, indicating a potential intermittent stream. The channel bottom is composed of clay with recent overlying deposits of sand, cobble, and gravel. Other than some remnant caddisfly casings, there was no evidence of aquatic life observed within the feature at the time of the site visit. STR-1 is assumed to be jurisdictional to TDEC and the USACE.

Representative conditions of STR-1, facing downstream near mid reach.

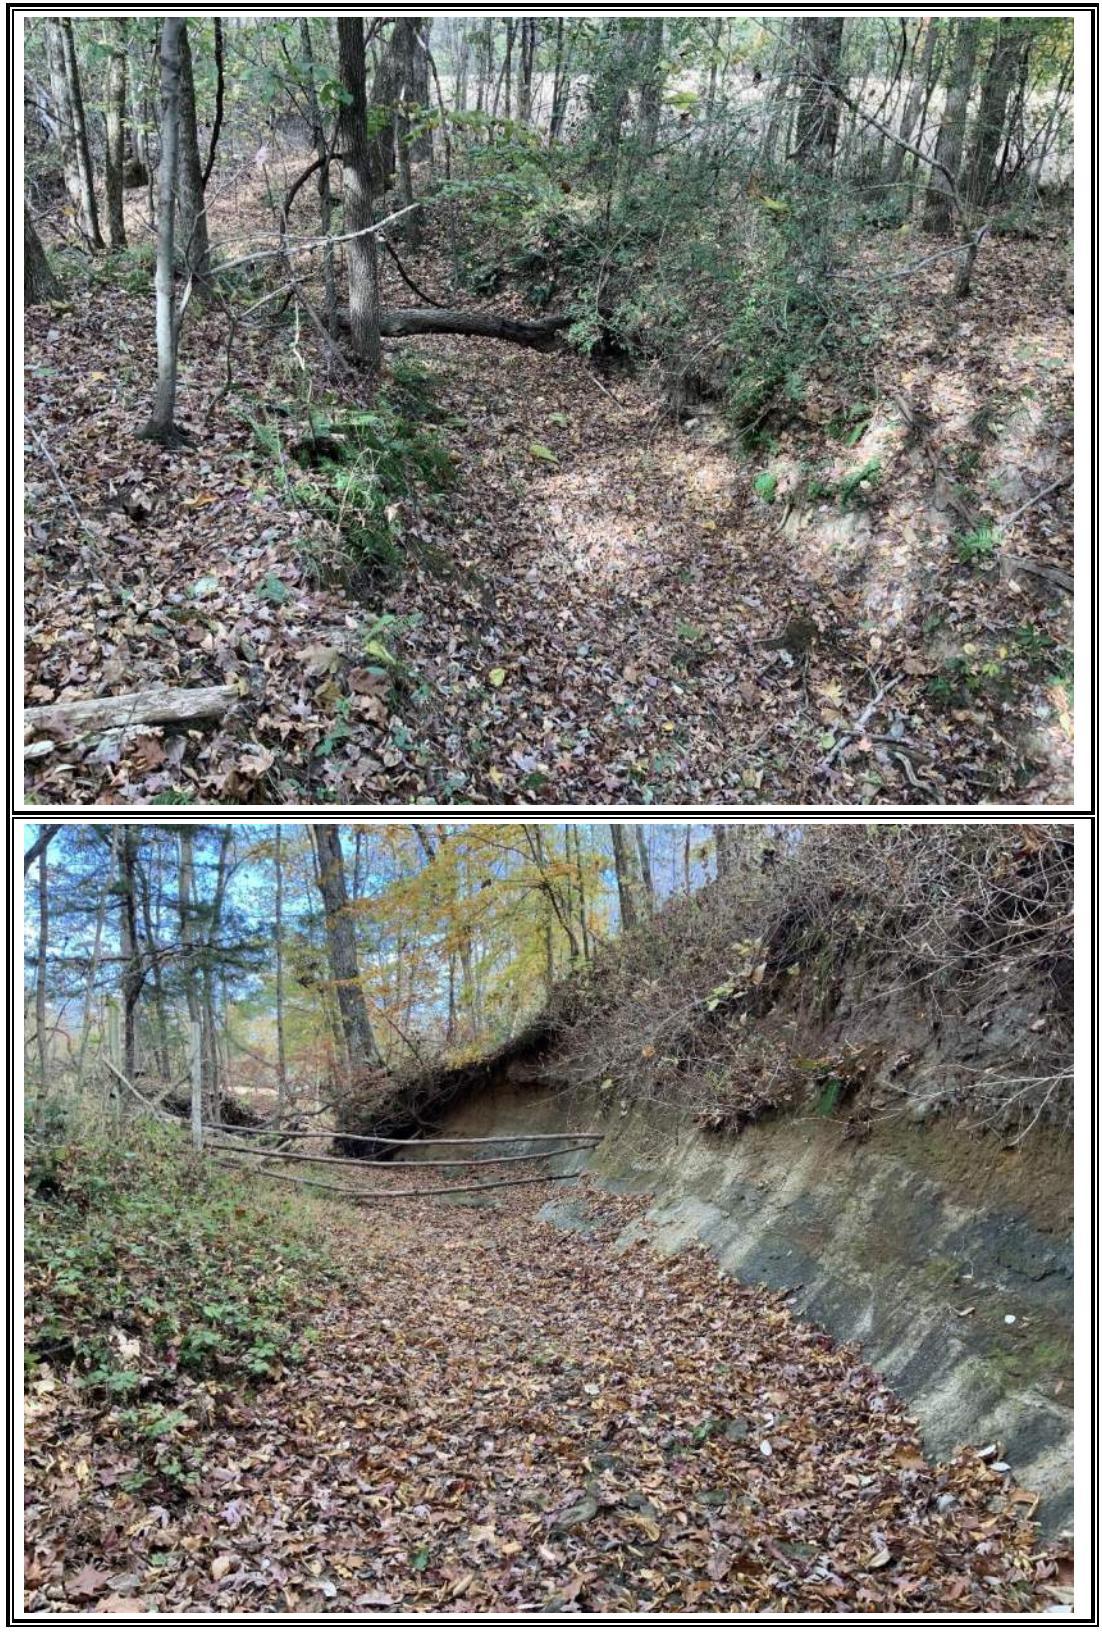
Photo: 3 By: F. Amatucci Date: October 24, 2022 Feature: STR-2 Lat: 35.263401 Long: -88.369289

STR-2 was observed as an intermittent stream that enters the project study area from the north into the northcentral portion of the project study area. While no perceivable flow was observed throughout the evaluated reach, continuous bed and bank was moderately strong, as well as a presence of hydric soils on the channel bottom, indicating a potential intermittent stream. The stream channel bottom is composed of clay with some deposition of sand and silt as bars and benches. Other than some remnant caddisfly casings, there was no evidence of aquatic life observed within the feature at the time of the site visit. The stream transitions to a potentially perennial stream after the confluence with STR-4 at end of reach before leaving the project study area to the east. STR-2 is assumed to be jurisdictional to TDEC and the USACE.

Representative conditions of STR-2, facing downstream at end of reach before leaving property study area to the east.

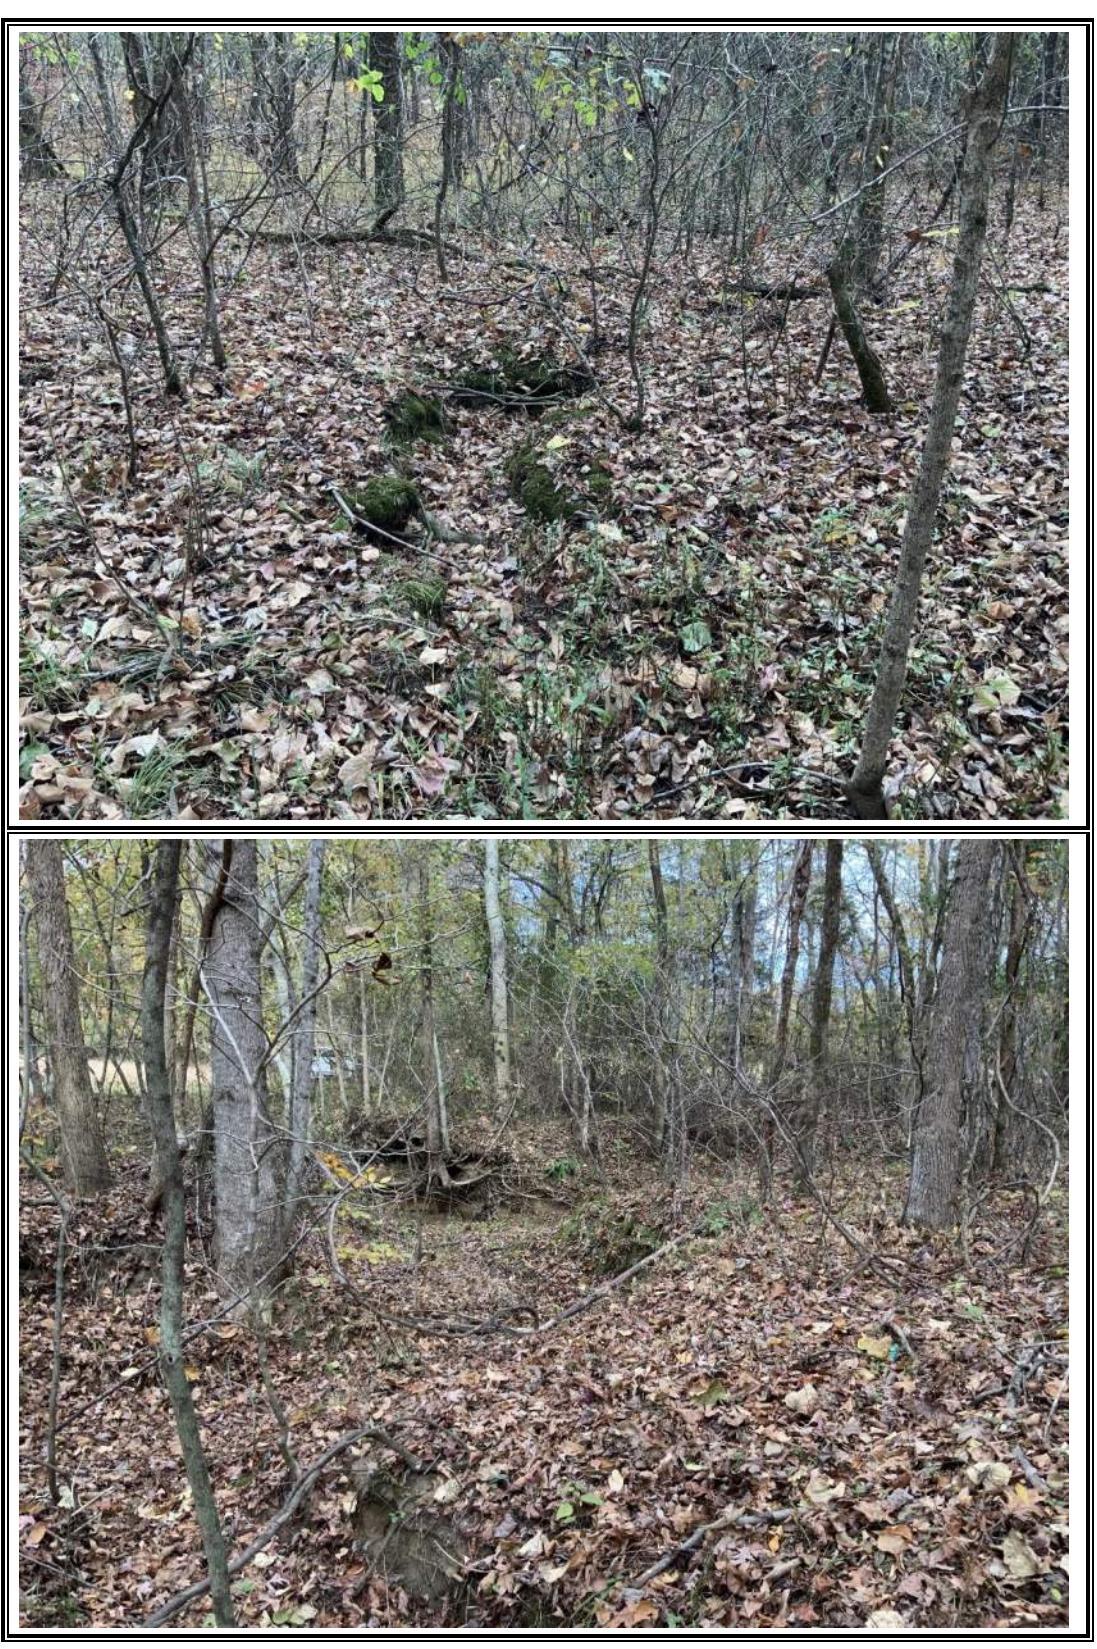
Photo: 5 By: F. Amatucci Date: October 24, 2022 Feature: STR-3 Lat: 35.261079 Long: -88.369104

STR-3 was observed as an intermittent stream that starts downslope of wetland (WTL) WTL-1 in the eastern central portion of the project study area. The feature potentially originates from groundwater seepage below the berm of WTL-1 and conveys excess surface water to the

confluence with STR-2. While no perceivable flow was observed throughout the evaluated reach, continuous bed and bank was moderate, as well as a presence of hydric soils on the channel bottom, indicating a potential intermittent stream. The stream channel bottom is composed of silt and sand with observed presence of substrate sorting. STR-3 is assumed to be jurisdictional to TDEC and the USACE.

Representative conditions of STR-3, facing downstream at end of reach before confluence with STR-2.

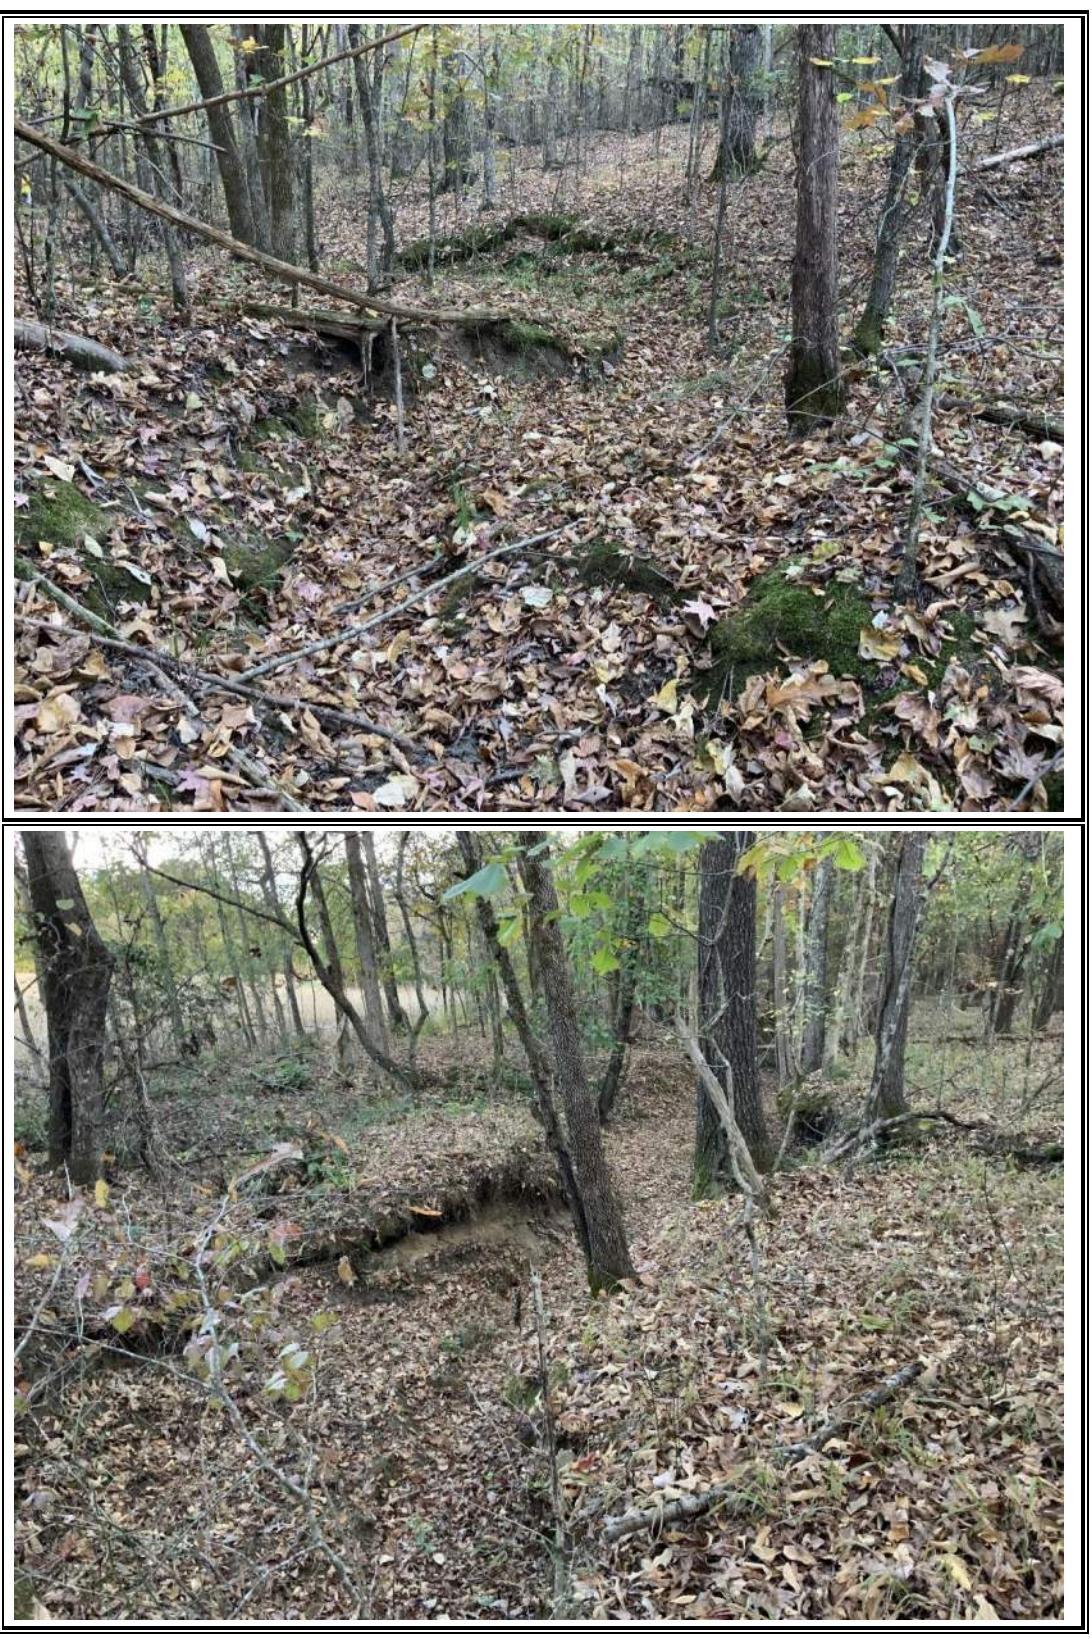
Photo: 7 By: F. Amatucci Date: October 24, 2022 Feature: STR-4 Lat: 35.263716 Long: -88.374461

STR-4 was observed as an intermittent stream that starts at a headcut immediately offsite in the northwestern portion of the project study area. STR-4 conveys excess surface water to the confluence with STR-2. While no perceivable flow was observed throughout the evaluated reach, continuous bed and bank was moderately present, as well as a presence of hydric soils on the channel bottom, indicating a potential intermittent stream. The stream channel bottom is composed of sand and silt with some depositional bars and benches and observed sorting. There was no aquatic life observed within the feature at the time of the site visit. STR-4 is assumed to be jurisdictional to TDEC and the USACE.

Representative conditions of STR-4 at mid reach, becomes more incised before eventually confluence with STR-2.

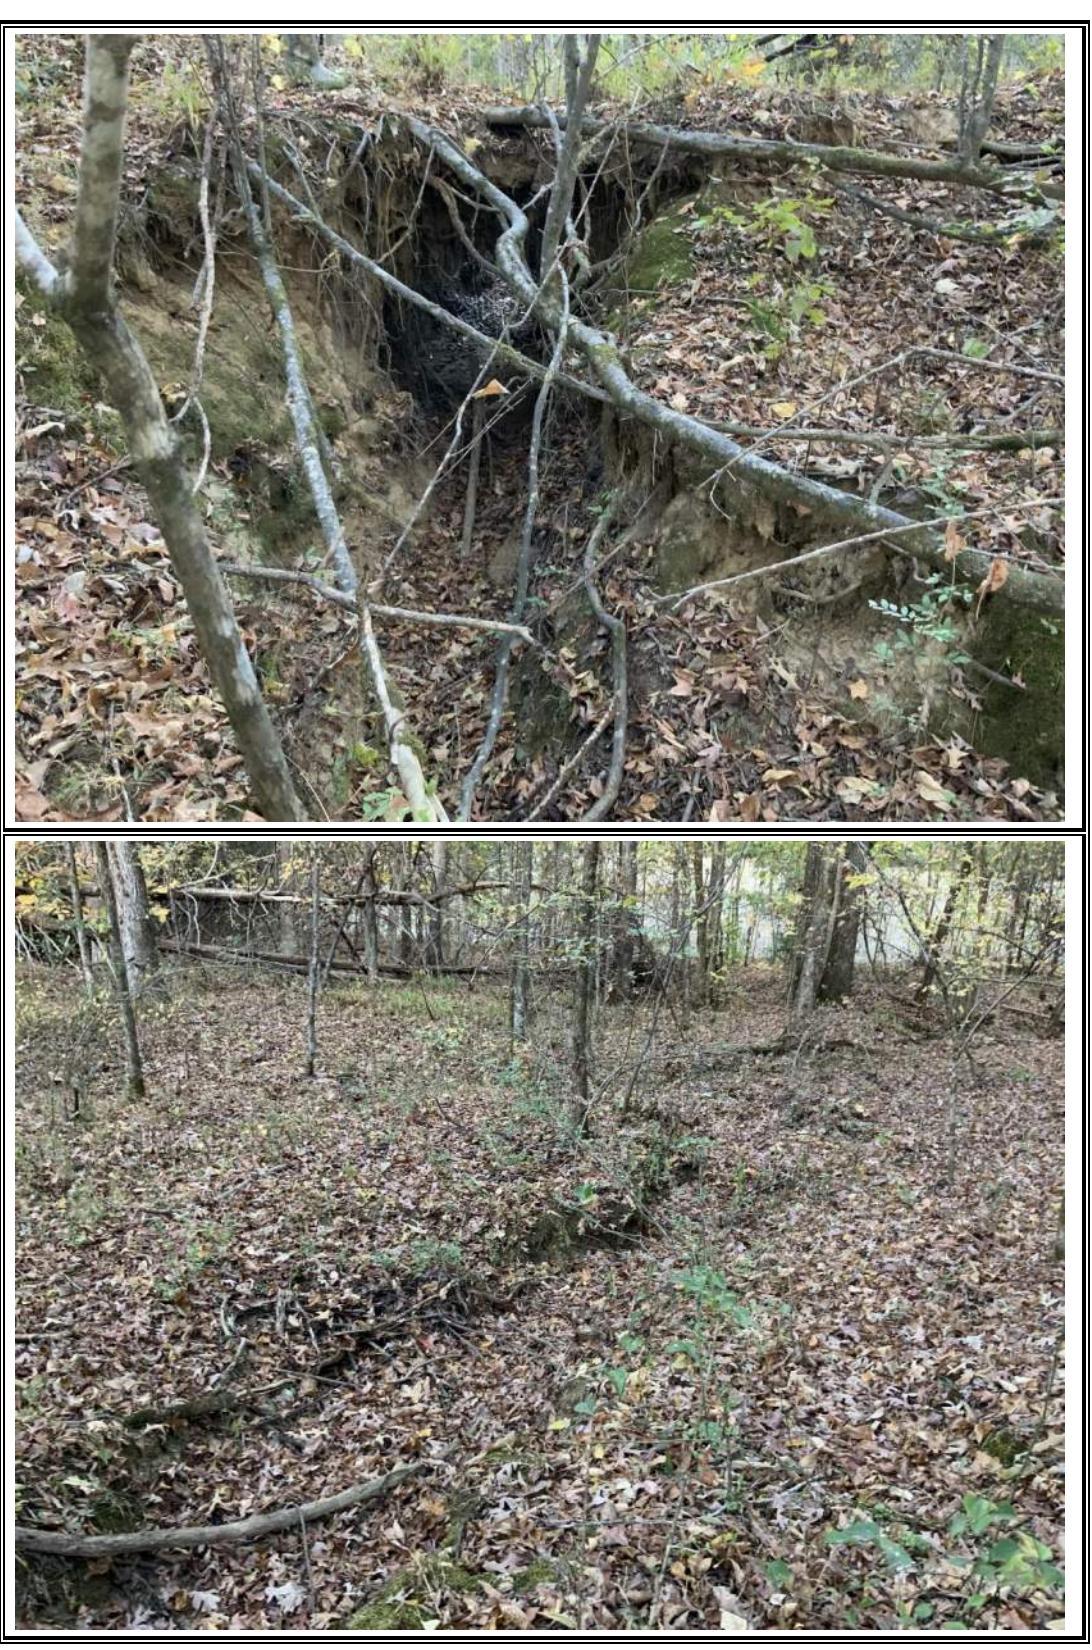
Photo: 9 Date: October 24, 2022 Feature: STR-5 Lat: 35.263224 Long: -88.374541

STR-5 was observed as an intermittent stream that begins at an eroded berm wall of pond (P) P-2 within the northwestern portion of the project study area. STR-5 conveys excess surface water to the confluence with STR-4. The stream may also be affiliated with a potential groundwater seep. While no perceivable flow was observed throughout the evaluated reach, continuous bed and bank was moderately present, as well as a presence of hydric soils on the channel bottom, indicating a potential intermittent stream. The stream channel bottom is composed of sand and silt, with some recent alluvial deposits. There was no aquatic life observed within the feature at the time of the site visit. STR-5 is assumed to be jurisdictional to TDEC and the USACE.

Representative conditions of STR-5, facing downstream mid reach before confluence with STR-4.

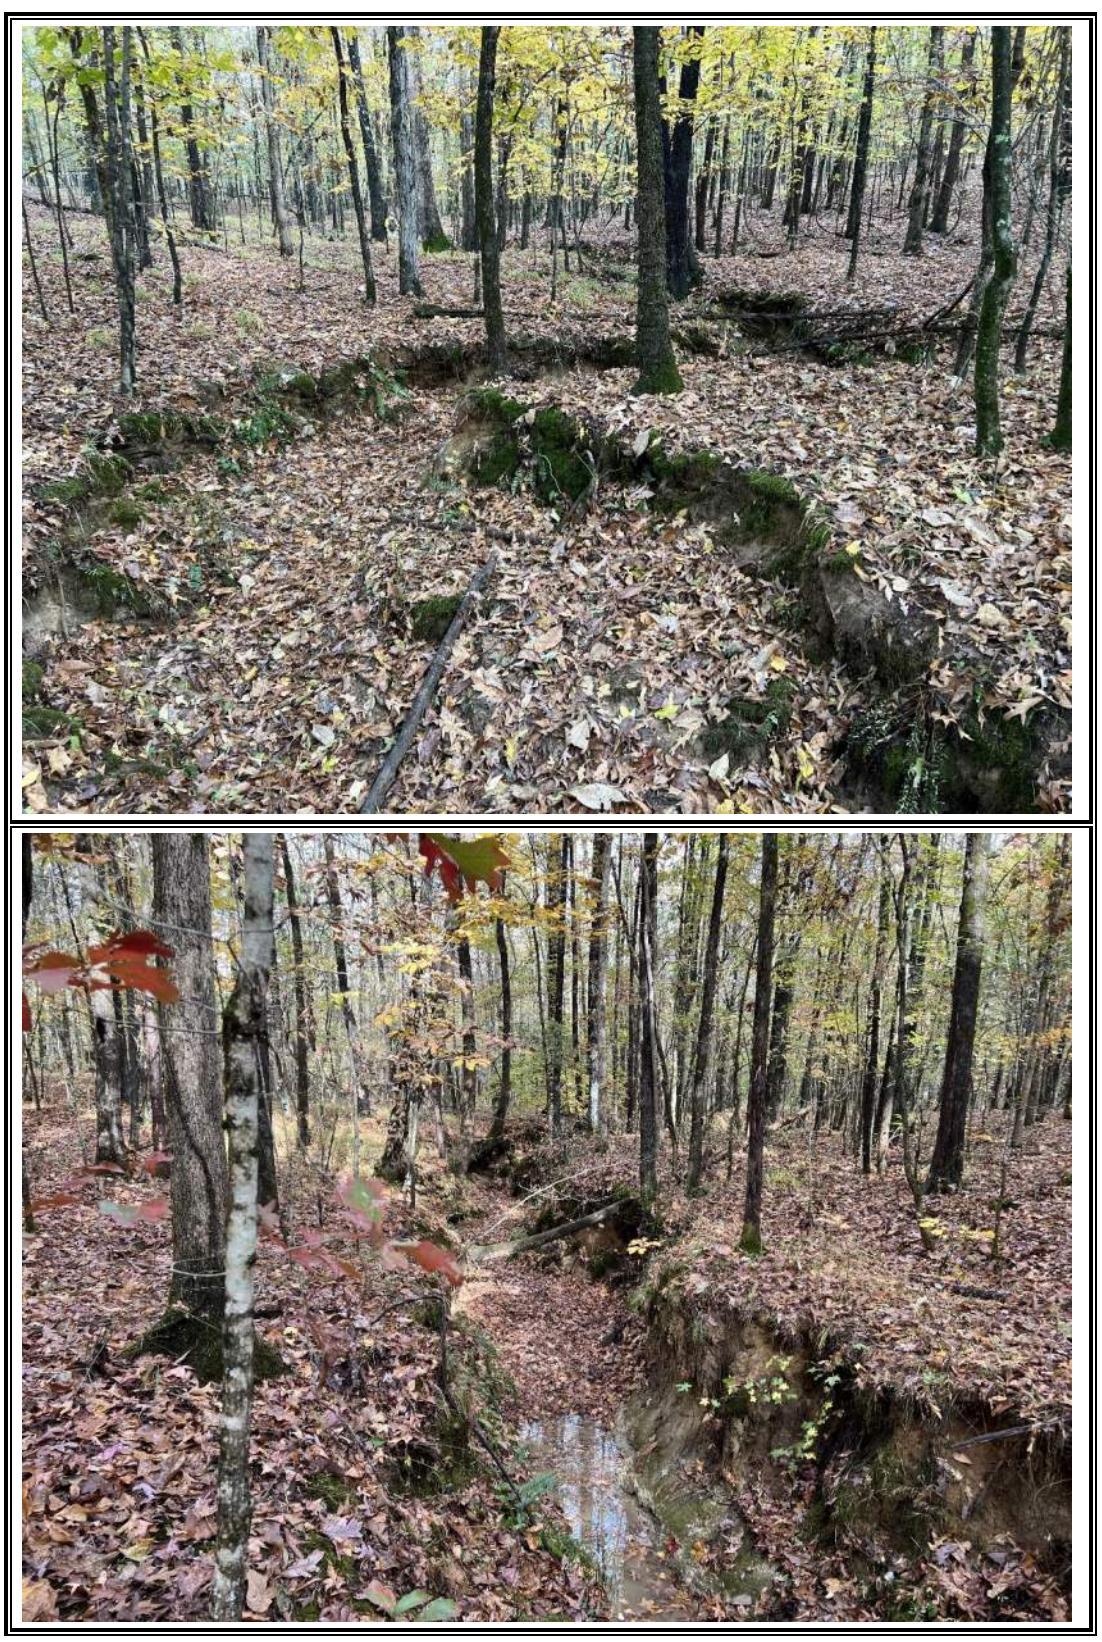
Photo: 11 By: F. Amatucci Date: October 25, 2022 Feature: STR-6 Lat: 35.261609 Long: -88.373657

STR-6 was observed as an intermittent stream that likely conveys excess surface water from the surrounding upland area into STR-4 in the northcentral portion of the project study area. While no perceivable flow was observed throughout the evaluated reach, continuous bed and bank was moderately present, as well as a presence of hydric soils on the channel bottom, indicating a potential intermittent stream. The stream channel bottom is composed of sand and silt, with observed sorting and some recent alluvial deposits. There was no aquatic life observed within the feature at the time of the site visit. STR-6 is assumed to be jurisdictional to TDEC and the USACE.

Representative conditions of STR-6, facing downstream mid reach before eventual confluence with STR-4.

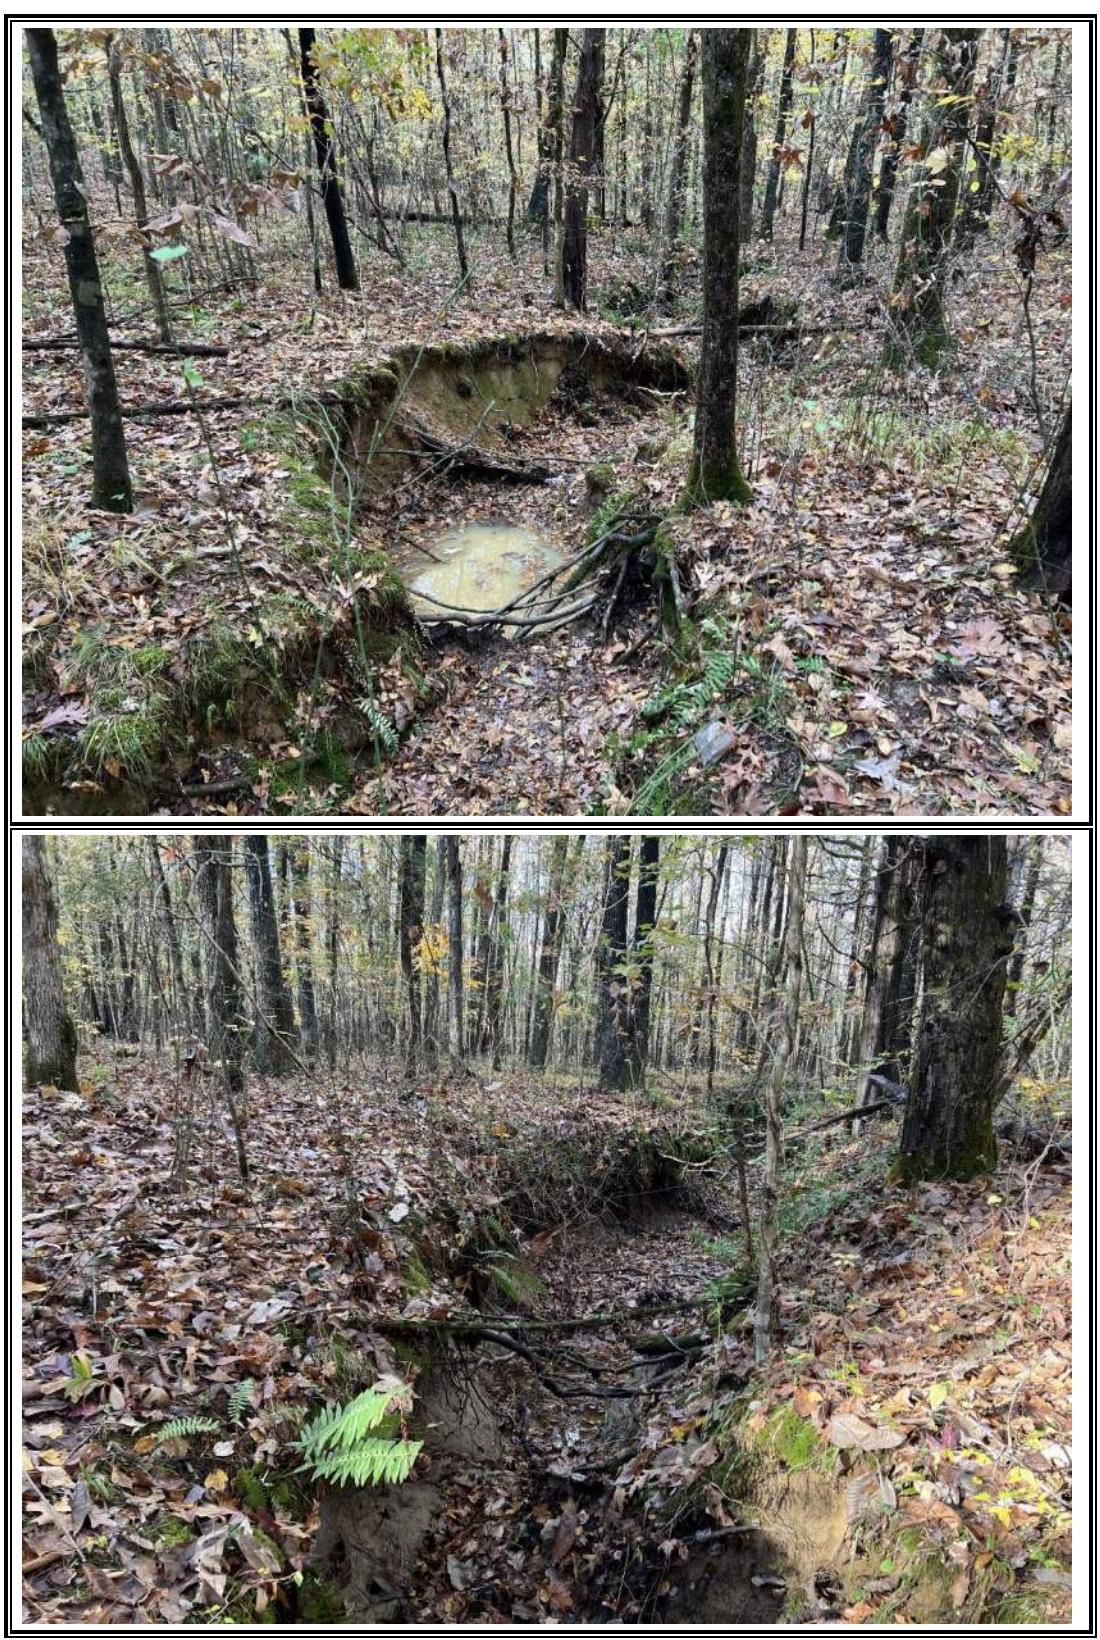
Photo: 13 By: F. Amatucci Date: October 25, 2022 Feature: STR-7 Lat: 35.261018 Long: -88.372310

STR-7 was observed as an intermittent stream that is likely affiliated with a potential groundwater seep at a moderate headcut. The feature likely conveys excess surface water from the surrounding upland area to the confluence with STR-6 in the northcentral portion of the project study area. While no perceivable flow was observed throughout the evaluated reach, continuous bed and bank was moderately present, as well as a presence of hydric soils on the channel bottom, indicating a potential intermittent stream. The stream channel bottom is composed of sand and silt with some depositional bars and benches, as well as recent alluvial deposits. STR-7 is assumed to be jurisdictional to TDEC and the USACE.

Representative conditions of STR-7, facing downstream at end of reach before confluence with STR-6.

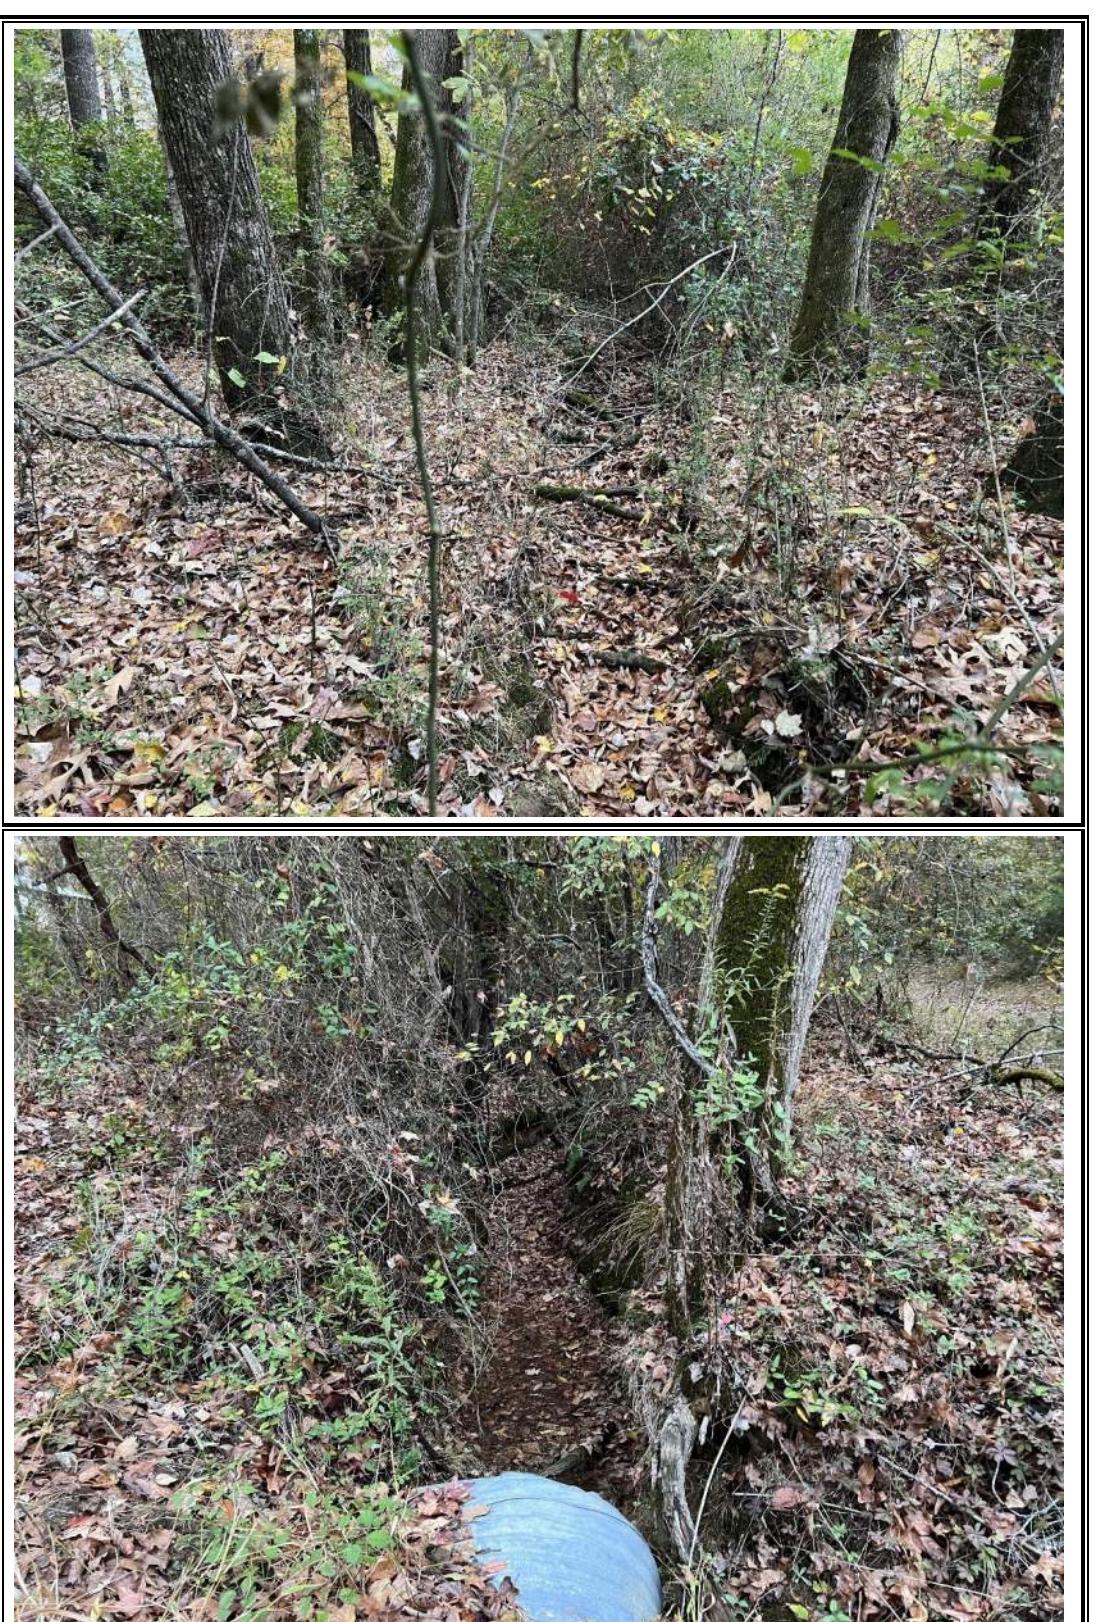
Photo: 15 By: F. Amatucci Date: October 25, 2022 Feature: STR-8 Lat: 35.257835 Long: -88.369110

STR-8 was observed as an intermittent stream in the eastern portion of the project study area. The feature likely drains excess surface water from WTL-4a. Further downslope the channel dissipates within WTL-4b and reforms at the downslope end of the same wetland feature. While no perceivable flow was observed throughout the evaluated reach, continuous bed and bank was semi-moderately present and there was a presence of hydric soils on the channel bottom, indicating a potential intermittent stream. The stream channel bottom is composed of sand and silt with some depositional bars and benches, as well as recent alluvial deposits. There was no aquatic life observed within the feature at the time of the site visit. STR-8 is assumed to be jurisdictional to TDEC and the USACE.

Representative conditions of STR-8, facing downstream at end of reach after flowing through culvert outlet and leaving project study area to the south.

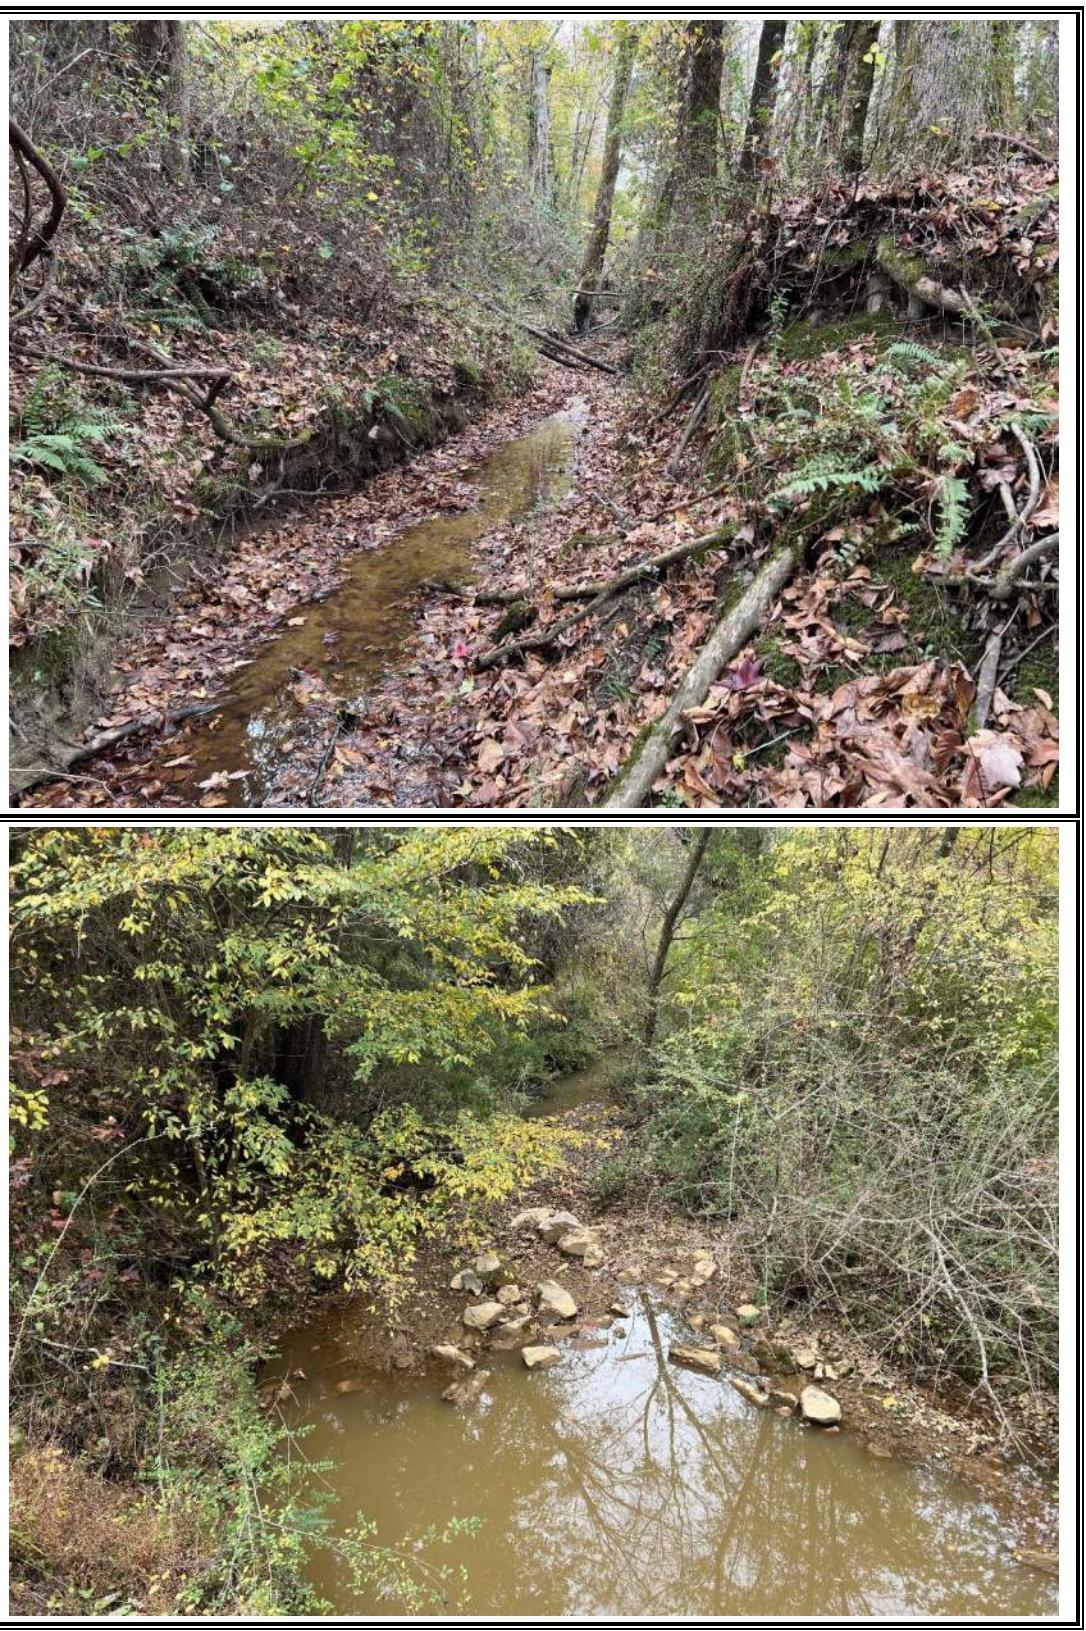
Photo: 17 By: F. Amatucci Date: October 26, 2022 Feature: STR-9 (Stratton Branch) Lat: 35.254130 Long: -88.374008

STR-9 (Stratton Branch) was observed as an intermittent stream that begins from the overflow of farm pond P-6 in the southern portion of the project study area. While no perceivable flow was observed throughout the evaluated reach, continuous bed and bank was moderately strong, as well as a presence of hydric soils on the channel bottom, indicating a potential intermittent stream. The stream channel bottom is composed of moderately sorted sand and silt with depositional bars and benches, as well as recent alluvial deposits. STR-9 is assumed to be jurisdictional to TDEC and the USACE.

Representative conditions of STR-9, facing downstream at end of reach after culvert outlet and leaving project study area to the east.

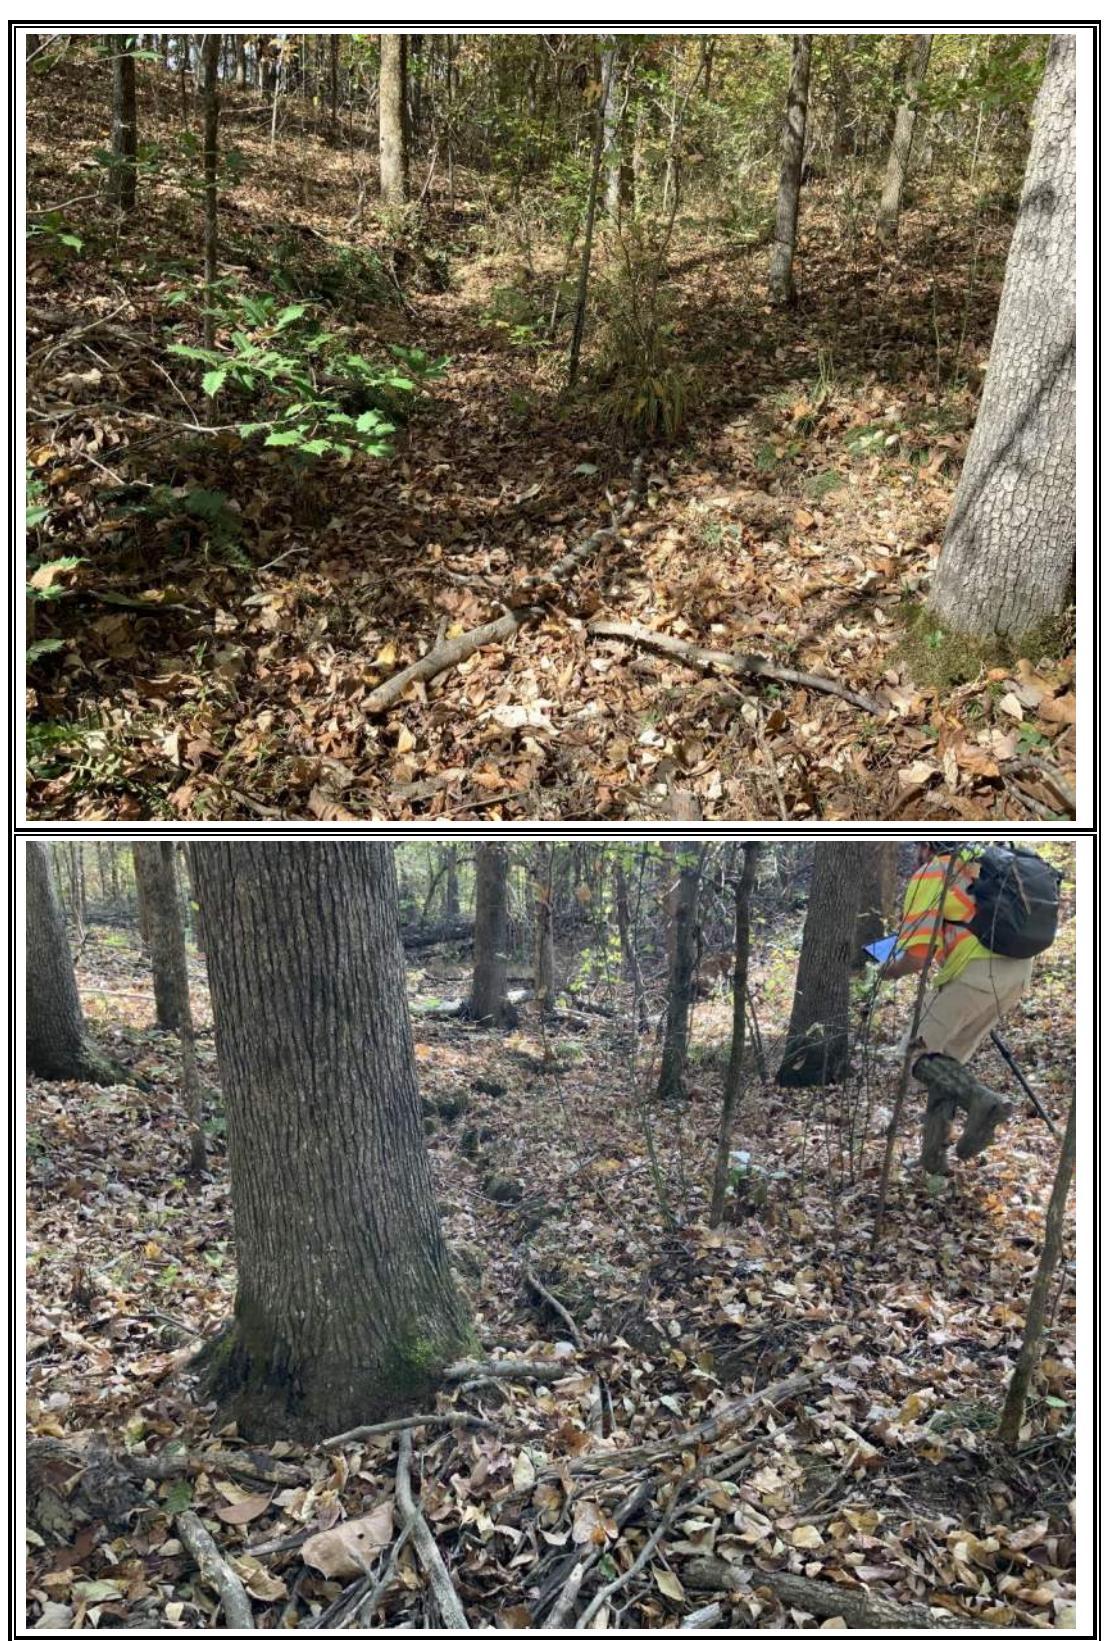
Photo: 19 By: F. Amatucci Date: October 24, 2022 Feature: EPH-1 Lat: 35.264357 Long: -88.362118

EPH-1 was observed as an ephemeral stream to the USACE and as a wet weather conveyance (WWC) to TDEC in the northeastern portion of the project study area. The feature displayed a weak-moderate bed and bank throughout most of the feature, as well as a slight presence of rifflepool sequences, and is within a natural upland drainage valley. No surface water or saturation was present within the reach during the site visit, and no hydric soils were observed within the channel. A slight presence of Japanese stiltgrass (*Microstegium vimineum*) was observed within the channel, as well as fibrous roots of terrestrial plants. EPH-1 was observed with a channel bottom of sand and silt. EPH-1 is potentially non-jurisdictional to the USACE, with its relatively small drainage area, and is assumed to be non-jurisdictional to TDEC, as a WWC.

Representative conditions of EPH-1, facing downstream mid reach before leaving property study area to the south.

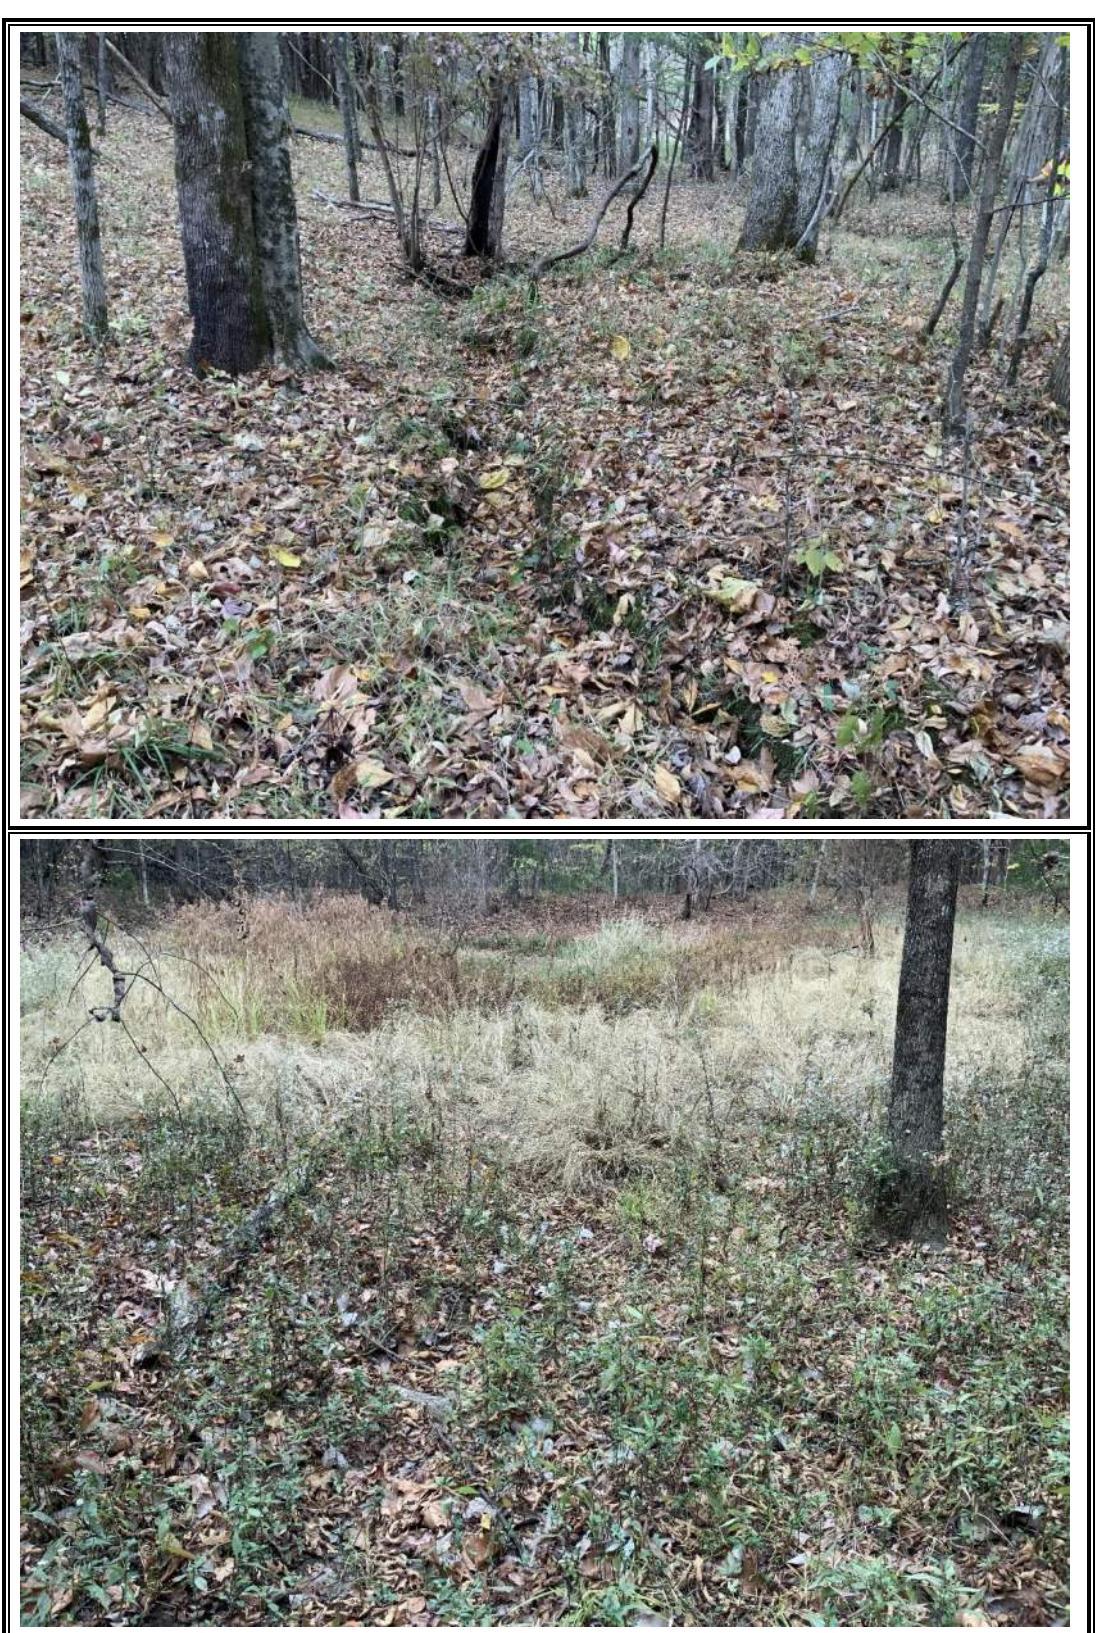
Photo: 21 By: F. Amatucci Date: October 24, 2022 Feature: EPH-2 Lat: 35.259936 Long: -88.368503

EPH-2 was observed as an ephemeral stream to the USACE and as a WWC to TDEC in the northern portion of the project study area, which directly drains into relic farm pond wetland WTL-1. The feature displayed a semi-moderate bed and bank, as well as two or more ordinary high-water mark (OHWM) indicators such as vegetative cut lines and wrack lines. No surface water or saturation was present within the reach during the site visit, and no hydric soils were observed within the channel. A slight presence of longleaf wood oats was observed within the channel, as well as fibrous roots of terrestrial plants. EPH-2 was observed with a channel bottom of sand and clay. EPH-2 is potentially non-jurisdictional to the USACE, with its relatively short section of reach, and is assumed to be non-jurisdictional to TDEC, as a WWC.

Representative conditions of EPH-2, facing downstream at end of reach before dissipating into WTL-1.
