SUMMARY OF ENVIRONMENTAL FEATURES FOR THE

ADAMSVILLE SOLAR PROJECT

ADAMSVILLE, MCNAIRY & HARDIN COUNTIES, TENNESSEE

36095-17 TVA# 412154 September 2023

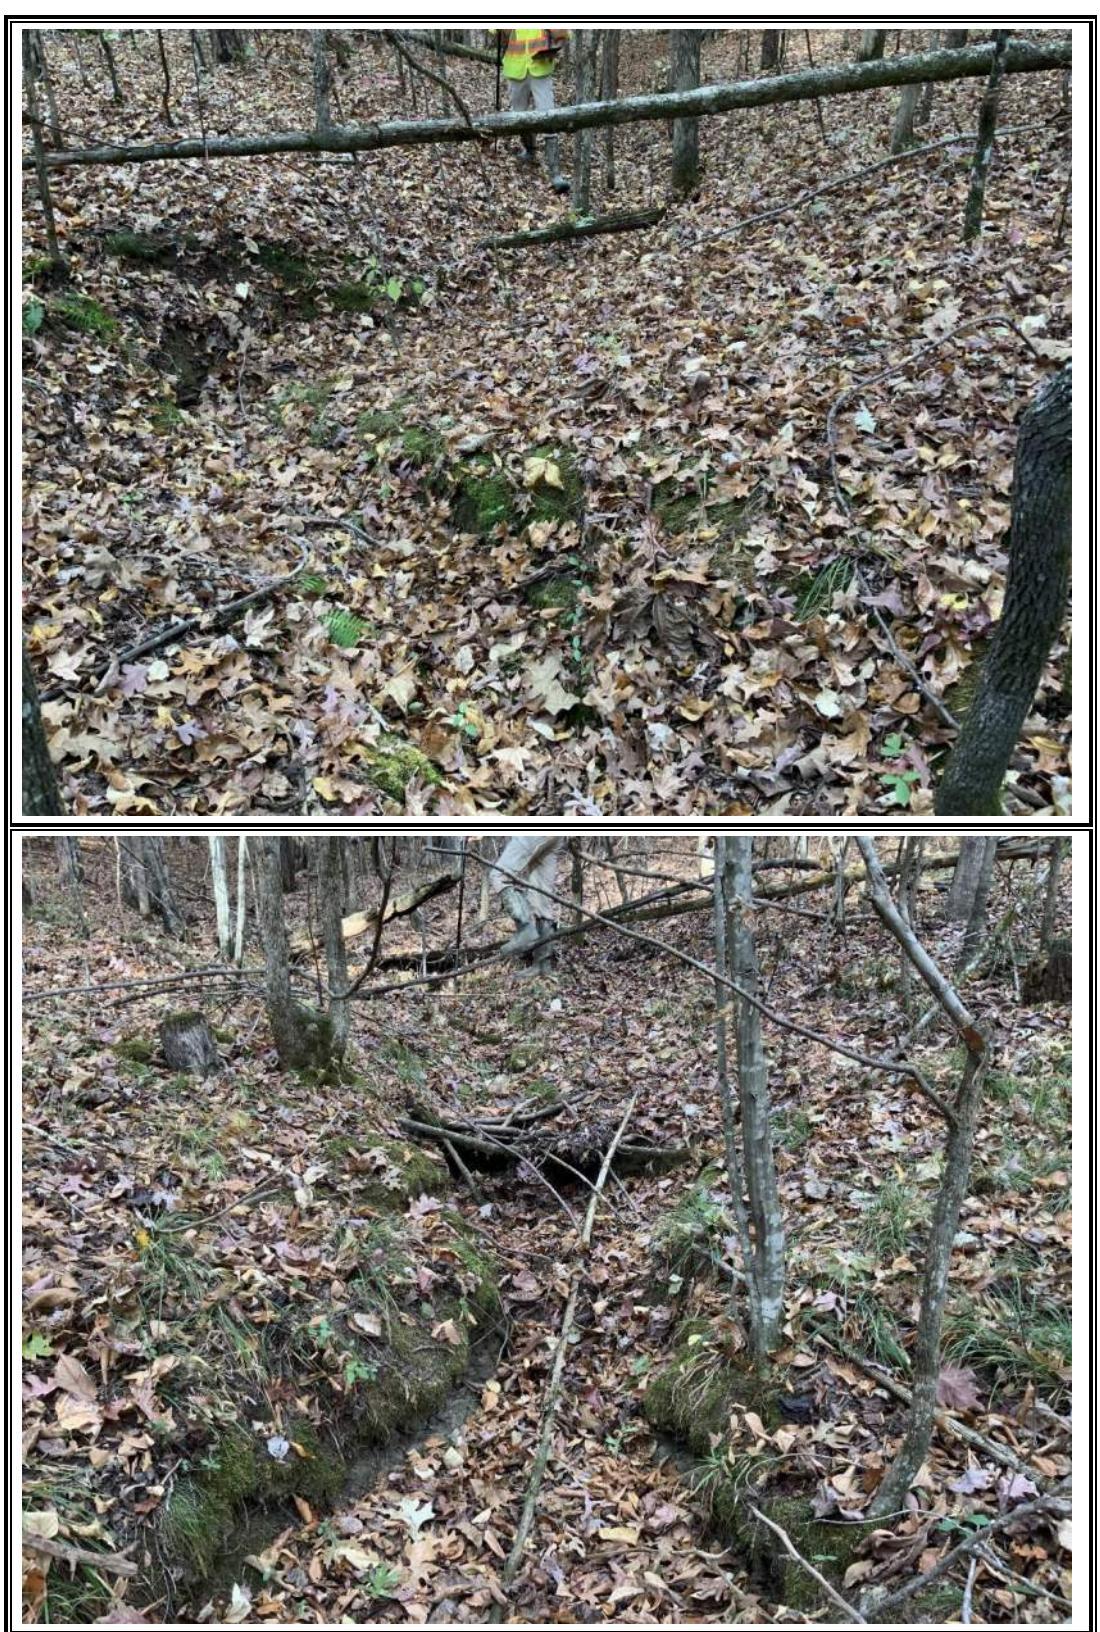
Photo: 23 By: F. Amatucci Date: October 24, 2022 Feature: EPH-4 Lat: 35.264891 Long: -88.374641

EPH-4 was observed as a relatively short reach of ephemeral stream to the USACE and as a WWC to TDEC in the northwestern portion of the project study area. The feature displayed a semi-moderate bed and bank, as well as two or more OHWM indicators such as vegetative cut

Representative conditions of EPH-4, facing upstream at end of reach before confluence with EPH-3.

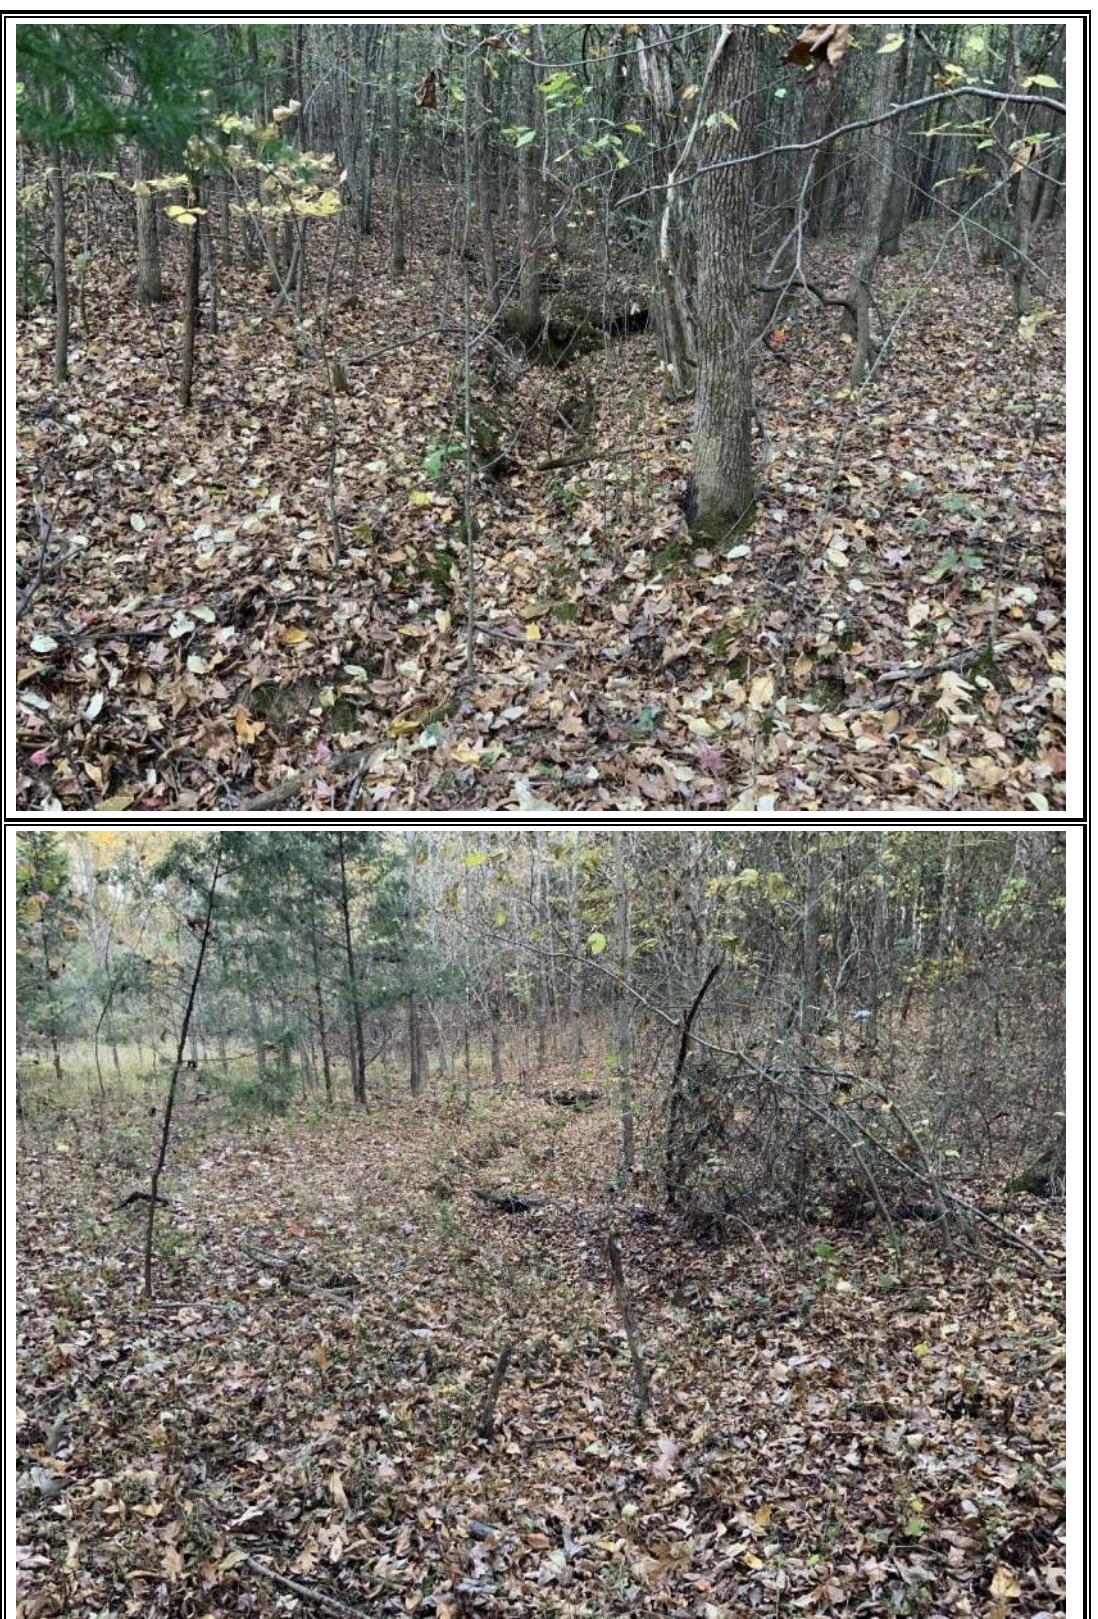
Photo: 25 By: F. Amatucci Date: October 24, 2022 Feature: EPH-5 Lat: 35.261562 Long: -88.376462

Representative conditions of EPH-5, facing downstream at end of reach before dissipating into P-2.

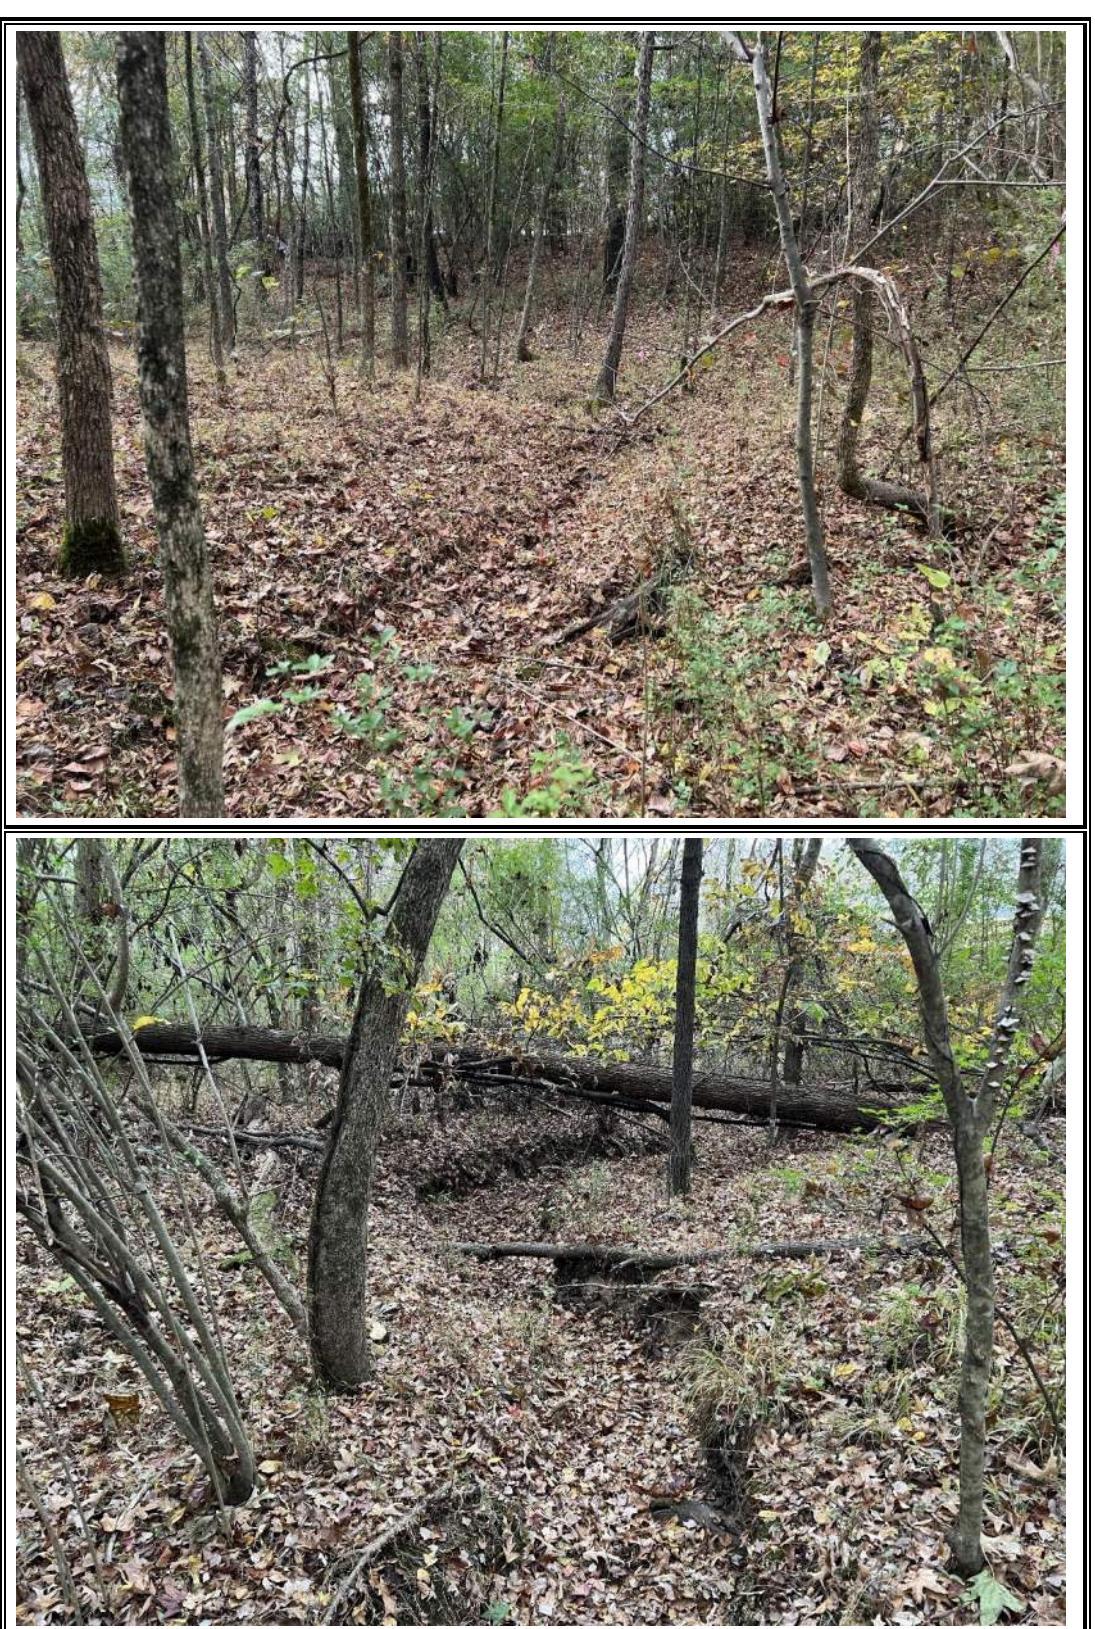
Photo: 27 By: F. Amatucci Date: October 25, 2022 Feature: EPH-6 Lat: 35.254993 Long: -88.370210

Representative conditions of EPH-6, facing downstream at end of reach before leaving property study area to the south.

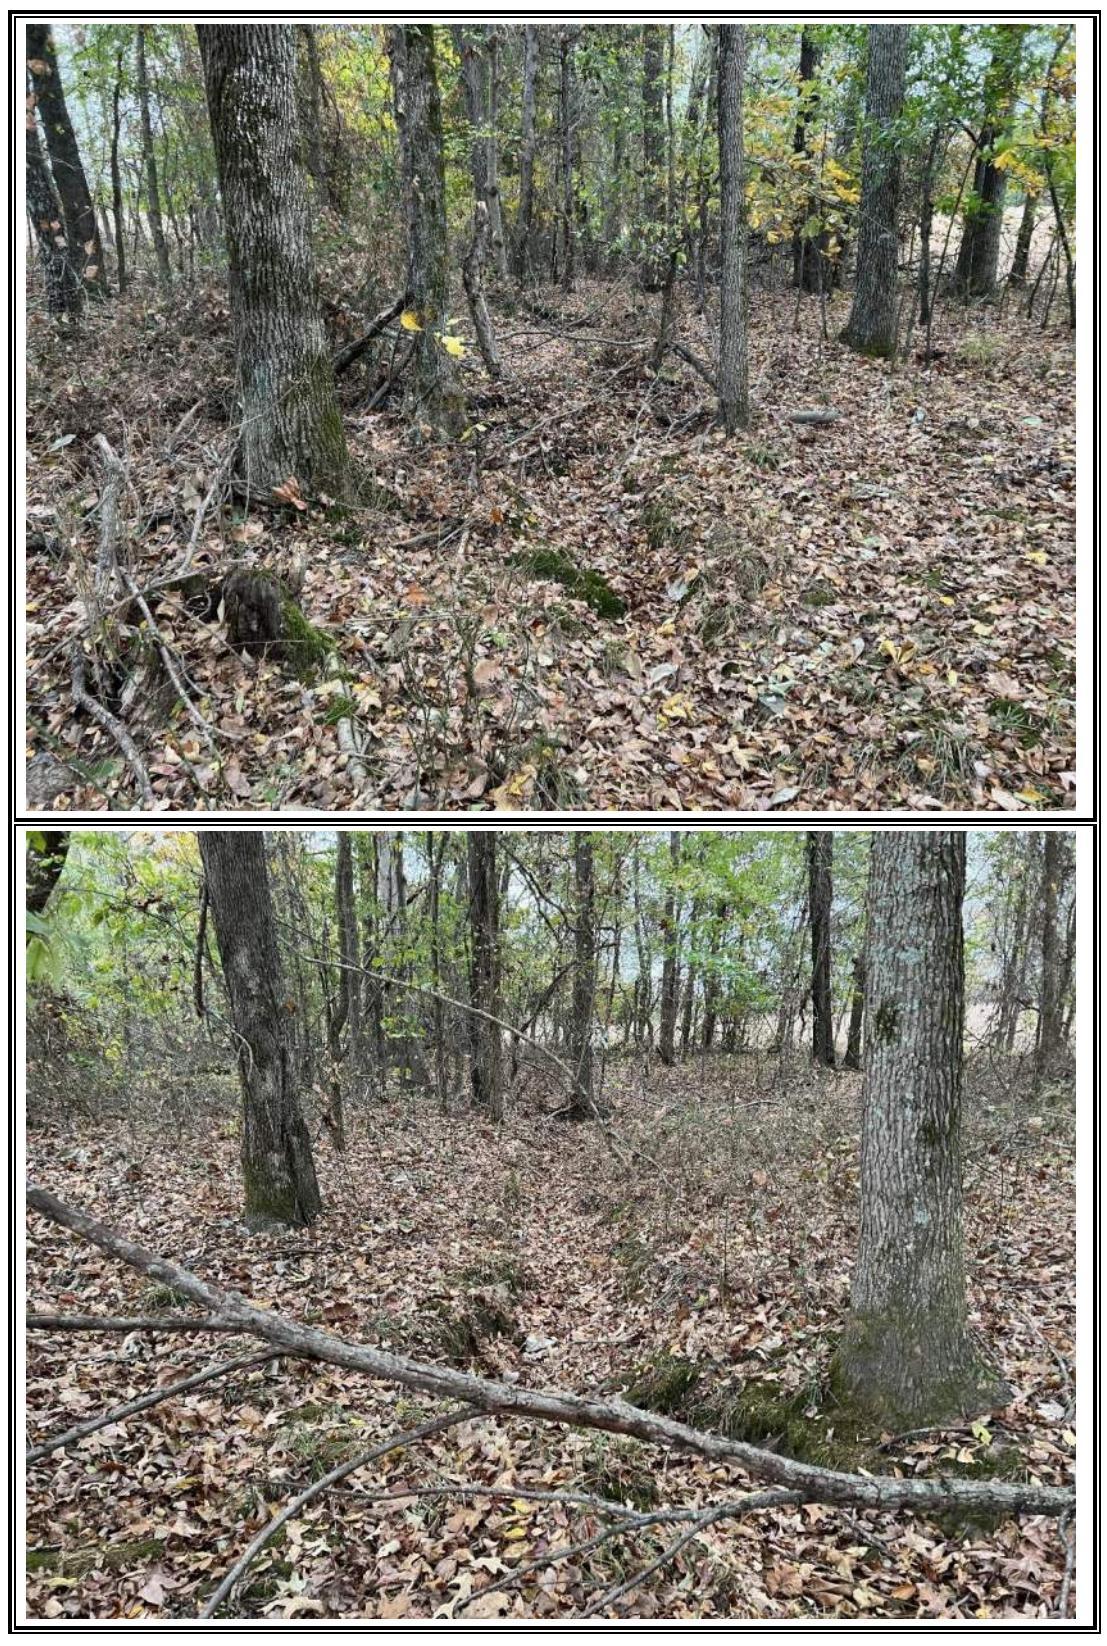
Photo: 29 By: F. Amatucci Date: October 25, 2022 Feature: EPH-7 Lat: 35.258838 Long: -88.371079

Representative conditions of EPH-7, facing downstream at end of reach before dissipating into WTL-4.

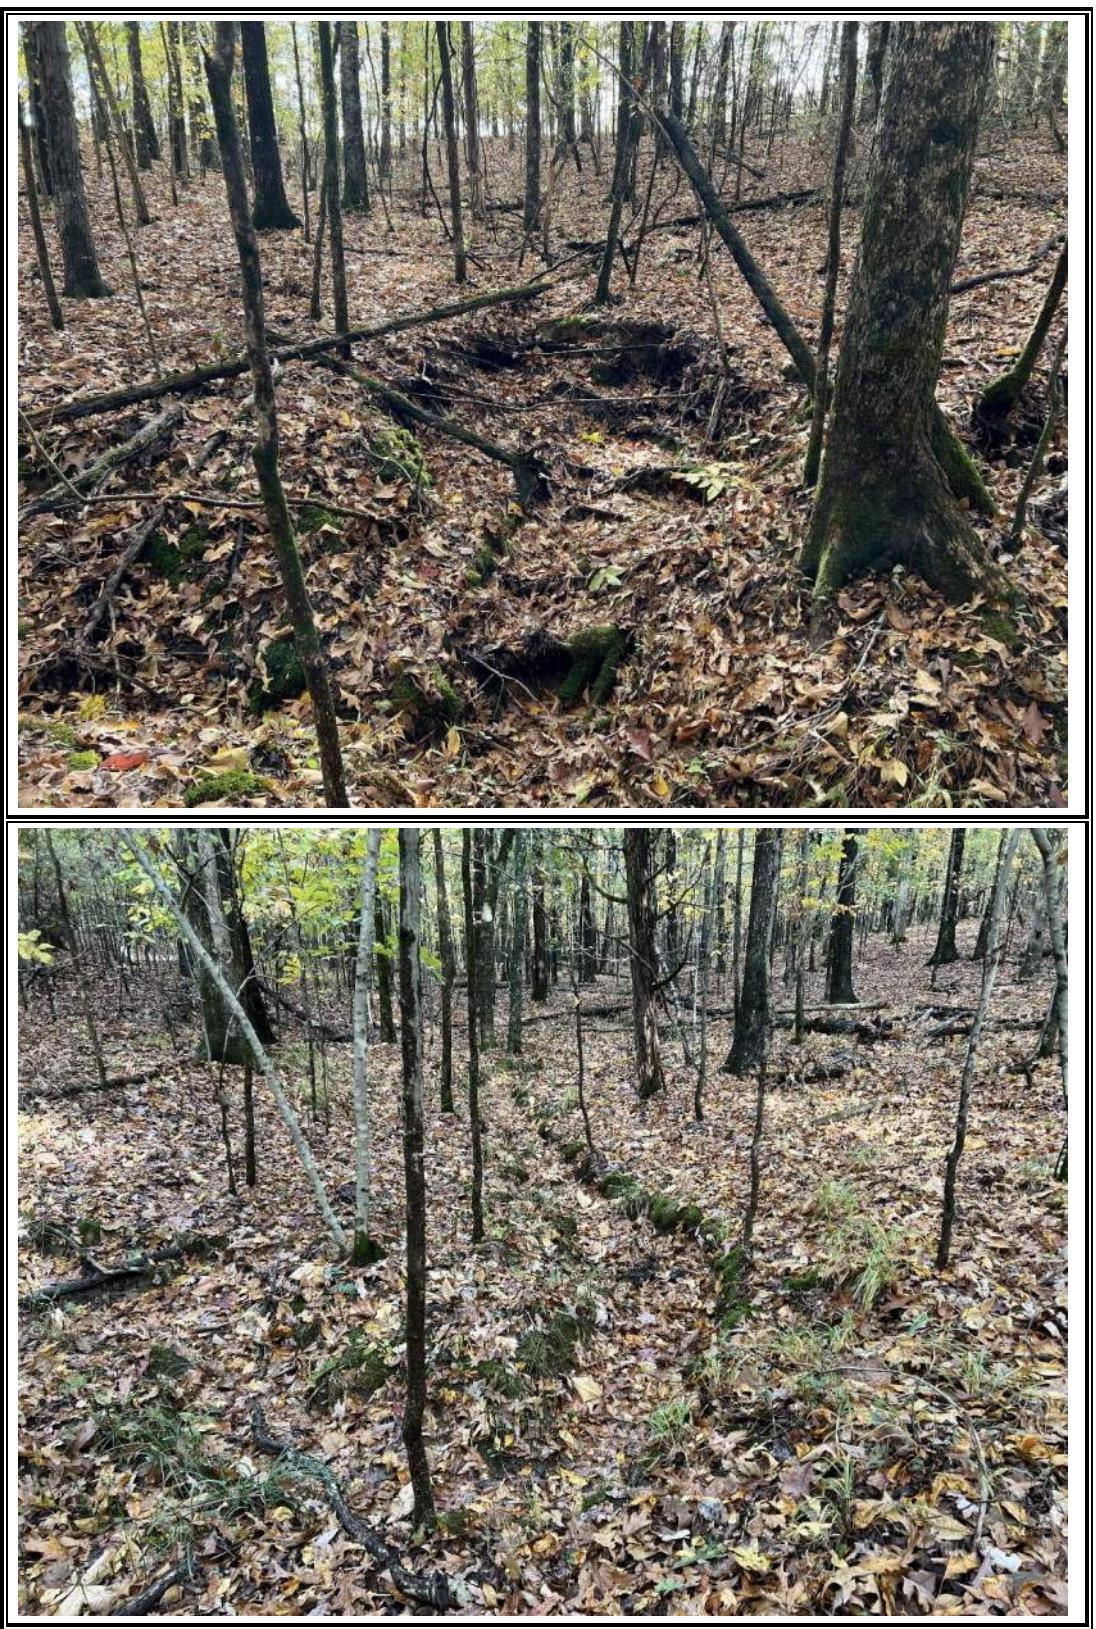
Photo: 31 By: F. Amatucci Date: October 25, 2022 Feature: EPH-8 Lat: 35.261159 Long: -88.374301

Representative conditions of EPH-8, facing downstream at end of reach before transition into STR-6.

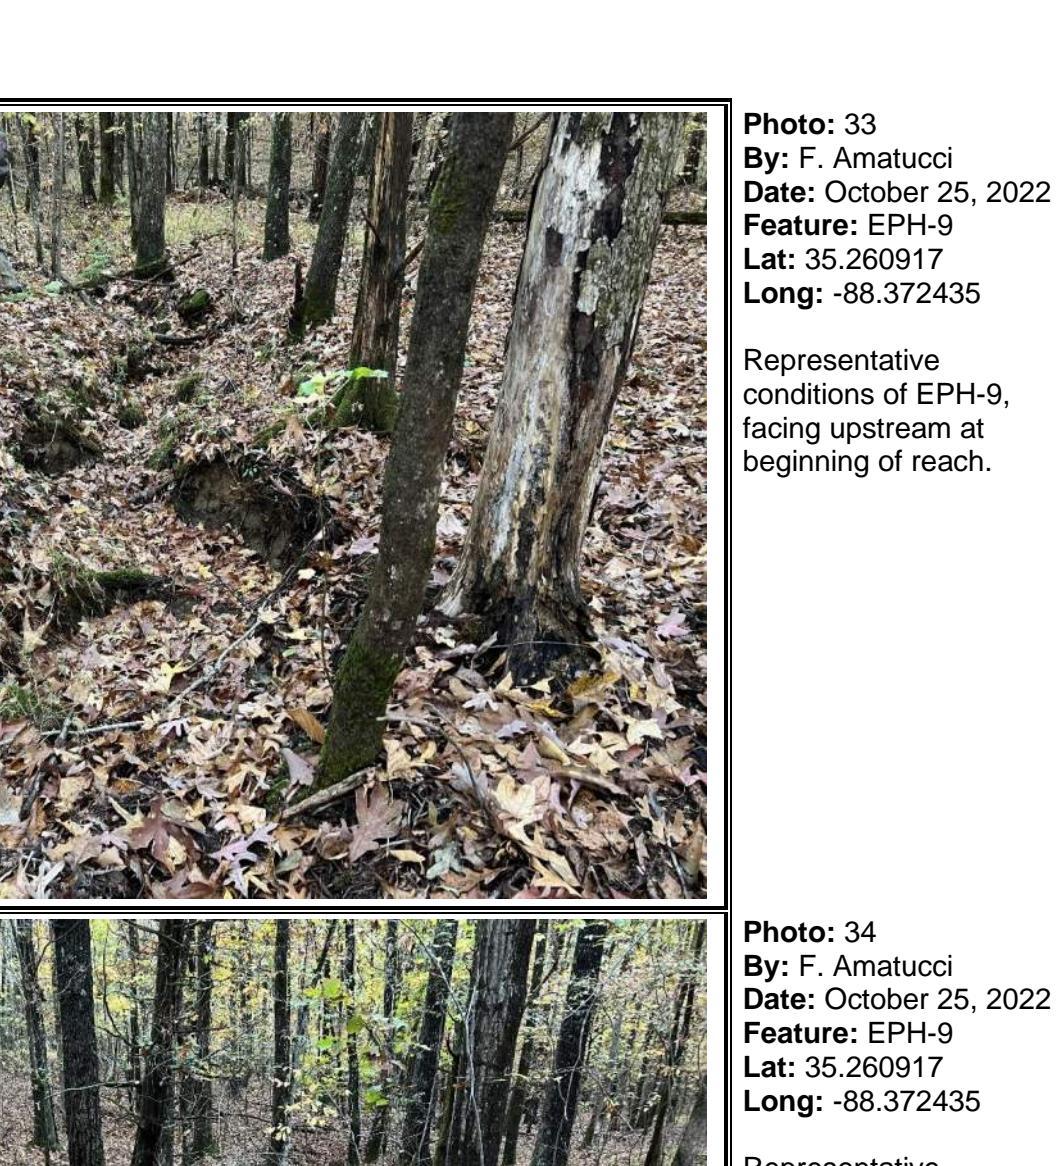
Representative conditions of EPH-9, facing downstream at end of reach before confluence with EPH-10.

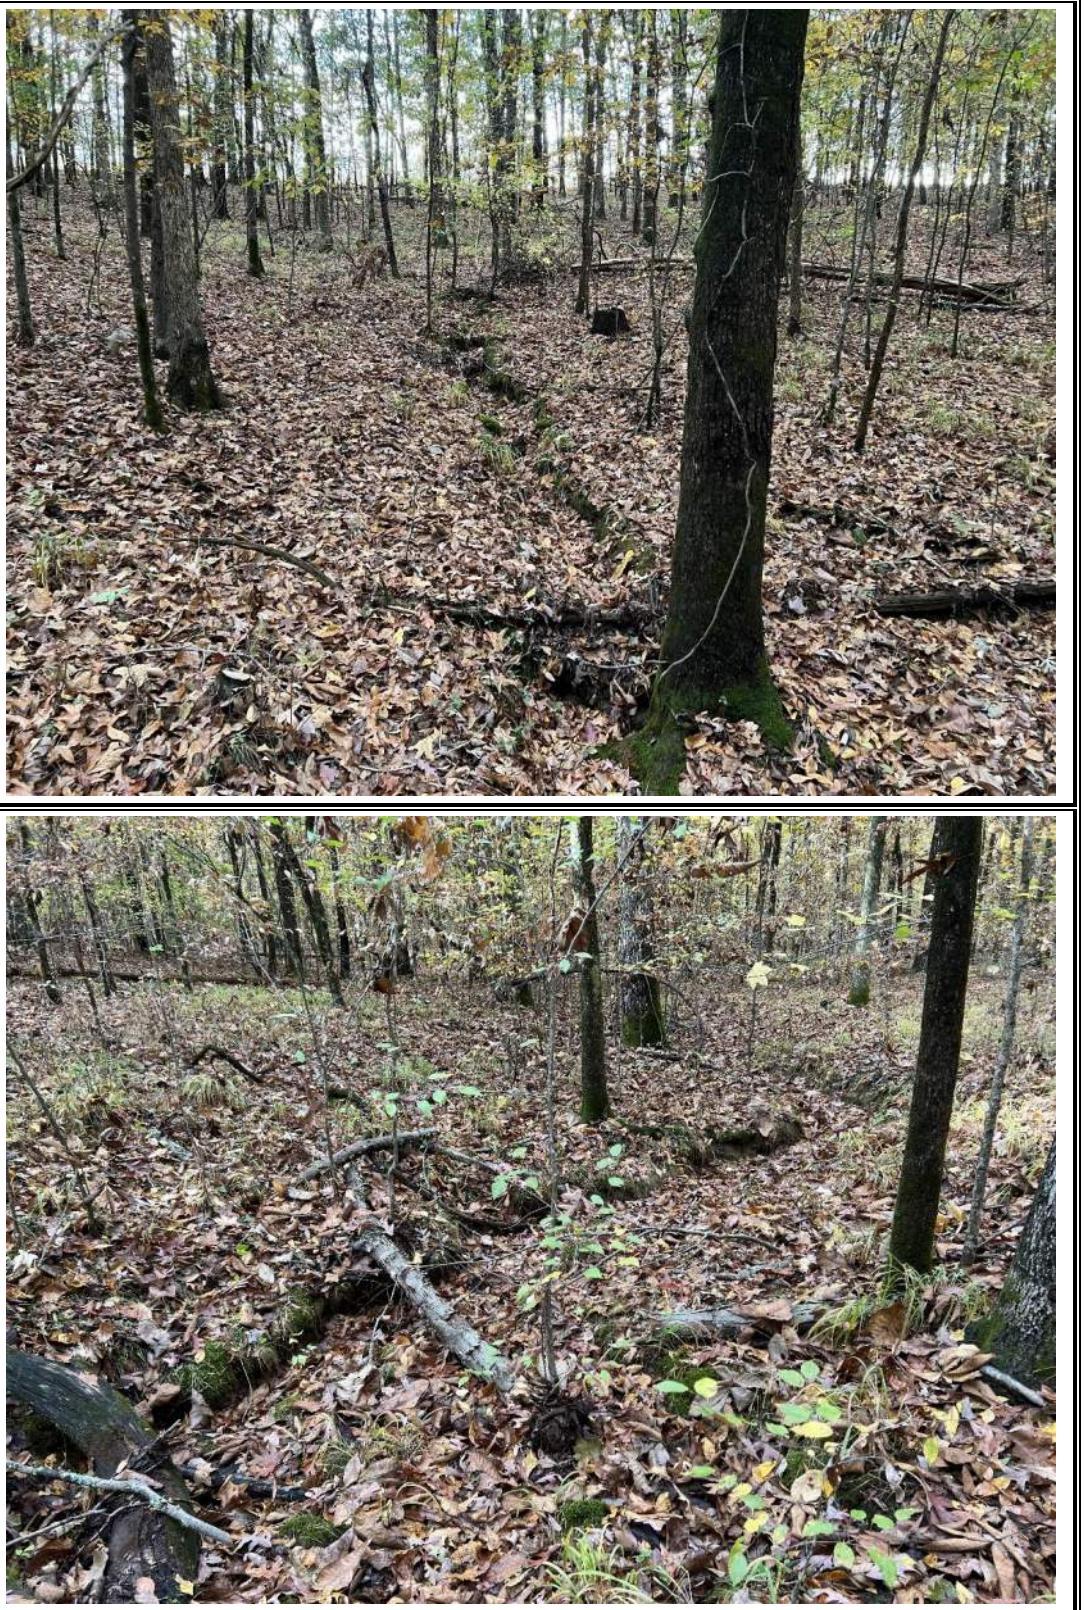
Photo: 35 By: F. Amatucci Date: October 25, 2022 Feature: EPH-10 Lat: 35.260267 Long: -88.372032

Representative conditions of EPH-10, facing downstream at end of reach before transition into STR-7.

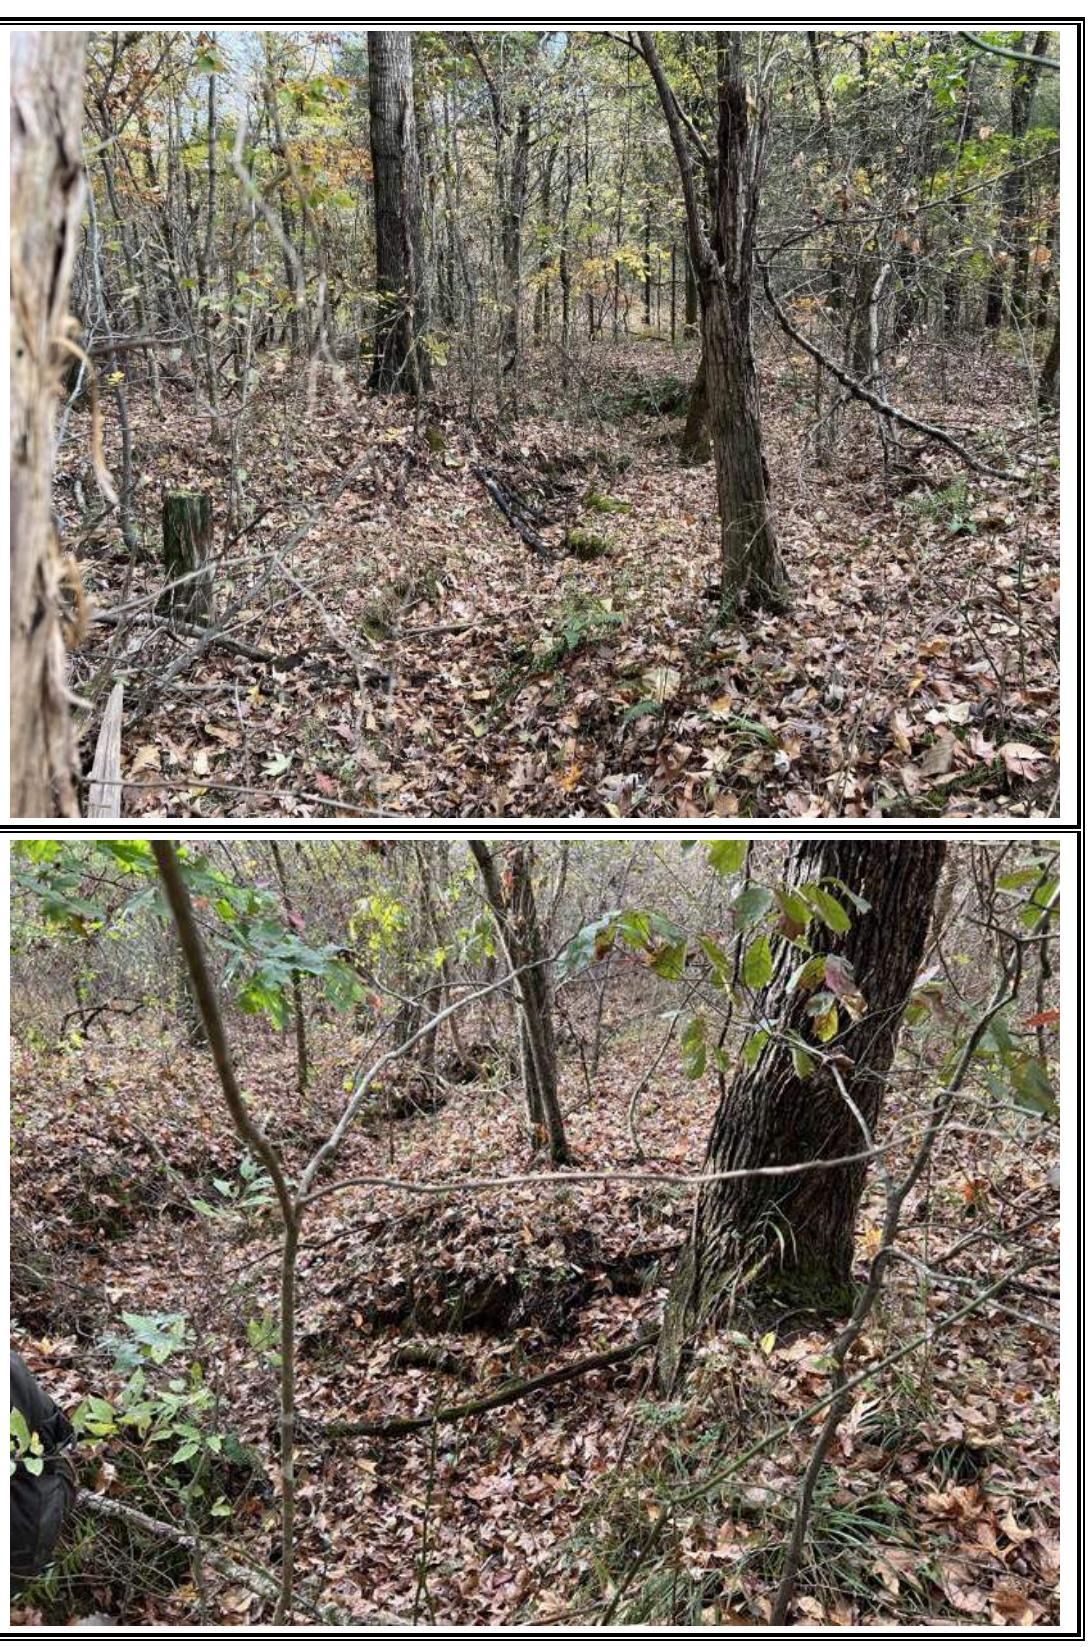
Photo: 37 By: F. Amatucci Date: October 25, 2022 Feature: EPH-11 Lat: 35.262724

Representative conditions of EPH-11, facing upstream at end of reach before confluence with STR-4.

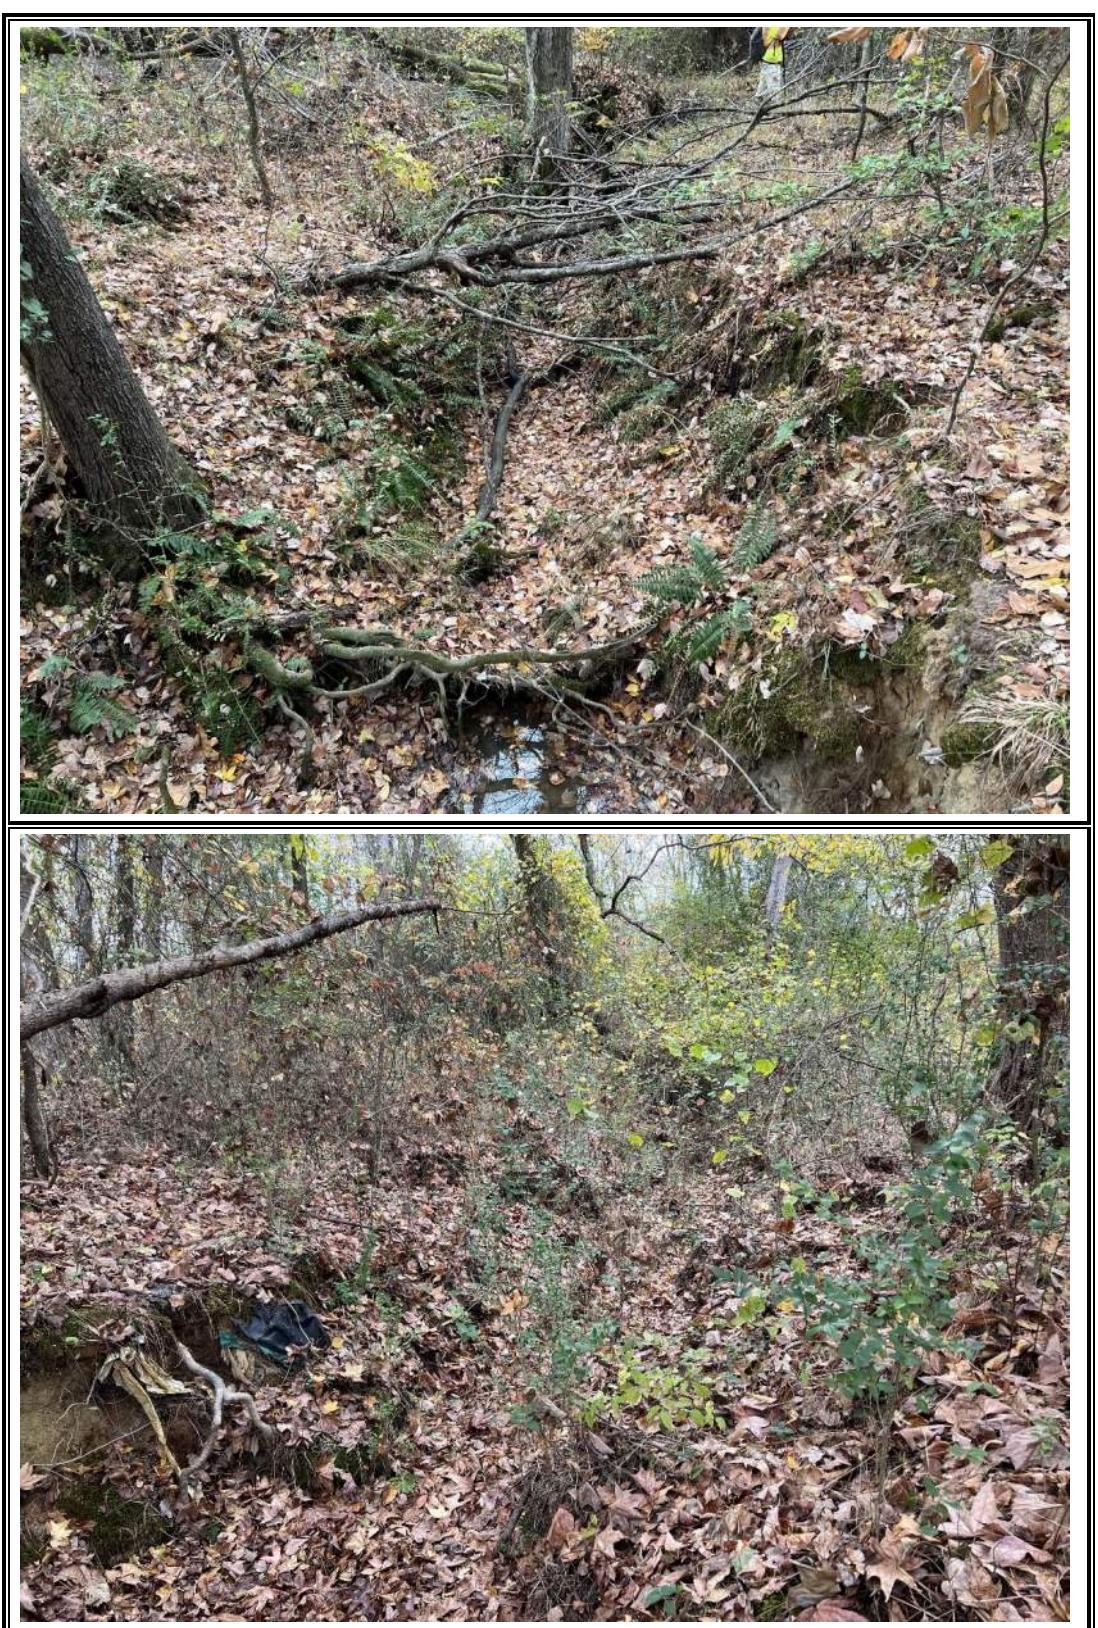
Photo: 39 By: F. Amatucci Date: October 26, 2022 Feature: EPH-12 Lat: 35.252734 Long: -88.374409

Representative conditions of EPH-12, facing downstream at end of reach before confluence with Stratton Branch.
