Volume 3, No. 44
October 3, 2017

Progress Update: Upstream/Downstream Berm Construction Underway

Slurry Cell Testing, Drilling Continues at Boone Dam

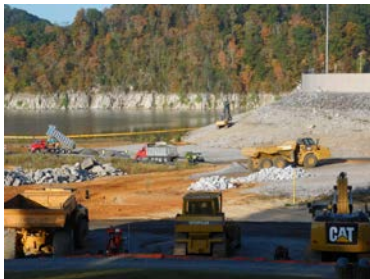
Above: Heavy equipment is visible to neighbors and boaters near Boone Dam.

Construction activities remain highly visible at Boone Dam as trucks roll onto the site hauling loads of stone from local quarries for the upstream berm construction. Already nearly 4,000 tons of stone has been placed on the upstream berm. The new rock will add stability to the earthen embankment. Work is also underway on the downstream side of the dam where some instruments are being relocated in preparation for the new construction. The fortified berms are the first part of construction plans that call for widening the top of the dam to create an improved working surface for cutoff wall construction.

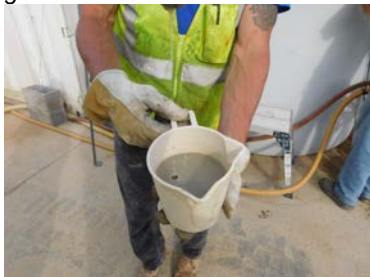
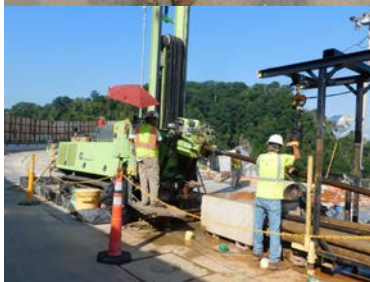
Below: An up-close look at the slurry mixture used in testing rows of grout. Sonic drill rigs inject the grout.

Slurry cell testing on the dam's earthen embankment involves drilling and then injecting a cement, water and bentonite clay slurry mixture into the dam along the previously constructed grout lines, or "grout curtains." Engineers and geologists are evaluating the grout curtain's ability to contain slurry and provide stability during cutoff wall construction.

The slurry is similar to the material used in completing the cutoff wall, a key component in the composite seepage barrier being constructed inside and underneath the embankment, to depths that could approach 300 feet. You can see a basic schematic of the cutoff wall [here](#). Collectively, these improvements will prevent further erosion or seepage under the embankment.

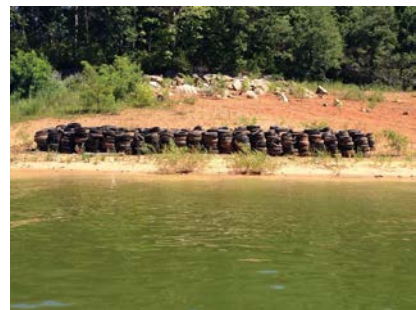
The Boone Lake Association recently completed the cleanup of 1,200 tires from Boone Lake with the support of TVA, which underwrote the removal costs of the tires that were once used for fish habitats on the lake. After pulling the tires from the lake, the Boone Lake Association crew hauled them to a staging area across from Boone Beach and Boat Ramp where they were transported to the Washington County Tire Recycling Facility in Gray. The project began July 13 and ended August 24. Boone Lake Association’s Ron Siegfried said, “I would like to thank our crew for all their hard work to complete this project in record time.” Siegfried said several board members and volunteers were also instrumental in the tire clean-up. Next up, TVA will work with Tennessee Wildlife Resources Agency to create new fish habitats on Boone Lake.

Below: 750 of the 1200 tires that the Boone Lake Association cleaned up from Boone Lake.
