Volume 3, No. 44
October 3, 2017

Progress Update: Upstream/Downstream Berm Construction Underway

Slurry Cell Testing, Drilling Continues at Boone Dam

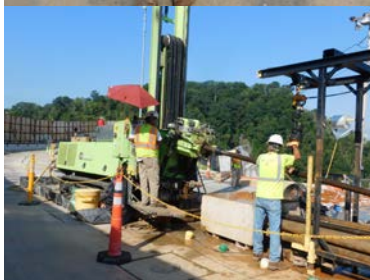
Below: An up-close look at the slurry mixture used in testing rows of grout. Sonic drill rigs inject the grout.

Slurry cell testing on the dam's earthen embankment involves drilling and then injecting a cement, water and bentonite clay slurry mixture into the dam along the previously constructed grout lines, or "grout curtains." Engineers and geologists are evaluating the grout curtain's ability to contain slurry and provide stability during cutoff wall construction.

The slurry is similar to the material used in completing the cutoff wall, a key component in the composite seepage barrier being constructed inside and underneath the embankment, to depths that could approach 300 feet. You can see a basic schematic of the cutoff wall [here](#). Collectively, these improvements will prevent further erosion or seepage under the embankment.
