APPENDIX A
TVA ROW CLEARING SPECIFICATIONS

Tennessee Valley Authority Right-of-Way Clearing Specifications

Figure 1. Proposed Muscle Shoals Solar Project Site

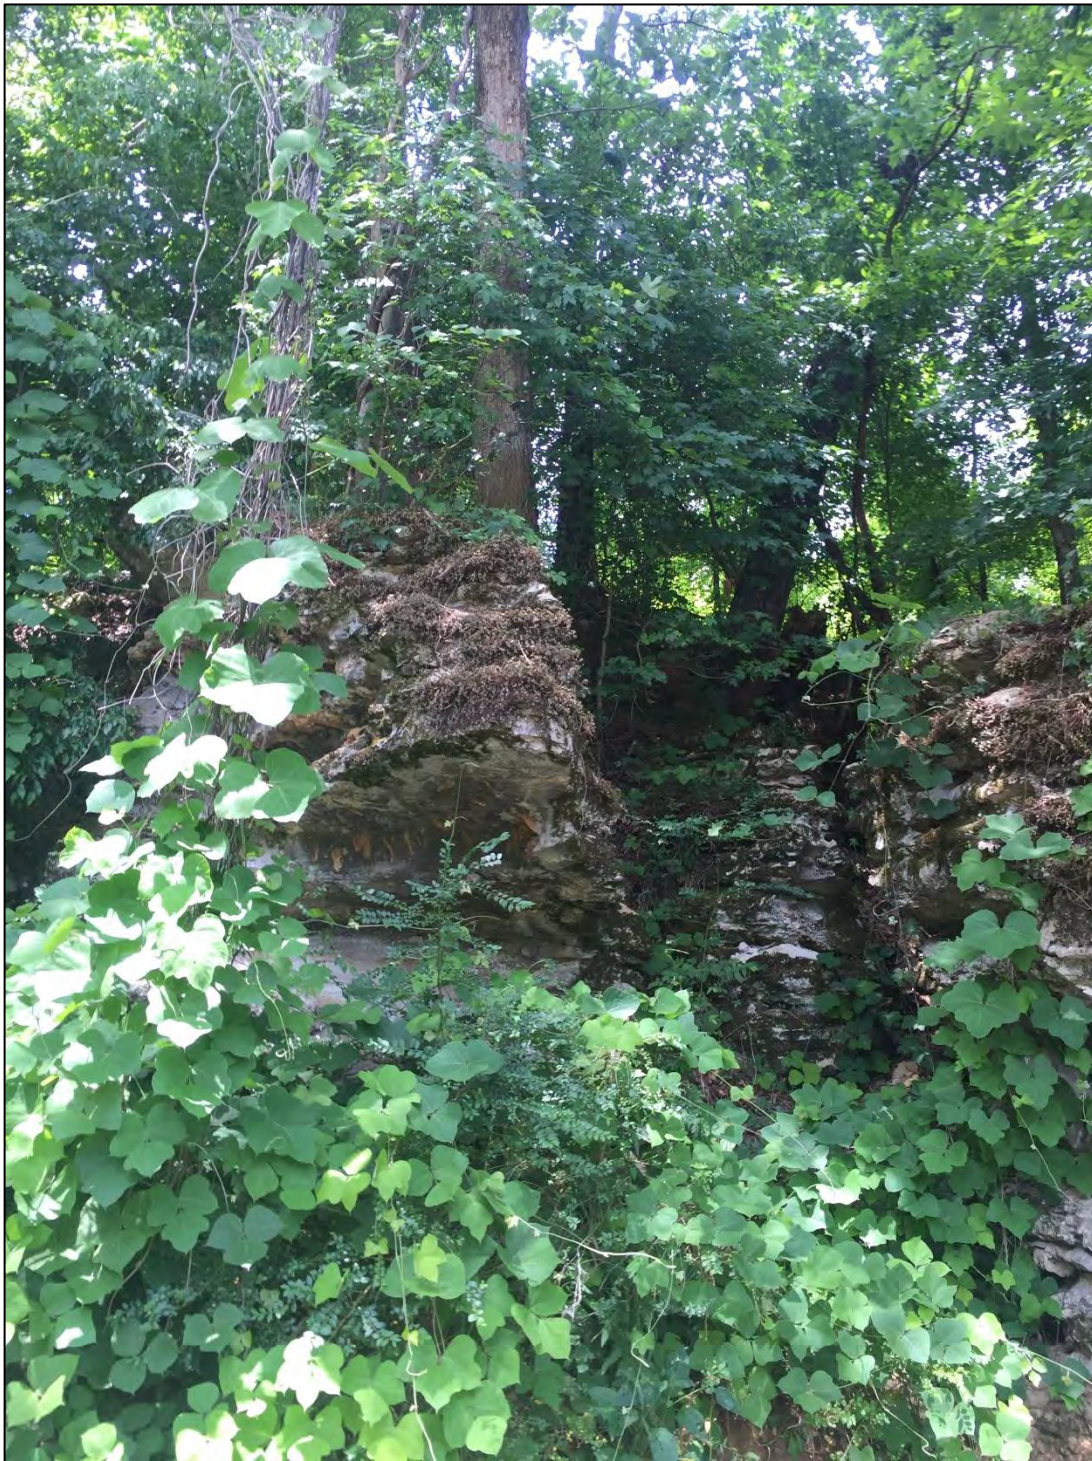
Figure 3 – Identified Potential Vertical Karst Feature 2016.
