WILBUR RESERVOIR BRIDGE REPLACEMENT ENVIRONMENTAL ASSESSMENT

Carter County, Tennessee

Prepared by:
TENNESSEE VALLEY AUTHORITY
Carter County, Tennessee
November 2024

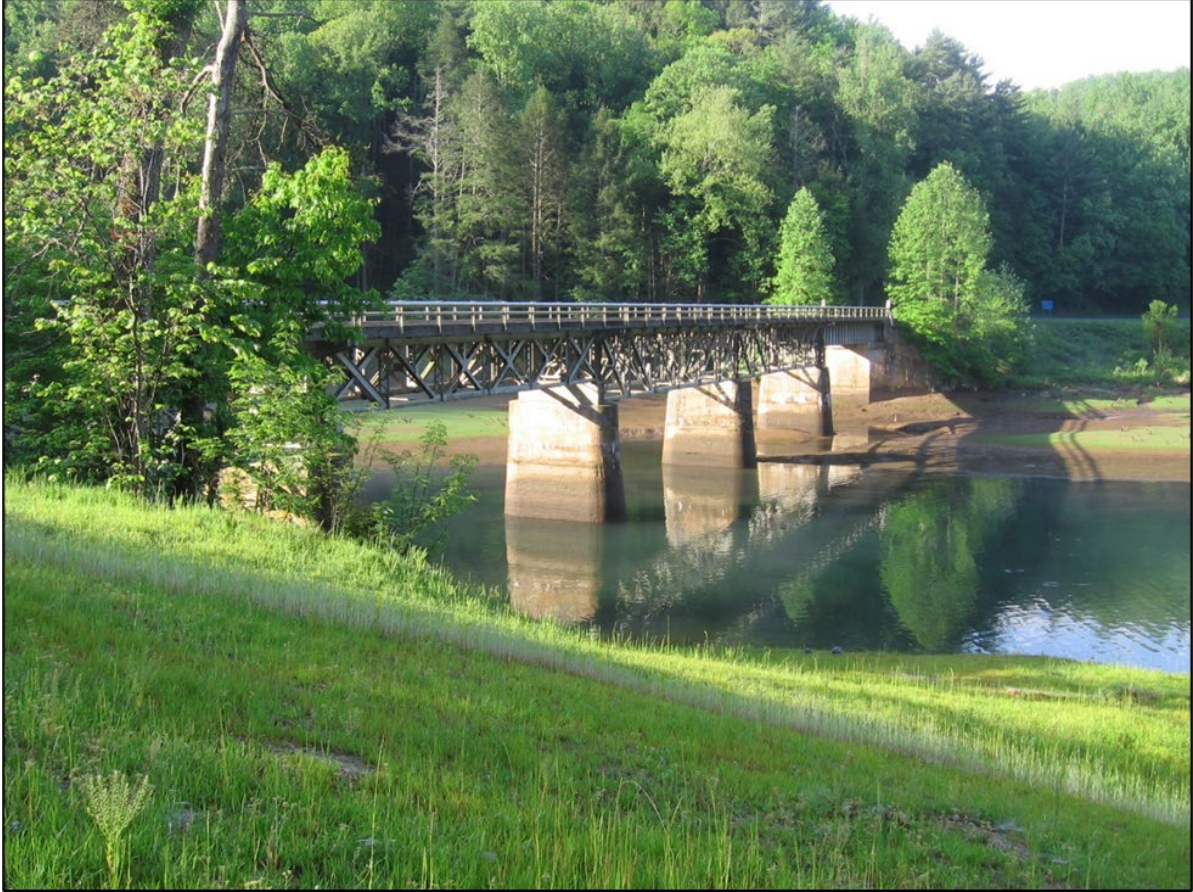
Figure 2. The existing Wilbur Reservoir Bridge, carrying Wilbur Dam Road over Wilbur Reservoir

TVA's purpose and need of the Proposed Action (or Project) is to improve the safety and reliability of the bridge carrying Wilbur Dam Road over Wilbur Reservoir. The existing bridge, Wilbur Reservoir Bridge, was assembled in 1942 from a repurposed railroad bridge dating from the 1890's. It is a fracture critical¹ truss bridge with steel trusses (some of which are nearly 130 years old), concrete decking, and abutments and piers made of reinforced concrete. The bridge is currently "load posted," which means it cannot safely carry normal highway loads and has structural issues that require it to be inspected annually.

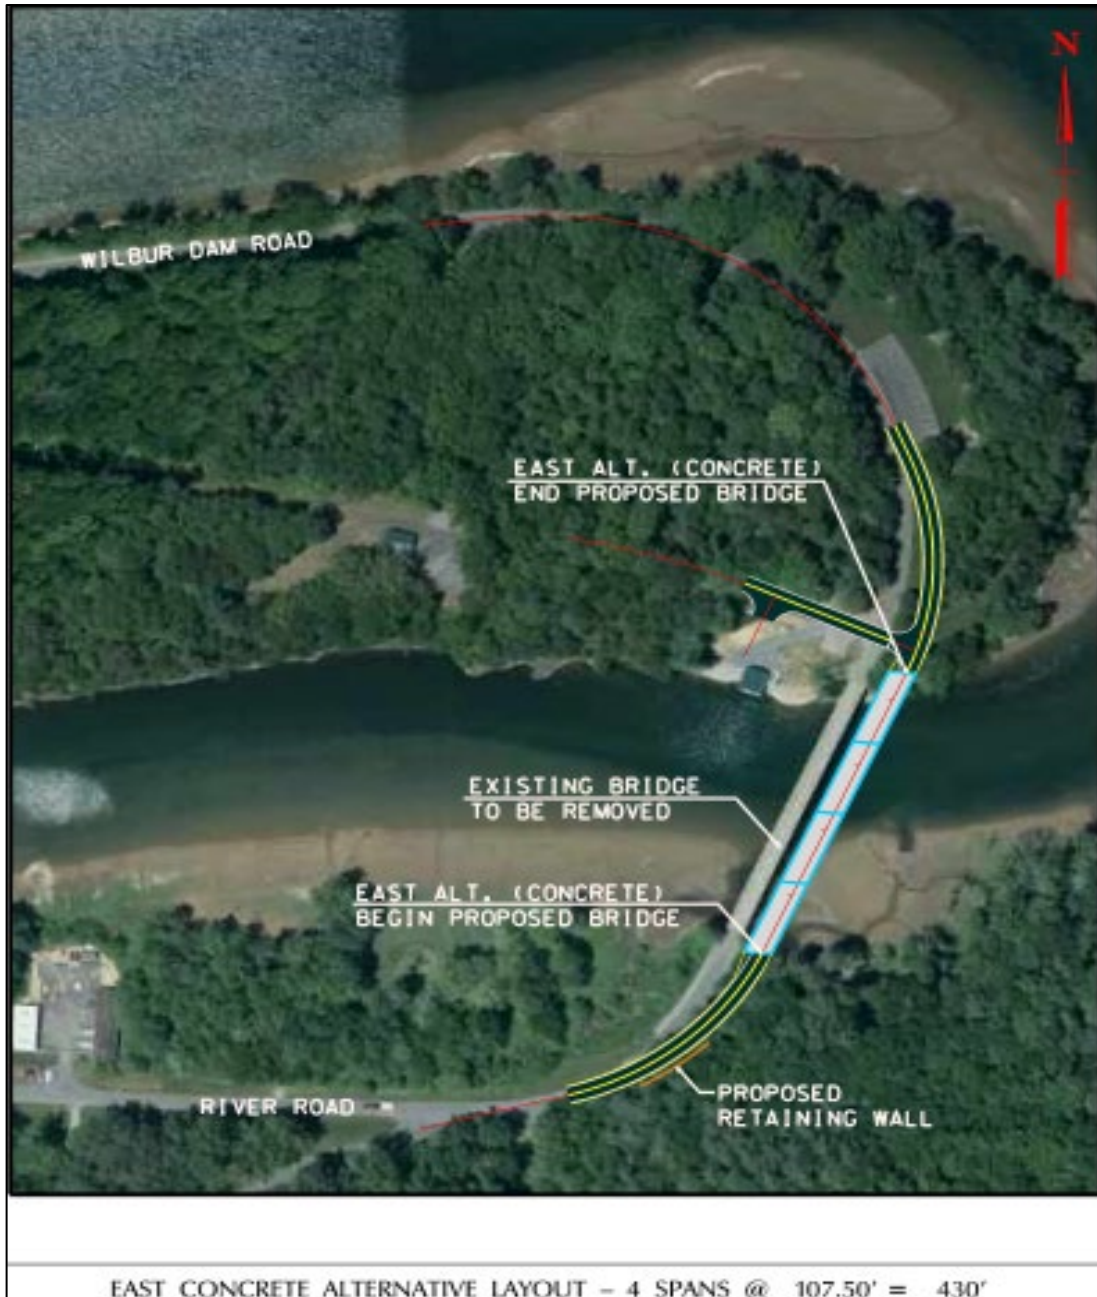
Figure 3. Depiction of a new concrete bridge alternative, aligned on the east side, or just downstream, of the existing Wilbur Reservoir Bridge

Under this alternative, TVA would replace the existing bridge, Wilbur Reservoir Bridge, with a new concrete bridge aligned on the eastern side, or just downstream, of the existing bridge (see Figure 3 below). Based on initial project design, TVA would use five concrete spans (three spans at 110 feet in length and two spans at 85 feet in length) with four piers in the reservoir. The bridge construction would necessitate a slight realignment of Wilbur Dam Road on each side of the reservoir to accommodate the placement of the new bridge. Therefore, there would be areas of land disturbed from the new alignment on each side of the bridge.

Under this alternative, the Wilbur Reservoir Bridge would be replaced by a new bridge constructed downstream and parallel to the existing bridge. The new concrete bridge would be supported by four piers in the reservoir. Placement of these support structures in a regulated aquatic feature, such as Wilbur Reservoir, requires adherence to CWA permits that ensure no more than minimal impacts to the aquatic environment. TVA is required to obtain coverage and comply with the terms and conditions of a CWA Section 404 permit for construction of the bridge supports in the reservoir and associated temporary impacts for the installation of a temporary bulkhead or causeway. In addition, an ARAP is also required to satisfy Tennessee water quality regulations and antidegradation policy. The ARAP application review and approval process ensures the project does not result in significant degradation to regulated waters. The ARAP also serves as Water Quality Certification for the federal CWA 404 permit, ensuring the federal permit is issued in alignment with state water regulations. This certification meets CWA Section 401 obligations. TVA has received both the USACE 404 permit and TDEC ARAP for certain activities evaluated under this alternative. These permits would be amended as necessary to ensure coverage of final design pending selection of the alternative.

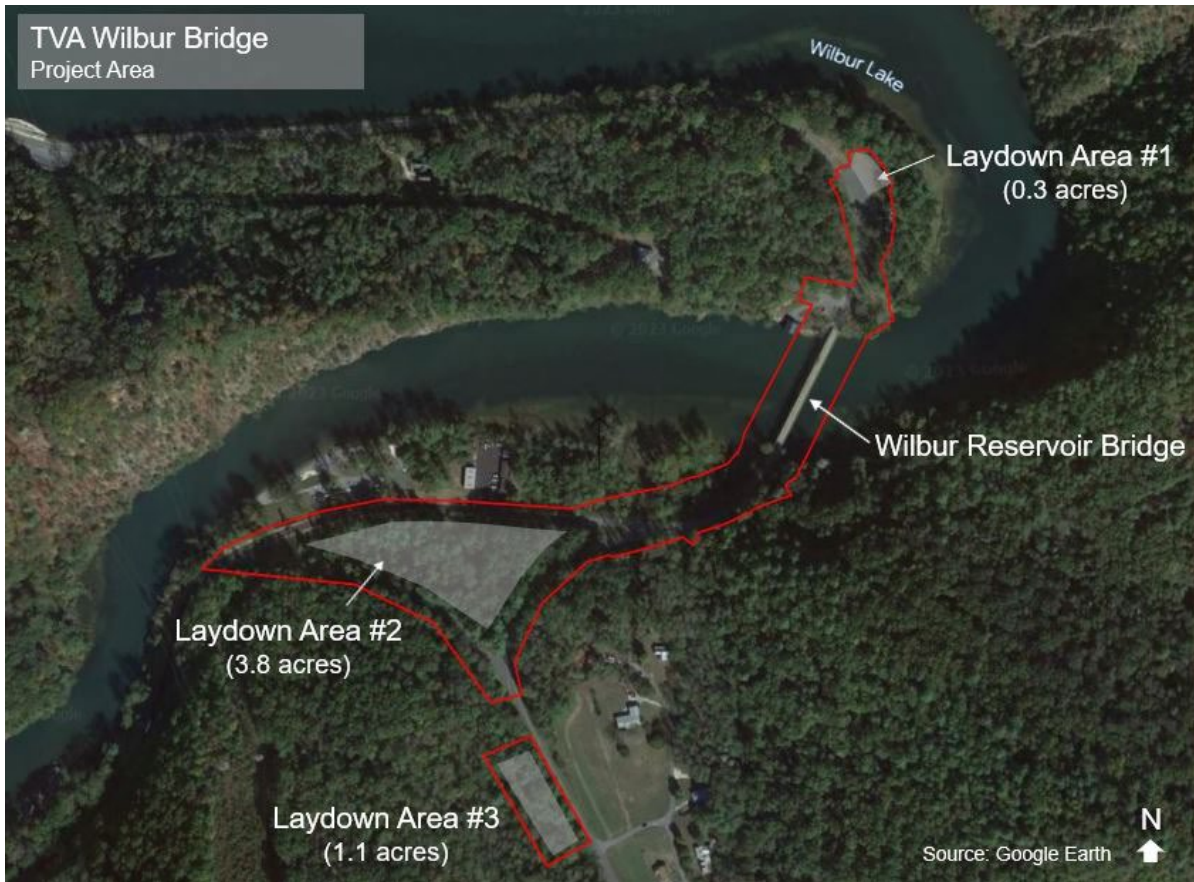
Figure 4. Project Area: Areas to be impacted by the Proposed Action (bridge location and lay down areas)

Clearing and/or grading would be needed to stage the laydown areas. After construction and demolition activities are completed, the laydown areas and other disturbed areas would be graded, covered with topsoil, and seeded to establish permanent vegetative cover or otherwise permanently stabilized.

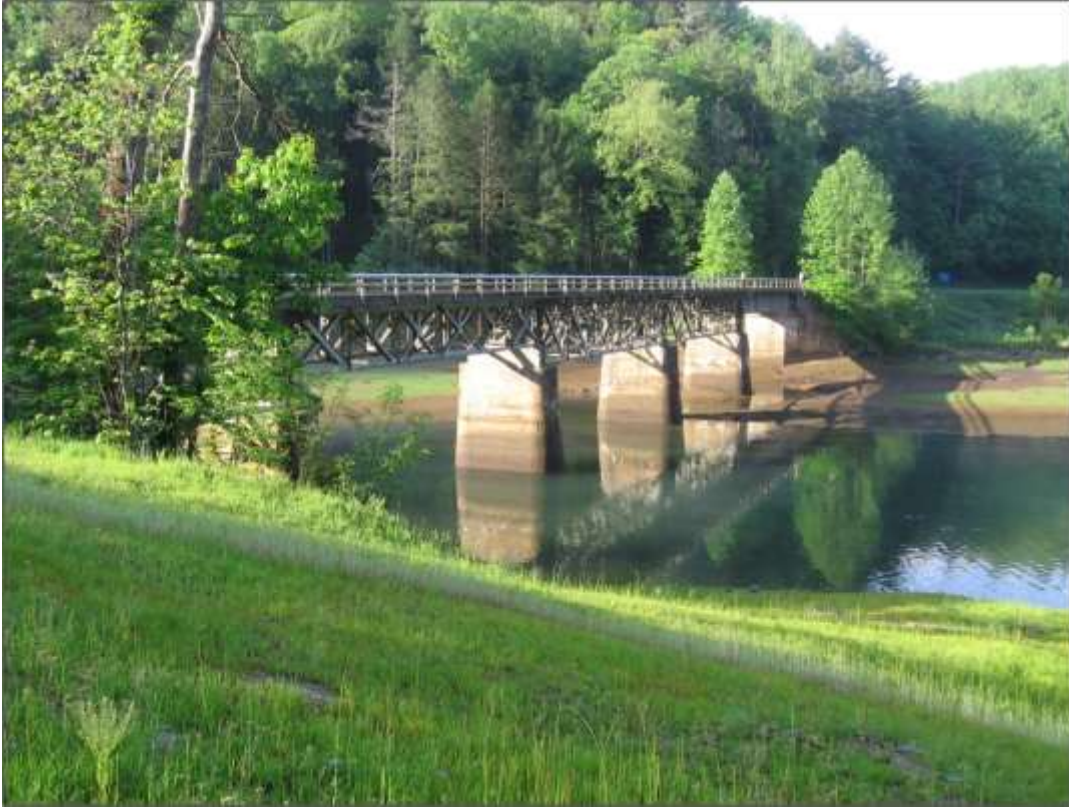
Figure 1. The existing Wilbur Reservoir Bridge, carrying Wilbur Dam Road over Wilbur Reservoir. View to north.

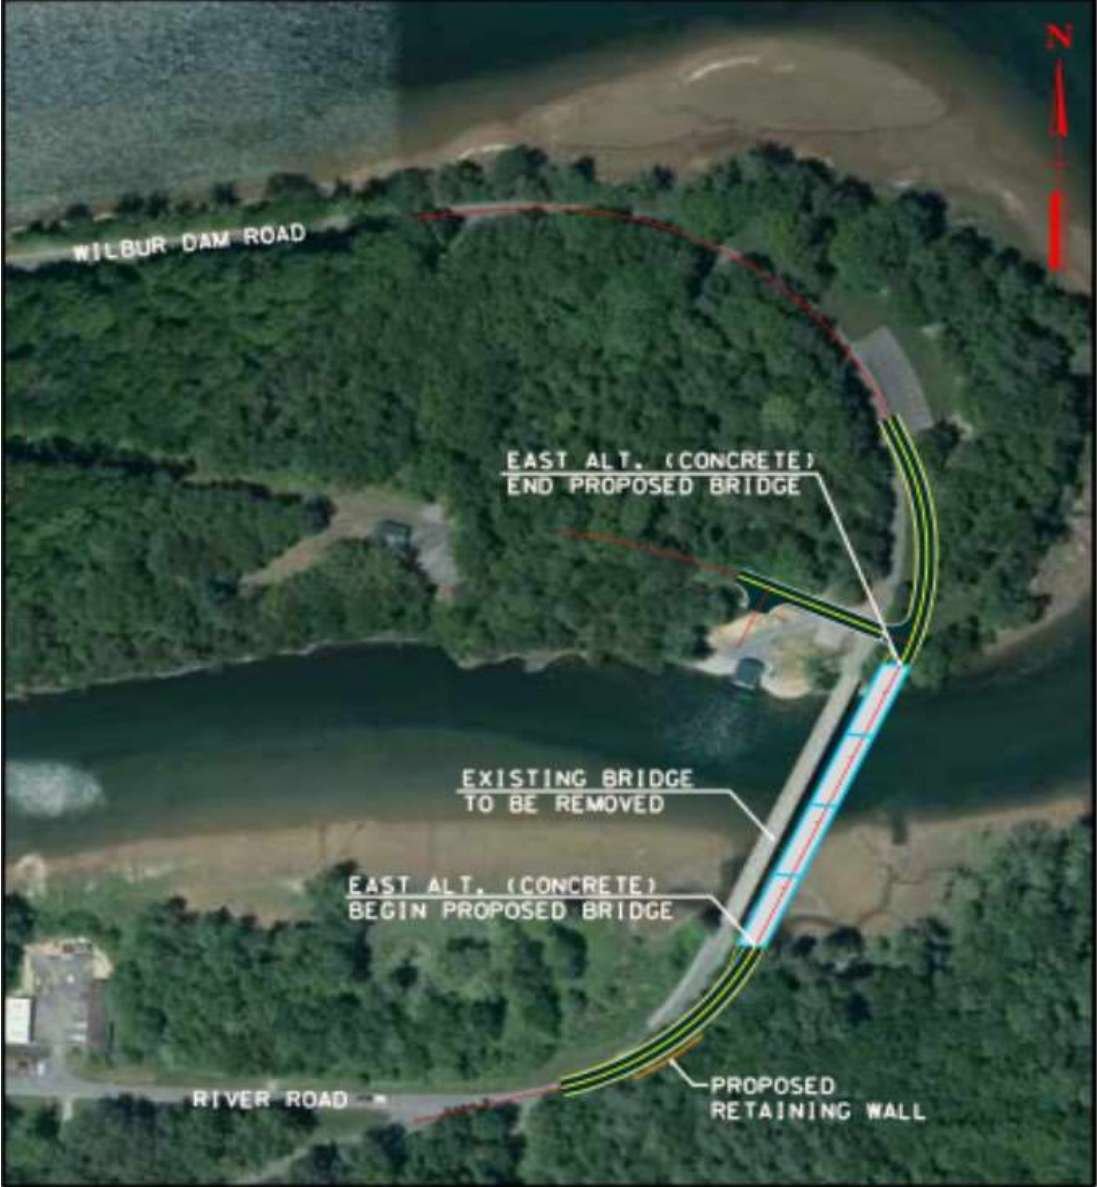
Figure 3. Proposed location of new bridge.
