Environmental Assessment Report

John Sevier Fossil Plant
Rogersville, Tennessee
Tennessee Valley Authority

Effective Date: July 3, 2023 Revision: 1

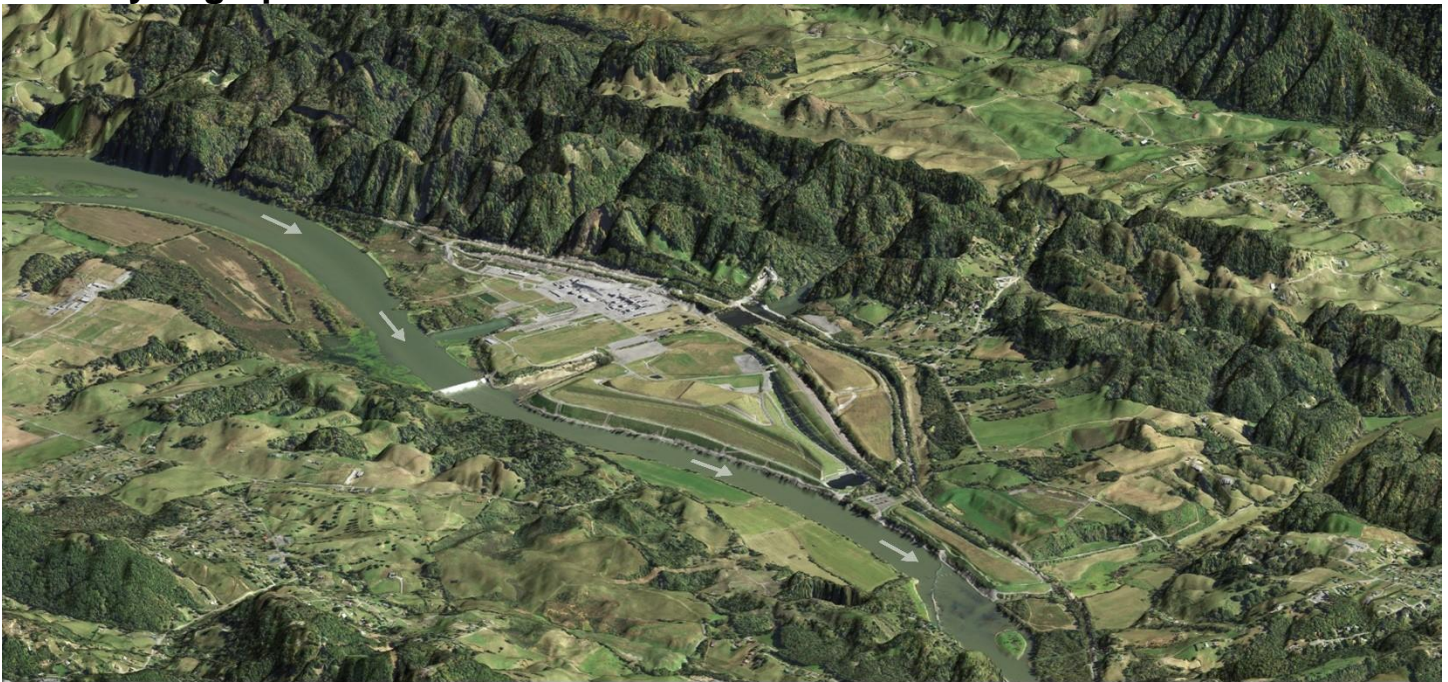
JSF Physiographic Features

← Typical surface stream flow direction

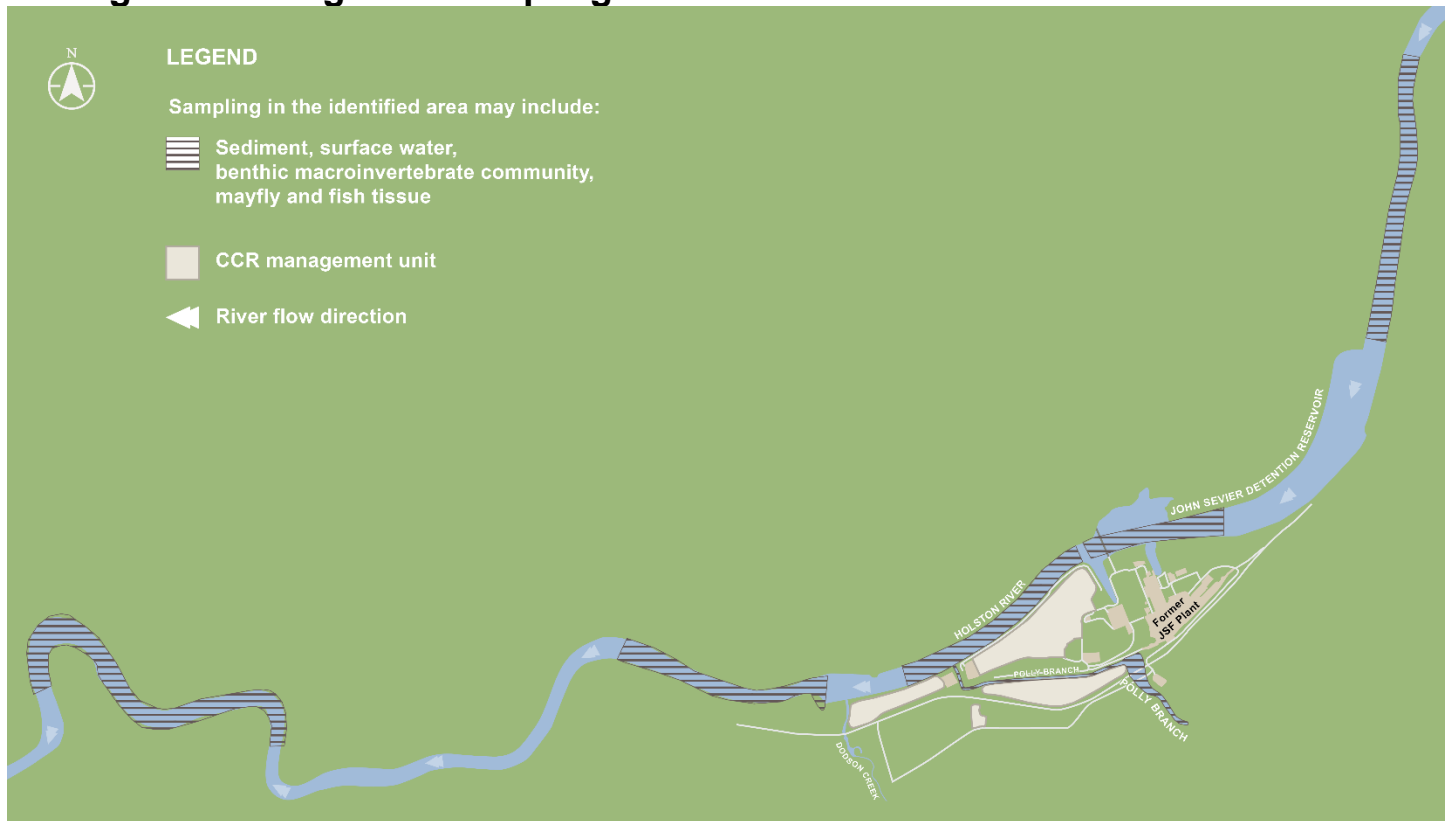
Ecological Investigation Sampling Transects and Reaches

- A total of 120 surface stream samples were collected during EI activities (90 from transects located in the Holston River and 30 from transects and single points in Polly Branch). Technical evaluation of these sampling results is presented in the *Technical Evaluation of Surface Stream Data* (Appendix J.1), and investigation sampling information is provided in the *Surface Stream SAR* (Appendix J.2).

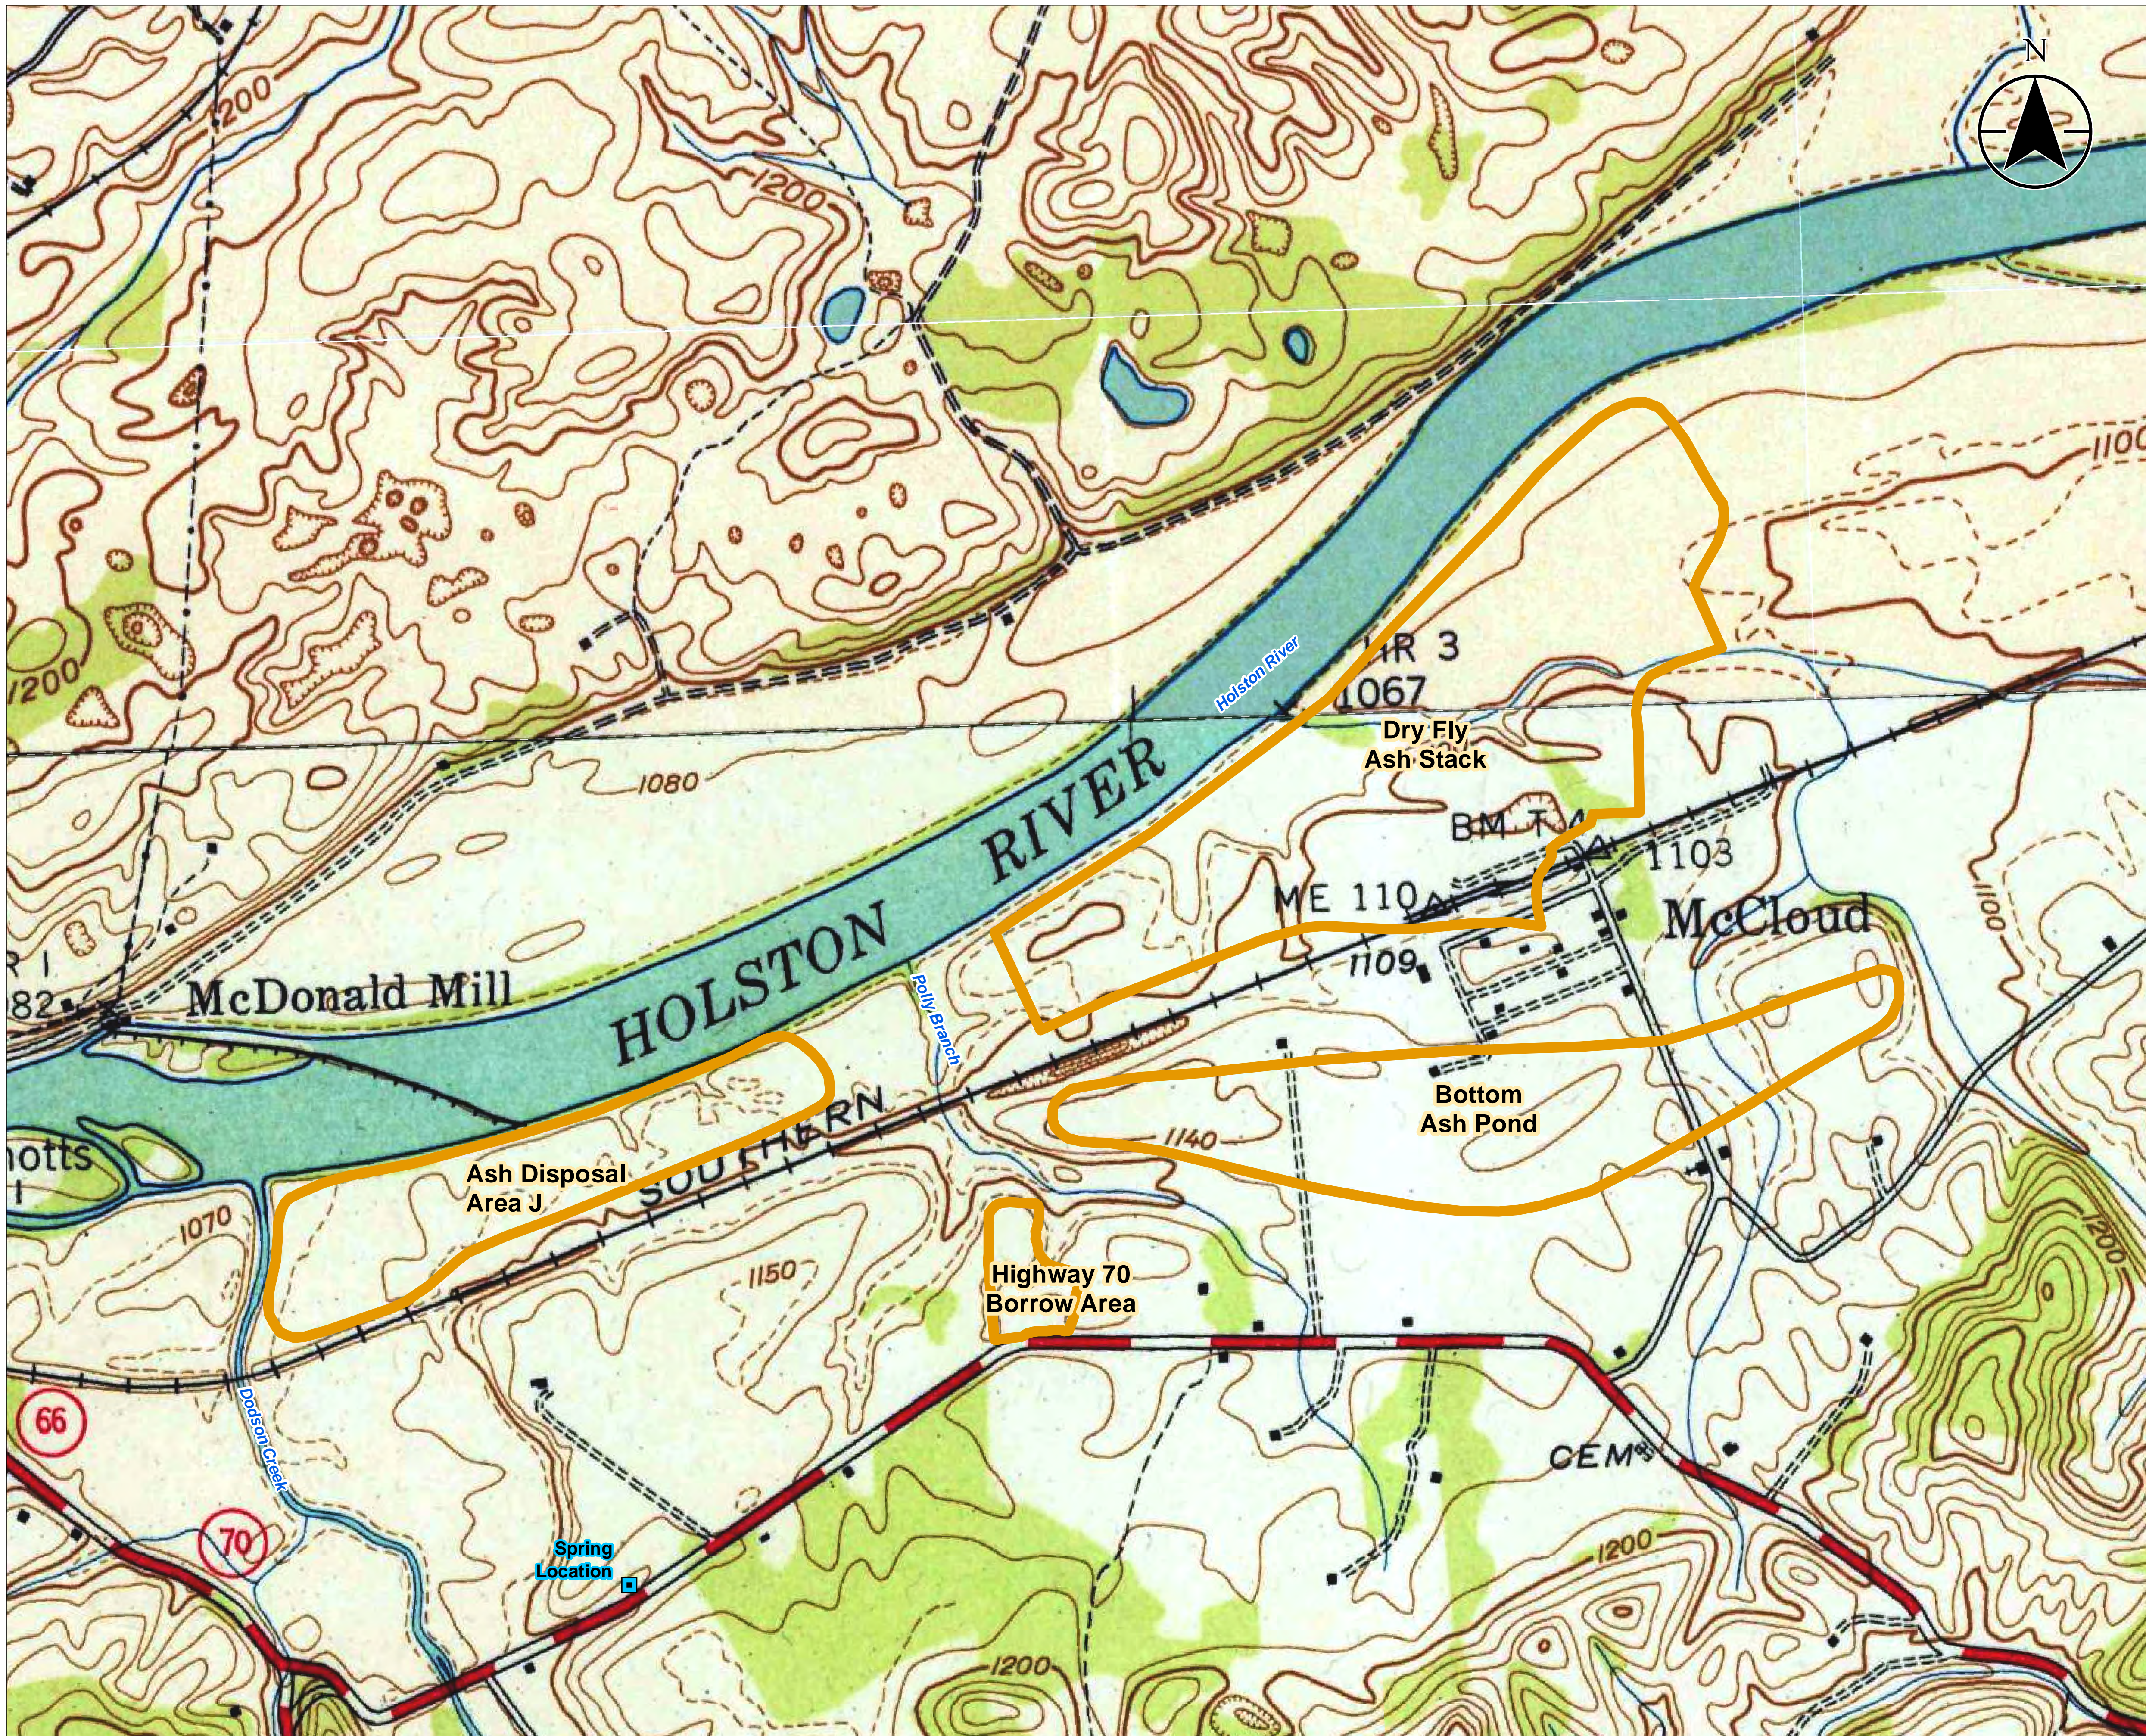
Exhibit No. **2-3b**
 Title **Topographic Map - USGS (1940)**

- Notes**
1. Coordinate System: NAD 1983 StatePlane Tennessee FIPS 4100 Feet
 2. Topographic Map: USGS McCCloud and Burem, Tennessee Quadrangles, 1940; 24,000 scale

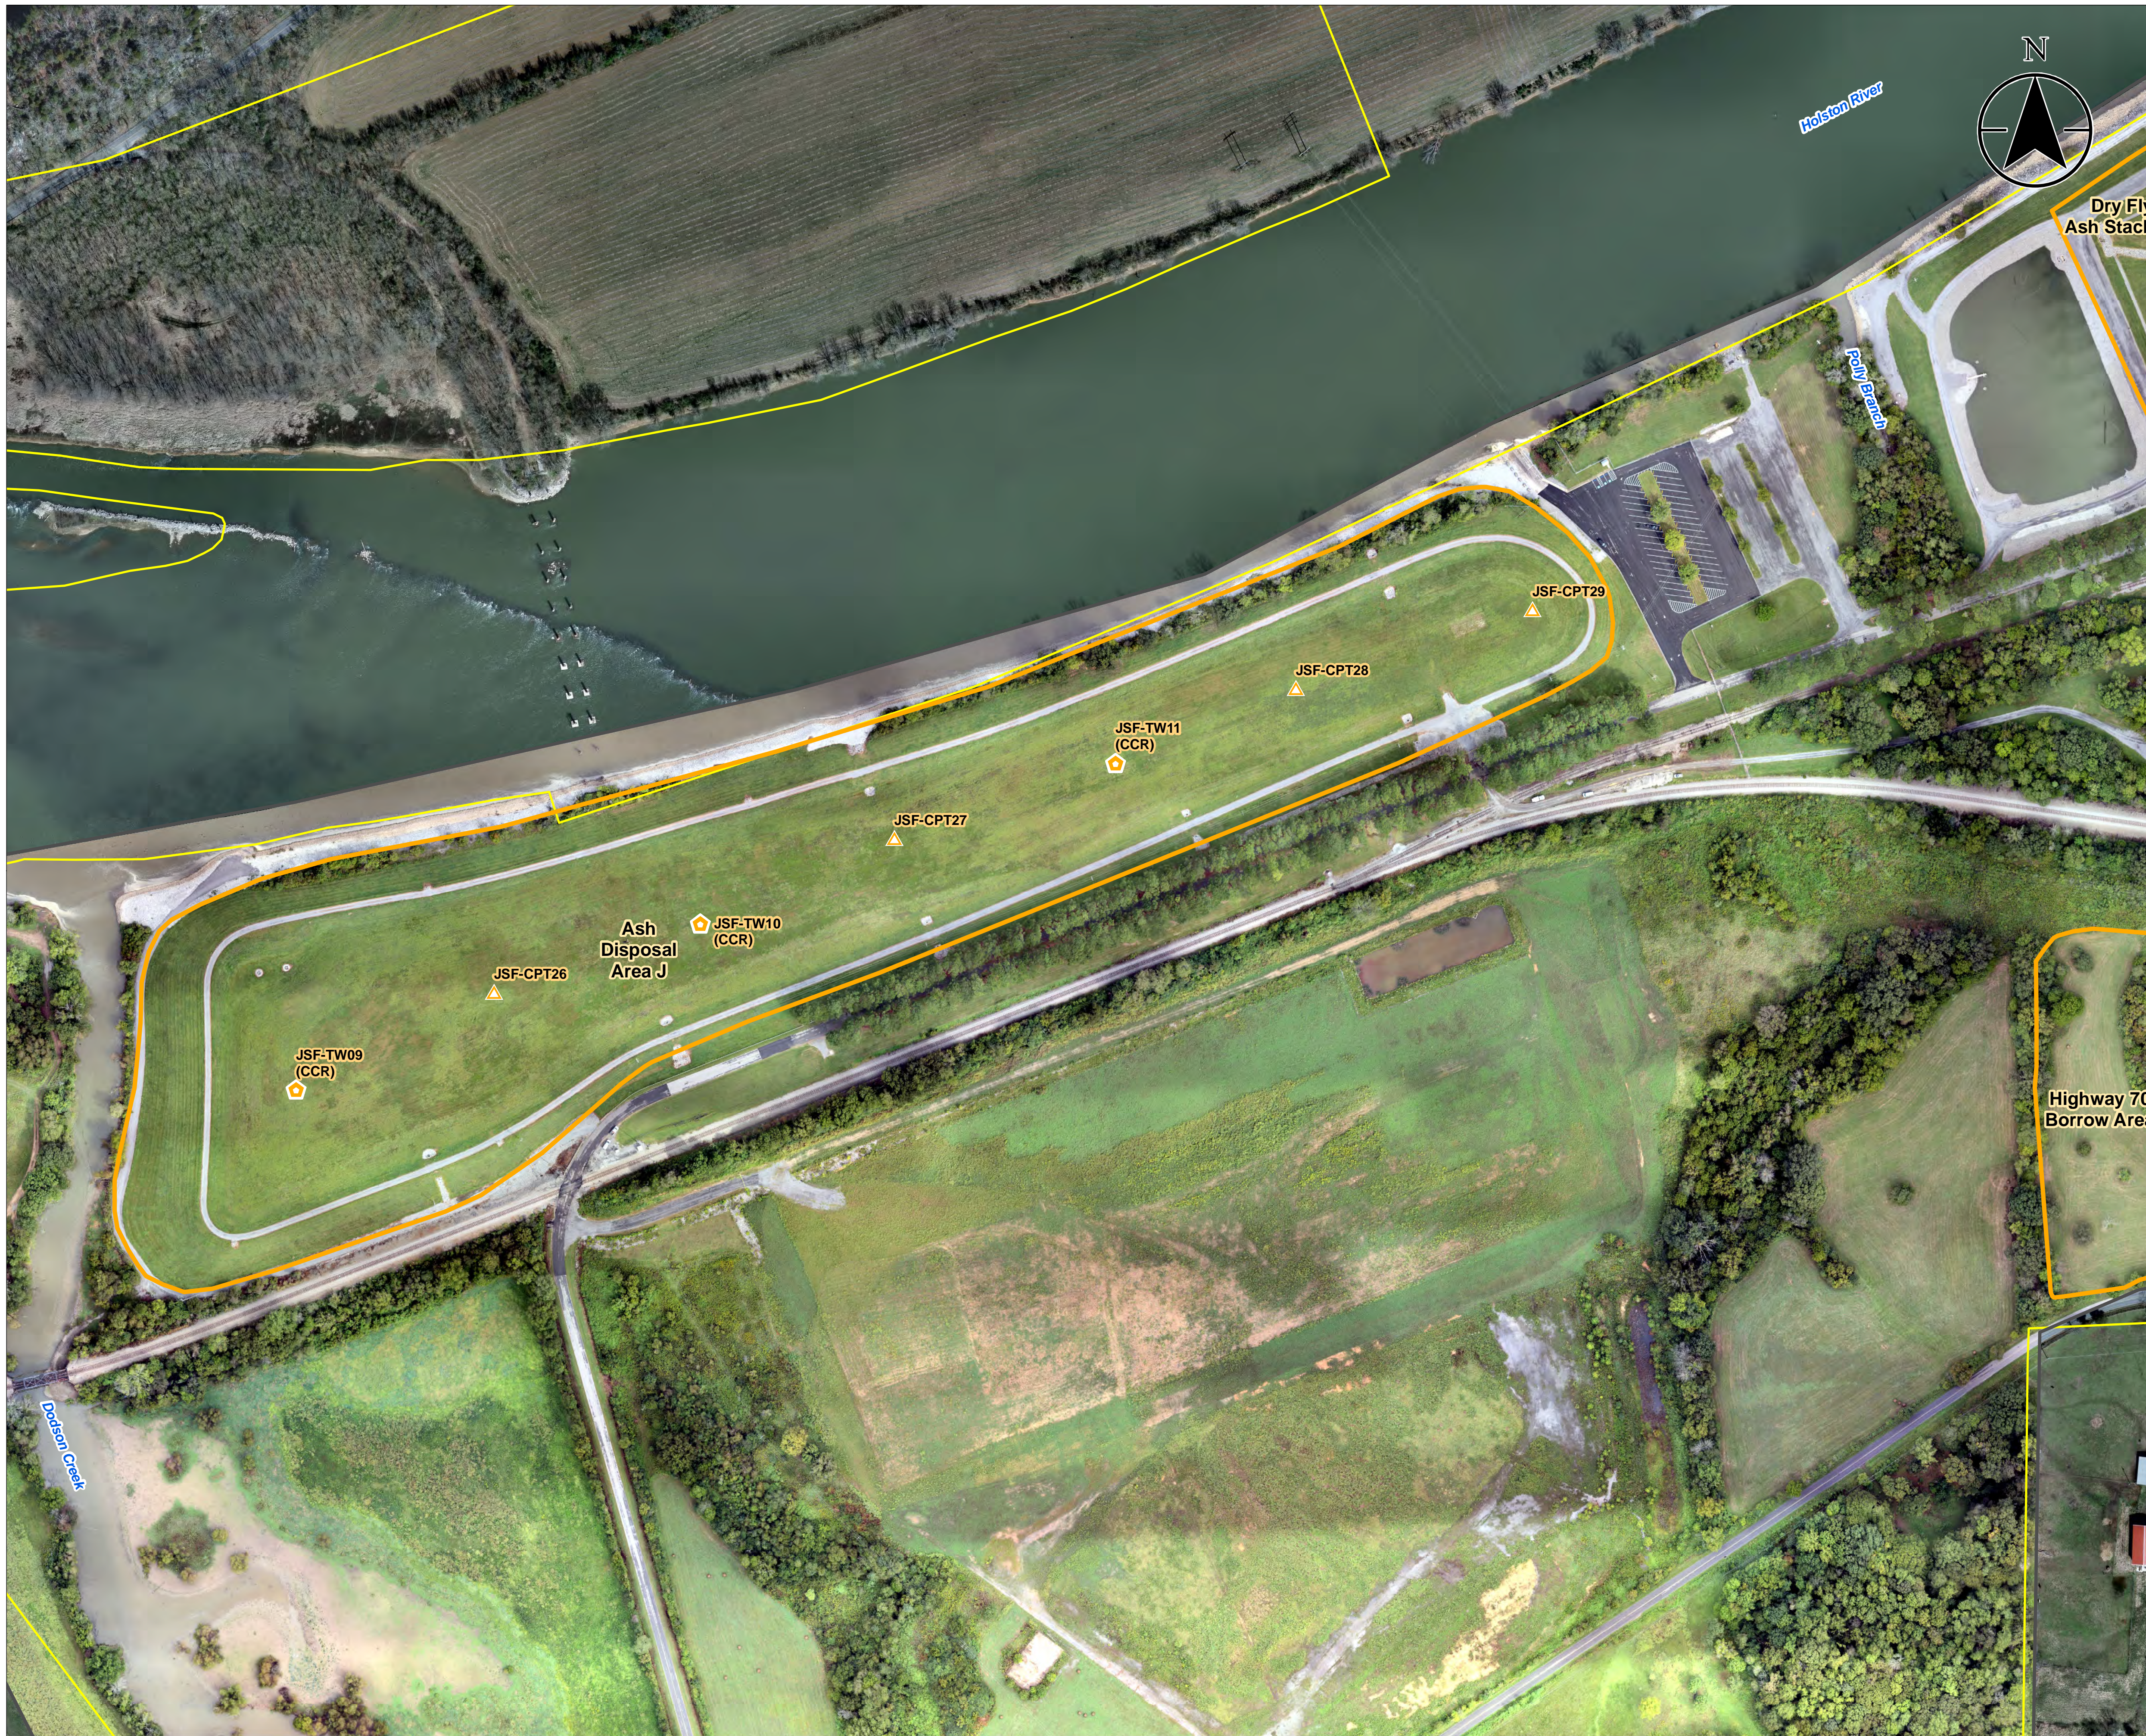
Exhibit No.
4-1

Title
**Phase 1 Boring Locations
Ash Disposal Area J**

1. Coordinate System: NAD 1983 StatePlane Tennessee FIPS 4100 Feet
2. Imagery Provided by Tuck Mapping (2017-03-08) and TVA (2018-09-11)
3. Boring locations for JSF-TW09 through JSF-TW11 were surveyed by the R.L.S. Group on April 11, 2019. CPT locations for JSF-CPT26 through JSF-CPT29 were surveyed by Stantec on November 4, 2019.

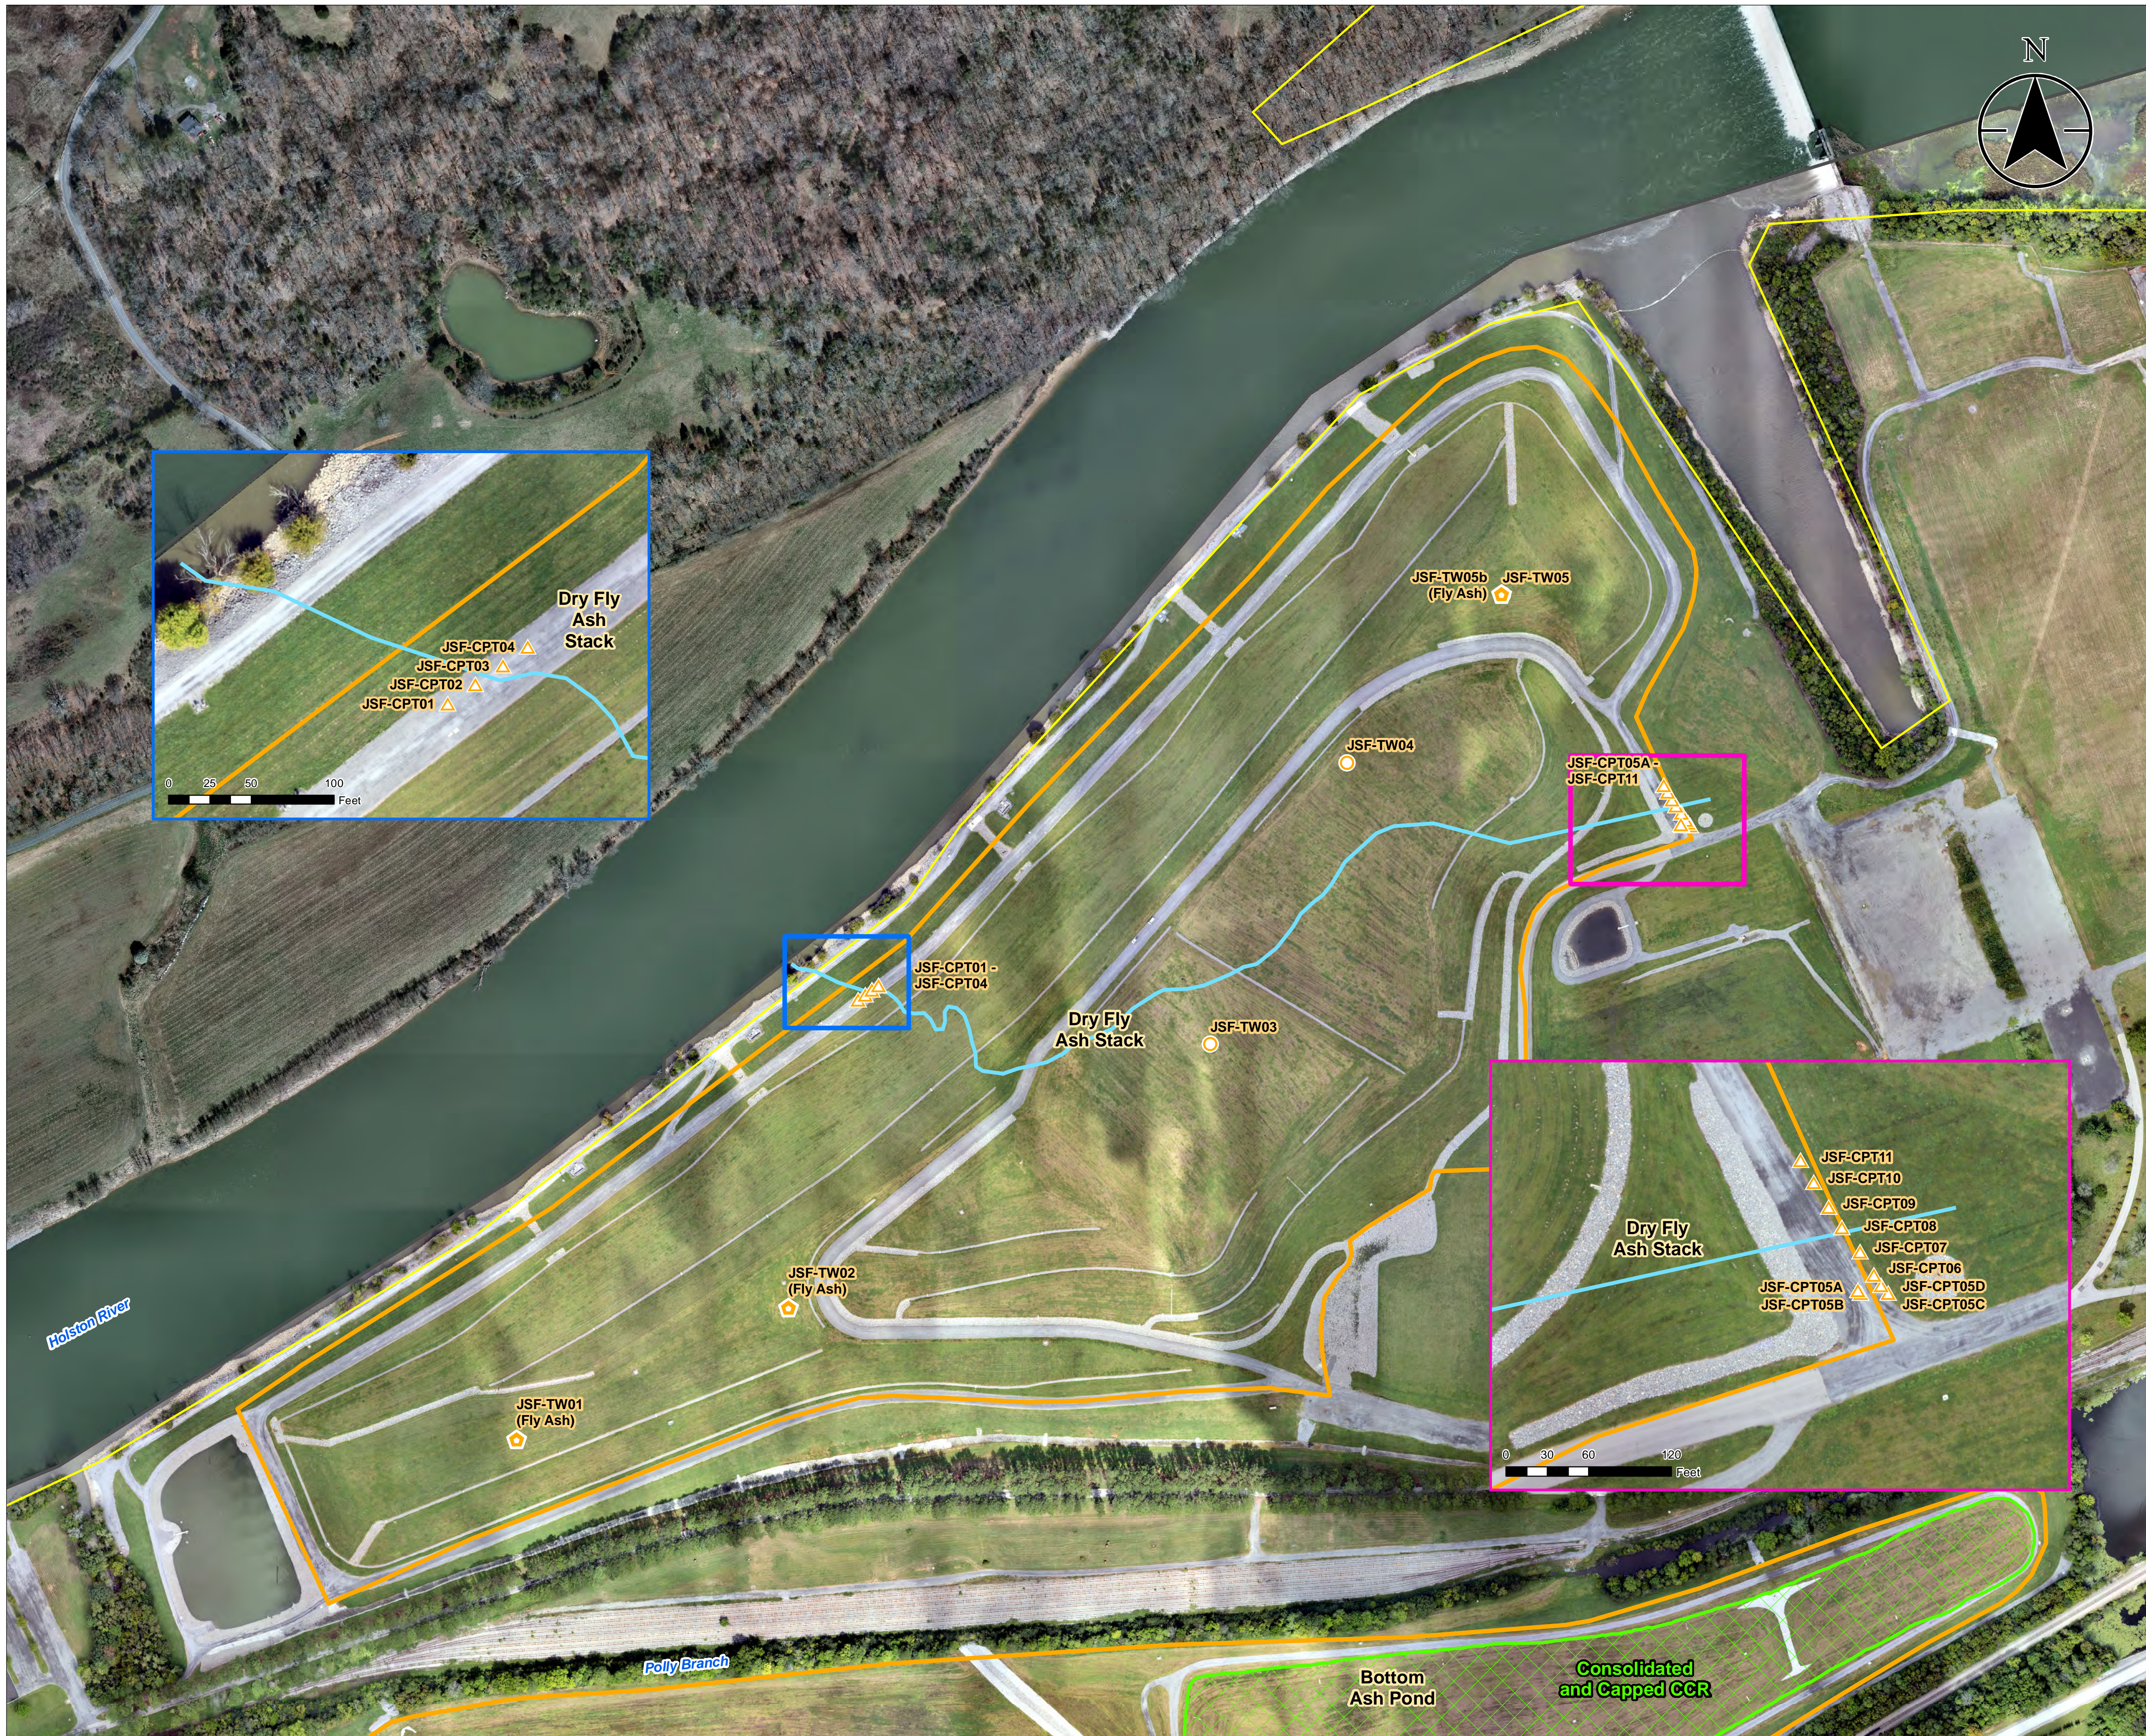
Exhibit No. **4-3**
 Title **Phase 1 Boring Locations
 Dry Fly Ash Stack**

6. Temporary well JSF-TW05 was installed in boring location JSF-TW05b. This offset boring is located approximately 3 feet horizontally from the original proposed location.

7. Boring locations for JSF-TW01 through JSF-TW05b and CPT locations JSF-CPT01 through JSF-CPT11 were surveyed by Stantec on November 4, 2019.

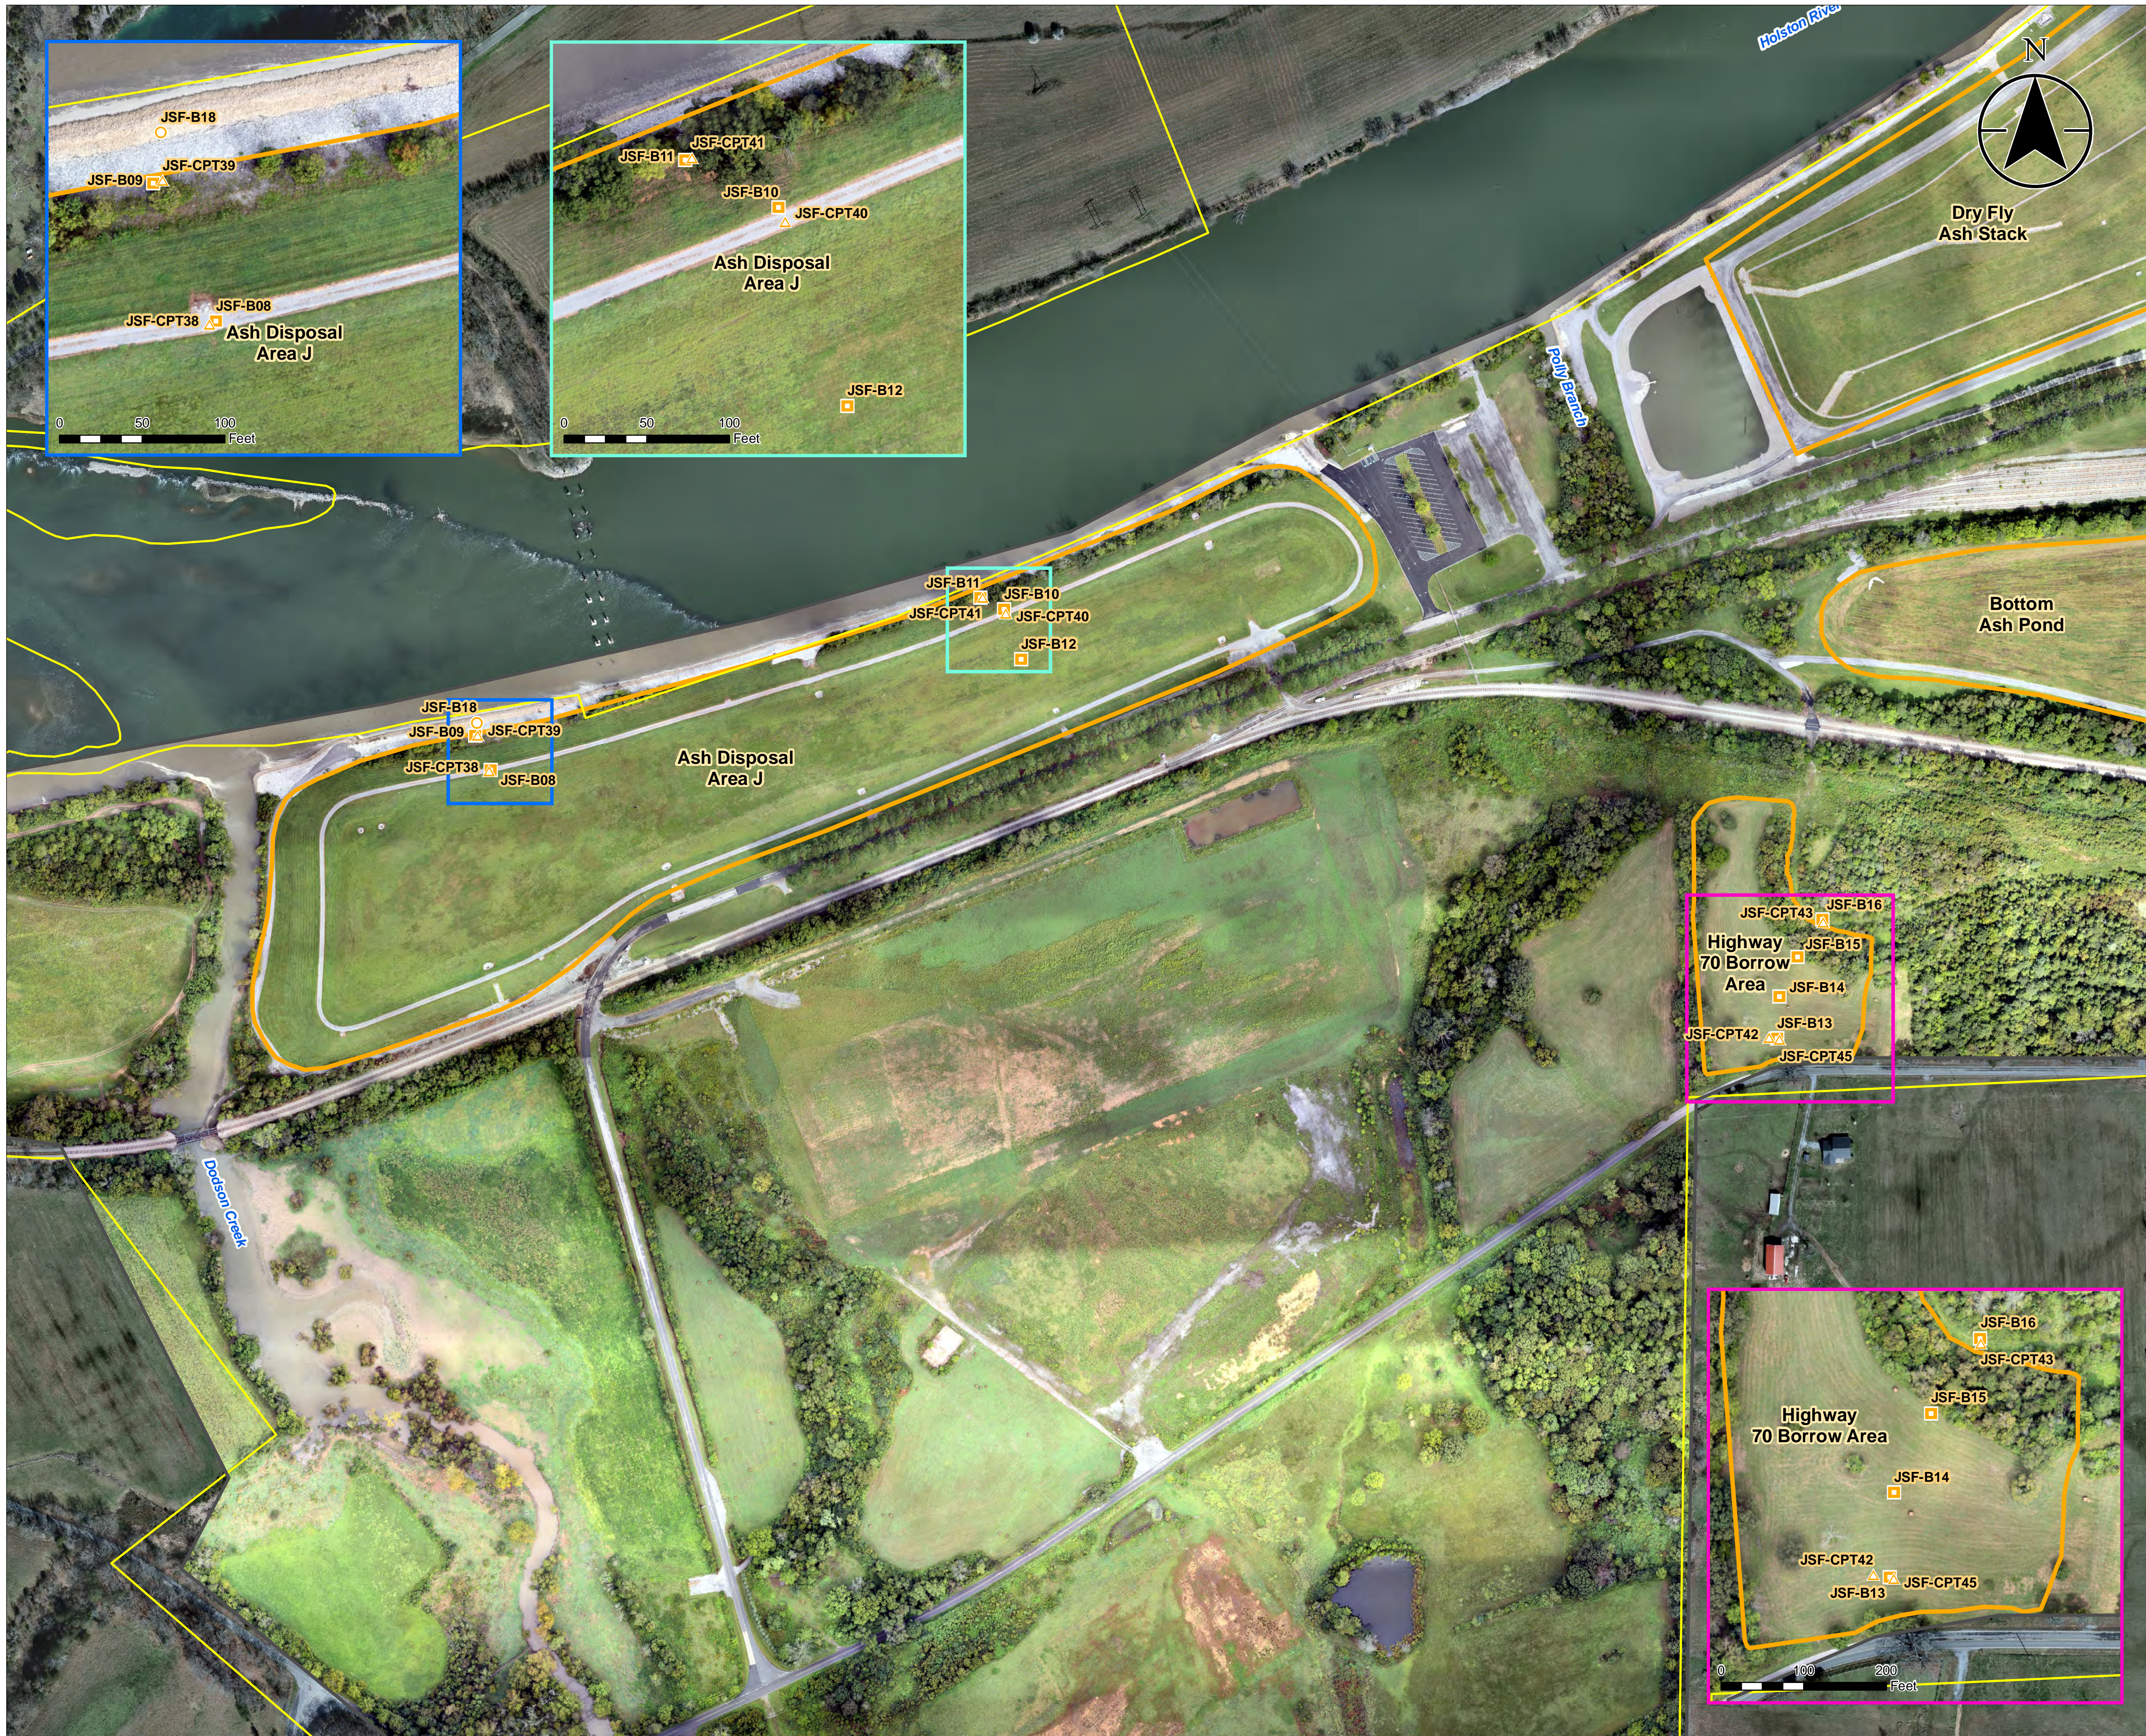
Exhibit No. **4-4**
 Title **Phase 2 Boring Locations Ash Disposal Area J and Hwy 70 Borrow Area**

- Notes**
1. Coordinate System: NAD 1983 StatePlane Tennessee FIPS 4100 Feet
 2. Imagery Provided by Tuck Mapping (2017-03-08) and TVA (2018-09-11)
 3. Borings surveyed by TVA on April 11, 2019 and Nov 4, 2019.
 4. As-drilled boring location not surveyed. Horizontal coordinates based on proposed boring location.
 5. Adjacent boring locations shown as single boring symbol due to close proximity.
