Structural Assessment

Muscle Shoals Reservation
adaptive re-use study

Conditions/Market/Planning/Implementation

July 31, 2009
Revised August 25, 2009

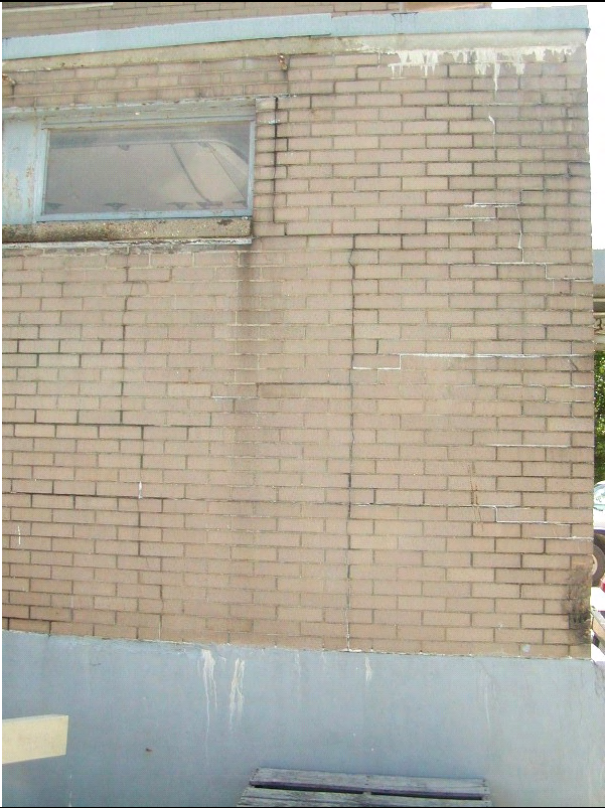
<p>Photograph #: 3</p> <p>Cracks in masonry on north side</p>

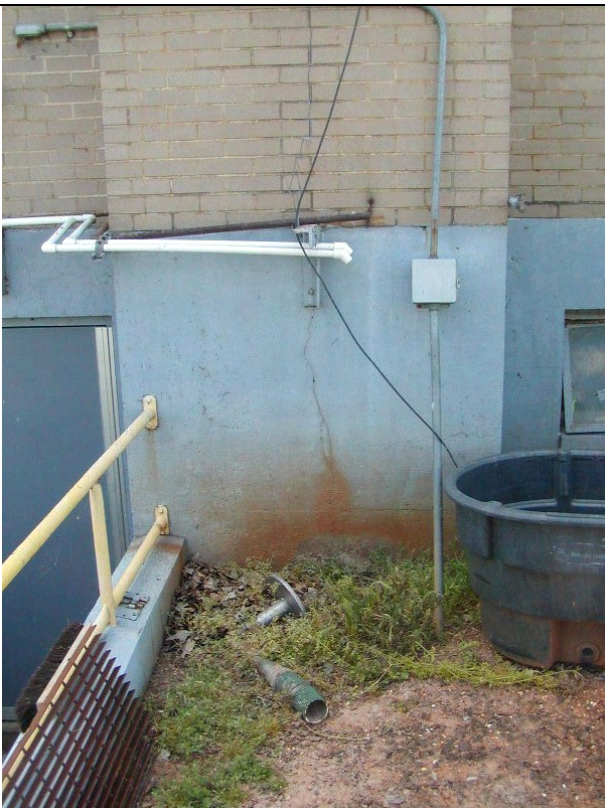
<p>Photograph #: 4</p> <p>Crack in masonry and foundation wall on east side</p>

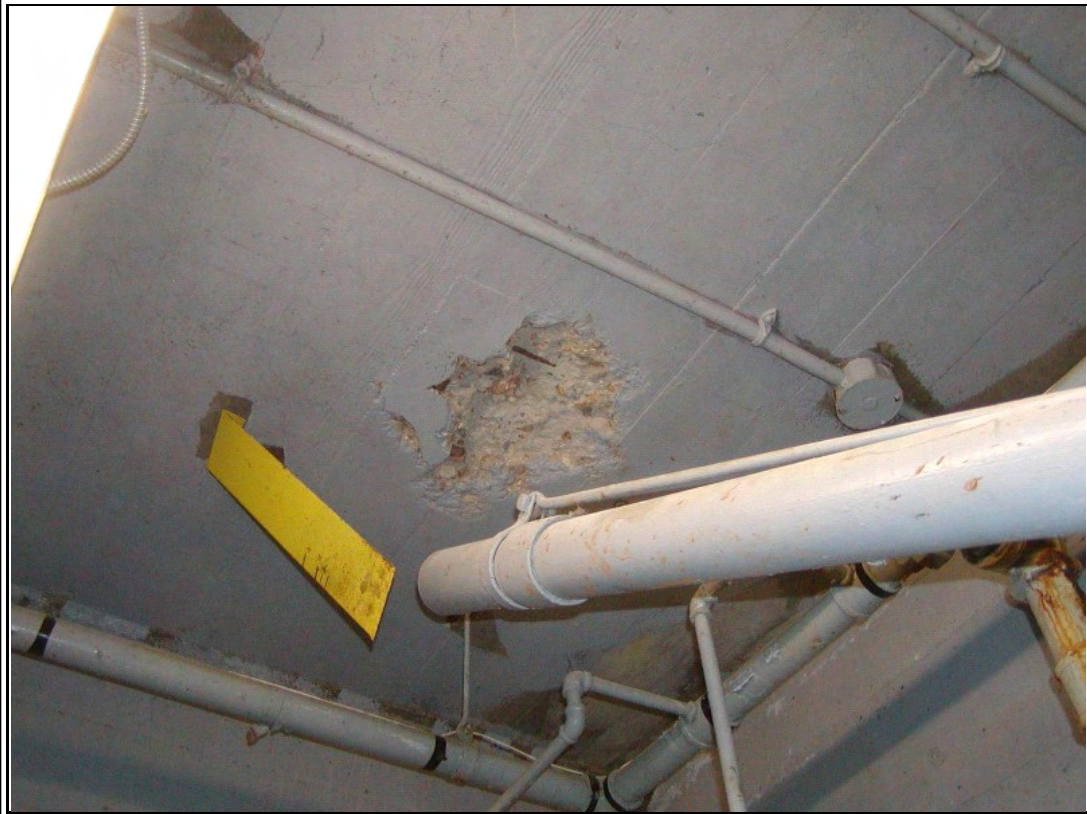
Photograph #: 7

Spall in soffit of floor slab above basement

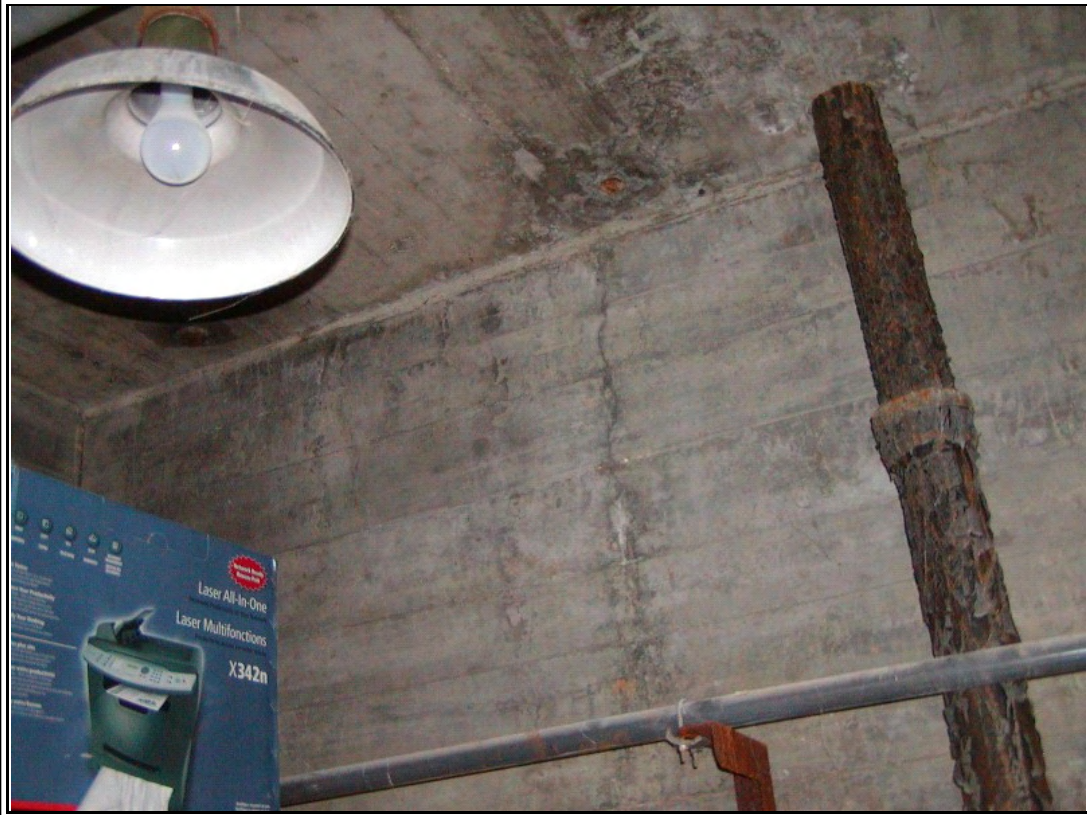
Photograph #: 8

Evidence of water intrusion at basement wall and ceiling

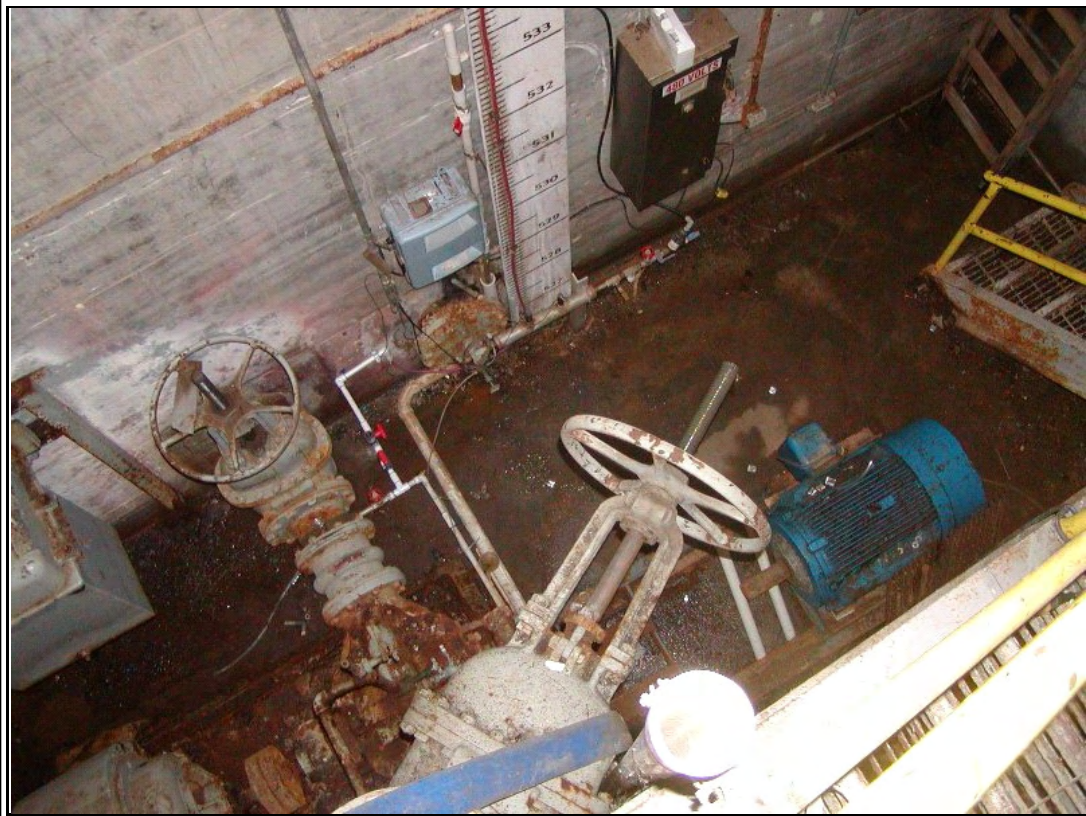
Photograph #: 5

Pump pit floor

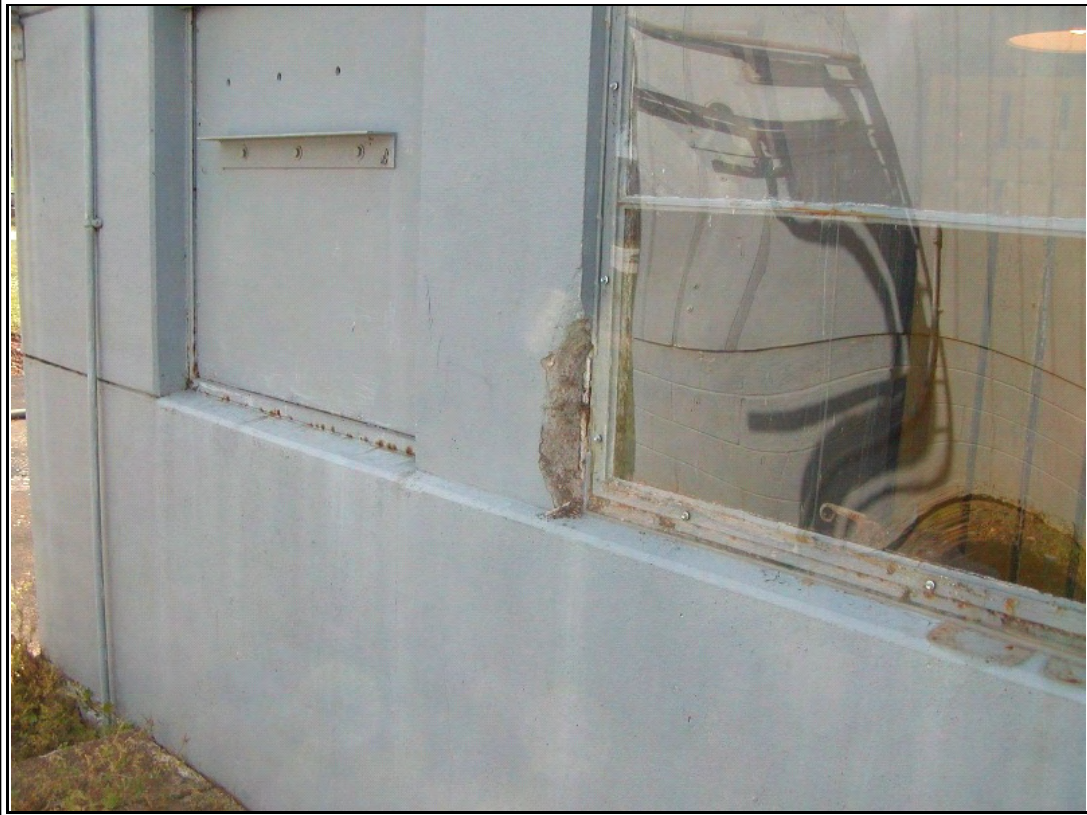
Photograph #: 8

Minor spall at window on east side

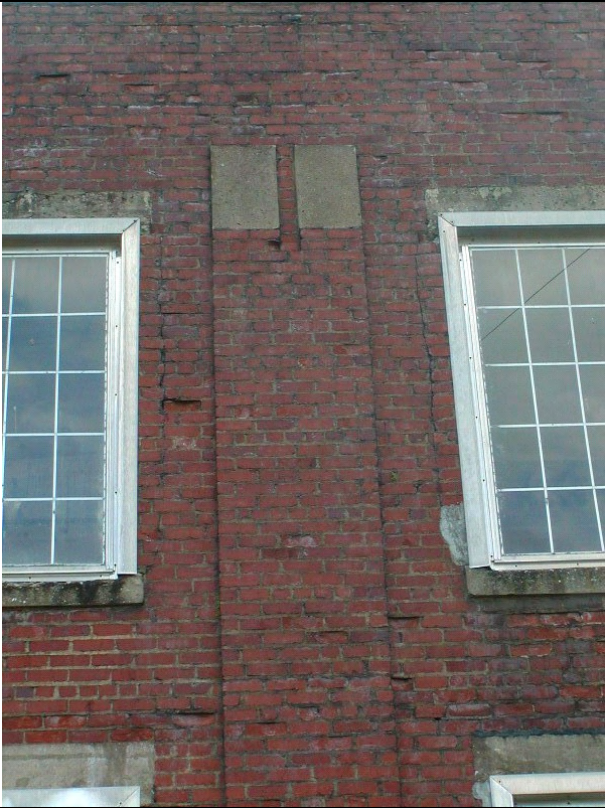
<p>Photograph #: 3</p> <p>Vertical cracks in masonry adjacent to windows</p>

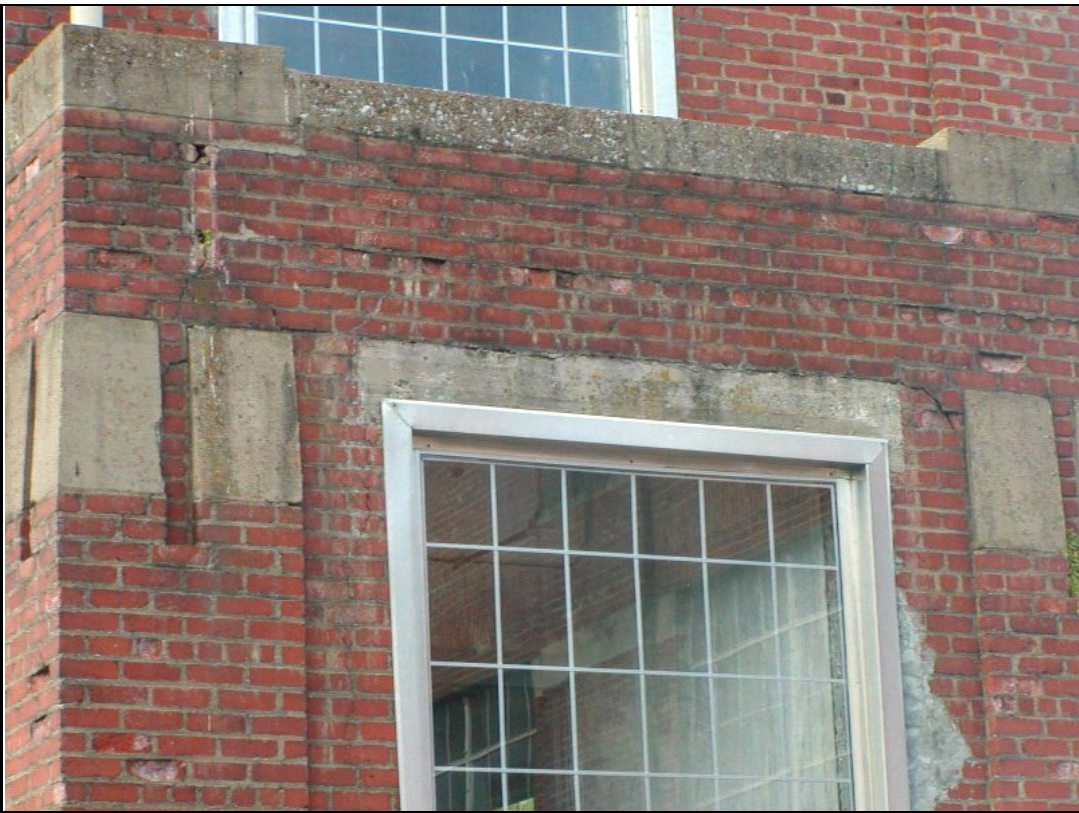
<p>Photograph #: 4</p> <p>Spalled masonry at exterior wall</p>

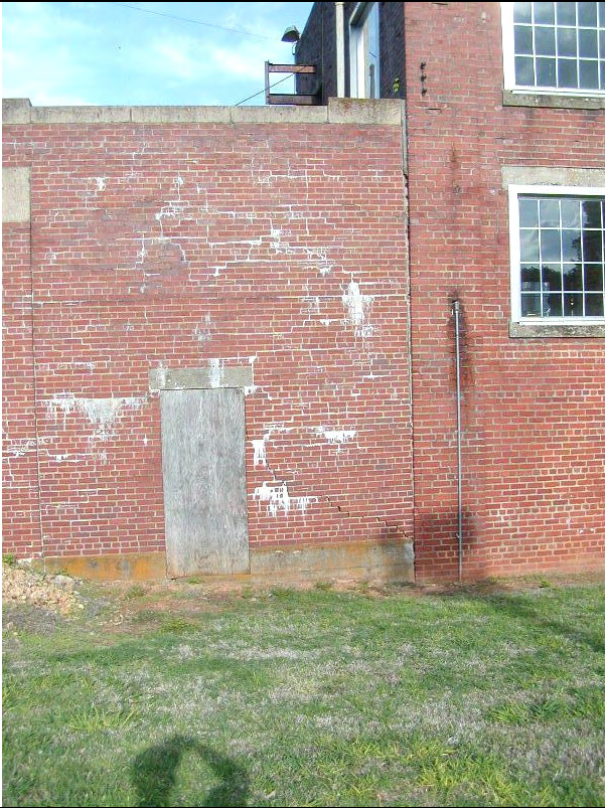
<p>Photograph #: 5</p> <p>Heavy efflorescence at exterior masonry</p>

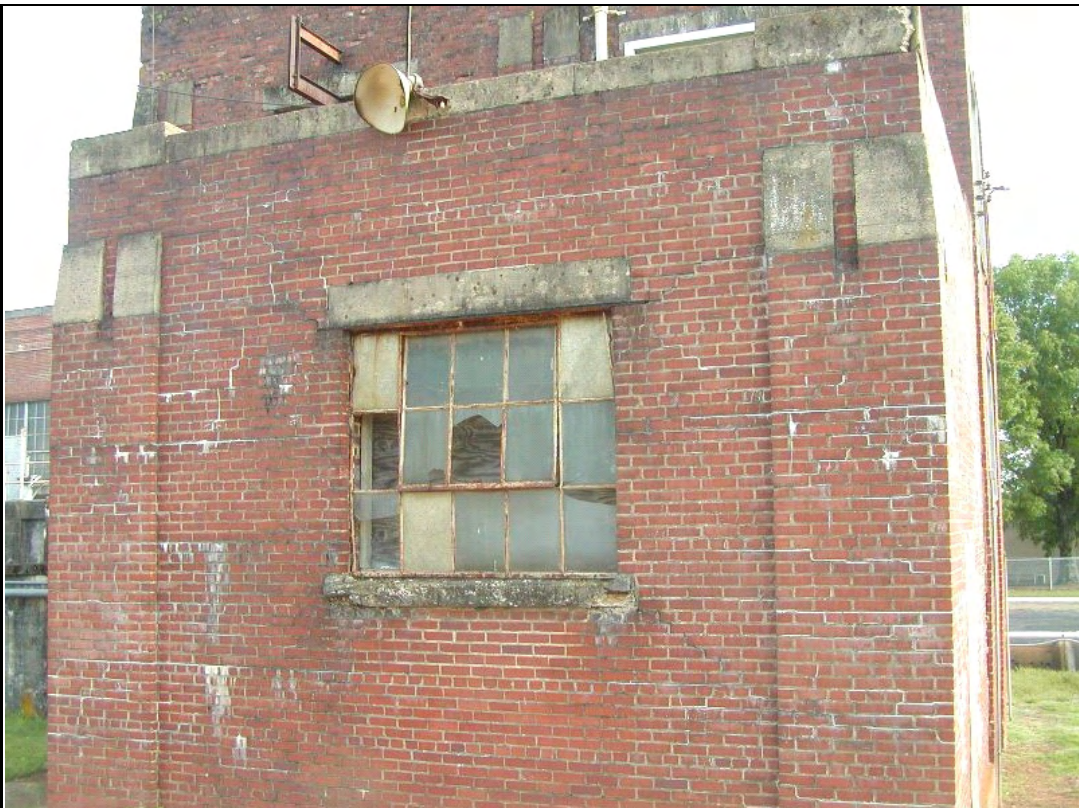
<p>Photograph #: 6</p> <p>General deterioration of exterior masonry</p>

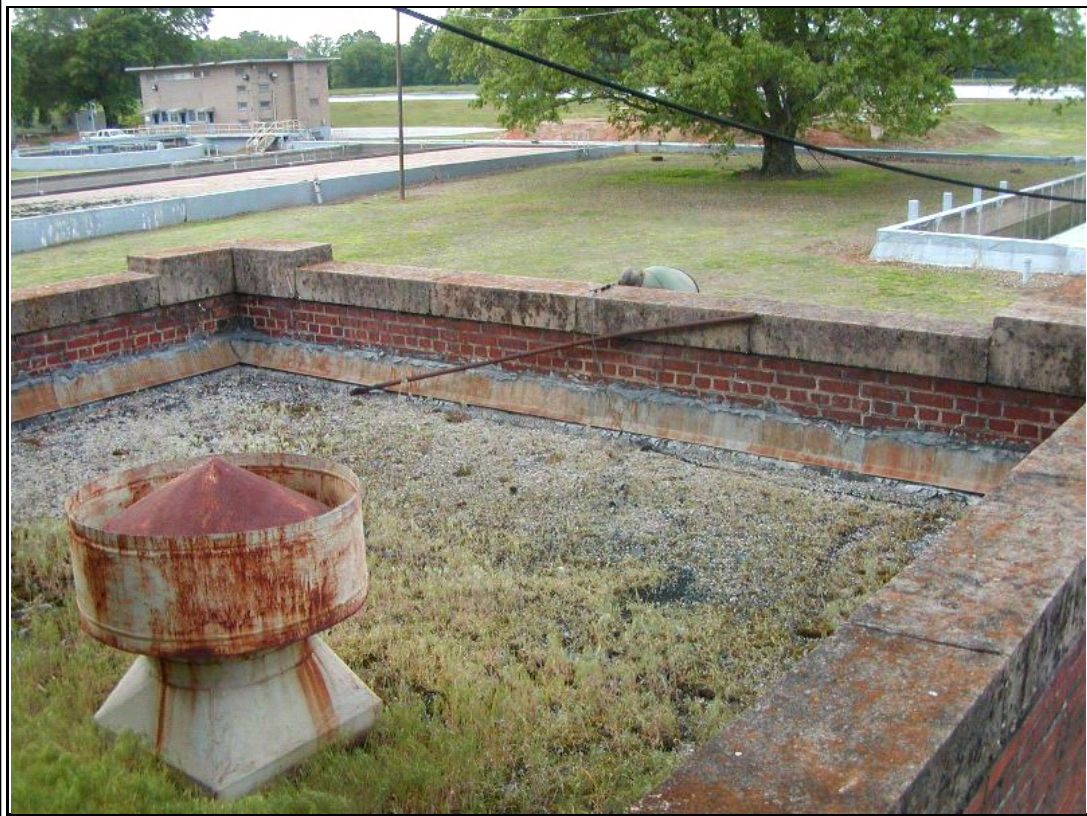
Photograph #: 7

Poor drainage at low roof

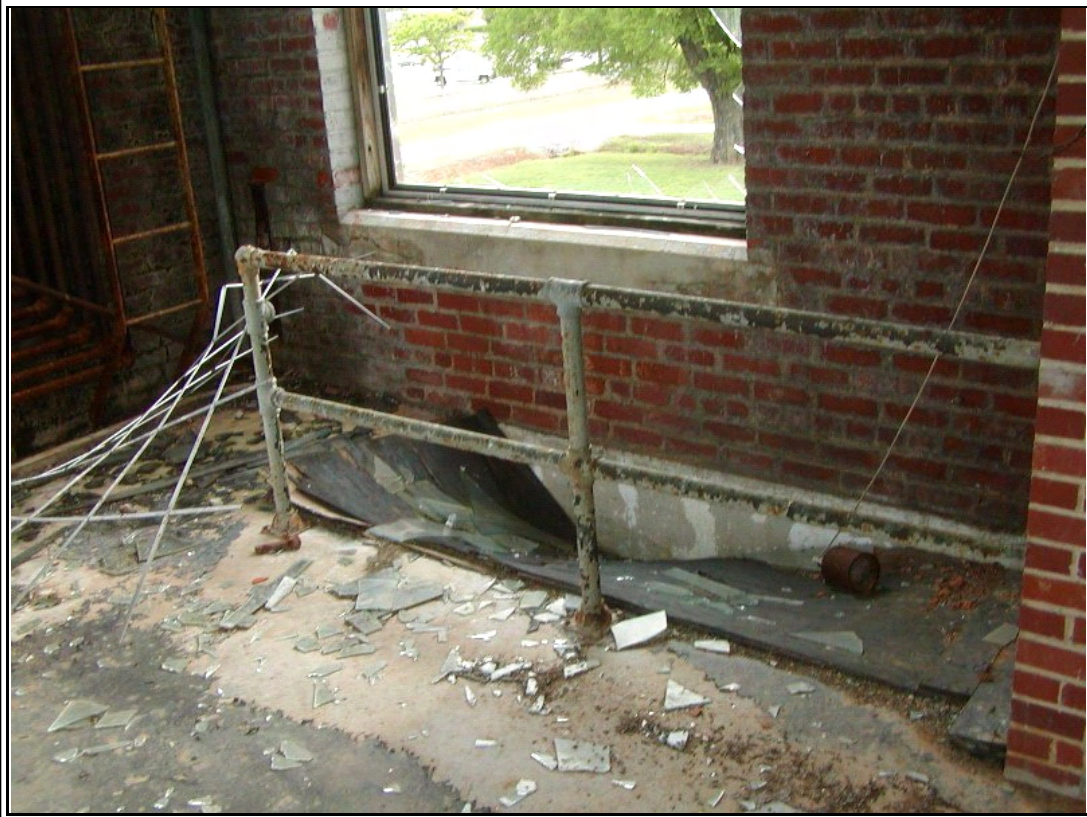
Photograph #: 8

Upper floor open to weather

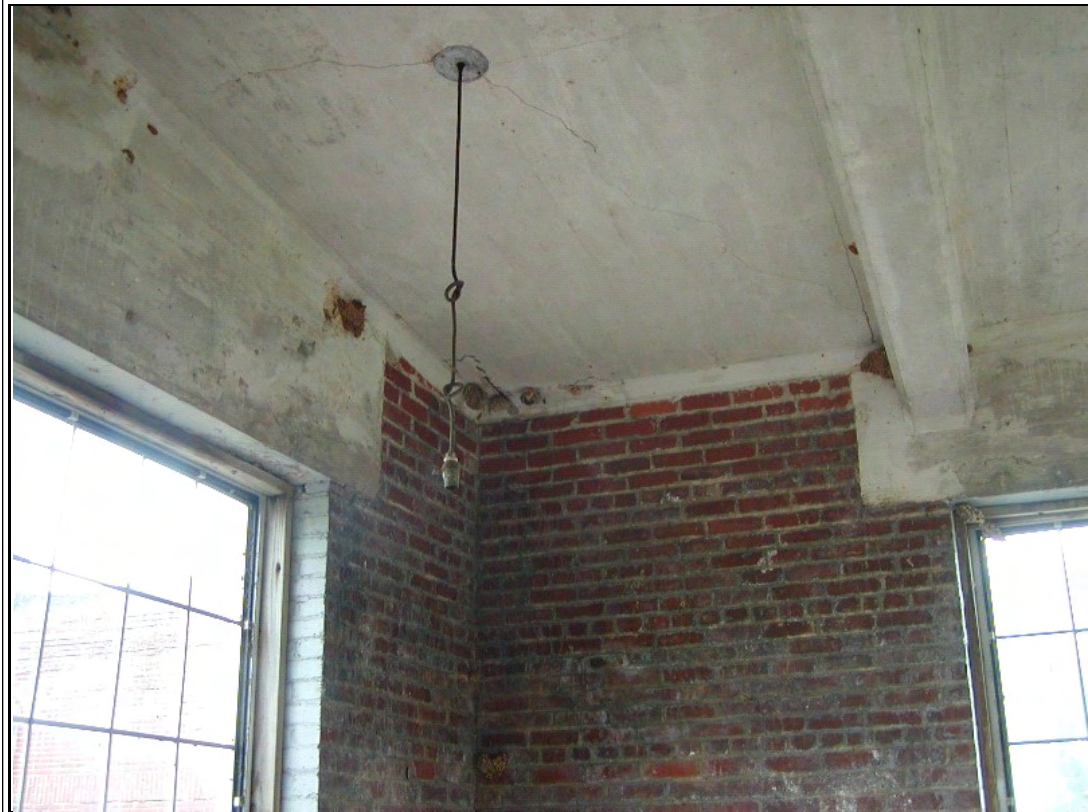
Photograph #: 9

Spalled concrete at roof deck

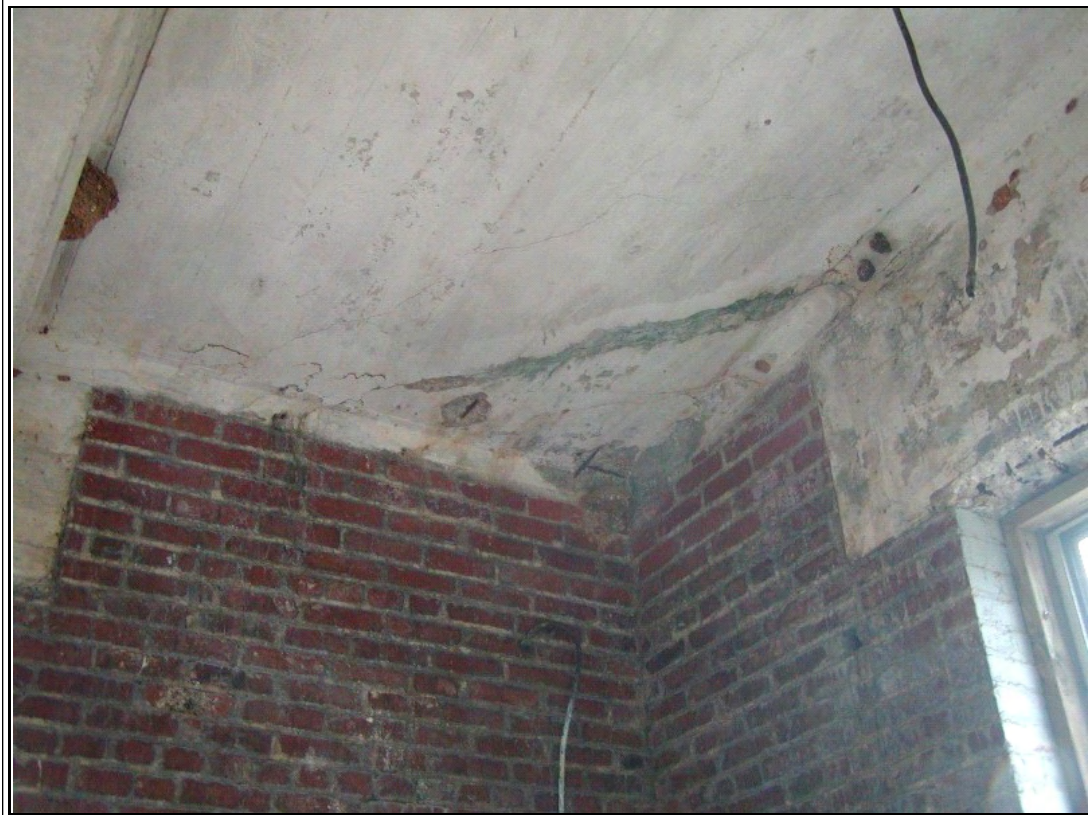
Photograph #: 10

Cracked and spalled concrete at roof deck

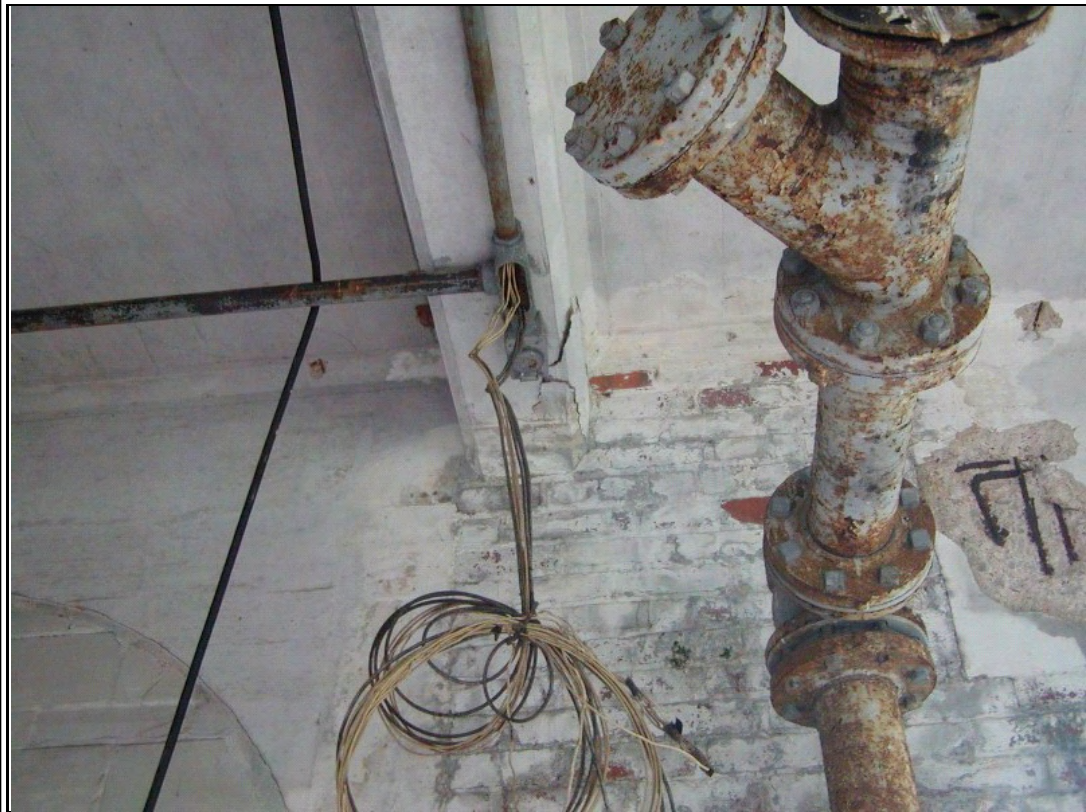
Photograph #: 11

Cracked roof beam and
spalled concrete wall at
upper floor

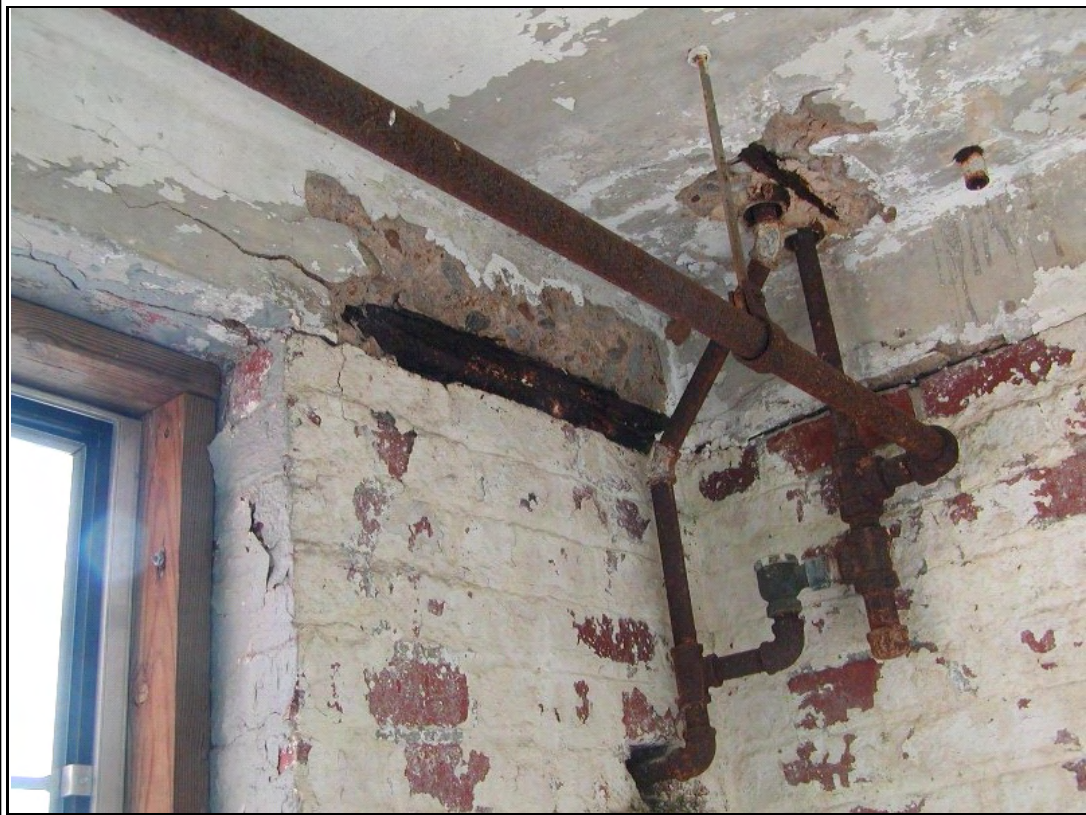
Photograph #: 12

Spalled concrete at
underside of upper floor

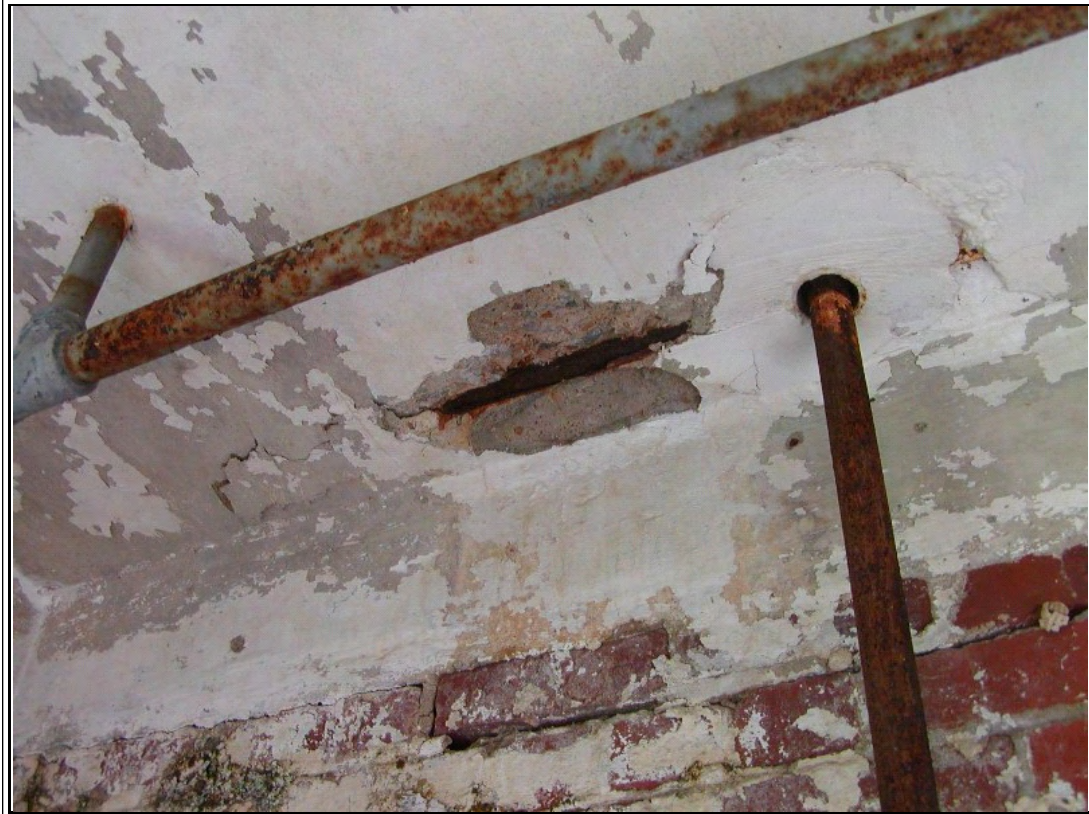
Photograph #: 13

Spall in concrete at underside of upper floor

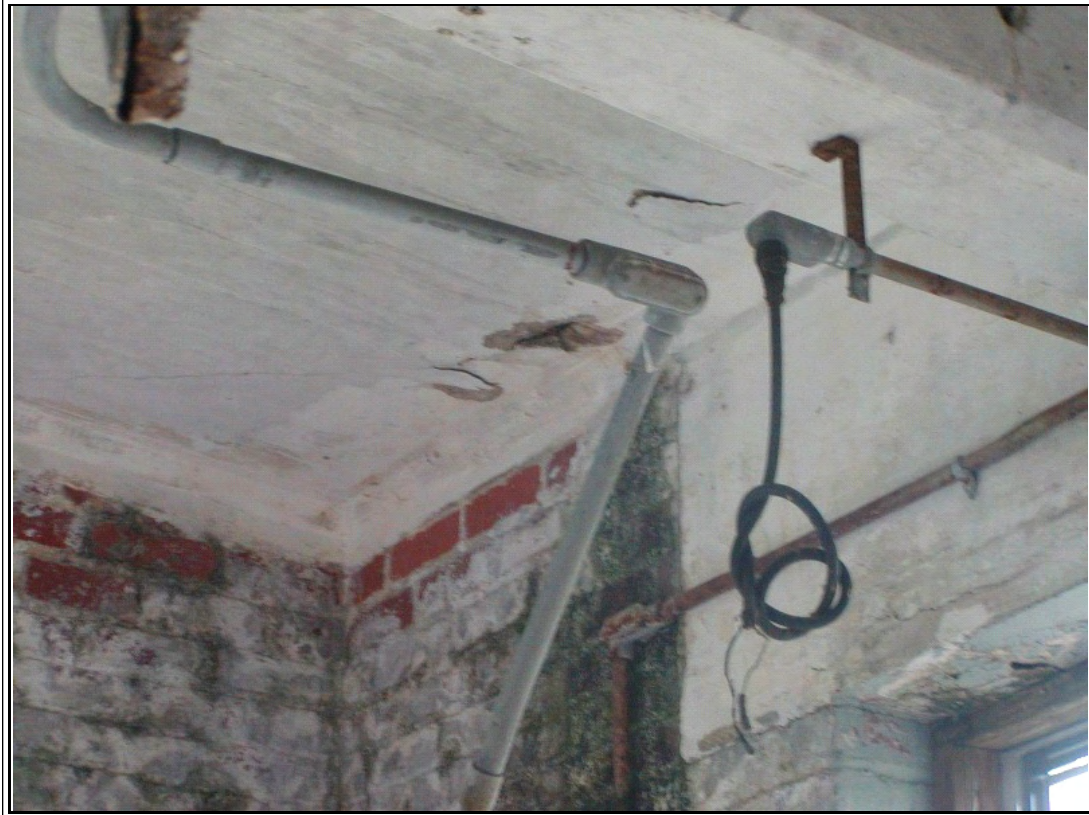
Photograph #: 14

Spalls in concrete at underside of upper floor

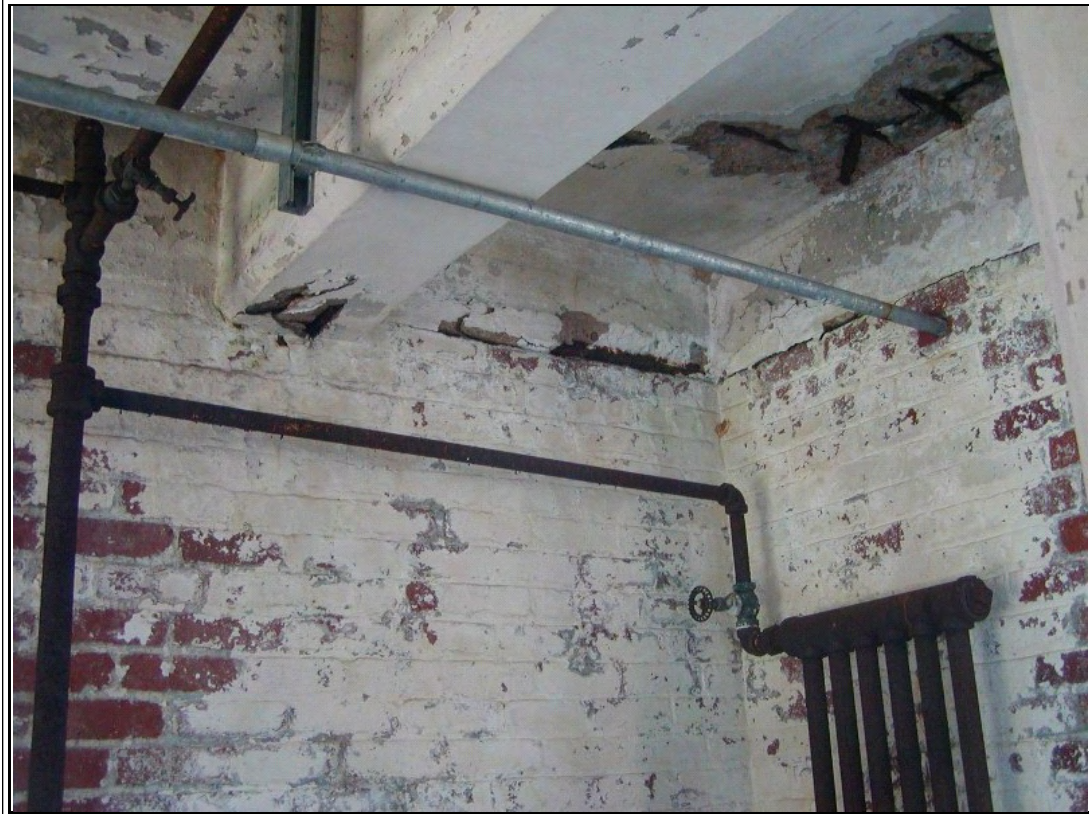
Photograph #: 15

Severe spalls in concrete at underside of upper floor

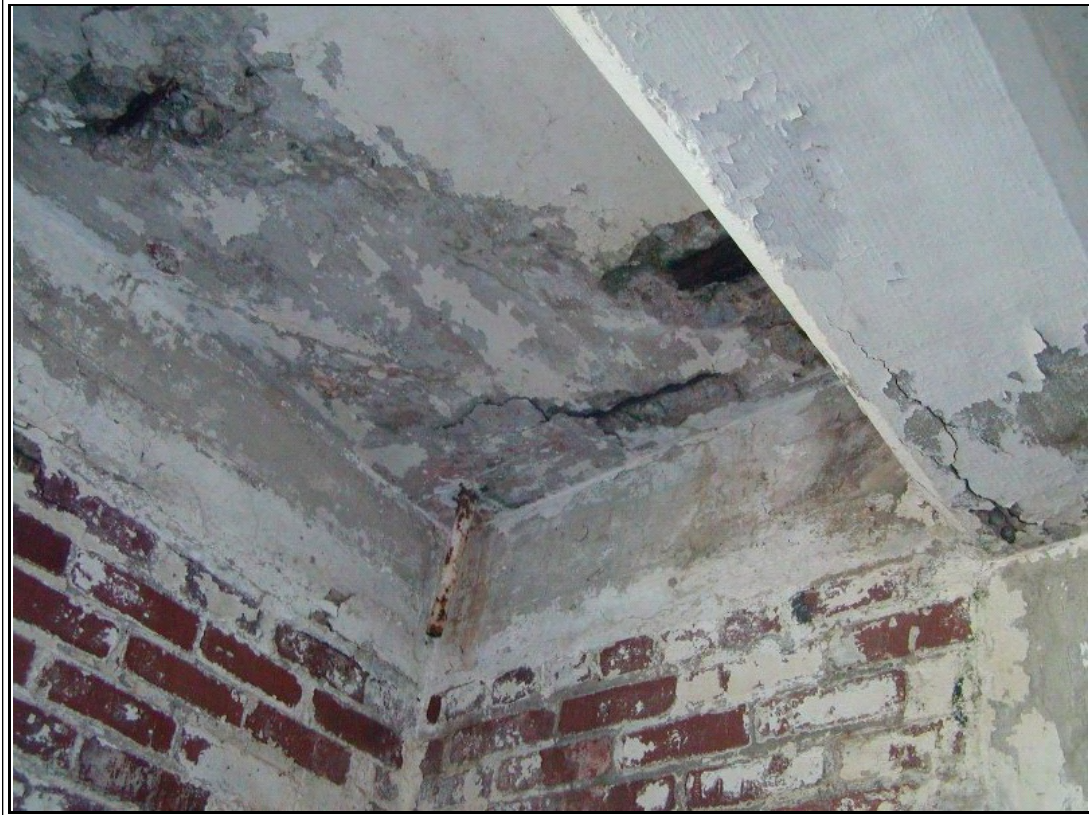
Photograph #: 16

Deteriorated concrete of underside of upper floor

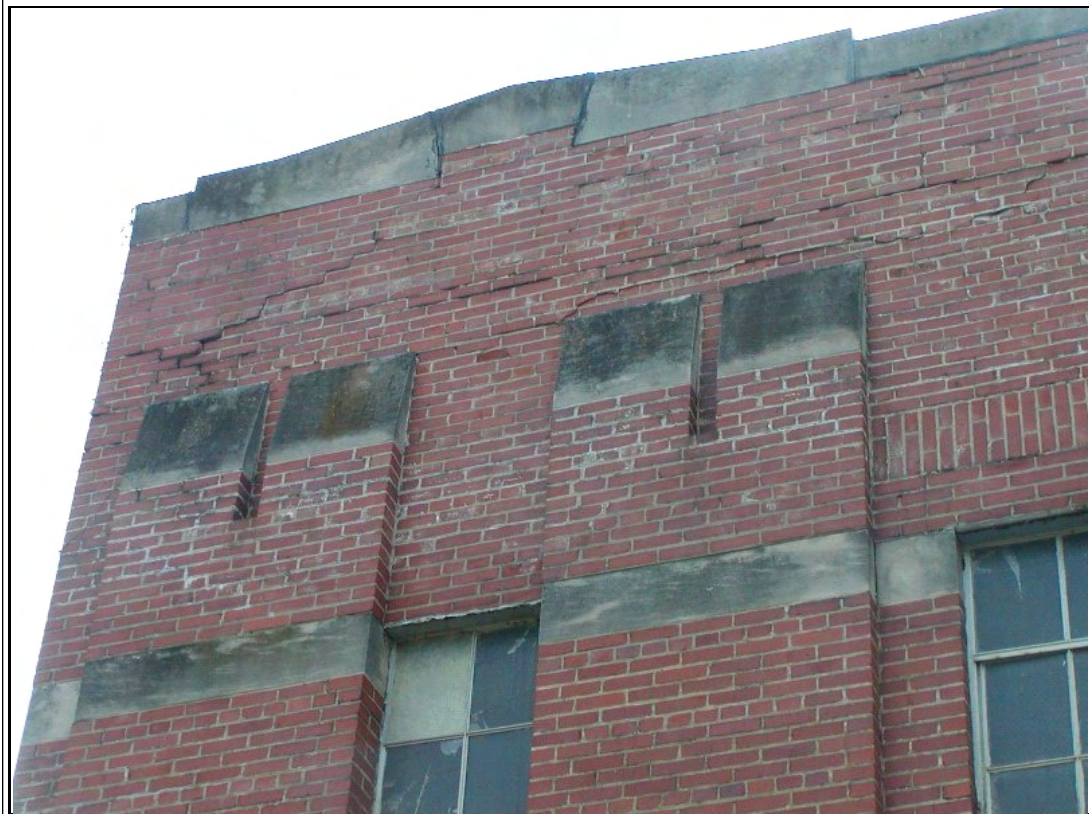
Photograph #: 5

Horizontal and diagonal cracks in masonry west side

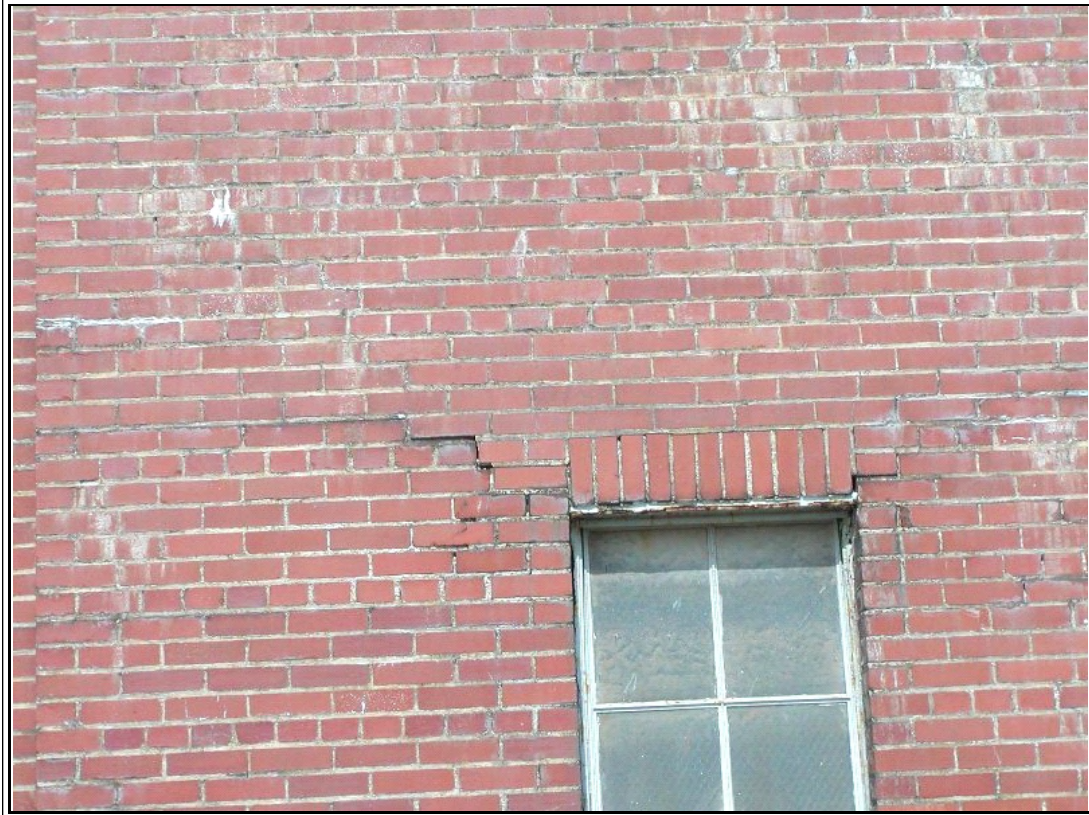
Photograph #: 6

Cracked masonry partially dislodged at lintel

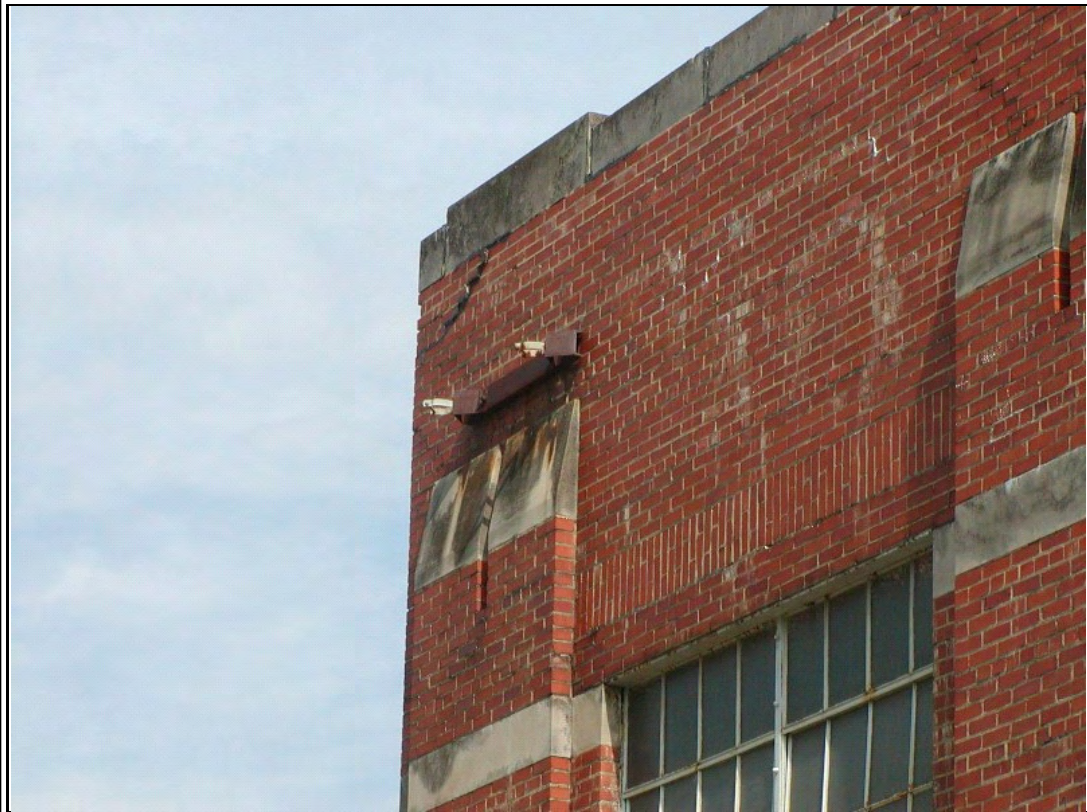
Photograph #: 7

Cracked masonry partially dislodged at west end of south wall

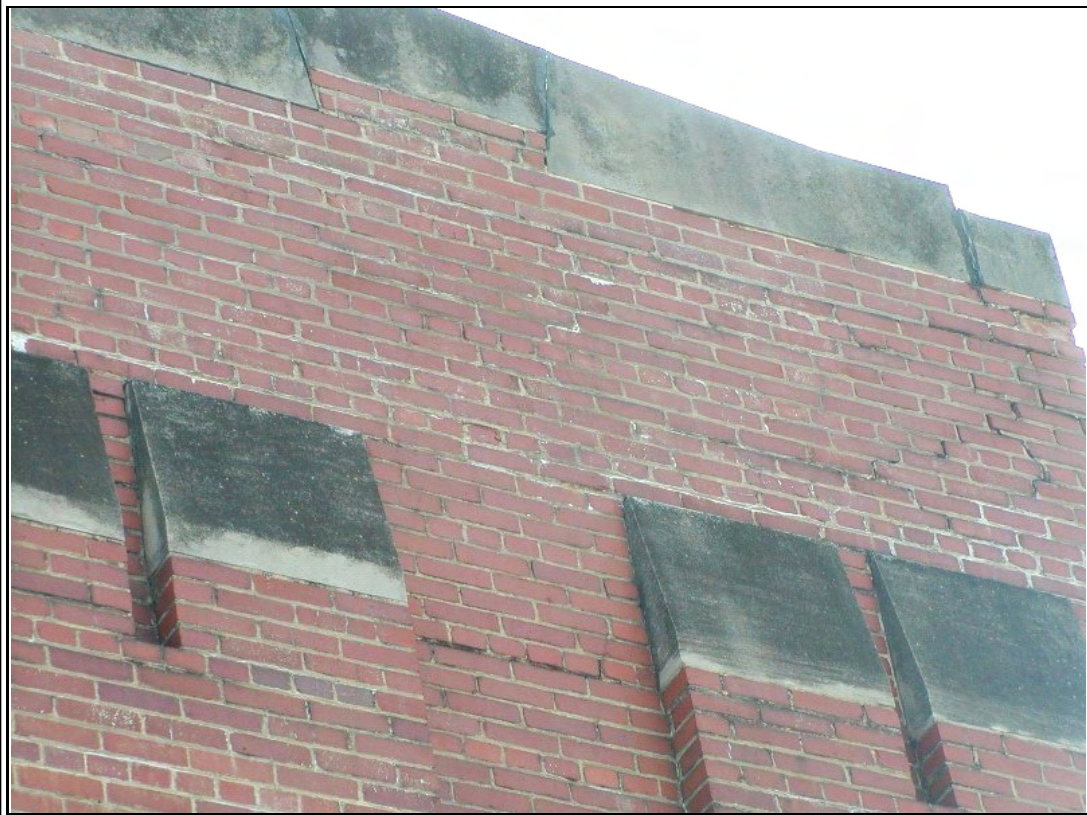
Photograph #: 8

Cracks in masonry at south end of west wall

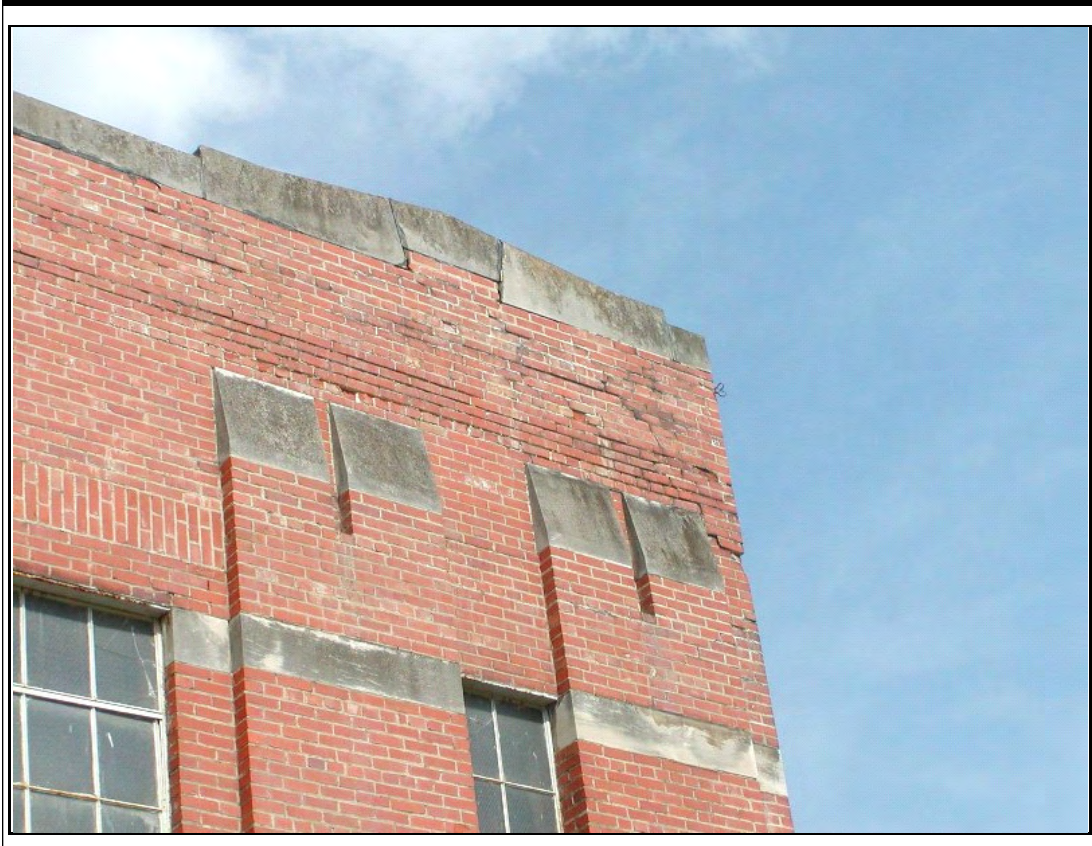
<p>Photograph #: 9</p> <p>Cracked and partially dislodged masonry at north end of east wall</p>

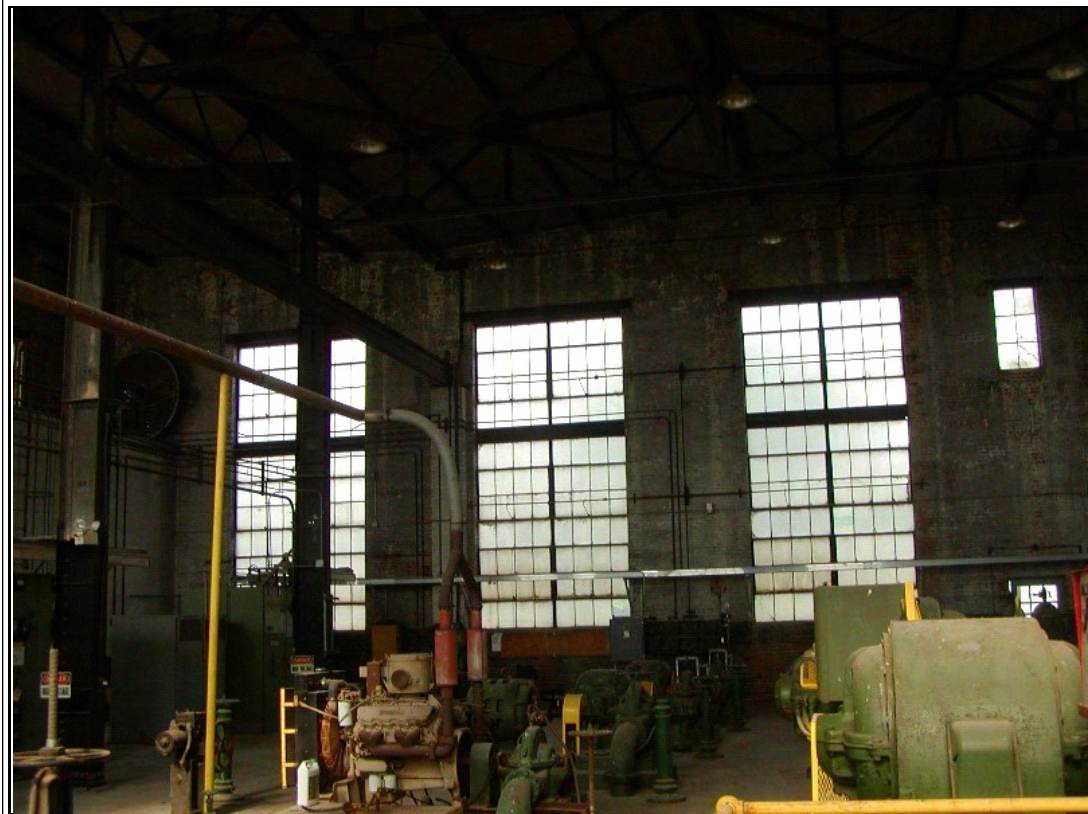
Photograph #: 11

Interior building looking west

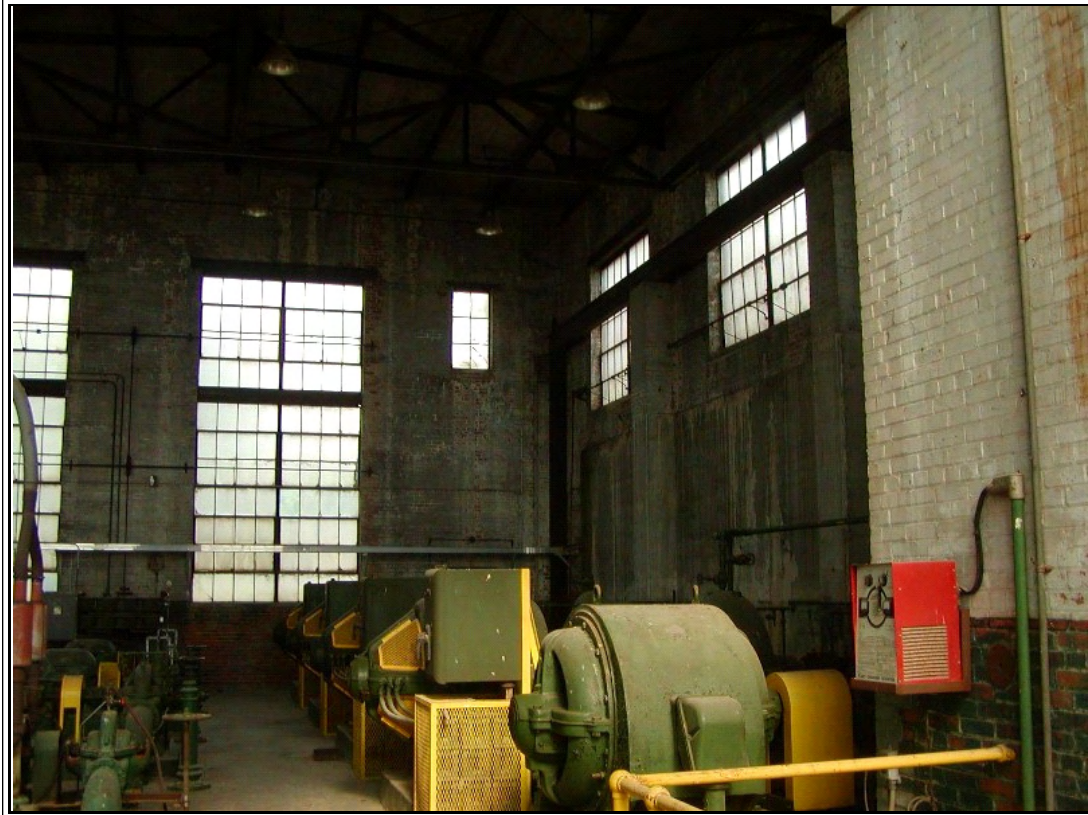
Photograph #: 12

Interior building looking west
