Structural Assessment

Muscle Shoals Reservation
adaptive re-use study

Conditions/Market/Planning/Implementation

July 31, 2009
Revised August 25, 2009

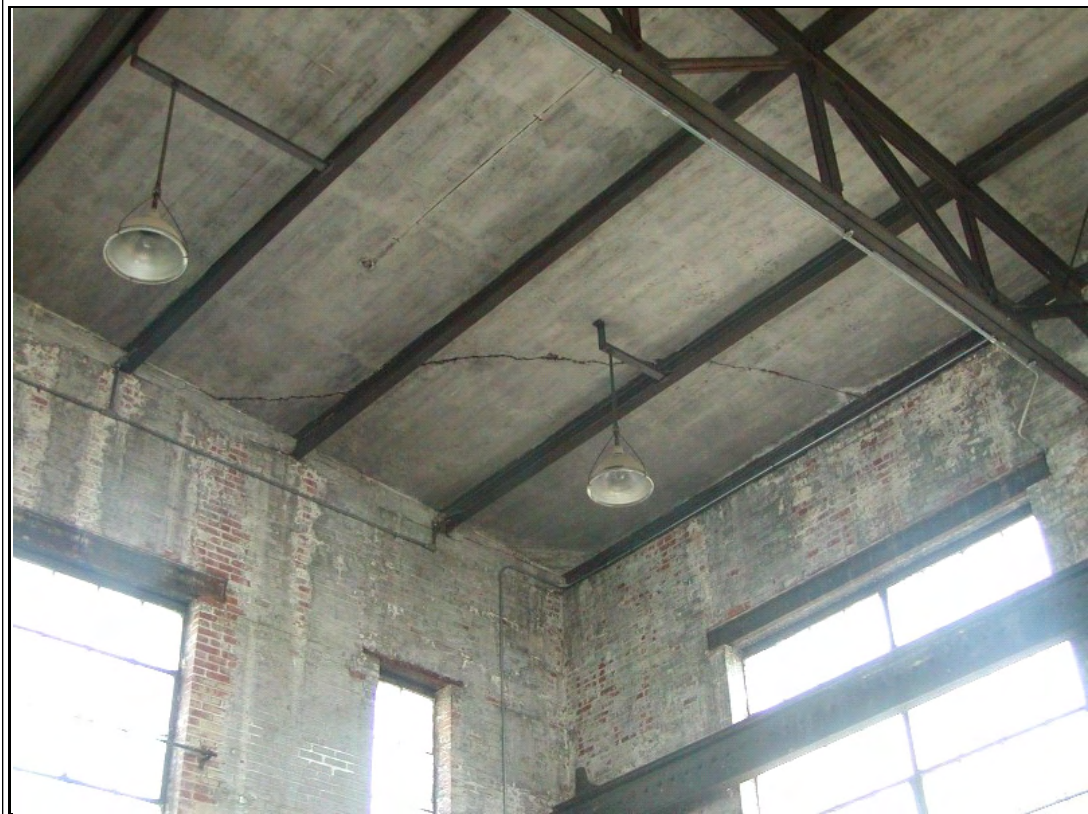
Photograph #: 13

Crack in concrete roof deck
at northeast corner

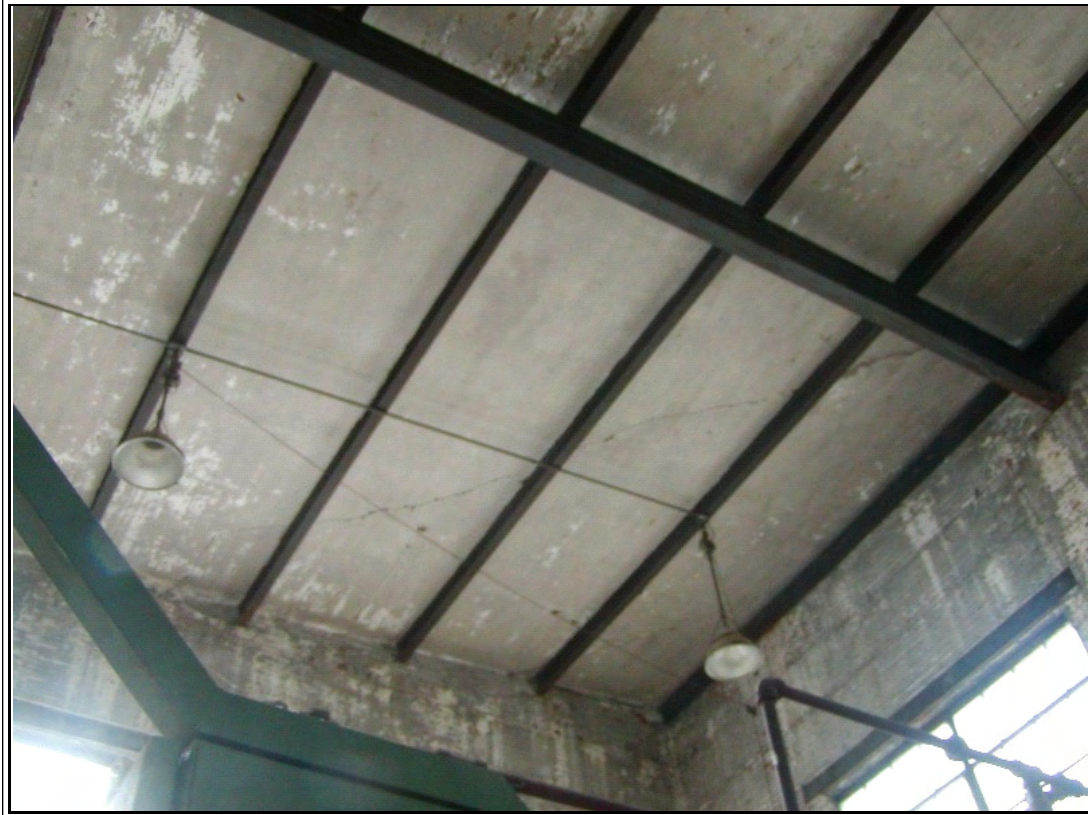
Photograph #: 14

Crack in concrete roof deck

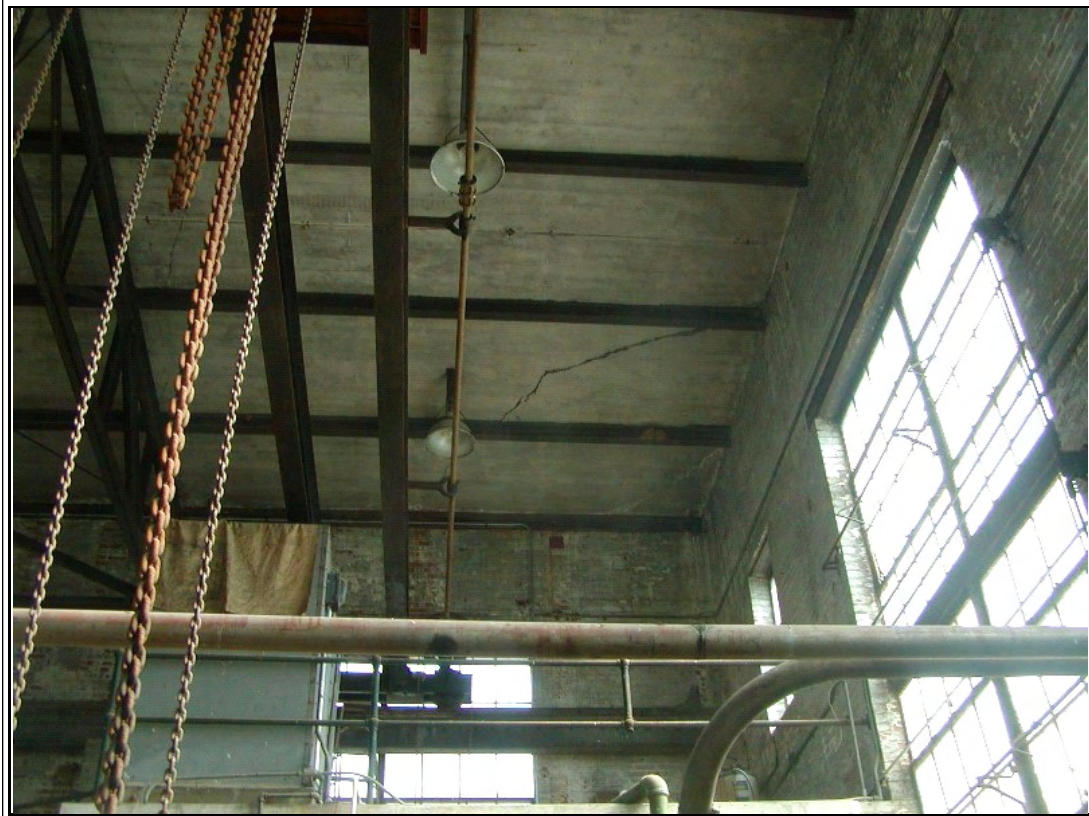
Photograph #: 15

Crack in concrete roof deck
at southeast corner

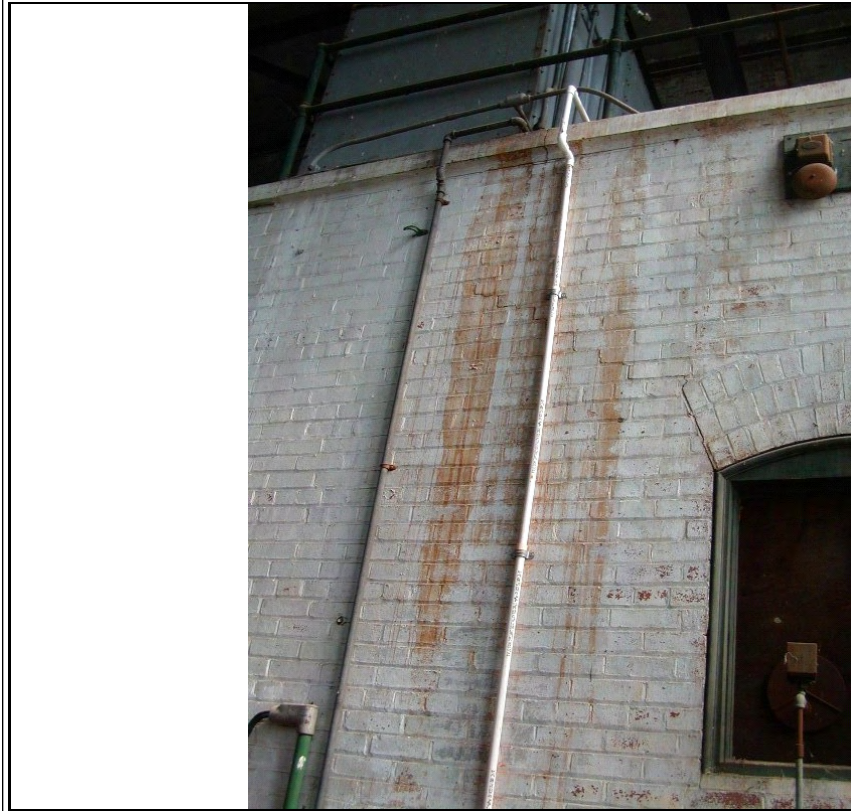
Photograph #: 16

Diagonal cracks in load
bearing masonry at south
wall

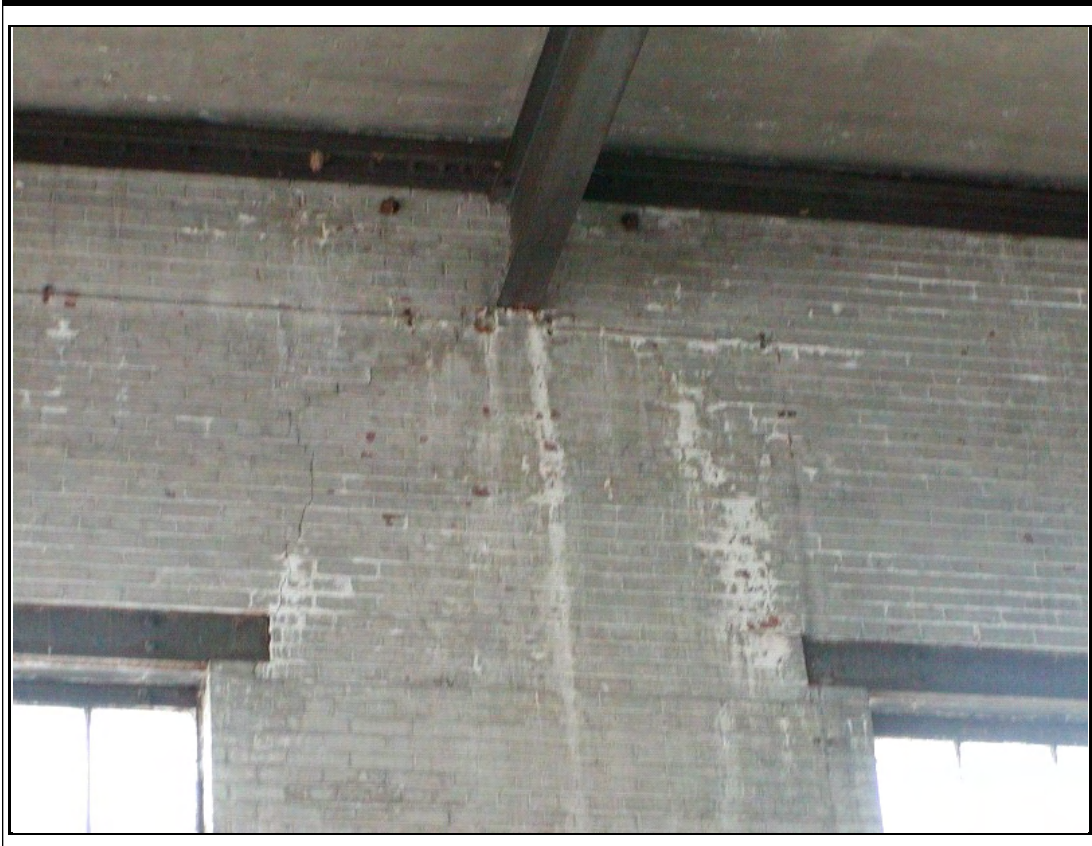
<p>Photograph #: 17</p> <p>Vertical and diagonal cracks in load bearing masonry at south wall</p>

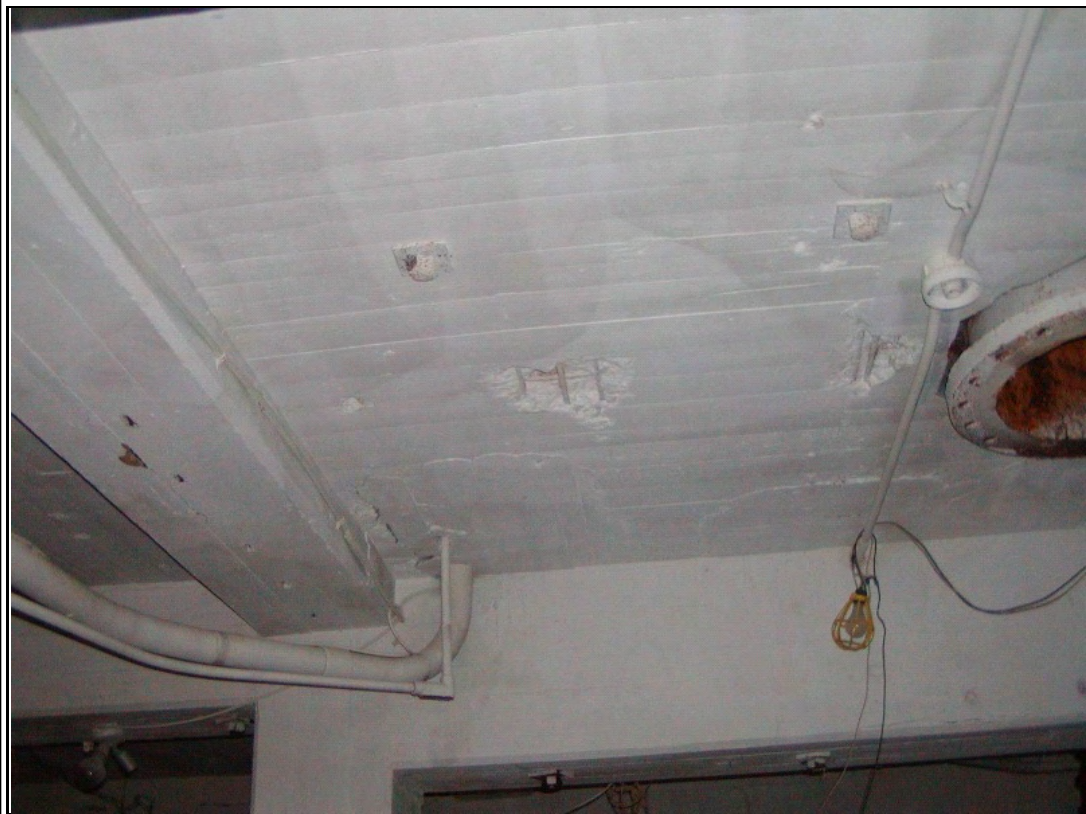
Photograph #: 19

Spalled concrete soffit at basement ceiling

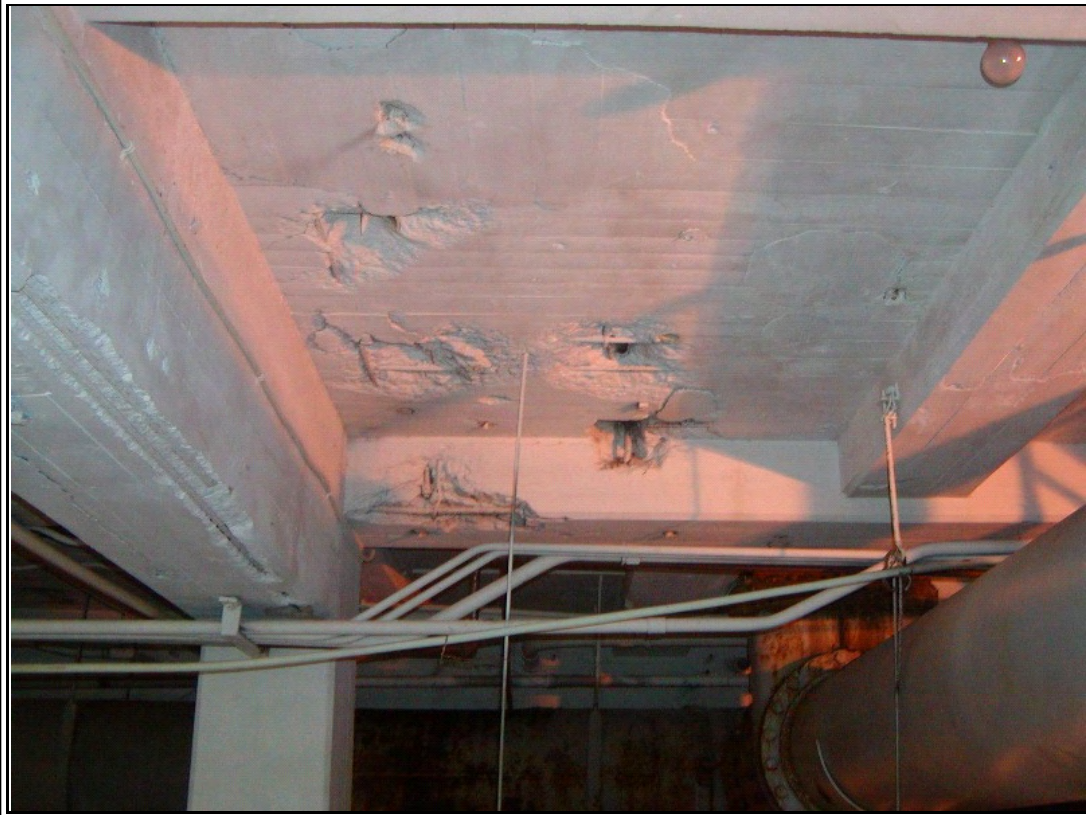
Photograph #: 20

Spalled concrete soffit at basement ceiling

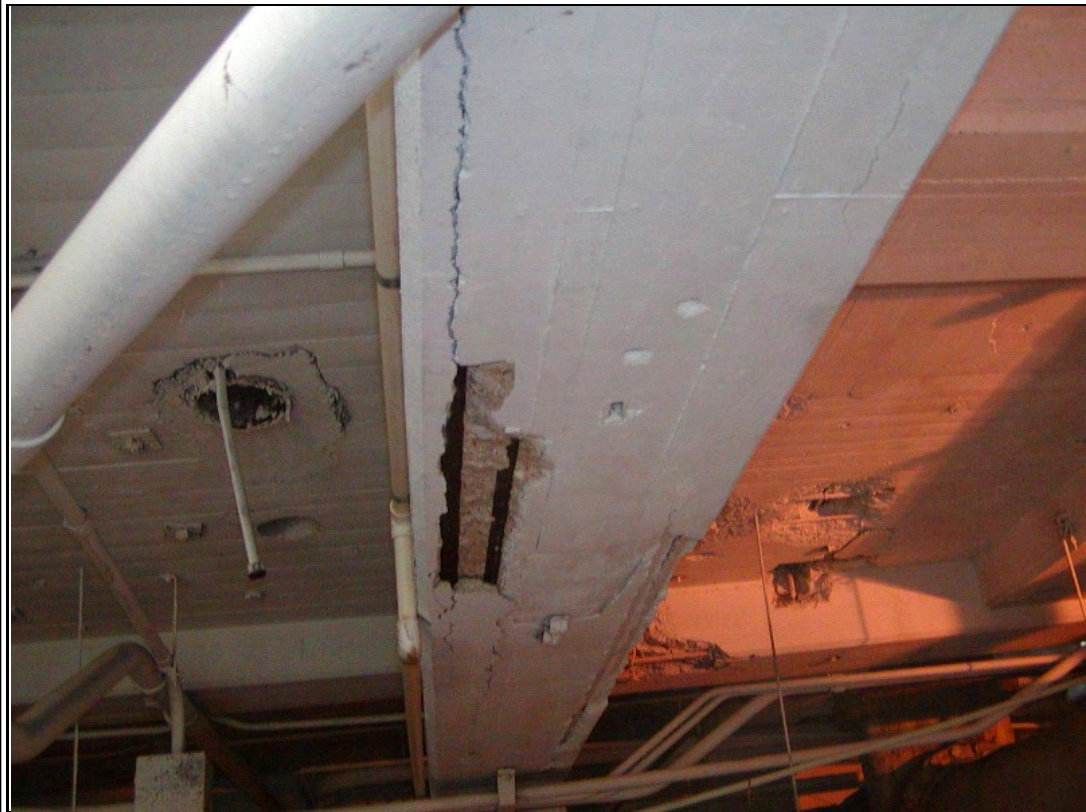
Photograph #: 21

Severely spalled concrete beam at basement ceiling

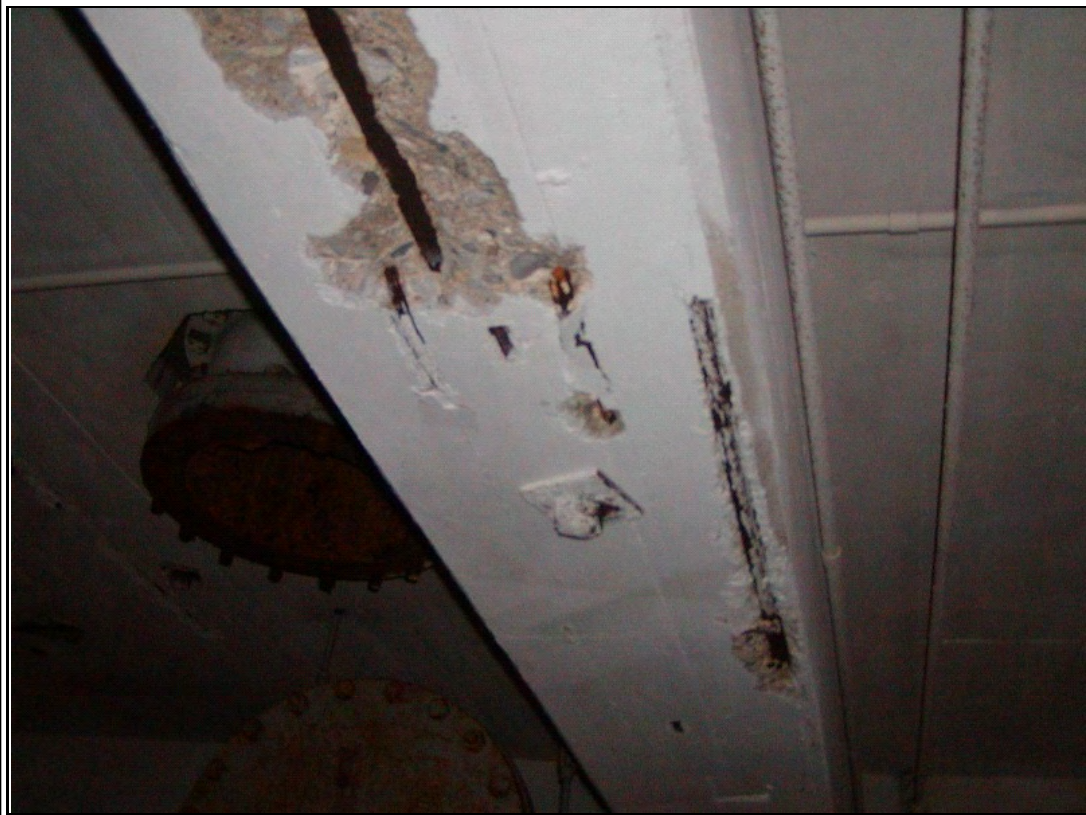
Photograph #: 22

Severely spalled concrete beam at basement ceiling

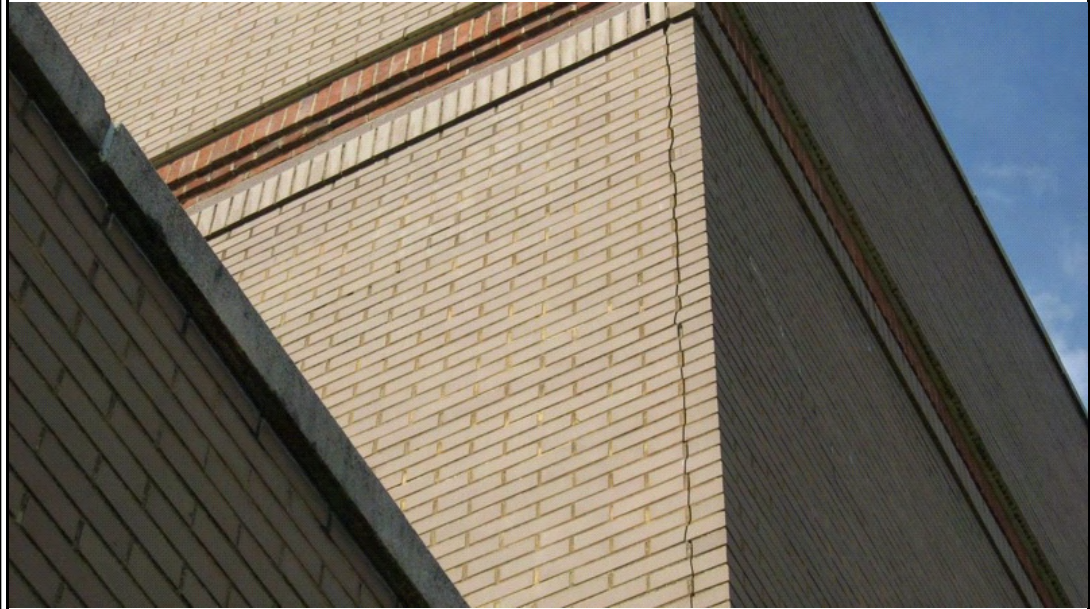
<p>Photograph #: 3</p> <p>Full height crack in exterior masonry wall at northeast corner.</p>

Summary of Recommended Structural Repairs:	Corroded interior steel framing needs to be cleaned and painted. Masonry parapets at the north extension need to be demolished and reconstructed. The crack at the northeast corner of the masonry exterior should be repaired.
Additional Recommendations:	Not applicable.

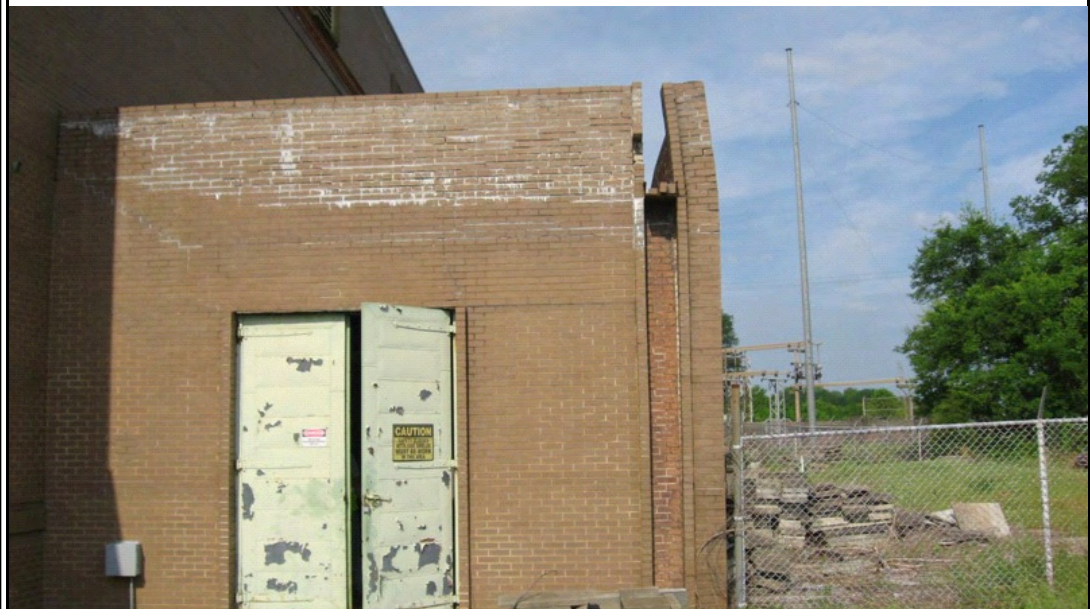
<p>Photograph #: 4</p> <p>Structurally unstable masonry parapet at north extension.</p>

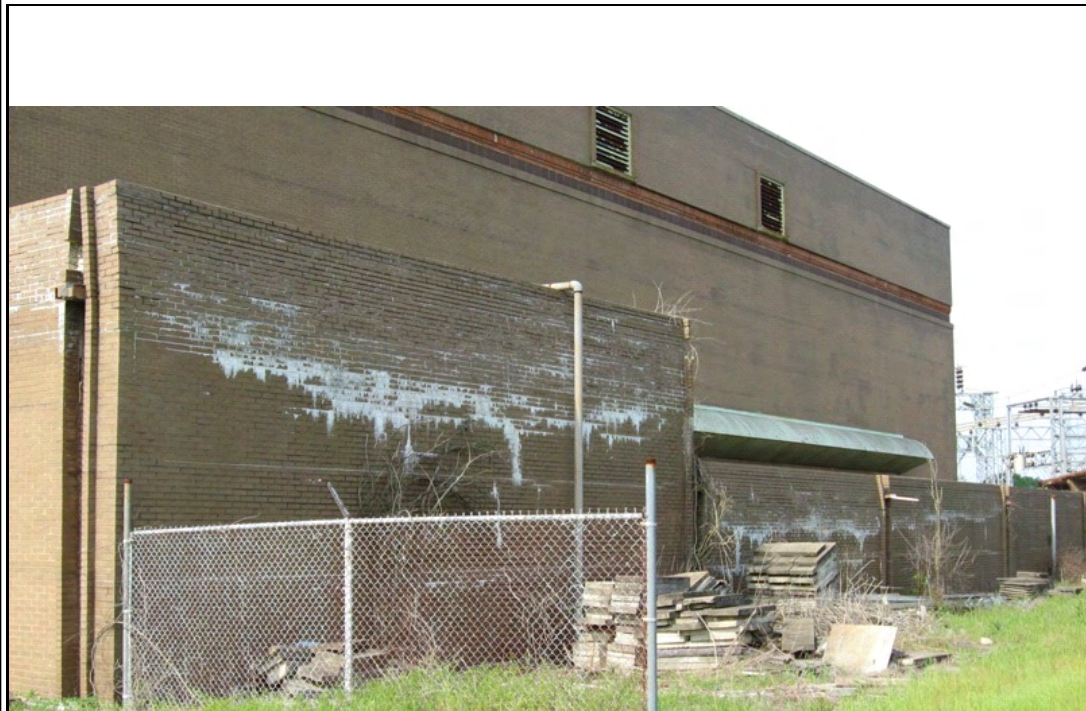
Photograph #: 5

Structurally unstable masonry parapet at north extension.

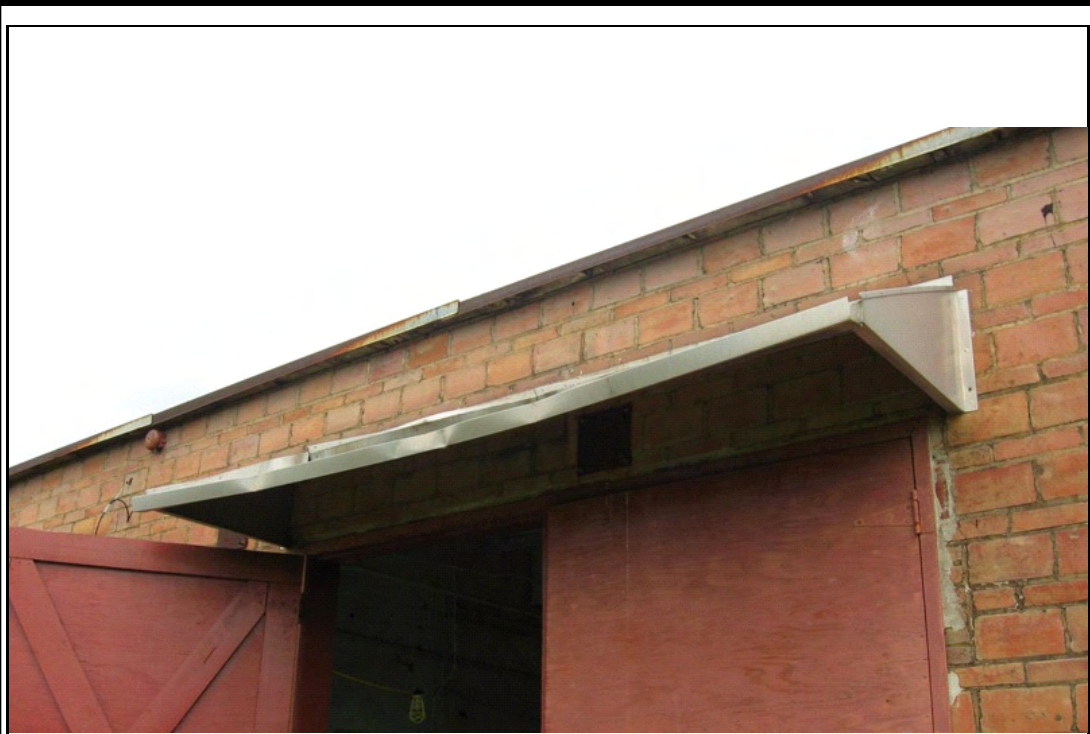
<p>Photograph #: 5</p> <p>Impact damage at metal awning on south side.</p>

Summary of Recommended Structural Repairs:	Voids in exterior masonry should be repaired to prevent further deterioration. Defective concrete roof plank must be replaced, necessitating associated repairs to roof covering. The floor deck of the mechanical mezzanine and the damaged metal awning should be replaced.
Additional Recommendations:	Not applicable.

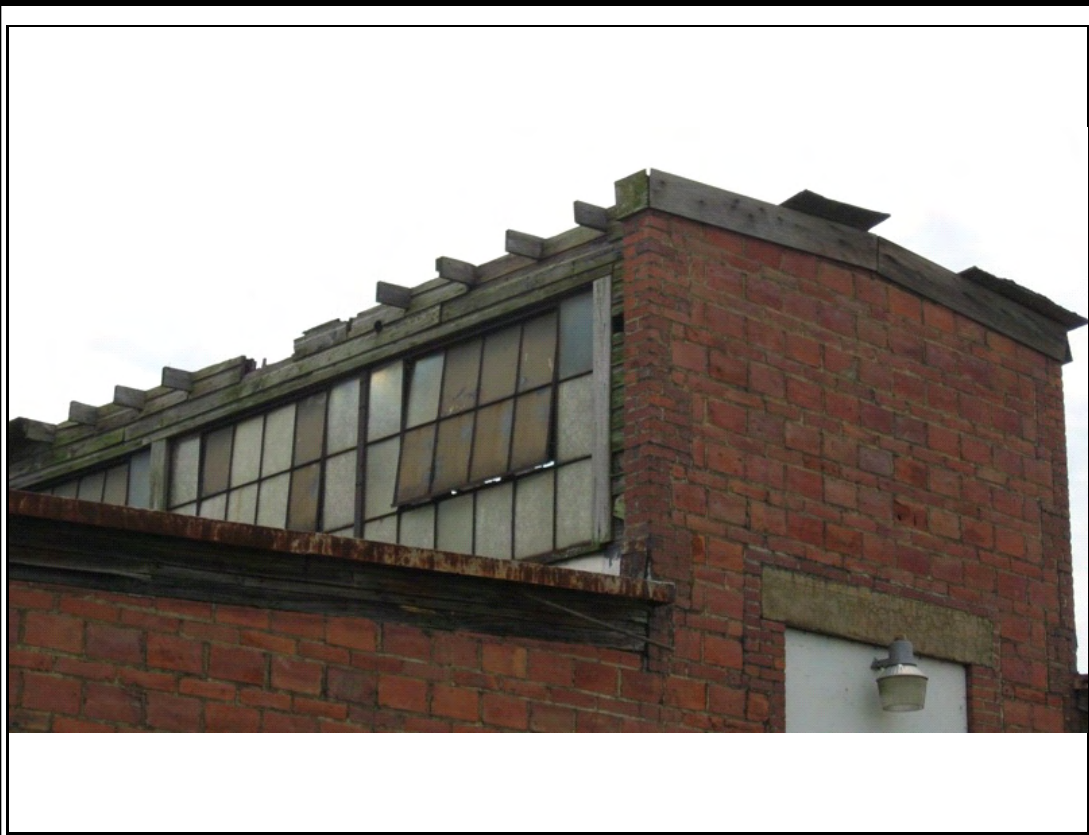
Photograph #: 3

View of clerestory monitor with deteriorated roof structure.

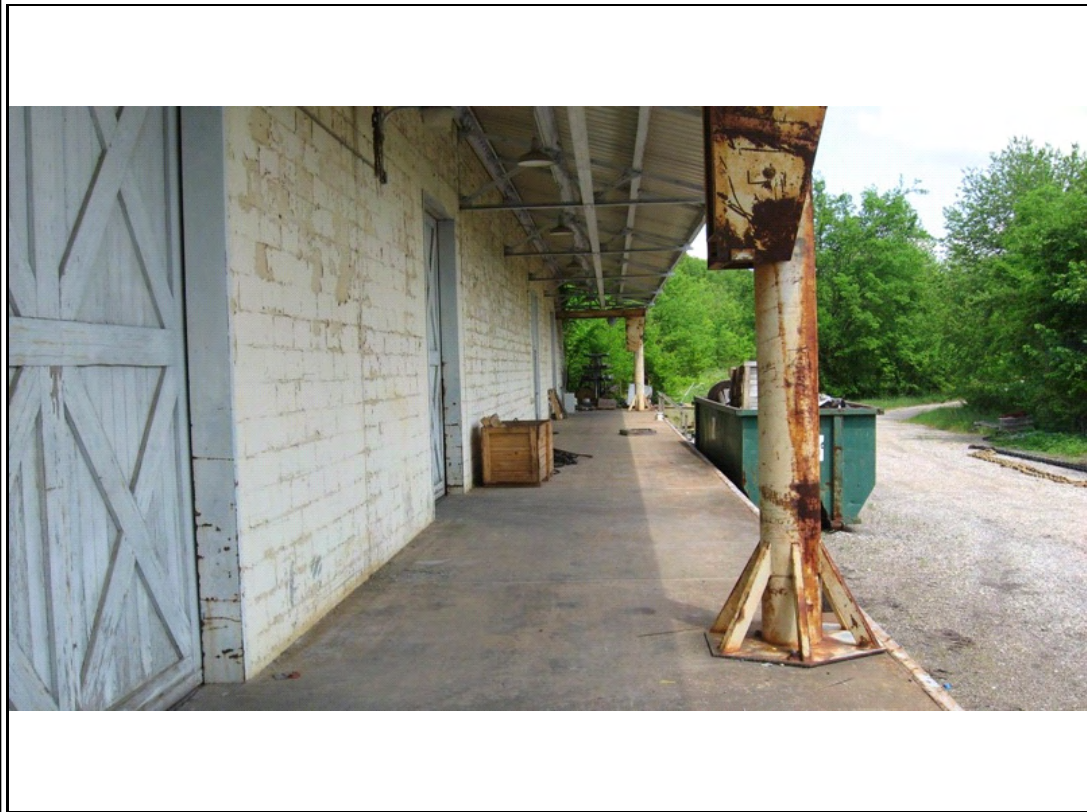
South dock looking east.

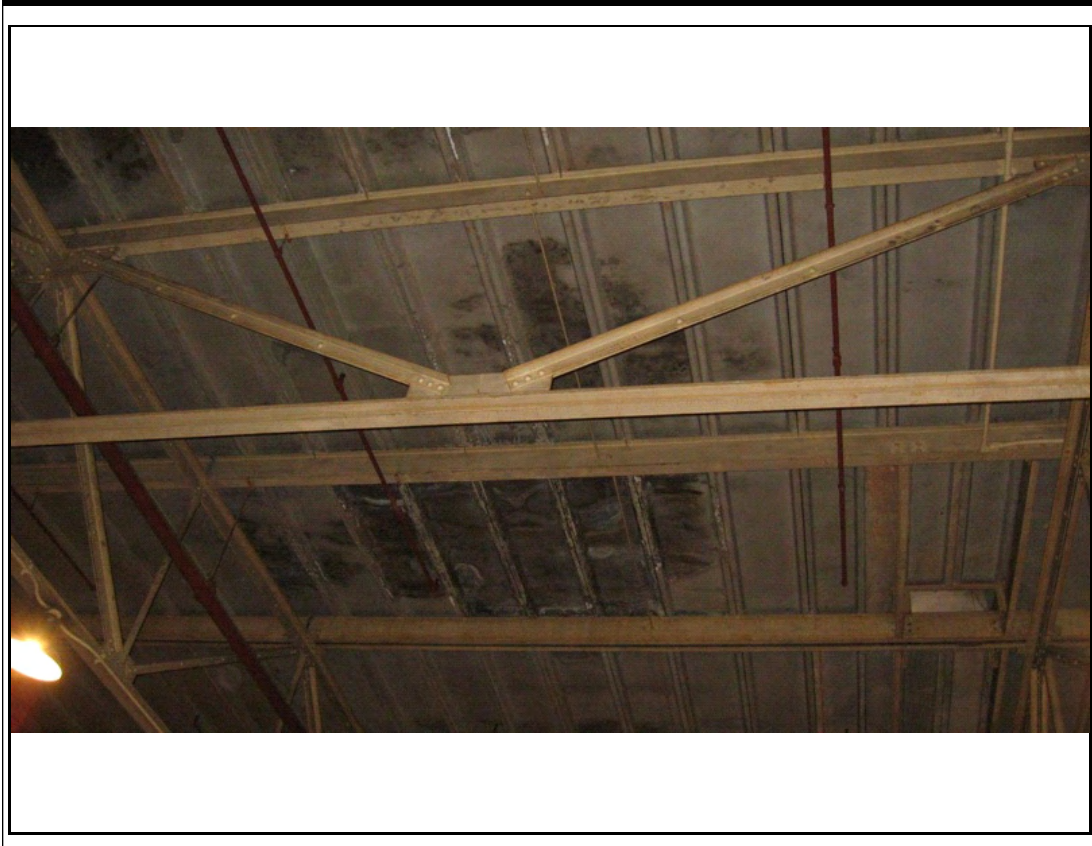
<p>Photograph #: 5</p> <p>Evidence of water intrusion at concrete plank roof deck.</p>

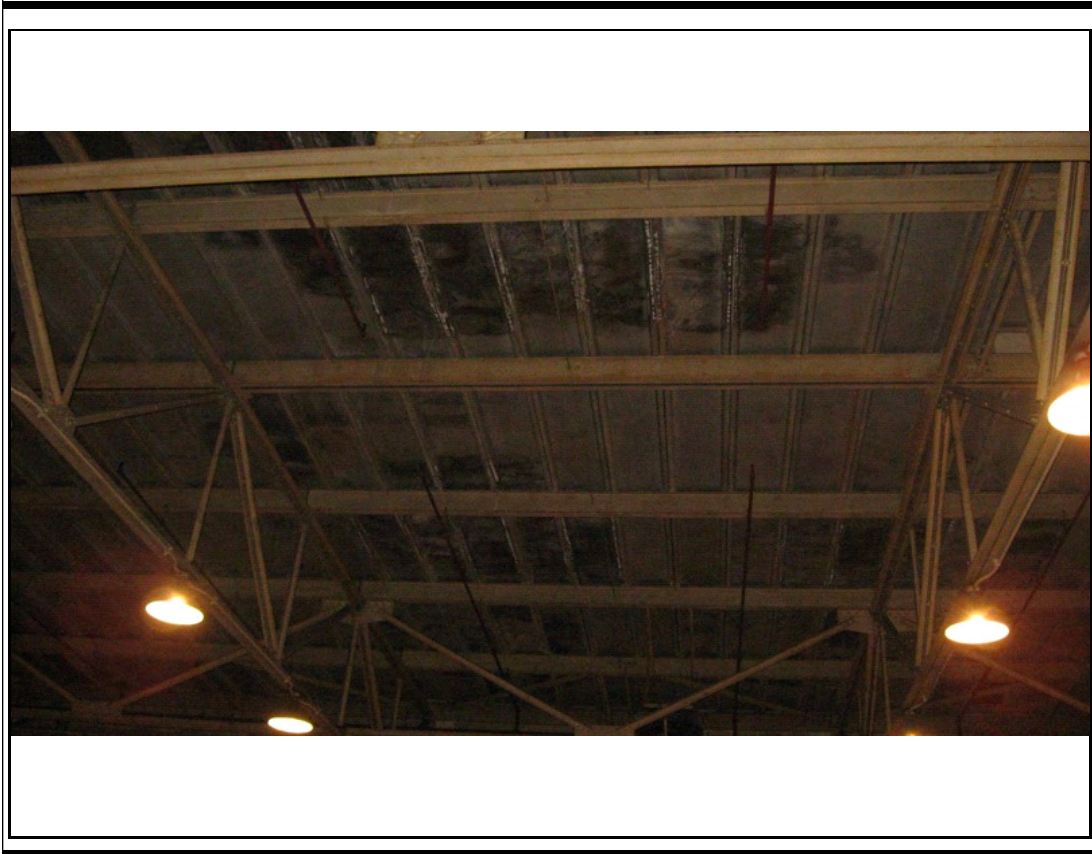
<p>Photograph #: 6</p> <p>Evidence of water intrusion at concrete plank roof deck.</p>

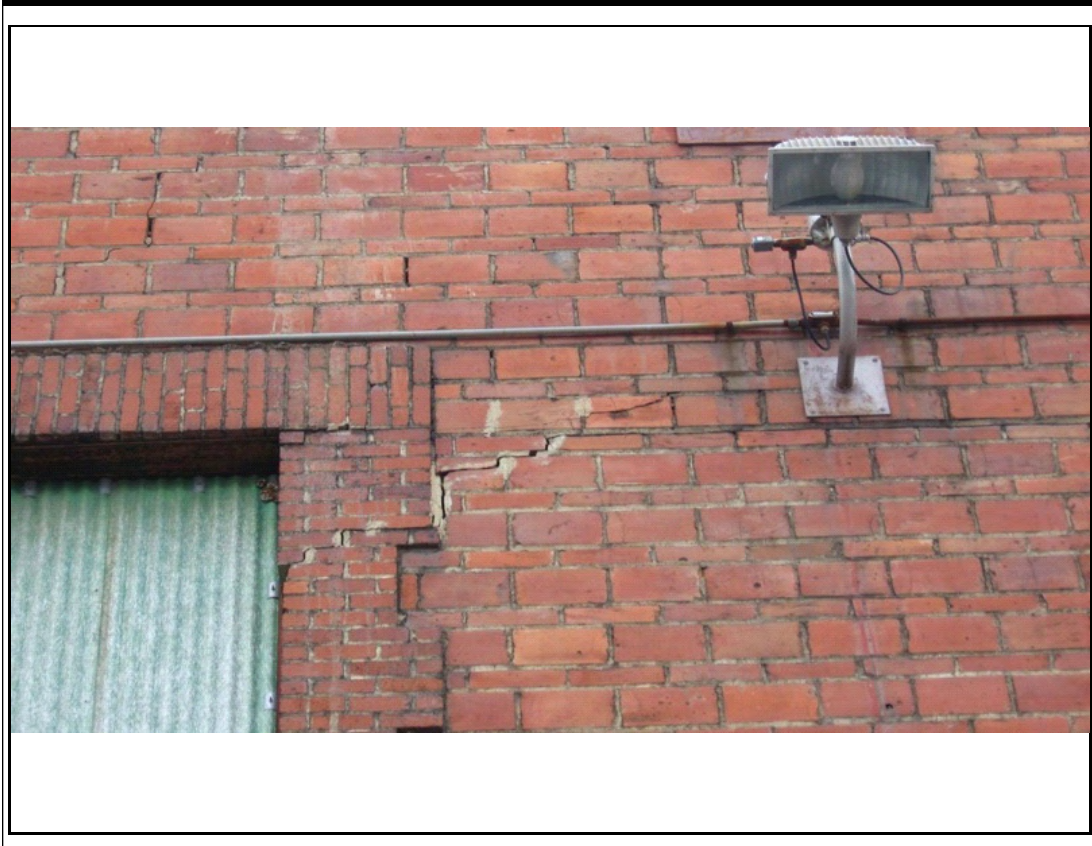
<p>Photograph #: 3</p> <p>Crack in masonry at east wall</p>

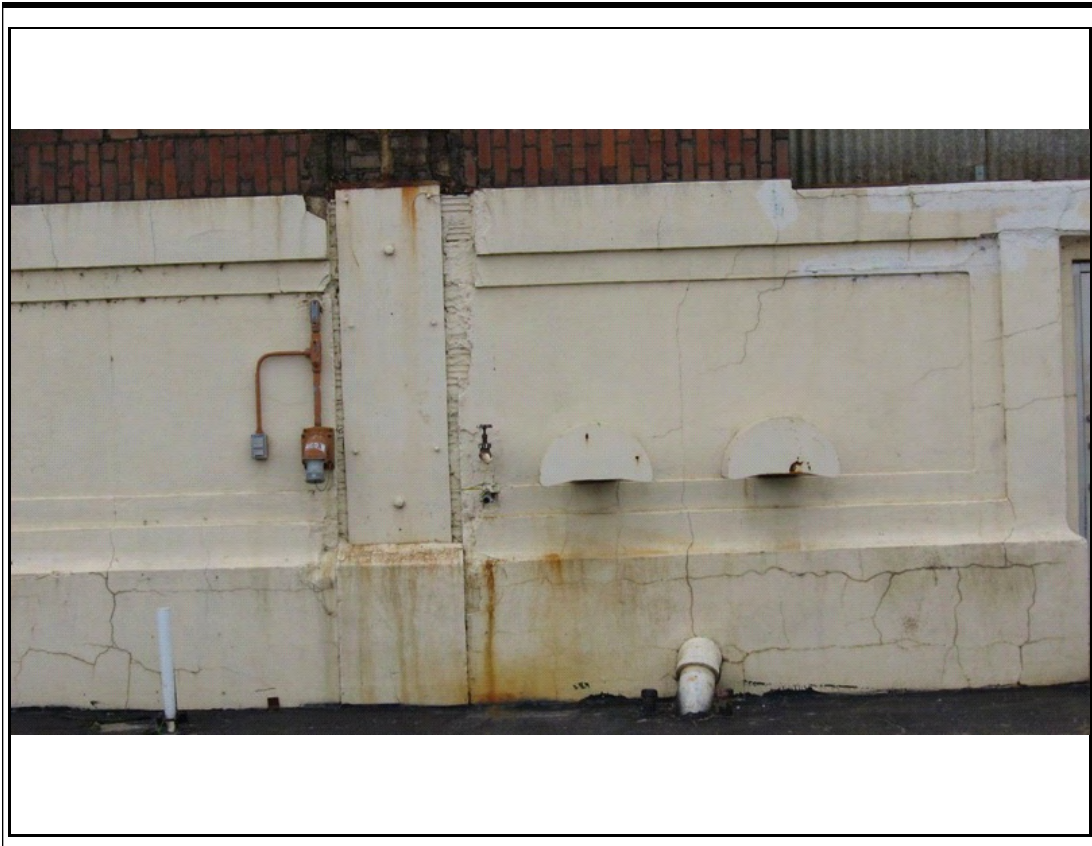
<p>Photograph #: 5</p> <p>Deteriorated plaster veneer at east wall</p>

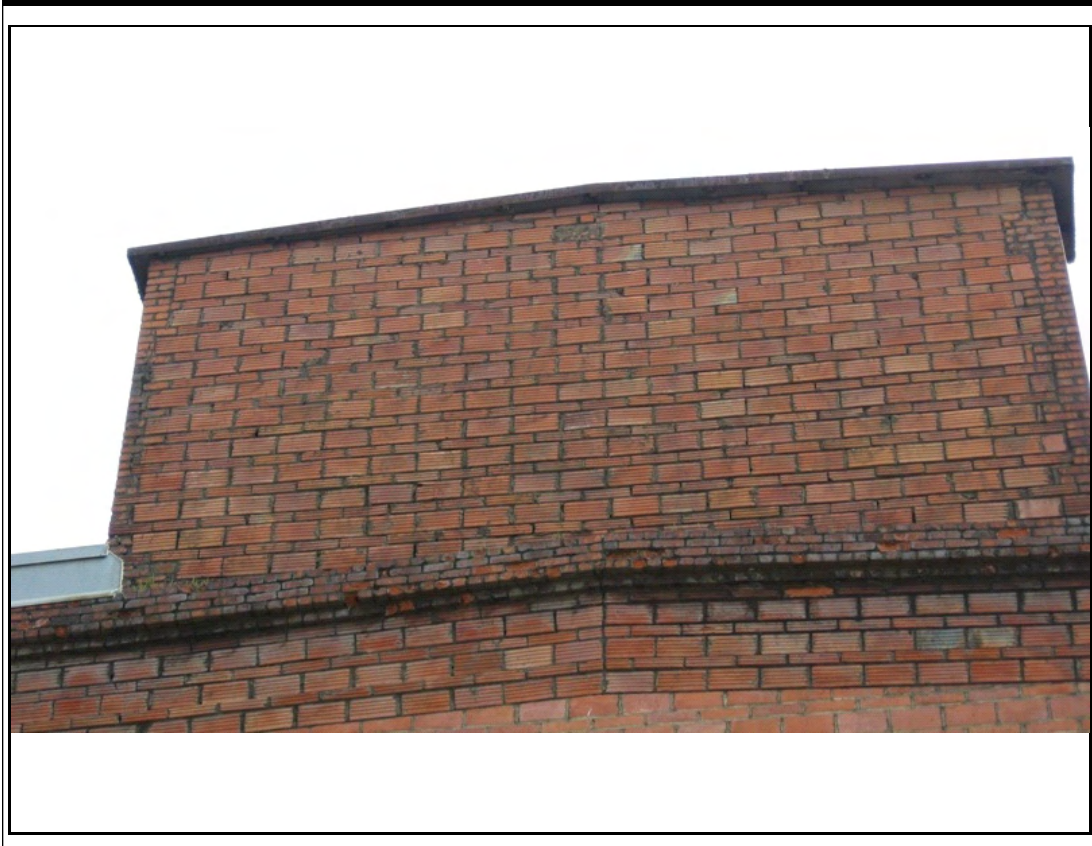
<p>Photograph #: 7</p> <p>Deteriorated plaster veneer at west wall</p>

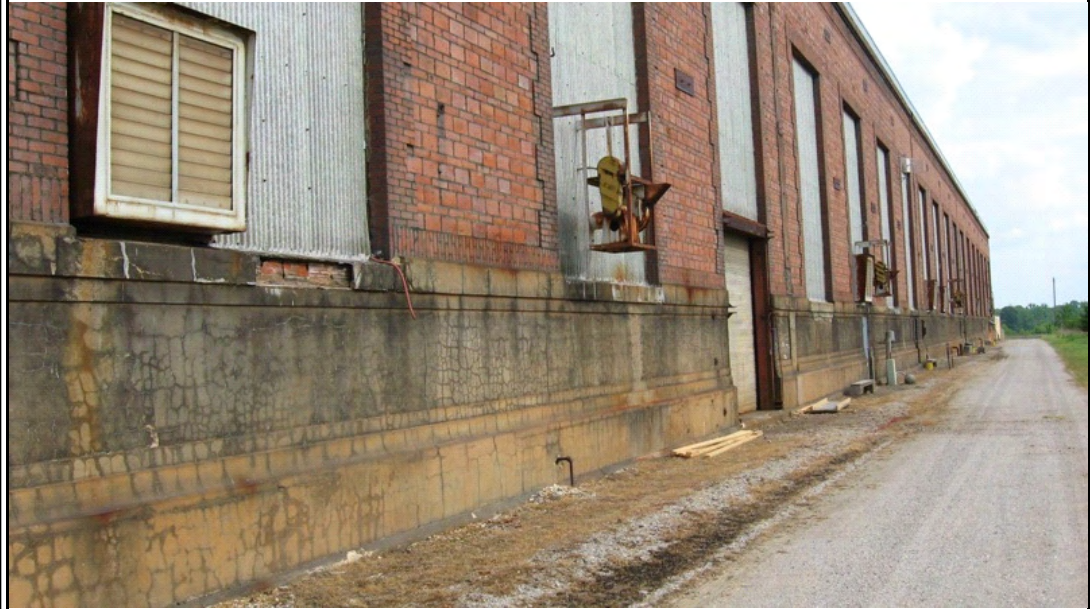
<p>Photograph #: 9</p> <p>Deteriorated plaster veneer at west wall</p>

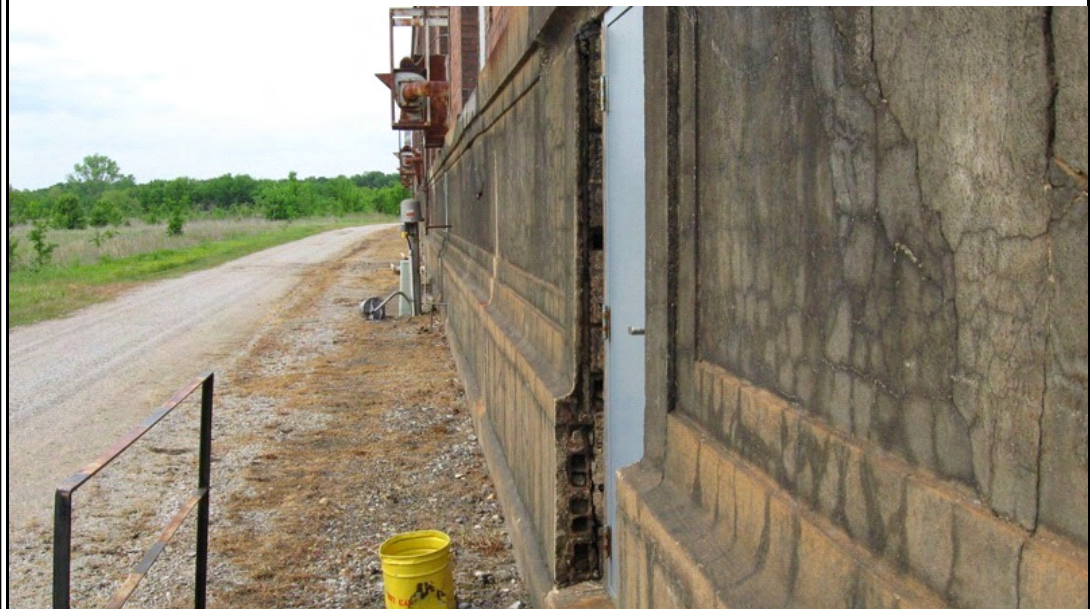
<p>Photograph #: 10</p> <p>Plaster veneer on exposed masonry at west wall</p>

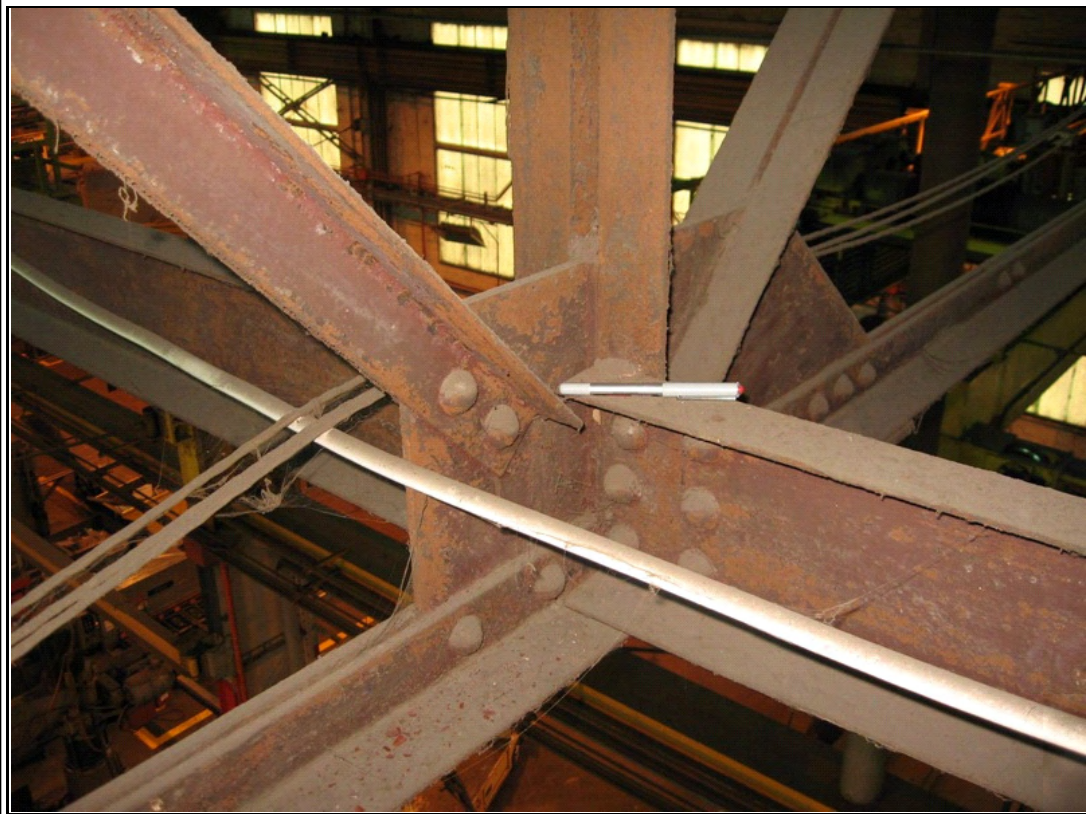
Photograph #: 17

Moderately corroded roof framing

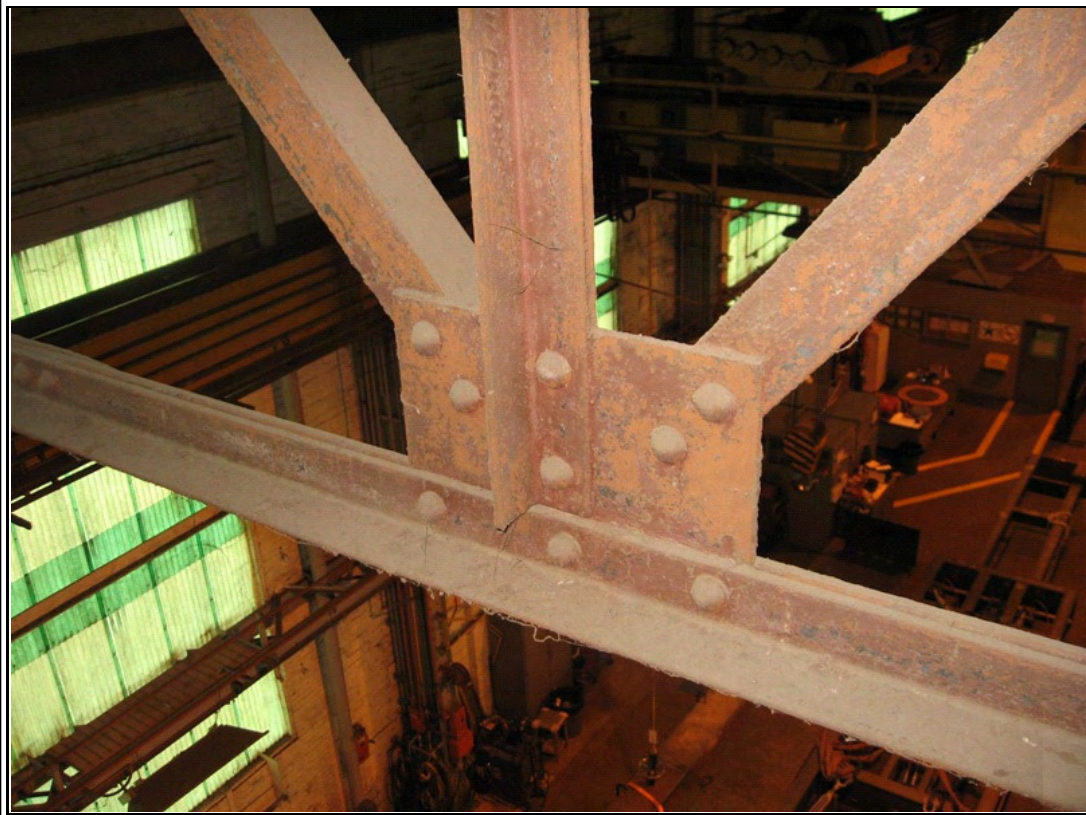
Photograph #: 18

Moderately corroded roof framing

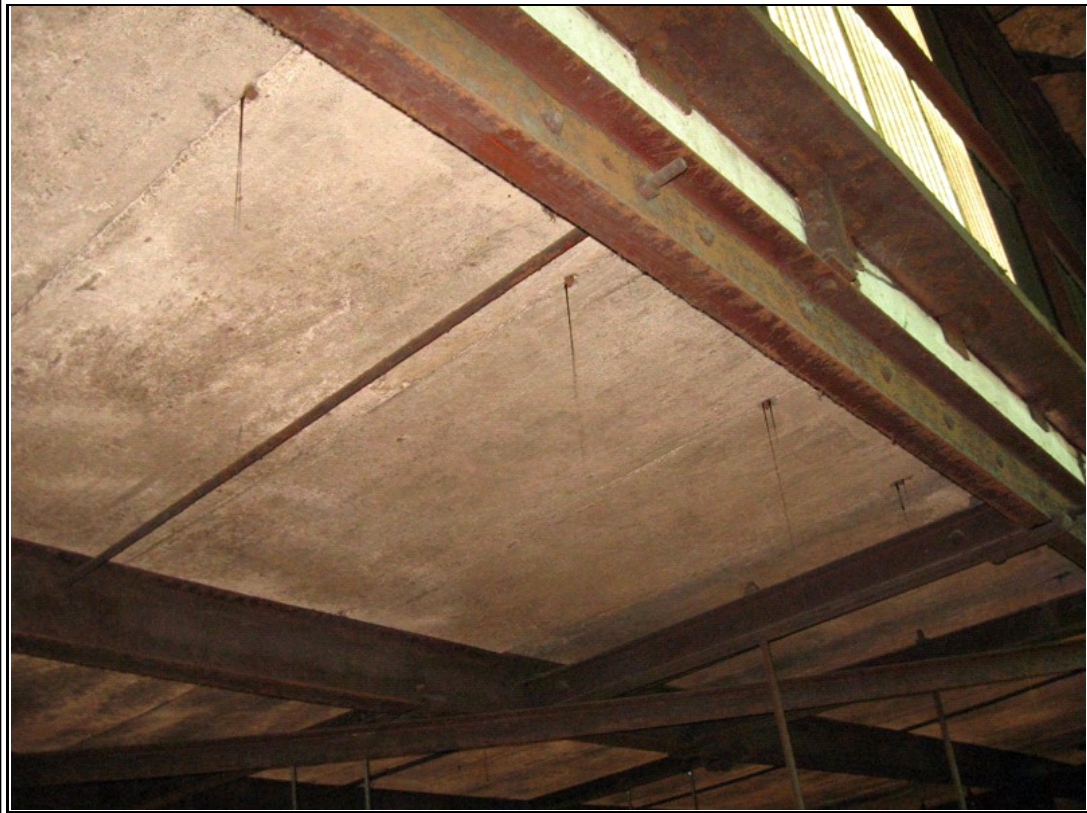
Photograph #: 20

Moderately corroded roof framing at clerestory monitor

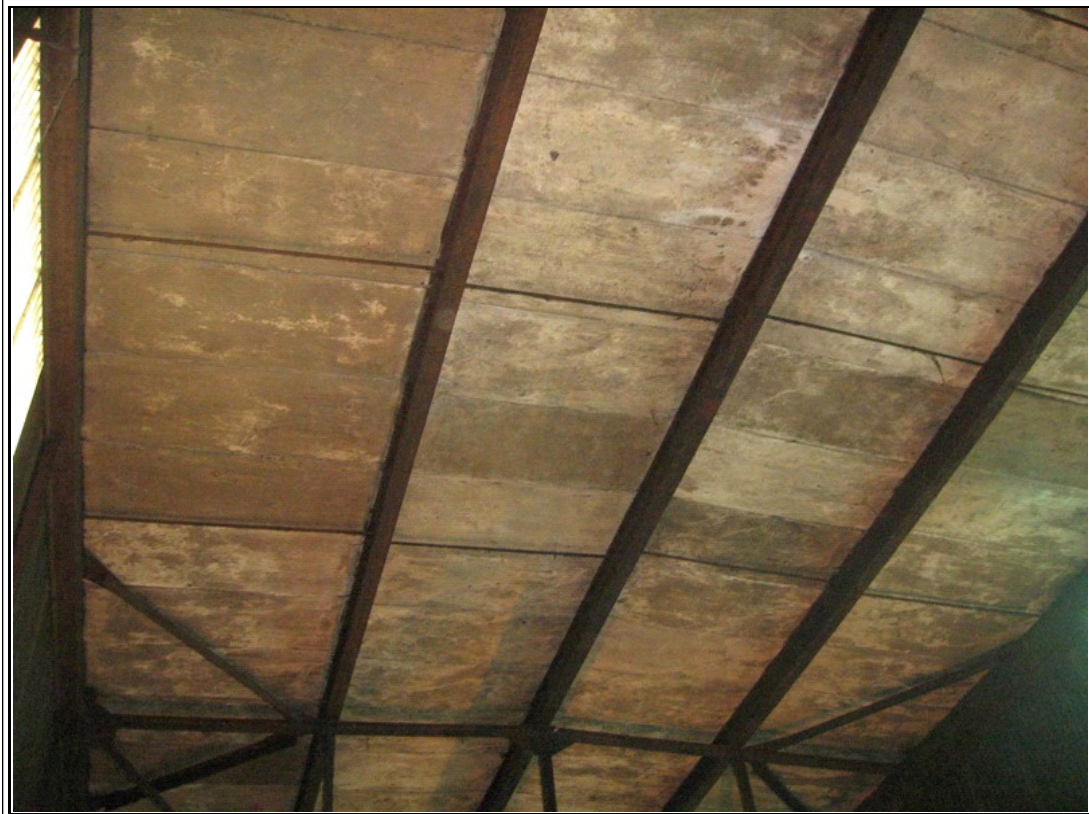
Photograph #: 21

Surface deterioration of roof deck at monitor
