Structural Assessment

Muscle Shoals Reservation
adaptive re-use study

Conditions/Market/Planning/Implementation

July 31, 2009
Revised August 25, 2009

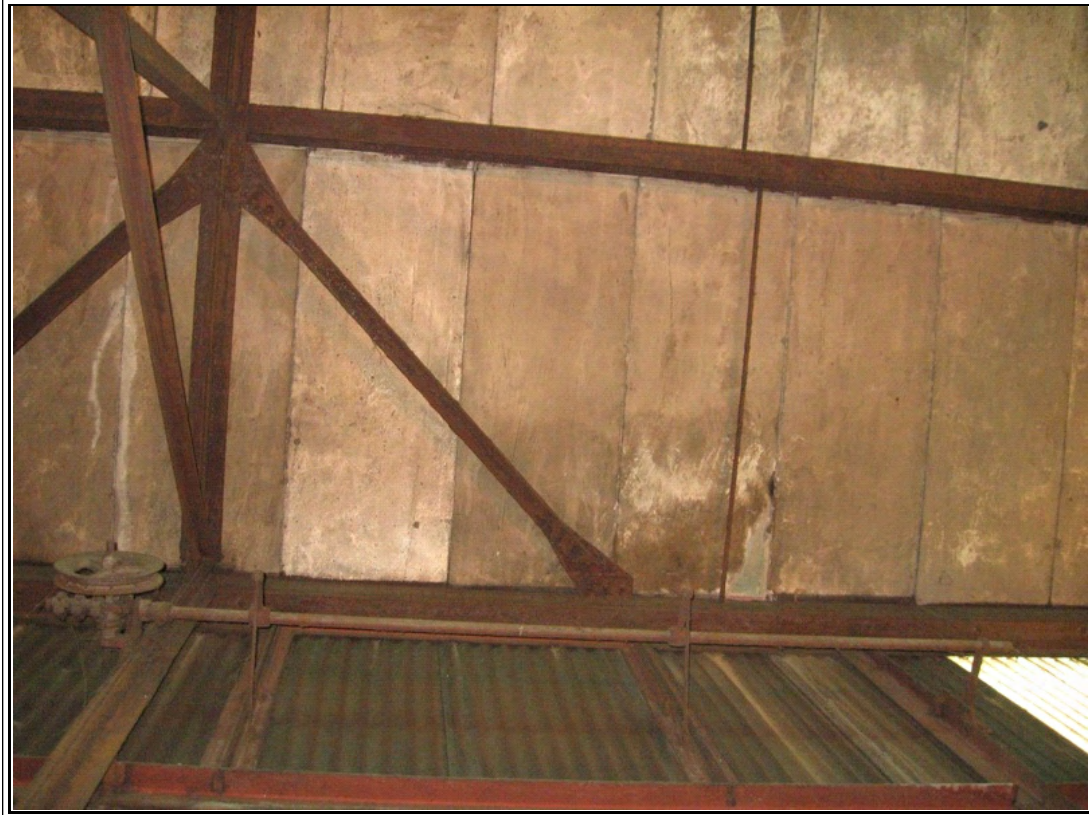
Photograph #: 22

Surface deterioration at roof deck and moderately corroded steel framing at monitor

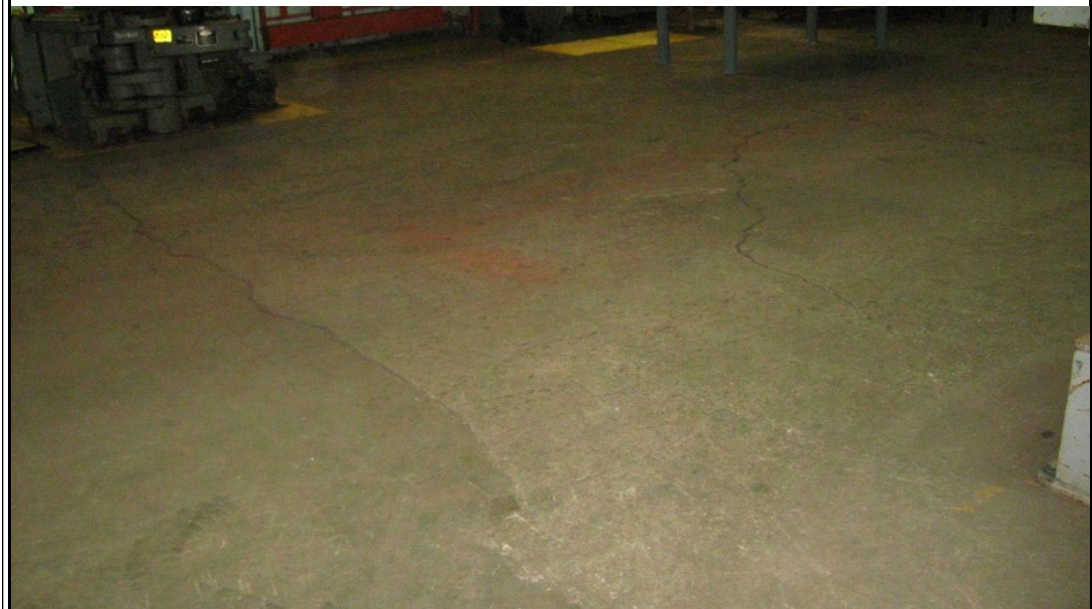
<p>Photograph #: 24</p> <p>Cracks in concrete floor slab</p>

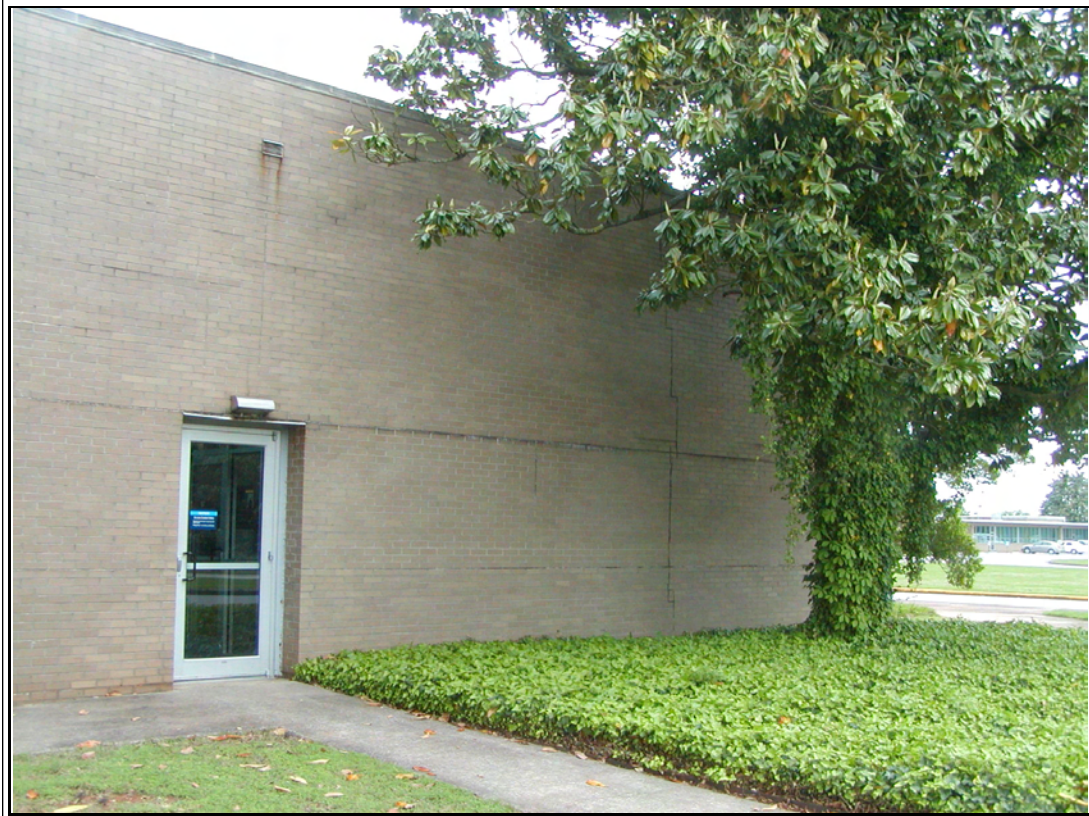
Photograph #: 5

ERC Building - vertical crack in exterior wall

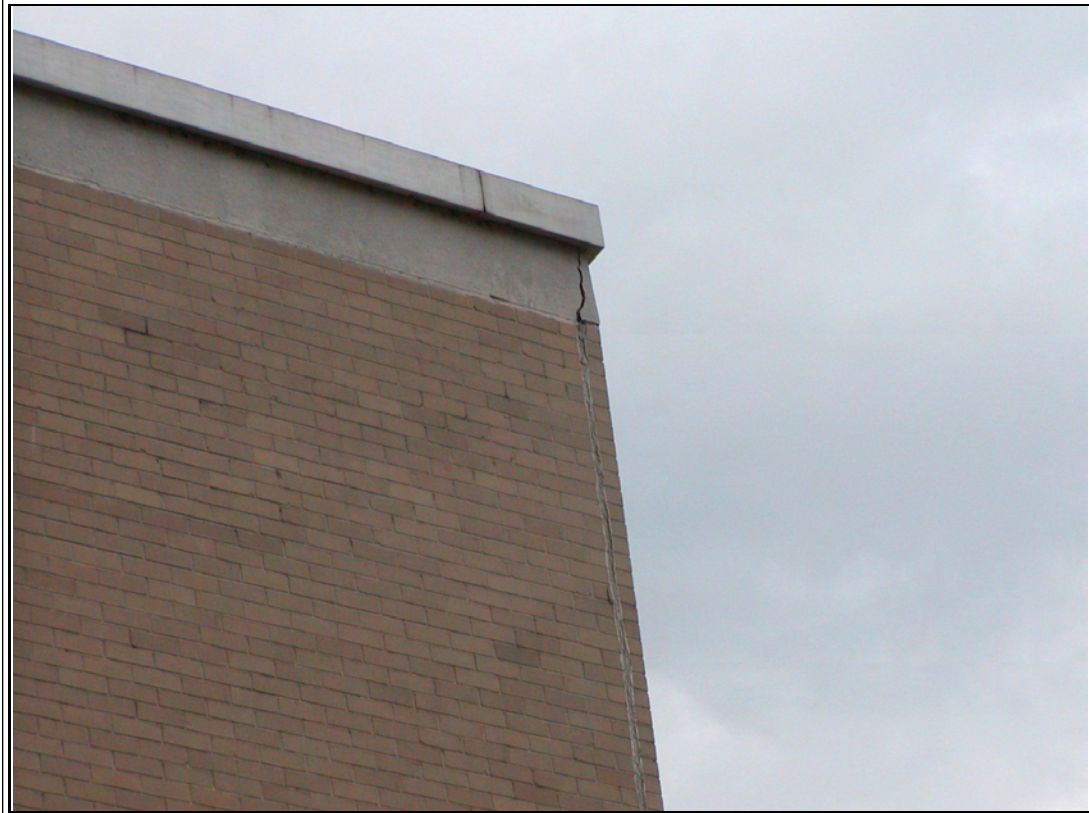
Photograph #: 6

ERC Building - crack in corner at top of auditorium wall

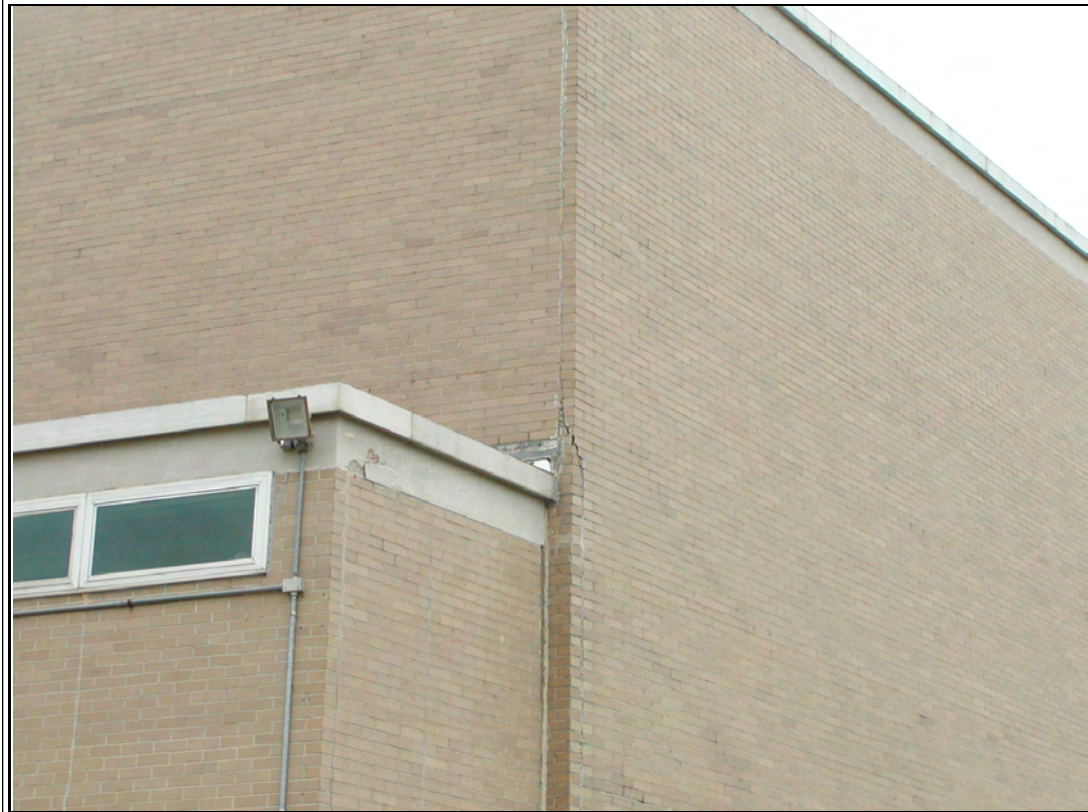
Photograph #: 7

ERC Building - crack at corner of auditorium wall

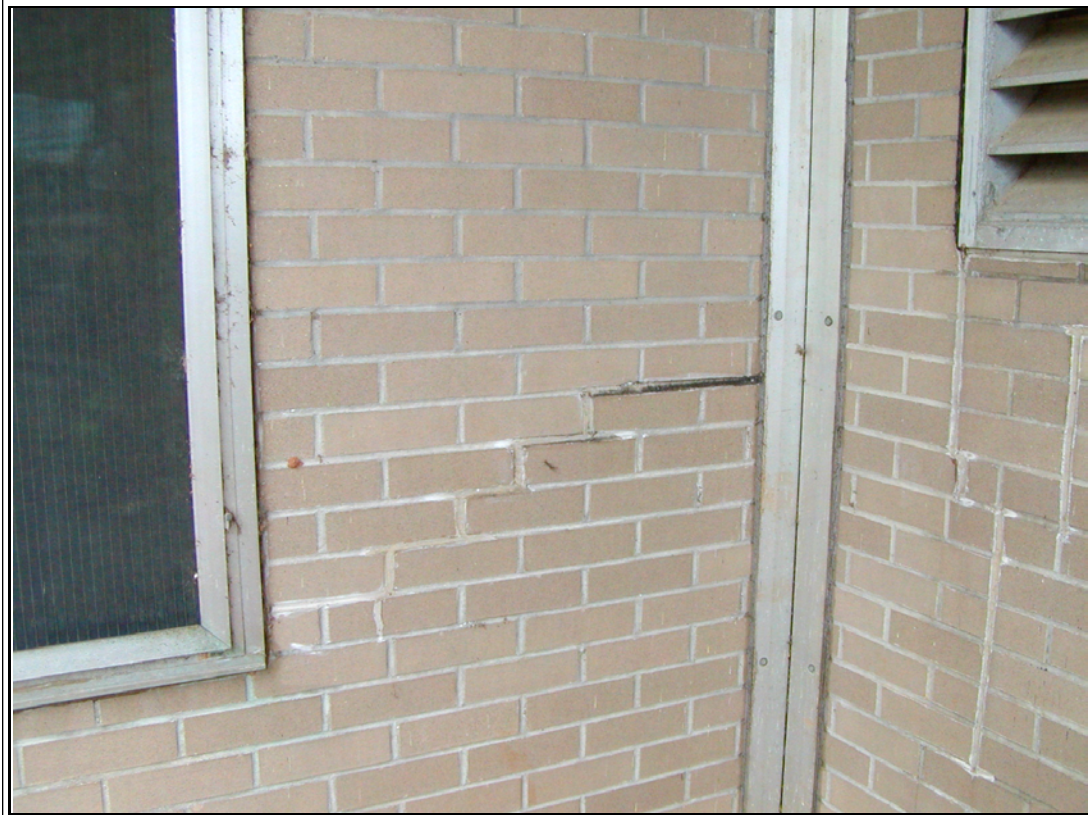
Photograph #: 8

ERC Building - crack in wall near building entrance

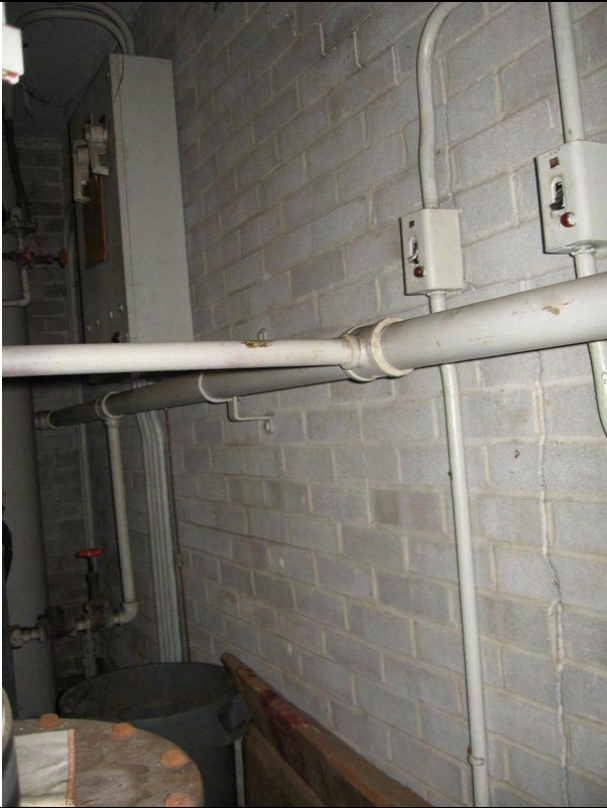
A photograph showing a section of a brick wall in a utility room. Several white PVC pipes and electrical conduits run horizontally across the wall. Two electrical boxes are mounted on the wall. In the background, a large metal tank and other equipment are visible.	<p>Photograph #: 9</p> <p>ERC Building - minor crack in interior brick wall</p>

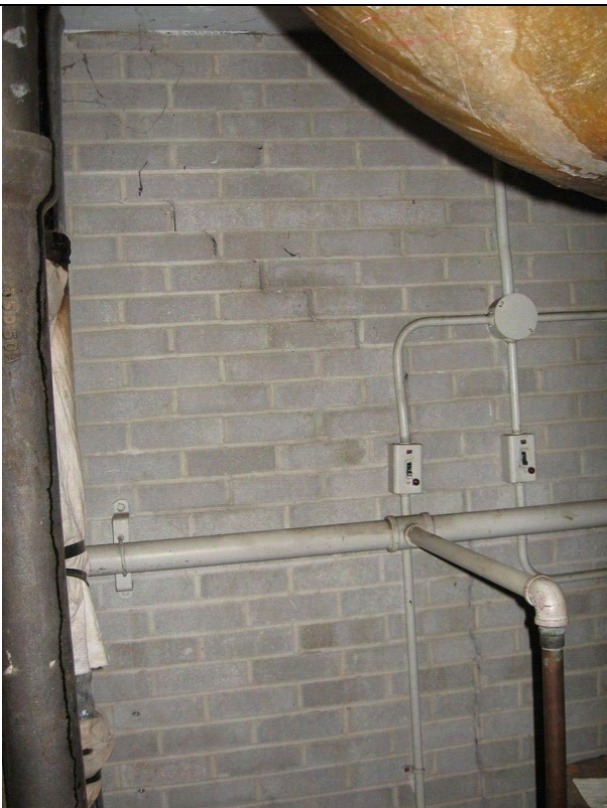
A photograph showing another section of the same brick wall. Similar to the first photo, it features white PVC pipes and electrical conduits. A large, curved metal structure is visible in the upper right corner. The brickwork shows some signs of wear and minor cracking.	<p>Photograph #: 10</p> <p>ERC Building - minor crack in interior brick wall</p>

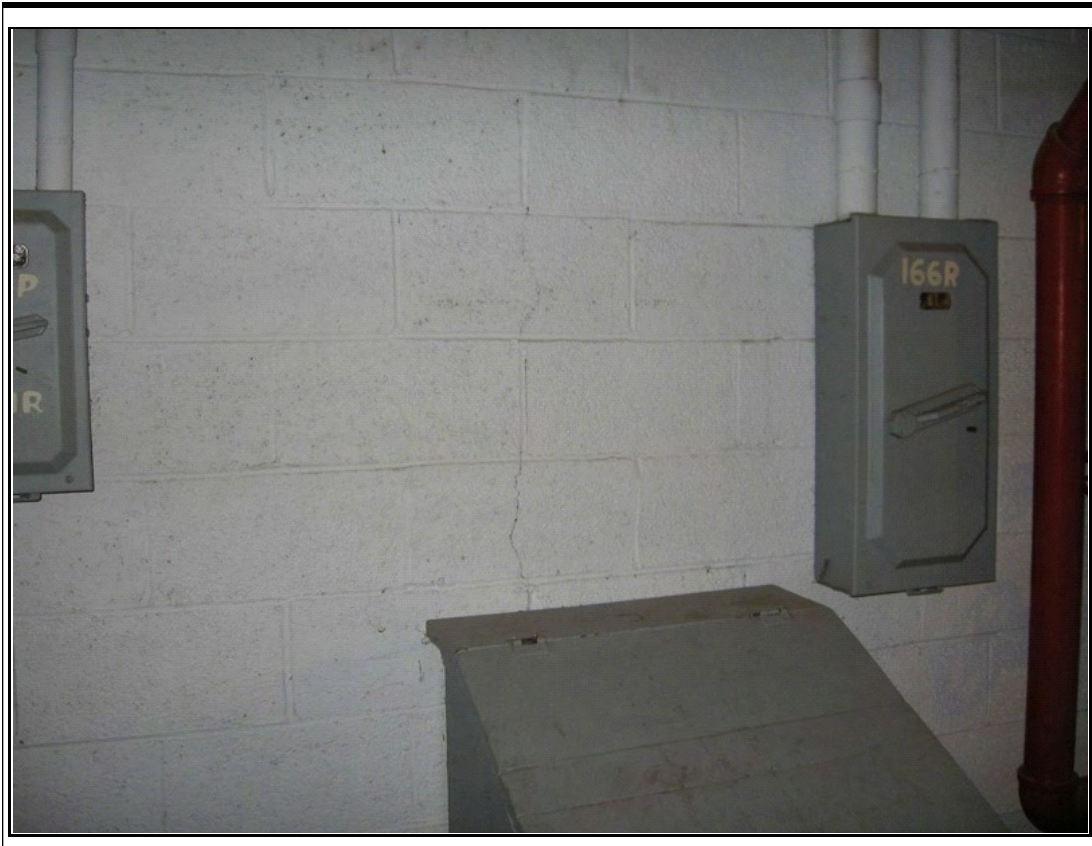
A photograph of an interior concrete masonry wall. A vertical crack runs down the center of the wall. Two electrical boxes are mounted on the wall; the one on the right is labeled '166R'. A red fire pipe is visible on the right side of the wall. A concrete ledge or base is in the foreground.	<p>Photograph #: 11</p> <p>ERC Building - minor crack in interior concrete masonry wall</p>

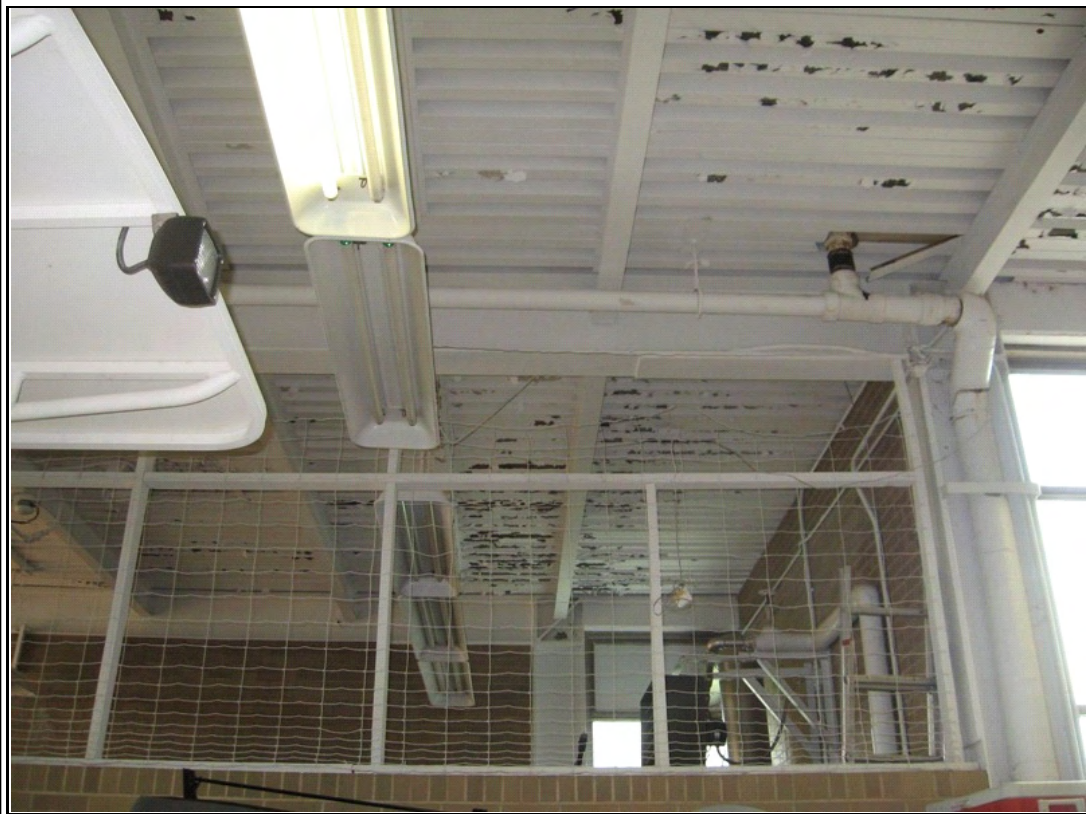
Photograph #: 15

Service Building - flaking paint at metal deck in vehicle storage area

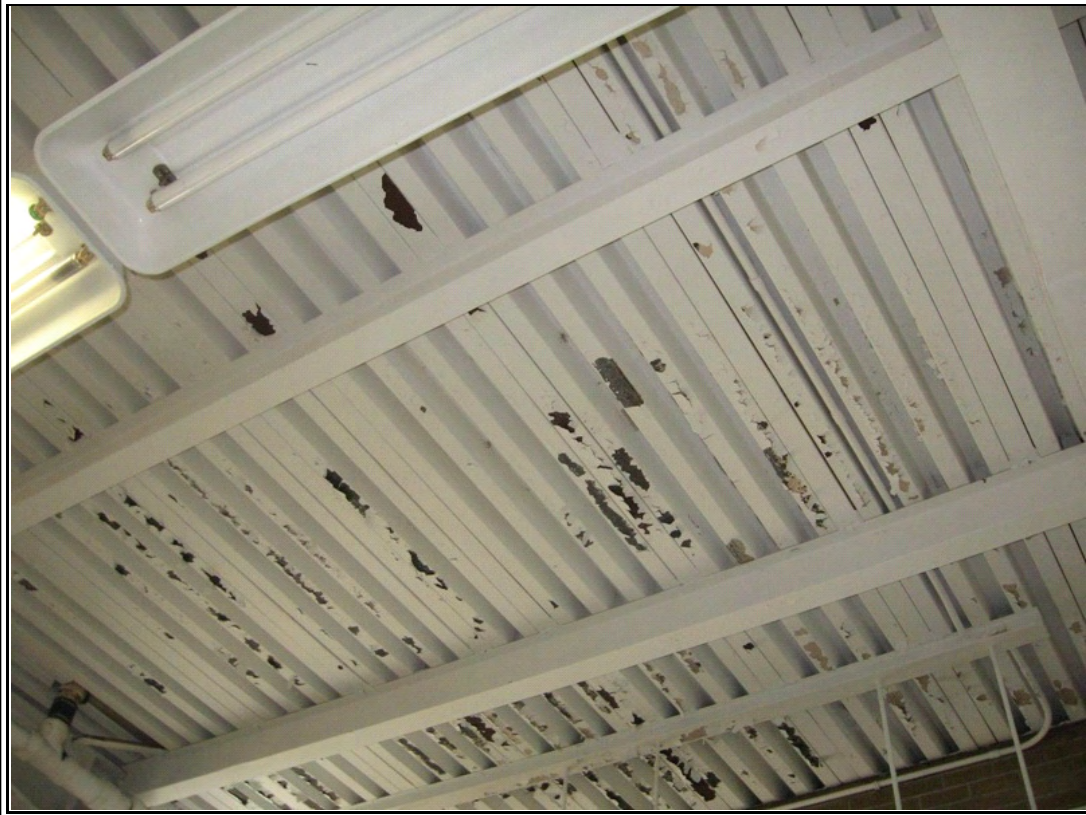
Photograph #: 16

Service Building - flaking paint at metal roof deck in vehicle storage area

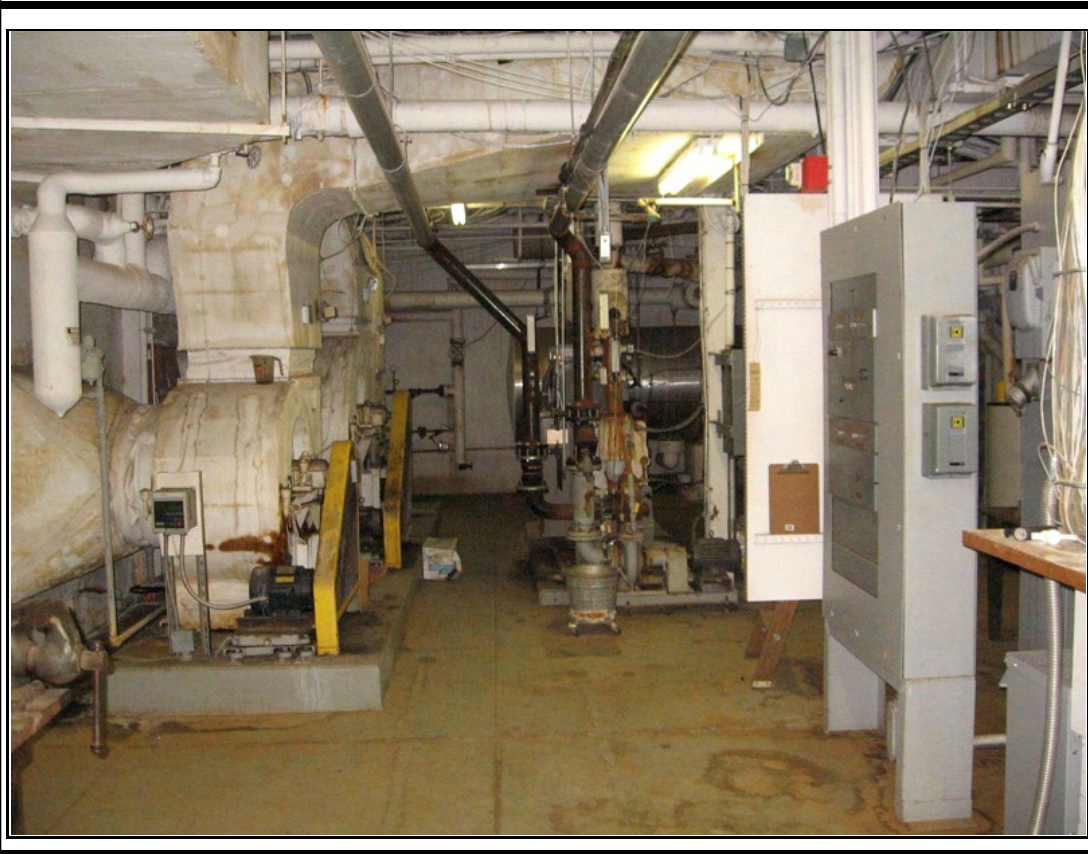
<p>Photograph #: 22</p> <p>Service Building - mechanical equipment in basement</p>

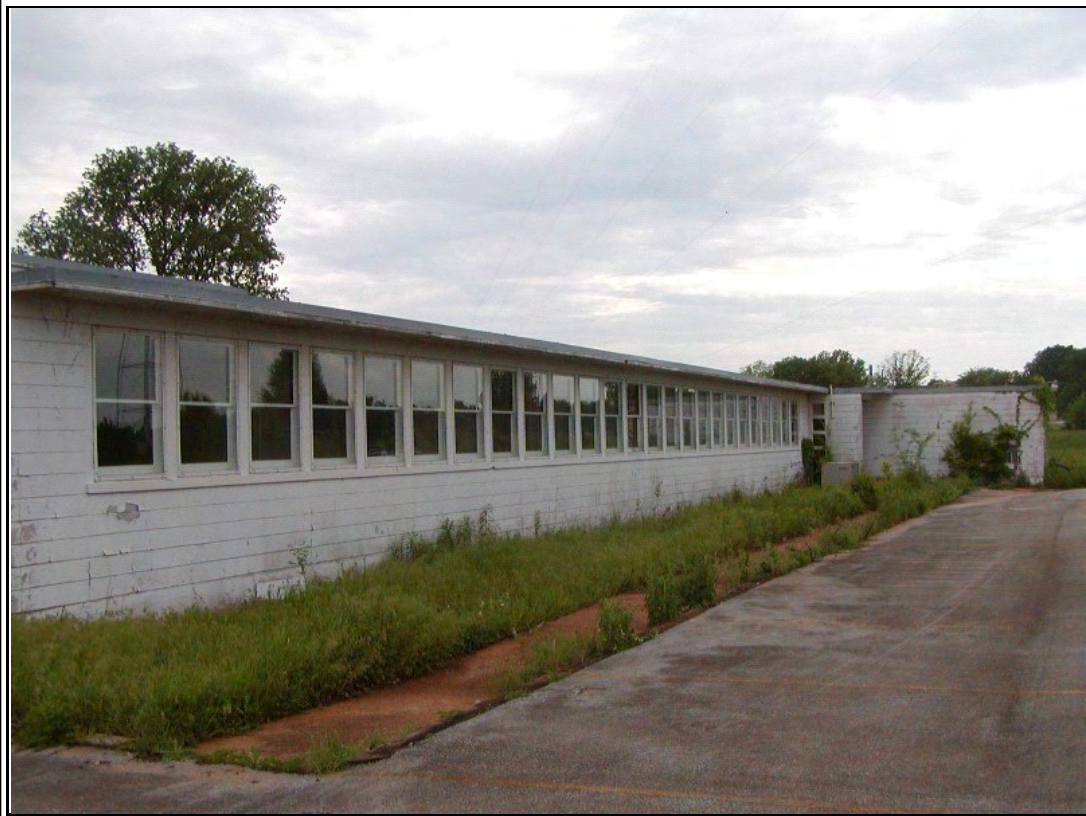
Photograph #: 3

Exterior building - north side

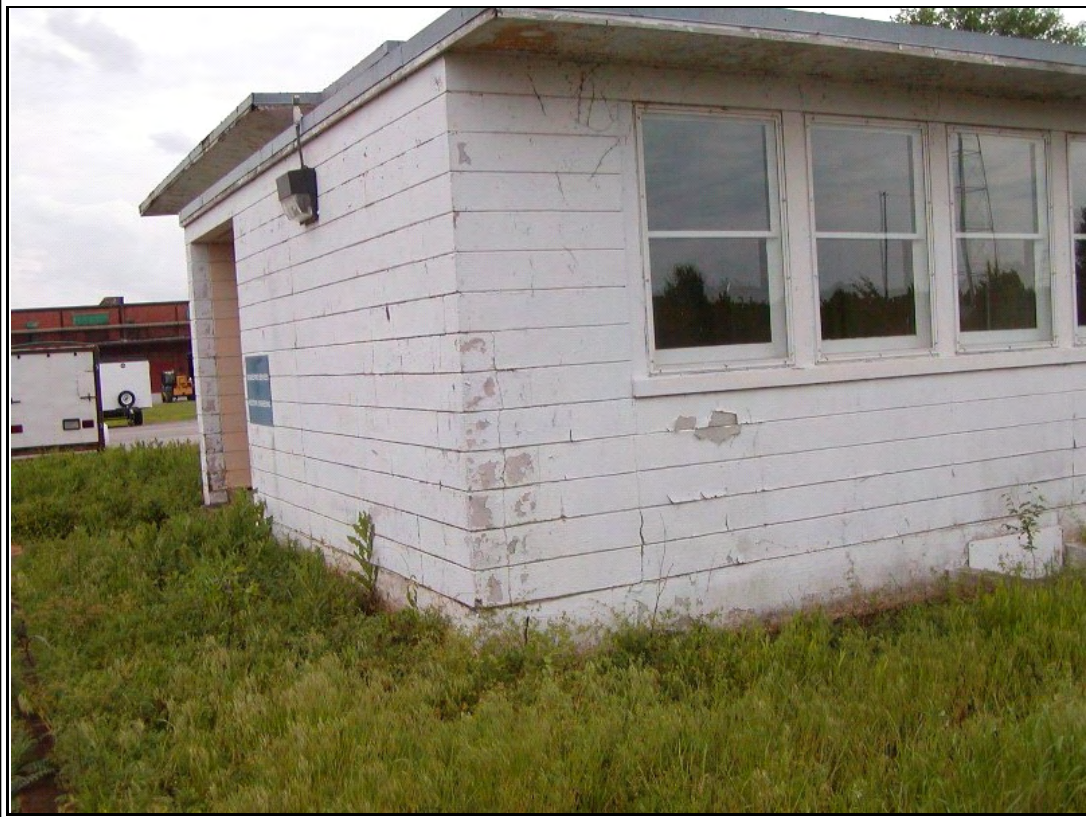
Photograph #: 4

Exterior building - northeast corner

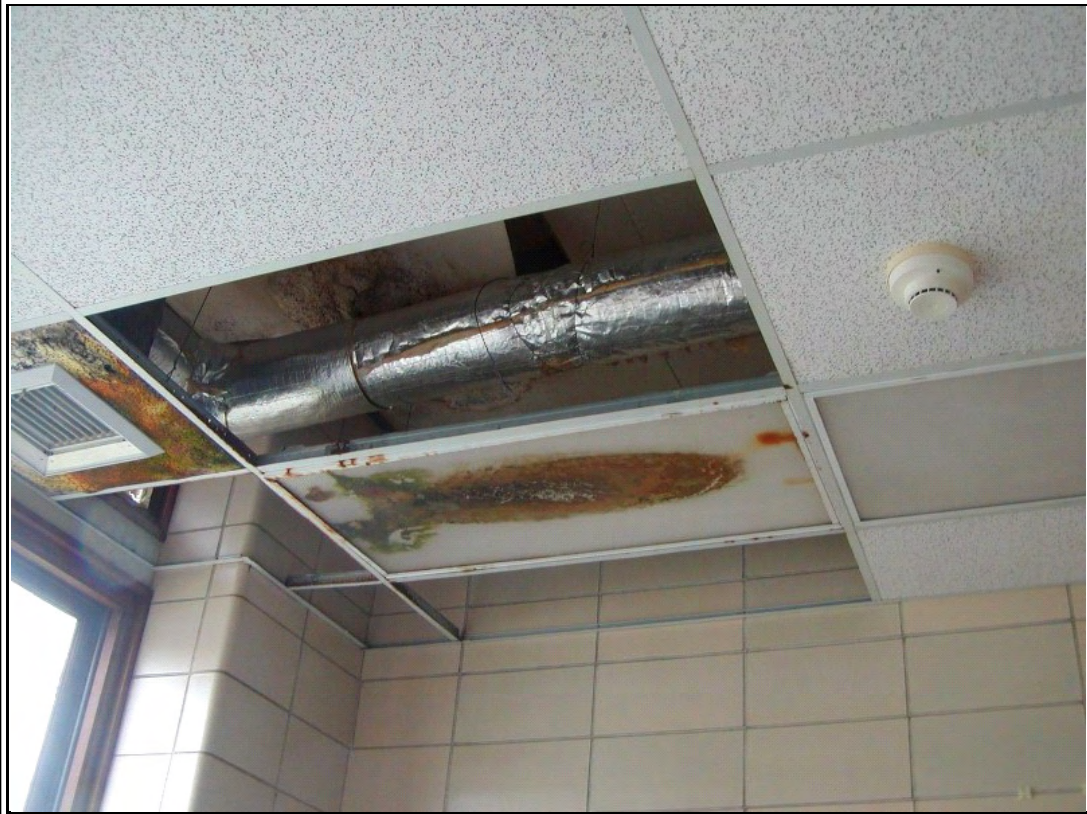
Photograph #: 11

Interior water intrusion damage

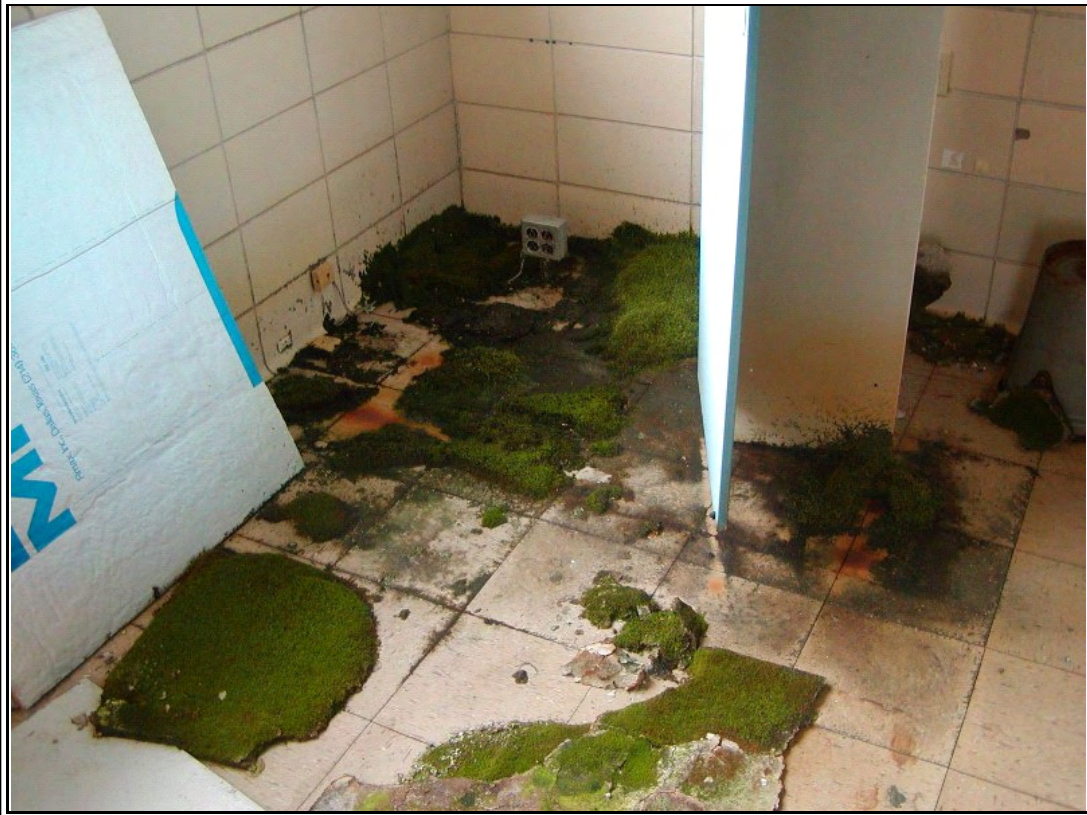
Photograph #: 12

Interior water intrusion damage

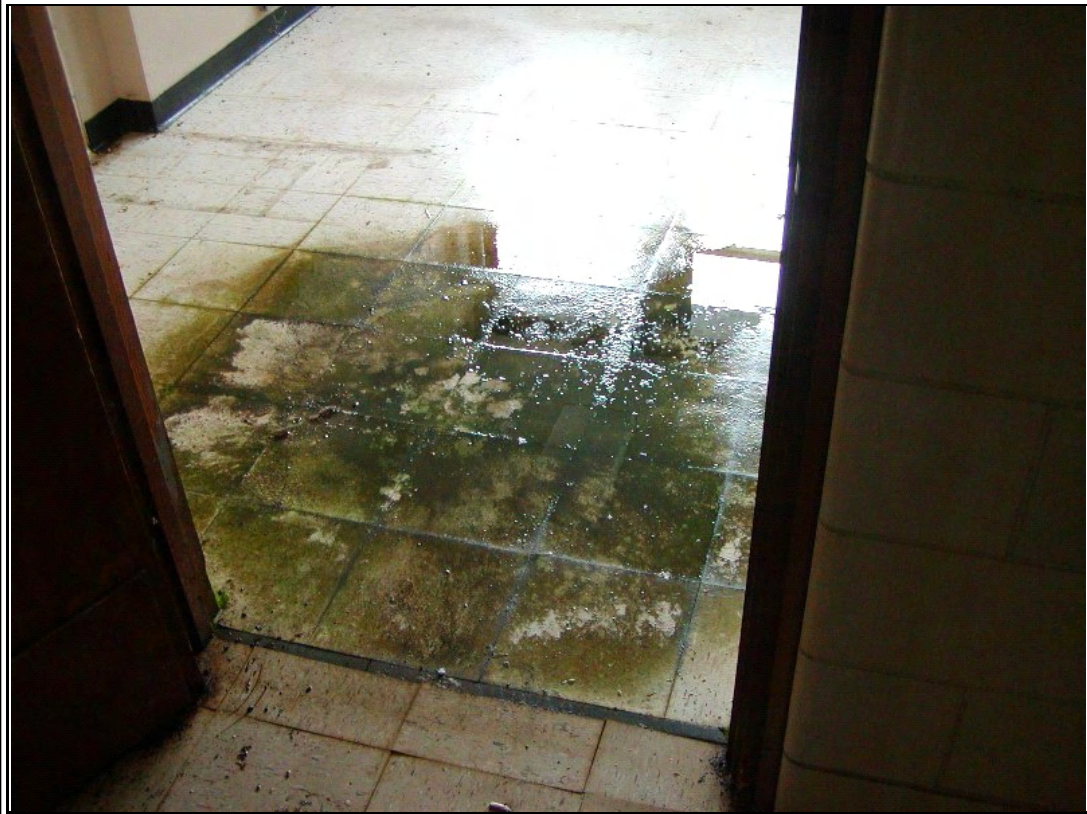
Photograph #: 13

Interior water intrusion damage

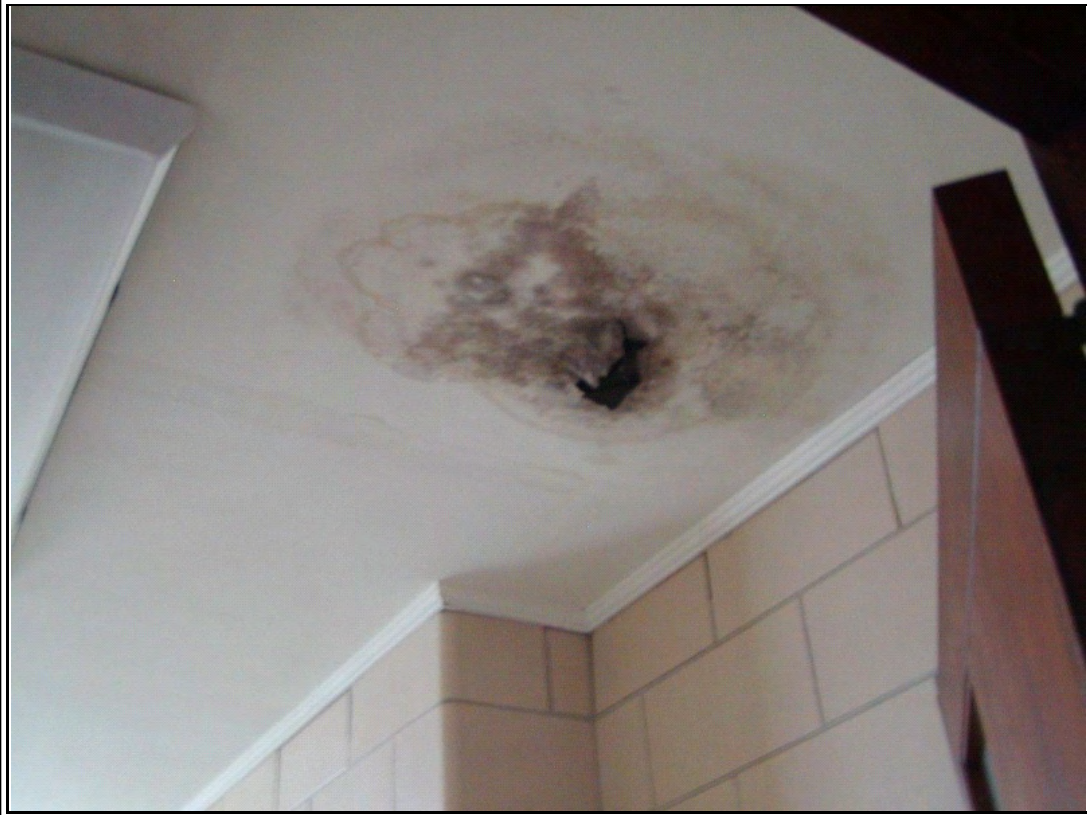
Photograph #: 14

Interior water intrusion damage

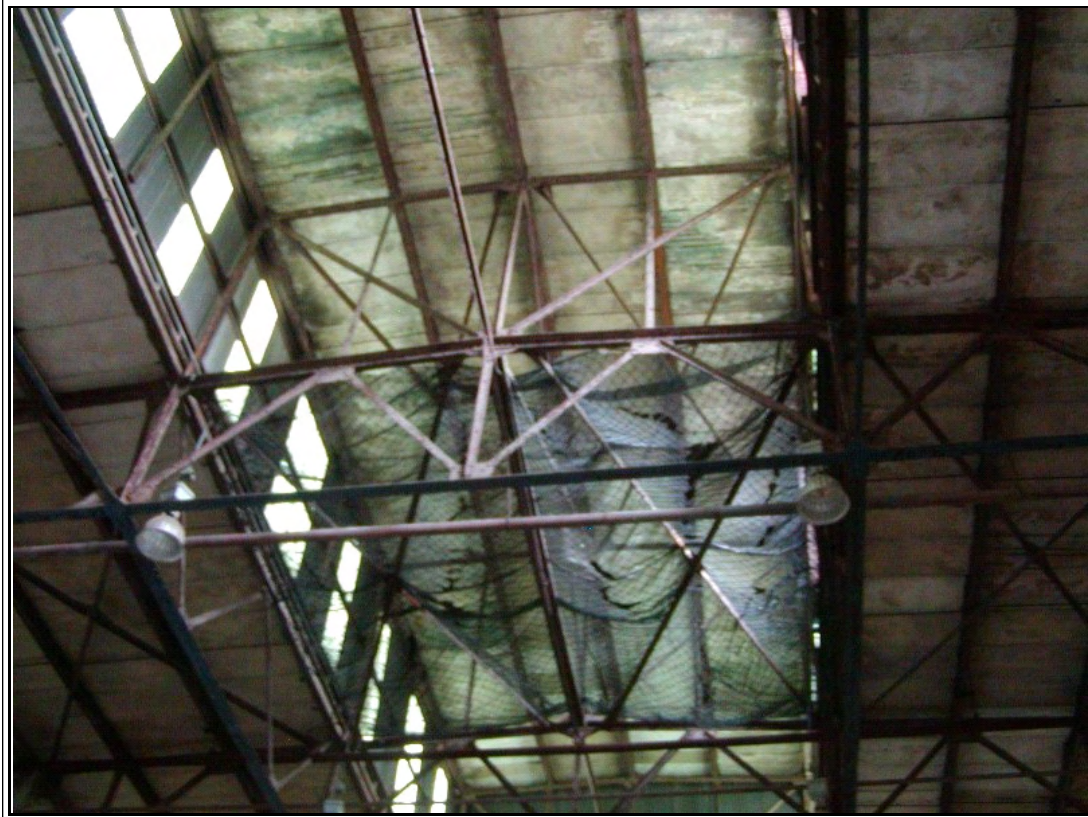
Photograph #: 4
Deteriorated concrete plank roof deck

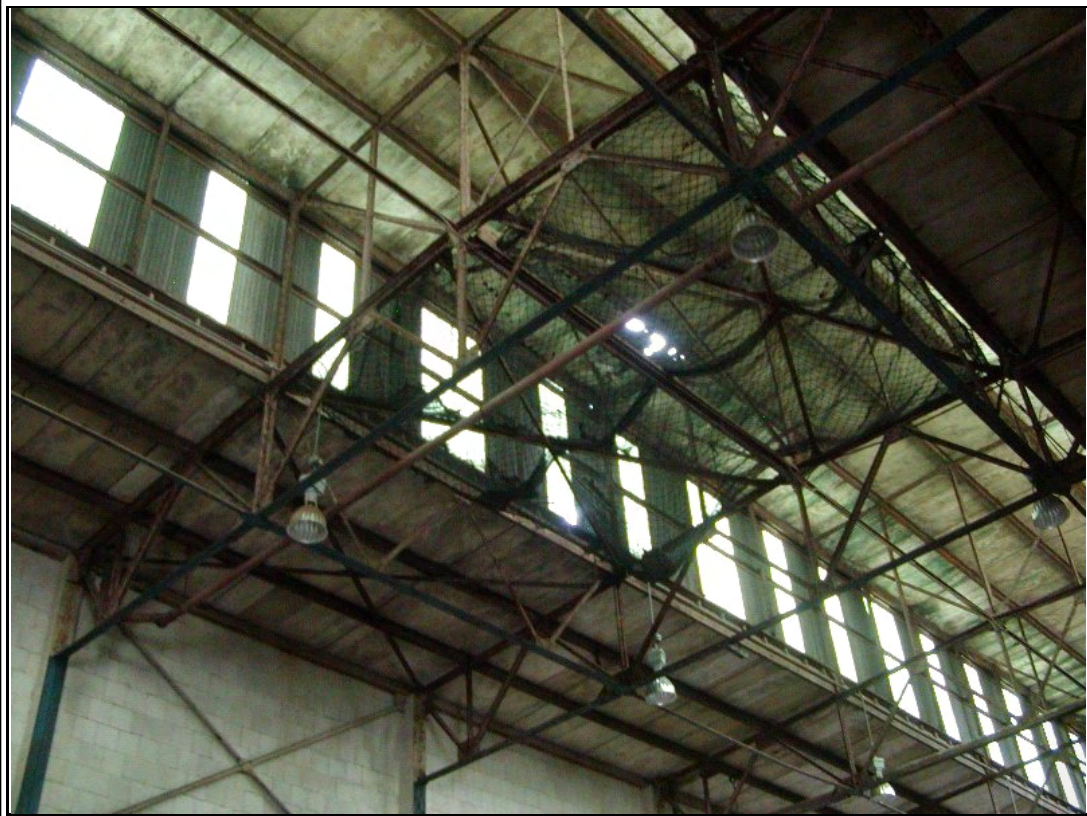
Photograph #: 5

Holes in deteriorated
concrete plank roof deck

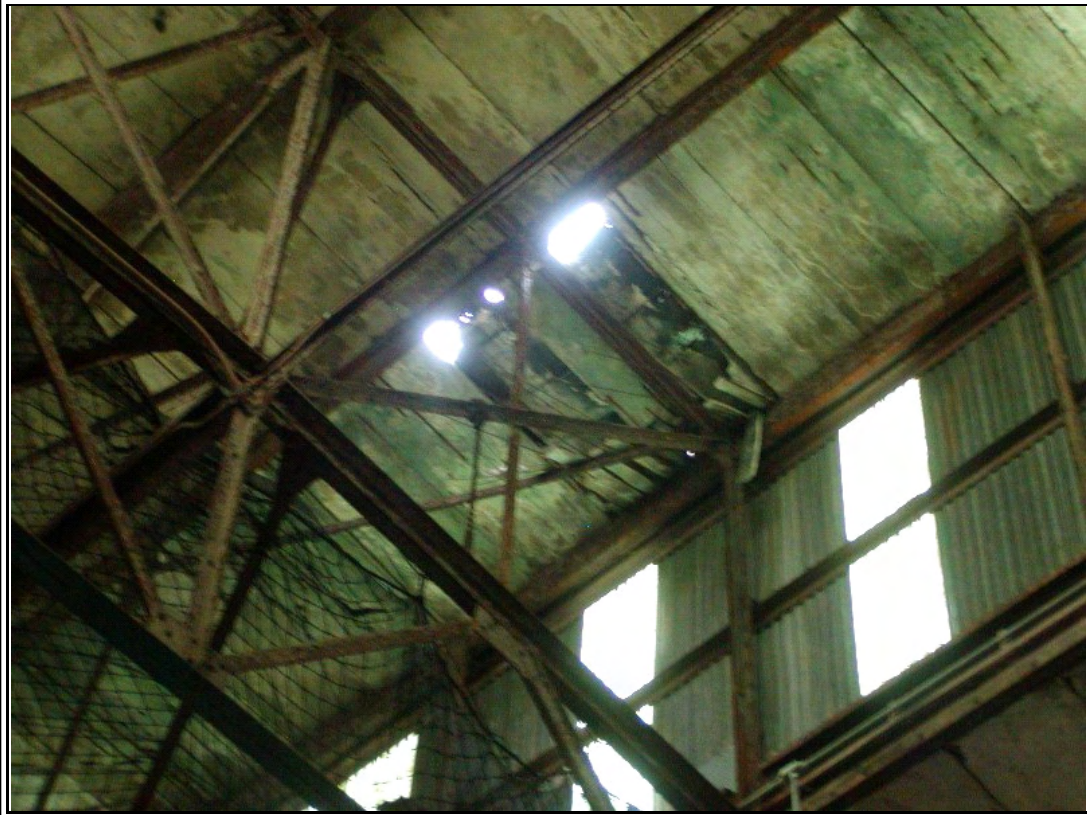
Photograph #: 6

Areas of ruined concrete
plank roof deck

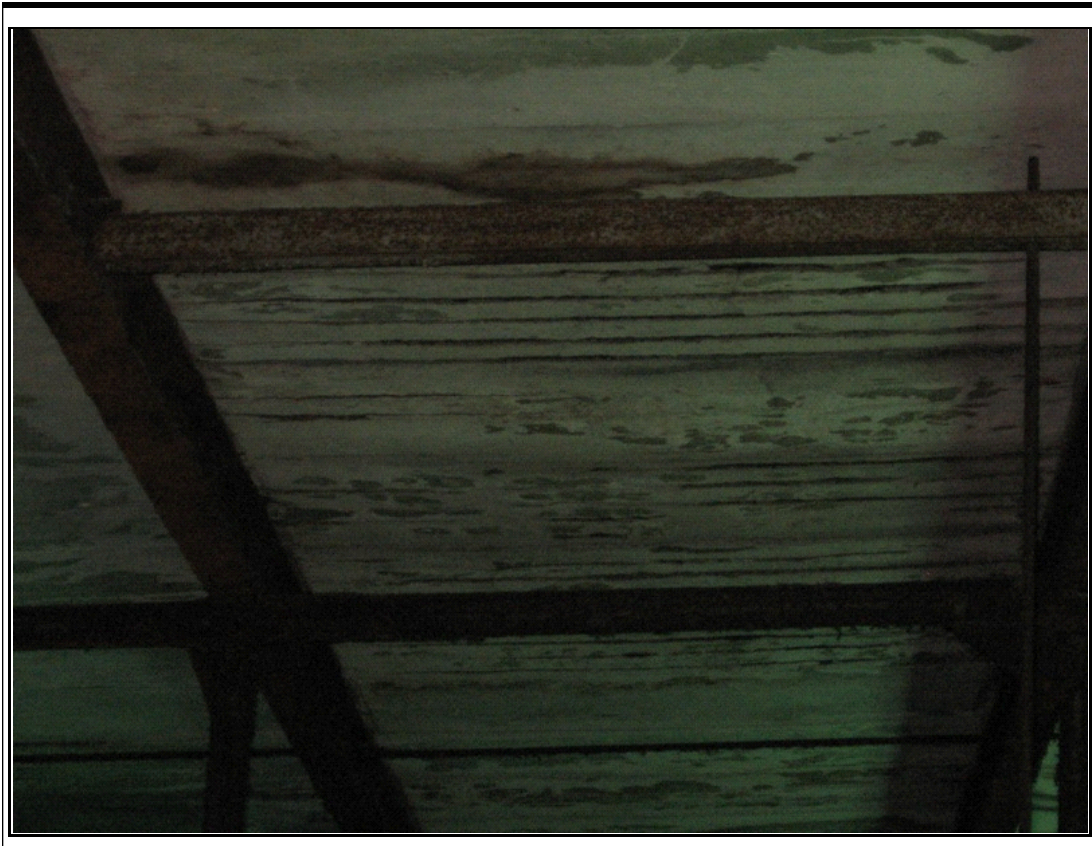
Photograph #: 7
	Ruined concrete roof planks

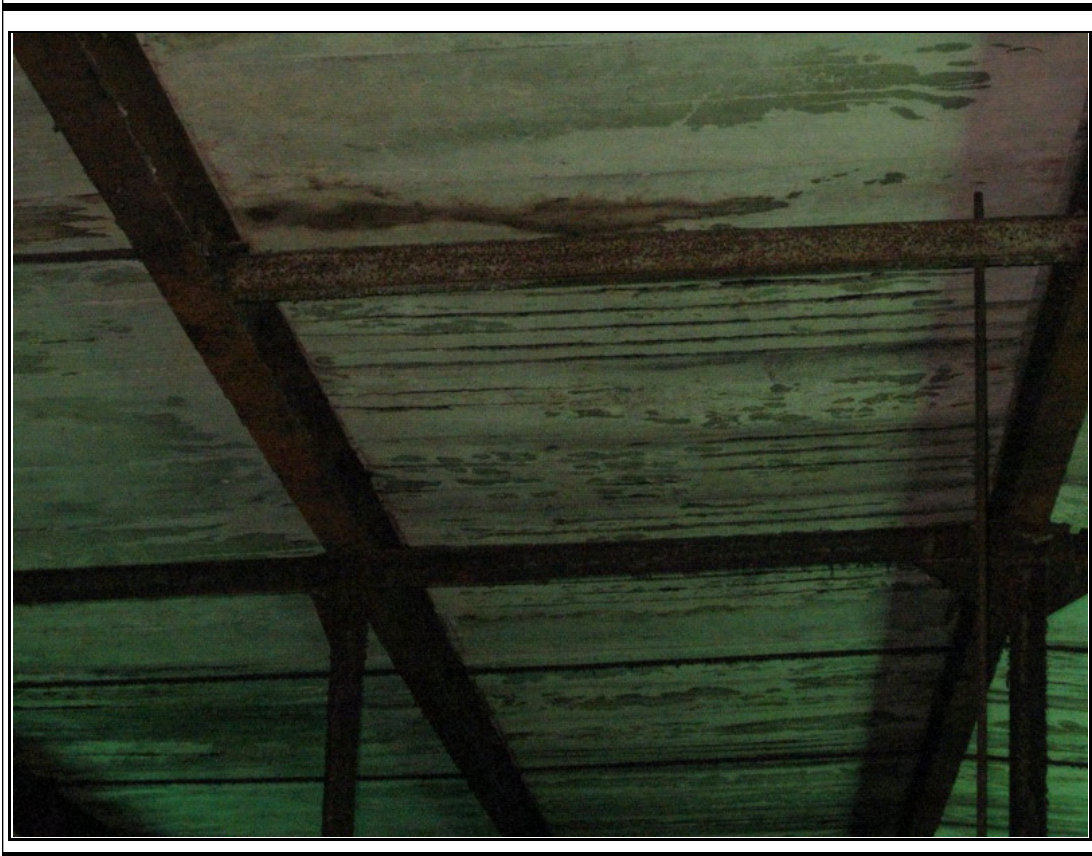
Photograph #: 8
	Ruined concrete roof planks

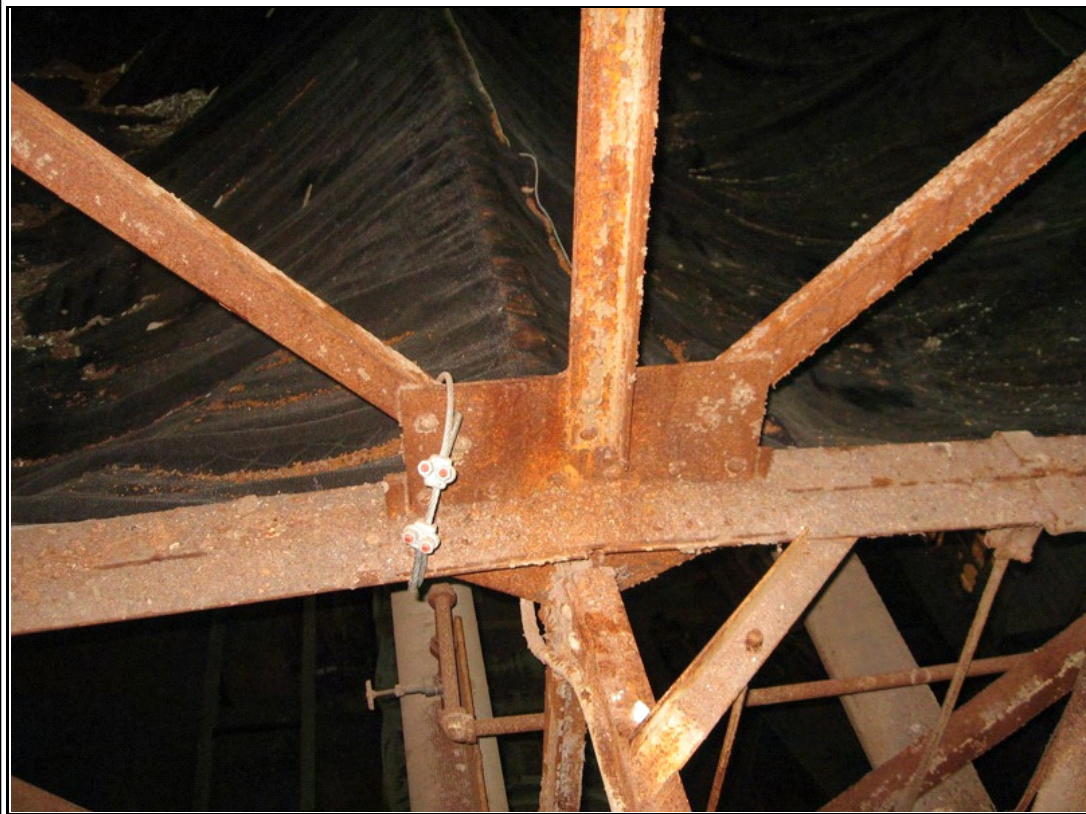
Photograph #: 11
Severely corroded structural steel

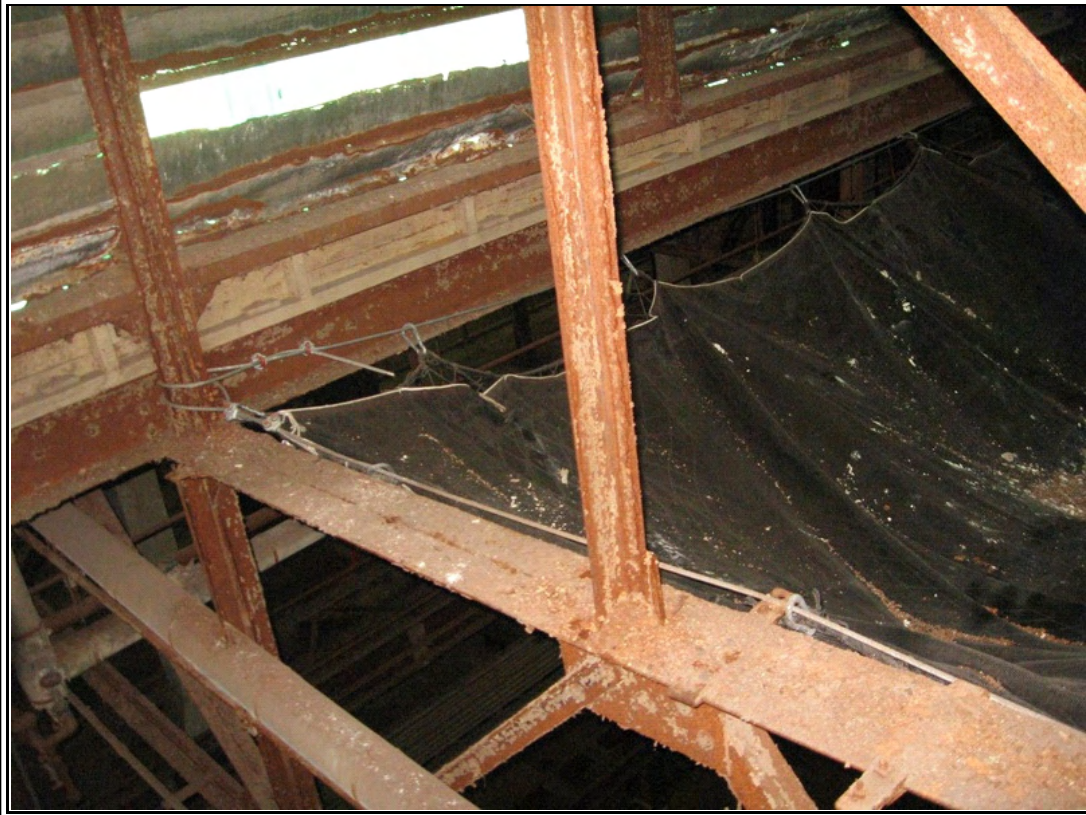
Photograph #: 12
Severely corroded structural steel

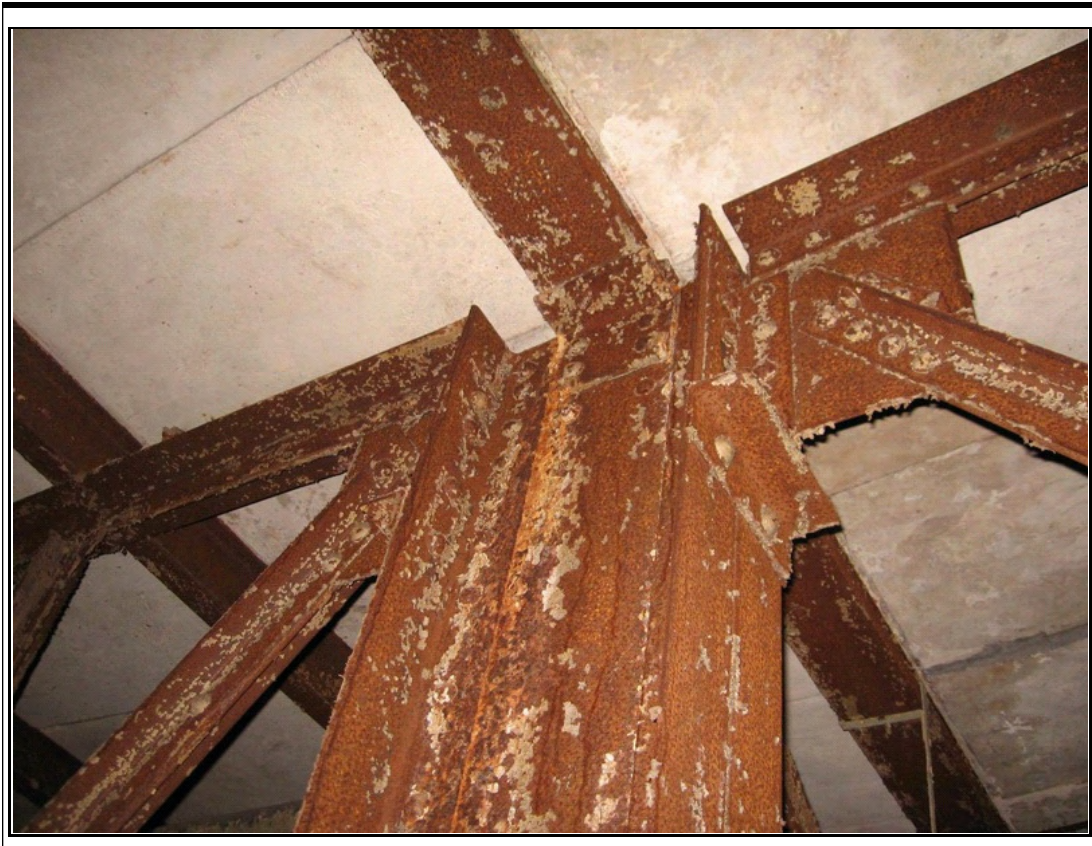
Building 22 L-N Building				
Defect Item No.	Defect Description	Quantity/ Unit of Measure	Repair Code/ Remarks	Photo Log Reference No.
1	Significant corrosion to columns G-25 (0.3" thickness compromised)	20 LF	R-S-4	13,14
2	Deteriorated soffit of 1st level concrete slab - spalling, exposed corroded rebar, efflorescence	1000 SF	R-W-4	17,18
3	Cracking in the exterior brick masonry wall on the west side of the building	50 LF	R-M-8	
4	Damaged interior load bearing wall at the northwest corner	20 LF	R-M-9	
5	Roof/clerestory framing is moderately to severely corroded throughout the entire area of the building	52000 SF	R-S-4	11,12,13,14
6	Roof concrete planks are deteriorated due to spalling of concrete, cracking in the panels and exposed corroded rebar. Nets have been installed to retain the spalling debris from the concrete planks	52000 SF	R-D-1	4,5,6,7,8
Repair Code - Description				
R-D-1	Replace defective concrete planks at roof deck

<p>Photograph #: 13</p> <p>Severely corroded structural steel</p>
