Structural Assessment

Muscle Shoals Reservation
adaptive re-use study

Conditions/Market/Planning/Implementation

July 31, 2009
Revised August 25, 2009

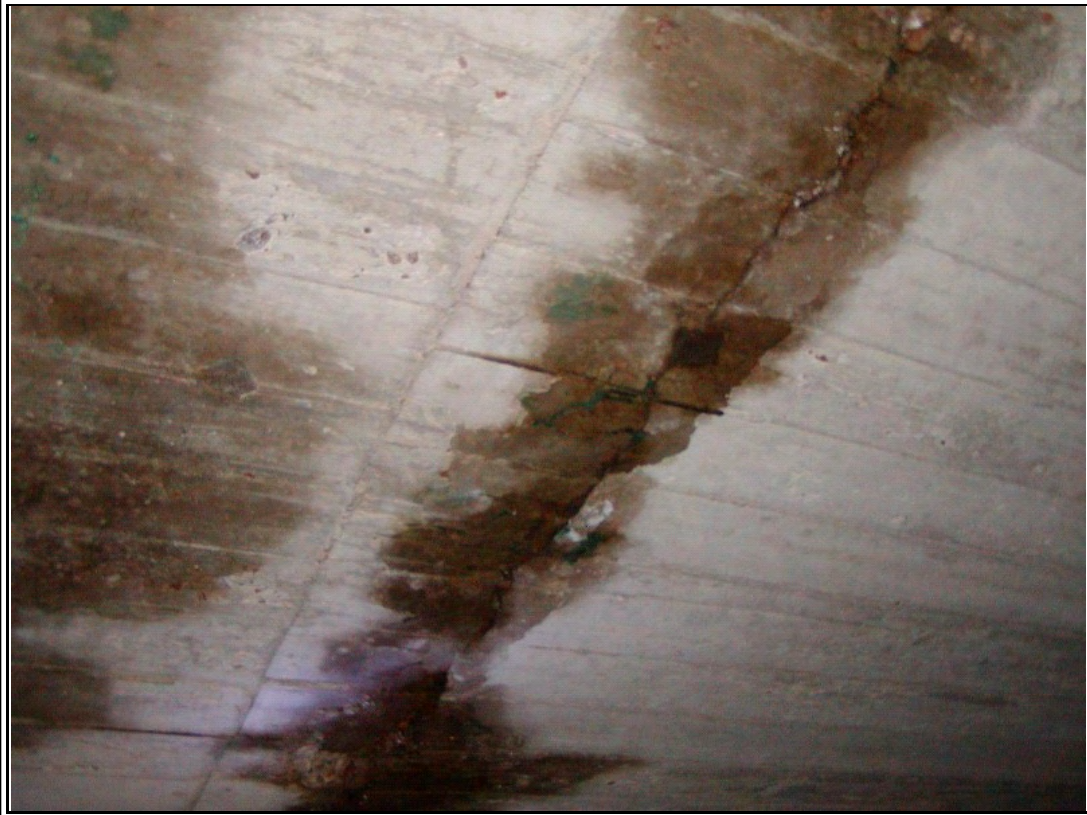
Photograph #: 16

Defective concrete at
basement ceiling

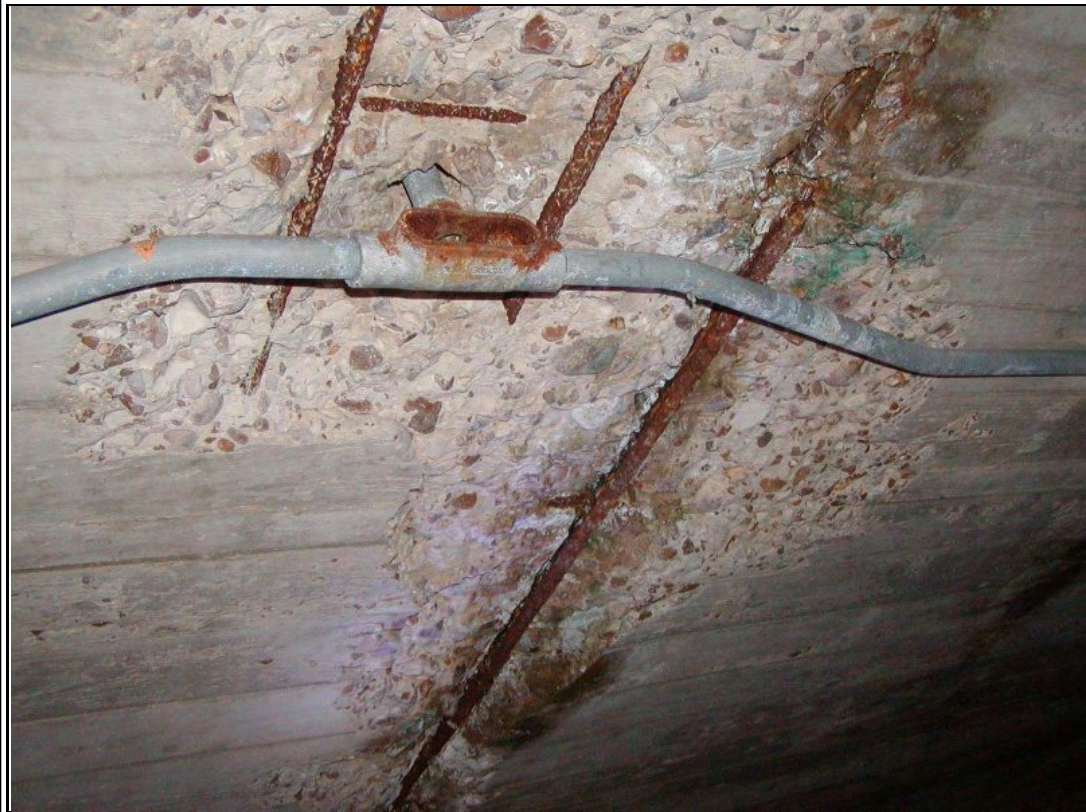
Photograph #: 17

Severely spalled concrete at basement ceiling

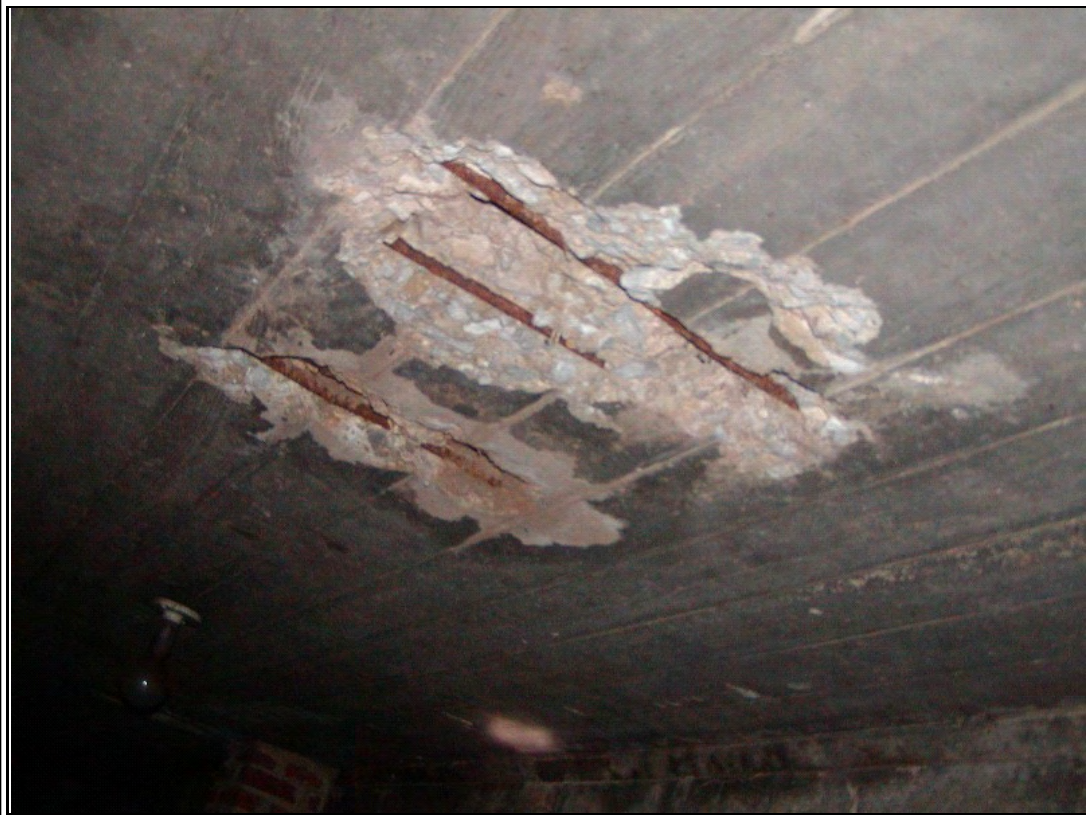
Photograph #: 18

Severely spalled concrete at basement ceiling

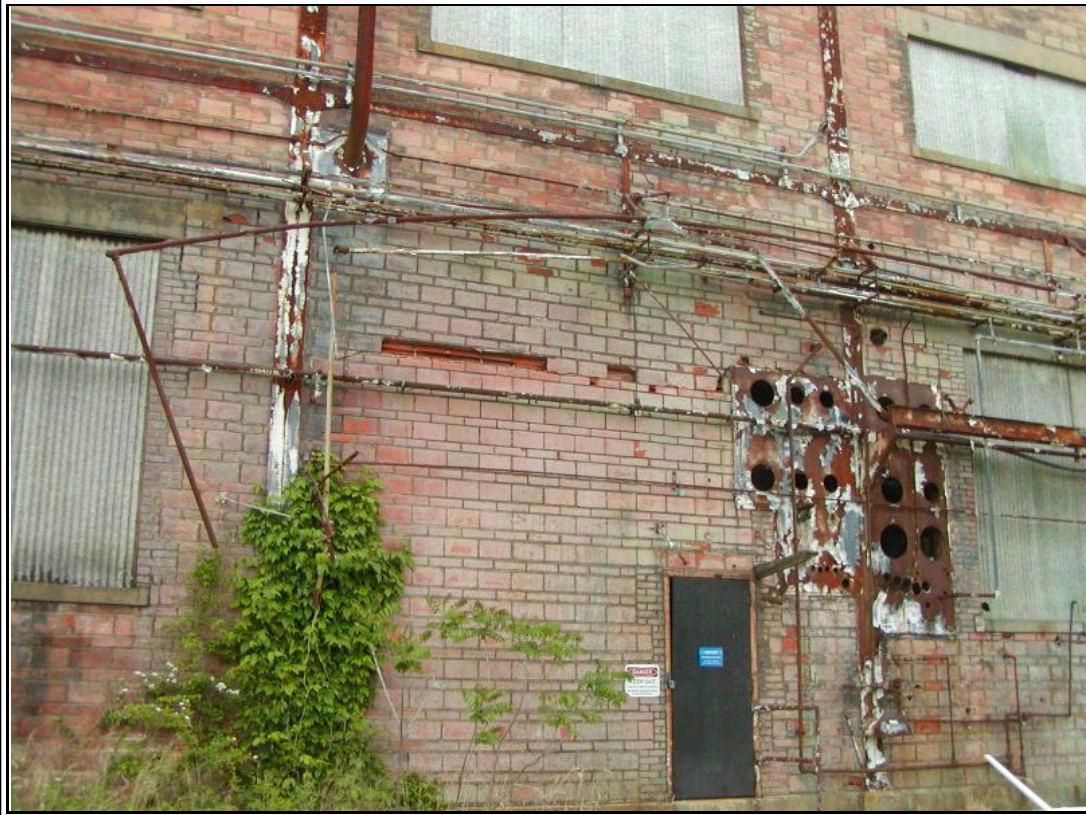
Photograph #: 4

Deteriorated steel and masonry at exterior building - east side

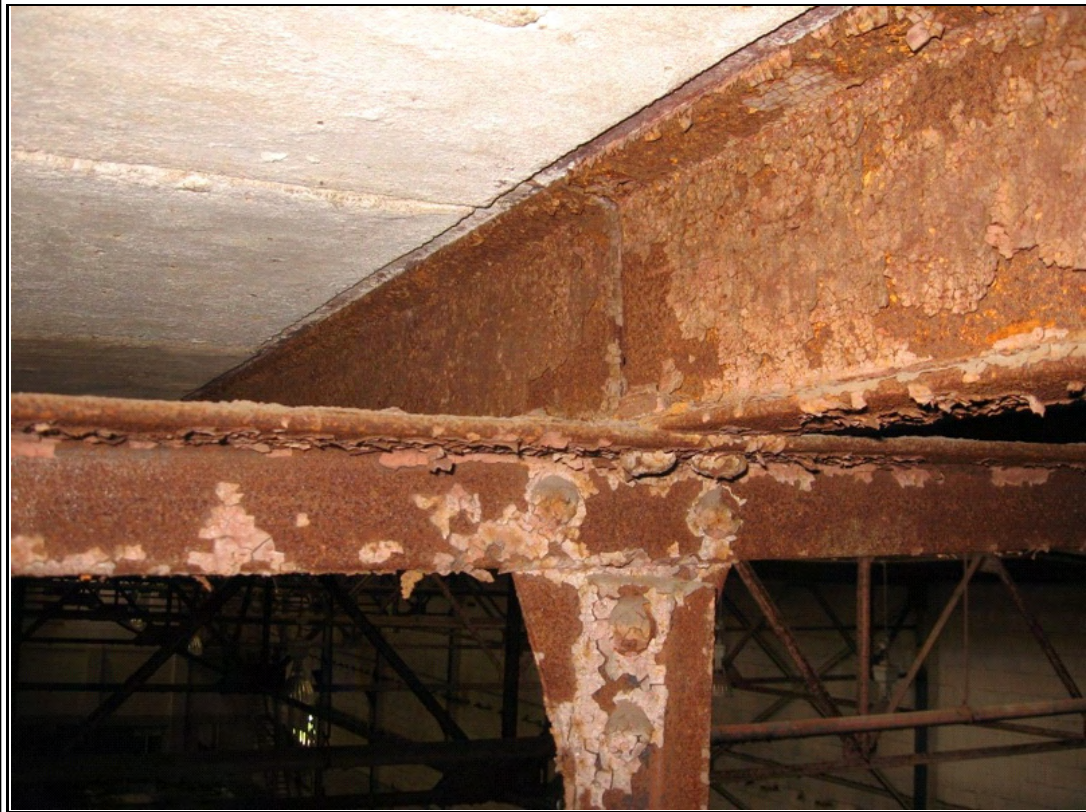
Photograph #: 7

Severely corroded steel framing

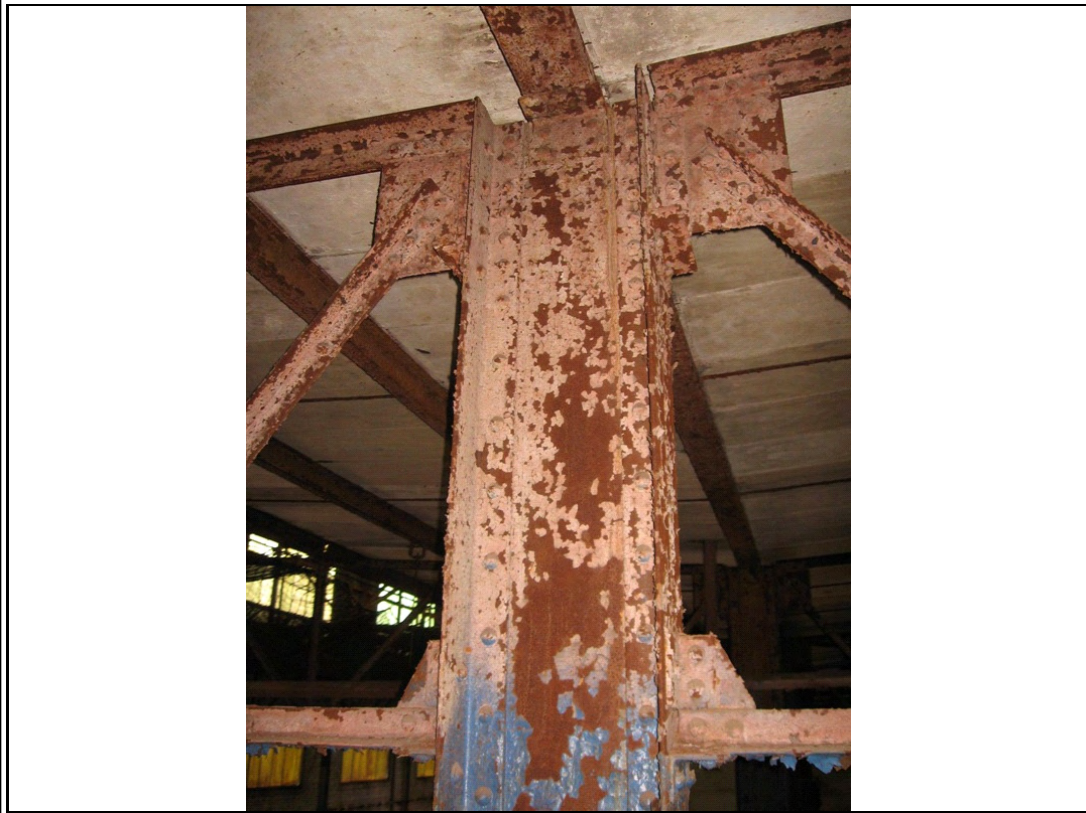
Photograph #: 8

Severely corroded steel framing

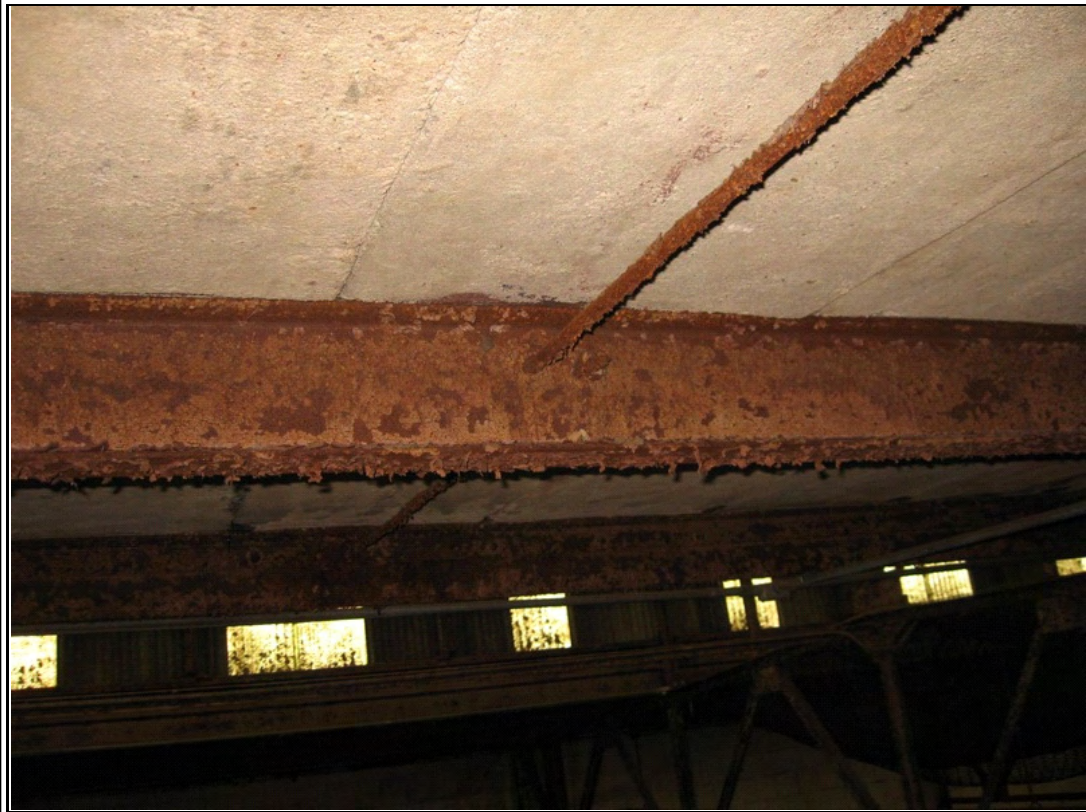
Photograph #: 9

Severely corroded steel framing

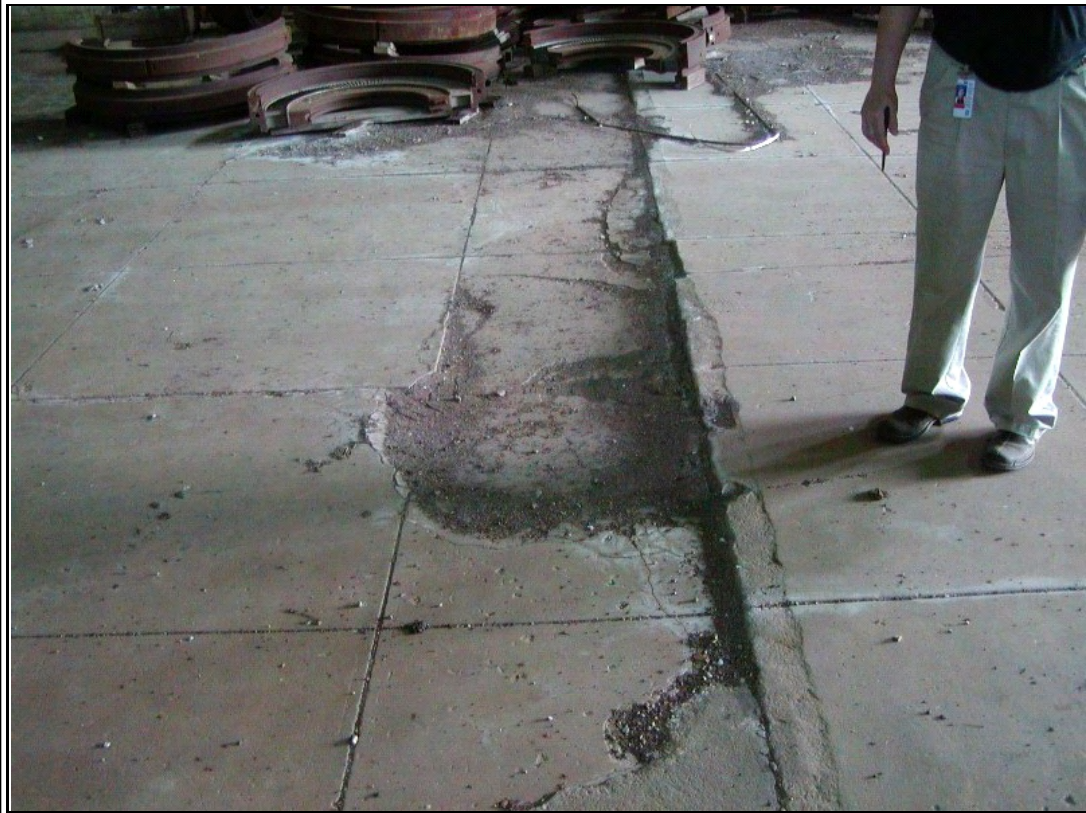
Photograph #: 10

Defective area of elevated slab above basement

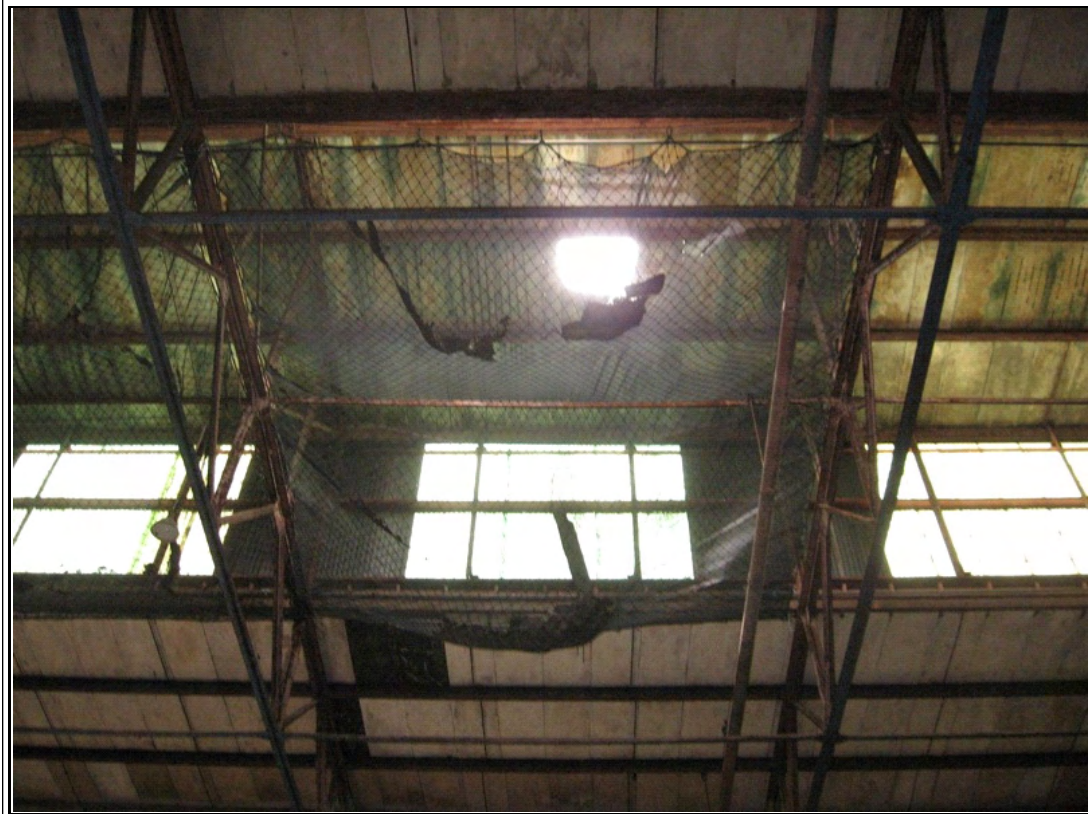
Photograph #: 11

Large hole in deteriorated concrete plank roof deck

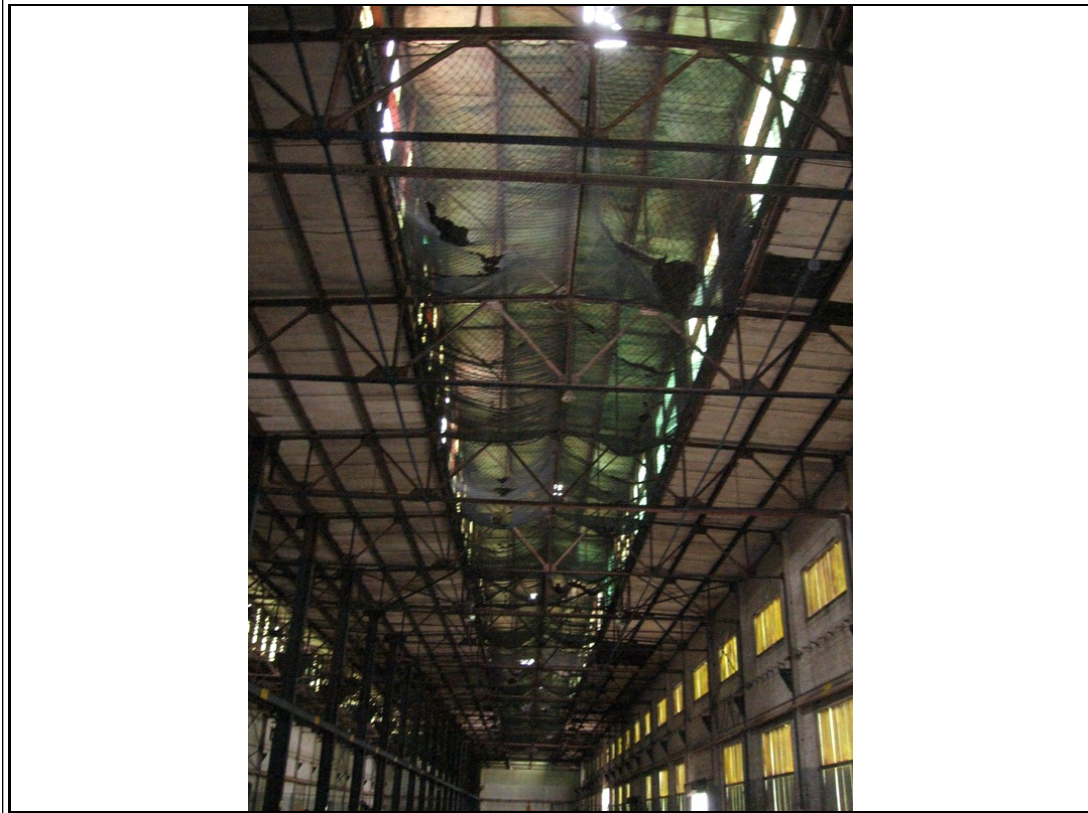
Photograph #: 12

Holes in deteriorated concrete plank roof deck

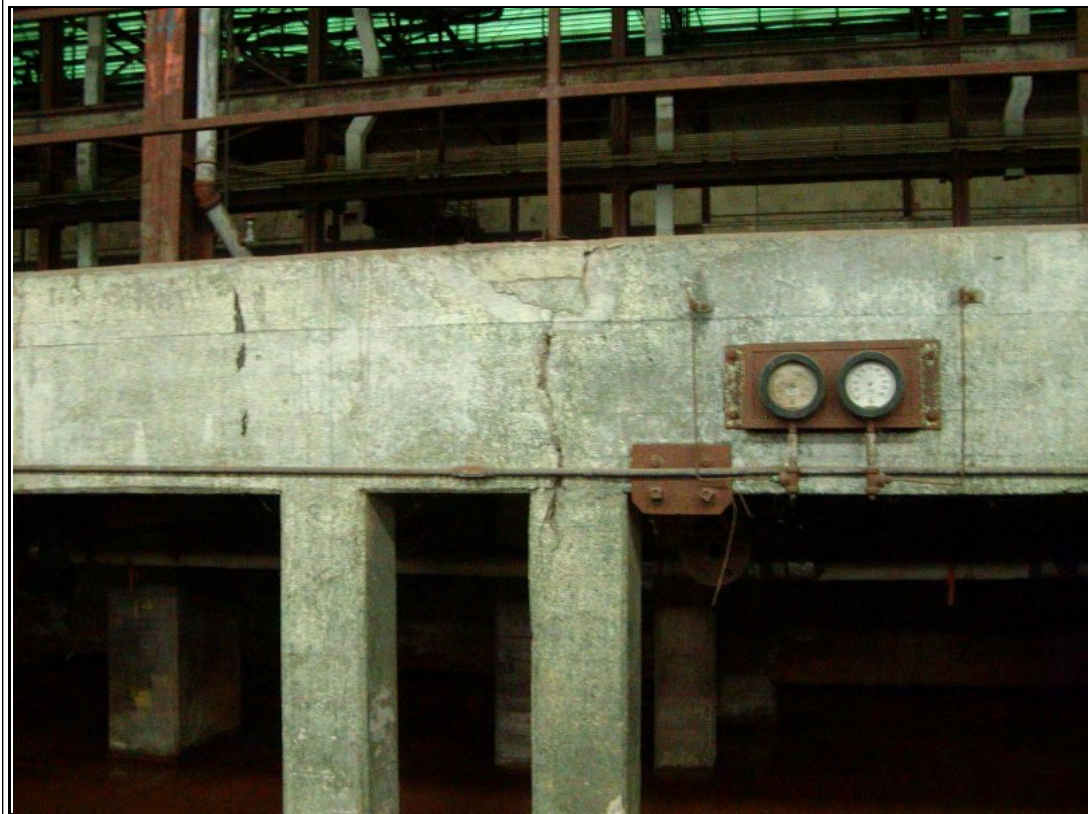
Photograph #: 17

Cracks at edge of elevated slab above basement

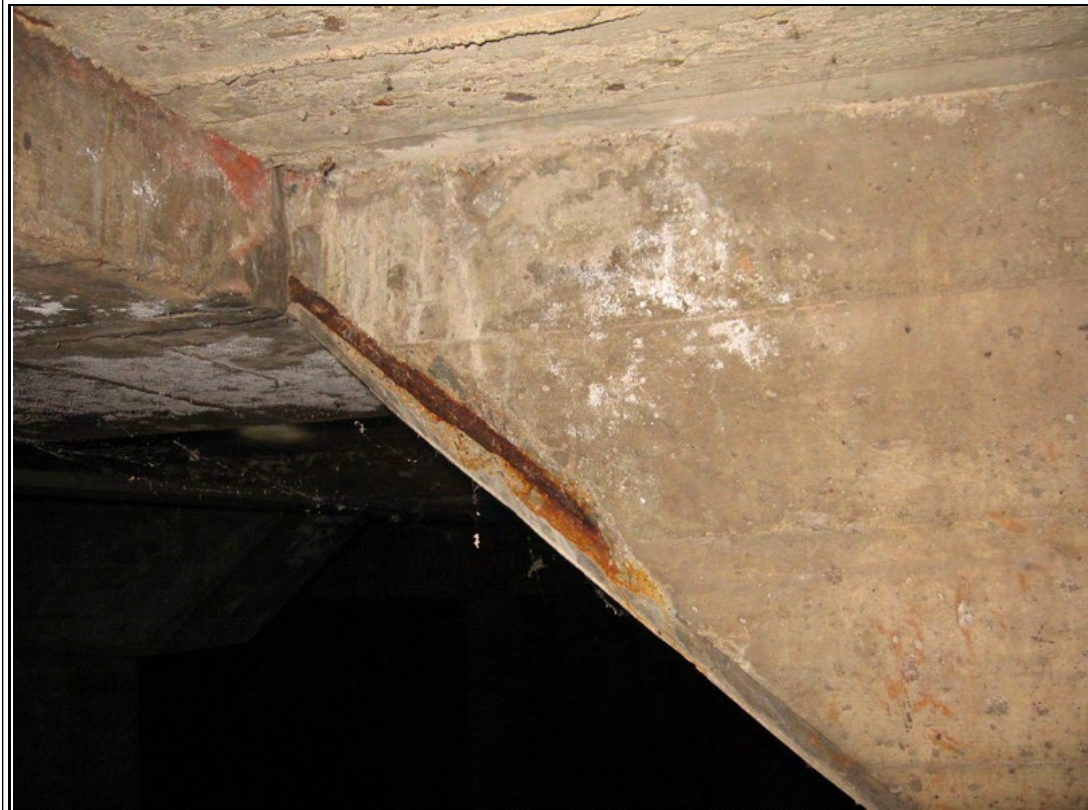
Photograph #: 18

Spalled concrete at basement structure

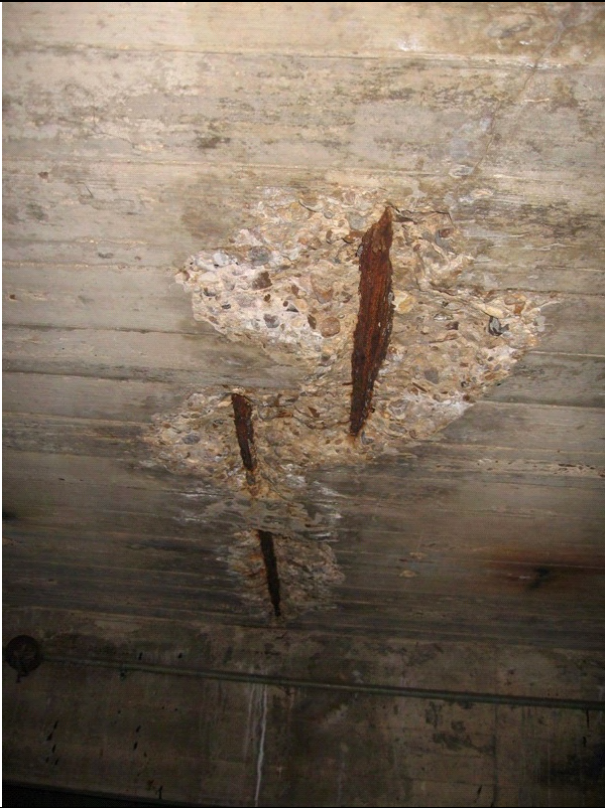
<p>Photograph #: 19</p> <p>Spalled concrete at basement structure</p>

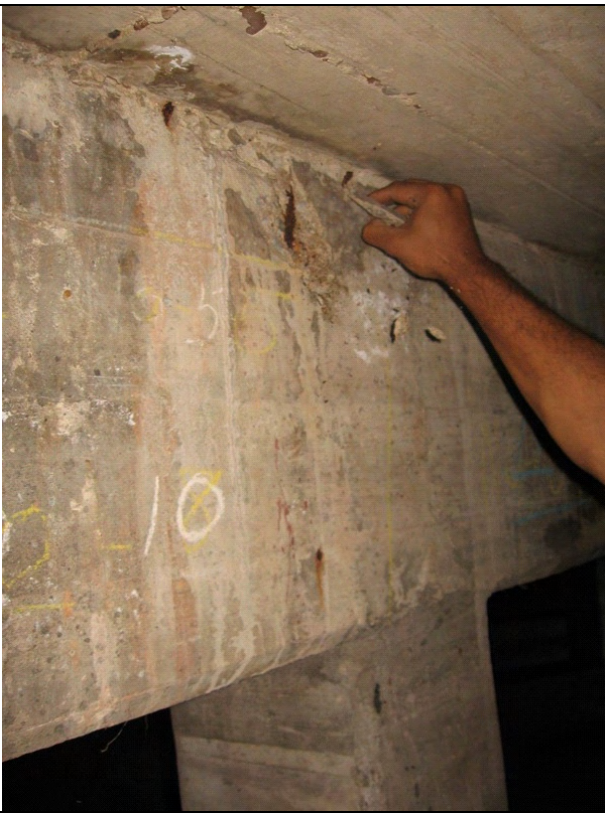
<p>Photograph #: 20</p> <p>Spalled concrete at basement structure</p>

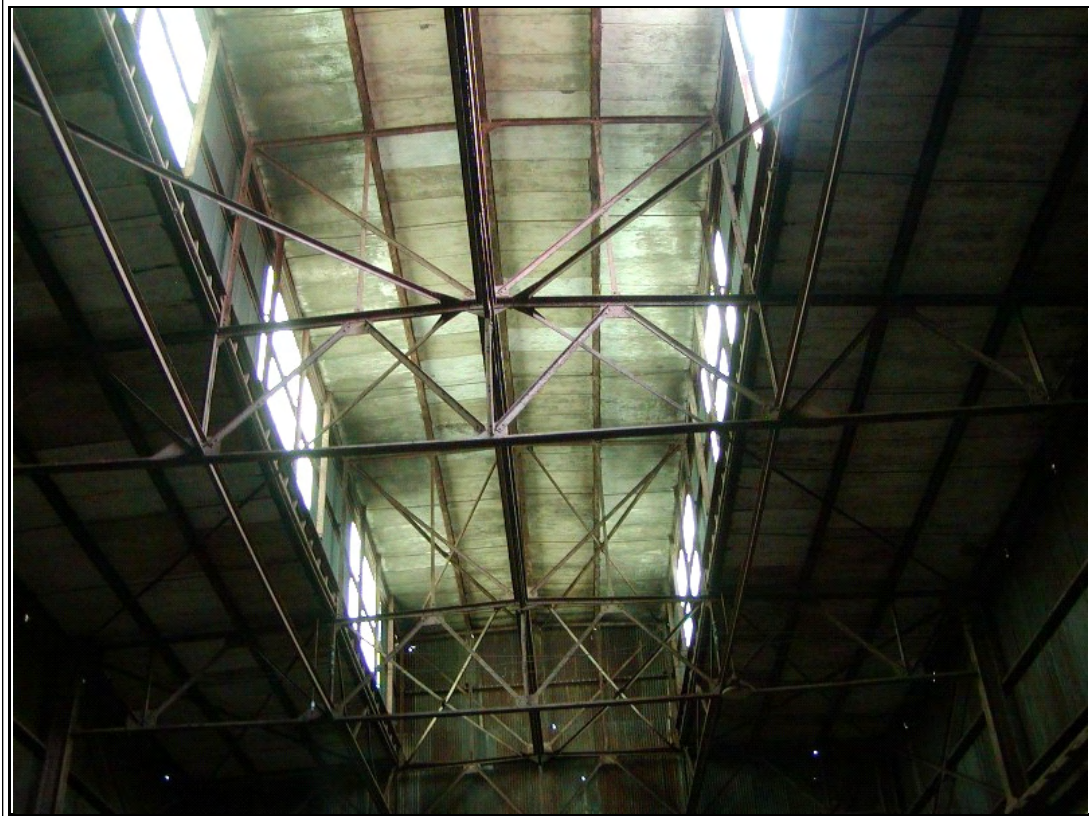
Photograph #: 5

Deteriorated concrete
plank roof deck

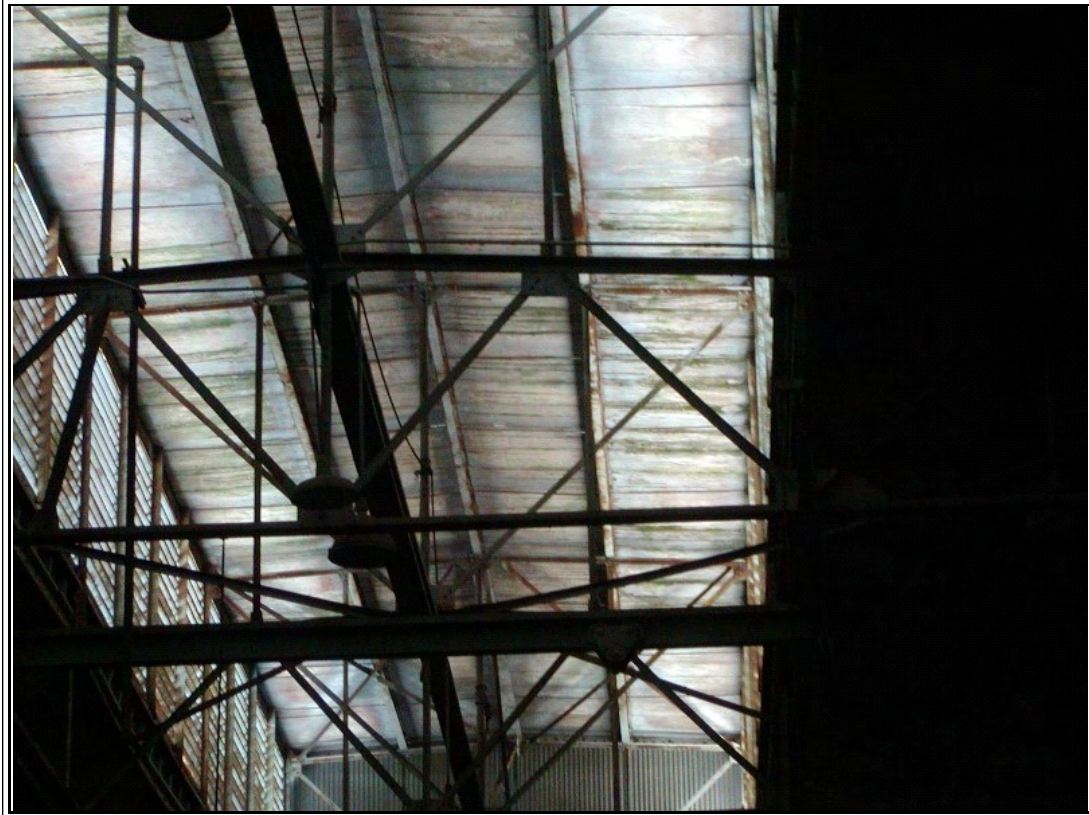
Photograph #: 6

Deteriorated concrete
plank roof deck

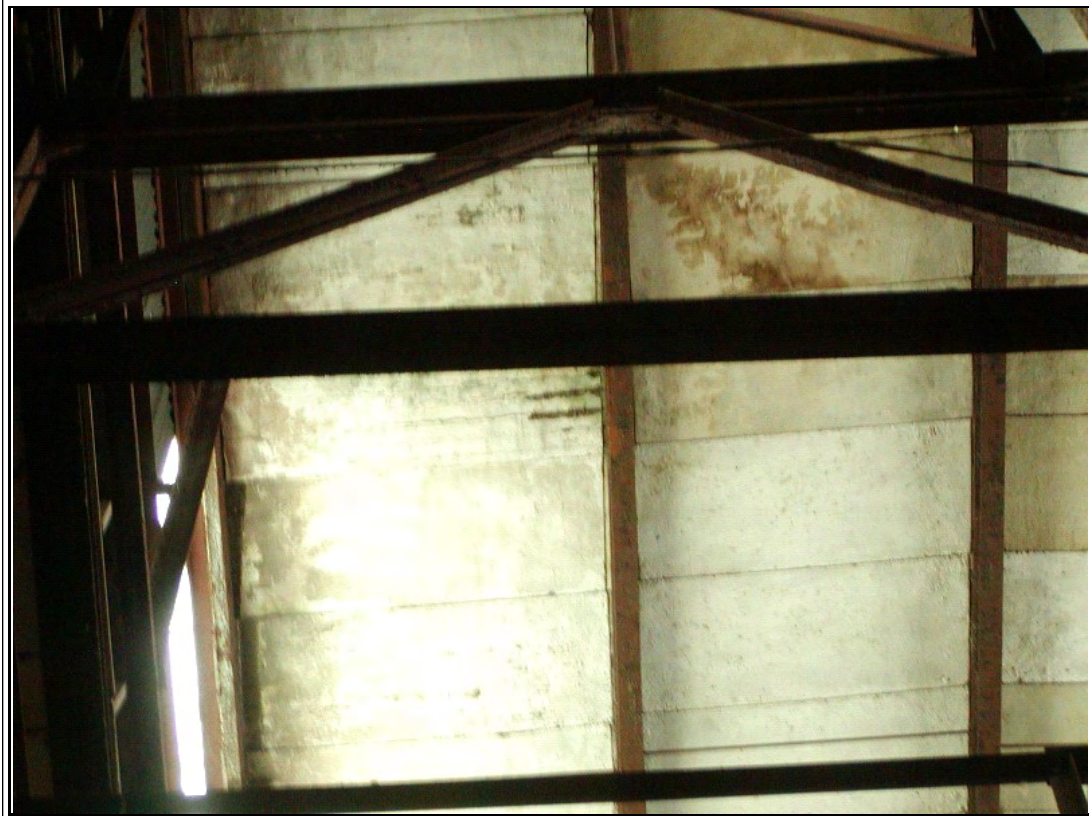
Photograph #: 7

Structurally deficient
concrete roof plank

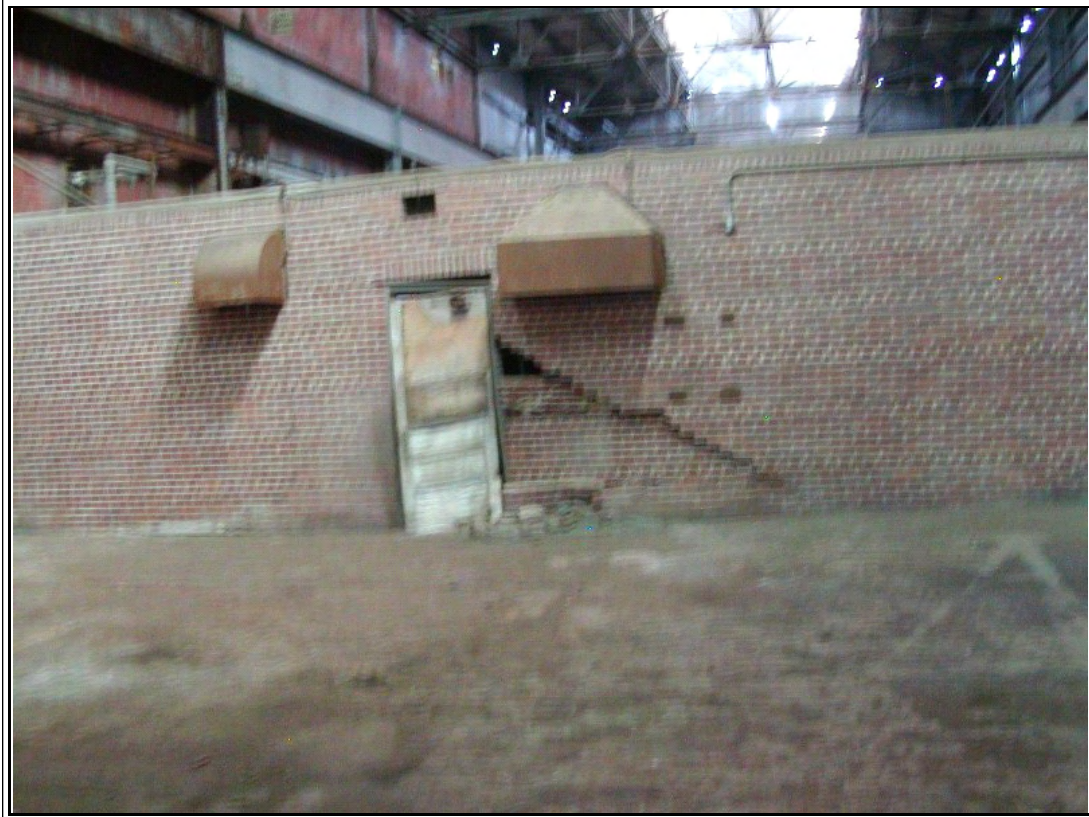
Photograph #: 8

Partially collapsed interior
masonry partition

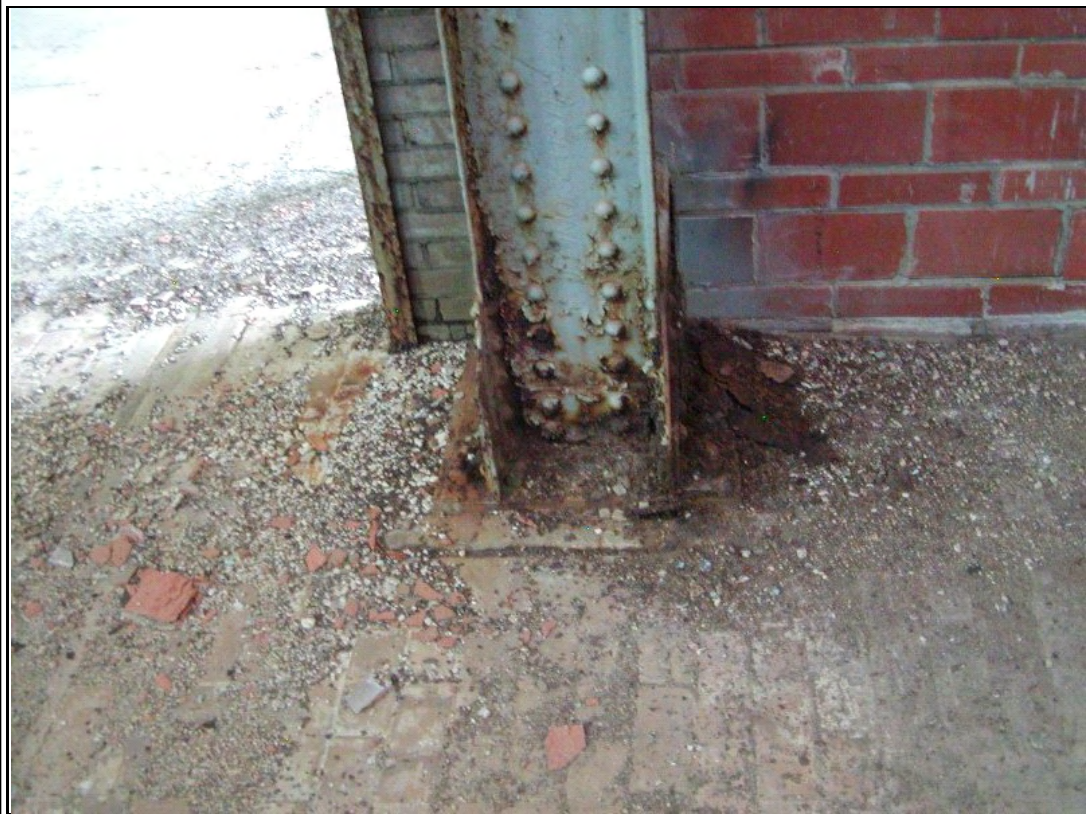
Photograph #: 9

Severe corrosion at column
base plate attachment

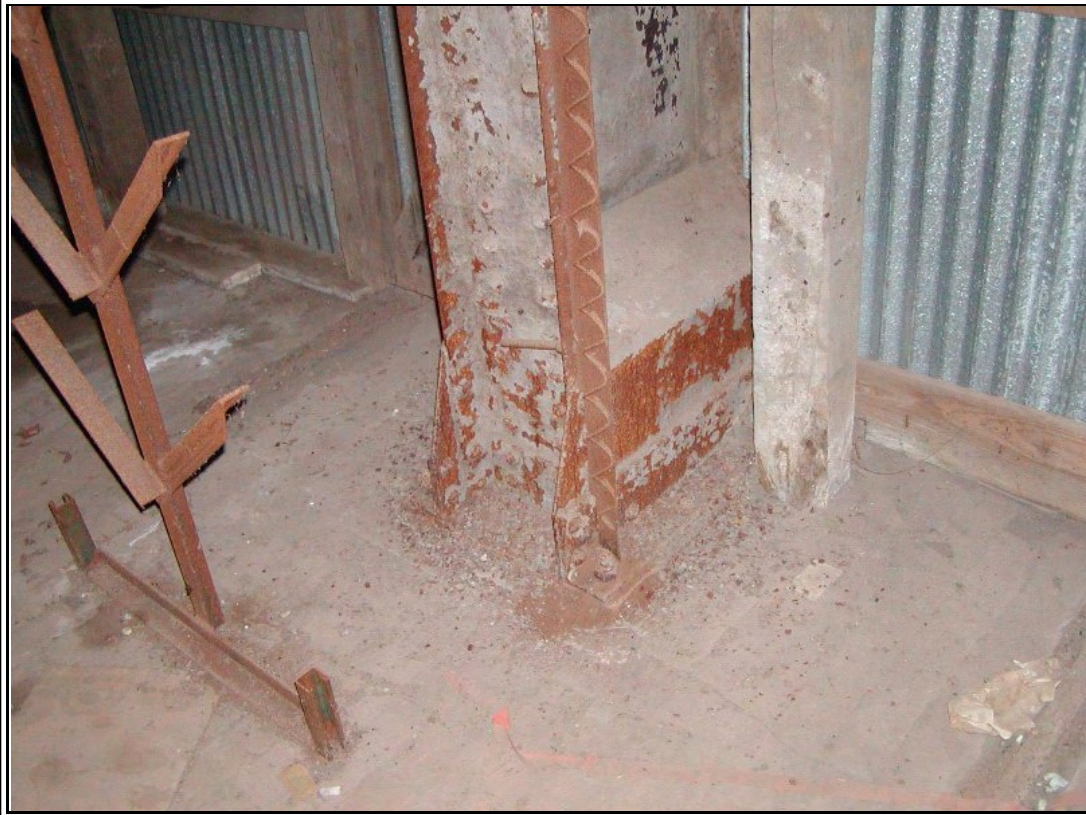
Photograph #: 10

Severely corroded steel
column

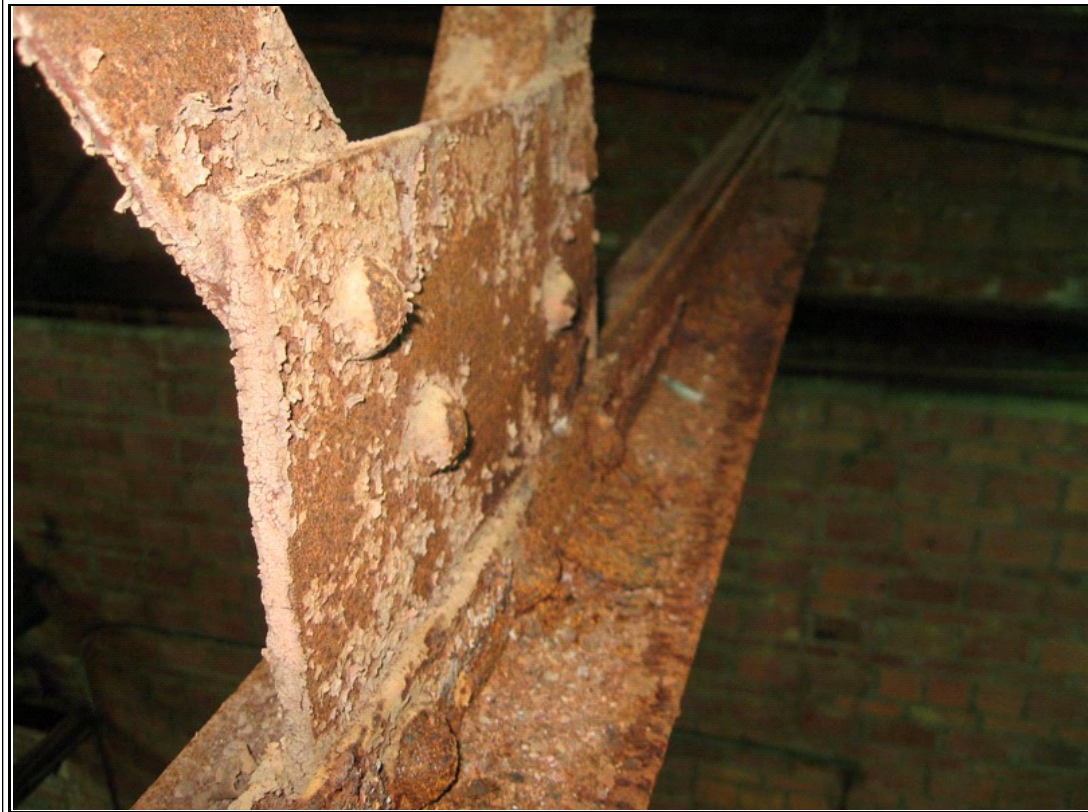
Photograph #: 5

Severely corroded steel framing

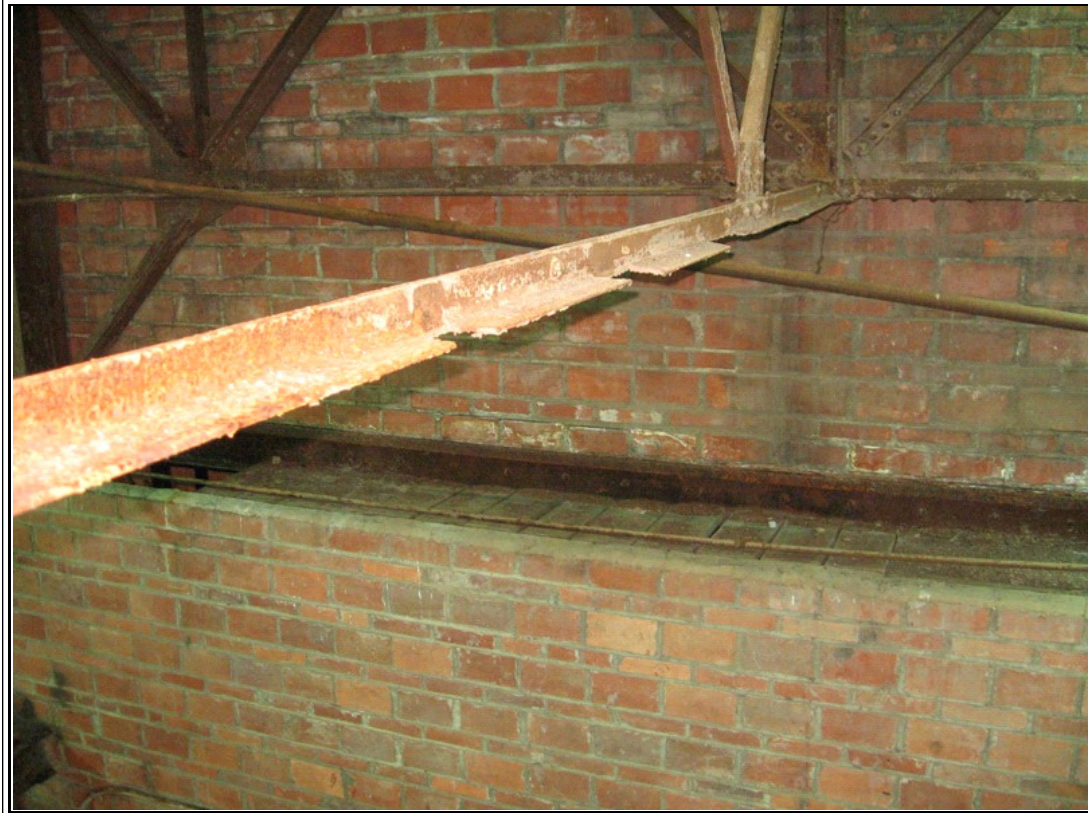
Photograph #: 6

Severely deteriorated steel framing

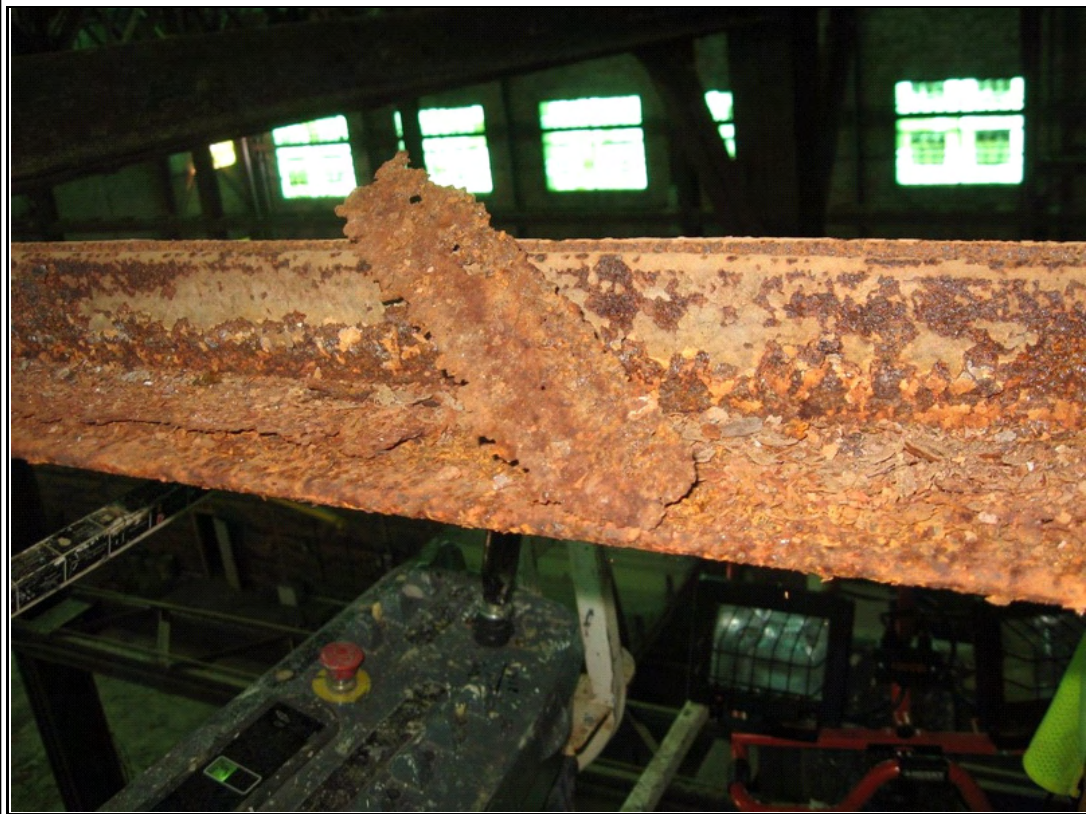
Photograph #: 7

Severely corroded steel framing

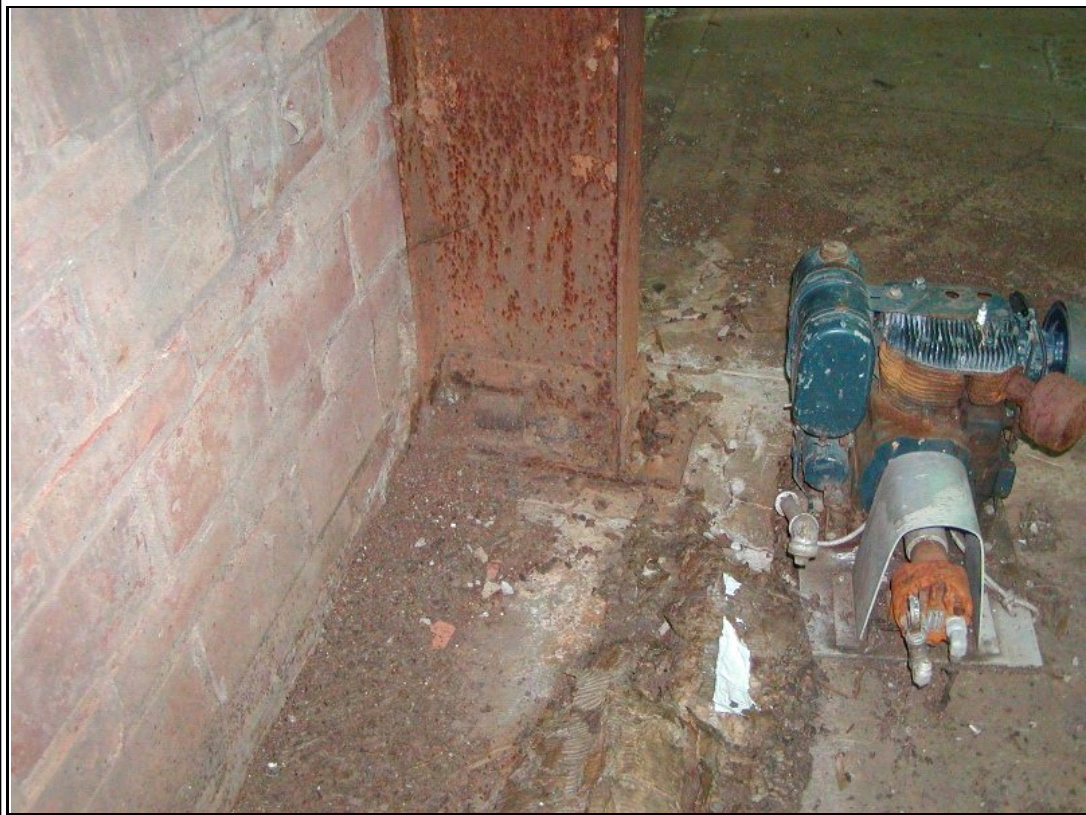
Photograph #: 8

Severely corroded steel framing

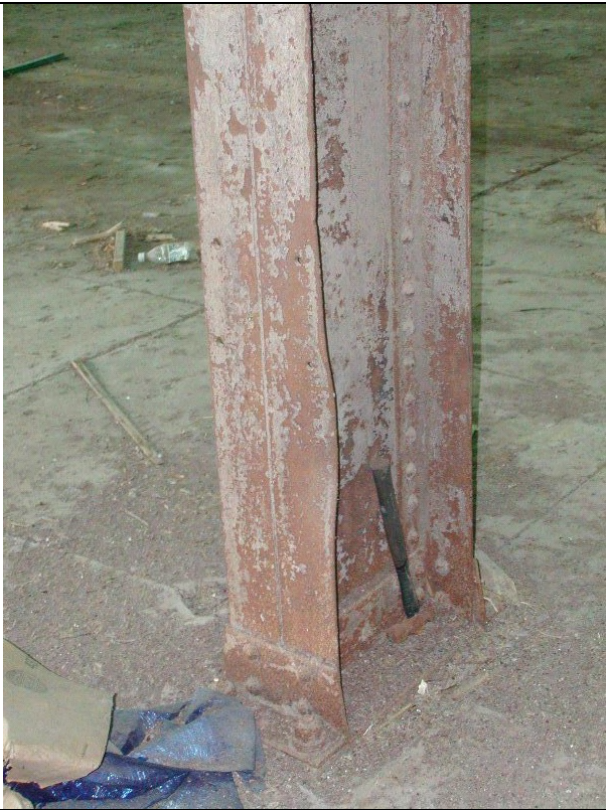
<p>Photograph #: 9</p> <p>Moderately corroded steel column with impact damage</p>

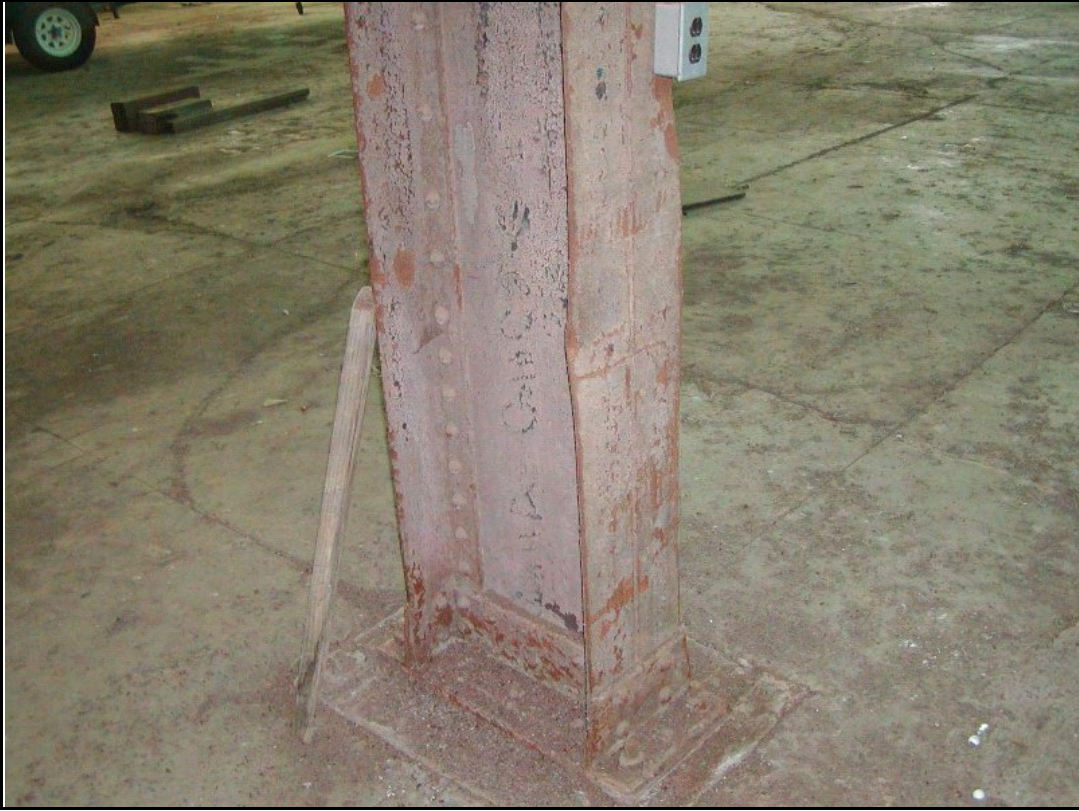
<p>Photograph #: 10</p> <p>Moderately corroded steel column with impact damage</p>

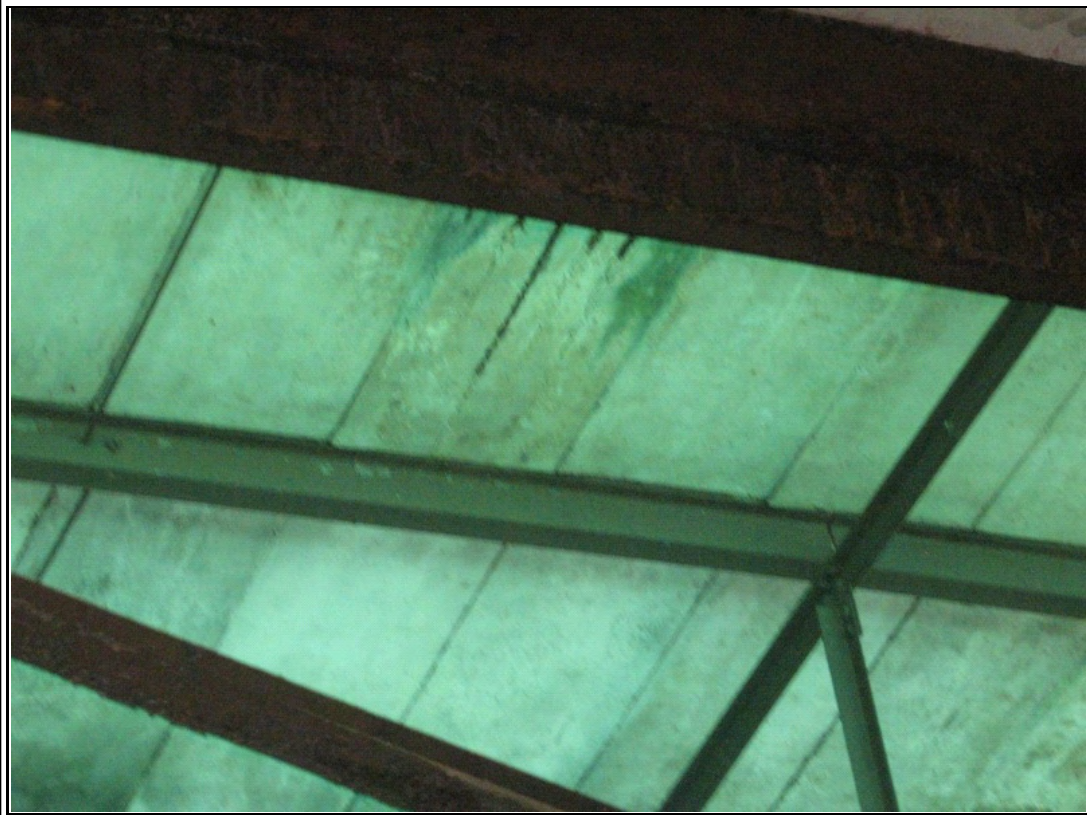
Photograph #: 12

Structurally deficient
concrete roof planks
